[54] TURBINE BLADE REPAIR

A method of repairing a turbine blade of the type having discontinuities such as lacing wire holes the method including the steps of driving a plug into any such discontinuity that is not in the immediate area that is likely to be subjected to consideration thermal energy as occurs during welding. The presence of the plug decreases the tendency for stress to concentrate around the discontinuity if the blade is subjected to stress caused by physical force or high temperatures.

TURBINE BLADE REPAIR

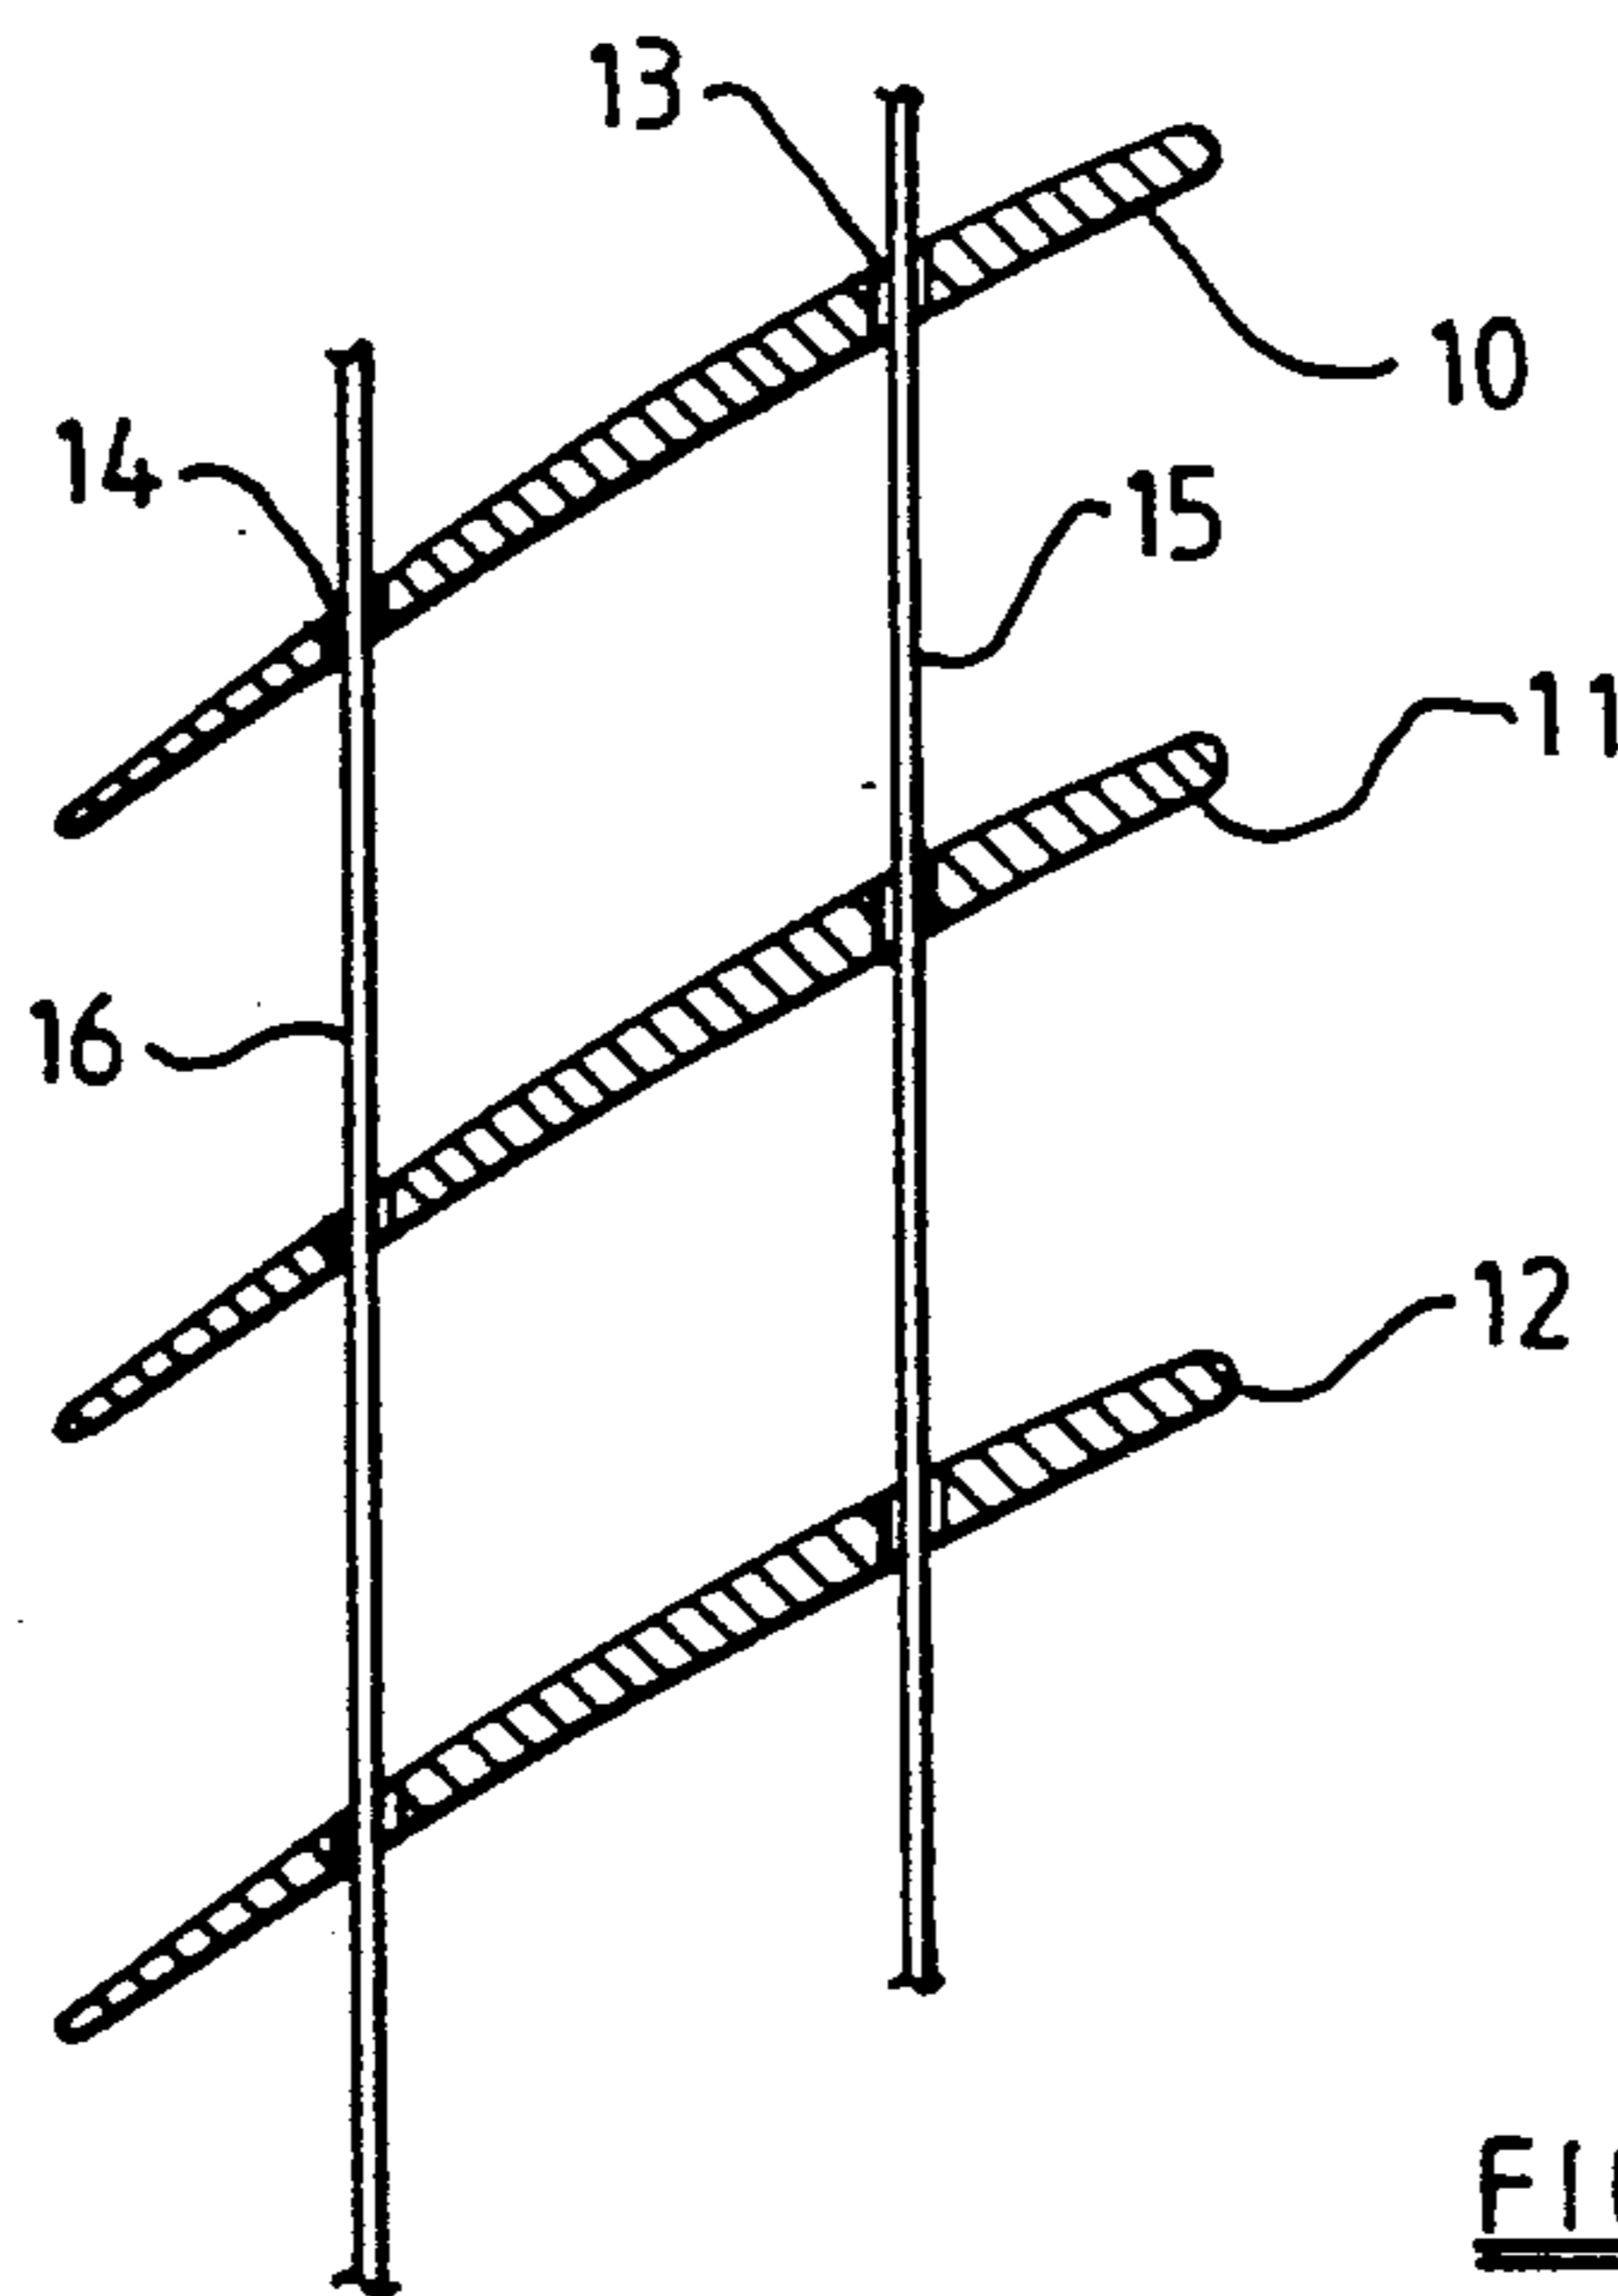
FIG 2

FIG. 2 is a perspective view of a complete turbine rotor;

FIG. 2 illustrates an example of a rotor from a turbine, the turbine blades 10, 11 and 12 being three of a considerable number of blades forming the complete array in the rotor.

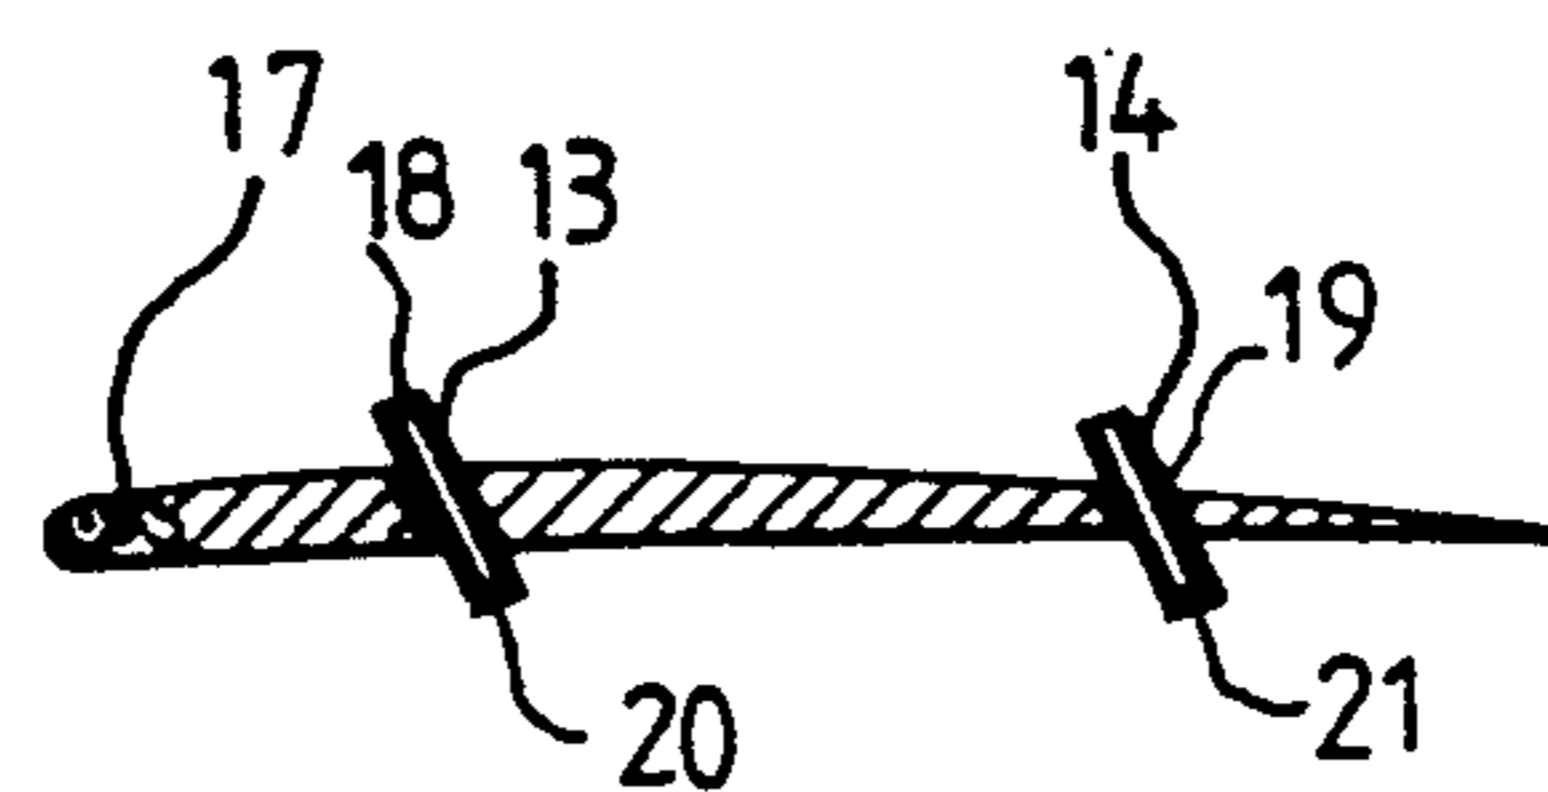
FIG 6

FIG. 6 is a cross-section of the turbine blade taken along the line A—A of FIG. 5;

15 FIG. 6 is a cross-section of the turbine blade 10 and even though the erosion may be fairly severe in the area 17, it is not normally so extensive as to reach as far back in the blade as the nearest lacing wire hole 13.

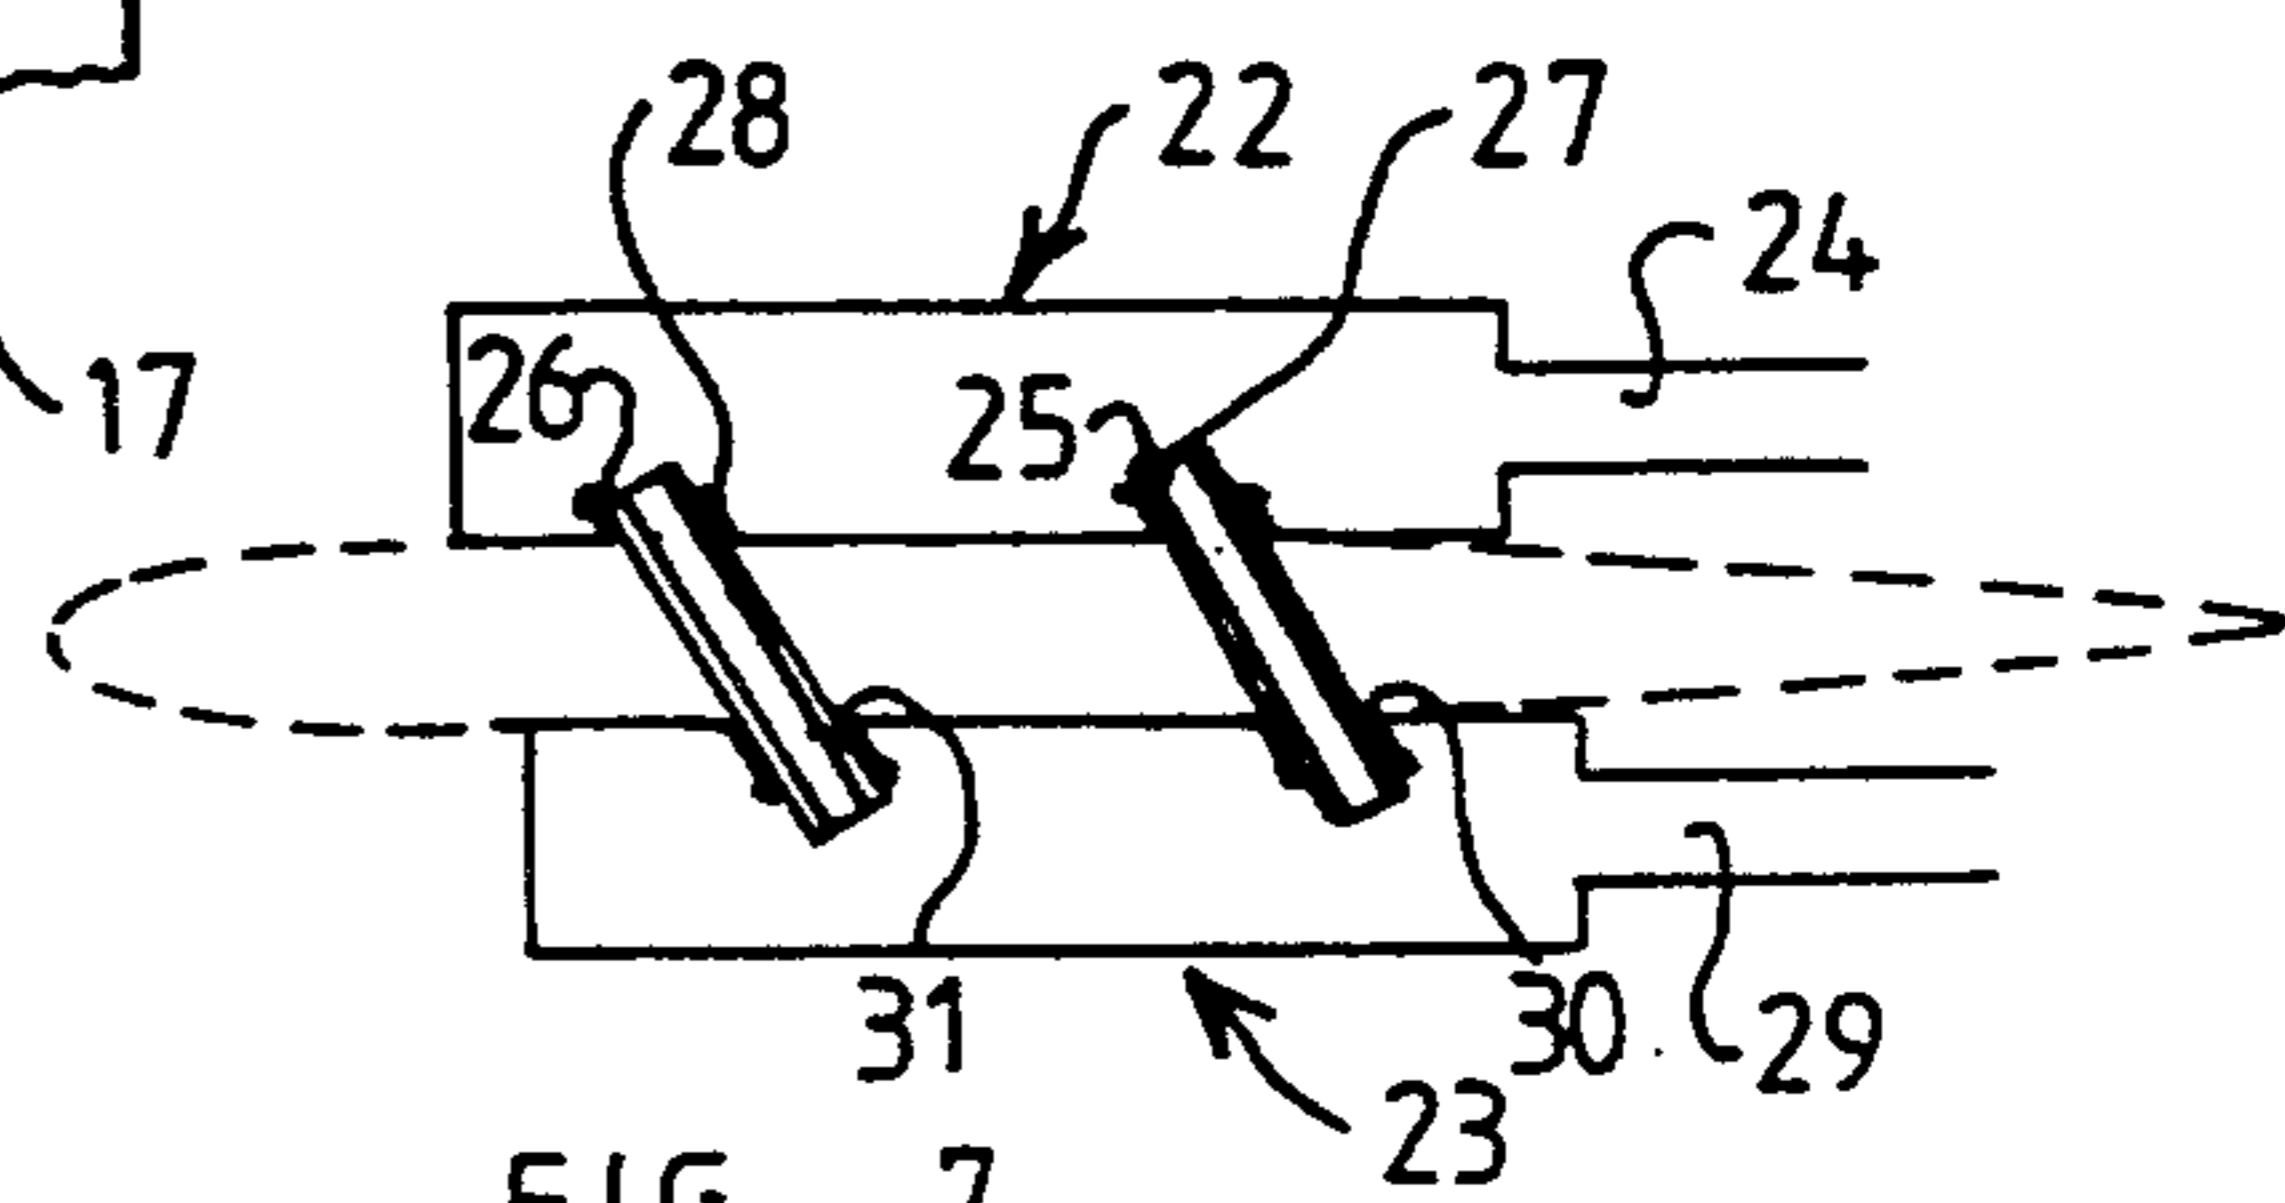
FIG 7

FIG. 7 is a cross-sectional view through one embodiment of a heat sink;

The plugs 18 and 19 are longer than the thickness of the turbine blade through which they project and are dimensioned so as to be a tight fit in the lacing wire holes 13 and 14. The reason for the extra length of the plugs 18 and 19 is such that they can co-operate with a heat sink or chill comprising a pair of box-like members through which cooling fluid may flow and as illustrated in more detail in FIG. 7.

30 FIG. 7 illustrates an embodiment of the heat sink or chill and comprises a pair of box-like members 22 and 23. The box 22 has an inlet 24 for fluid and a pair of apertures 25 and 26 provided with respective seals 27 and 28.

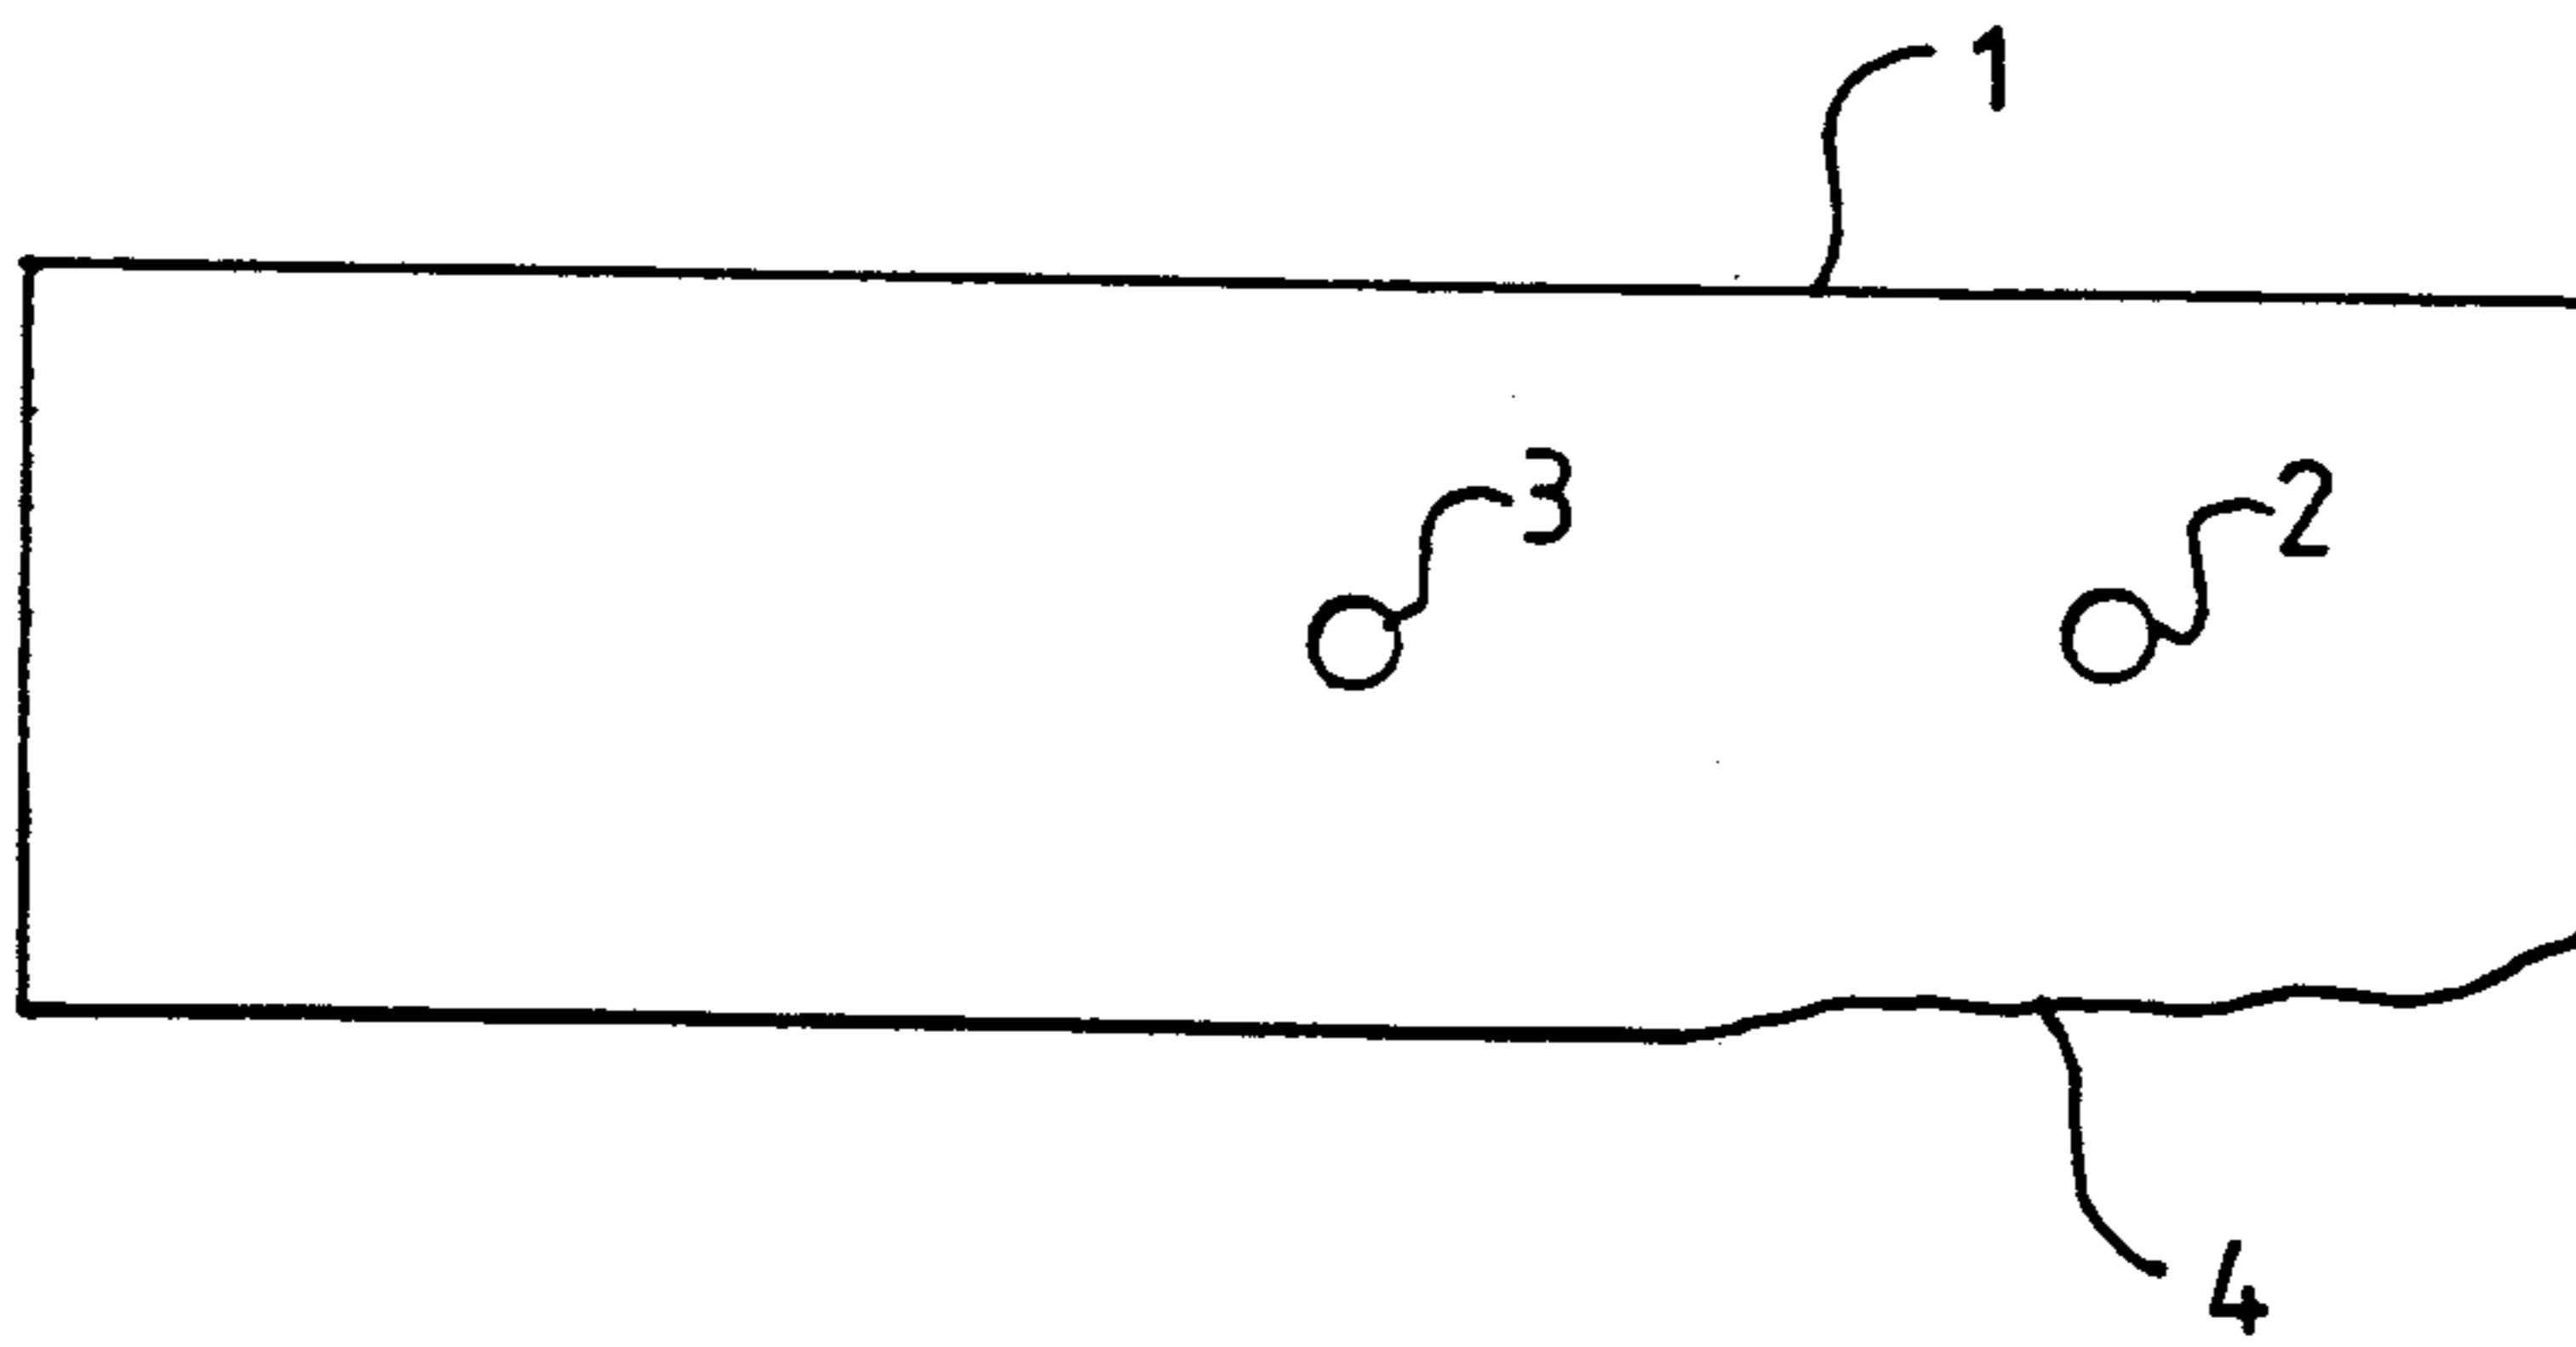
FIG 3

FIG. 3 is a diagrammatic view of a turbine blade having a pair of lacing wire holes and also showing erosion and damage on the leading outer edge;

Referring now to FIGS. 3 and 4, a turbine blade 1 has a pair of lacing wire holes 2 and 3. Damage is shown in the area 4 which damage may comprise erosion, cracks and the like and the nature of the repair normally requires an area at the outer leading edge as shown by arrow 4 to be removed from the blade and a new piece of material welded thereto.

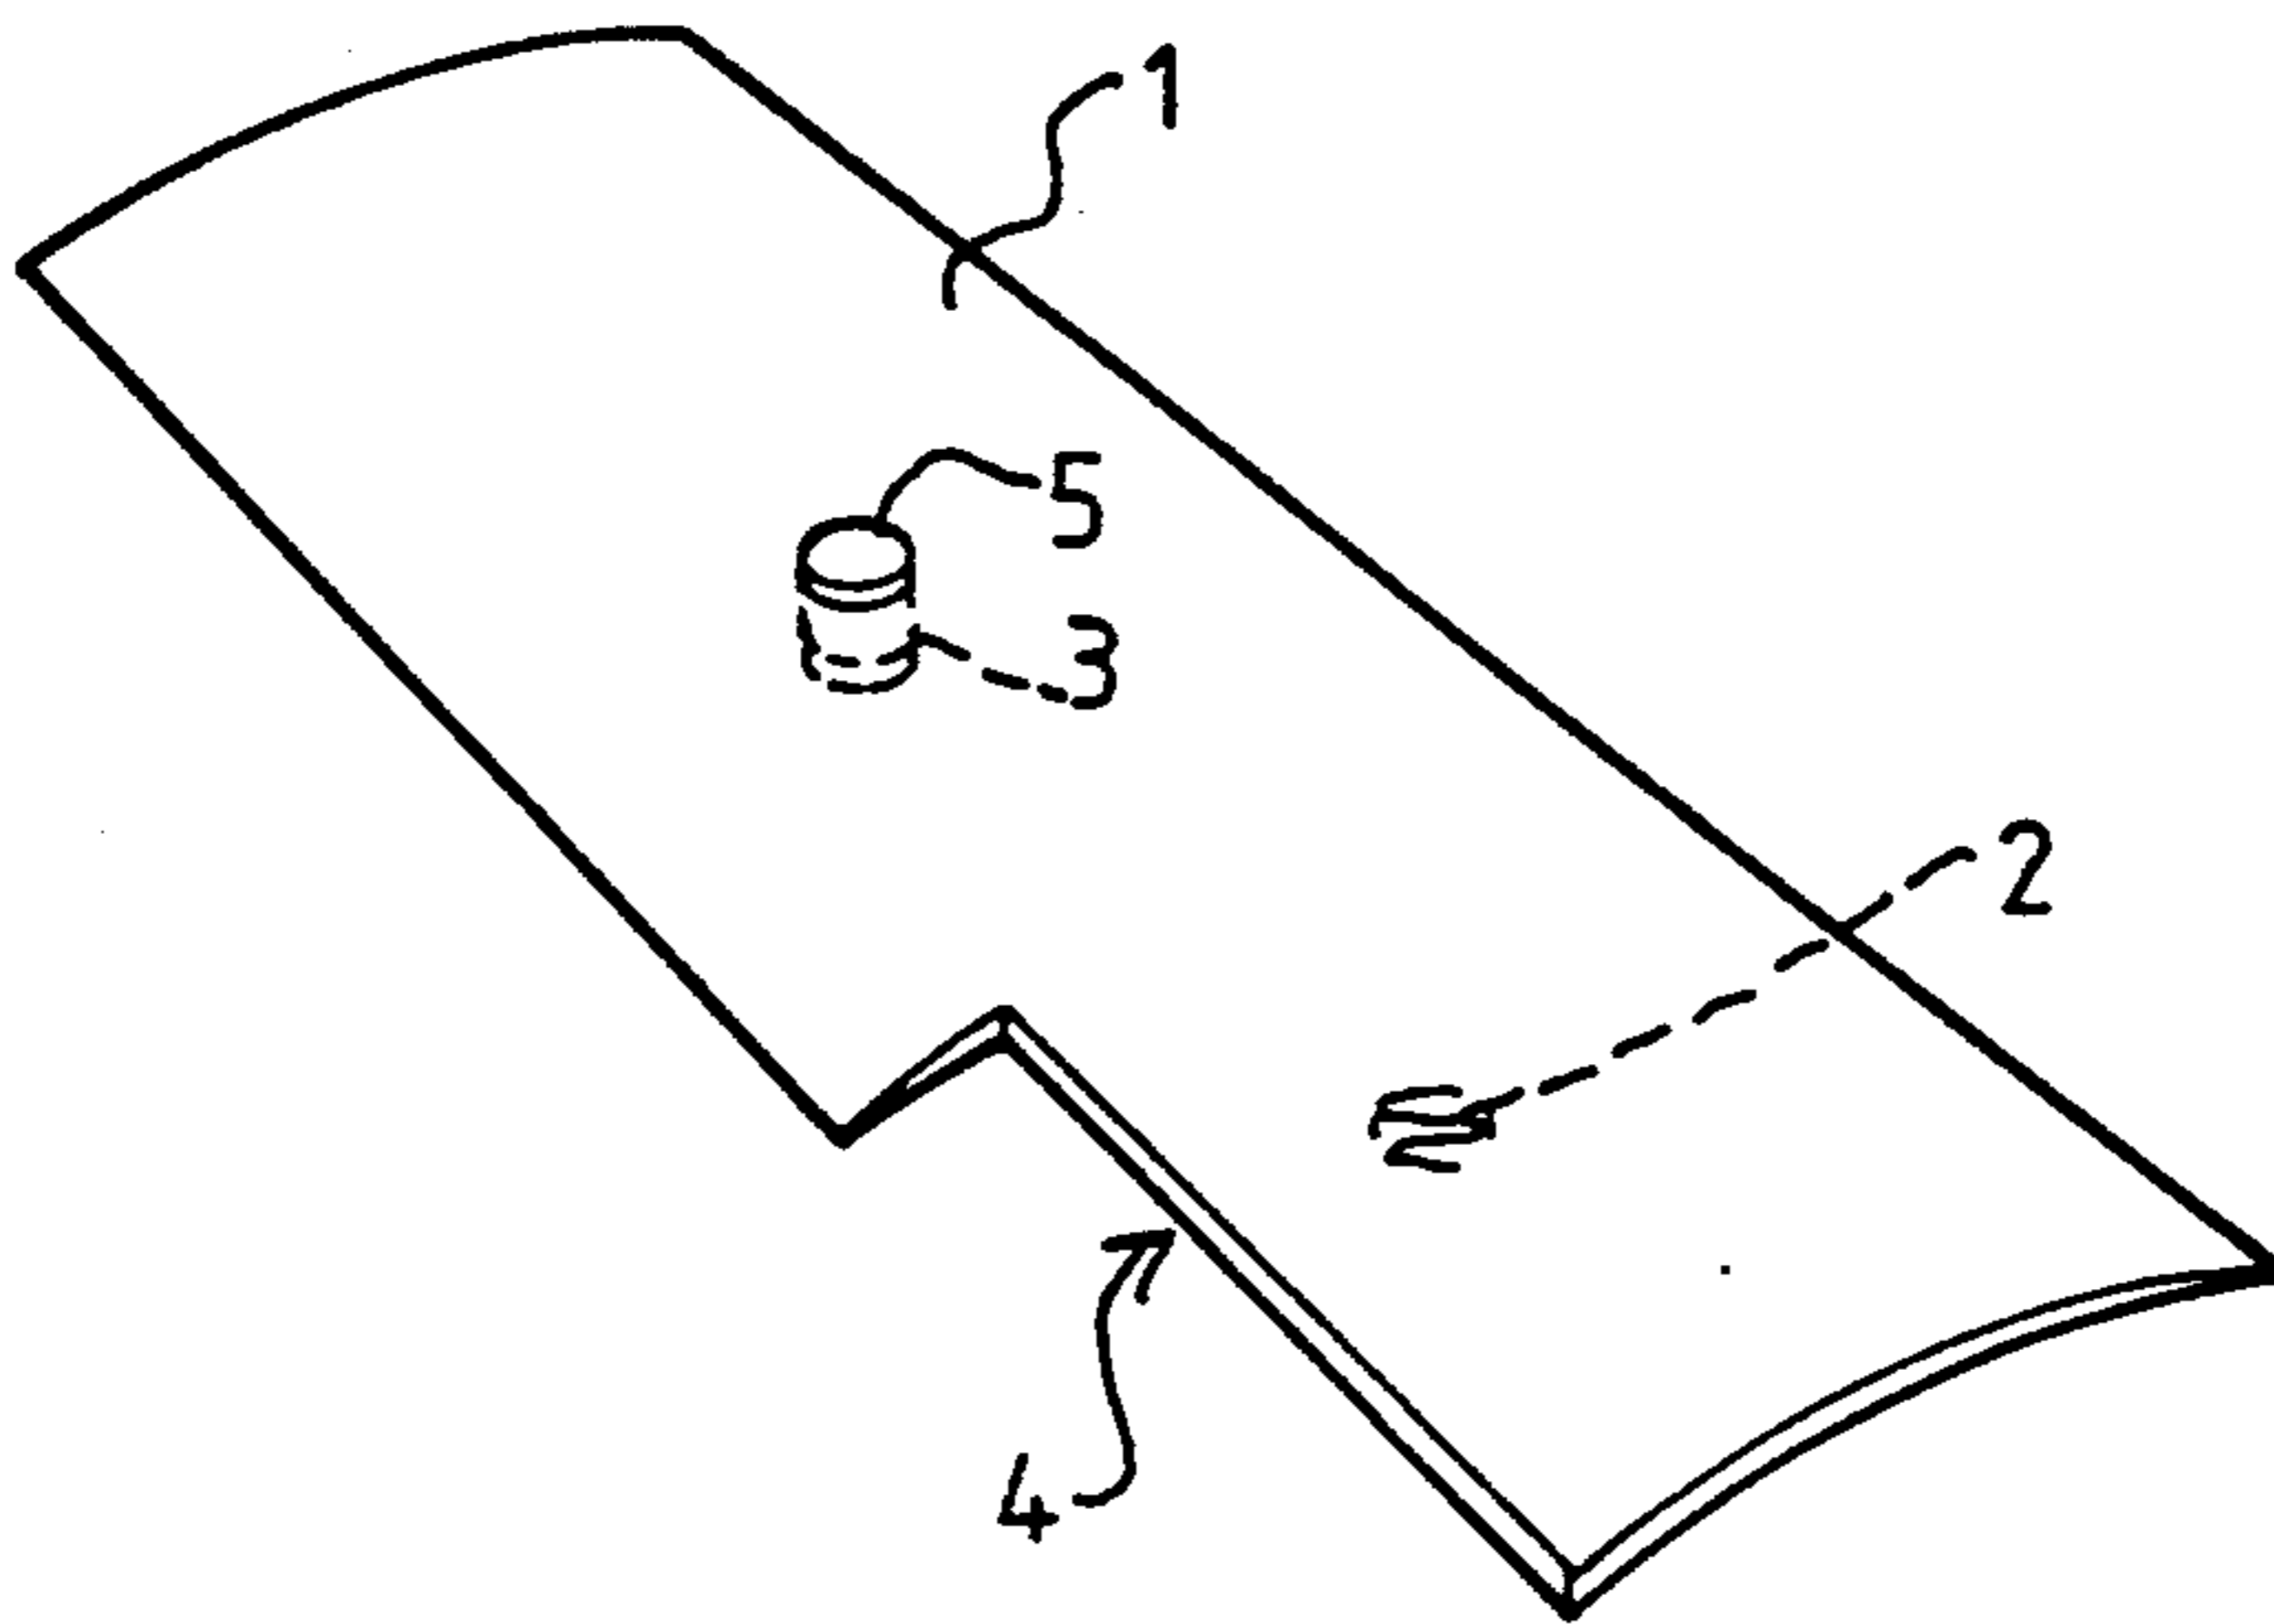
FIG 4

FIG. 4 is a view of the turbine blade shown in FIG. 3 in which one lacing wire hole has been plugged and the other filled;

Referring now in addition to FIG. 4, the turbine blade 1 has had the lacing wire hole 2 filled with weld metal. As an alternative a plug may be welded into the lacing wire hole, thus removing the discontinuity.
