United States Patent [19]

[54] **TURBINE BLADE REPAIR**

[57] **ABSTRACT**

A method of repairing a turbine blade of the type having discontinuities such as lacing wire holes the method including the steps of driving a plug into any such discontinuity that is not in the immediate area that is likely to be subjected to consideration thermal energy as occurs during welding. The presence of the plug decreases the tendency for stress to concentrate around the discontinuity if the blade is subjected to stress caused by physical force or high temperatures.

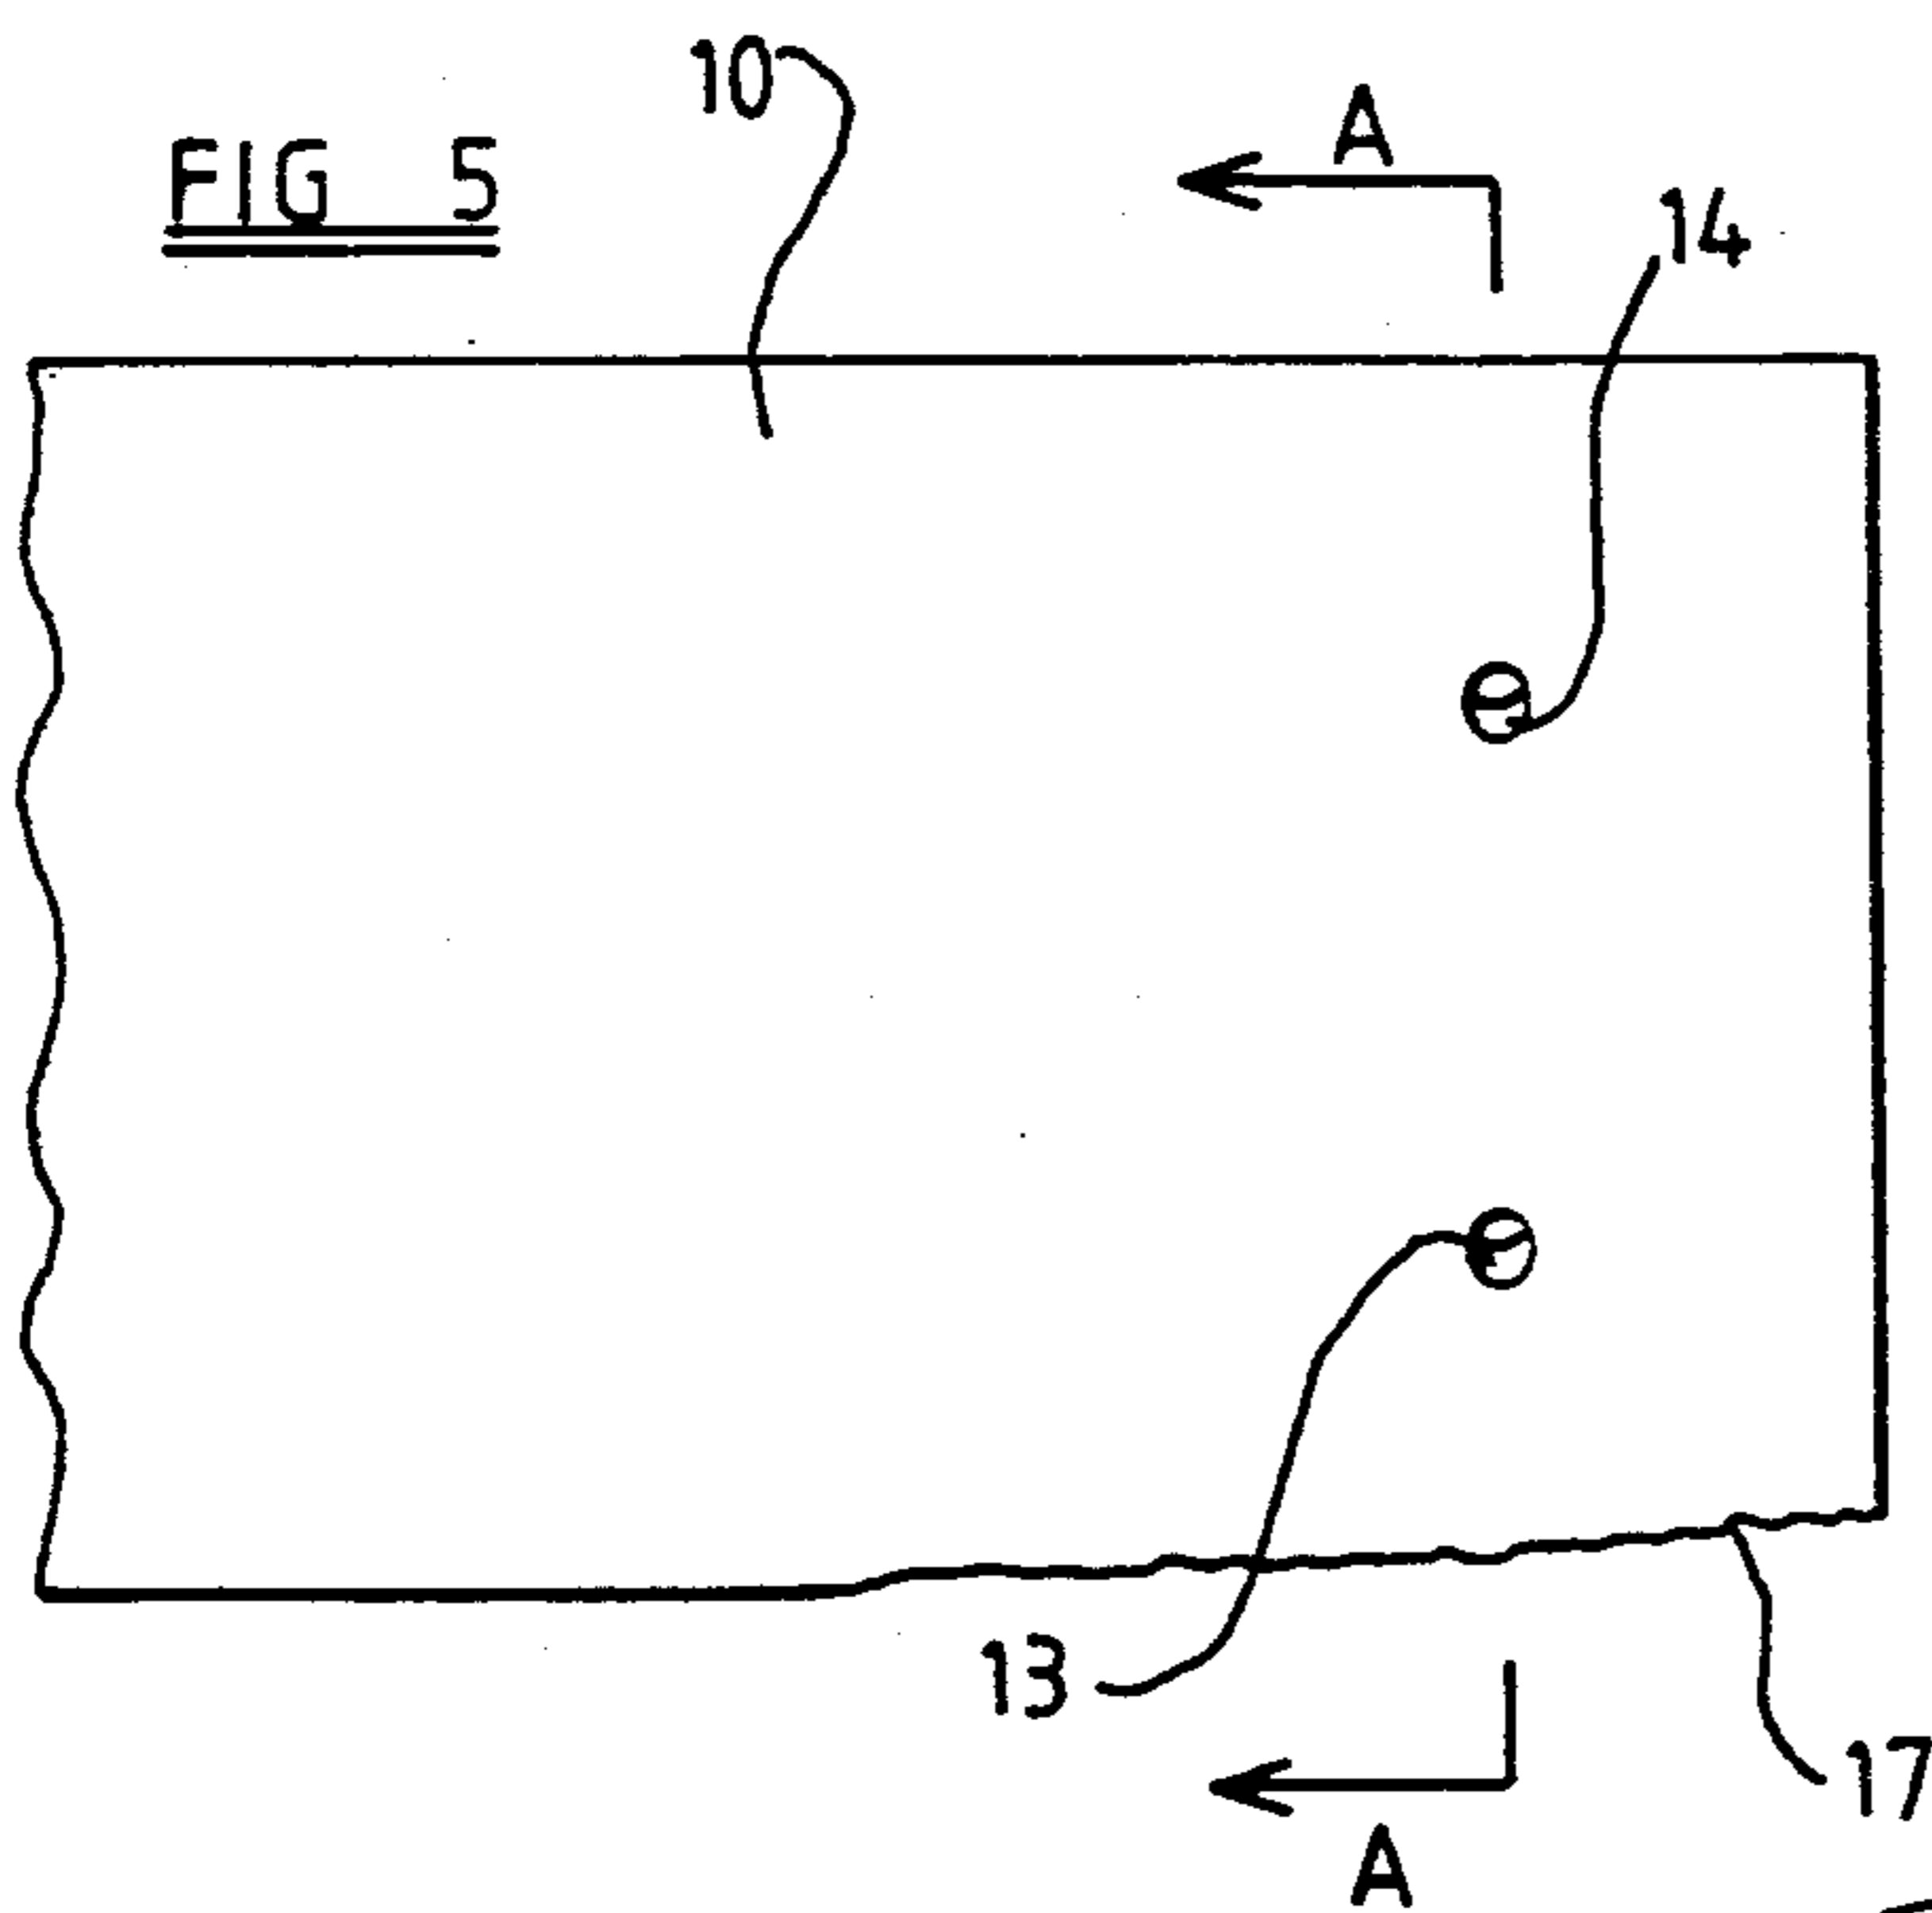
FIG 5

FIG. 5 is a view of an end region of the turbine blade illustrating an area where erosion is common;

10 Referring now in addition to FIG. 5, the area of the turbine blade which is most prone to erosion is illustrated, this being the leading edge 17 of the outer end of the turbine blade since it is this part of the blade which collides with the steam or particles carried thereby during use of the turbine blade, and it is the part of the turbine blade which has the greatest linear speed, being the radially outermost point from the axis of rotation.

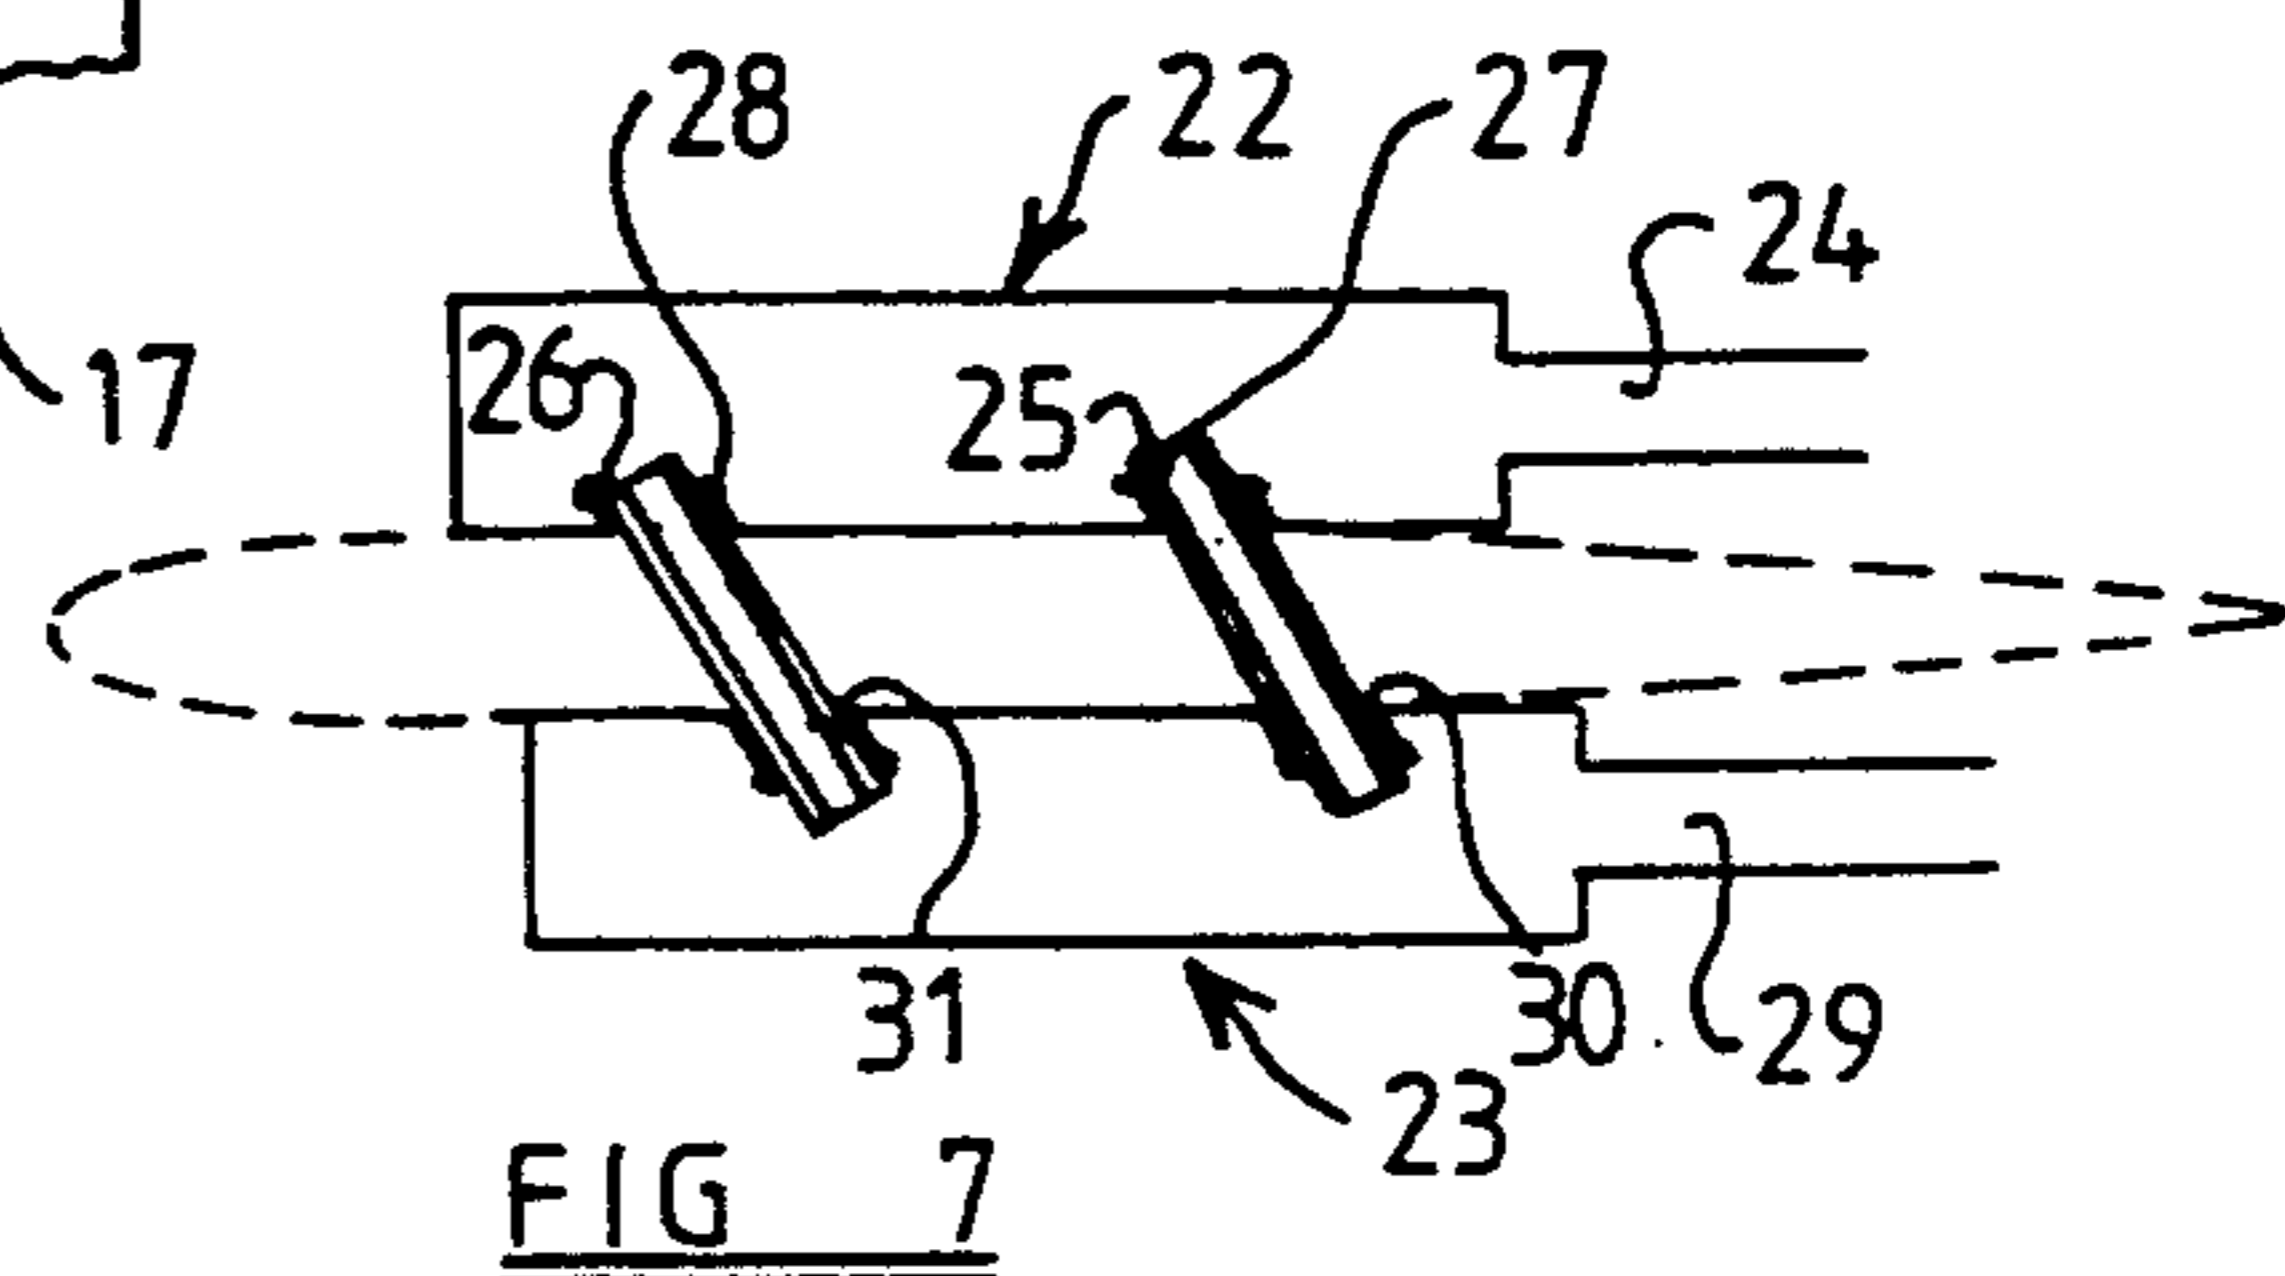
FIG 7

FIG. 7 is a cross-sectional view through one embodiment of a heat sink;

The plugs 18 and 19 are longer than the thickness of the turbine blade through which they project and are dimensioned so as to be a tight fit in the lacing wire holes 13 and 14. The reason for the extra length of the plugs 18 and 19 is such that they can co-operate with a heat sink or chill comprising a pair of box-like members through which cooling fluid may flow and as illustrated in more detail in FIG. 7.

30 FIG. 7 illustrates an embodiment of the heat sink or chill and comprises a pair of box-like members 22 and 23. The box 22 has an inlet 24 for fluid and a pair of apertures 25 and 26 provided with respective seals 27 and 28.

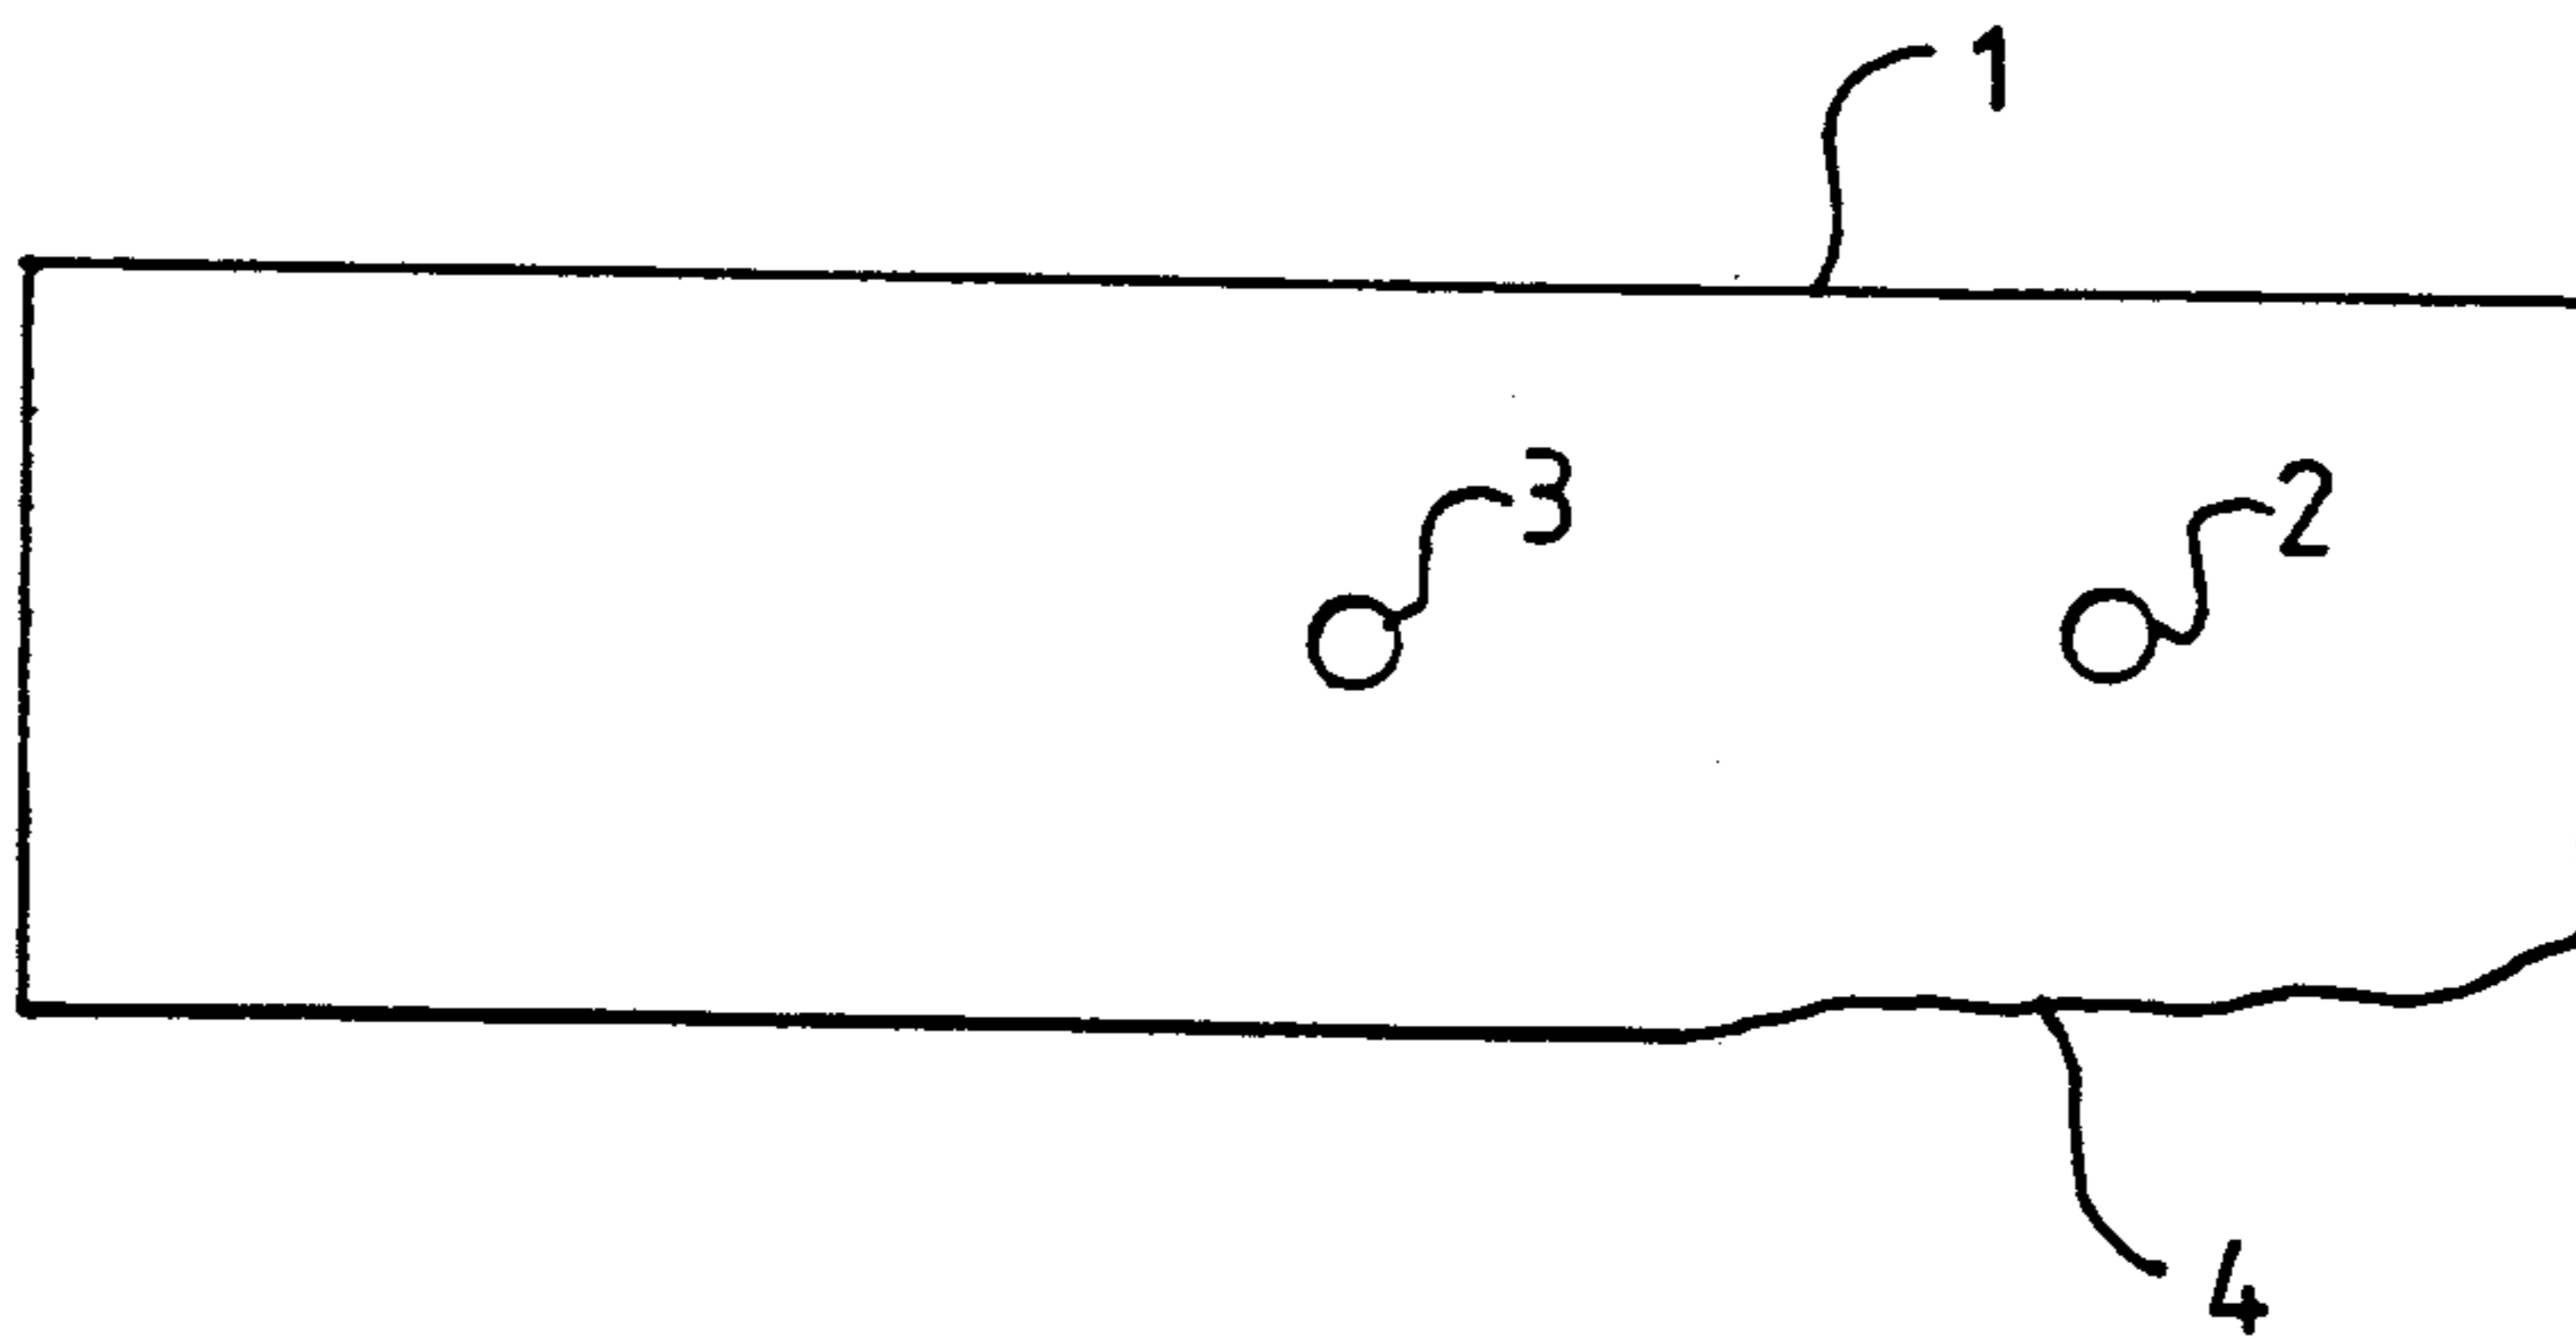
FIG 3

FIG. 3 is a diagrammatic view of a turbine blade having a pair of lacing wire holes and also showing erosion and damage on the leading outer edge;

Referring now to FIGS. 3 and 4, a turbine blade 1 has a pair of lacing wire holes 2 and 3. Damage is shown in the area 4 which damage may comprise erosion, cracks and the like and the nature of the repair normally requires an area at the outer leading edge as shown by arrow 4 to be removed from the blade and a new piece of material welded thereto.
