[11] Patent Number: **5,193,736**

The present invention discloses a method for repairing metal edges using wire and a braze alloy. Using this method, it is possible to restore a damaged metal edge to blueprint dimensions. In the preferred embodiment, the disclosed method relates to the restoration of damaged or worn turbine vanes. The method comprises a preparation step of cleaning and milling the edge of the base metal to be repaired. A repair wire is then placed along the edge, and a braze compound is applied to the junction of the base metal and the repair wire. A brazing step follows which integrates the base metal, the wire and the brazing compound. After standard finishing steps, the repaired vane meets blueprint specifications and is ready for use in a turbine.

METHOD FOR REPAIRING TURBINE VANES

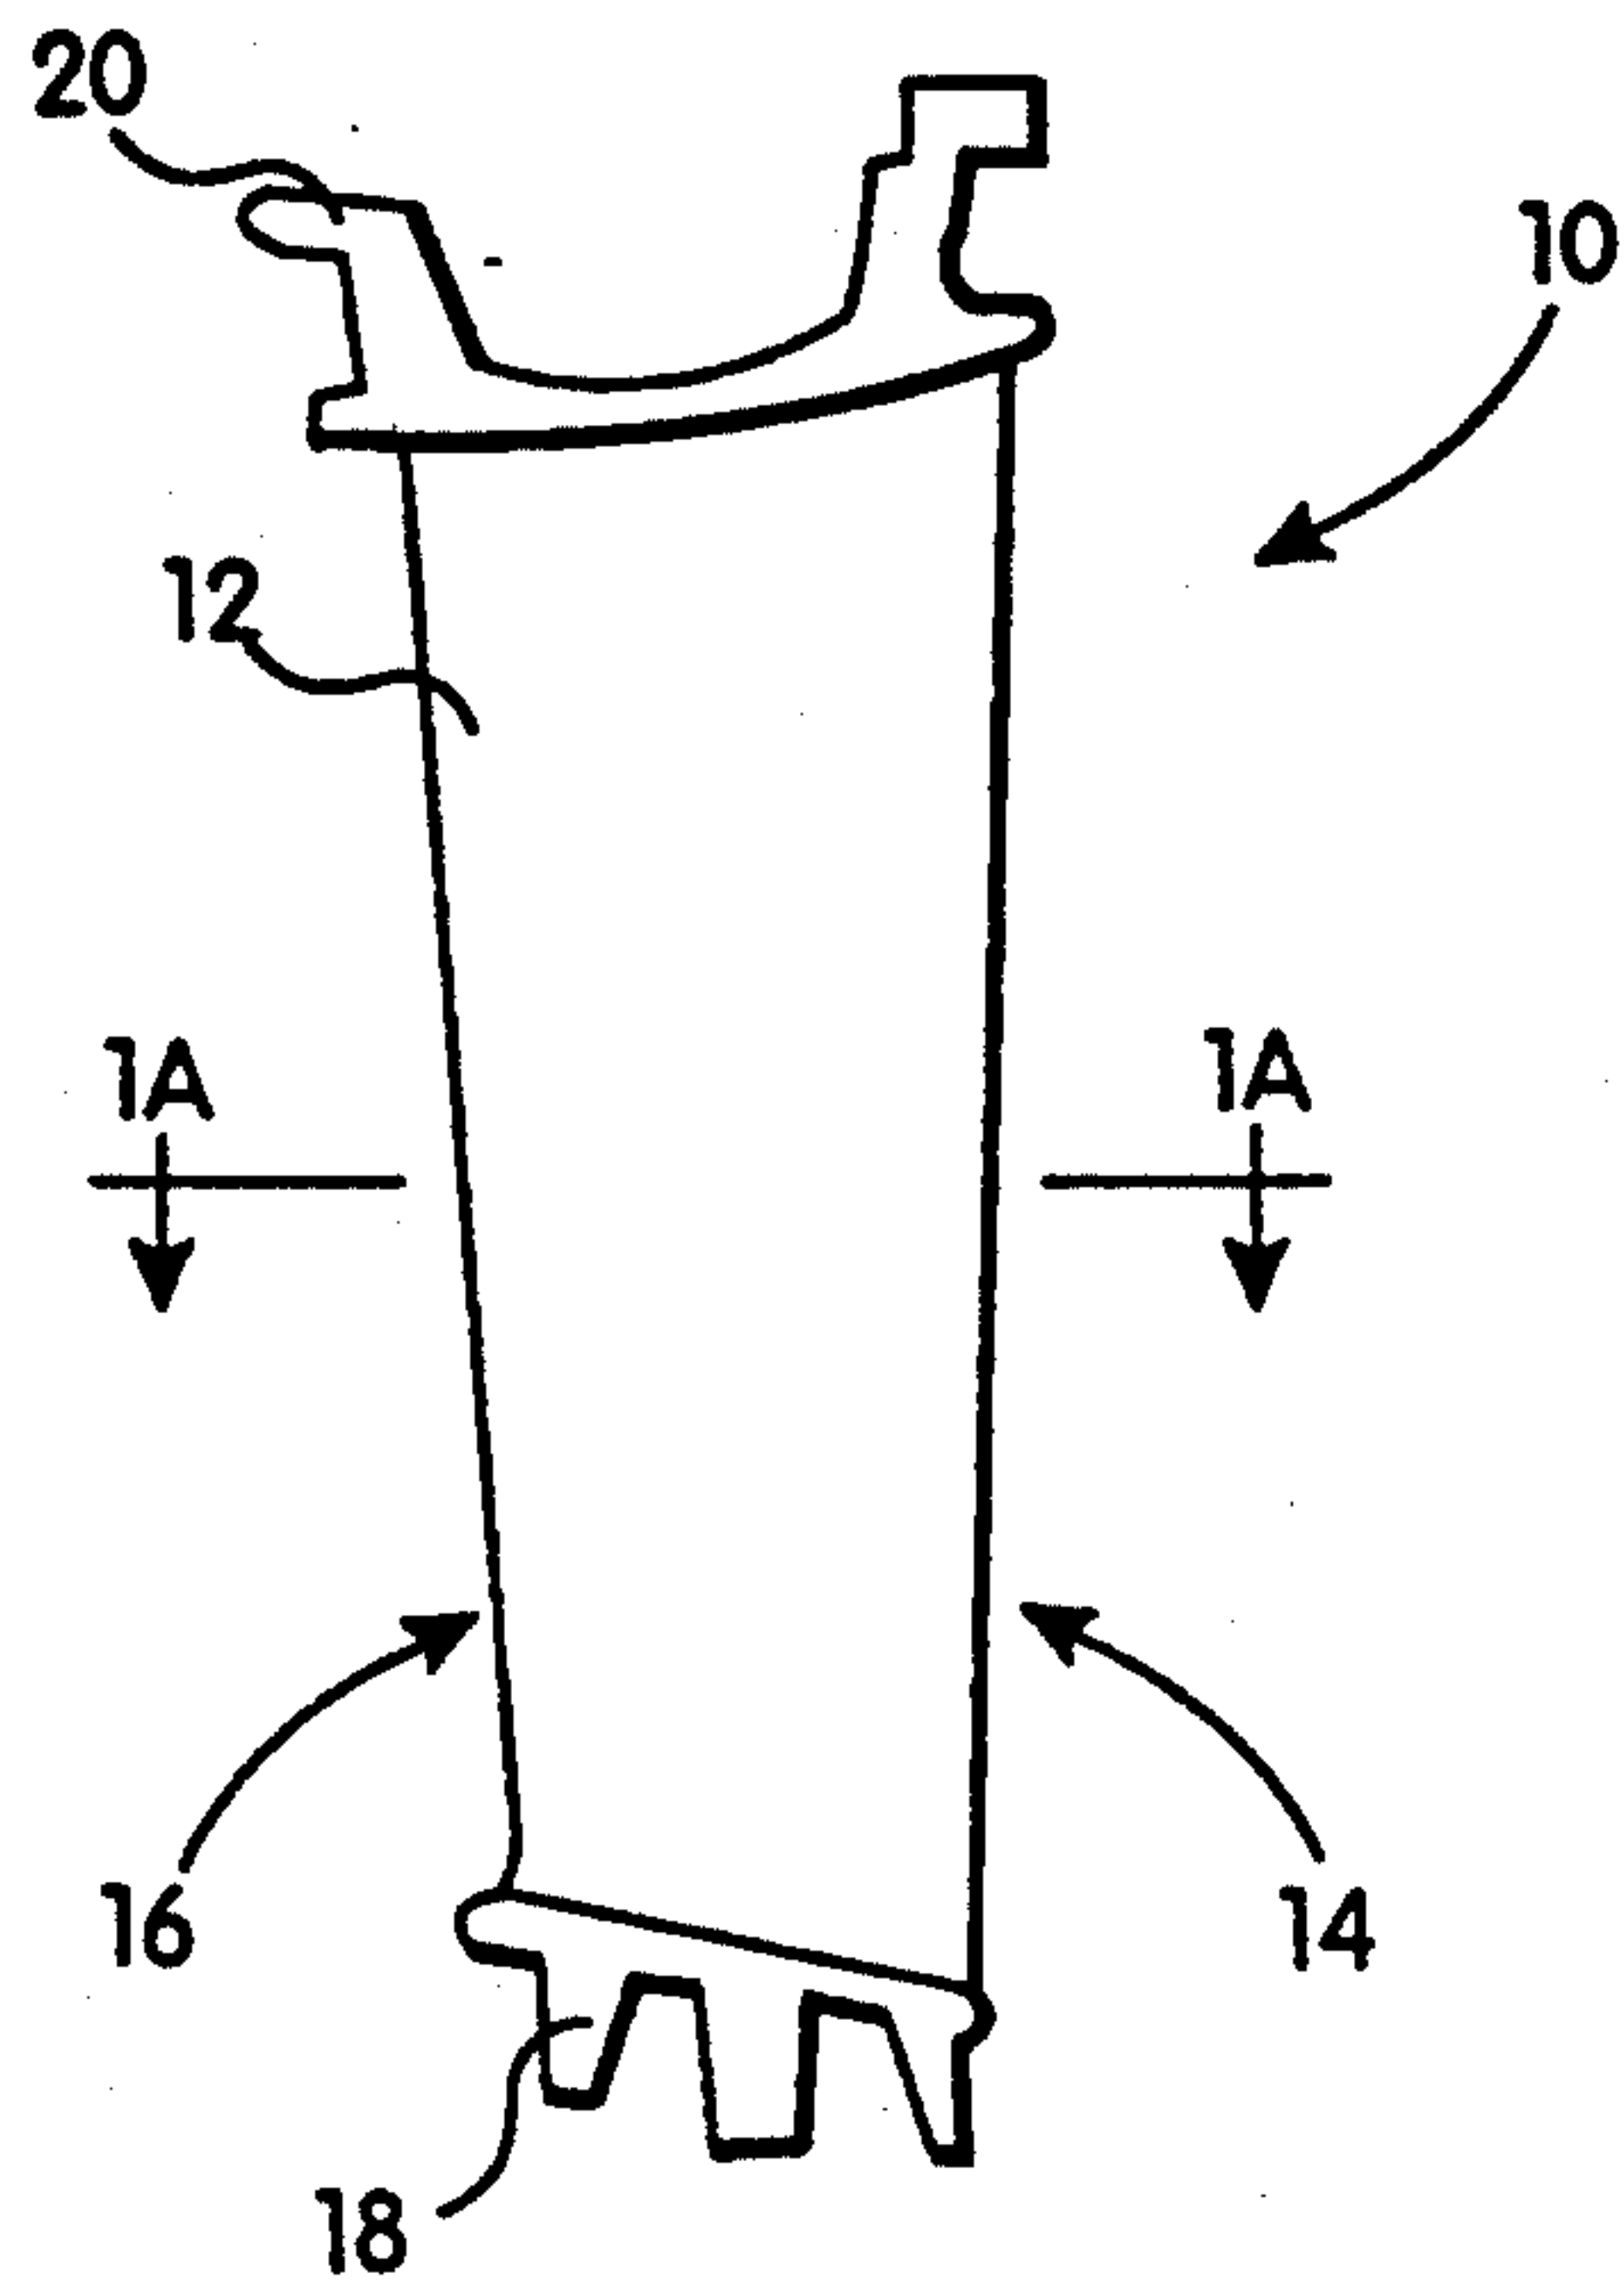
Fig. 1

FIG. 1 is a plan view of an undamaged turbine vane assembly;

With reference now to FIG. 1, a turbine vane assembly 10 is shown with a turbine vane 12, having a trailing edge 14 and a leading edge 16, attached to an inner foot 18 and an outer foot 20 which serve to anchor the vane 12 in position within the turbine. The line A—A' represents a cross-section through the vane 12. Referring also to FIG. 1(A), the cross-section of the vane 12 indicated by line A—A' in FIG. 1 is shown, with the vane chord width at this location being represented by the line B—B'. The leading edge 16, the trailing edge 14, and vane thickness 22 are typical wear areas in the vane 12.

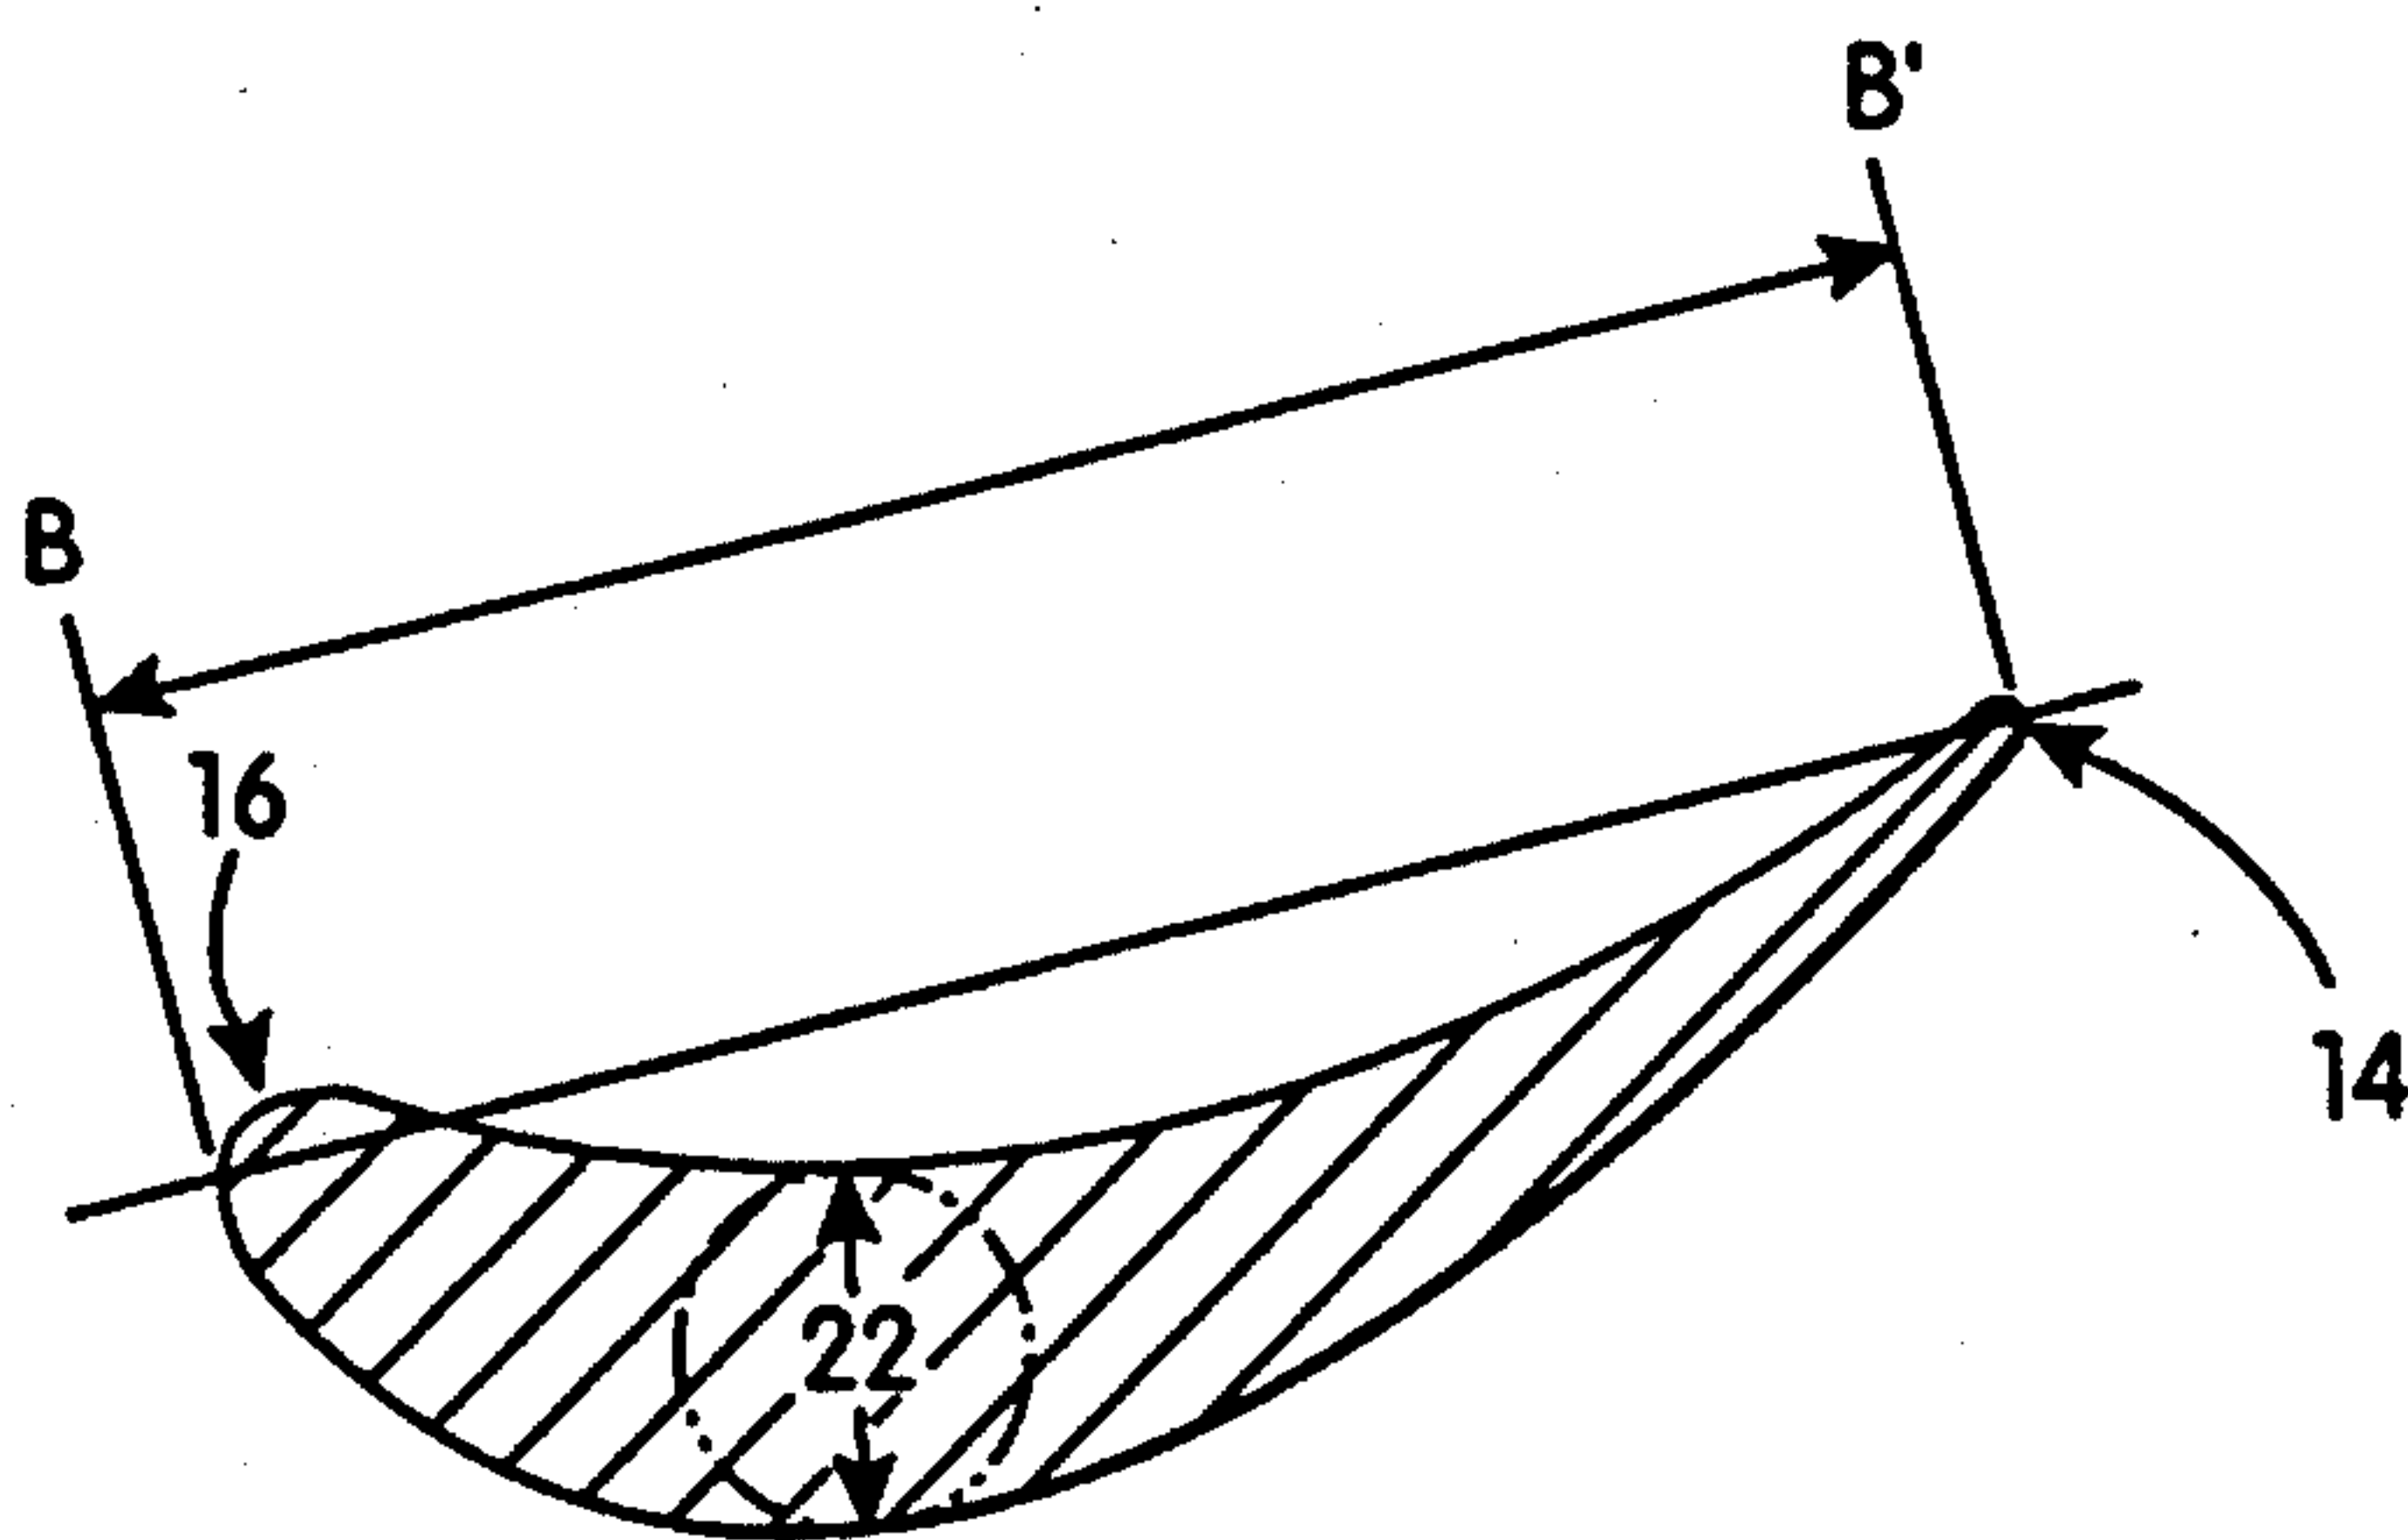
Fig. 1A

FIG. 1(A) is a representative cross-sectional view of the turbine vane assembly of FIG. 1 taken along line A—A' of FIG. 1;

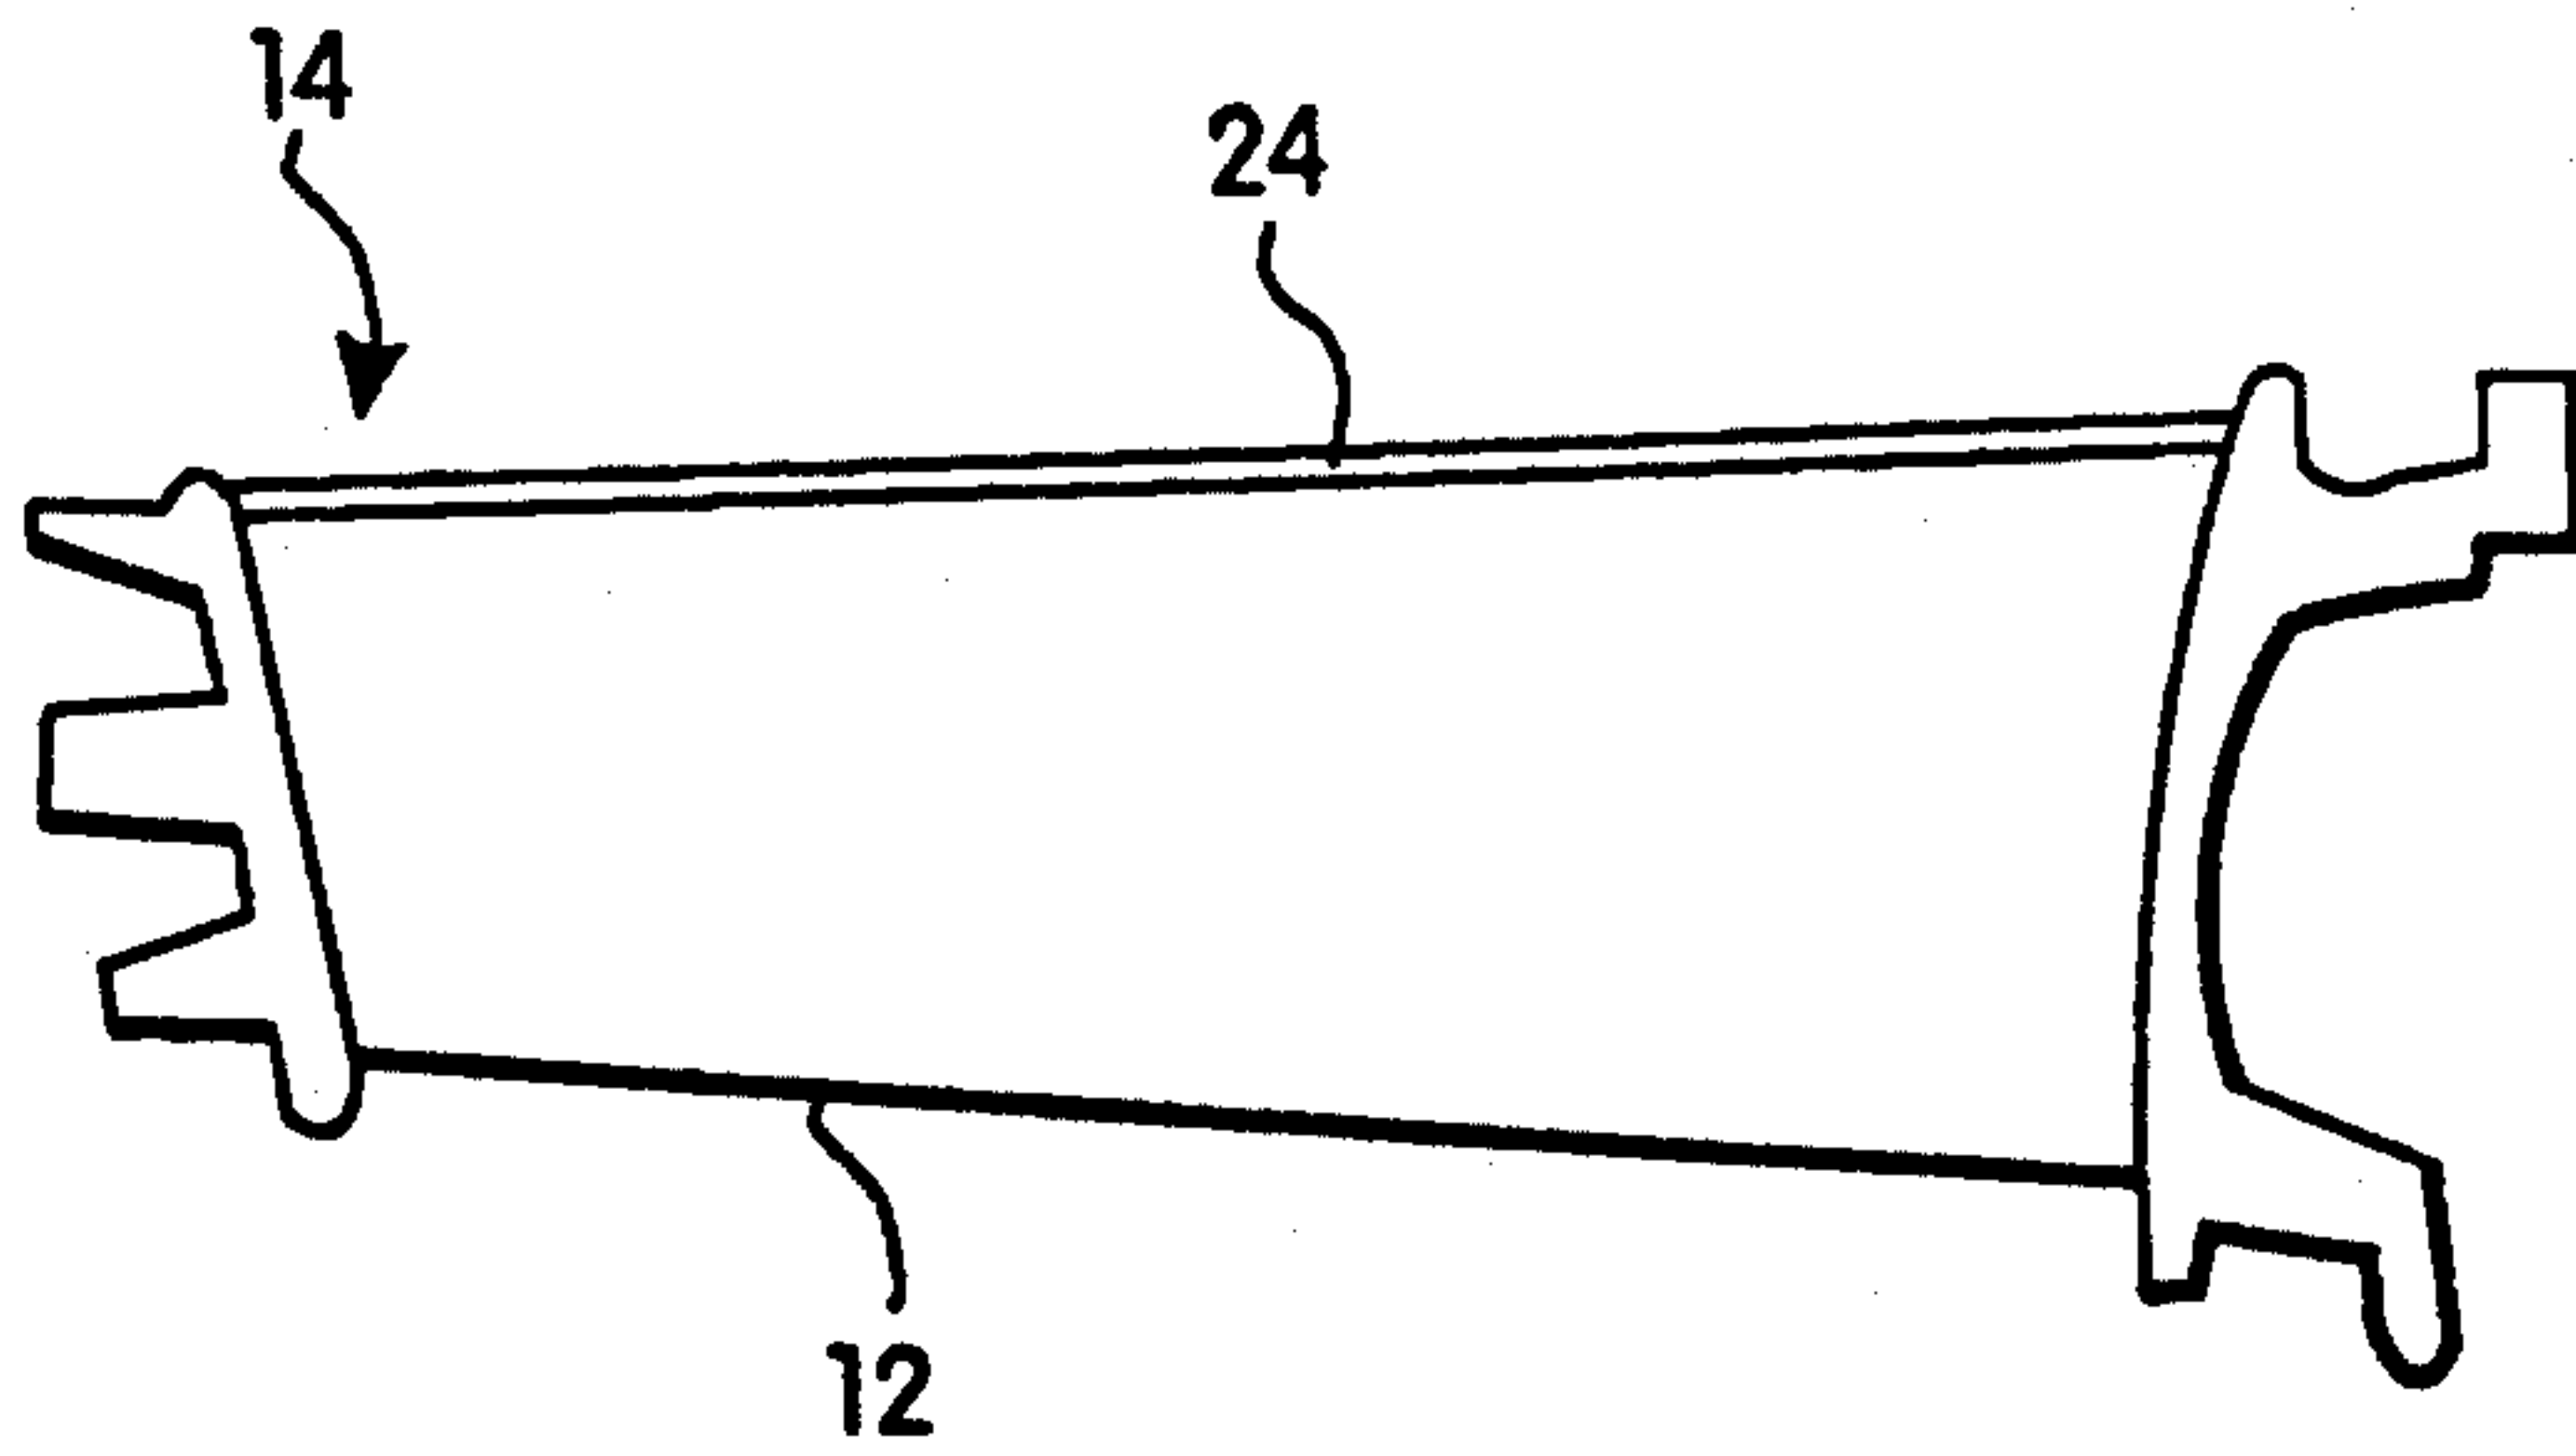
Fig. 2

FIG. 2 is a plan view of a damaged vane showing the placement of a repair wire used in performing wire repair;

Referring to FIG. 2, in the preferred embodiment, for example to repair the trailing edge 14, any coatings on the vane 12 are removed prior to a visual inspection to ensure the vane is a suitable candidate for repair. The point of maximum chord width is then determined along the trailing edge 14 of the vane. The trailing edge 14 is then milled back to accept a repair wire 24. Typically no more than 0.015 inches will be removed to accept repair wires 24 of varying diameter. The vane is then cleaned by a silicon carbide grit or other suitable blast media.

The vane 12 with a damaged trailing edge 14 is shown in FIG. 2 with repair wire 24 anchored in position adjacent to the edge 14 to be repaired. In one embodiment, a super alloy, Aerospace Material Specification (AMS) 5391, is the base metal of the turbine vane 12 subject to repair. A section of metallurgically compatible weld wire 24, here AMS 5837, is cut to match the entire trailing edge 14 of the vane 12. The weld wire 24 is tack welded along the trailing edge 14 with three tack welds, one at each end and one in the center of the vane 12. To optimize the later brazing step, a maximum of 0.010 inch gap is allowed between wire 24 and trailing edge 14. The welding is performed in a dry box weld chamber filled with an argon.

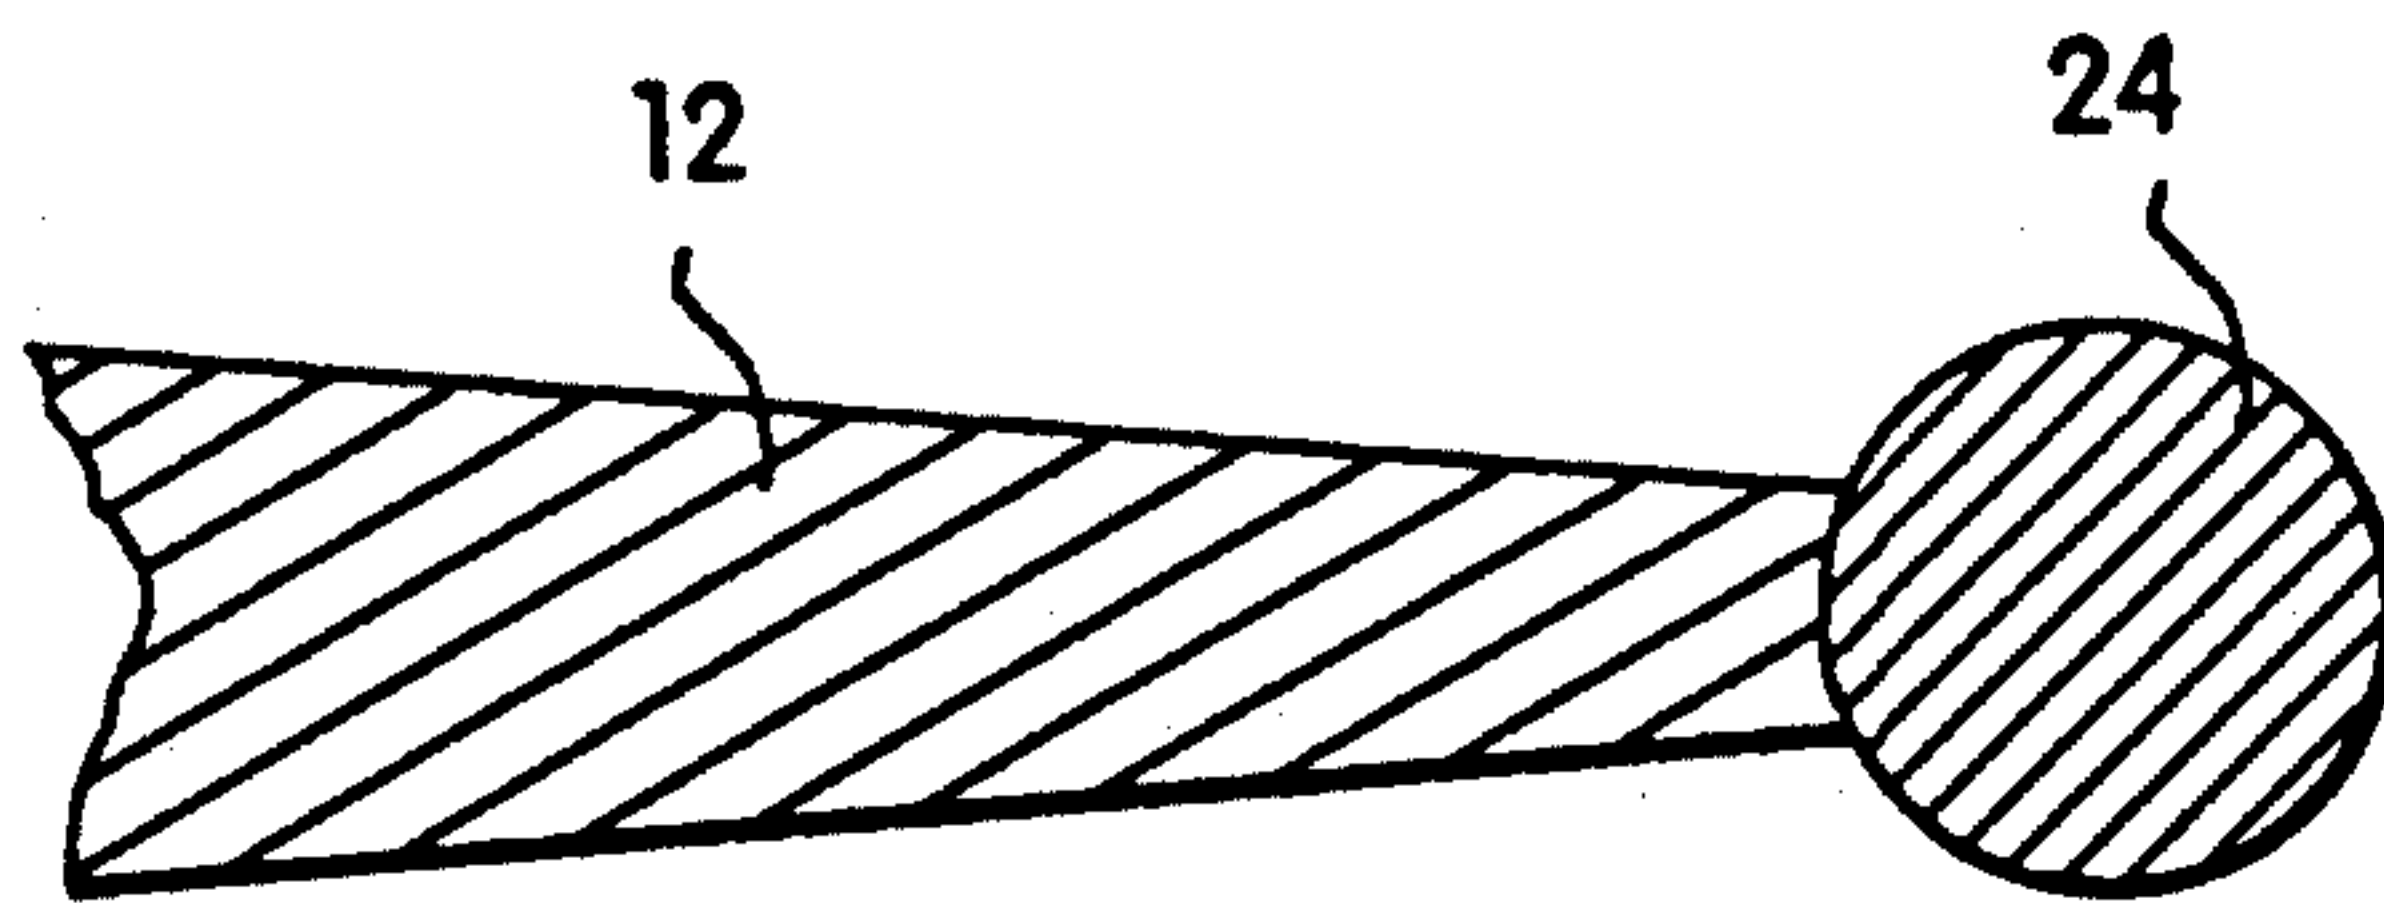
Fig. 2A

FIG. 2(A) is a cross-sectional view of the trailing edge of the vane shown in FIG. 2;

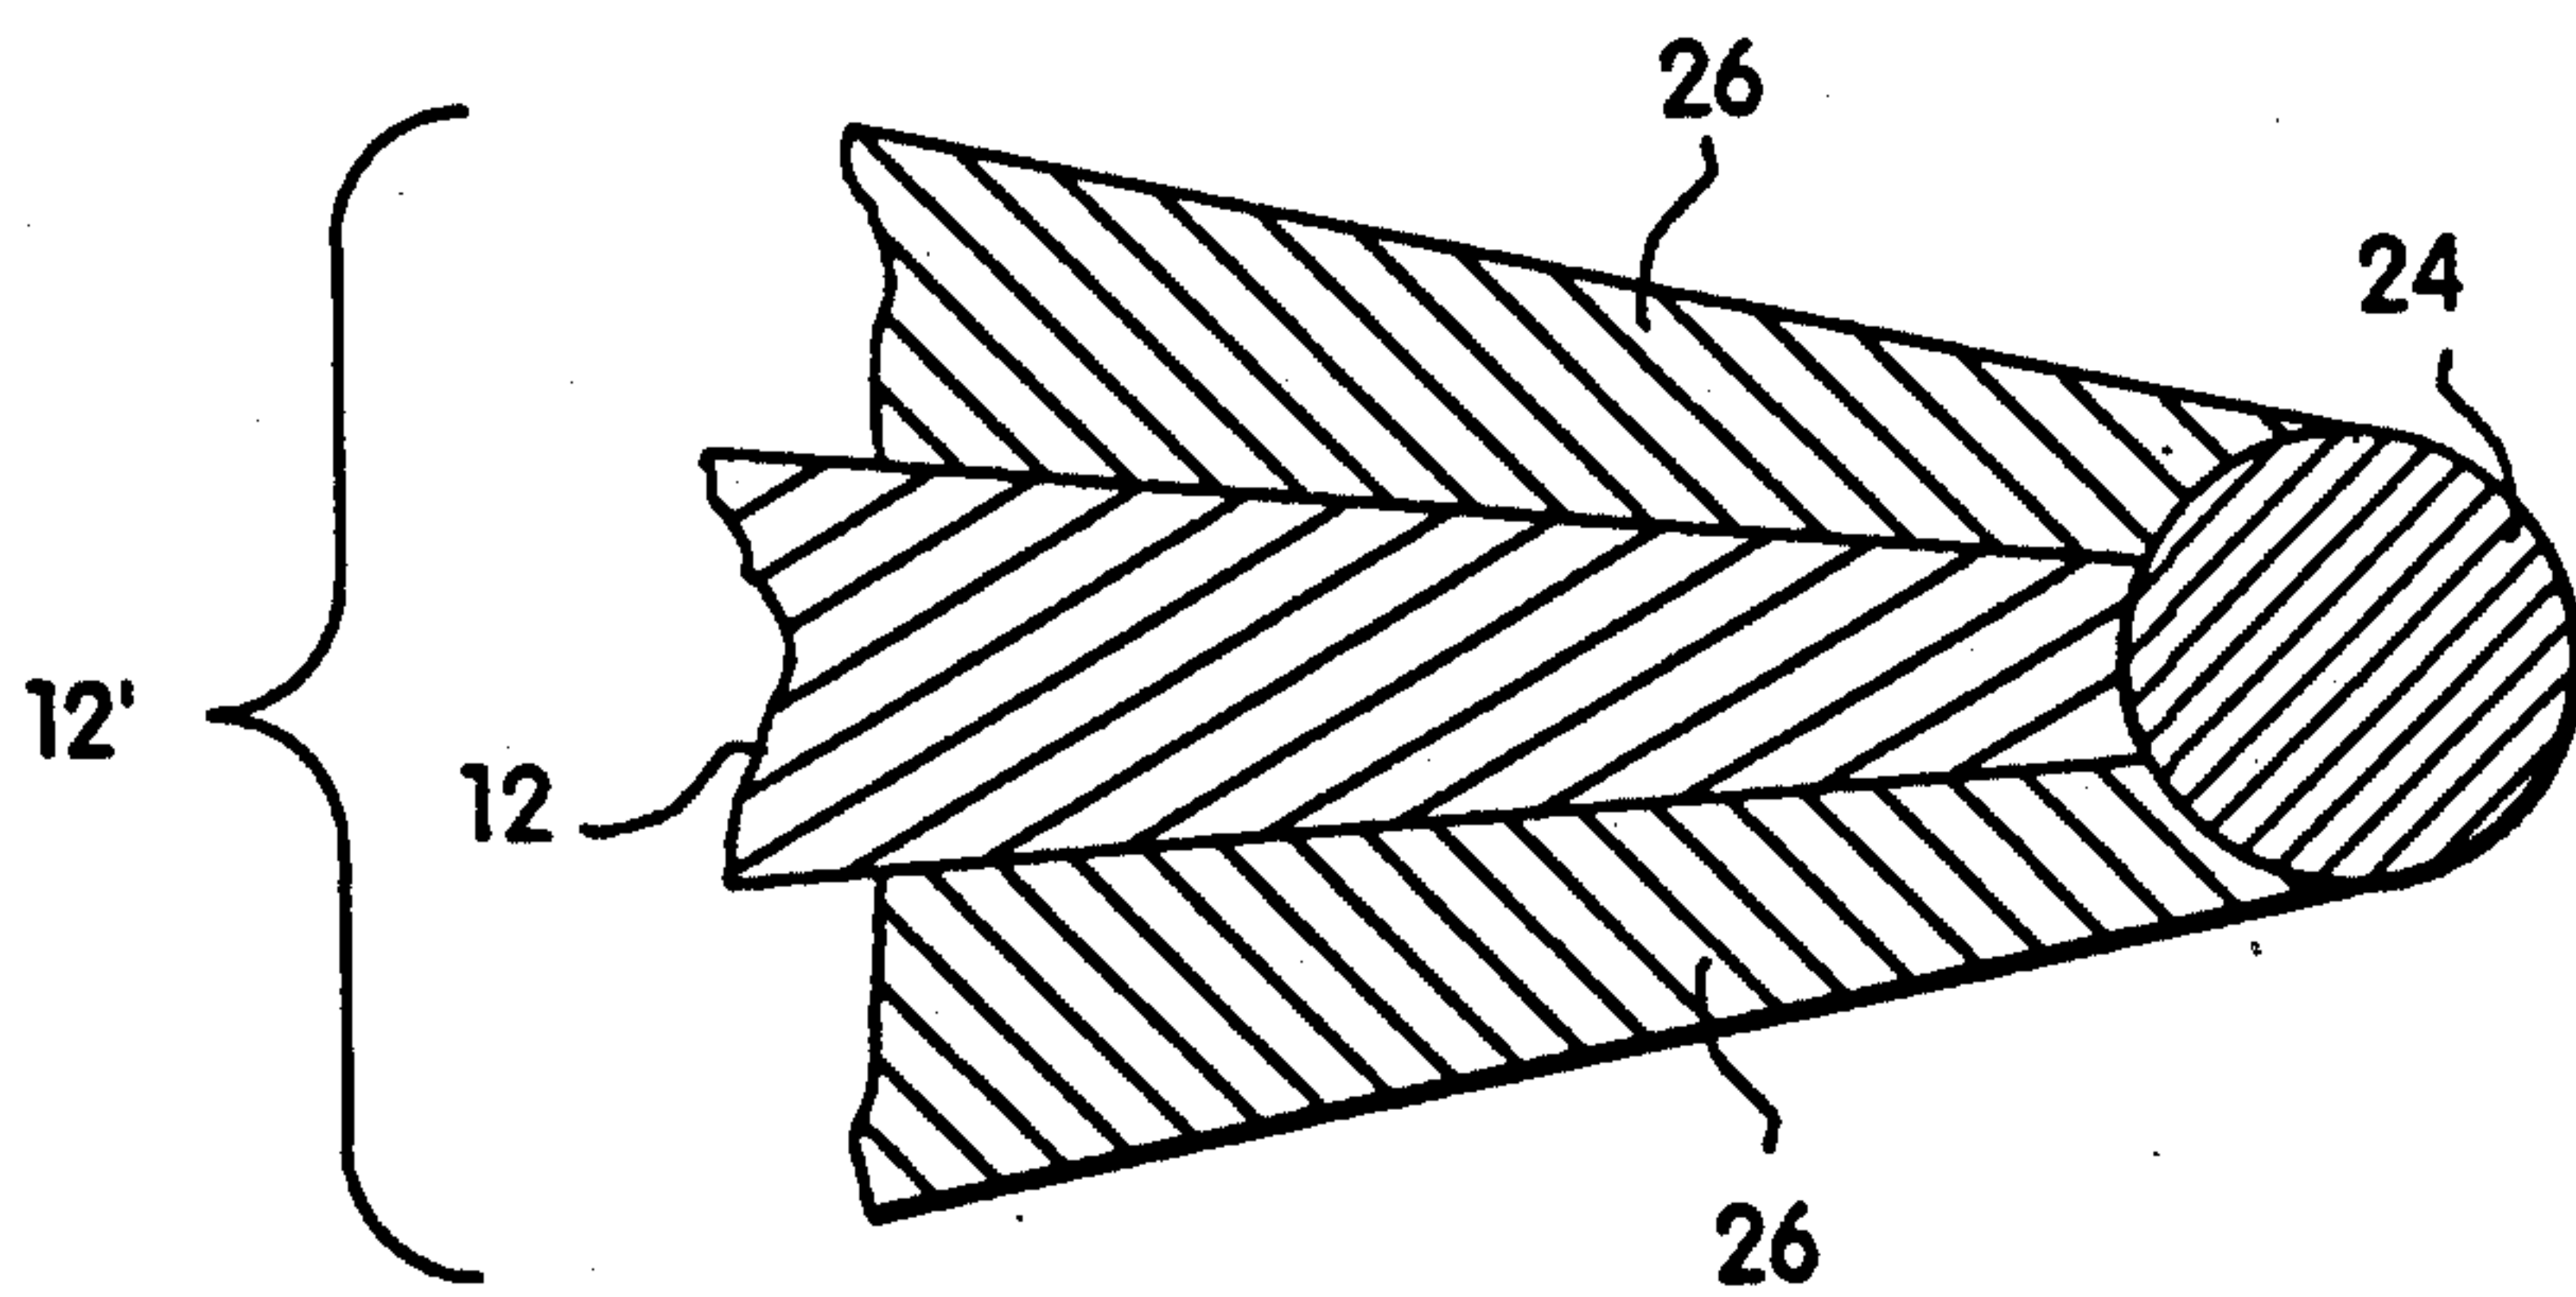
Fig. 2B

FIG. 2(B) is a cross-sectional view of the trailing edge of the vane shown in FIG. 2 after application of the braze alloy; and

Referring now to FIG. 2(B), the built-up vane 12' is shown in cross-section with wire 24 in place. Braze compound 26, a material developed to be compatible with base material 12, wire 24, and protective coating 28, has been applied in sufficient quantity to cover the joined area, the wire 24 and a portion of the vane 12. The braze compound material 26 is applied in sufficient thickness to allow for blending and to achieve the required dimensions after brazing.

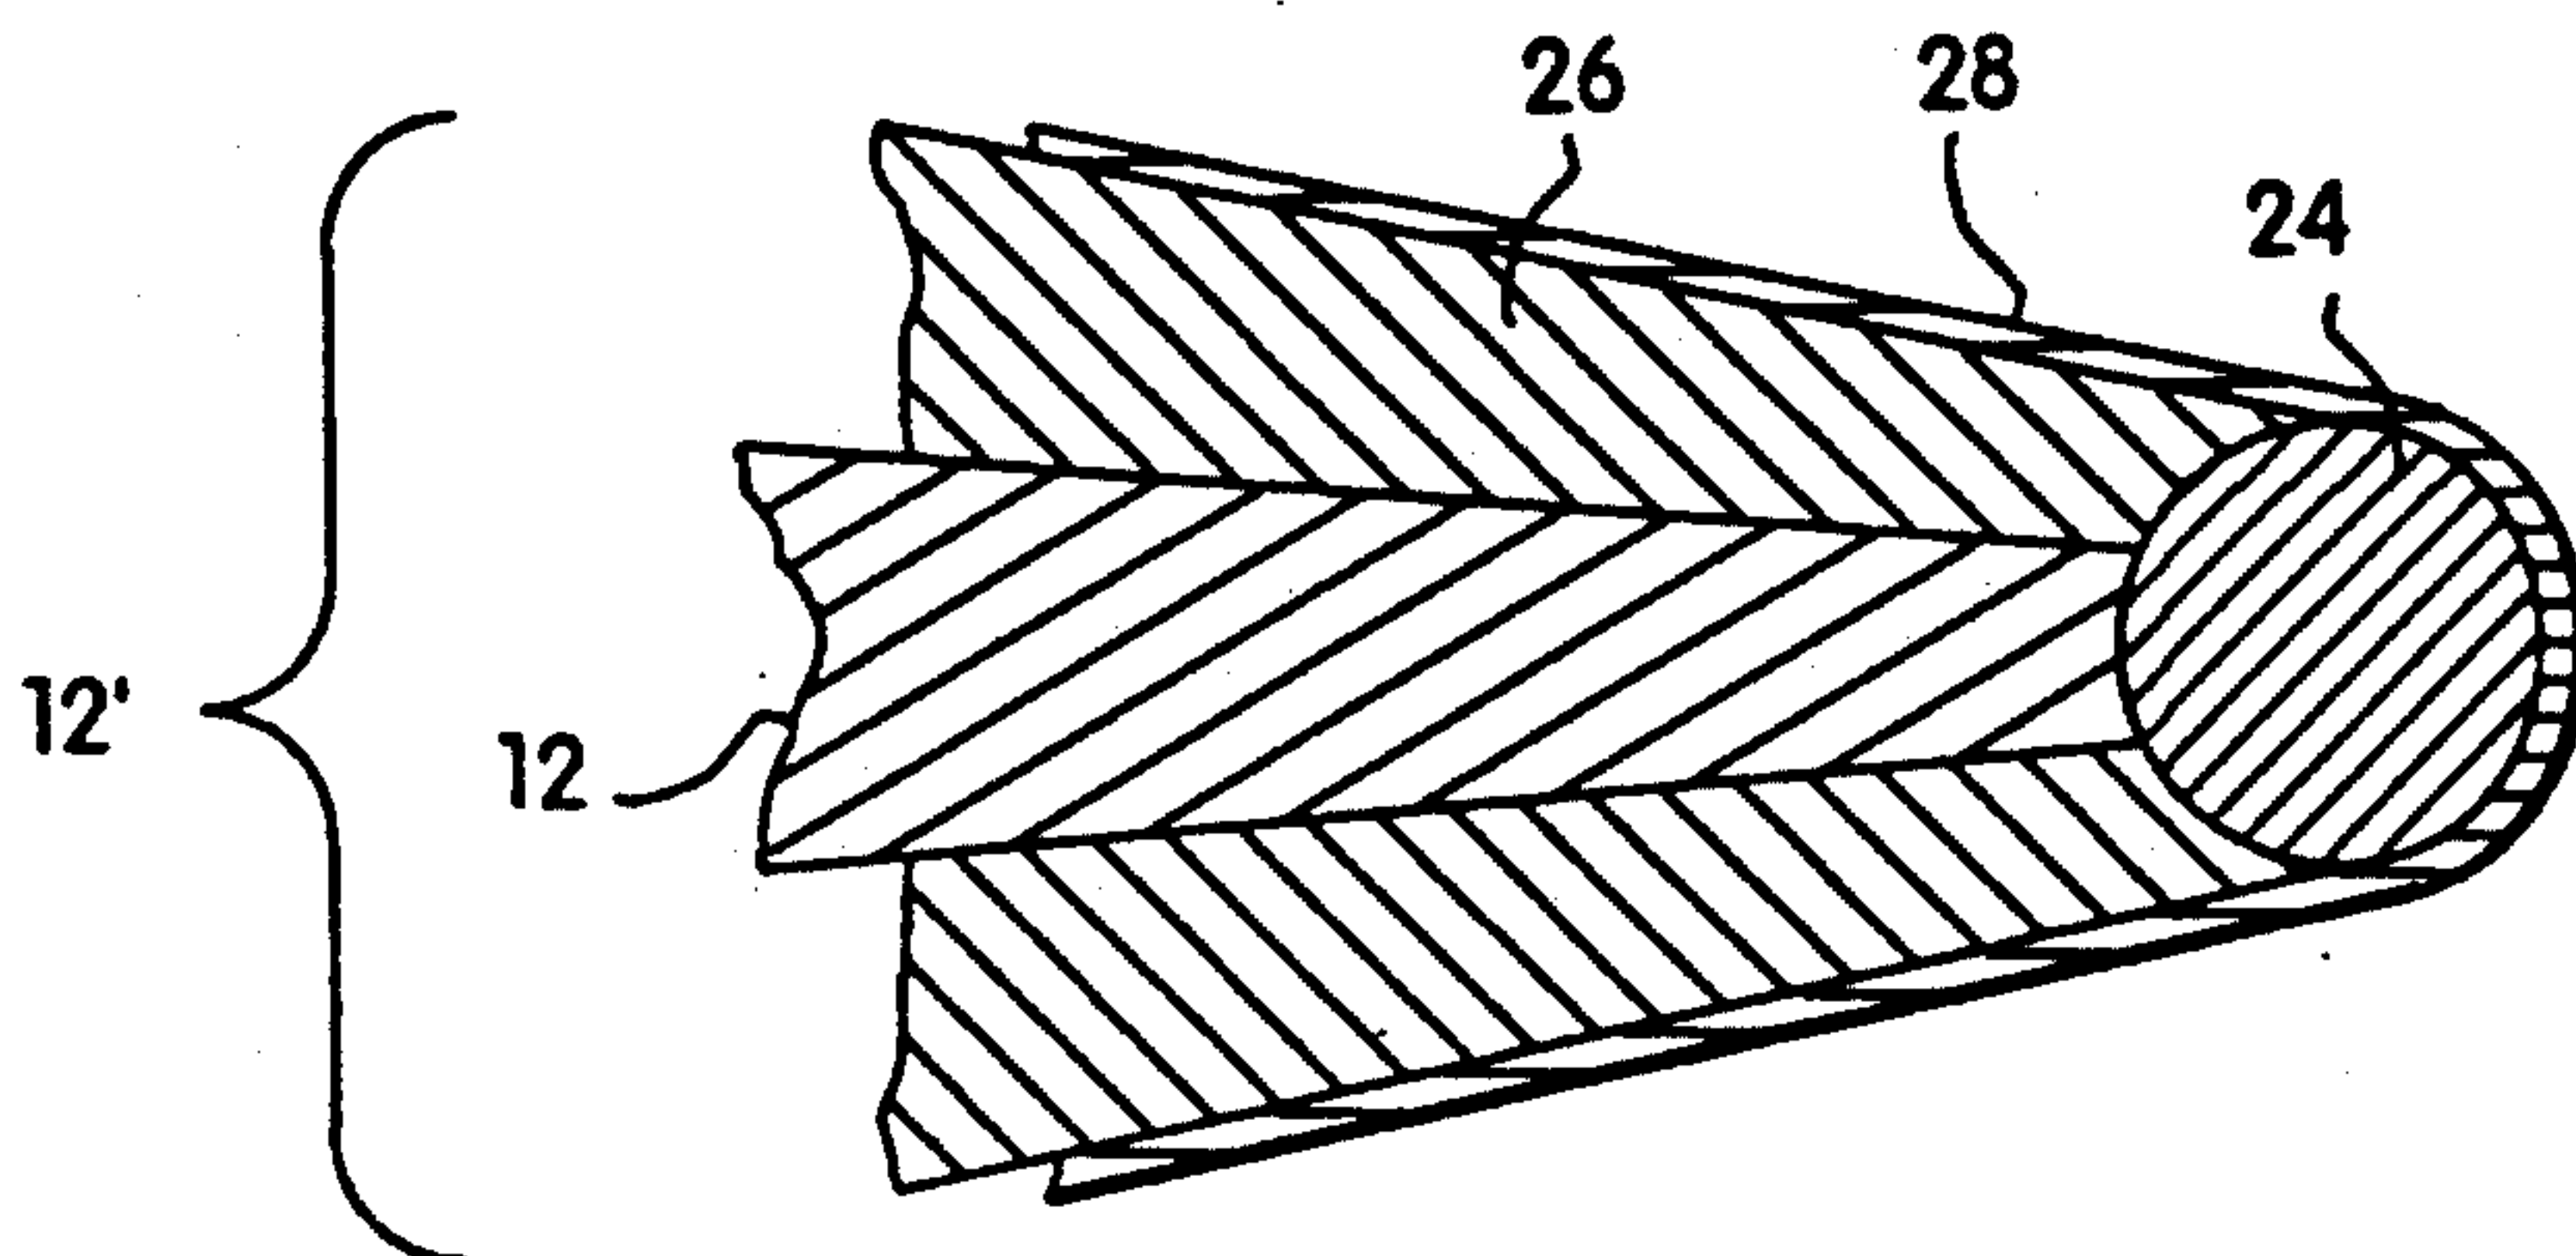
Fig. 2C

FIG. 2(C) is a cross-sectional view of the vane of FIG. 2(B) after completion of wire repair.

Referring to FIG. 2(C) a sectional view of the vane 12' at the completion of wire repair is shown. The original vane 12, having been worn to below design specification, has been built-up with wire 24, braze 26, and protective coating 28.
