- [54] **METHOD FOR REPAIRING TURBINE VANES**
- [75] **Inventors:** Gillion H. Marijnissen, NC Beringe, Netherlands; Timothy P. Vastine, North Richland Hills; Gerald T. Smith, Arlington, both of Tex.
- [73] **Assignee:** Interturbine Corporation, Grand Prairie, Tex.
- [21] **Appl. No.:** 662,743
- [22] **Filed:** Mar. 1, 1991
- [51] **Int. Cl.⁵** B23P 15/02
- [52] **U.S. Cl.** 228/119; 228/175; 228/246; 29/402.13; 29/889.1
- [58] **Field of Search** 228/119, 246, 247, 254, 228/173.5, 175; 29/402.11, 402.09, 402.13, 402.16, 889.1; 416/230 A, 230 R

The present invention discloses a method for repairing metal edges using wire and a braze alloy. Using this method, it is possible to restore a damaged metal edge to blueprint dimensions. In the preferred embodiment, the disclosed method relates to the restoration of damaged or worn turbine vanes. The method comprises a preparation step of cleaning and milling the edge of the base metal to be repaired. A repair wire is then placed along the edge, and a braze compound is applied to the junction of the base metal and the repair wire. A brazing step follows which integrates the base metal, the wire and the brazing compound. After standard fi

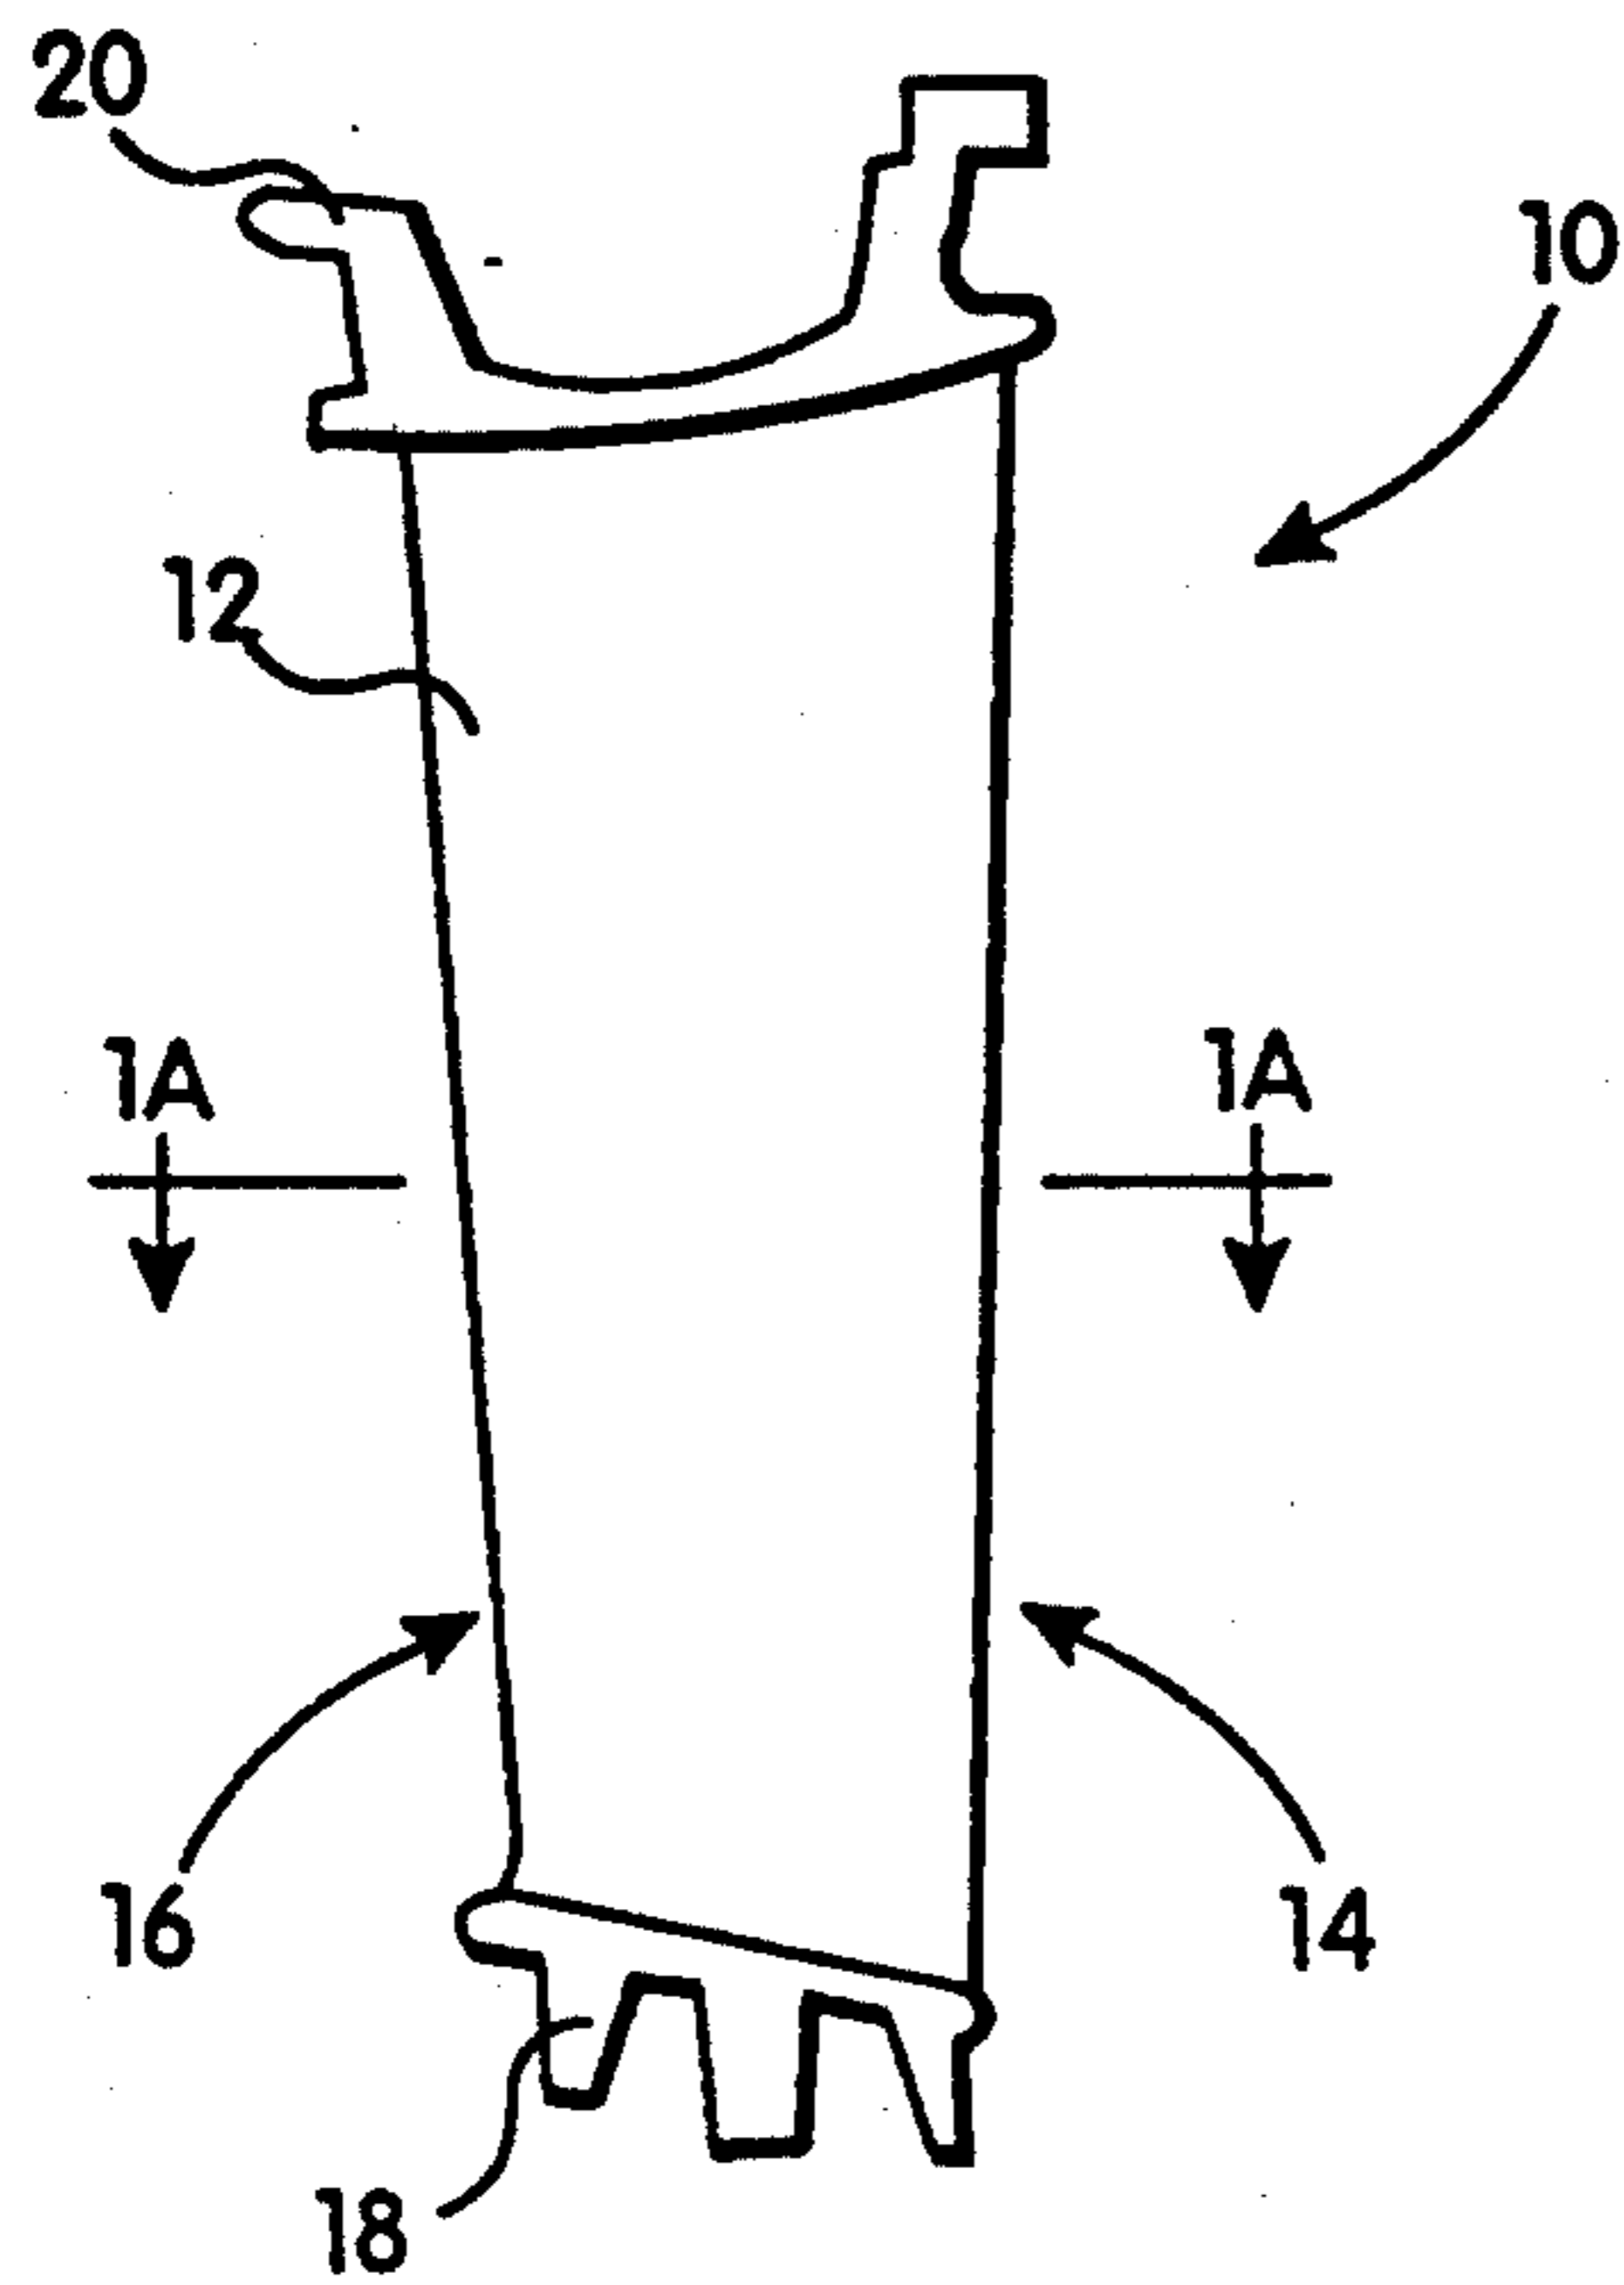
Fig. 1

FIG. 1 is a plan view of an undamaged turbine vane assembly;

With reference now to FIG. 1, a turbine vane assembly 10 is shown with a turbine vane 12, having a trailing edge 14 and a leading edge 16, attached to an inner foot 18 and an outer foot 20 which serve to anchor the vane 12 in position within the turbine. The line A—A' represents a cross-section through the vane 12. Referring also to FIG. 1(A), the cross-section of the vane 12 indicated by line A—A' in FIG. 1 is shown, with the vane chord width at this location being represented by the line B—B'. The leading edge 16, the trailing edge 14, and vane thickness 22 are typical wear areas in the vane 12.

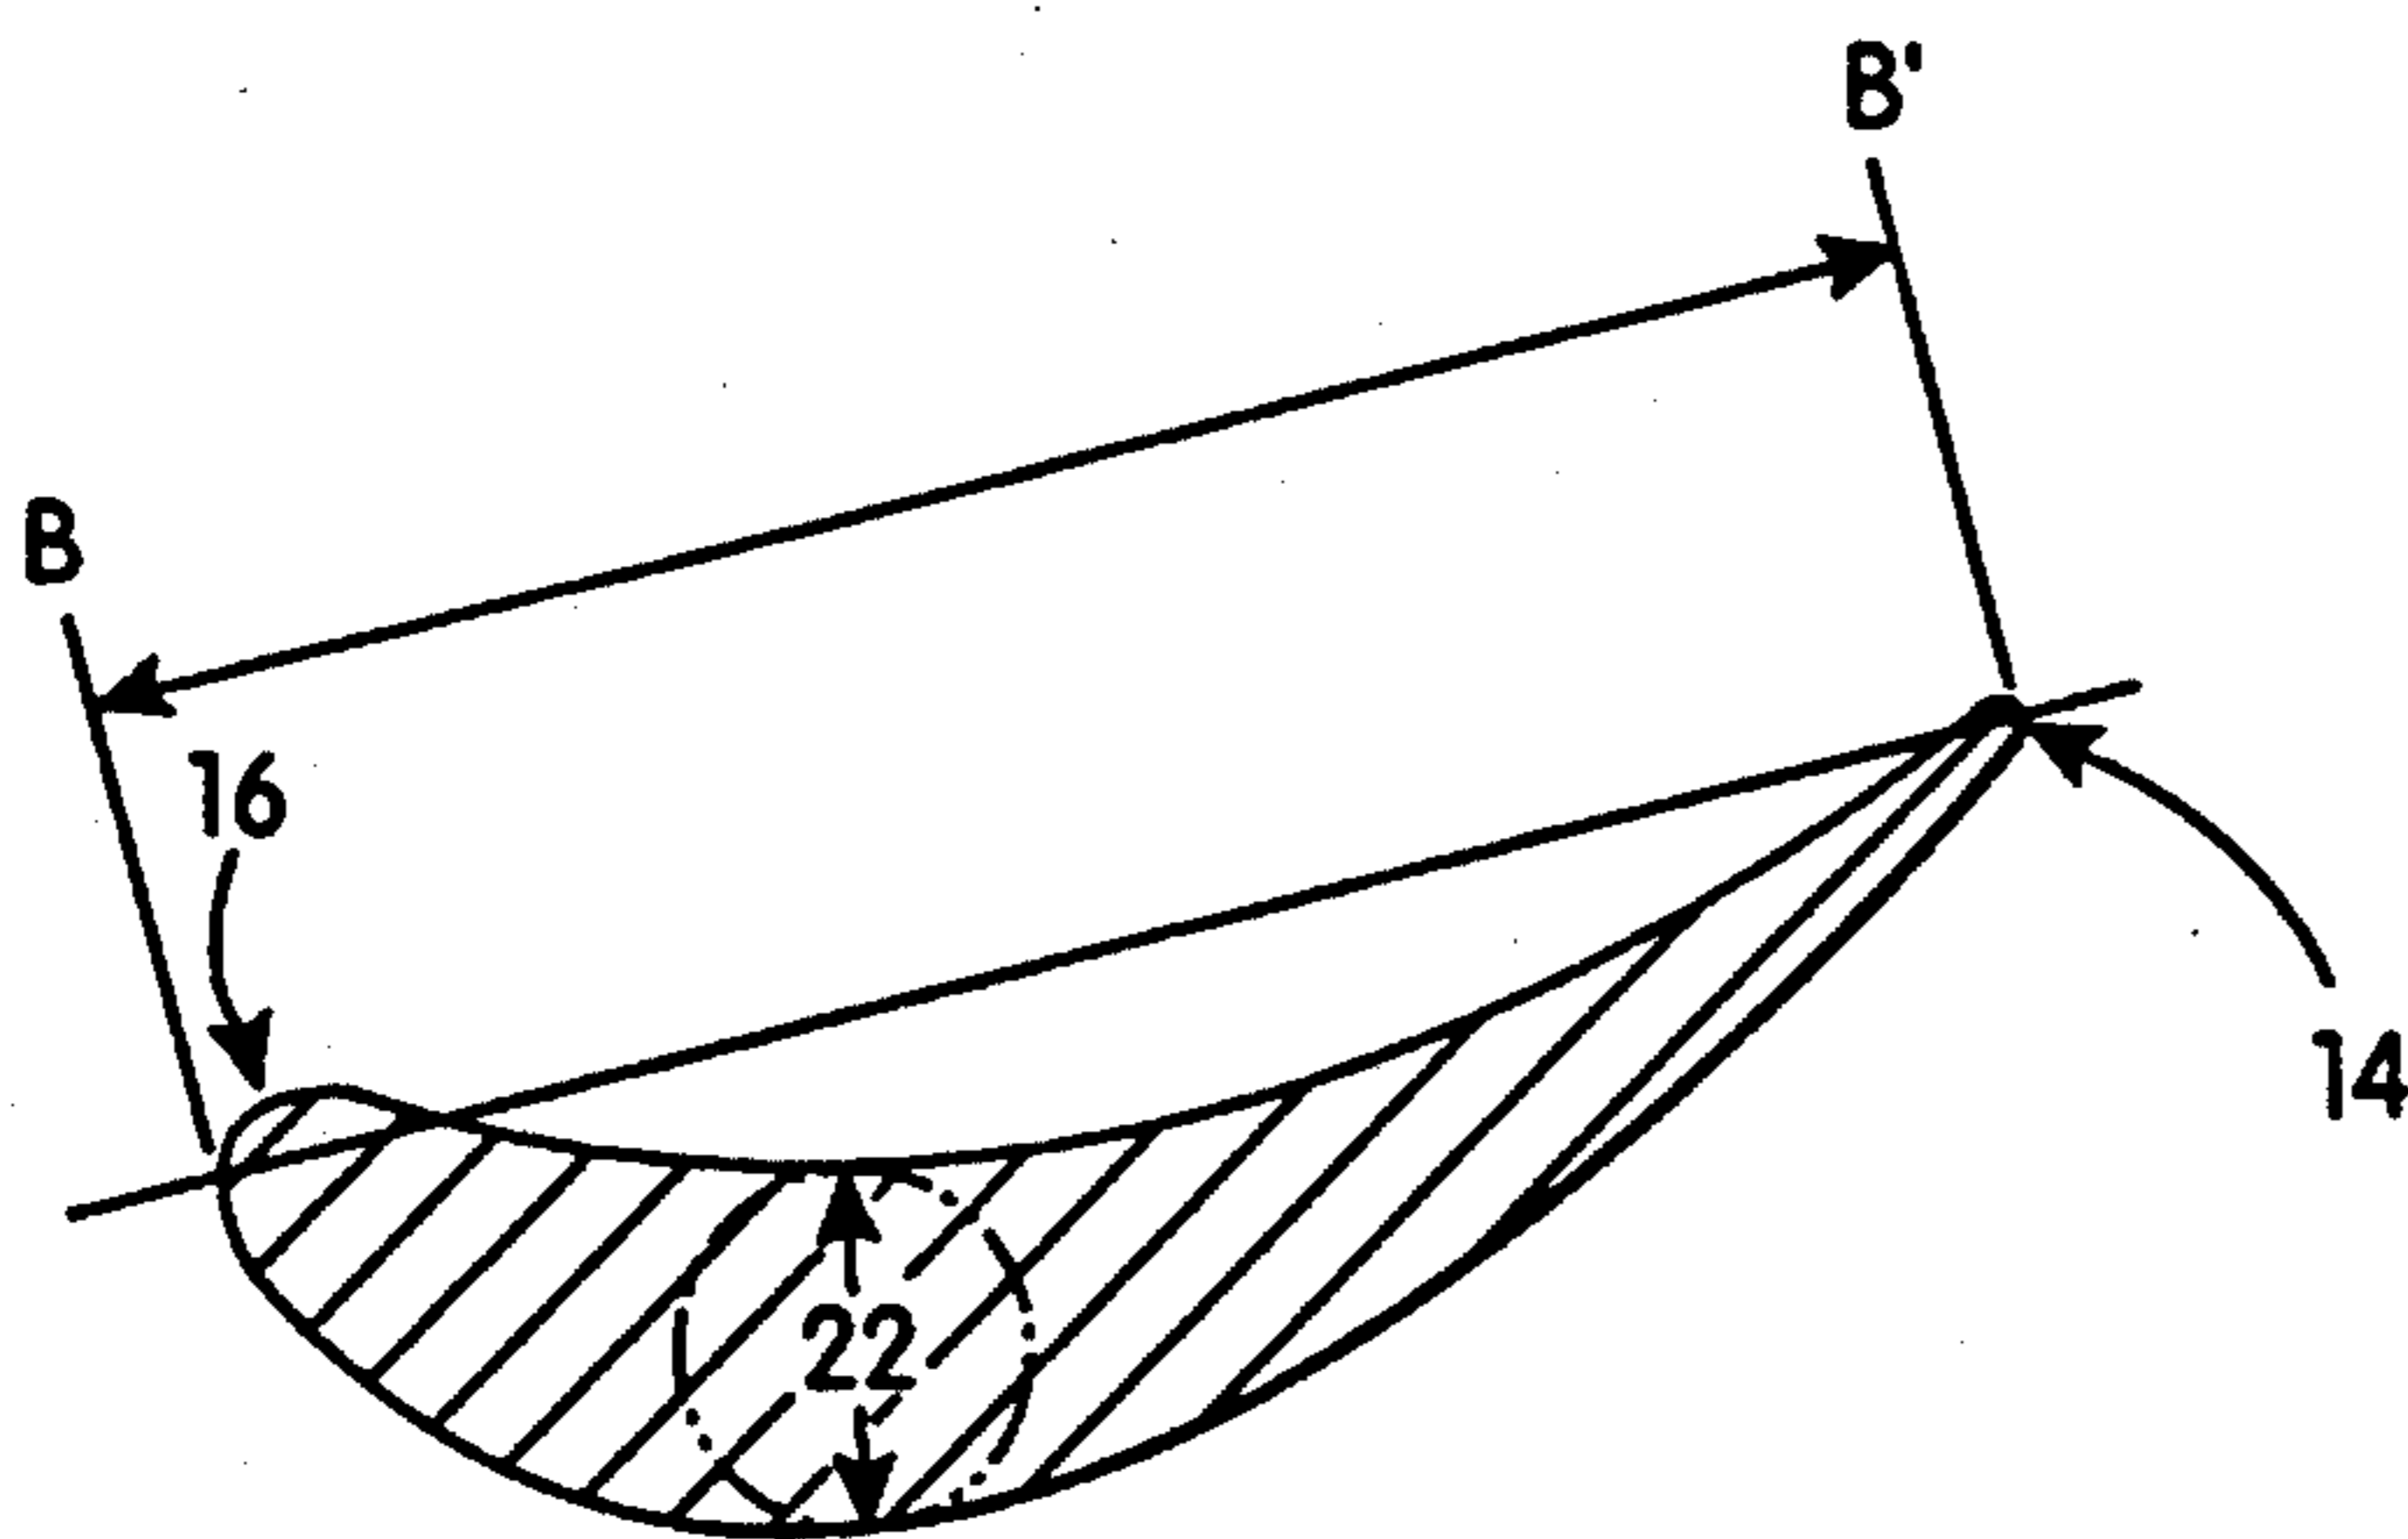
Fig. 1A

FIG. 1(A) is a representative cross-sectional view of the turbine vane assembly of FIG. 1 taken along line A—A' of FIG. 1;

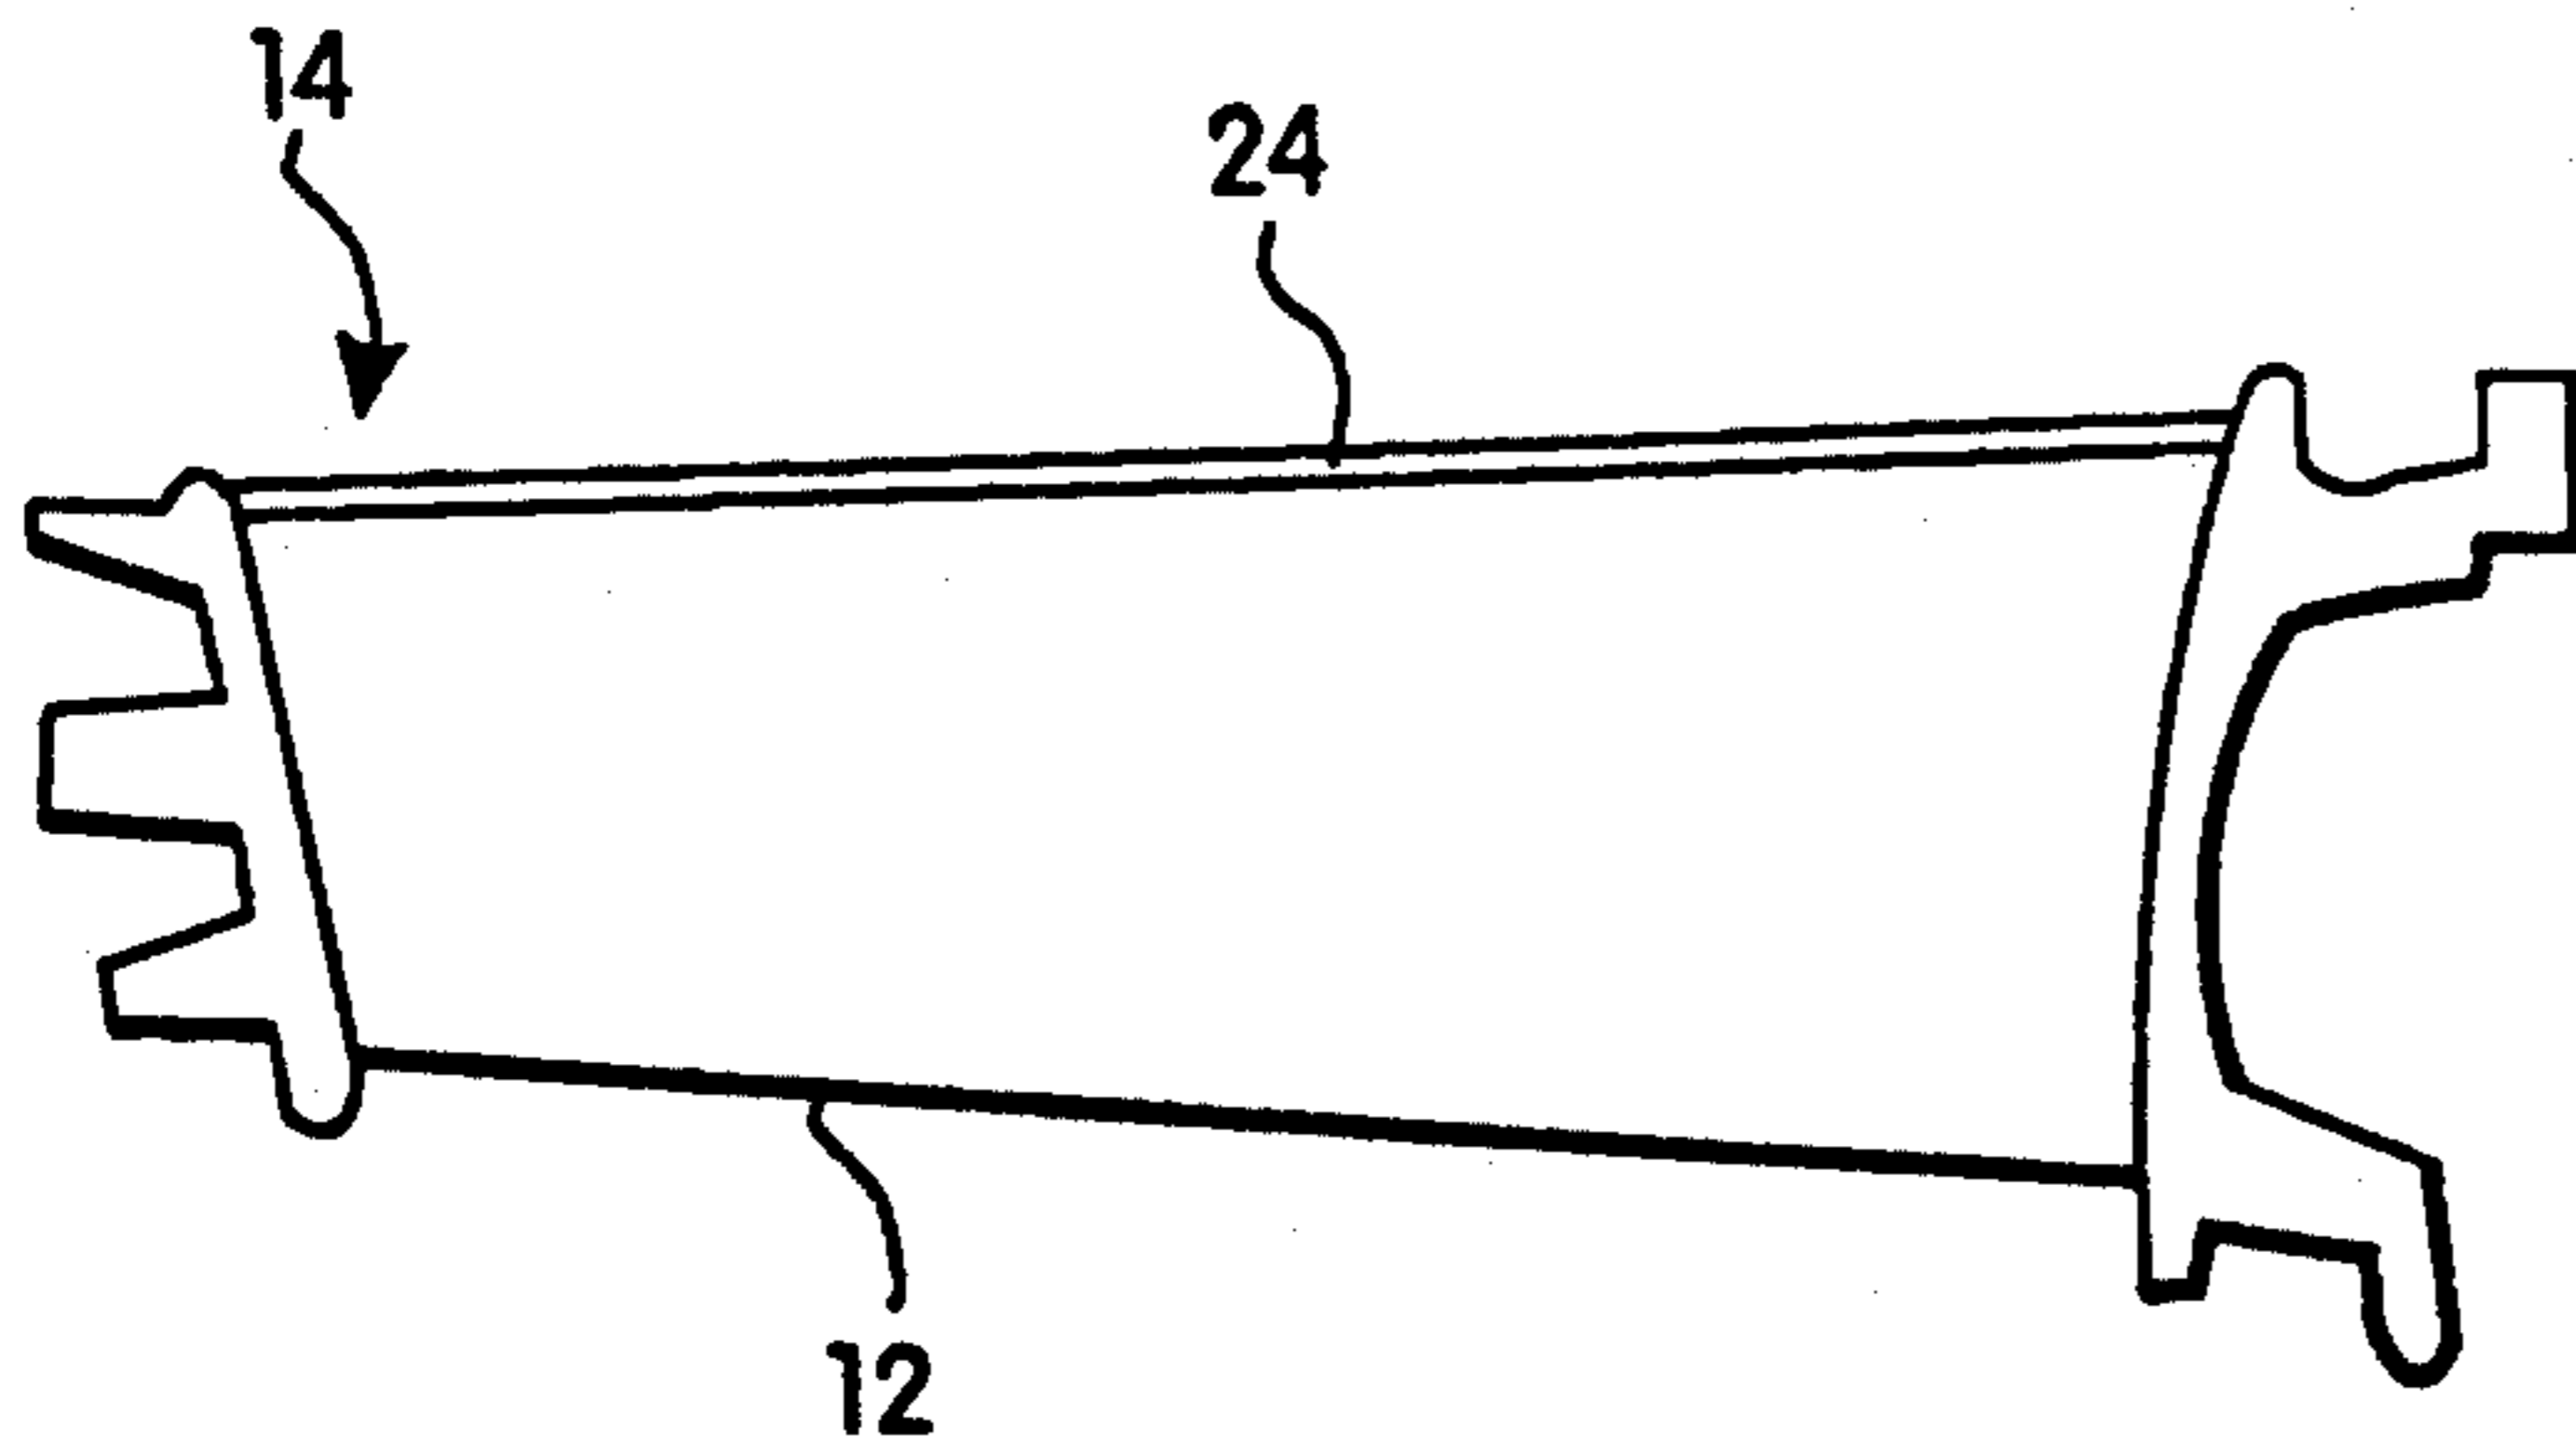
Fig. 2

FIG. 2 is a plan view of a damaged vane showing the placement of a repair wire used in performing wire repair;

Referring to FIG. 2, in the preferred embodiment, for example to repair the trailing edge 14, any coatings on the vane 12 are removed prior to a visual inspection to ensure the vane is a suitable candidate for repair. The point of maximum chord width is then determined along the trailing edge 14 of the vane. The trailing edge 14 is then milled back to accept a repair wire 24. Typically no more than 0.015 inches will be removed to accept repair wires 24 of varying diameter. The vane is then cleaned by a silicon carbide grit or other suitable blast media.

The vane 12 with a damaged trailing edge 14 is shown in FIG. 2 with repair wire 24 anchored in position adjacent to the edge 14 to be repaired. In one embodiment, a super alloy, Aerospace Material Specification (AMS) 5391, is the base metal of the turbine vane 12 subject to repair. A section of metallurgically compatible weld wire 24, here AMS 5837, is cut to match the entire trailing edge 14 of the vane 12. The weld wire 24 is tack welded along the trailing edge 14 with three tack welds, one at each end and one in the center of the vane 12. To optimize the later brazing step, a maximum of 0.010 inch gap is allowed between wire 24 and trailing edge 14. The welding is performed in a dry box weld chamber filled with an argon.

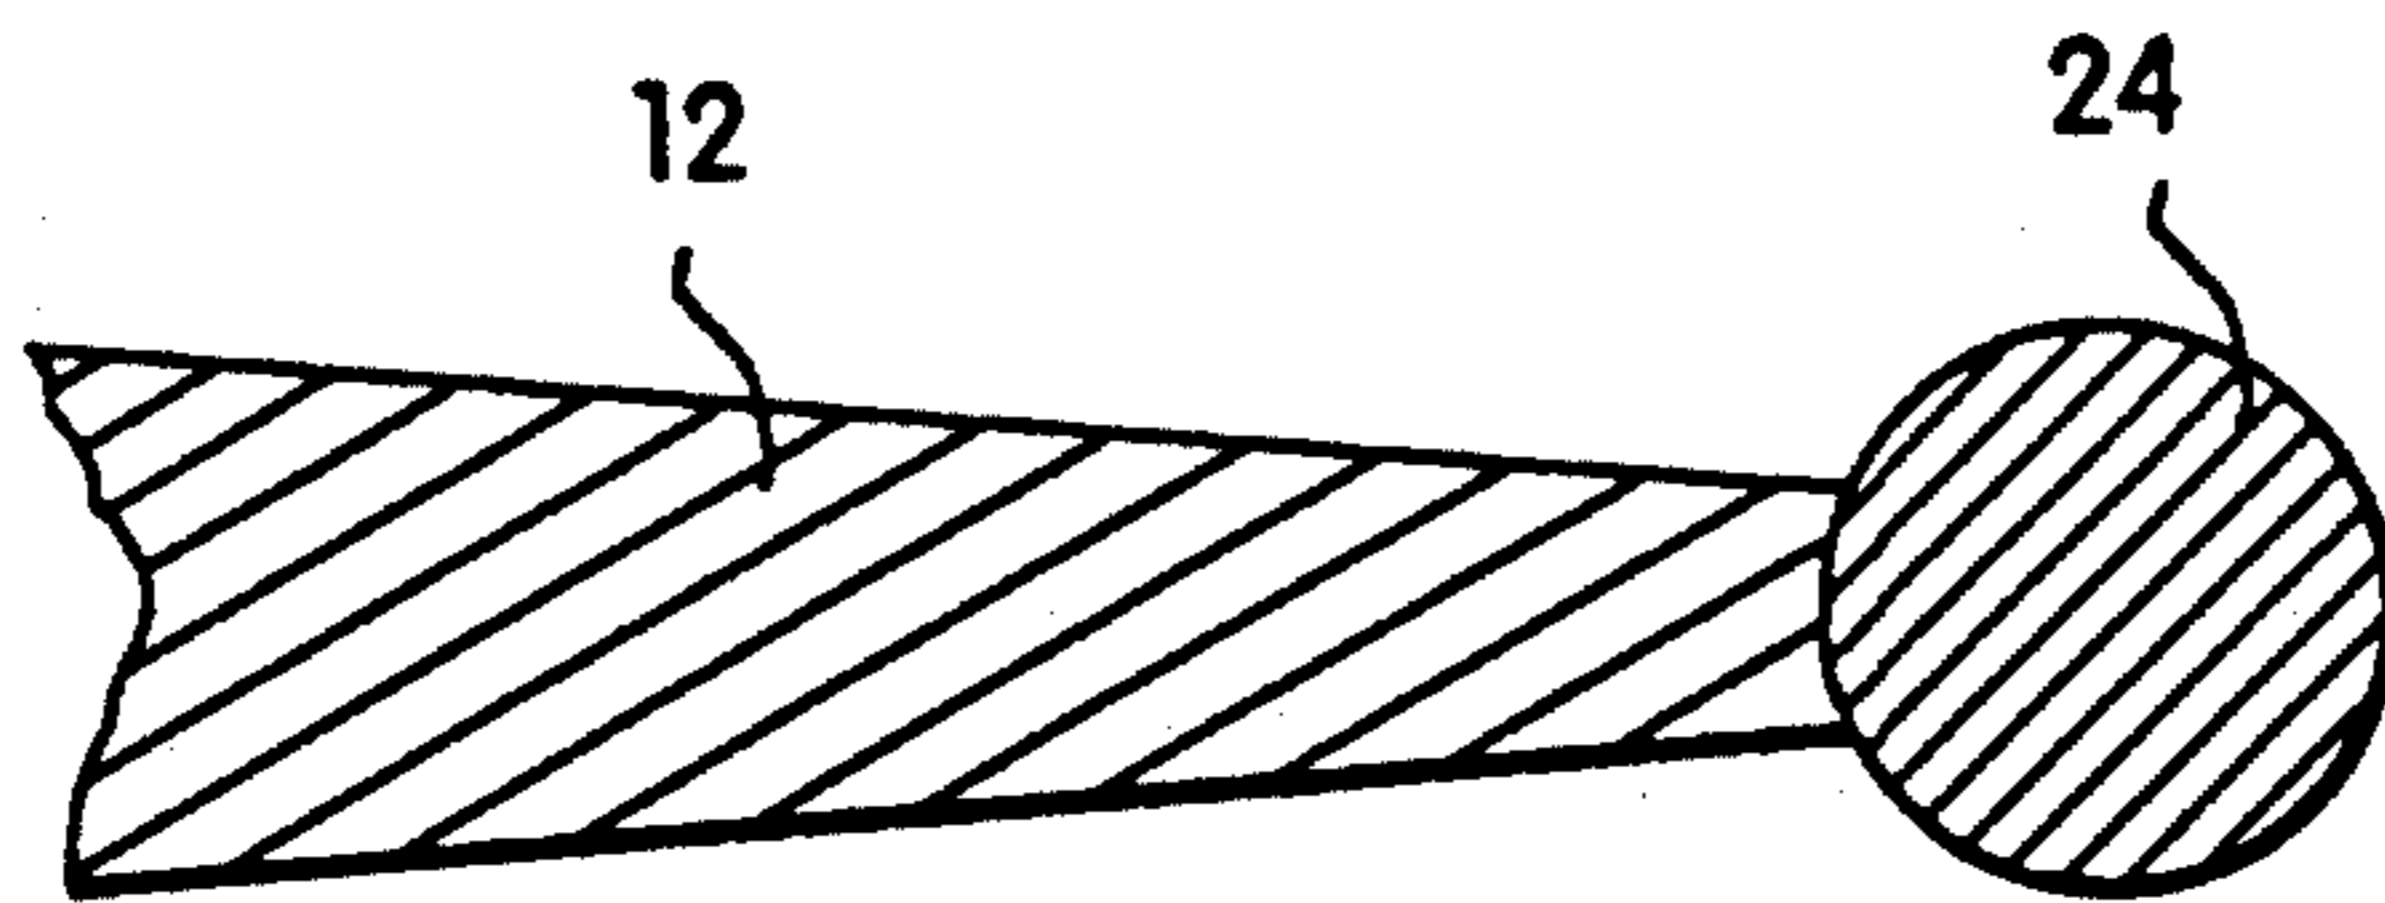
Fig. 2A

FIG. 2(A) is a cross-sectional view of the trailing edge of the vane shown in FIG. 2;

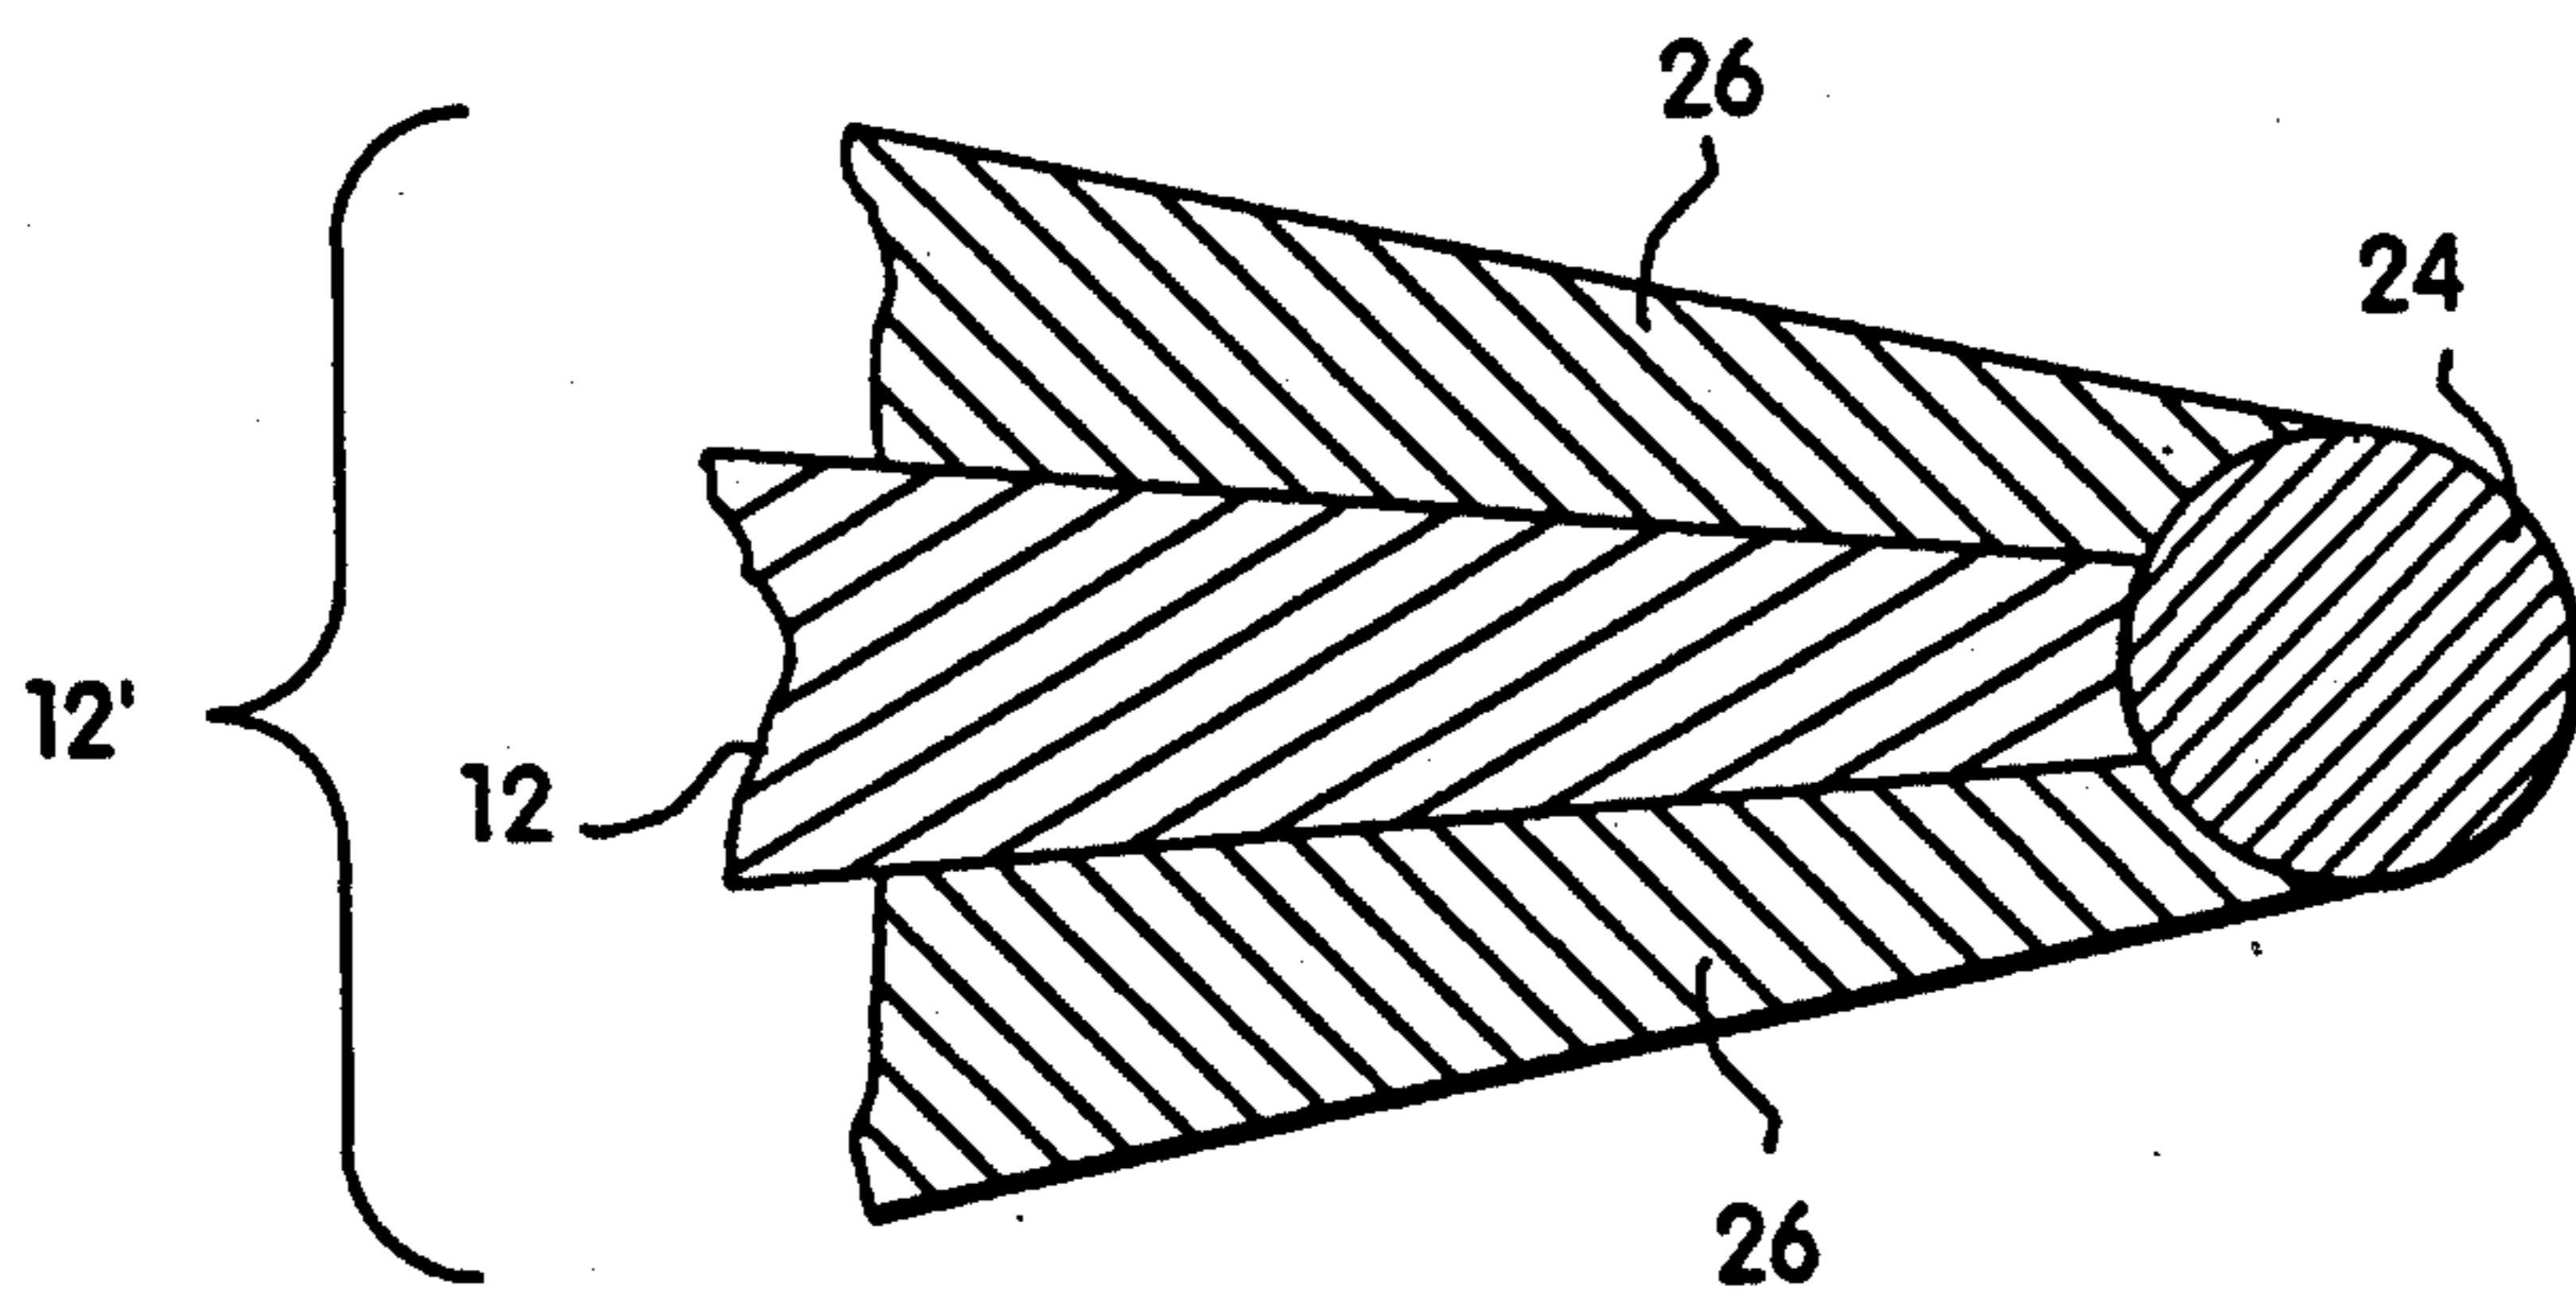
Fig. 2B

FIG. 2(B) is a cross-sectional view of the trailing edge of the vane shown in FIG. 2 after application of the braze alloy; and

Referring now to FIG. 2(B), the built-up vane 12' is shown in cross-section with wire 24 in place. Braze compound 26, a material developed to be compatible with base material 12, wire 24, and protective coating 28, has been applied in sufficient quantity to cover the joined area, the wire 24 and a portion of the vane 12. The braze compound material 26 is applied in sufficient thickness to allow for blending and to achieve the required dimensions after brazing.

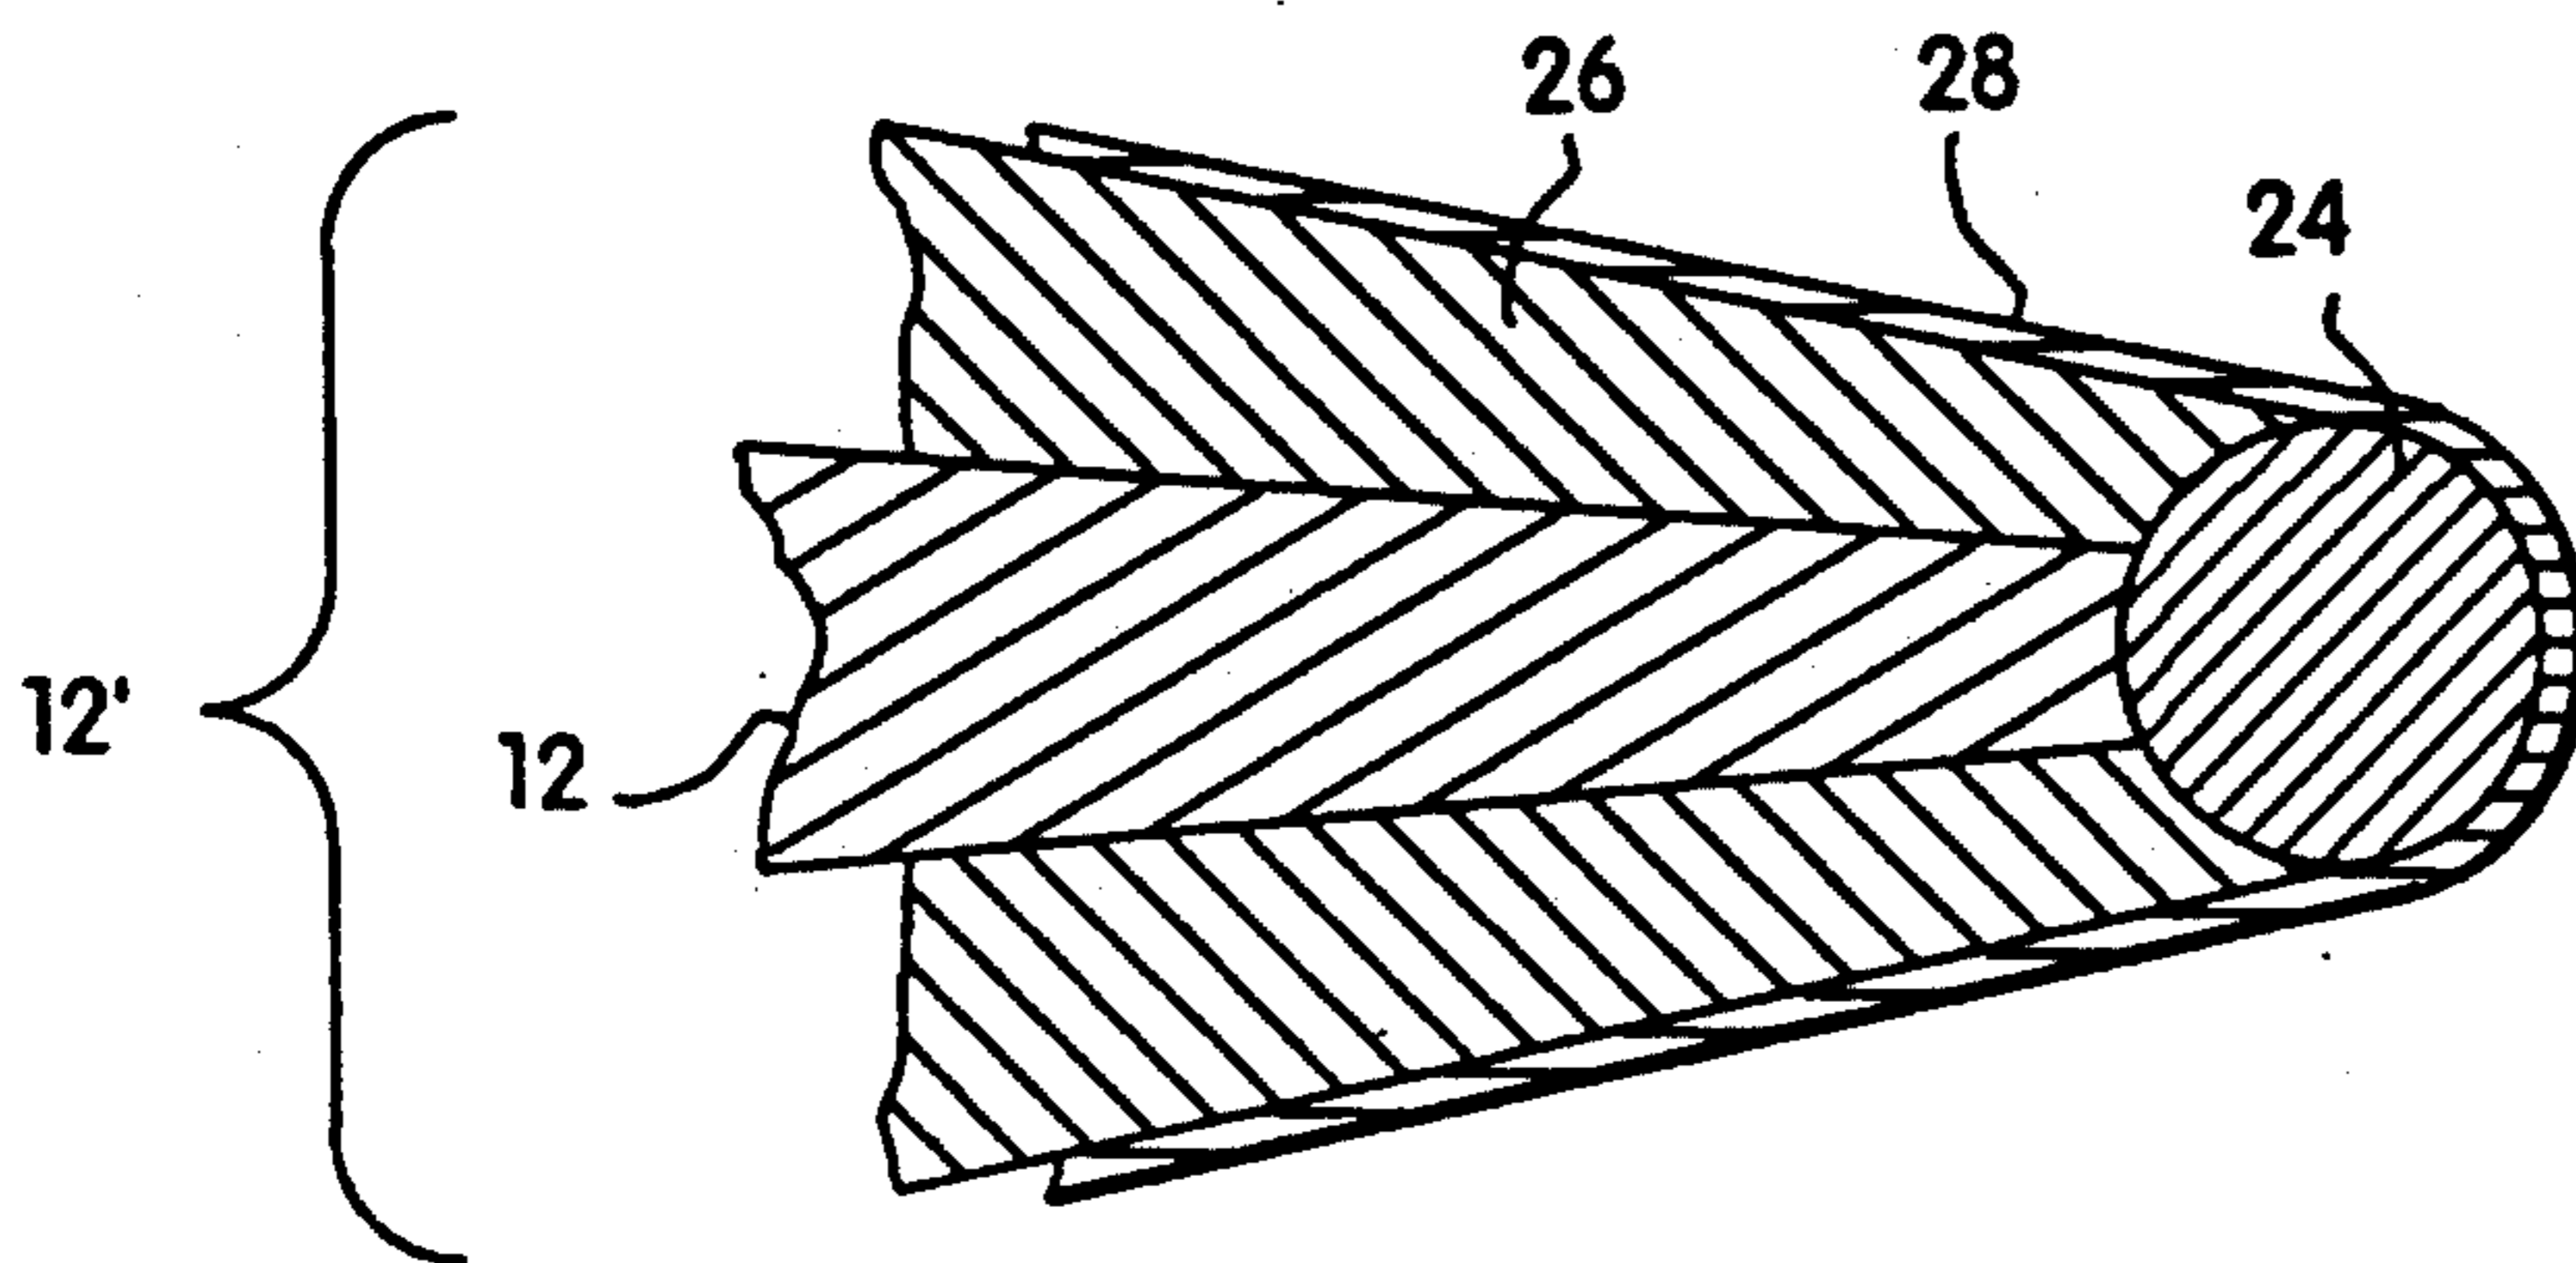
Fig. 2C

FIG. 2(C) is a cross-sectional view of the vane of FIG. 2(B) after completion of wire repair.

Referring to FIG. 2(C) a sectional view of the vane 12' at the completion of wire repair is shown. The original vane 12, having been worn to below design specification, has been built-up with wire 24, braze 26, and protective coating 28.
