[11] Patent Number: **5,316,790**

[54] TUNGSTEN DISULFIDE MODIFIED EPOXY

[73] Assignee: Allied-Signal Inc., Morristown, N.J.

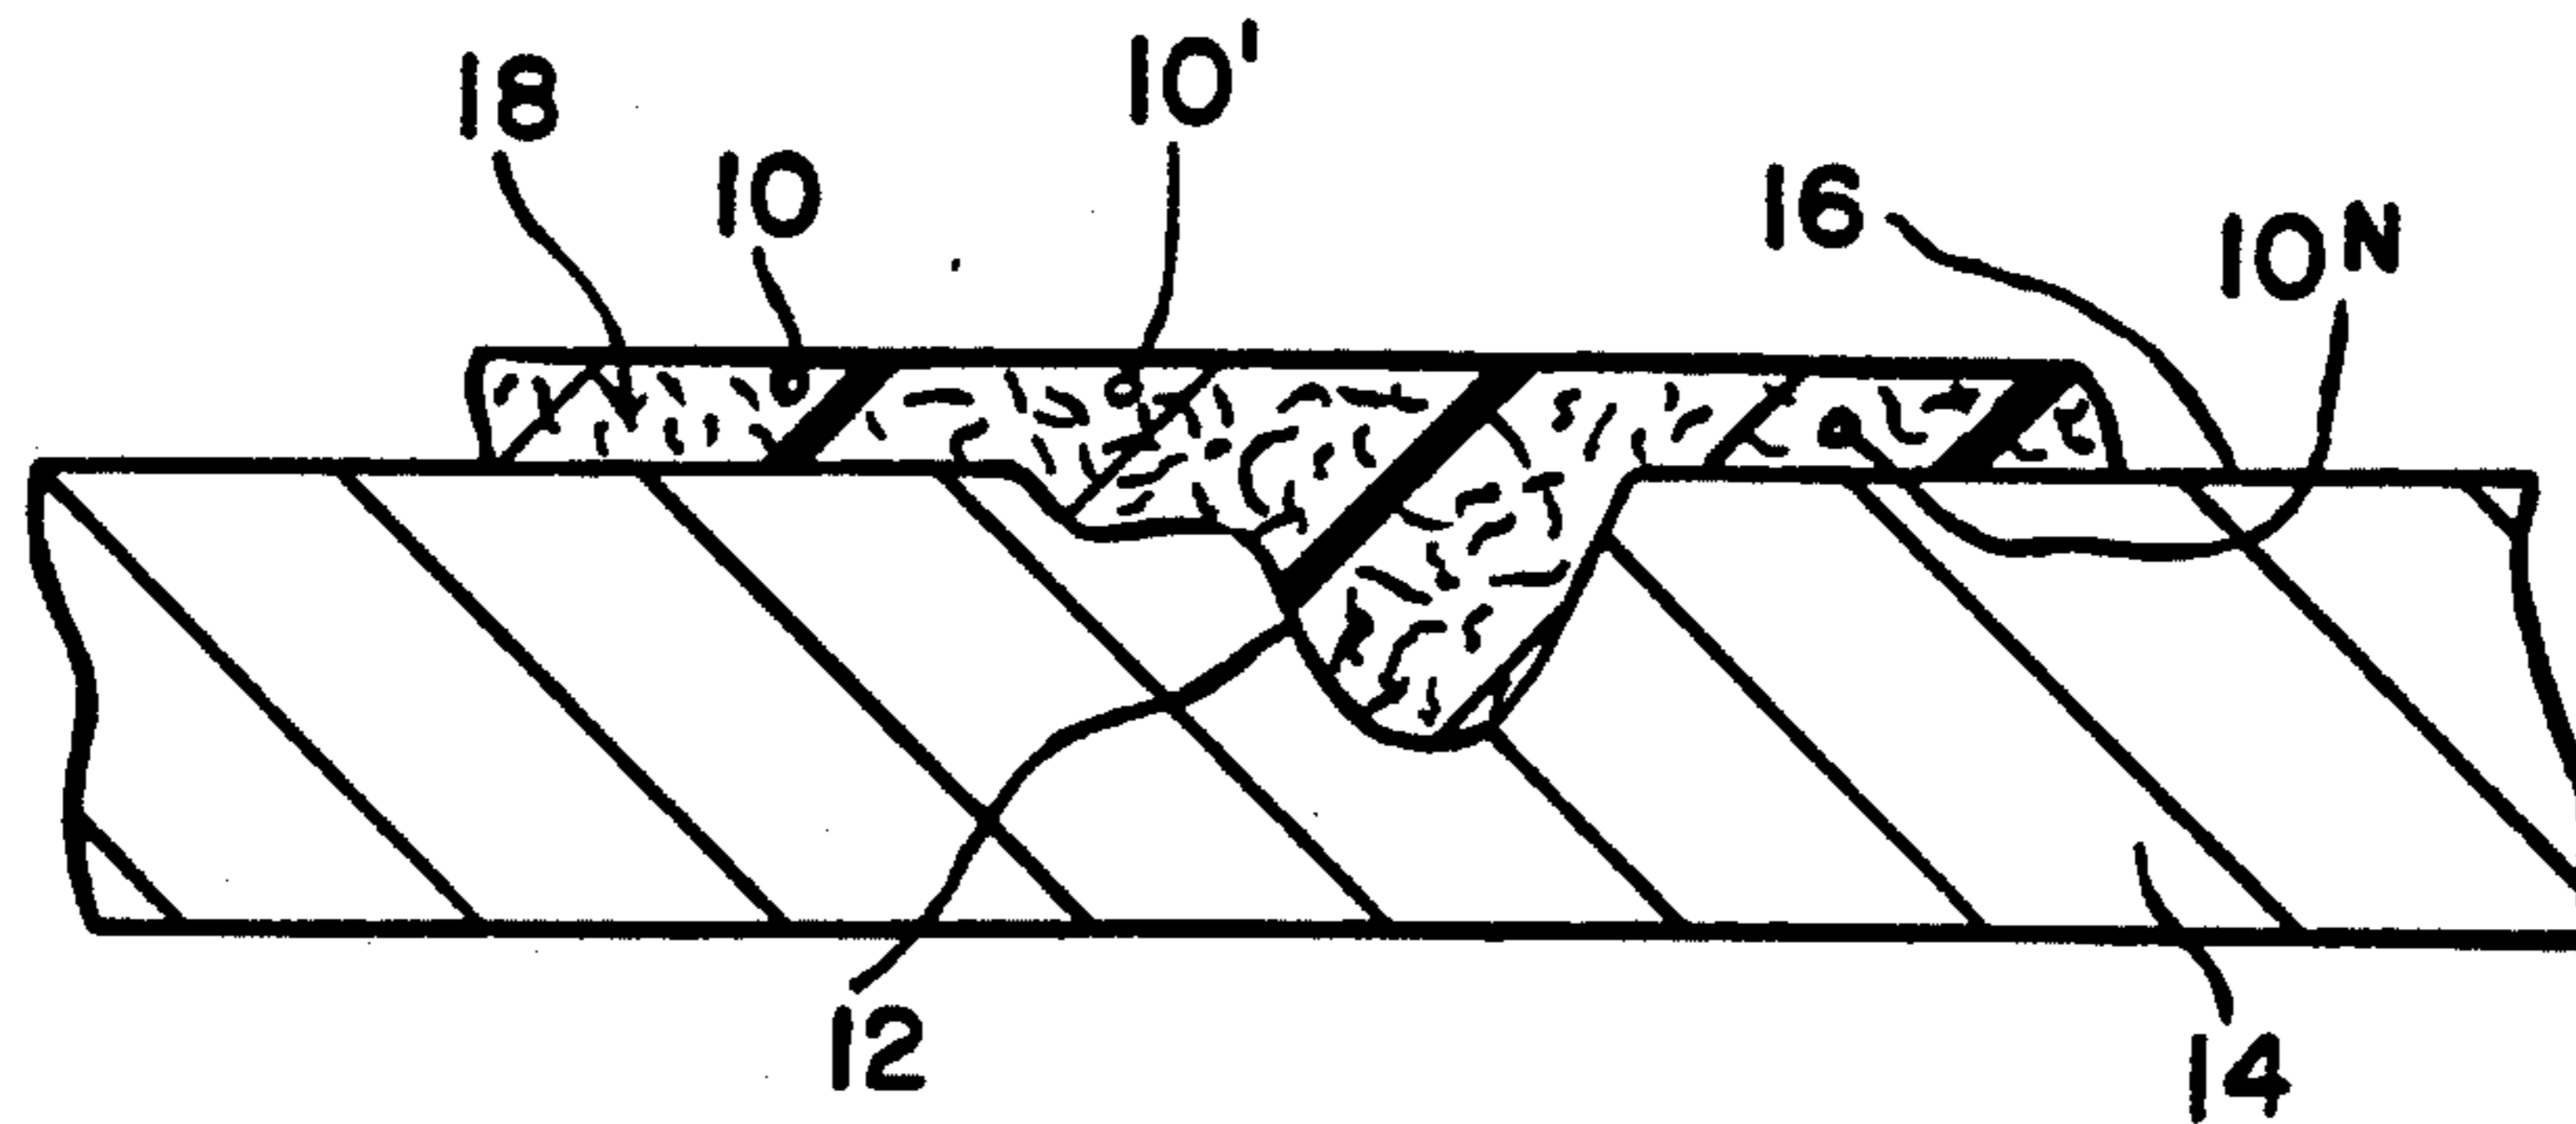
FIG. 1 is an illustration of a substrate having a filler applied thereto to restore a surface to an operational condition;

FIG. 1 illustrates a cross section of an aluminum strip 14 having a surface 16 with a surface defect 12 which was filled with the tungsten disulfide modified epoxy mixture 18 with a plurality of voids 10, 10' . . . 10" therein. From investigation it was determined that the voids 10, 10' . . . 10" and resulting porosity in the restoration material is primarily the result of evaporation of the solvent IPA during the curing of the modified epoxy mixture.

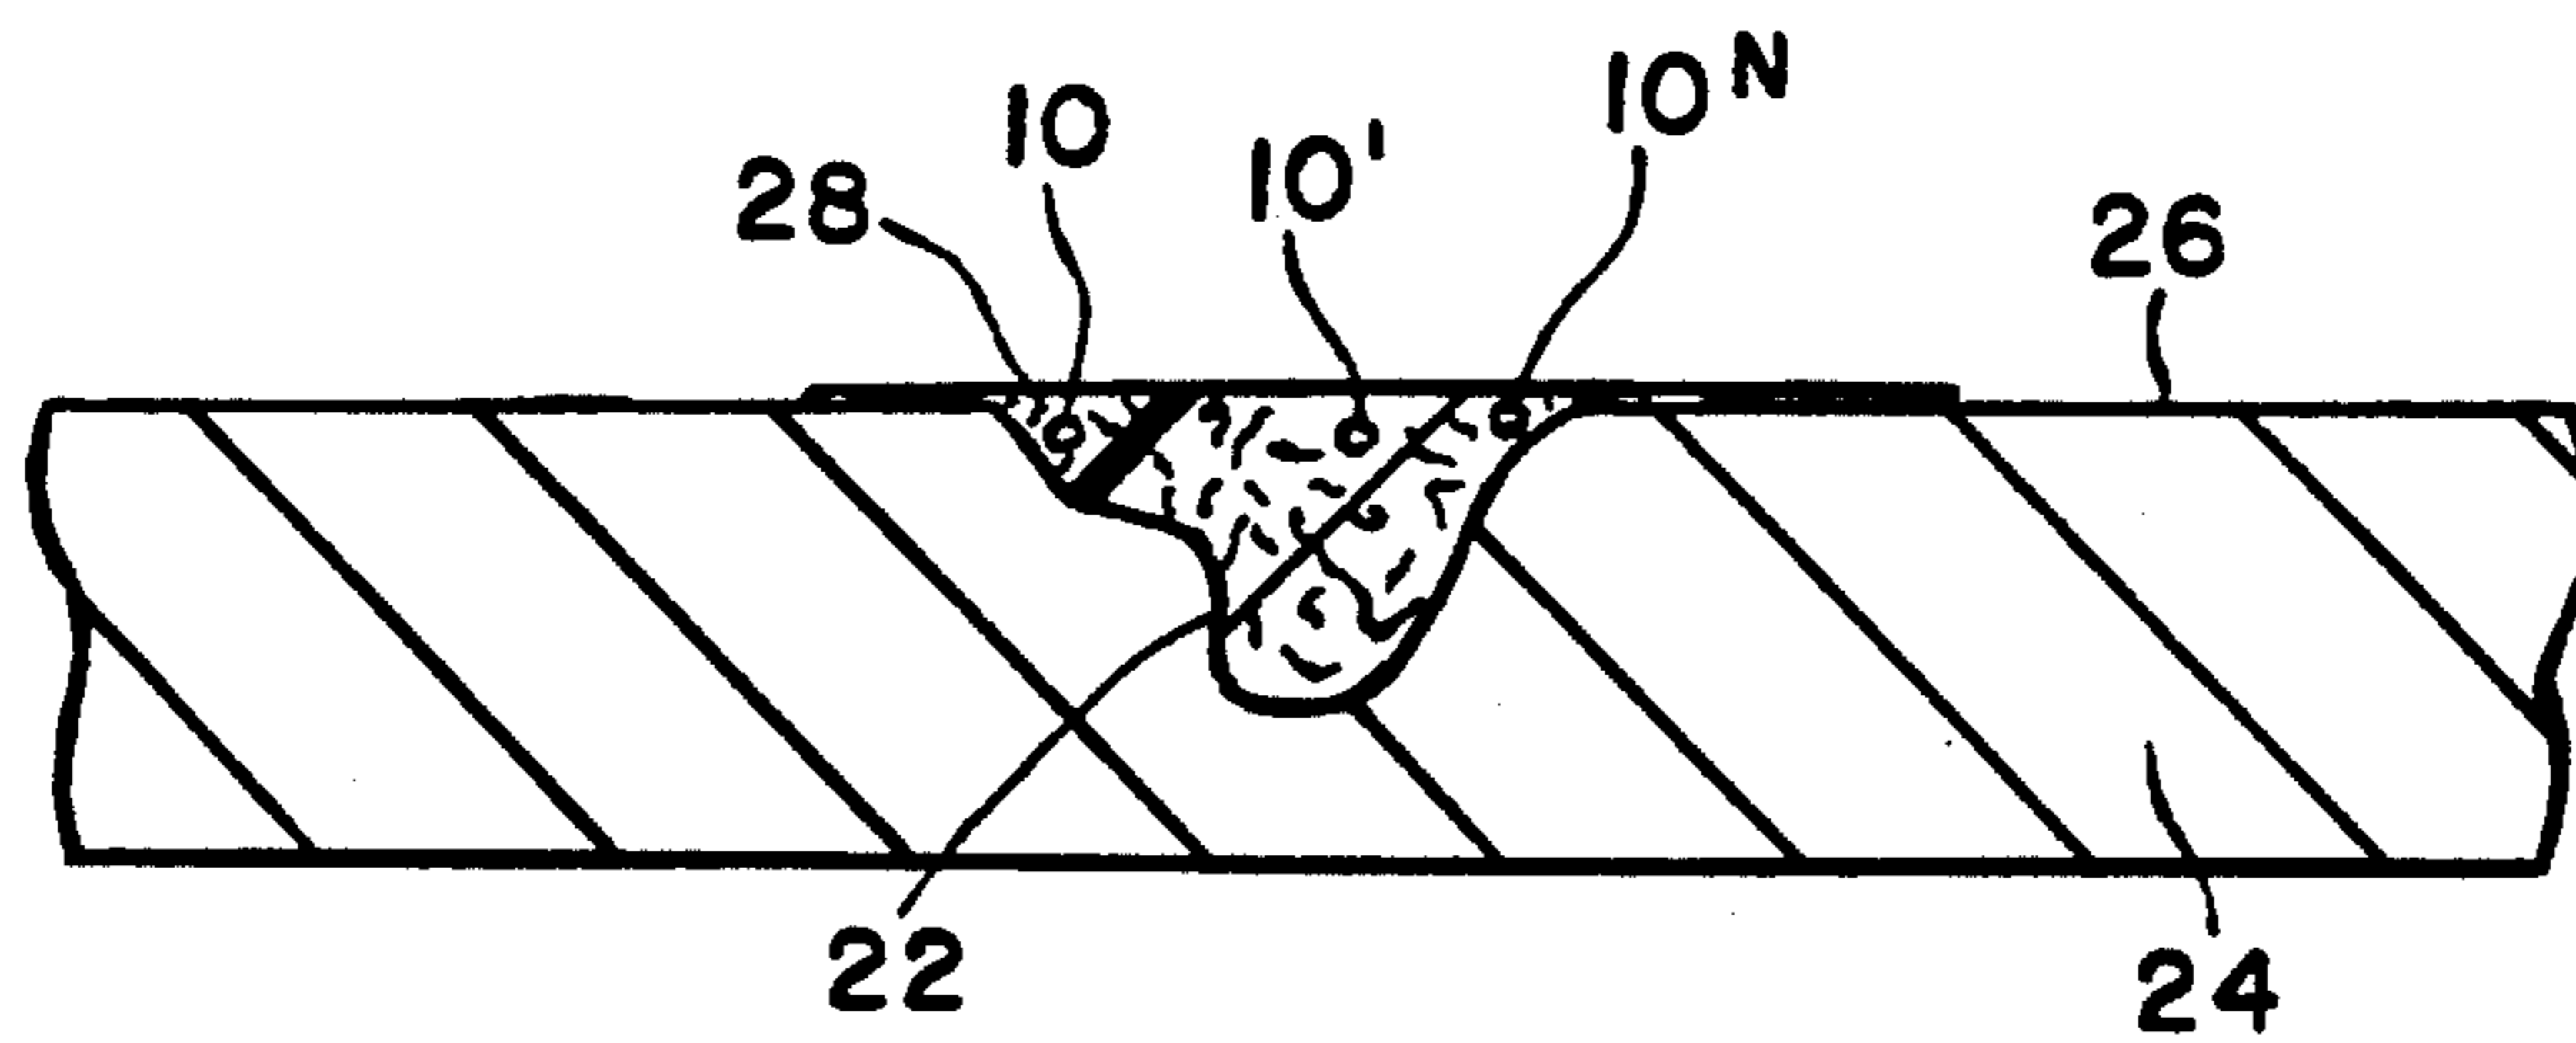
FIG. 2 is an illustration of a substrate having a filler material applied to restore a surface to an operational condition in accordance with the principals of this invention;

In order to reduce the amount of porosity in the restored area on surface 16, it was determined that the modified epoxy mixture 18 must be solvent-free. In addition because of the low coefficient of friction of tungsten disulfide it was determined that the ratio of tungsten disulfide in a mixture could be reduced and still perform in an adequate manner in the restoration of a surface defect or damaged area 12. Thereafter, modified epoxy mixture 28 was made with a 10:1 ratio by weight of epoxy resin (Hysol 929NA) and tungsten disulfide. No IPA was added at any time during the mixing even though additional care was required to assure that a uniform consistency was obtained. Samples and tests were repeated per ASTM D1002 utilizing a two hour ramp rate from room temperature to 300 degrees F. followed by 90 minutes at 300 degrees F. Test results from these samples indicated an average overlap shear strength of 1710 psi was produced through the use of this modified epoxy mixture or resin filler material 28. On examination of the aluminum strip 24 used in these tests and as illustrated in FIG. 2, substantially no voids (approximately a 90% reduction from the modified epoxy mixture 18) were found in the cured modified epoxy mixture 28 used as a filler material for a defect 22 in surface 26 and as a result it can be asserted that this tungsten disulfide modified epoxy and the method of curing the same reduces the resulting porosity in the cured modified epoxy mixture 28 used as a restoration material.

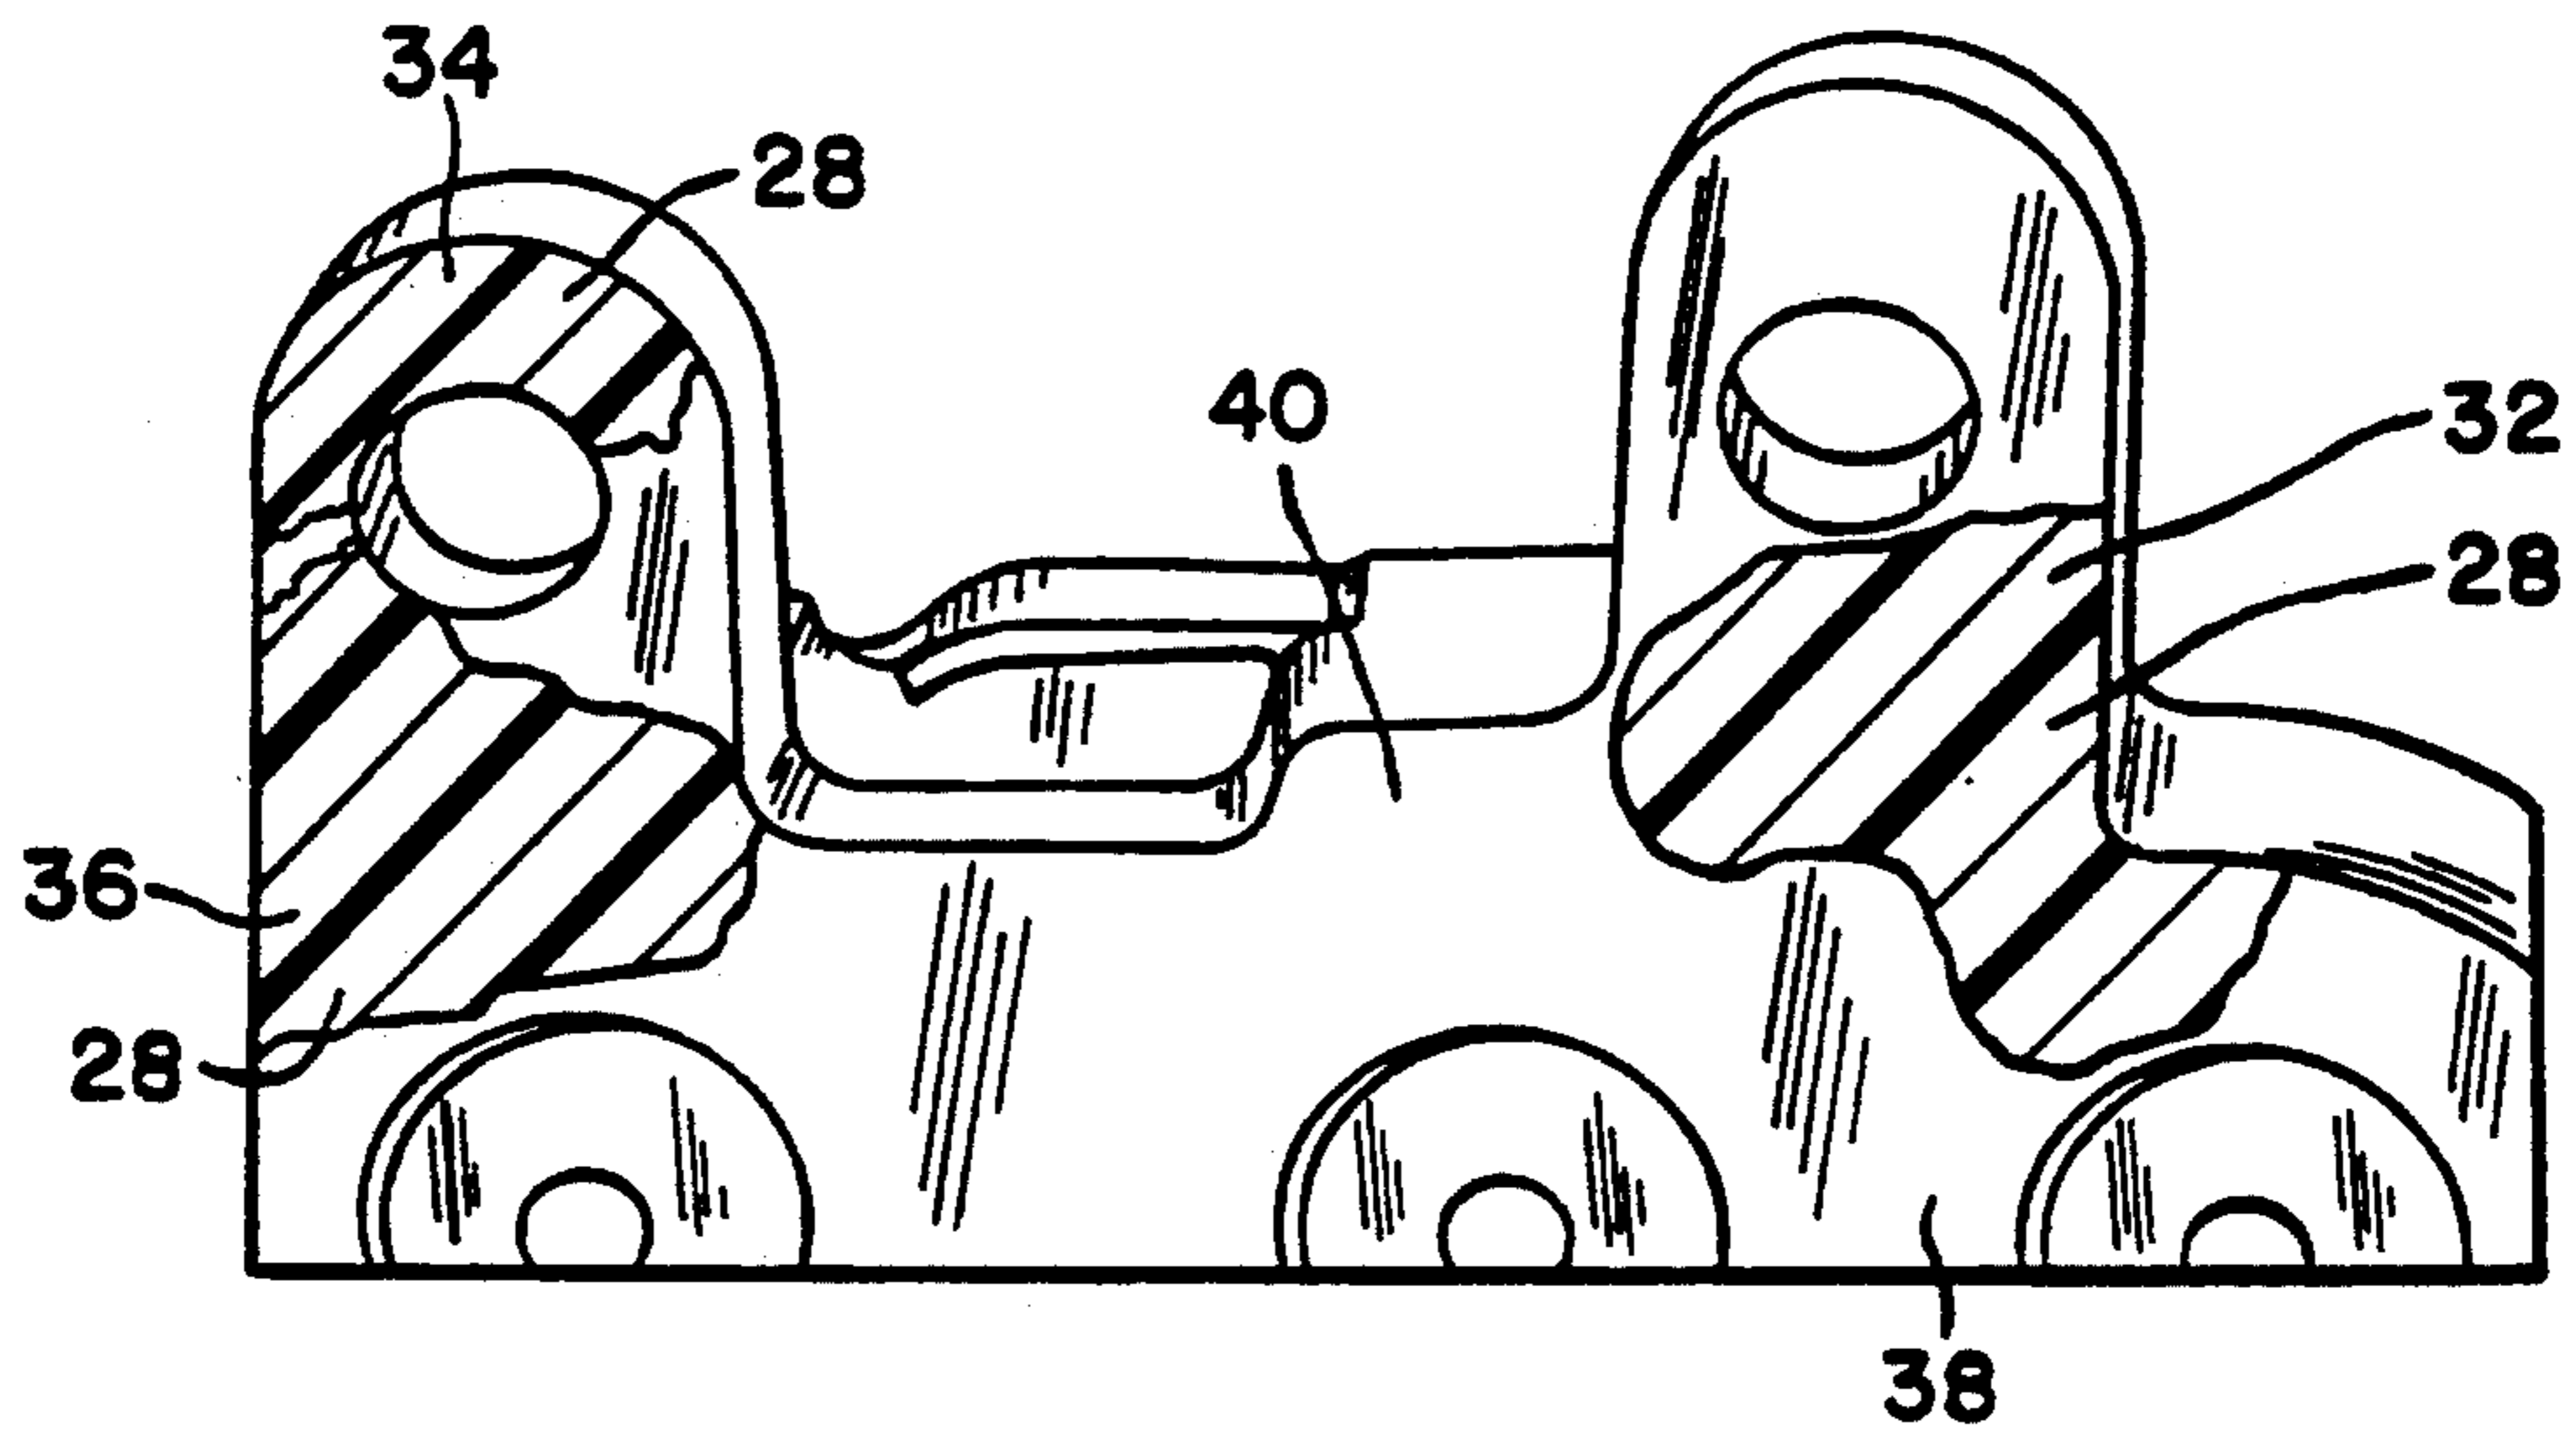
FIG. 3 is a illustration of a metallic member having a surface with a plurality of damaged areas some of which have a filler material made according to the teaching herein applied thereto; and

Thereafter, the modified epoxy mixture 28, made of tungsten disulfide and epoxy resin in the 1:10 ratio, was applied to areas 32, 34 and 36 of a hard anodized aluminum casting 38 that had been damaged, as shown in FIG. 3. Thereafter, the casting 38 was placed in an oven and the temperature uniformly raised to 300 degrees F. in a time period of one hour and maintained at the 300 degree F. temperature for a time period of ninety minutes. The excess epoxy mixture 28 was then machined to the original dimensions of the surface 40 of casting 38 as shown in FIG. 4. No difficulties were encountered during the machining process to remove excessive cured modified epoxy mixture 28 from casting 38 nor during machining did the epoxy mixture 28 delaminate as the damaged area was being sized to an restored condition. Visual inspection of the restored surface indicate that the damaged areas 32, 34 and 36 were successfully repaired with a negligible surface porosity of less than one percent of the surface area.

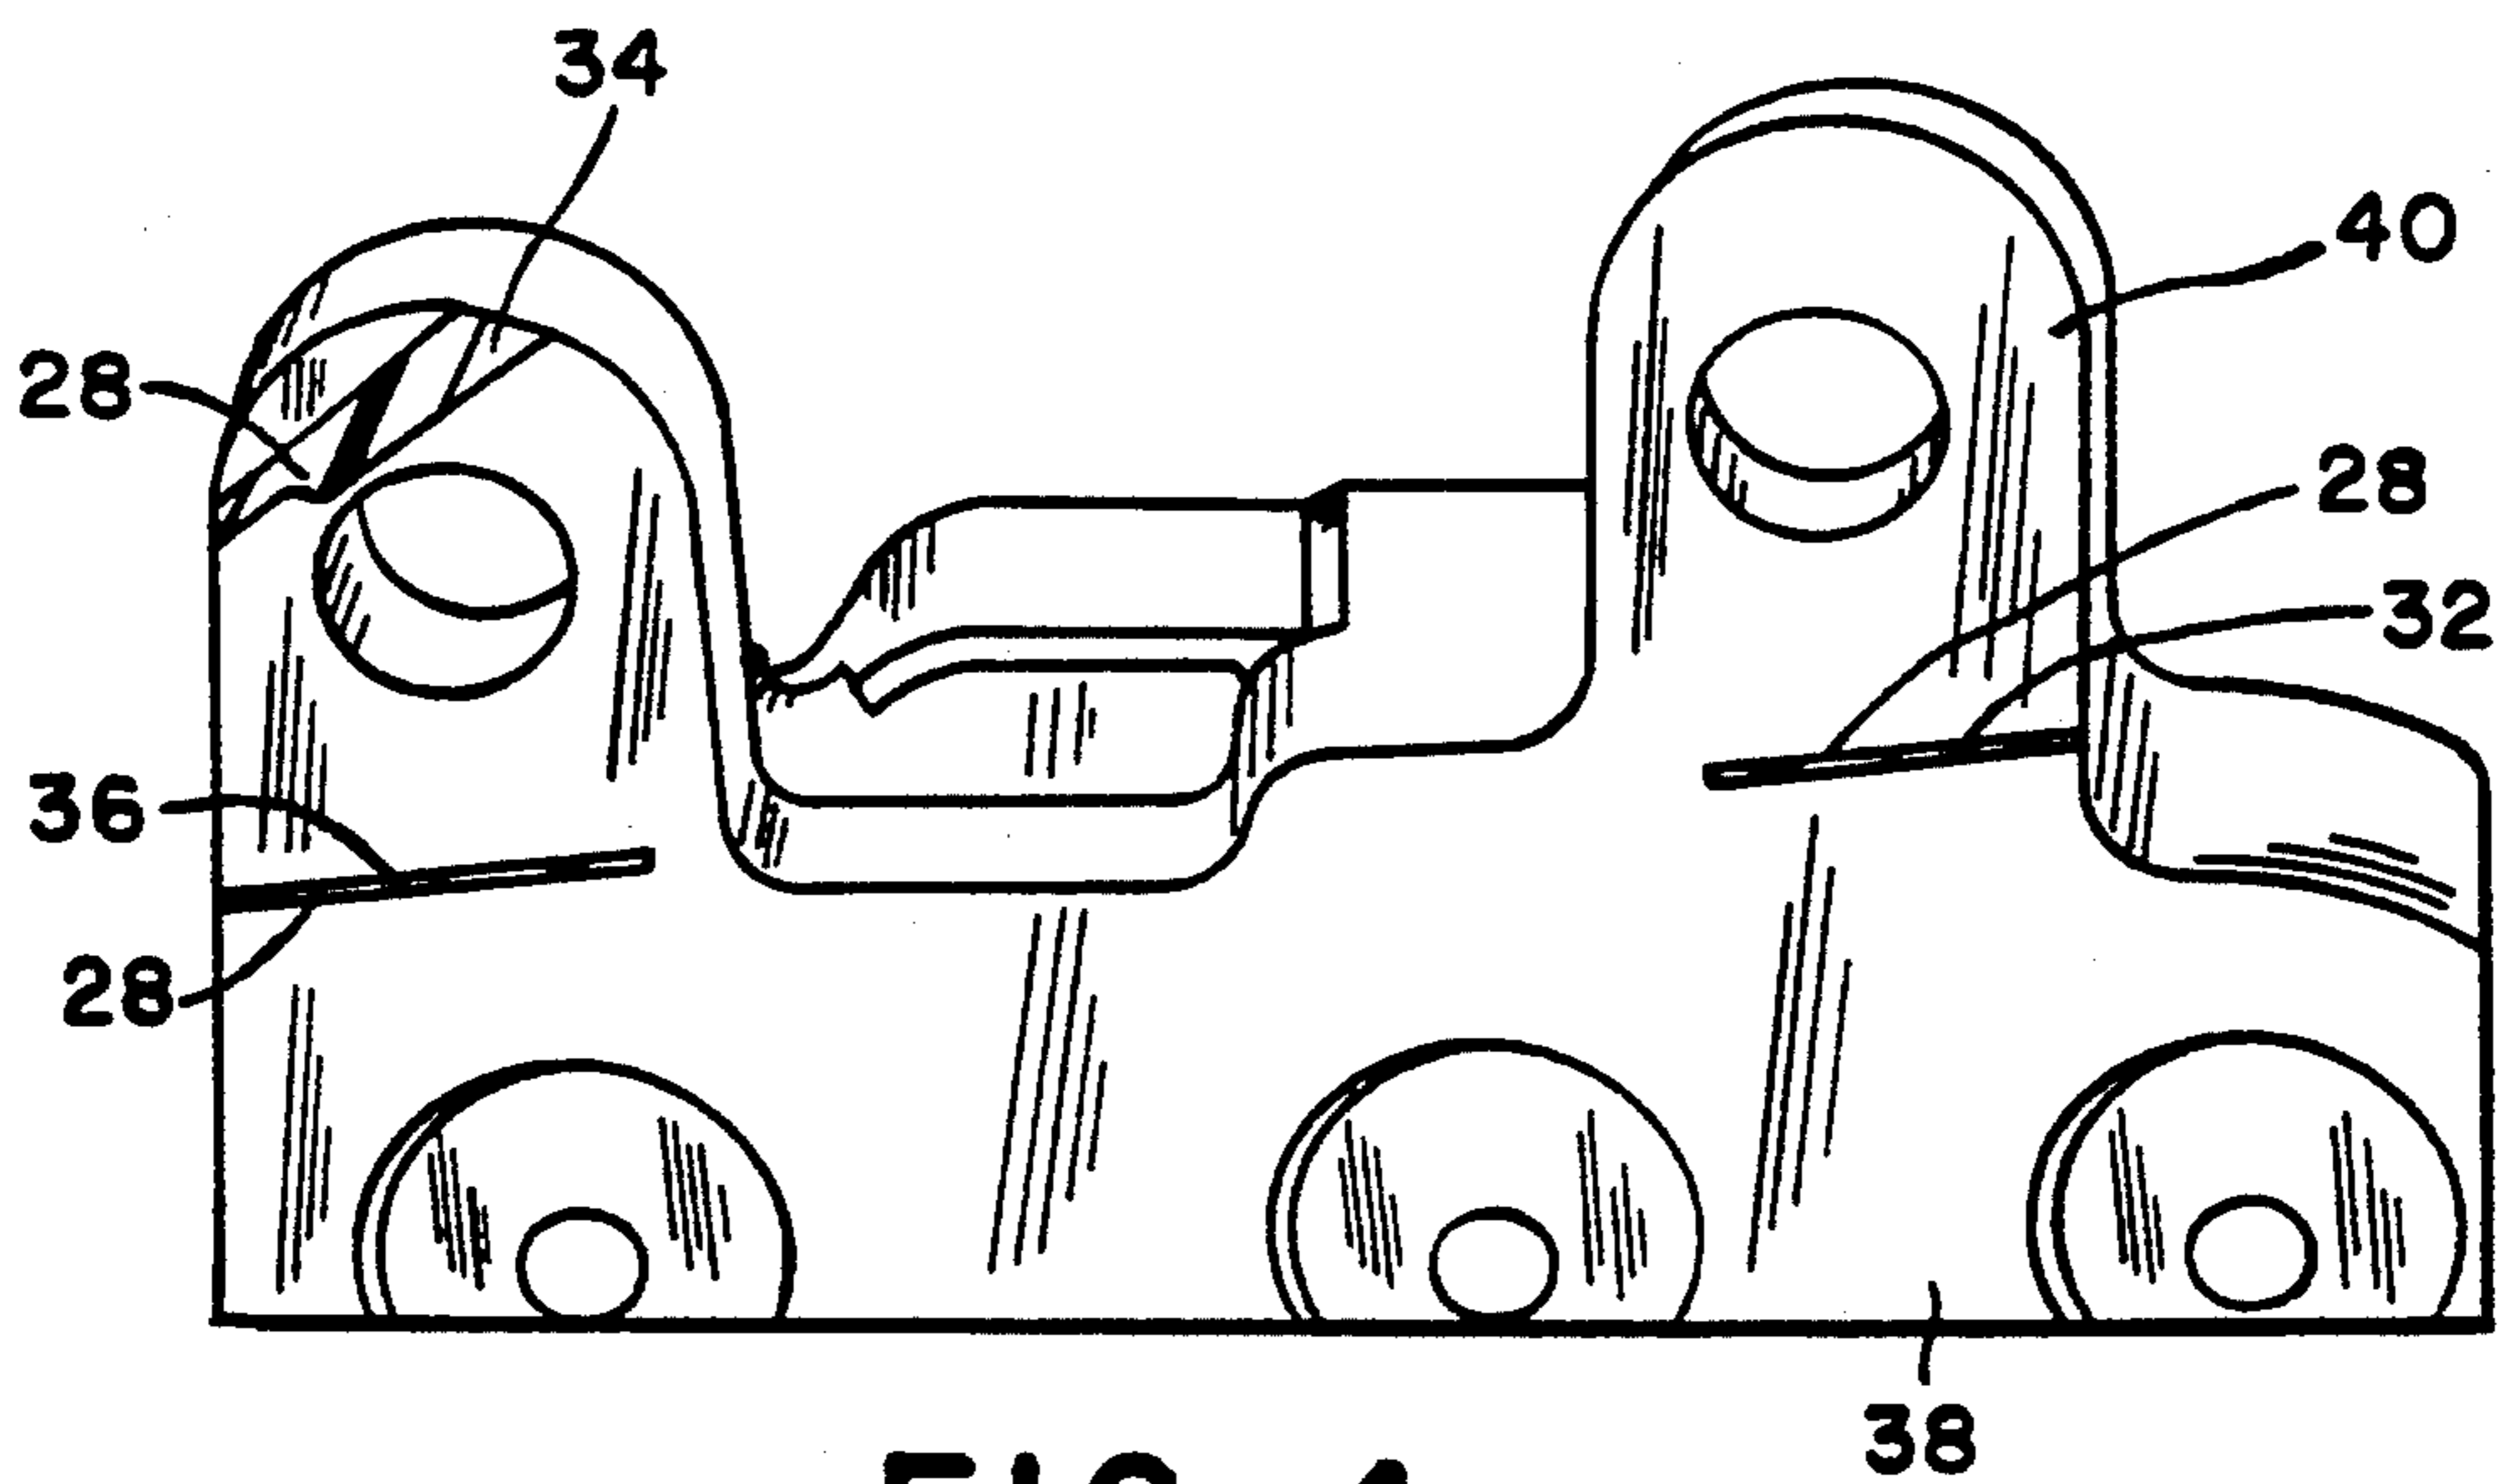
FIG. 4 is a illustration of the metallic member of FIG. 3 with the damaged area in a restored.
