5,606,797

[54]	PROCESS TO RESTORE AND REFURBISH		
	TURBOCHARGER HOUSING

A process to restore and refurbish a turbocharger housing having a gasket seal surface, an alignment ring, a cylindrical seal bore and a seal bore face. The process includes the steps of machining off the gasket seal surface, the alignment ring and the seal bore face and machining out the diameter of the seal bore. The gasket surface, the alignment ring, the seal bore face and the seal bore are built up in excess of finished dimensions by welding. The gasket surface, alignment ring, flanges, seal bore face and seal bore are thereafter machined to their finished dimensions.

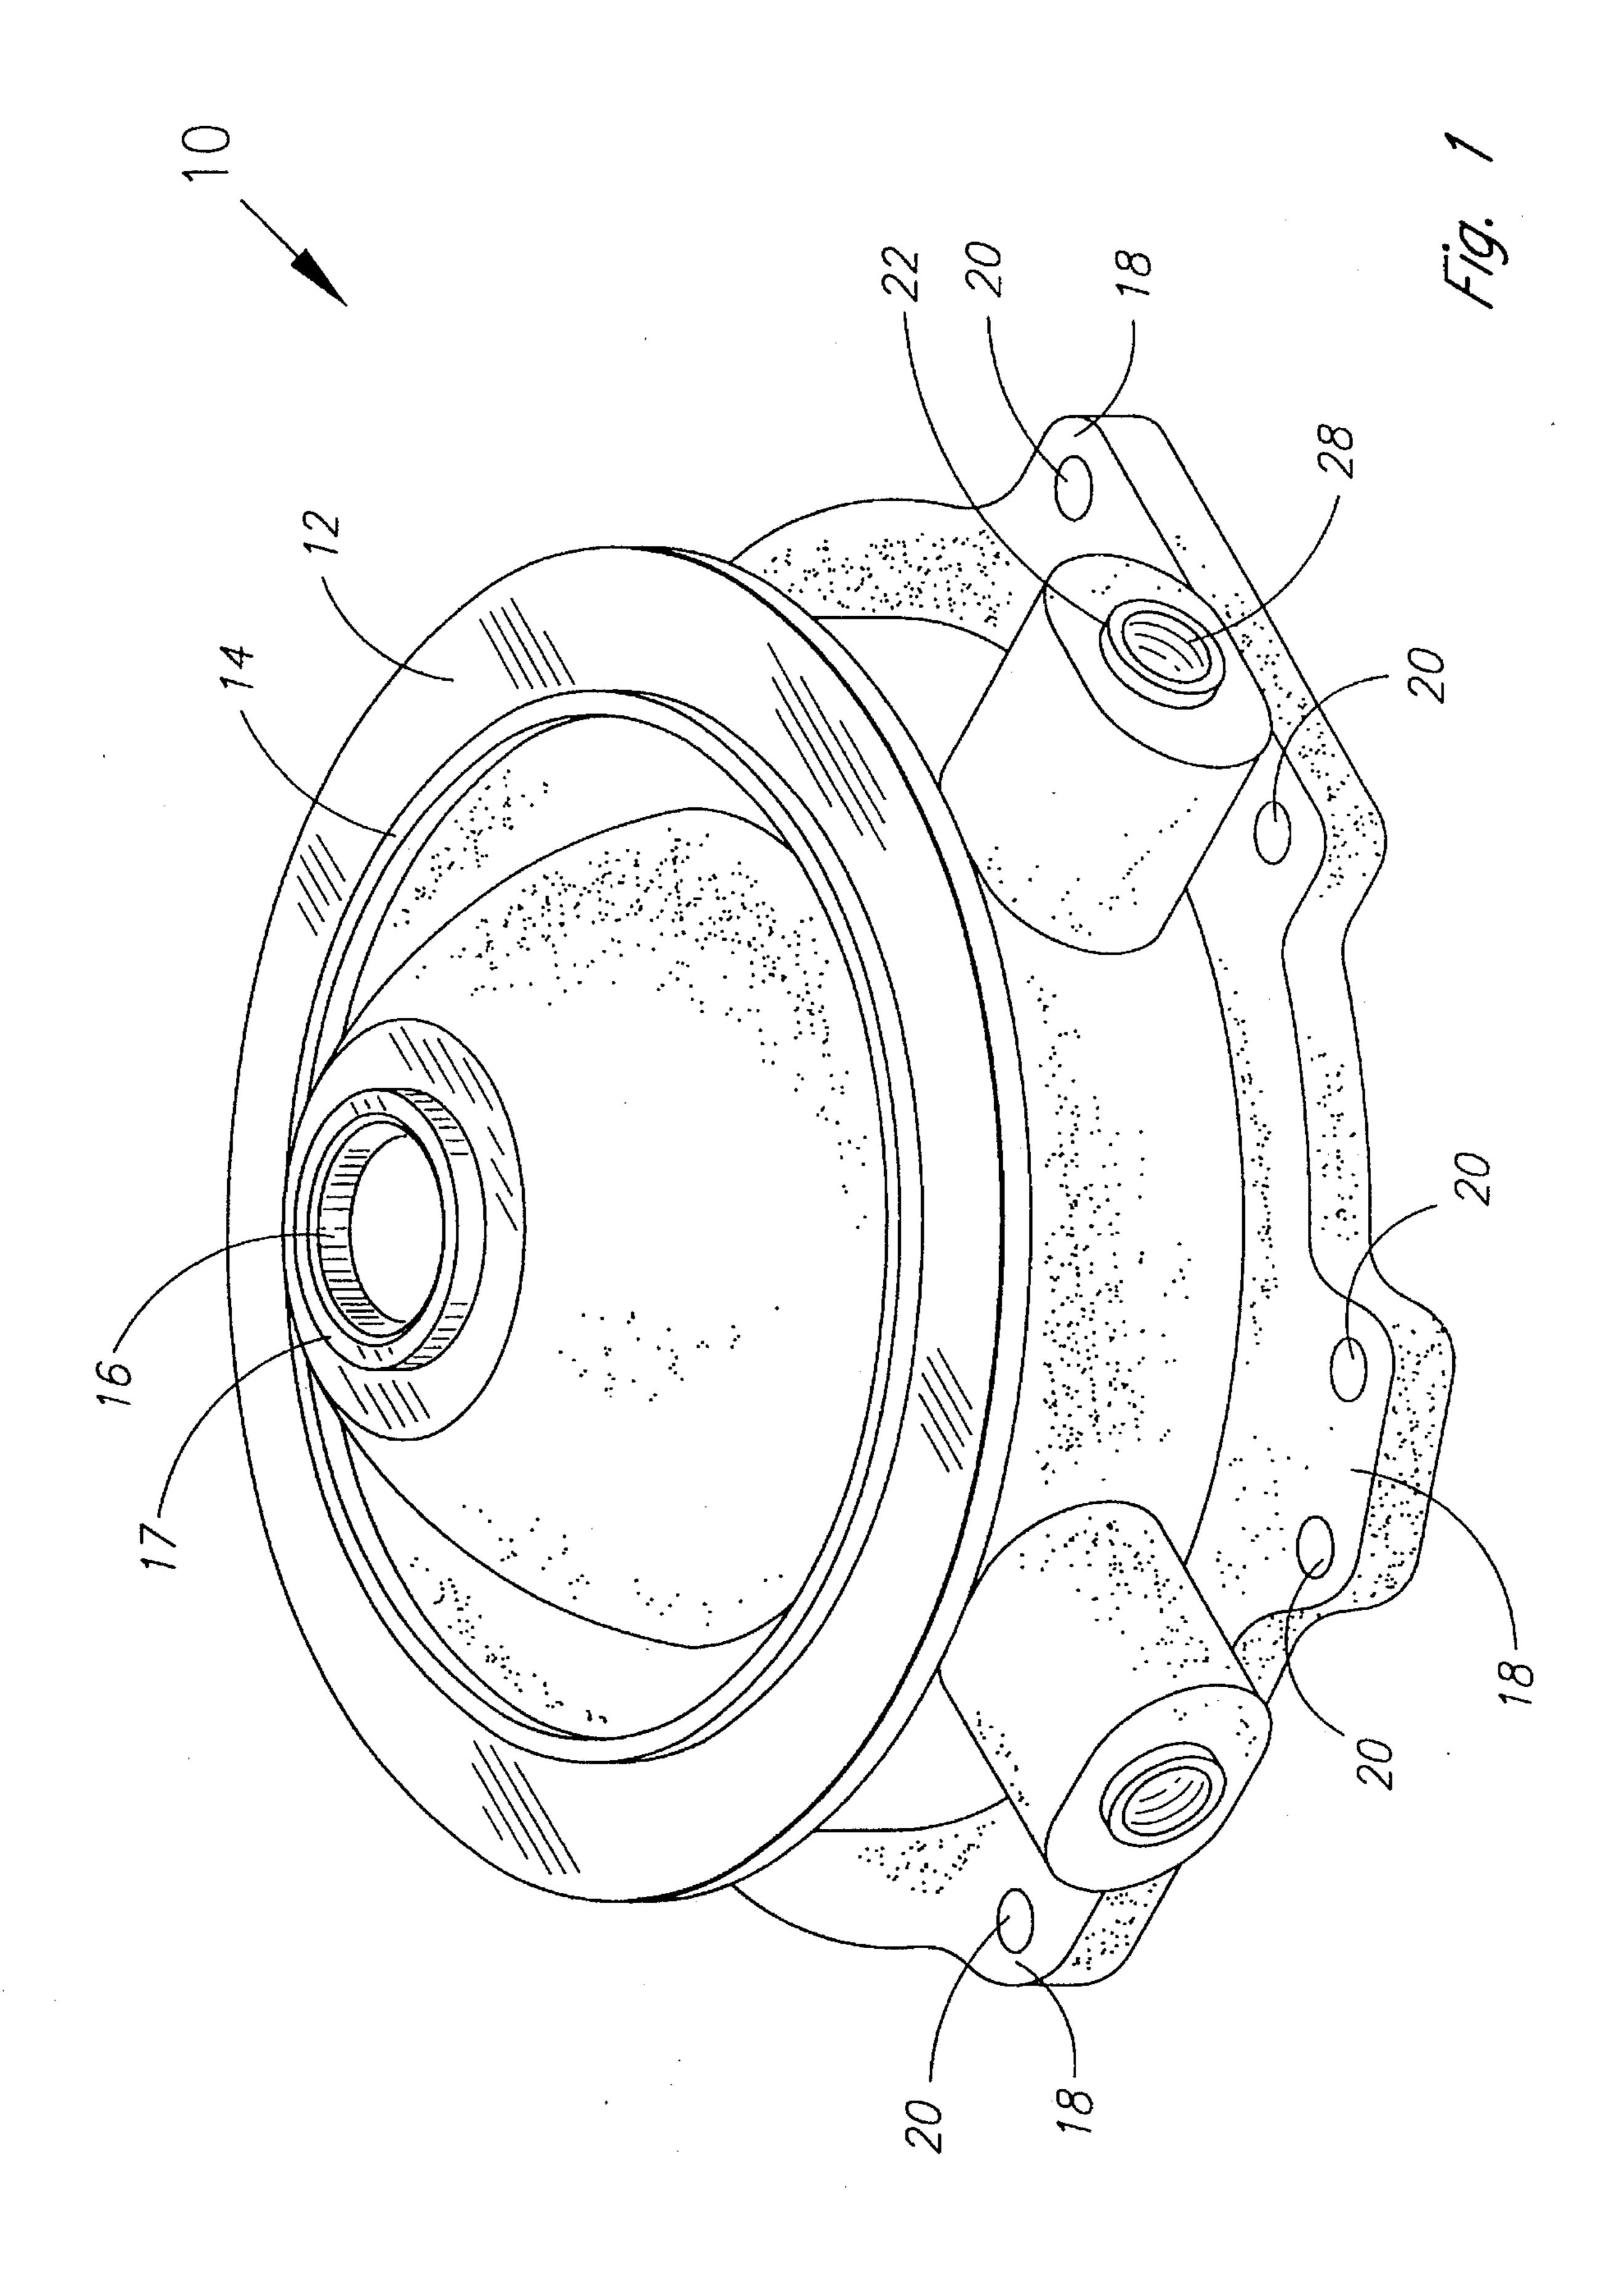
FIG. 2 is a top view of a turbocharger housing after use showing indications of corrosion, pitting and wear;

FIGS. 2 and 3 illustrate a center or bearing housing 10 which has been removed from a turbocharger after considerable use. It will be observed that the alignment ring 14 is broken or chipped away at various places such as at reference numerals 24 and 26. The threads 28 of the small lubricant passage 30 have been stripped.

One of the flanges 18 is cracked at the opening 20. Additionally, the seal bore 16 is chipped at 32 and 34.
