US005732467A

[54] **METHOD OF REPAIRING DIRECTIONALLY SOLIDIFIED AND SINGLE CRYSTAL ALLOY PARTS**

A new method is provided for repairing cracks in the outer surfaces of structural parts being a superalloy article having a directionally oriented microstructure, such as a blading member. The article may have internal passageways communicating through the end of the article. The method coats and seals cracked outer-surface areas of directionally solidified and single crystal structures by coating the defective area using a High Velocity Oxy-Fuel process (herein also referred to as HVOF), followed by hot isostatic pressing the part.

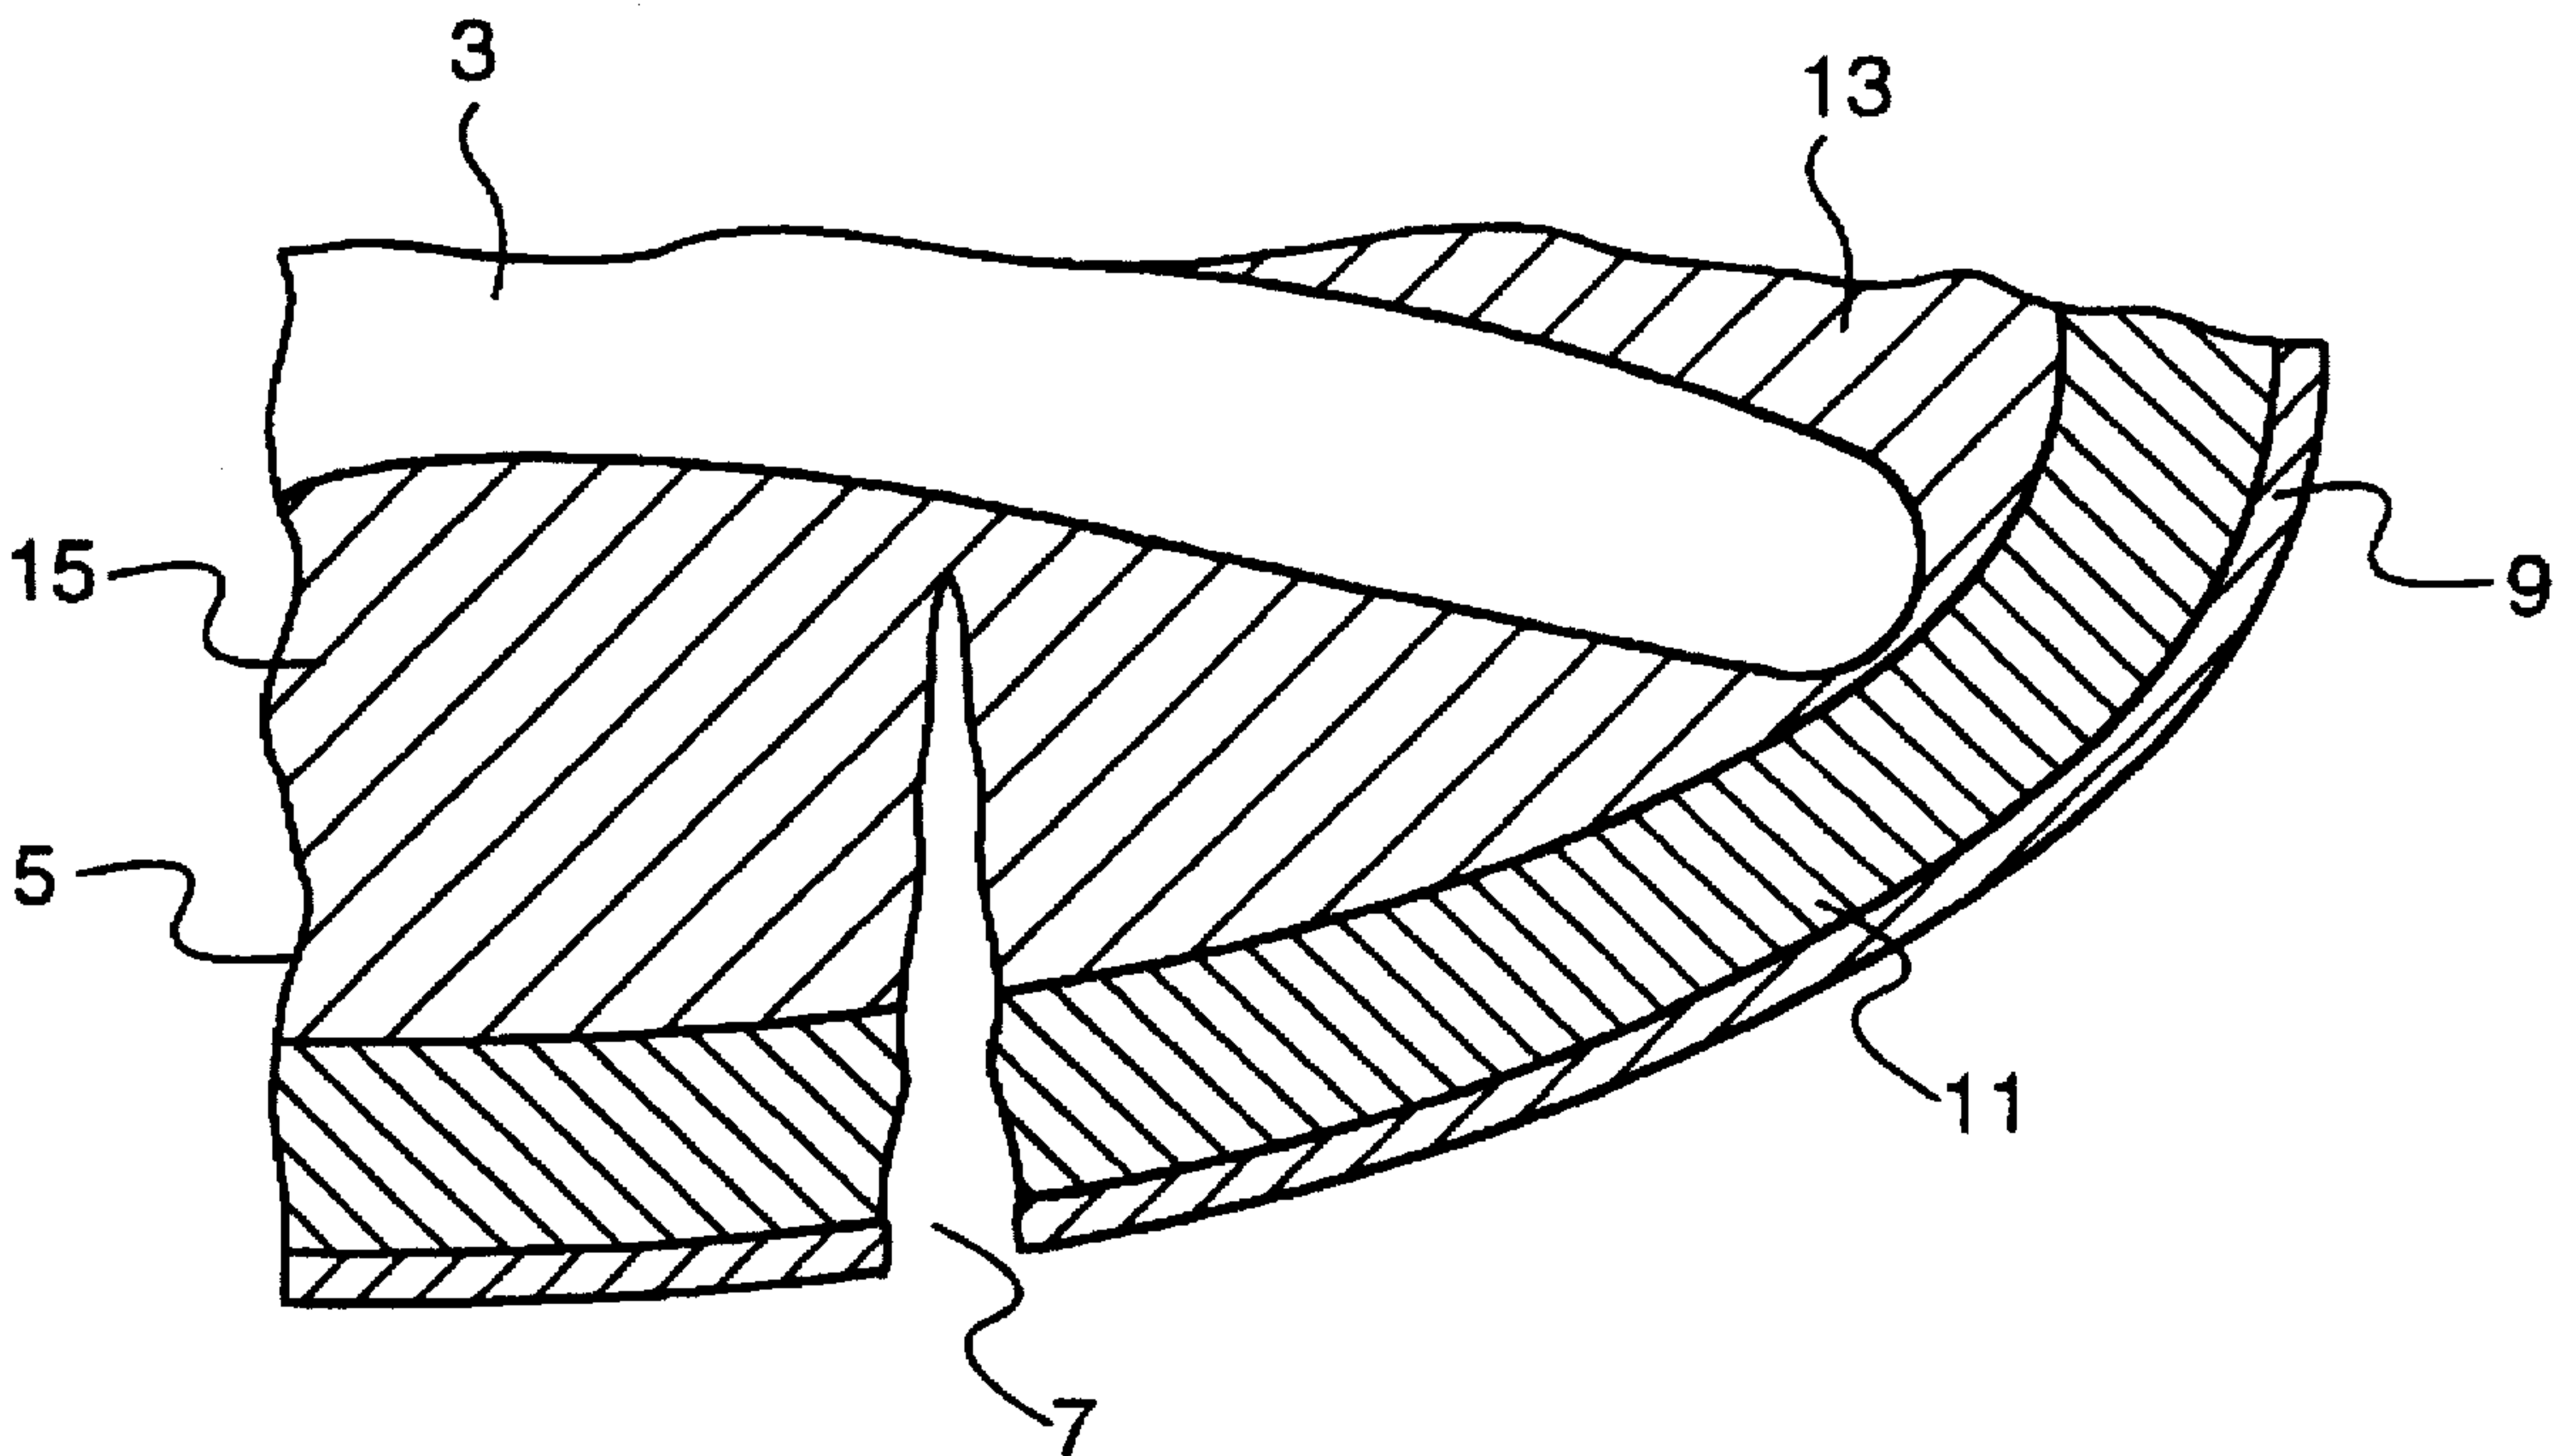
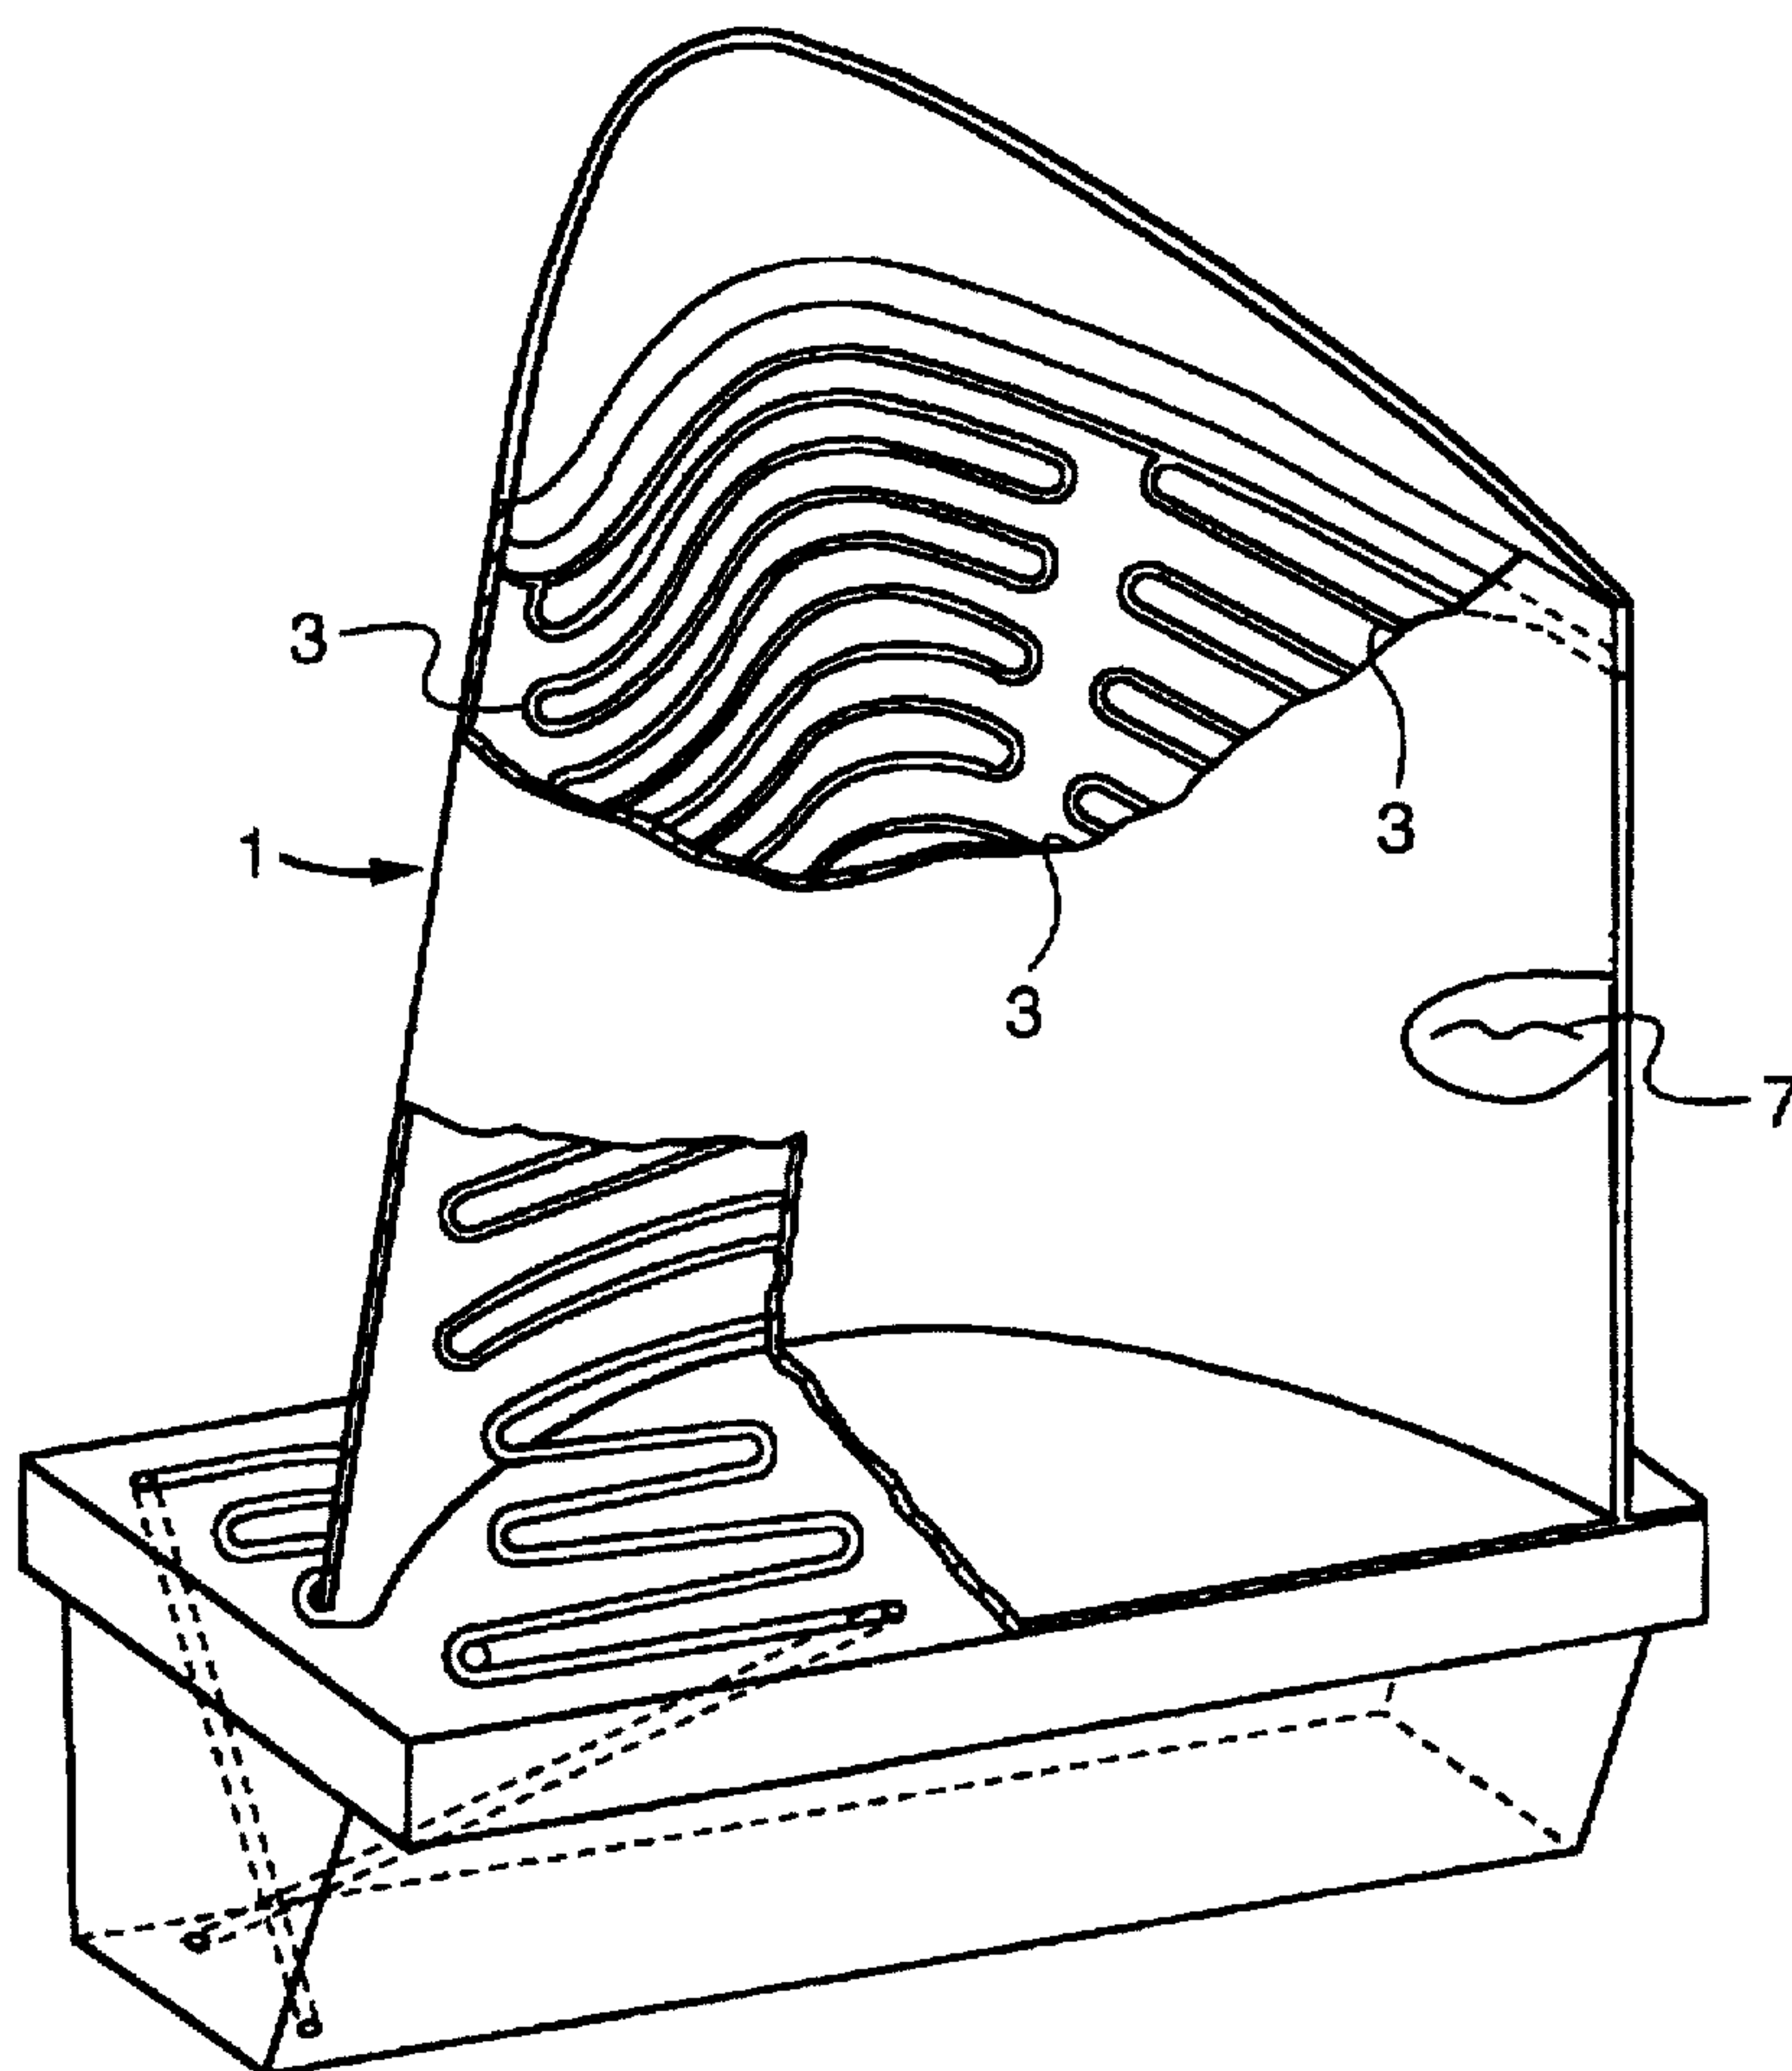
FIG. 1a is a three-dimensional view, partly cut away, showing a typical overall inner and outer arrangement for at least one turbine bucket that is made from a directionally solidified superalloy and that has a crack on the outer surface.

The present invention comprises methods to repair cracks and defects on the outer surface of directionally oriented, superalloy articles, through the cleaning, coating and hot isostatic pressing of the superalloy article. The method may be used to repair the crystal structure and overall microstructure of the superalloy article that is compatible with and continuous with that of the article. While potentially useful on a wide variety of articles, the method of this invention is particularly useful in repairing outer surface cracks on an article having a hollow interior and openings or passages communicating with the hollow interior, such as a turbine blade shown in FIG. 1a.

As noted herein, the method is particularly useful for repairing outer surface defects or cracks on an airfoil including an airfoil blading member such as a turbine blade or vane, which is depicted in FIG. 1a. A selected article, such as FIG. 1a, has a superalloy composition and directionally oriented crystal structure. The superalloy may have a superalloy composition of a nickel-base, iron-base, or cobalt-base superalloy, such as is well known and described, for example, in Metals Handbook Tenth Edition, Vol. 1, Properties Selection: Iron, Steel and High-Performance Alloys, ASM International (1990), pages 981-994 and 995-1006, which describes many castable superalloys, and specifically nickel-base superalloys that may be directionally solidified or formed as single crystals. For purposes of this invention, acceptable superalloys would also include high temperature alloys that are not presently in widespread commercial use, such as niobium-base and titanium-base alloys, including niobium-titanium alloys, directionally oriented nickel-base or titanium-base composite alloys and niobium-aluminum alloys.

Turning to FIG. 1a, the blade 1 is shown cut away to demonstrate the internal cooling passages 3 which are surrounded by an outer surface 5. Looking at FIG. 1b, the outer surface 5 is generally a superalloy metal 15 and may have coating overlays, such as a bond coat 11 and a thermal barrier coating 9. The bond coat 11 is any acceptable metallic or ceramic coating that serves to improve adhesion between the subsequent thermal barrier coating 9 and the underlying substrate 15. Examples of bond coats are MCrAlY, where M is nickel, iron, cobalt, or mixtures thereof; and aluminides. The thermal barrier coating 9 provides a protective coating that enables the substrate 15 to operate at higher temperatures. Thermal barrier coatings also protect the underlying parts from corrosive and oxidative environments. An example of a thermal barrier coating is chemically stabilized zirconia, such as yttria stabilized zirconia, where yttria is present in about 1 to 20 weight percent, with the preferred range being about 6-12 weight percent yttria.

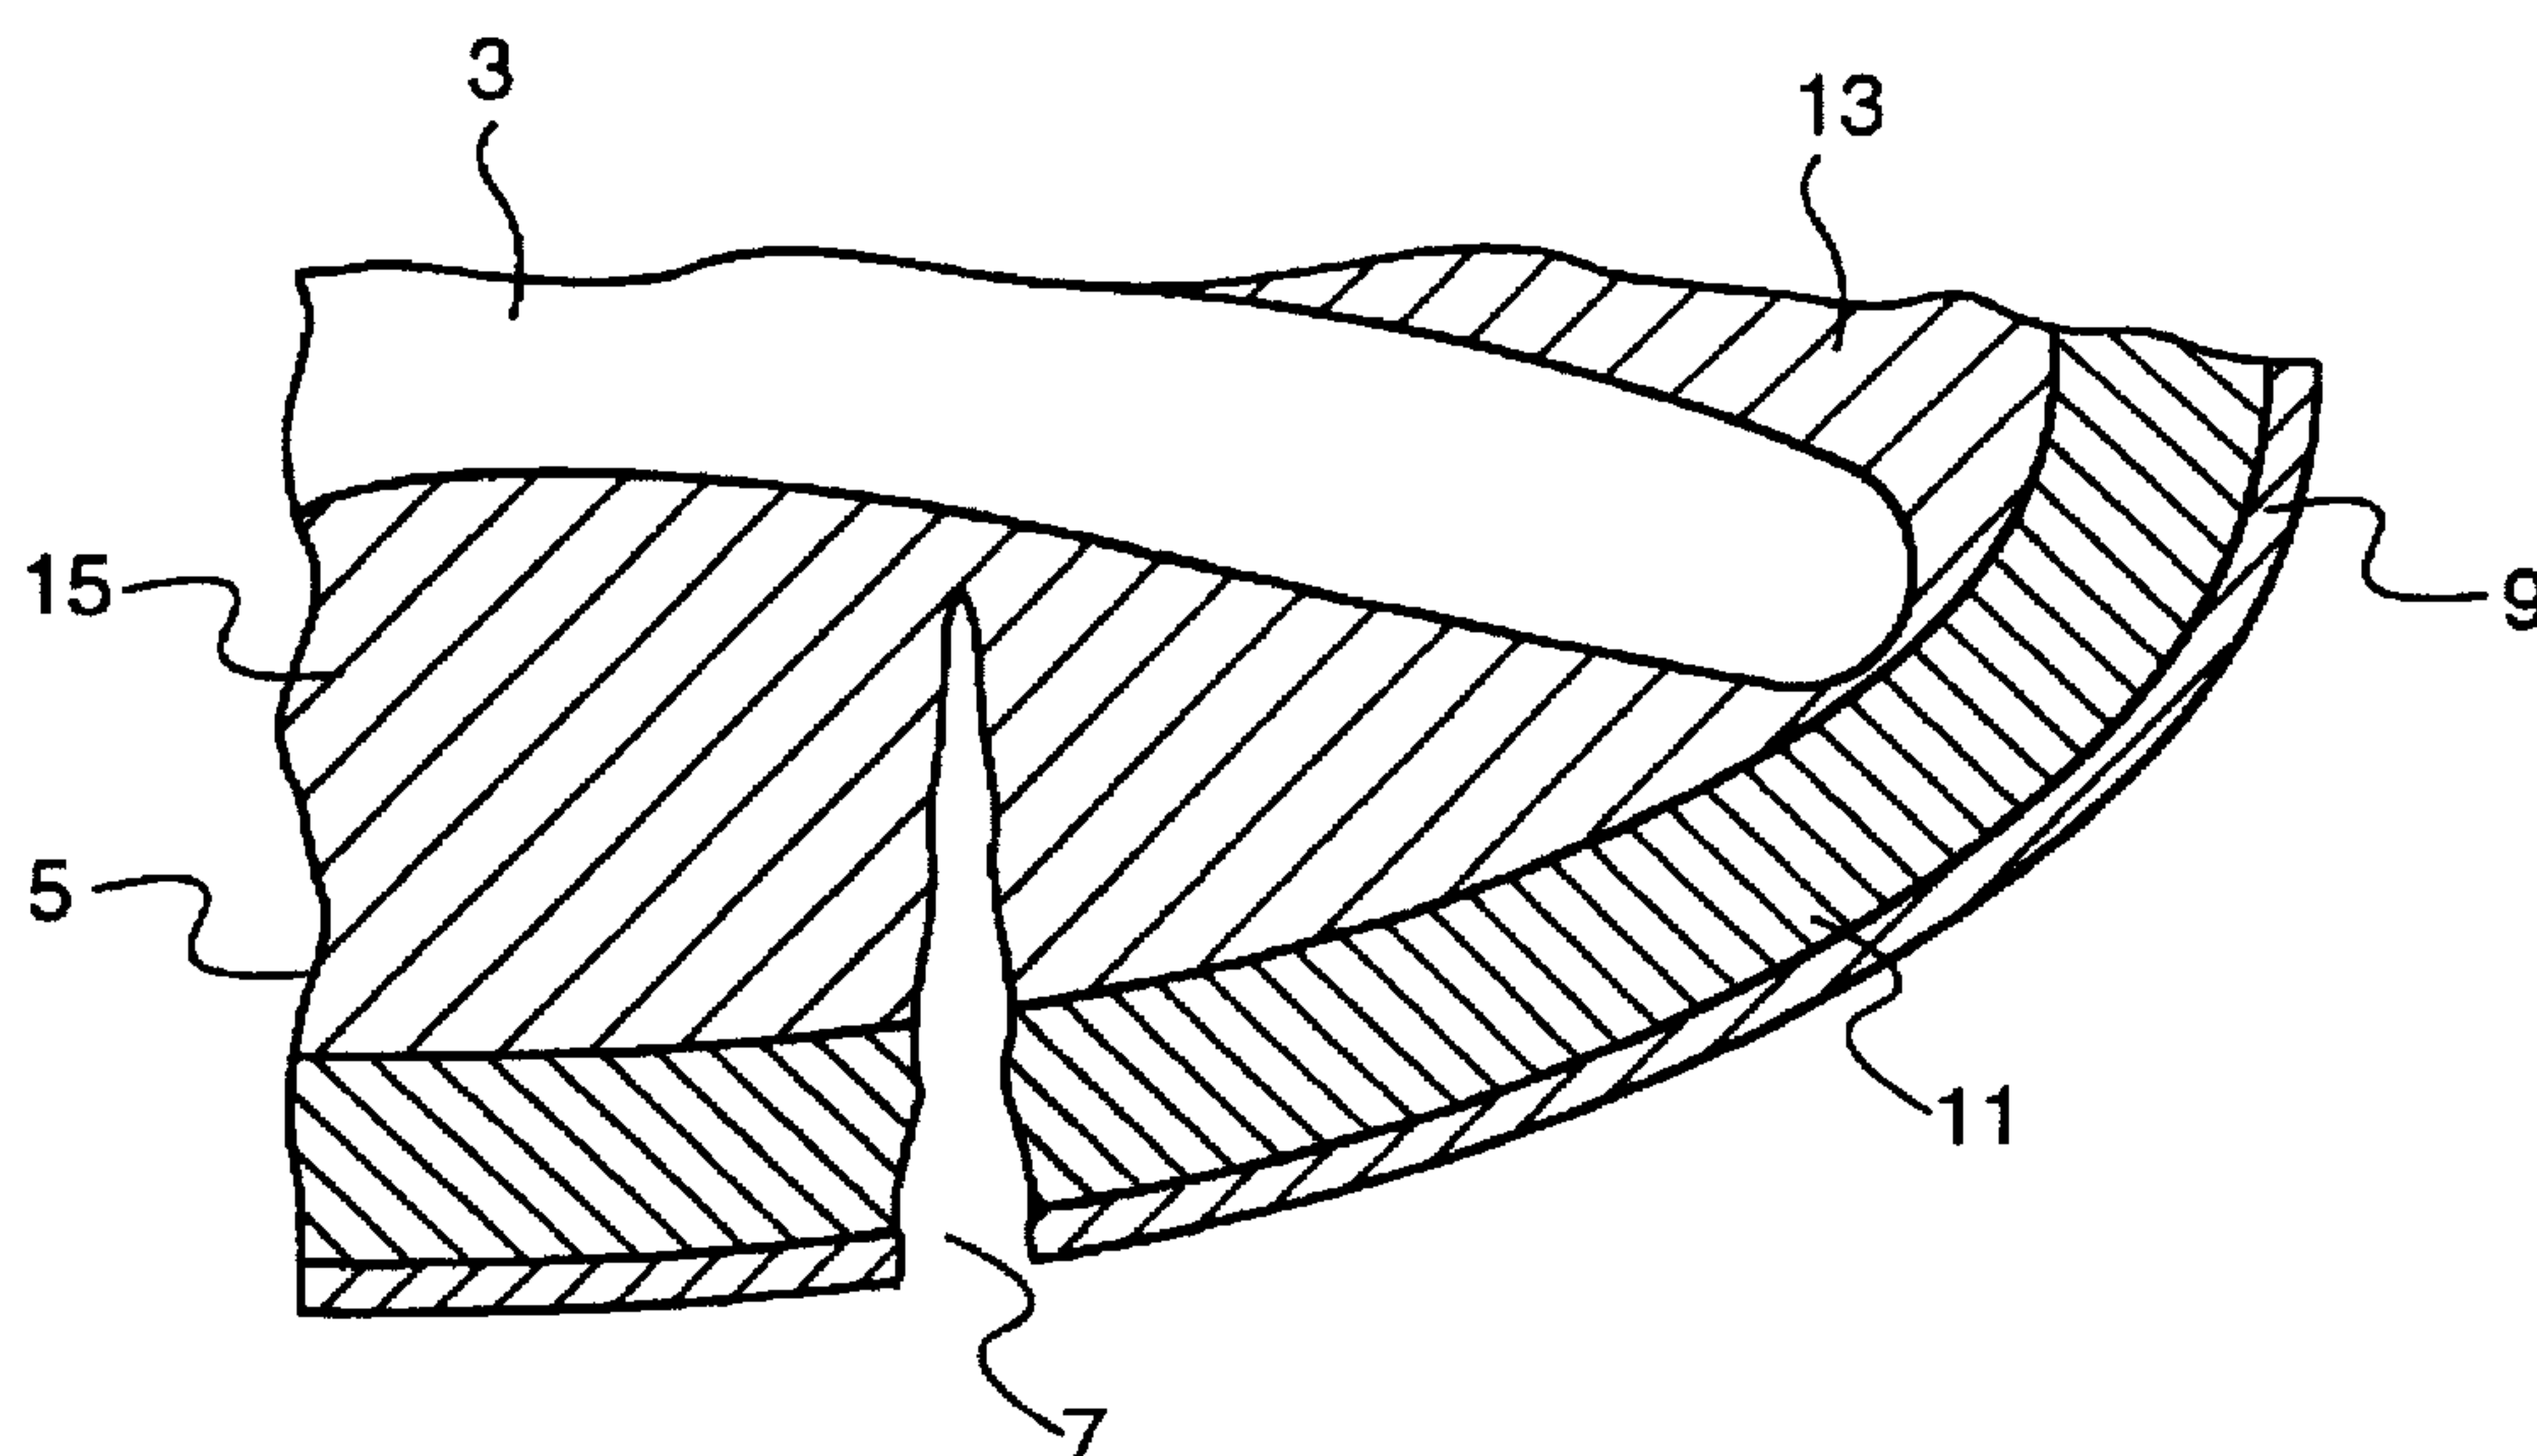
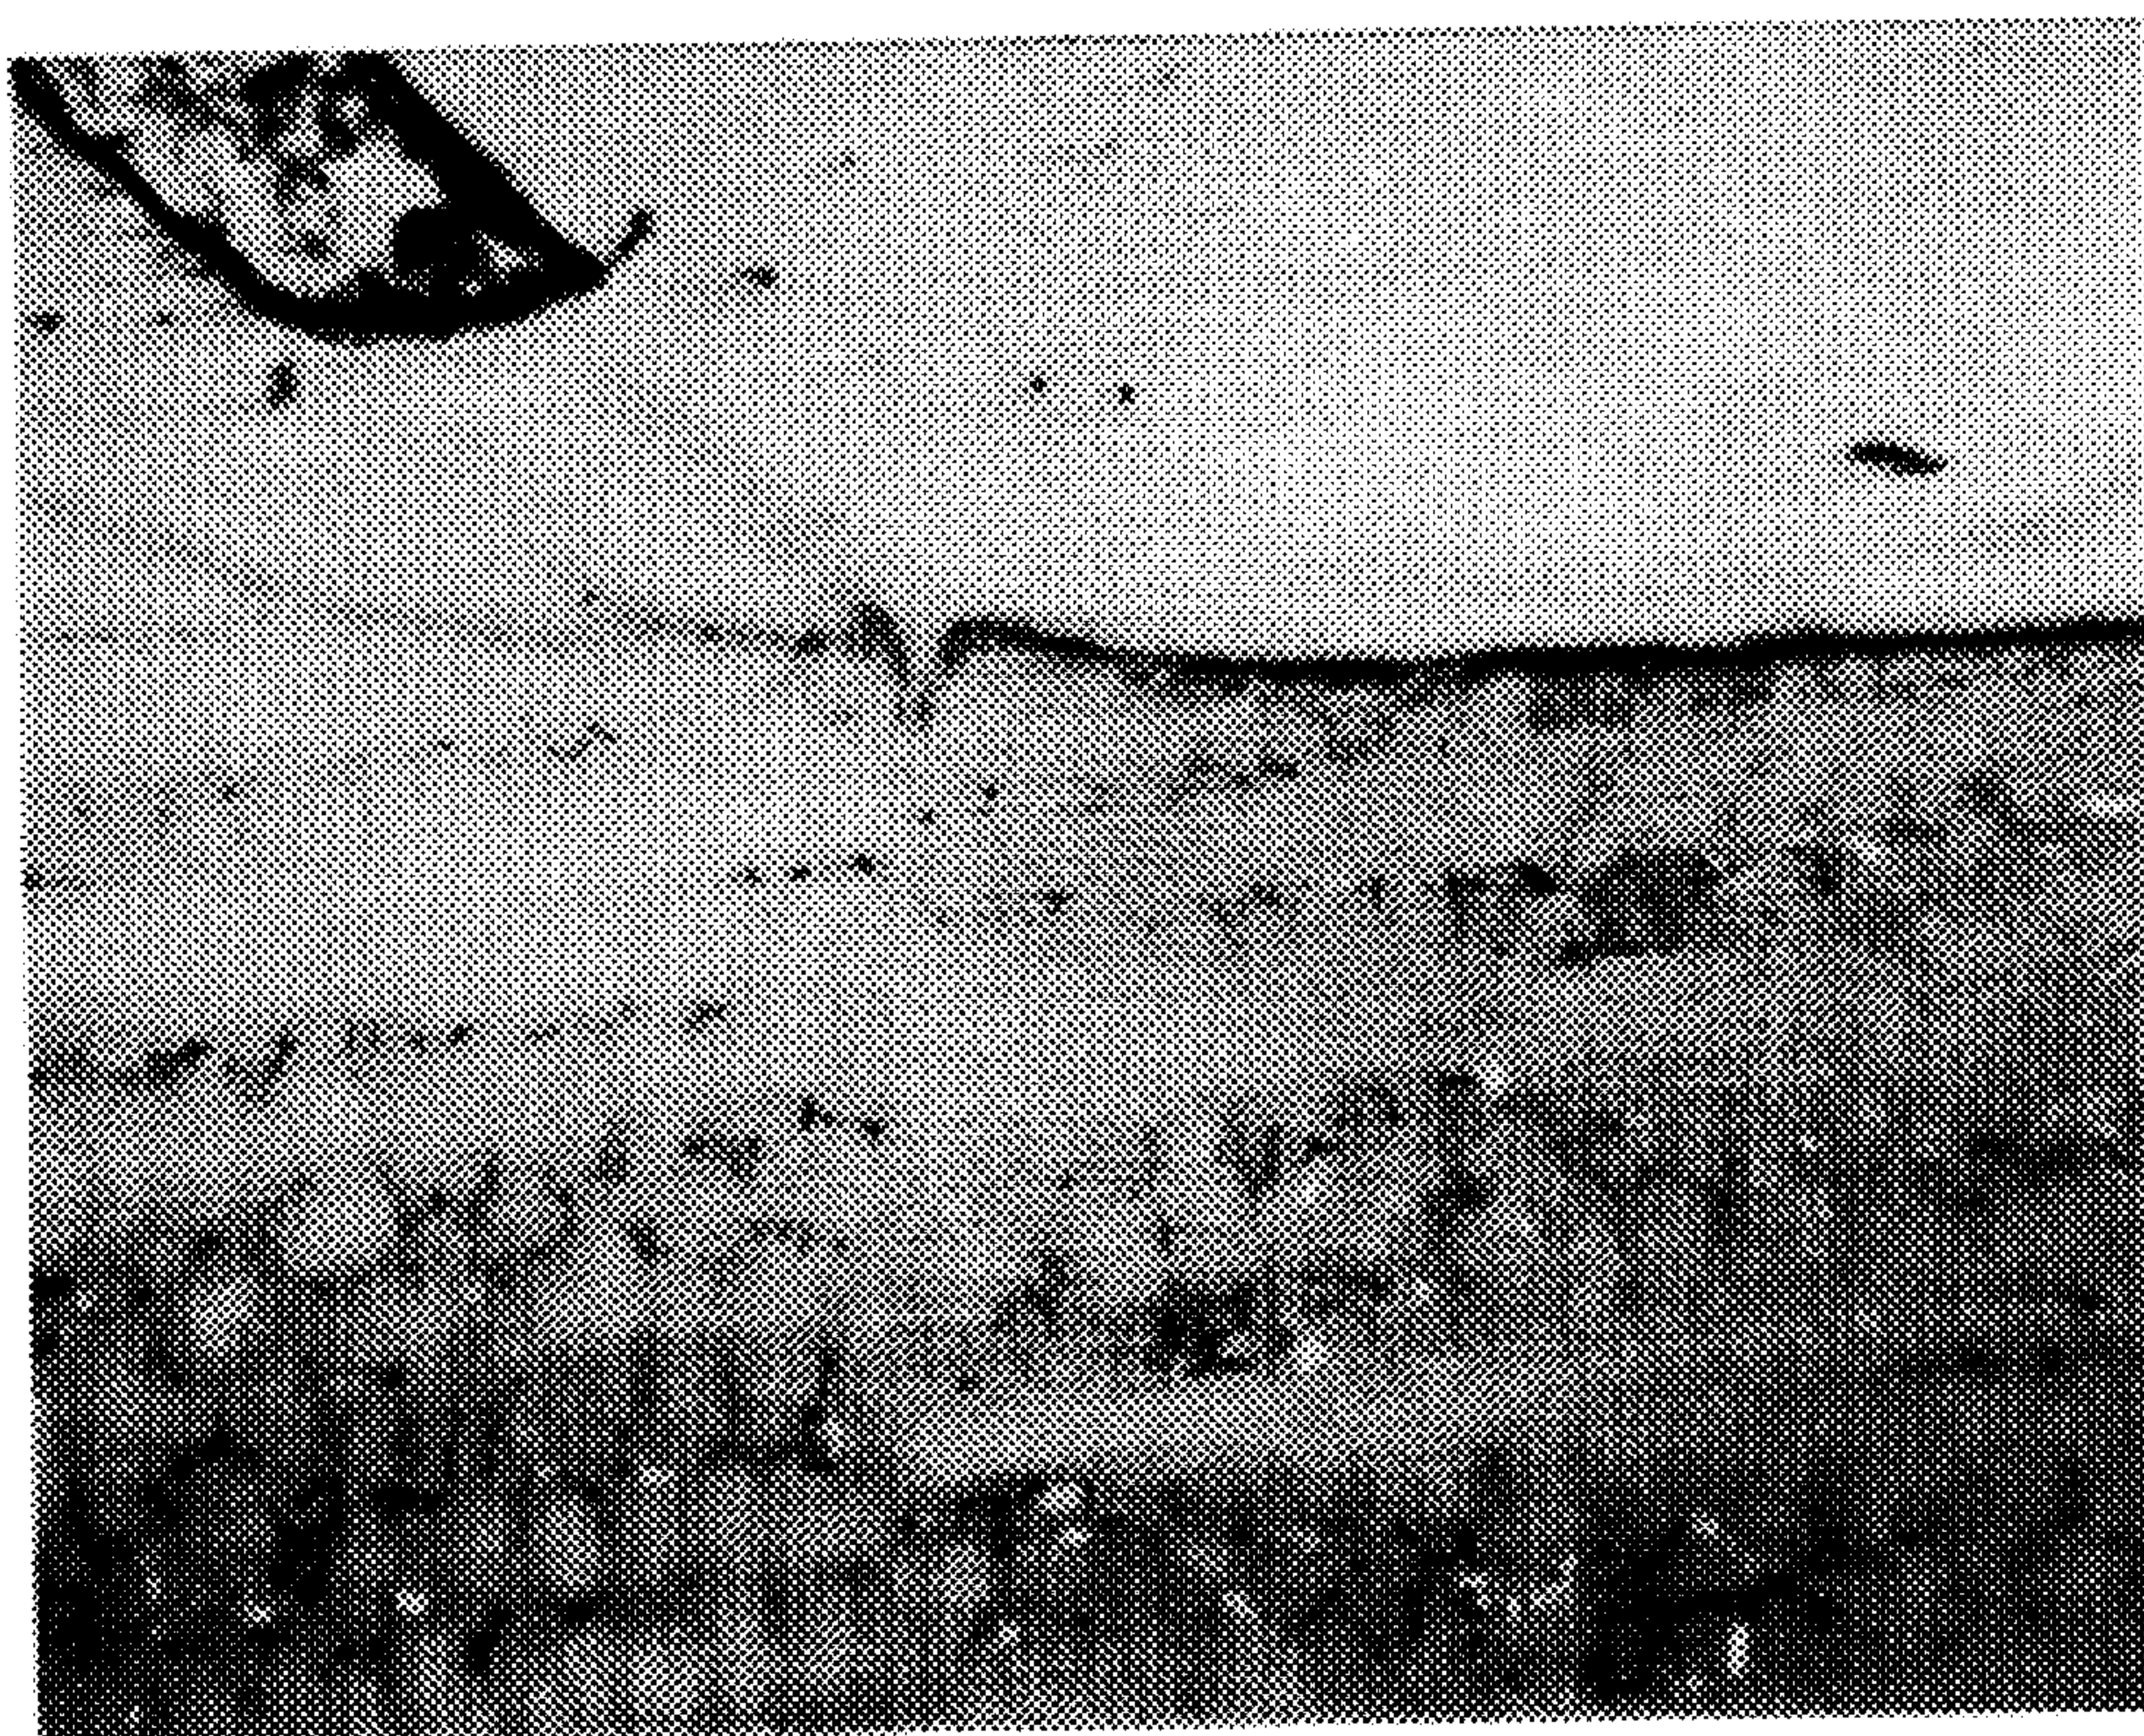
FIG. 1b depicts a cross-sectional view of the cracked surface area shown in FIG. 1a.

FIG. 1b shows a cross-sectional view of an outer surface area 5 of a blade member having a surface defect or crack 7. The surface defects or cracks often are heavily oxidized areas. It is desirable to remove heavily oxidized contami-

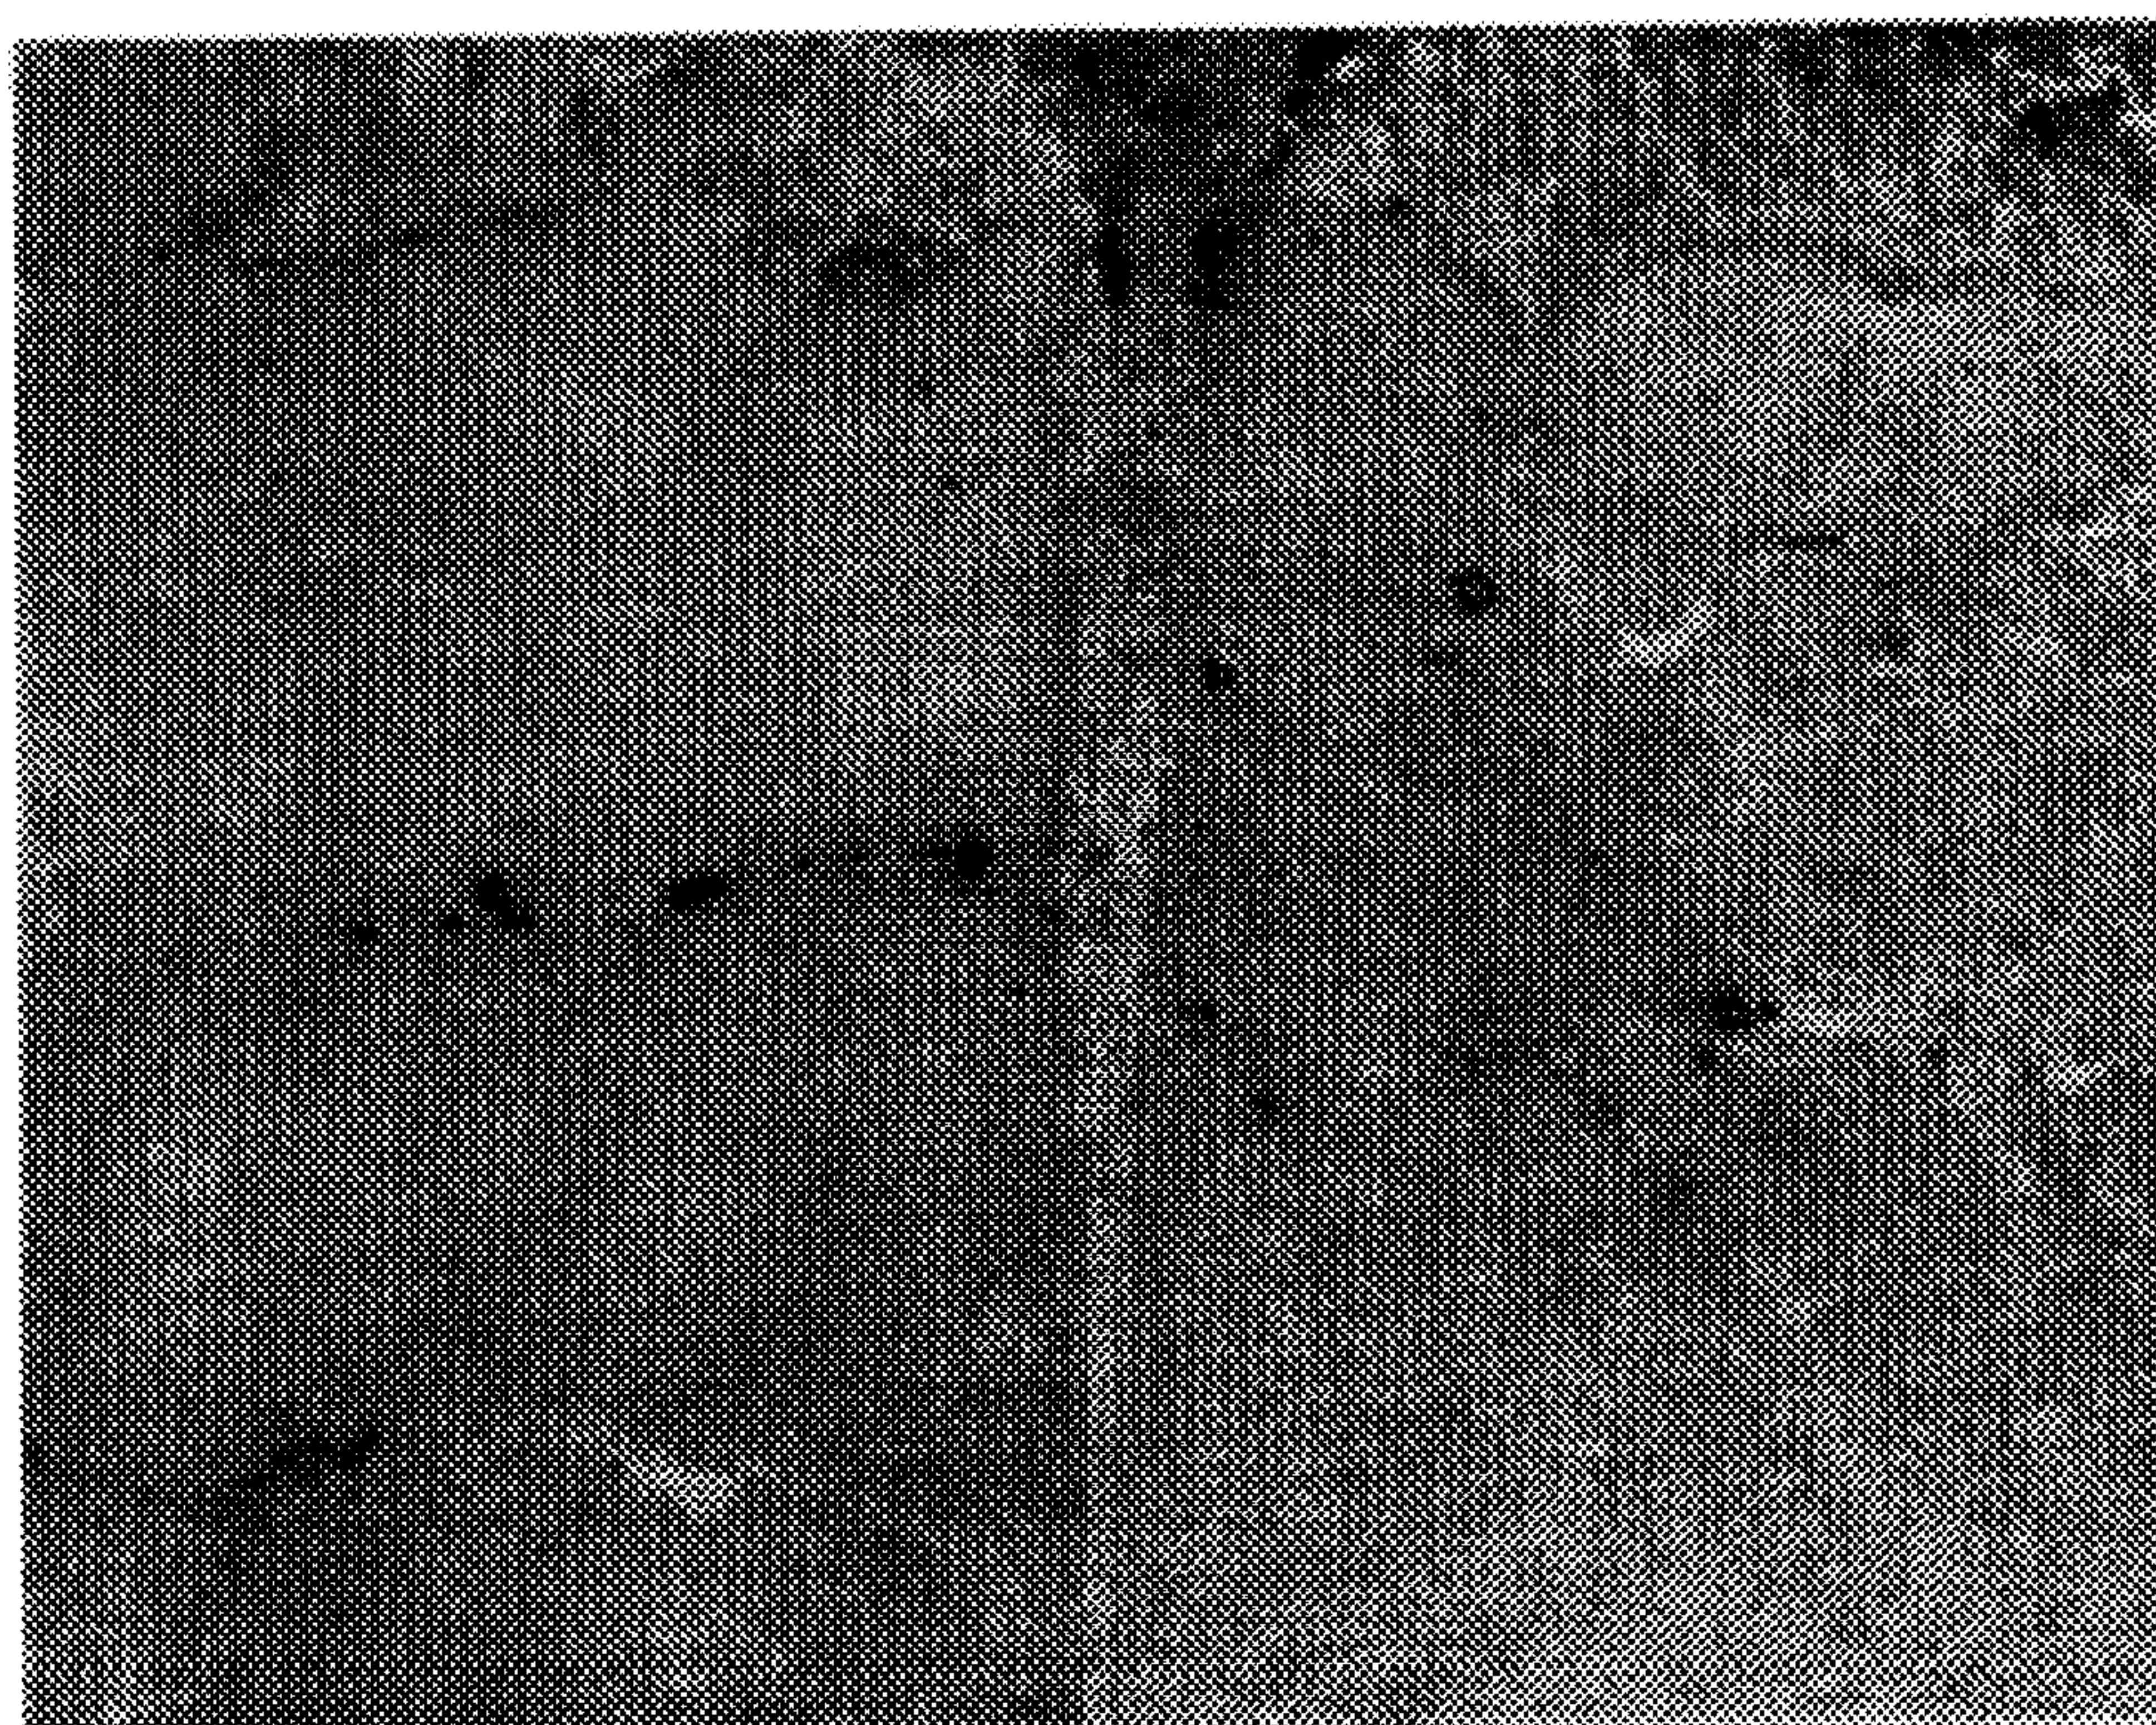
FIG. 2a is a photomicrograph at 50× magnification of a healed crack by the method of this invention.

FIGS. 2a and 2b show photomicrographs of a specimen that was coated and HIPed to seal outer surface cracks in superalloy parts. FIG. 2a shows the crack being sealed at the outer surface of the part at 50x. FIG. 2b demonstrates complete sealing (100% bonding) of the entire cracked area from the tip of the crack to the outermost surface of the superalloy part at 200x. This is the preferred sealing configuration and possible to achieve with sufficient cleaning.

exterior outermost surface. After the coating application, the coatings were found to be leak tight. The Rene N5 single crystal specimens that were coated by HVOF with pure nickel, were then hot isostatic pressed. The conditions for hot isostatic pressing were 1150° C. at 30 ksi for 3 hours. Metallography revealed that the crack was bonded 100% (FIGS. 2a and 2b).
