US005732467A

[54] **METHOD OF REPAIRING DIRECTIONALLY SOLIDIFIED AND SINGLE CRYSTAL ALLOY PARTS**

A new method is provided for repairing cracks in the outer surfaces of structural parts being a superalloy article having a directionally oriented microstructure, such as a blading member. The article may have internal passageways communicating through the end of the article. The method coats and seals cracked outer-surface areas of directionally solidified and single crystal structures by coating the defective area using a High Velocity Oxy-Fuel process (herein also referred to as HVOF), followed by hot isostatic pressing the part.

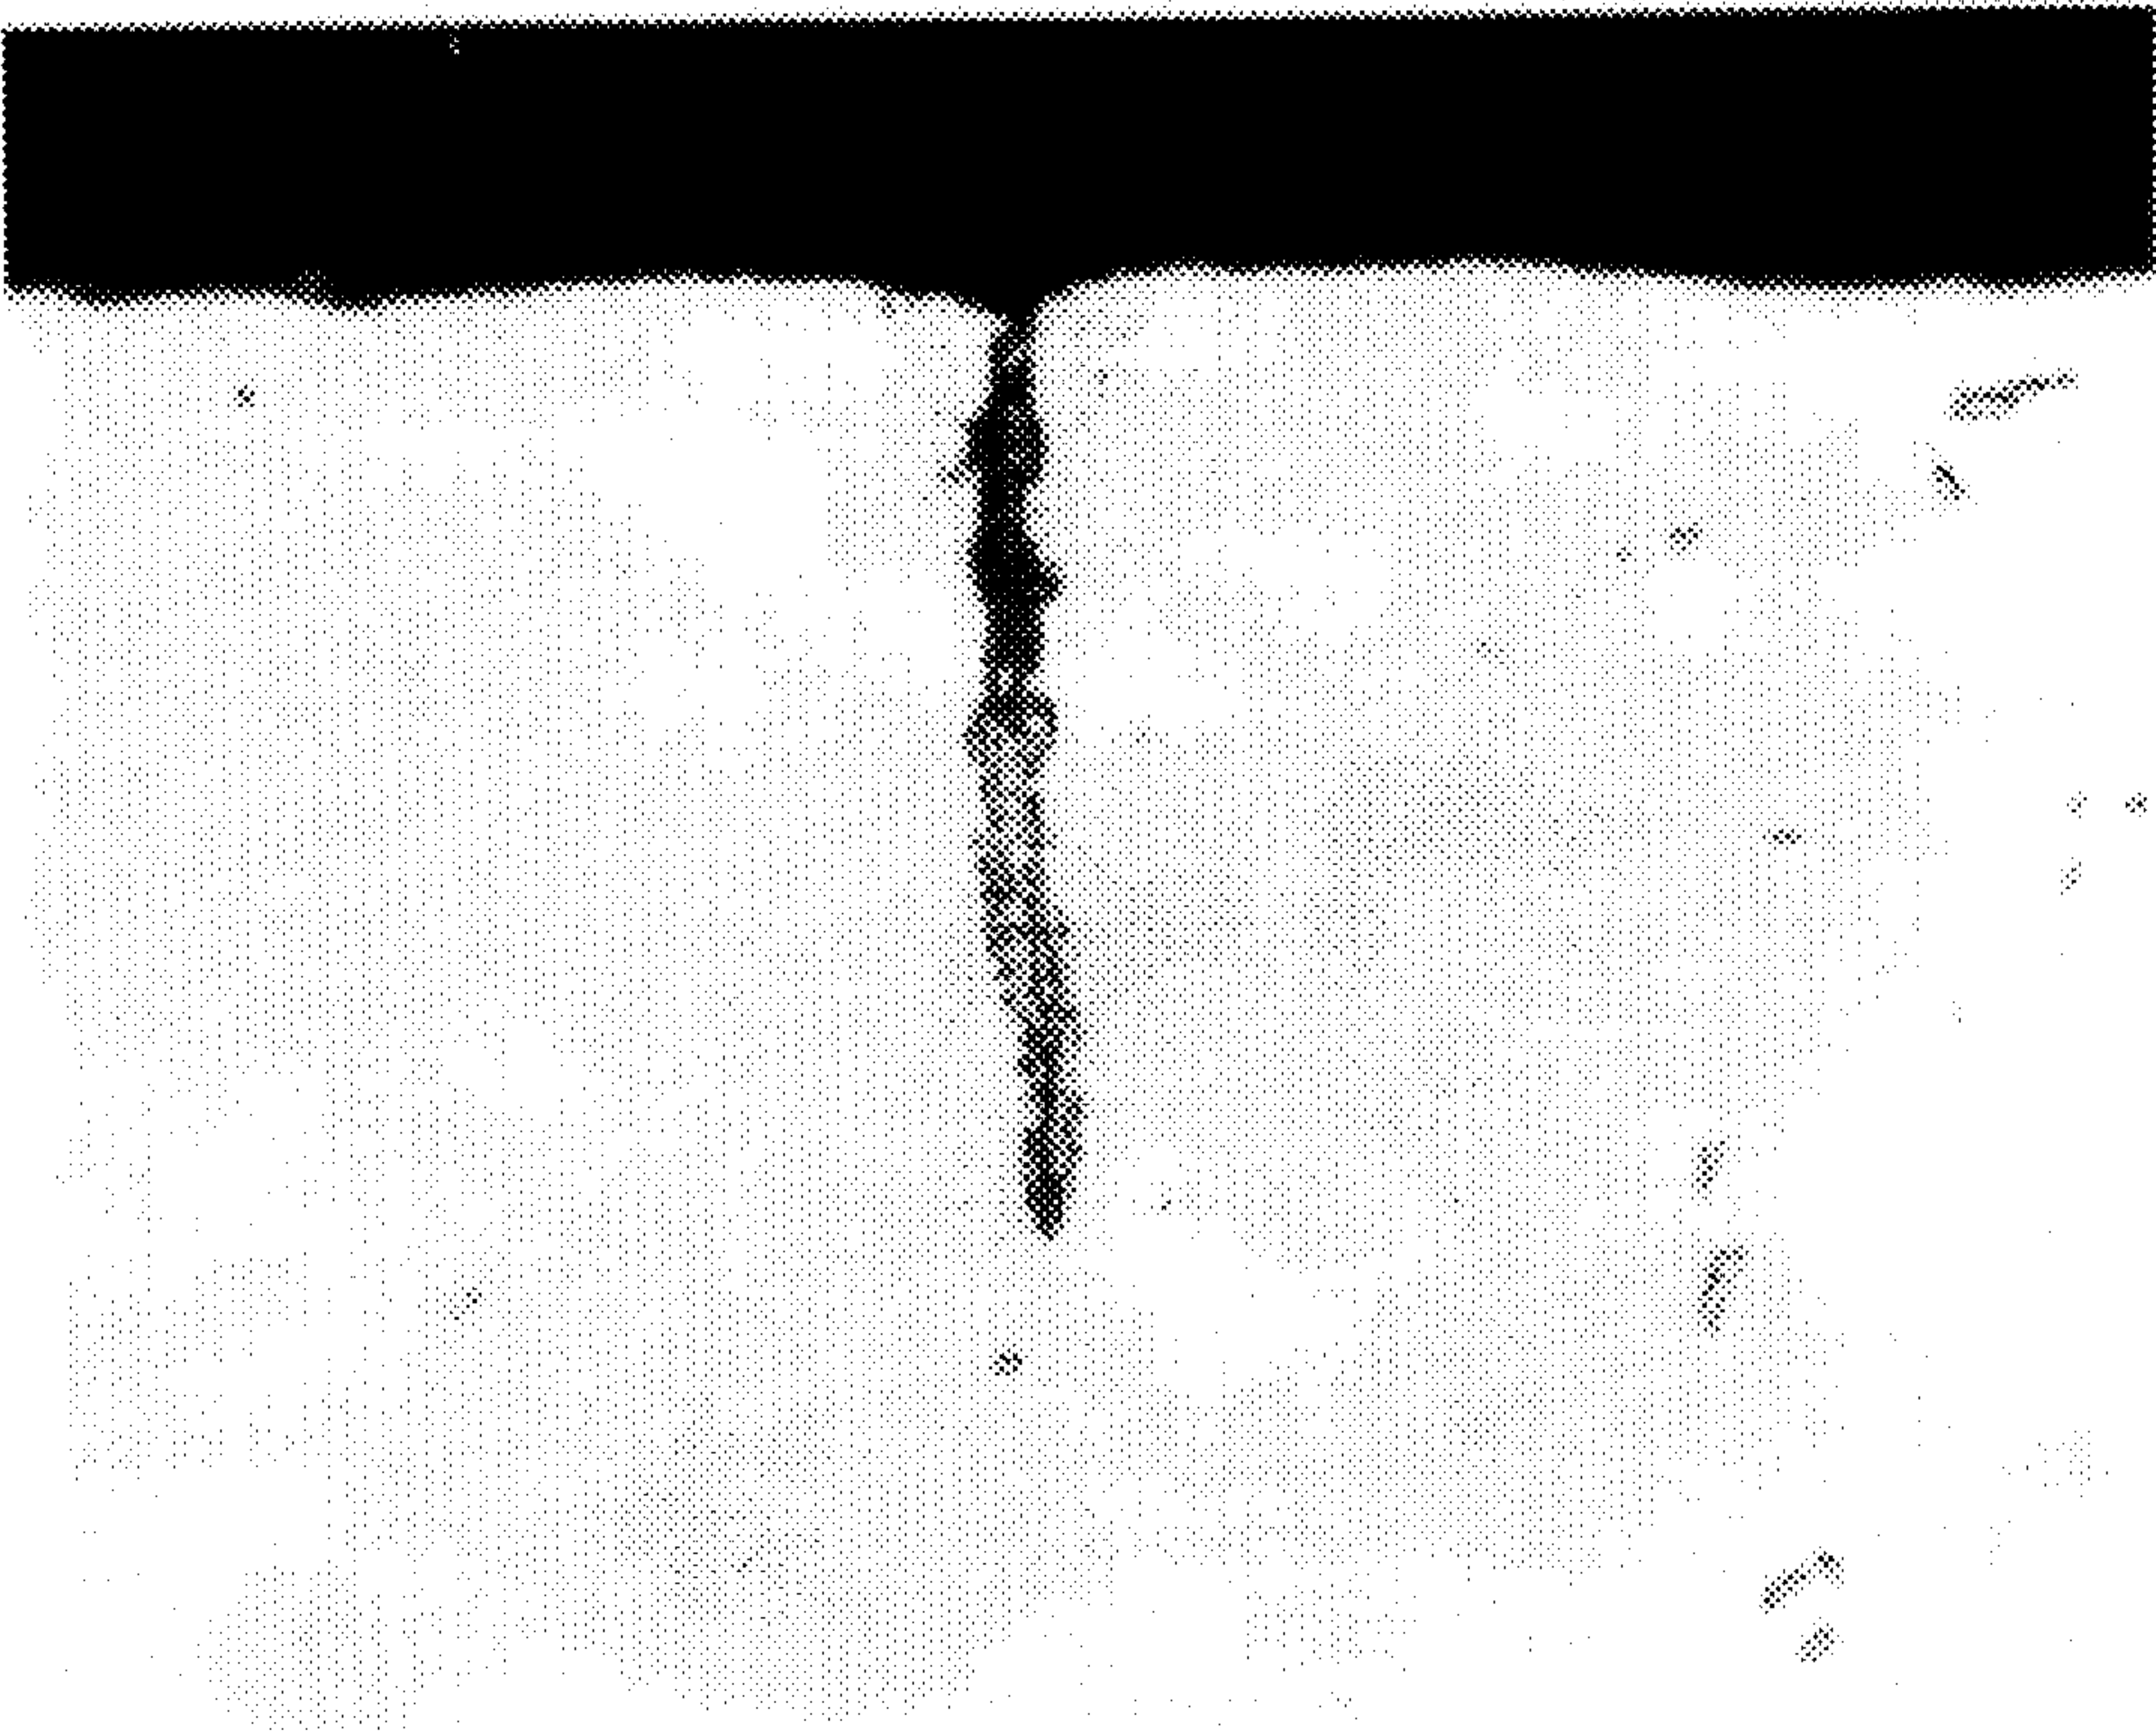
FIG. 2b shows the healed crack of FIG. 2a at 200× magnification.

FIGS. 2a and 2b show photomicrographs of a specimen that was coated and HIPed to seal outer surface cracks in superalloy parts. FIG. 2a shows the crack being sealed at the outer surface of the part at 50x. FIG. 2b demonstrates complete sealing (100% bonding) of the entire cracked area from the tip of the crack to the outermost surface of the superalloy part at 200x. This is the preferred sealing configuration and possible to achieve with sufficient cleaning.

exterior outermost surface. After the coating application, the coatings were found to be leak tight. The Rene N5 single crystal specimens that were coated by HVOF with pure nickel, were then hot isostatic pressed. The conditions for hot isostatic pressing were 1150° C. at 30 ksi for 3 hours. Metallography revealed that the crack was bonded 100% (FIGS. 2a and 2b).

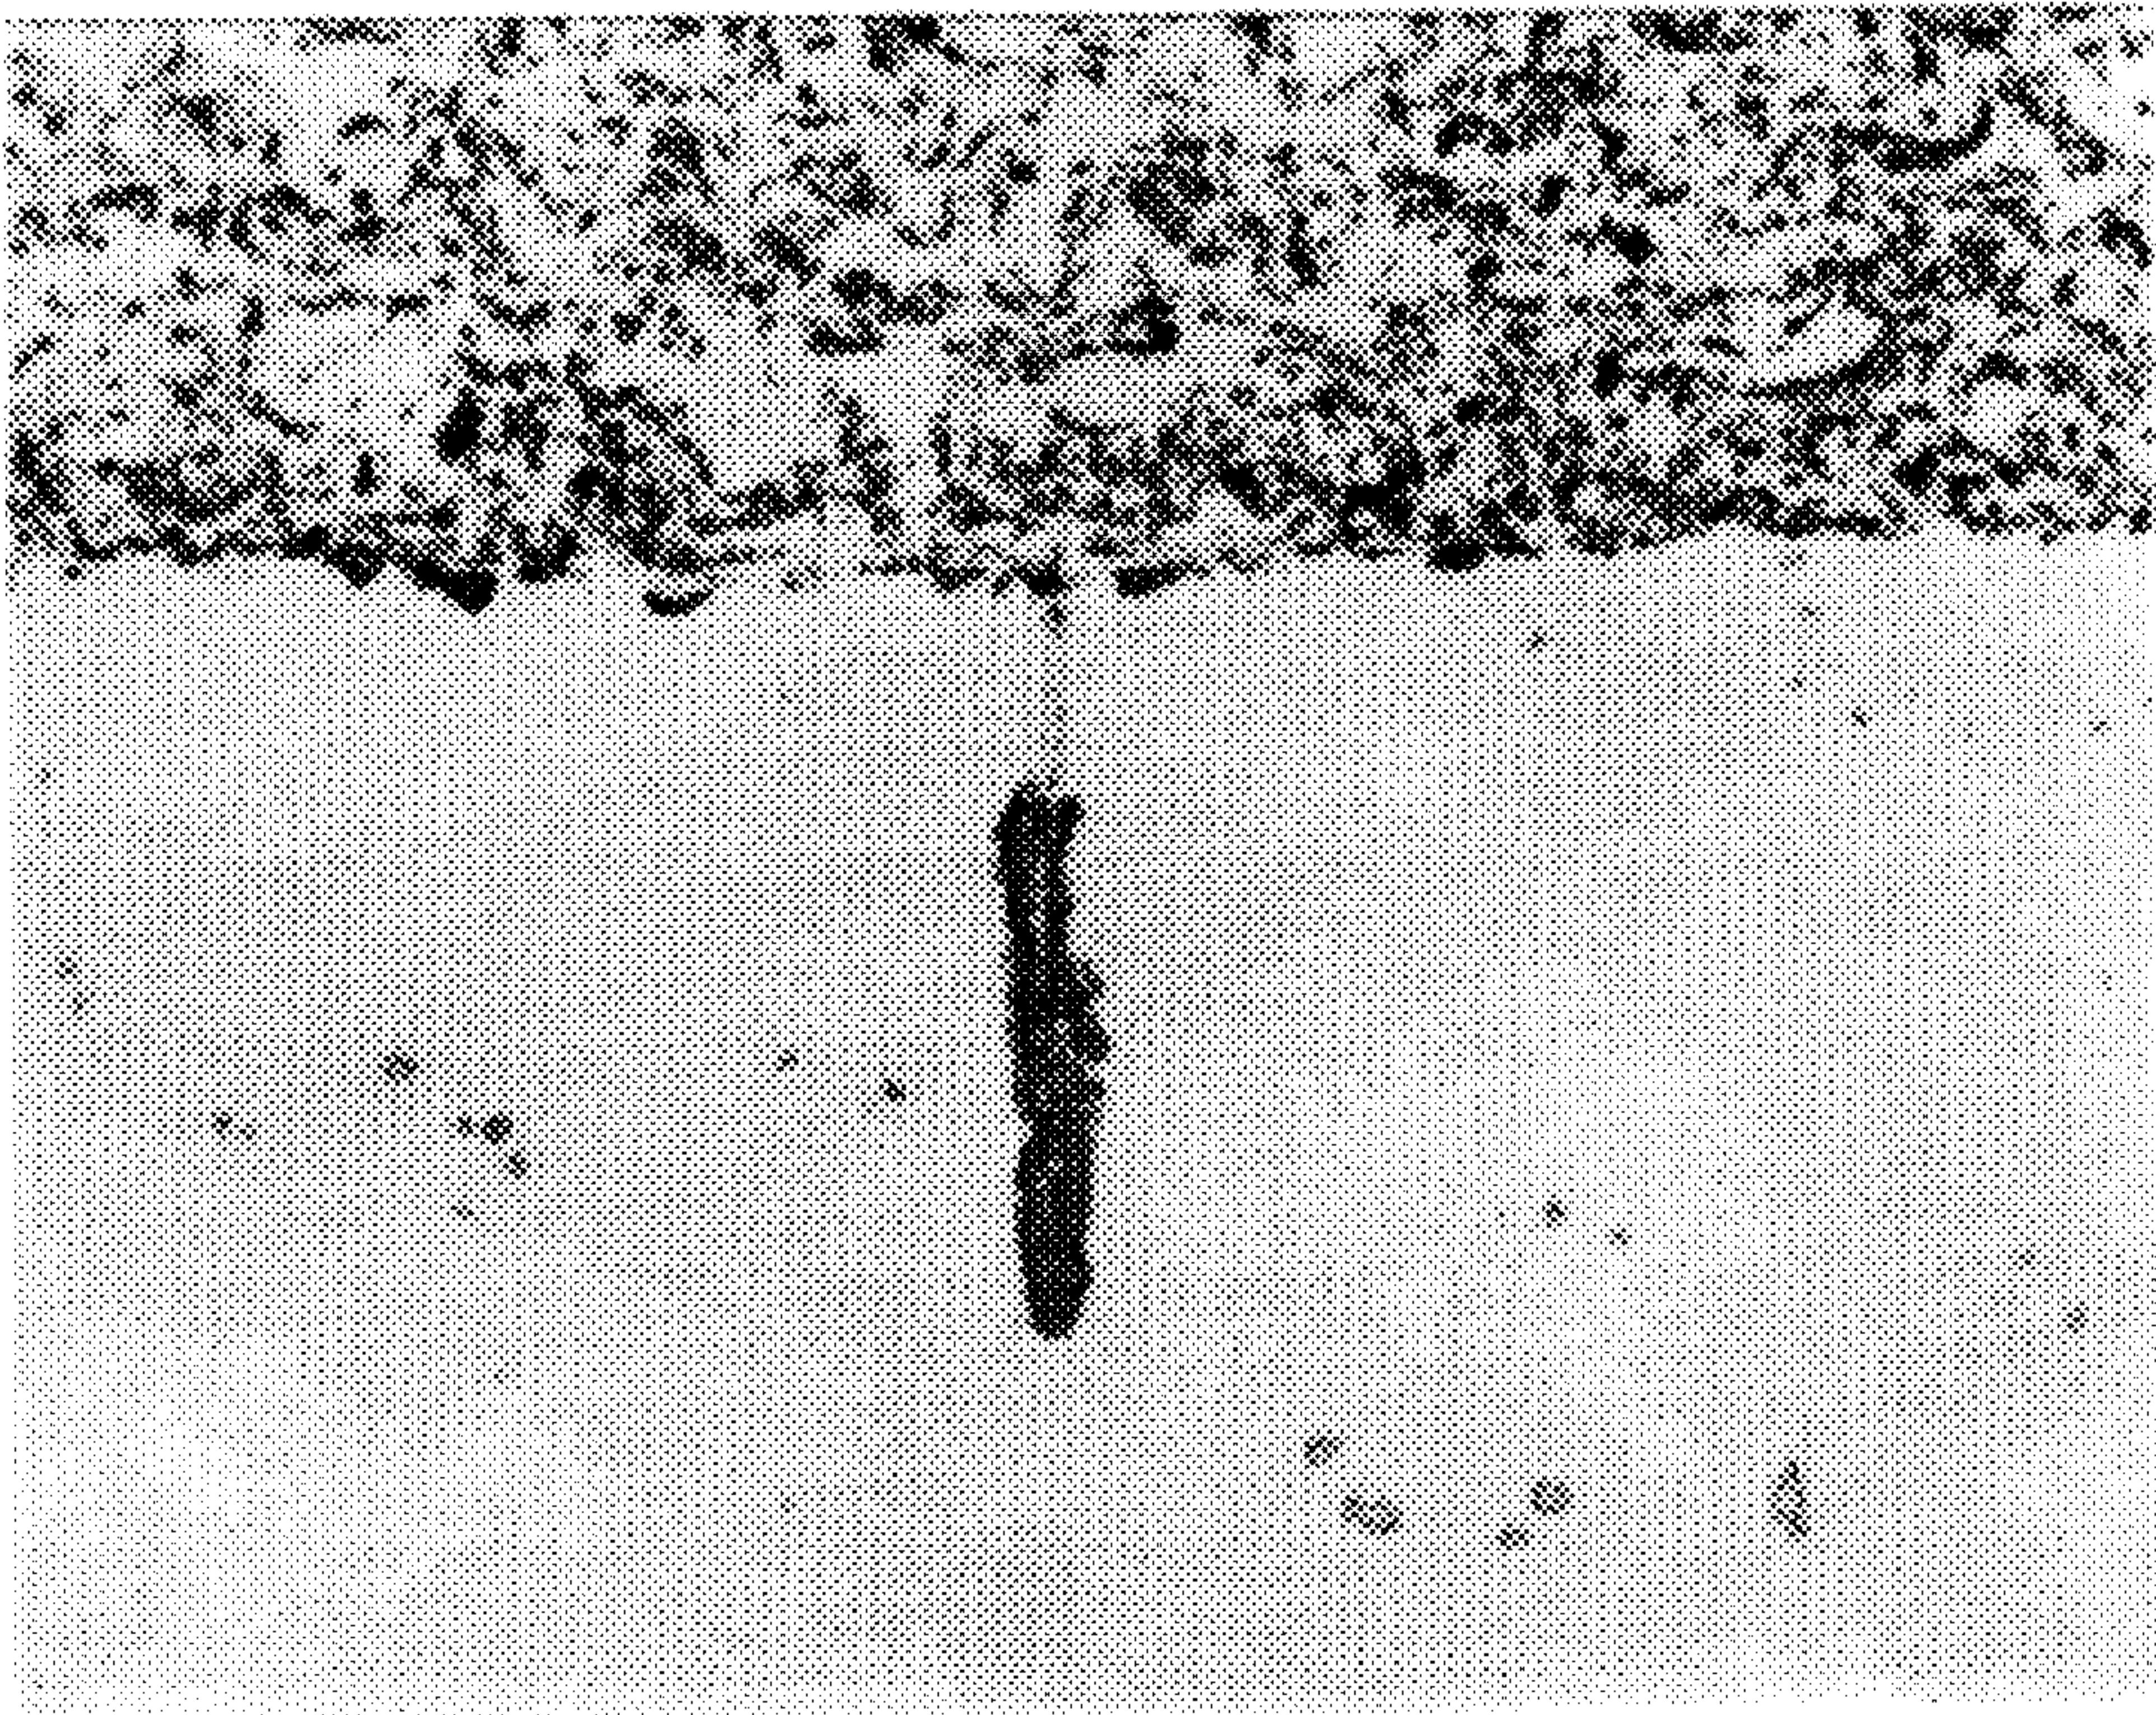
FIG. 3a

FIG. 3A is a photomicrograph representing a surface crack before coating and hot isostatic pressing at 200×.
