United States Patent [19]

[11] Patent Number: **5,732,467**

[54] METHOD OF REPAIRING DIRECTIONALLY SOLIDIFIED AND SINGLE CRYSTAL ALLOY PARTS

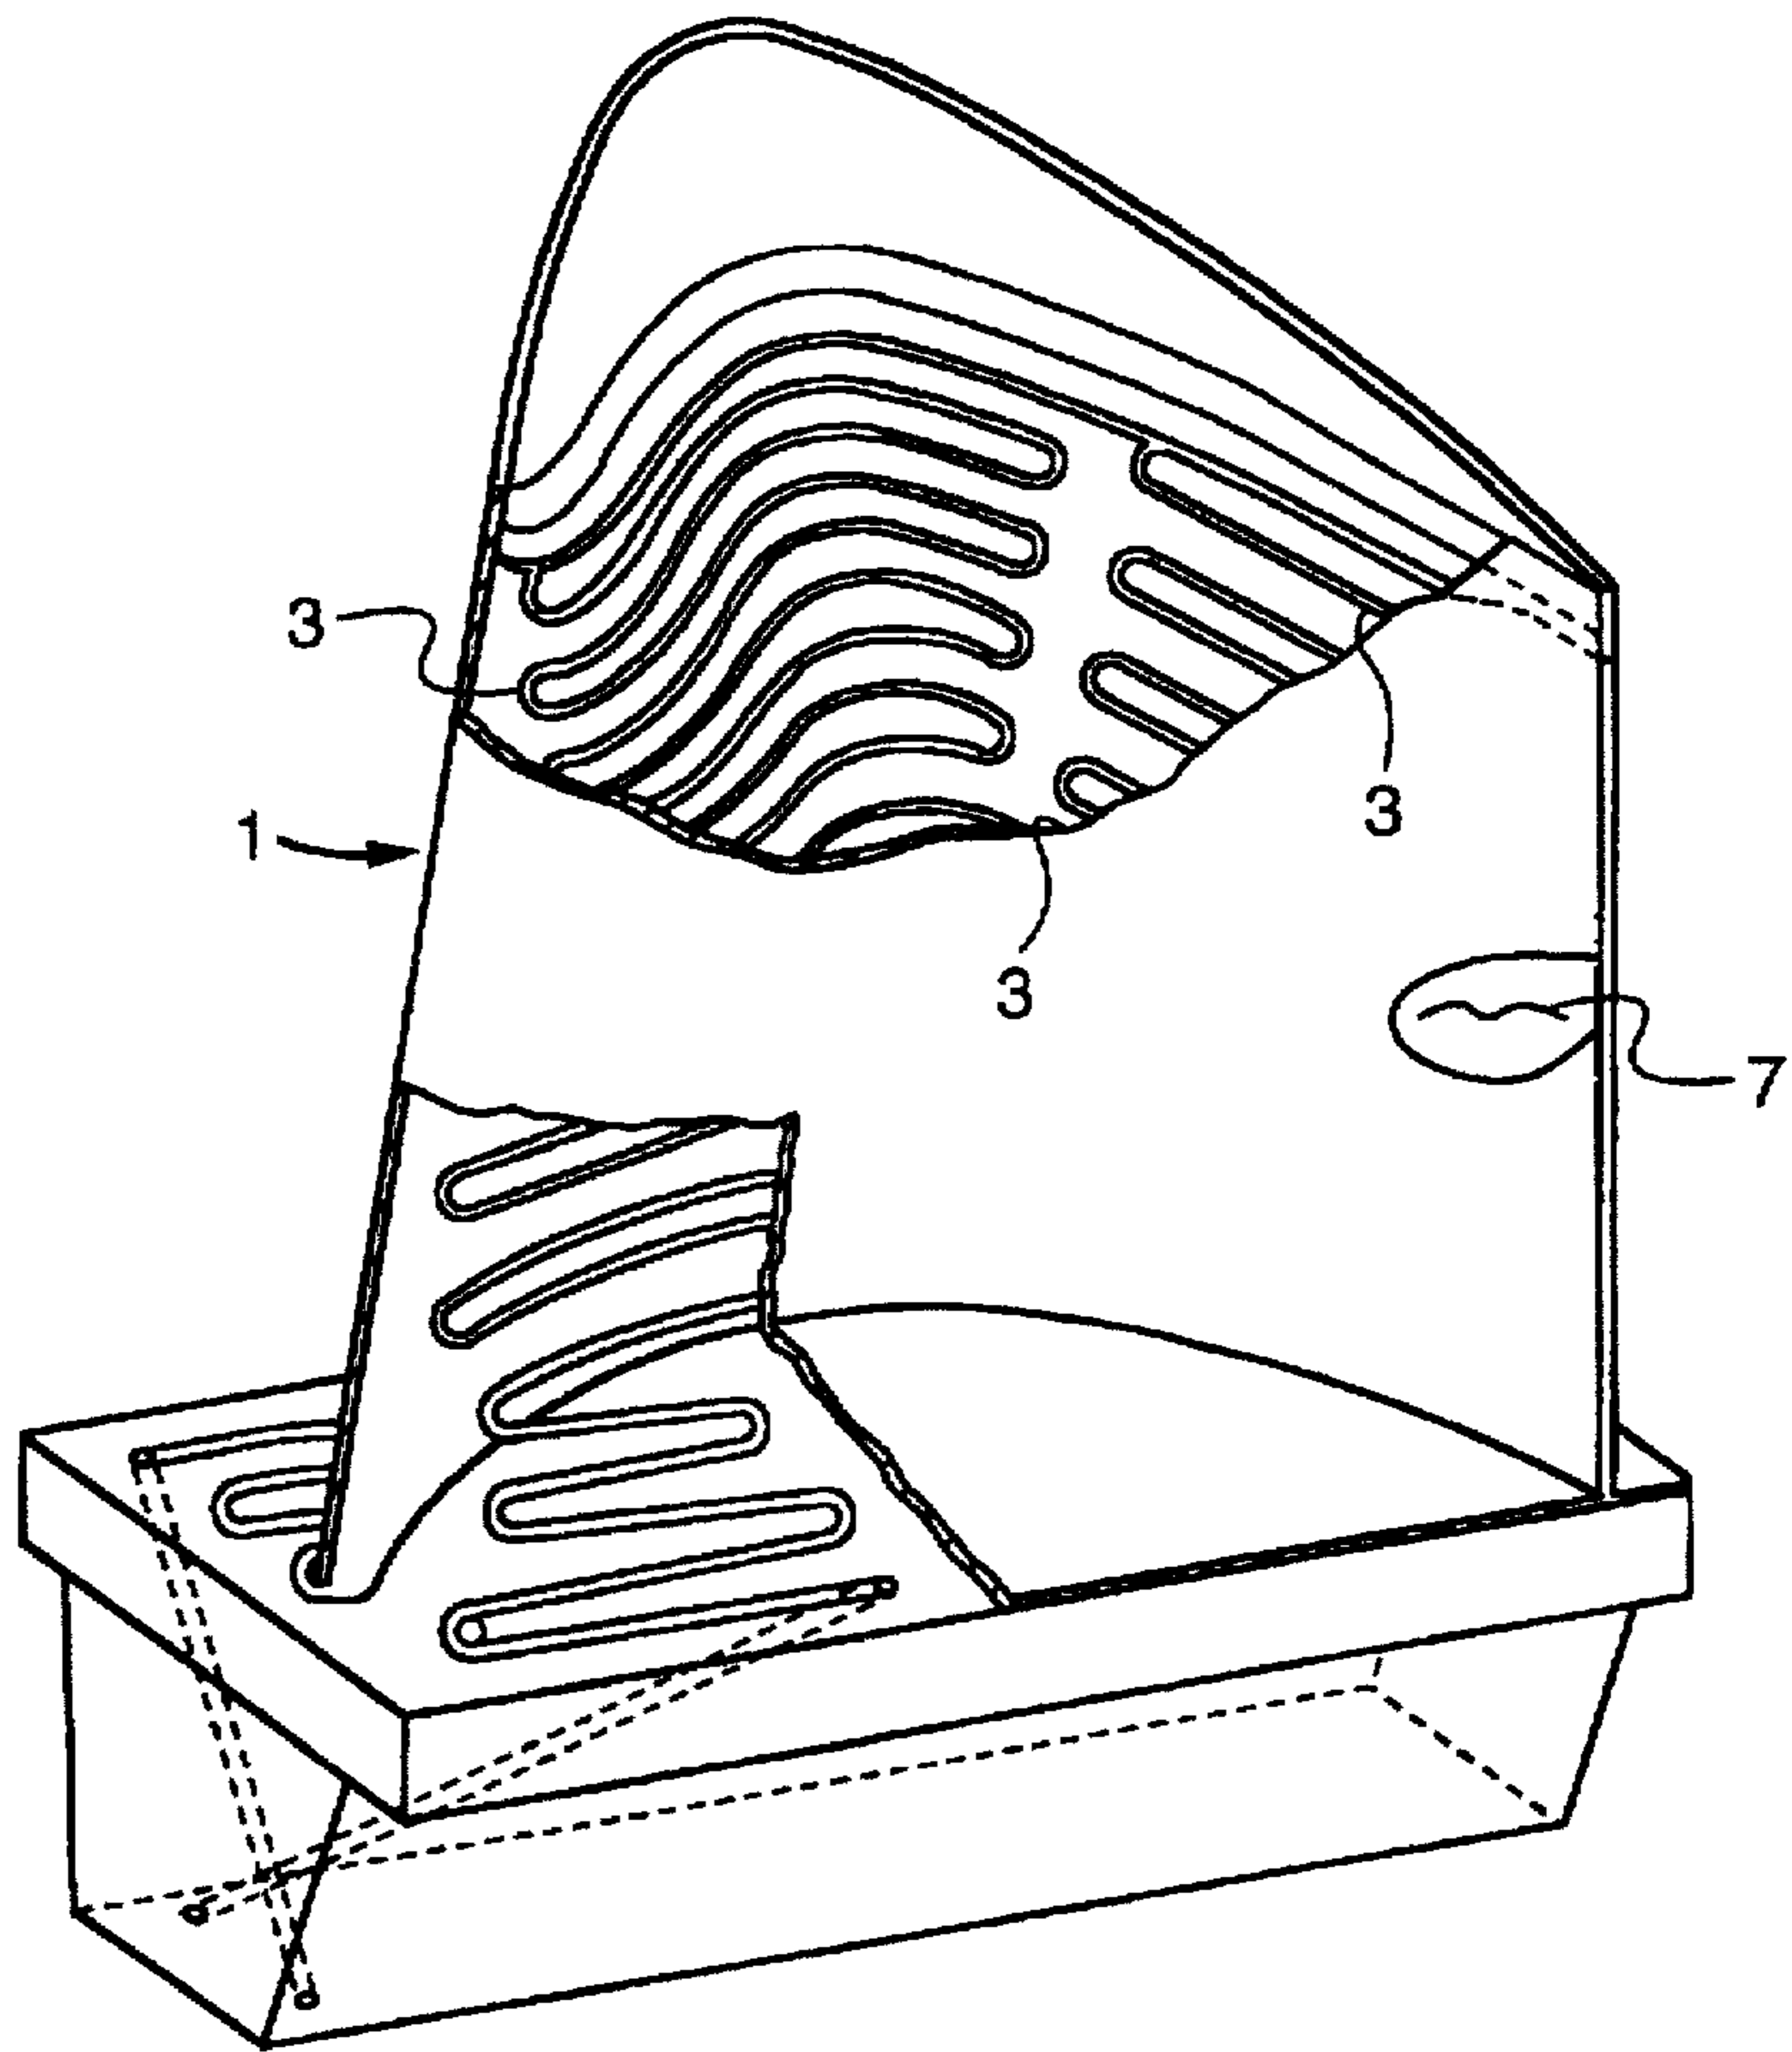
FIG. 1a is a three-dimensional view, partly cut away, showing a typical overall inner and outer arrangement for at least one turbine bucket that is made from a directionally solidified superalloy and that has a crack on the outer surface.

As noted herein, the method is particularly useful for repairing outer surface defects or cracks on an airfoil including an airfoil blading member such as a turbine blade or vane, which is depicted in FIG. 1a. A selected article, such as FIG. 1a, has a superalloy composition and directionally oriented crystal structure. The superalloy may have a superalloy composition of a nickel-base, iron-base, or cobalt-base superalloy, such as is well known and described, for example, in Metals Handbook Tenth Edition, Vol. 1, Properties Selection: Iron, Steel and High-Performance Alloys, ASM International (1990), pages 981-994 and 995-1006, which describes many castable superalloys, and specifically nickel-base superalloys that may be directionally solidified or formed as single crystals. For purposes of this invention, acceptable superalloys would also include high temperature alloys that are not presently in widespread commercial use, such as niobium-base and titanium-base alloys, including niobium-titanium alloys, directionally oriented nickel-base or titanium-base composite alloys and niobium-aluminum alloys.

Turning to FIG. 1a, the blade 1 is shown cut away to demonstrate the internal cooling passages 3 which are surrounded by an outer surface 5. Looking at FIG. 1b, the outer surface 5 is generally a superalloy metal 15 and may have coating overlays, such as a bond coat 11 and a thermal barrier coating 9. The bond coat 11 is any acceptable metallic or ceramic coating that serves to improve adhesion between the subsequent thermal barrier coating 9 and the underlying substrate 15. Examples of bond coats are MCrAlY, where M is nickel, iron, cobalt, or mixtures thereof; and aluminides. The thermal barrier coating 9 provides a protective coating that enables the substrate 15 to operate at higher temperatures. Thermal barrier coatings also protect the underlying parts from corrosive and oxidative environments. An example of a thermal barrier coating is chemically stabilized zirconia, such as yttria stabilized zirconia, where yttria is present in about 1 to 20 weight percent, with the preferred range being about 6-12 weight percent yttria.

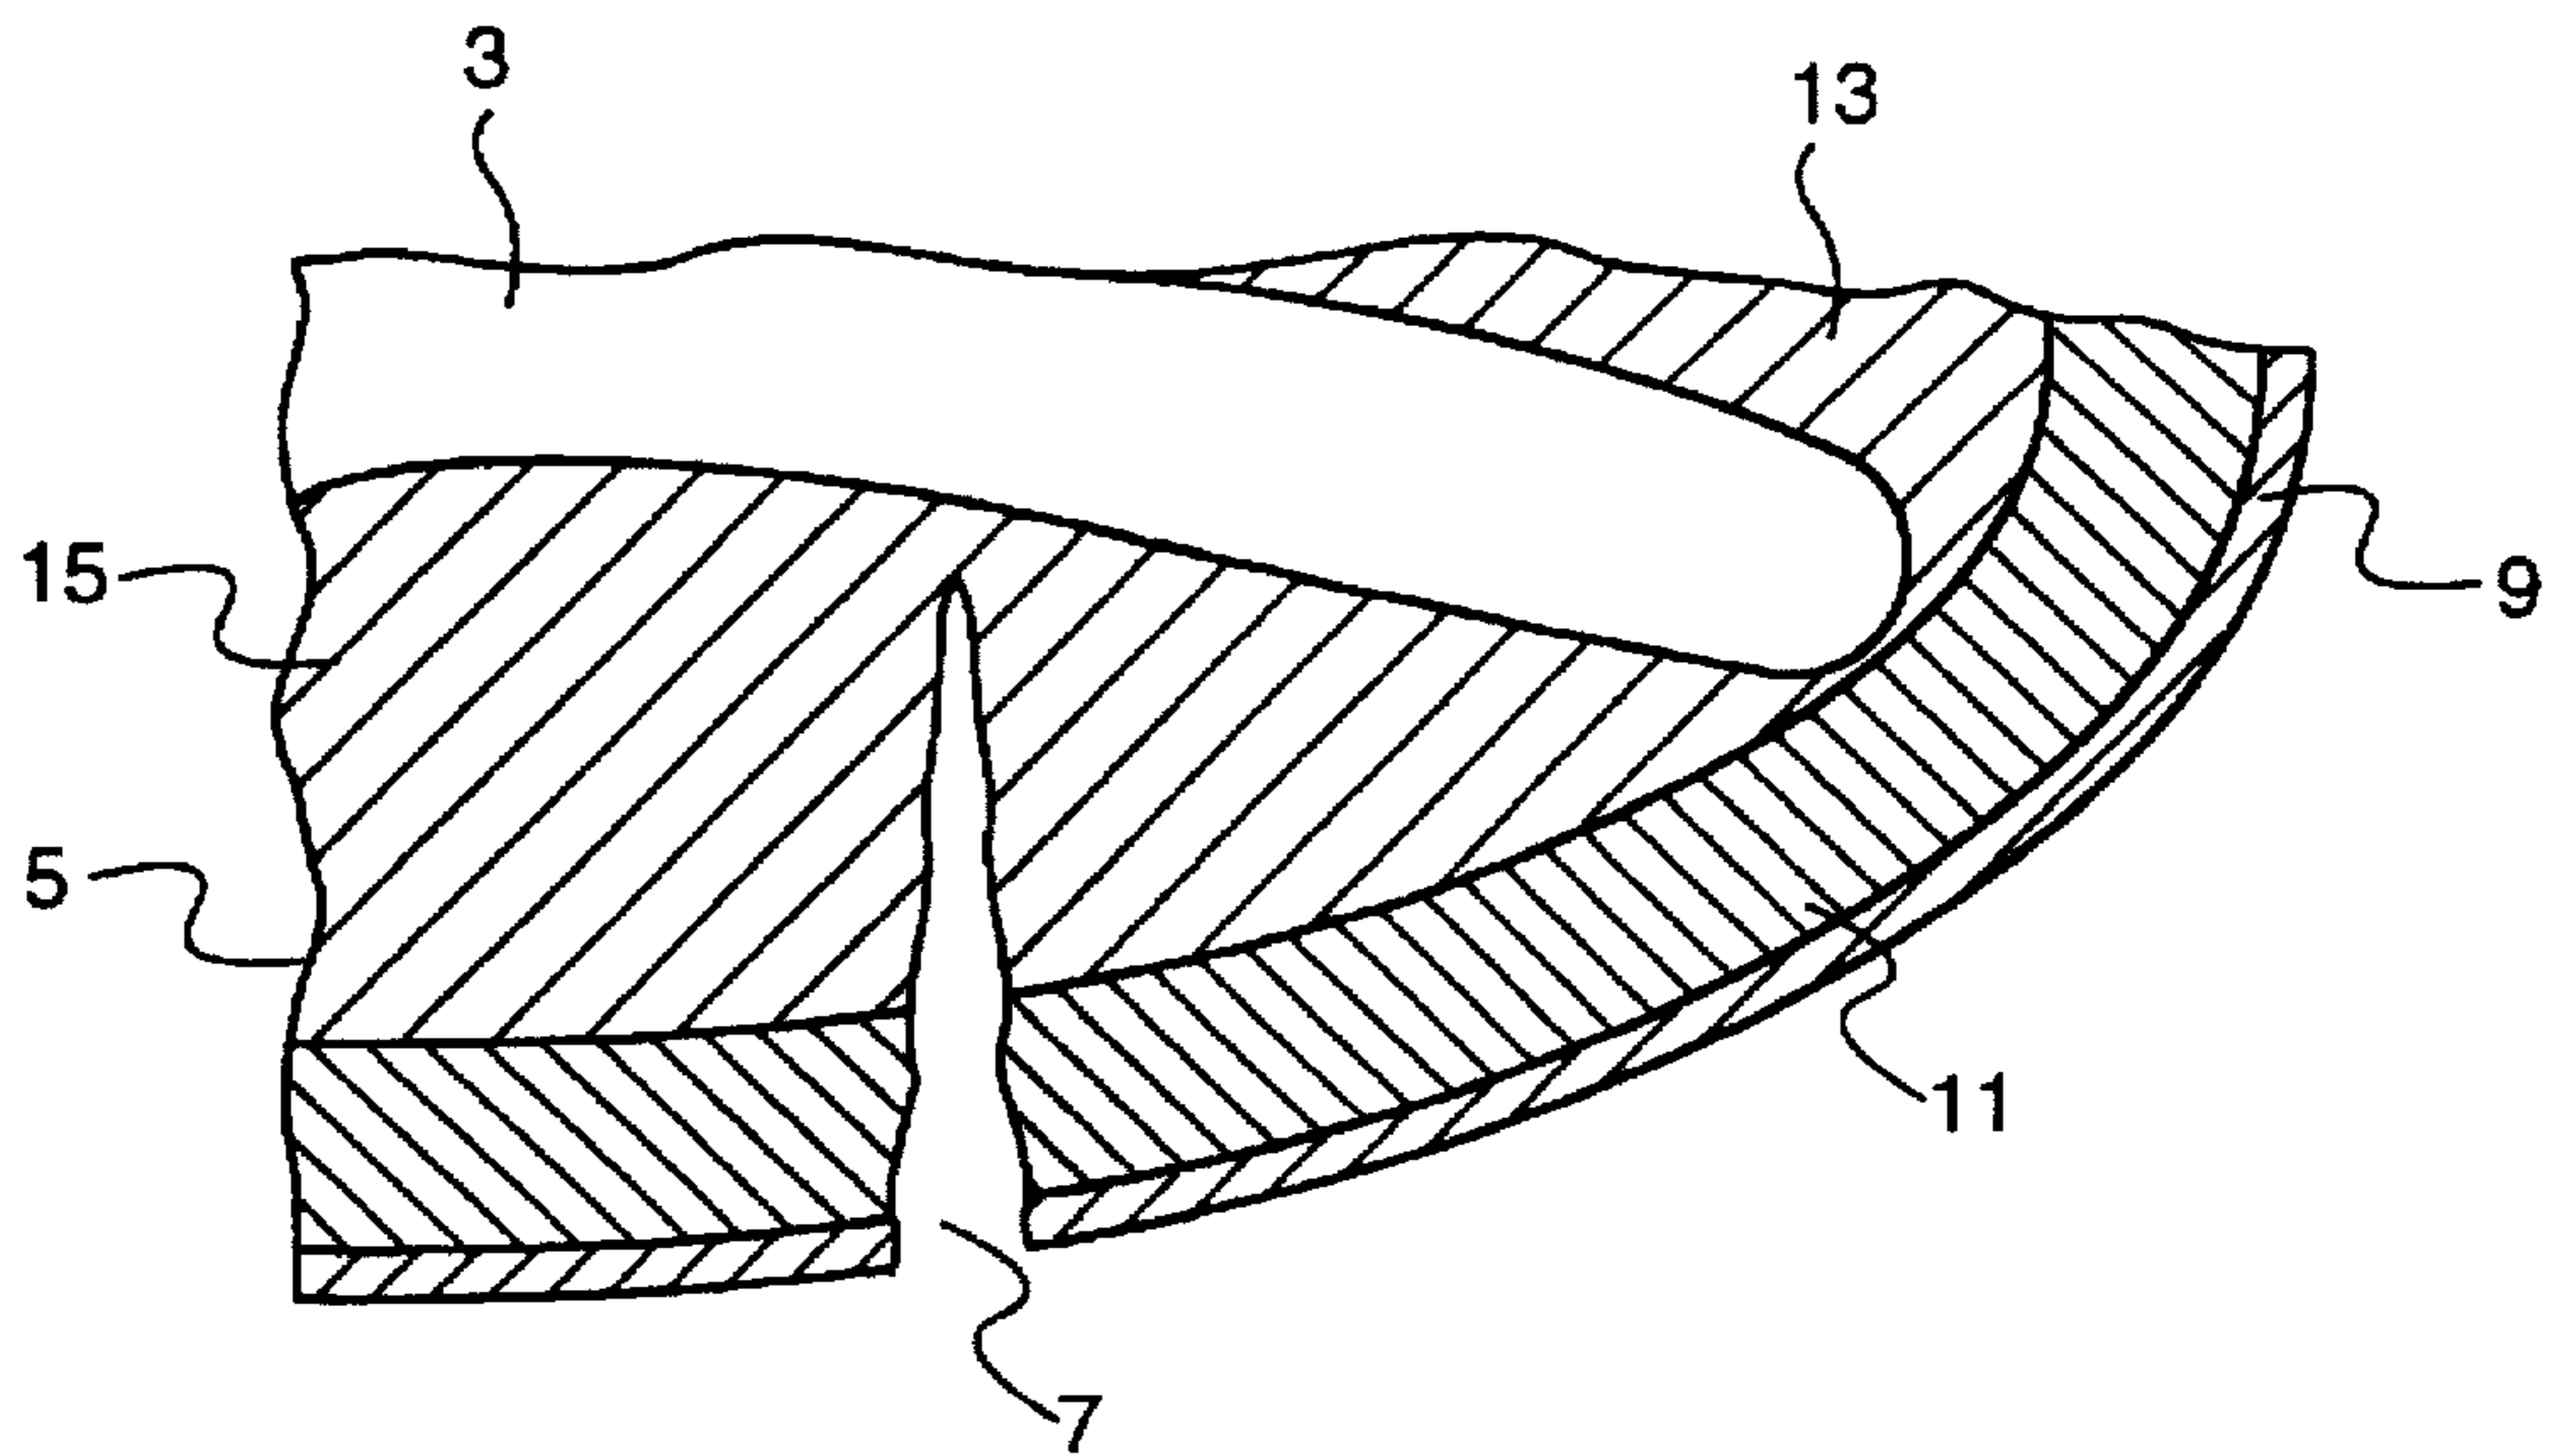
FIG. 1b depicts a cross-sectional view of the cracked surface area shown in FIG. 1a.

FIG. 1b shows a cross-sectional view of an outer surface area 5 of a blade member having a surface defect or crack 7. The surface defects or cracks often are heavily oxidized areas. It is desirable to remove heavily oxidized contami-

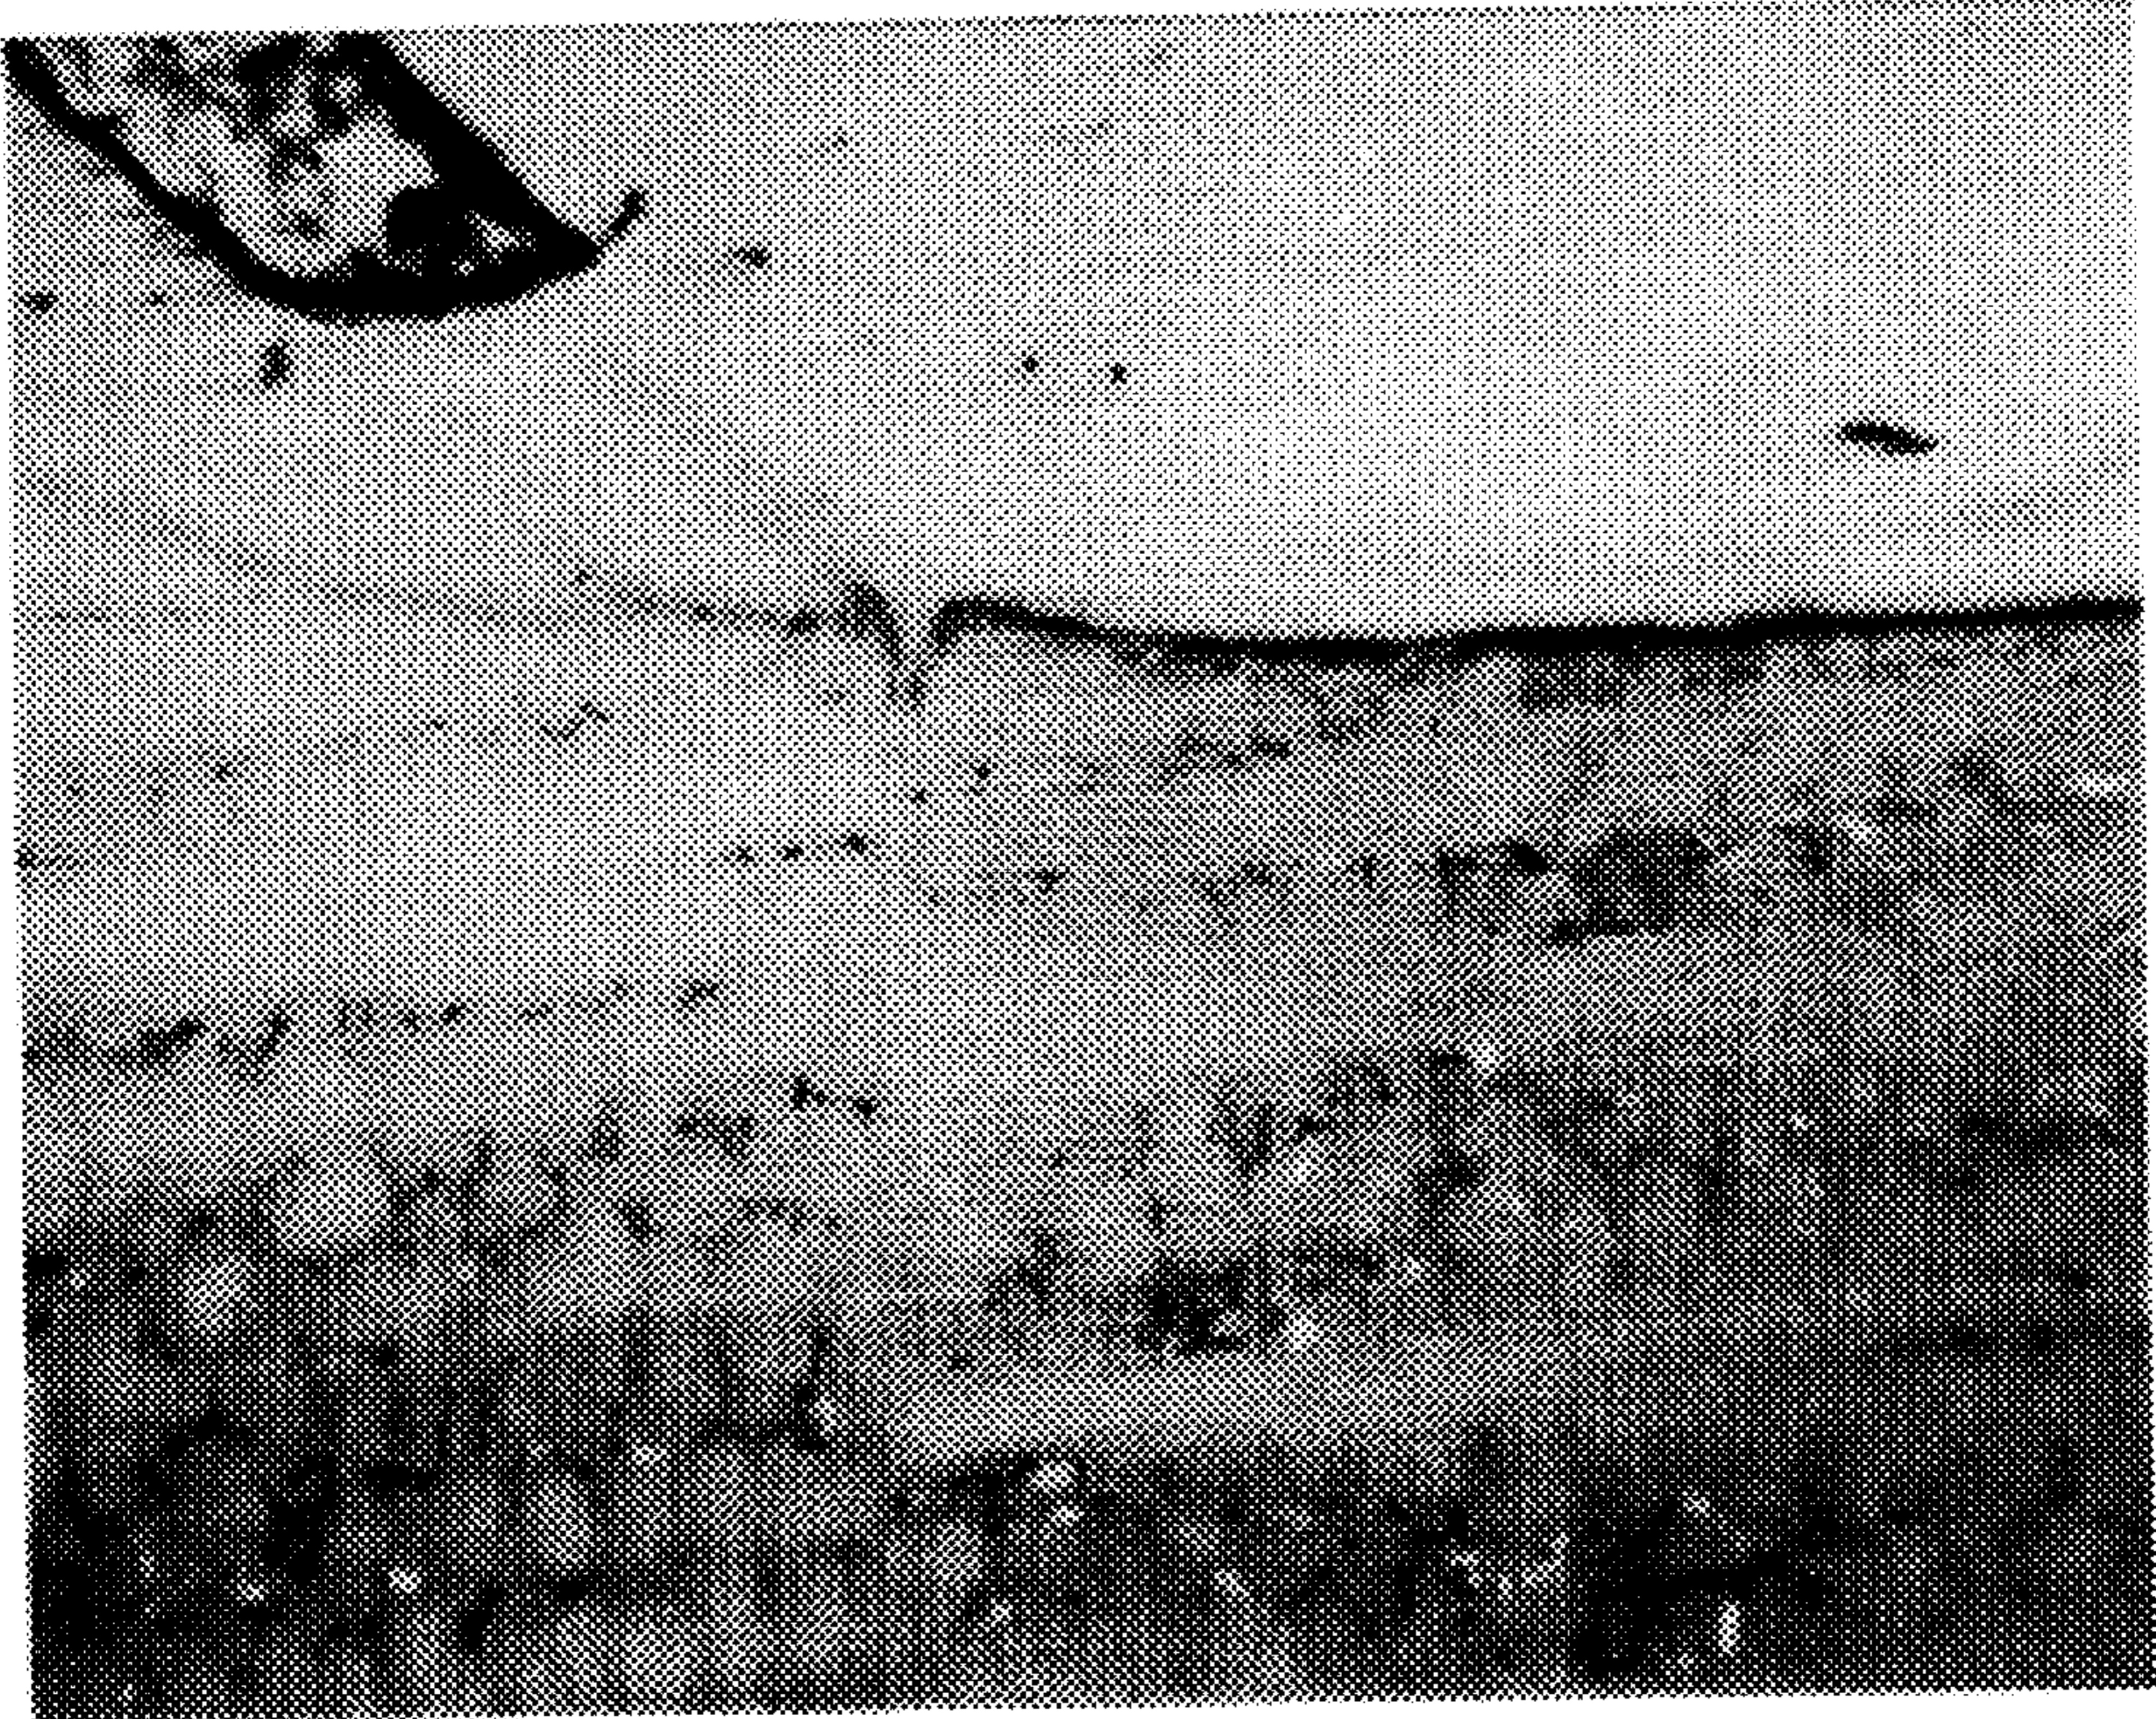
FIG. 2a is a photomicrograph at 50× magnification of a healed crack by the method of this invention.

FIGS. 2a and 2b show photomicrographs of a specimen that was coated and HIPed to seal outer surface cracks in superalloy parts. FIG. 2a shows the crack being sealed at the outer surface of the part at 50 \times . FIG. 2b demonstrates complete sealing (100% bonding) of the entire cracked area from the tip of the crack to the outermost surface of the superalloy part at 200 \times . This is the preferred sealing configuration and possible to achieve with sufficient cleaning.

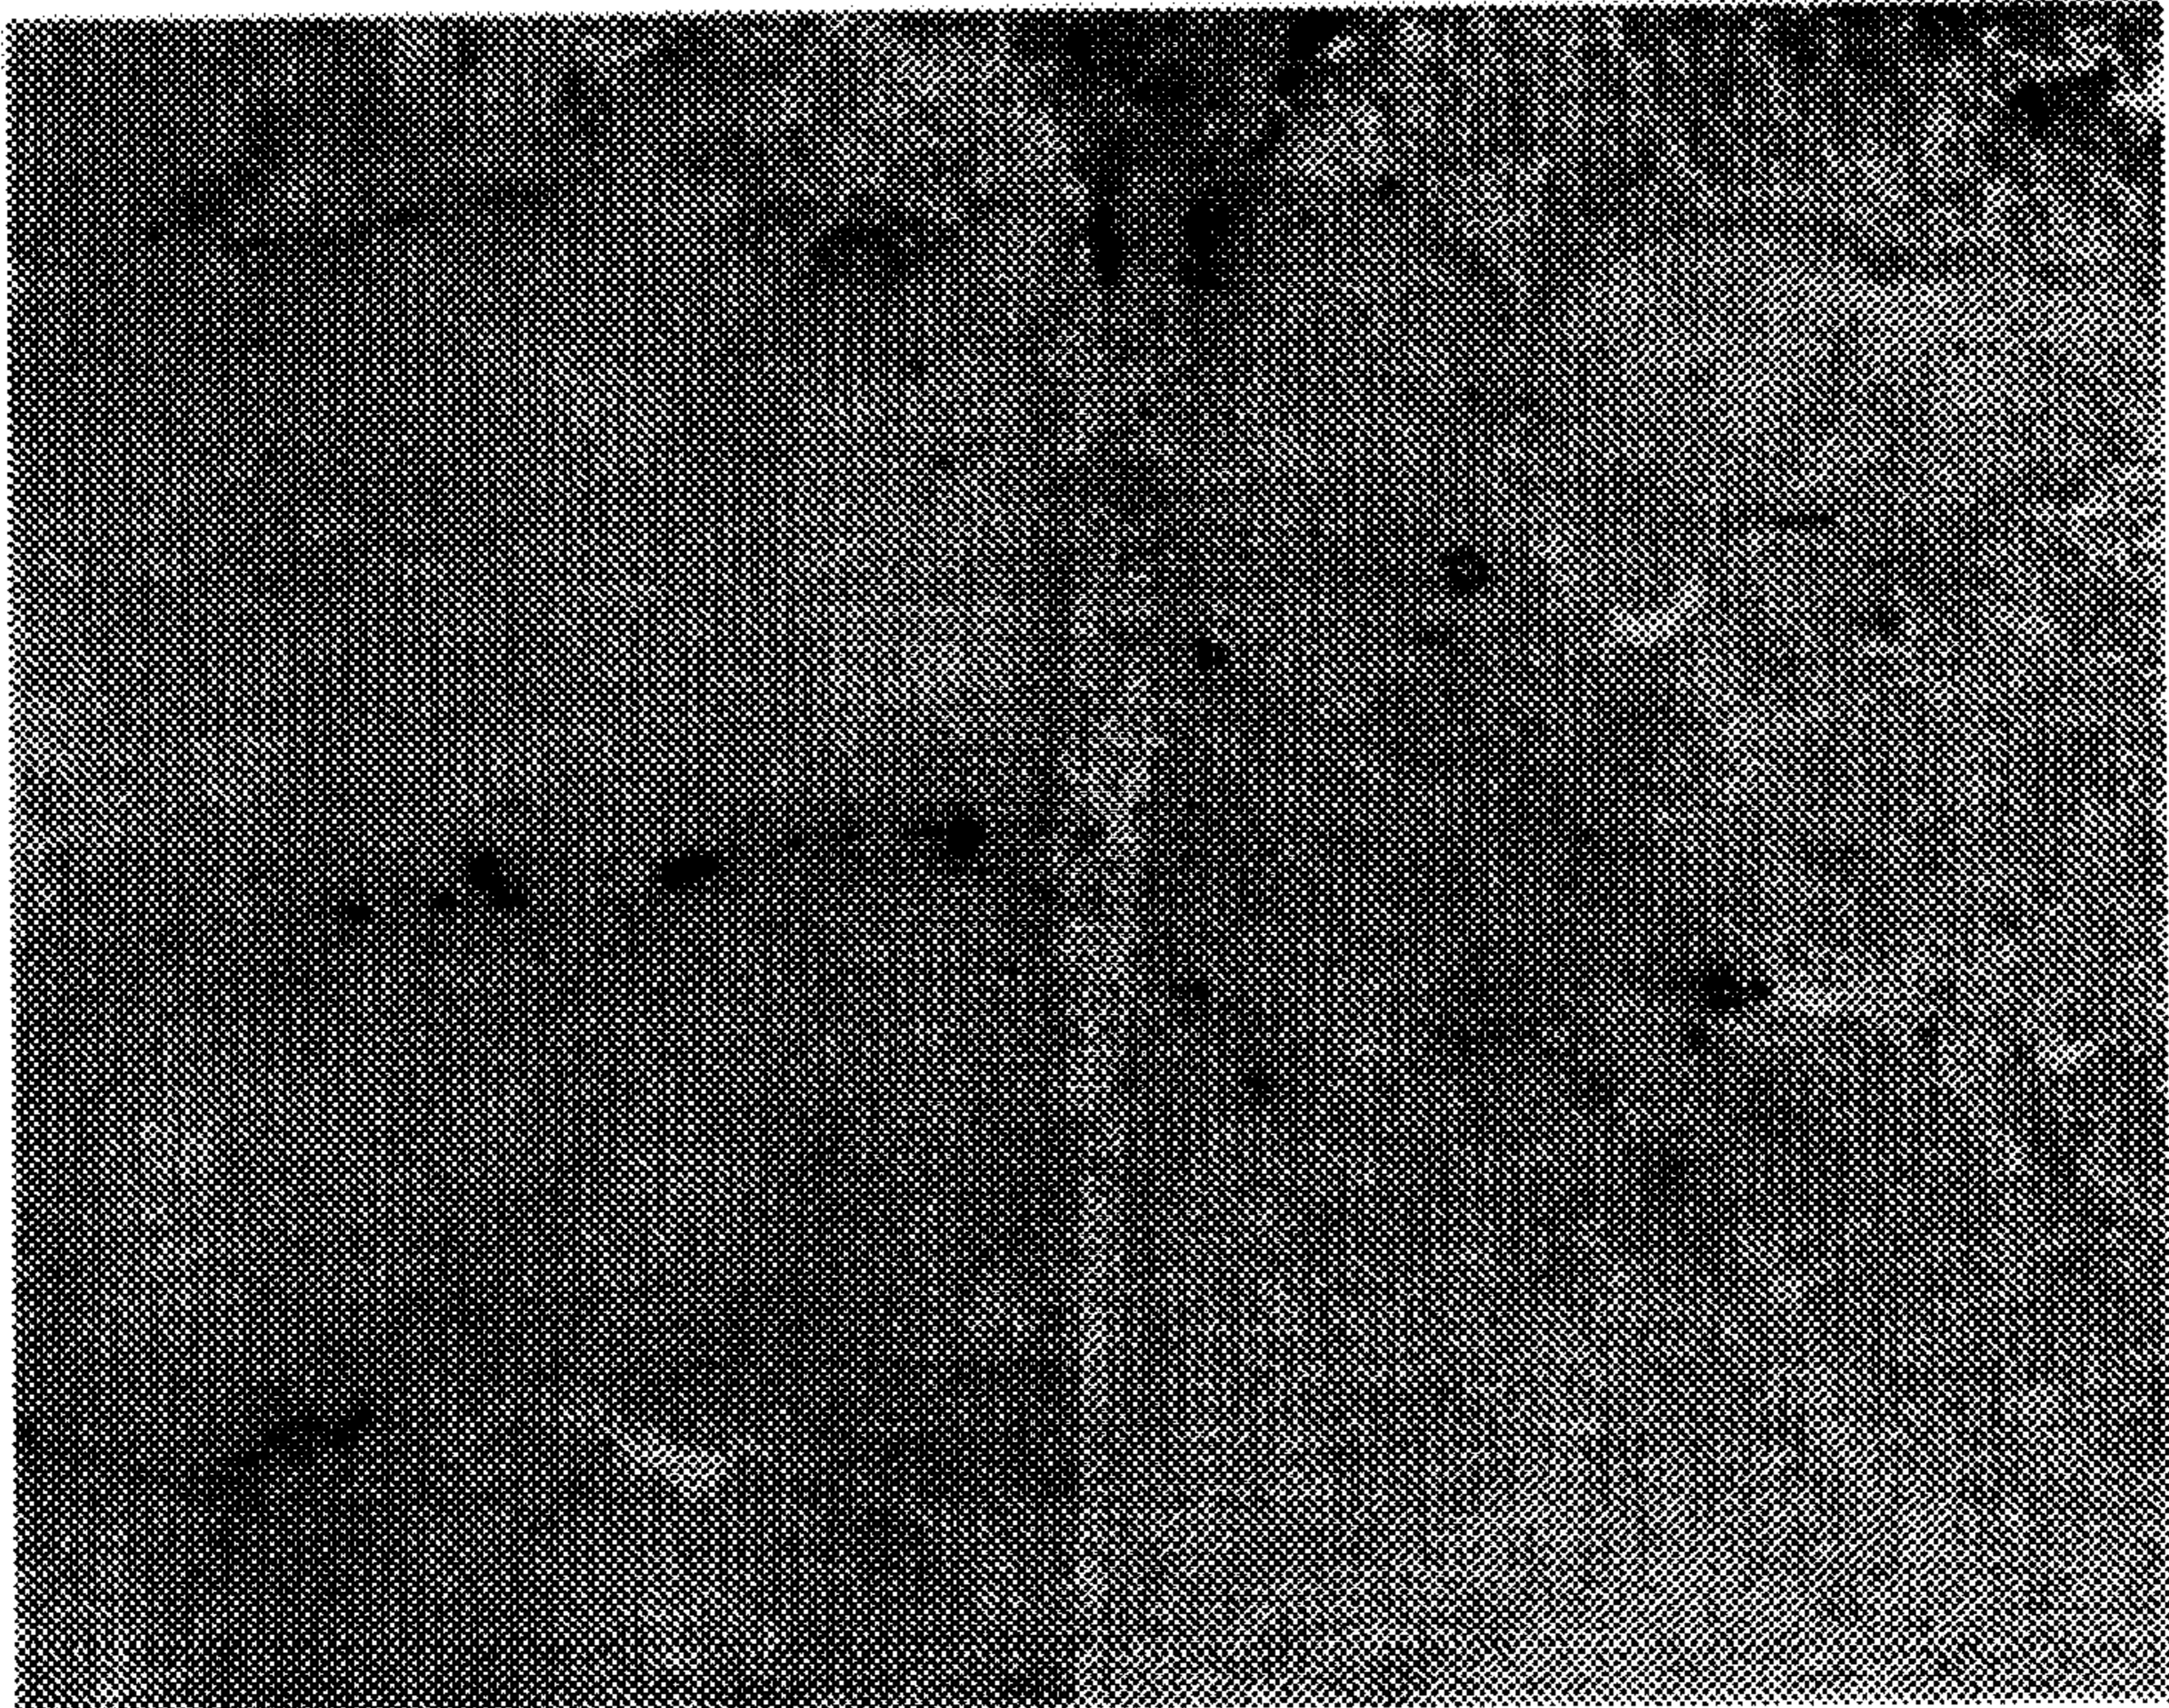
FIG. 2b shows the healed crack of FIG. 2a at 200× magnification.

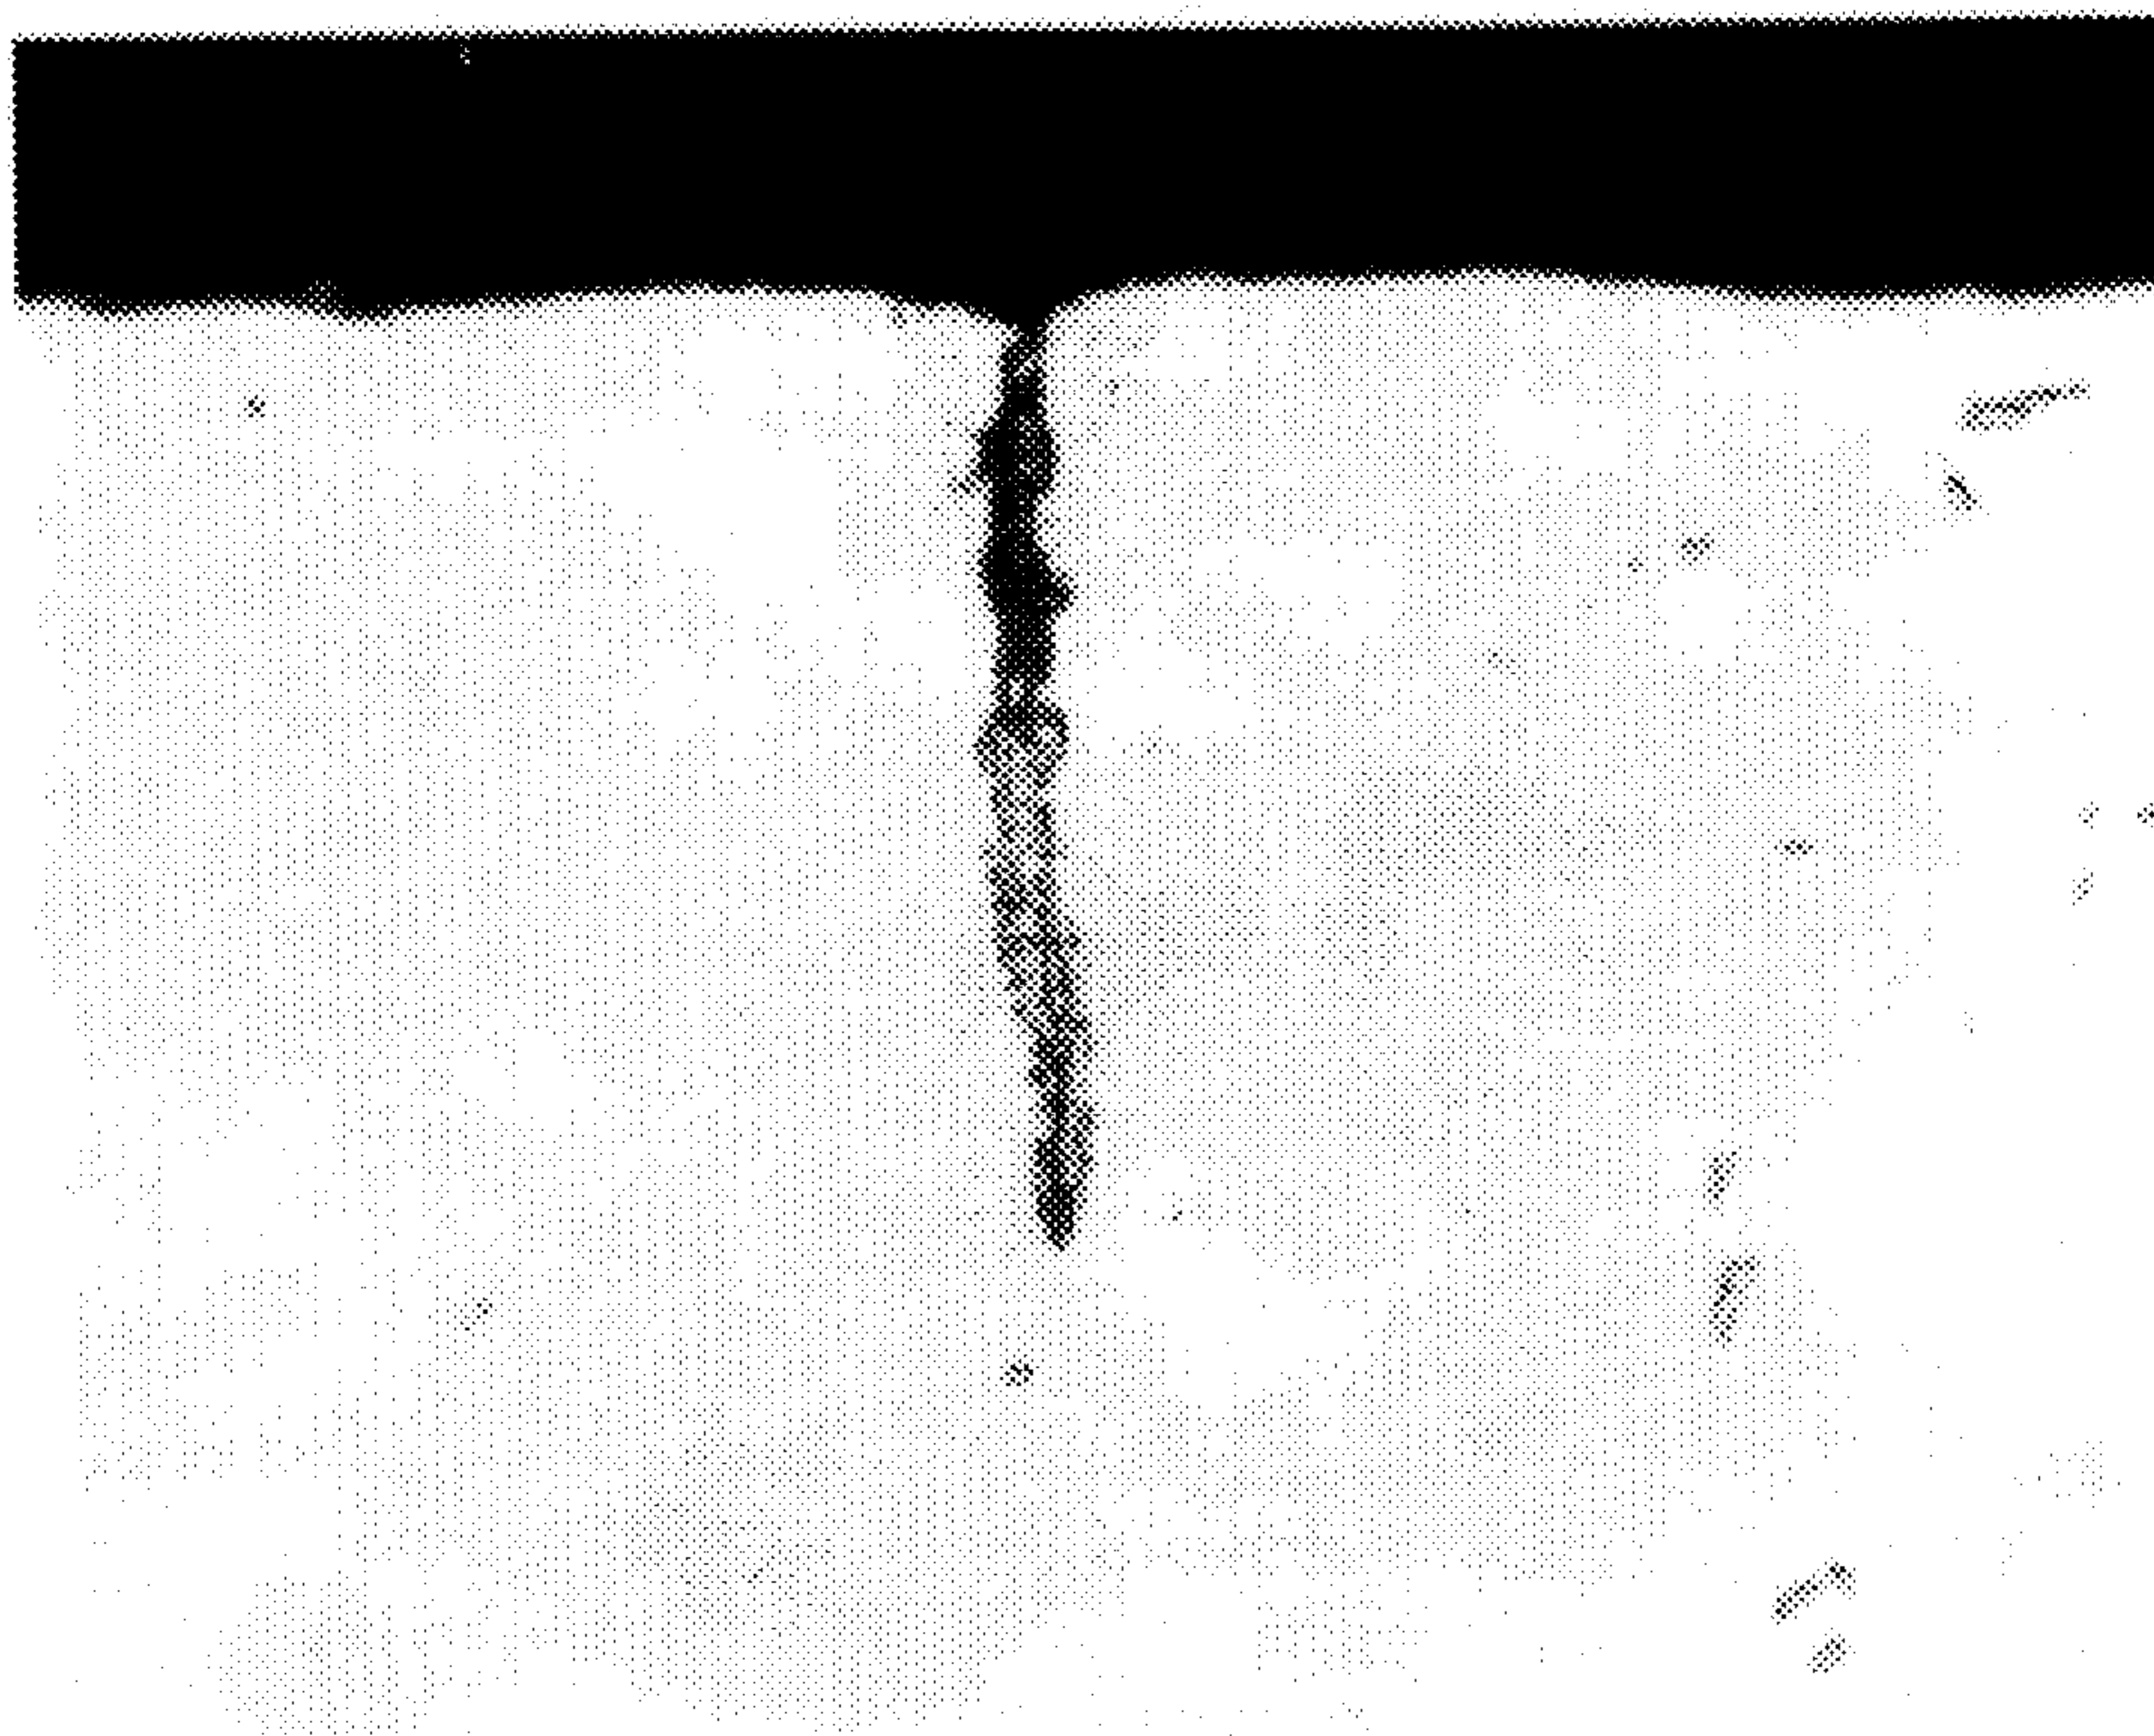
FIG. 3a

FIG. 3A is a photomicrograph representing a surface crack before coating and hot isostatic pressing at 200×.
