United States Patent [19]

[11] Patent Number: **5,732,467**

[54] METHOD OF REPAIRING DIRECTIONALLY SOLIDIFIED AND SINGLE CRYSTAL ALLOY PARTS

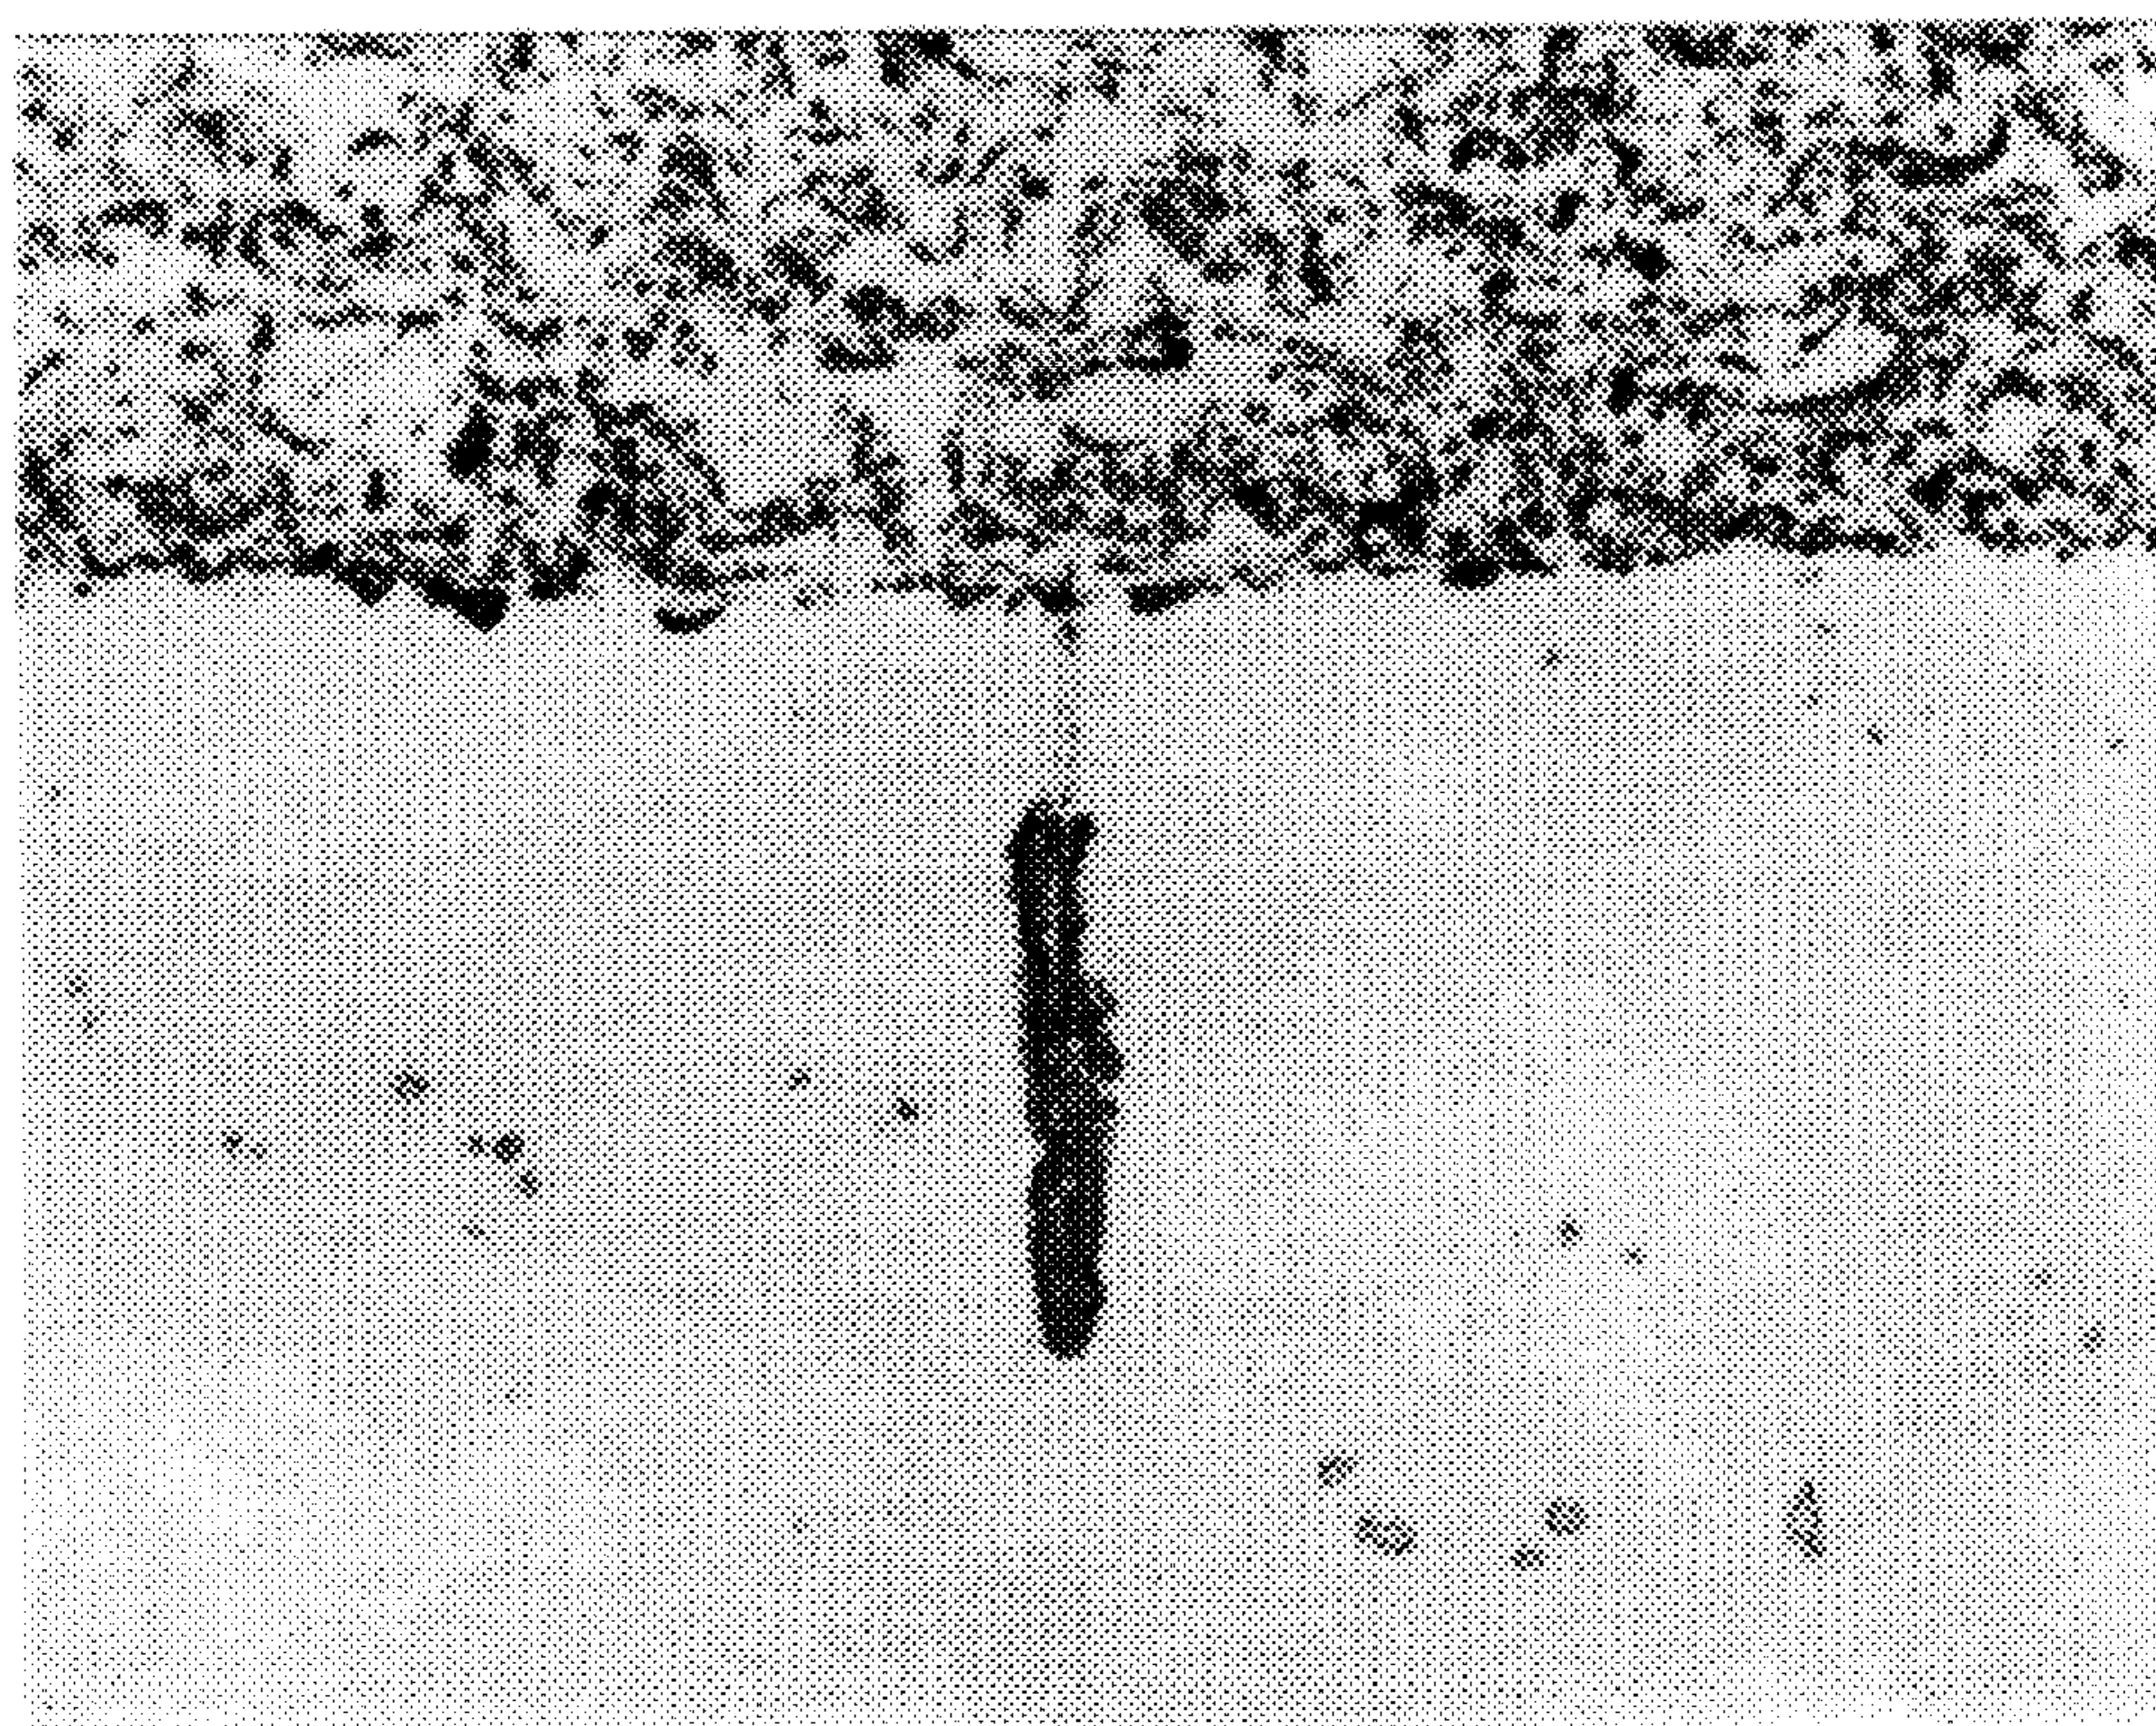
FIG. 3b is a photomicrograph of the representative crack of FIG. 3a after spray coating and hot isostatic pressing and shows the top closure of the crack at the part surface at 200×.
