[11] Patent Number: **5,735,044**

## [54] LASER SHOCK PEENING FOR GAS TURBINE ENGINE WELD REPAIR

[73] Assignee: **General Electric Company**, Cincinnati,  
Ohio

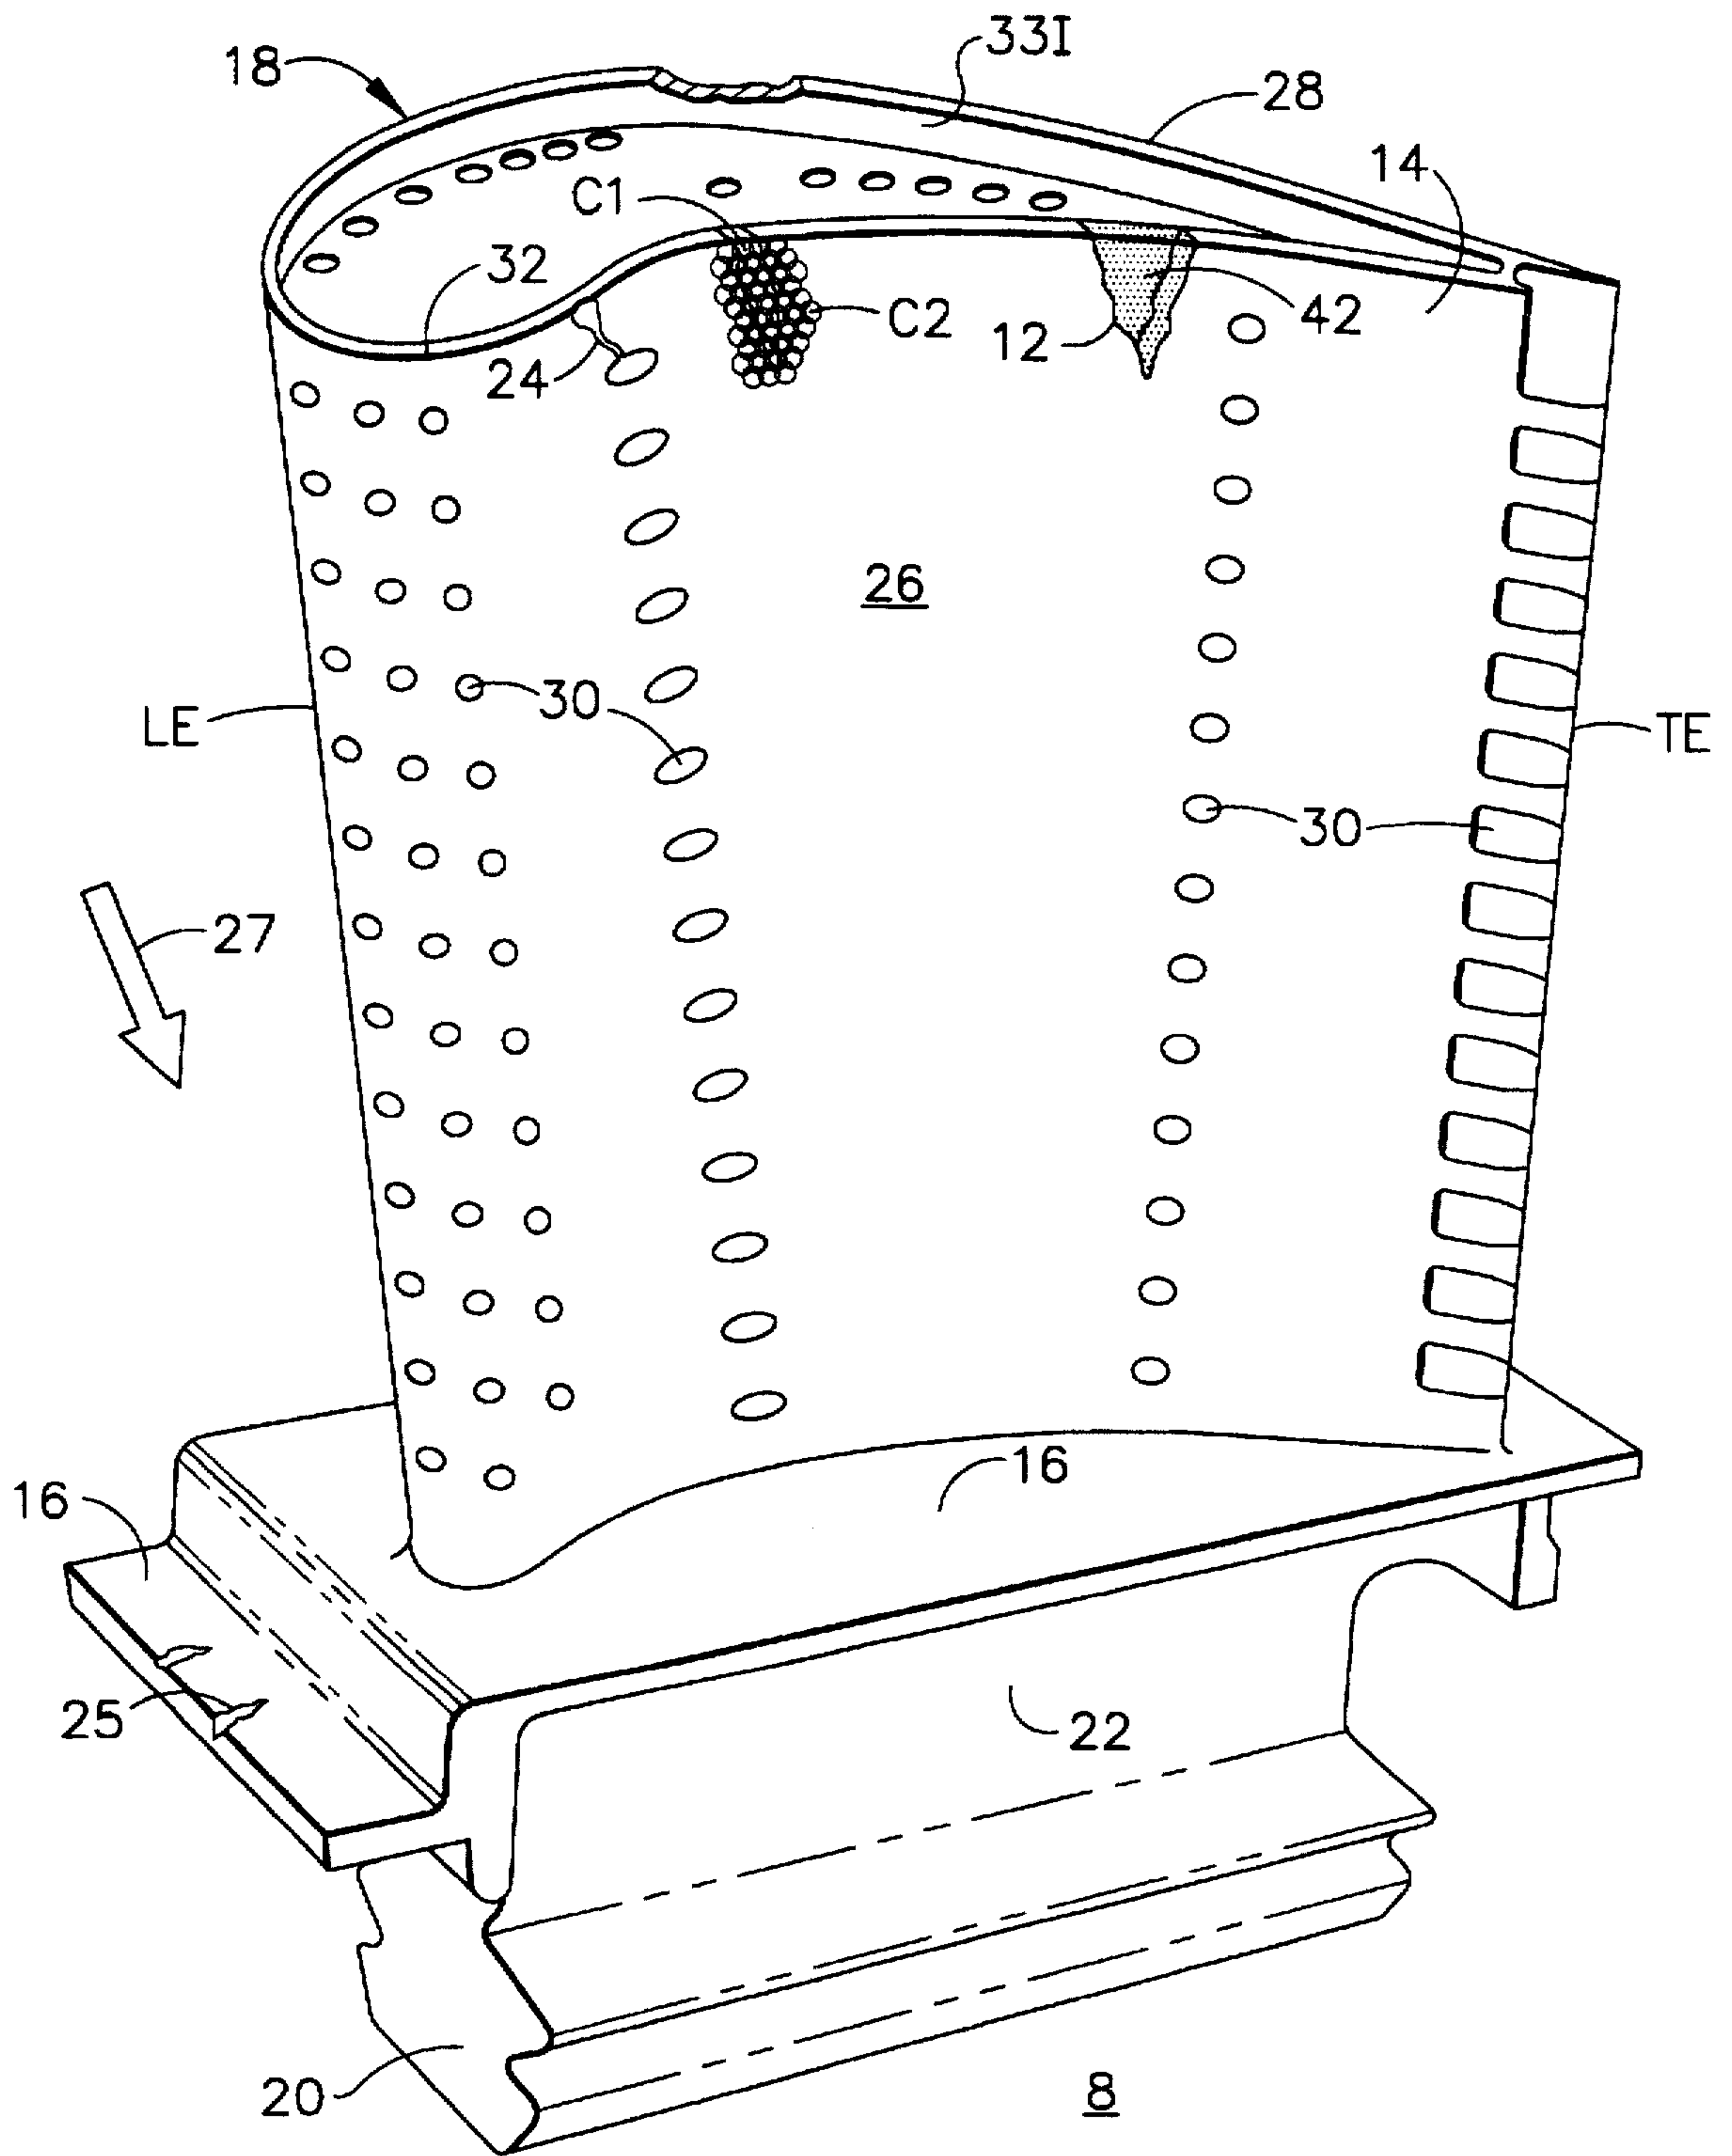
FIG. 1 is a perspective illustrative view of an exemplary aircraft gas turbine engine turbine blade in accordance with the present invention.

Illustrated in FIG. 1 is a turbine blade 8 which is typically circumscribed by a shroud (not shown) against which it seals and is illustrated as having a squealer type tip 18 that is often used in the high pressure turbines. The turbine blade 8 includes an airfoil 14 extending radially outward from a blade platform 16 to the blade tip 18. The turbine blade 8 includes a root 20 connected to the platform 16 to by a blade shank 22. The airfoil 14 includes a pressure side 26, facing in the general direction of rotation as indicated by an arrow 27, and a suction side 28. Cooling holes 30 are disposed through an outer wall 32 of the turbine blade 8 on its leading edge LE, trailing edge TE, and the pressure and suction sides 26 and 28, respectively.

The turbine blade 8 rubs on the shroud causing tip damage in the form of blade tip cracks 12 shown filled with a filler in the form of a metallic weld material 42 in accordance with the present invention. Cooling hole cracks 24 and blade platform cracks 25 also form due to normal wear and engine usage. All of these types of cracks have been and continue to be repaired by welding and brazing in other types of crack repairs for gas turbine engine components. These repairs are generally done by filling the an empty void 40, illustrated in FIG. 2, of each of the cracks with the metallic weld material 42, illustrated in FIGS. 3 and 4, to produce a filled void 48 bonded to an inner crack surface 44. Often the crack surface 44 is prepared in some time consuming manner and the crack repair is subject to fatigue failure of portions of the filled void 48 often along the crack surface itself. The blade 8, as well as many other gas turbine components, is subject to extreme thermal cycling which causes thermal fatigue and oxidation damage generated during engine operation. These repairs, even when filled with the braze or weld material 42 are subject to thermal fatigue failure.

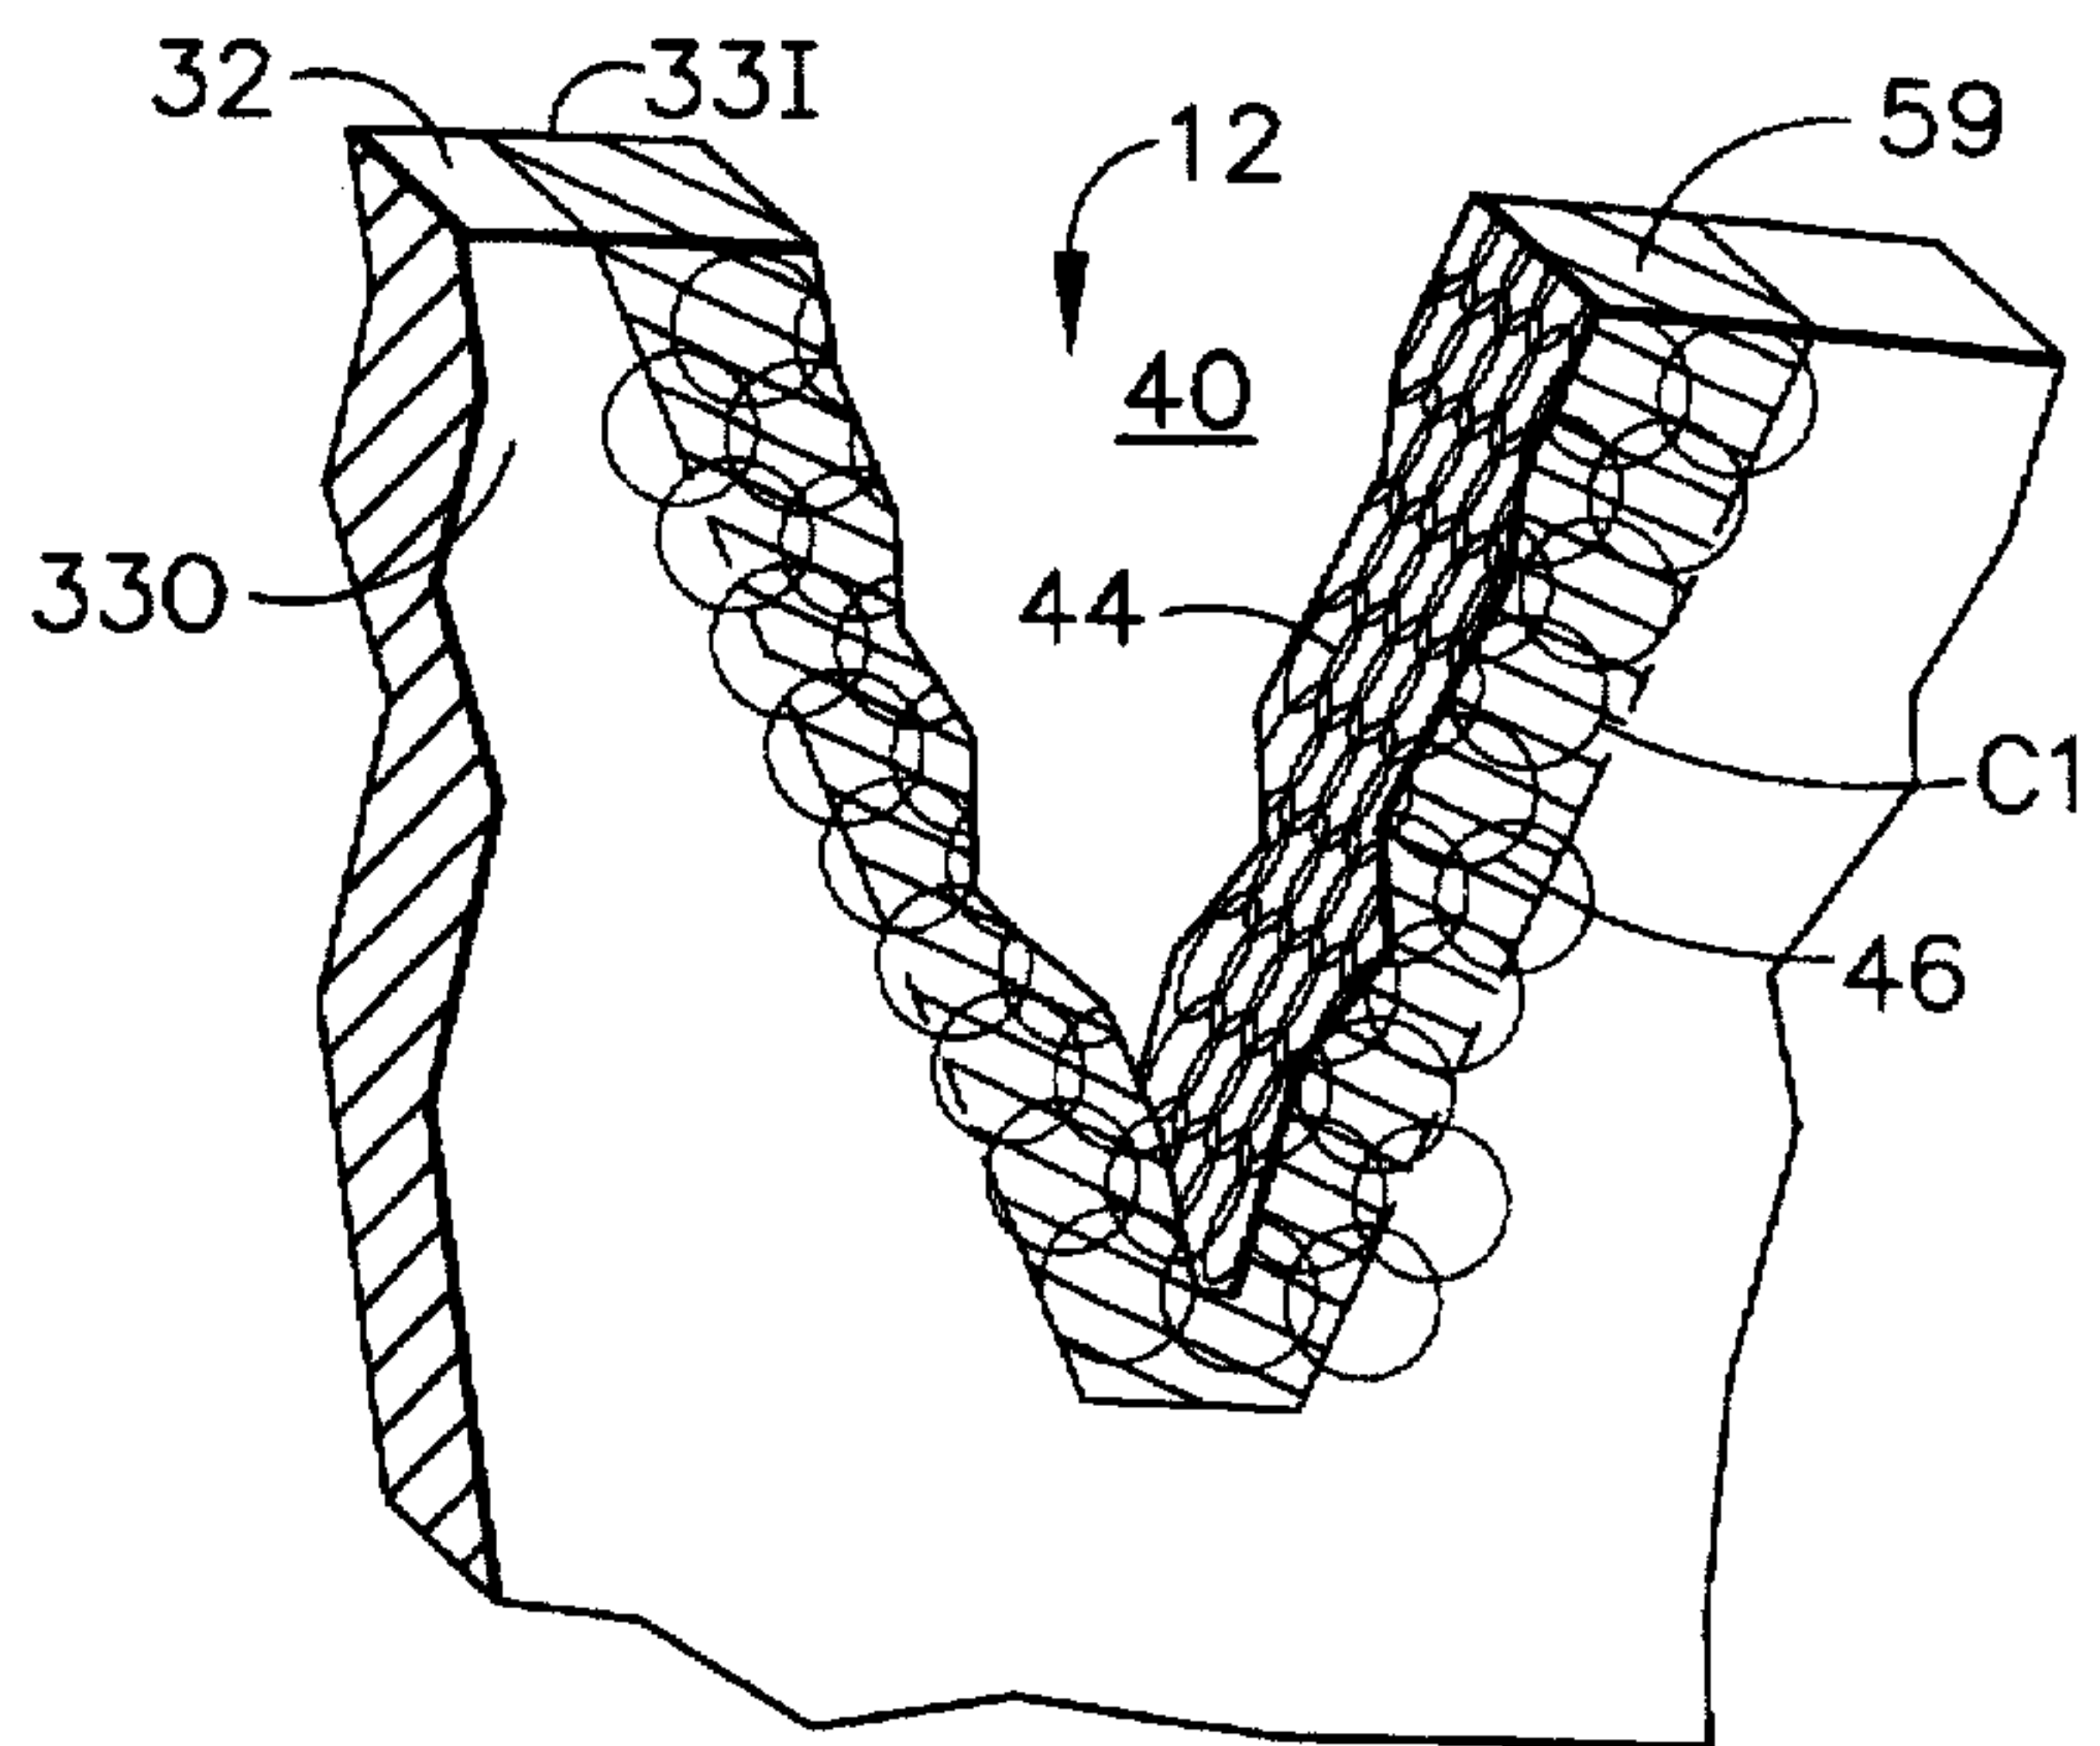
FIG. 2 is a cross-sectional illustrative view of a tip of the turbine blade in FIG. 1 showing a partially repaired crack in accordance with the present invention.

The present invention counters this fatiguing process by laser shock peening the crack surface 44 as well as the areas on an outer side 330 and preferably on an inner side 331 of the outer wall 32 at the tip 18 to form a laser shock peened surface 46 that includes all of the crack surface 44. The present invention produces laser shock peened surfaces, such as the laser shock peened surface 46, with laser beam induced shock waves generally indicated by overlapping laser shock peened circular spots indicated generally by a circle labelled C1 for a first set of circles or spots and C2 for a second set of circles or spots in FIGS. 2, 3 and 4 and, therefore, are referred to as laser beam shocked surfaces. The filled void 48 extending between surface areas of the metallic body, of the blade or other metallic component, that bounds the void is filled with a metallic repair material which is bonded to the laser shock peened surface 46 and indicated by the first set of circles C1. A corresponding first laser shock peened region 59 extends into the body from and bounds the filled void 48 and from the outer side 330 and the inner side 331 along the laser shock peened surface 46. The first laser shock peened region 59 has deep compressive residual stresses imparted by laser shock peening extending into the body from the laser shock peened surface 46. Even if the laser beam cant be directly impinged on the entire

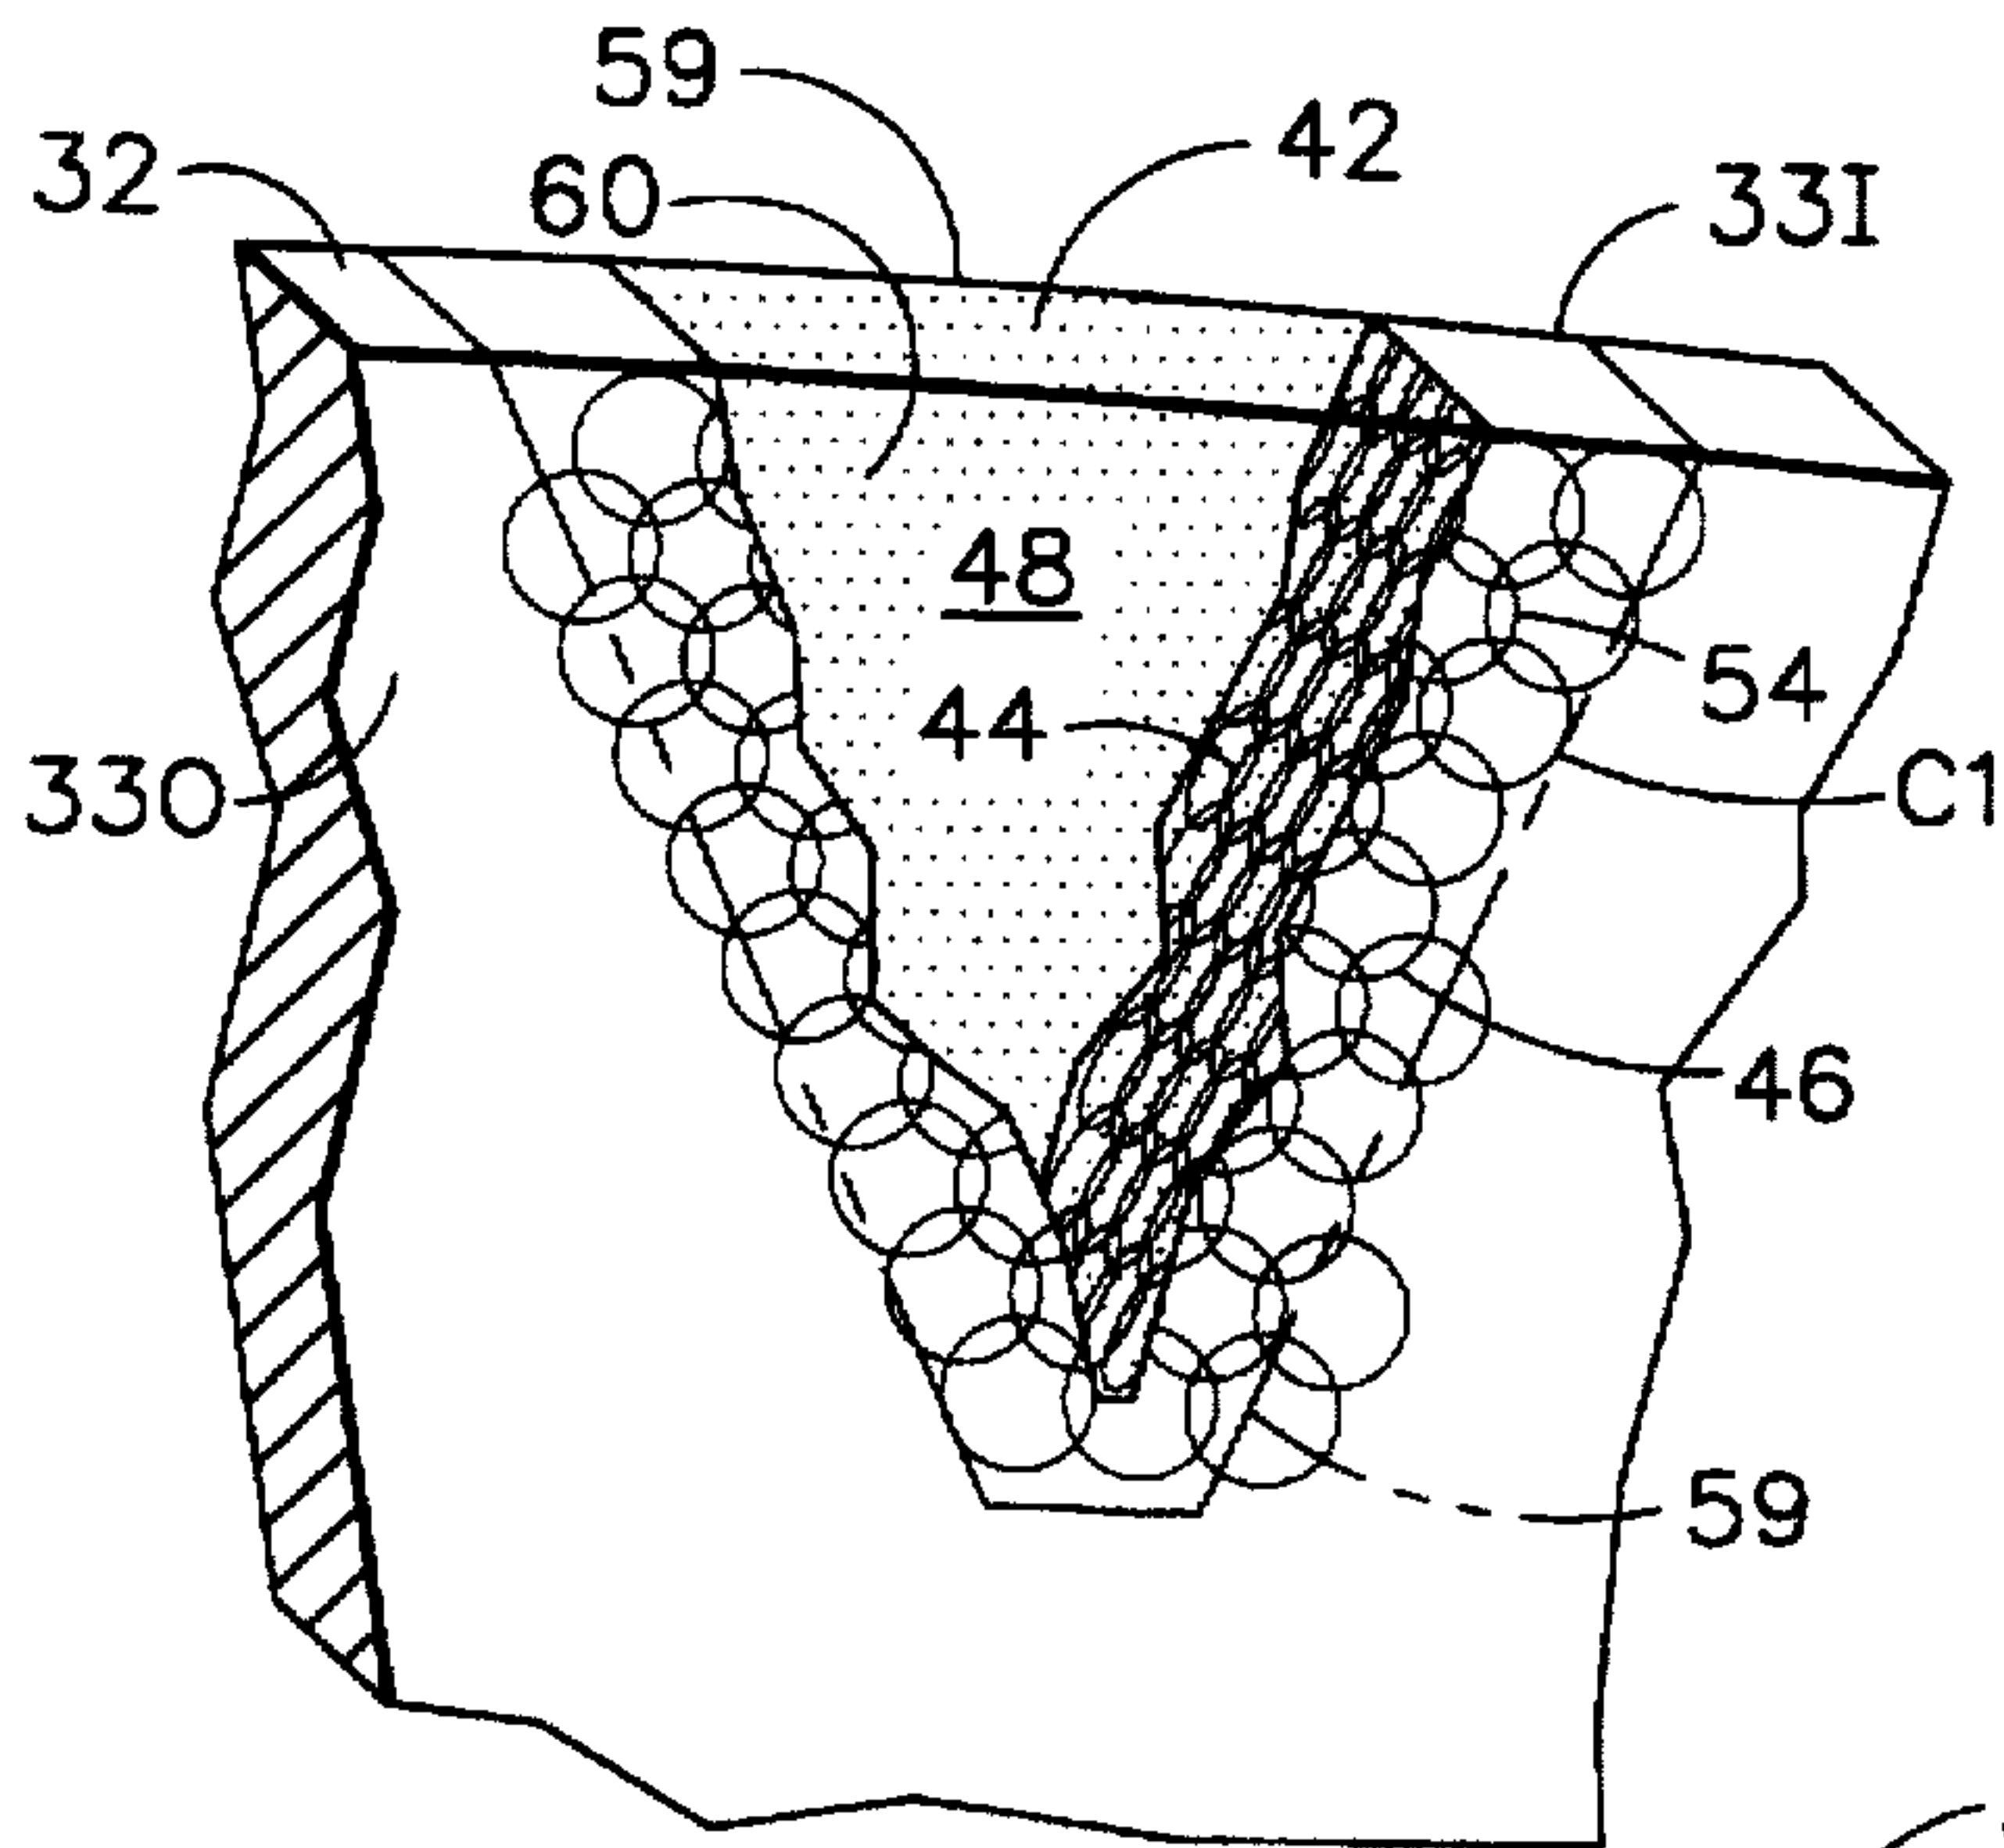
FIG. 3 is a cross-sectional view of the partially repaired crack in FIG. 2 illustrating a further step in the repair of the crack in accordance with the present invention.

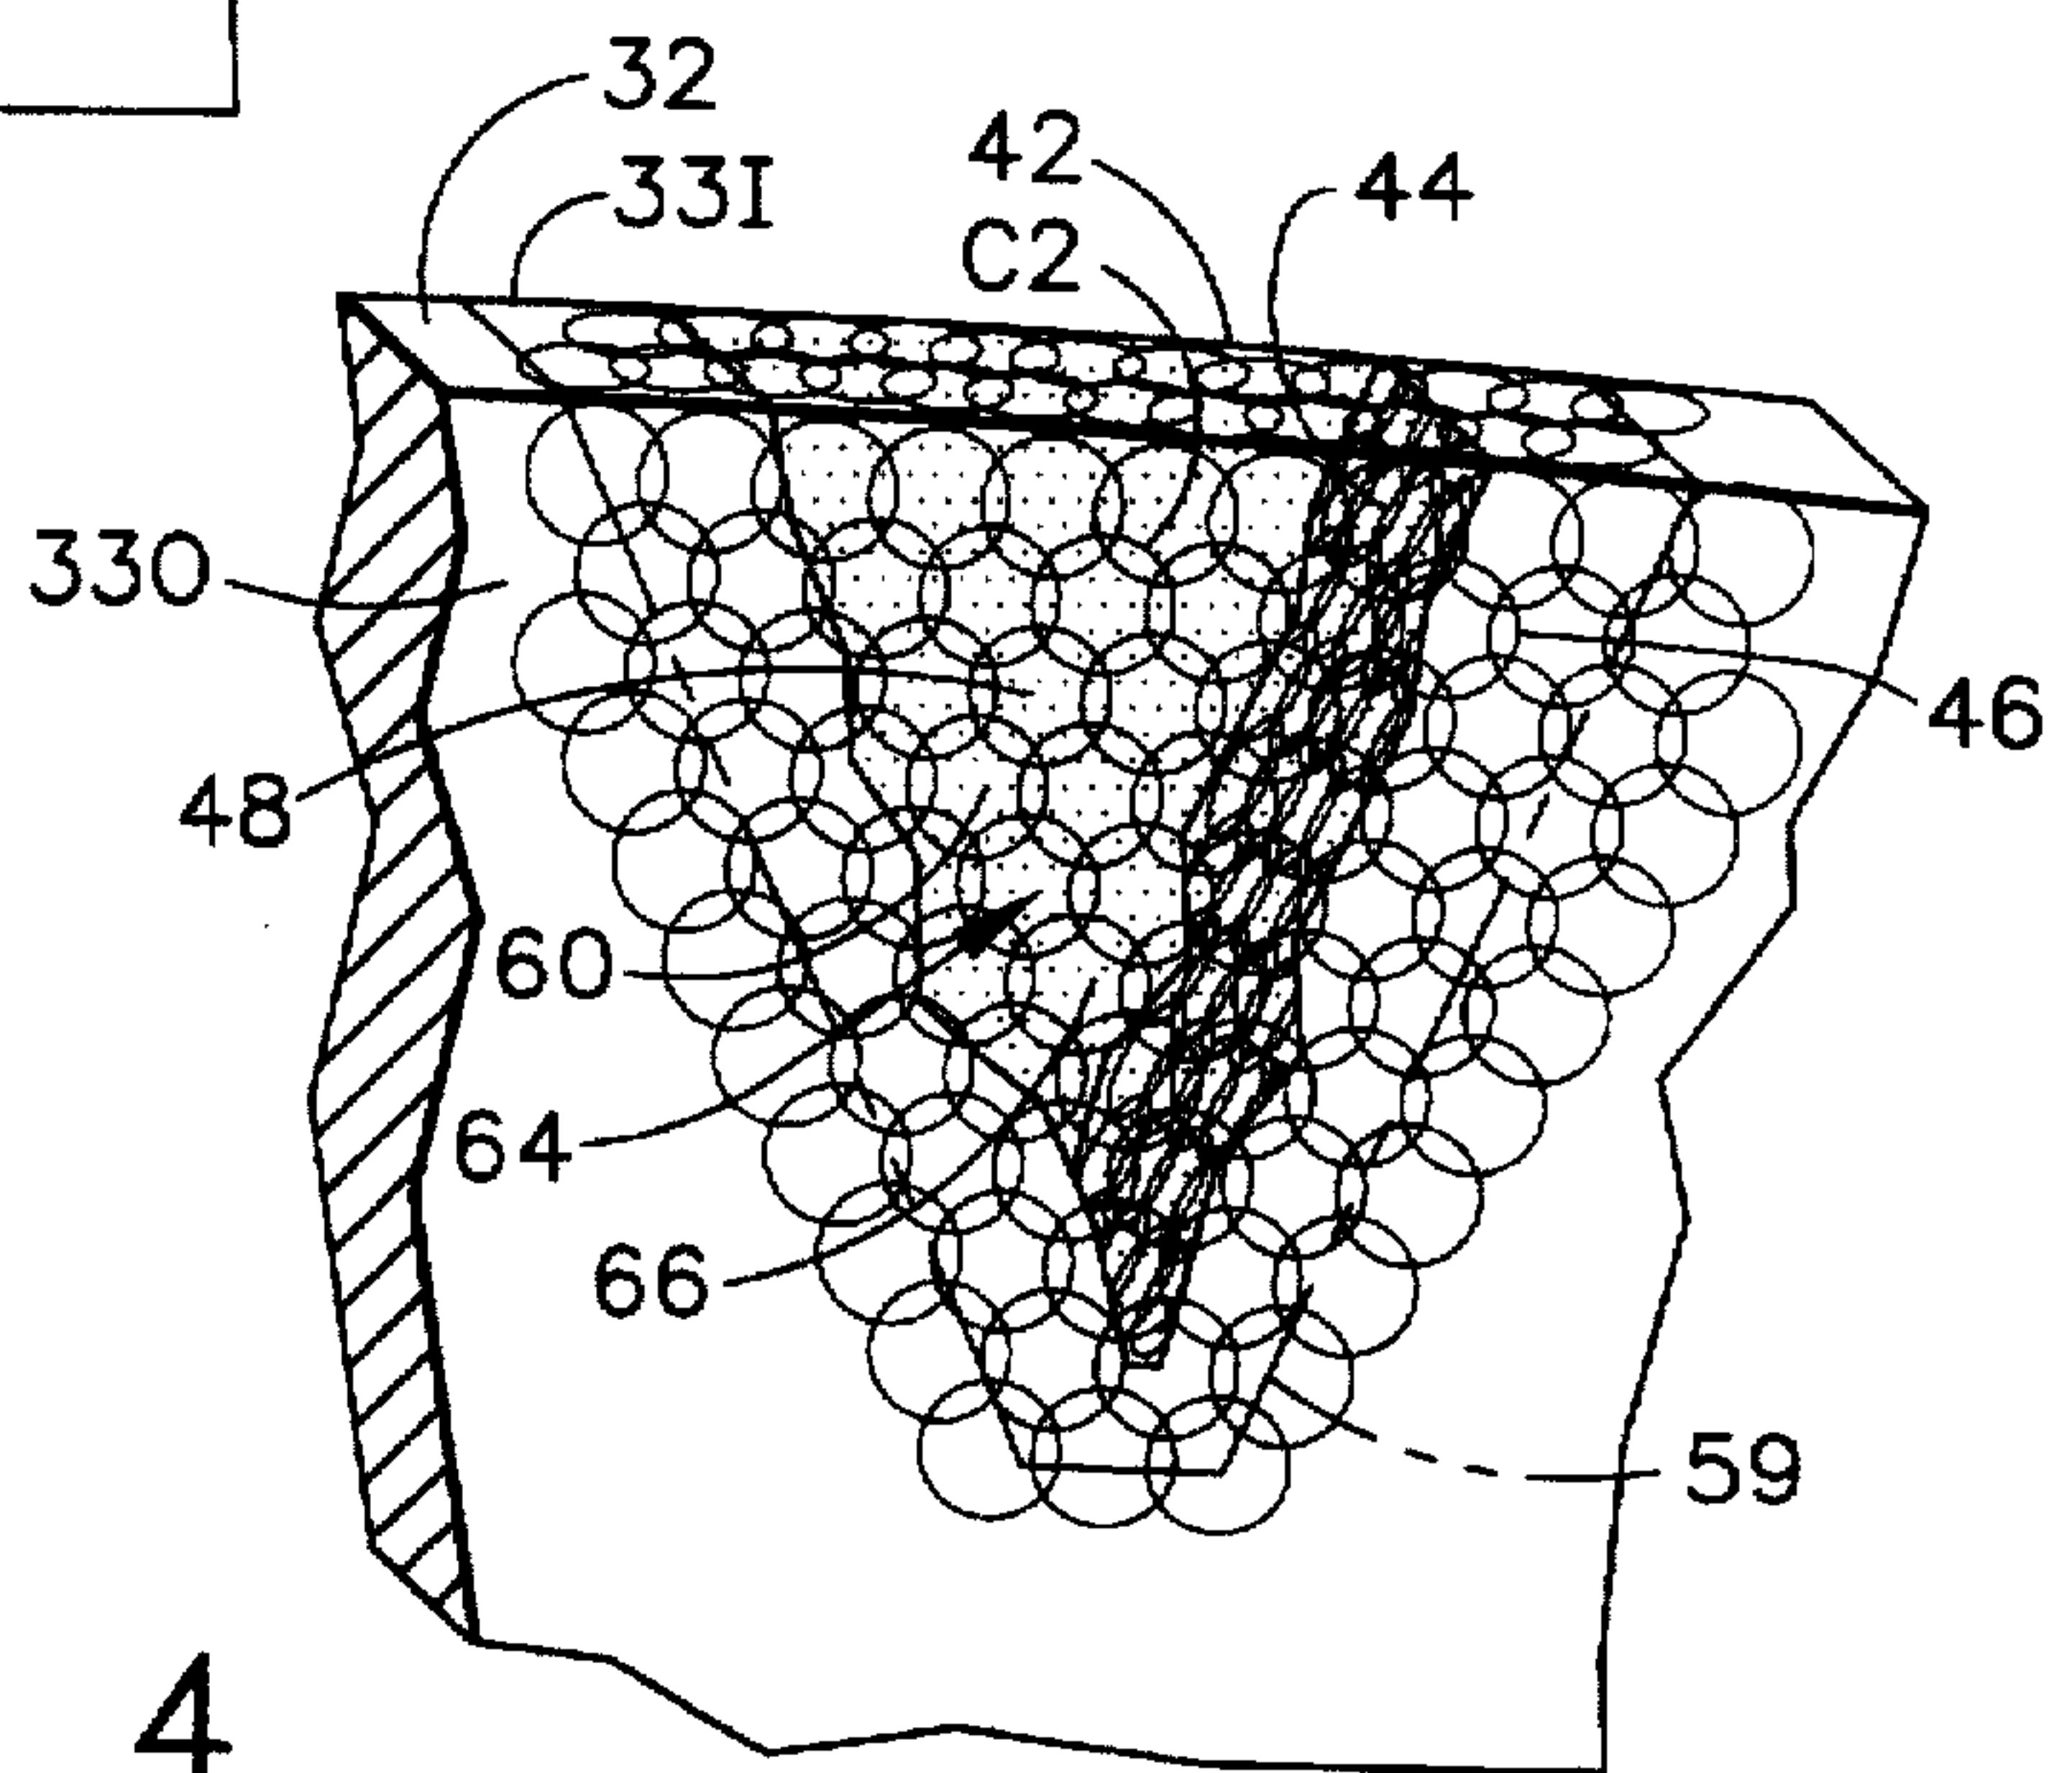
FIG. 4 is a cross-sectional view of the repaired crack in FIG. 3 illustrating a further step in the repair of the crack in accordance with an alternative embodiment of the present invention.

It is well known in the art to construct gas turbine engine components such as the turbine blade 8 from Cobalt and nickel-base superalloy materials. The components are often cast with a process to produce directionally solidified components, with grains aligned parallel to the axis of the airfoil, or a single crystal component, with no grain boundaries. The weld material 42 or braze material is preferably also made of these alloys and the weld or braze repair does not restore all of the original properties, particularly single crystal and directionally solidified mechanical properties, in the repaired areas of the blade 8. Therefore, the present invention provides an alternative embodiment that is more particularly illustrated in FIG. 4. To counter the loss of material and process properties and capabilities the filled voids 48 are laser shock peened on their outside surfaces 60 forming a second outer laser shock peened surface 64 as indicated by second set of circles C2 and a second laser shock peened region 66 beneath it. This further strengthens the entire weld repair.

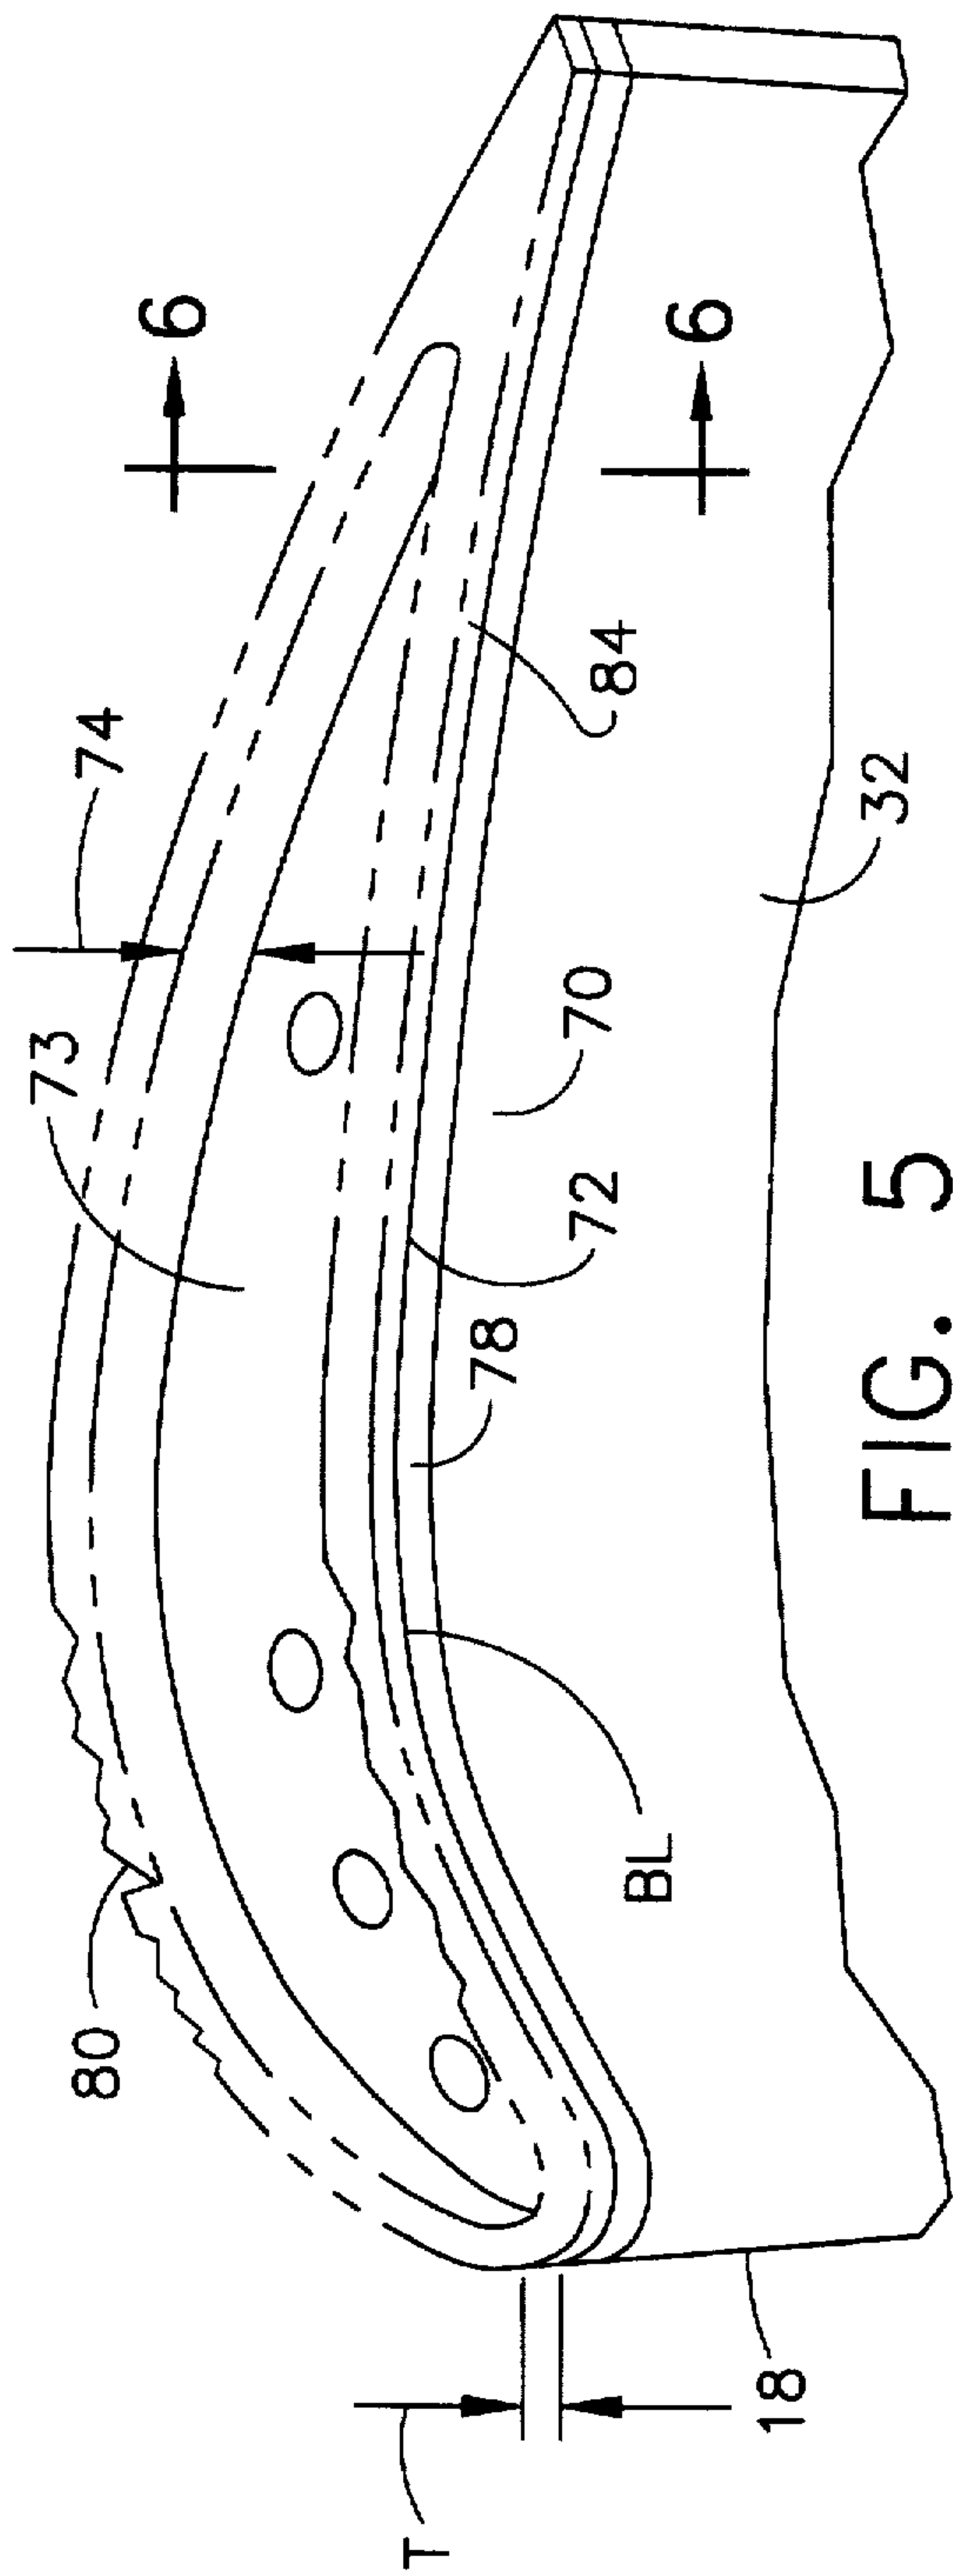
FIG. 5 is a perspective illustrative view of a weld built up tip on the turbine blade in FIG. 1.

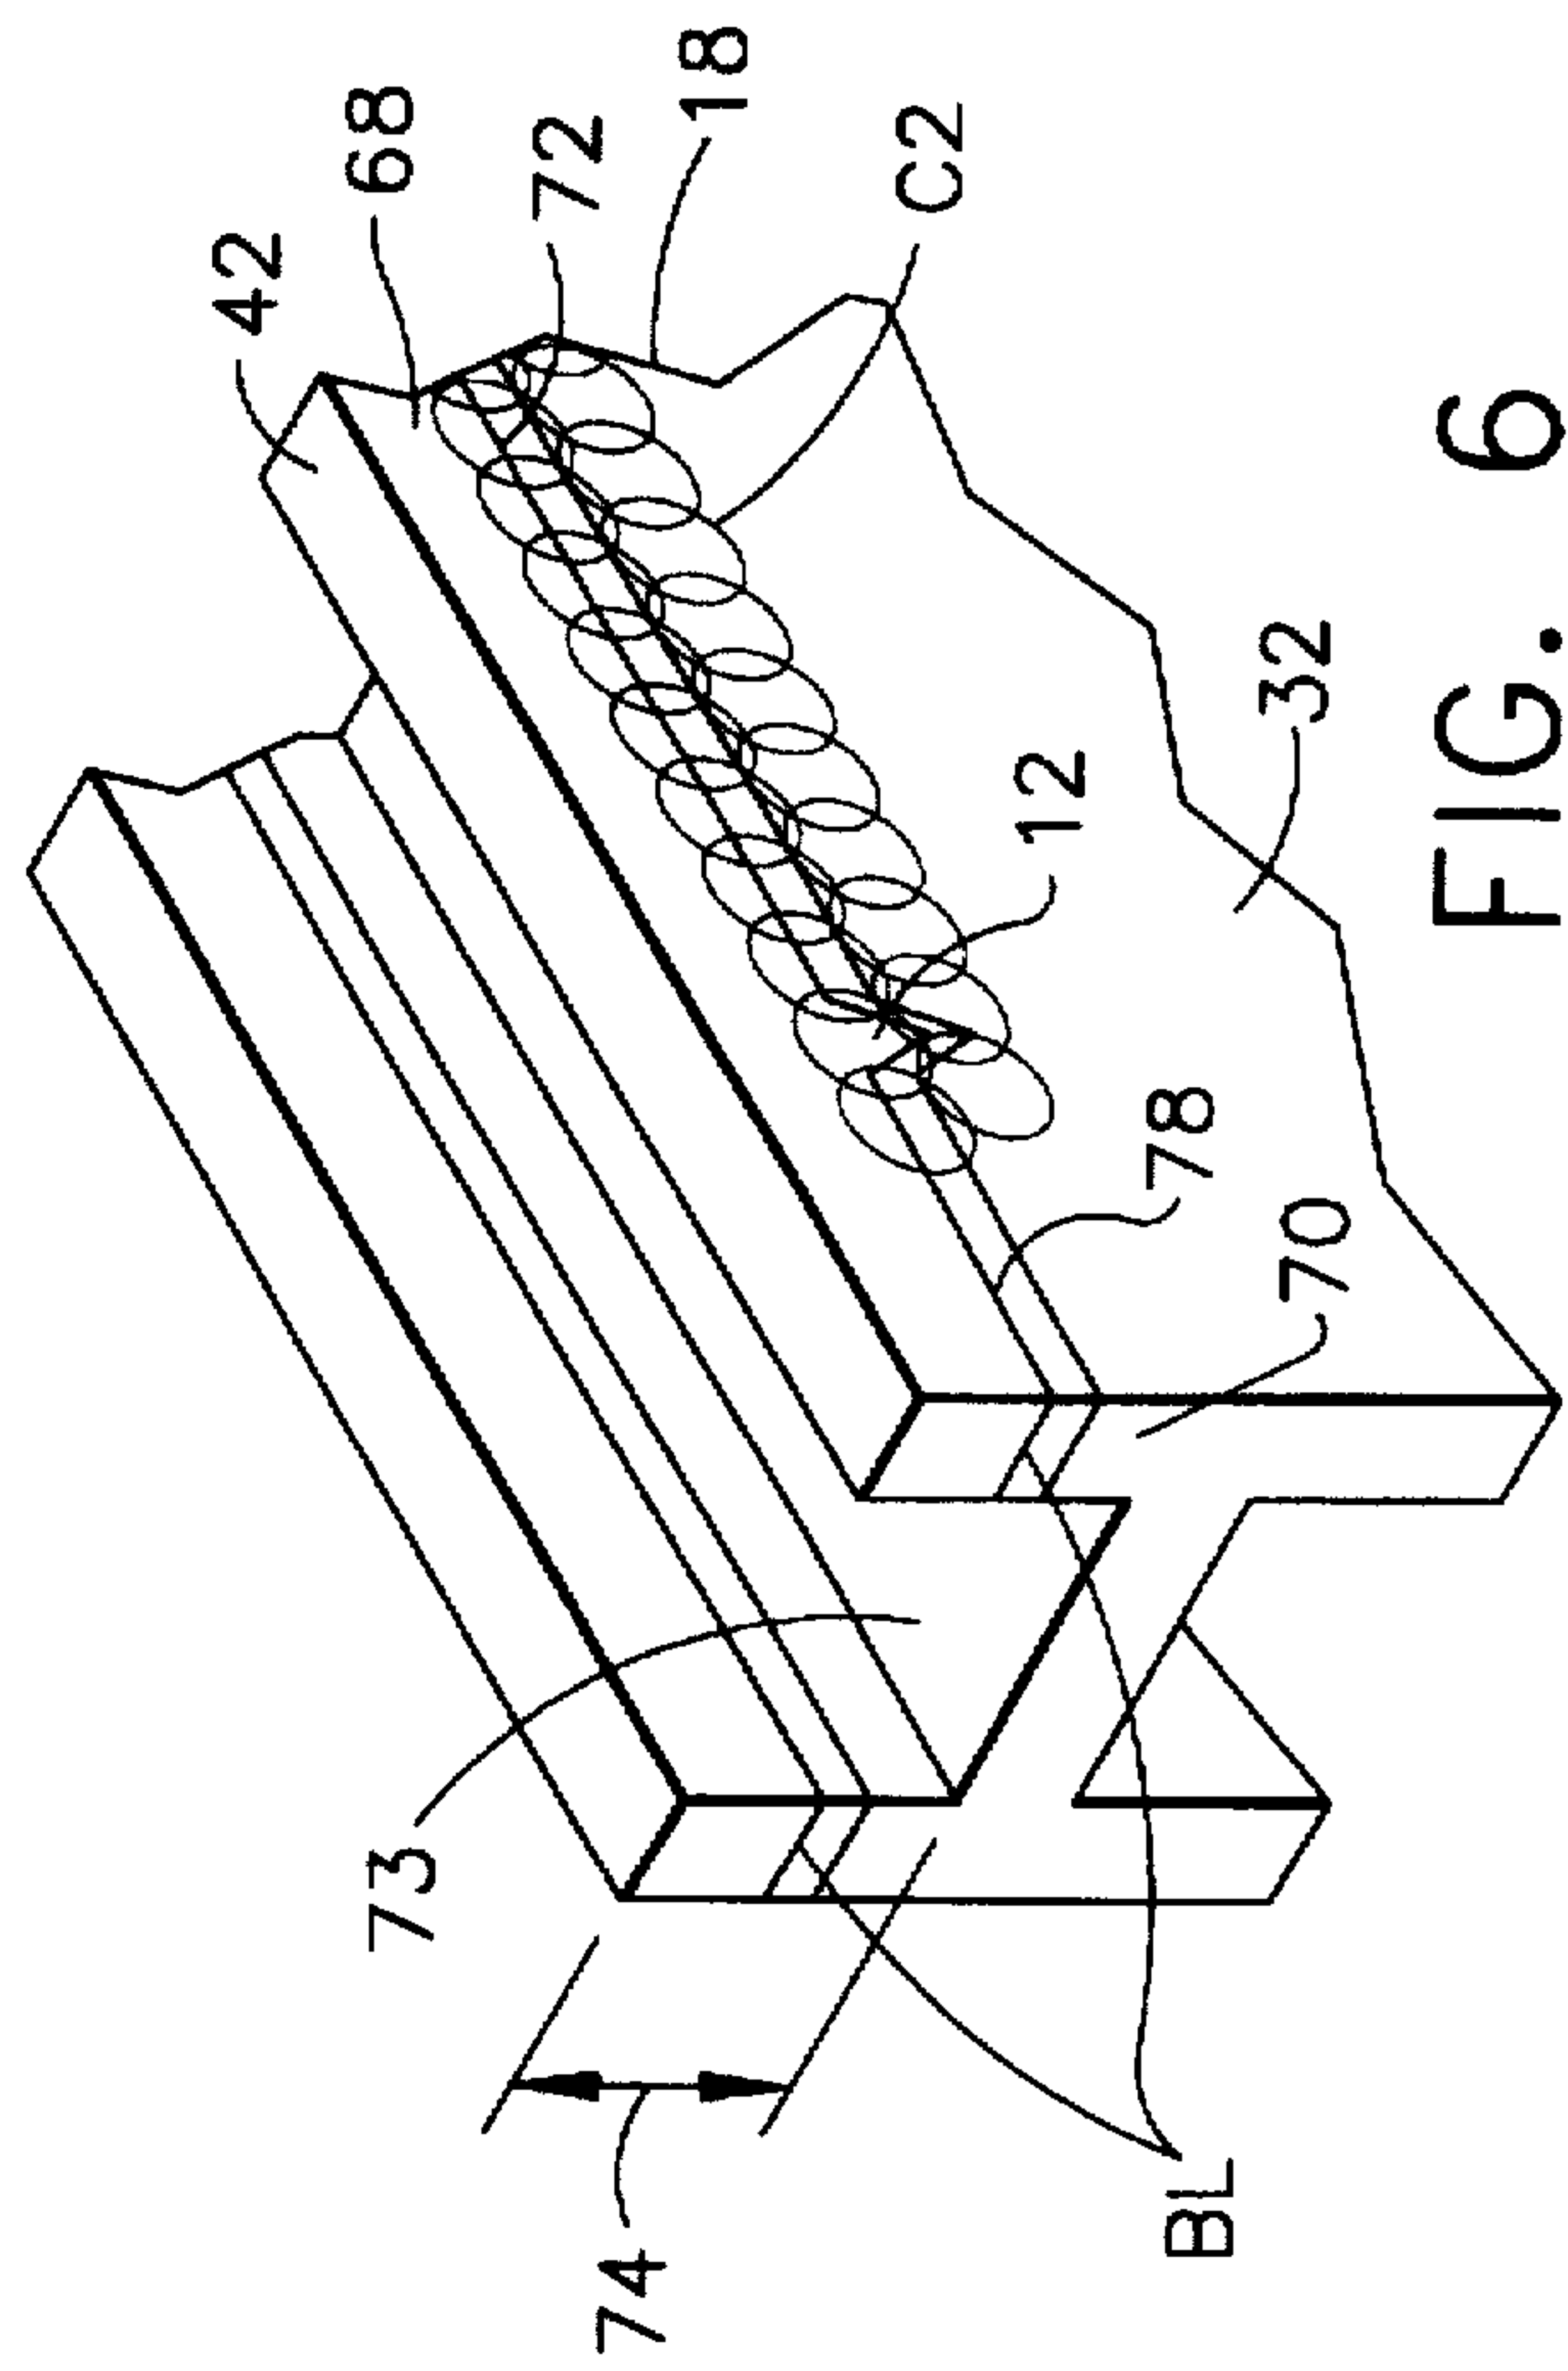
FIG. 6 is a blown up portion of the perspective illustrative view of a weld built up tip on the turbine blade in FIG. 5 further showing a repaired crack in accordance with the present invention.
