**United States Patent** [19]  
**Fraser**

- [54] **TURBINE BLADE REPAIR**
- [75] Inventor: **Michael James Fraser**, Cheltenham,  
United Kingdom
- [73] Assignee: **Turbine Blading Limited**, Shipton on  
Stour, England
- [21] Appl. No.: **652,453**
- [22] PCT Filed: **Dec. 1, 1994**
- [86] PCT No.: **PCT/GB94/02633**  
§ 371 Date: **Jul. 29, 1996**  
§ 102(e) Date: **Jul. 29, 1996**
- [87] PCT Pub. No.: **WO95/15240**  
PCT Pub. Date: **Jun. 8, 1995**
- [30] **Foreign Application Priority Data**  
Dec. 2, 1993 [GB] United Kingdom ..... 9324766
- [51] **Int. Cl.<sup>6</sup>** ..... **B23P 15/00**
- [52] **U.S. Cl.** ..... **29/889.1; 29/402.07**
- [58] **Field of Search** ..... **29/889.1, 402.07,**  
**29/402.01, 402.08, 402.09, 402.13, 402.21;**  
**228/119**

A method of repairing a turbine blade in which damaged material around a lacing wire hole is removed by machining or chemical etching. New metal is then added by welding such that the lacing wire hole is much smaller or completely eliminated and prior to reforming the lacing wire hole, flats may be formed either by the addition or removal of metal in the region of the lacing wire hole so that a lacing wire hole forming dr

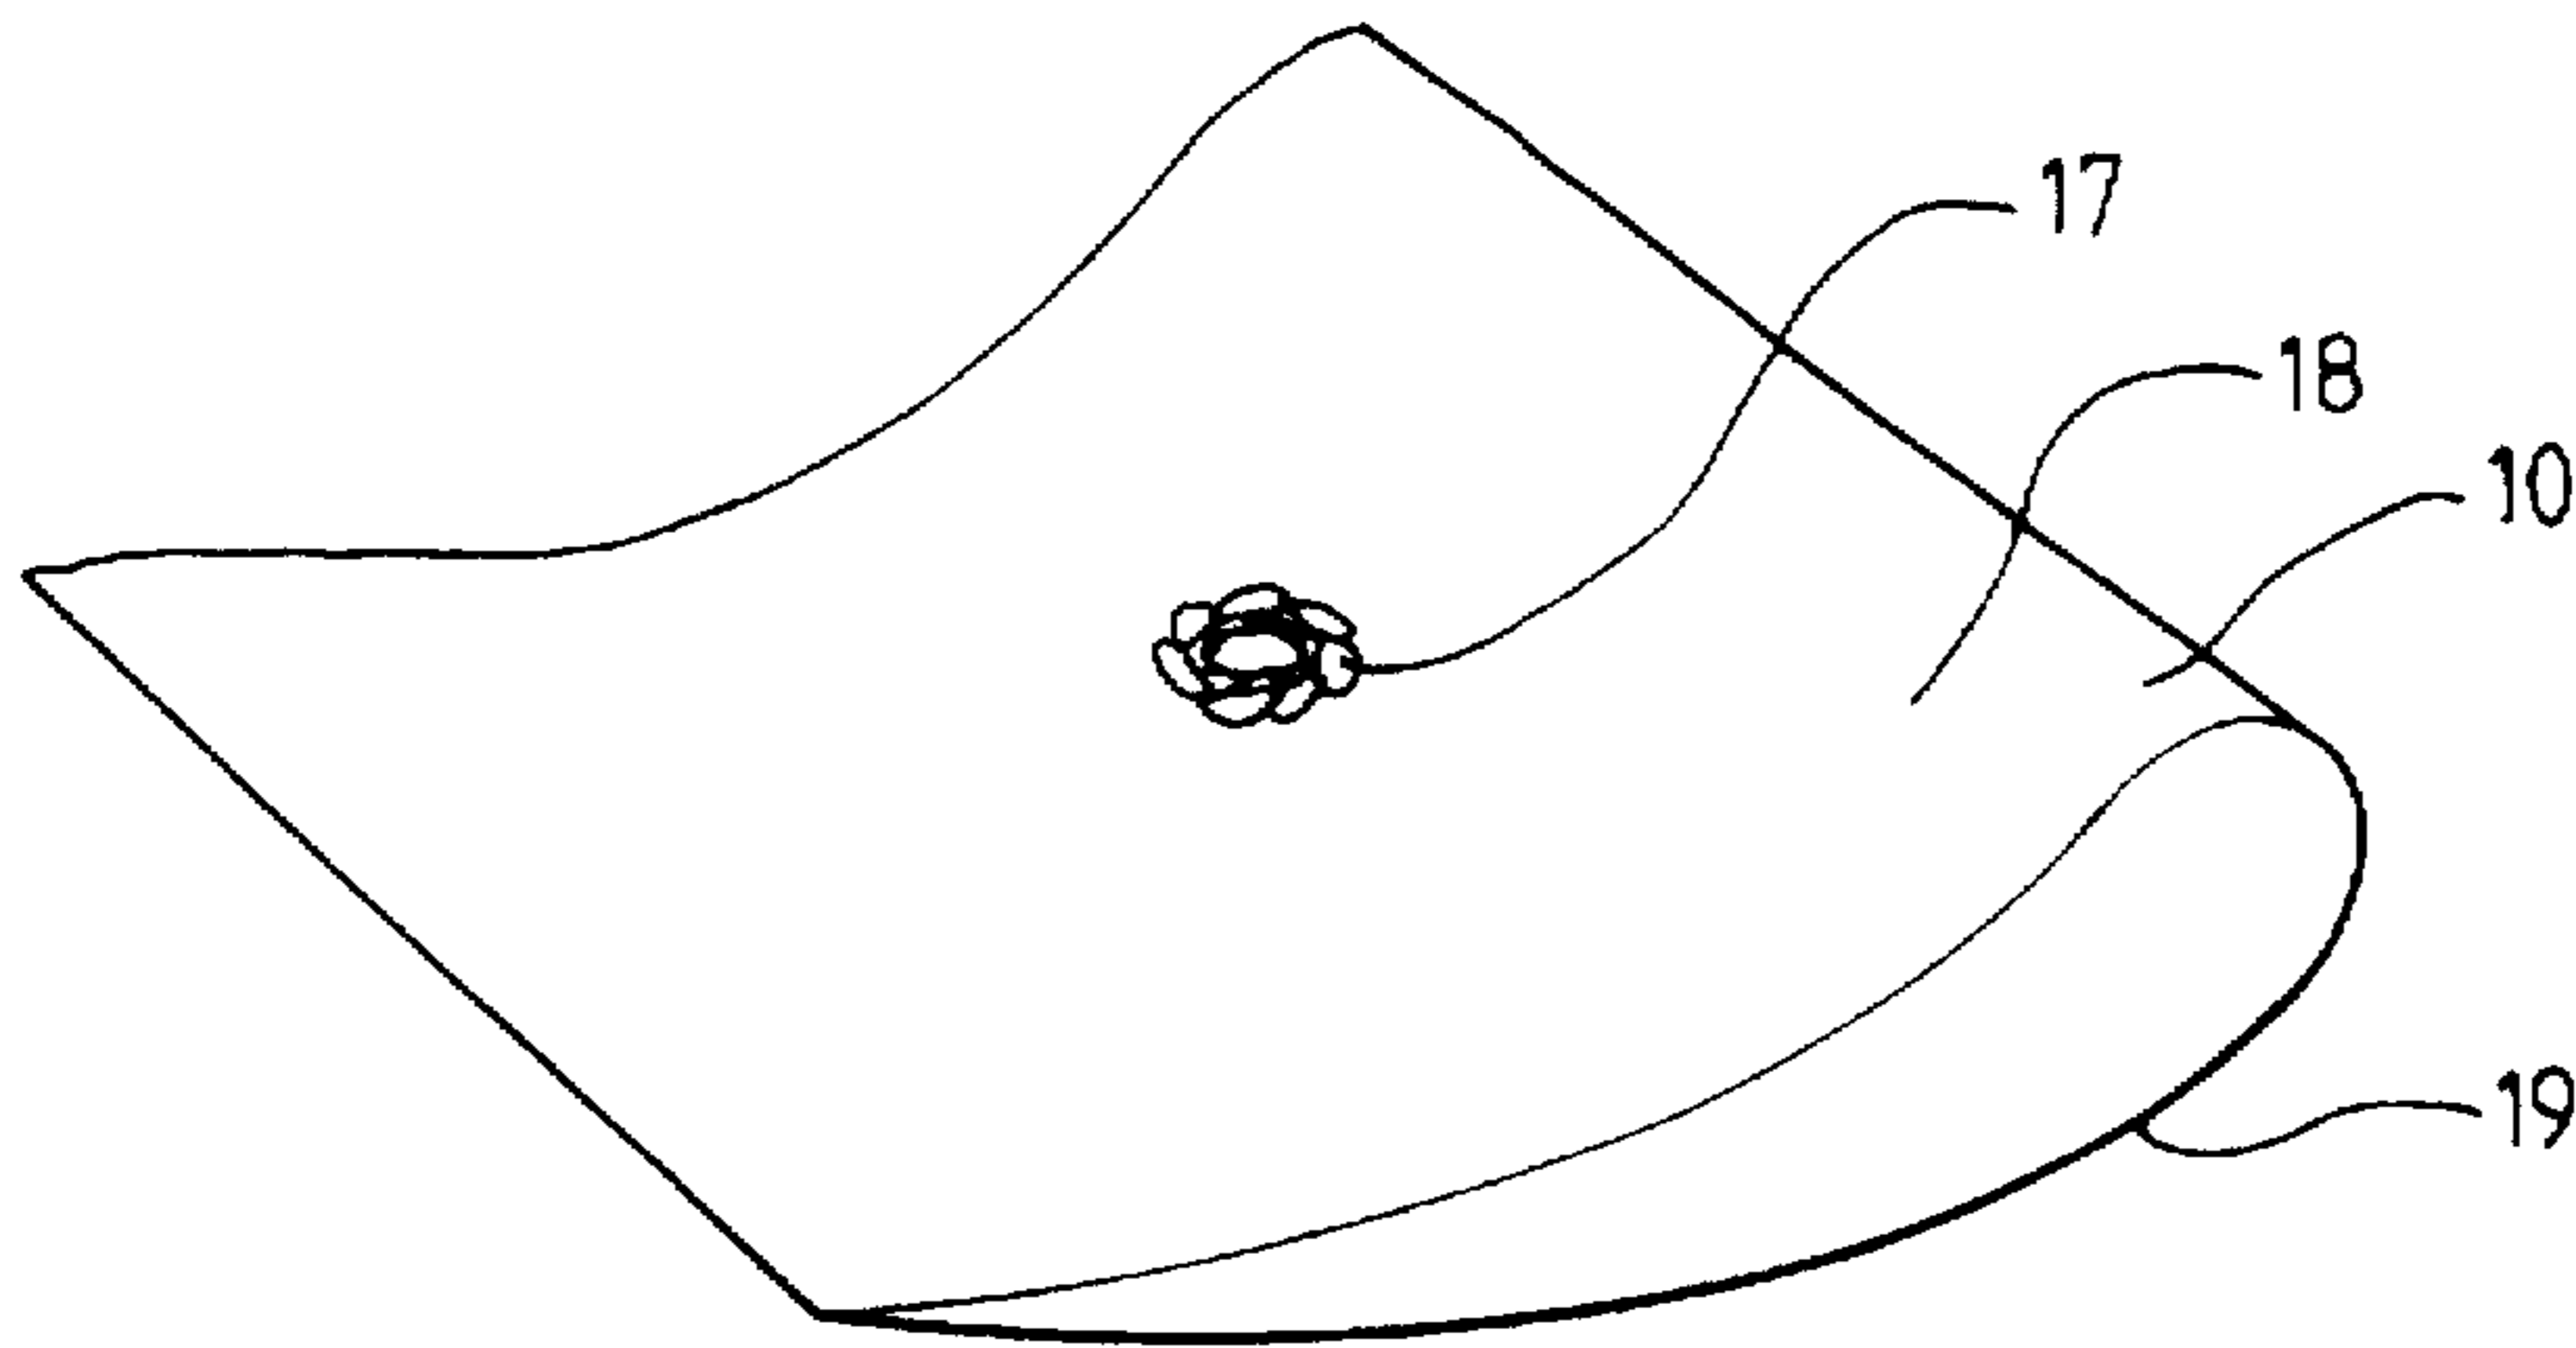
FIG 3

FIG. 3 illustrates the blade of FIG. 1 with the enlarged hole partly filled with weld metal;

blade itself but possibly including other metals alloyed in a manner to provide a durable but long lasting surface is welded to the blade as shown in FIG. 3. It is envisaged that welding of new metal 17 may take place on either side of the blade or possibly both.

The new metal 17 may be ground or polished so that the concave surface 18 and convex surface 19 of the blade 10 are returned to their original form and then a heat treatment process may be carried out as shown in FIG. 4 in which the area of the blade surrounding the lacing wire hole is heated to a predetermined temperature for predetermined lengths of time.

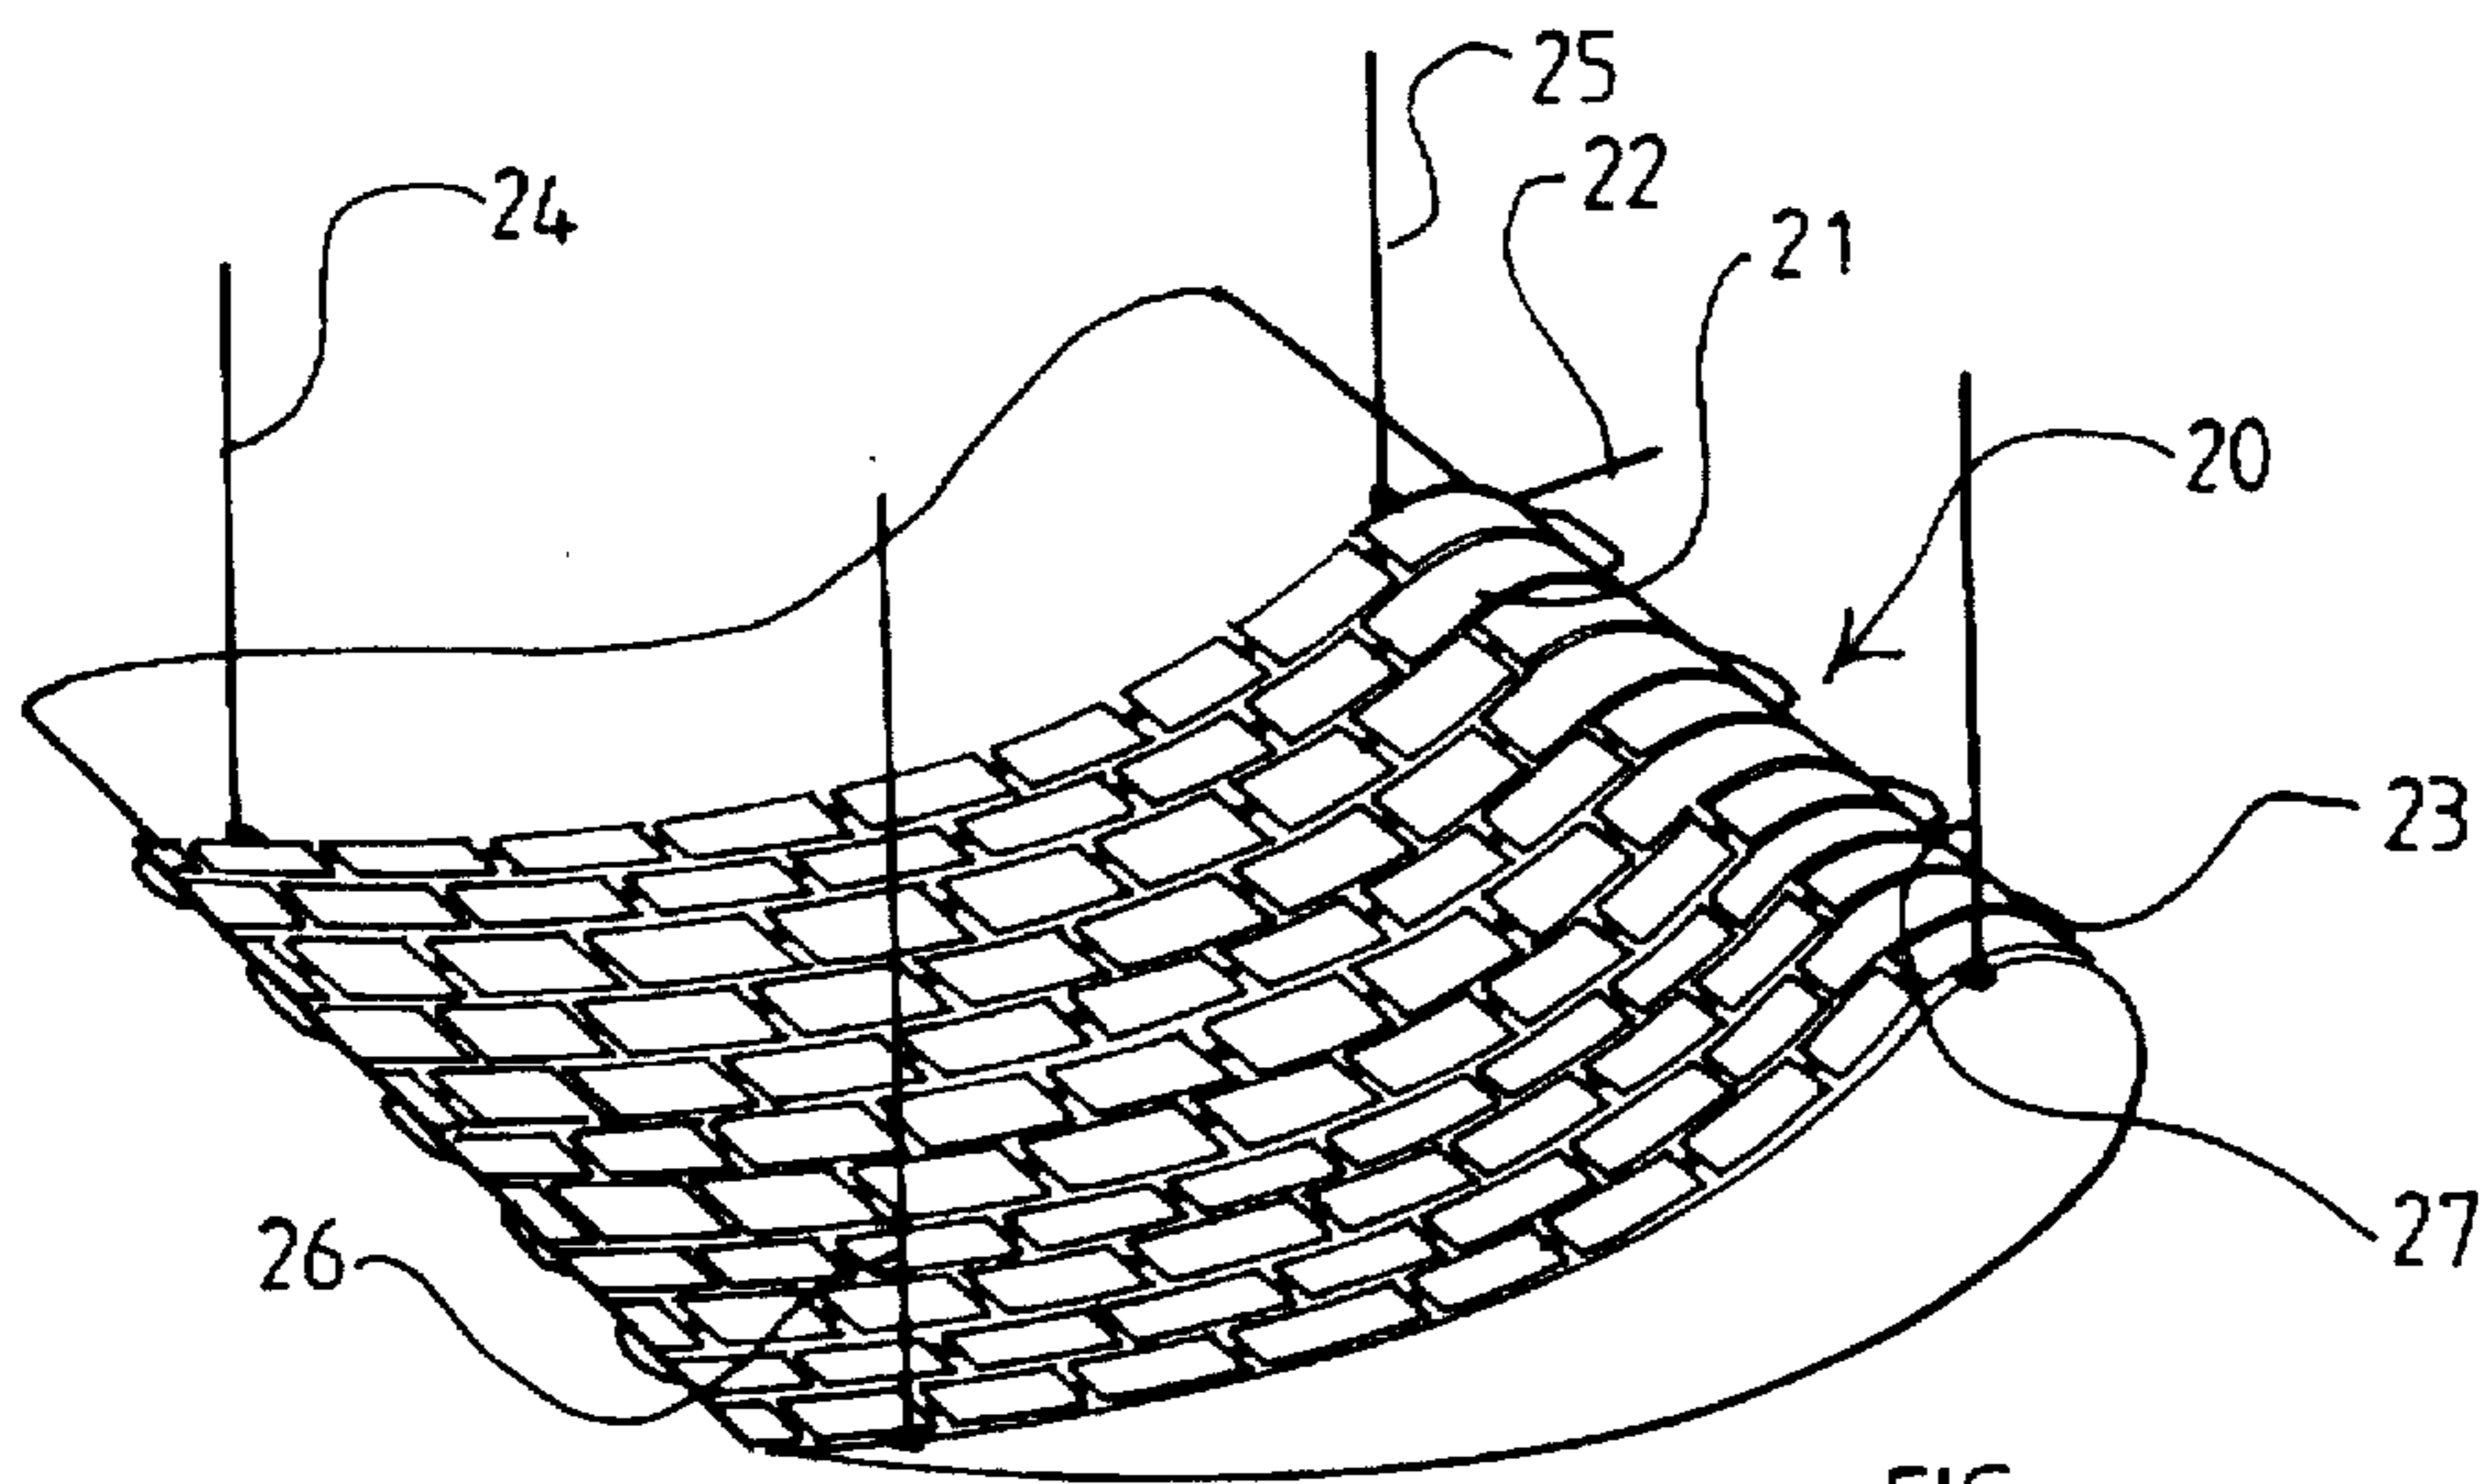
FIG 4

FIG. 4 illustrates part of the blade being subjected to a heat treatment process;

FIG. 4 shows a heating mat generally indicated at 20 comprising a plurality of ceramic beads 21 through which heating elements pass and a controlled current is passed through the heating mat 20 from inlet 22 to outlet 23.

In order to ensure that the blade is heated to the required temperatures, the temperature of the blade during the heating process may be carefully monitored by means of thermocouples shown at 24, 25, 26 and 27. The thermocouples may be placed at other parts of the blade to ensure that those parts of the blade are not adversely affected during the welding to provide weld metal 17 or during the heat treatment processes as shown in FIG. 4.

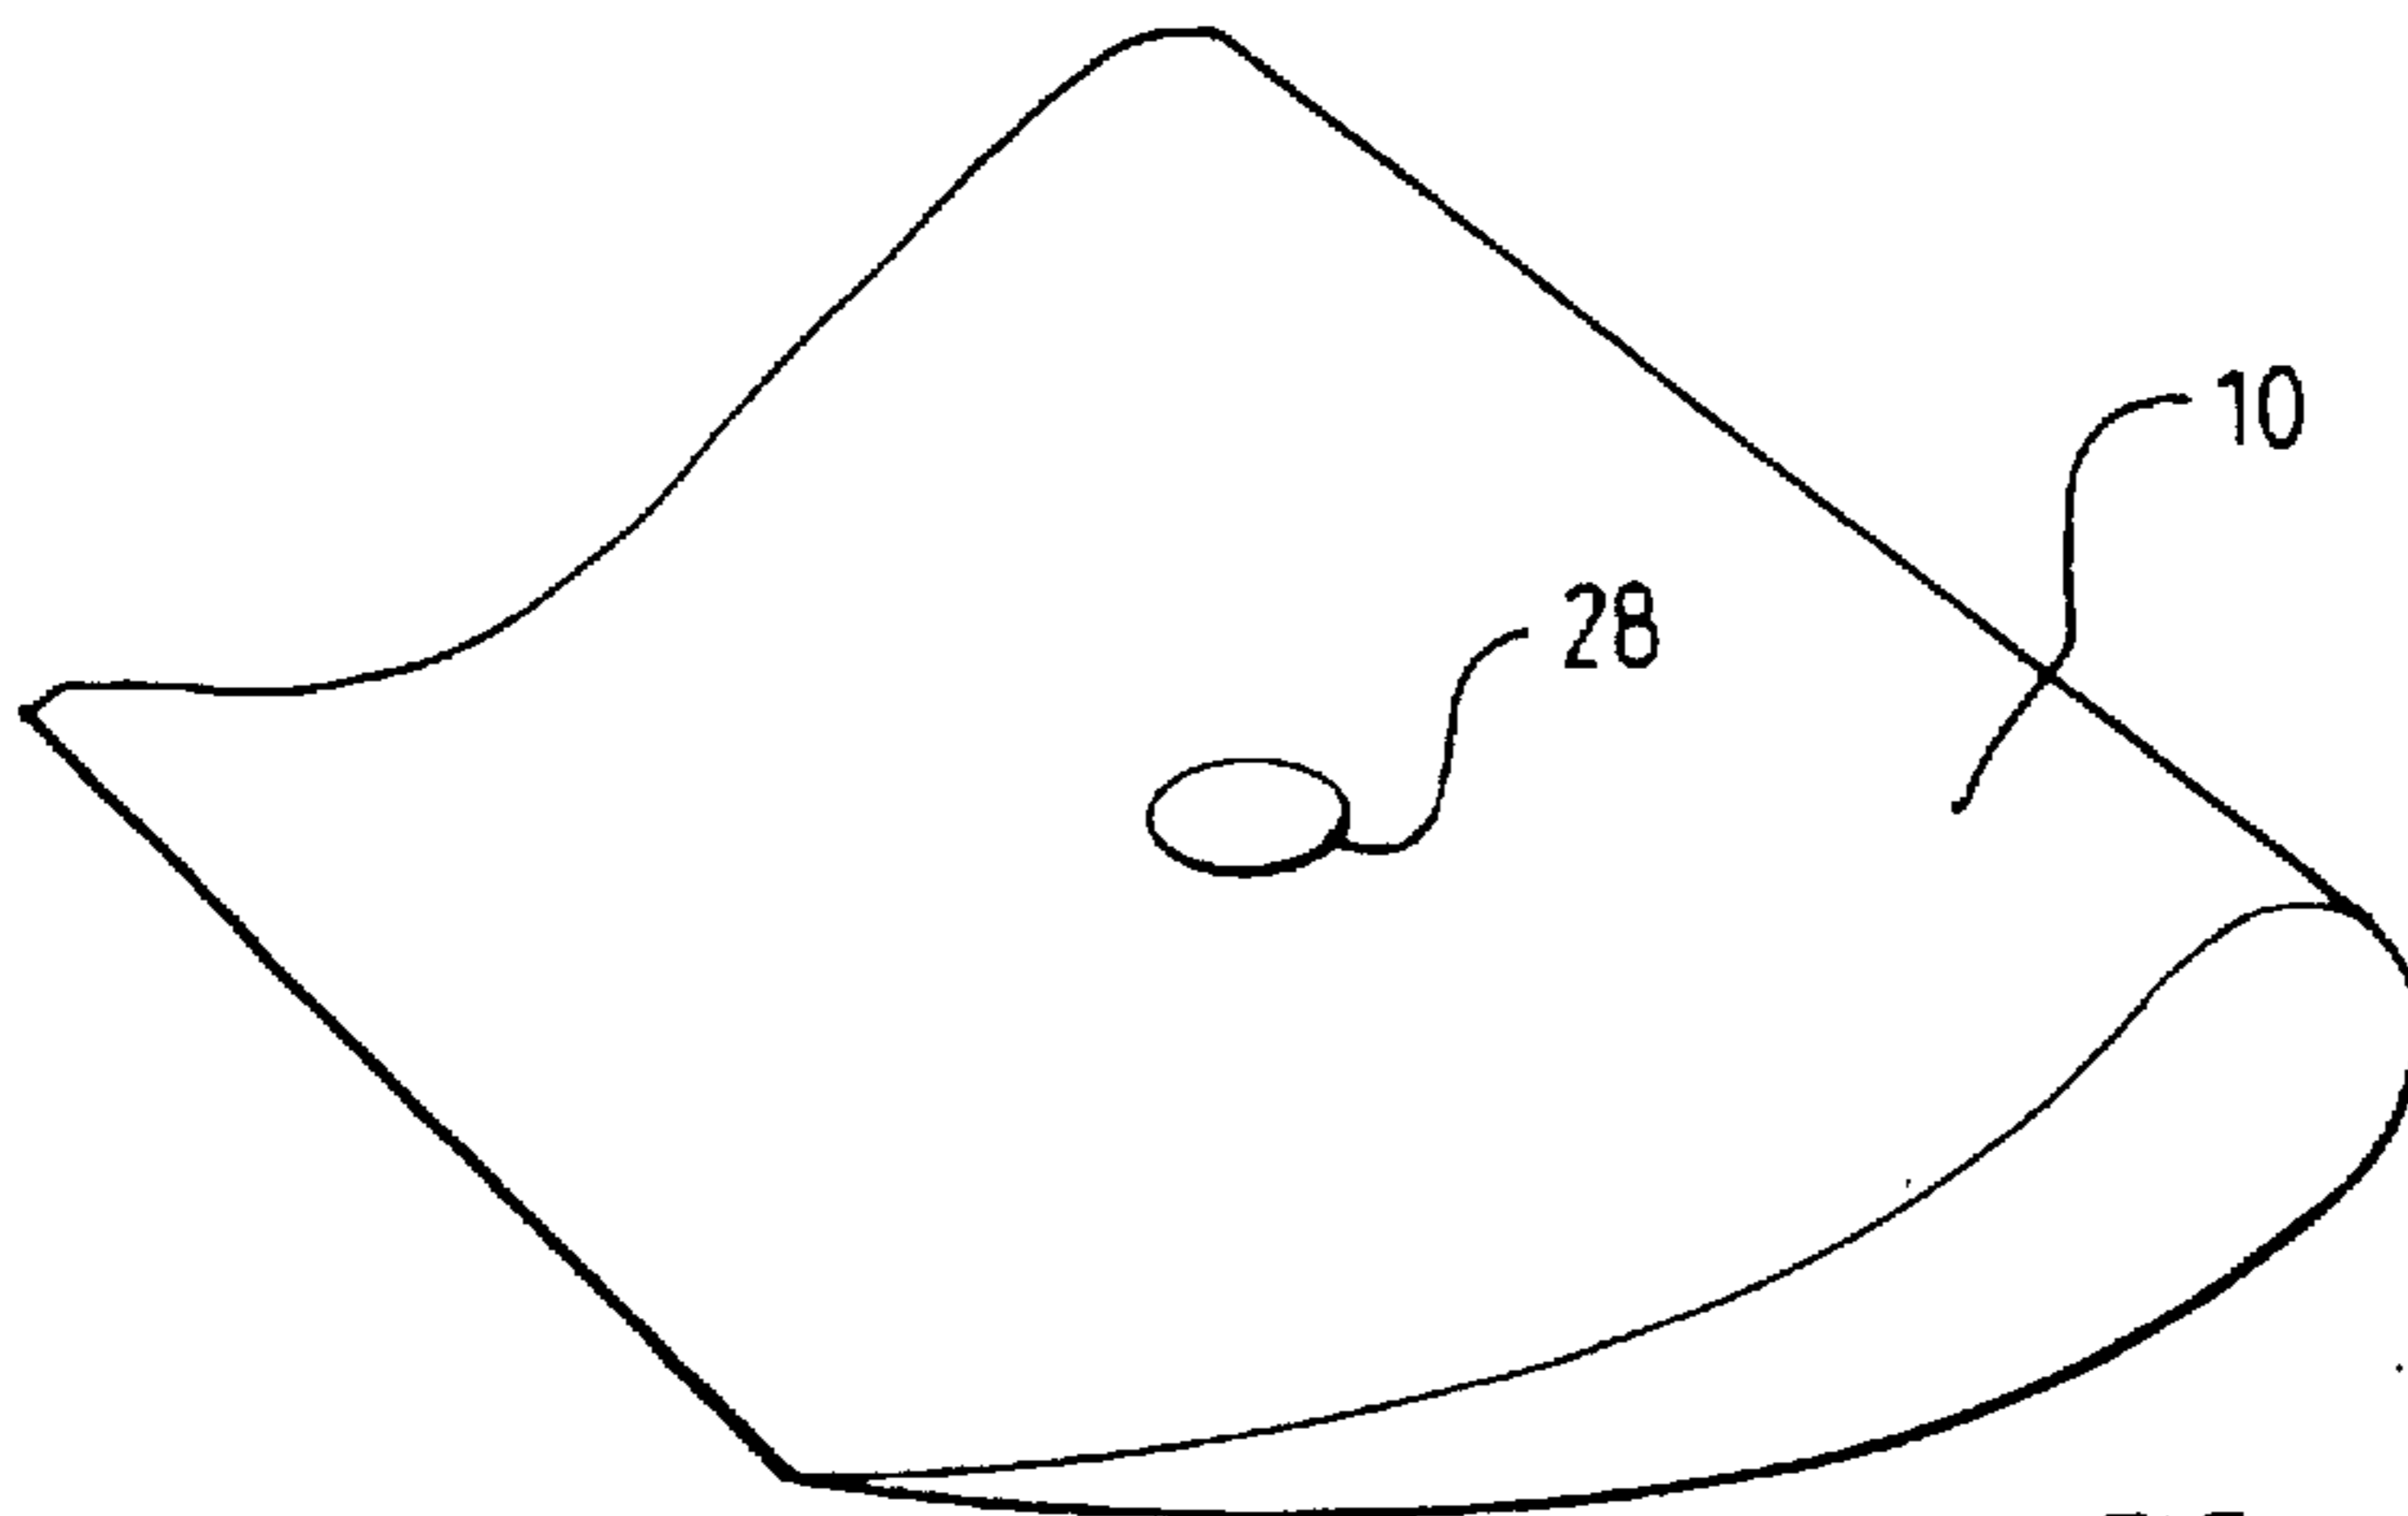
FIG 5

FIG. 5 illustrates the blade with the lacing wire hole re-formed.

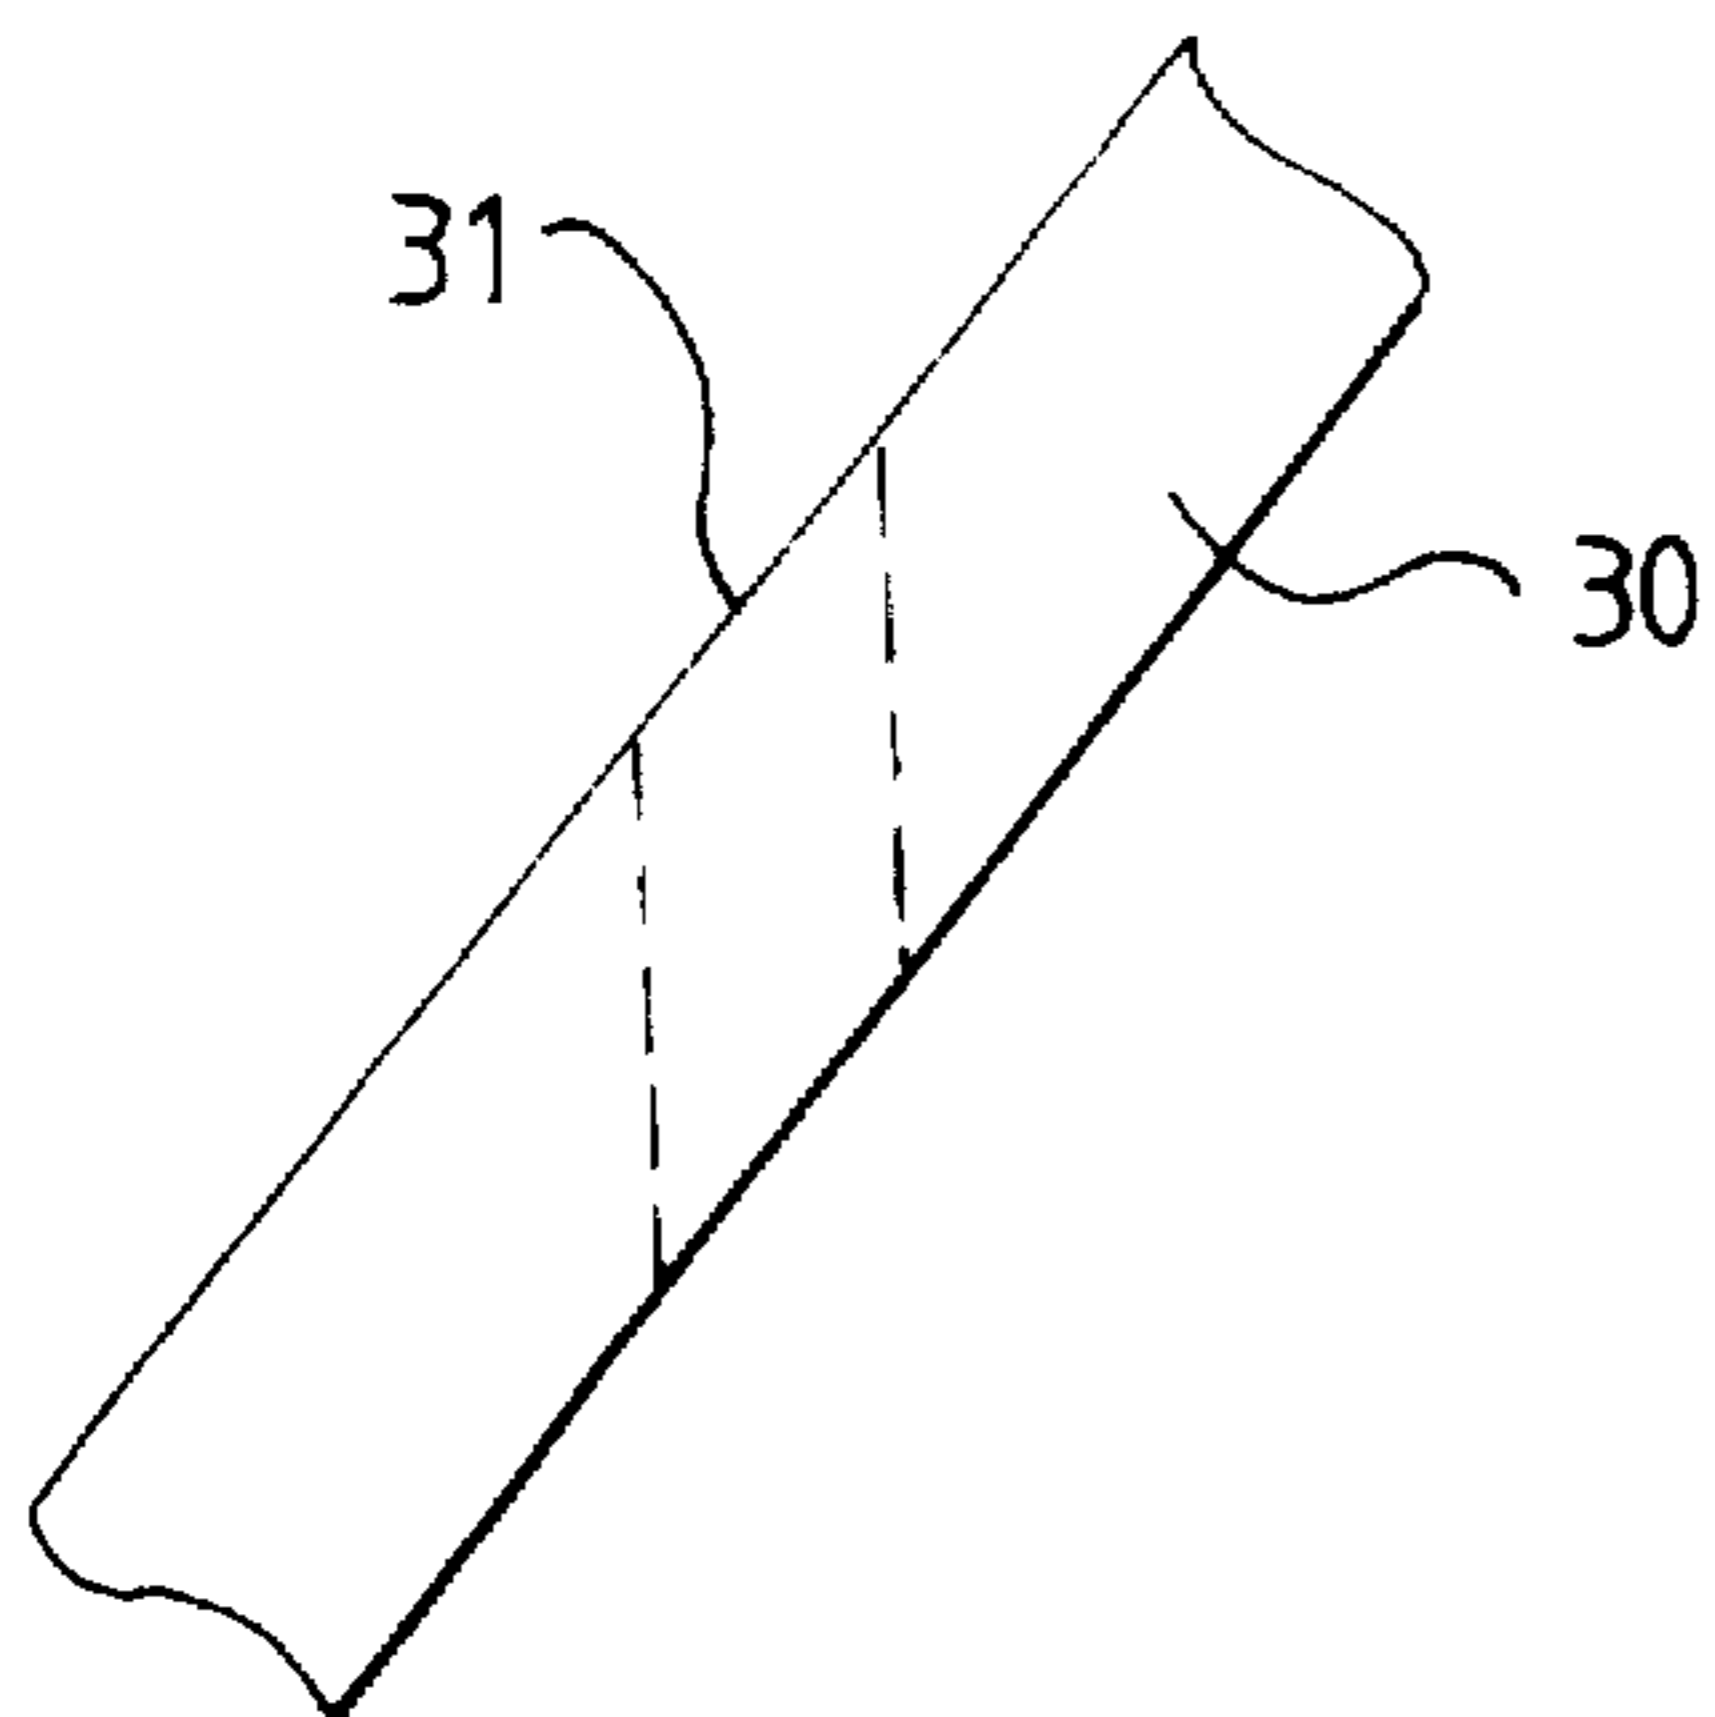
FIG 7

FIG. 7 illustrates the blade shown in FIG. 6 after welding;

Referring now to FIGS. 6 and 7, FIG. 6 shows a turbine blade 30 having a lacing wire hole 31. The lacing wire hole 31 is filled with weld material either completely or partially and excess weld material 32 and 33 is applied to the blade 30 so that when it is required to reform the lacing wire hole 31 the machine bit, for example a drill, can approach a surface 34 that is substantially normal to the direction of travel of the drill during the reforming of the lacing wire hole.

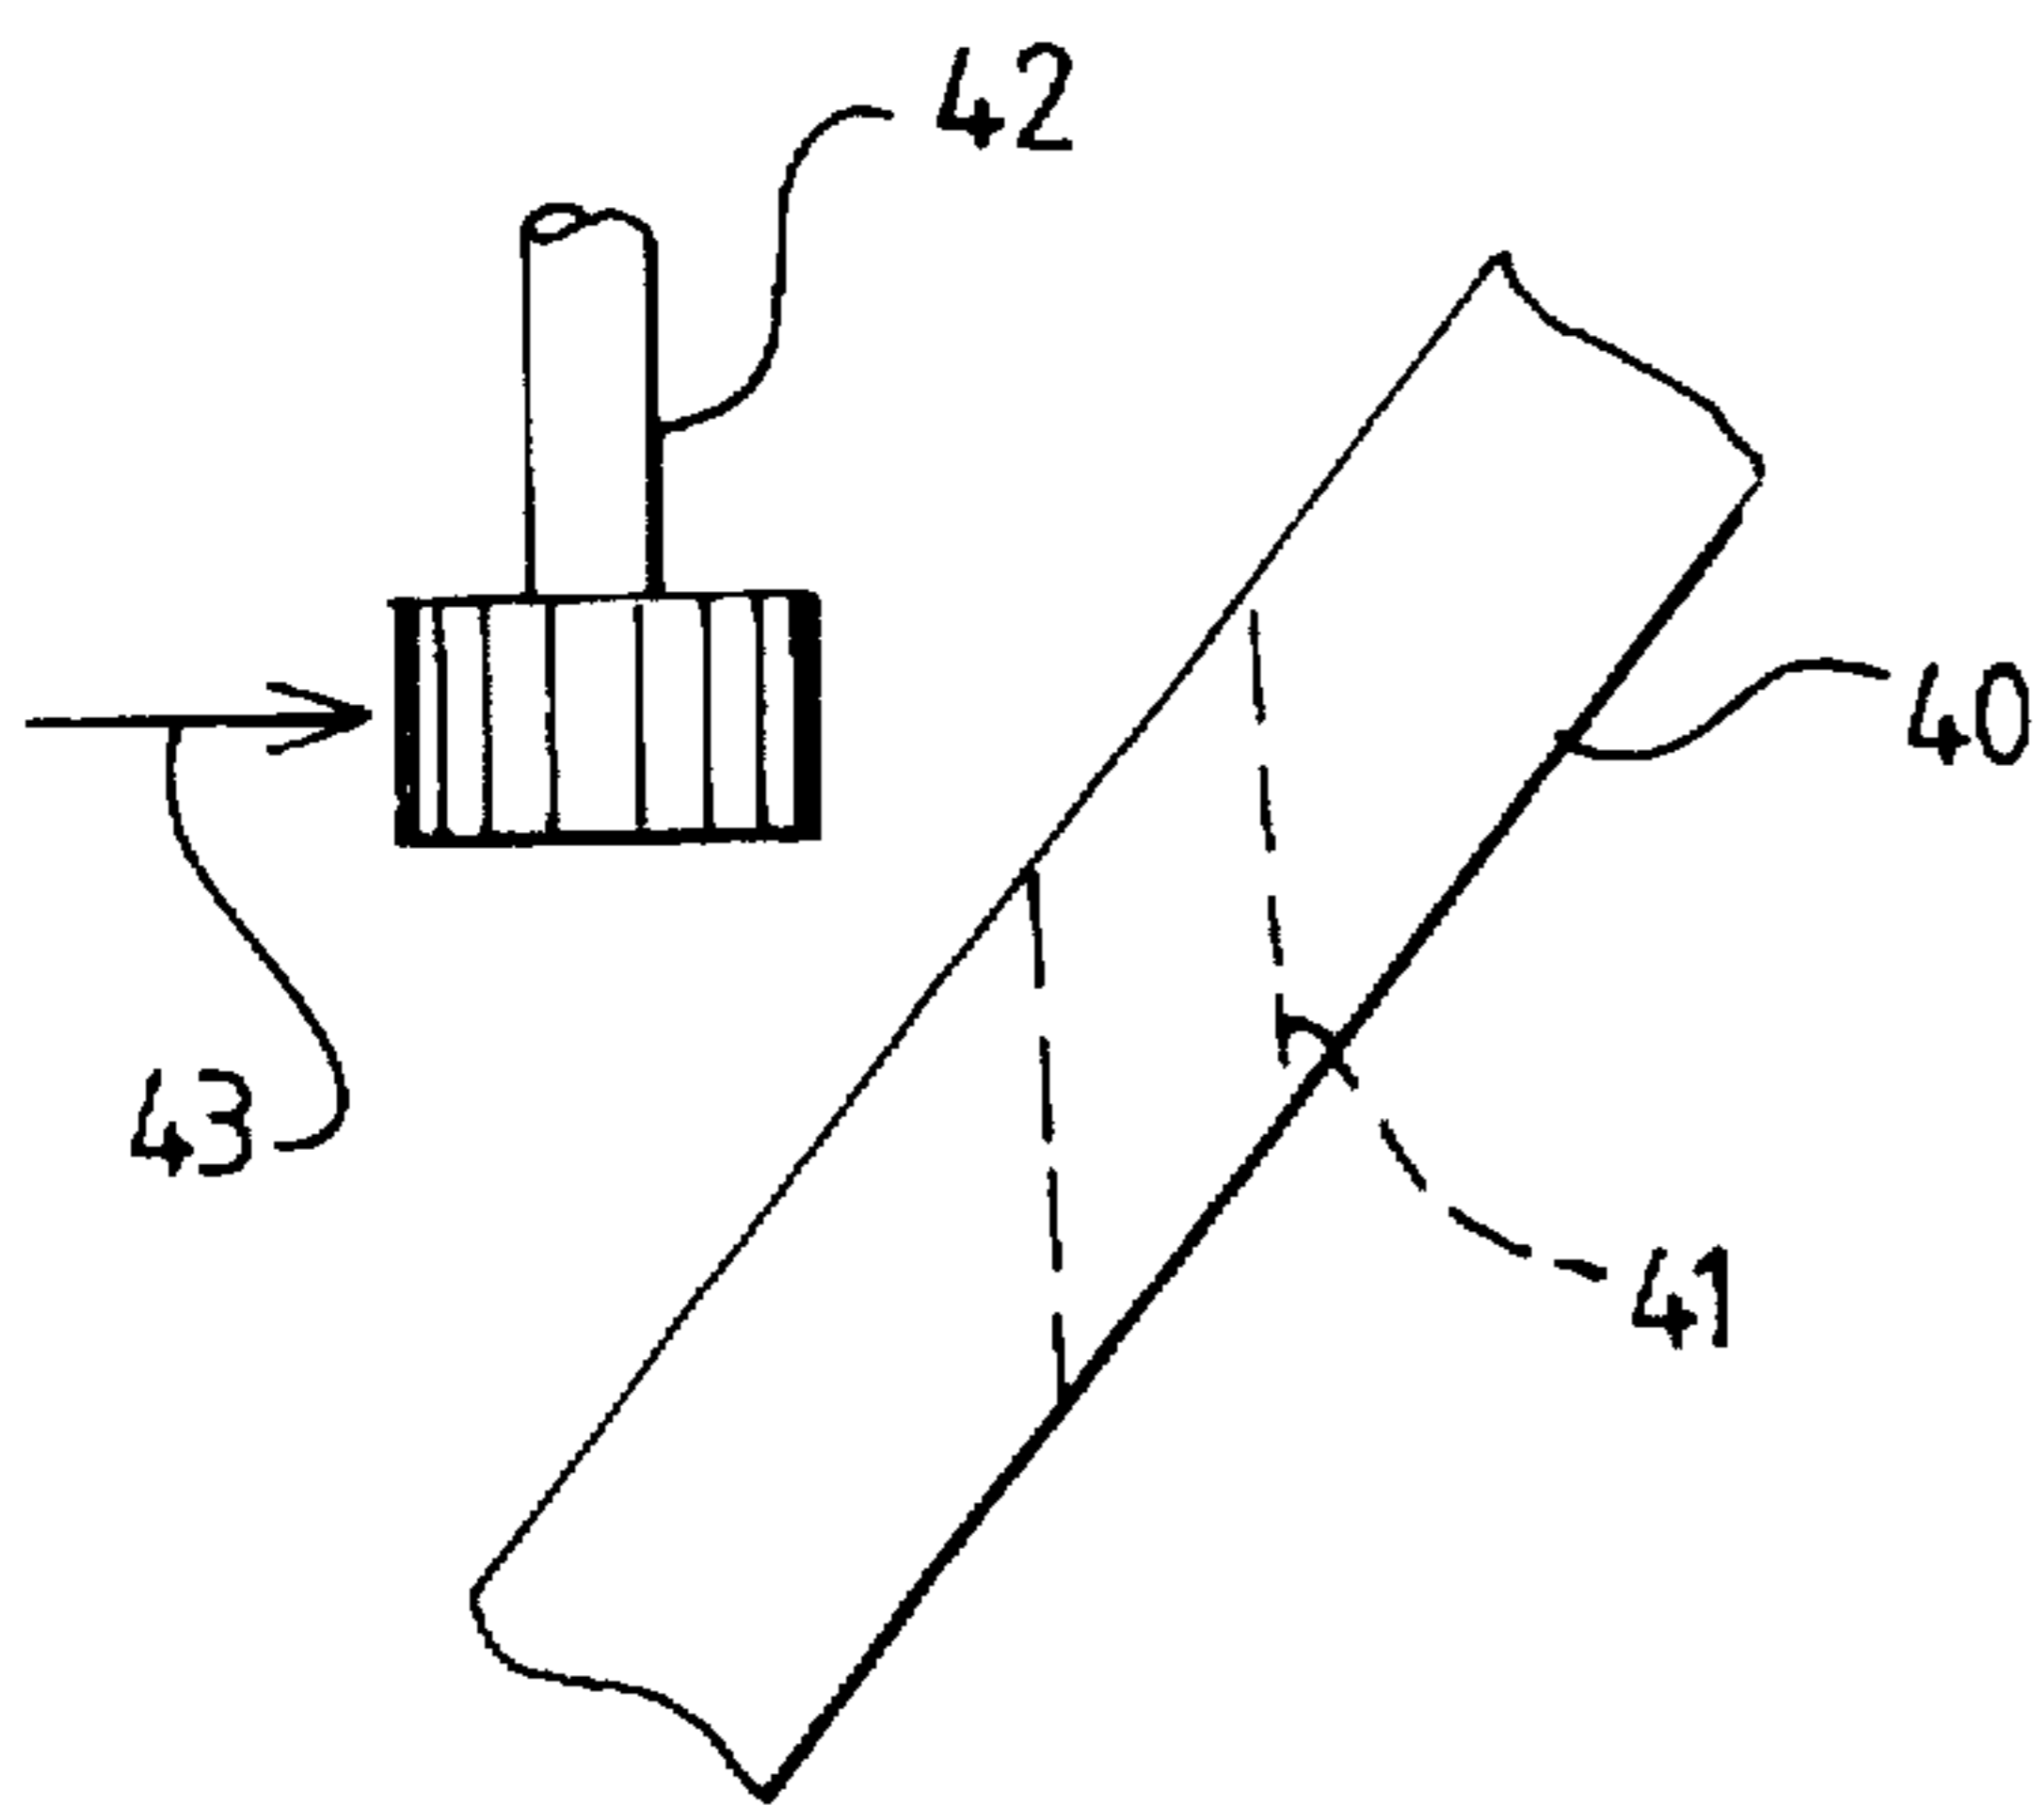
FIG 8

FIG. 8 illustrates a further turbine blade;

An alternative method is shown in FIGS. 8 and 9. A turbine blade 40 in which it is desired to have a lacing wire hole 41 is approached by a machine bit, for example a milling cutter 42 in a direction as shown by arrow 43. A flat 44 is milled into the surface of the turbine blade 40 thus leaving a substantially normal surface 45 which may be approached by a lacing wire hole forming tool such as a drill.

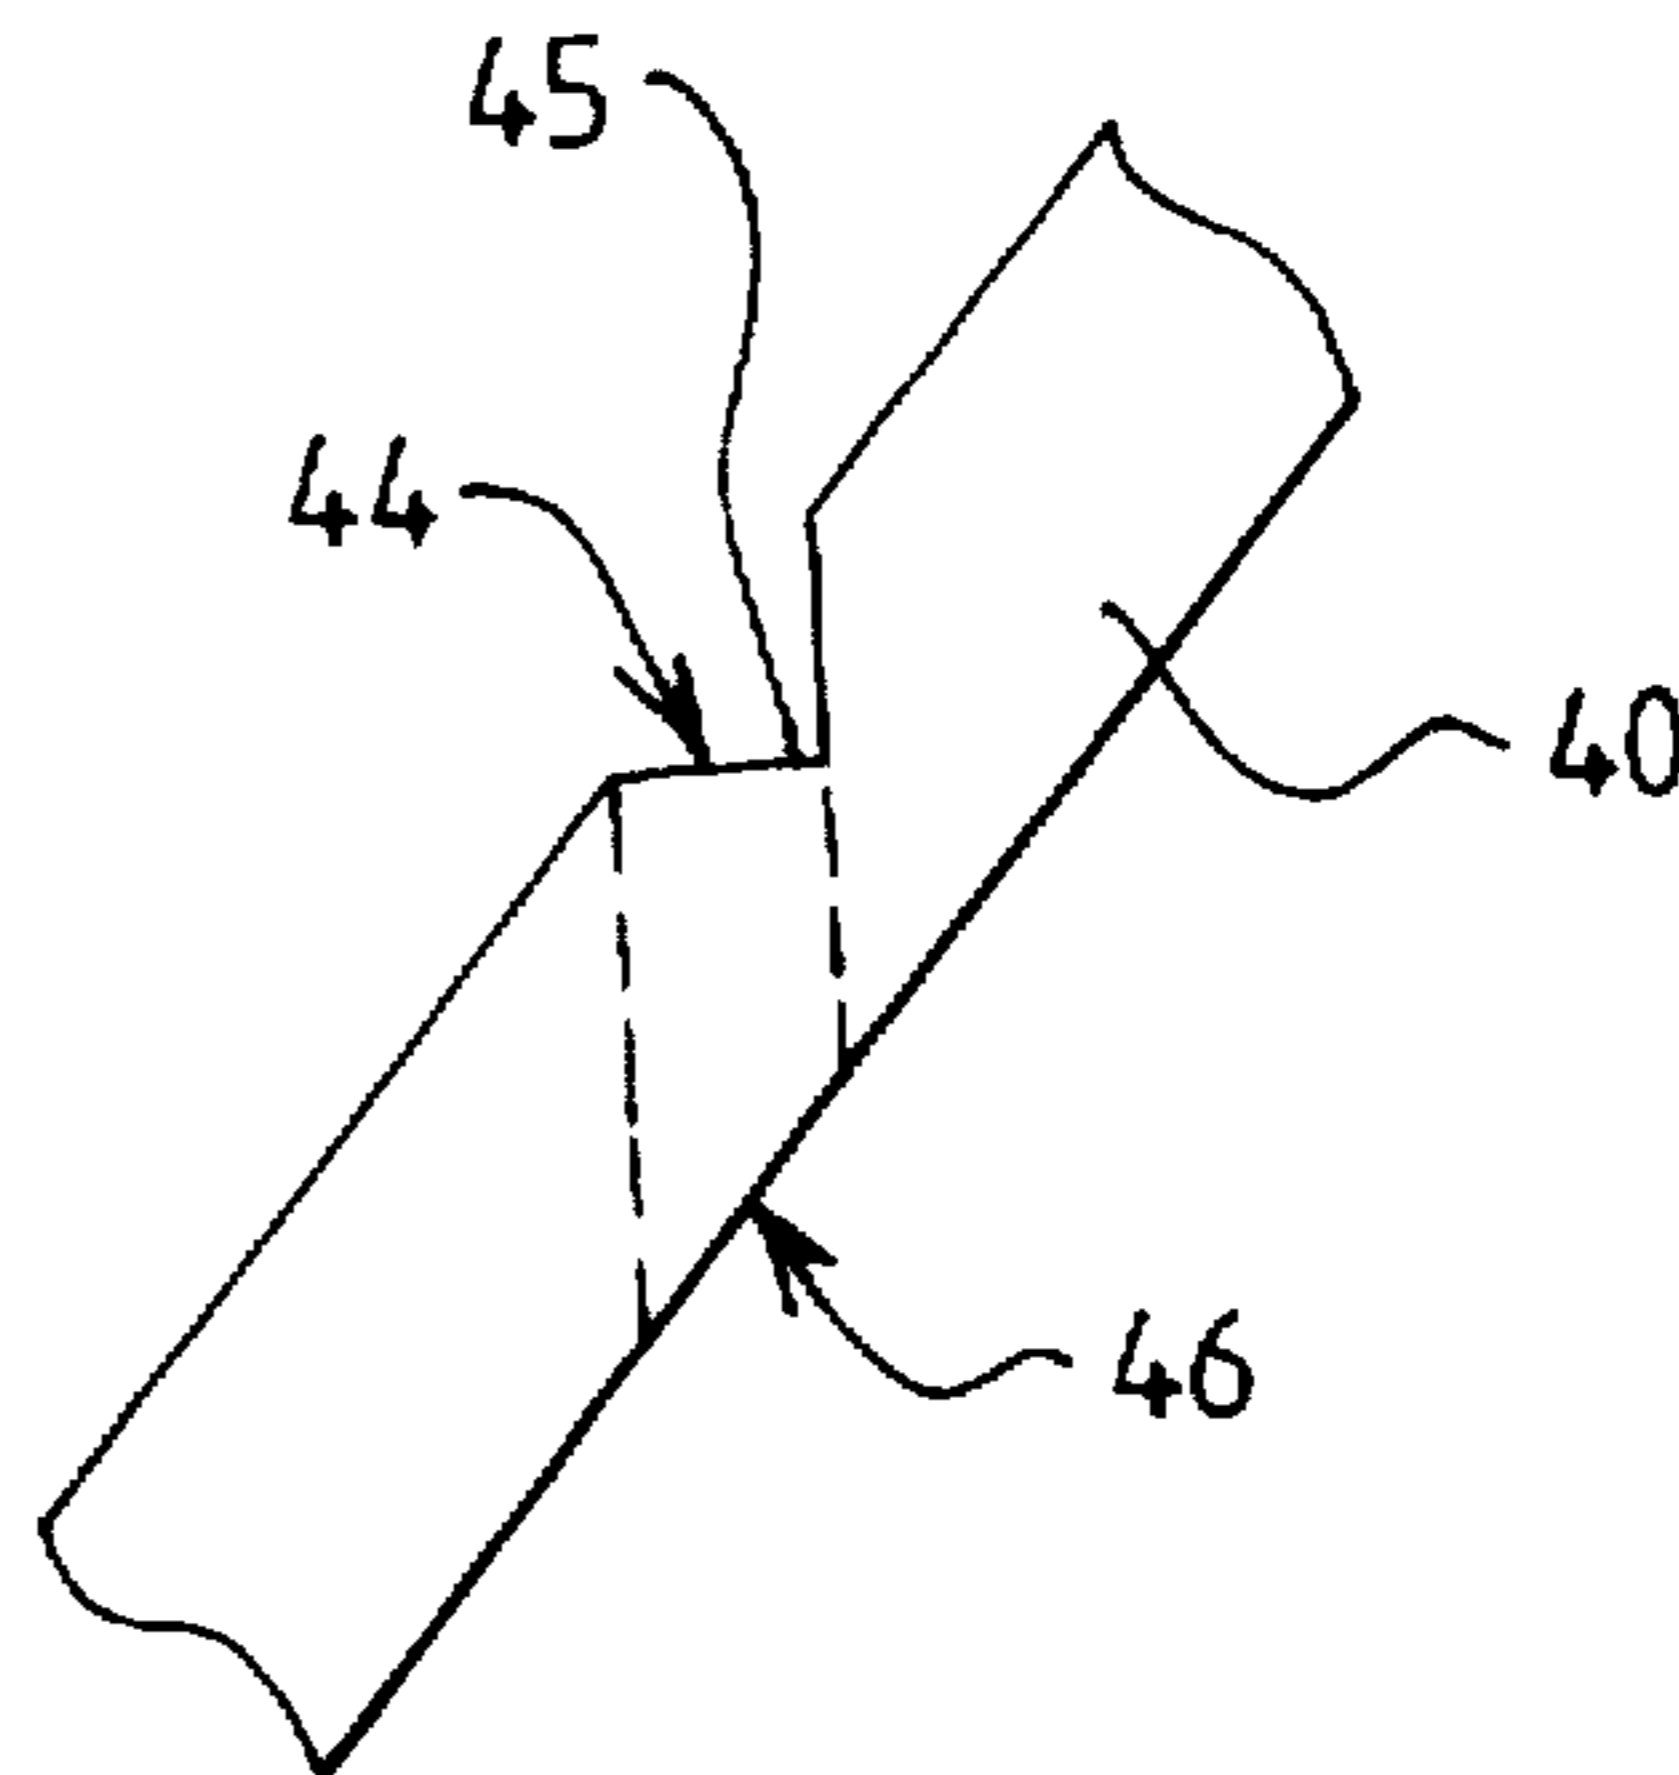
FIG 9

FIG. 9 illustrates the blade shown in FIG. 8 after a flat has been machined.
