[11] Patent Number: **5,760,371**

[54] WATER-COOLED STATOR COIL HEADER REPAIR PROCESS

A process is disclosed for repairing leaks in turbine generators that have water cooled stator coils with hollow conductor strands. Such generators have a tendency to leak where the stator coil joins a header. Once a leak is detected the repair is accomplished by following the steps off the invention. First, the header is cut into an outboard section, and into an inboard section that remains attached to the conductor strands. Second, the exposed lead ends of the conductor strands and the attached inboard section are cleaned to remove oxidation. Third, a water-tight braze seal is applied over the lead ends of the conductor strands. And finally, the stator coil and the inboard section are joined to a new outboard section.

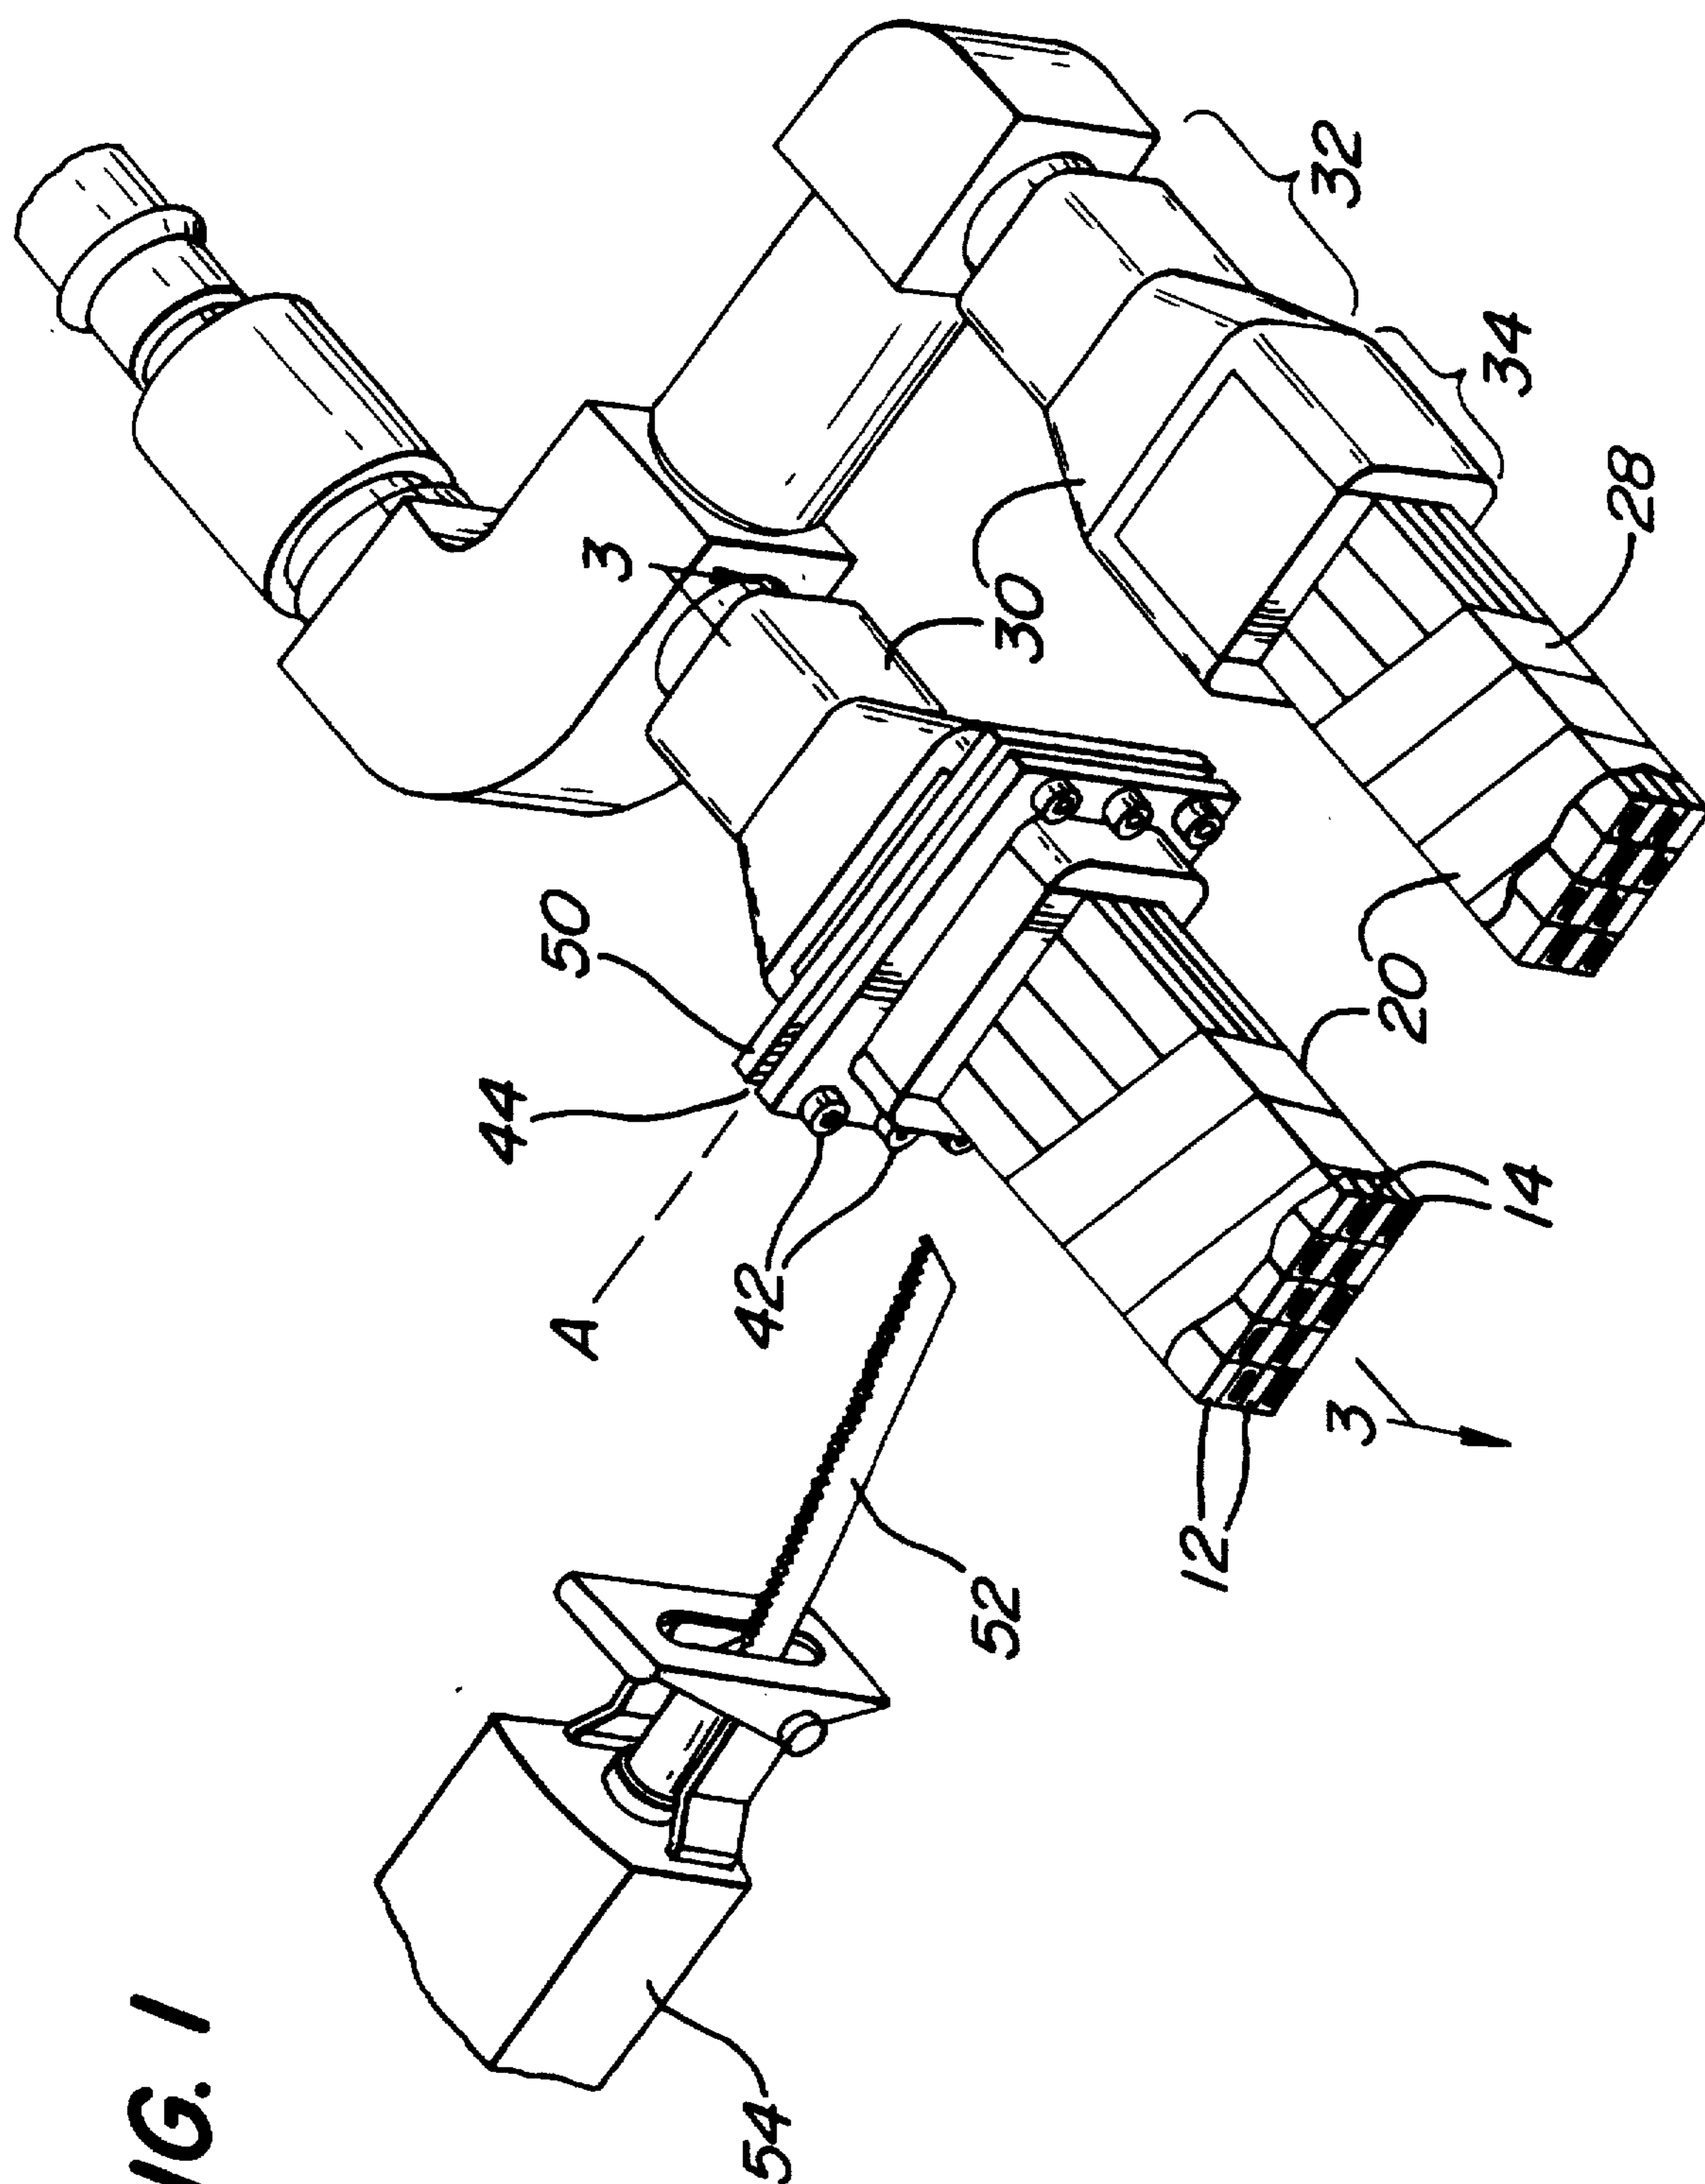
FIG. 1 illustrates a water cooled header connected to stator coils.

Referring to the drawings wherein like numerals indicate like elements throughout, FIG. 1 depicts the header and stator coil sub-assembly. In the normal operating condition, the stator coils 20 are inserted into the openings in the header 30 at the inboard side 34 of the header 30. Water flows through opening 36 to cool the stator coils 20 during operation of the turbine generator (not shown).

A design particularly susceptible to this water leakage problem is shown in FIG. 1. In this design, the hollow conductor strands 14 and solid conductor strands 12 are bundled together to form a stator coil 20. After the conductor strands are bundled together and bent to the desired form, an epoxy resin binds the conductor strands 12, 14. The entire stator coil 20 assembly is then wrapped with a groundwall insulation 28. At the lead end 26 of the stator coil 20, where the stator coil 20 joins the header 30, the conductor strands 12, 14 are exposed to facilitate the connection. Thus, the conductor strands 12, 14 are not epoxied or wrapped with the groundwall insulation 28 at that point. This lead end 26 of stator coil 20 is extended into the header 30 to interface stator coil 20 to header 30, completing the electrical/hydraulic circuit.

Second (step 1010), the header 30 is sectioned to reveal the lead ends 26 of the conductor strands 12, 14. The objective is to cut through the header 30 at a point A, which is illustrated throughout the various views of the header 30 and stator 20 interface in FIGS. 1-3. In particular, FIG. 2 shows the stator coil 20 and the portion of header 30 that remains attached to the stator coil 20 after the header 30 has been sectioned at point A. The header 30, thus sectioned, comprises an inboard portion 34, which remains connected to the stator coil 20, and an outboard portion 32, which is disconnected from the stator coil 20. Importantly, the lead ends 26 of the stator coil are not themselves cut. Rather, the

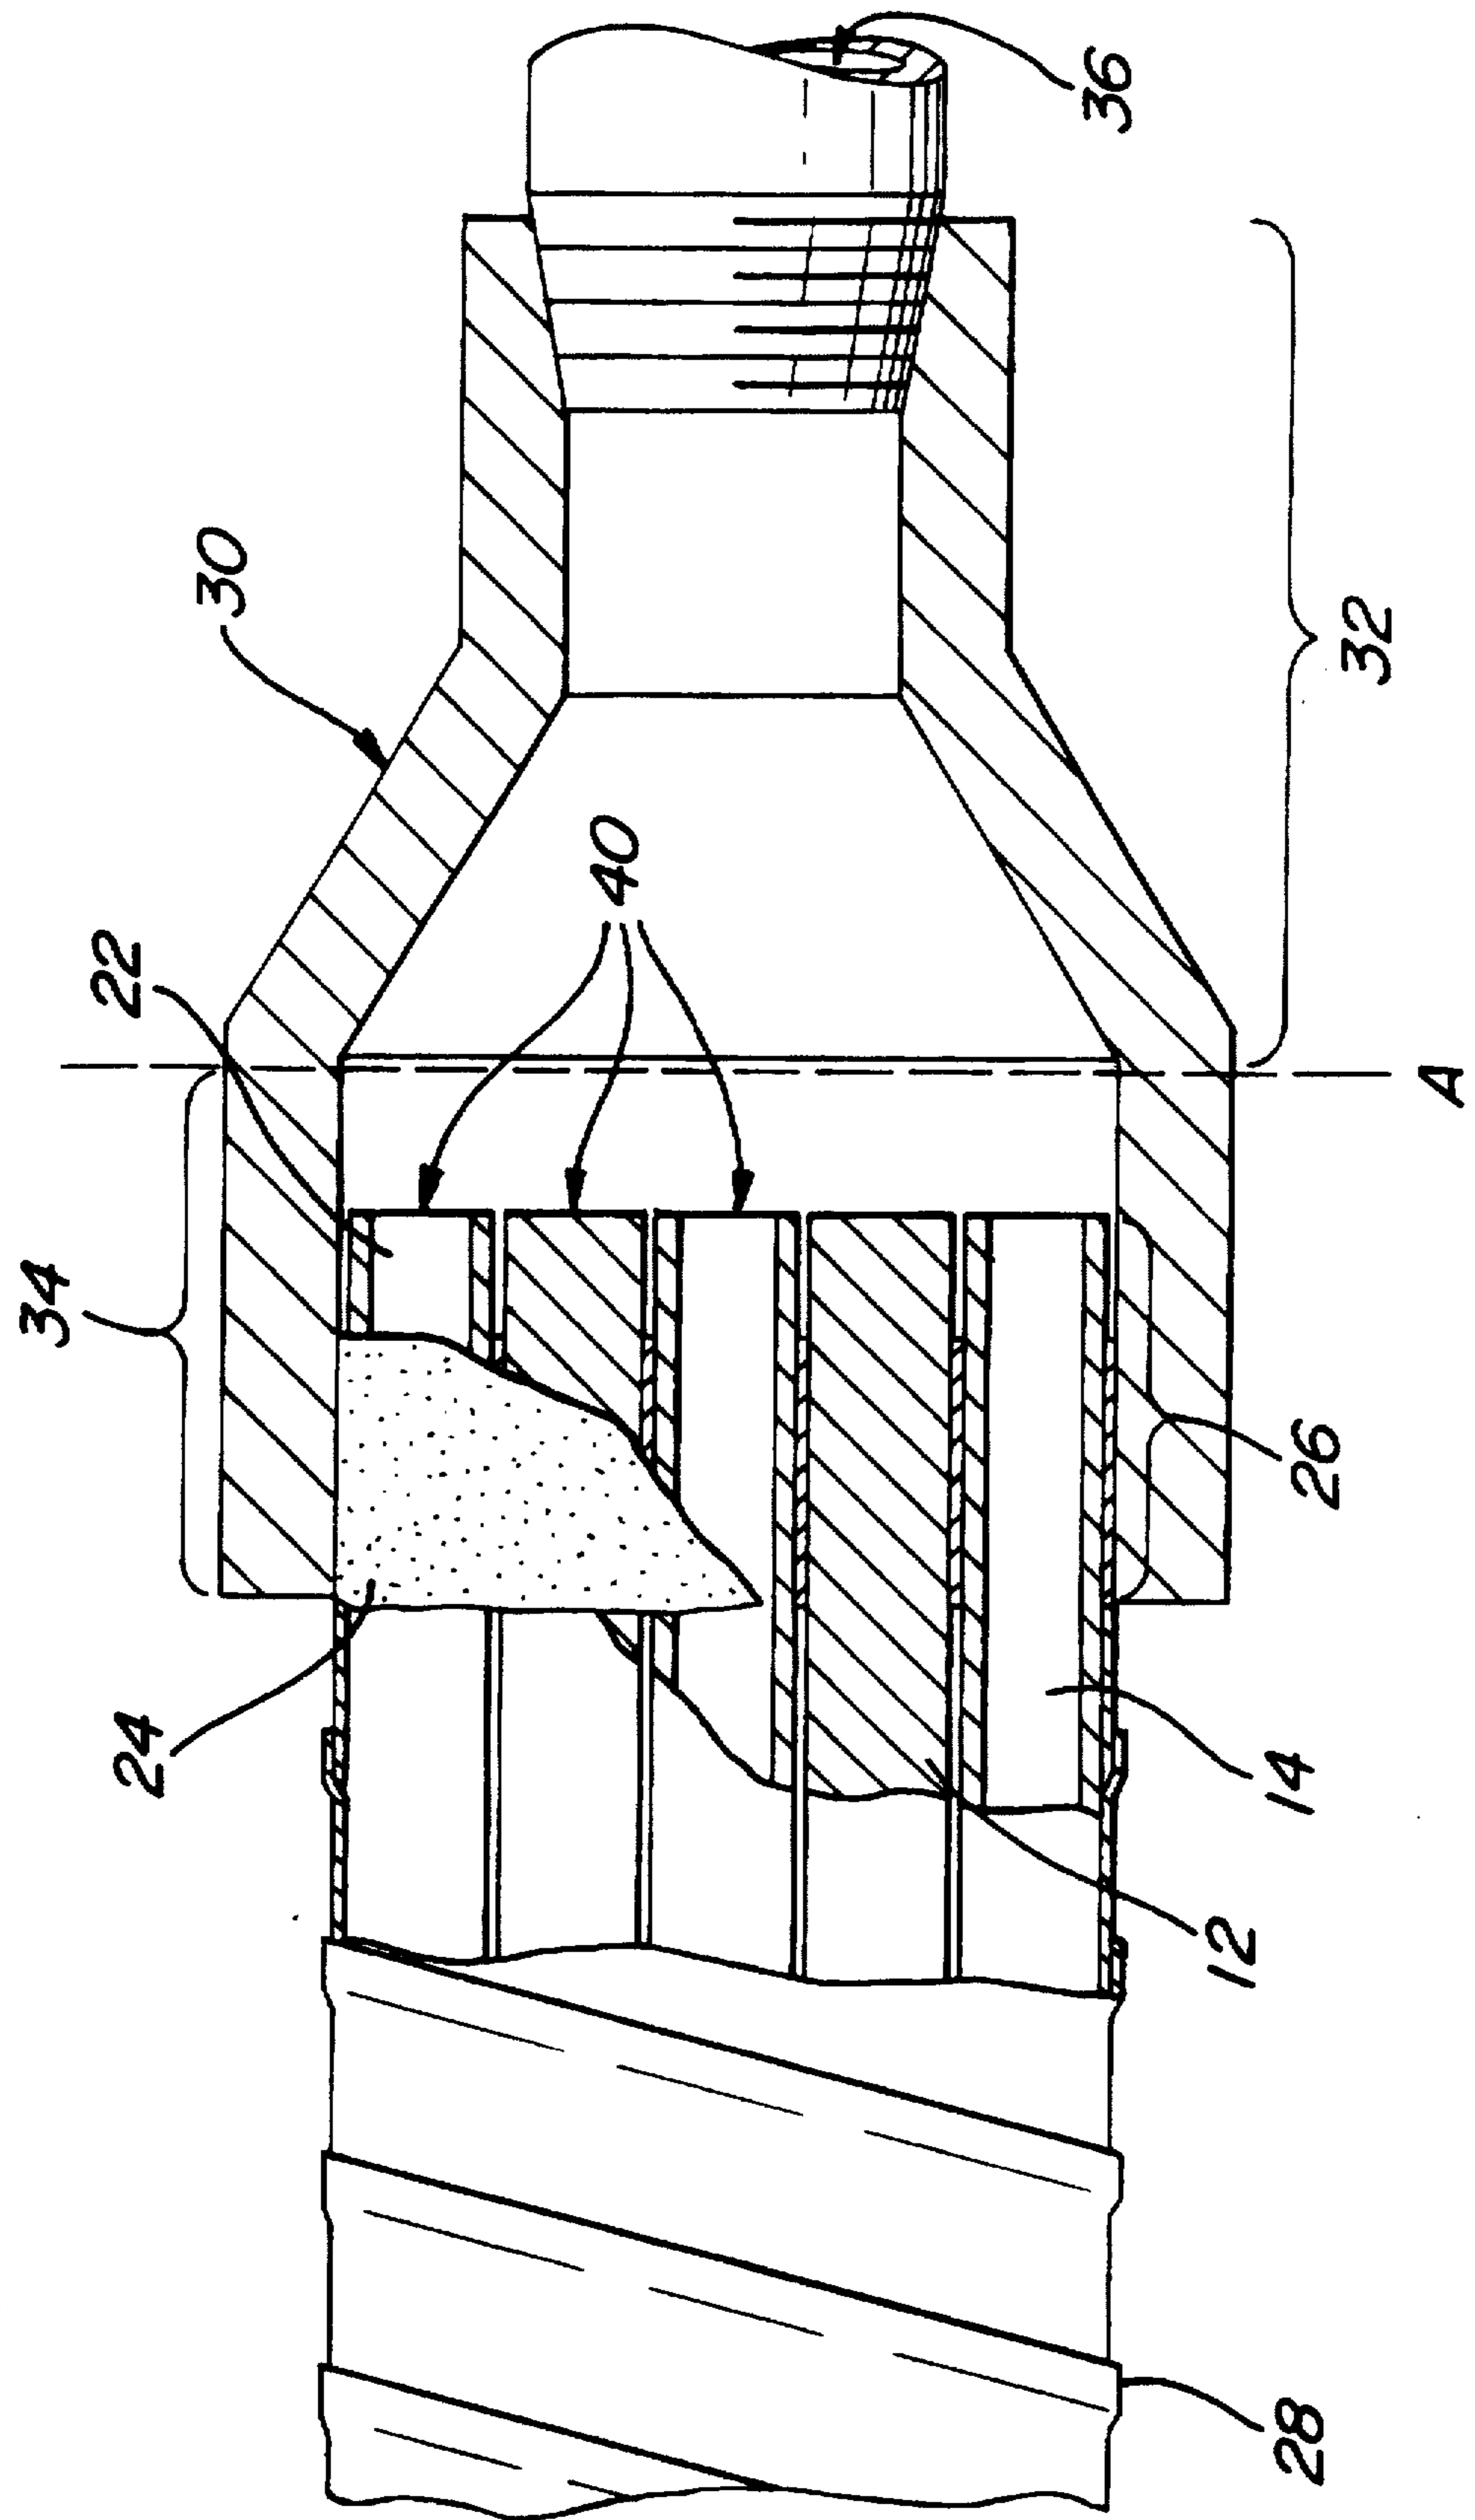
FIG. 3 illustrates a side view of the stator coil lead ends inserted into the header.

FIG. 3 shows a cut-away side view of the stator coil 20 and header 30 interface along line 3—3 in FIG. 1. As illustrated, the lead end 26 of the stator coil 20 is inserted into the header 30. No insulation separates the lead ends 26 from the header 30. Importantly, the lead end 26 is further divided between a non-brazed leading portion 22 and a brazed trailing portion 24 portion. The non-brazed leading portion 22 extends deeper into the header 30 and is characterized by voids 40 between the conductor strands 12, 14. As noted above, these voids 40 provide an opportunity for water to mix with the brazing flux, contributing significantly to the origin of water leakage. The disposition of the voids 40 can also be appreciated from the cross-sectional view provided in FIG. 2. As shown, columns and rows of the voids 40 exist between the conductor strands 12, 14 of the stator coil 20. These voids 40 must be sealed to prevent the development of leak-causing acid.

FIG. 3 shows a cross section of the stator coil 20 and header 30 interface taken along the line 3—3 in FIG. 1. As illustrated, only the trailing portion 24 of the lead end 26 is brazed to header 30. The leading portion 22 is not brazed to
