## [54] WATER-COOLED STATOR COIL HEADER REPAIR PROCESS

## [57] ABSTRACT

A process is disclosed for repairing leaks in turbine generators that have water cooled stator coils with hollow conductor strands. Such generators have a tendency to leak where the stator coil joins a header. Once a leak is detected the repair is accomplished by following the steps off the invention. First, the header is cut into an outboard section, and into an inboard section that remains attached to the conductor strands. Second, the exposed lead ends of the conductor strands and the attached inboard section are cleaned to remove oxidation. Third, a water-tight braze seal is applied over the lead ends of the conductor strands. And finally, the stator coil and the inboard section are joined to a new outboard section.

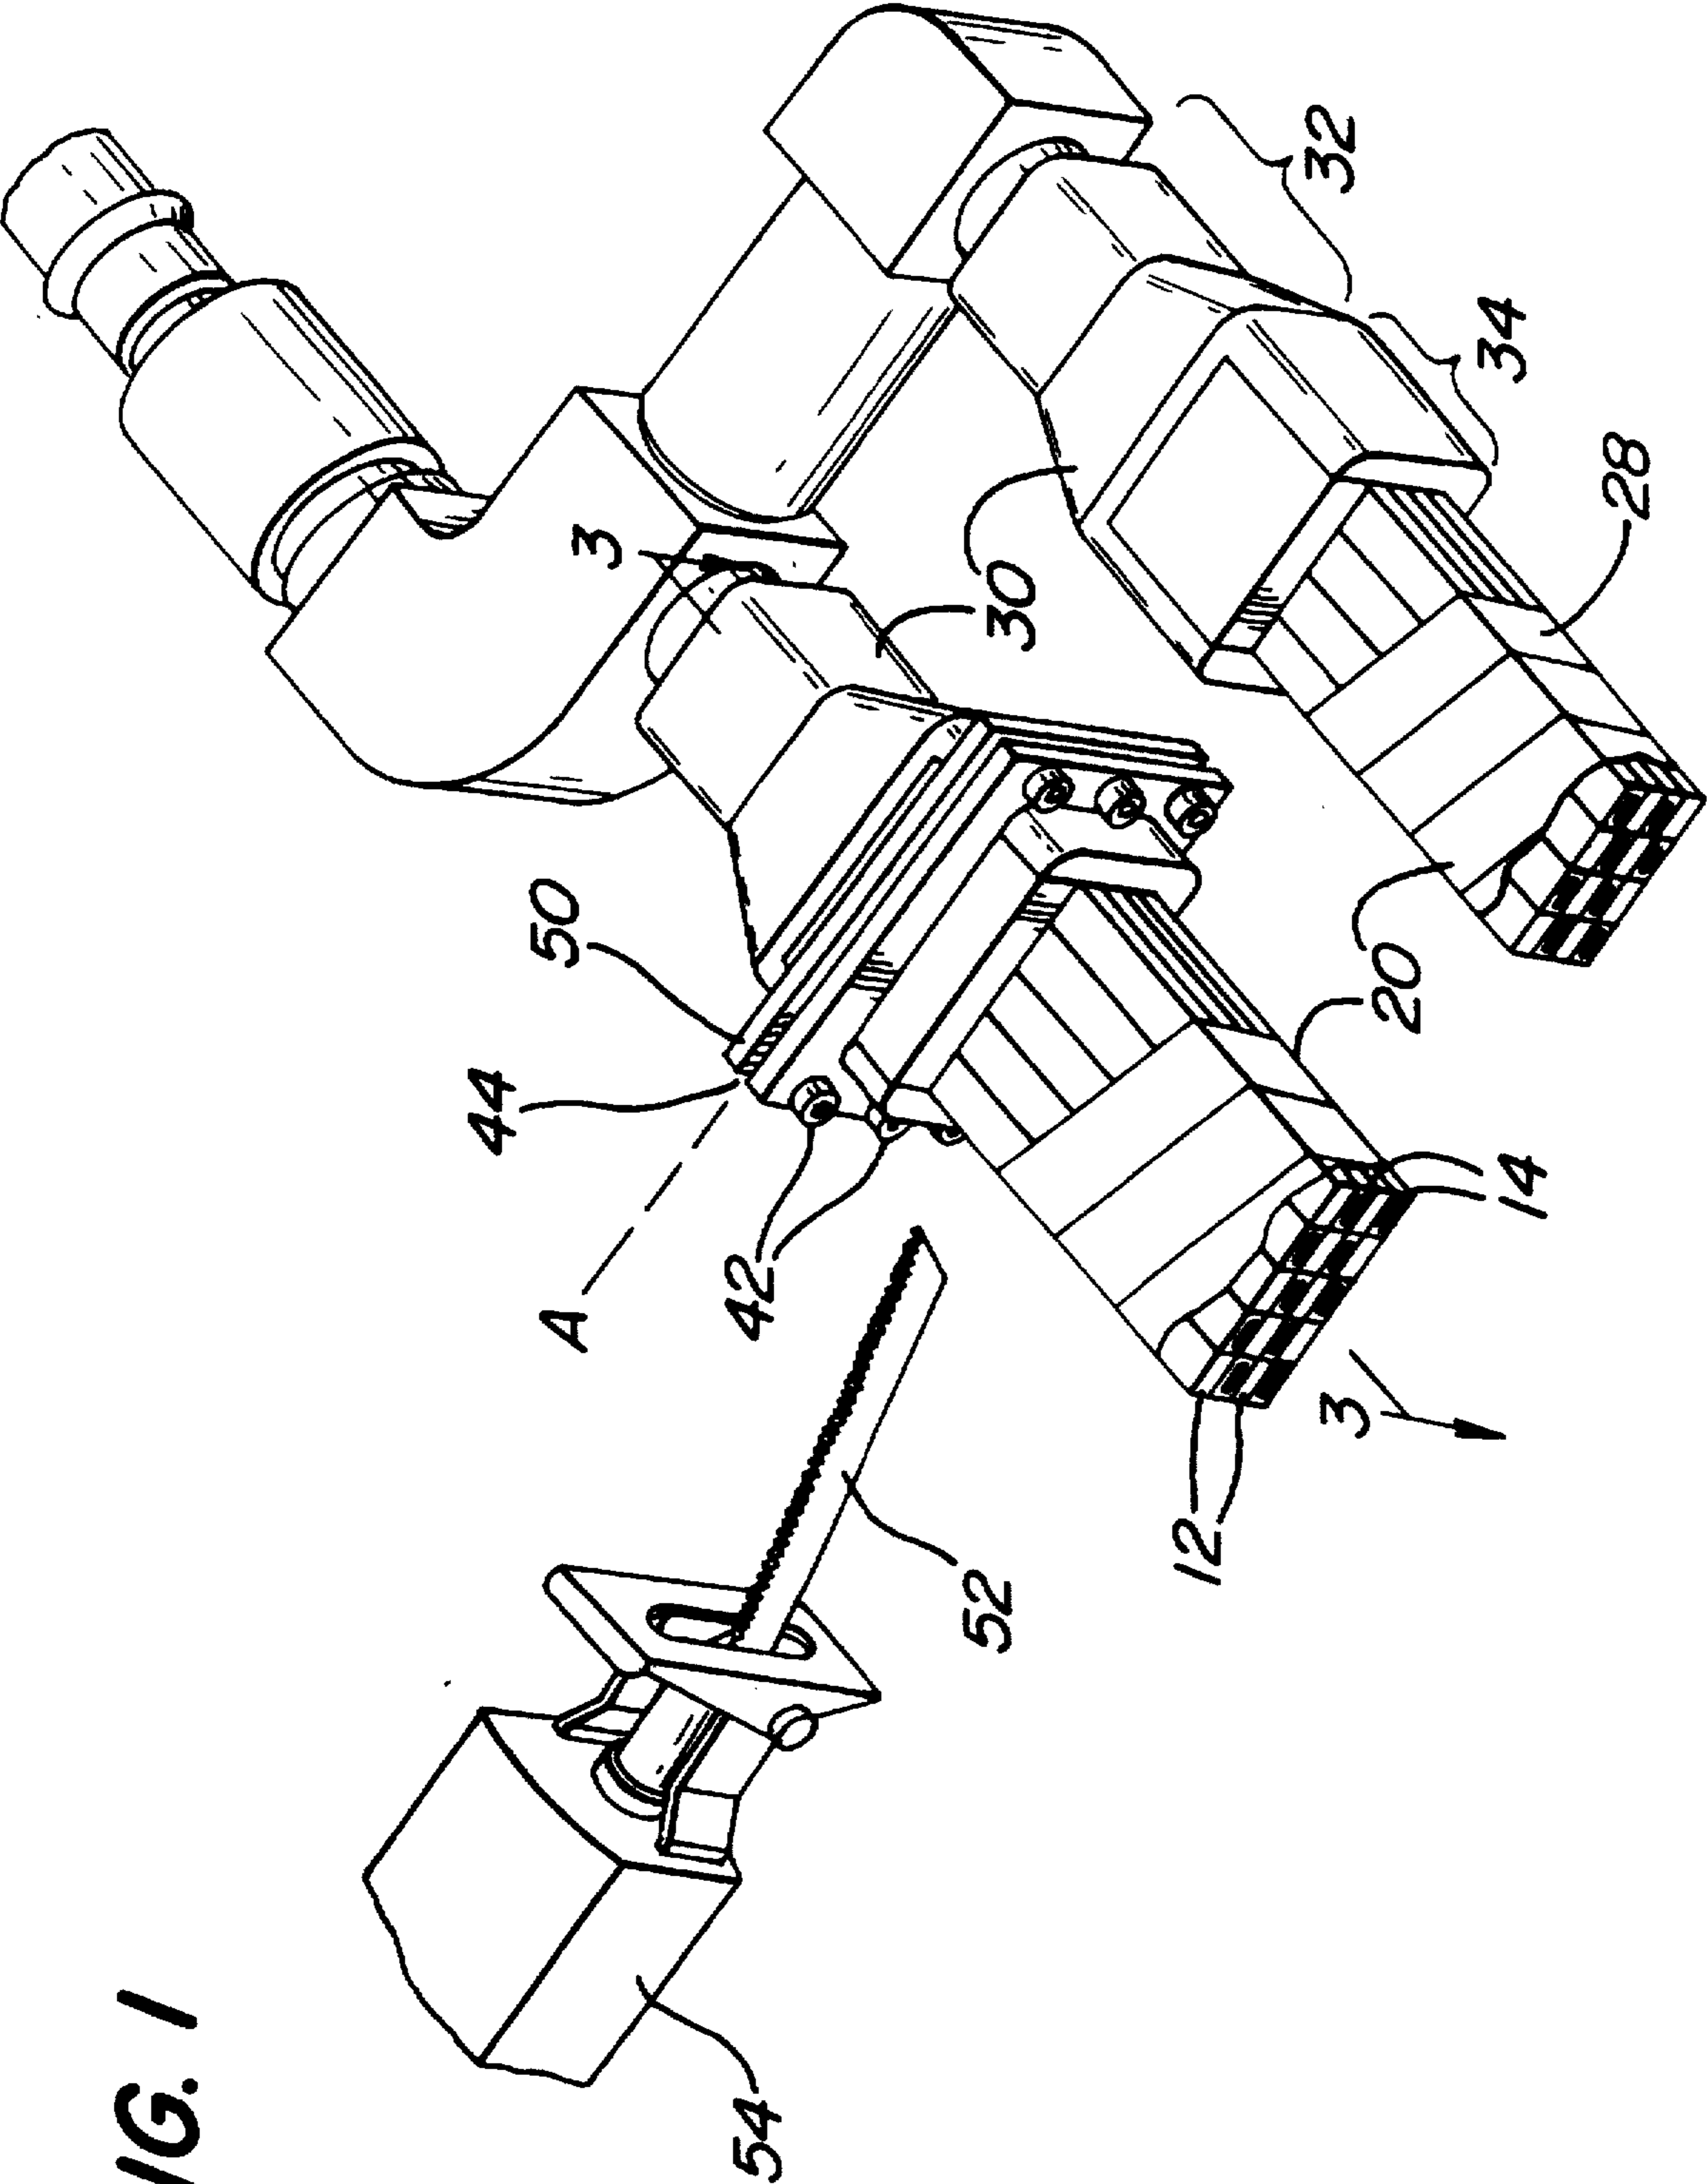
A design particularly susceptible to this water leakage problem is shown in FIG. 1. In this design, the hollow conductor strands 14 and solid conductor strands 12 are bundled together to form a stator coil 20. After the conductor strands are bundled together and bent to the desired form, an epoxy resin binds the conductor strands 12, 14. The entire stator coil 20 assembly is then wrapped with a groundwall insulation 28. At the lead end 26 of the stator coil 20, where the stator coil 20 joins the header 30, the conductor strands 12, 14 are exposed to facilitate the connection. Thus, the conductor strands 12, 14 are not epoxied or wrapped with the groundwall insulation 28 at that point. This lead end 26 of stator coil 20 is extended into the header 30 to interface stator coil 20 to header 30, completing the electrical/hydraulic circuit.

FIG. 1 illustrates a water cooled header connected to stator coils.

Referring to the drawings wherein like numerals indicate like elements throughout, FIG. 1 depicts the header and stator coil sub-assembly. In the normal operating condition, the stator coils 20 are inserted into the openings in the header 30 at the inboard side 34 of the header 30. Water flows through opening 36 to cool the stator coils 20 during operation of the turbine generator (not shown).

Second (step 1010), the header 30 is sectioned to reveal the lead ends 26 of the conductor strands 12, 14. The objective is to cut through the header 30 at a point A, which is illustrated throughout the various views of the header 30 and stator 20 interface in FIGS. 1-3. In particular, FIG. 2 shows the stator coil 20 and the portion of header 30 that remains attached to the stator coil 20 after the header 30 has been sectioned at point A. The header 30, thus sectioned, comprises an inboard portion 34, which remains connected to the stator coil 20, and an outboard portion 32, which is disconnected from the stator coil 20. Importantly, the lead ends 26 of the stator coil are not themselves cut. Rather, the

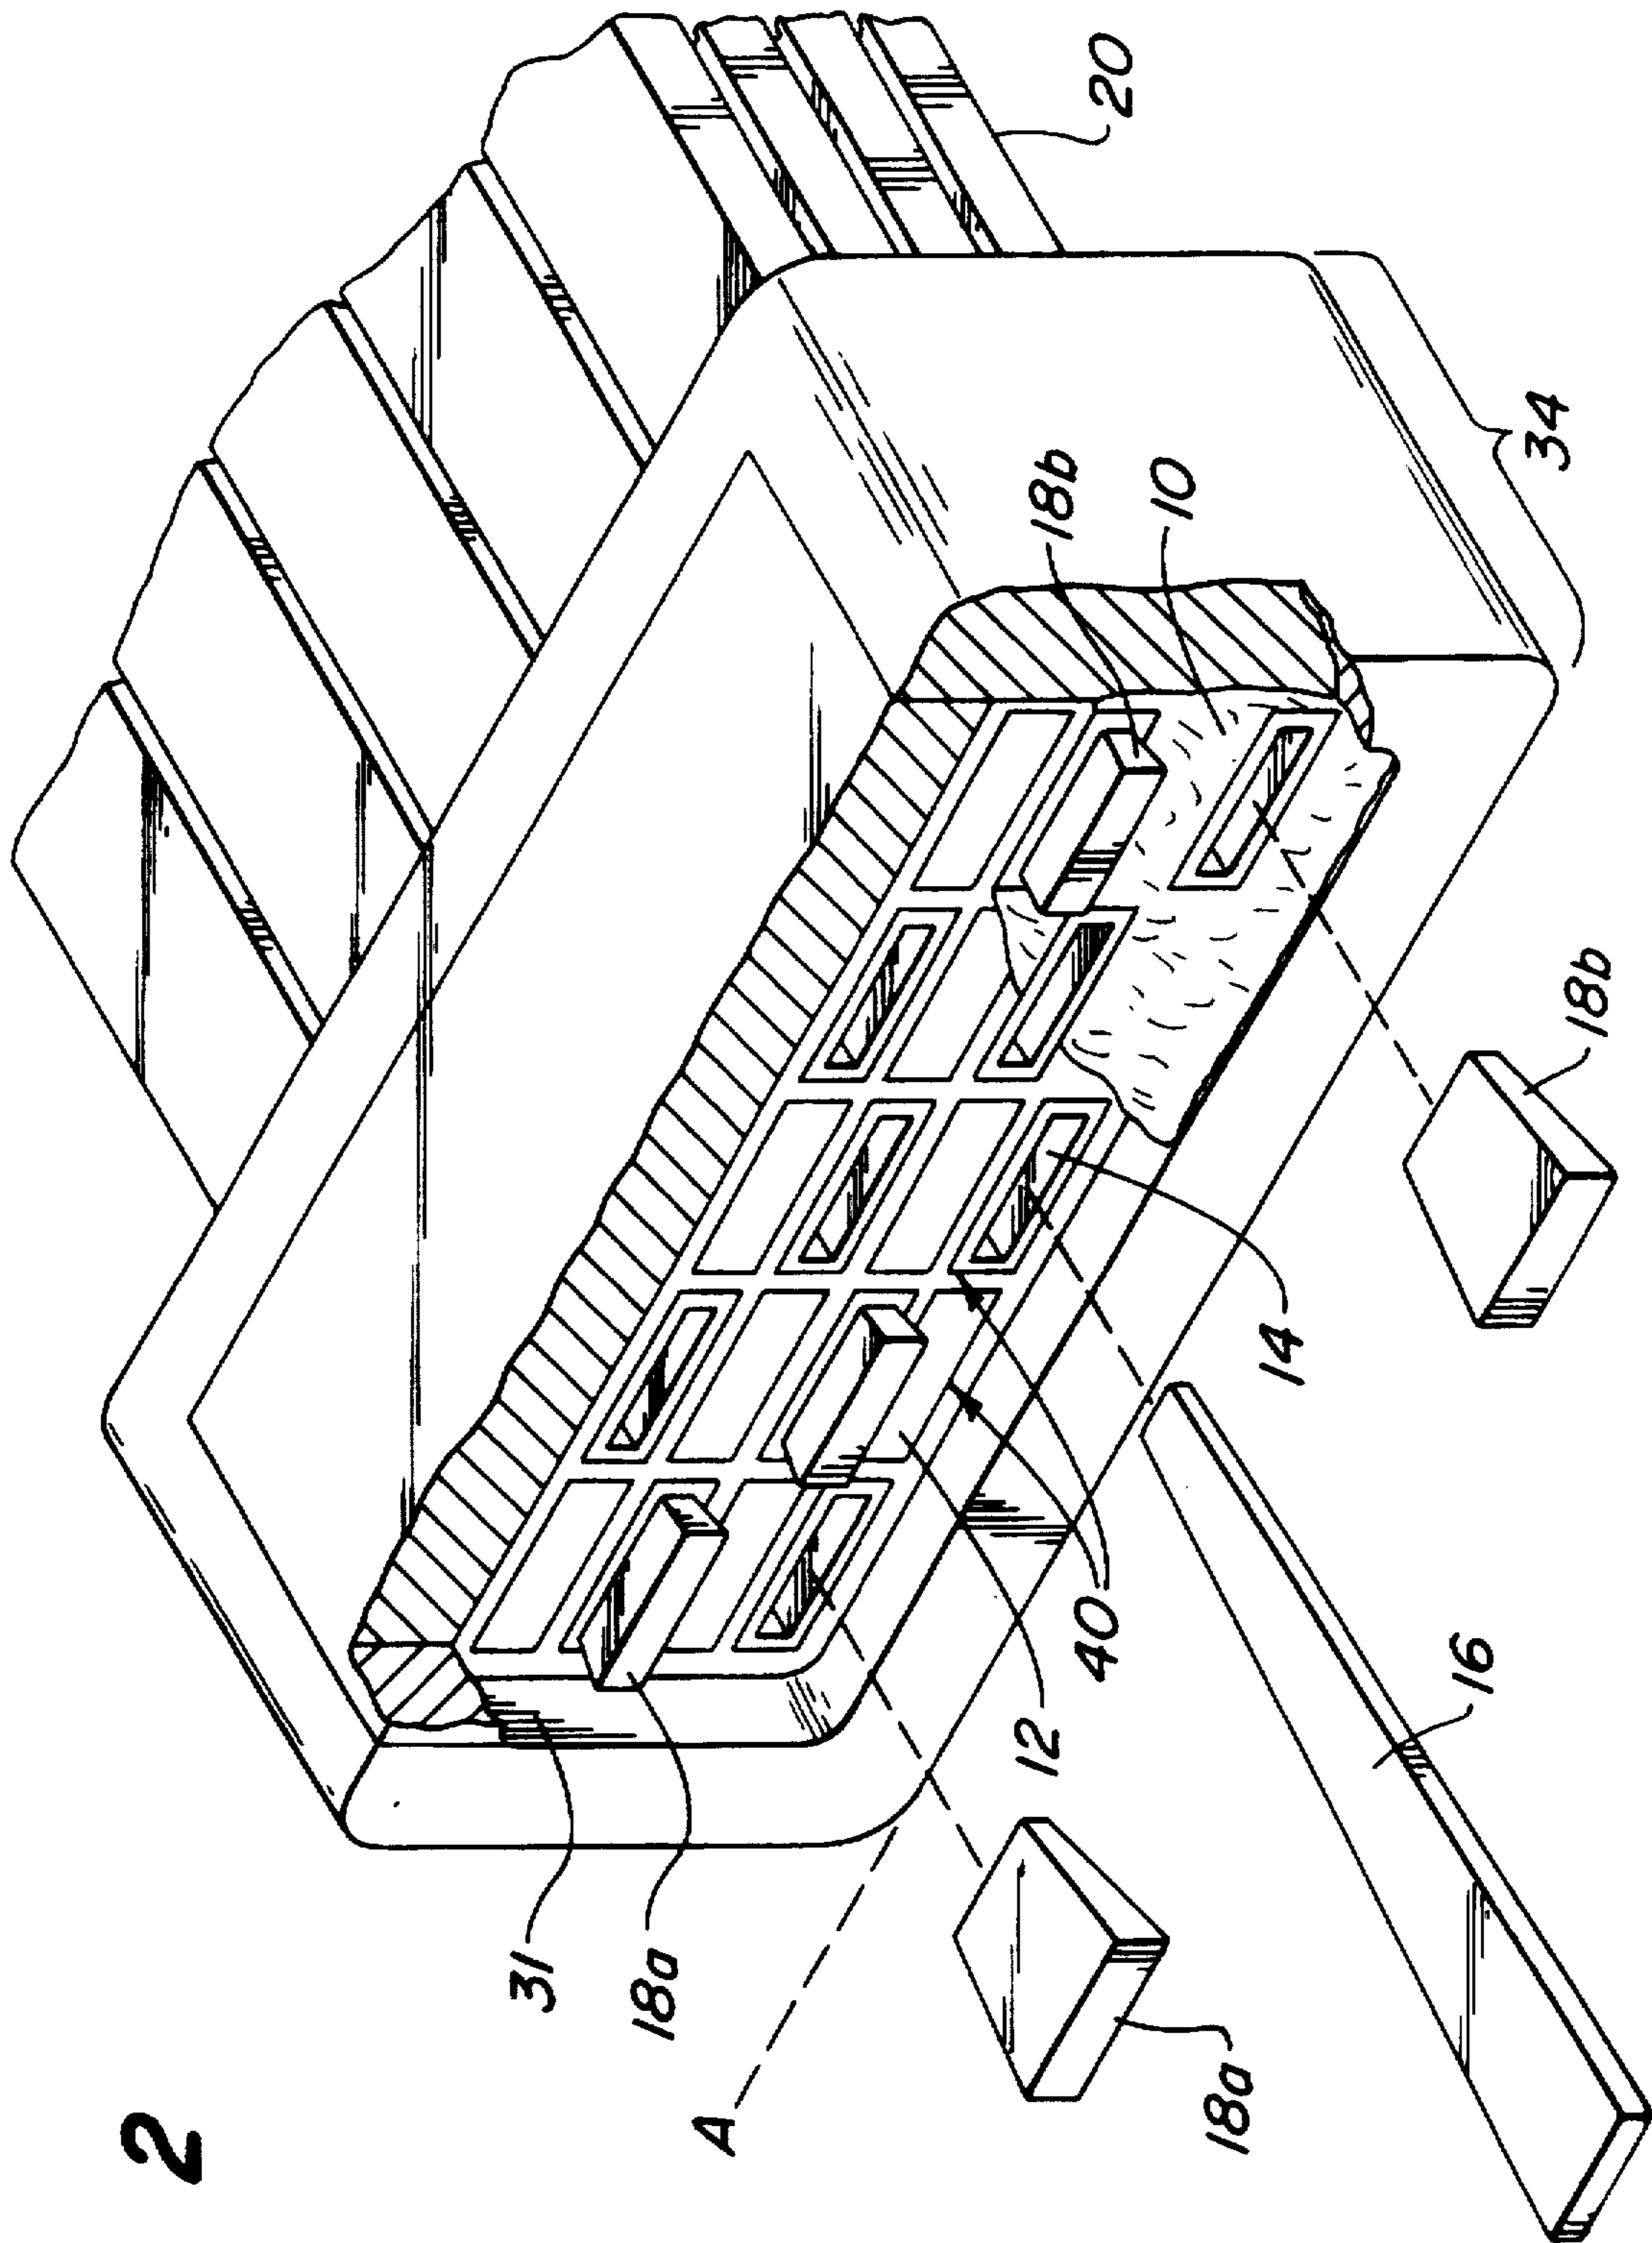
FIG. 2 illustrates a view of the stator coil and a section of the header remaining attached thereto.

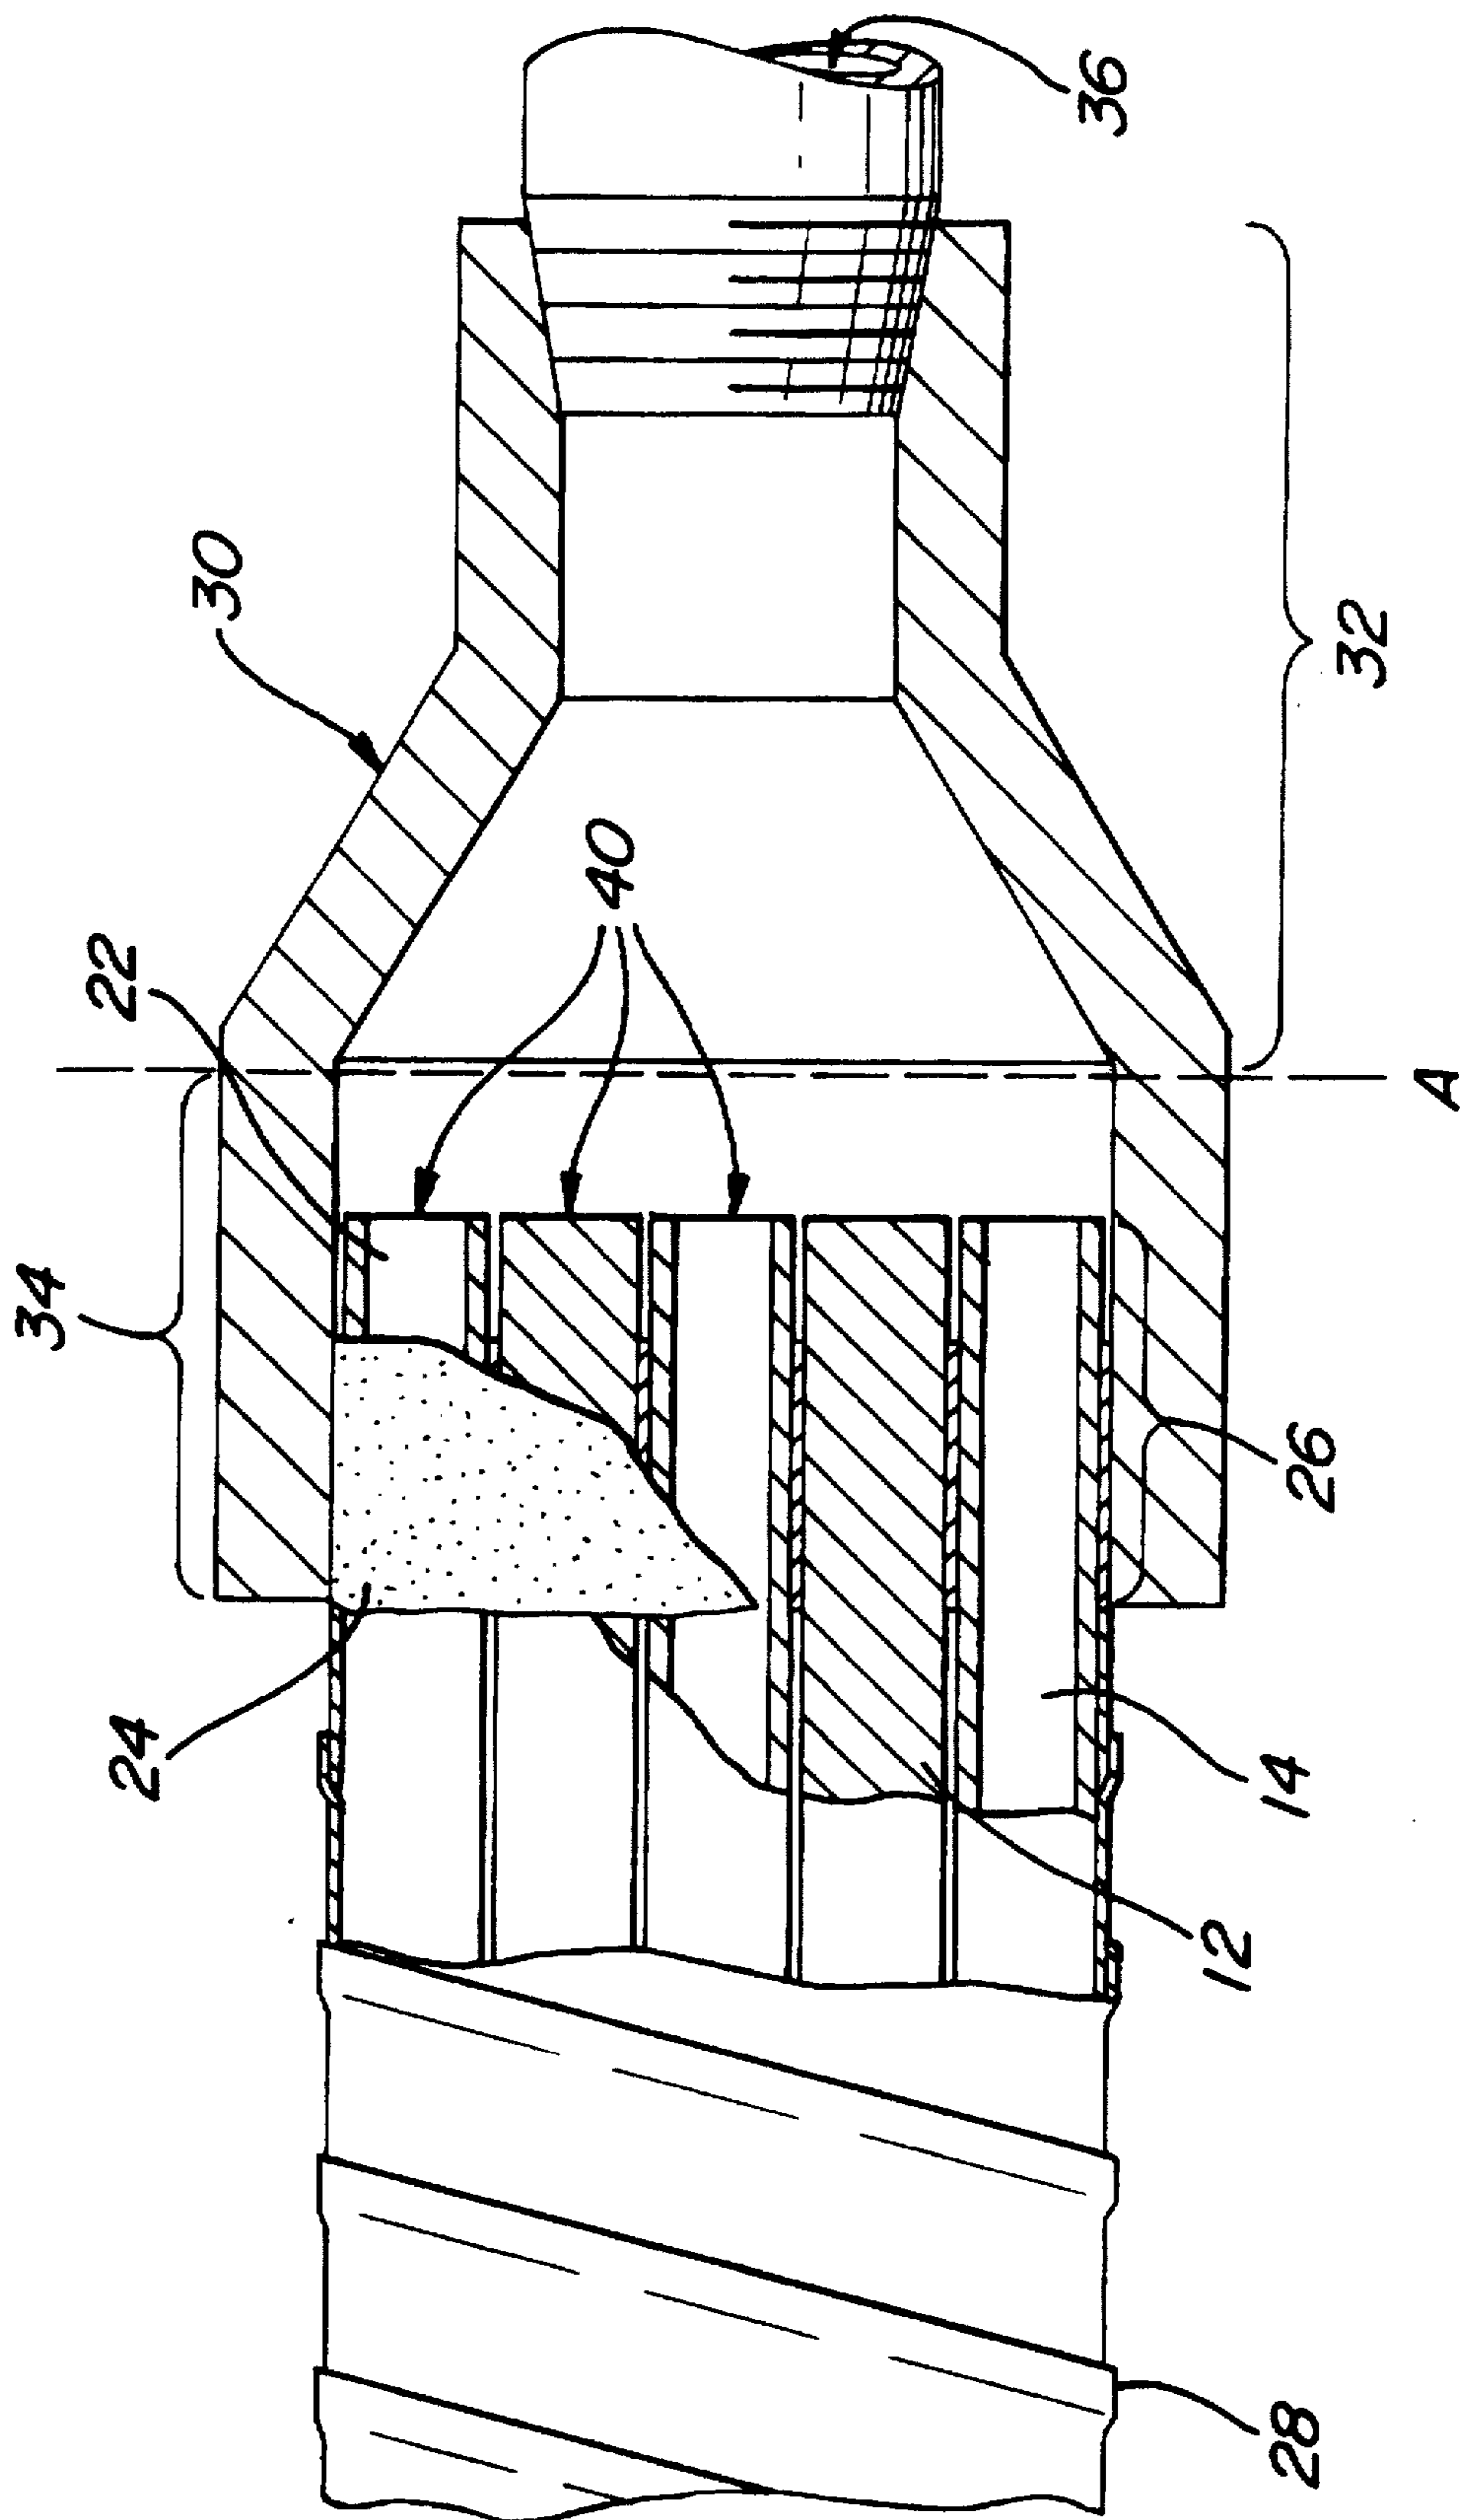
FIG. 3 shows a cross section of the stator coil 20 and header 30 interface taken along the line 3—3 in FIG. 1. As illustrated, only the trailing portion 24 of the lead end 26 is brazed to header 30. The leading portion 22 is not brazed to

FIG. 3 illustrates a side view of the stator coil lead ends inserted into the header.

FIG. 3 shows a cut-away side view of the stator coil 20 and header 30 interface along line 3—3 in FIG. 1. As illustrated, the lead end 26 of the stator coil 20 is inserted into the header 30. No insulation separates the lead ends 26 from the header 30. Importantly, the lead end 26 is further divided between a non-brazed leading portion 22 and a brazed trailing portion 24 portion. The non-brazed leading portion 22 extends deeper into the header 30 and is characterized by voids 40 between the conductor strands 12, 14. As noted above, these voids 40 provide an opportunity for water to mix with the brazing flux, contributing significantly to the origin of water leakage. The disposition of the voids 40 can also be appreciated from the cross-sectional view provided in FIG. 2. As shown, columns and rows of the voids 40 exist between the conductor strands 12, 14 of the stator coil 20. These voids 40 must be sealed to prevent the development of leak-causing acid.
