United States Patent [19]

[54] **METHOD FOR REPAIRING A TURBINE ENGINE MEMBER DAMAGED TIP**

[73] Assignee: **General Electric Company, Cincinnati, Ohio**

METHOD FOR REPAIRING A TURBINE ENGINE MEMBER DAMAGED TIP

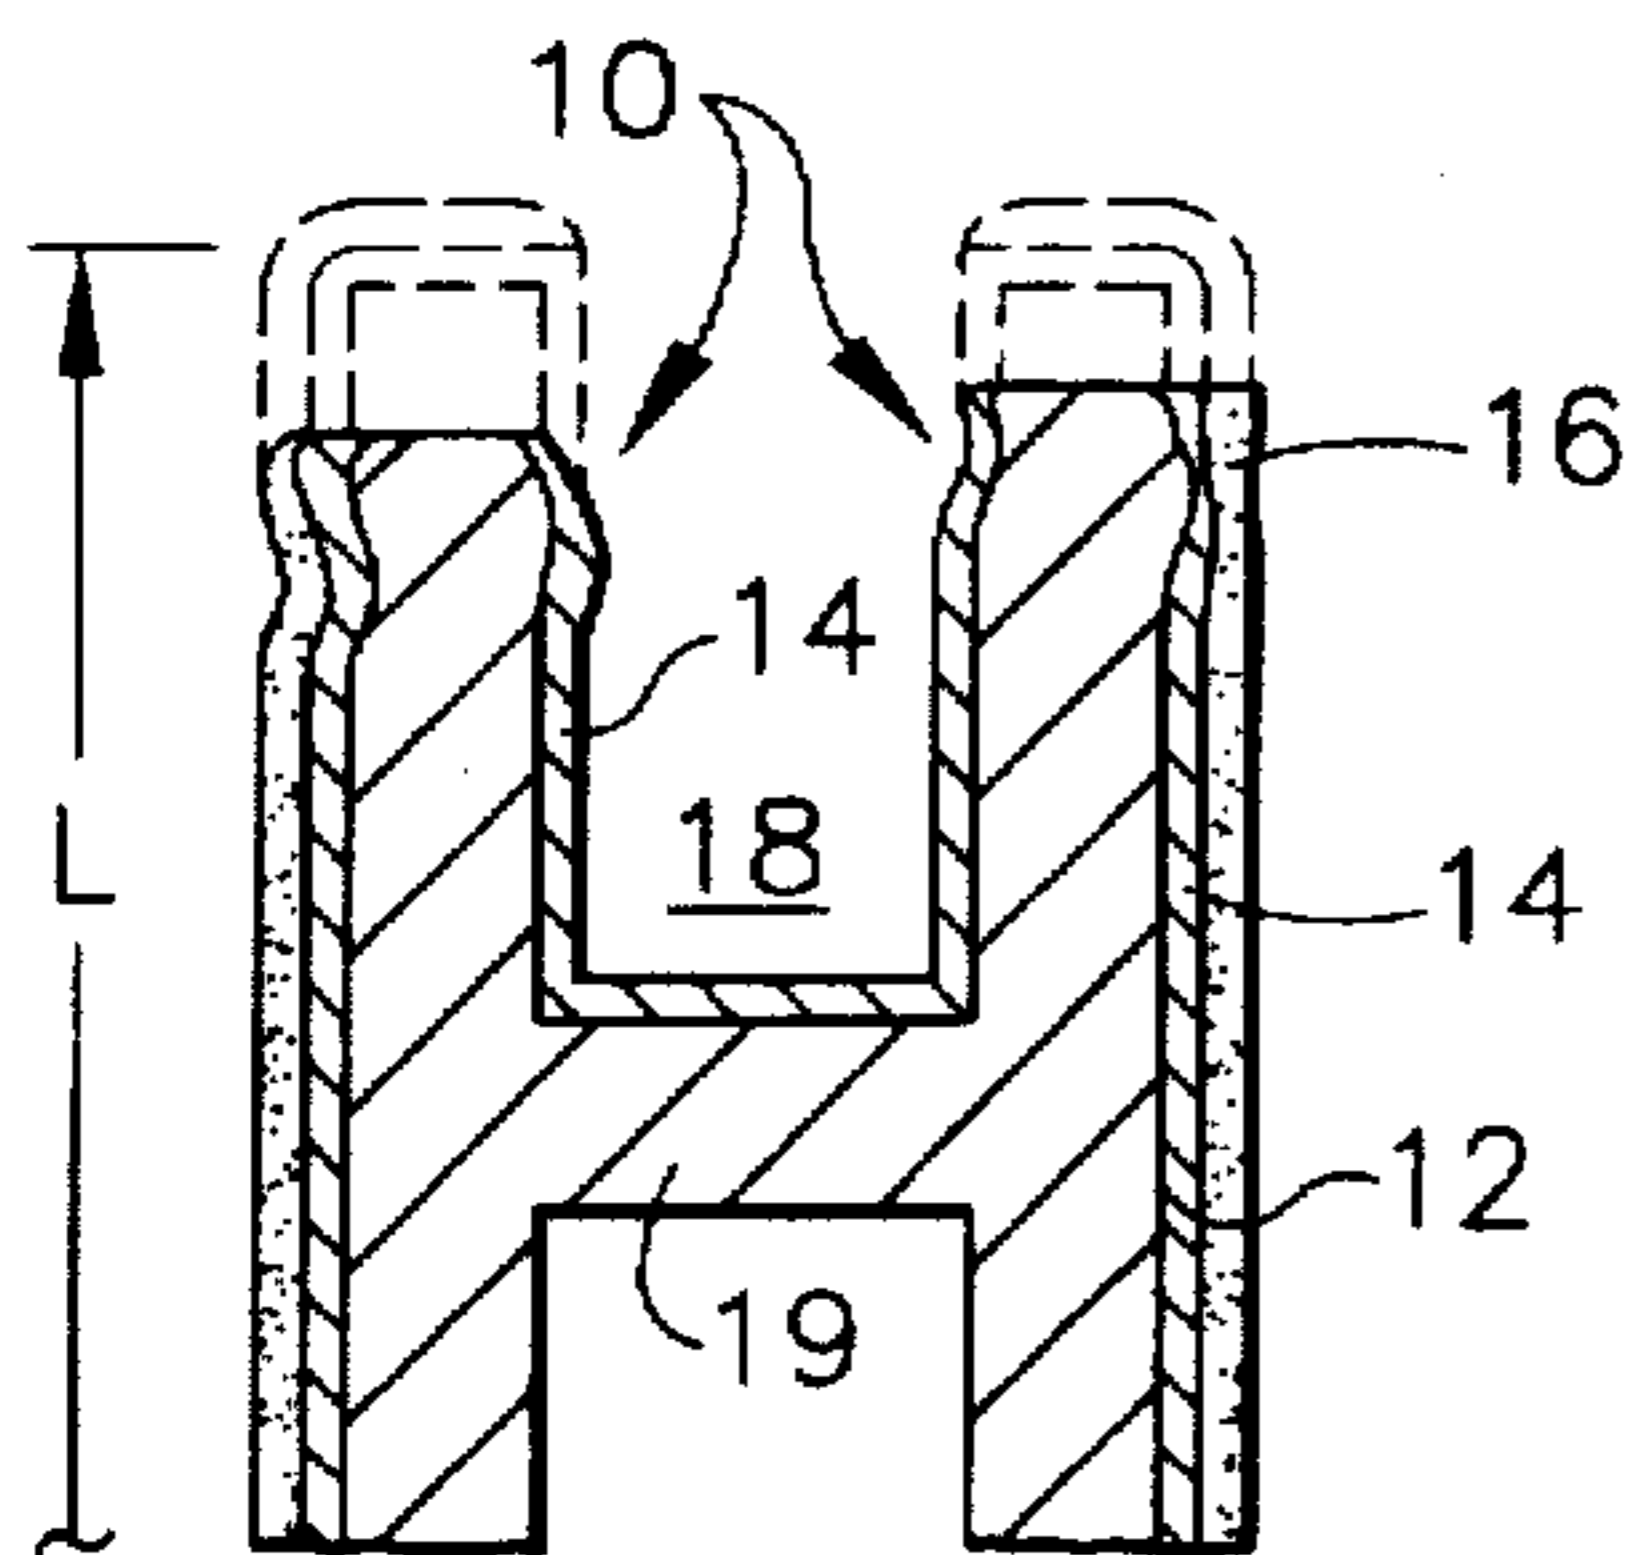
FIG. 1 is a fragmentary sectional view of a coated, damaged blade tip having a hollow interior or recess at the tip.

Current established repair of the damaged, environmentally coated tip of an air cooled gas turbine engine high temperature operating turbine blade, for example of the type shown in the fragmentary sectional view of FIG. 1, requires removal of the coating not only from the damaged tip but also from the blade surface adjacent the tip to be repaired. Generally the blade tip is damaged to the point at which the blade is considered unserviceable, the tip being worn, abraded, oxidized, etc. away to a length significantly less than the length to which it was designed, herein call the designed length. Such wear frequently is uneven, including for example of uneven length between the concave and convex sides of the blade. Such a typical condition is shown in FIG. 1 in which the original condition and designed length of the blade is shown in phantom. After coating removal according to current practice, the condition of the blade is shown in the diagrammatic sectional view of FIG. 2. This coating removal results in additional effort and expense, and, in addition, can result in a reduction in blade operating life due to the removal of parent or substrate material and thinning of cavity walls and edges. The present invention simplifies such a repair by providing a method which does

The invention will be more clearly understood by reference to the drawings and in connection with the specific examples presented below. The embodiment of FIG. 1 depicts the tip of a hollow, air cooled turbine blade generally of the type shown in the above-identified Zelahy U.S. Pat. No. 4,214,355, with a damaged tip shown generally at 10 and a substantially radially extending designed length L. For example, designed length L can be measured from a point on the root or dovetail of the blade, not shown, to establish the blade's relative radial position in the engine. In connection with the blade shown in the drawings, the designed length L was measured from a blade dovetail serration. The blade includes an outer wall 12, defining a blade hollow interior, and a tip inner wall 13, defining an open recess 18. Included on outer wall 12 of the tip is a complex environmental resistant coating combination including a first coating 14 of an aluminide, such as the above describe Codep aluminide coating, bonded at the surface of outer wall 12. Bonded over coating 14 at outer wall 12 is a ceramic type second coating 16 of the above described TBC type. The first coating 14 extends into the recess 18 of tip 10 for protection of that portion of the blade tip.

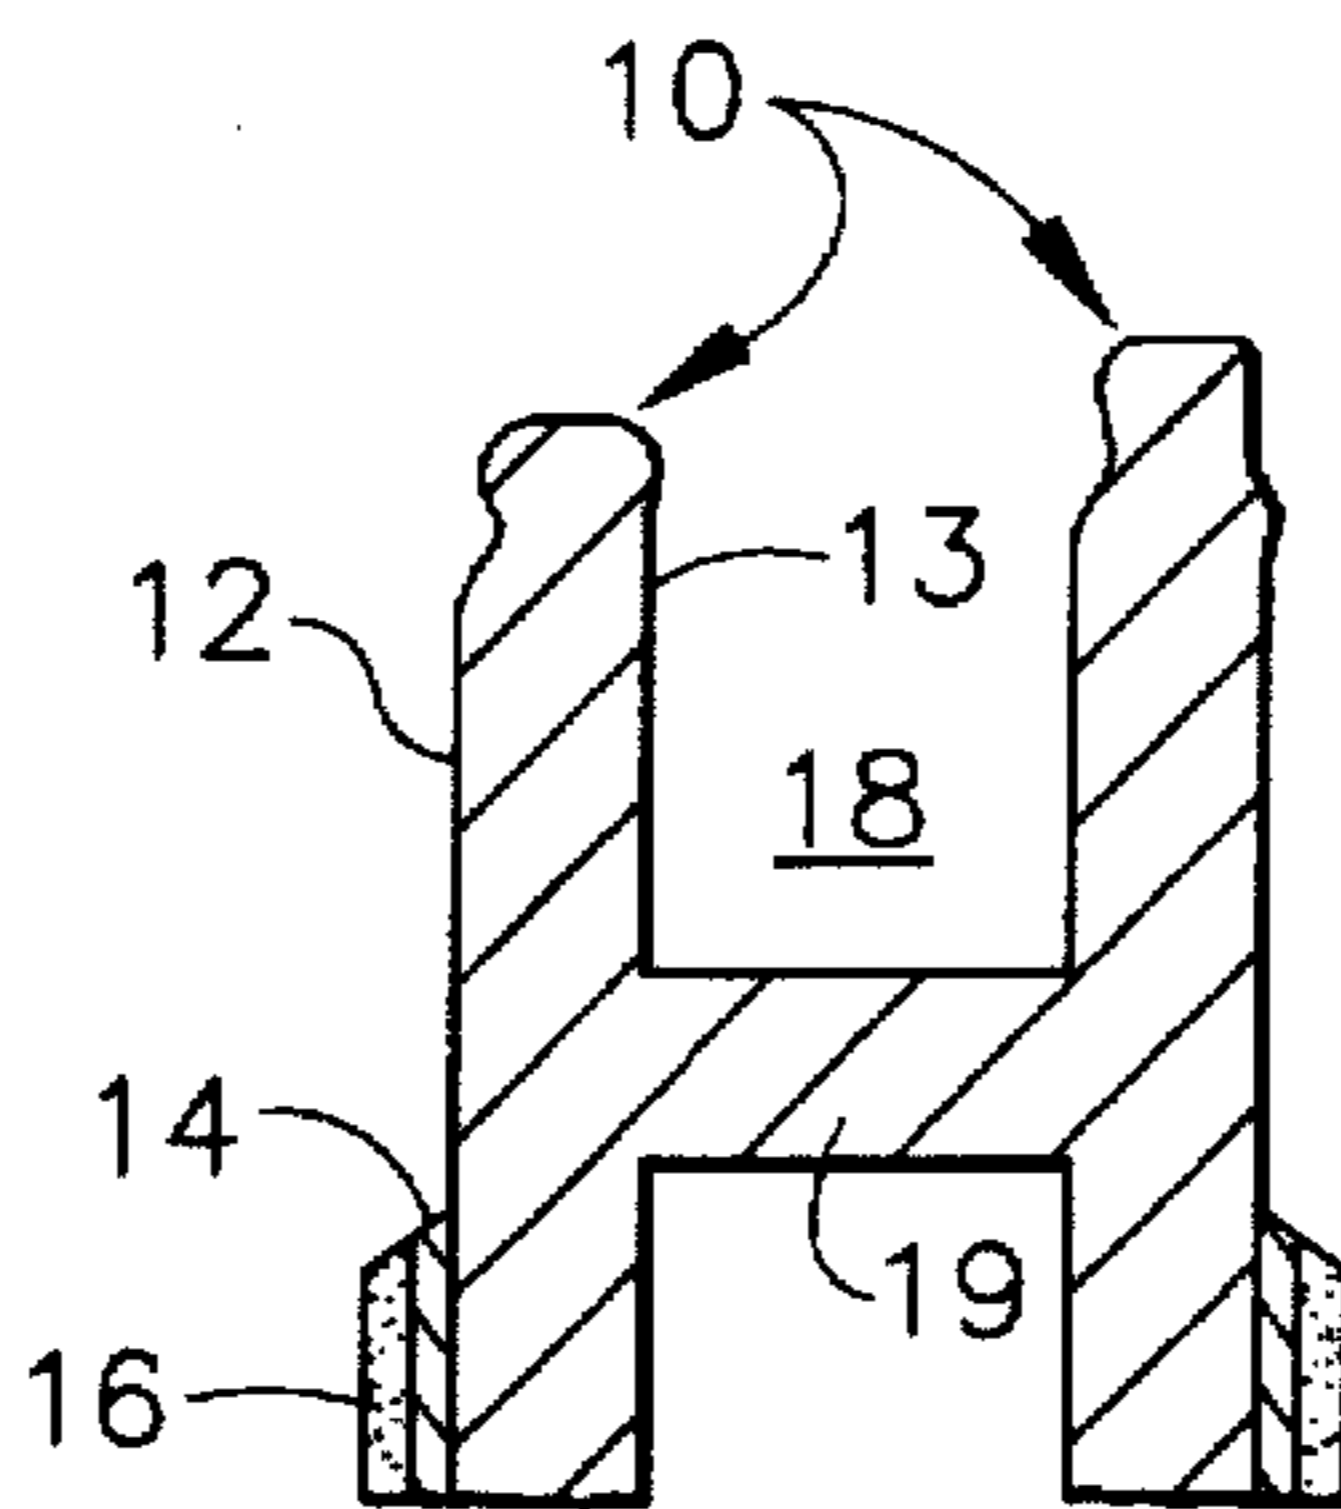
FIG. 2

FIGS. 2 through 6 are a diagrammatic sequence of steps showing one current practiced method for repairing the damaged blade tip of FIG. 1.

A currently established repair method for damaged blade tip 10 is shown in the diagrammatic sequence of FIGS. 2 through 6. In FIG. 2, the coating combination is removed, such as by grit blasting, mechanical blending, etc., from the damaged blade tip as well as from the outer wall 12 adjacent the damaged tip and from within recess 18. The damaged tip 10 is removed, as in FIG. 3, and a preform replacement tip material 20 is bonded, such as by a series of welding steps, to the wall, as shown in FIG. 4. Thereafter, preform replacement tip material 20 is shaped, such as by machining, grinding, etc., to provide a replacement tip 22, FIG. 5, which must then be recoated at least with the environmental coating 14. This then provides the blade with a repaired tip as shown in FIG. 6. As was mentioned above, this known method involves the costly and time consuming steps of first stripping the environmental coating not only from the damaged tip but also from outer walls adjacent the damaged tip, and coating from within the tip recess 18 which is not in need of repair. In addition, such stripping can result in removal and thinning of the outer wall and edges, particularly of the blade outer wall radially inward from tip shelf 19, thereby reducing the potential operating life of the blade. Also, such thinning jeopardizes the possibility of subsequent blade tip repairs after later engine operation.

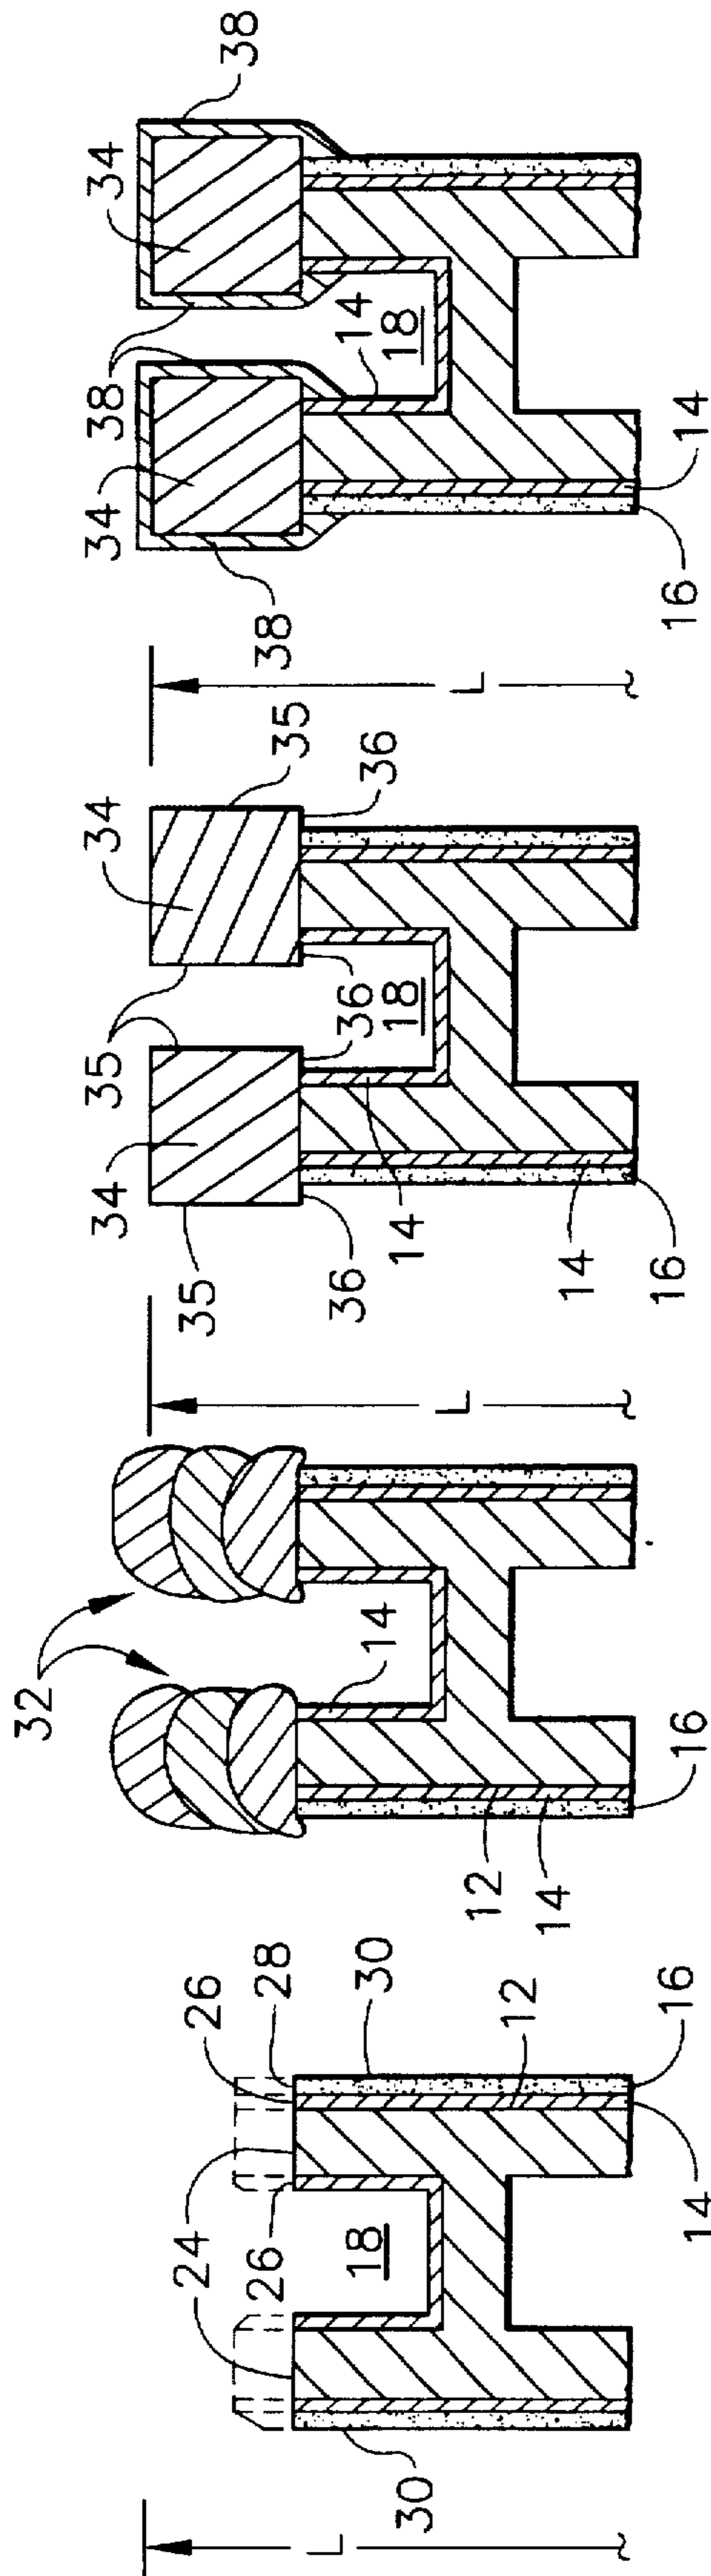
FIG. 7 FIG. 8 FIG. 9 FIG. 10

FIGS. 7 through 9 are a diagrammatic sequence of steps showing the present invention for repairing the damaged blade tip of FIG. 1.

FIG. 10 is a fragmentary sectional view of the blade tip repaired according to the present invention and coated with an additional coating at least to the original environmental coating.

Reference to the sequence of FIGS. 7 through 9 shows one form of the present invention to repair the damaged tip 10 of the coated blade of FIG. 1. Instead of first removing the coating as in FIG. 2, the damaged tip 10 shown in phantom in FIG. 7, including any of its adhering coating, was removed, as shown in FIG. 7, for example as by grinding, machining, etc., to provide a preform end surface 24 which includes edges 26 and 28, respectively, of the complex outer coating 14, 16, as well as the edge 26 of coating 14 in open recess 18. The coating was retained on walls adjacent the damaged tip as shown in FIG. 7.

As shown in FIG. 8, a replacement tip material 32 was bonded by fusion welding in a series of welding steps onto preform end surface 24, including overhanging the coating edges 26 and 28. This provided the repaired member preform shown in FIG. 8 having a second length greater than designed length L, as shown in that Figure. Then a portion of replacement tip material 32 was removed, such as by grinding, machining, etc., as shown in FIG. 9, to provide the blade member with a repaired member tip 34 of substantially the designed length L, while retaining coating 14, 16 on the outer wall adjacent the repaired member tip and coating 14 on the wall of recess 18. In the embodiment shown in FIG. 9, the portion of replacement tip material 32 was removed in a manner which provided a positive step 36 between replacement tip 34 and the coatings: 16 on the outer wall and 14 on the wall of recess 18. This was done to assure no wall thinning or damage to the surface of such adjacent coatings 14 and 16 and for use in avoiding wall thinning in any necessary subsequent repairs after engine operation of the repaired tip.
