United States Patent [19]

[11] Patent Number: **5,828,969**

[54] **PROCESS FOR USE WITH AIRCRAFT REPAIRS**

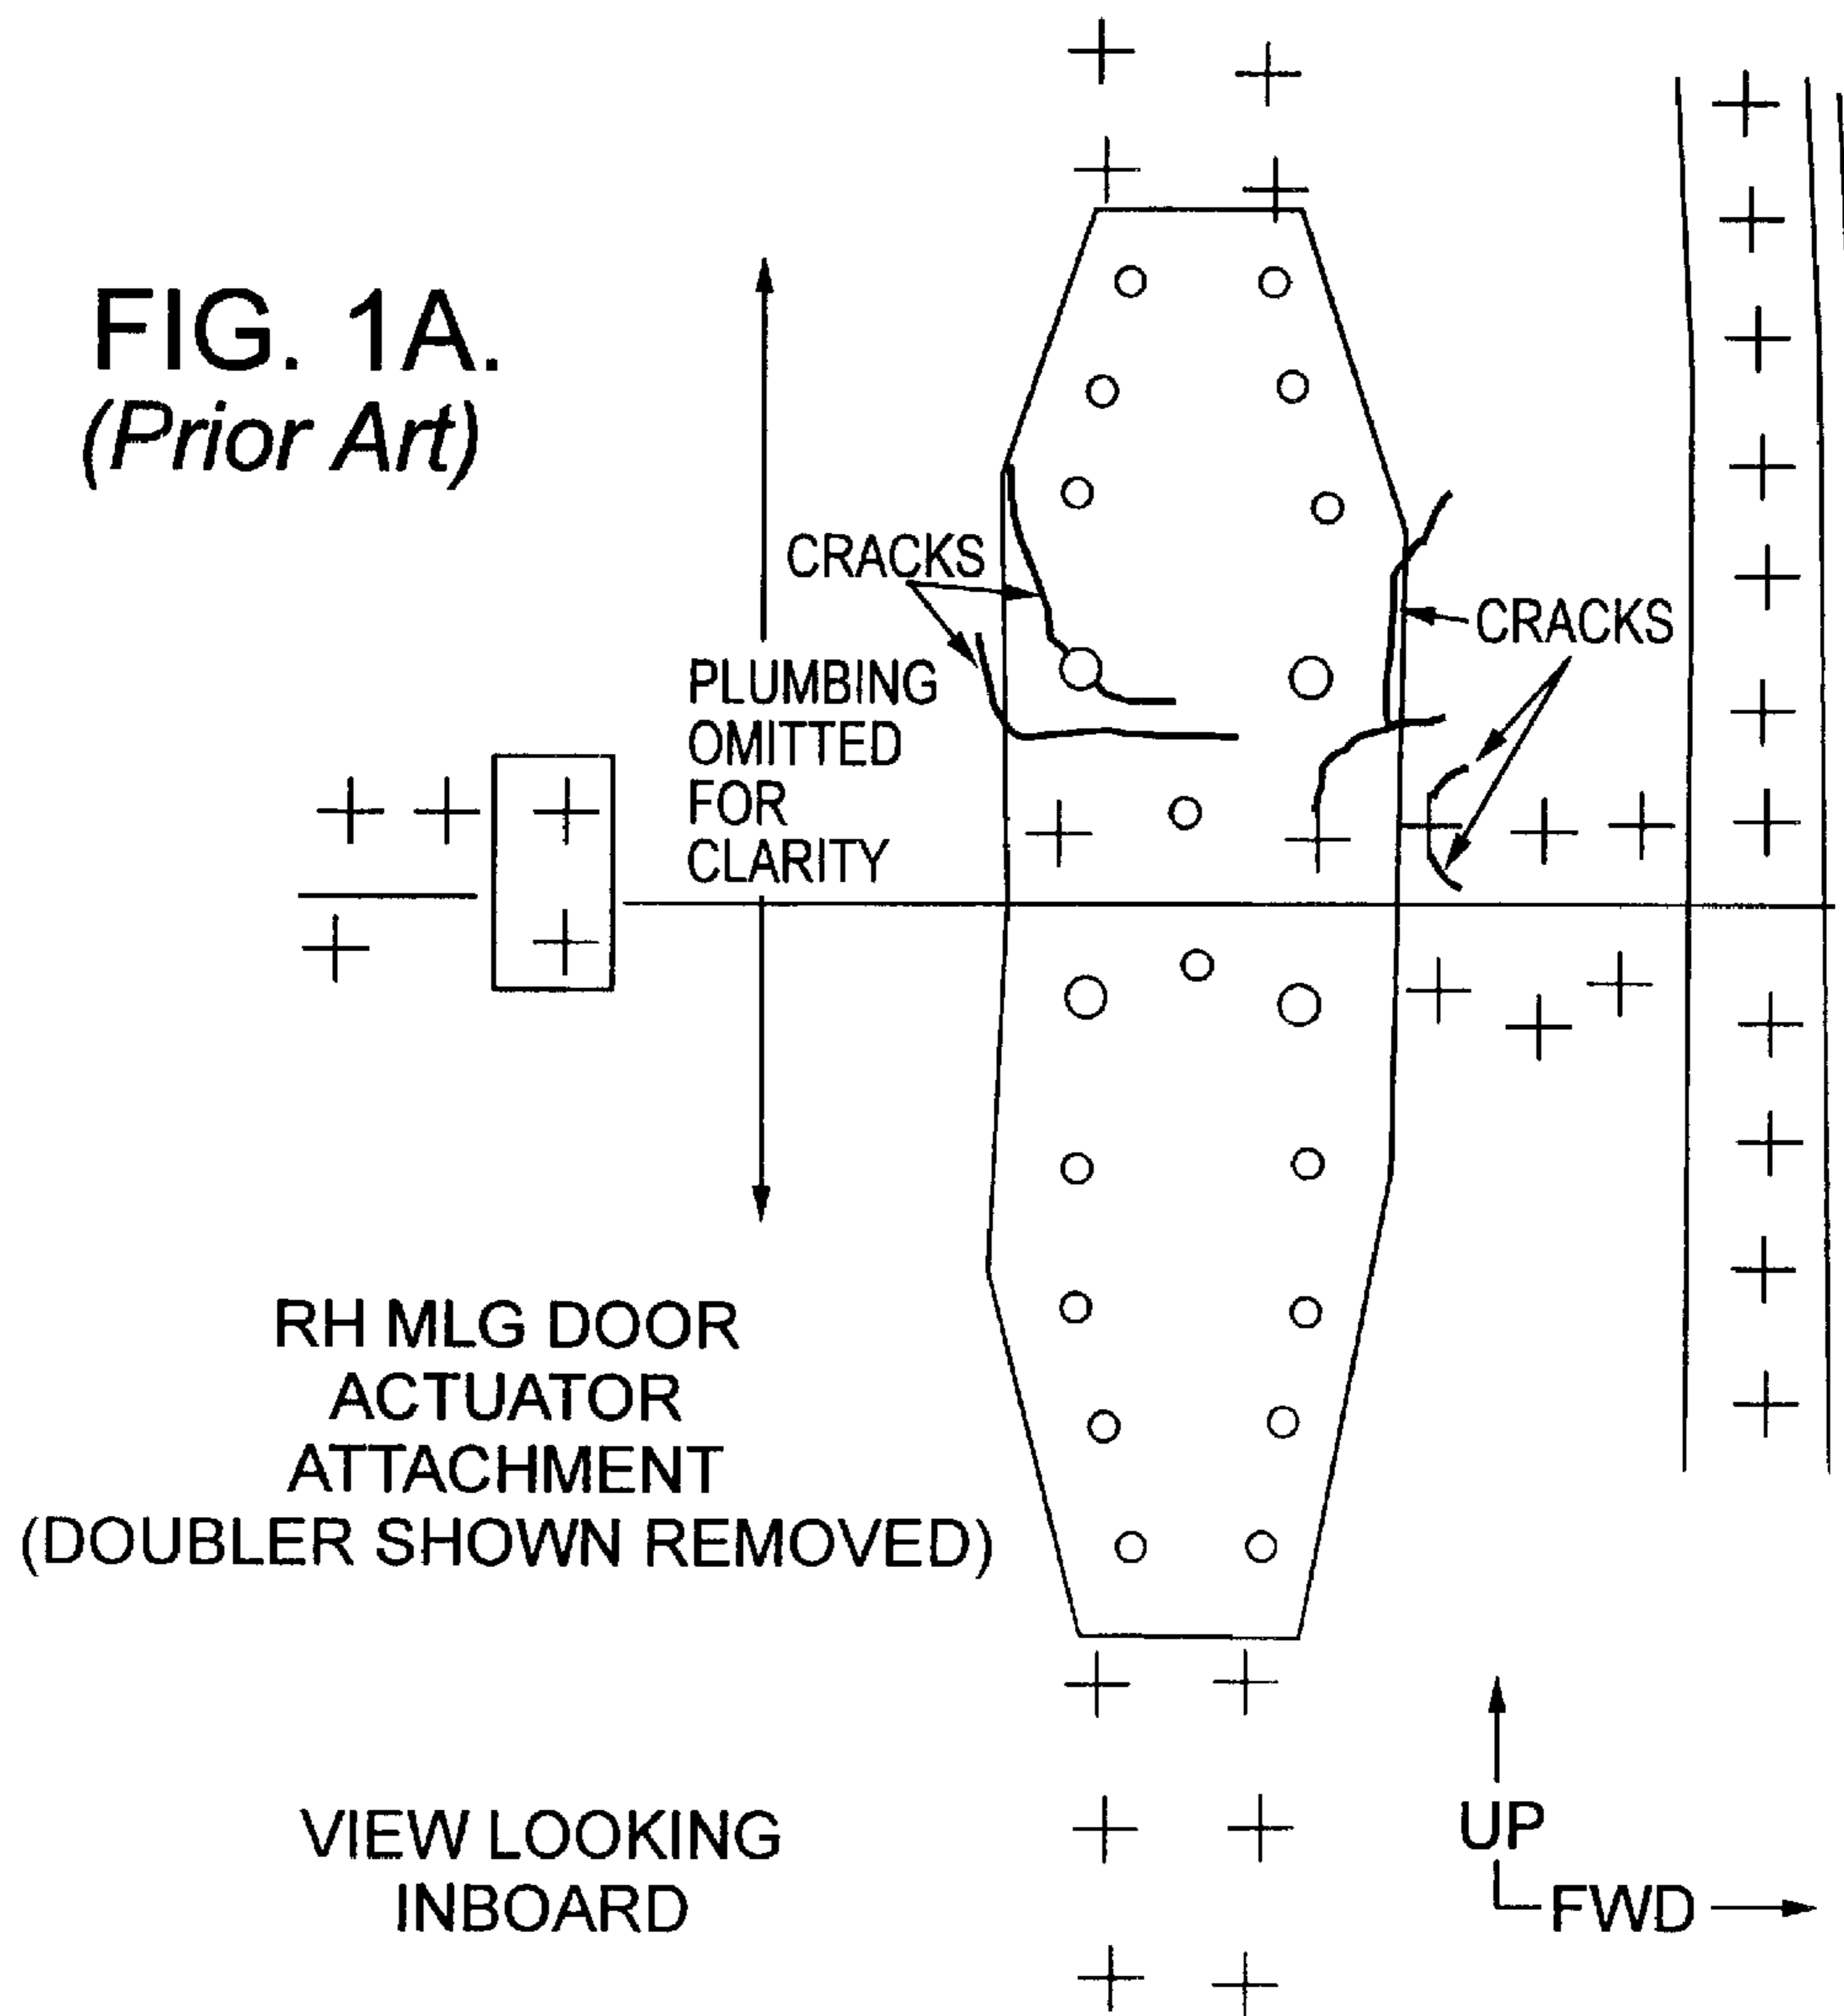
FIG. 1B.
(Prior Art)

Comments on Sketch:

Re: RH MLG Bay, Inboard Wall - cracks at MLG door fwd. actuator, upper attachment.

There has been similar damage to this a/c as on a/c s/n XXXXX, your ref. YYYYY. However, XXXXX has damage to the skin as indicated in the sketch. We will be ordering "T"-section p/n a30956-049 as it is badly cracked at the upper end. The plate as mentioned in (3.) of your fax, is "oil canned" a bit, but we will see how it "releases" when drilled off. Anyway, what we REALLY NEED is a repair for the skin cracks under the doubler.

FIGS. 1a and 1b represent a sketch, having had descriptive text added, which are typical of the prior art;

The current system for reporting the physical characteristics of component damage and obtaining a repair assessment is presented in FIGS. 1a, 1b and 2. In this case, the maintenance facility of the operator of the aircraft prepared a hand sketch of cracking damage (FIG. 1a) sustained by the structure of an aircraft wheel well. A textual description accompanied the sketch (FIG. 1b). The information was sent by facsimile to the original aircraft manufacturer as an authorized agent. An action report for repair was issued.

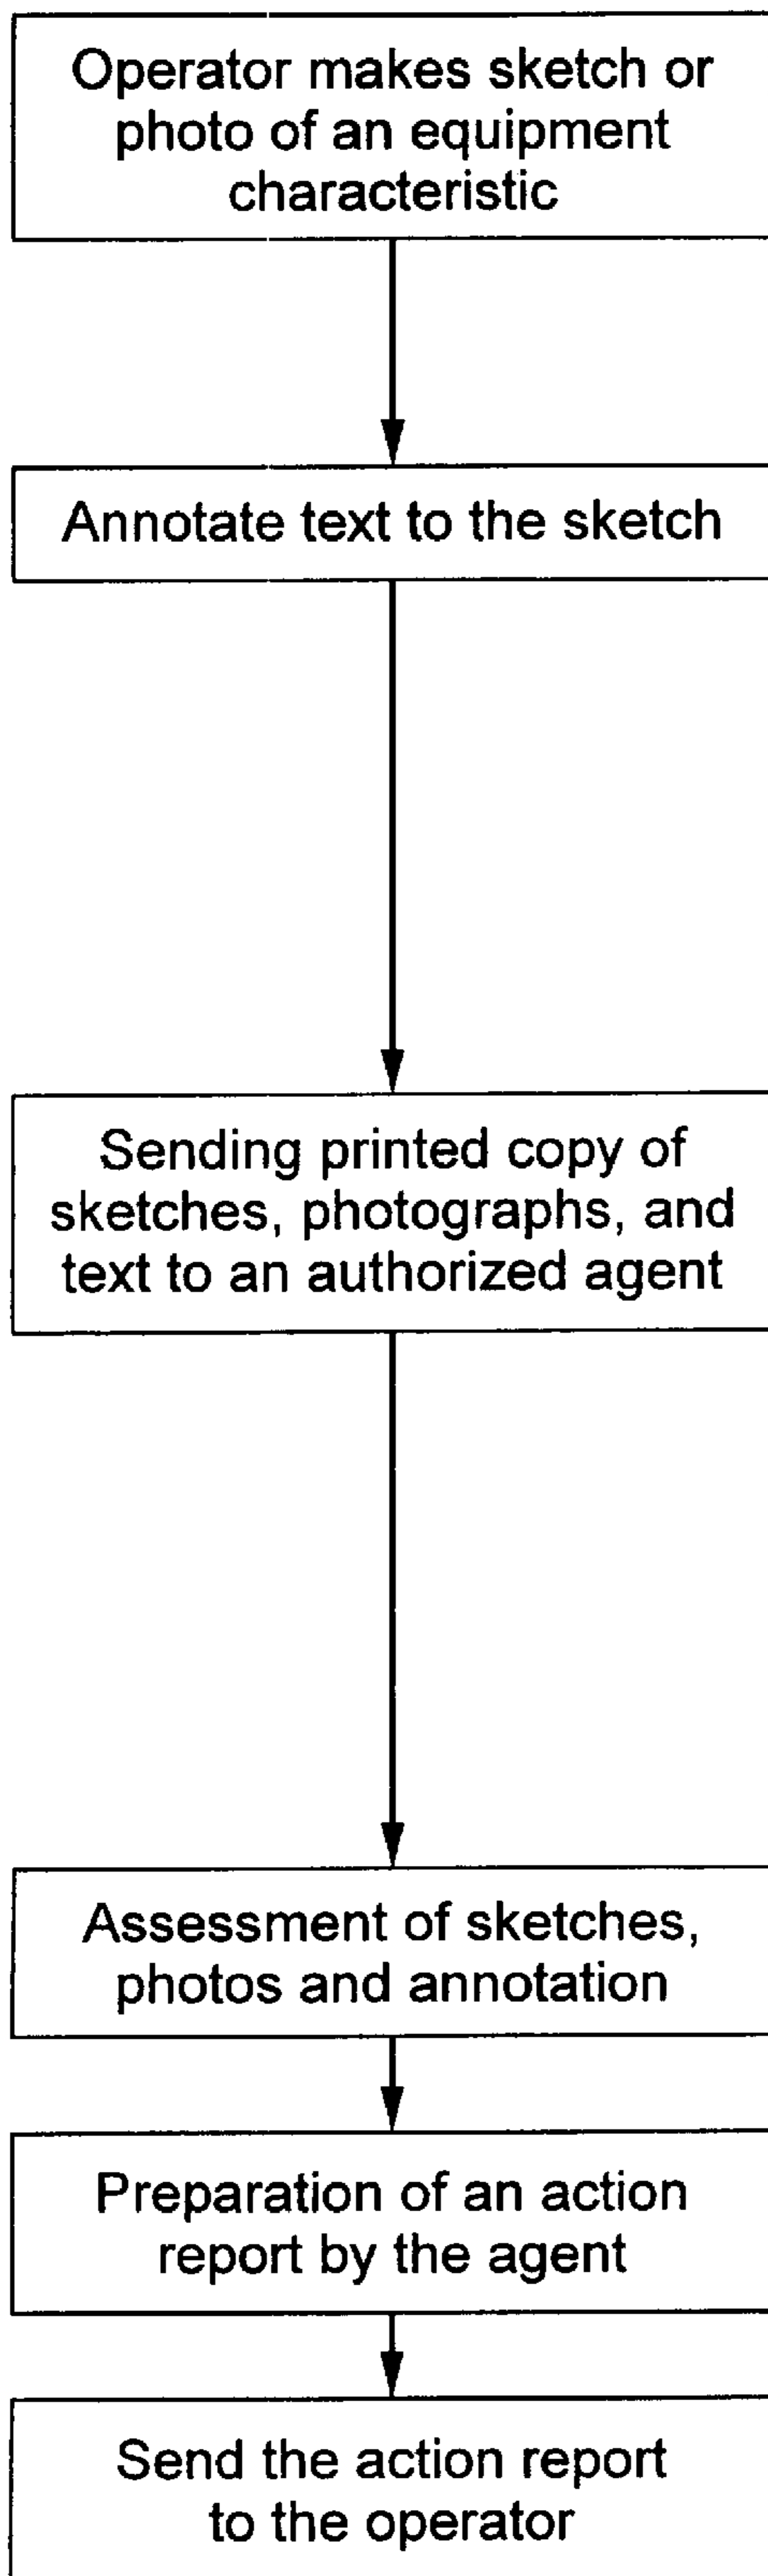
FIG. 2.
(Prior Art)

FIG. 2 is a schematic flow chart depicting the system of the prior art;

In accordance with the prior art system, in assessing the damage, the agent had to rely upon their familiarity with the aircraft, prior experience with this particular failure, and trust that the second-hand information from the operator fully disclosed and identified the damage. This prior art process is represented in the flow chart of FIG. 2. The process comprises:

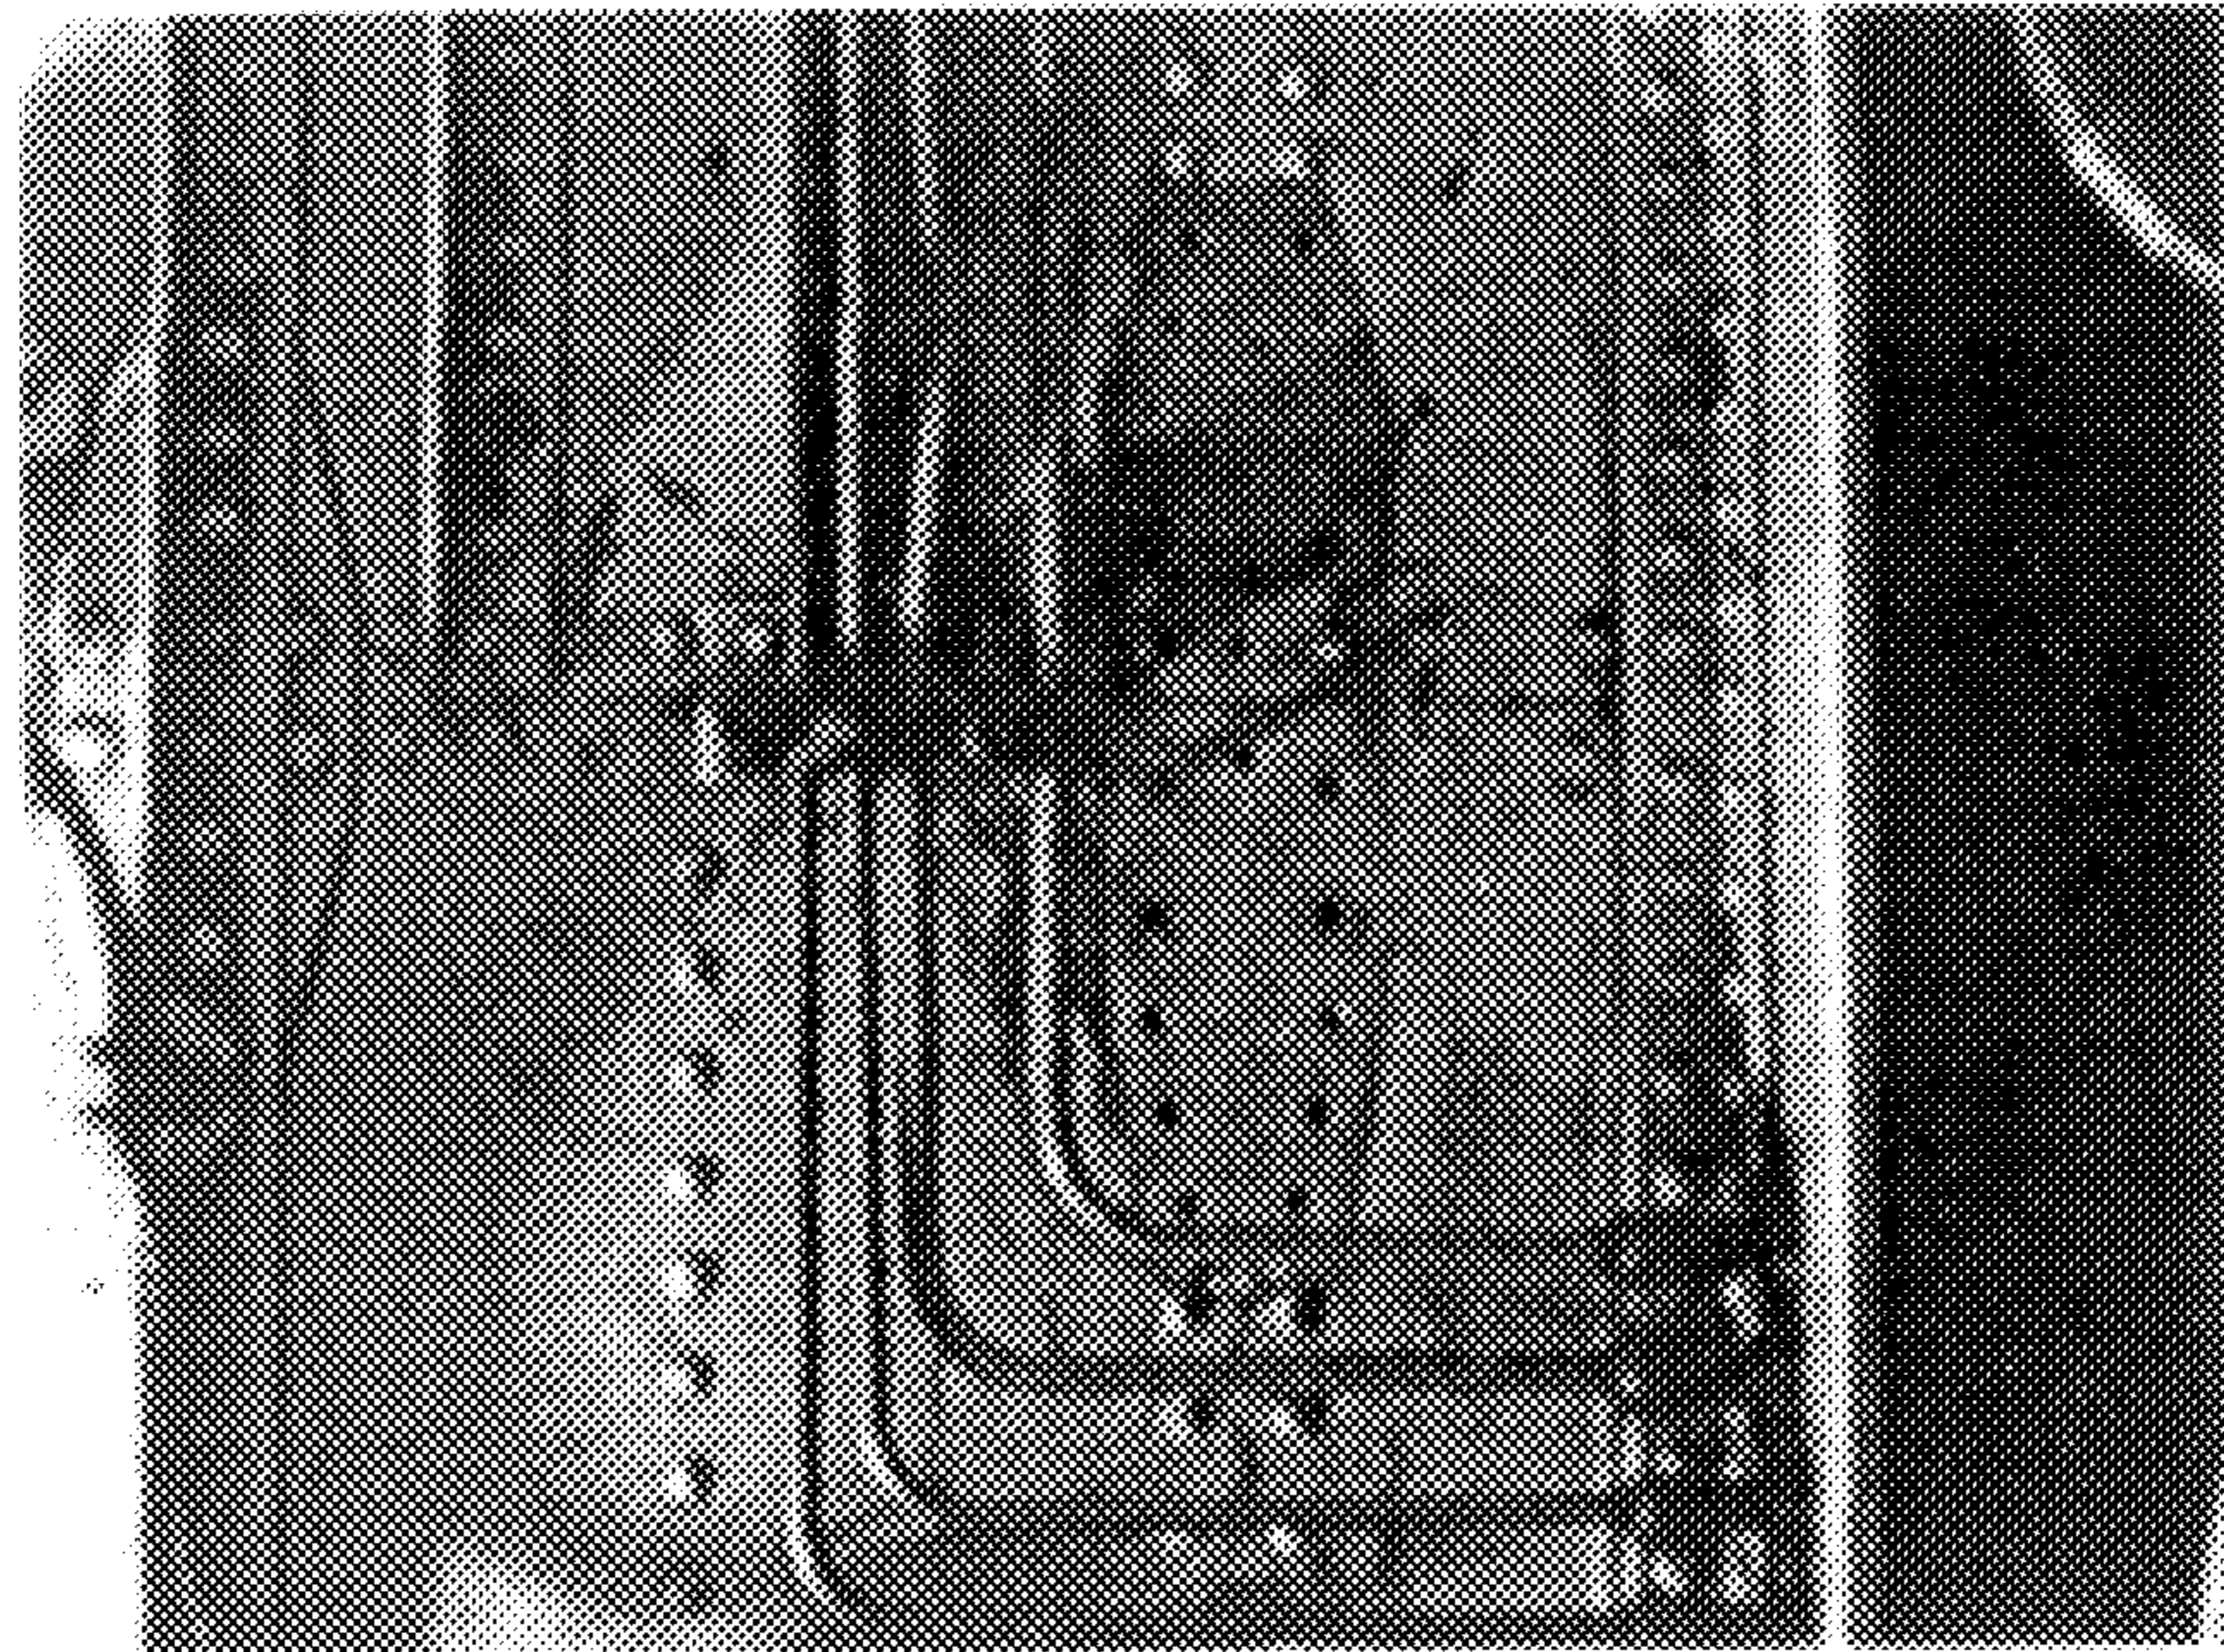
FIG. 4.

FIG. 4 is a line drawing representation of a digital photographic image taken of aircraft fuselage cracking damage;

This comprises obtaining one or more photographic images (FIG. 4) of the damage. The particular physical characteristic of the equipment must be capable of being rendered into a visual form, such as by photograph or X-ray image.

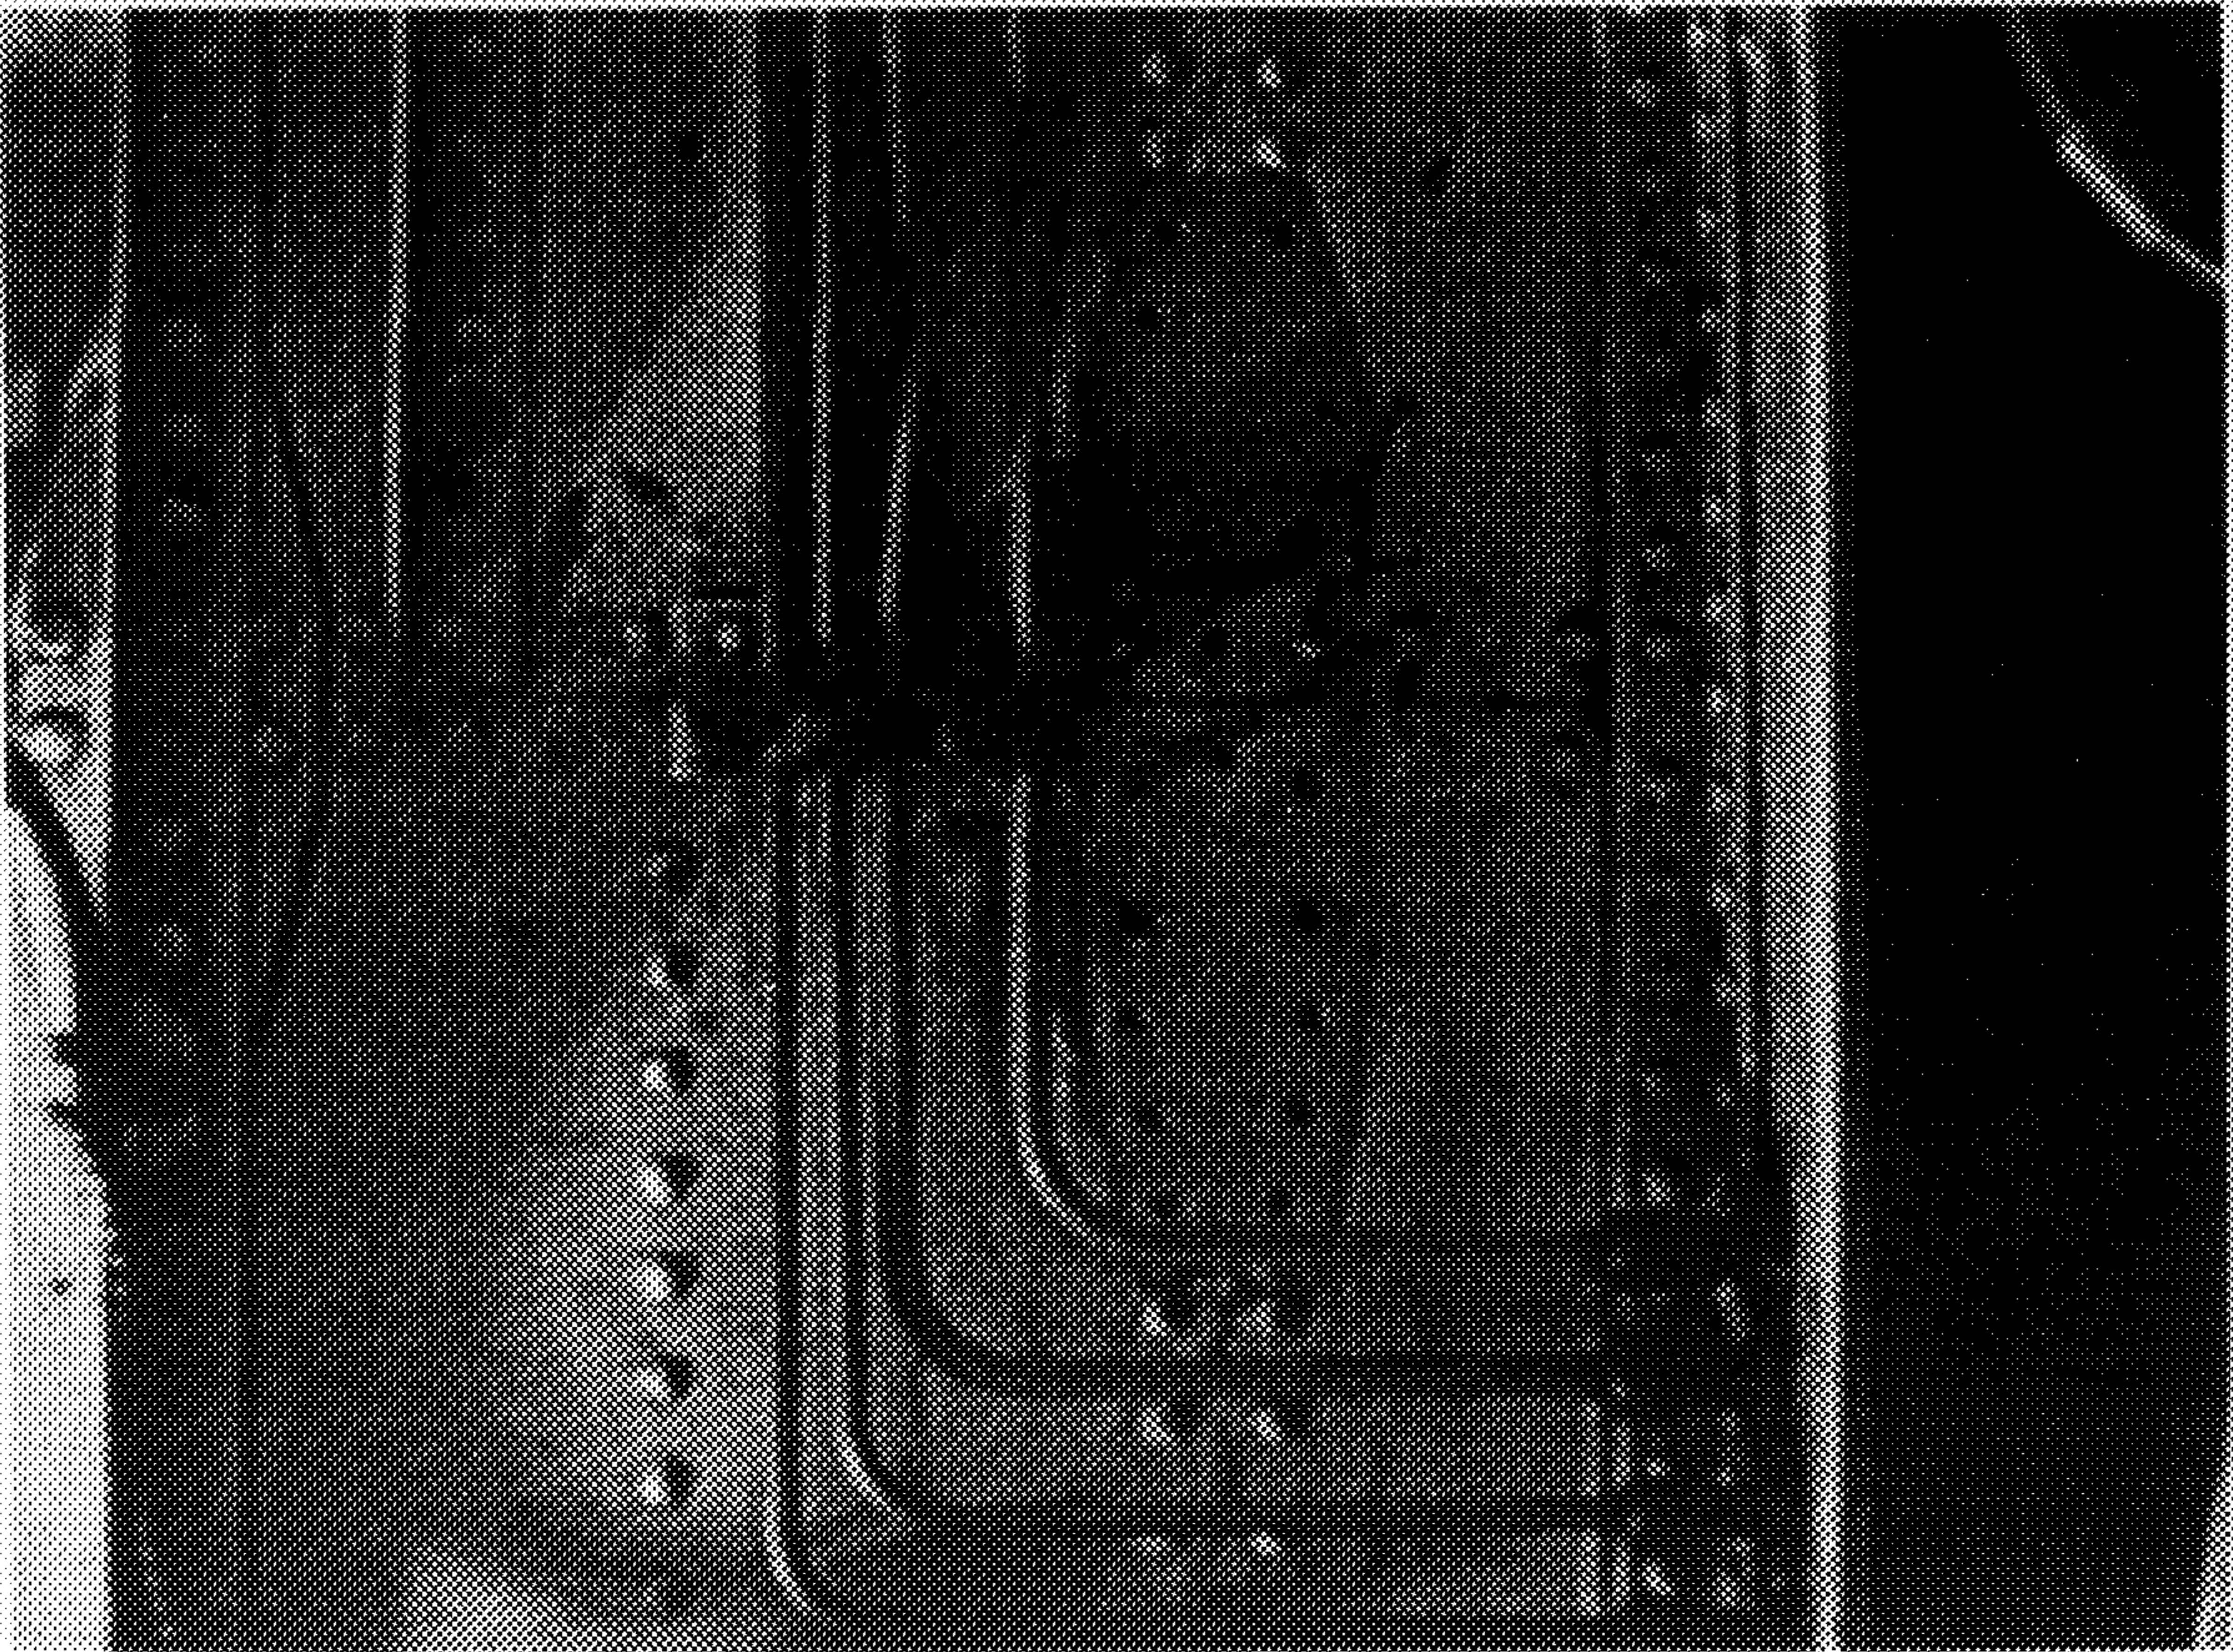
FIG. 5.

Registration C-XXXX	A/C Type F-28 MK 1000
Serial Number XXXX	Total Time 34,228.8
Tail Number	Total Cycles 36,004
<input checked="" type="radio"/> H.M.V.	Date 25 May 95
<input type="radio"/> Line	Time 11:39
<input type="radio"/> Initial	
<input type="radio"/> In Progress	
<input type="radio"/> Completed

Position R/H Inboard Fwd.			
<input type="checkbox"/> L/H	<input type="checkbox"/> Top	<input checked="" type="checkbox"/> Inboard	
<input checked="" type="checkbox"/> R/H	<input type="checkbox"/> Centre	<input type="checkbox"/> Outboard	
<input type="checkbox"/> L/R/H	<input type="checkbox"/> Bottom	<input checked="" type="checkbox"/> Fwd.	
<input type="checkbox"/> Only		<input type="checkbox"/> All	
Frame	Station 12180	Stringer	Rib
W/L	R/L 225 RH	Position #

Comments
 - there has been similar damage to this a/c as on a/c s/n: ZZZZ your ref. YYYYY. However, XXXX has damage to the skin as indicated in the digital image. We will be ordering "T"-section pin a30956-049 as it is badly cracked at the upper end. The plate, as mentioned in (3.) of your fax, is "oil-canned" a bit, but we will see how it "releases" when drilled off. Anyway, what we REALLY NEED is a repair for the skin cracks under the doubler.

FIG. 5 is a printed representation of a database record illustrating both the image according to FIG. 4 and annotated text;

later retrieval (FIG. 5). Textual information may be also superimposed onto the visual image field using specialized image editing computer software such as CORELDraw (CORELDraw v.5 available from Corel Corporation, Ottawa, Ontario). Both text and graphical elements can be superimposed; some of the graphical elements shown on FIG. 5 include linear lines (as UP and DoF axes), and curved lines (highlighting the path of the cracks).

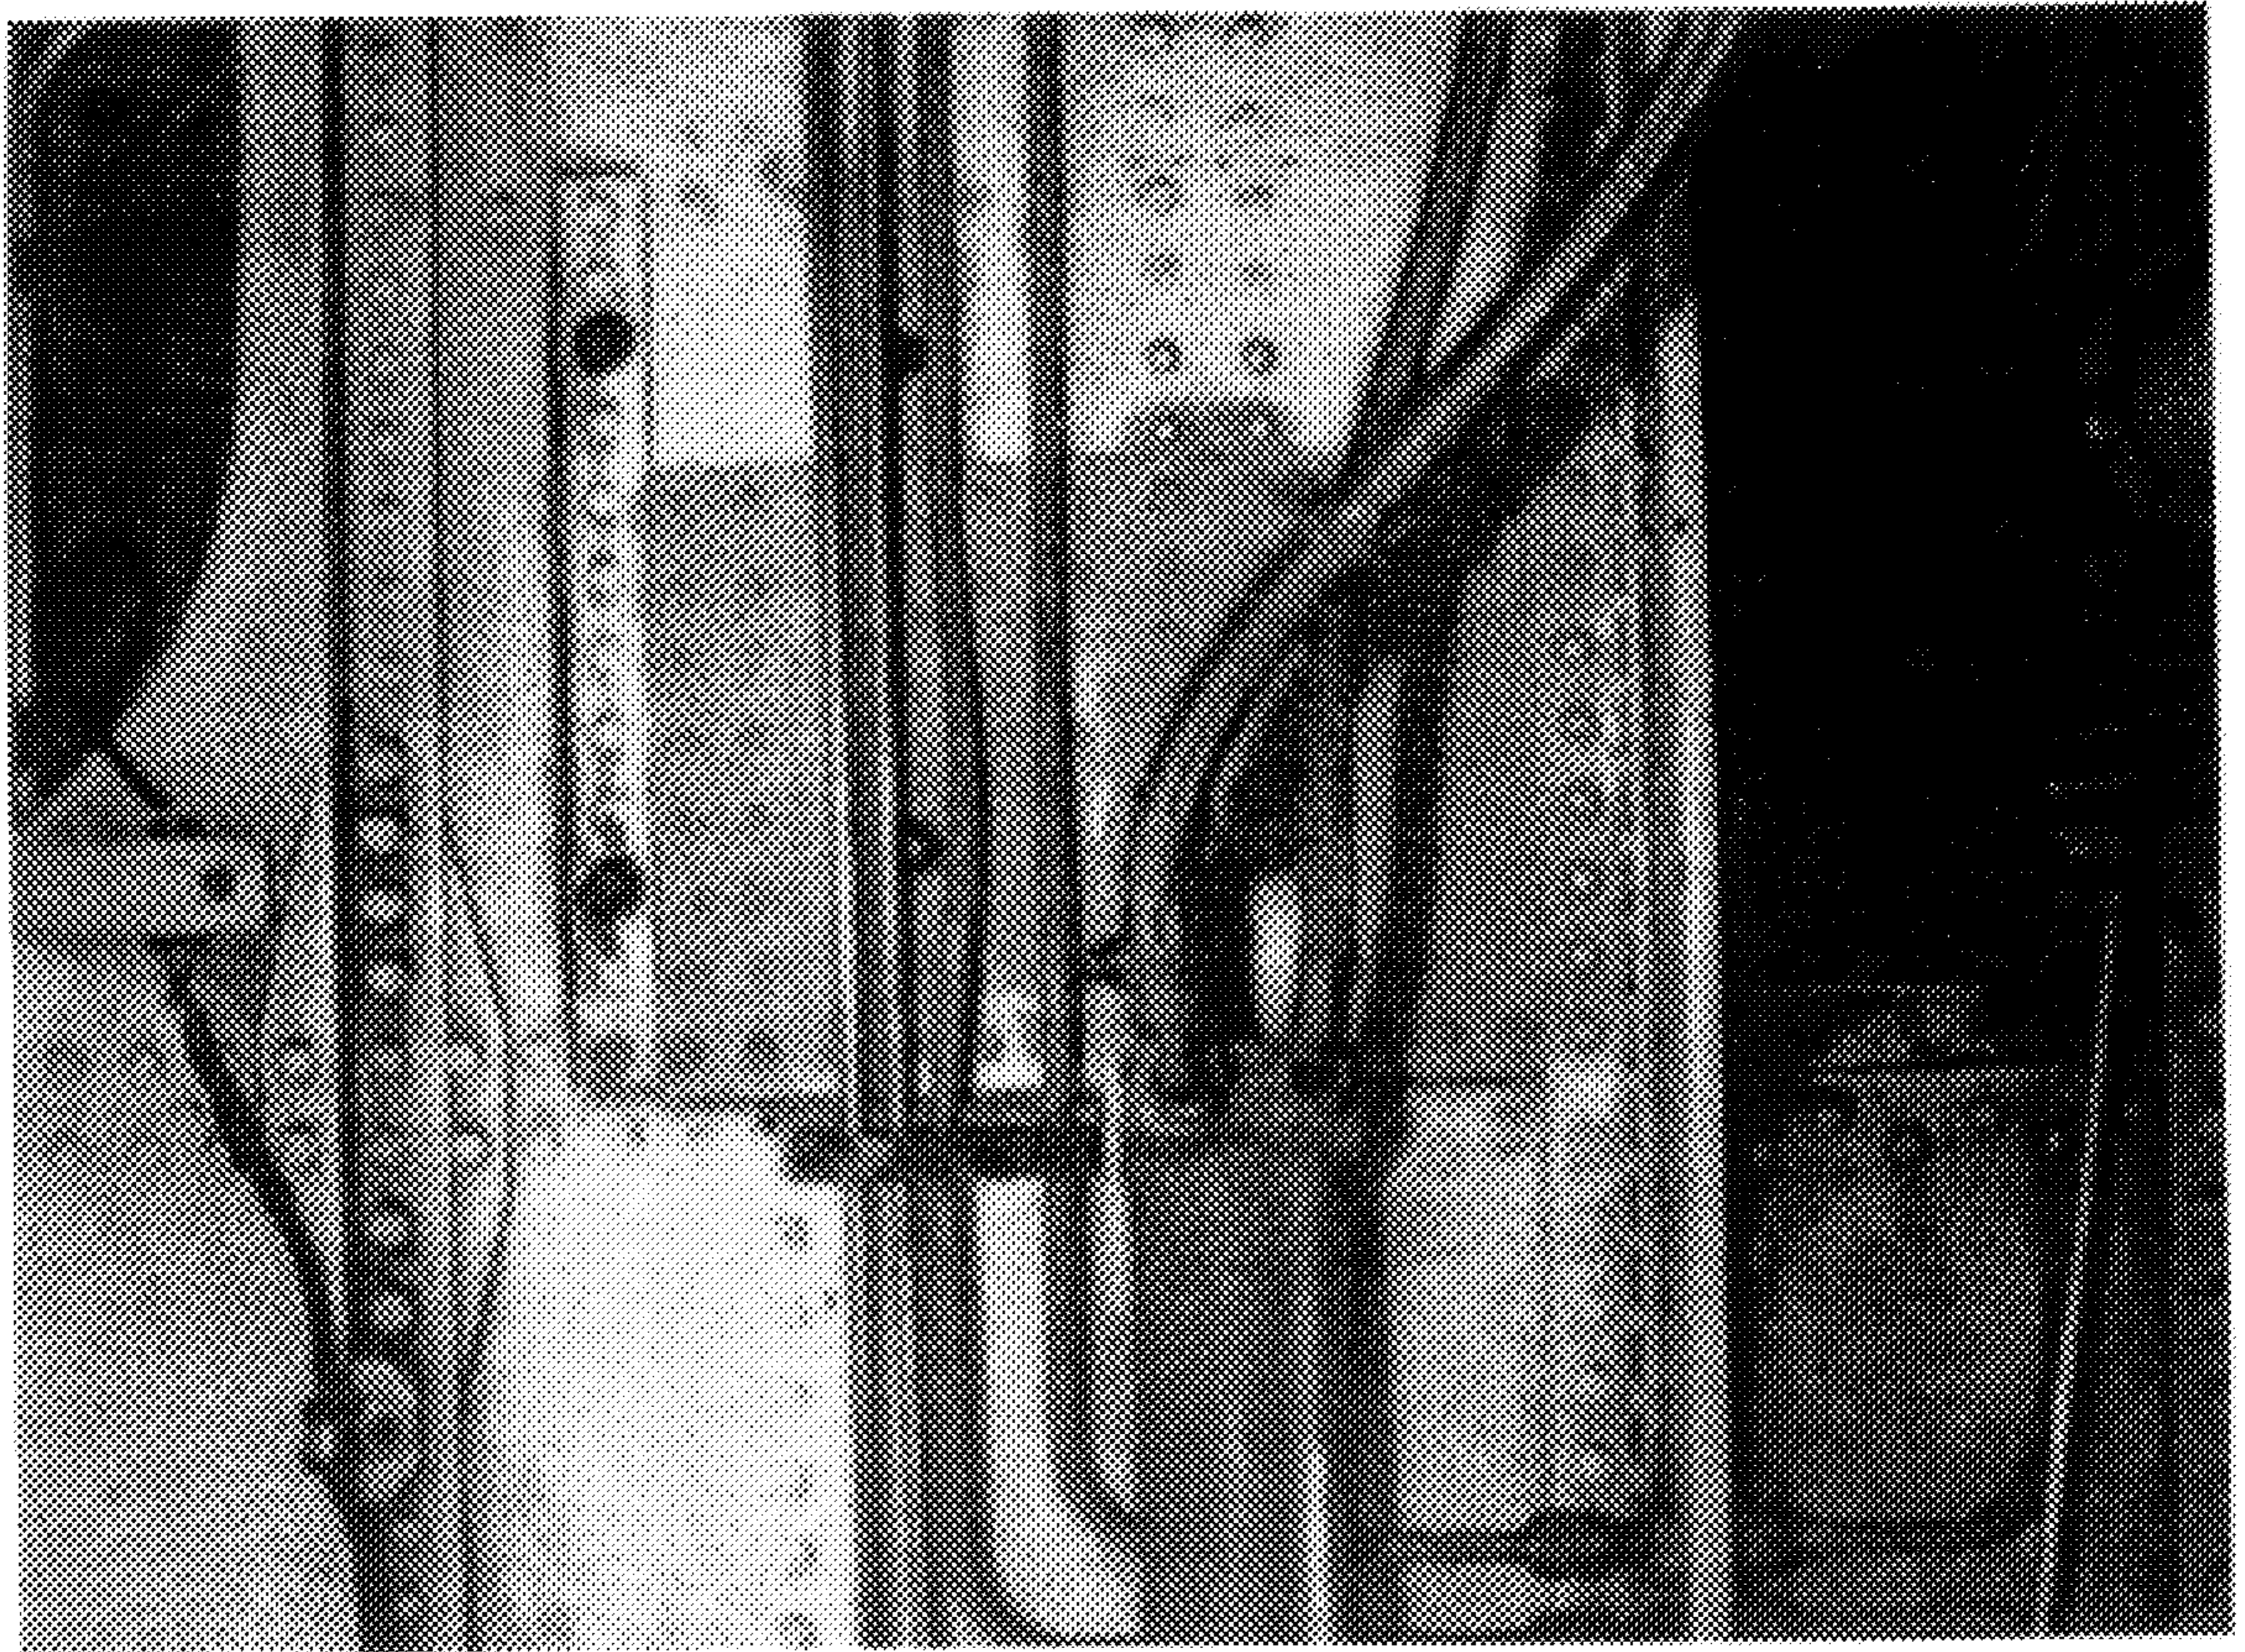
FIG. 8.

FIG. 8 is a line drawing representation of a digital photographic image taken of a repair made in accordance with an action report provided in response to the damage according to FIG. 4.
