[54] **METHOD FOR REPAIRING PARTITIONS OF A TURBINE DIAPHRAGM**

The repair method includes removing eroded or damaged trailing edge portions of partitions in the diaphragm of a turbine, over 50% of the length of the partitions being removed commencing at the trailing edge. A coupon which is a precise replication of a portion of an originally specified partition is welded to the remaining or extant partition portion by a seal weld along the radial length of the coupon on the suction side of the repaired partition and two full penetration welds at the ends of the coupon to secure it to the inner and outer rings or side walls of the diaphragm. The repaired partition is thus substantially identically contoured as the original partition.

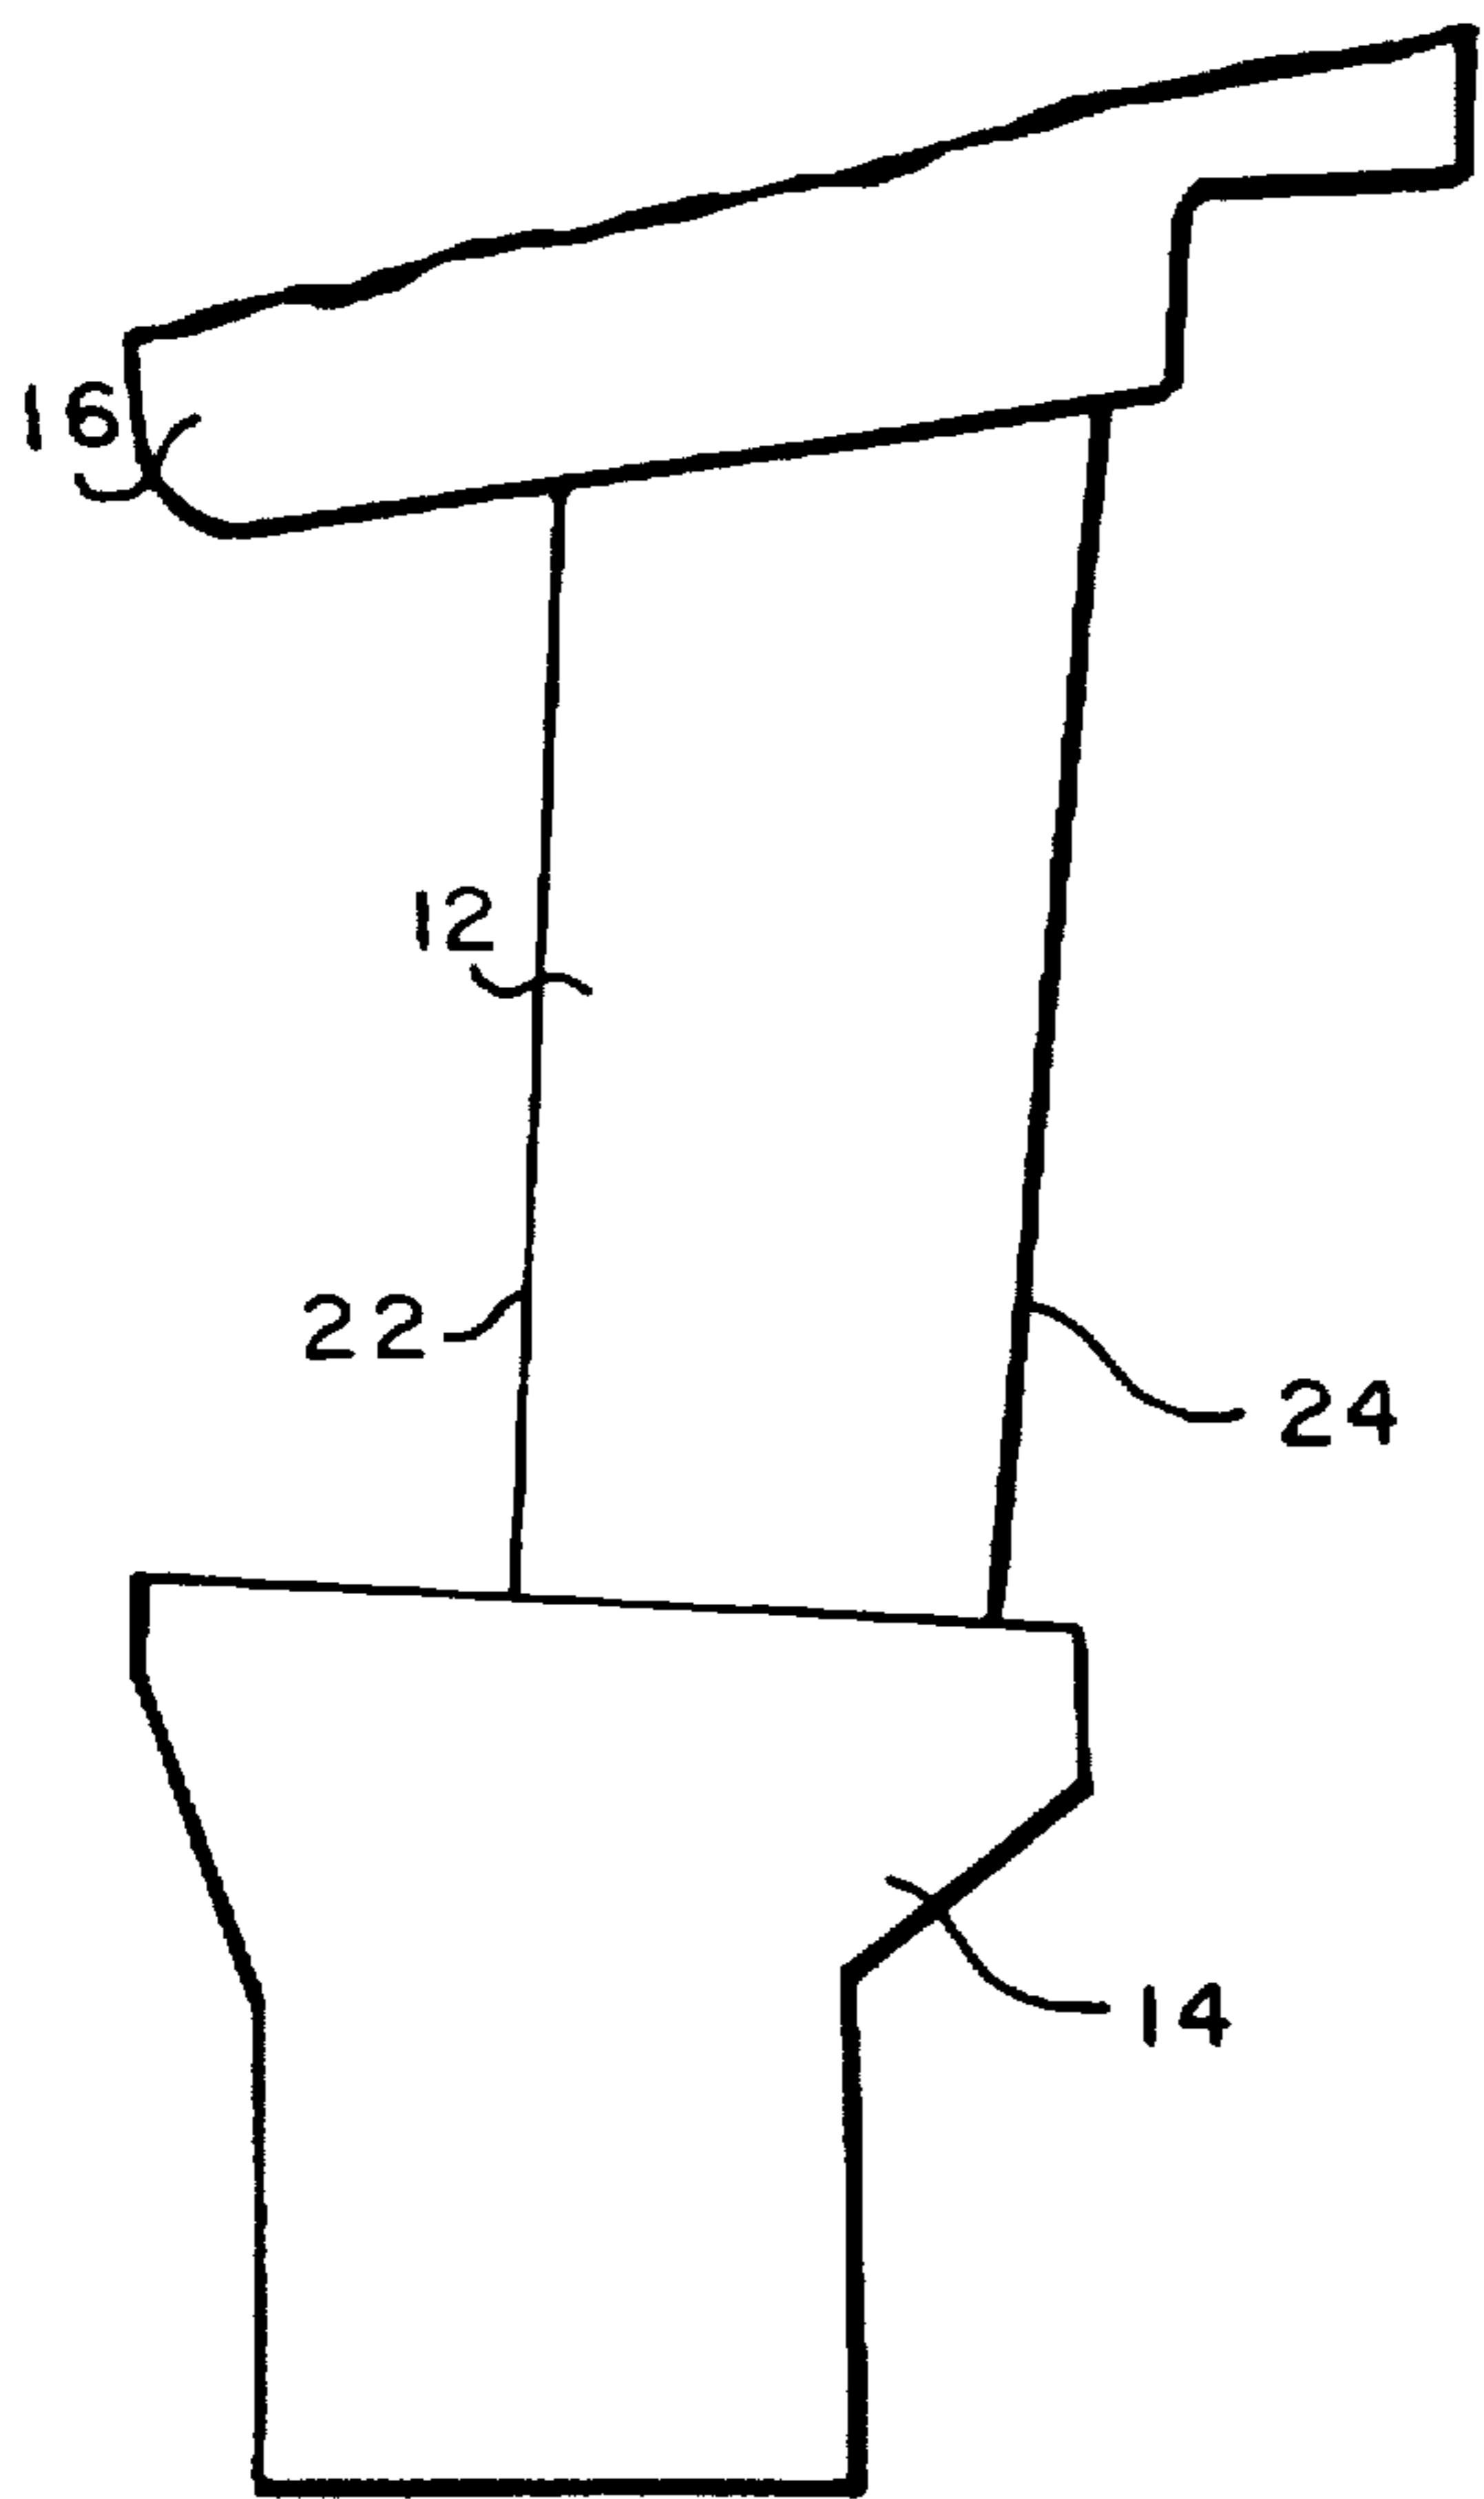
FIG. 1 is a schematic side elevational view illustrating a partition between opposite side walls in a diaphragm for a turbine:

Referring now to the drawings, particularly to FIGS. 1 and 2, there is illustrated a portion of a diaphragm, generally designated 10, for use in turbines and including a plurality of partitions or stator blades 12 interposed between inner and outer side walls 14 and 16 of diaphragm 10. The side walls may have inner and outer bands or rings, for example as illustrated at 18 and 20, respectively, in FIG. 2. The diaphragms are generally provided in cylindrical halves for ease of manufacture and installation as illustrated in FIG. 2. It will be appreciated that the partitions 12 are closely spaced relative to one another, extend generally along radii of the diaphragm and have leading and trailing edges 22 and 24, respectively. As noted previously, the trailing edges erode and pit over time with use, particularly in steam turbines, whereby significant performance losses occur absent repair or replacement of the partitions. Replacement of the partitions with wholly new partitions is not economically justified because repairs can be effected, particularly in accordance with the present method at a small percentage of the replacement cost.

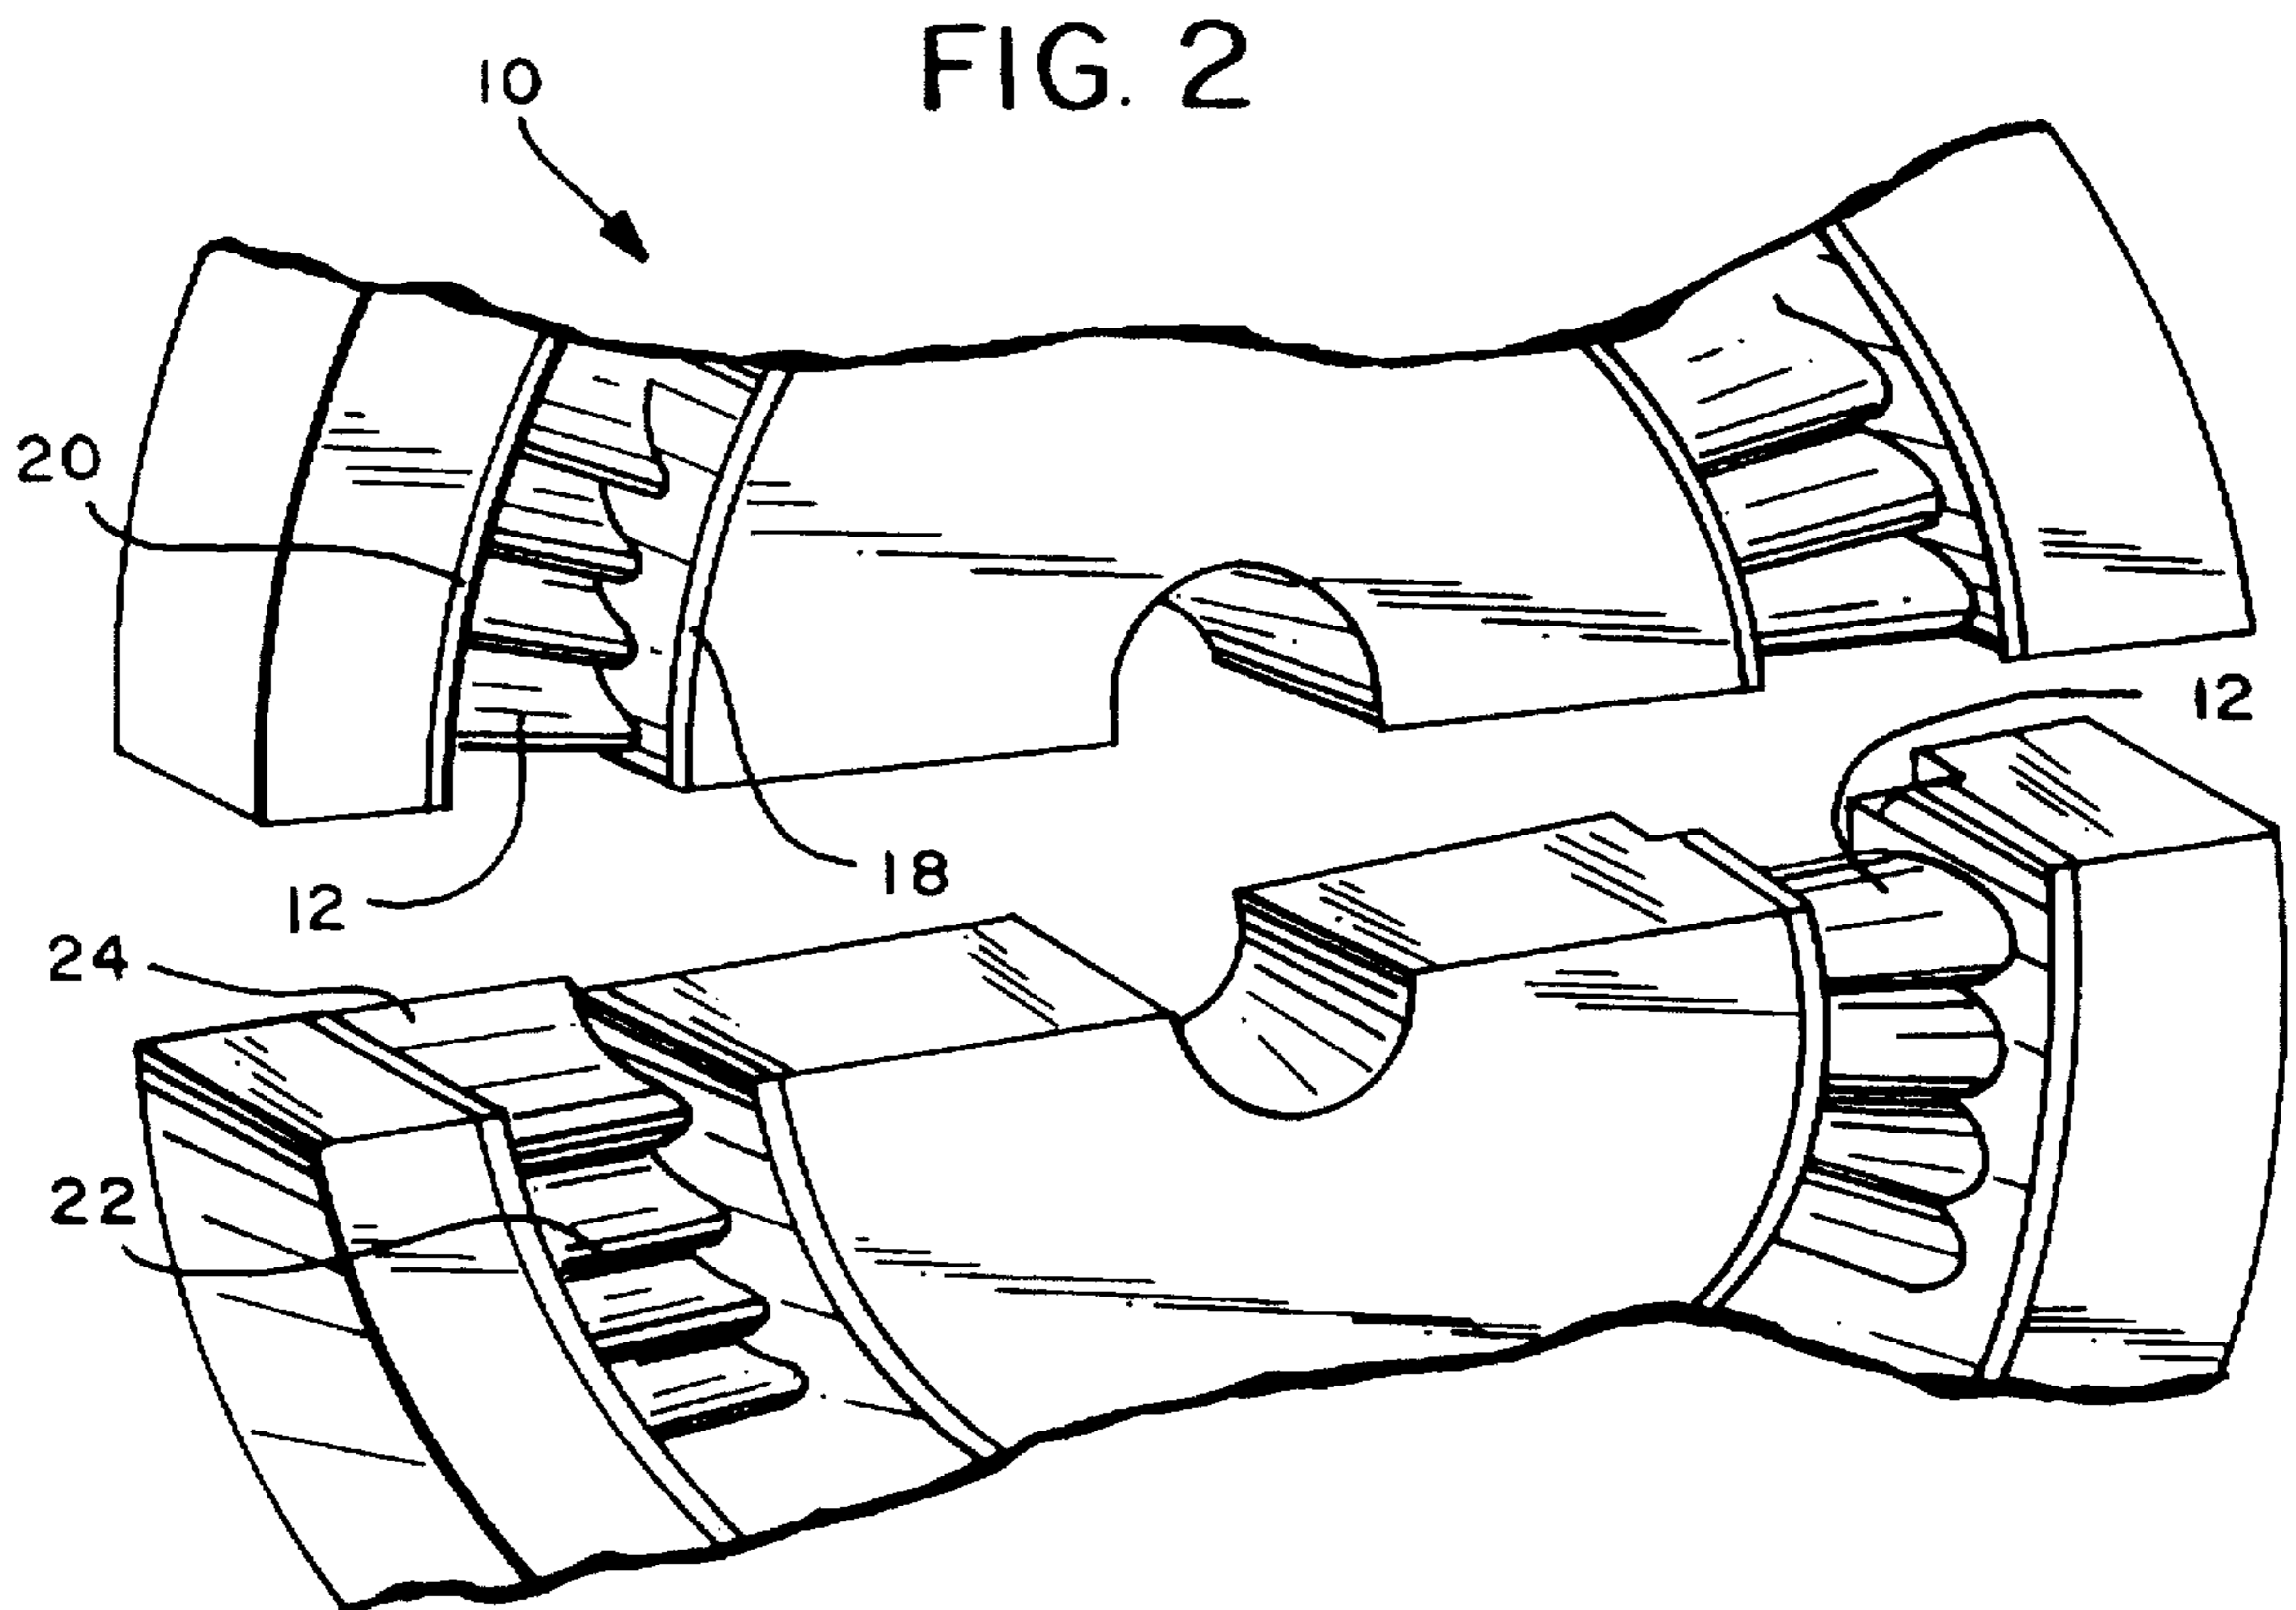
FIG. 2 is a fragmentary perspective view of the opposed halves of a turbine diaphragm:

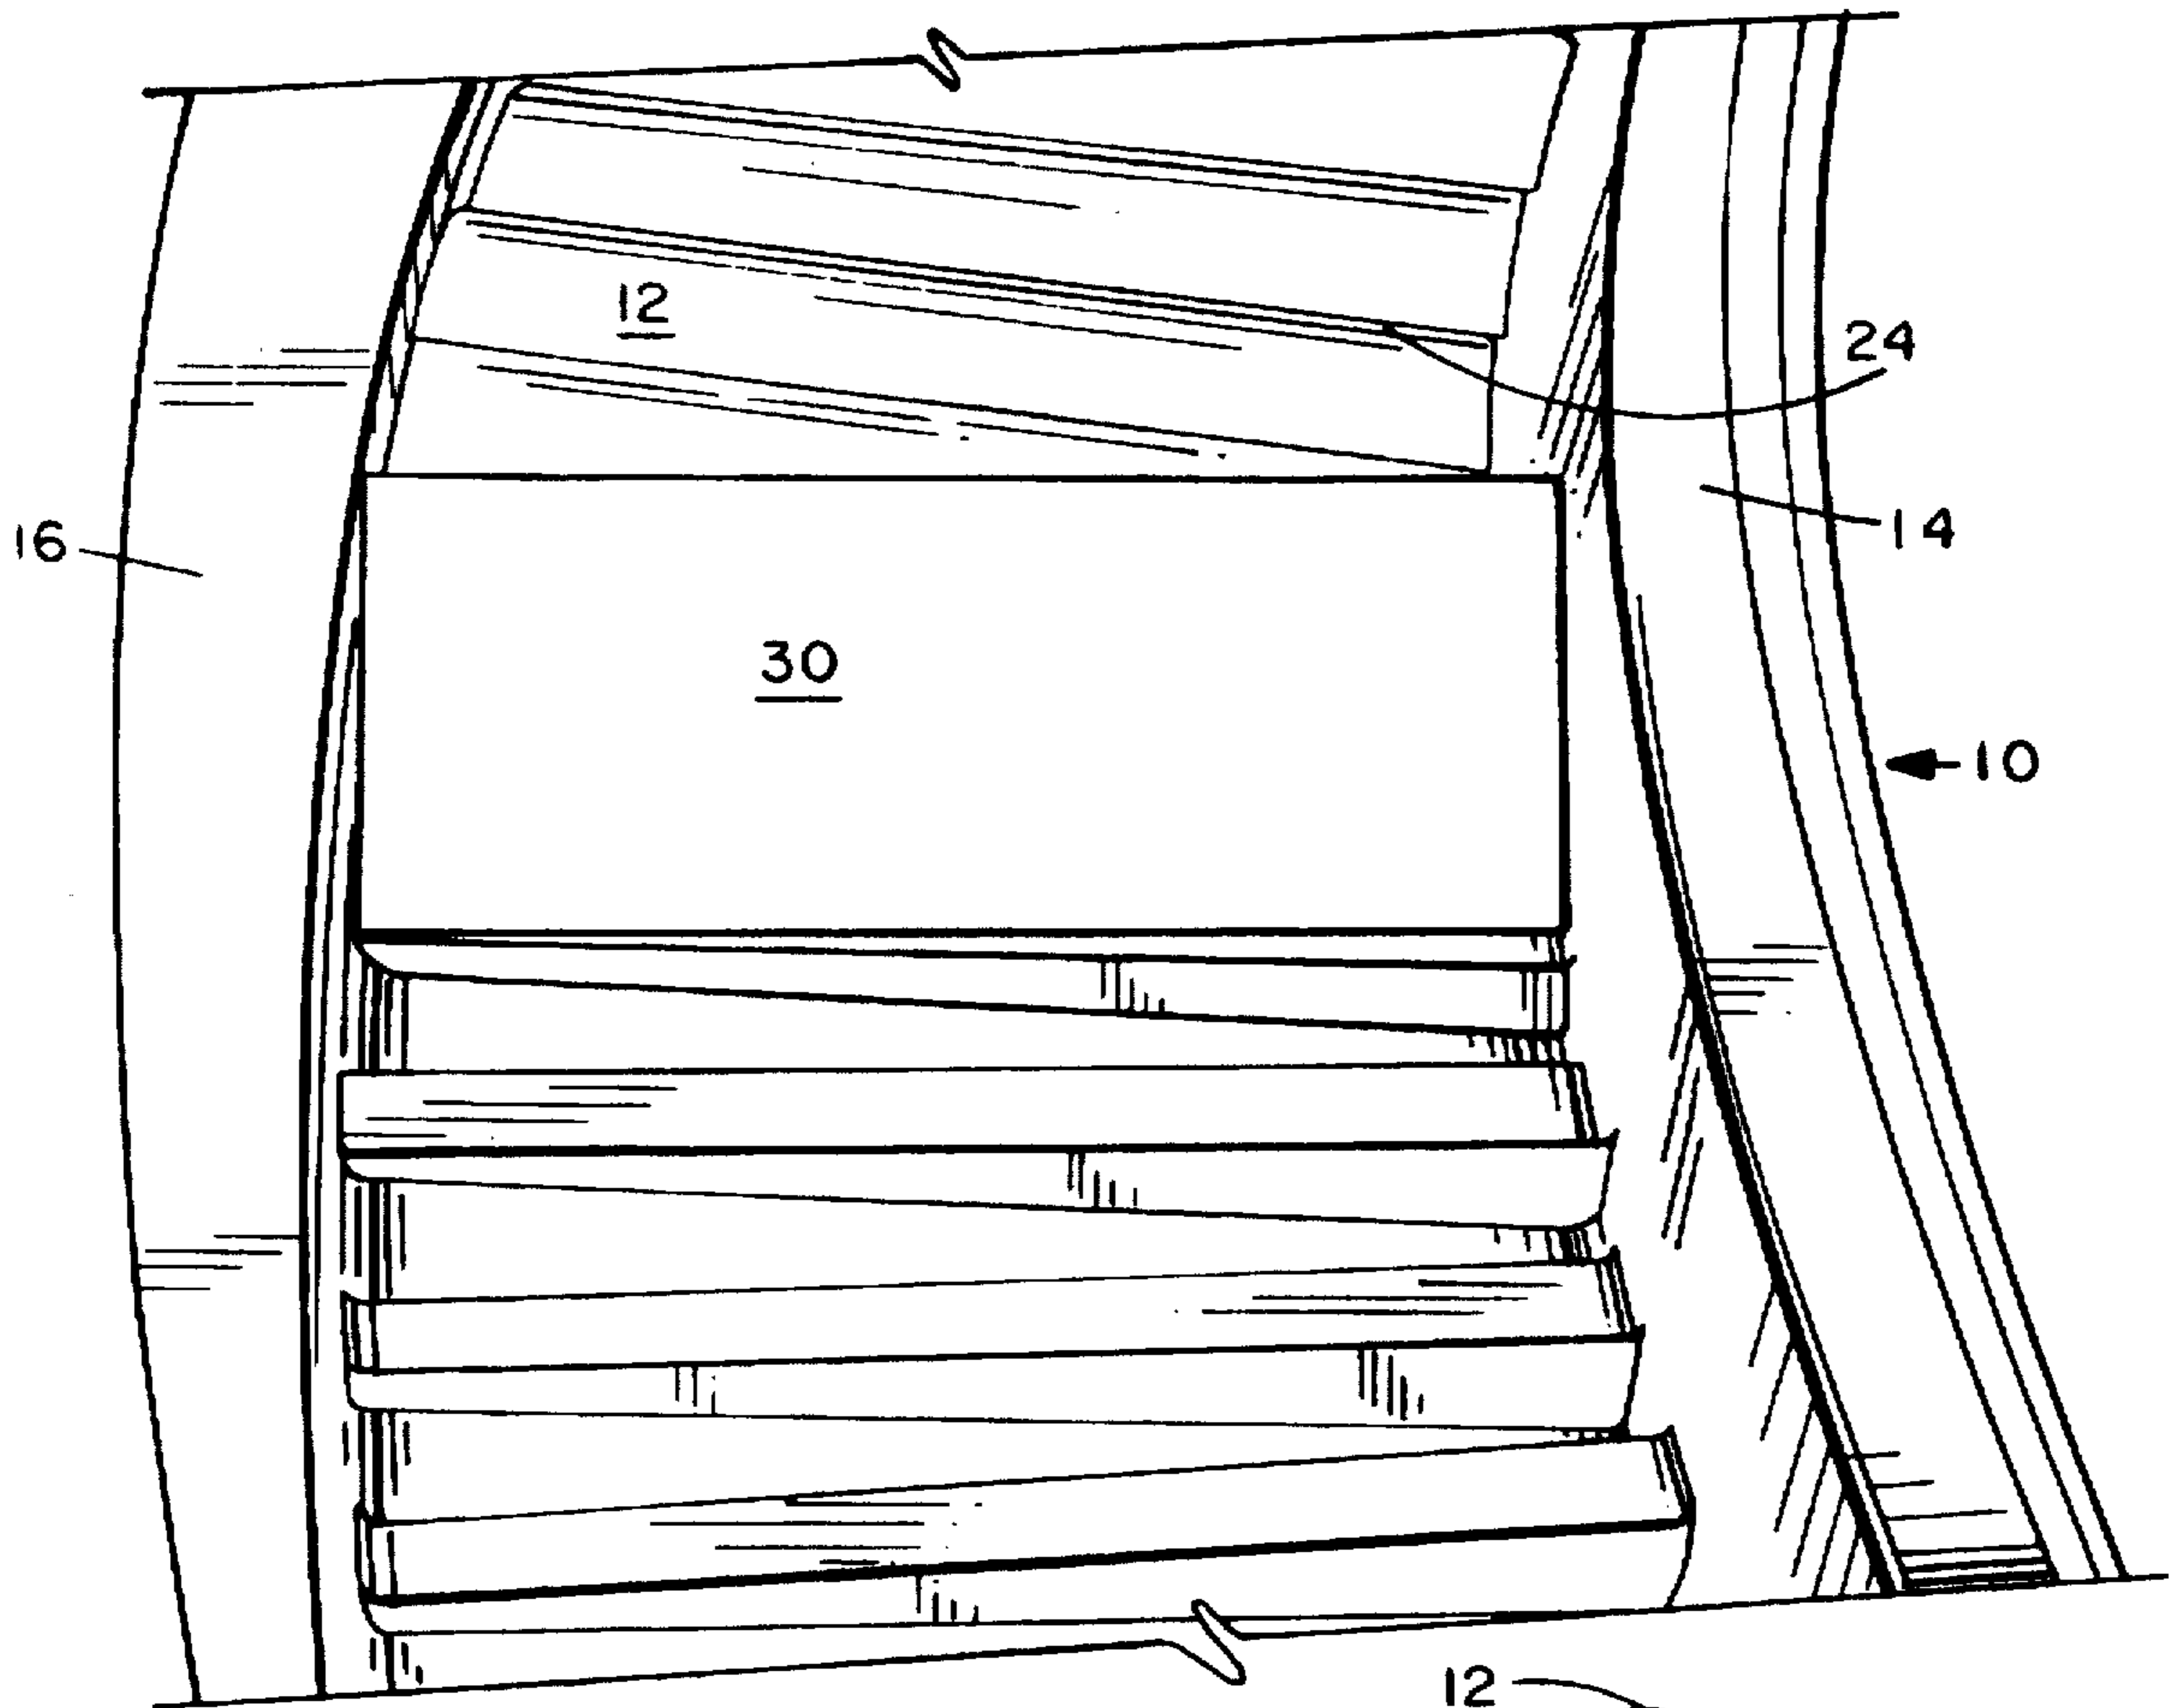
FIG. 3 is a perspective view schematically illustrating the removal of over 50% of the partition by a milling machine:

Particularly, and referring to FIG. 3, the diaphragm 10 undergoing repair is set up in a milling machine with a milling head schematically and generally designated 30. The diaphragm 10 may be mounted on a rotary table and rotated under the milling head 30 such that a majority of the partitions commencing at their trailing edges are removed. For example, the diaphragm 10 illustrated in FIG. 3 may be disposed on the rotary table with the trailing edges 24 in an upwardly facing orientation with the milling head cutting

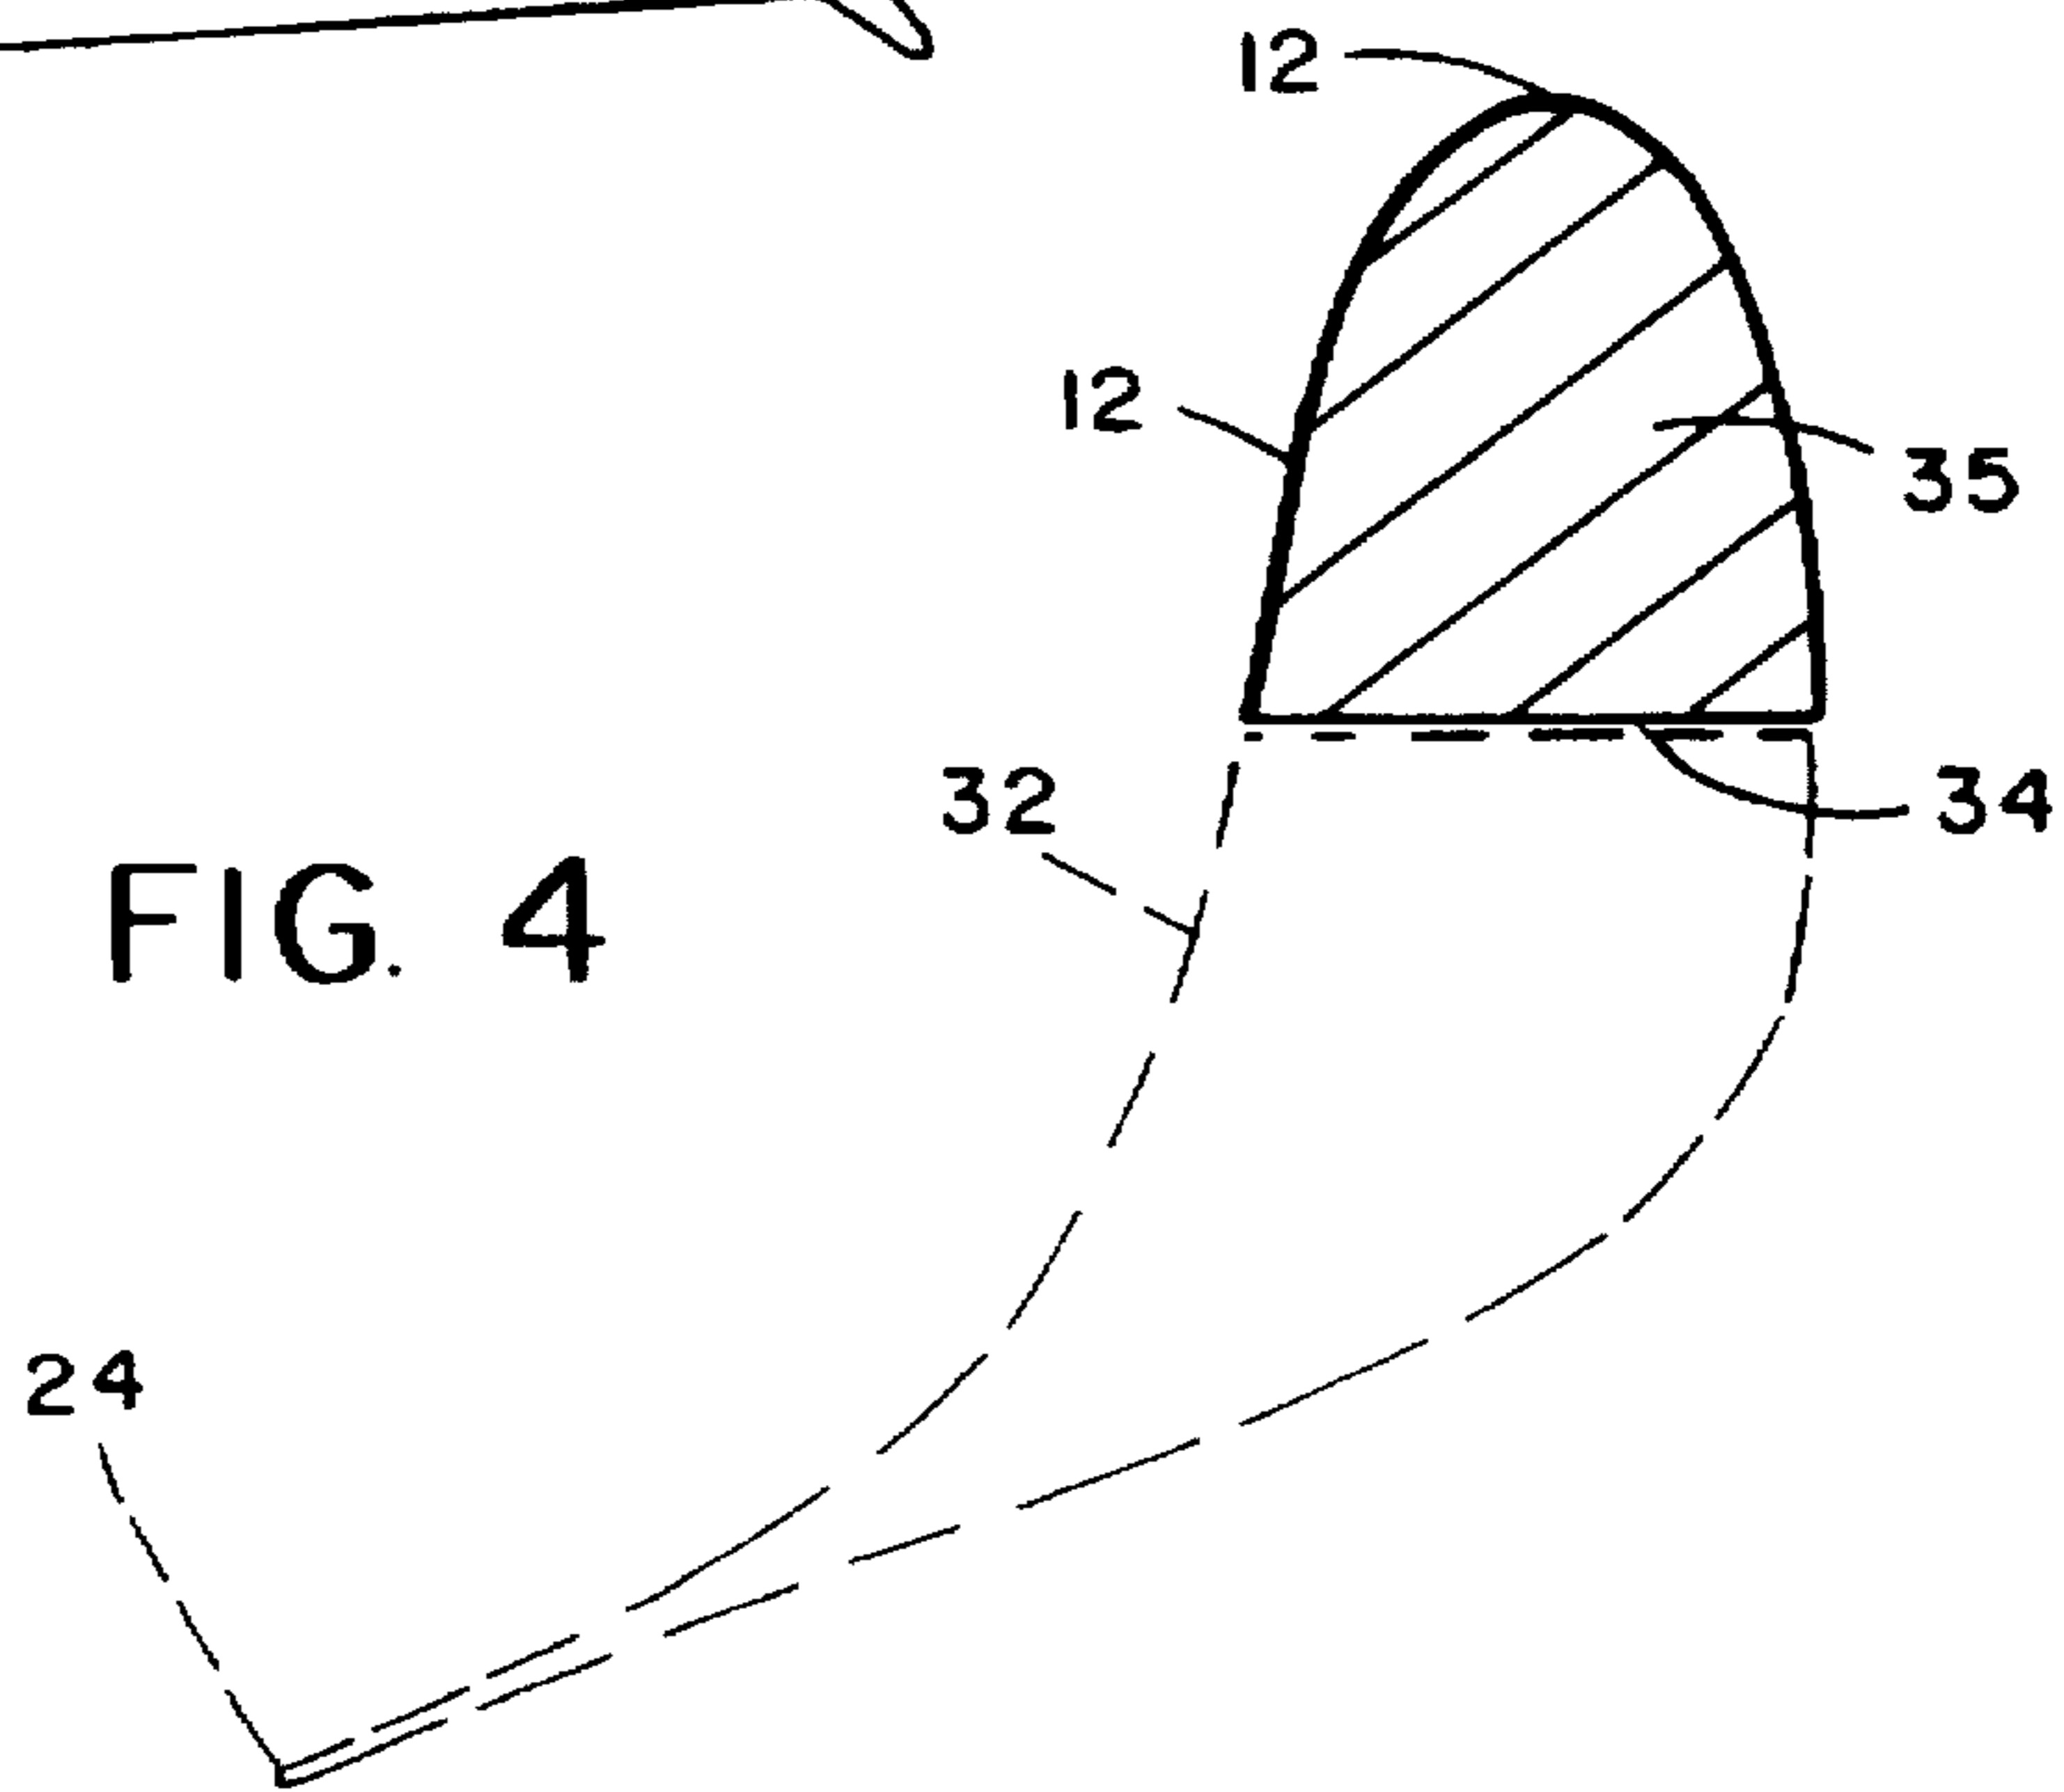
FIG. 4 is a cross sectional view illustrating the remaining leading edge portion of the original partition with the removed portion illustrated by dashed lines:

away the damaged trailing edge portions consistently and repeatedly from each partition. In FIG. 4, the extent of the partition which is to be removed by the milling head 30 is illustrated by the dashed lines 32. It will be appreciated that the length of the partition removed lies within a range preferably about 50–85% of the partition, e.g., as measured along a chord of the partition commencing with the trailing edge 24. The removal of the majority of the partition leaves a flat face 34 along the remaining leading edge portion 35 of the original partition 12. The removal of the metal can also be accomplished using a VBM and machining with a single point tool.

To effect the repair, the eroded and damaged portions of the partitions are removed to the full designed depth as illustrated in FIG. 4 corresponding to the depth of each coupon. After their removal, the sidewalls or inner and outer rings of the diaphragm may then be repaired by applying weld material at any eroded or damaged locations. These peripheral surfaces may then be ground back or machined to its original specifications.

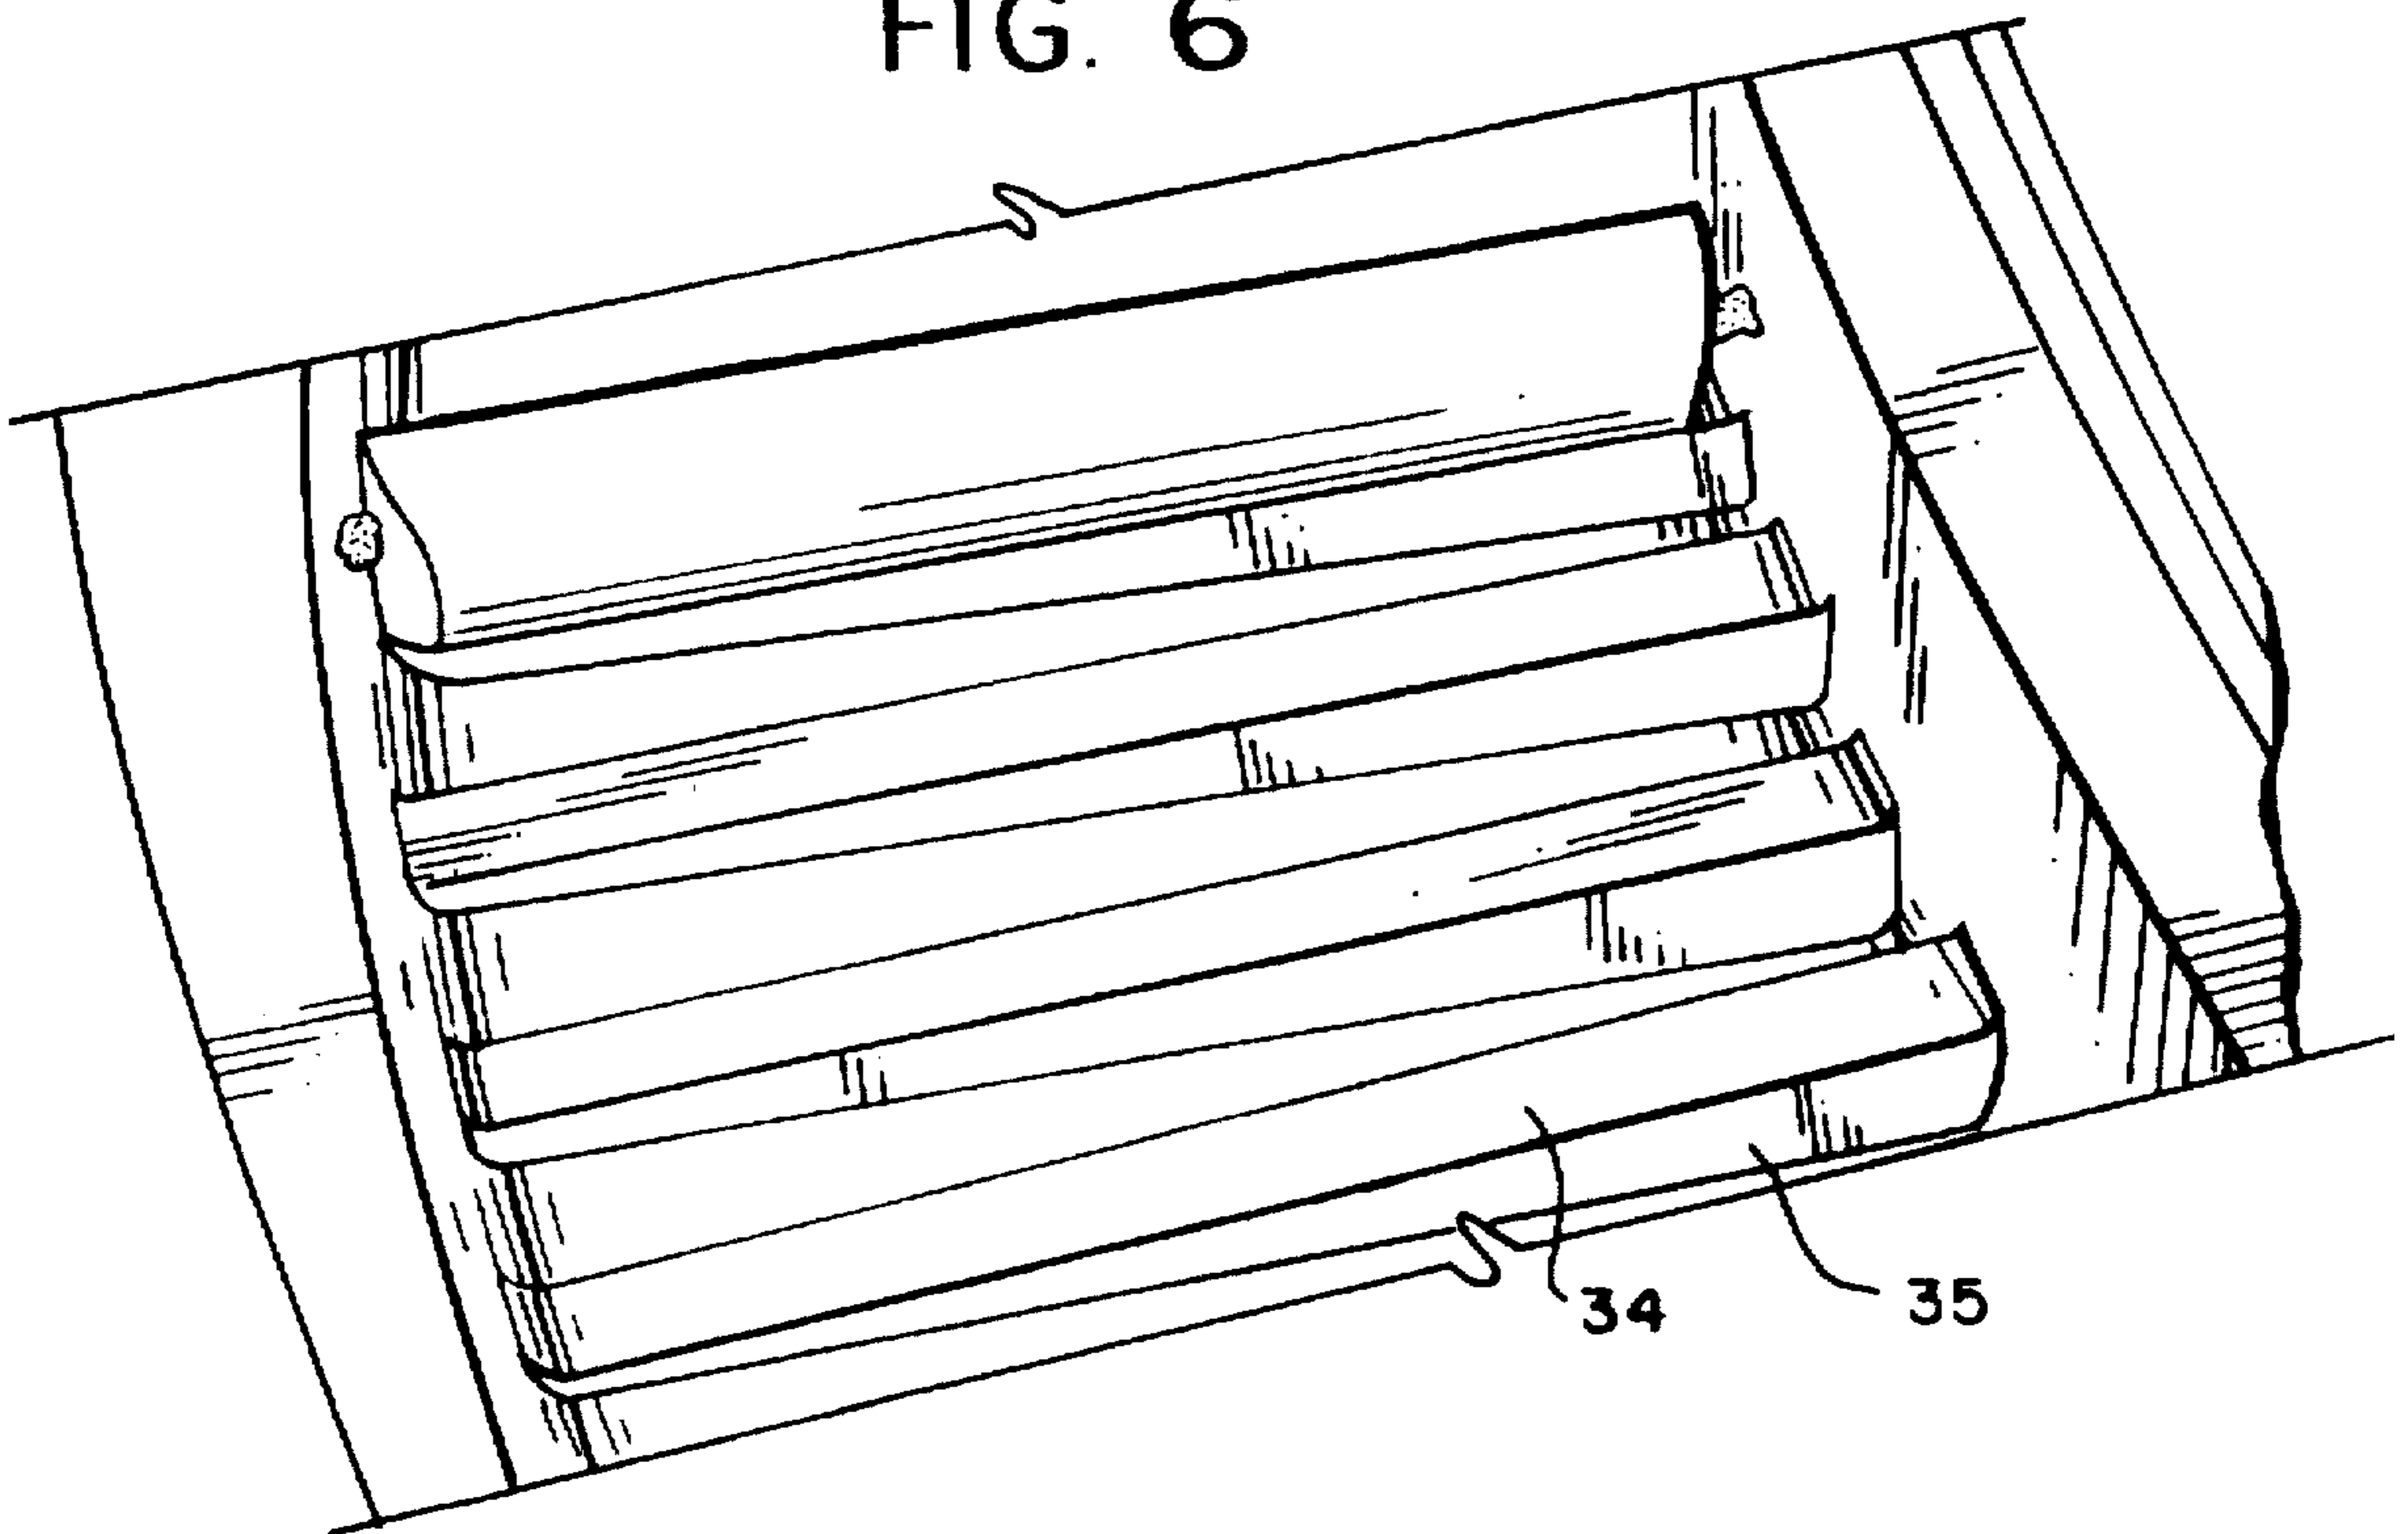
FIG. 6 is a view similar to FIG. 3 illustrating an initial application of the coupon to the remaining leading edge portion of the original partition:

After the diaphragm has been preheated, e.g., to about 250° F., a coupon 36 is then placed in position with its flat face 38 bearing against the flat face 34 of the remaining leading edge portion 35 of the original partition as illustrated in FIG. 6 and clamped to the partition. A copper chill fixture, not shown, is disposed at each ring or sidewall. The coupons are then tack-welded at opposite ends to the rings or sidewalls using preferably a TIG weld. Thereafter, a seal weld is provided across the radial length of the partition on the suction side filling in the gap between the chamfered surface 40 and margin of the flat face 34 on the suction side. A chill fixture is then applied to the side wall and one end of the
