[54] **METHOD FOR REPAIRING PARTITIONS OF A TURBINE DIAPHRAGM**

The repair method includes removing eroded or damaged trailing edge portions of partitions in the diaphragm of a turbine, over 50% of the length of the partitions being removed commencing at the trailing edge. A coupon which is a precise replication of a portion of an originally specified partition is welded to the remaining or extant partition portion by a seal weld along the radial length of the coupon on the suction side of the repaired partition and two full penetration welds at the ends of the coupon to secure it to the inner and outer rings or side walls of the diaphragm. The repaired partition is thus substantially identically contoured as the original partition.

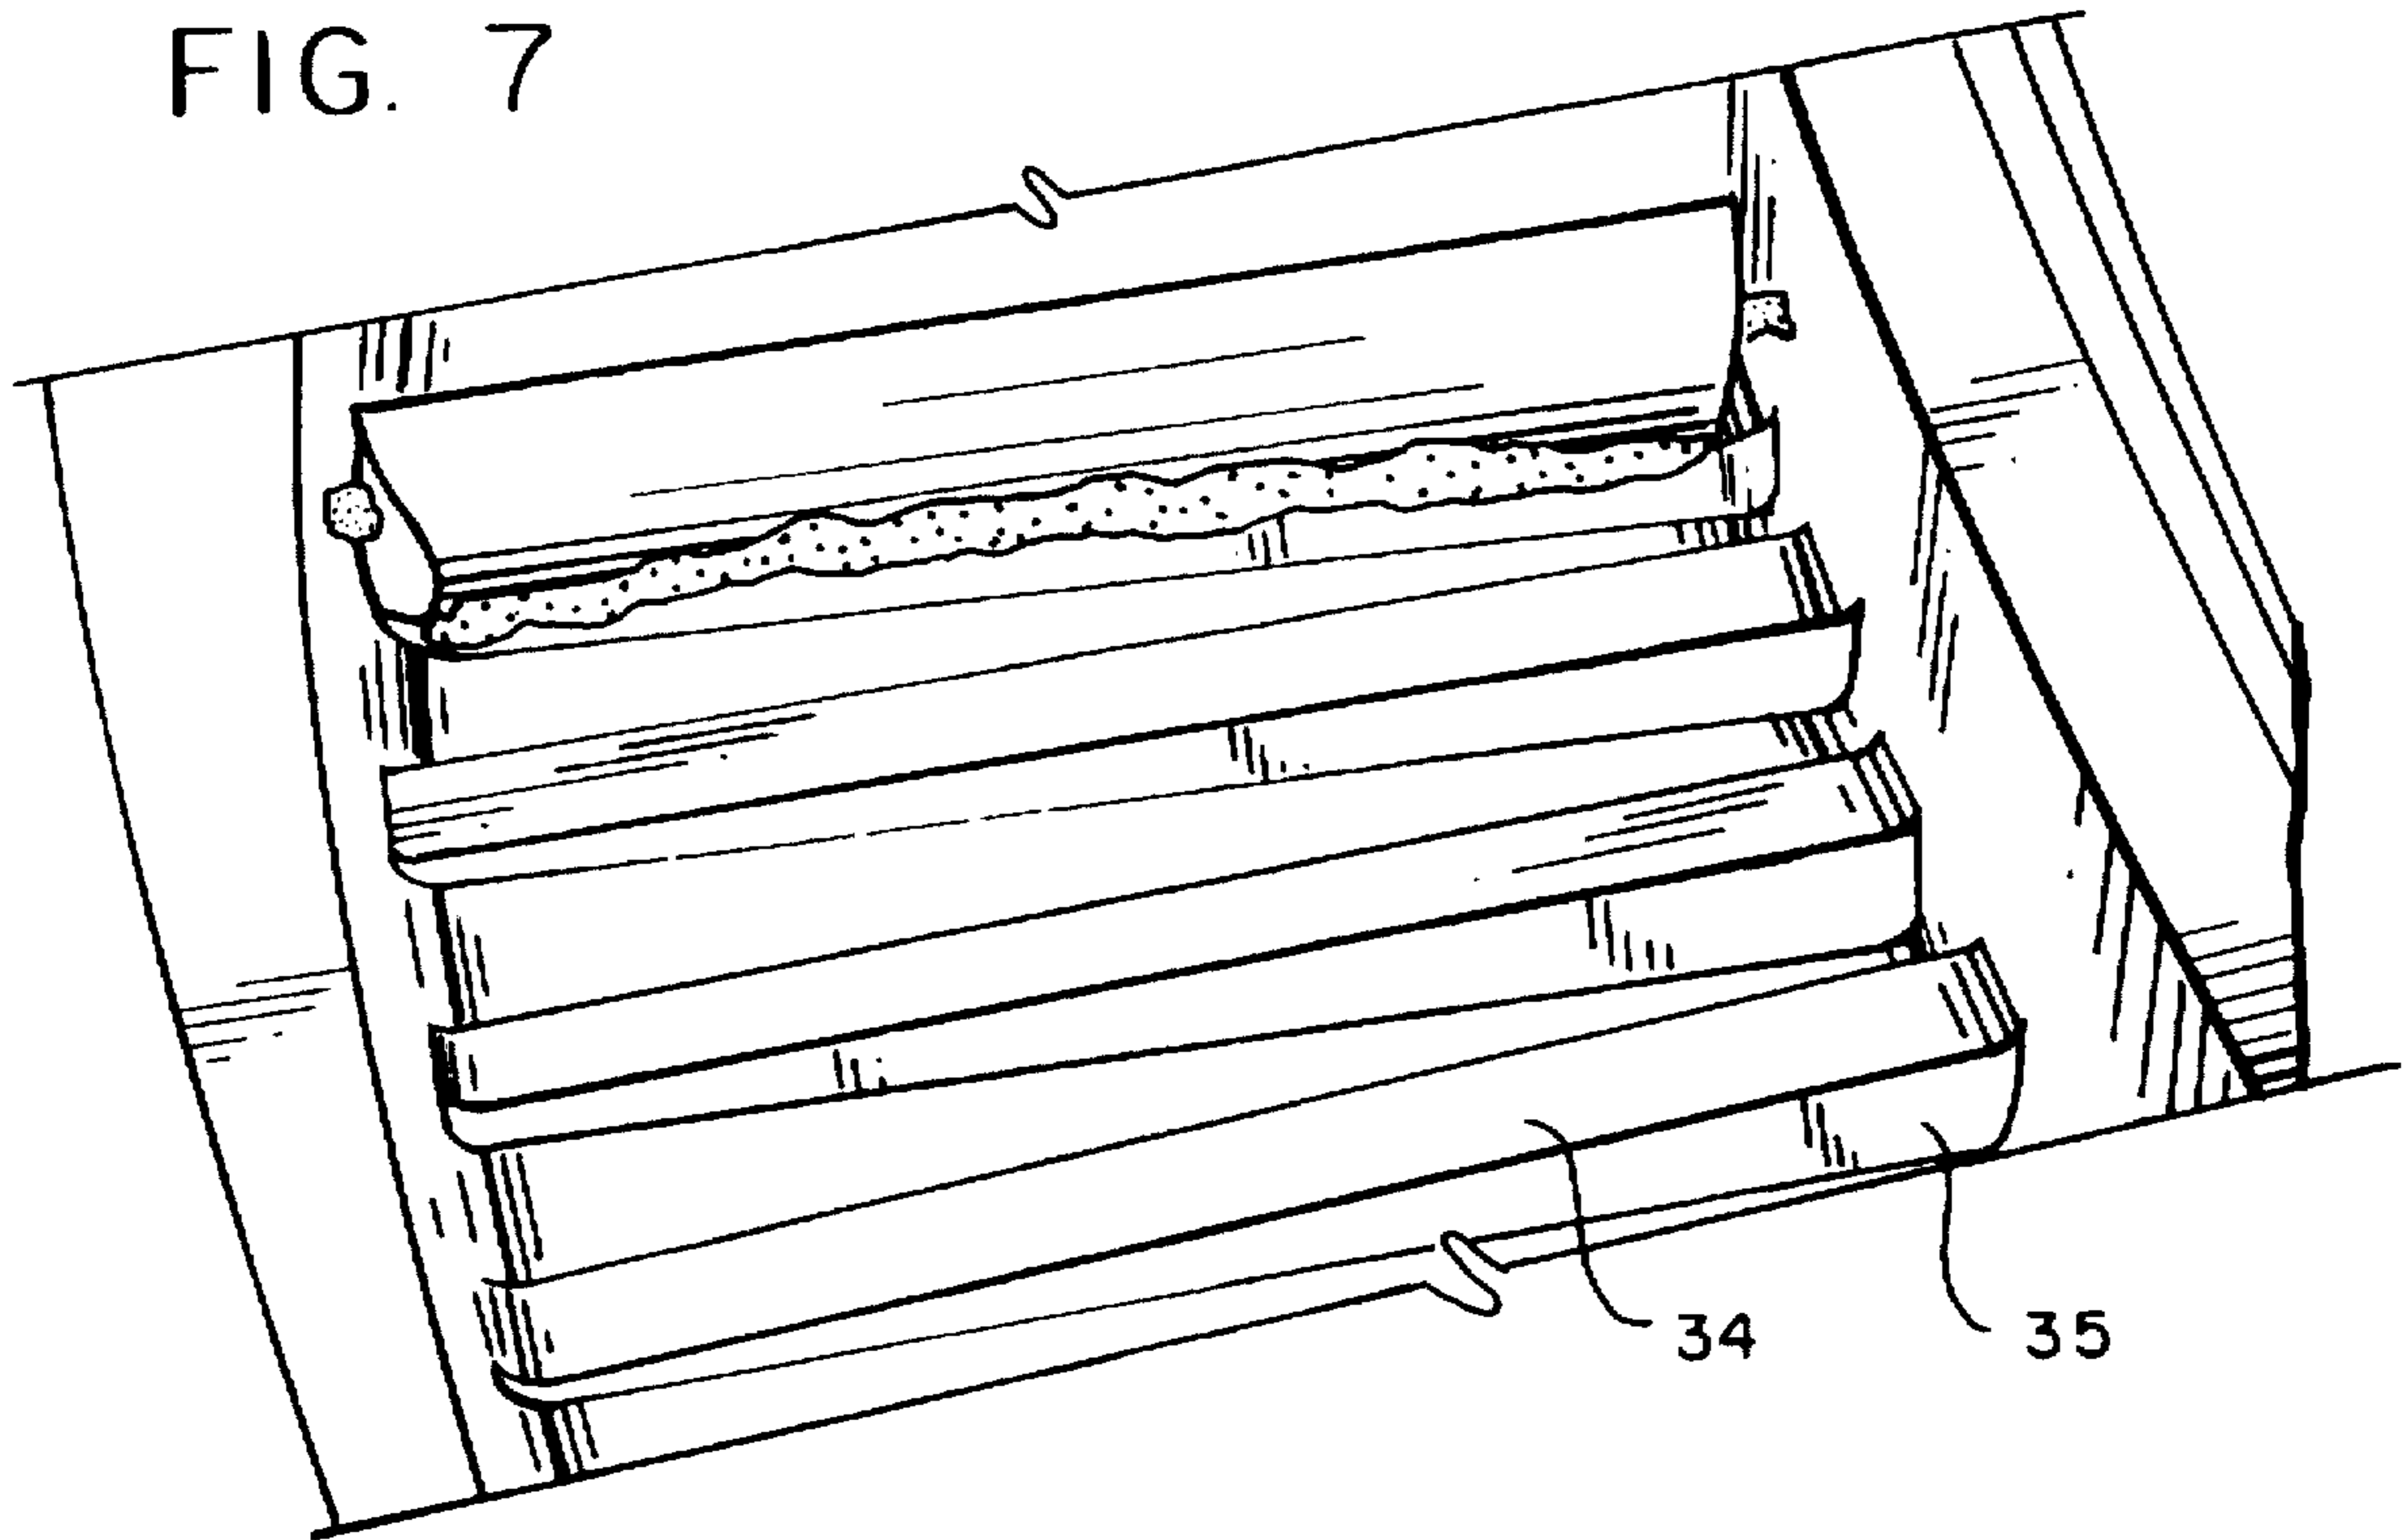
FIG. 7

FIGS. 7-8 are views similar to FIG. 6 illustrating application of a radial seal weld and full penetration welds at the opposite ends of the repair coupon; and

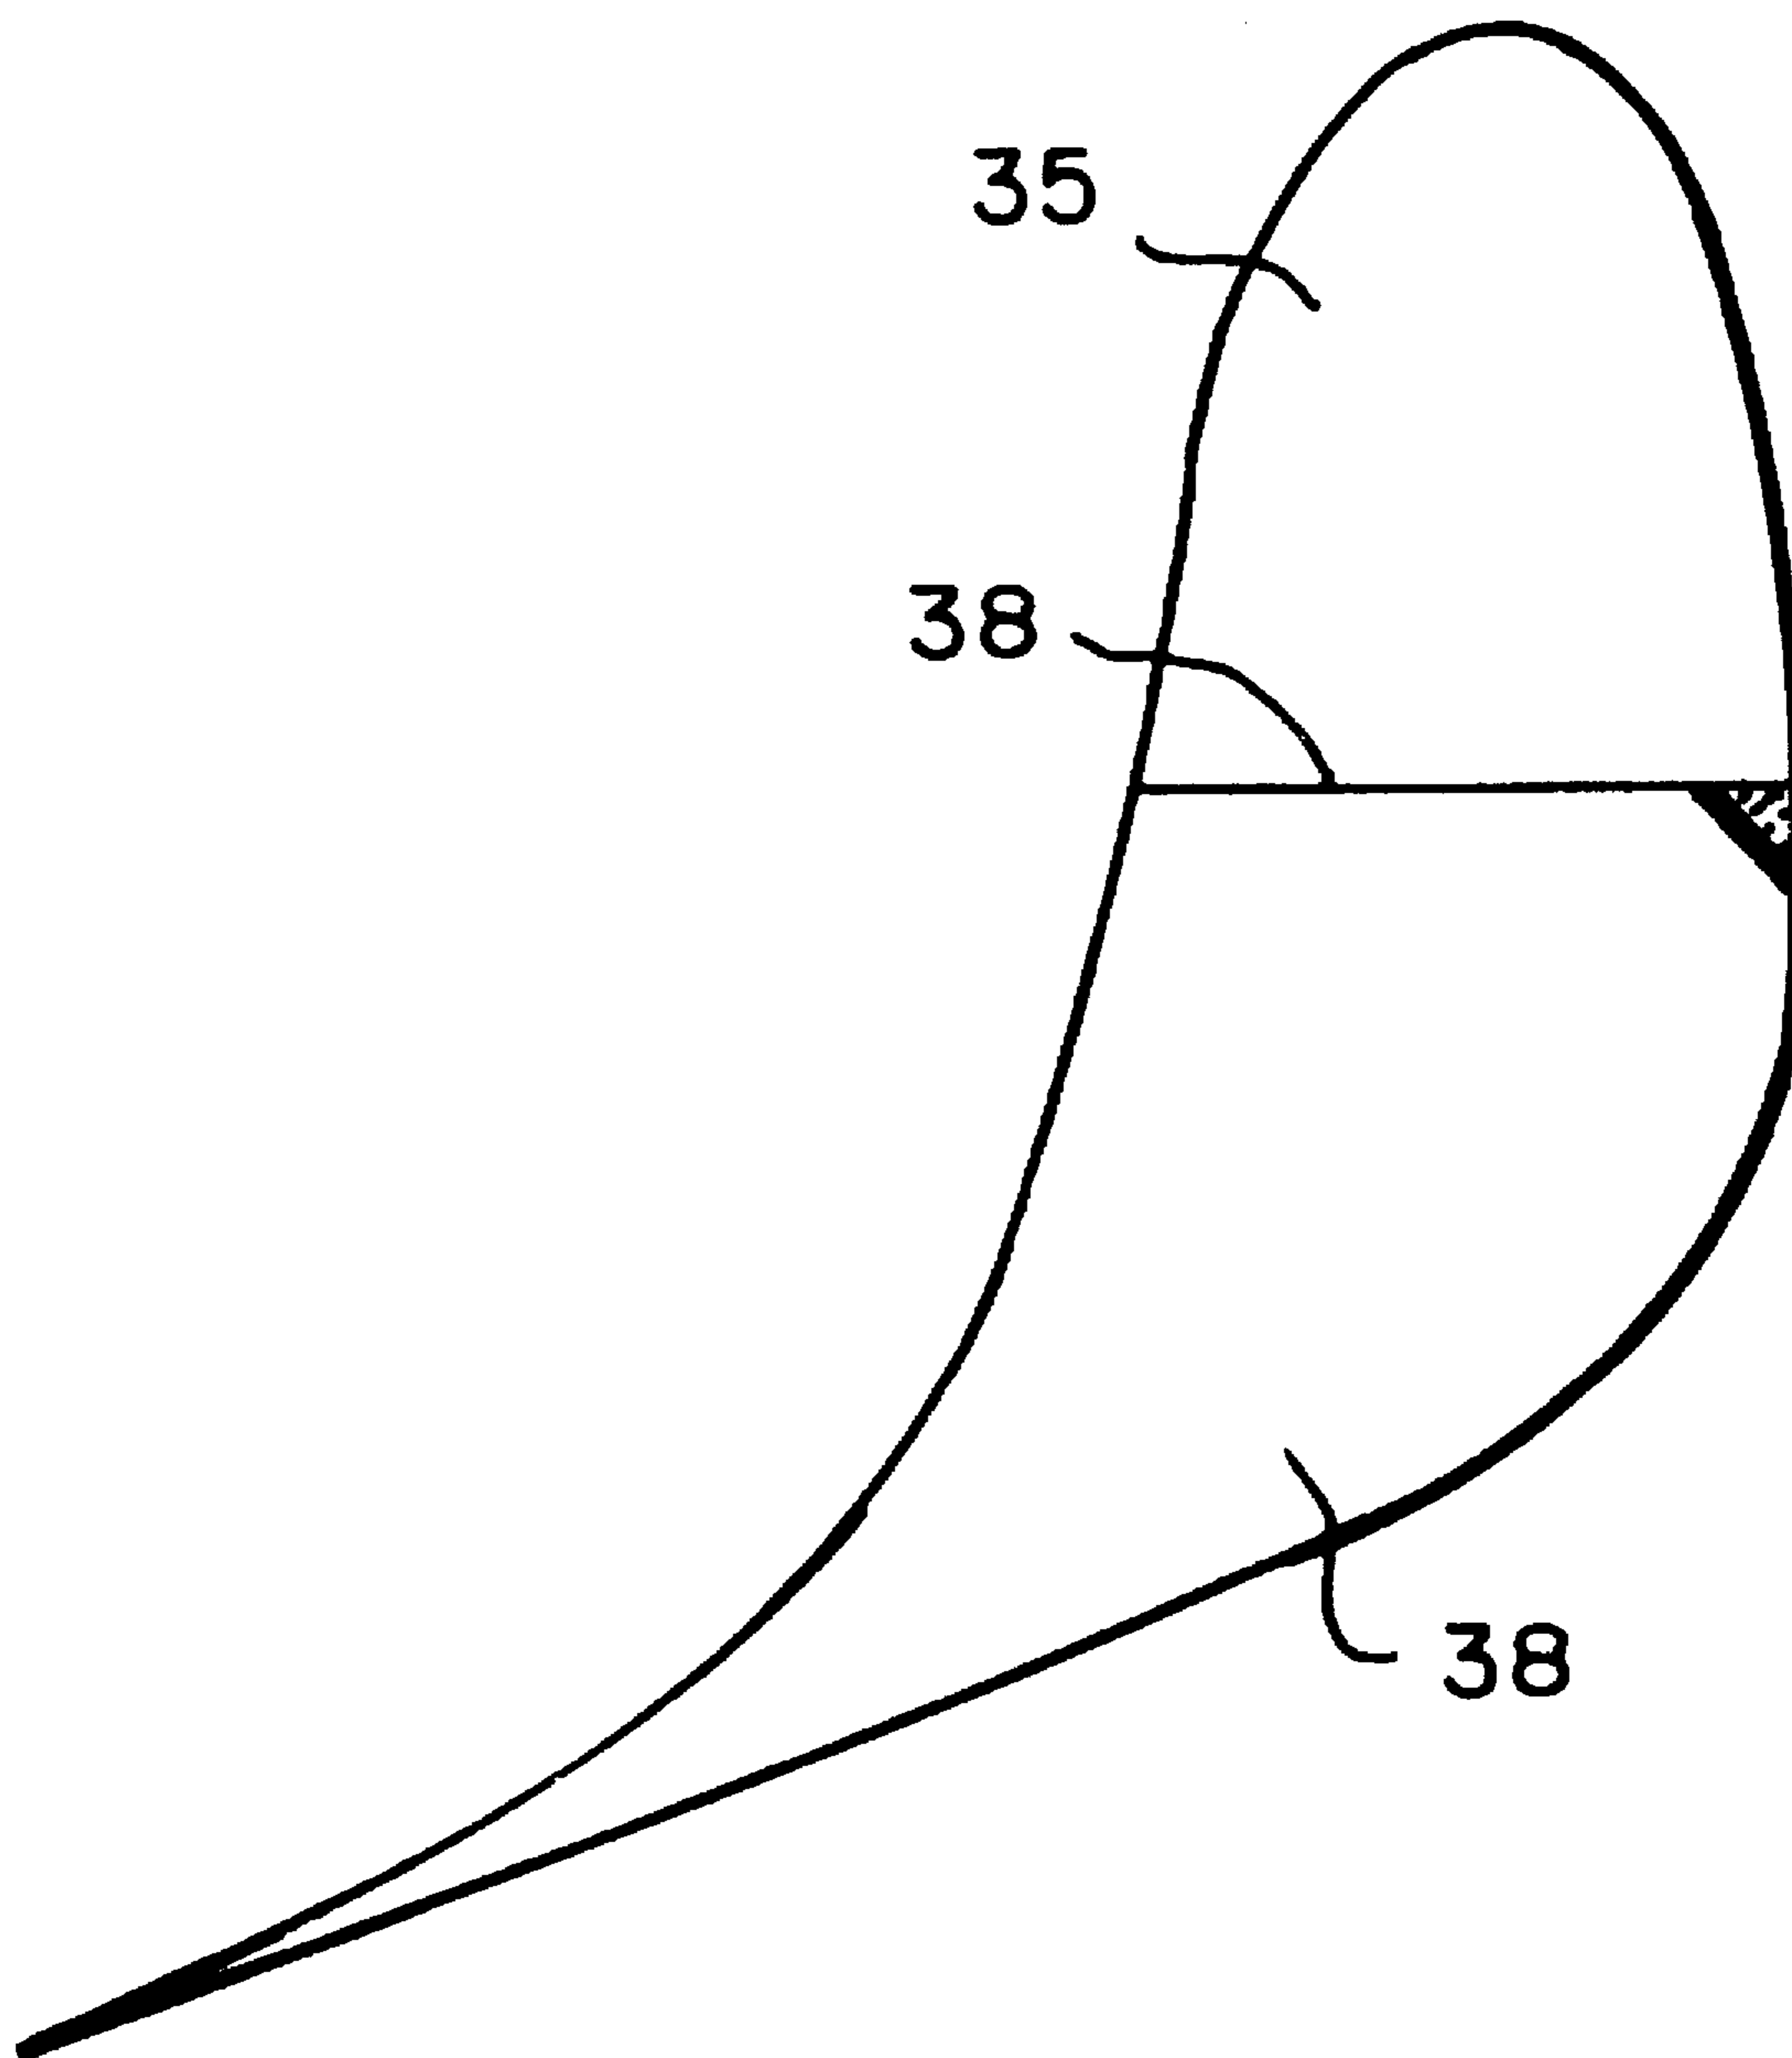
FIG. 9 is a cross-sectional view of a repaired partition particularly illustrating the joint between the original leading edge portion and the repair coupon.
