US006077465A

[54] **METHOD OF REPAIRING A VINYL WINDOW FRAME**

A defect in a vinyl window frame is repaired by filling the defect with a PVC filler including a PVC cement and allowing the PVC filler to cure.

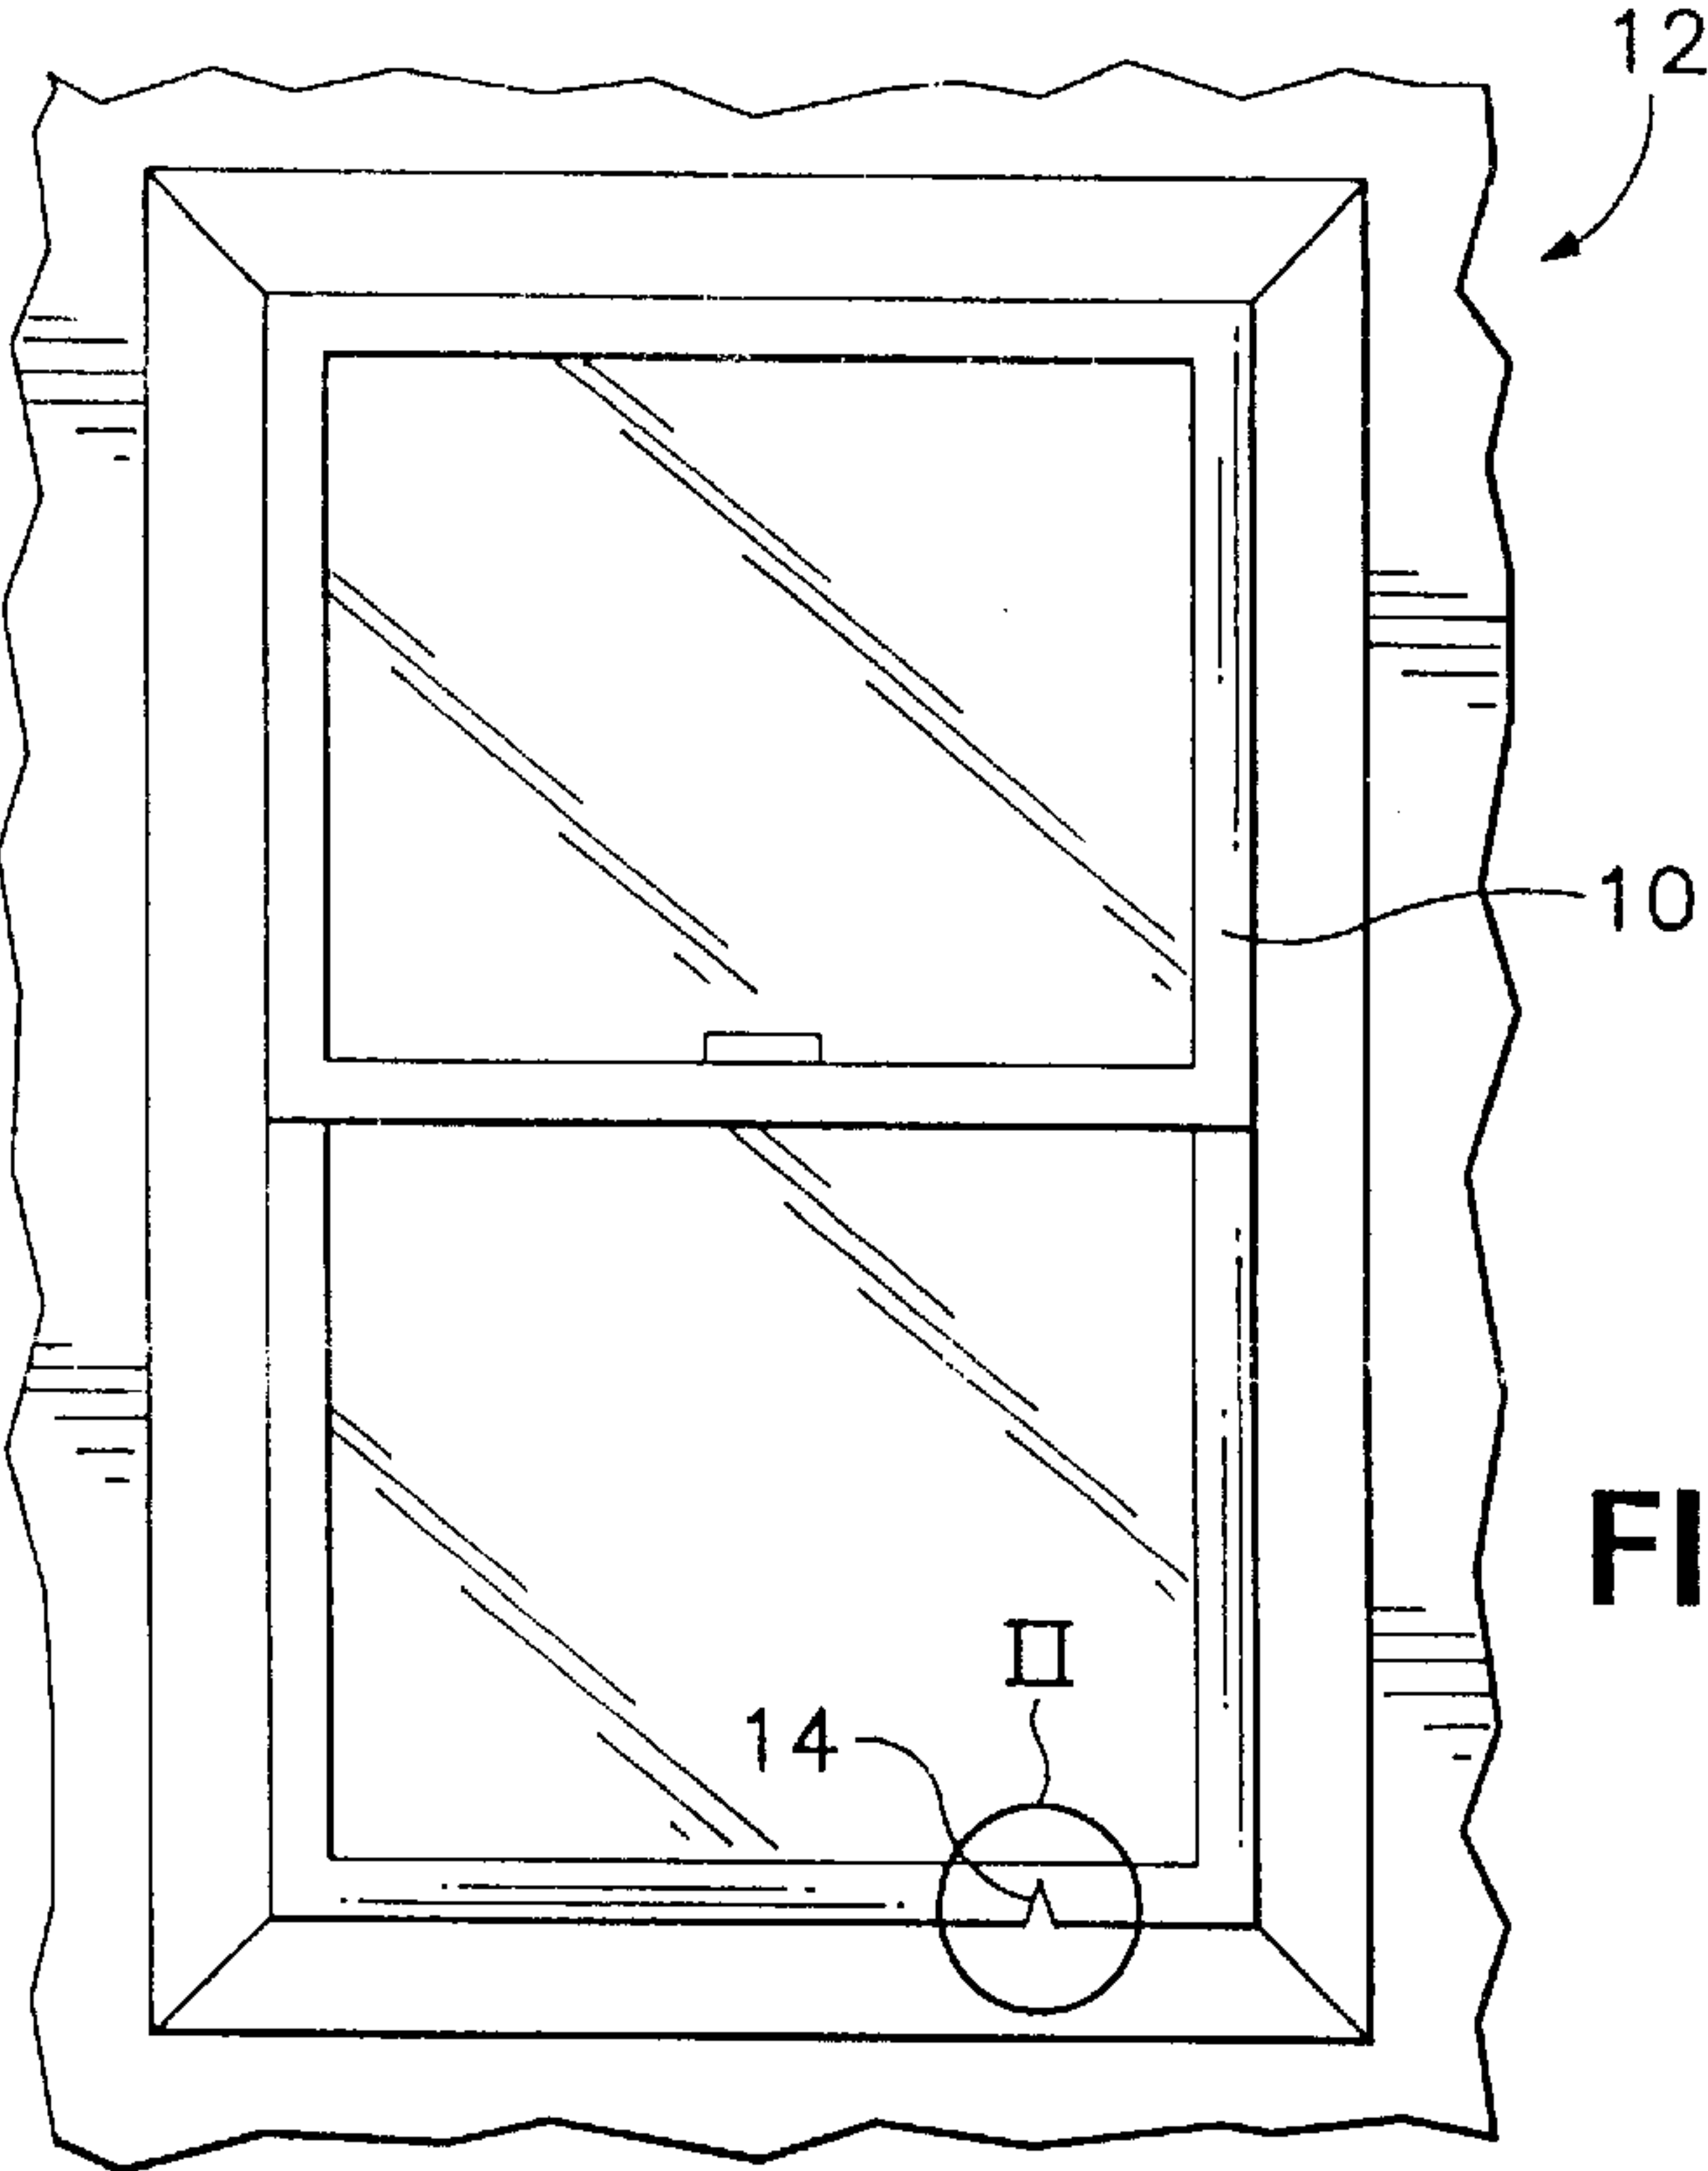
FIG. 1 is a general elevation view of a window frame that has been installed in a wooden frame but has been damaged,

FIG. 1 illustrates schematically a window frame 10 installed in a wood structure 12. The window frame is made of high density PVC. The frame will generally be white, but other colors of frames are also possible. The frame has been gouged at 14, e.g. by a drywall knife. The gouge 14 does not impair significantly the structural integrity of the window frame 10 but it is unsightly and, under normal circumstances, the presence of the gouge would necessitate that the window frame 10 be removed and a new window frame installed.

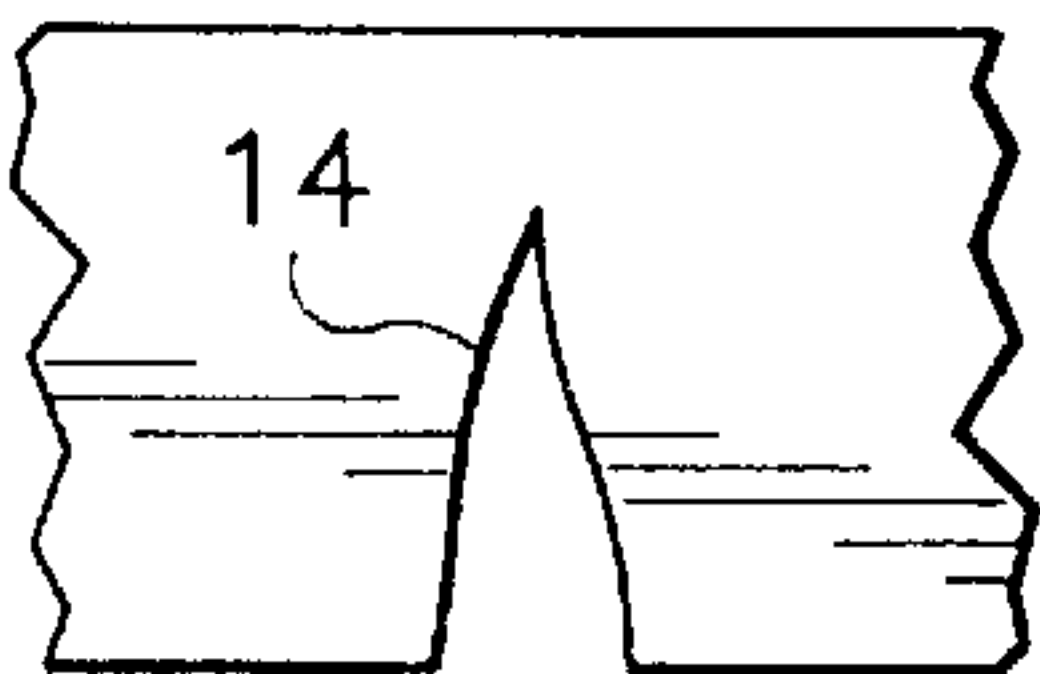
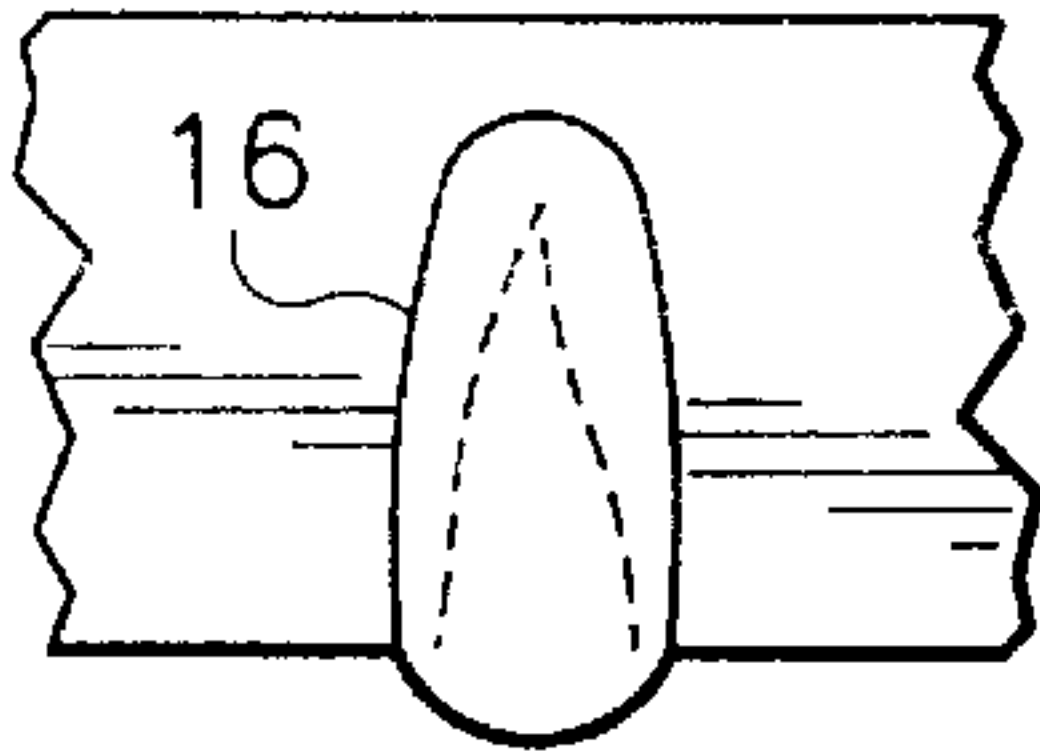
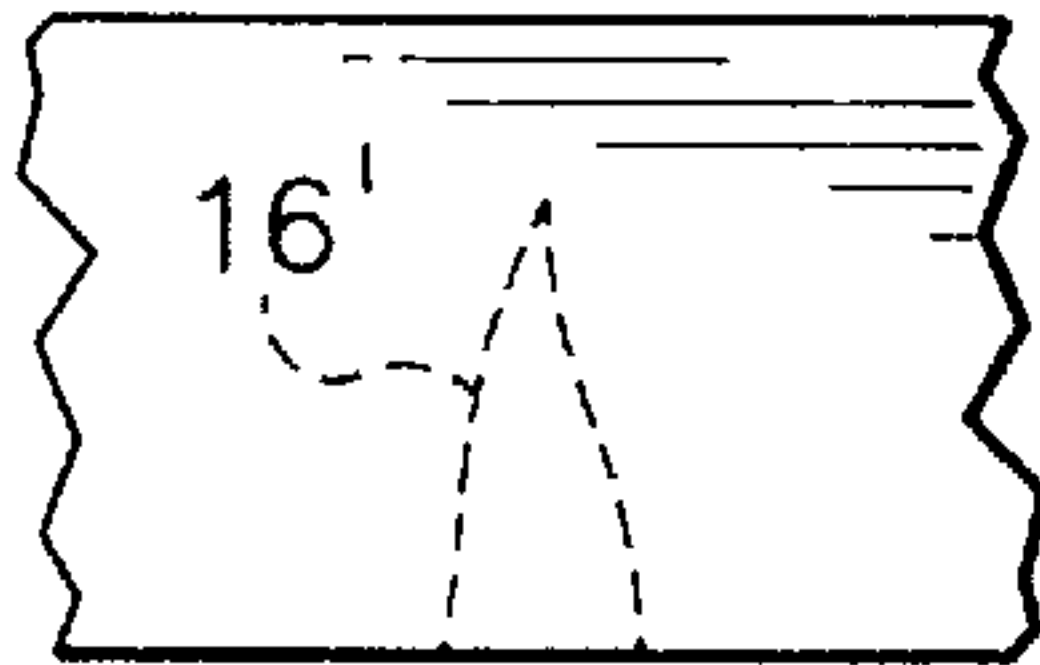
FIGS. 2A-2C, collectively referred to as FIG. 2, illustrate the detail II of FIG. 1 at successive stages during repair of the damage by a first method in accordance with the present invention, and

Referring to FIG. 2, the gouge 14 is filled with a PVC filler. A suitable filler can be made by adding pigment to a clear PVC cement to give a paste-like consistency. The pigment is selected so that the filler will match the color of the window frame. For example, white titanium dioxide pigment may be used in the case of a white window frame. It is preferred that the PVC cement be fairly heavy bodied, but even a light bodied cement can be used. Suitable clear PVC cements are used for repair of PVC pipe and fittings and are sold by Oatey Manufacturing of Cleveland, Ohio and by IPS Corporation under the designation WELD-ON. Sufficient filler is used to fill the gouge and stand slightly proud of the surrounding frame, as shown in FIG. 2B. When the filler has cured, the fillet 16 is securely bonded to the frame and it can be sanded down flush with the surrounding frame using a fine abrasive. The sanded fillet 16' is barely perceptible.

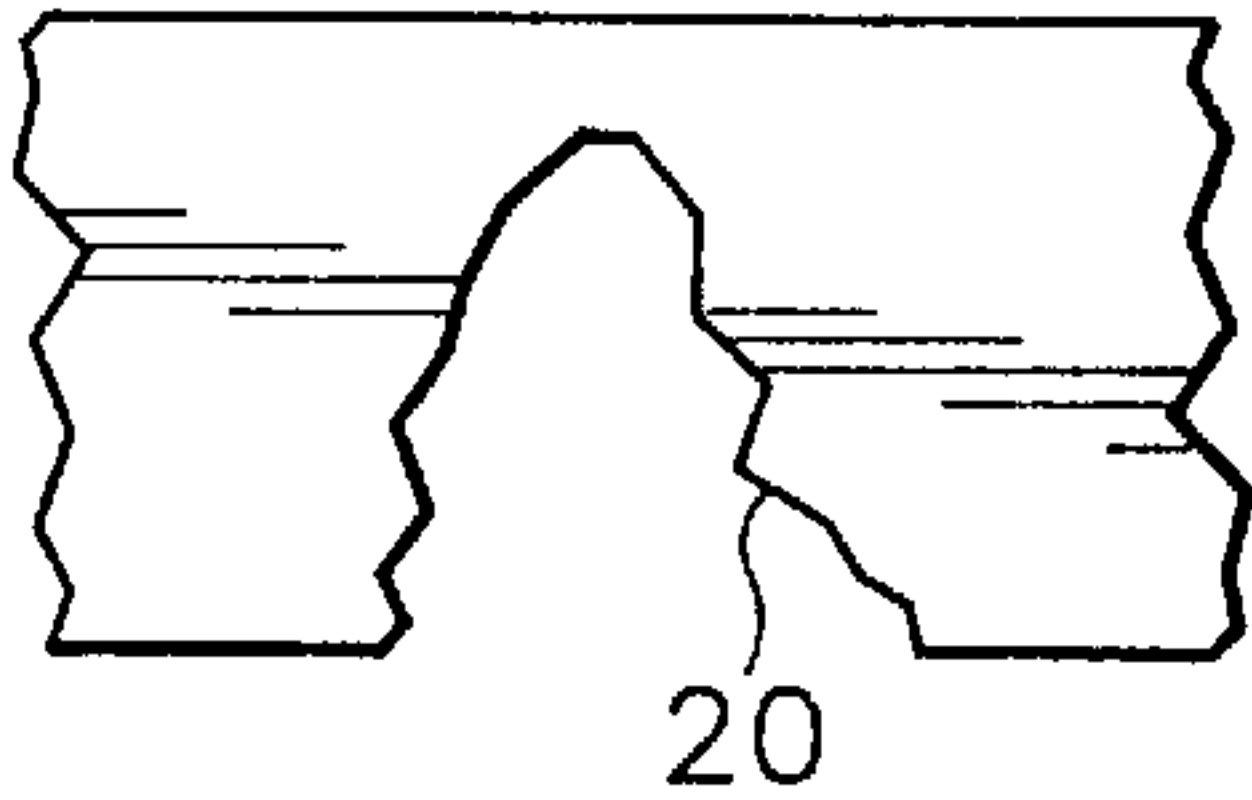
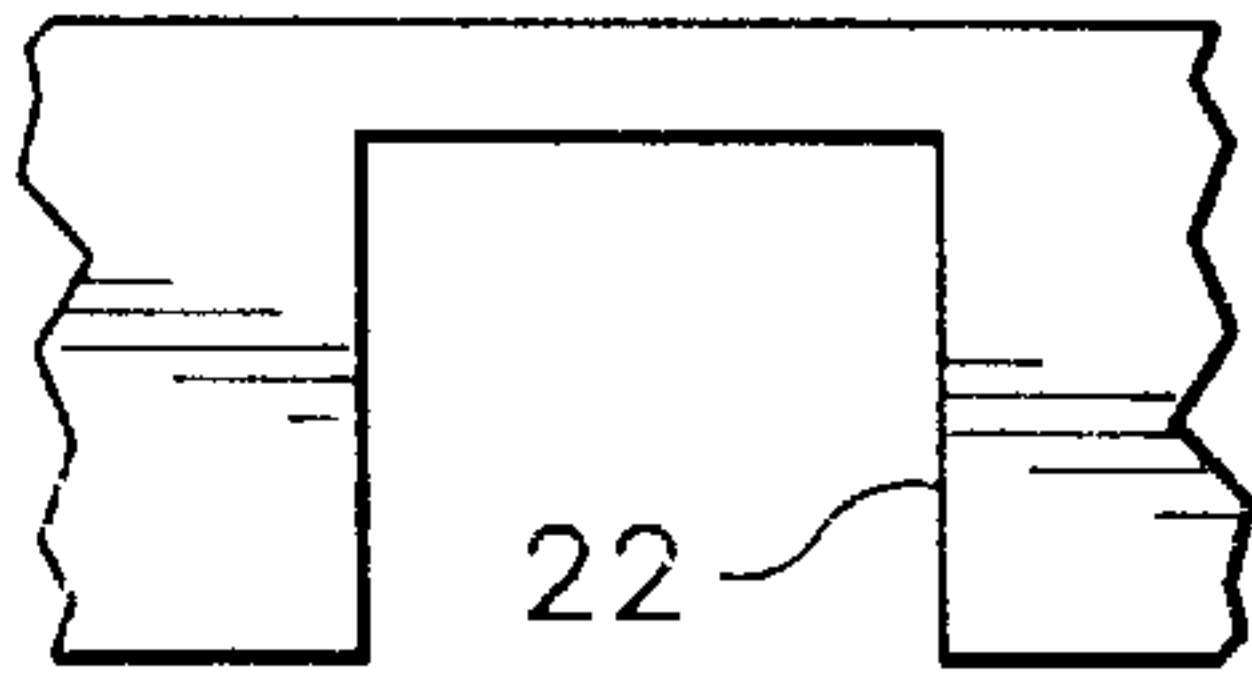
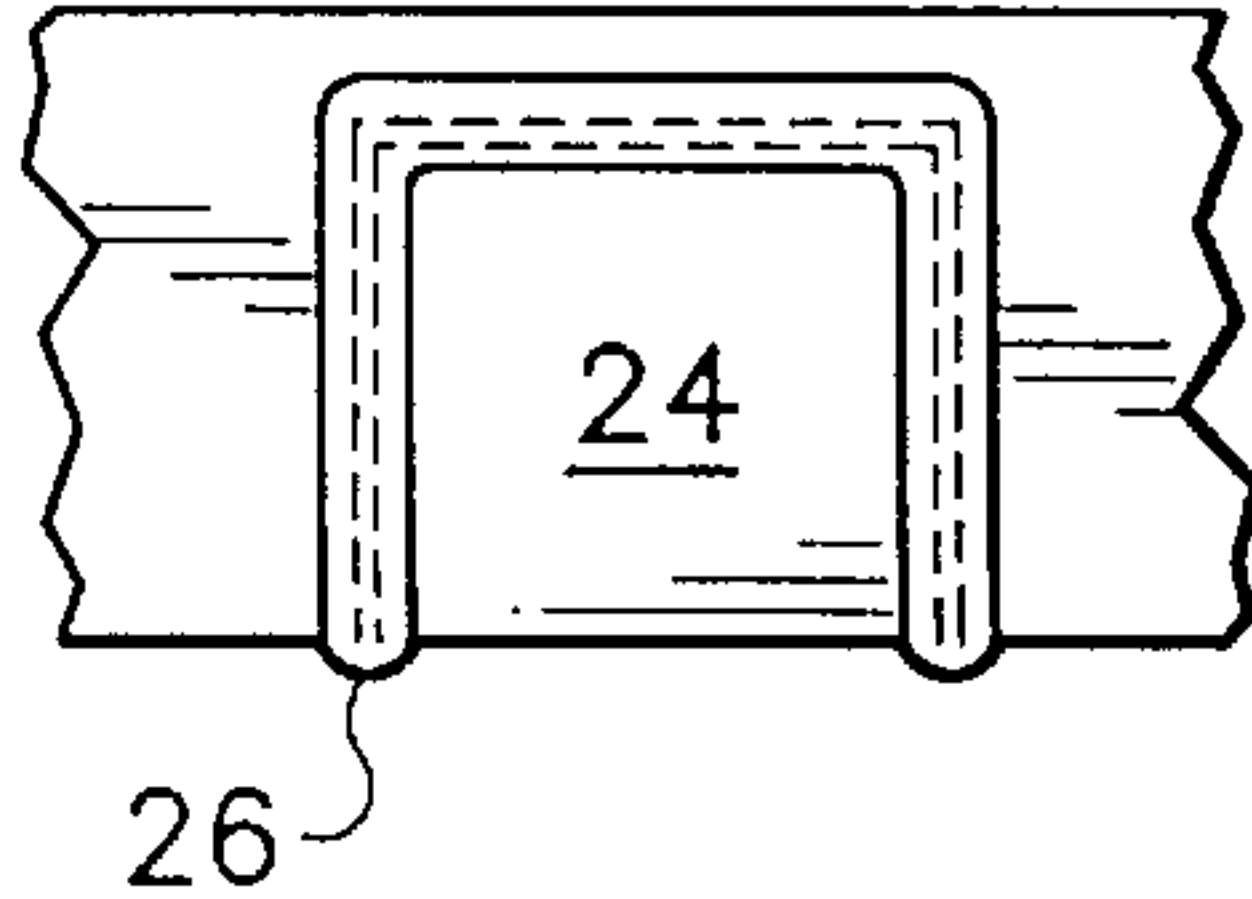
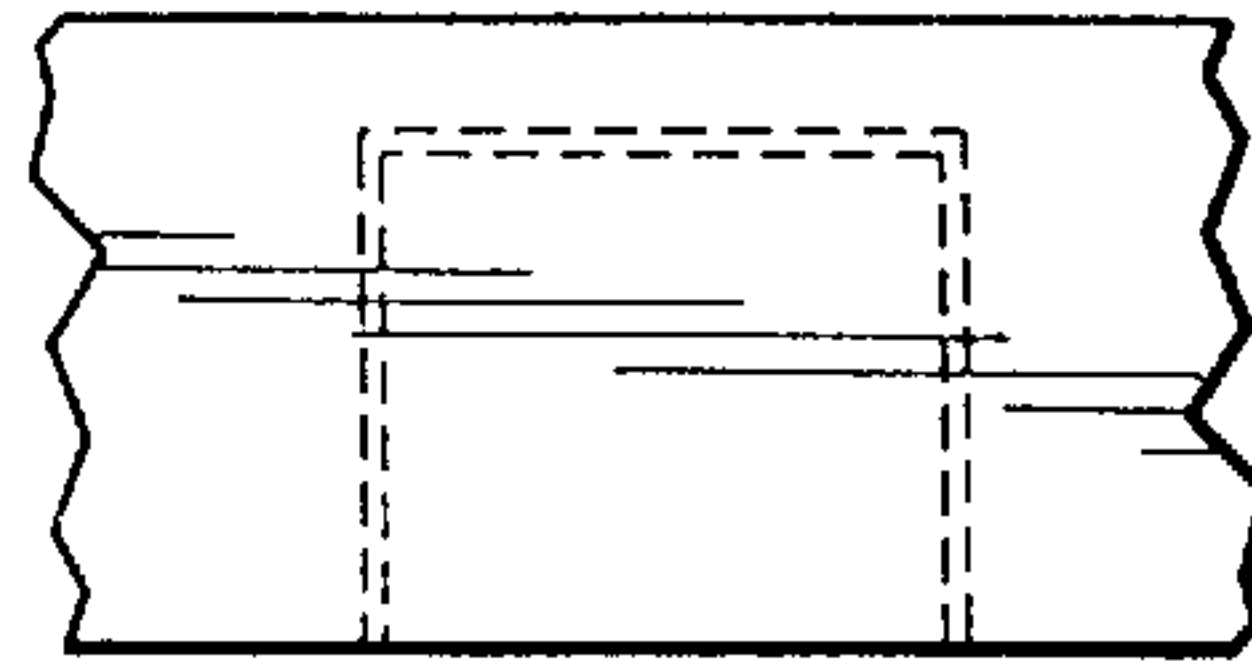
FIGS. 3A-3D, collectively referred to as FIG. 3, illustrate successive stages during repair of damage to a window frame by a second method in accordance with the present invention.

FIG. 3 shows a rather large chip 20 having been made in the frame. It is possible to repair the chip by cutting out the material around the chip to form a hole 22 of a desired shape, for example a rectangle, as shown in FIG. 3B. A patch 24 of PVC can then be cut to fit the hole 22 in the frame and it can be bonded in place using the PVC filler 26 (FIG. 3C). When the filler has cured, any surplus filler can be removed by sanding using a fine abrasive. The repair is barely perceptible and the structural integrity of the frame is not significantly impaired.
