US006077465A

[54] **METHOD OF REPAIRING A VINYL WINDOW FRAME**

A defect in a vinyl window frame is repaired by filling the defect with a PVC filler including a PVC cement and allowing the PVC filler to cure.

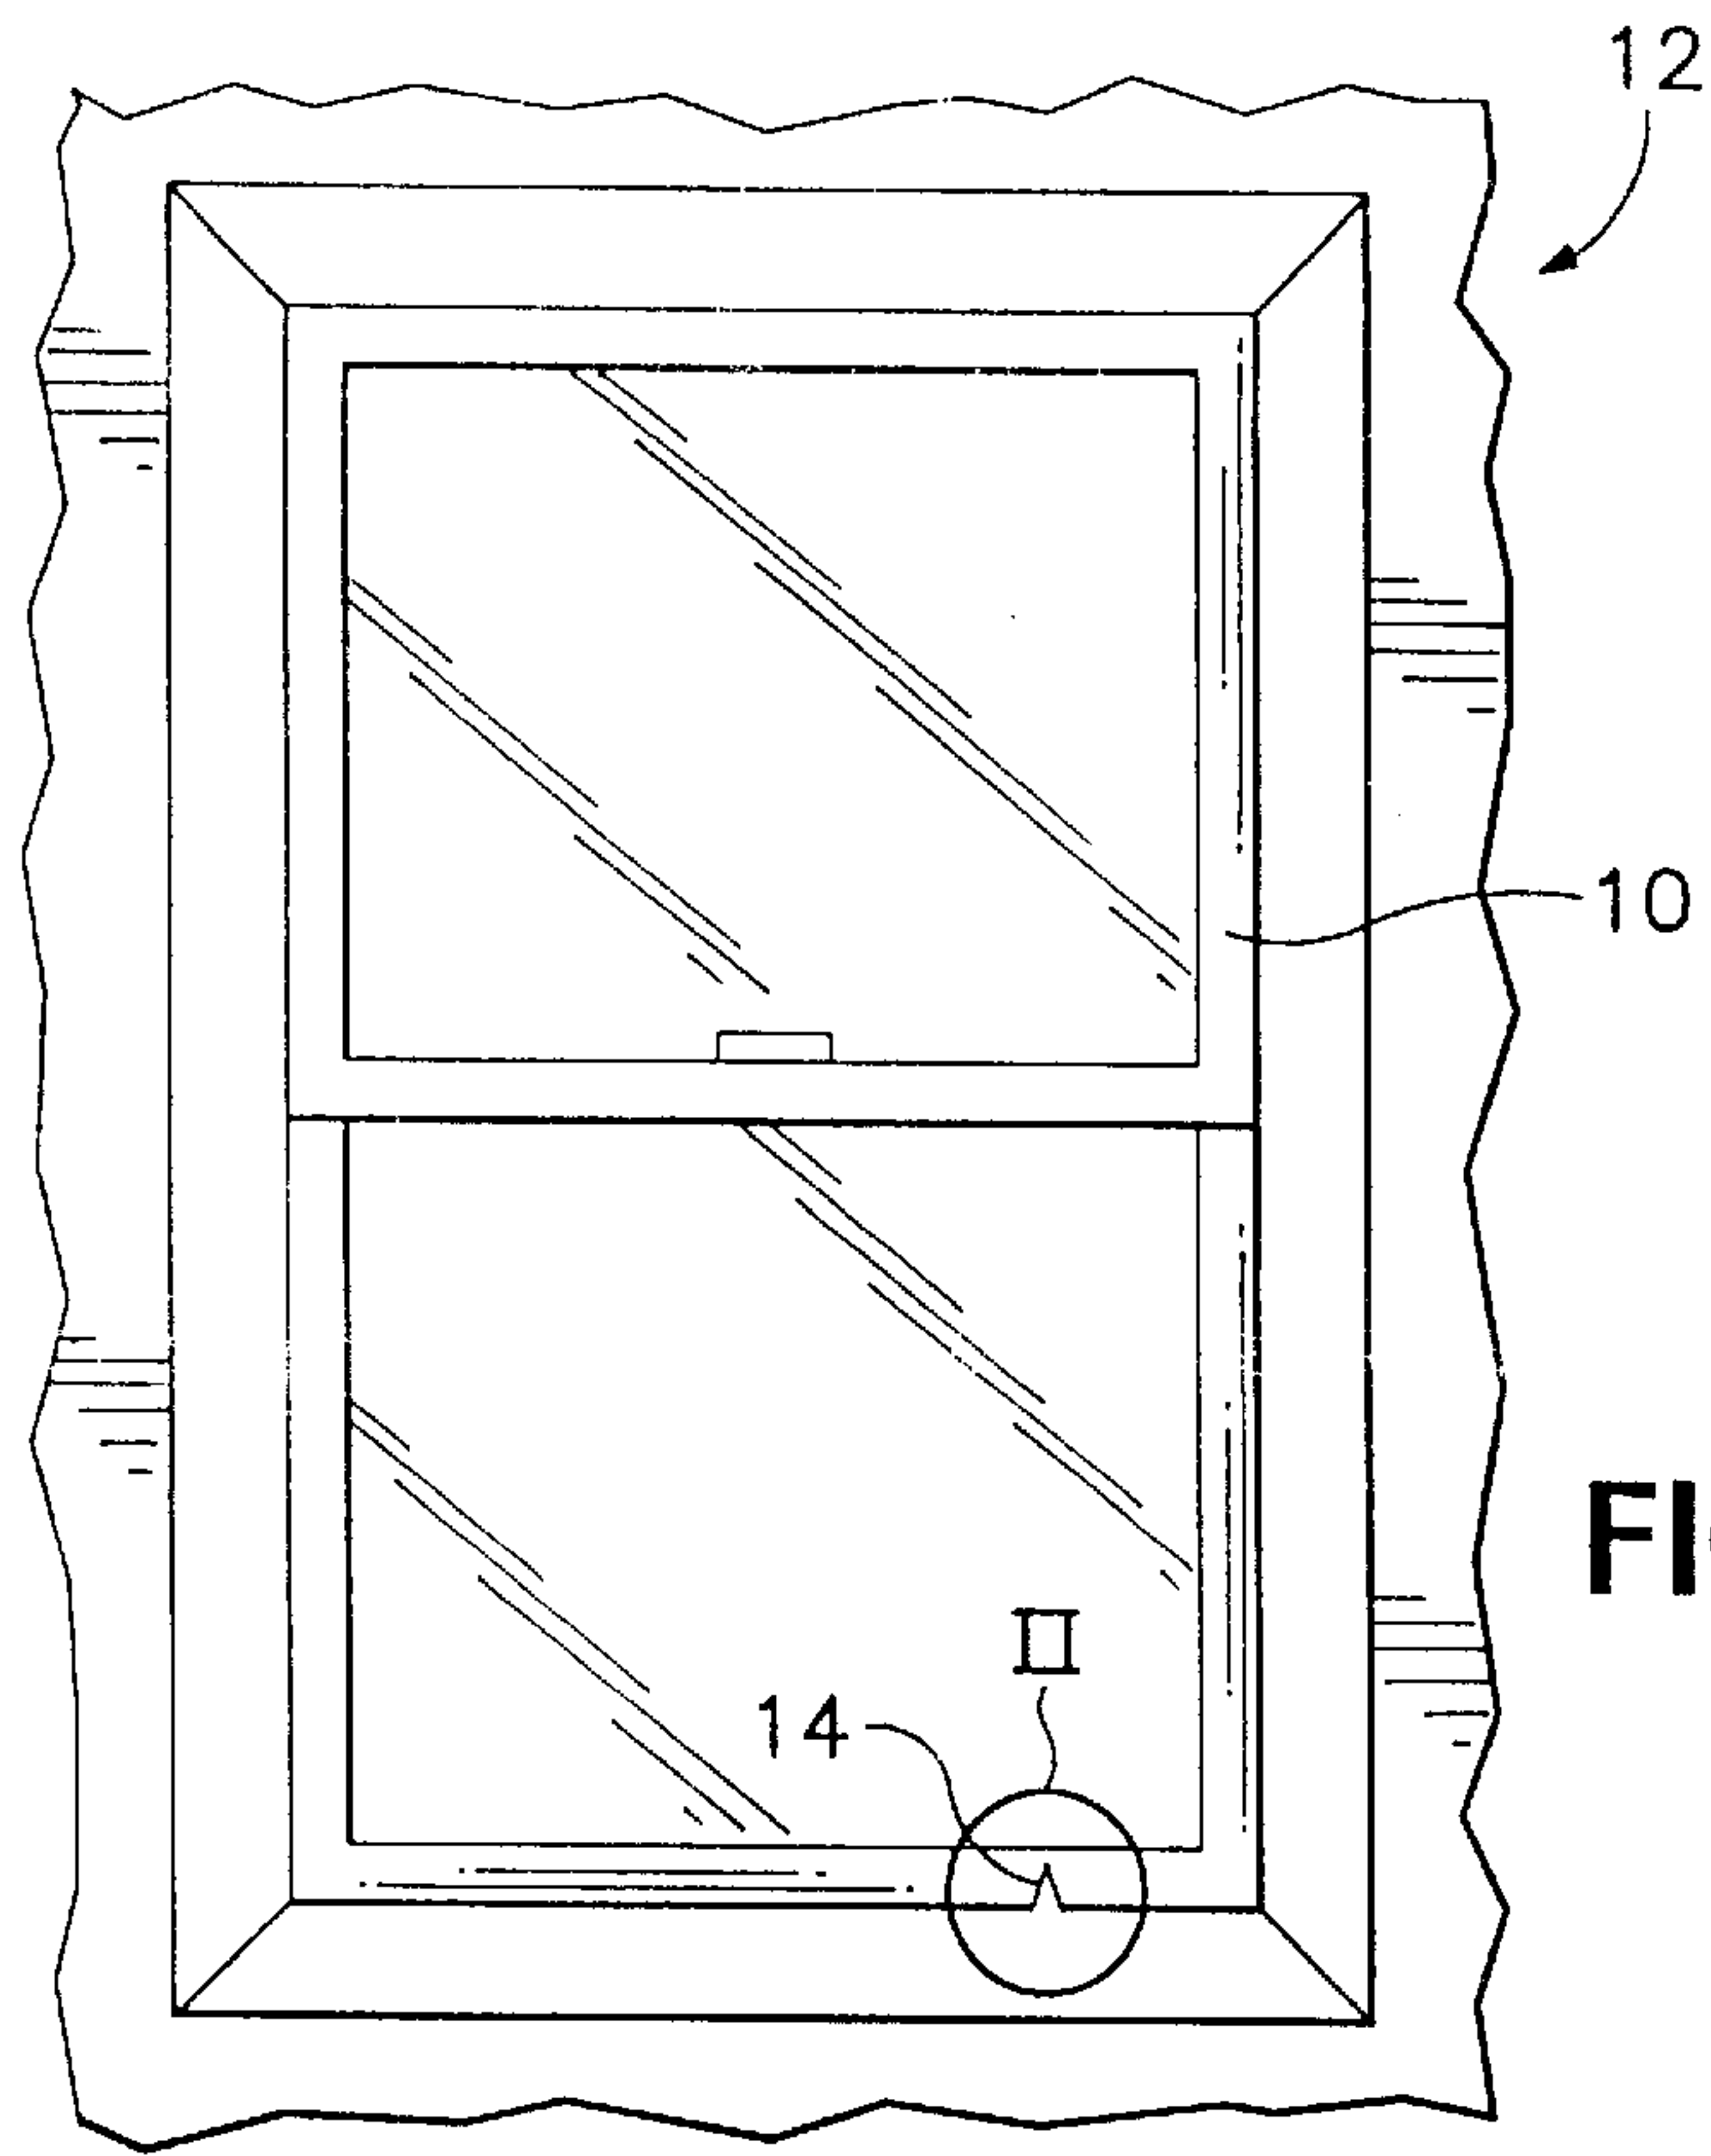
FIG. 1 is a general elevation view of a window frame that has been installed in a wooden frame but has been damaged,

FIG. 1 illustrates schematically a window frame **10** installed in a wood structure **12**. The window frame is made of high density PVC. The frame will generally be white, but other colors of frames are also possible. The frame has been gouged at **14**, e.g. by a drywall knife. The gouge **14** does not impair significantly the structural integrity of the window frame **10** but it is unsightly and, under normal circumstances, the presence of the gouge would necessitate that the window frame **10** be removed and a new window frame installed.

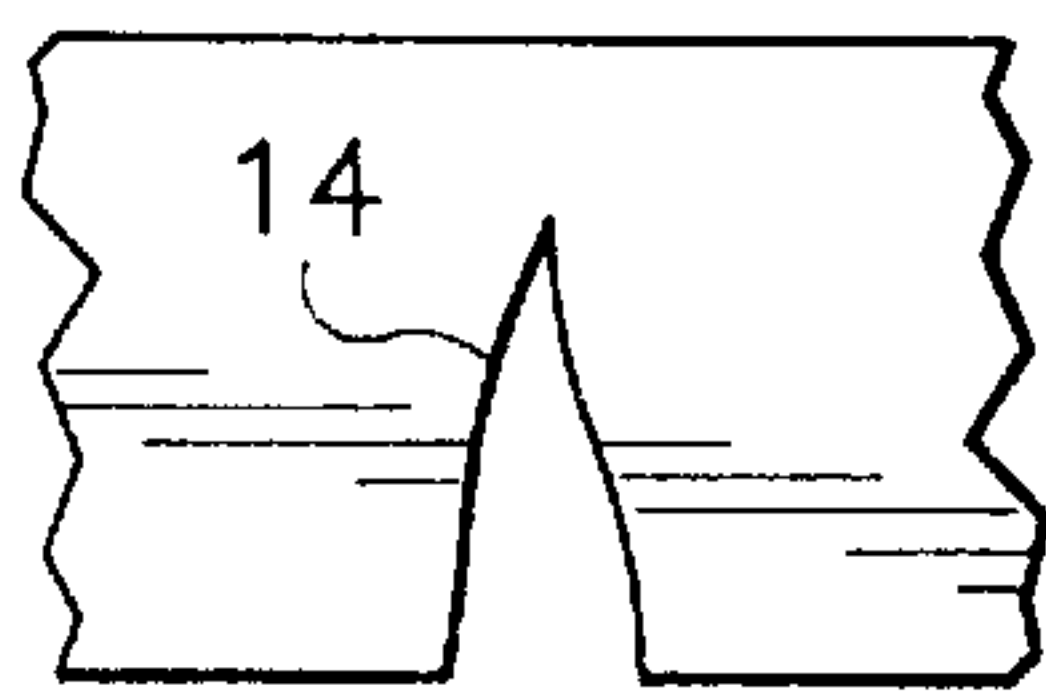
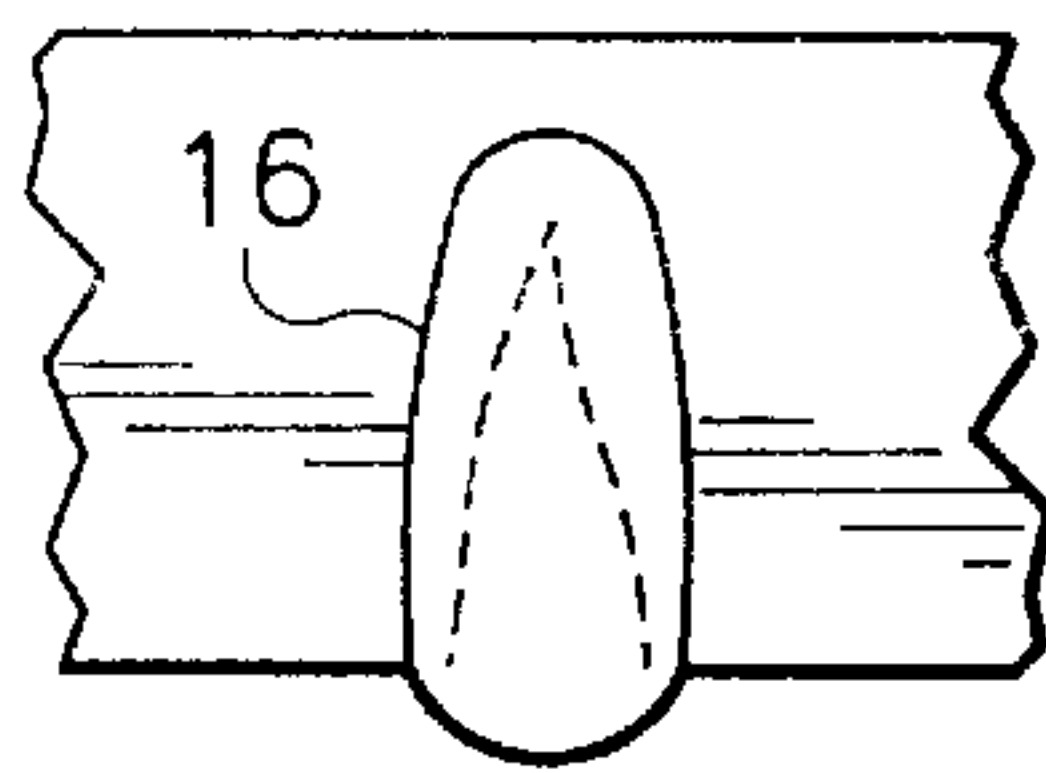
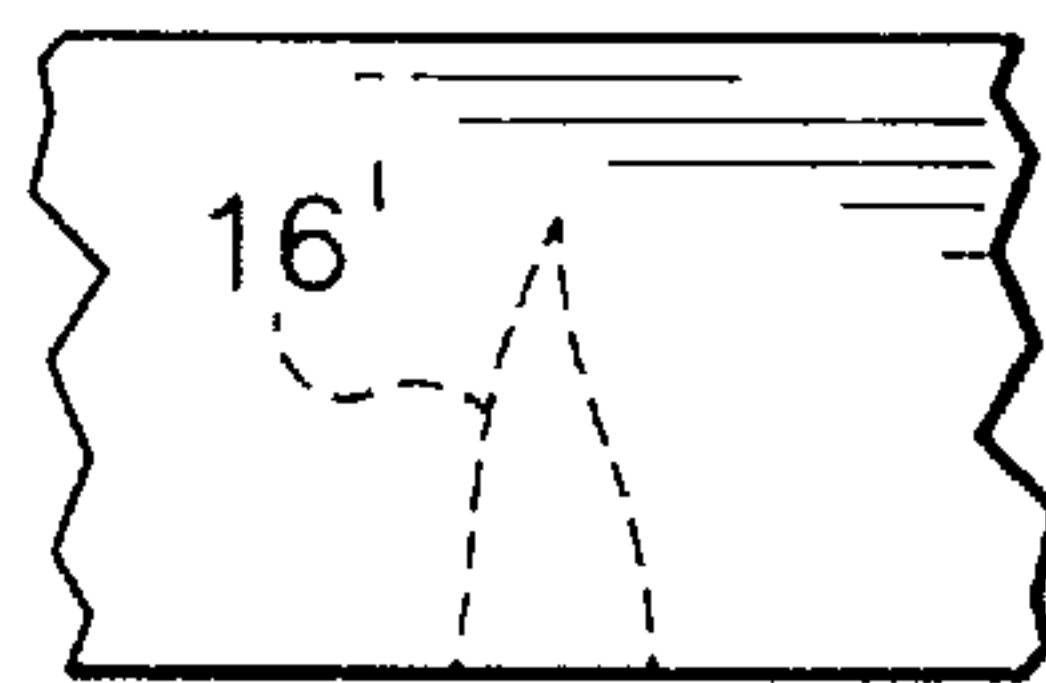
FIG. 2A

FIGS. 2A-2C, collectively referred to as FIG. 2, illustrate the detail II of FIG. 1 at successive stages during repair of the damage by a first method in accordance with the present invention, and

Referring to FIG. 2, the gouge **14** is filled with a PVC filler. A suitable filler can be made by adding pigment to a clear PVC cement to give a paste-like consistency. The pigment is selected so that the filler will match the color of the window frame. For example, white titanium dioxide pigment may be used in the case of a white window frame. It is preferred that the PVC cement be fairly heavy bodied, but even a light bodied cement can be used. Suitable clear PVC cements are used for repair of PVC pipe and fittings and are sold by Oatey Manufacturing of Cleveland, Ohio and by IPS Corporation under the designation WELD-ON. Sufficient filler is used to fill the gouge and stand slightly proud of the surrounding frame, as shown in FIG. 2B. When the filler has cured, the fillet **16** is securely bonded to the frame and it can be sanded down flush with the surrounding frame using a fine abrasive. The sanded fillet **16'** is barely perceptible.

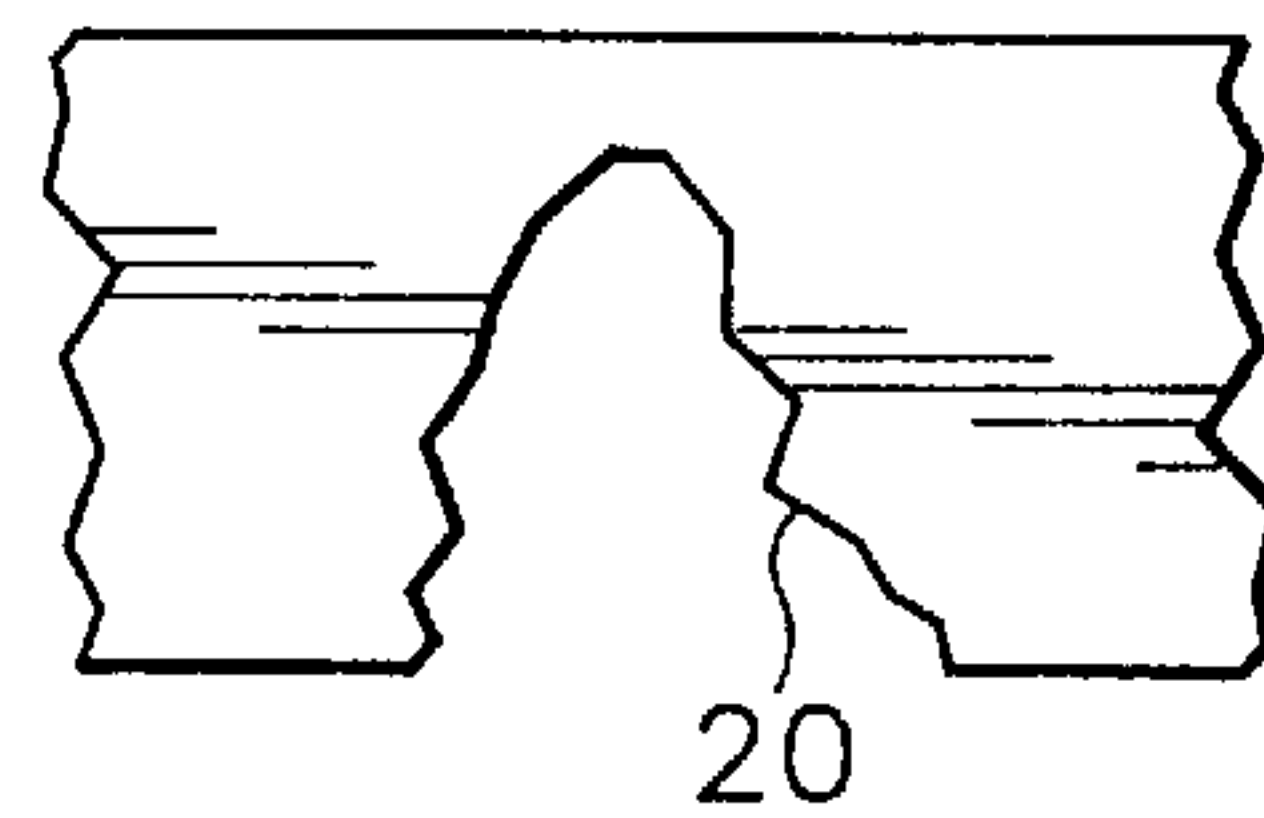
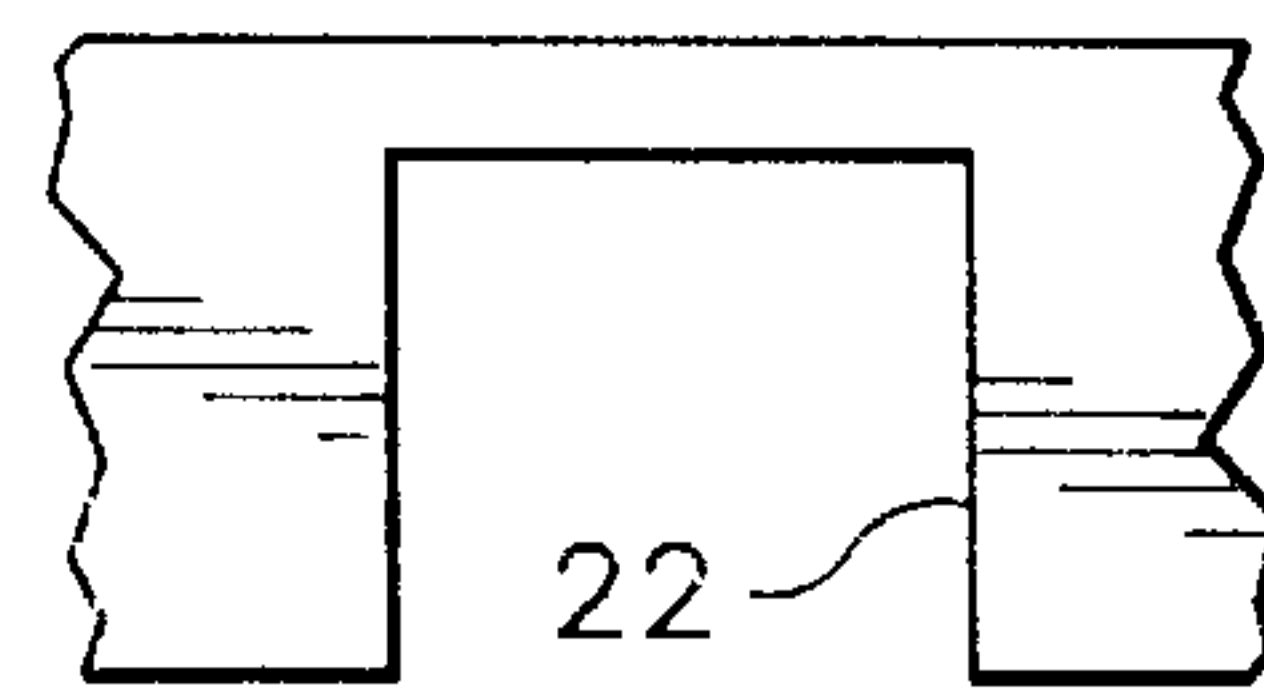
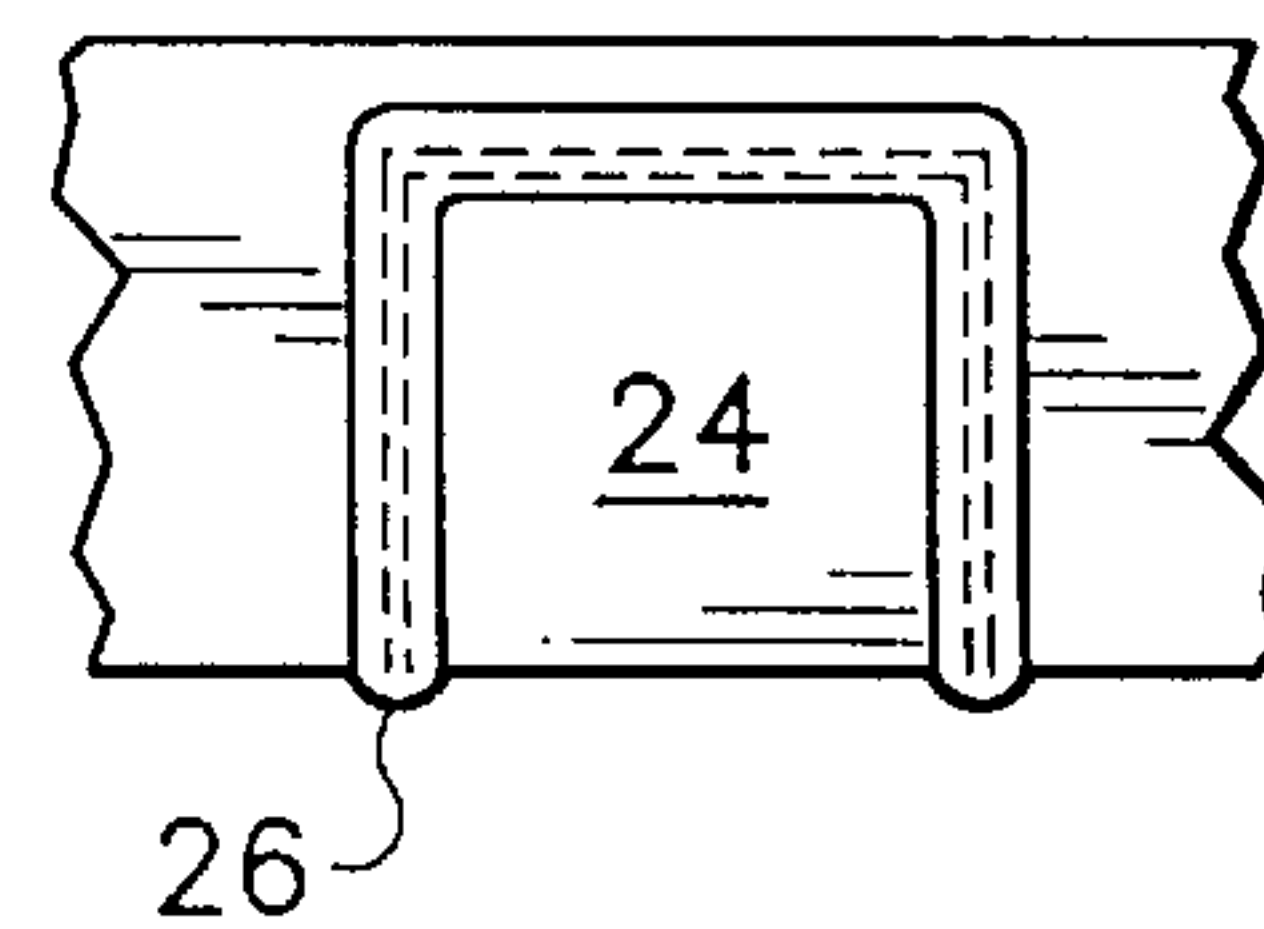
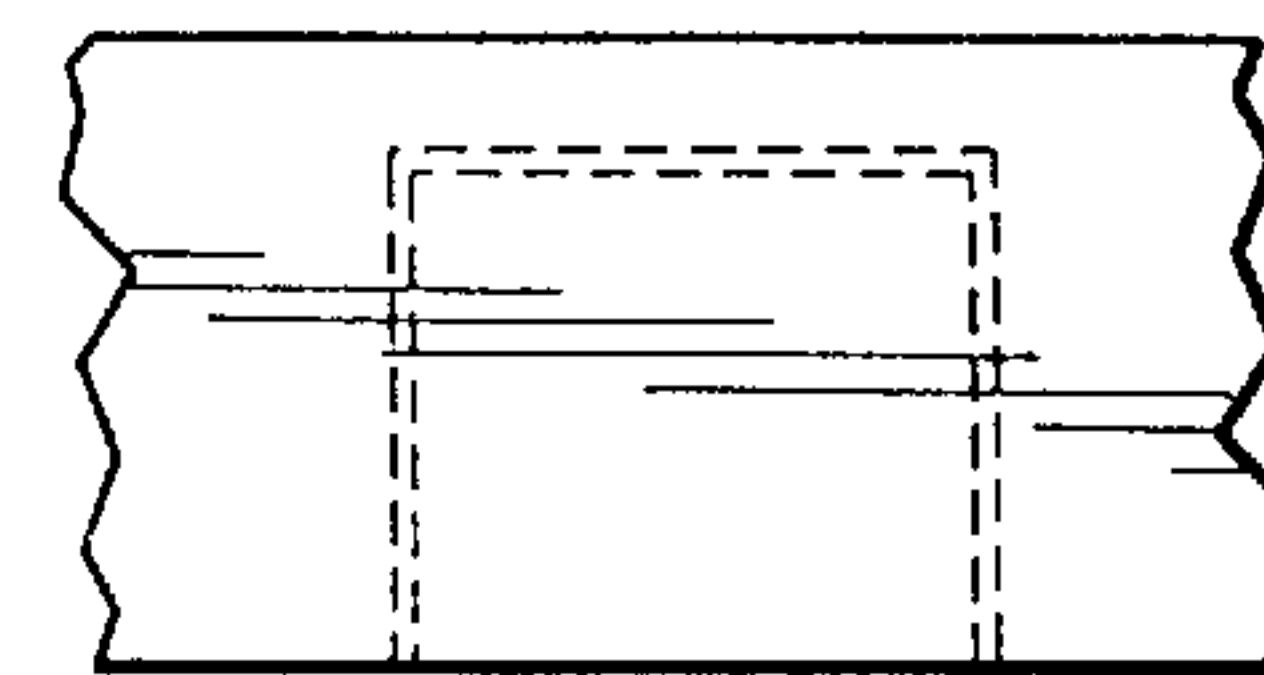
FIG. 3A

FIGS. 3A-3D, collectively referred to as FIG. 3, illustrate successive stages during repair of damage to a window frame by a second method in accordance with the present invention.

FIG. 3 shows a rather large chip **20** having been made in the frame. It is possible to repair the chip by cutting out the material around the chip to form a hole **22** of a desired shape, for example a rectangle, as shown in FIG. 3B. A patch **24** of PVC can then be cut to fit the hole **22** in the frame and it can be bonded in place using the PVC filler **26** (FIG. 3C). When the filler has cured, any surplus filler can be removed by sanding using a fine abrasive. The repair is barely perceptible and the structural integrity of the frame is not significantly impaired.
