[54] **REPAIR OF TURBINE EXHAUST CASE**

A process is provided for repairing the horizontal mount area of a JT9D turbine exhaust case having two mounting flanges by inspecting the horizontal mount area, weld repairing any defects found in the case wall and installing a reinforcement brace onto the inside of the case wall in the horizontal mount area, wherein the reinforcement brace overlaps an area under one mounting flange and extends to and overlaps the area under the second mounting flange.

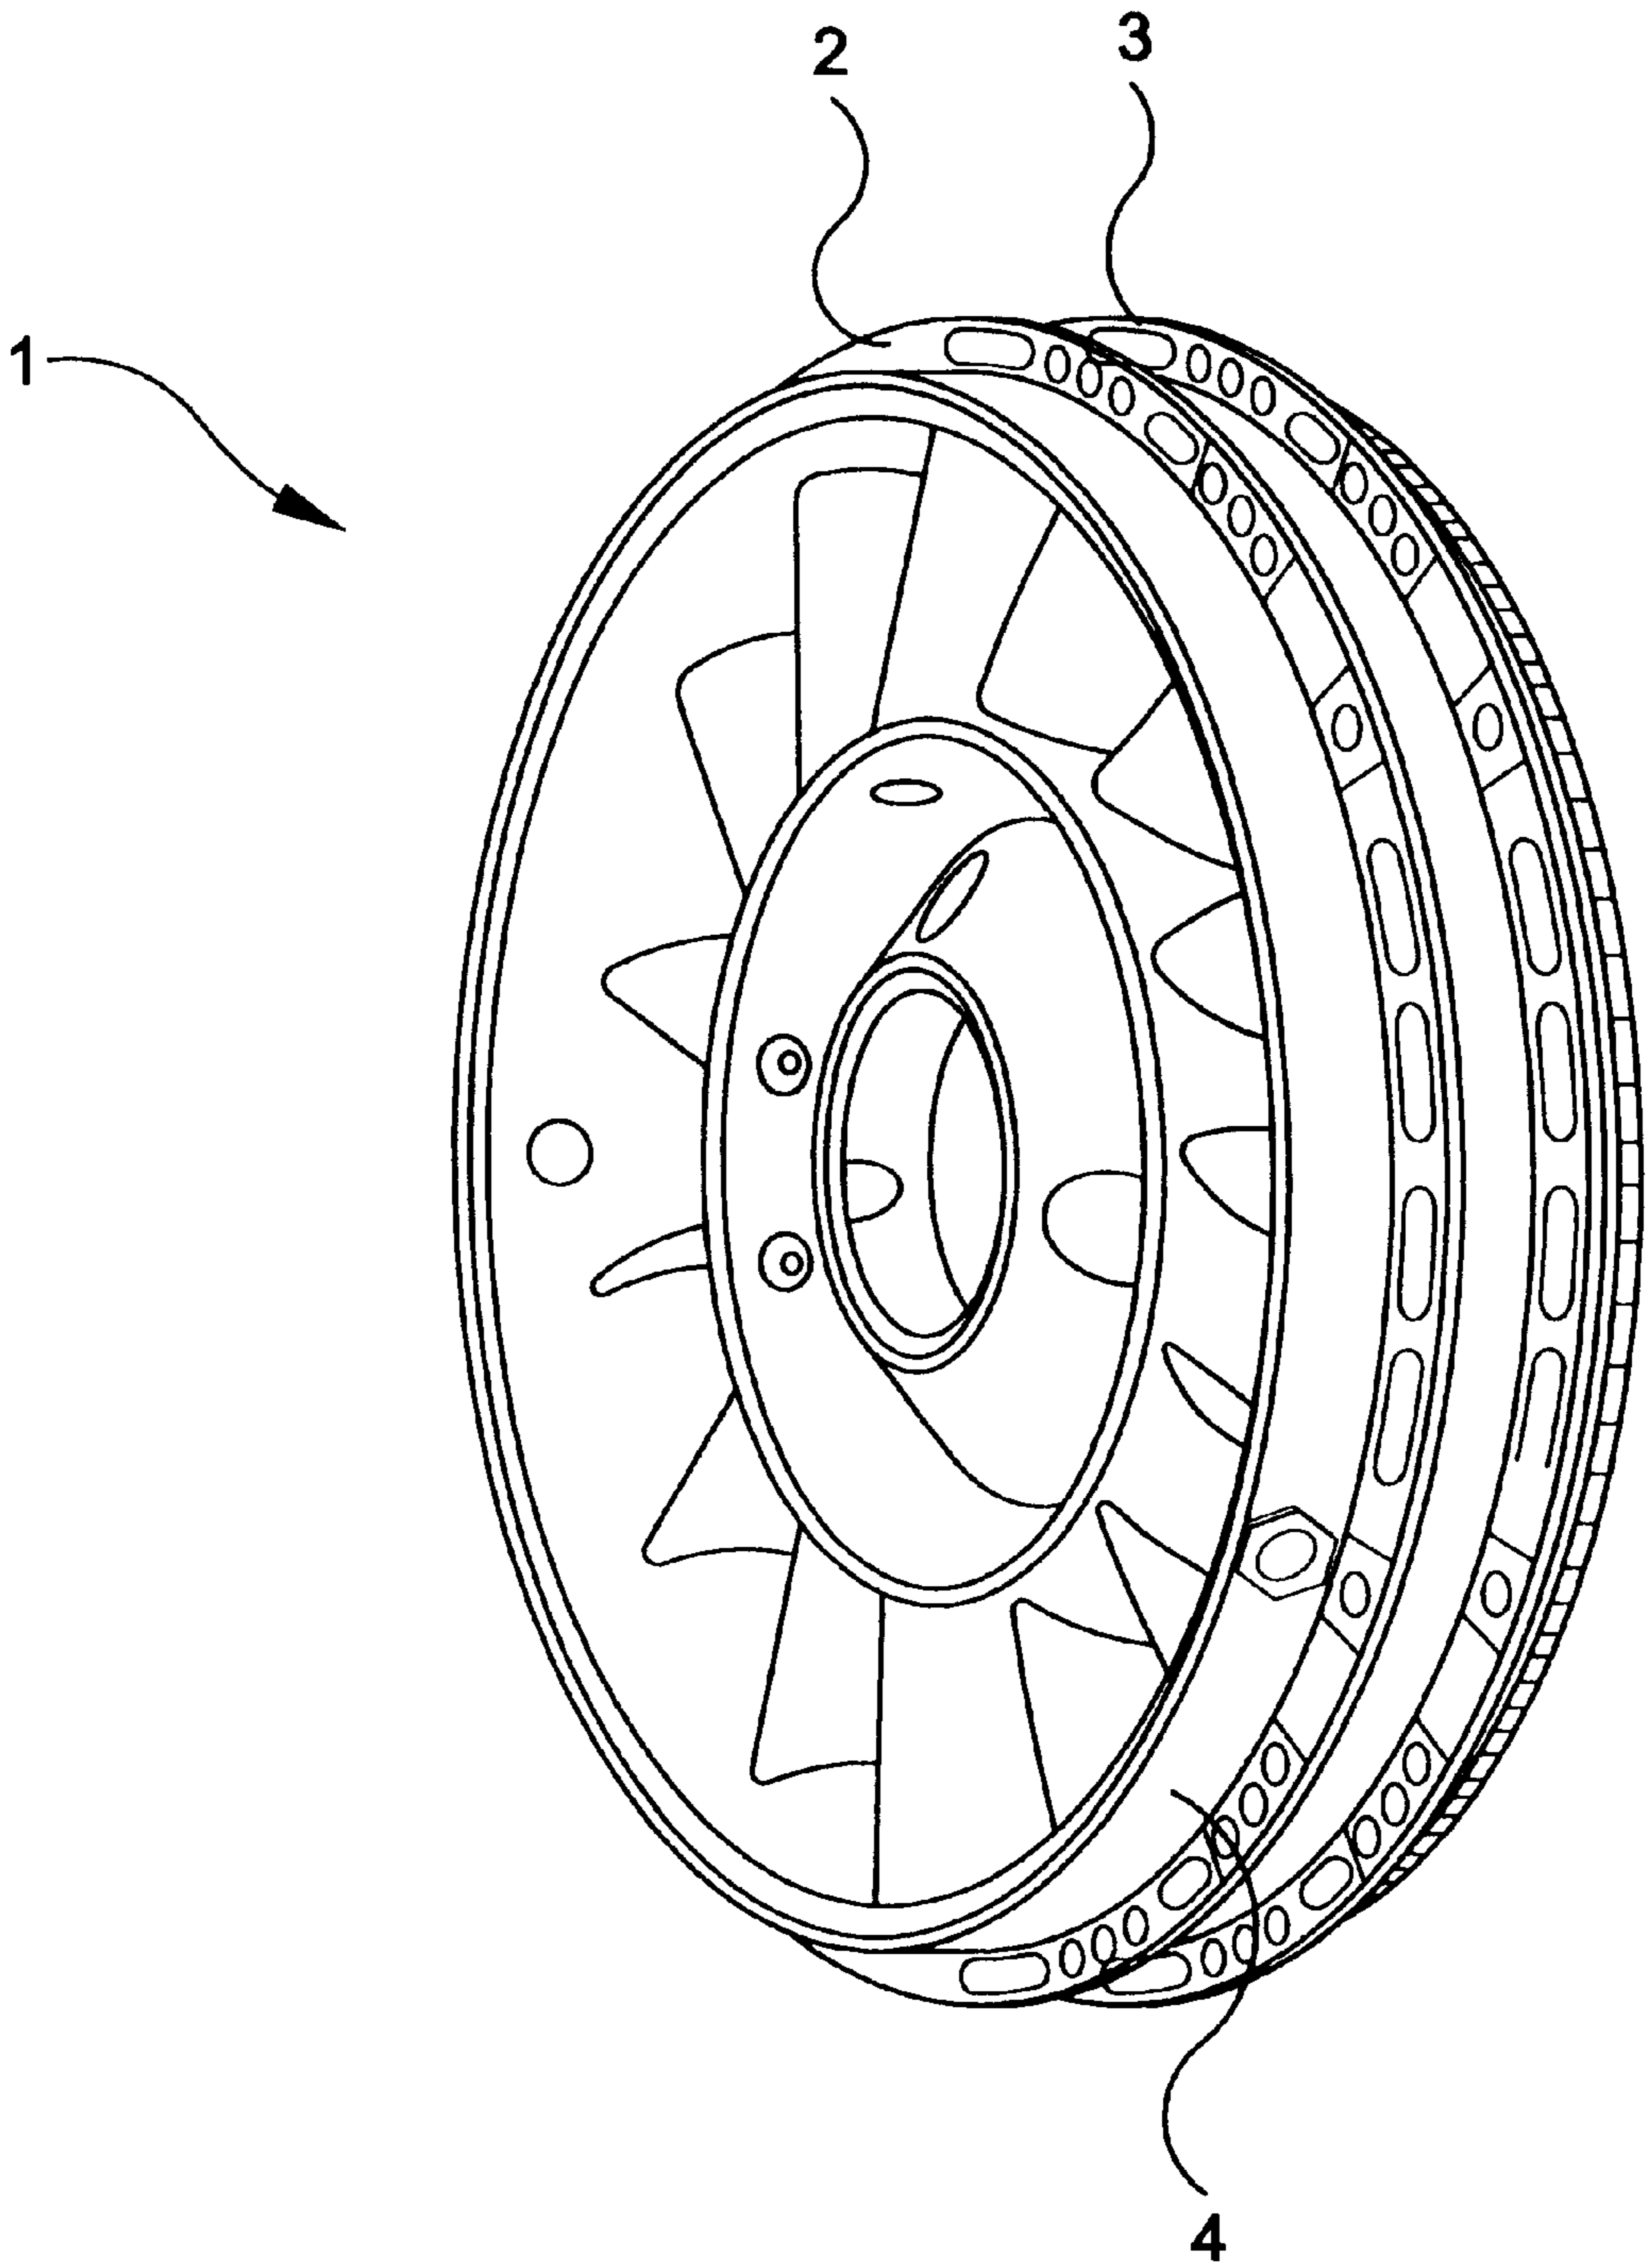
FIG-2

FIG. 2 is a partial top view of the exhaust case of FIG. 1; and

FIG. 1 shows a turbine exhaust case 1 of a JT9D gas turbine engine having two mounting flanges 2 and 3 on the outside of the case wall 4 which are used for attaching the turbine exhaust case to a rear engine mount (not shown). FIG. 2 is a partial top view of FIG. 1 showing the mounting flanges 2 and 3 with the mount lugs 10 secured through the mounting flanges. FIG. 3 is a sectional view along line 3—3 from FIG. 2. FIG. 3 shows the R-Rail mounting flange 2 and S-Rail mounting flange 3 each having therein horizontal mount pinholes 5 and 6 respectively, for insertion of the mount lugs 10 shown in FIG. 2. The horizontal mount area 7 is the area of the case wall 4 adjacent to and between the horizontal mount pinholes 5 and 6 in the two mounting flanges 2 and 3.
