(10) **Patent No.:** **US 6,298,537 B1**
(45) **Date of Patent:** **Oct. 9, 2001**

(54) **PALLET RACK REPAIR SYSTEM**

A method for repairing pallet racks wherein the assembly is used to replace a damaged front post. The repair assembly includes a tubular post having a floor plate at a lower end and a support plate at an upper end with a horizontal brace and a diagonal brace to replace the existing braces. The assembly is structurally solid and has the diagonal brace placed sufficiently high above the floor to avoid damage by forklift trucks.

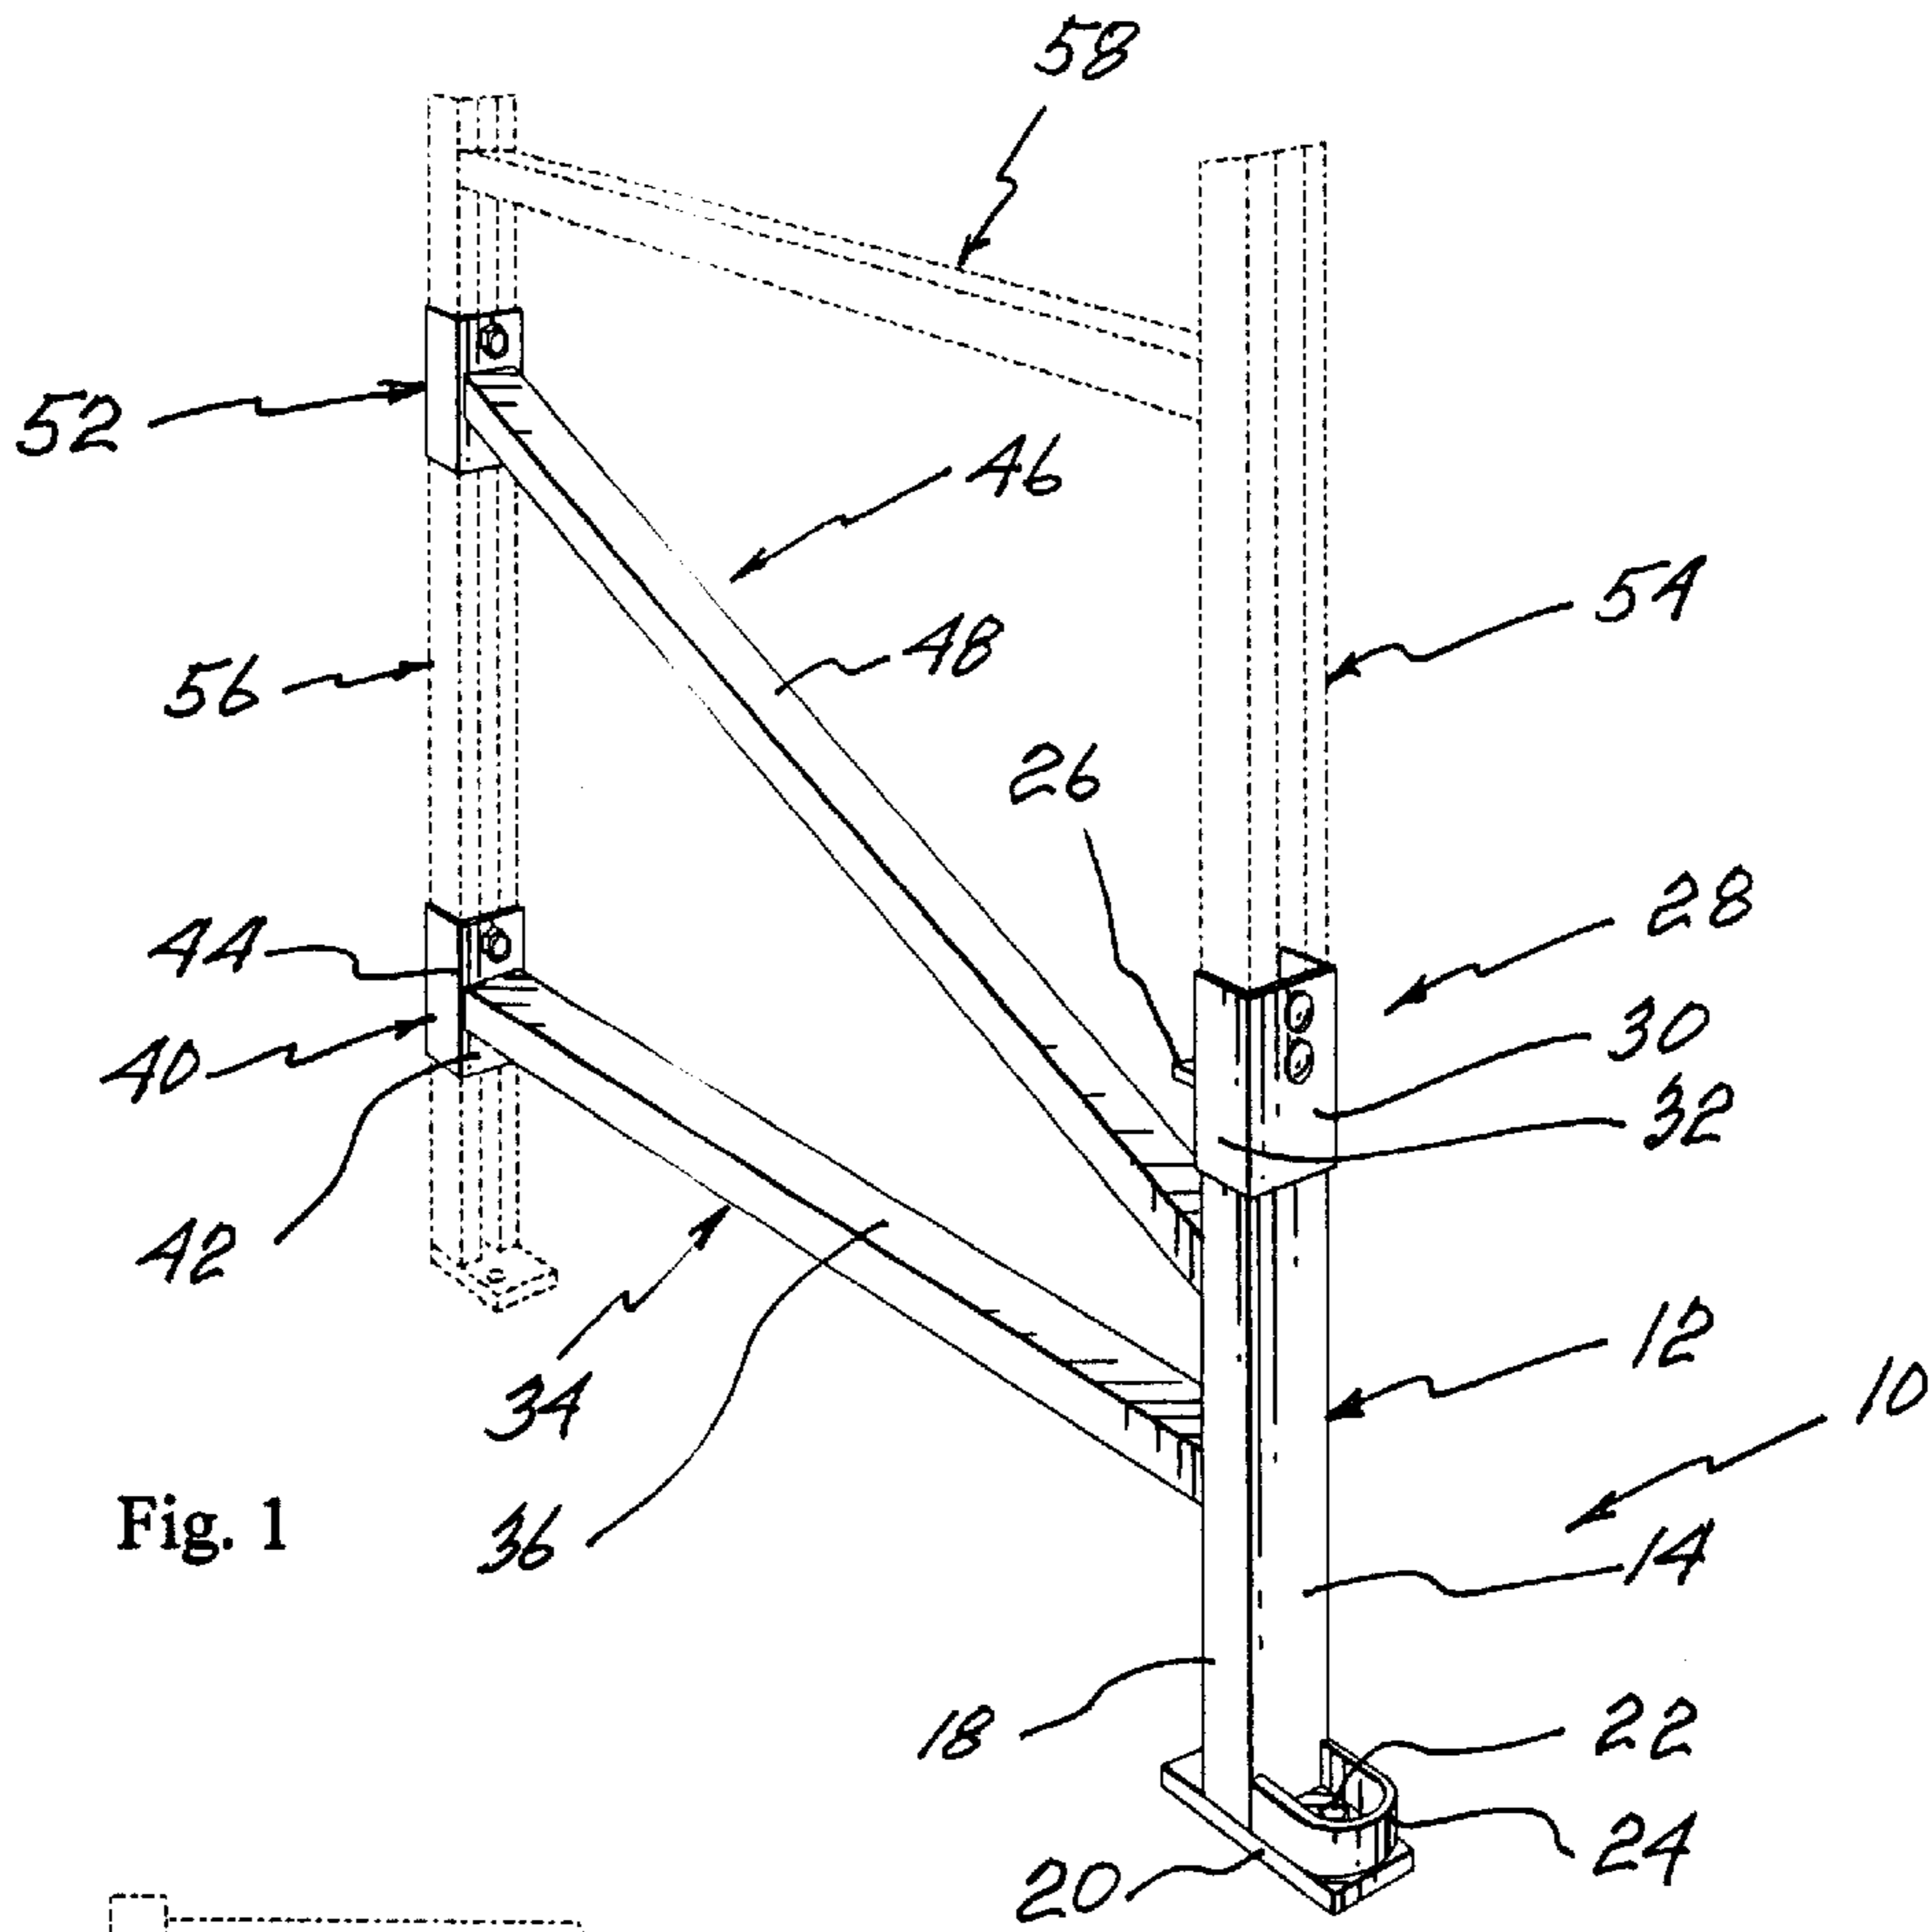
Fig. 1

FIG. 1 is a perspective view of a repair system according to the present invention;

Referring to the drawings in greater detail, and by reference characters thereto, there is illustrated in FIG. 1 a repair assembly which is generally designated by reference numeral 10.

Repair assembly 10, in FIGS. 1 and 2, is shown after having replaced a portion of a damaged post 54 as used in

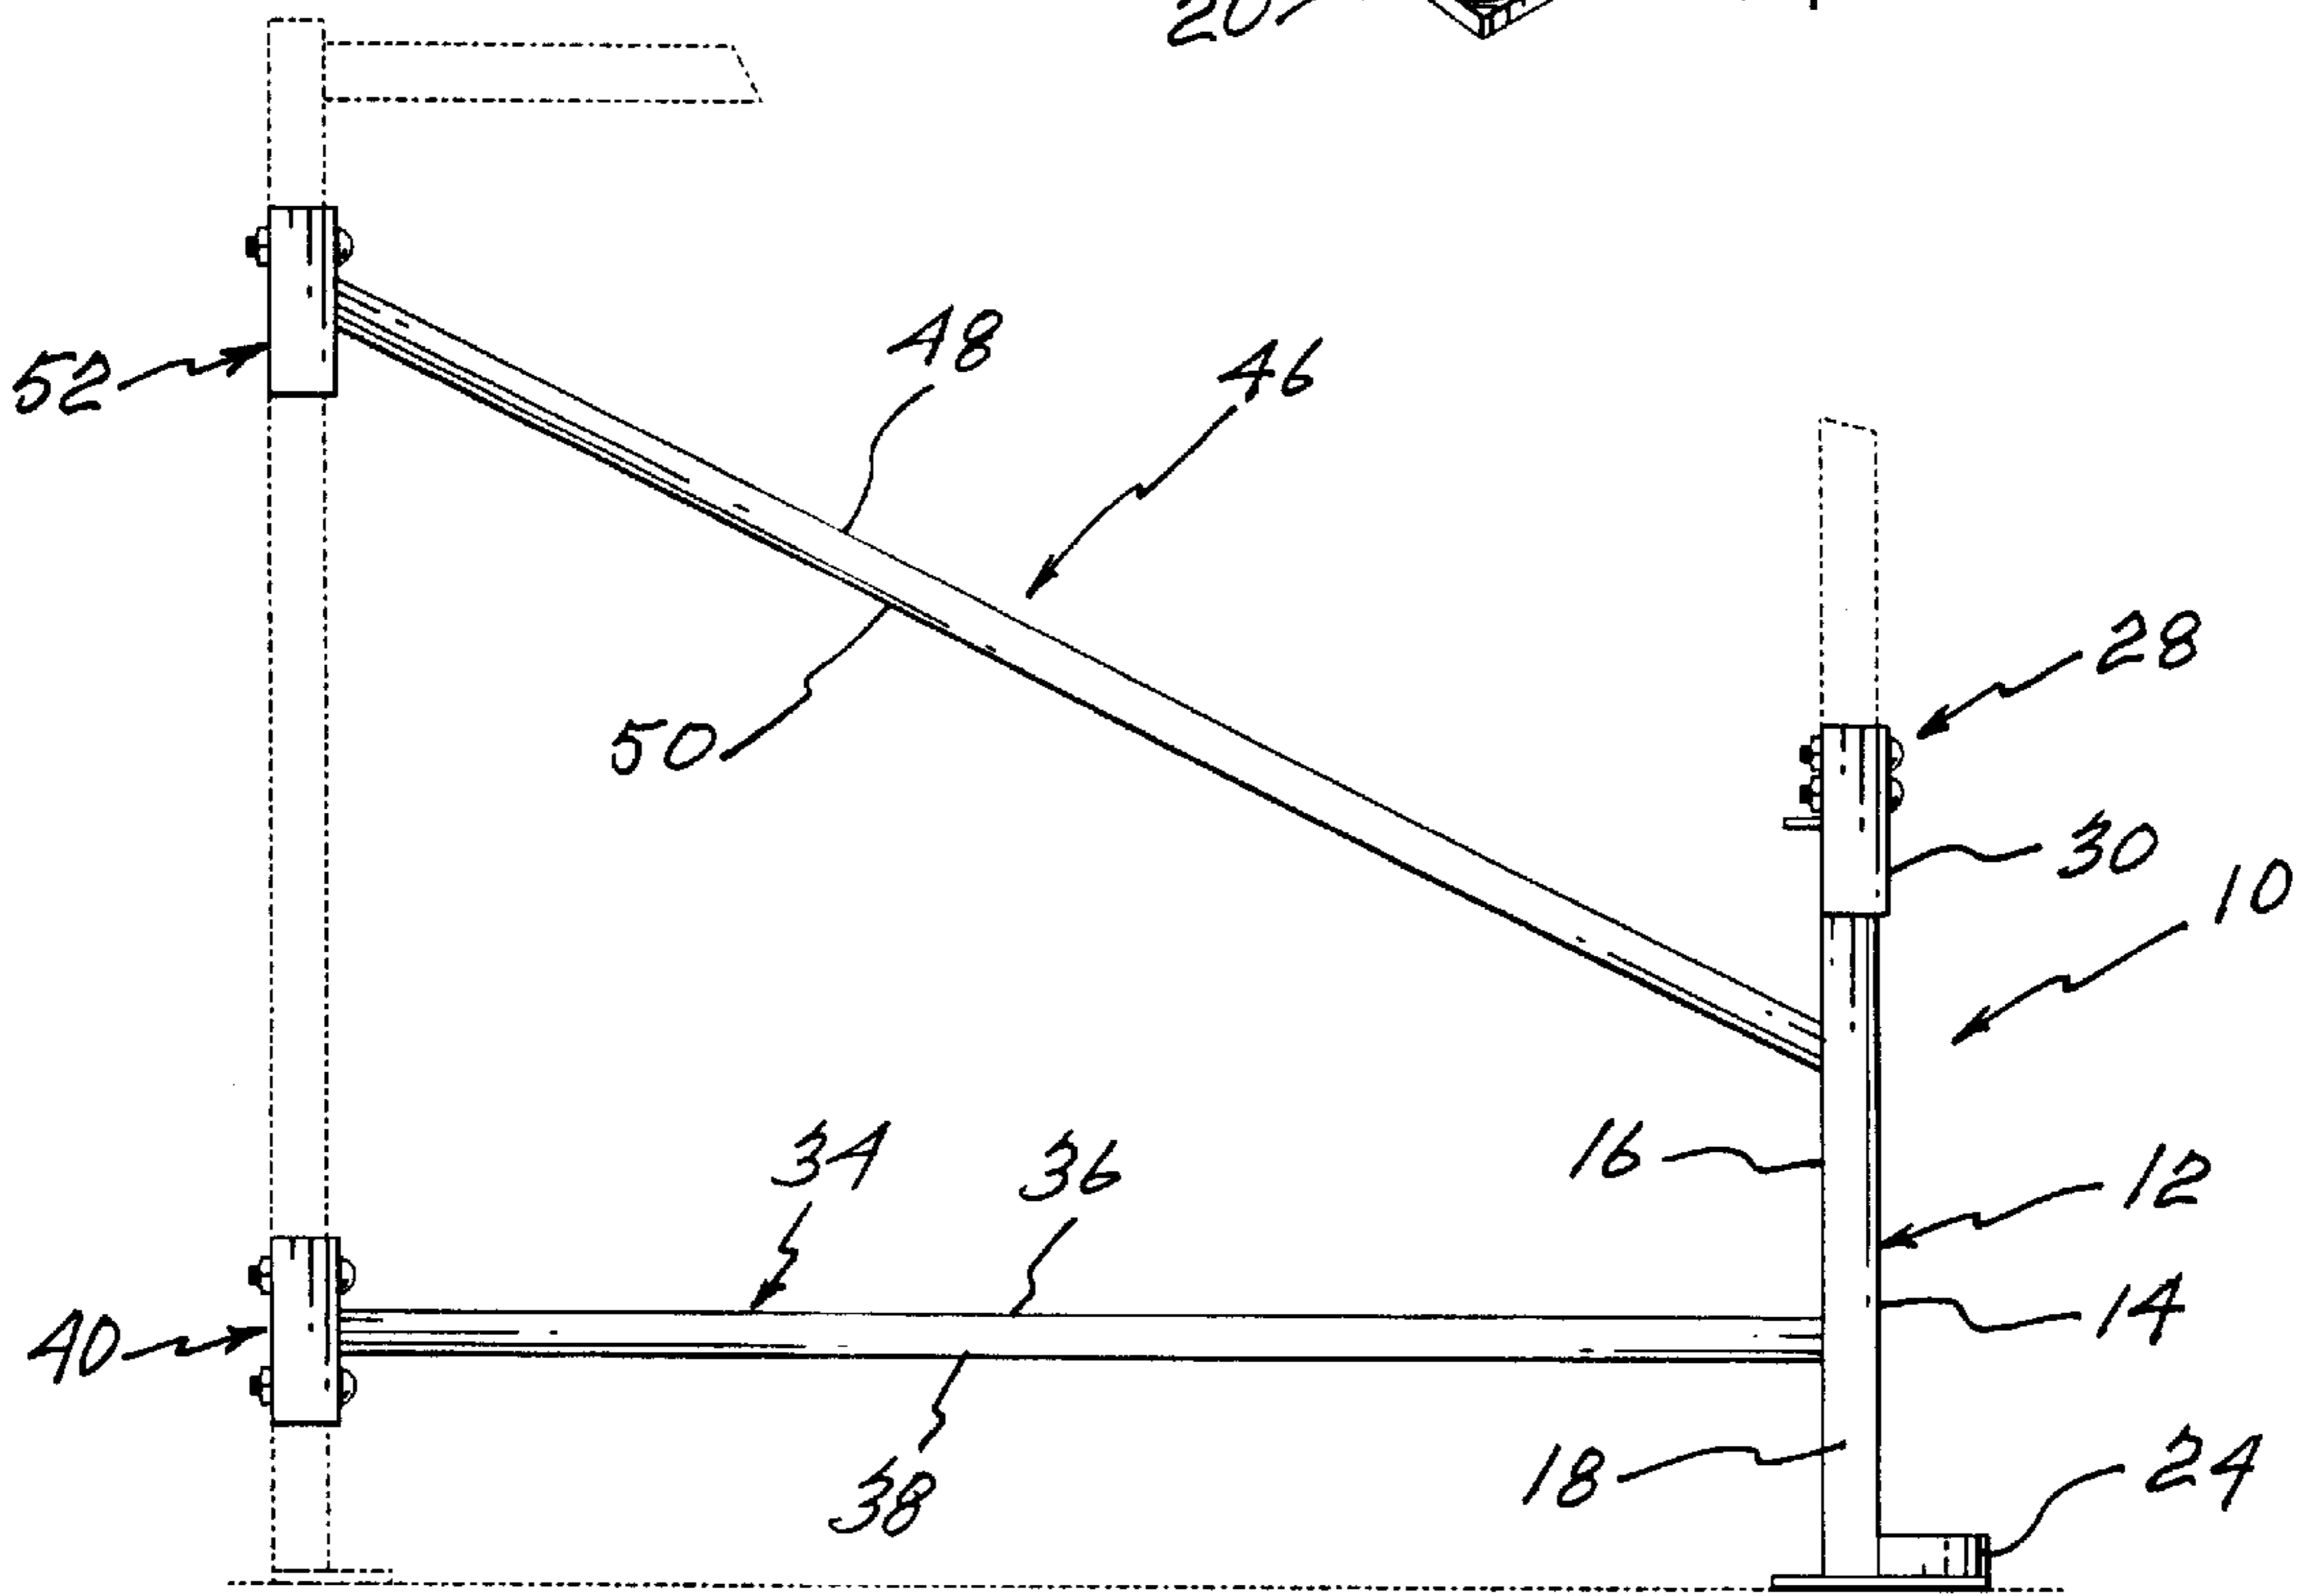
Fig. 2

FIG. 2 is a side elevational view thereof;

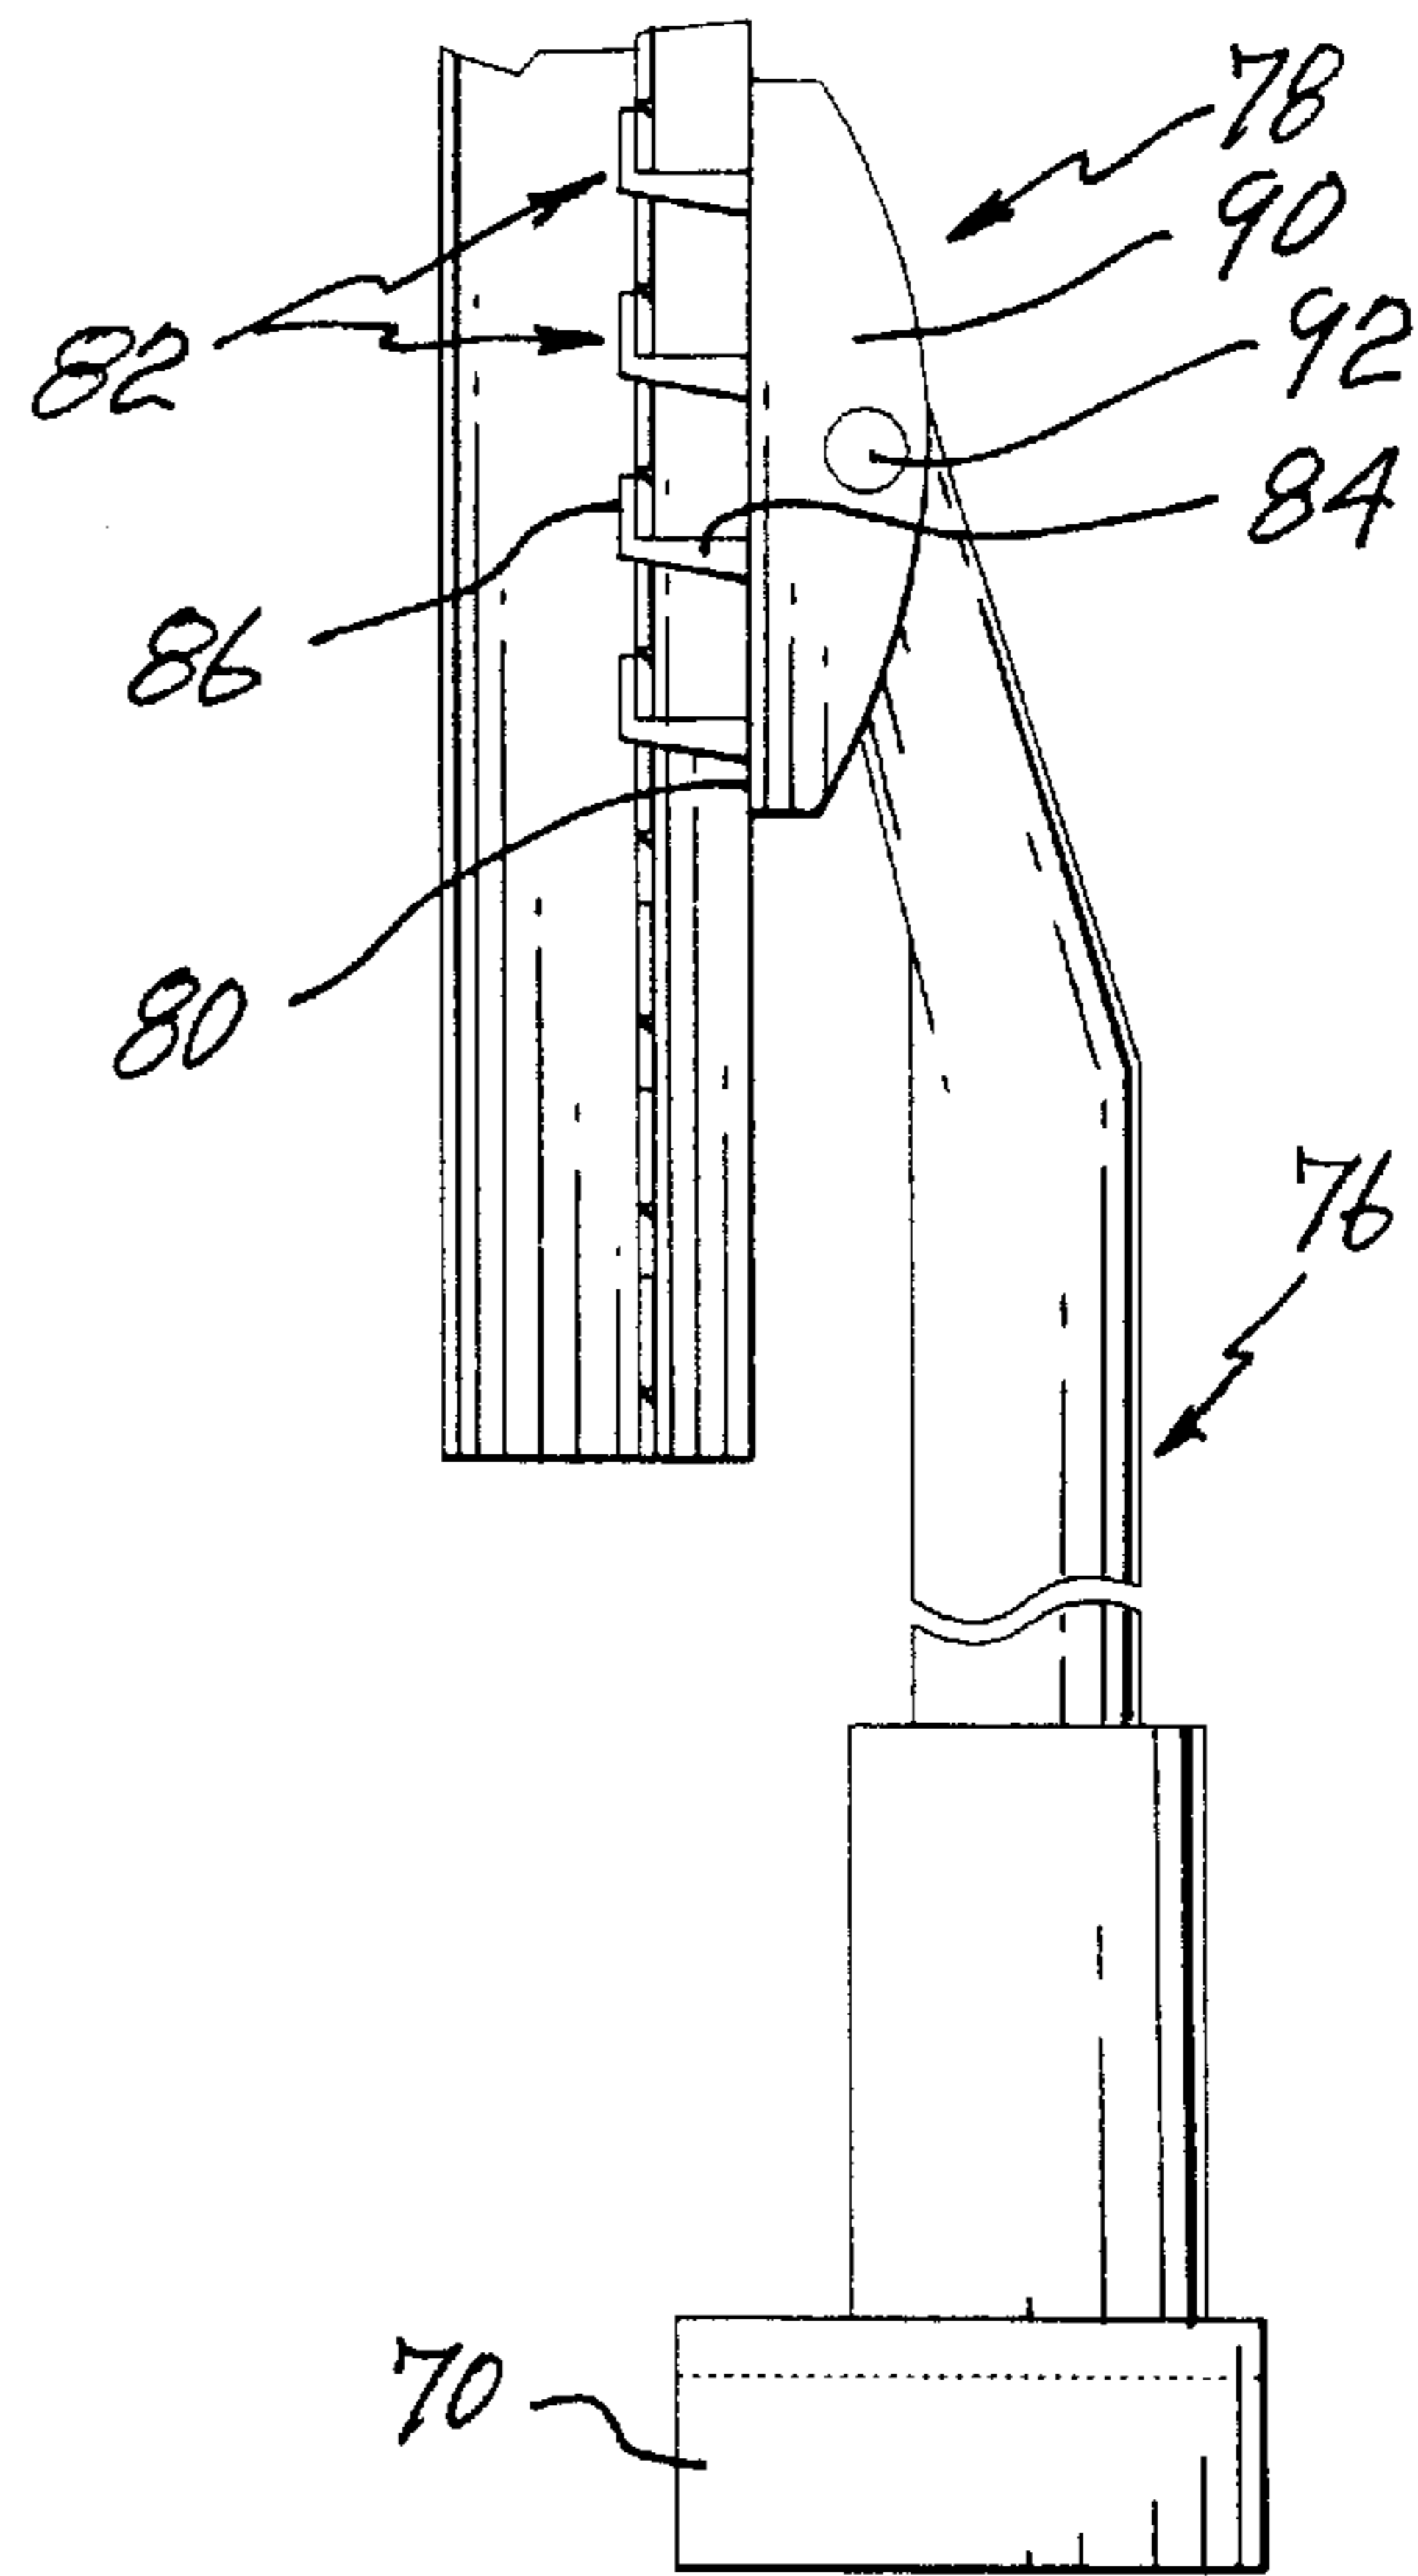
Fig.5

FIG. 5 is a side view illustrating engagement of the equipment with the damaged post;

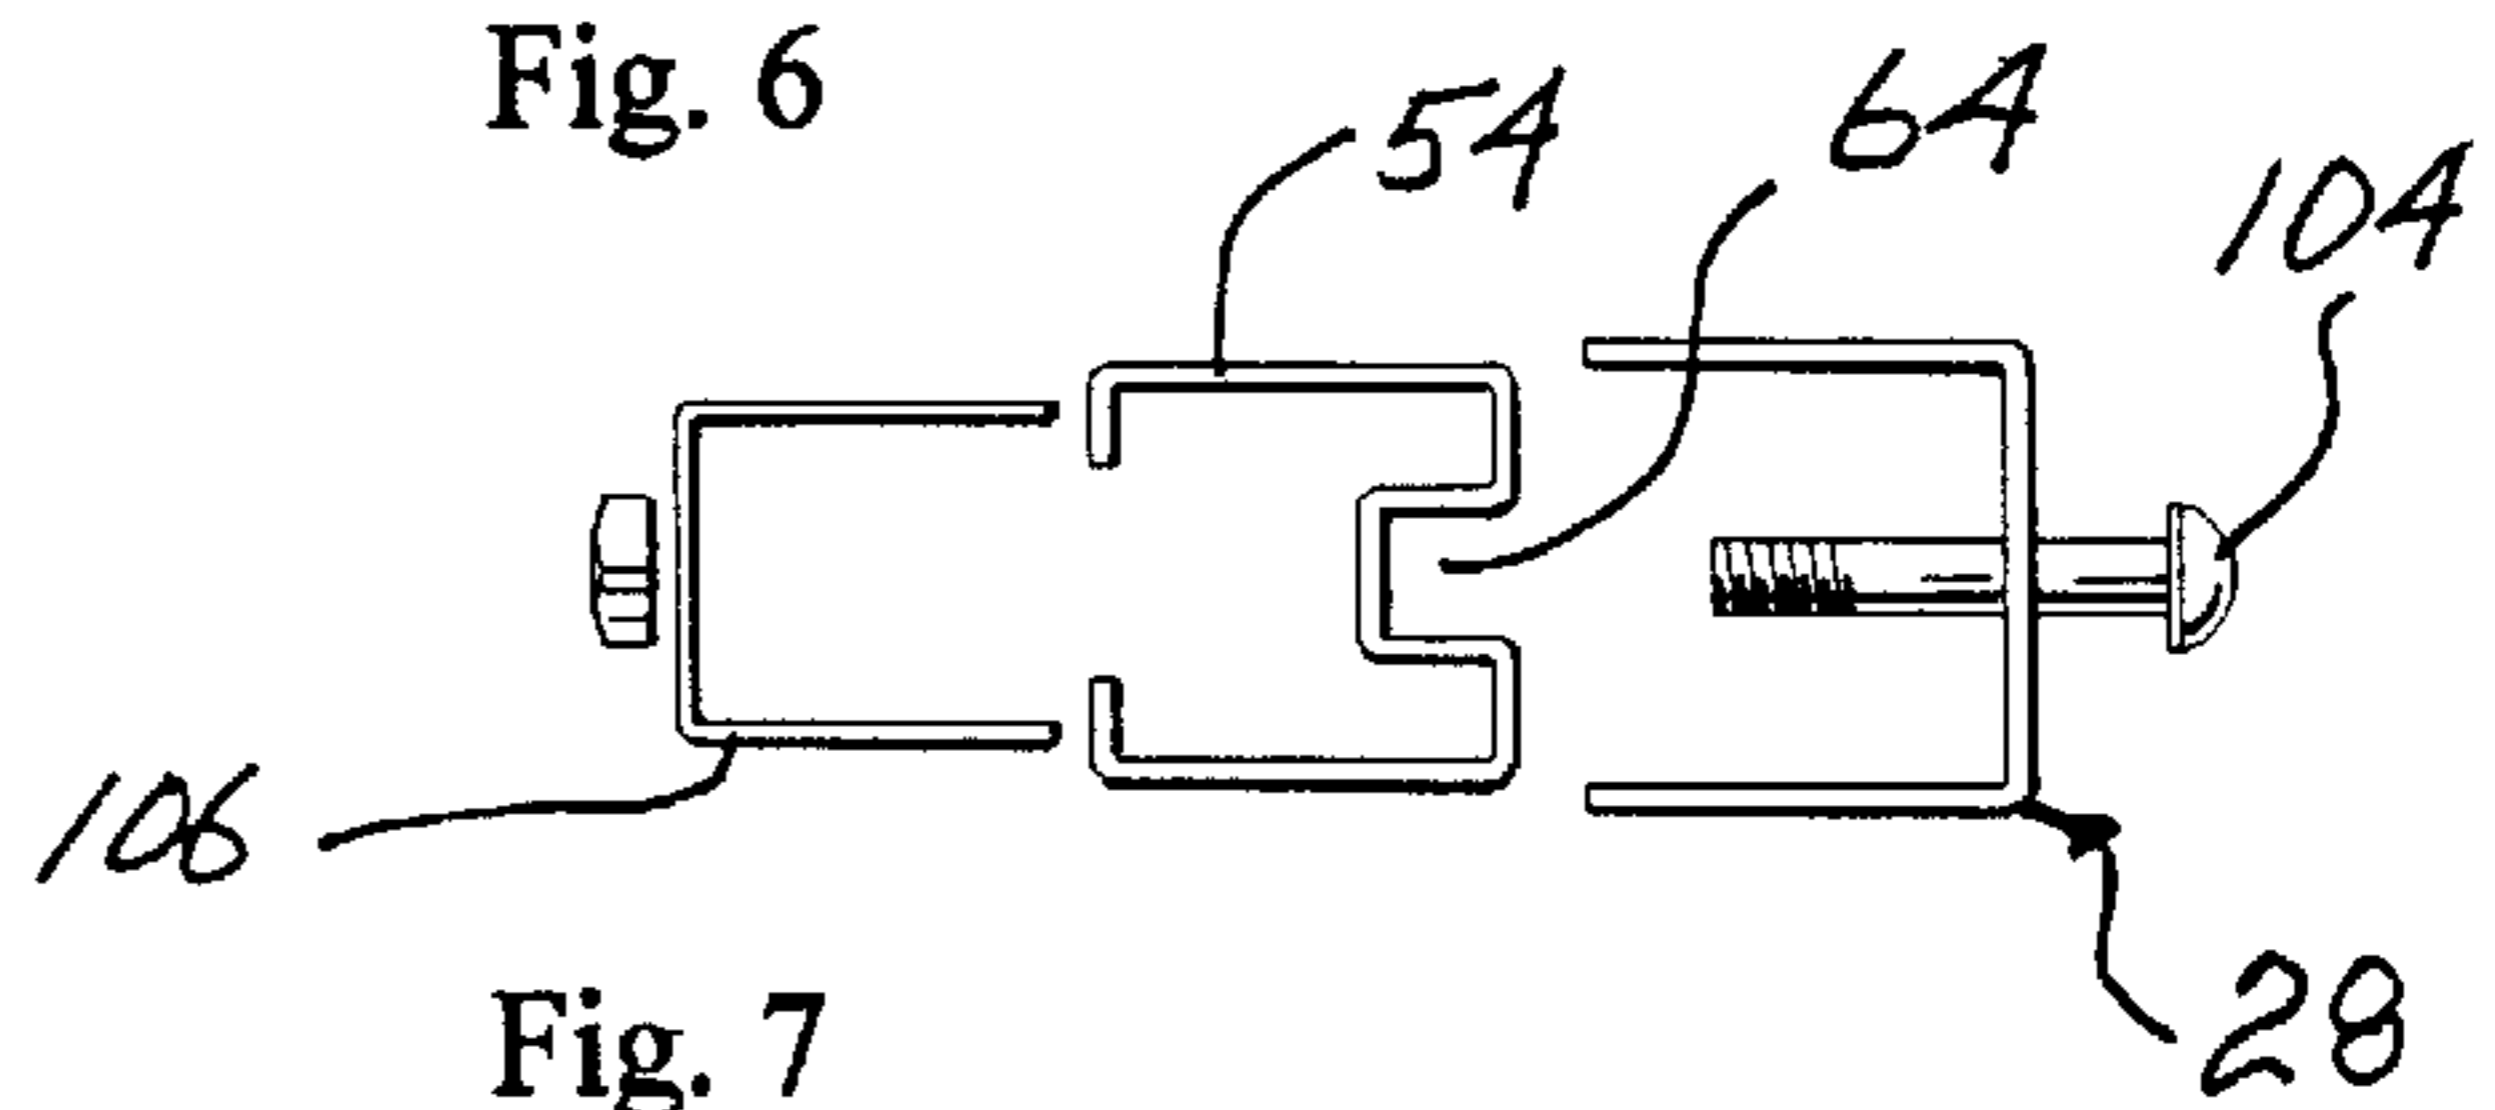
Fig. 7

FIG. 7 is a exploded view of the means of securing the repair assembly to the post; and

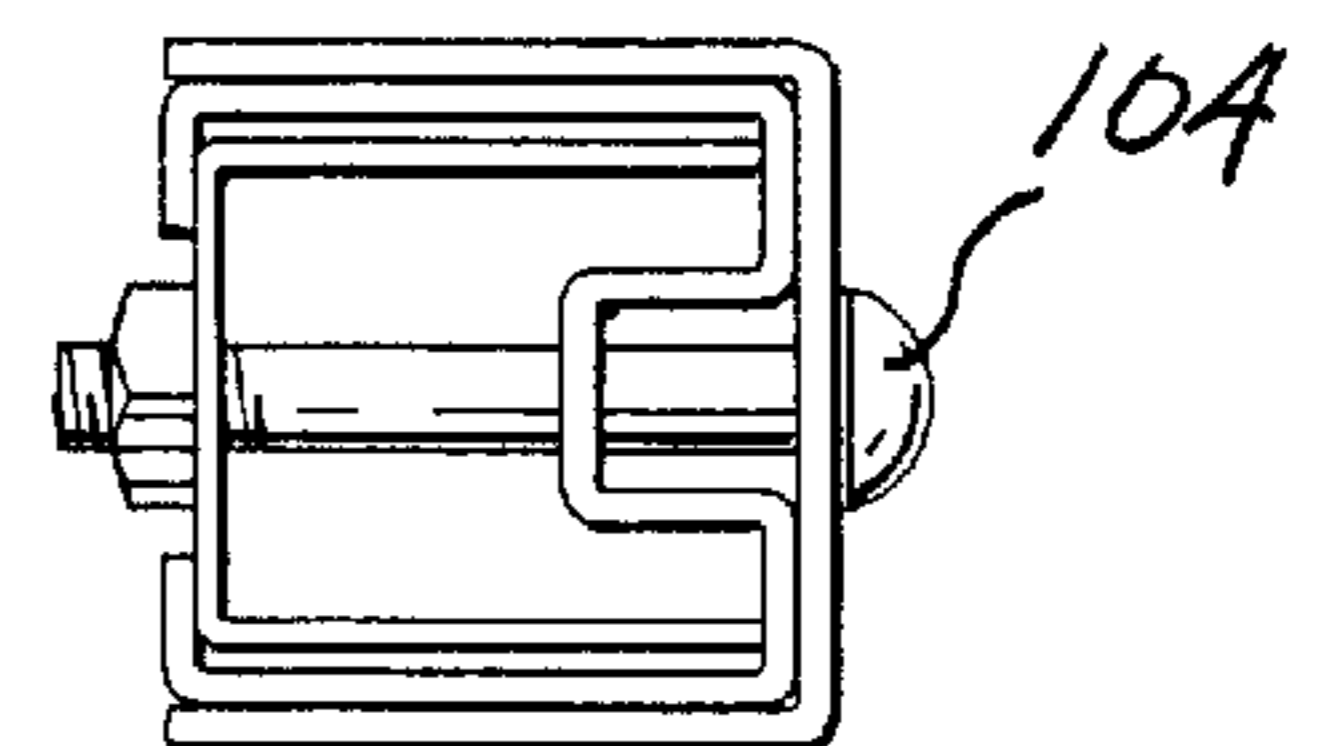
Fig. 8

FIG. 8 is a cross sectional view of the assembled connector of FIG. 7.
