(12) **United States Patent**  
**Dion**

(54) **PALLET RACK REPAIR SYSTEM**

A method for repairing pallet racks wherein the assembly is used to replace a damaged front post. The repair assembly includes a tubular post having a floor plate at a lower end and a support plate at an upper end with a horizontal brace and a diagonal brace to replace the existing braces. The assembly is structurally solid and has the diagonal brace placed sufficiently high above the floor to avoid damage by forklift trucks.

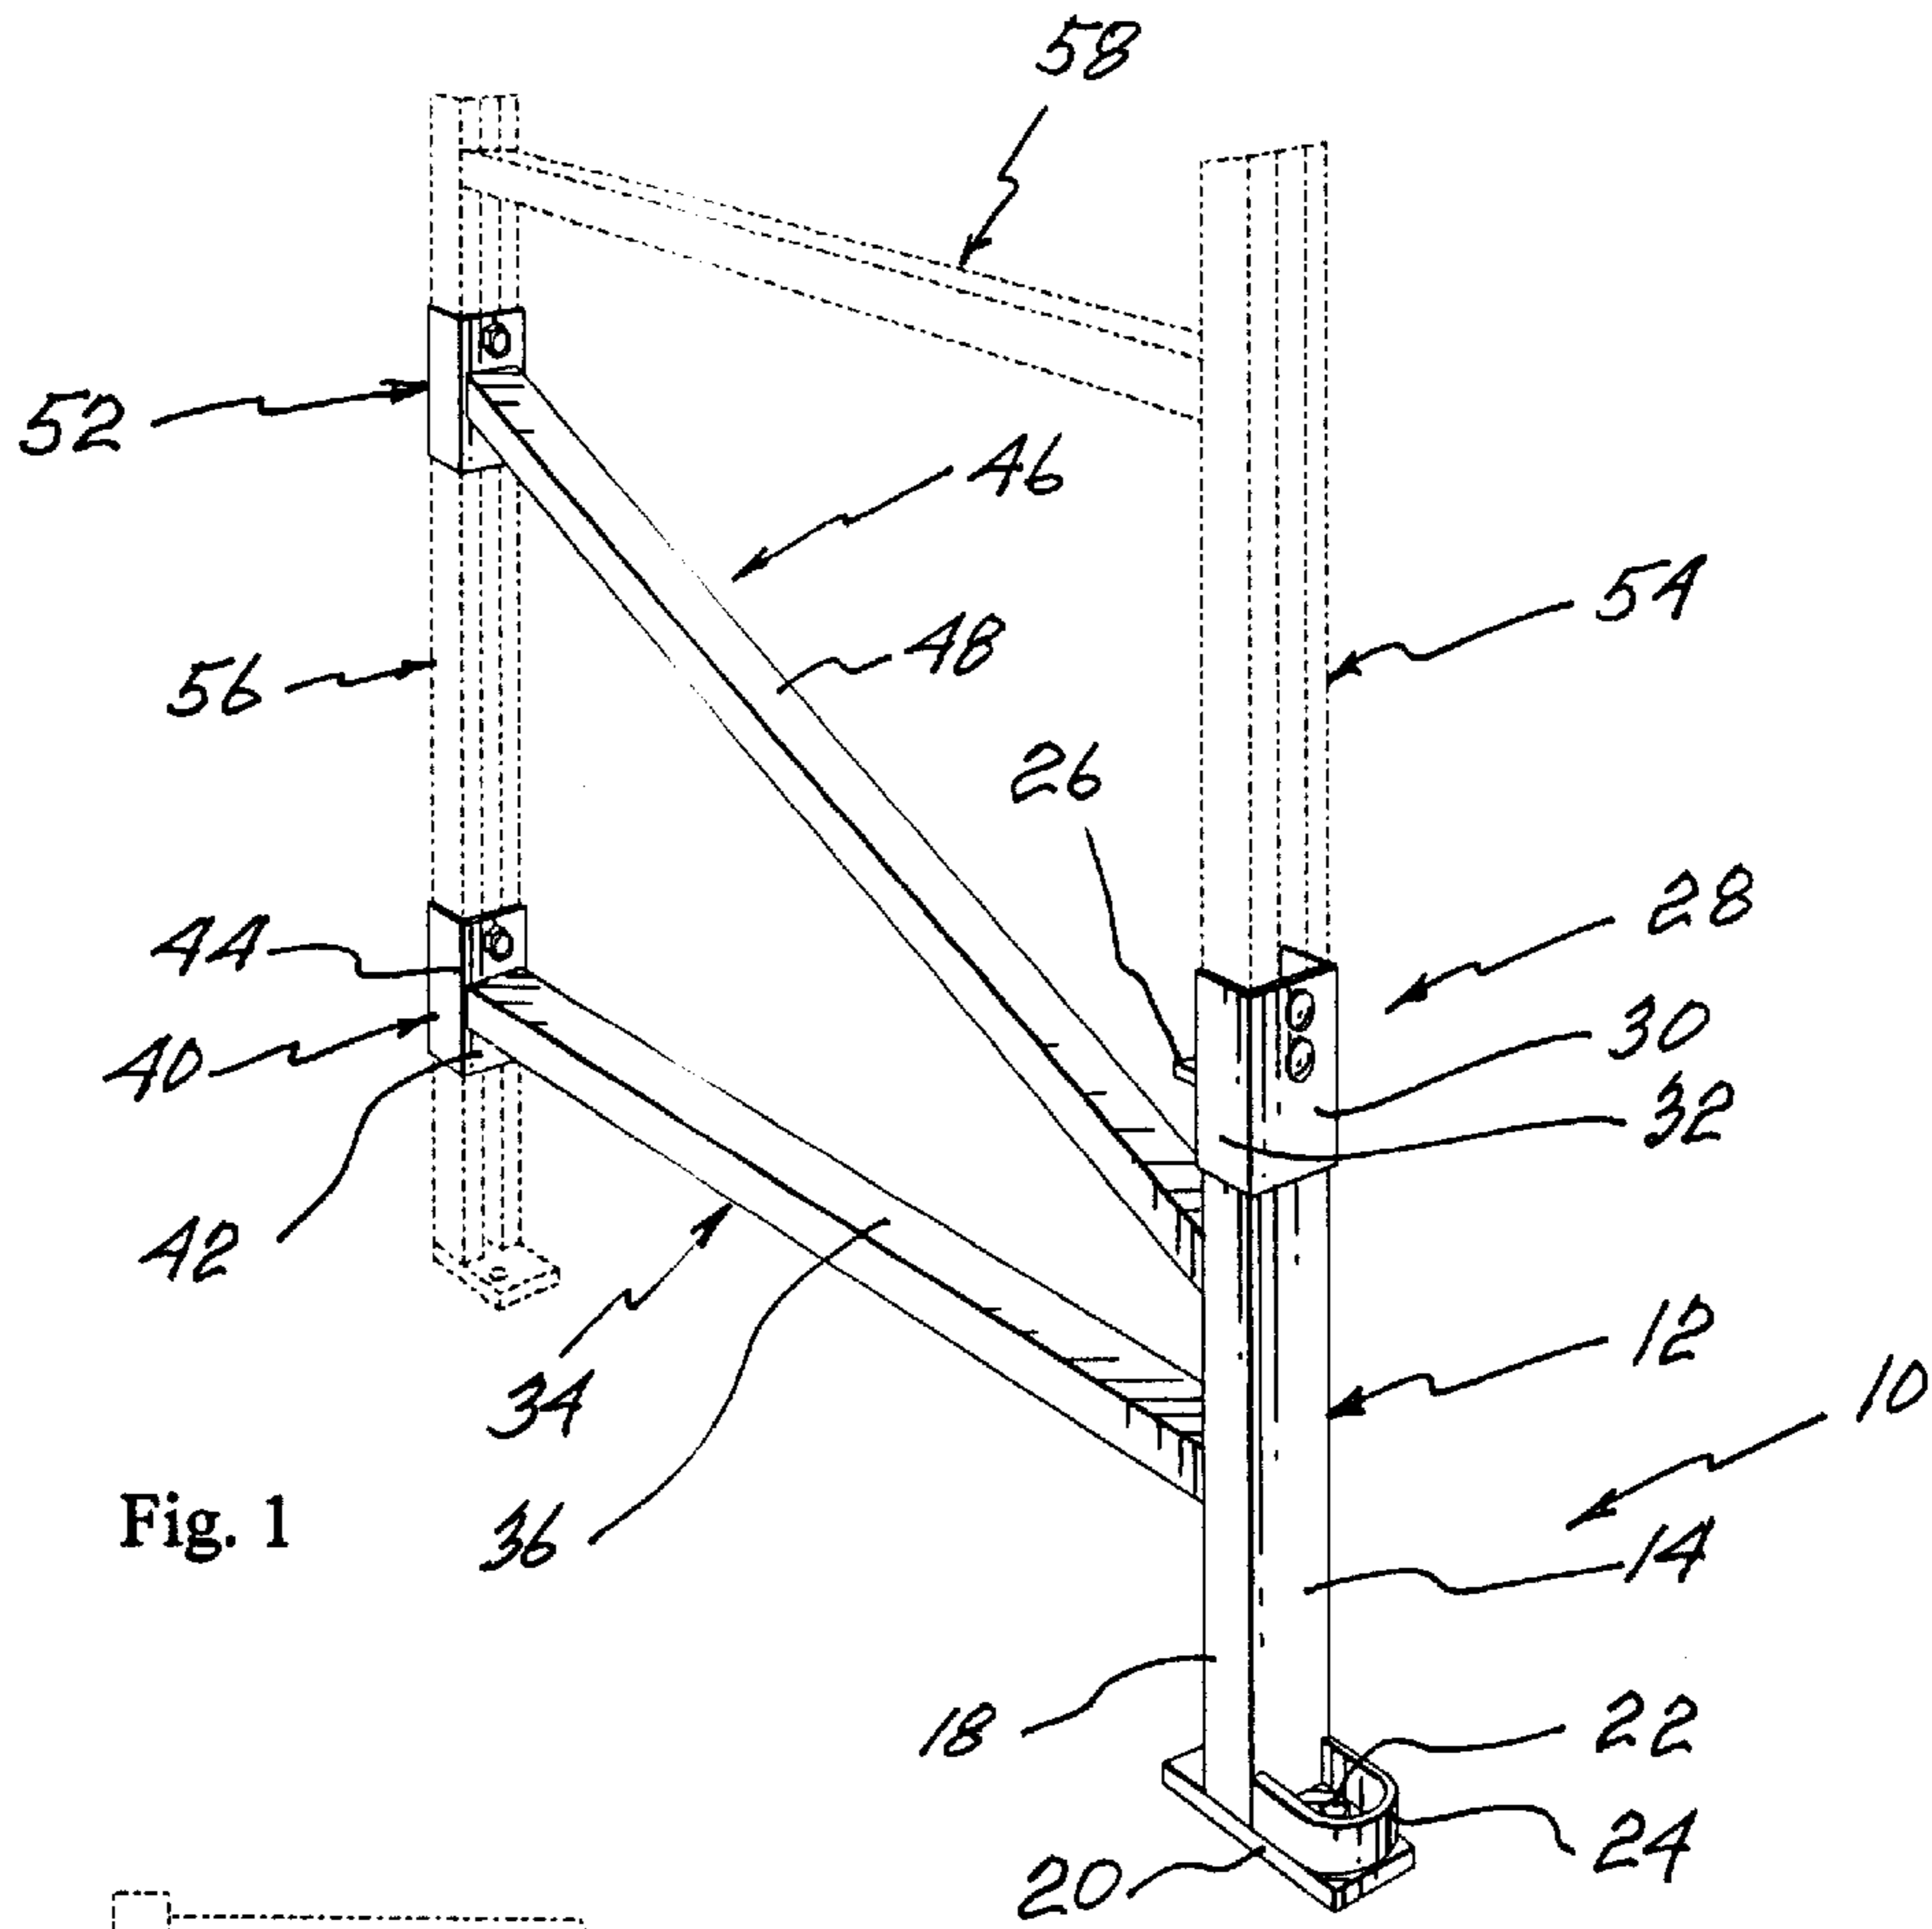
Fig. 1

FIG. 1 is a perspective view of a repair system according to the present invention;

Referring to the drawings in greater detail, and by reference characters thereto, there is illustrated in FIG. 1 a repair assembly which is generally designated by reference numeral 10.

Repair assembly 10, in FIGS. 1 and 2, is shown after having replaced a portion of a damaged post 54 as used in

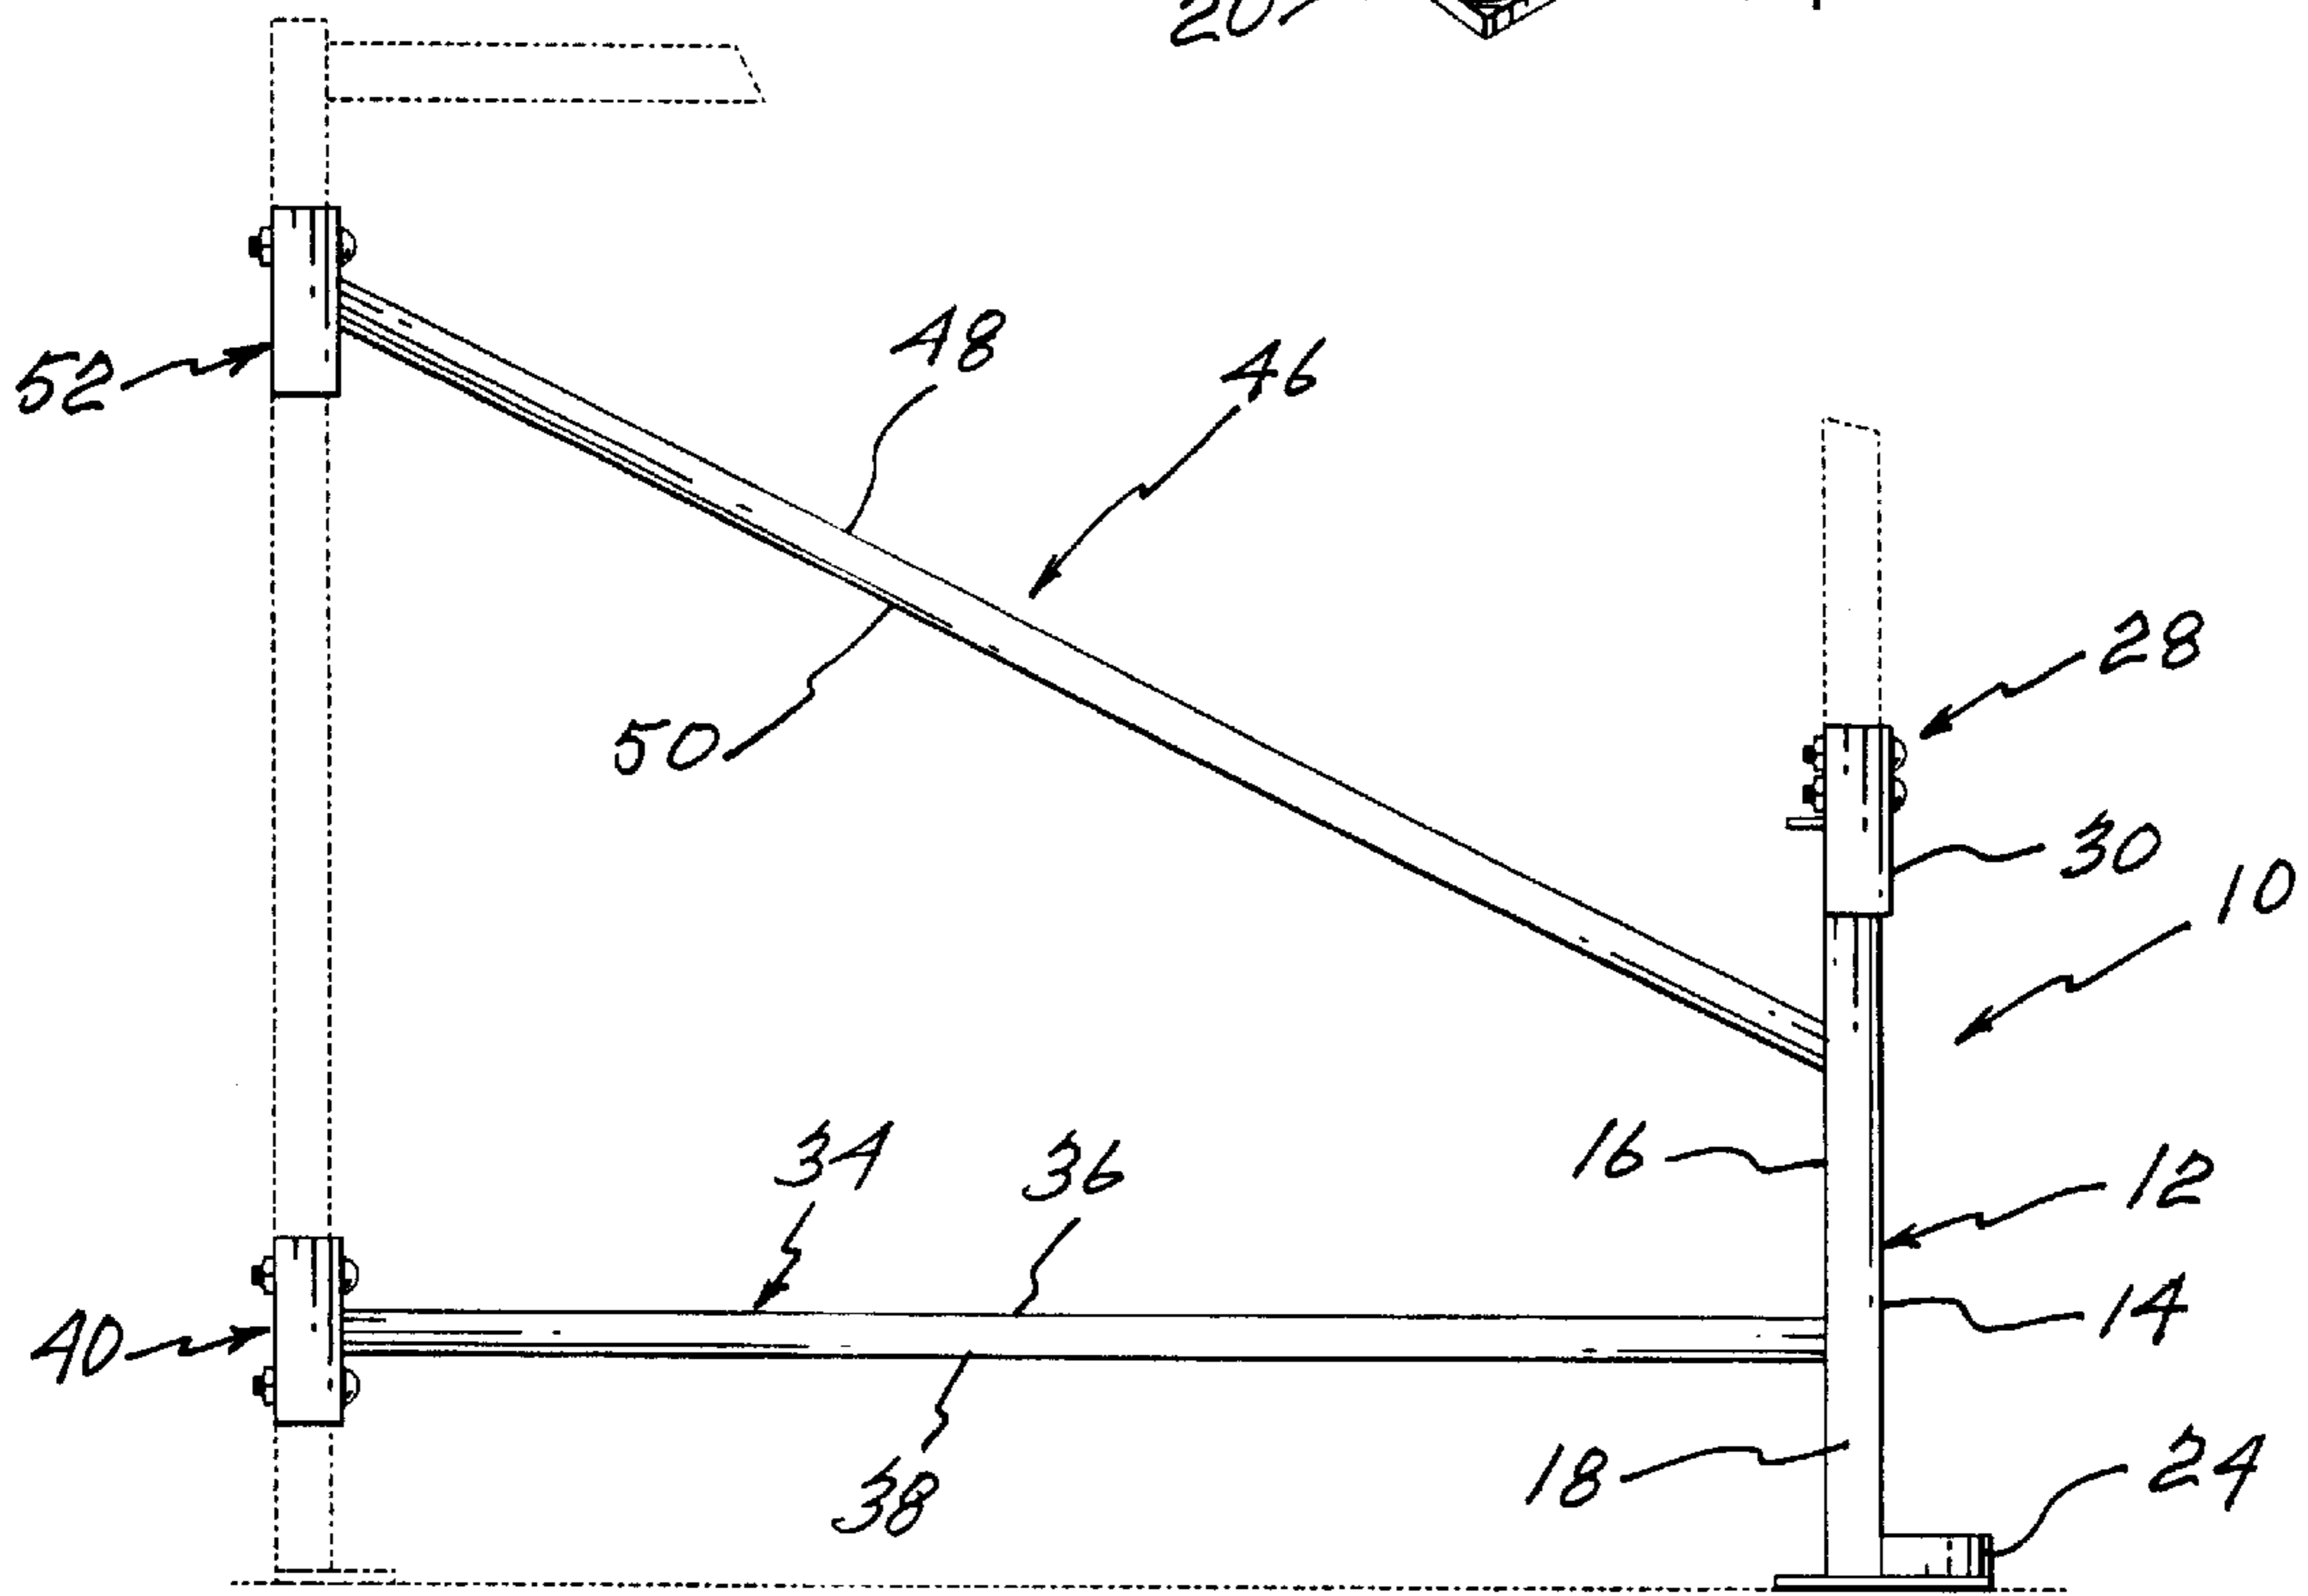
Fig. 2

FIG. 2 is a side elevational view thereof;

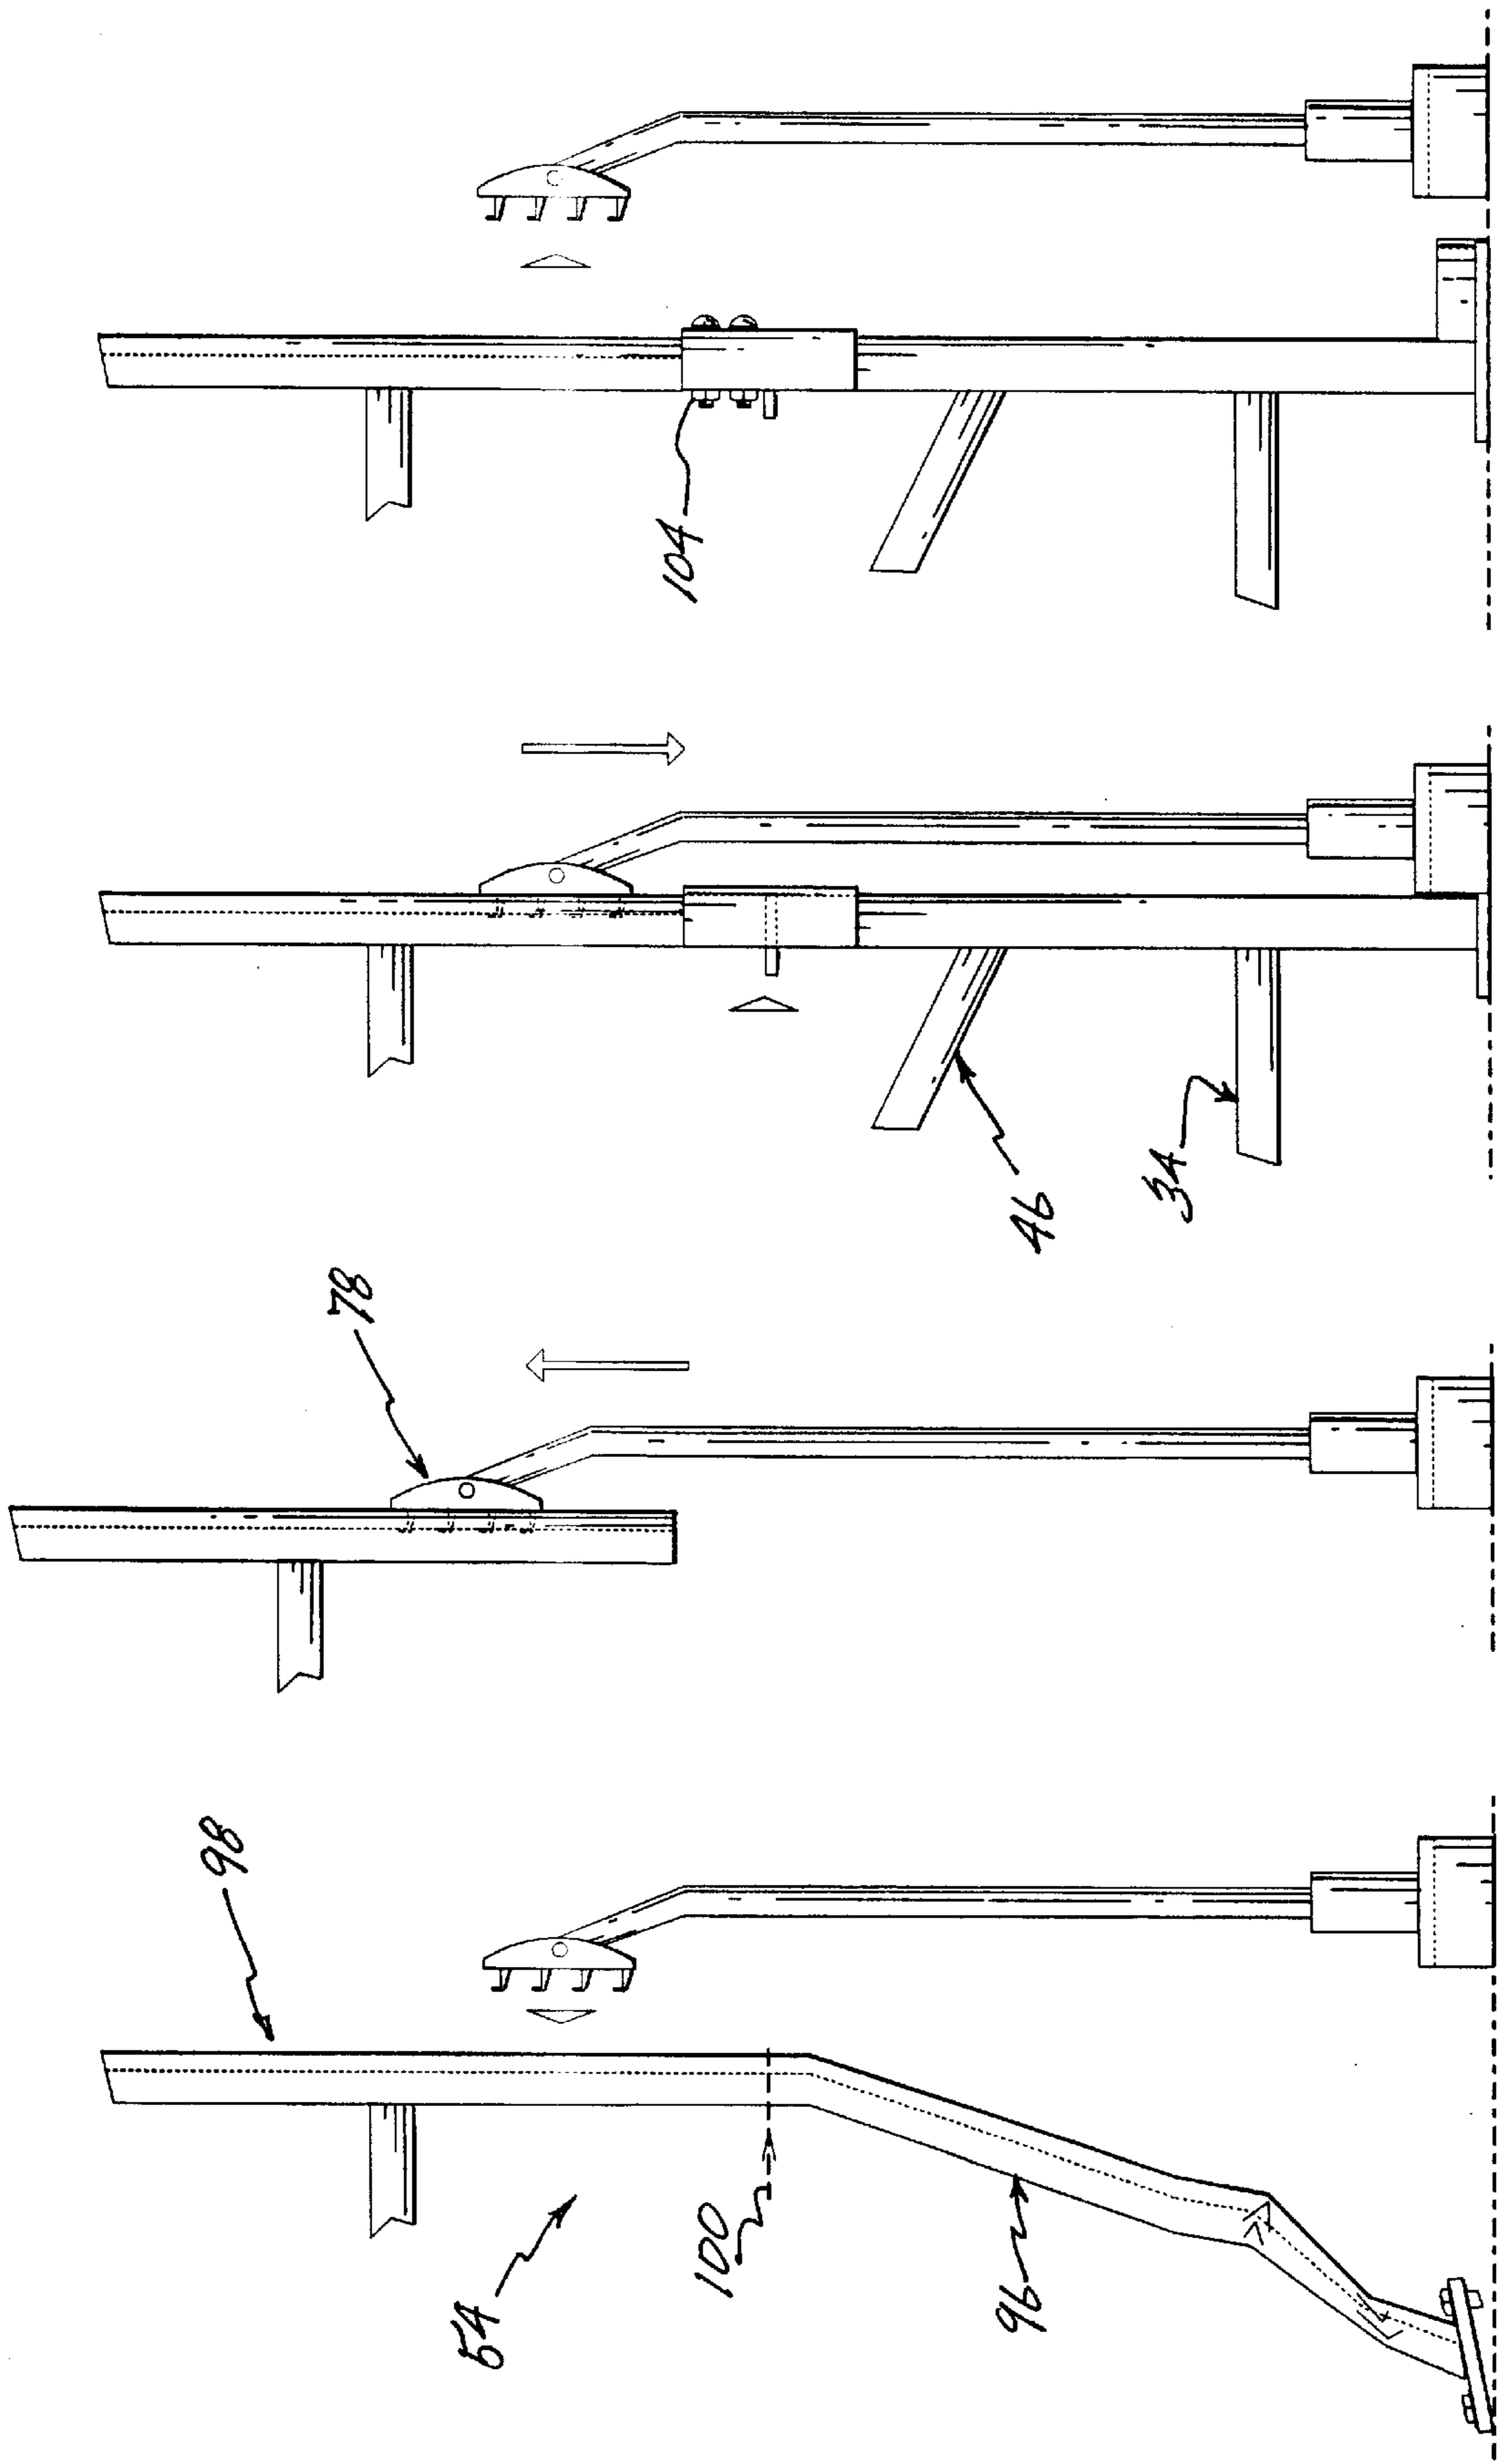
Fig.3

FIGS. 3, 3a, 3b and 3c illustrate the replacement of a damaged post of a pallet rack;

Referring to FIGS. 3, 3a, 3b and 3c, there is illustrated front post 54 which has been hit by a lift truck and has a lower damaged portion 96 and an upper undamaged portion 98 (horizontal and diagonal braces not shown). Initially, lifting mechanism 68 is placed into position whereby members 82 extending from front wall 80 will engage with upper undamaged portion 98 through apertures 66. Hydraulic jack 74 is then operated to lift post 54 to the extent necessary to remove any weight bearing on lower damaged portion 96. Lower damaged portion 96 is then removed as indicated by cut line 100.

Subsequently, repair assembly 10 is moved into position as shown in FIG. 3b and hydraulic jack 74 is then lowered to permit the bottom end of upper undamaged portion 98 to rest on horizontal plate 86. A rear C-shaped reinforcing plate 106 is placed inwardly of channel 64 and bolts 104 are then secured through C-shaped connector 28. A similar procedure is followed with respect to connectors 40 and 52 located at the distal ends of horizontal brace 34 and diagonal brace 46 respectively.

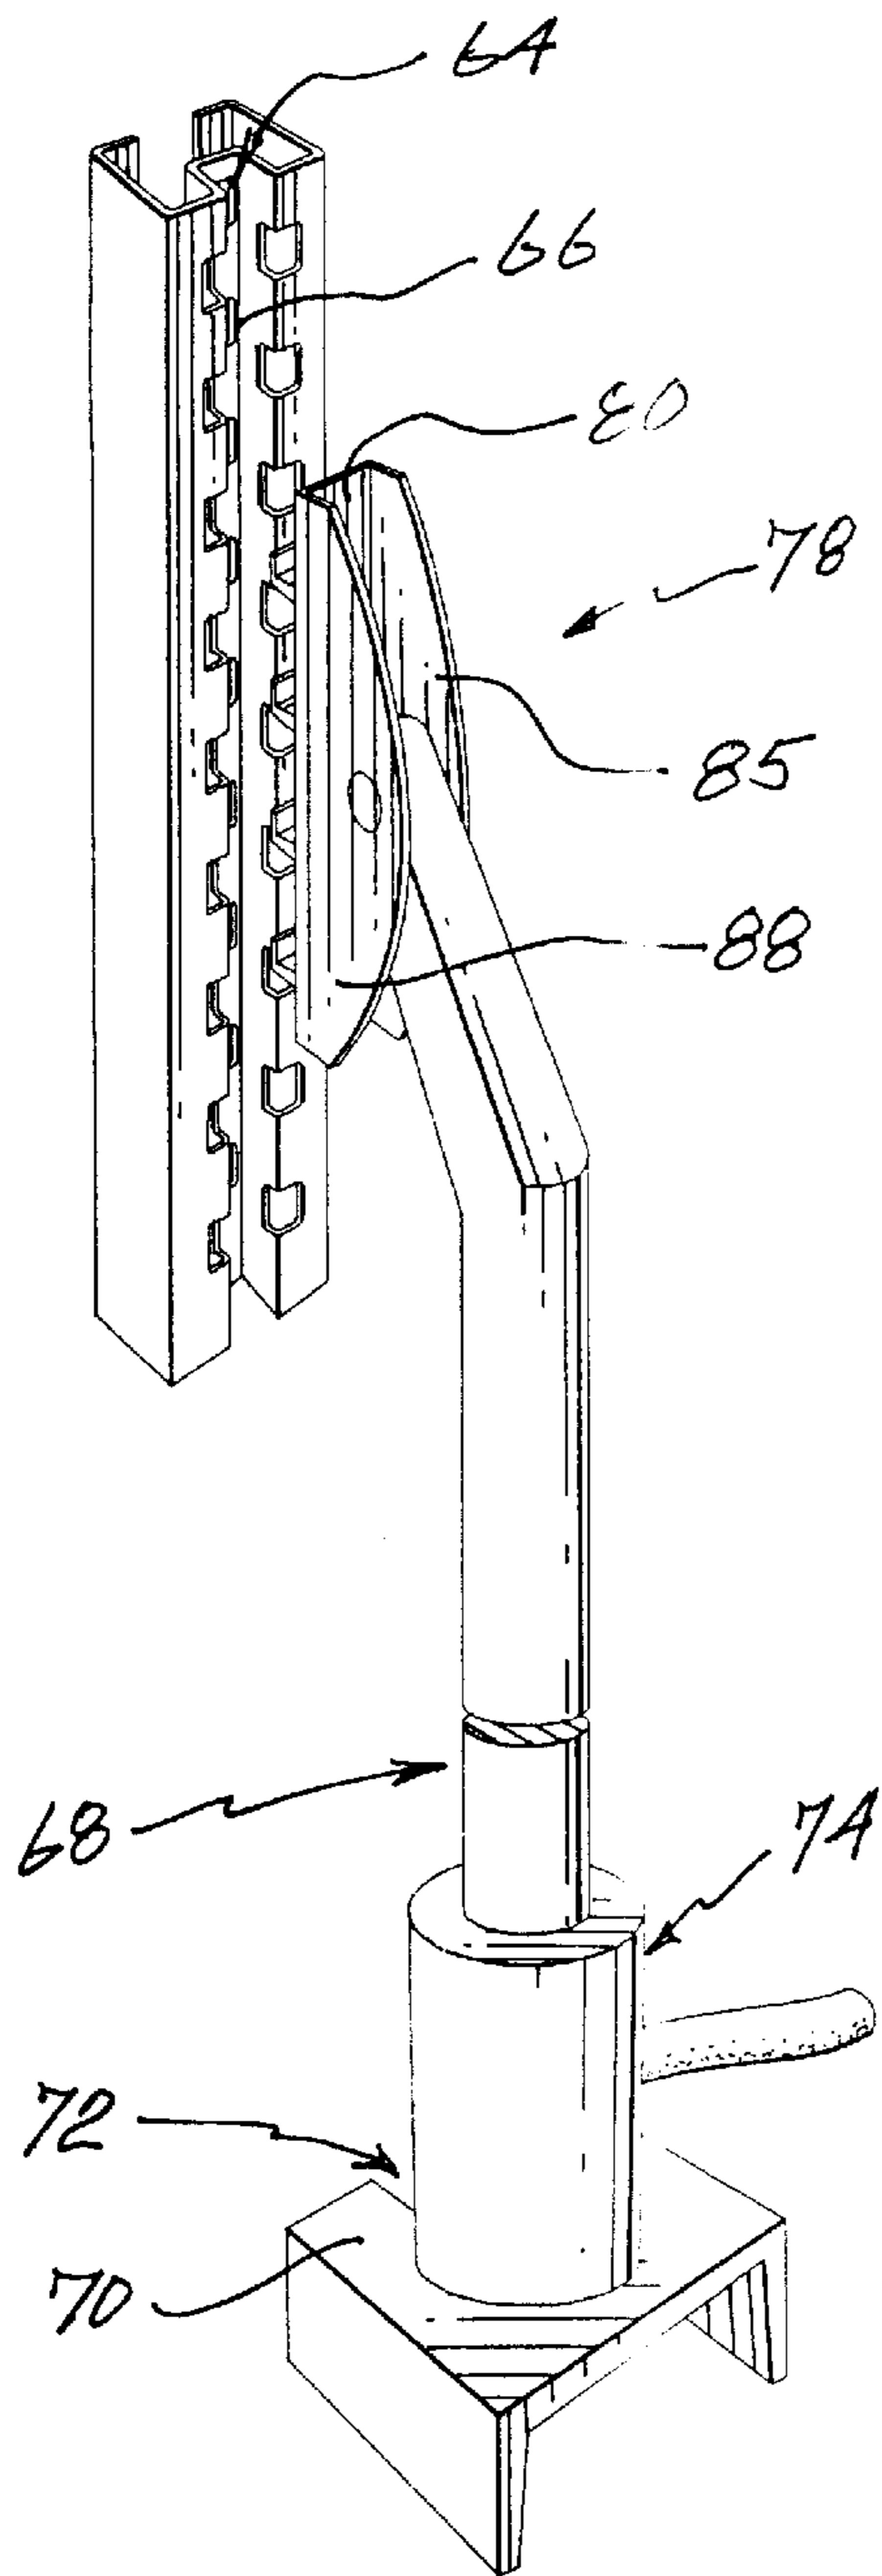
Fig.4

FIG. 4 is a perspective view of the equipment utilized during replacement of the damaged post of the pallet rack;

Each of posts 54 and 56, and as may be best seen in FIG. 4, is of a formed steel having an inwardly extending channel 64 with apertures 66 located therein. This is similar to the arrangement shown, for example, in U.S. Pat. No. 4,064,996 to Shillum.

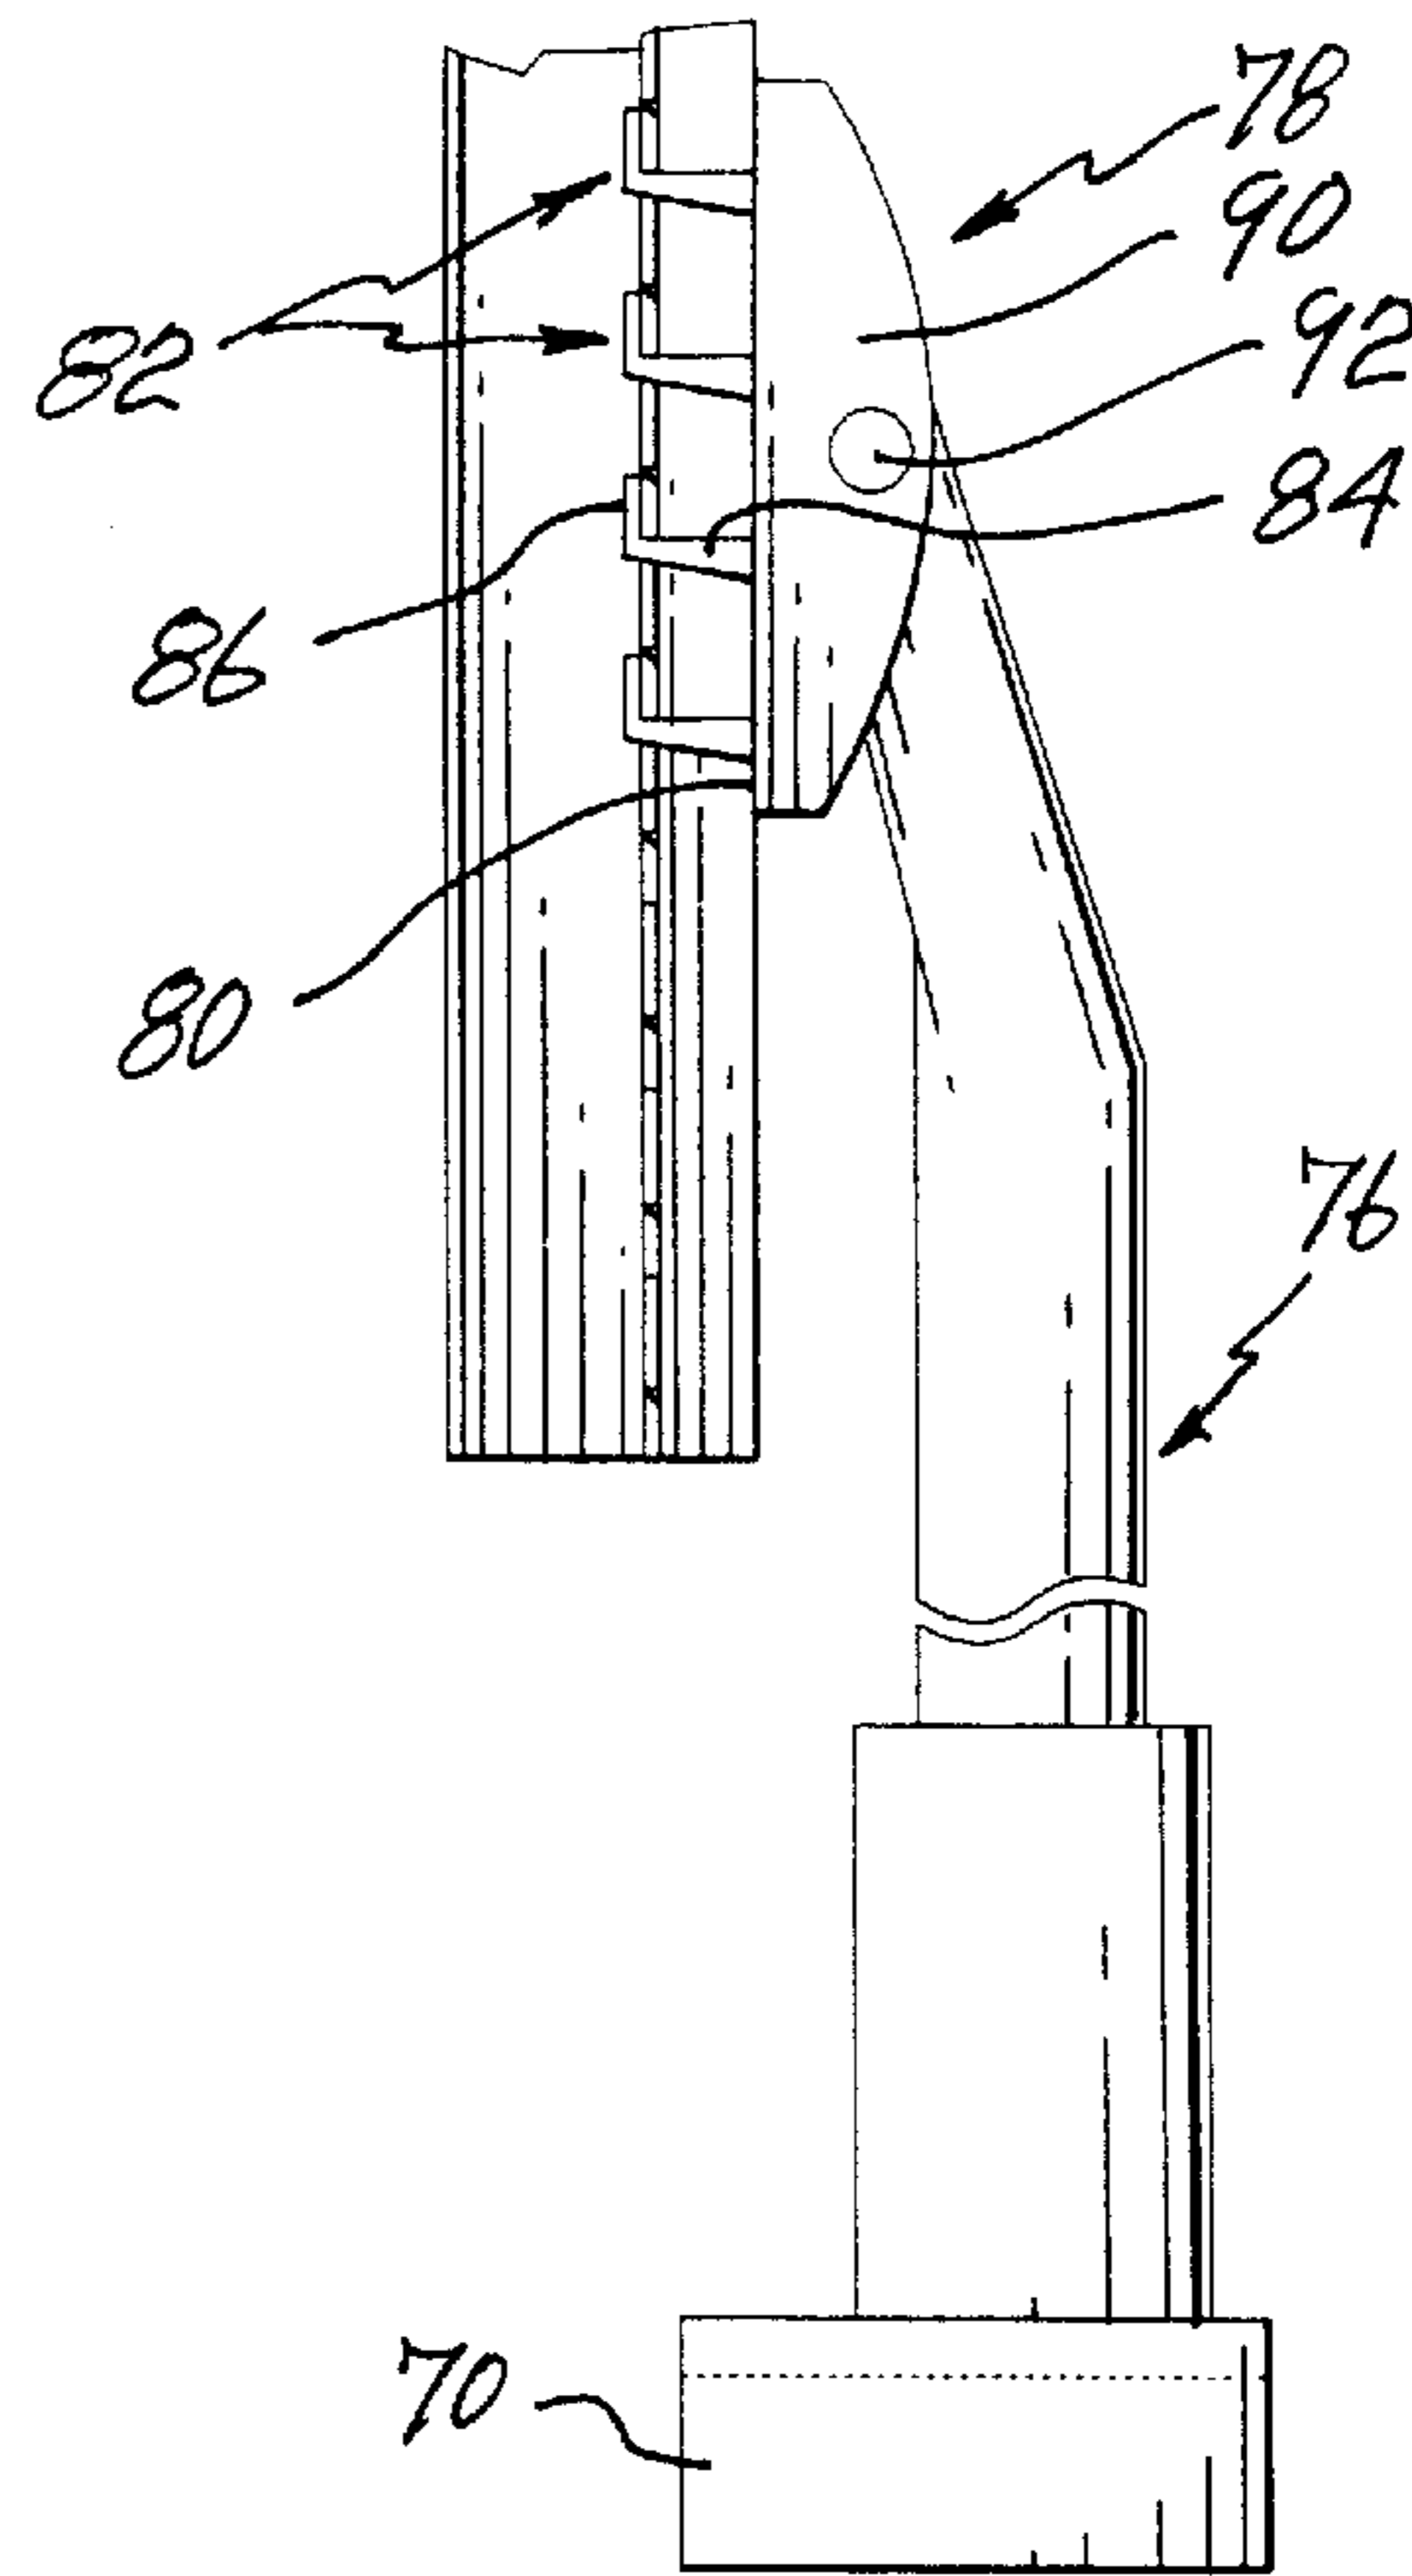
Fig.5

FIG. 5 is a side view illustrating engagement of the equipment with the damaged post;

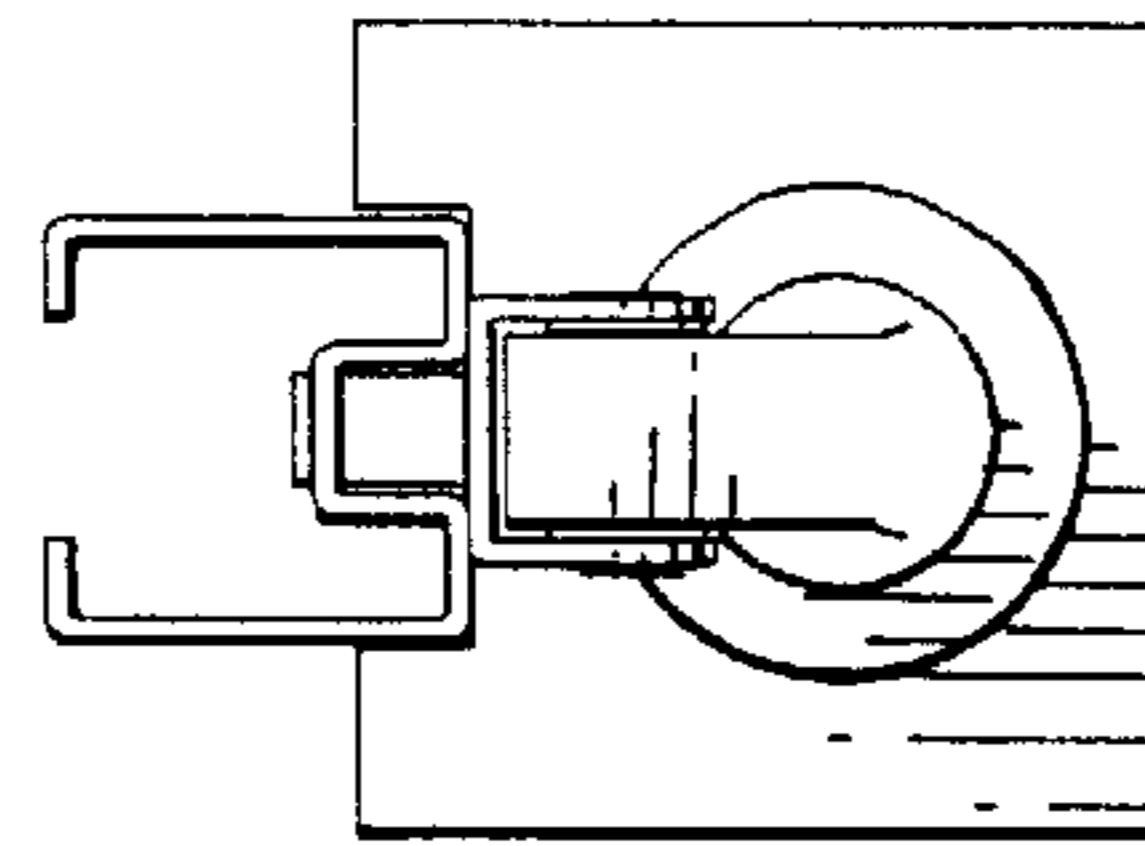
Fig. 6

FIG. 6 is a top plan view of the equipment of FIG. 5;

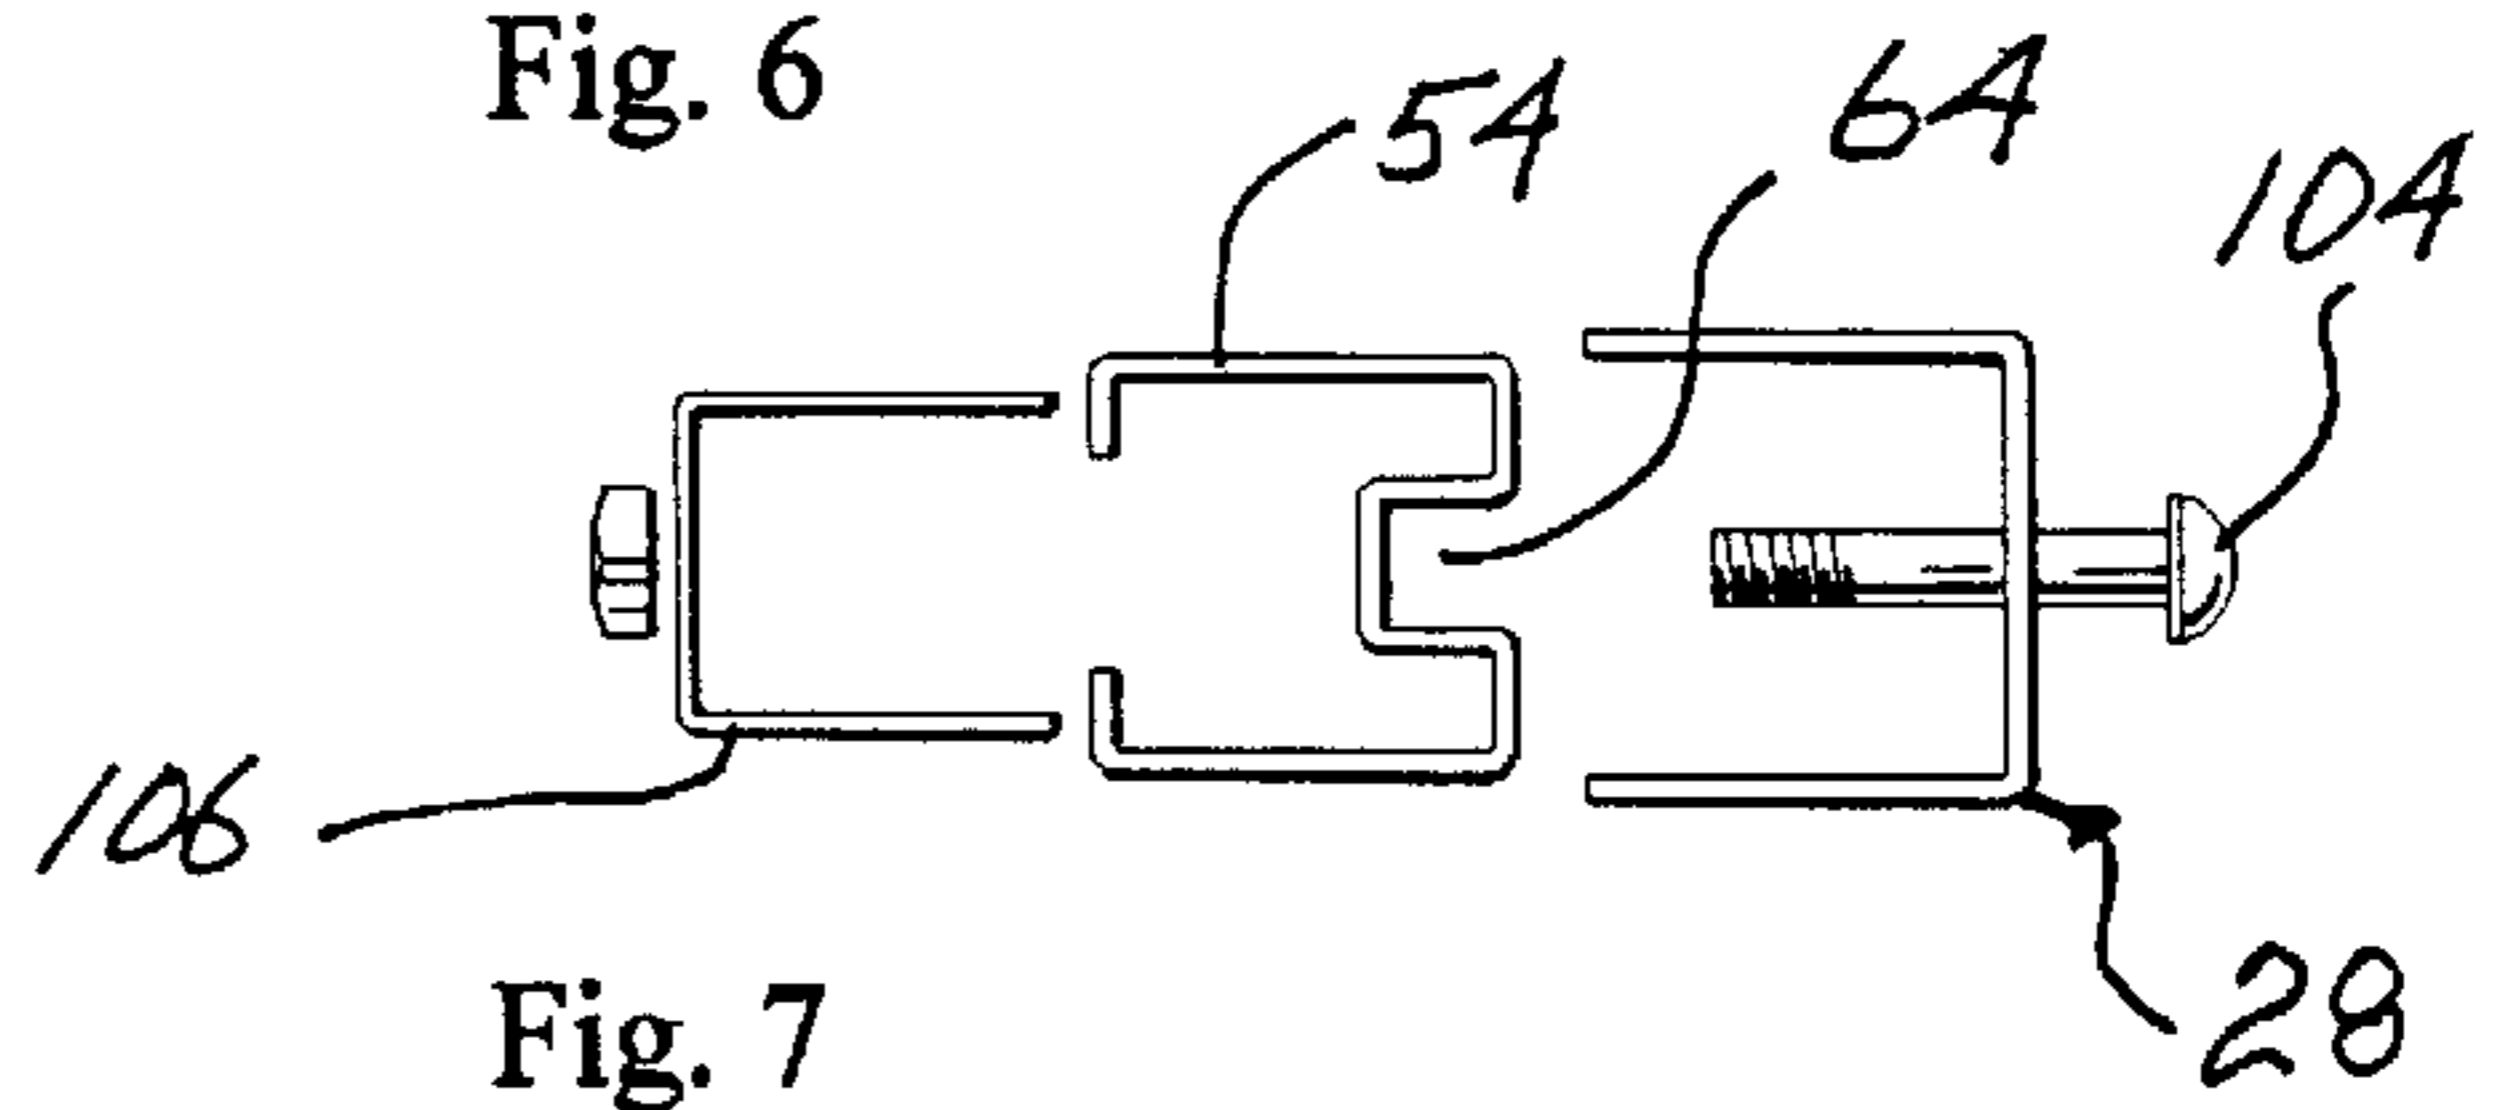
Fig. 7

FIG. 7 is a exploded view of the means of securing the repair assembly to the post; and

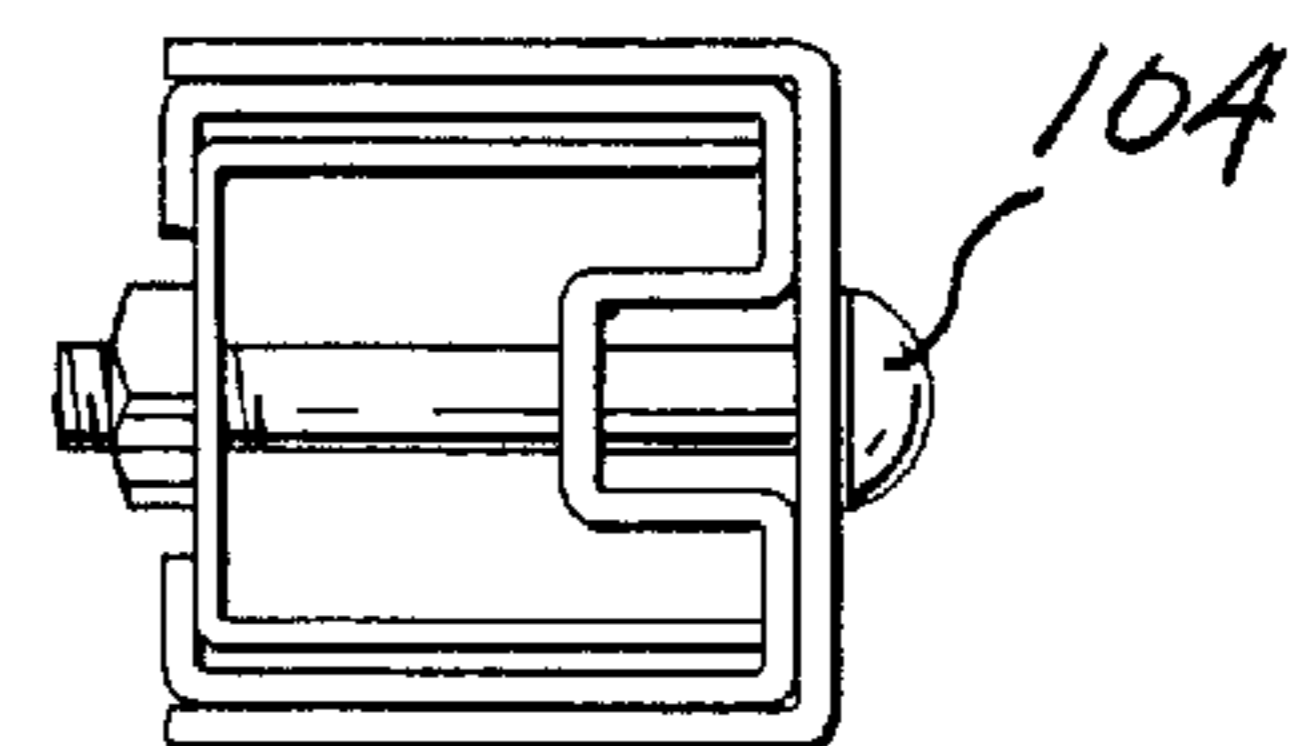
Fig. 8

FIG. 8 is a cross sectional view of the assembled connector of FIG. 7.
