US006332272B1

(10) **Patent No.:** **US 6,332,272 B1**
(45) **Date of Patent:** **Dec. 25, 2001**

(54) **METHOD OF REPAIRING A TURBINE
BLADE**

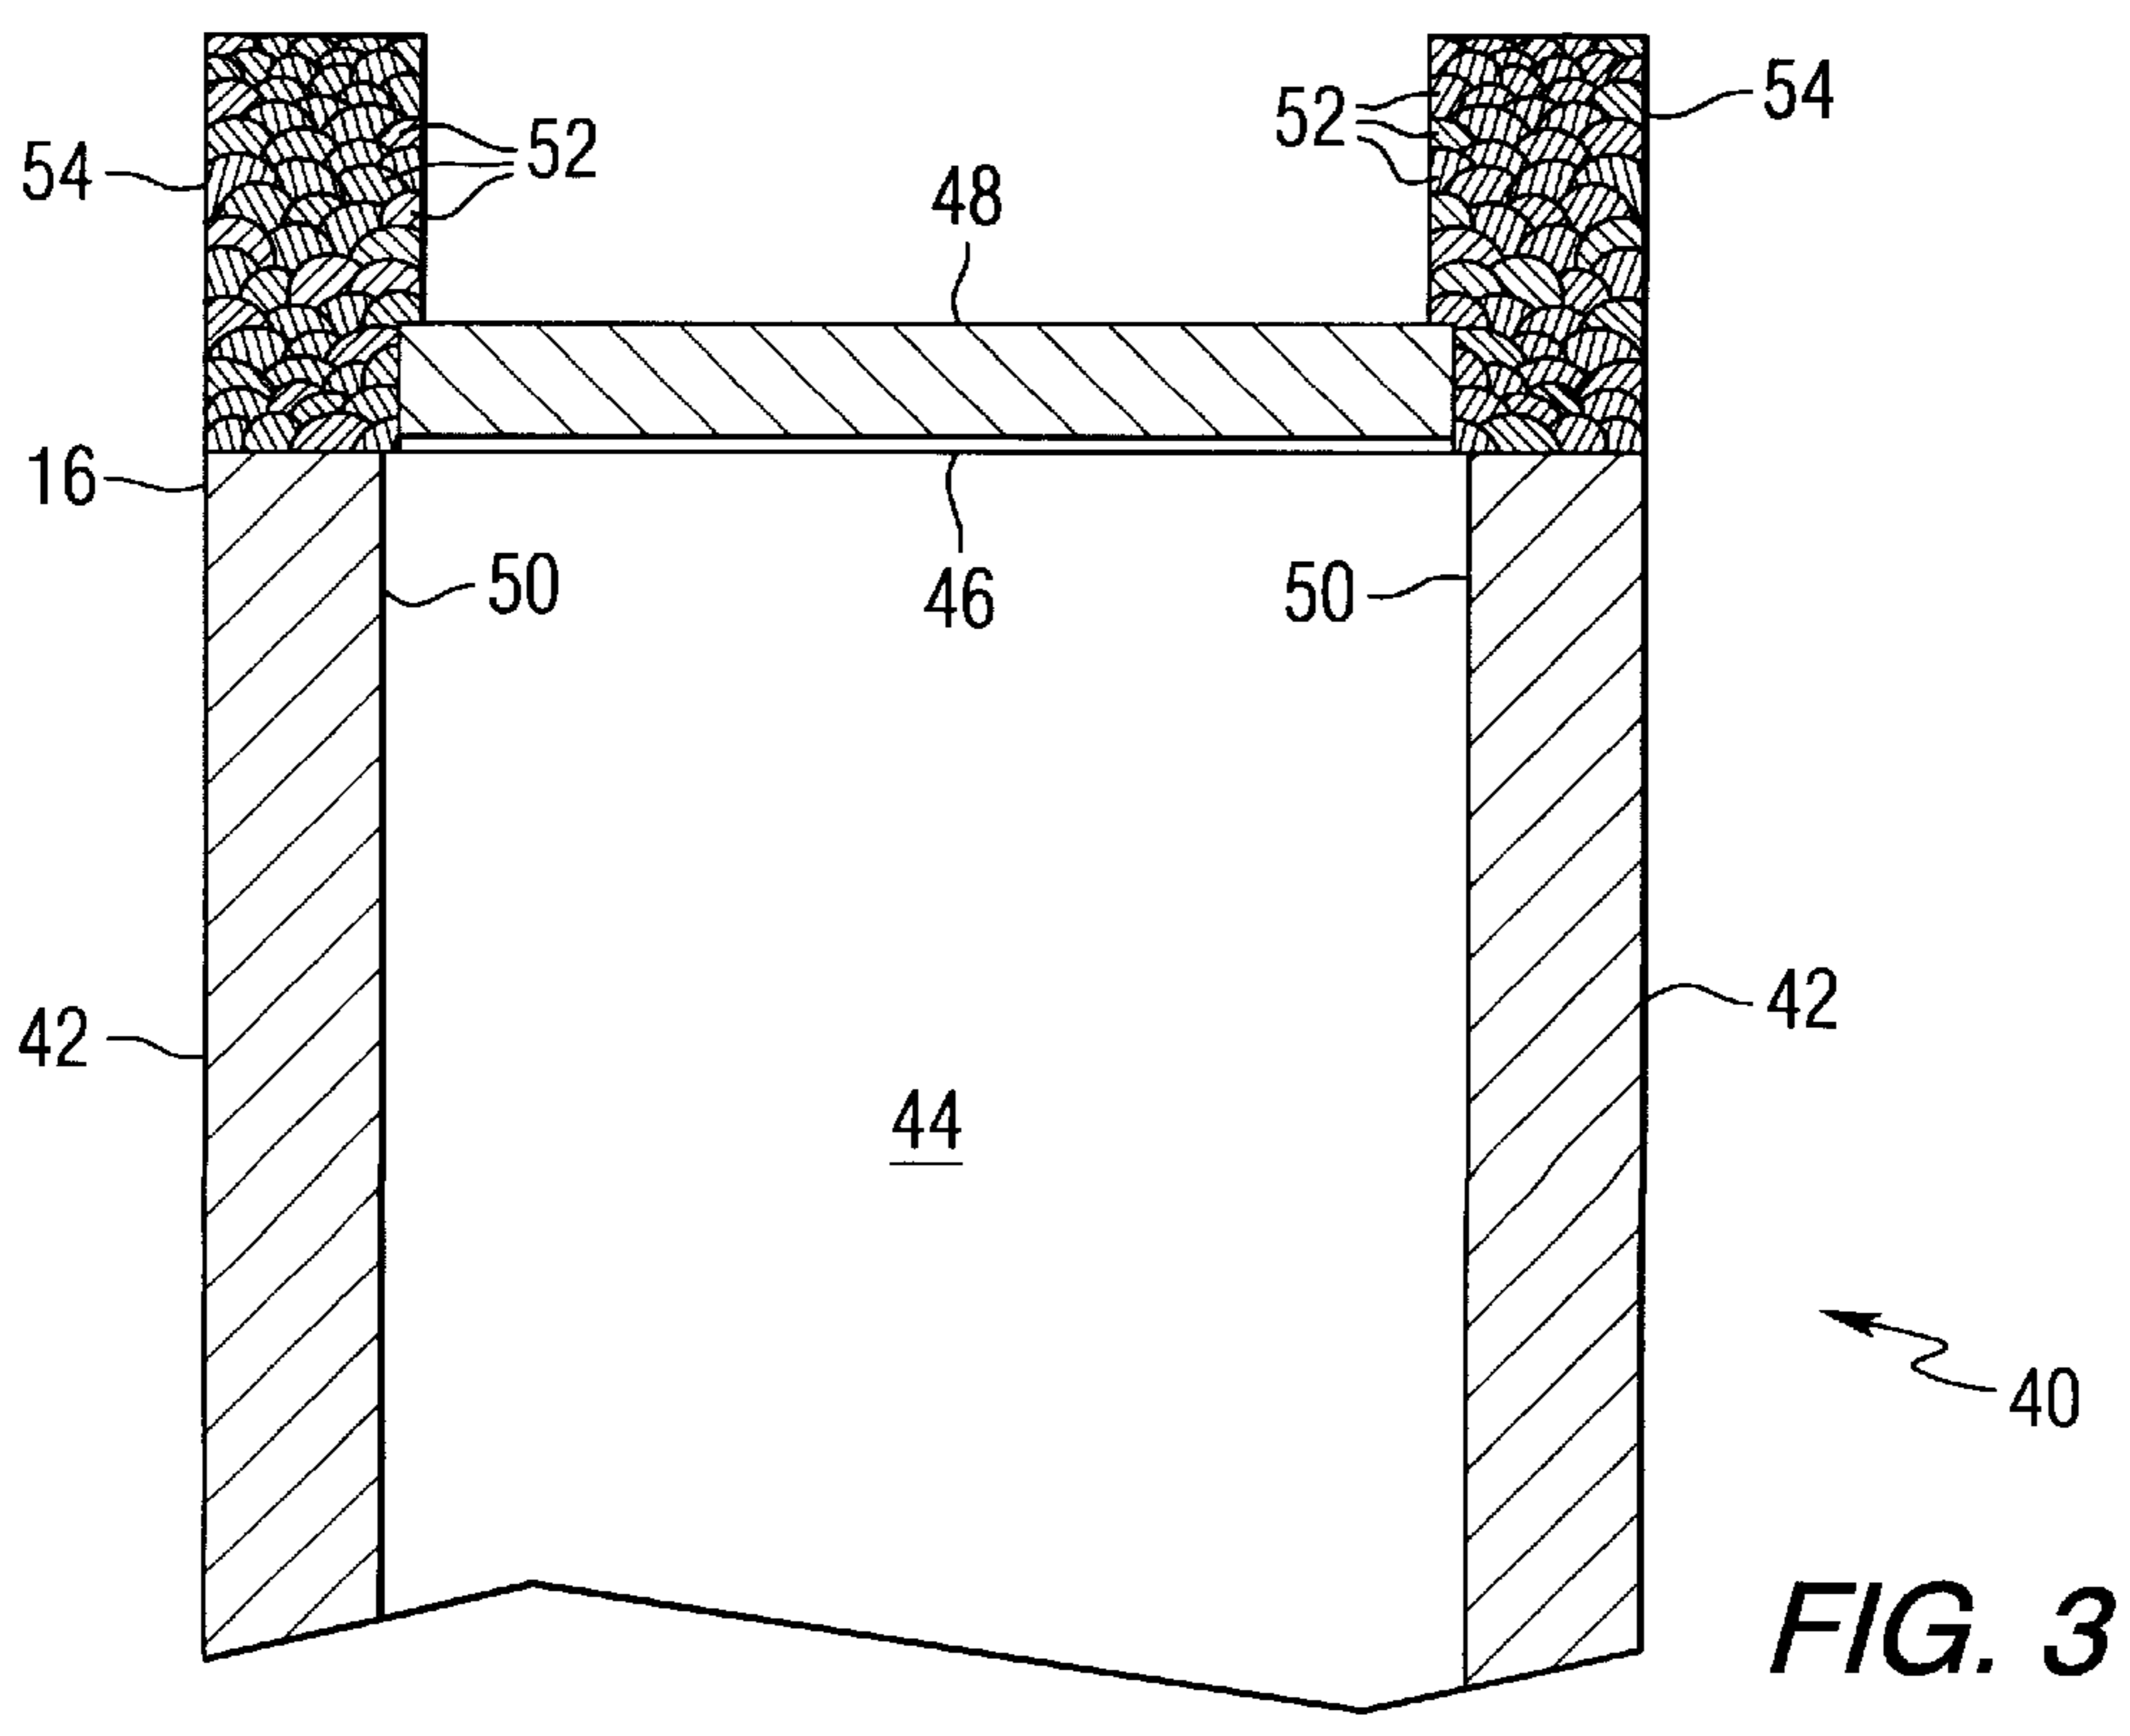
FIG. 3 is a partial sectional view of a turbine blade illustrating a repair made in accordance with the present invention.

FIG. 3 illustrates a turbine blade **40** manufactured or repaired in accordance with the present invention. The walls

42 of blade 40 correspond to the walls 28 of blade 10 of FIG. 2. Walls 42 form a portion of the boundary of a cooling passage 44 that is formed during the casting of the blade 40. These portions of blade 40 may be formed during the manufacturing of a new blade or may be the result of a partial repair process to a blade 10 taken out of service from a turbine. In accordance with the present invention, blade 10 of FIG. 2 may be repaired to become blade 40 of FIG. 3 by a sequence of steps illustrated schematically in FIG. 4. The first step 41 is to remove the squealer 22, cap plate 20, and all brazed material 34 from blade 10. The removal of these structures results in the formation of a repair surface 46 on the tip 16 of blade 40. The repair surface 46 is preferably flat and will expose the ends of each of the cooling passages 44. If the blade 10 had been rejected for a minimum wall violation, it may be possible to remove sufficient material to remove the portion of the blade 10 containing the minimum wall violation. The webs 30 of FIG. 2 are removed in step 43 to improve thermal characteristics at the tip and so that the webs 30 will not interfere with the ability to obtain a successful weld. In addition, removal of the webs 30 will expand the size of the opening of cooling passages 44 on repair surface 46. By improving the access to cooling passage 44, the inside surfaces 50 of the walls 42 become more accessible for nondestructive examination (NDE). It may be appreciated that the prior art blade designs utilize a web to minimize the core print opening at the tip of the blade, thereby making it easier to close the core print holes, either by attaching a plate by brazing or by welding to form a plug if the core print hole is small enough. A significant amount of effort is currently being expending in the casting industry to minimize core print hole size. However, the web material at the tip of the blade makes it more difficult to cool the tip of the blade. The current invention eliminates the problems associated with having a web for both newly manufactured and repaired blades.

A replacement cap, illustrated in FIG. 3 as plate 48, is then formed in step 45 to span cooling passage 44. Advantageously, a single plate 48 may be used to cover a plurality or all of the cooling passages 44 formed in blade 40 since the repair surface 46 is a single flat surface across the entire cross section of the blade 40. In this manner, the multiple plate design of the prior art blade 10 illustrated in FIG. 1 is eliminated. The plate 48 may be sized to span passage 44 leaving just a small gap between the edges of plate 48 and the edges of airfoil walls 42 to facilitate the subsequent welding process discussed below.

The material of plate 48 is chosen to facilitate the welding of the plate to the airfoil walls 42. In one embodiment the blade 40 is formed of a cast nickel-based super alloy such as IN-738LC, and both the plate 48 and the weld material 52 used to secure the plate onto the repair surface 46 are selected to be the same material as the blade 40. For a typical gas turbine row 1 blade, plate 48 may be in the range of 0.060–0.100 inches in thickness. Plate 48 may be held in place by mechanical means or by a tack weld as shown in step 47 of FIG. 4 before it is welded to the repair surface 46 in step 49. In one embodiment of the present invention, the welding process utilized in step 49 is a high temperature TIG welding process. The applicants have found that for blades cast either conventionally, directionally solidified, or as a single crystal from either IN-738, Mar M247, or CM 247LC material, a pre-heat and an in-process welding temperature of between 1,650–1,950 degrees Fahrenheit will provide acceptable results. If a tack weld is used in step 47, the tack weld and its heat affected zone are consumed during the welding of step 49 in order to obtain the more desirable
