FOD INSPECTION OF LASER SHOCK PEENED GAS TURBINE ENGINE AIRFOILS

This invention relates to operation of gas turbine engine laser shock peened airfoils and, more particularly, to extending tolerances of FOD damaged laser shock peened airfoils.

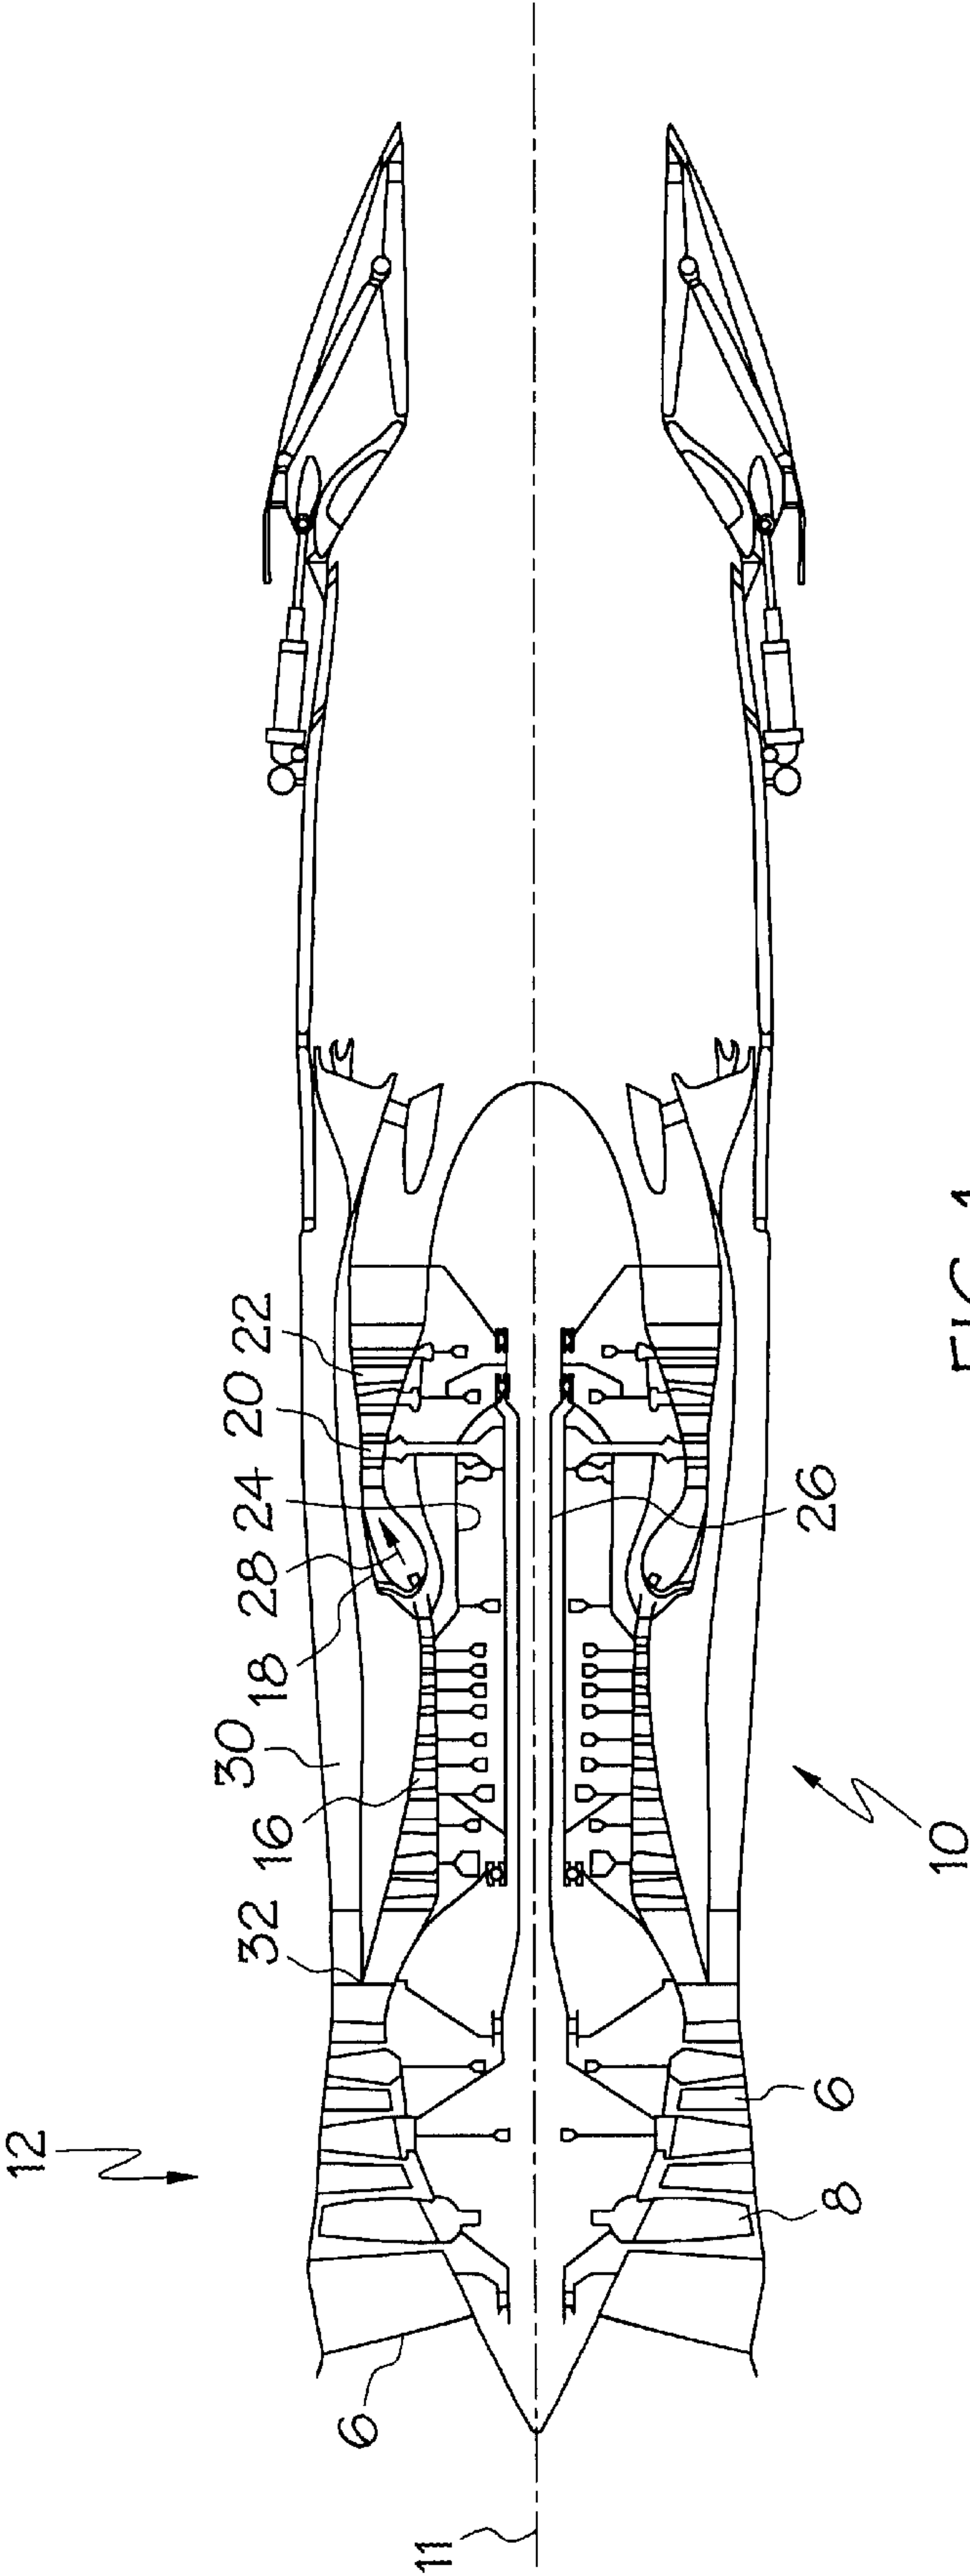
FIG. 1 is a cross-sectional illustrative view of an exemplary aircraft gas turbine engine having airfoils that are laser shock peened and inspected in an exemplary embodiment of the present invention.

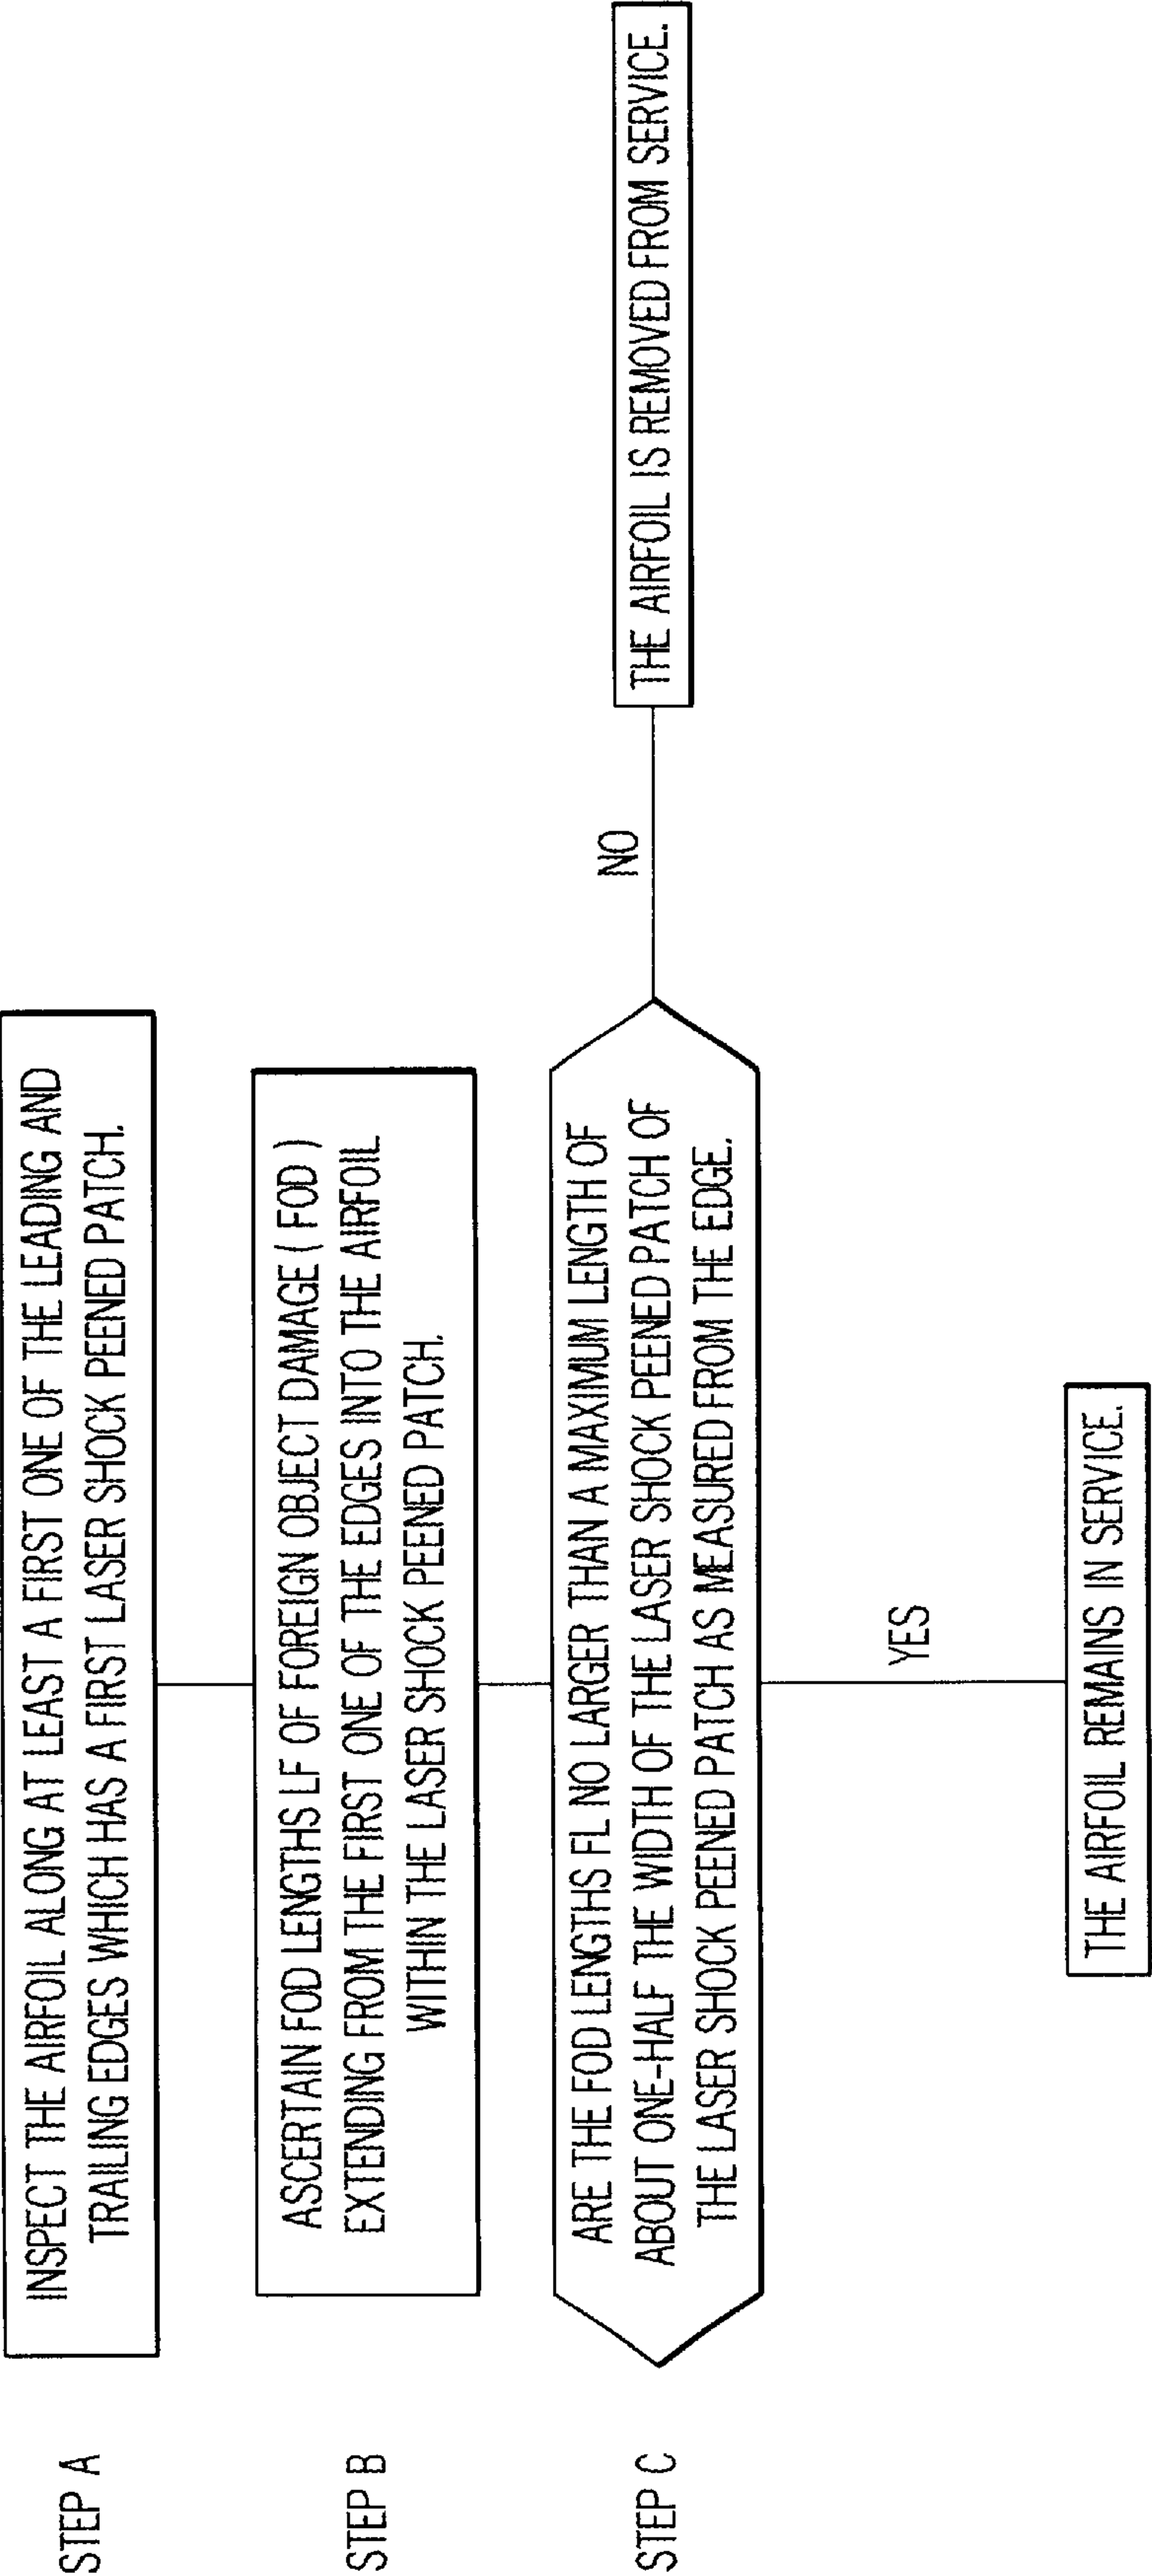
FIG. 5 is a flow chart illustrating a first exemplary method of inspecting and operating a laser shock peened airfoil of the present invention.

A first flow chart in FIG. 5 illustrated a first exemplary method of operating and inspecting the gas turbine engine airfoil having leading and trailing edges, LE and TE respectively, subject to FOD damage. The method is explained herein more particularly for leading edges but applies to trailing edges as well. The method includes the following steps:
