(10) **Patent No.: US 6,341,936 B1**
(45) **Date of Patent: Jan. 29, 2002**

(54) **FOD INSPECTION OF LASER SHOCK
PEENED GAS TURBINE ENGINE AIRFOILS**

(73) Assignee: **General Electric Company**, Cincinnati,
OH (US)

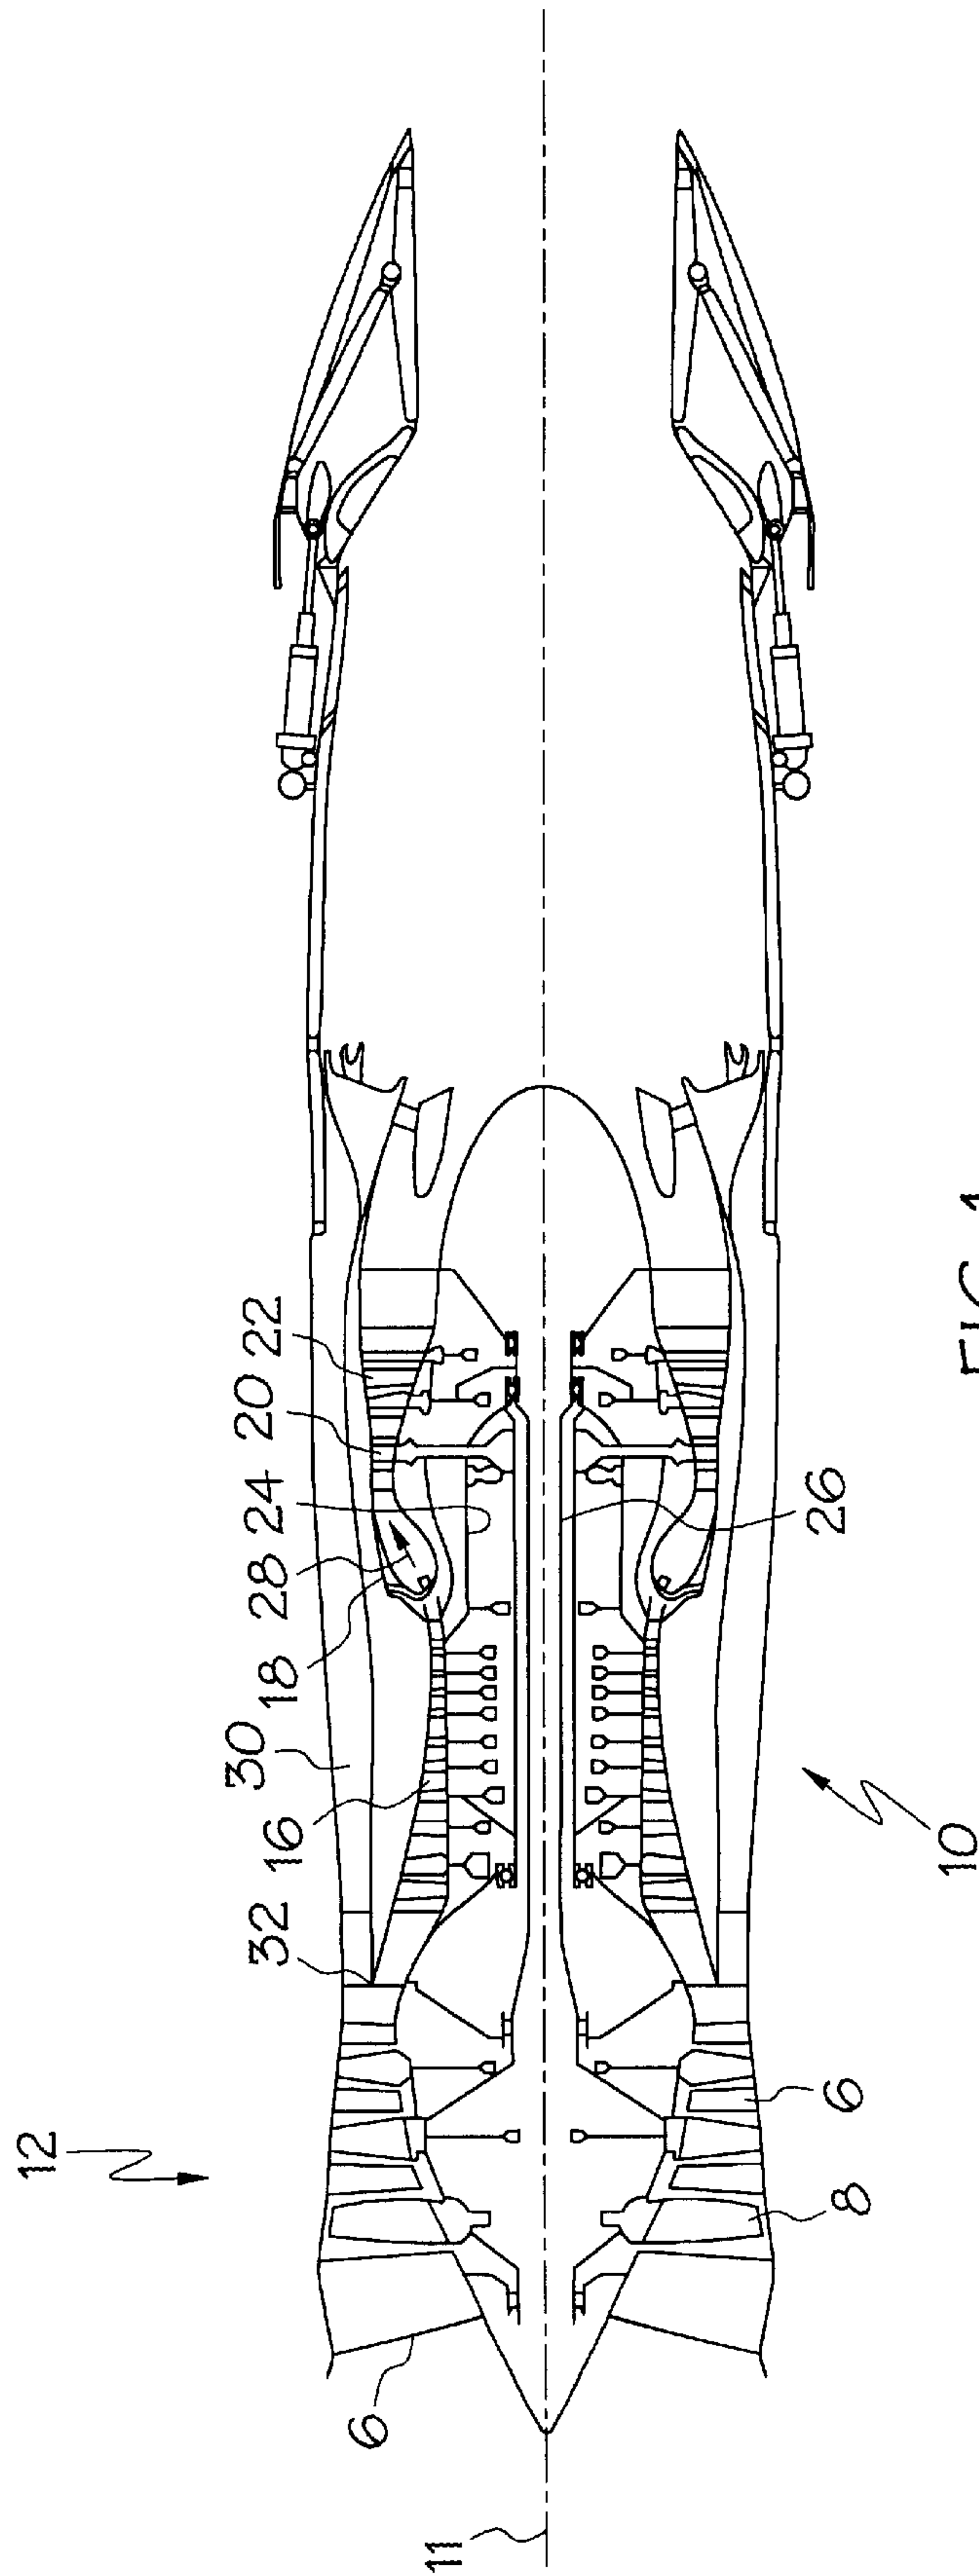
FIG. 1 is a cross-sectional illustrative view of an exemplary aircraft gas turbine engine having airfoils that are laser shock peened and inspected in an exemplary embodiment of the present invention.

Illustrated in FIG. 1 is a schematic representation of an exemplary aircraft turbofan gas turbine engine 10 including

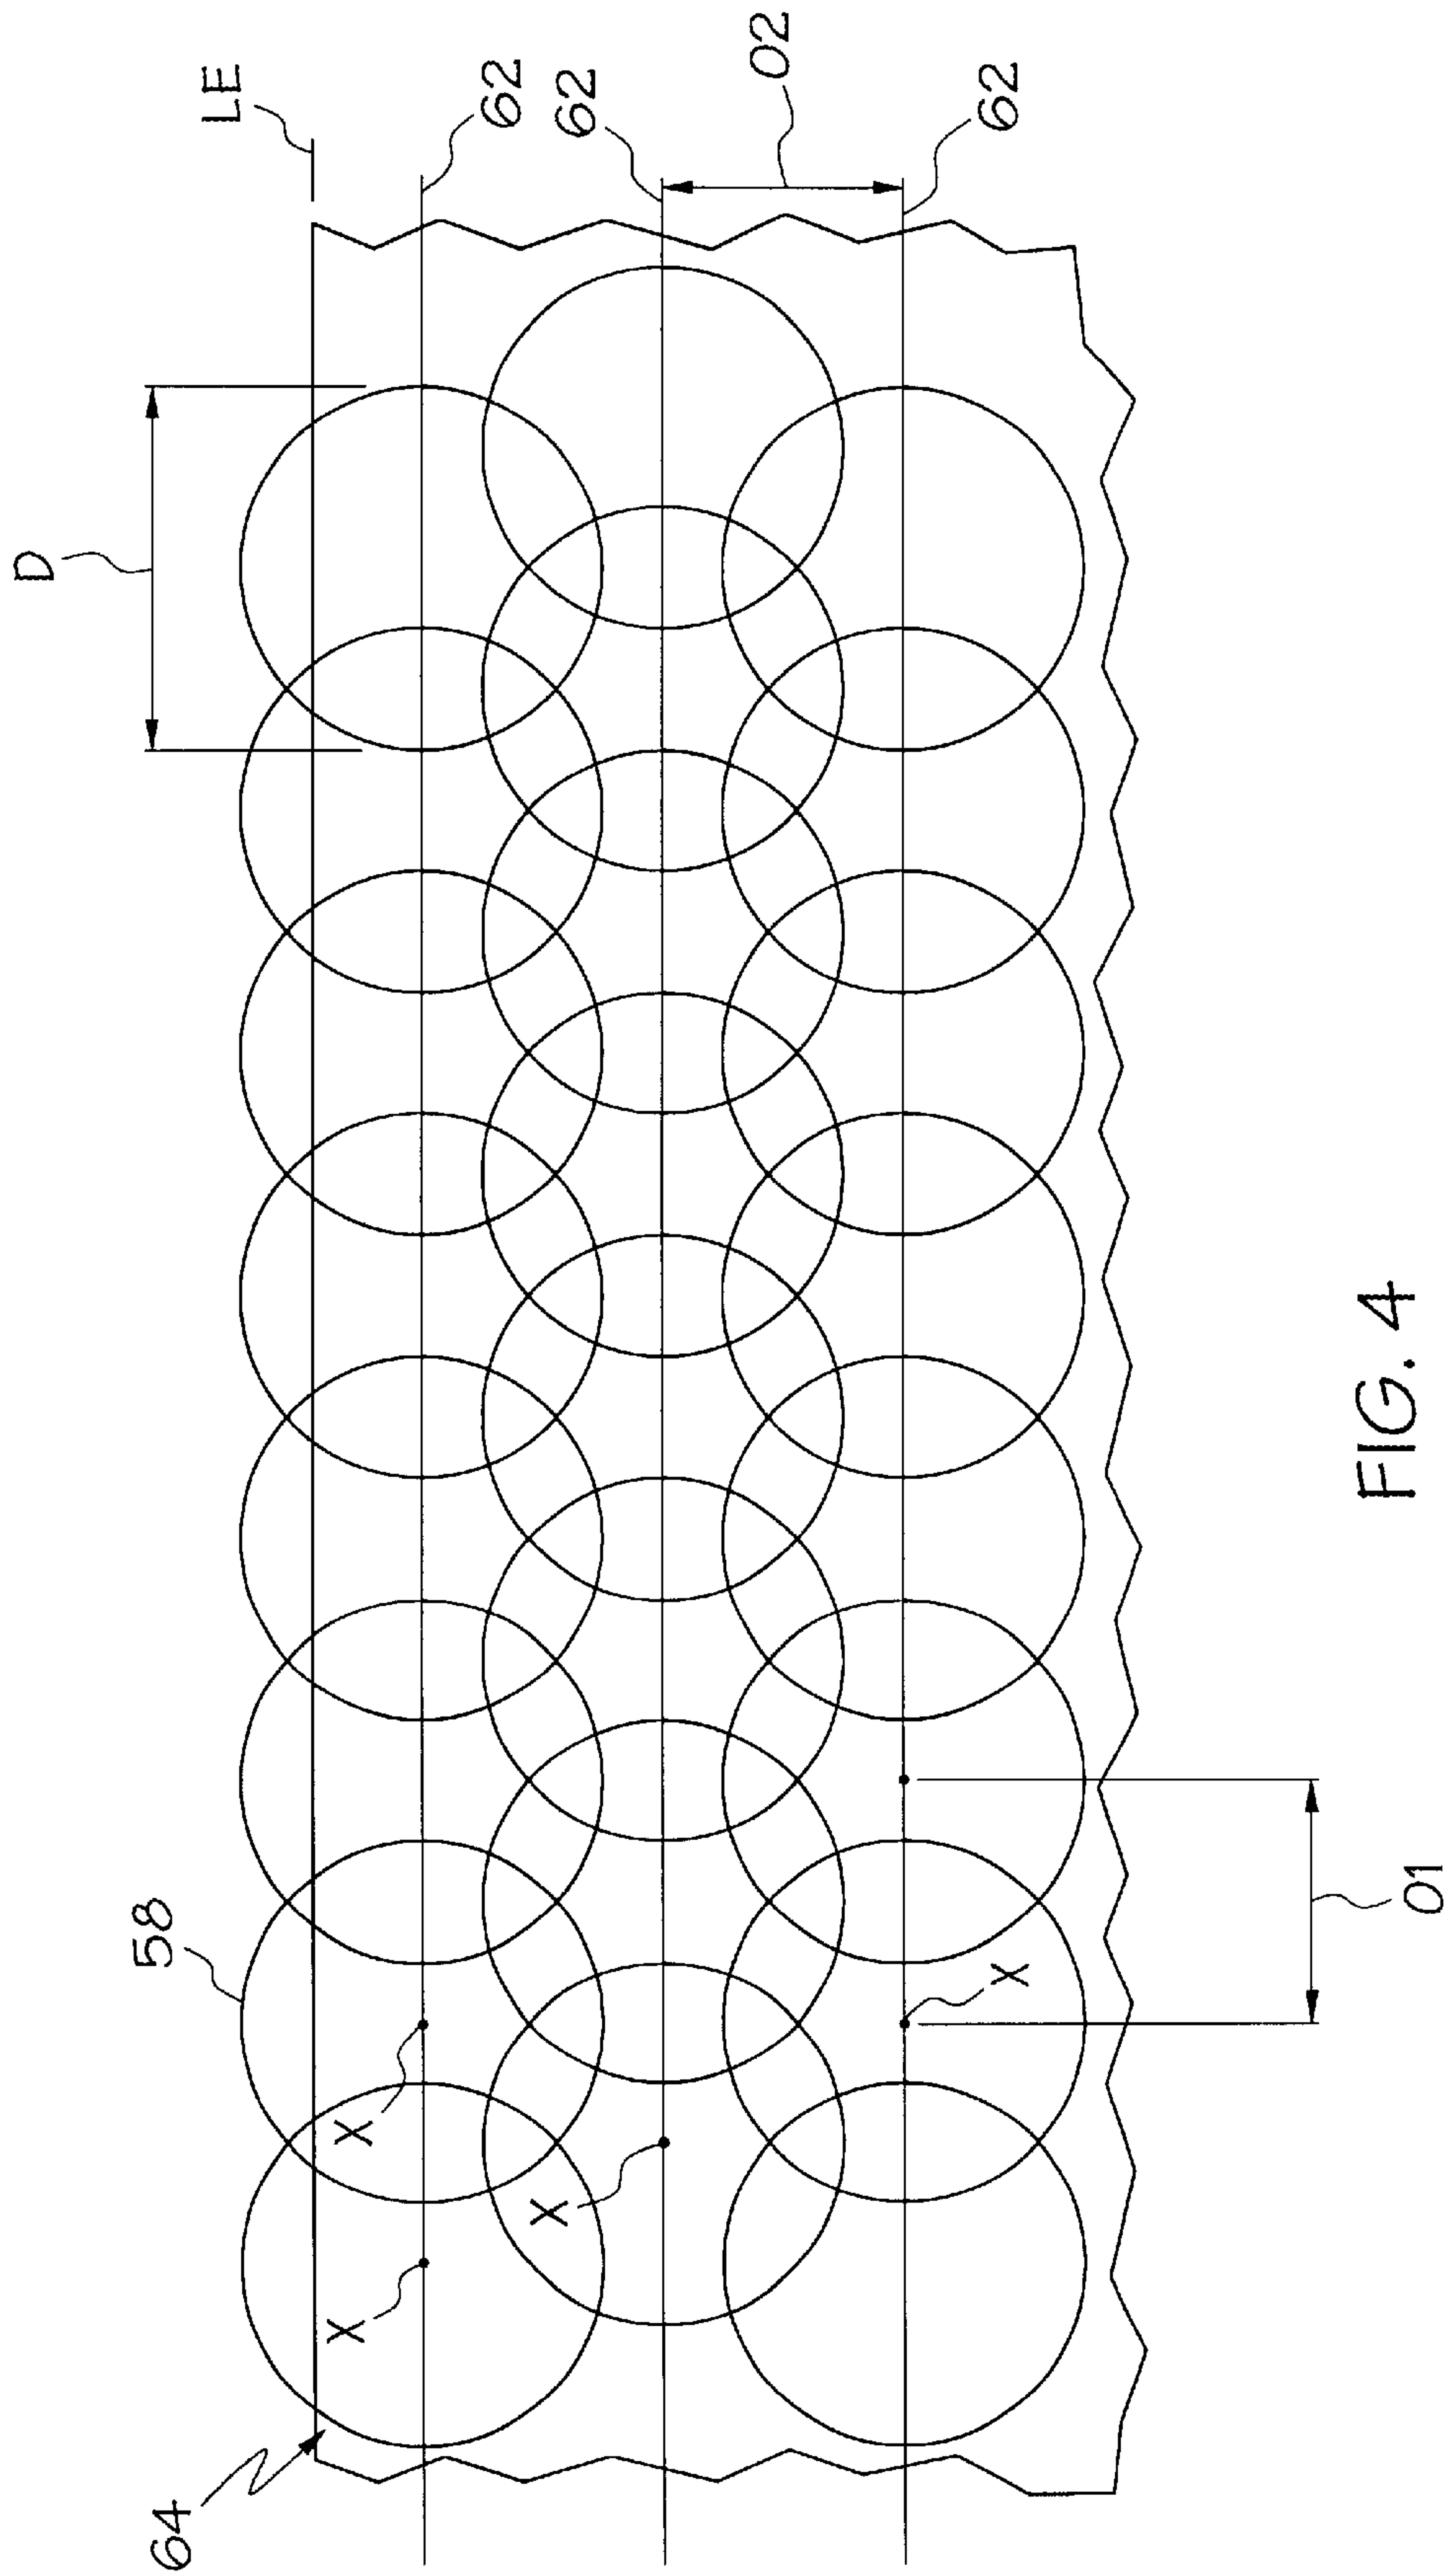
FIG. 4 is an enlarged view of the laser shock peened leading edge illustrated in FIG. 2.

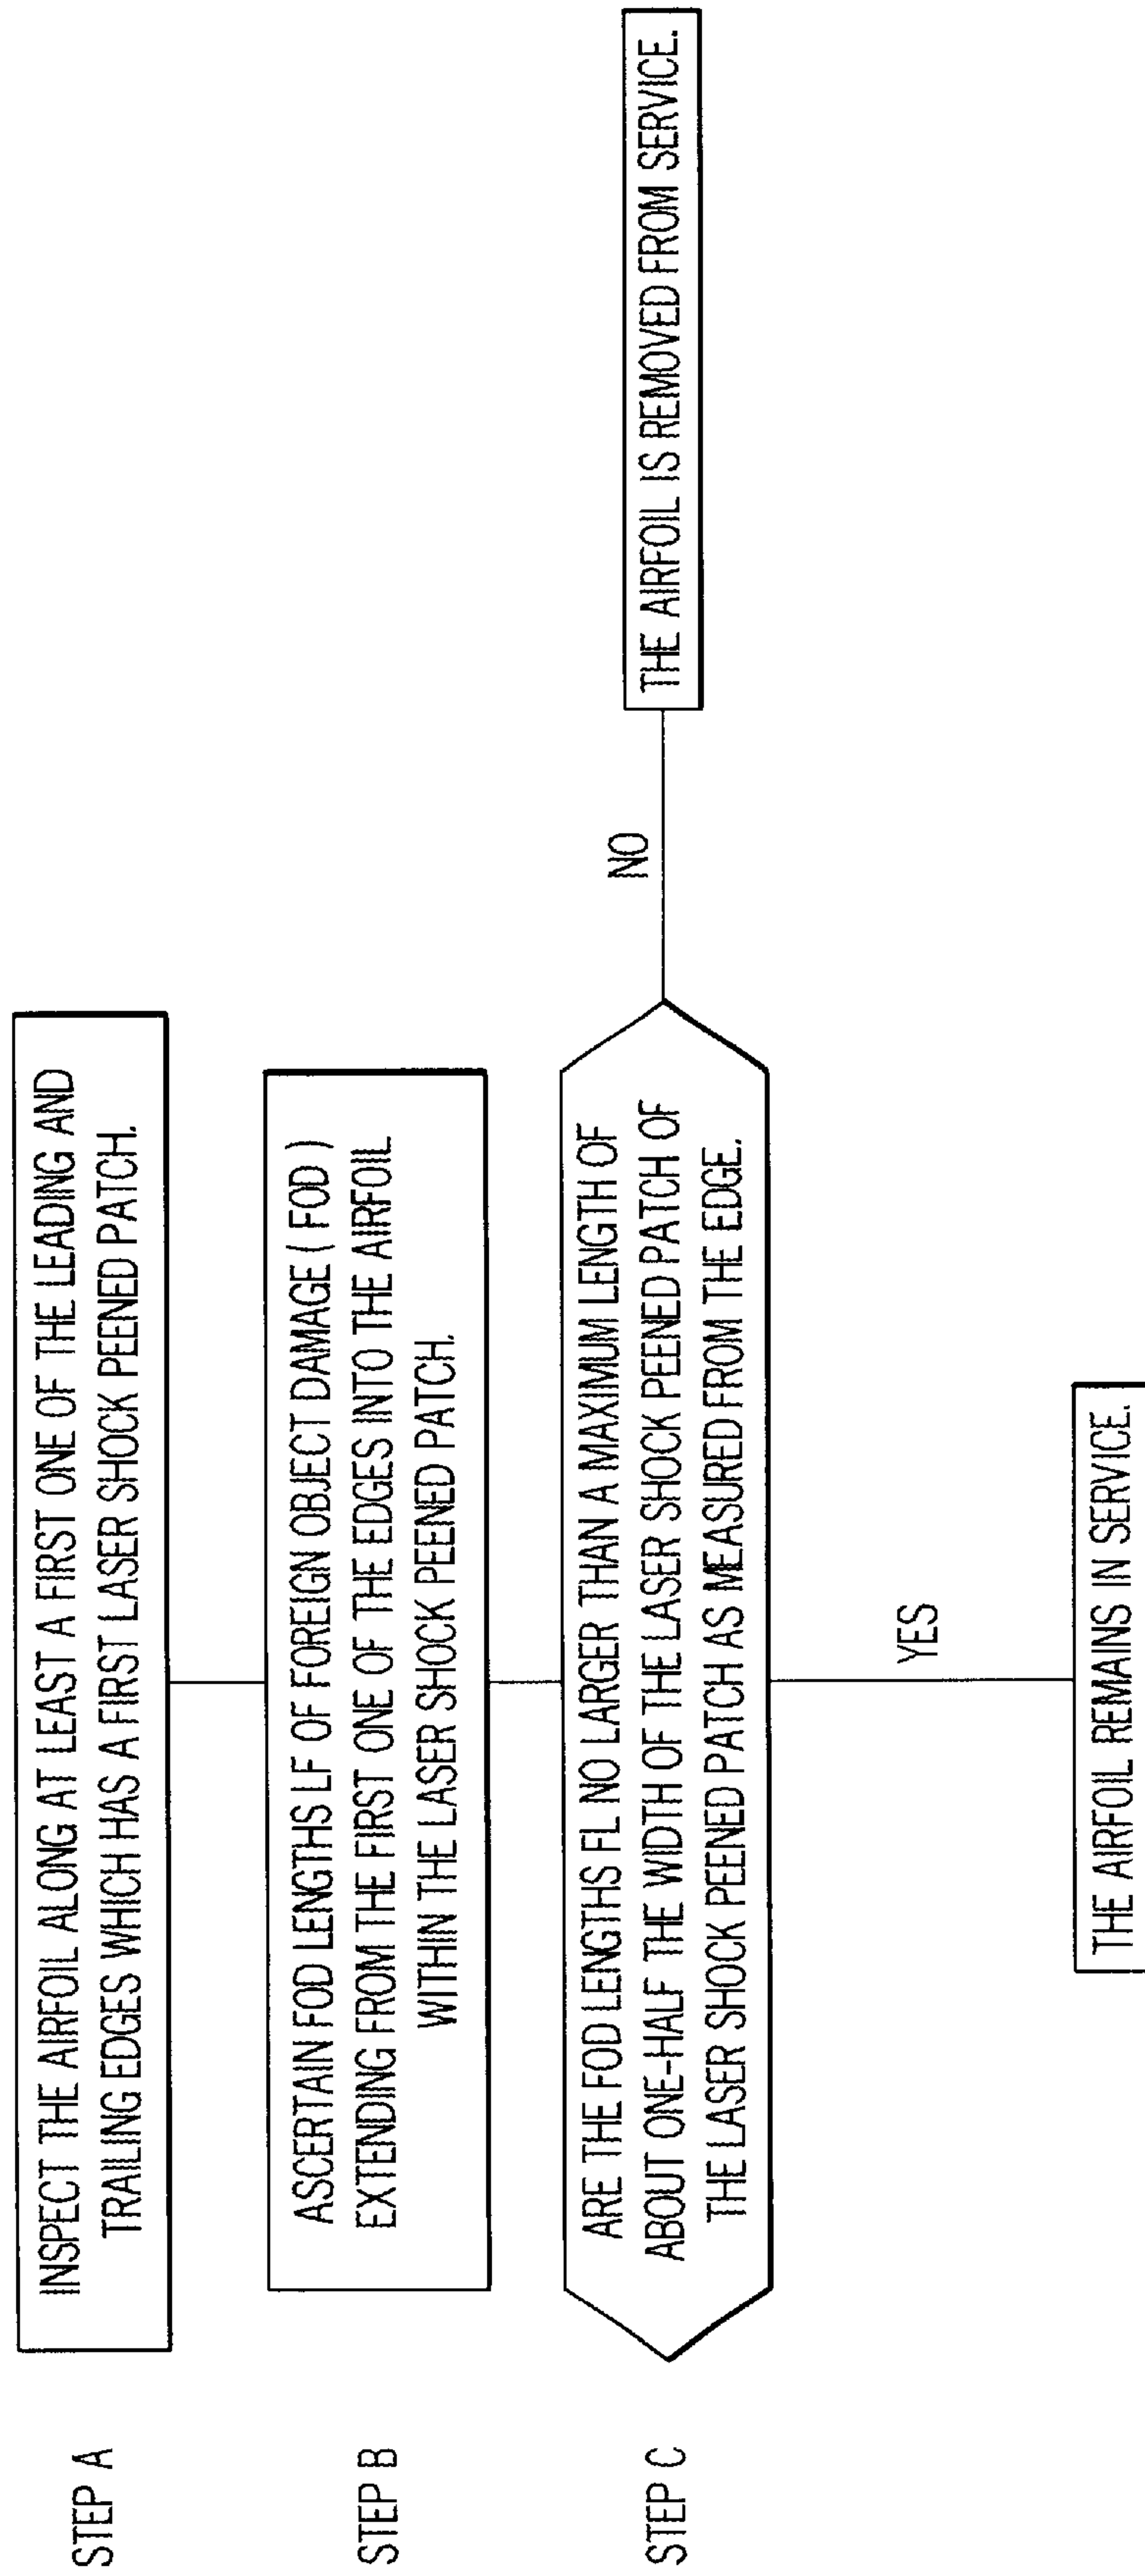
FIG. 5 is a flow chart illustrating a first exemplary method of inspecting and operating a laser shock peened airfoil of the present invention.

A first flow chart in FIG. 5 illustrated a first exemplary method of operating and inspecting the gas turbine engine airfoil having leading and trailing edges, LE and TE respectively, subject to FOD damage. The method is explained herein more particularly for leading edges but applies to trailing edges as well. The method includes the following steps:

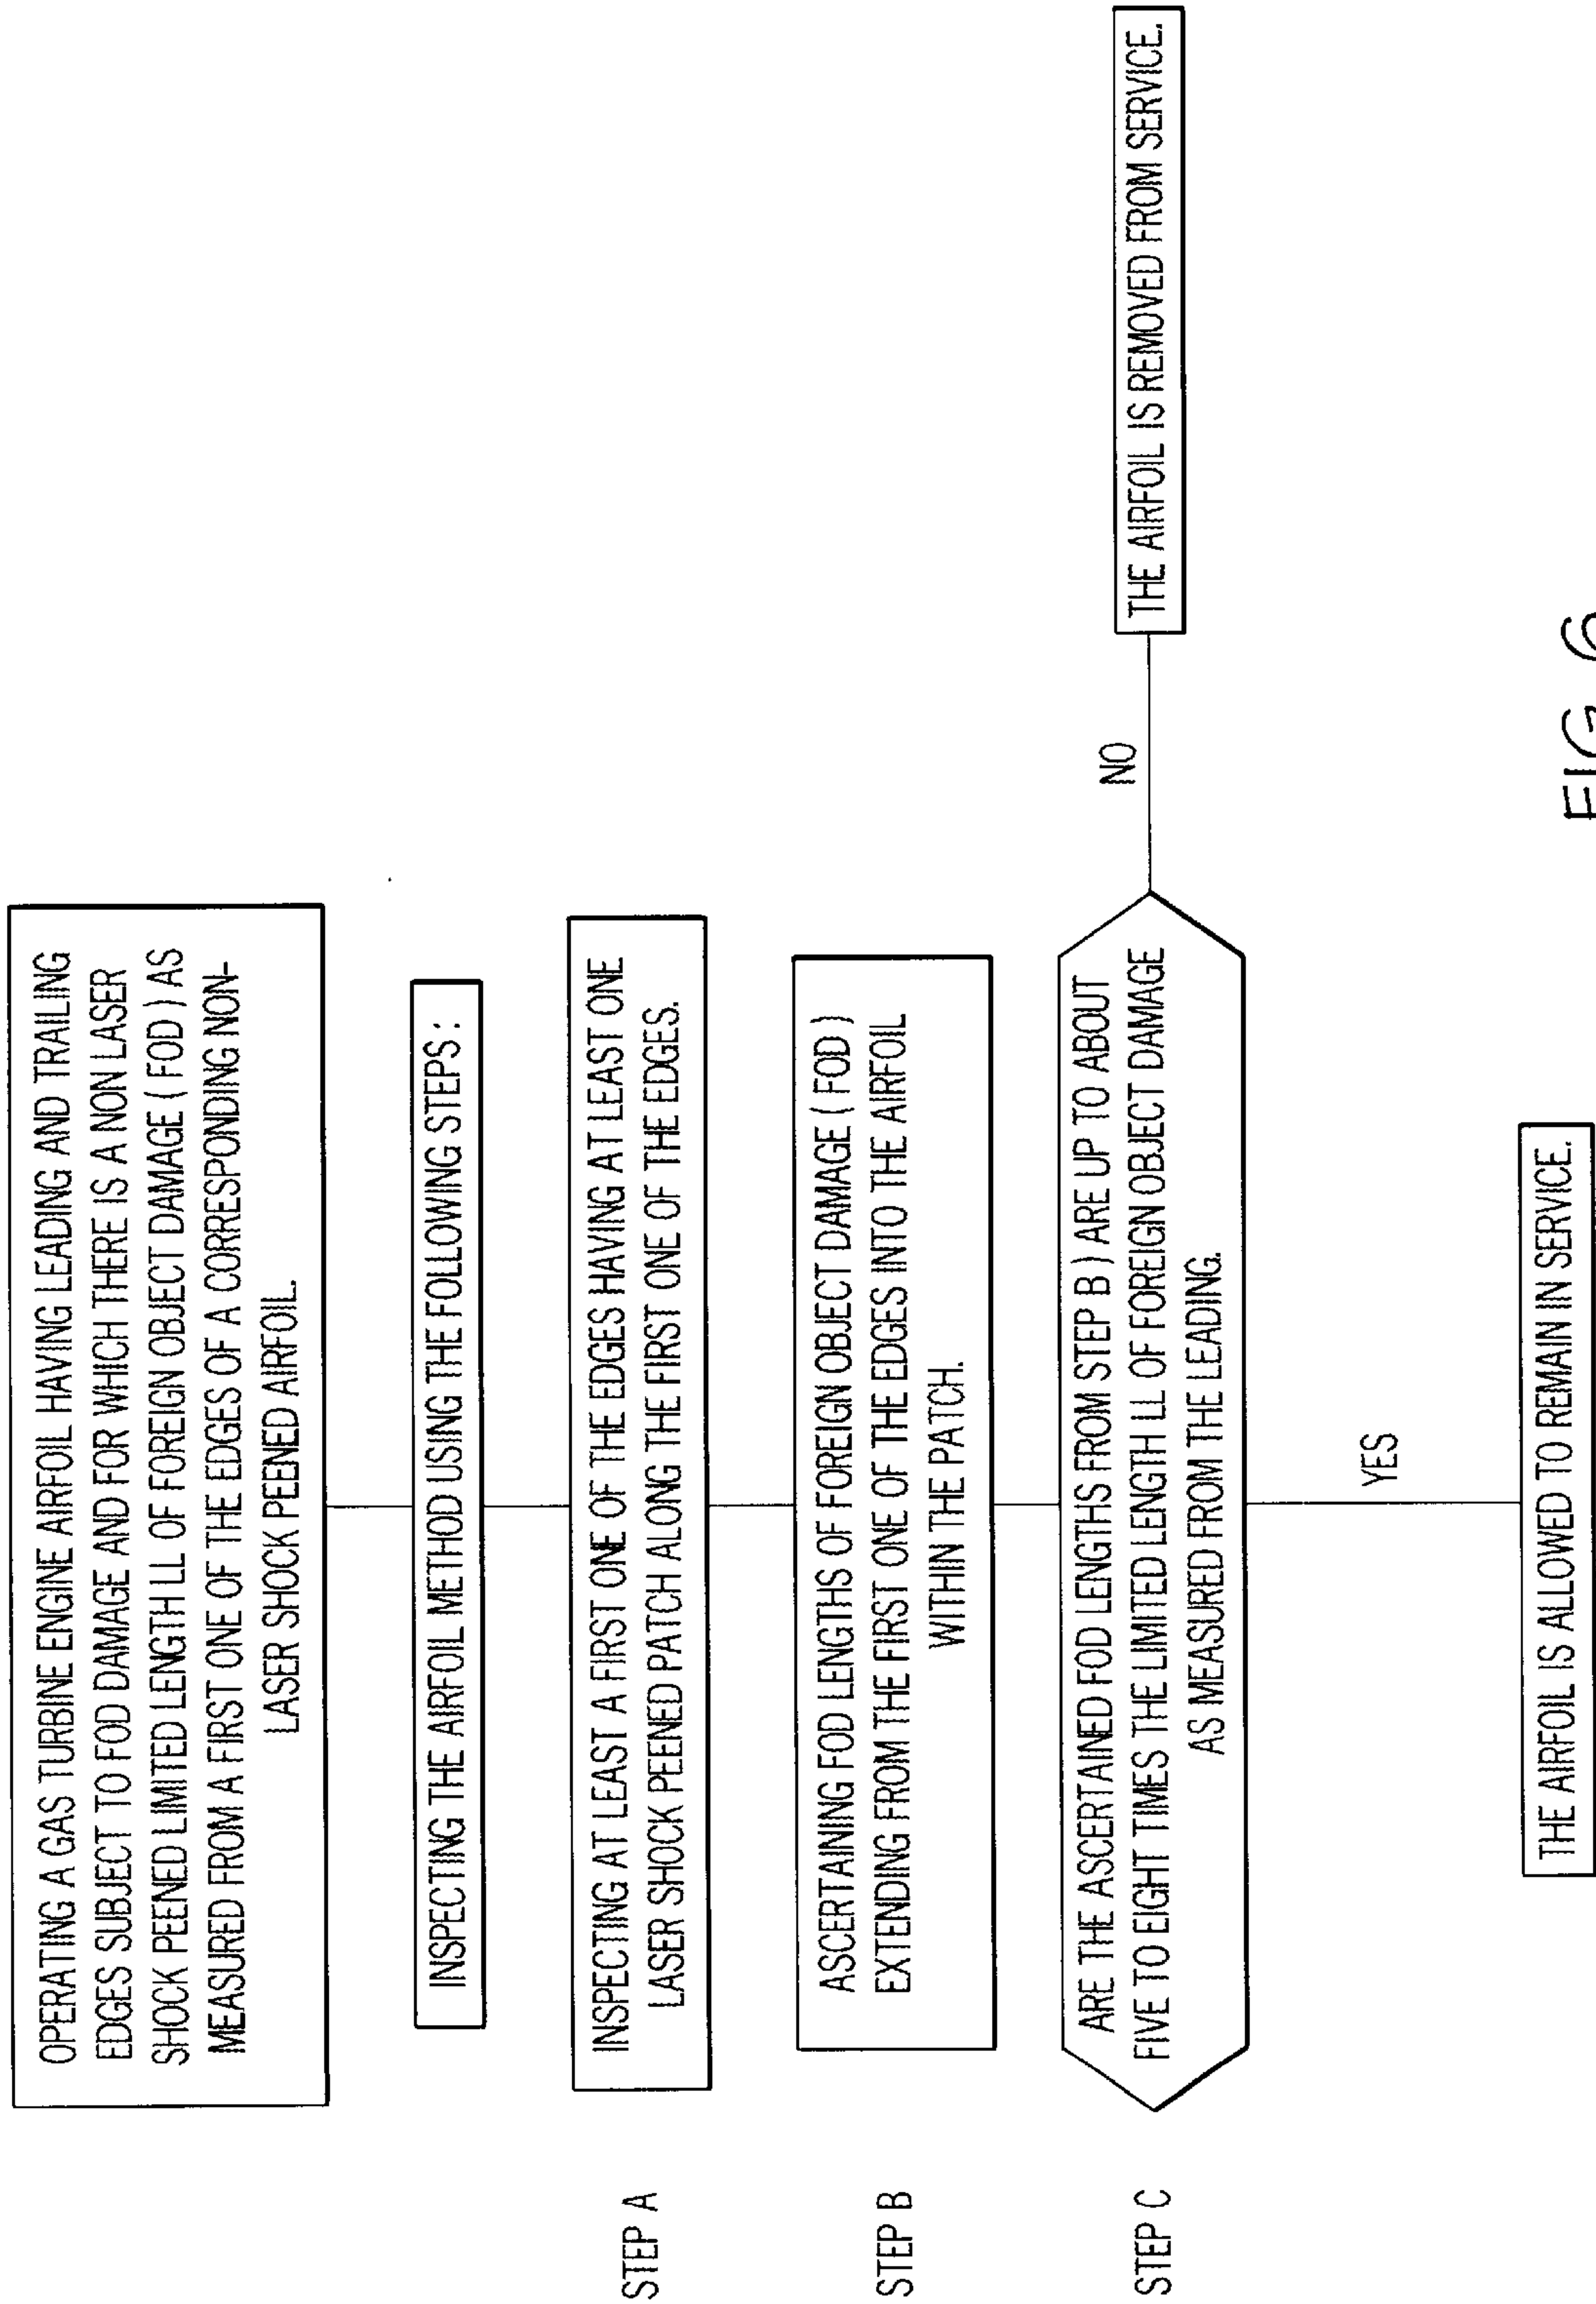
FIG. 6 is a flow chart illustrating a second exemplary method of inspecting and operating a laser shock peened airfoil of the present invention.

Illustrated in FIG. 6 is a second exemplary method of operating and inspecting the gas turbine engine airfoil having leading and trailing edges subject to FOD damage and for which there is a non-laser shock peened limited length LL in FIG. 8 of foreign object damage (FOD) as measured from a first one of the edges of a corresponding non-laser shock peened airfoil, i.e. an airfoil not having laser shock peened patches on the leading and/or trailing edges. This method includes the following steps: A) inspecting at least a first one of the edges having at least one laser shock peened patch along the first one of the edges, B) ascertaining FOD lengths of foreign object damage (FOD) extending from the first one of the edges into the airfoil within the patch, and C) allowing the airfoil to remain in service if the ascertained FOD lengths from step B) are up to about five to eight times the limited length LL of foreign object damage as measured from the leading edge.

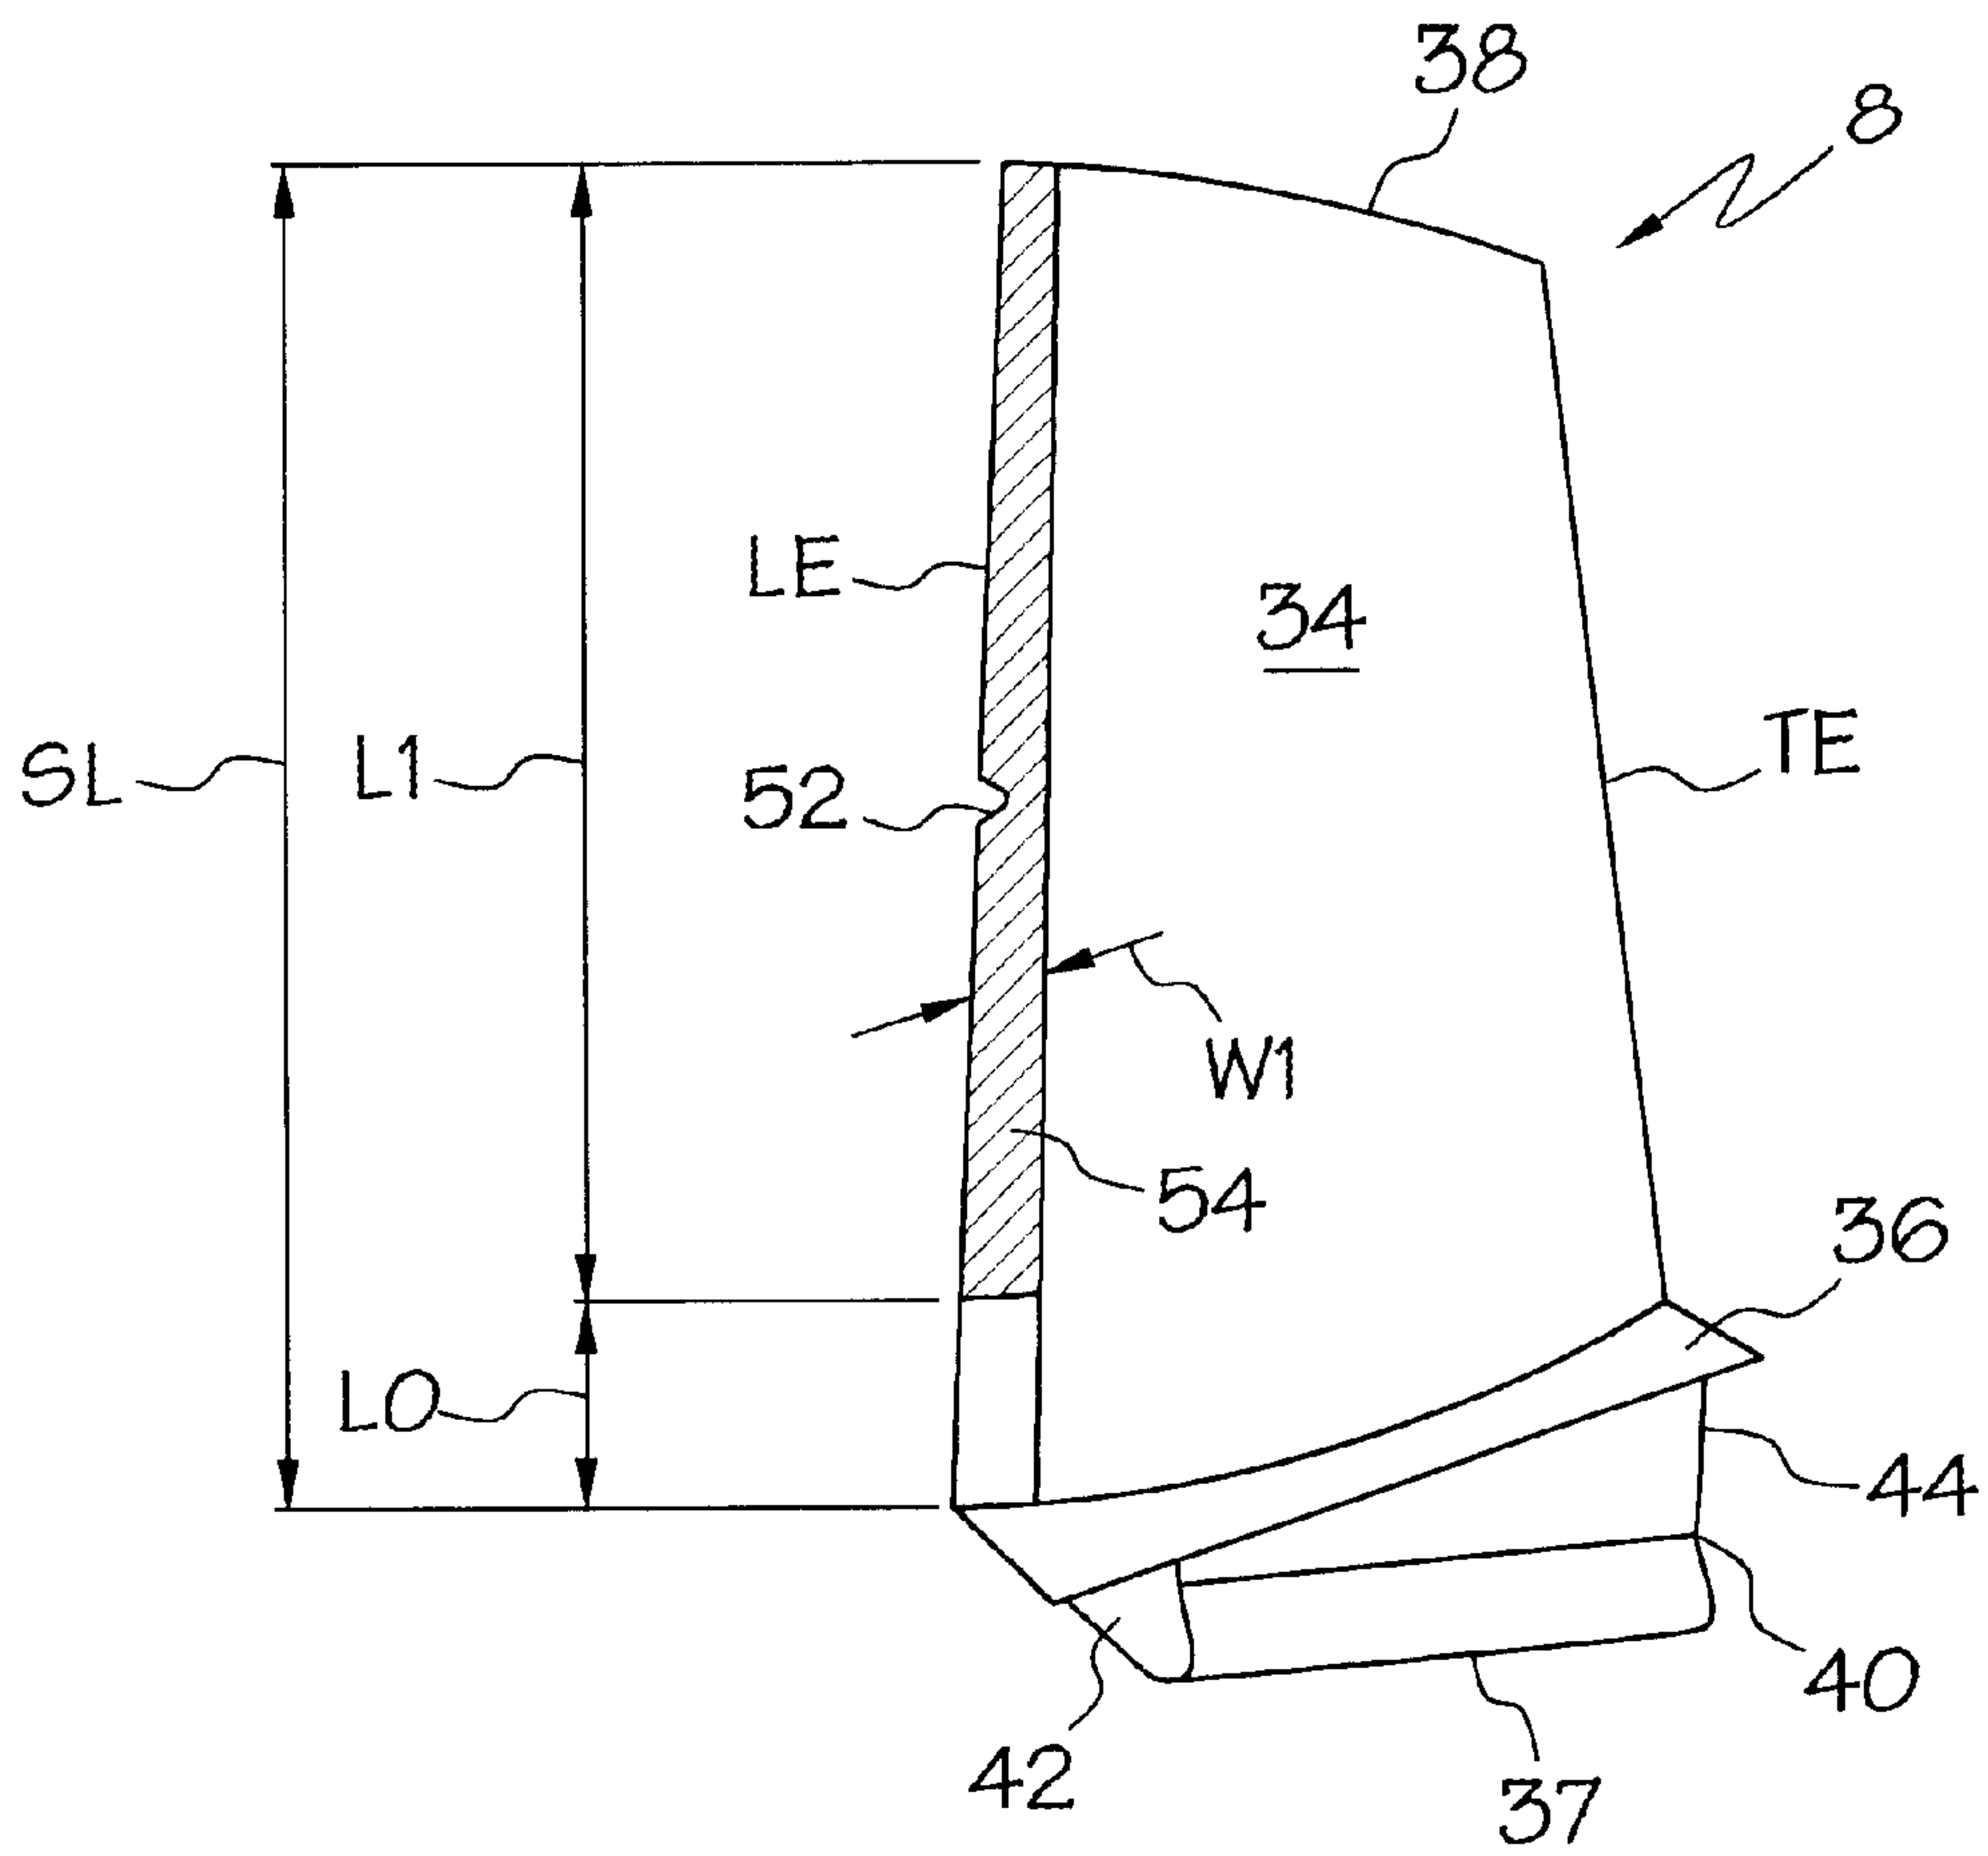
FIG. 9 illustrates another example of the present invention.
