(54)	METHOD OF CORRECTING A PRINT
, ,	ERROR CAUSED BY MISALIGNMENT
	BETWEEN CHIPS MOUNTED ON AN ARRAY
	HEAD OF AN INKJET PRINTER

A method of correcting a print error caused due to a misalignment between chips mounted on an array head of an inkjet printer. The method includes calculating an acceptable limit of a rotation angle of the chips with respect to reference positions, based upon a range that does not cause a white band to form on a printed image; determining whether the rotation angle of each chip is within the acceptable limit or not; correcting a machine error of each chip if it is determined that the rotation angle of each chip is not within the acceptable limit; if the rotation angle of each chip is within the acceptable limit, adding a plurality of nozzles on at least one end of each chip, determining which of the added nozzles to use based on a predetermined trial printing pattern, and correcting a print error in a horizontal direction that is caused due to a misalignment in the horizontal direction; and correcting a print error in a vertical direction due to a misalignment between the chips in a vertical direction by determining a reference time for voltage pulse app

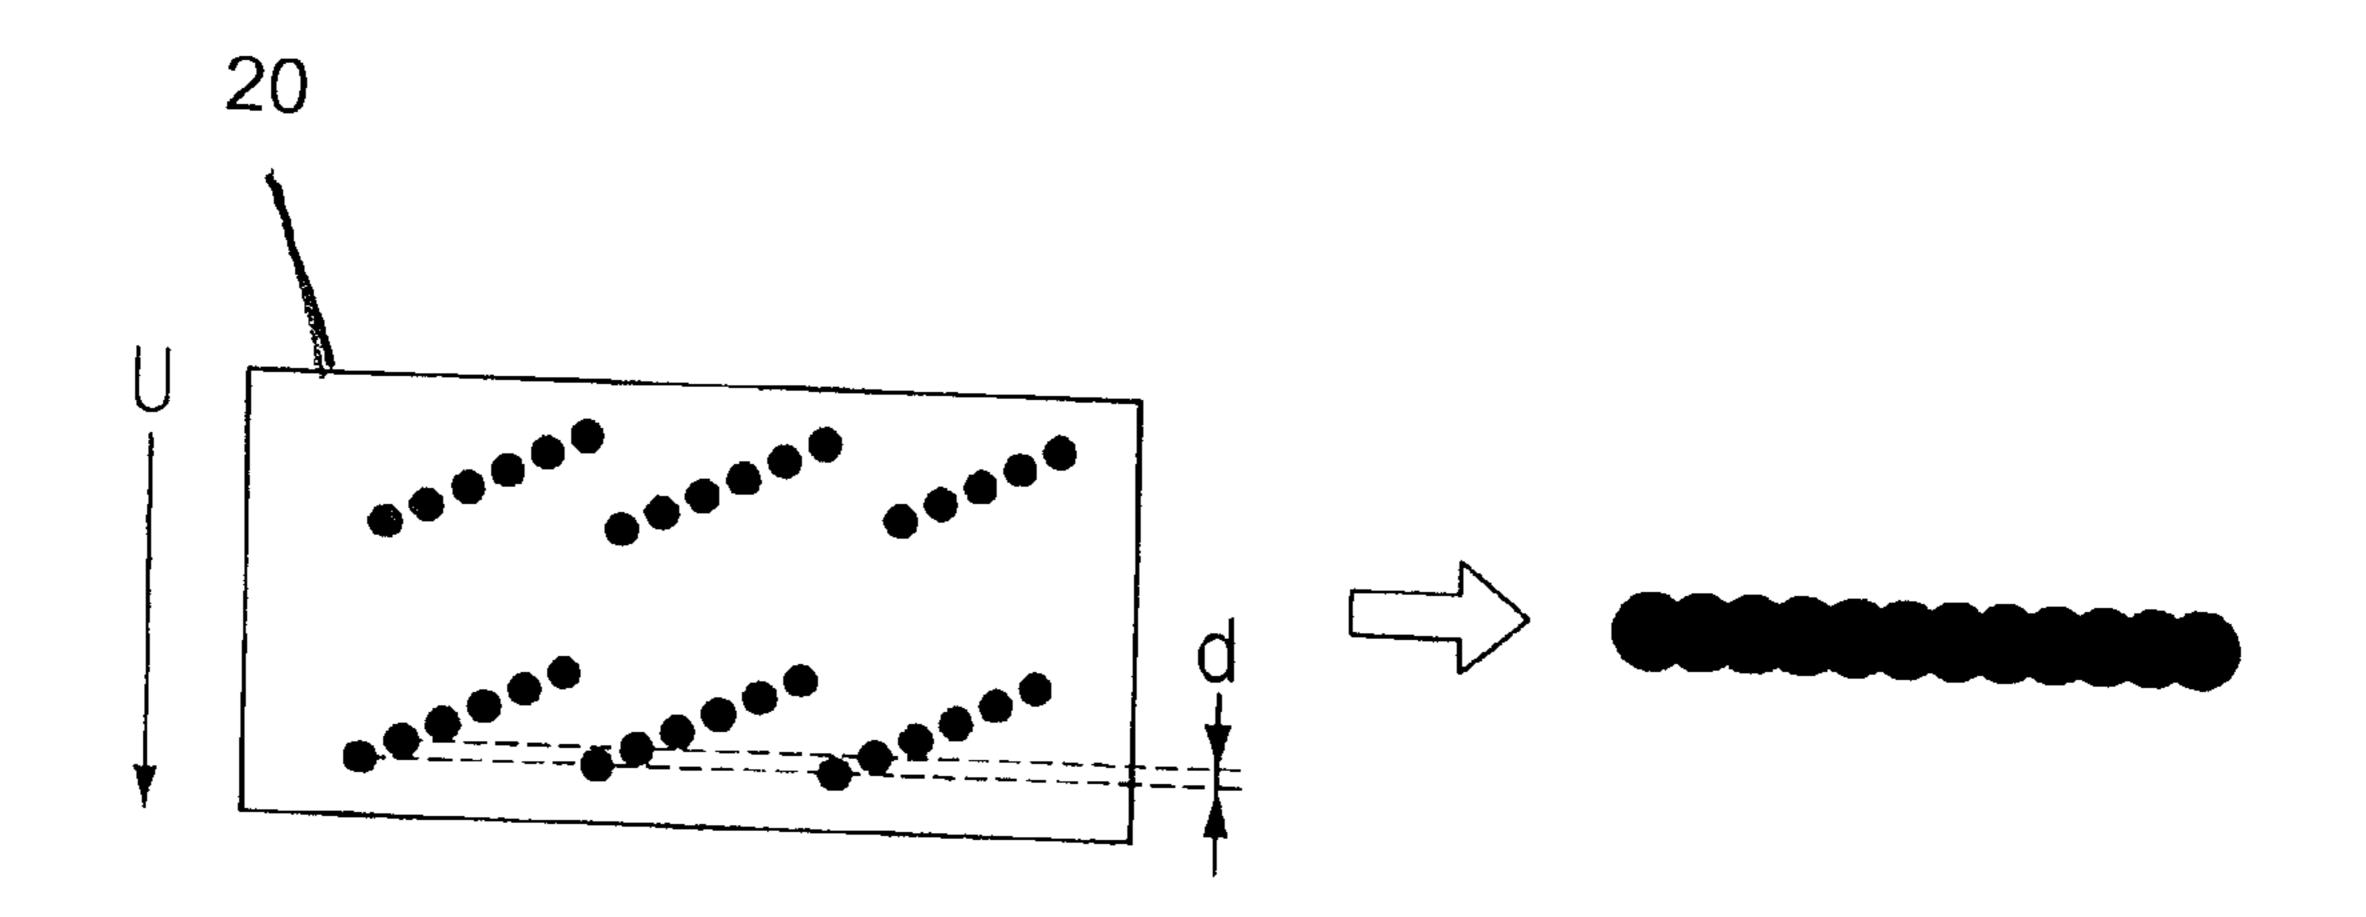
FIG. 4A is a diagram showing an ideal position of the unit chips and the respective printing image printed on the printing medium;

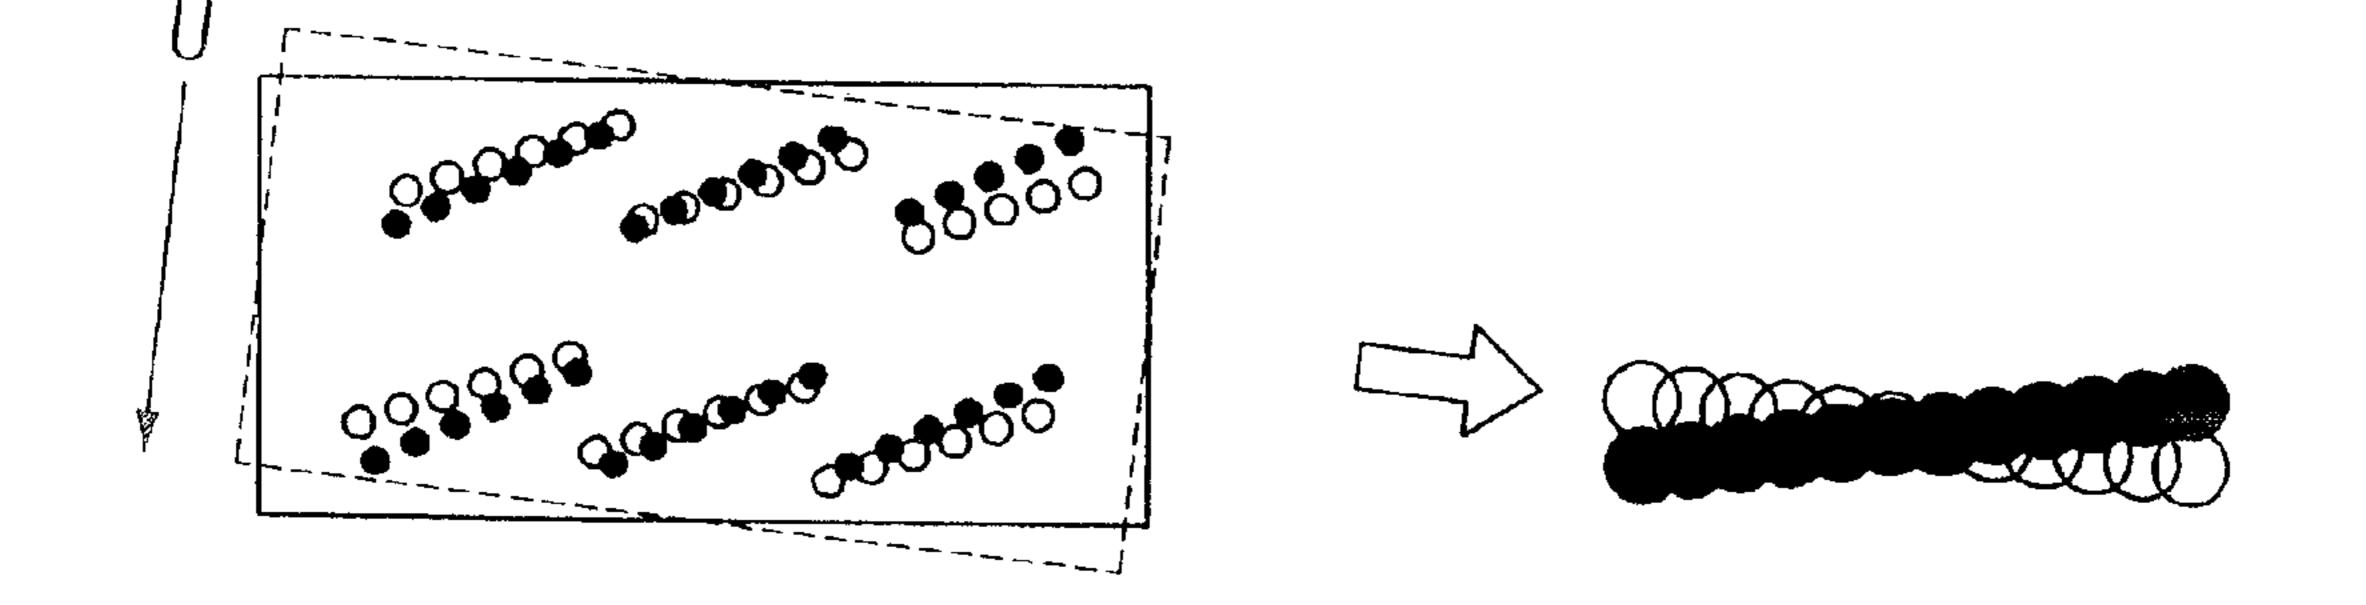
FIG. 4B is a diagram showing the unit chips being tilted, and the respective printing image printed 6n the printing medium;

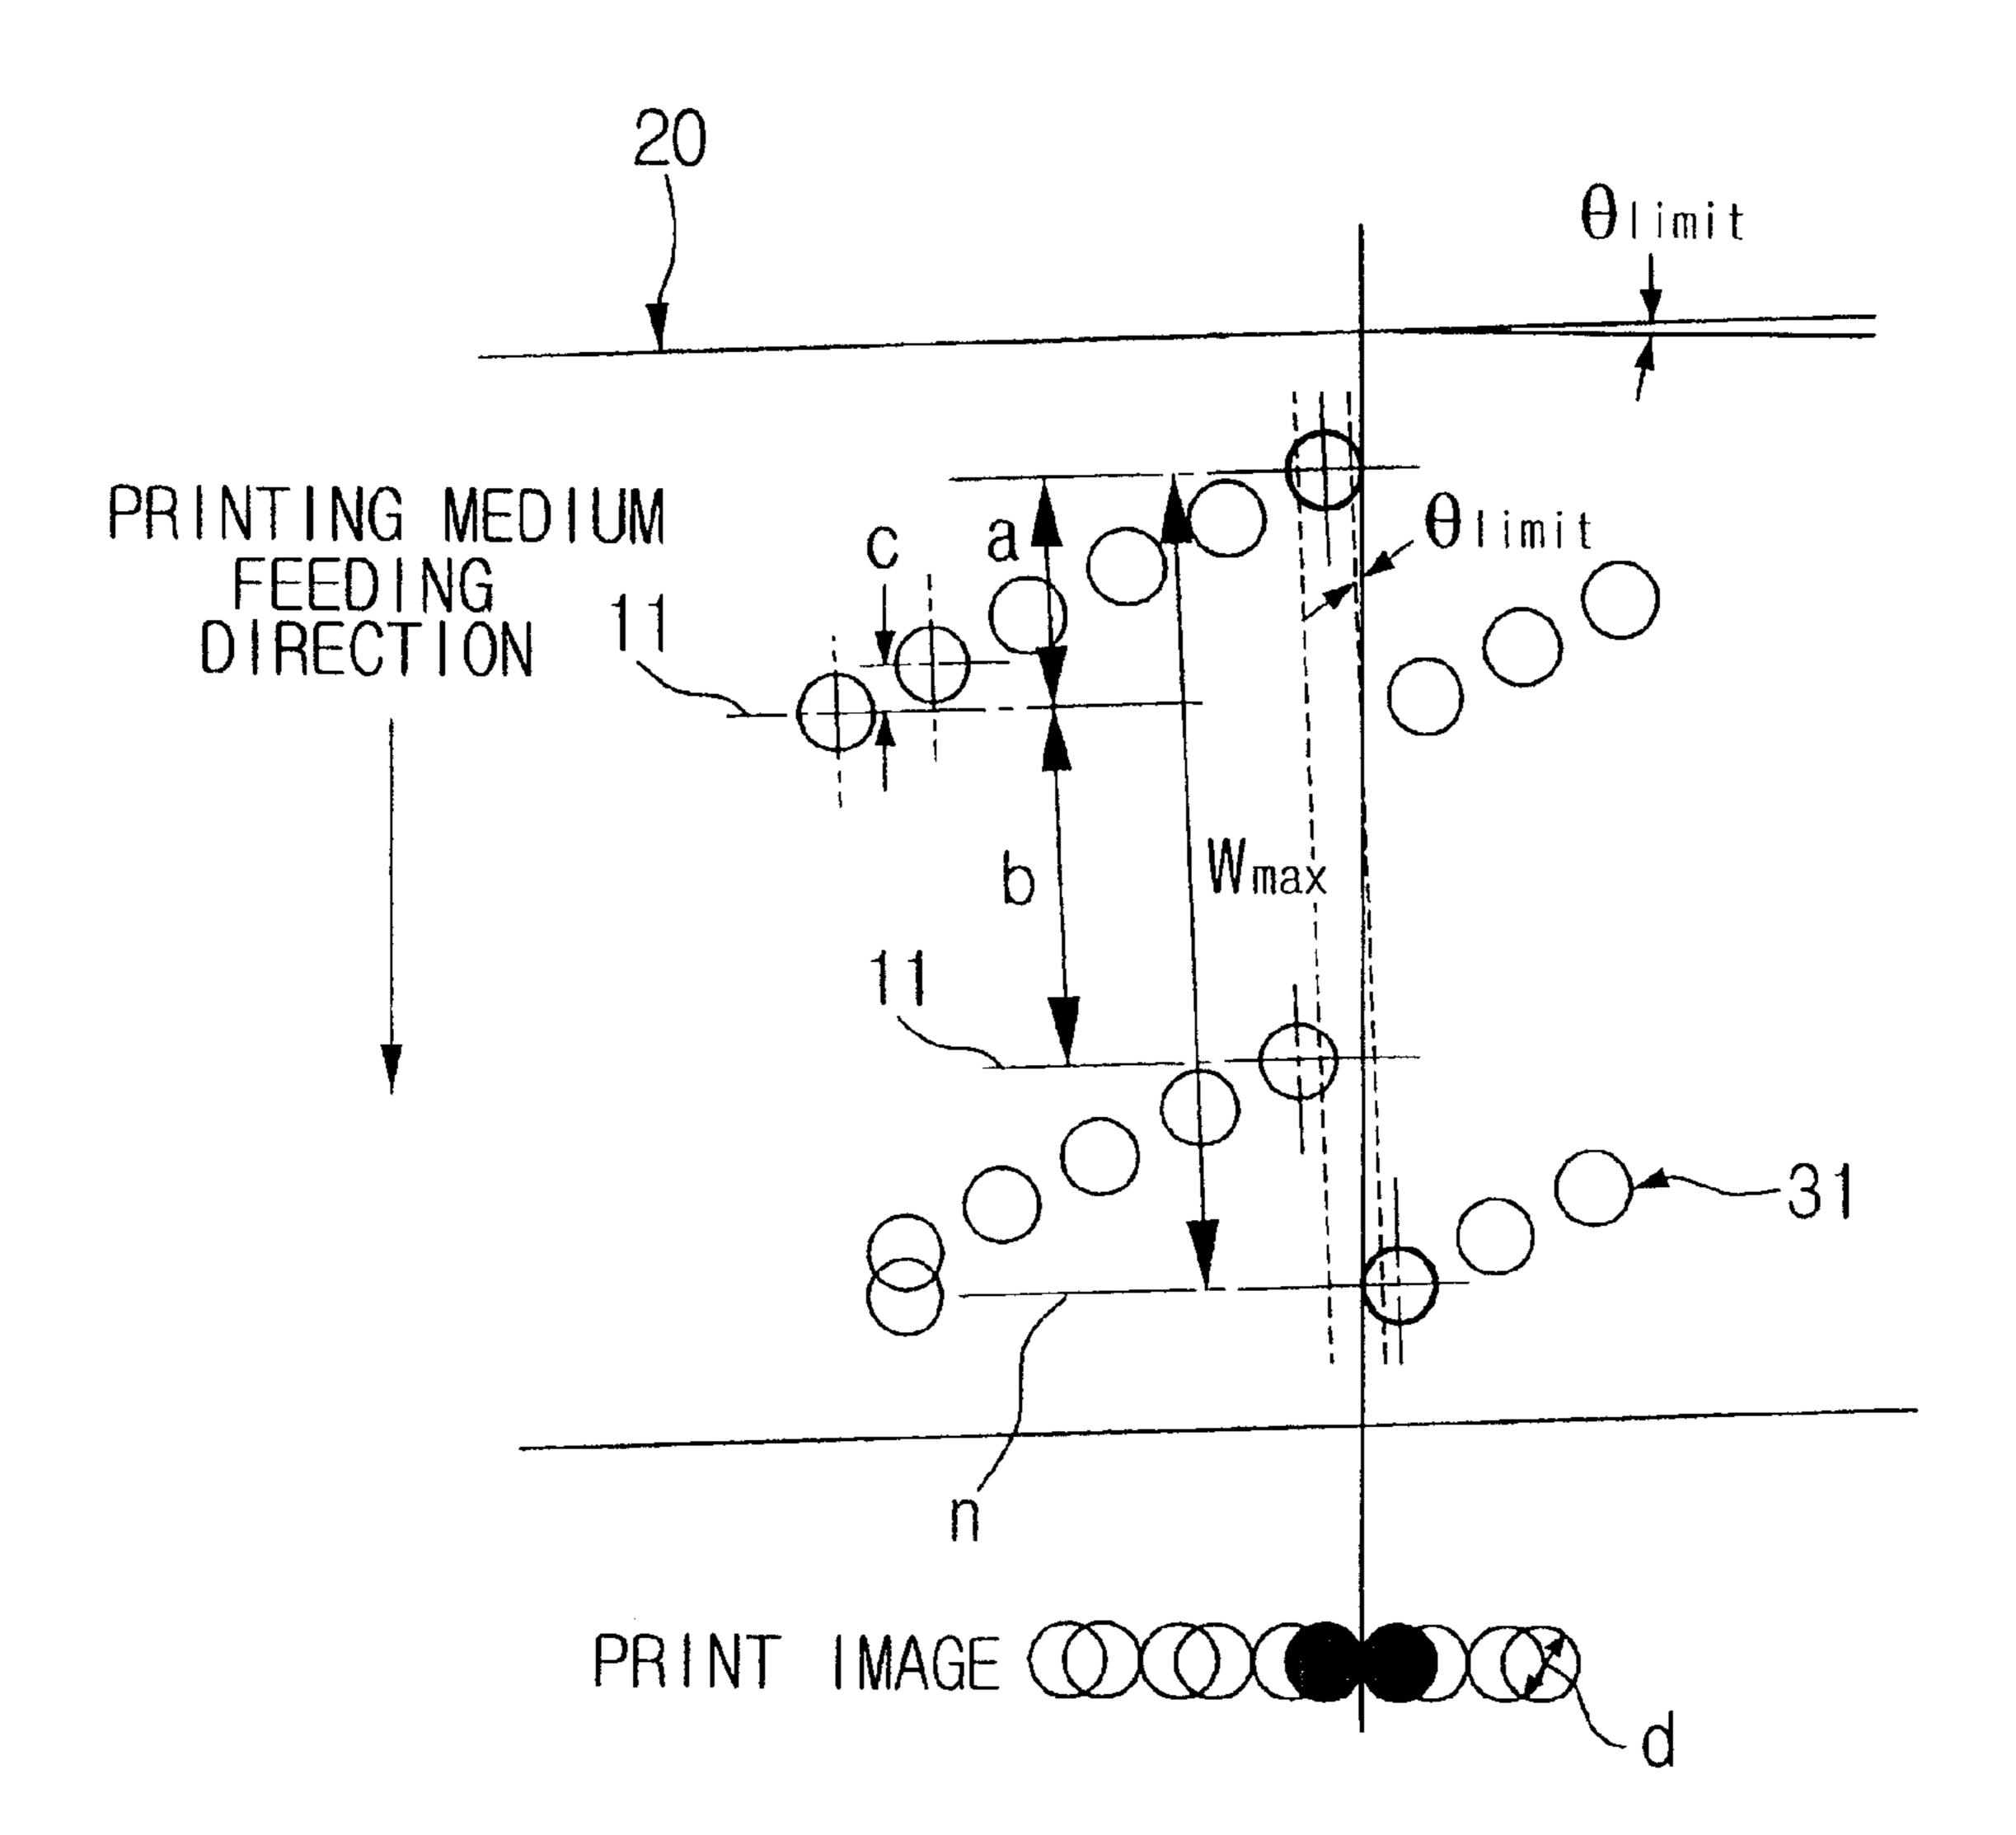
FIG.6

FIG. 6 is a diagram showing a tilting angle of the unit chips caused by a machine error;

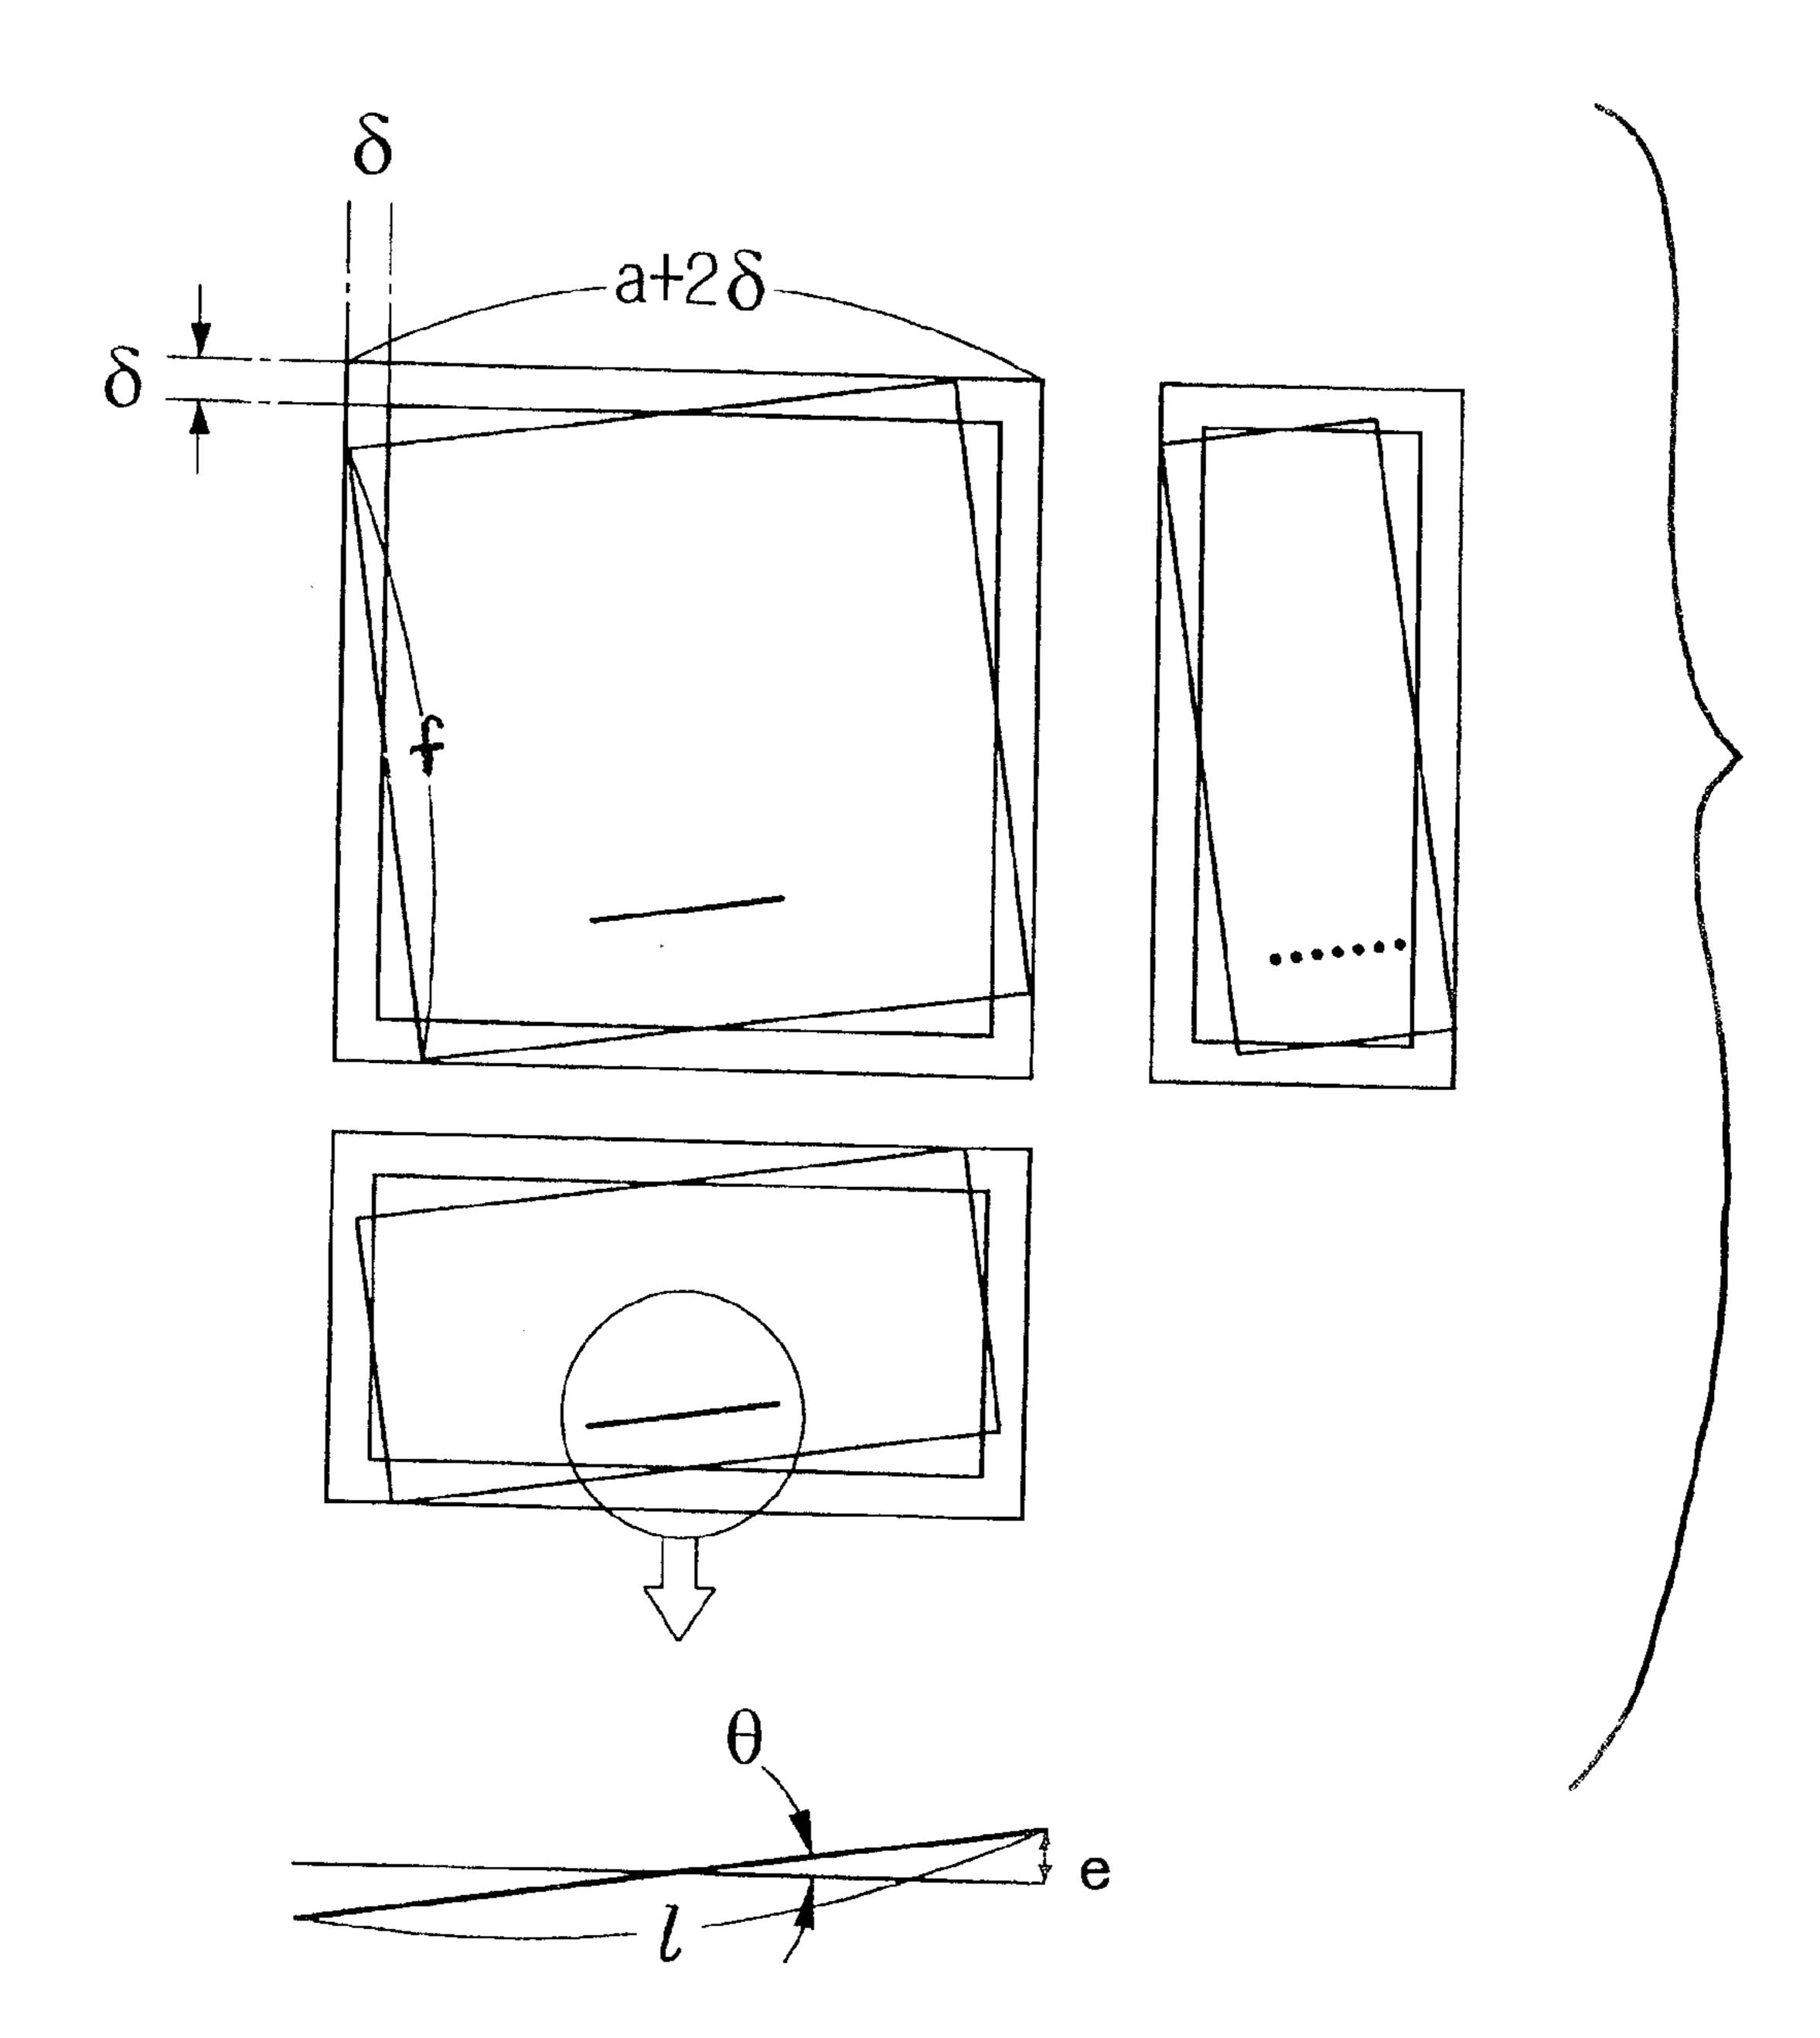
FIG.7

FIG. 7 is a diagram showing a print error caused by tilting of the unit chips when the machine error of the unit chips is 0.04 mm;

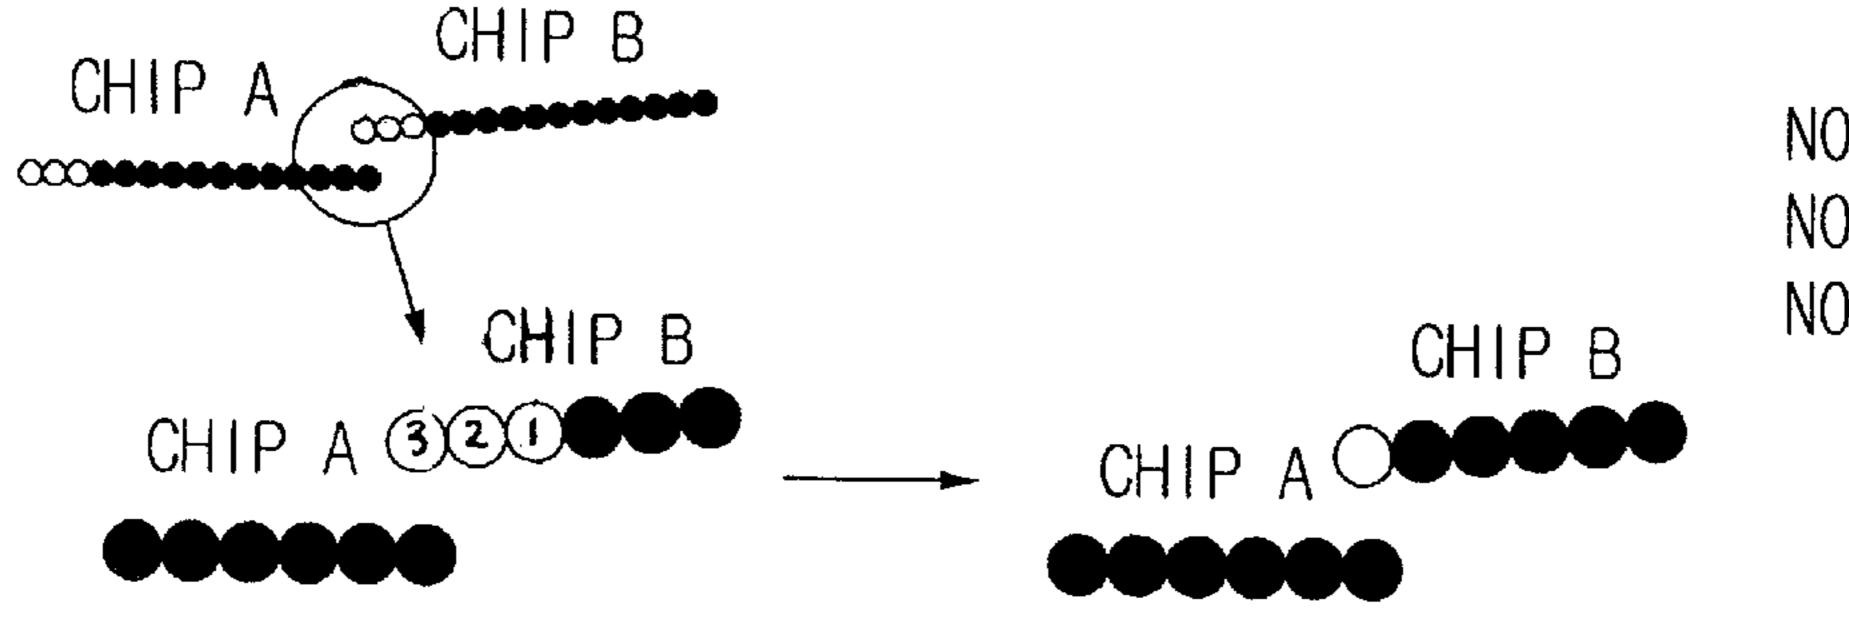
# FIG. 12A

NOZZLE 1: ON

NOZZLE 2: ON

NOZZLE 3: OFF

FIG. 12A is a diagram showing the print error caused by the vertical misalignment of the unit chips, being corrected in accordance with the print error correcting method of the present invention;

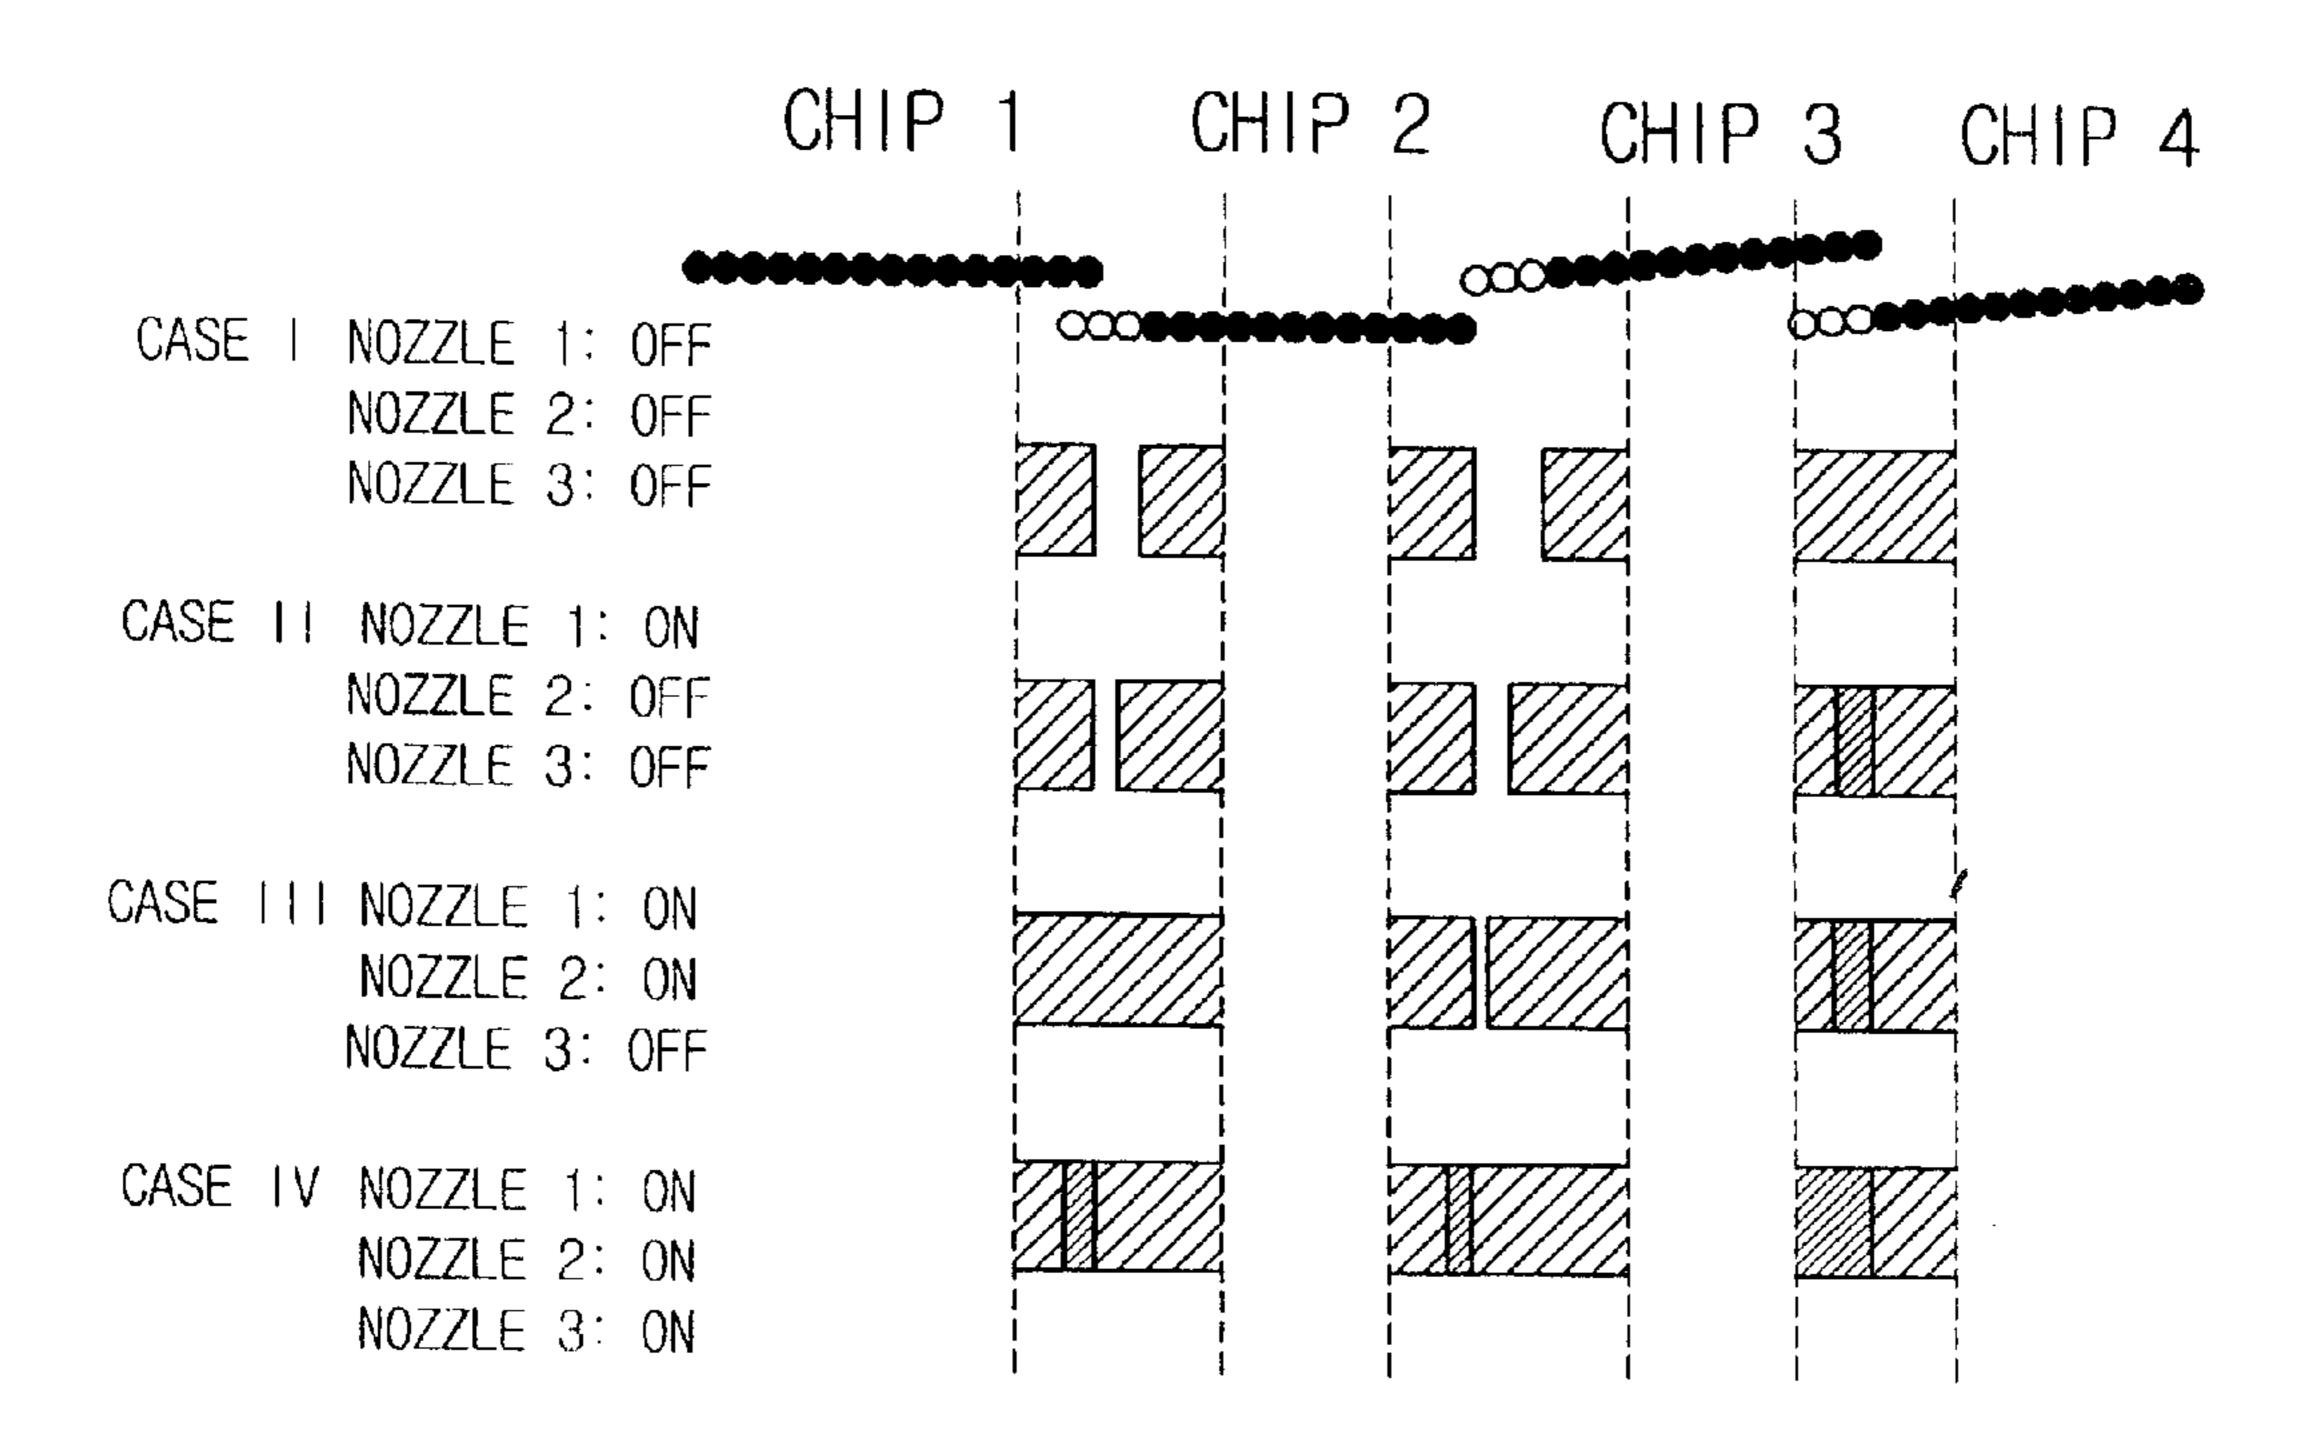
## FIG. 12B

FIG. 12B is a diagram of selected trial printing patterns for the corrected unit chips of FIG. 12A;

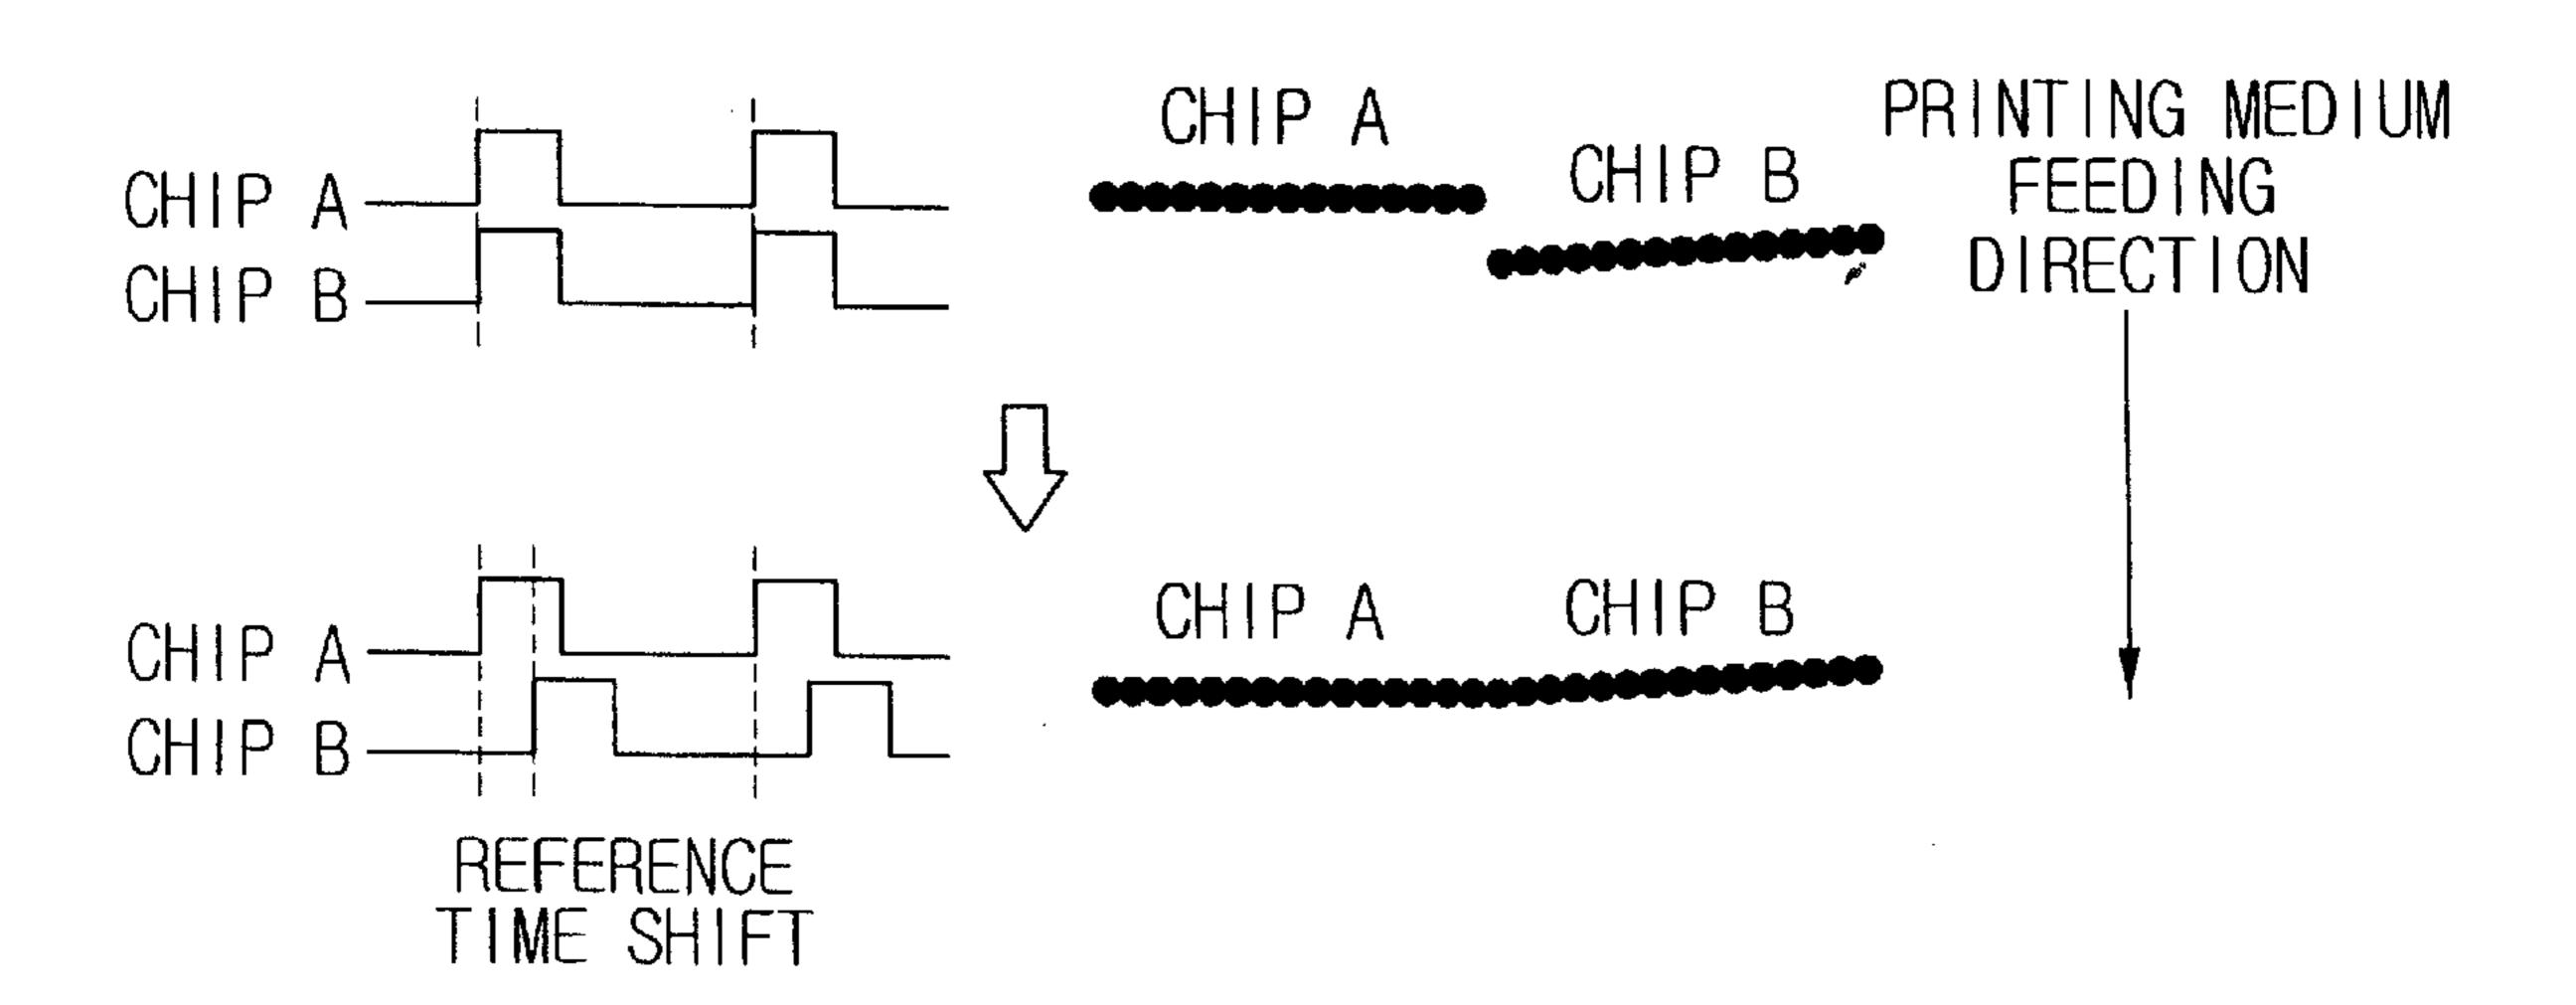
FIG. 14 is a diagram showing the print error caused by the vertical misalignment between the unit chips being corrected 15 in accordance with the present invention;
