(54) **METHOD FOR REPAIRING AND PRODUCING INTEGRALLY BLADED ROTORS FOR A TURBINE OR TURBO ENGINE**

**METHOD FOR REPAIRING AND
PRODUCING INTEGRALLY BLADED
ROTORS FOR A TURBINE OR TURBO
ENGINE**

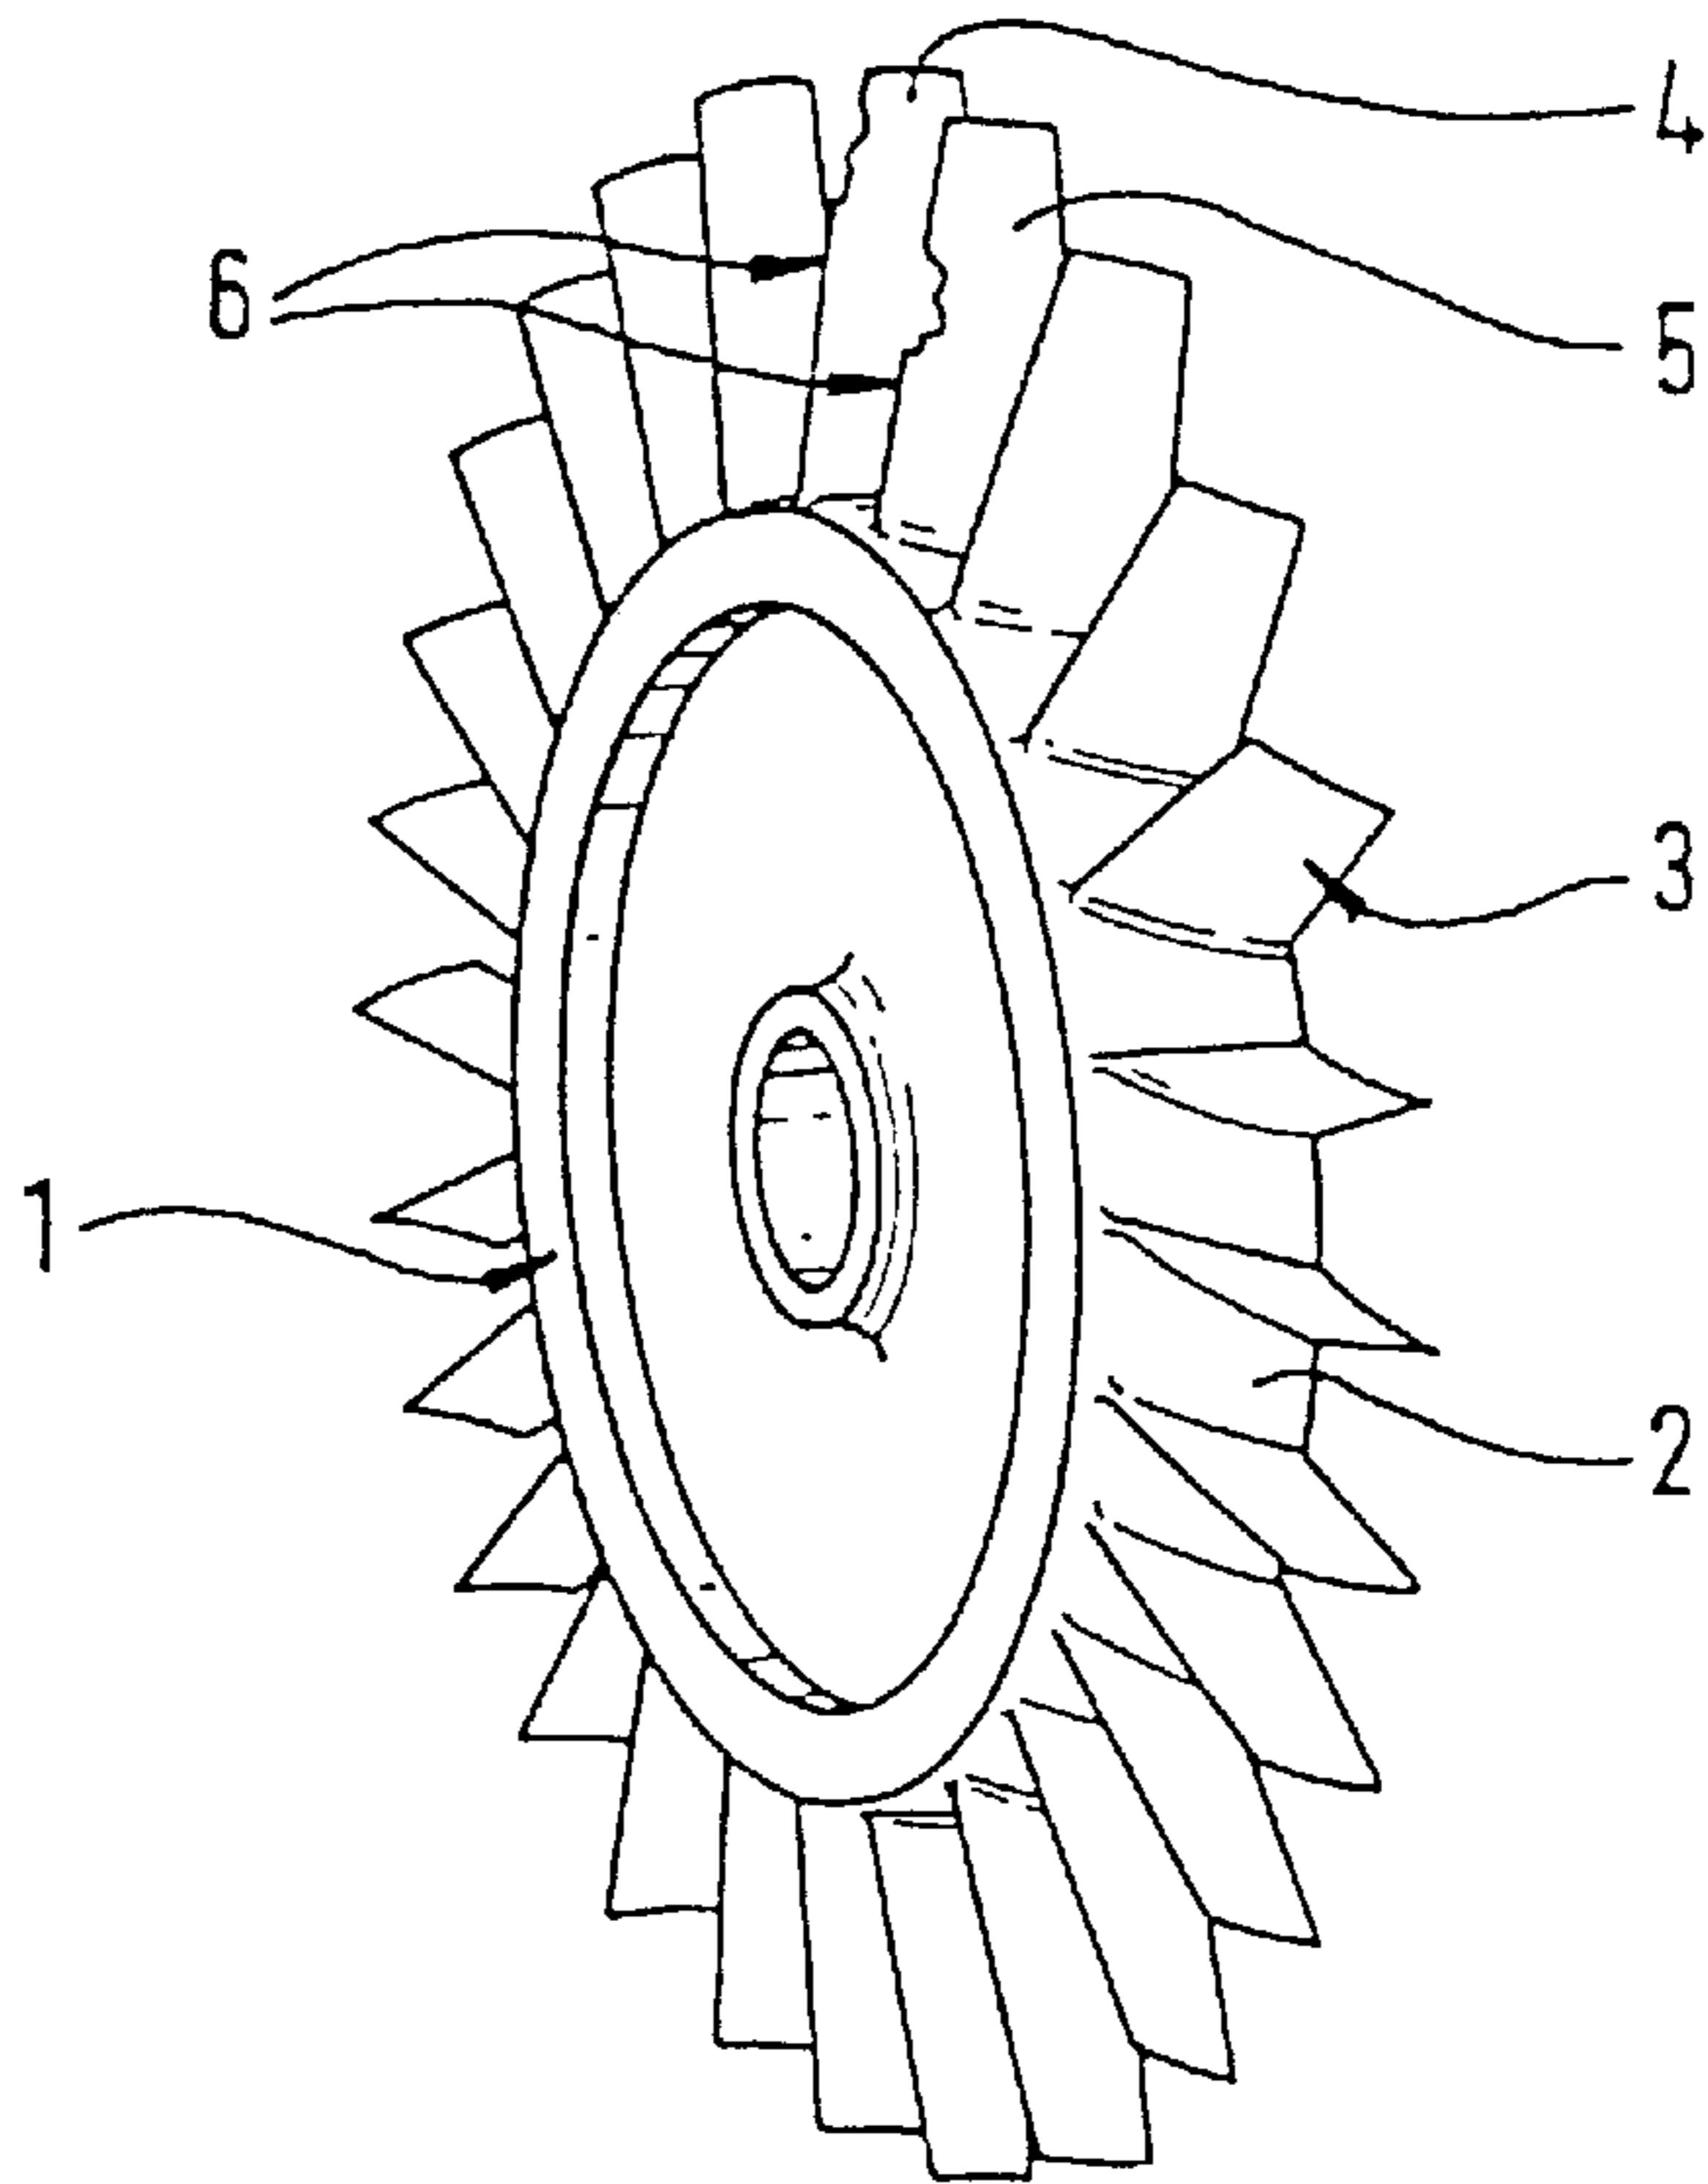
Fig. 2

FIG. 2 shows an enlarged detail from FIG. 1;

As can be seen more clearly in the detail of FIG. 2, damage on vanes 4 and 5 appear on their front edge 6, while the opposite rear edge 7 is basically undamaged. The damage on vane 4 appears in an area near a vane tip 8, so that in one embodiment of the repair method according to the present invention, a vane blade section 4' is removed along a parting plane 9 and a stub section 10 forming a part of vane 4, i.e., of the vane blade, and having front face 11, is left unremoved. For damages such as the damage on vane 4, it is not necessary to separate and almost fully remove vane 4 or its blade.

If a vane section 4' is removed along a parting line 9 as illustrated in FIG. 2 in a repair procedure and the respective joint 24 is located in the area of the blade, subsequent machining of the blade surface may be required for aerodynamic reasons. Also the use of high-frequency current may be advantageous, because it is concentrated at front face 11 of stub section 10 and on the respective surface of replacement vane section 20, only melting the areas near the surface.

The manufacturing method differs from the above-described repair method only in that no damaged vane section need be initially removed, and stub 13 has the shape and size according to parting plane 12 illustrated in FIG. 2 instead.
