(12) **United States Patent**
Meier et al.

(10) **Patent No.:** **US 6,438,838 B1**
(45) **Date of Patent:** **Aug. 27, 2002**

(54) **METHOD FOR REPAIRING AND
PRODUCING INTEGRALLY BLADED
ROTORS FOR A TURBINE OR TURBO
ENGINE**

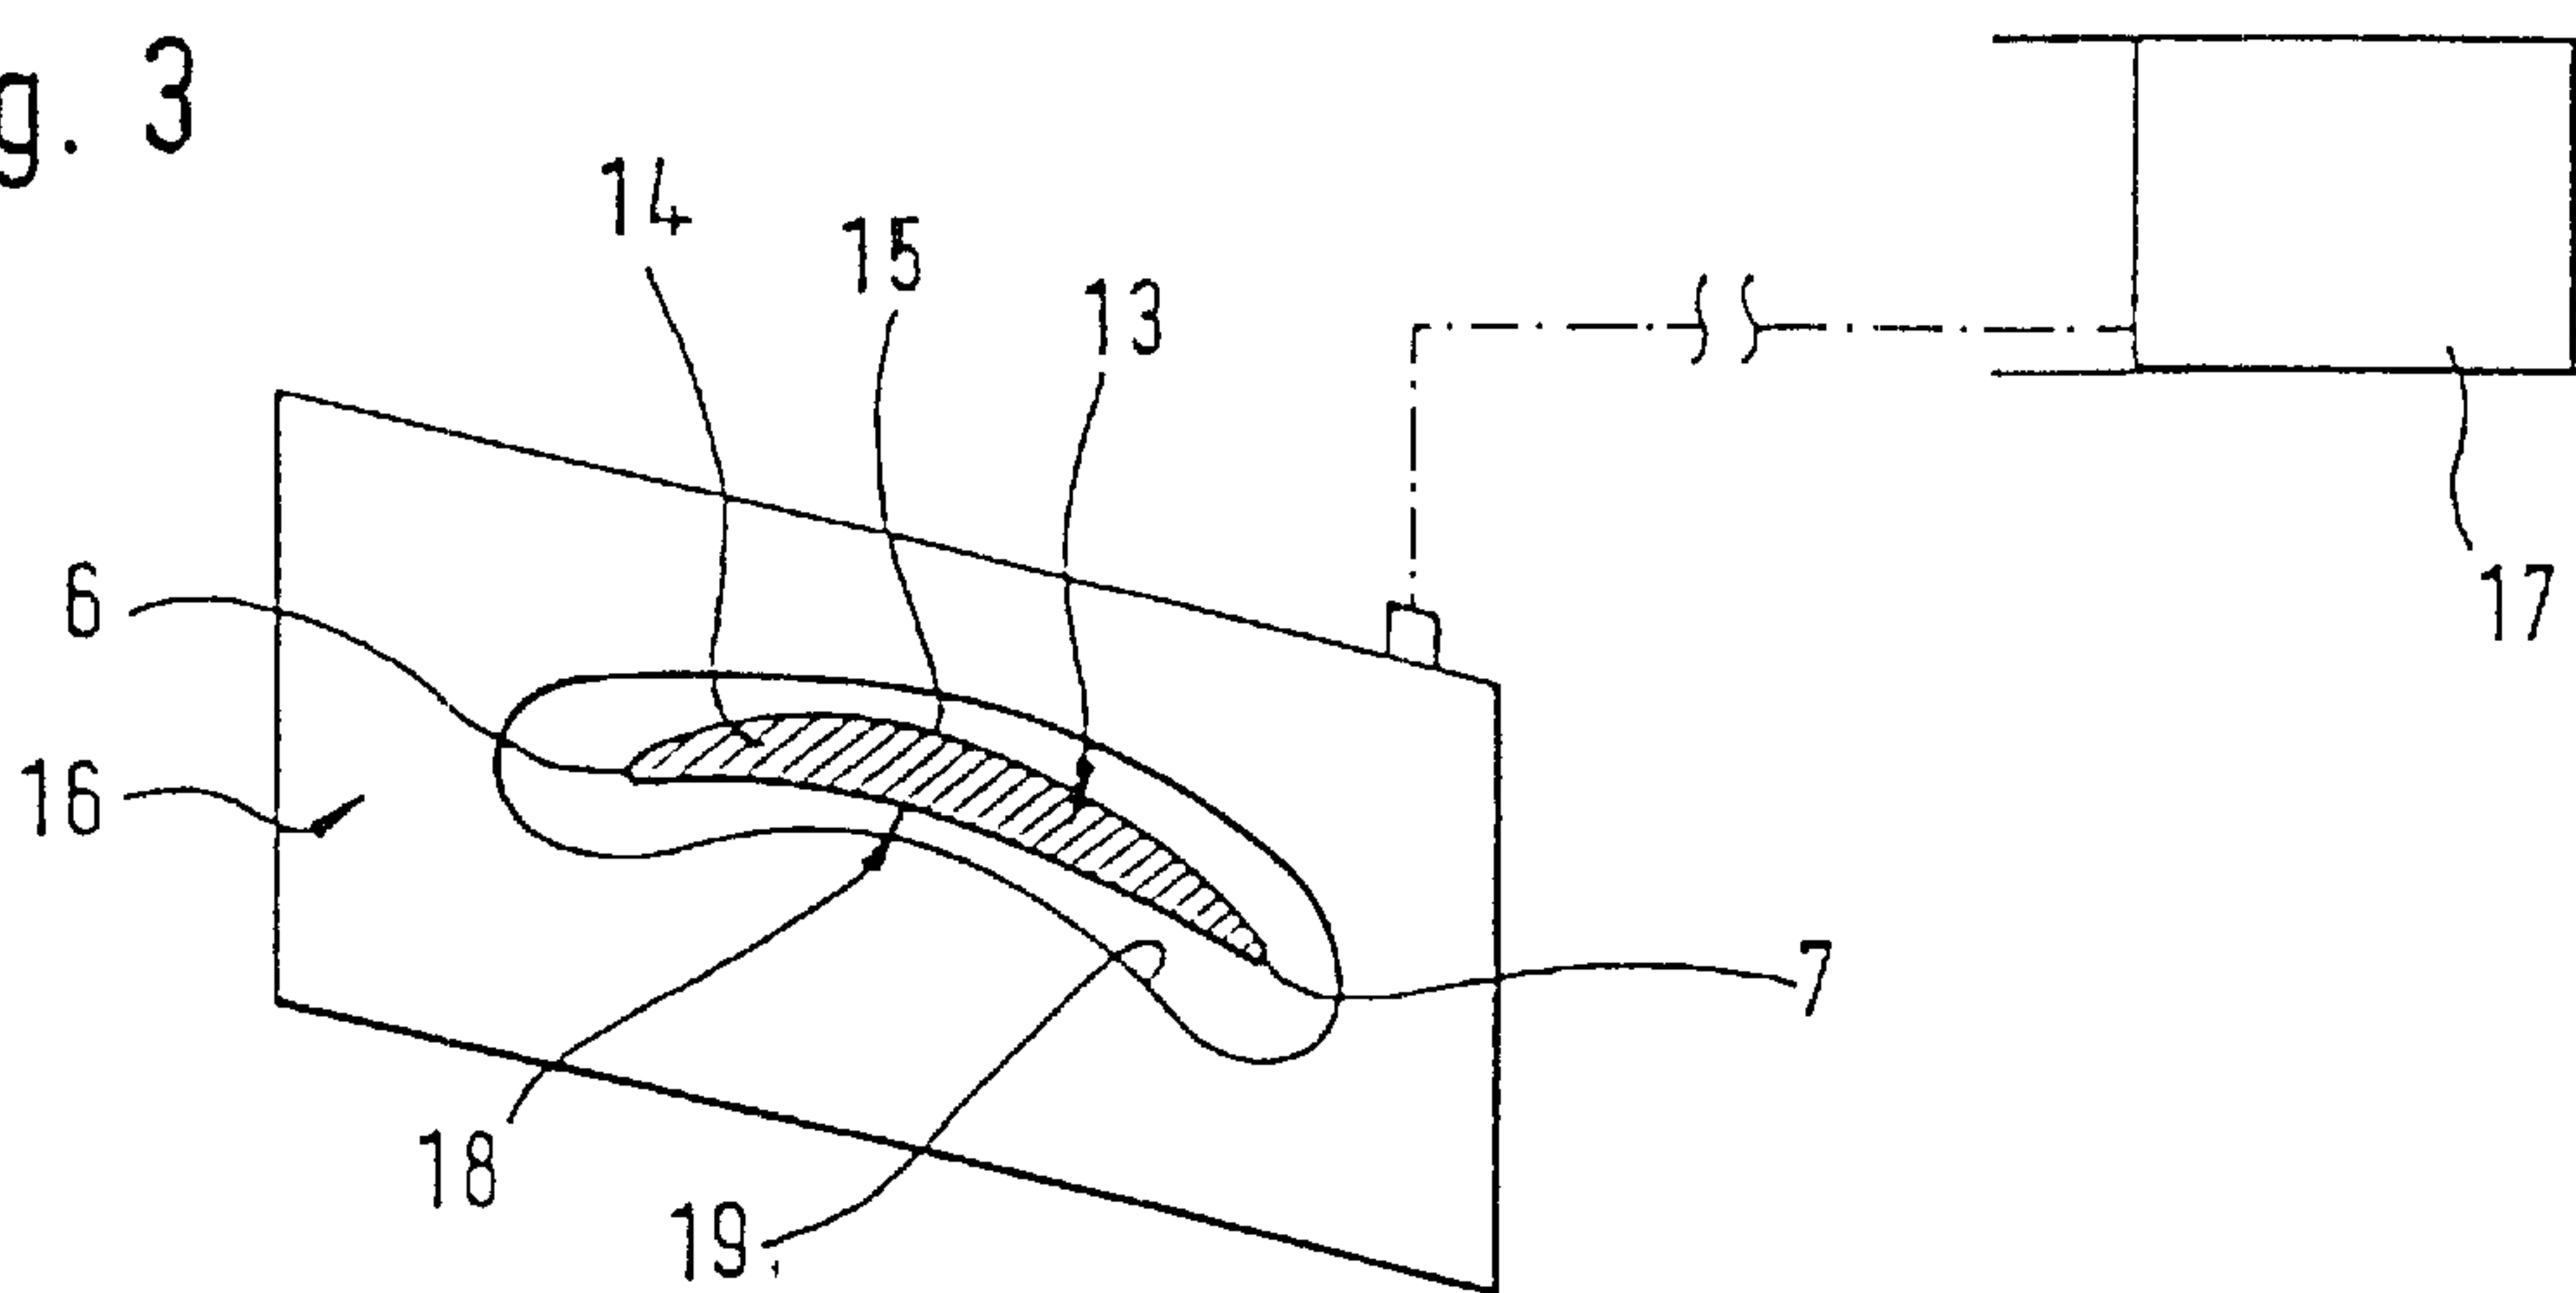
Fig. 3

FIG. 3 is a schematic perspective view of a stub section with an inductor, connected to a current source, arranged around the stub section according to one embodiment of the method according to the present invention; and

According to the next step of the repair method according to the present invention, an inductor 16 is arranged in the area of front face 14 of stub 13 around its periphery 15; The inductor is electrically connected to power source 17. As can be seen from the top view illustrated in FIG. 3, the distance between inductor 16 and stub 13 is greater in the area of front edge 6 and rear edge 7 of the vane than in central area 18 in order to achieve even heating of the joint formed by front face 14 of stub 13 during the subsequent welding step. The geometry of section 19 in which inductor 16 is located should be selected depending on the application, so that the material melts or softens only at the joint, i.e., front face 14 of stub 13, in order to allow quick welding and avoiding subsequent machining of the joint after welding.

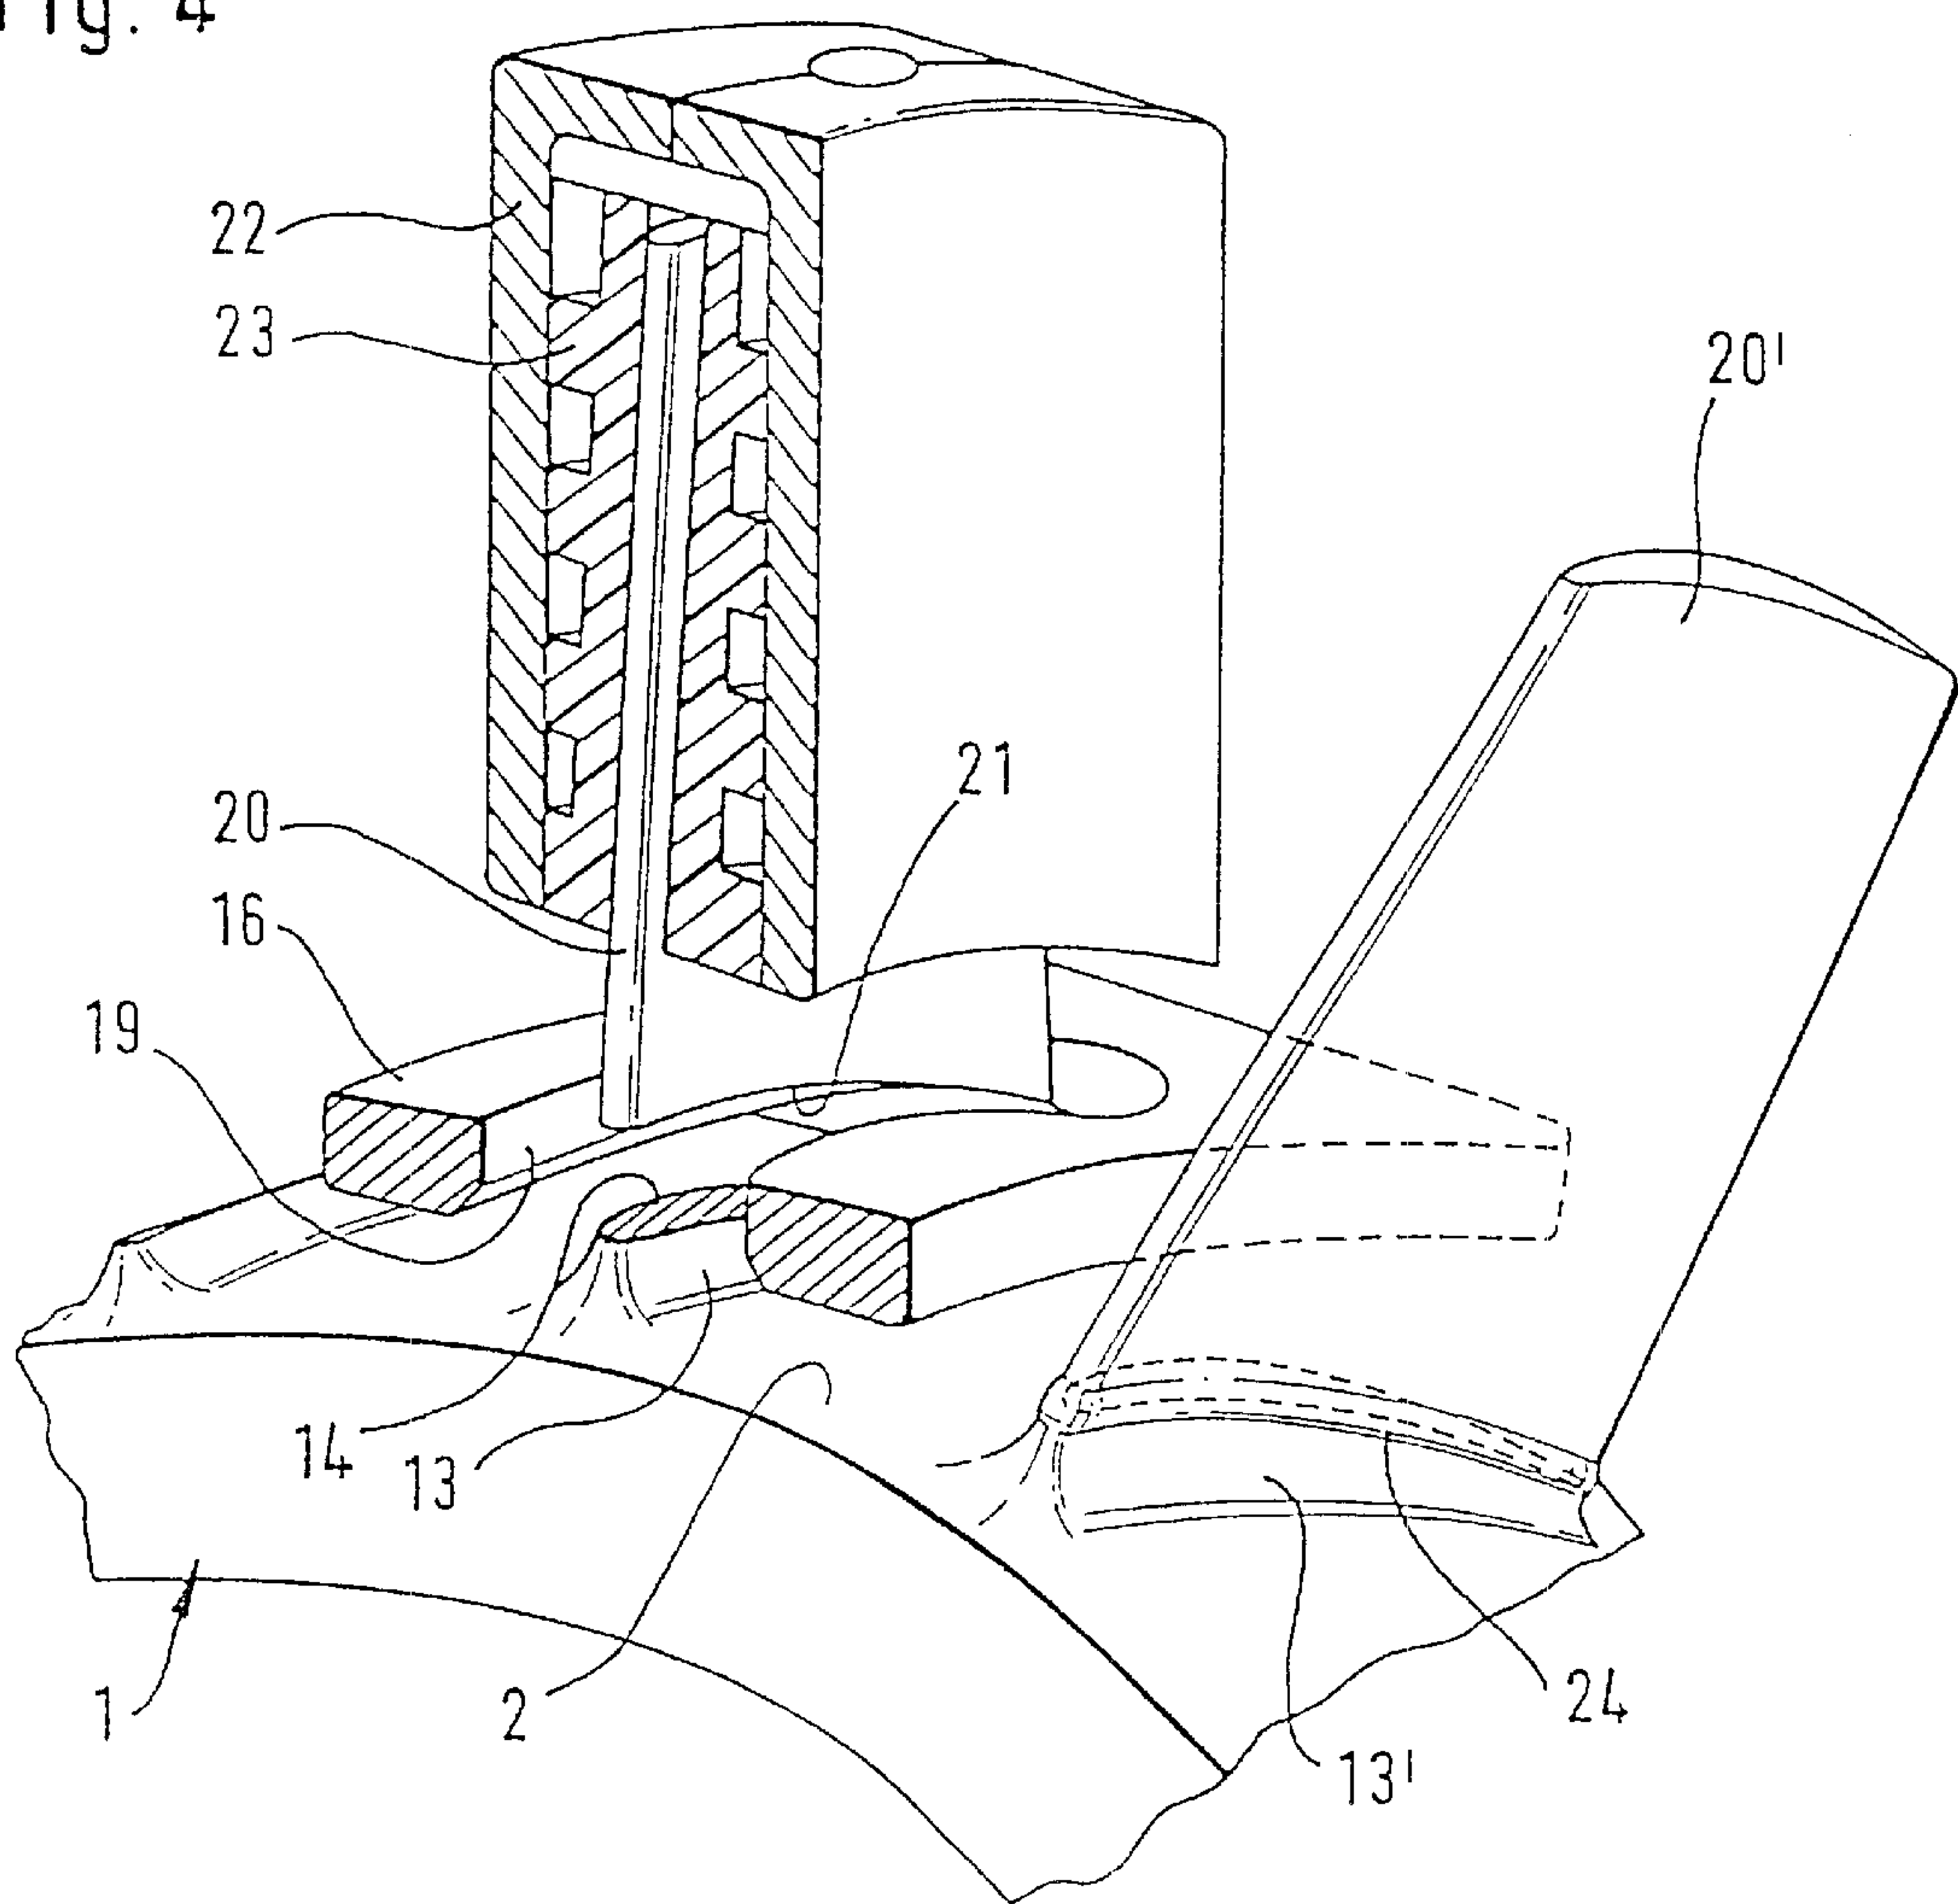
Fig. 4

FIG. 4 is a perspective view partially in section of a vane blade section held by a (plastic) block.

FIG. 4 shows the next step of the repair method according to the present invention as a perspective drawing in which inductor 16 is arranged with its section 19 around periphery 15 of front face 14 of stub 13 which projects over peripheral surface 2 of carrier 1. A replacement vane 20 having surface 21 is securely held in a two-part cassette 22 in a plastic block 23. Cassette 22 is secured in a machine slide. Surface 21 of replacement vane 20 corresponds in shape and curvature to front face 14 of stub 13. In order to position replacement vane 20 for the subsequent welding step, the machine slide is moved so that surface 21 of replacement vane 20 is exactly aligned with and opposite front face 14 of stub 13. Before testing, replacement vane 20 may be moved to such front face 14 with its surface 21, then moving them at part again to a distance of approximately 2 mm from one another before the welding step that follows.

FIG. 4 shows a replacement vane 20', which is bonded to a stub 13' by high-frequency welding. In the area of joint 24 a slight thickening can be seen. The extent of this thickening depends, in addition to the upsetting course, on the material of stub 13, 13' and of replacement vane 20, 20' and it may require removal in a subsequent machining step. In many cases, the thickening at joint 24 is so small that it can be tolerated from the aerodynamic point of view, so that no subsequent machining is required.
