(10) **Patent No.:** **US 6,520,836 B2**
(45) **Date of Patent:** **Feb. 18, 2003**

(54) **METHOD OF FORMING A TRAILING EDGE CUTBACK FOR A TURBINE BUCKET**

The trailing edge of a turbine bucket is cut back from a root portion of the bucket to a location 50–75% of the span of the bucket. The cutback portion is tapered, forming an obtuse angle between it and the remaining original portion of the trailing edge outwardly of the cutback portion. A new conical section is thus created of a slightly larger conical and, hence, transverse configuration. The crack is removed upon removal of the material forming the cutback. With the edges of the recreated conical section surrounded, the cutback portion assumes a scalloped configuration with the exit openings of the cooling holes as seen from opposite sides of the bucket.

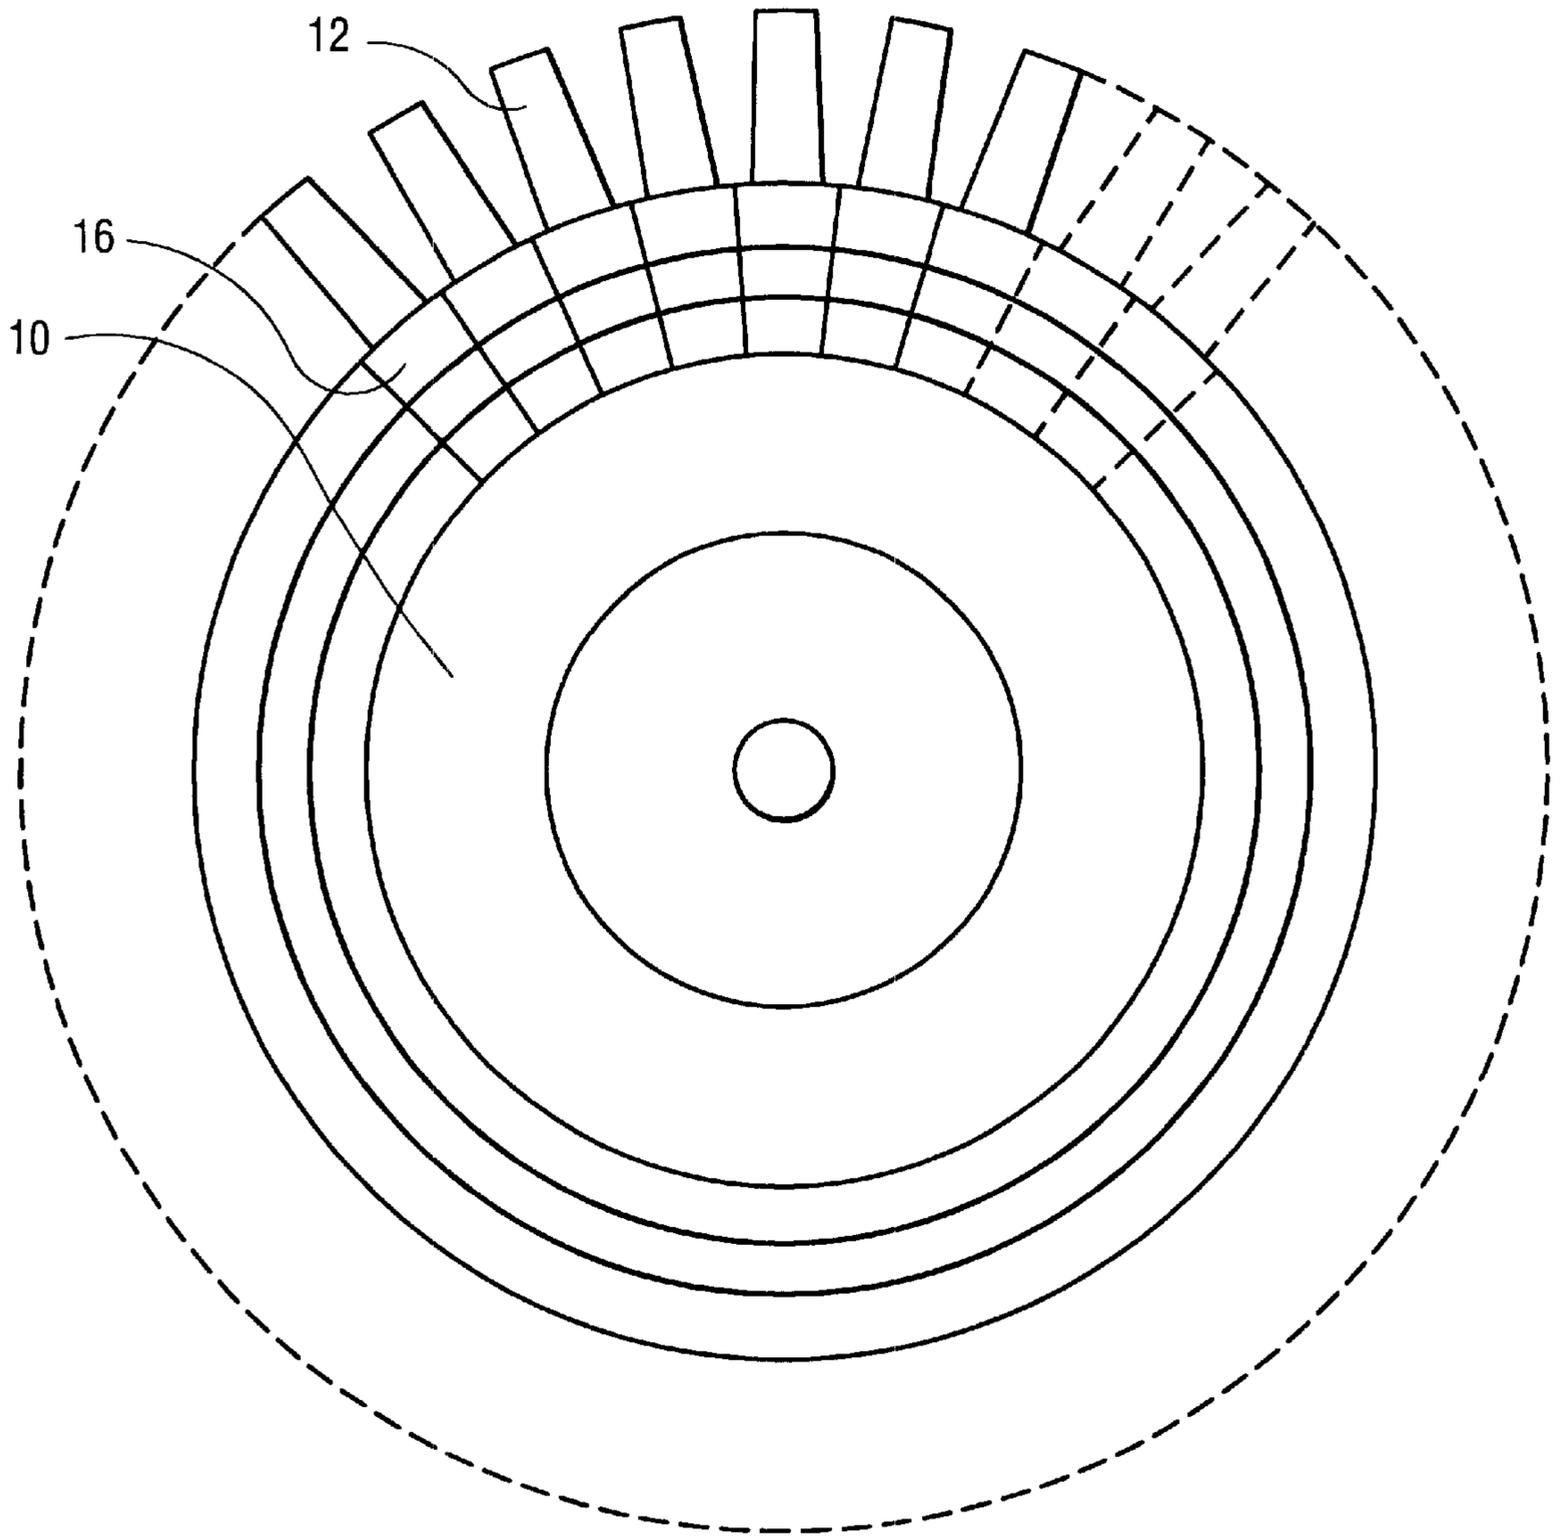
Fig. 1

FIG. 1 is a schematic axial elevational view of a turbine wheel mounting buckets;

Referring now to the drawings, particularly to FIG. 1, there is illustrated a turbine wheel **10** having a plurality of buckets **12** spaced circumferentially about the wheel and

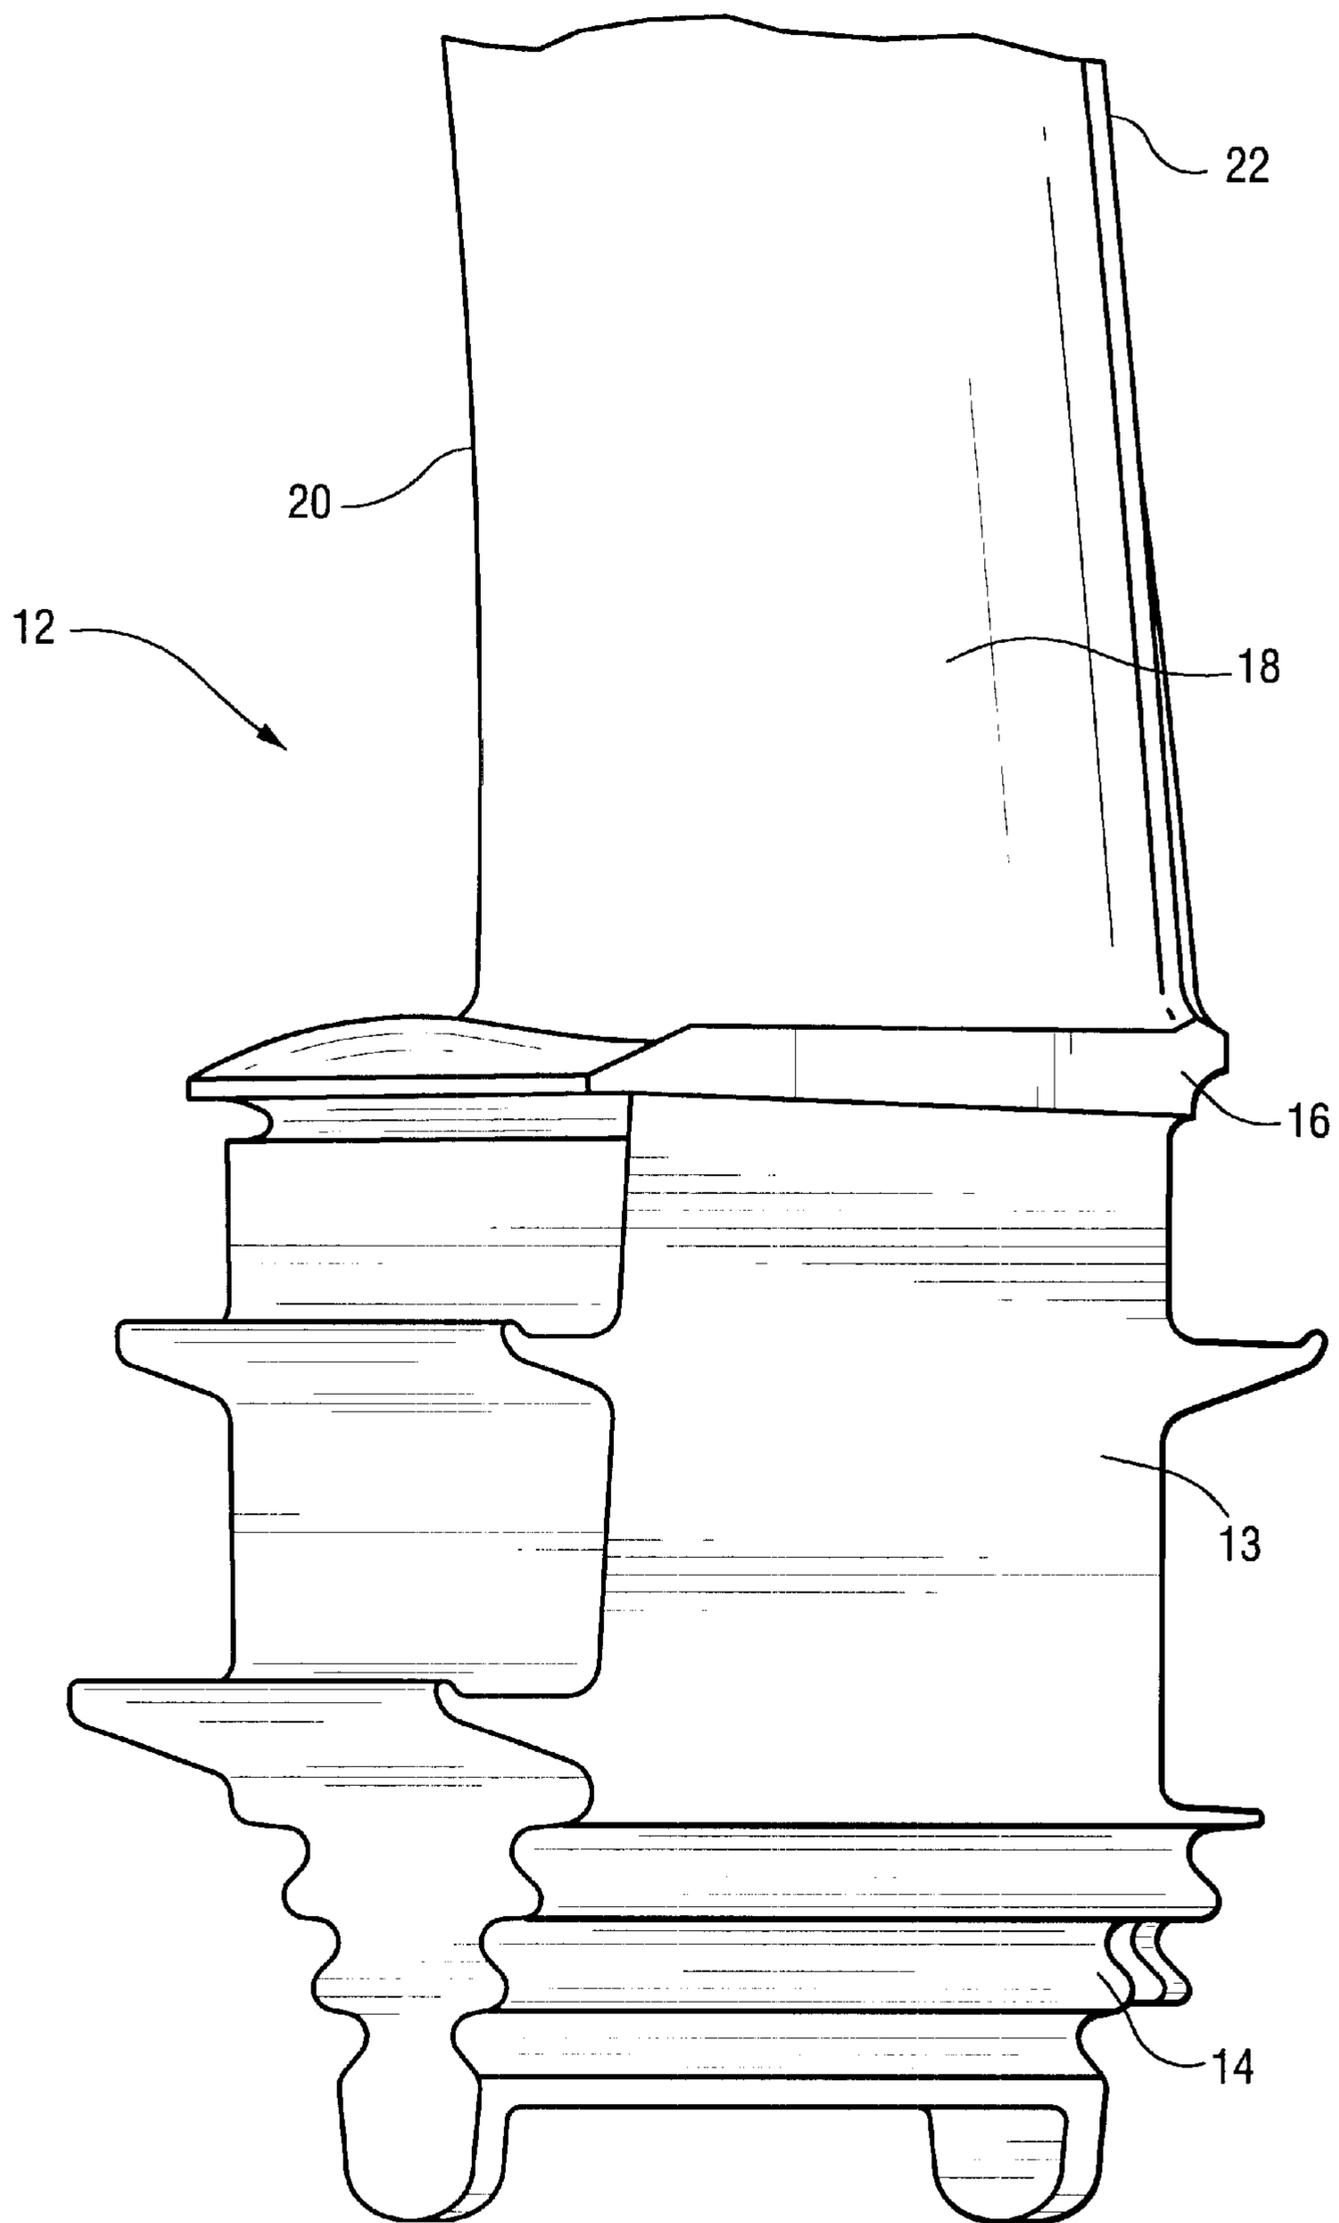
Fig. 2

FIG. 2 is an enlarged, generally axial view of a turbine bucket;

forming part of a turbine rotor. It will be appreciated, and with reference to FIG. 2, that the buckets 12 typically comprise a shank portion 13 having a dovetail 14 for coupling the bucket to a corresponding dovetail in the wheel 10. The root portion 16 of the bucket 12 mounts the airfoil-shaped body 18 of the bucket, it being appreciated that the bucket 12 is typically formed as an integral casting. As illustrated in FIG. 2, the airfoil body 18 has a leading edge 20 and a trailing edge 22. While not illustrated, the buckets are provided with generally radially extending passages for conducting a cooling medium along the length of the bucket from the shank portion 13 to the tip portion of the bucket where the cooling medium, e.g., compressor discharge air, exits into the hot gas path.

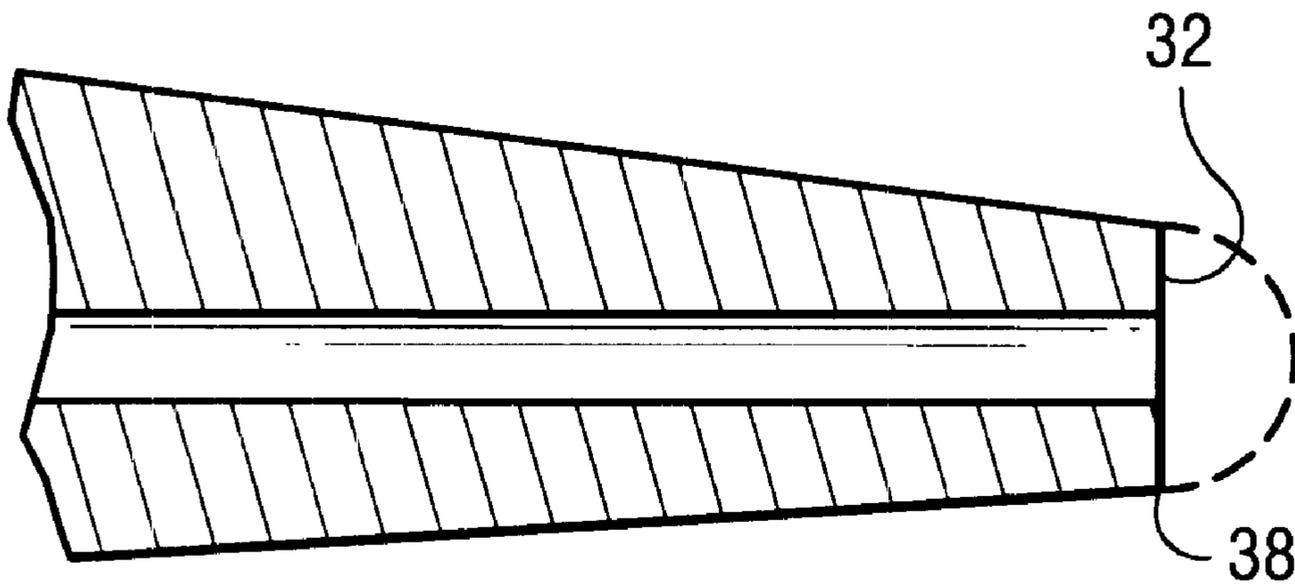
Fig. 4

FIGS. 4 and 5 are cross-sectional views of the trailing edge adjacent the root portion illustrating intermediate and final configurations thereof during a repair process.

In one form of the present invention, and referring to FIGS. 4 and 5, a machining operation is performed along the trailing edge to initially form a flat, planar surface 32, as illustrated in FIG. 4. The material 35 removed to form the cutback 37 is identified by the area of the trailing edge between the dashed line 34 representing, in FIG. 3, the unrepaired or original trailing edge, and the flat planar surface 32 of the trailing edge cutback after removal of the material therebetween as well as the radii 40 discussed below. It will be appreciated that a milling machine may be used to grind the trailing edge from the midspan portion 30 to the root portion 16 to form a planar surface 32 along the trailing edge cutback. The new flat planar surface 32 identifies the aft extent of the repaired or refurbished bucket and forms an obtuse angle α between the unrepaired outer span portion 38 and the repaired portion. The resulting surface constitutes the recreated trailing edge cutback 37.

From a review of FIG. 4, it will be appreciated that sharp edges 38 are formed between the planar surface 32 and the suction and pressure sides of the airfoil. Radii 40, as illustrated in FIG. 5, are formed between the planar edge 32 and the opposite sides of the airfoil along the cutback. This is accomplished by grinding the airfoil edges to the appropriate radii at various locations along the span of the trailing edge from a datum line. The radii and cutback surfaces are calculated to provide a close approximation of the original airfoil shape to maintain minimal variation between original non-repaired and repaired airfoils. Radius gauges are employed at the various span locations from the datum to ensure accurate radii formation.
