## (10) Patent No.: US 6,532,066 B1

# (54) VISION SYSTEM FOR IDENTIFICATION OF DEFECTS IN WET POLYMERIC COATINGS

An apparatus and method of detecting defects or abnormalities in a wet polymeric surface coating of an object to limit or eliminate costs associated with retouching or reapplying the coatings on the object. The apparatus and method is accomplished by capturing an image of the wet coating surface of the object and comparing the image to known defect images to determine the type and location of the defect in the coating surface on the object. The coating application process can then be modified to remedy the coating application defect at the earliest possible instance.

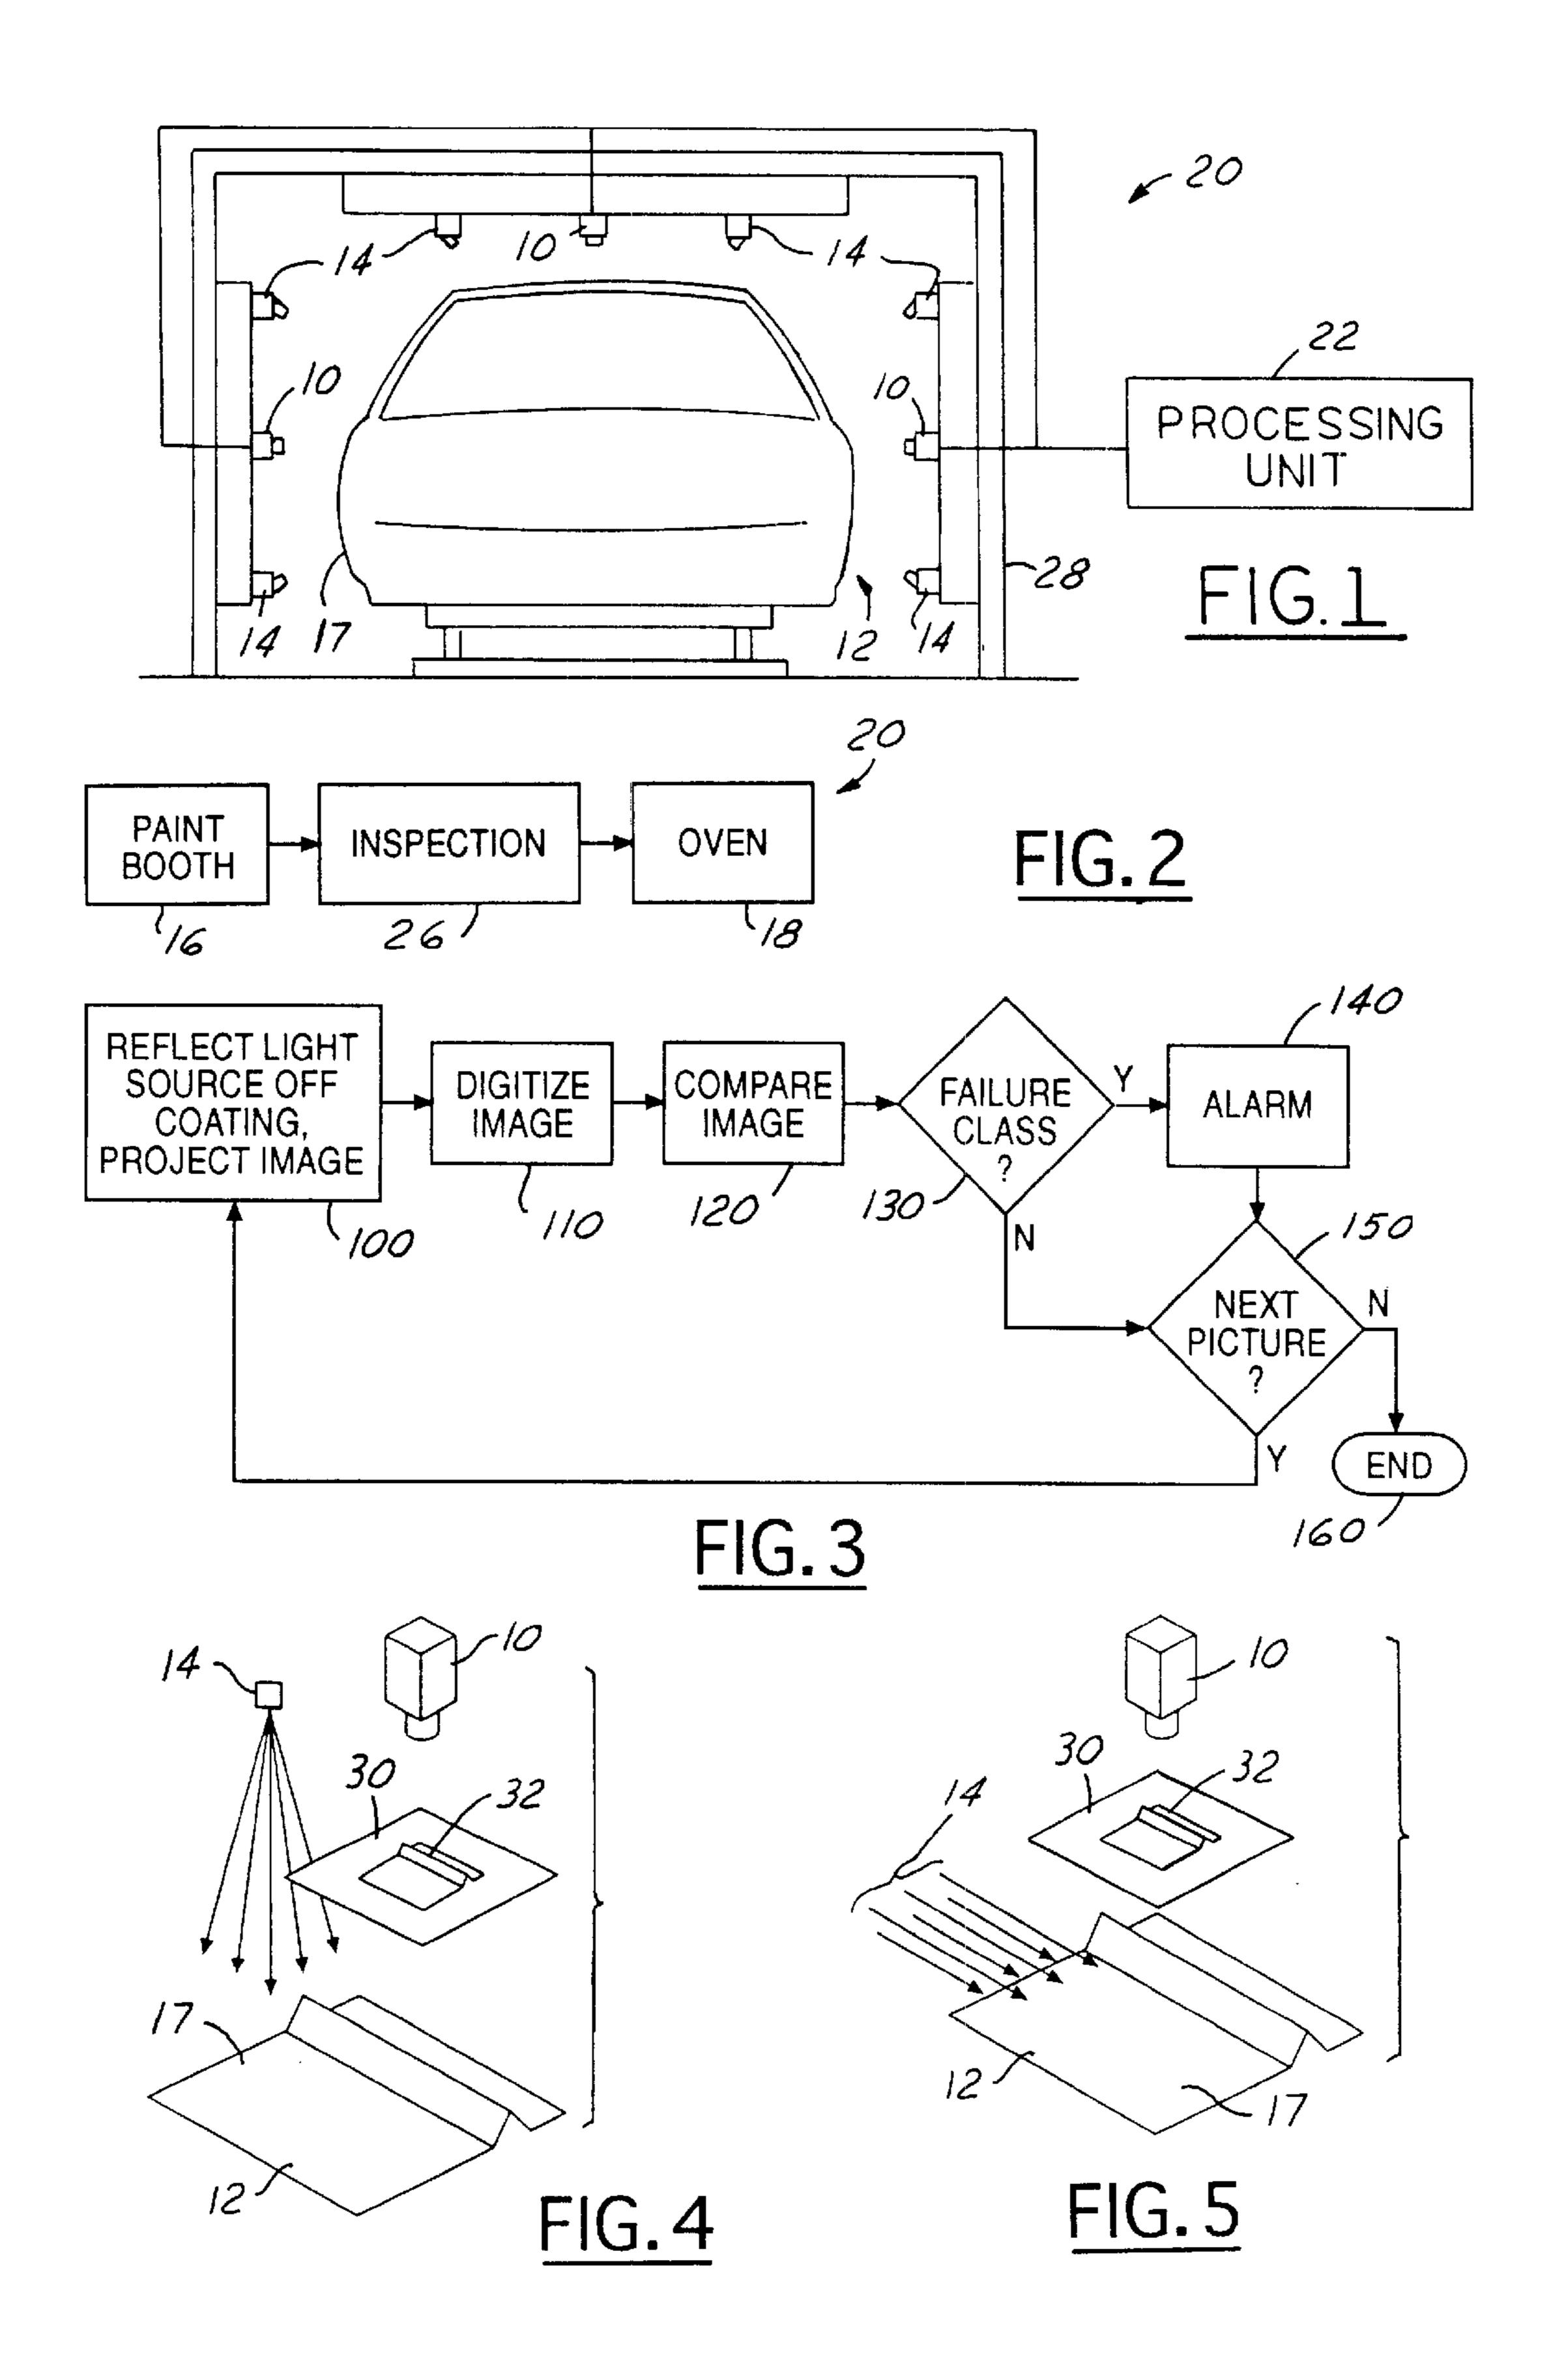
FIG. 1 is a schematic diagram showing one embodiment of a surface defect system in accordance with the invention;
