(54) **METHOD AND ARRANGEMENT FOR INSPECTION AND REQUALIFICATION OF VEHICLES USED FOR TRANSPORTING COMMODITIES AND/OR HAZARDOUS MATERIALS**

(73) Assignee: **General Electric Railcar Services Corporation**, Chicago, IL (US)

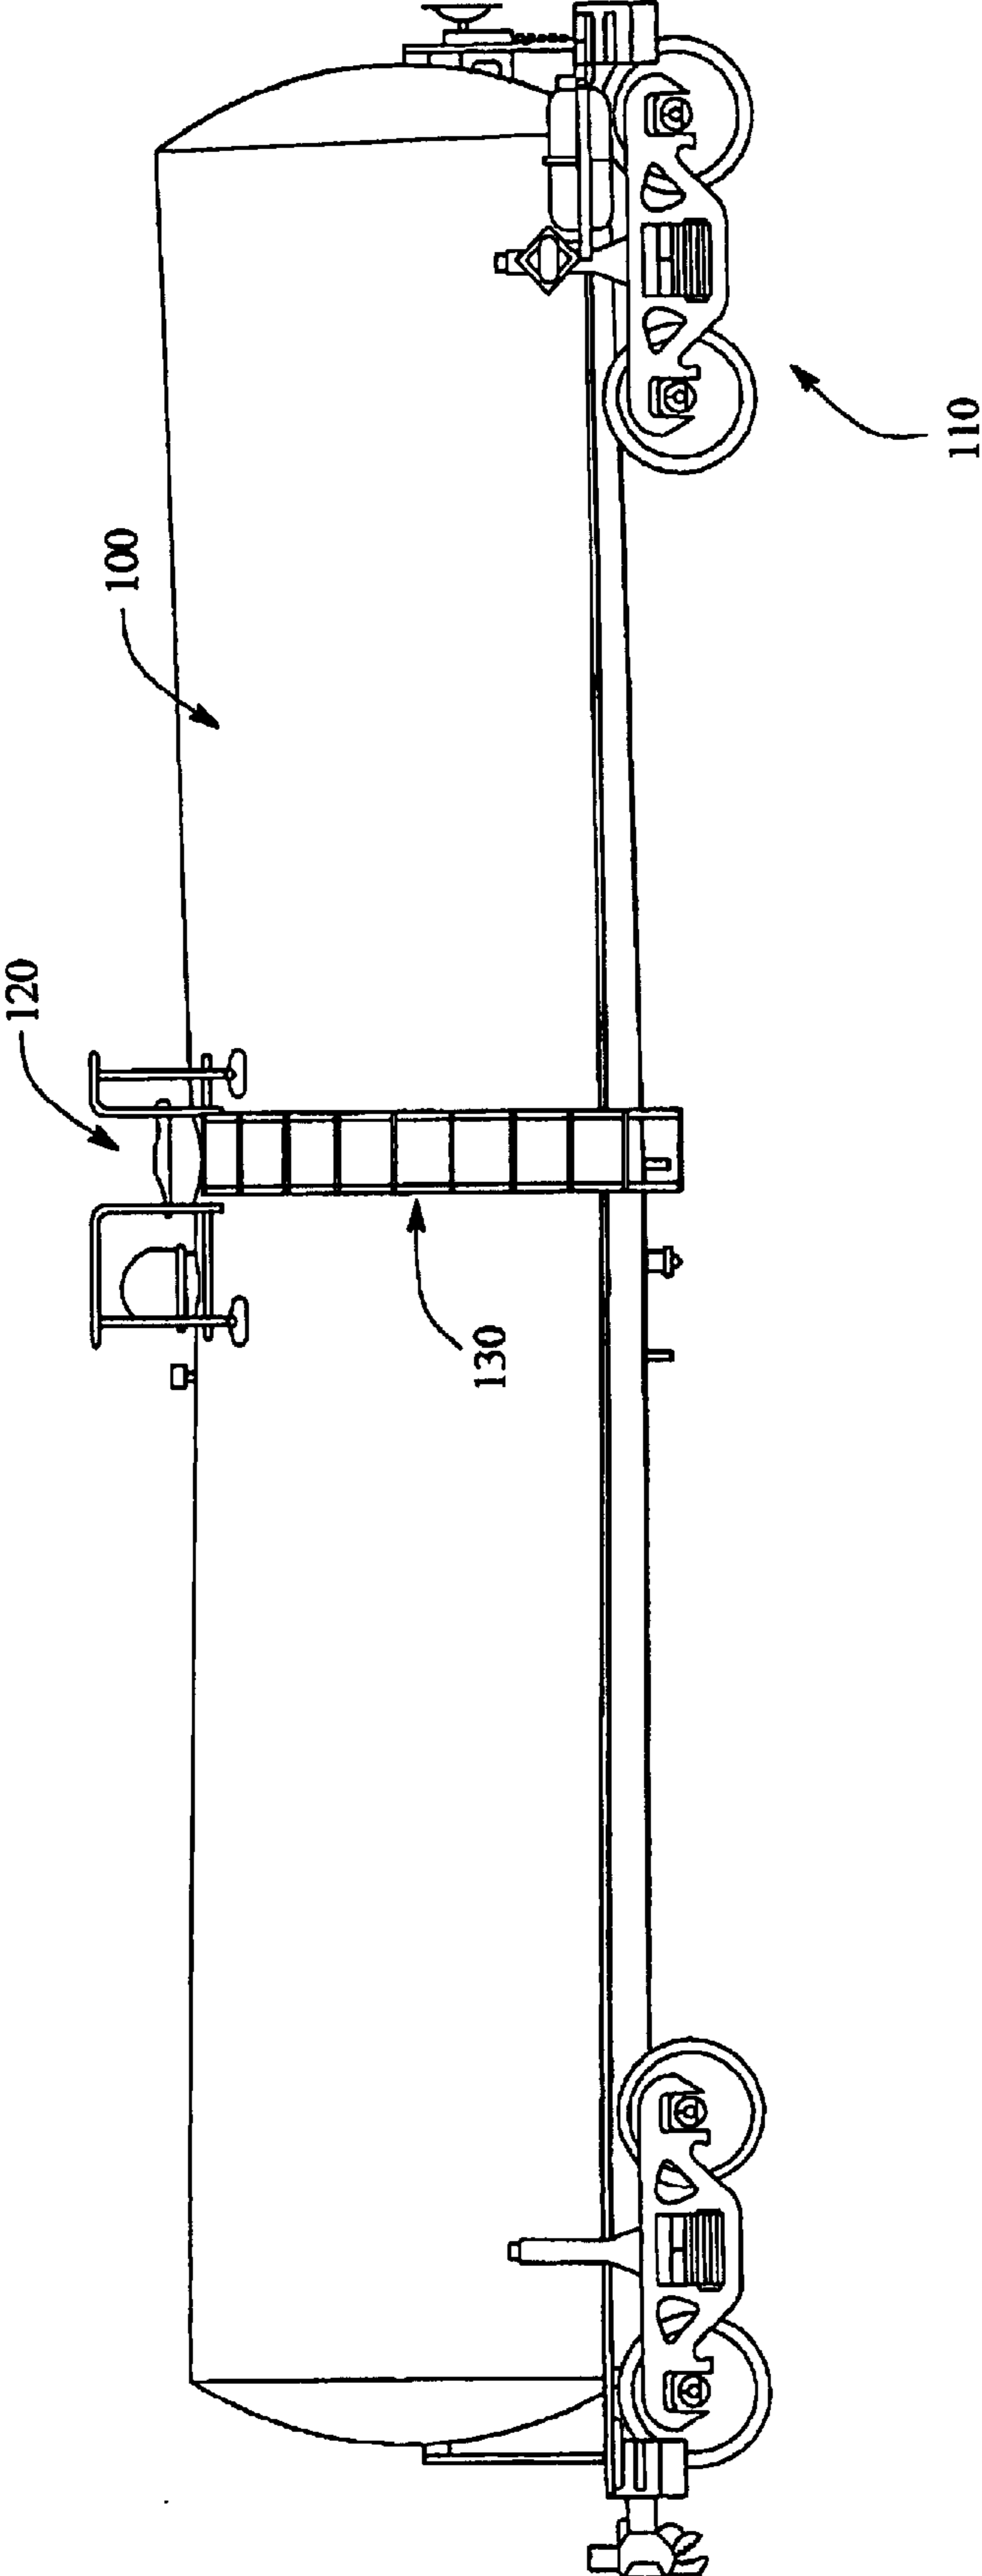
FIG. 1 is a side view showing a typical tank car configuration;

FIG. 1 depicts a typical tank car which is subjected to examination and requalification according to the present invention. As shown, this vehicle is used to transport commodities and possesses a tank structure **100** with wheeled carriages **110** connected to the underside. It should be noted that, independent of the type of tank car which is involved, the tank per se is invariably a self-contained structure sufficiently rigid/strong to support not only its own weight but the weight of the cargo which is introduced into the tank. The understructure includes two or more wheeled carriage members or bogies **110** secured to the tank, such as by connectors or by the weight of the tank itself, to complete the basic unit. While various other conventional structures, such as a hatch **120**, ladder **130**, etc., are illustrated, these elements will for brevity not be discussed.

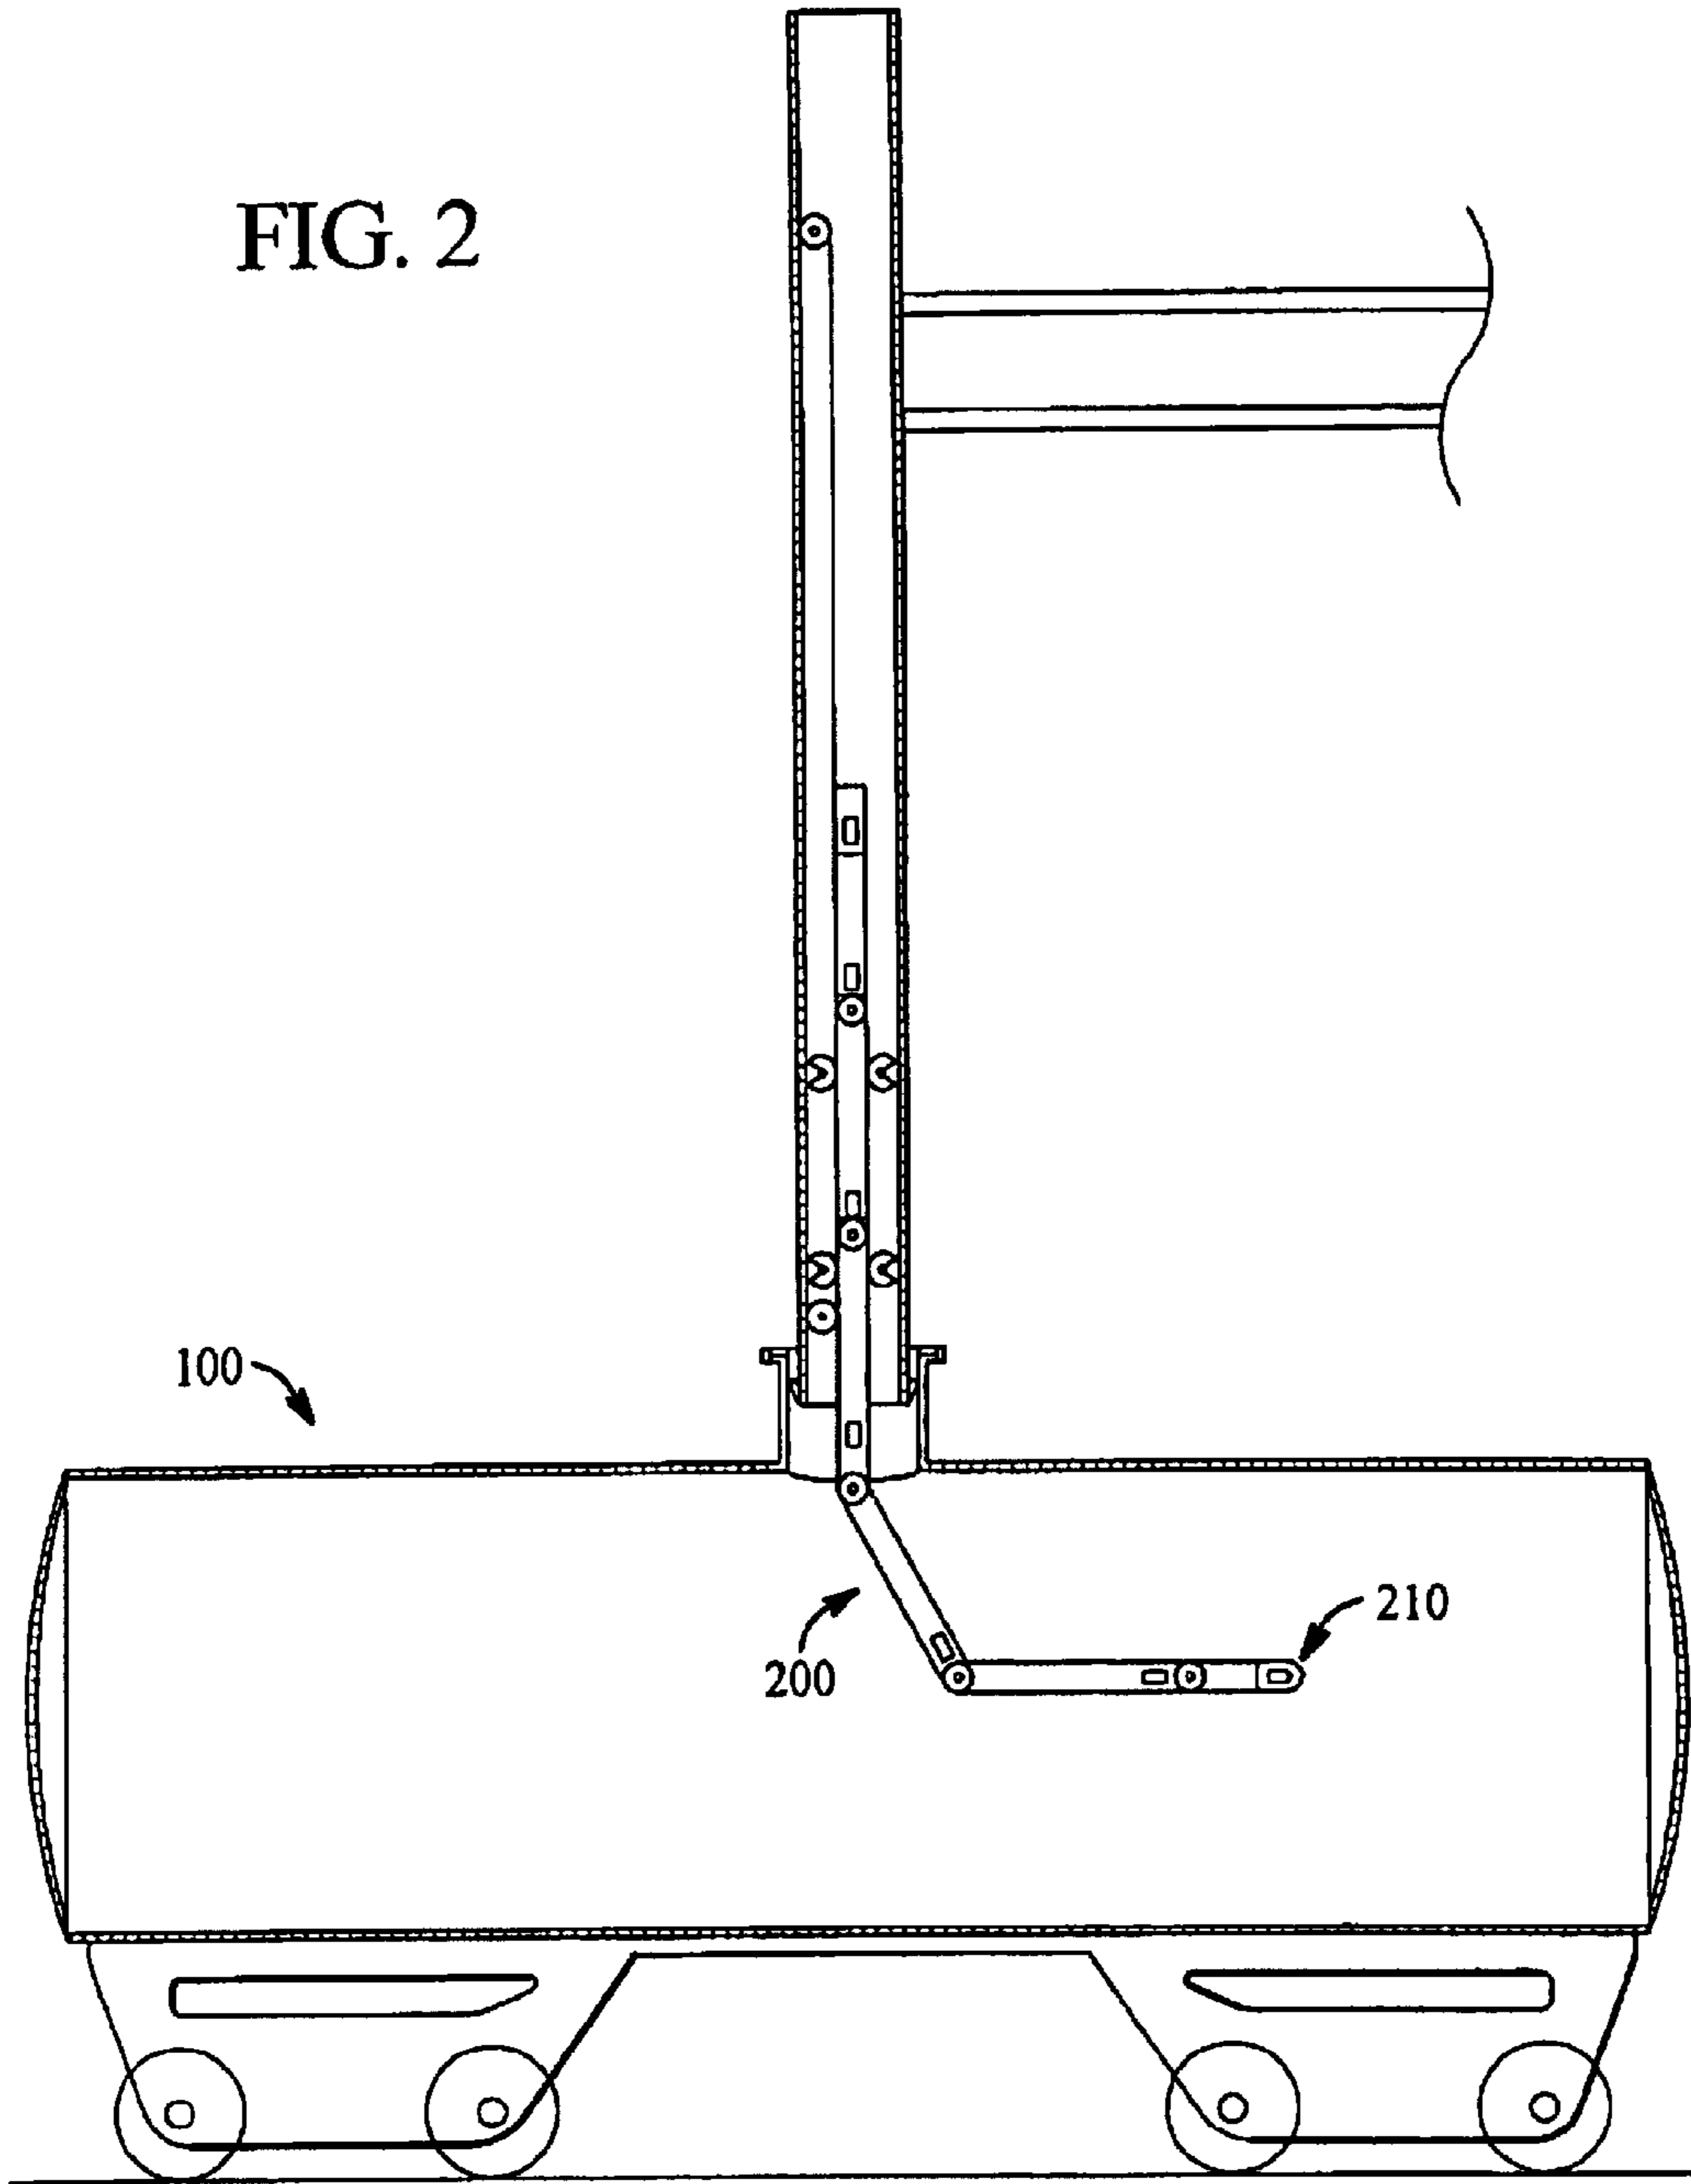
FIG. 2 is a schematic representation of a tank car which is being inspected robotically using an arrangement which could be used with the present invention in order to assist in inspecting/measuring the interior of a cylindrical vessel which forms a vital part of the tank car structure;

FIG. 2 depicts a tank car being inspected robotically via an arrangement provided in U.S. Pat. No. 5,956,077 issued on Sep. 21, 1999 to Qureshi et al. As shown, the tip of the snake-like probe **200** is provided with a sensor **210**. Sensor **210** can, for the purposes of the present invention, take the form of an ultrasonic sensor or any other form of non-destructive sensing arrangement. Alternatively and/or in addition to the sensor, the tip can be provided with a camera and powerful illumination means for facilitating tank interior inspection. This type of arrangement has merit in the instances that the tank has not been cleaned out to the degree that it is safe for a person or persons to physically enter the tank and perform the required inspections, tests and data recordation. Non-limiting examples of sensor types and configurations compatible with the present invention are provided in U.S. Pat. No. 5,256,966 issued on Oct. 26, 1993; U.S. Pat. No. 5,036,707 issued on Aug. 6, 1991 to Paciej et al.; U.S. Pat. No. 4,368,644 issued on Jan. 18, 1983 to Wentzell et al.; U.S. Pat. No. 4,658,649 issued on Apr. 21, 1987; U.S. Pat. No. 5,648,619 issued to Gustafsson et al. on Jul. 15, 1997; U.S. Pat. No. 4,490,833 issued to Inomata et al. on Dec. 25, 1984; or U.S. Pat. No. 5,619,423 issued on Apr. 8, 1997 to Scrantz.

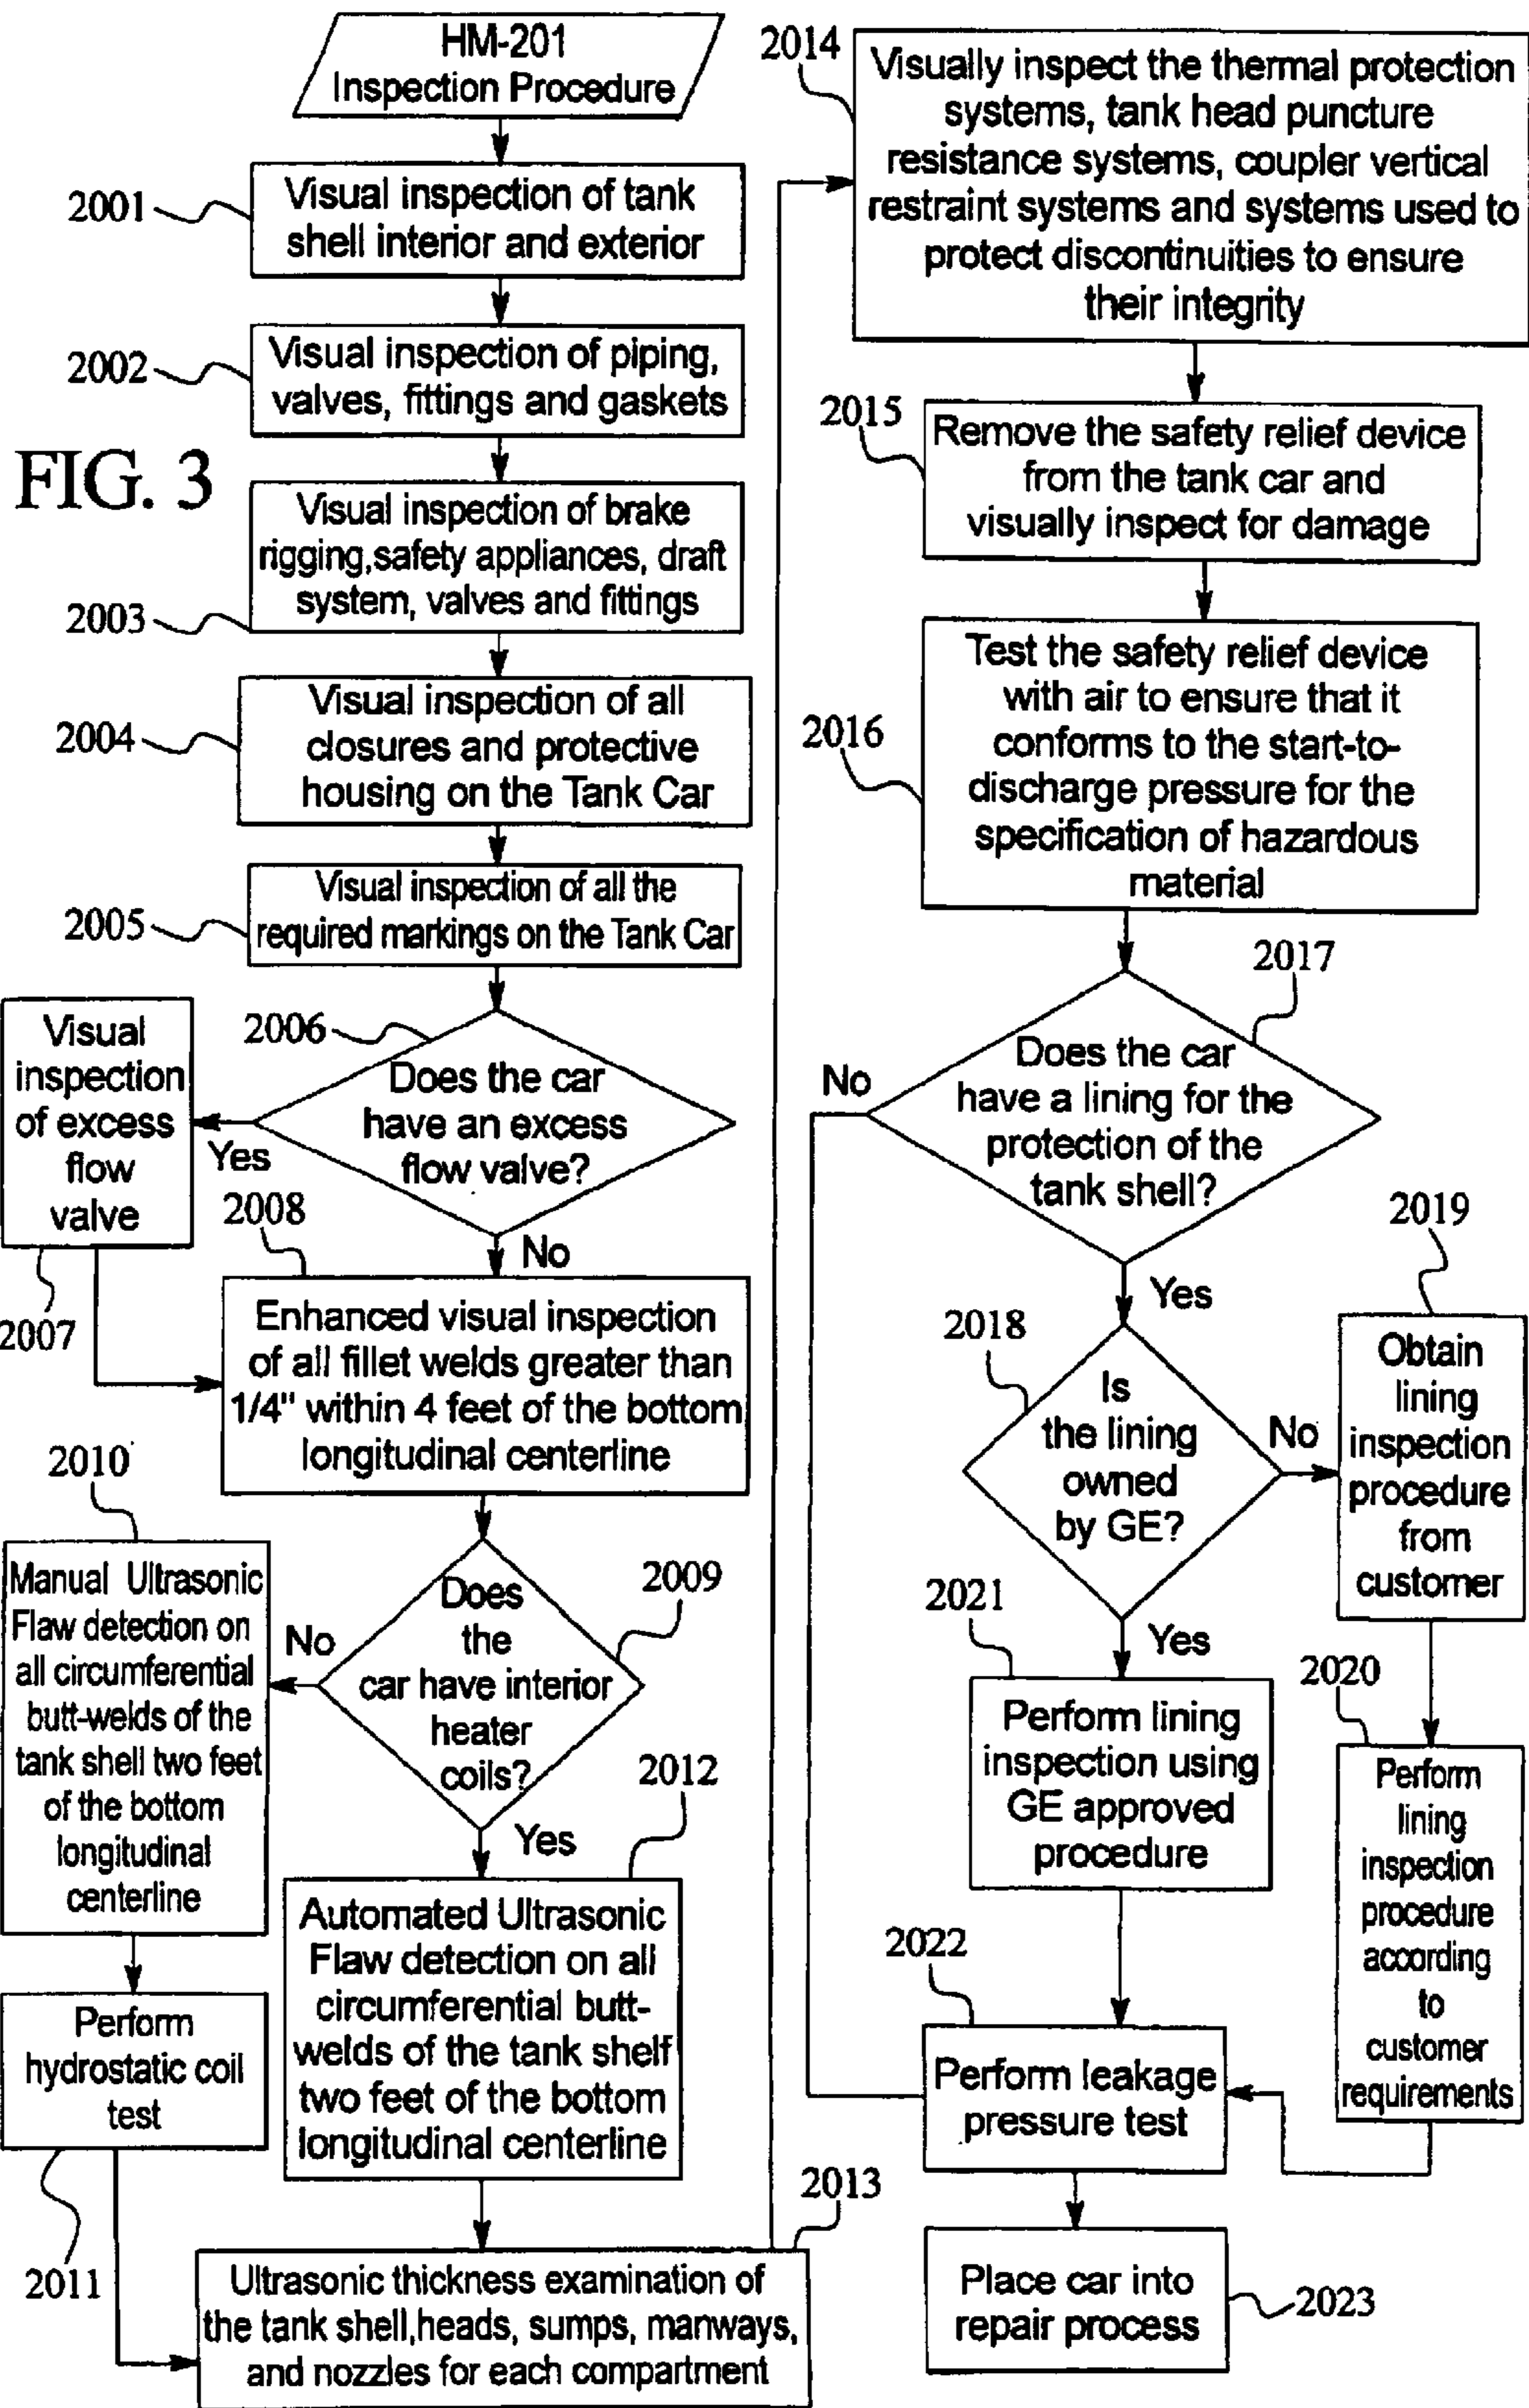
FIG. 3 is a flow chart depicting the general procedure in accord with the present invention;

As noted above, the requalification according to the present invention can be classified into six separate types of inspection delineated in 49 C.F.R. §180.509: (1) Visual Inspection, (2) Structural Inspection, (3) Service Life Shell Thickness Inspection, (4) Safety System Inspection, (5) Lining and Coating Inspection, and (6) Leakage Pressure Test. The flow chart in FIG. 3 depicts the general flow of the process in accord with the invention.

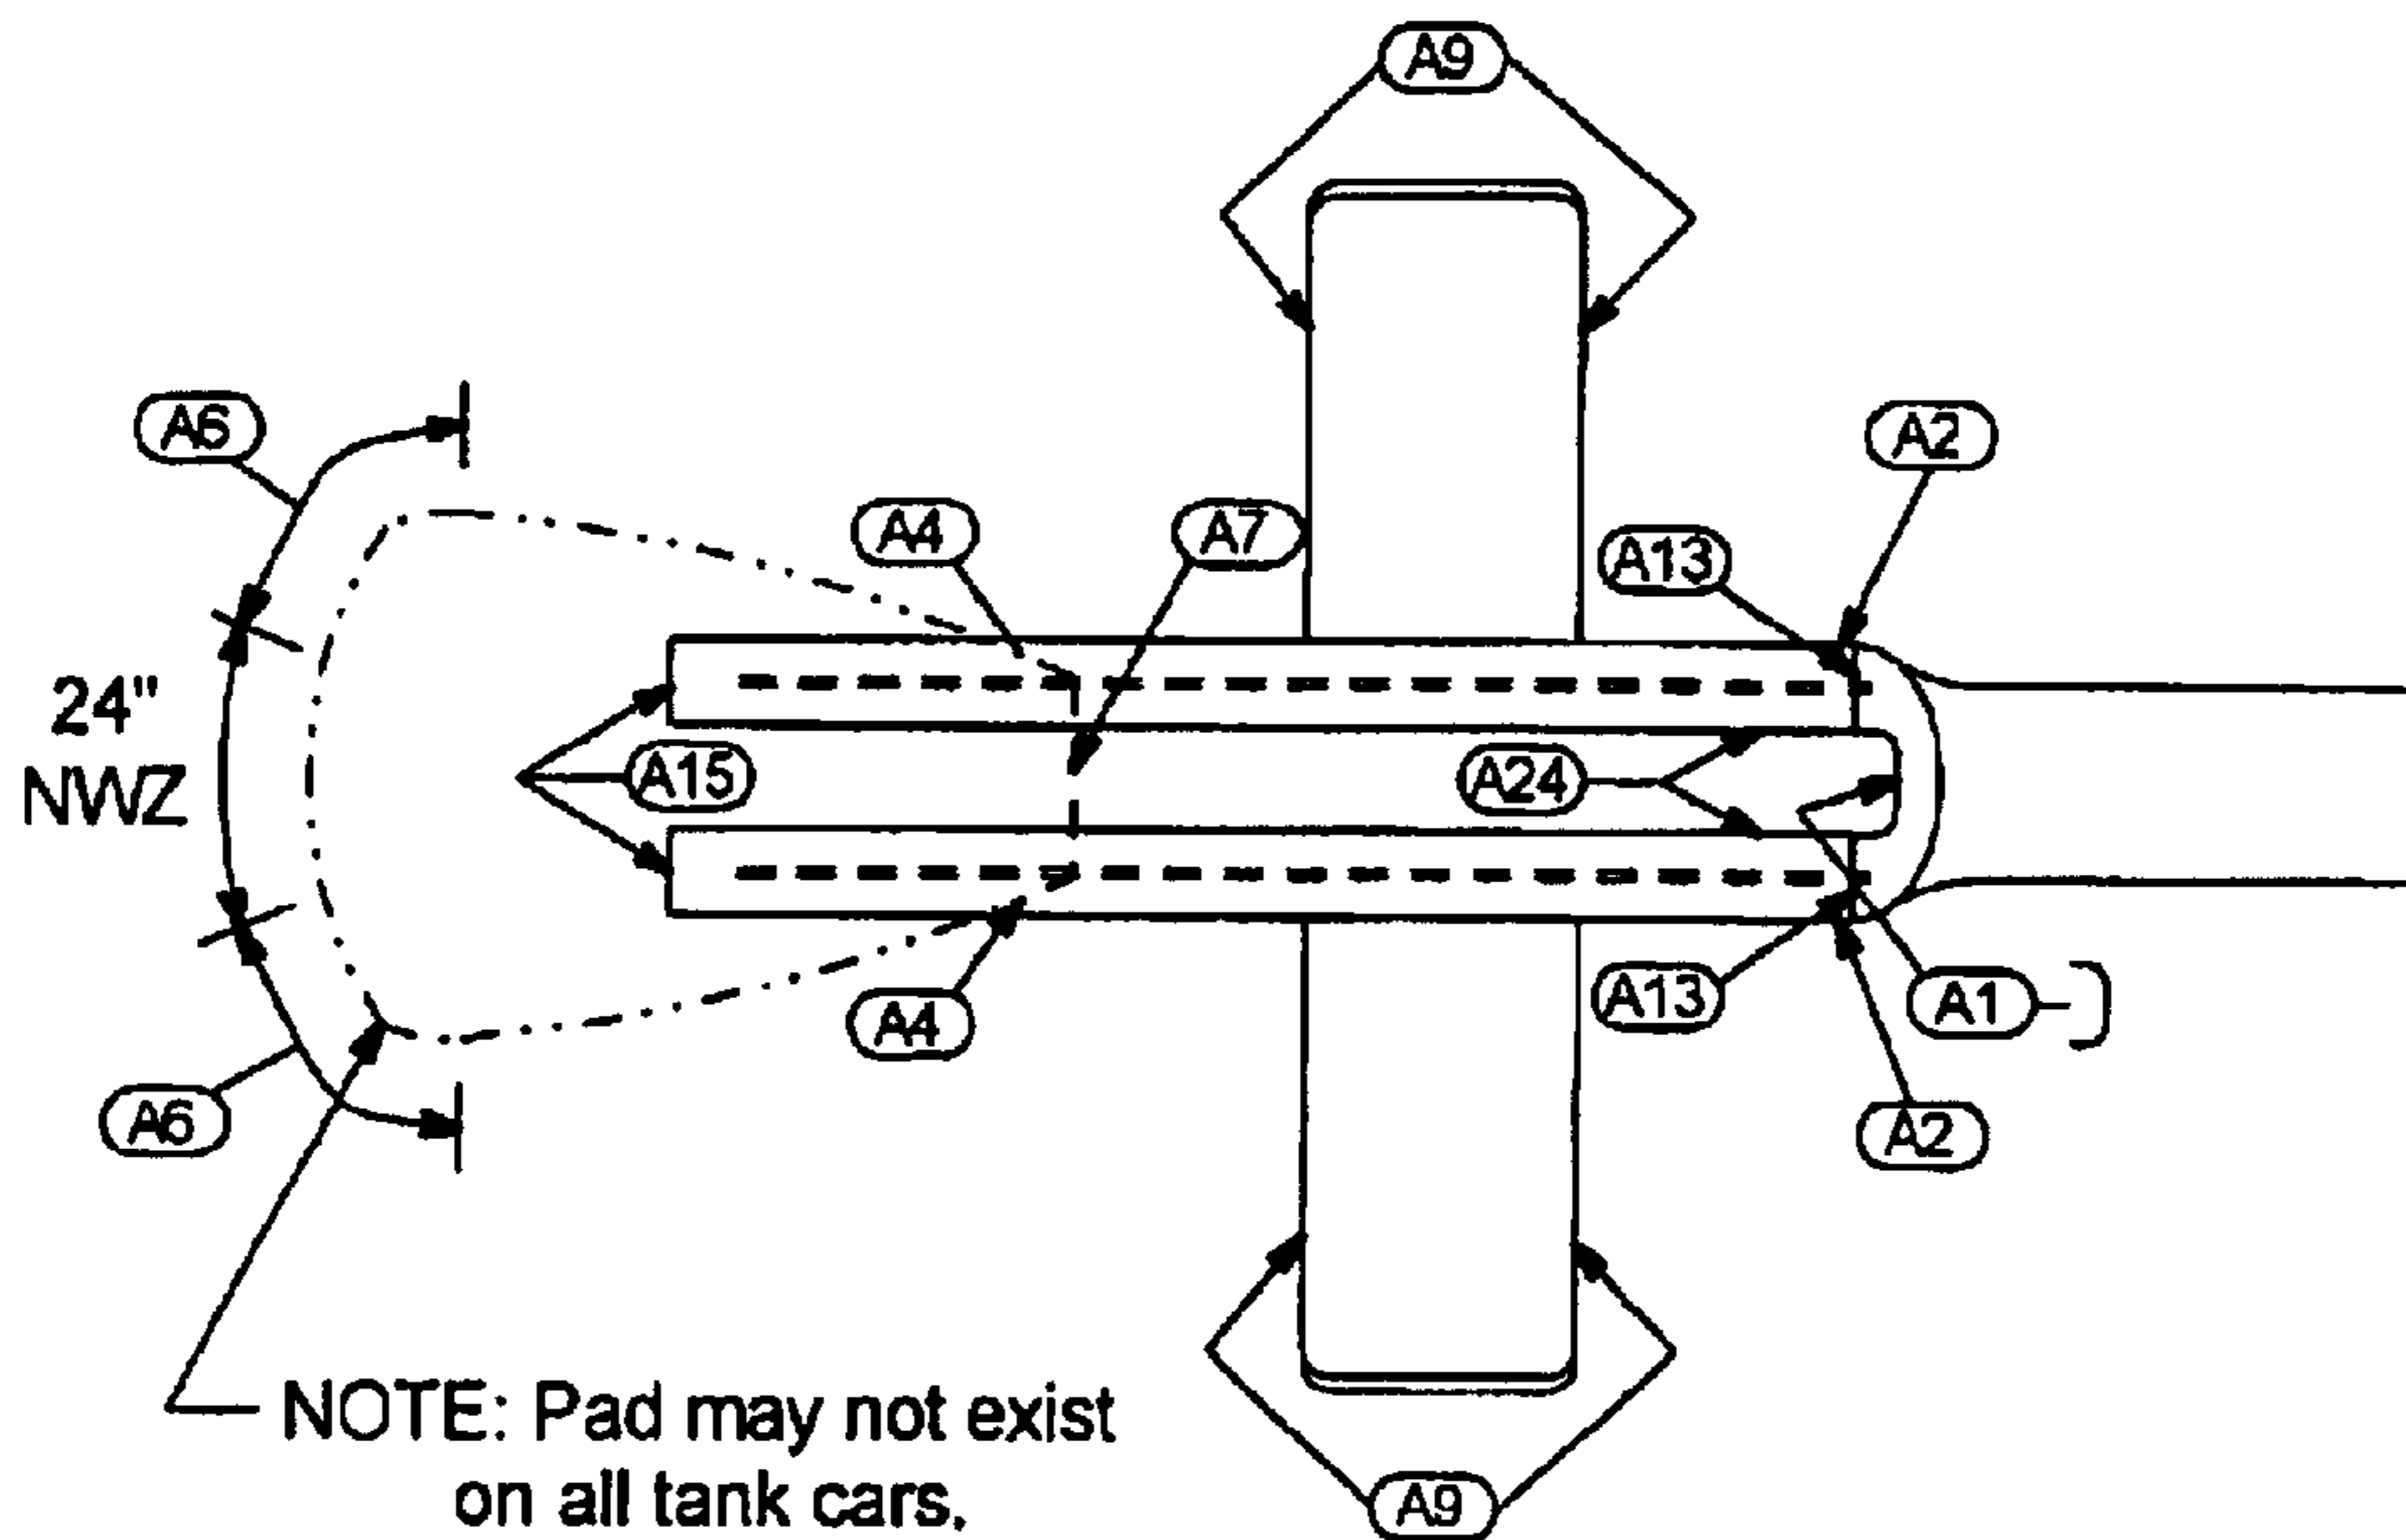
FIG. 8A

FIGS. 8A–8H depict yet another aspect of the invention wherein the detailed weld inspection relates to welds on tank cars built using ABC and JKL stub sill designs, such as those built by North American Car (NAC), AMF Beard (AMF), Davie Shipbuilding Ltd. (DSL), and Hawker Siddeley Ltd. (HST).

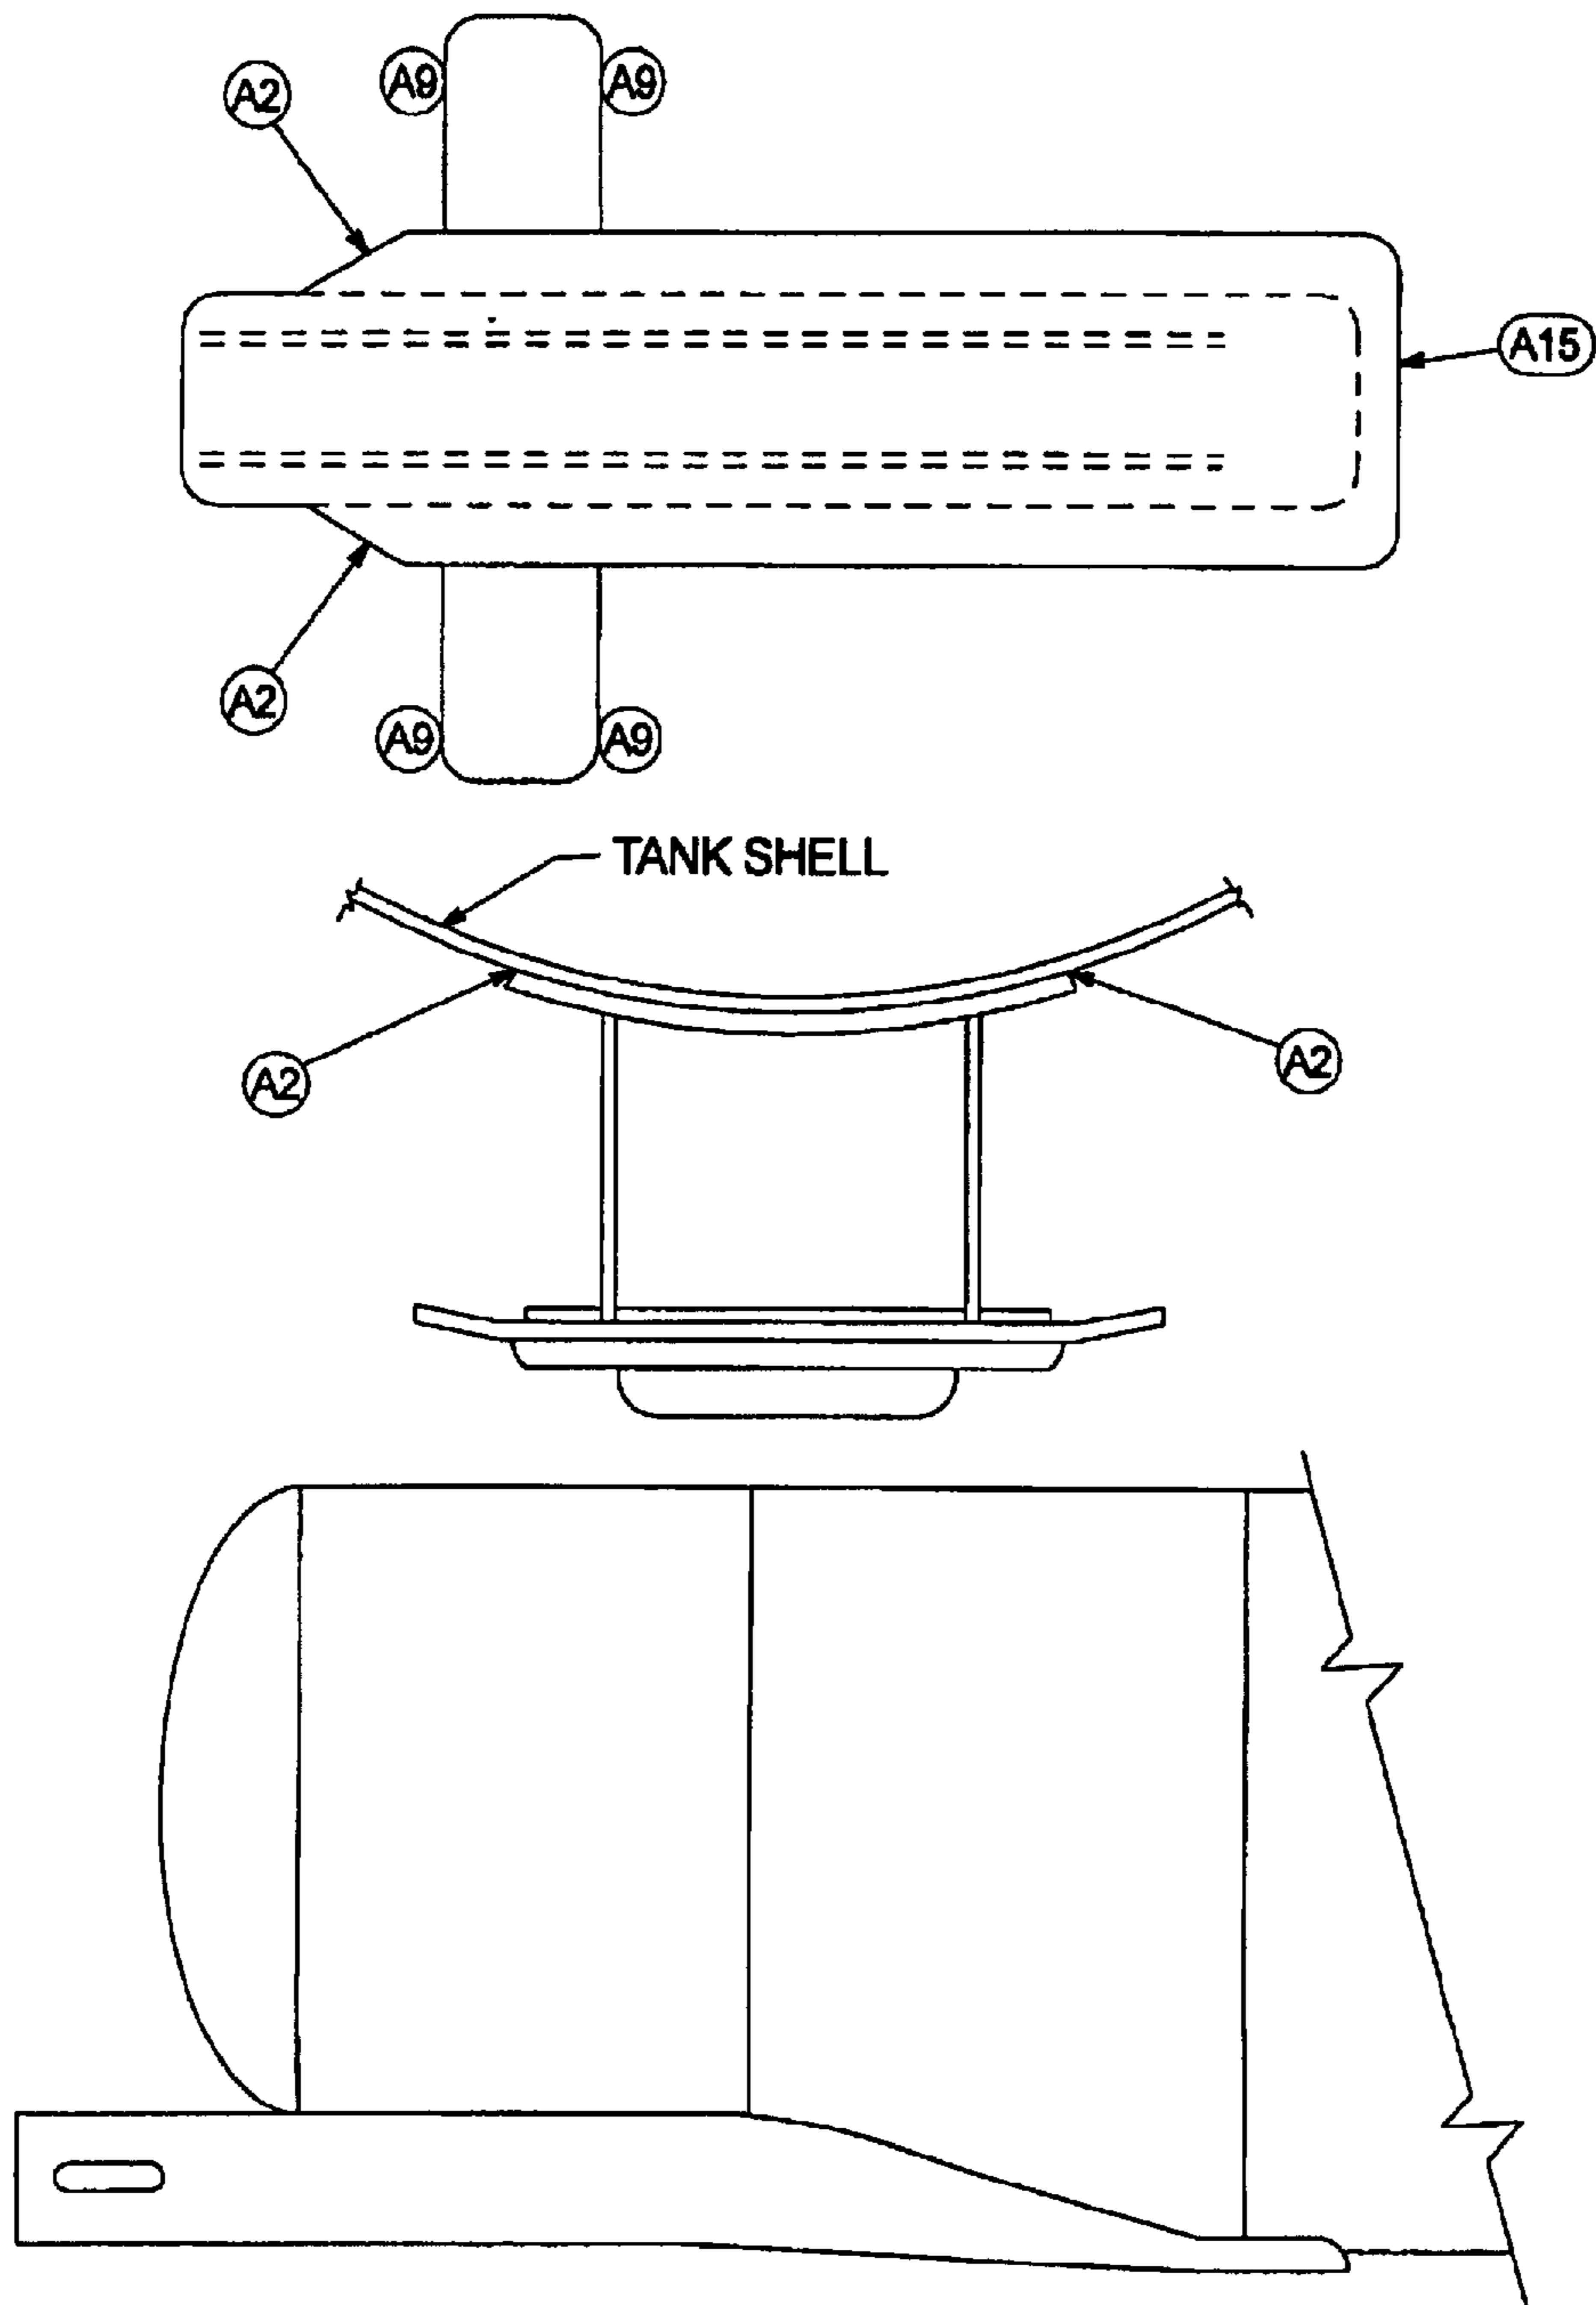
FIG. 9A

FIGS. 9A–9G illustrate another aspect of the invention wherein the detailed weld inspection relates to welds on tank cars built using ACF-100 stub sill designs.

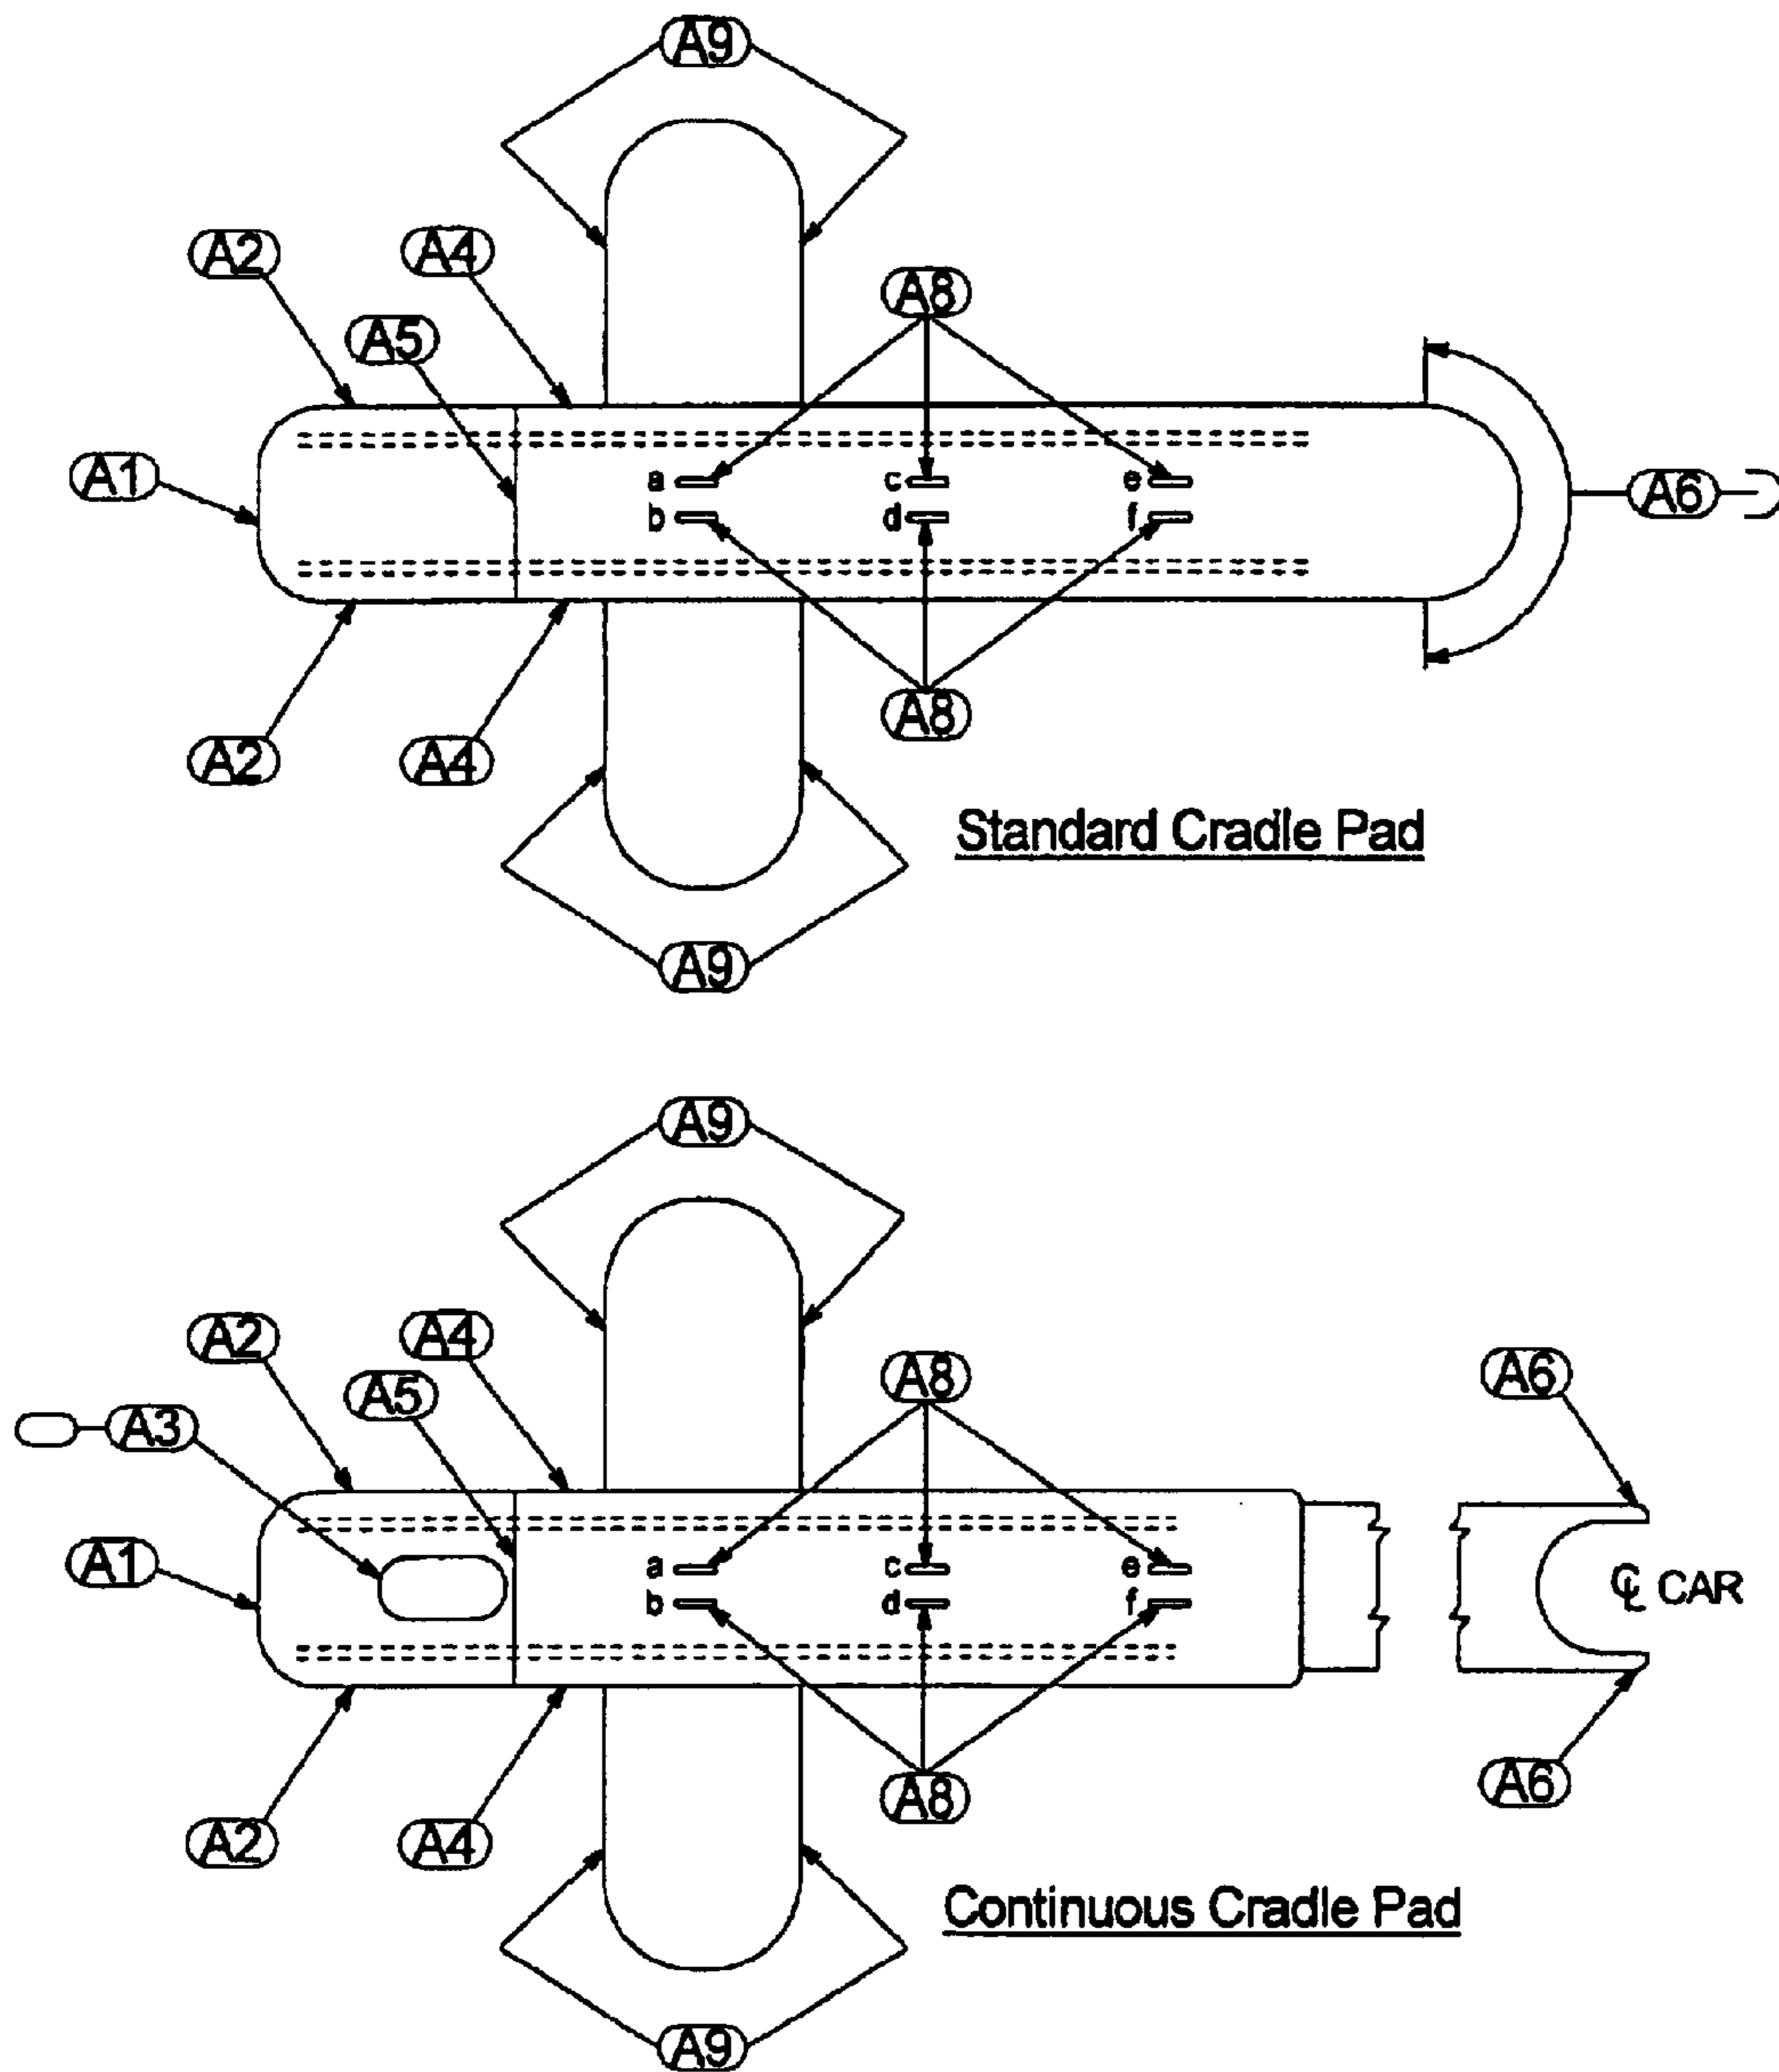
FIGS. 12A–12H depict an aspect of the invention wherein the detailed weld inspection relates to welds on tank cars built using the ZBN stub sill design.

FIGS. 12A–12H depict yet another preferred aspect of the invention wherein the detailed weld inspection in accord with step 2008 particularly relates to welds on ZBN stub sill designed tank cars, primarily manufactured by Union Tank Car Company (UTC).

FIG. 12A shows various pad-to-tank weld locations. Weld location A1 satisfies inspection requirements under HM-201, SSIP, and Rule 88.B.2. It depicts a front sill pad-to-tank transverse weld located at the A and B ends and is inspected along a full length of the weld, including a portion around the corner of the pad. Weld location A2 meets
