(54) **METHOD AND ARRANGEMENT FOR INSPECTION AND REQUALIFICATION OF VEHICLES USED FOR TRANSPORTING COMMODITIES AND/OR HAZARDOUS MATERIALS**

(73) Assignee: **General Electric Railcar Services Corporation**, Chicago, IL (US)

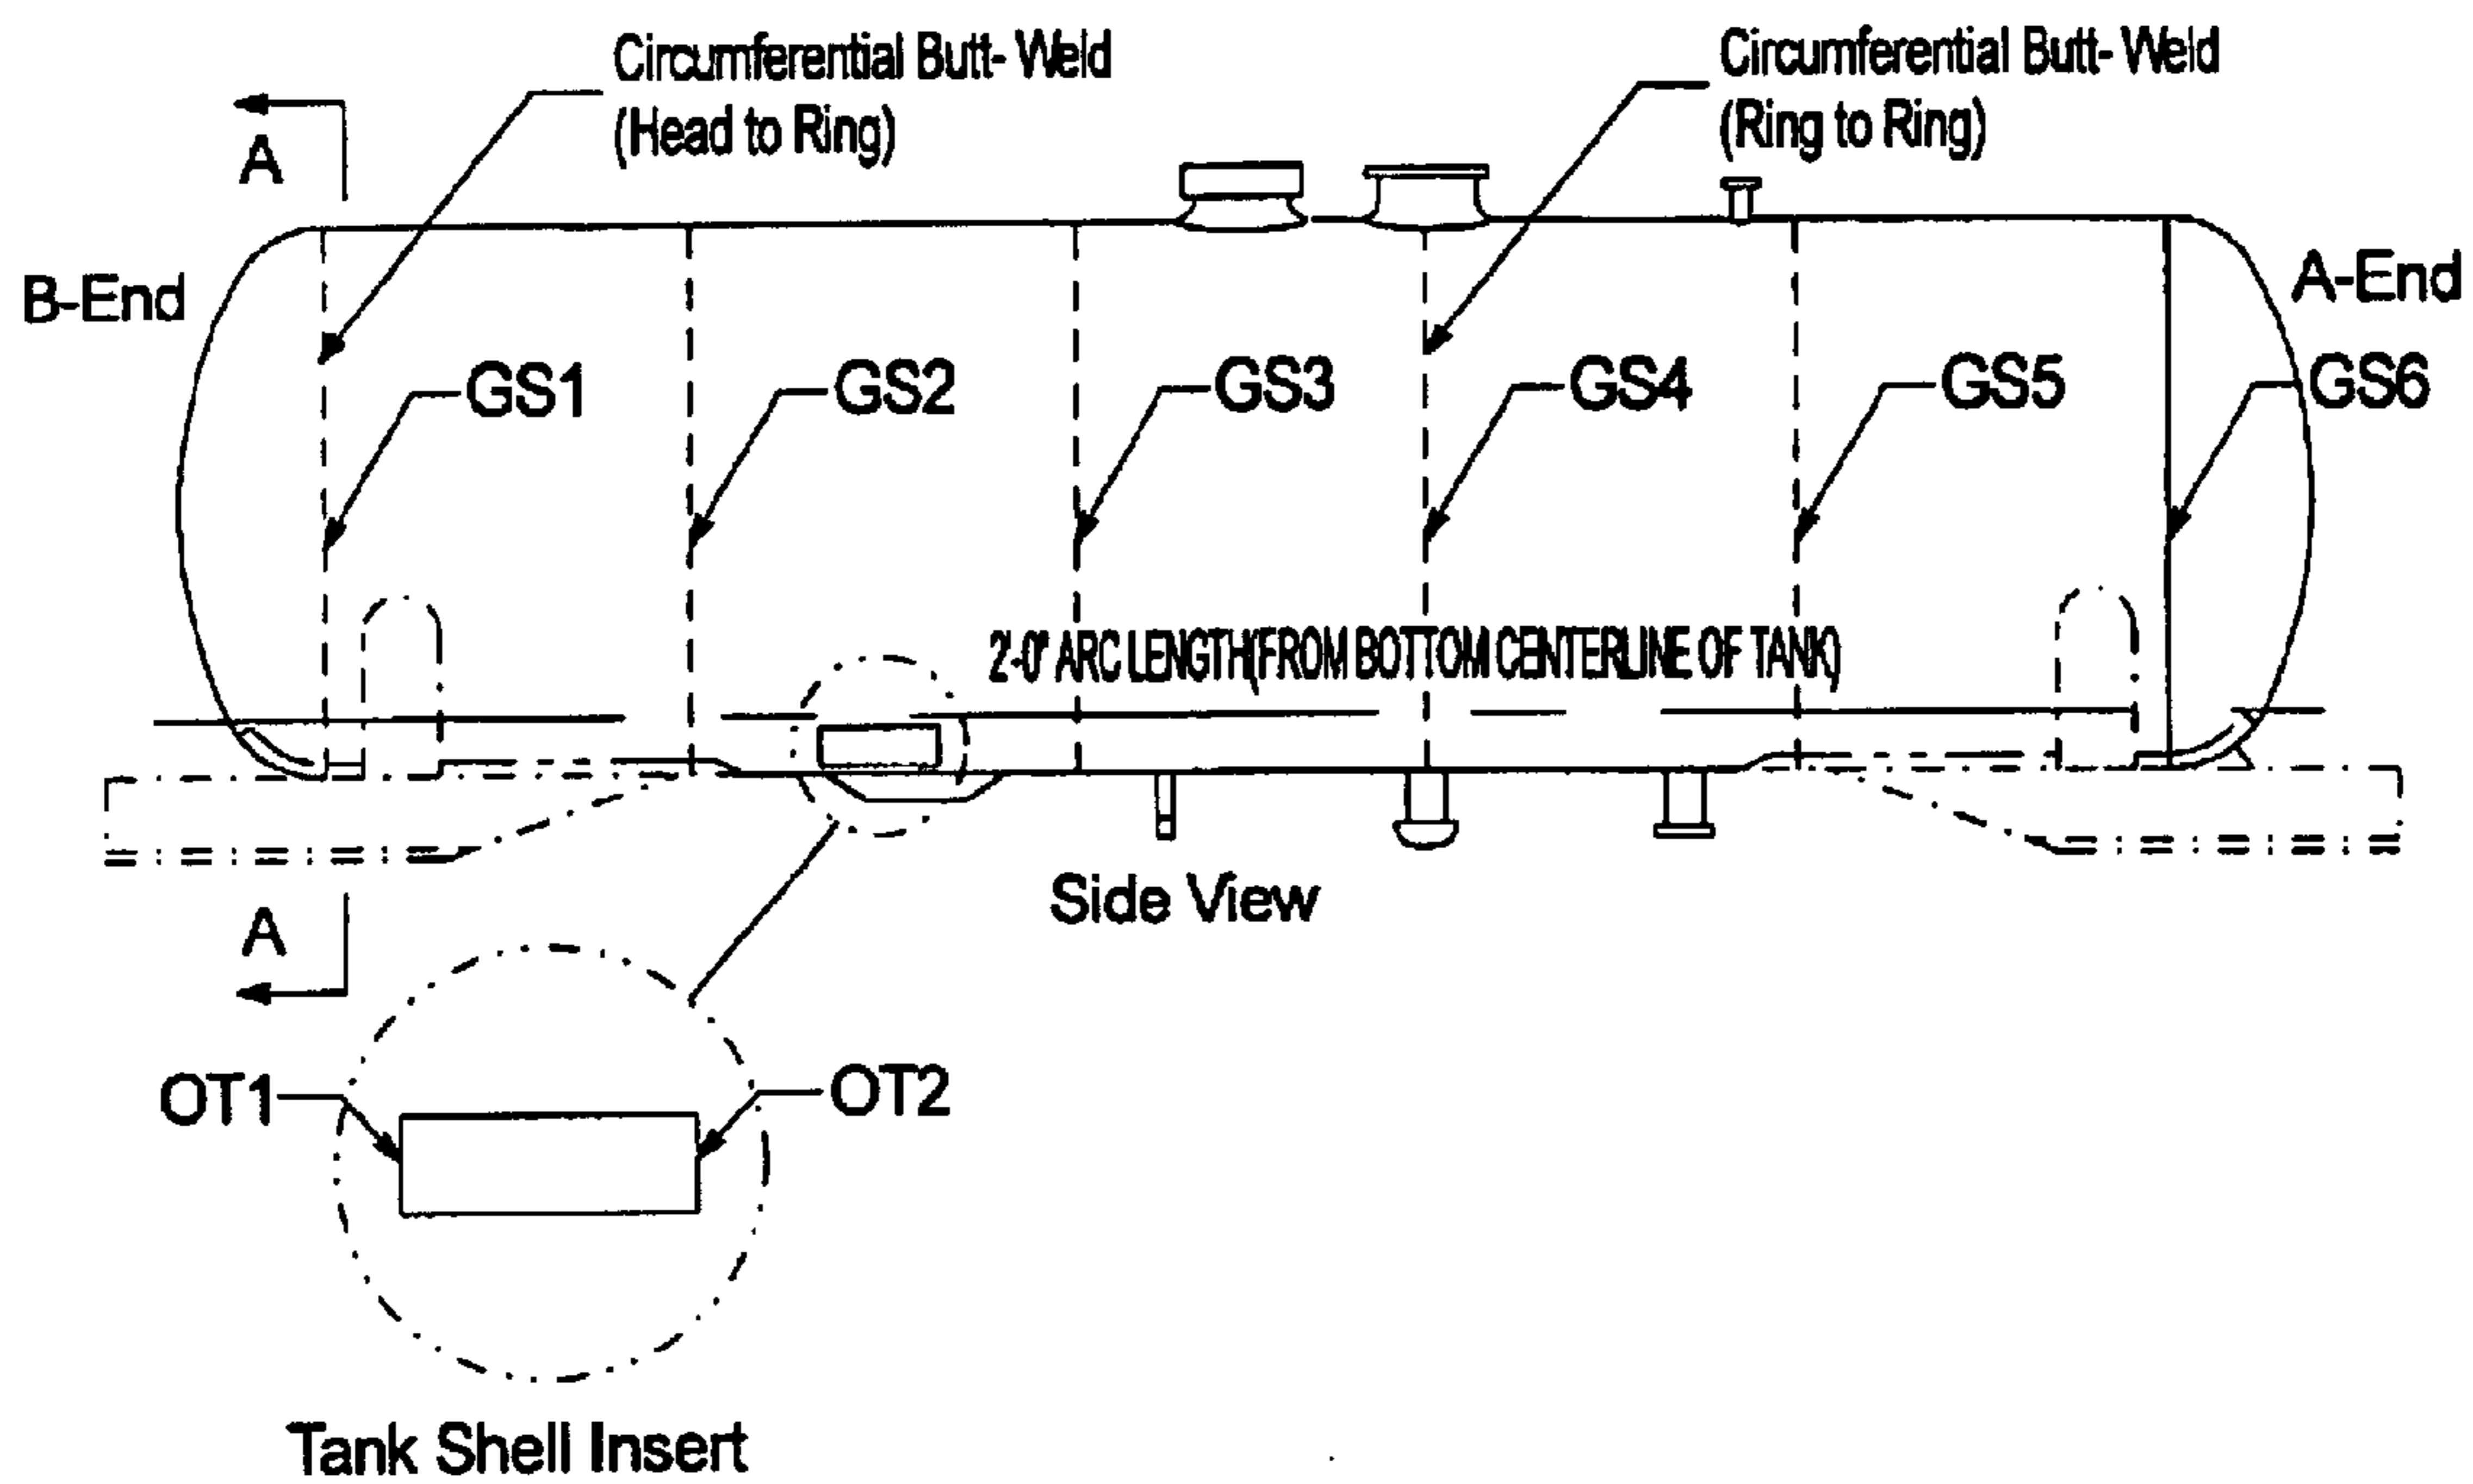
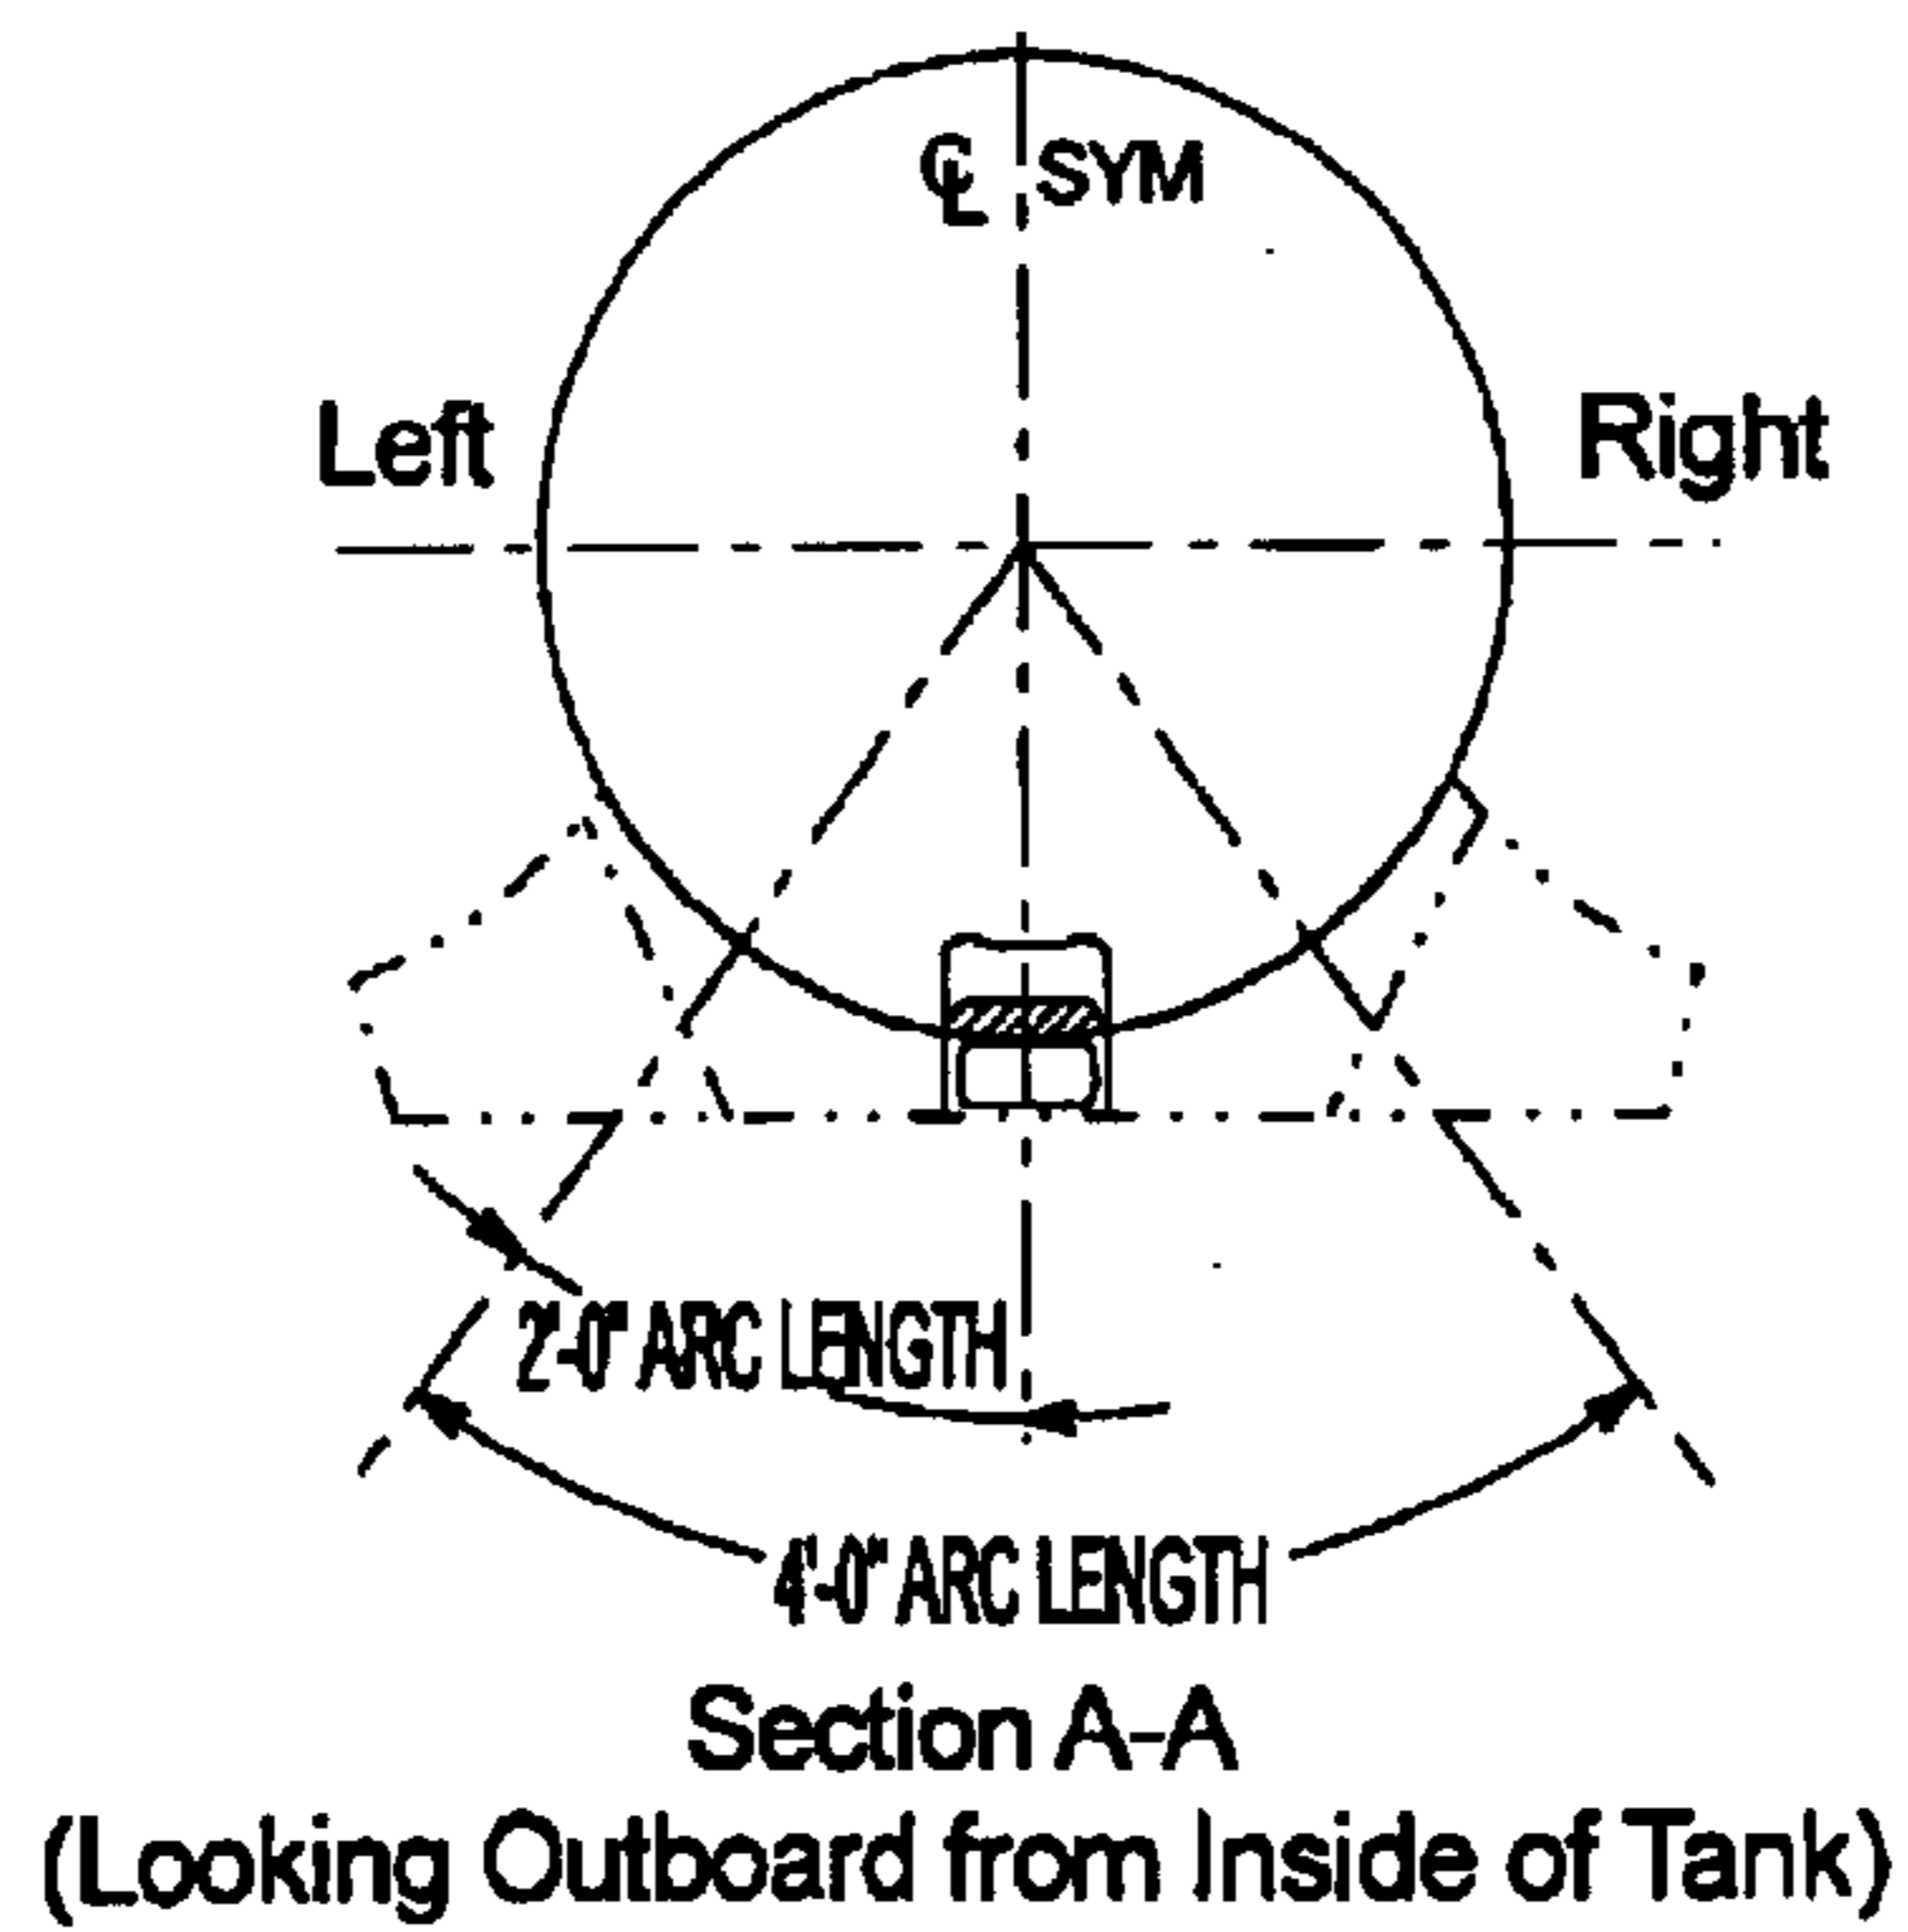
FIG. 13A illustrates a side view and a cross-sectional view of a tank car circumferential butt-welds.

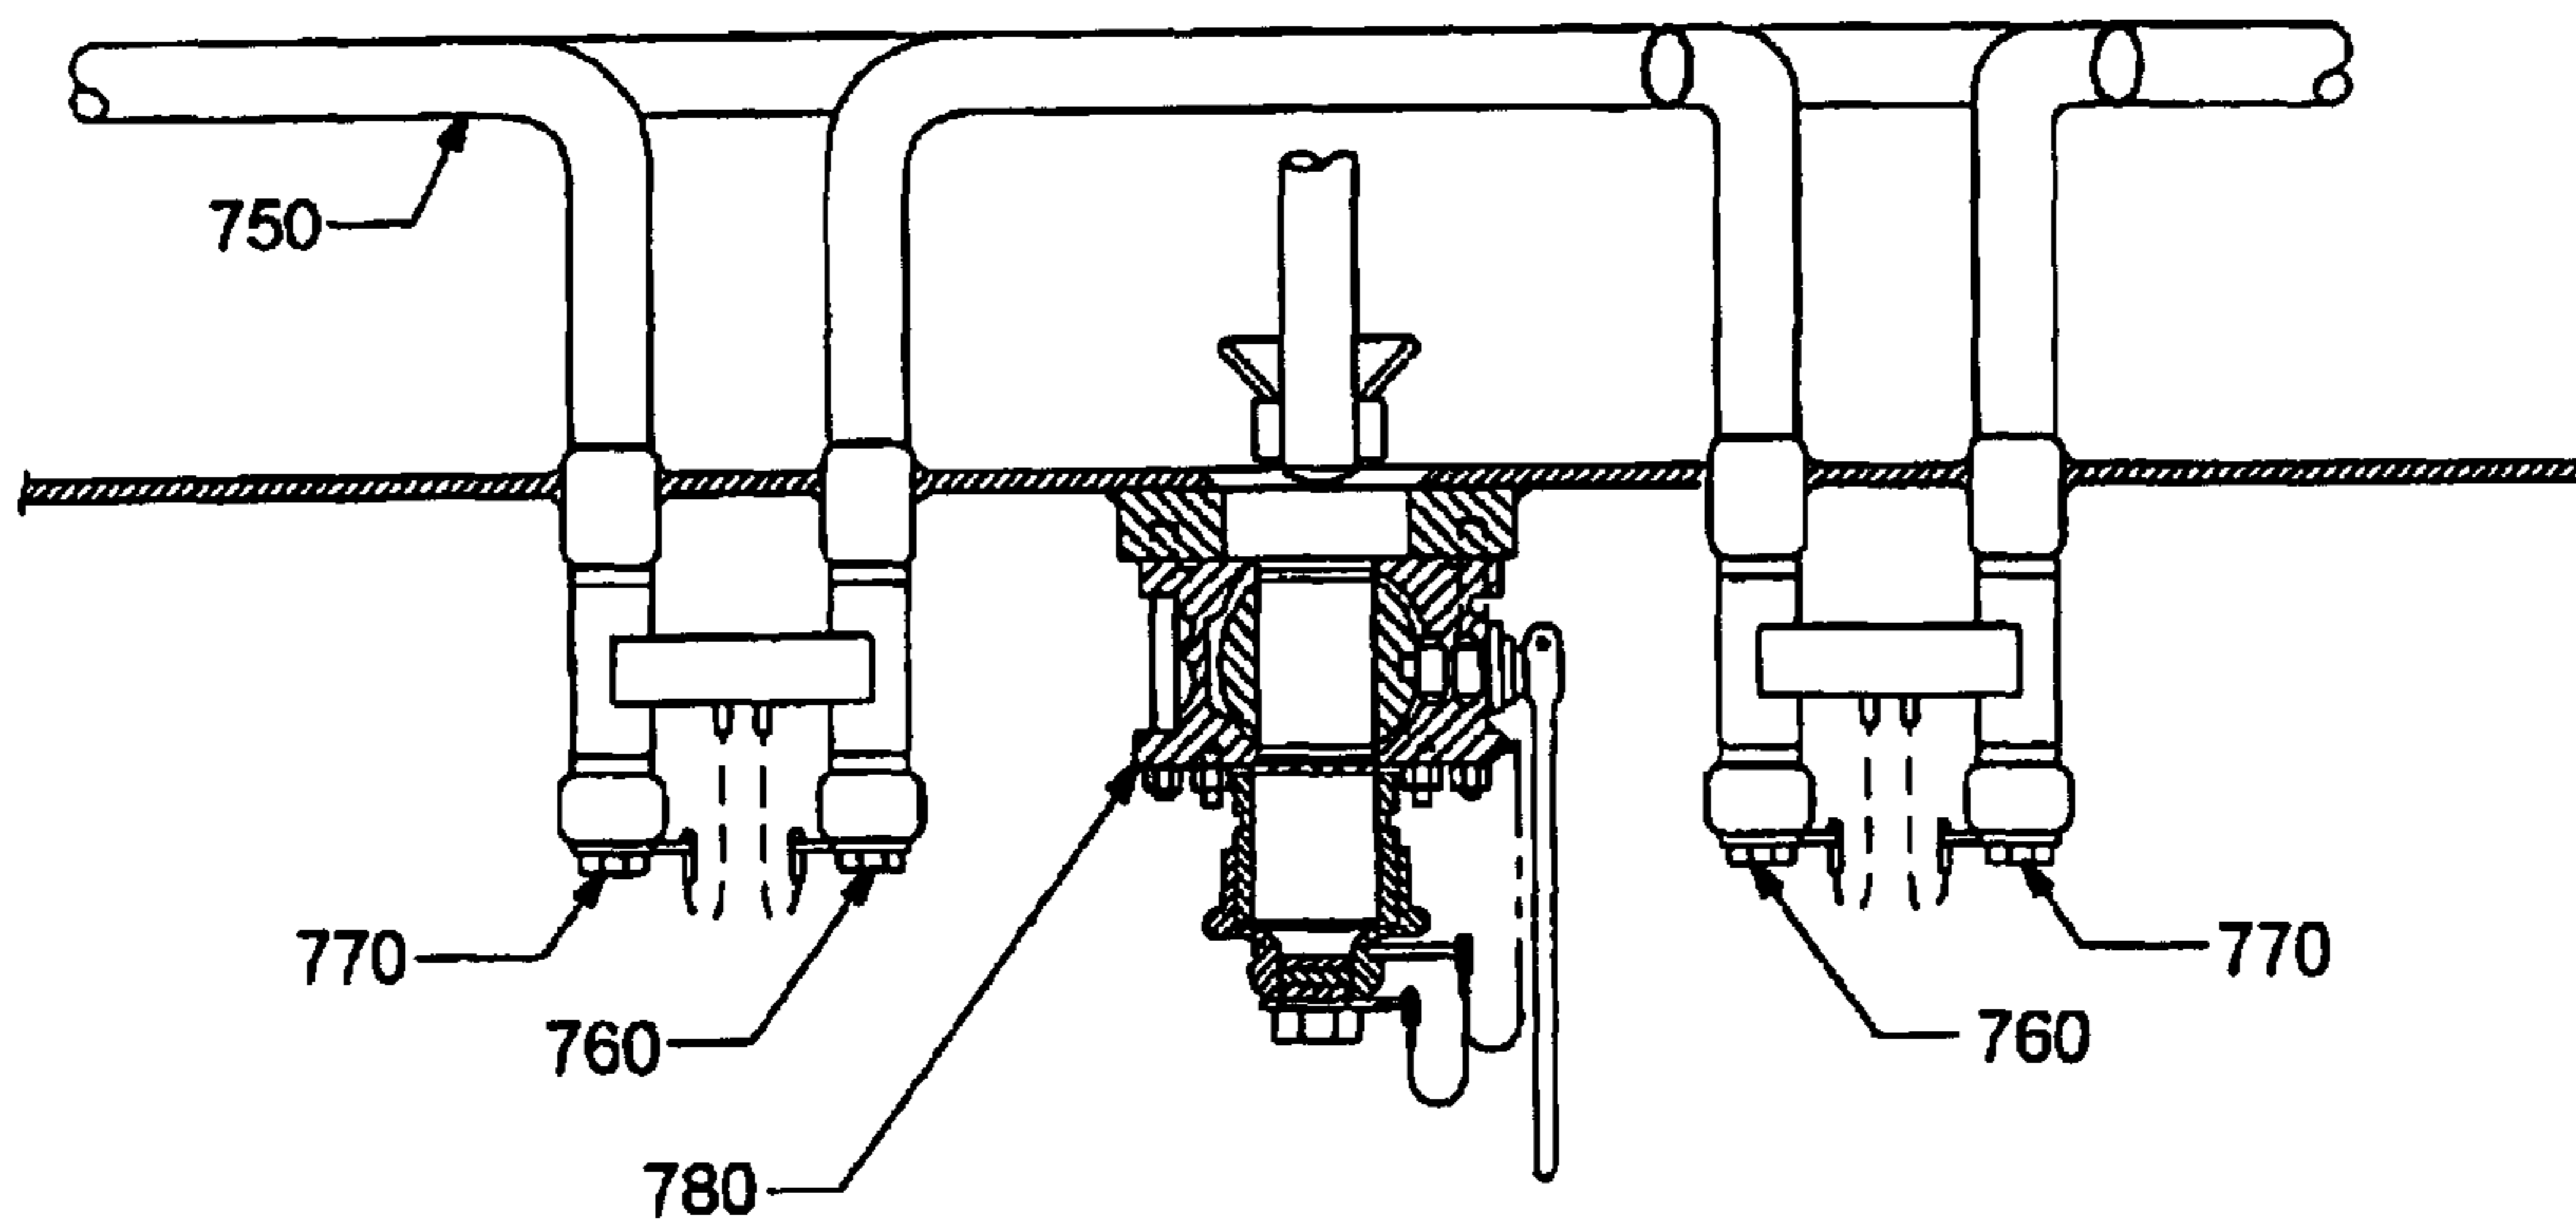
FIG. 13B illustrates a typical coil leg arrangement.

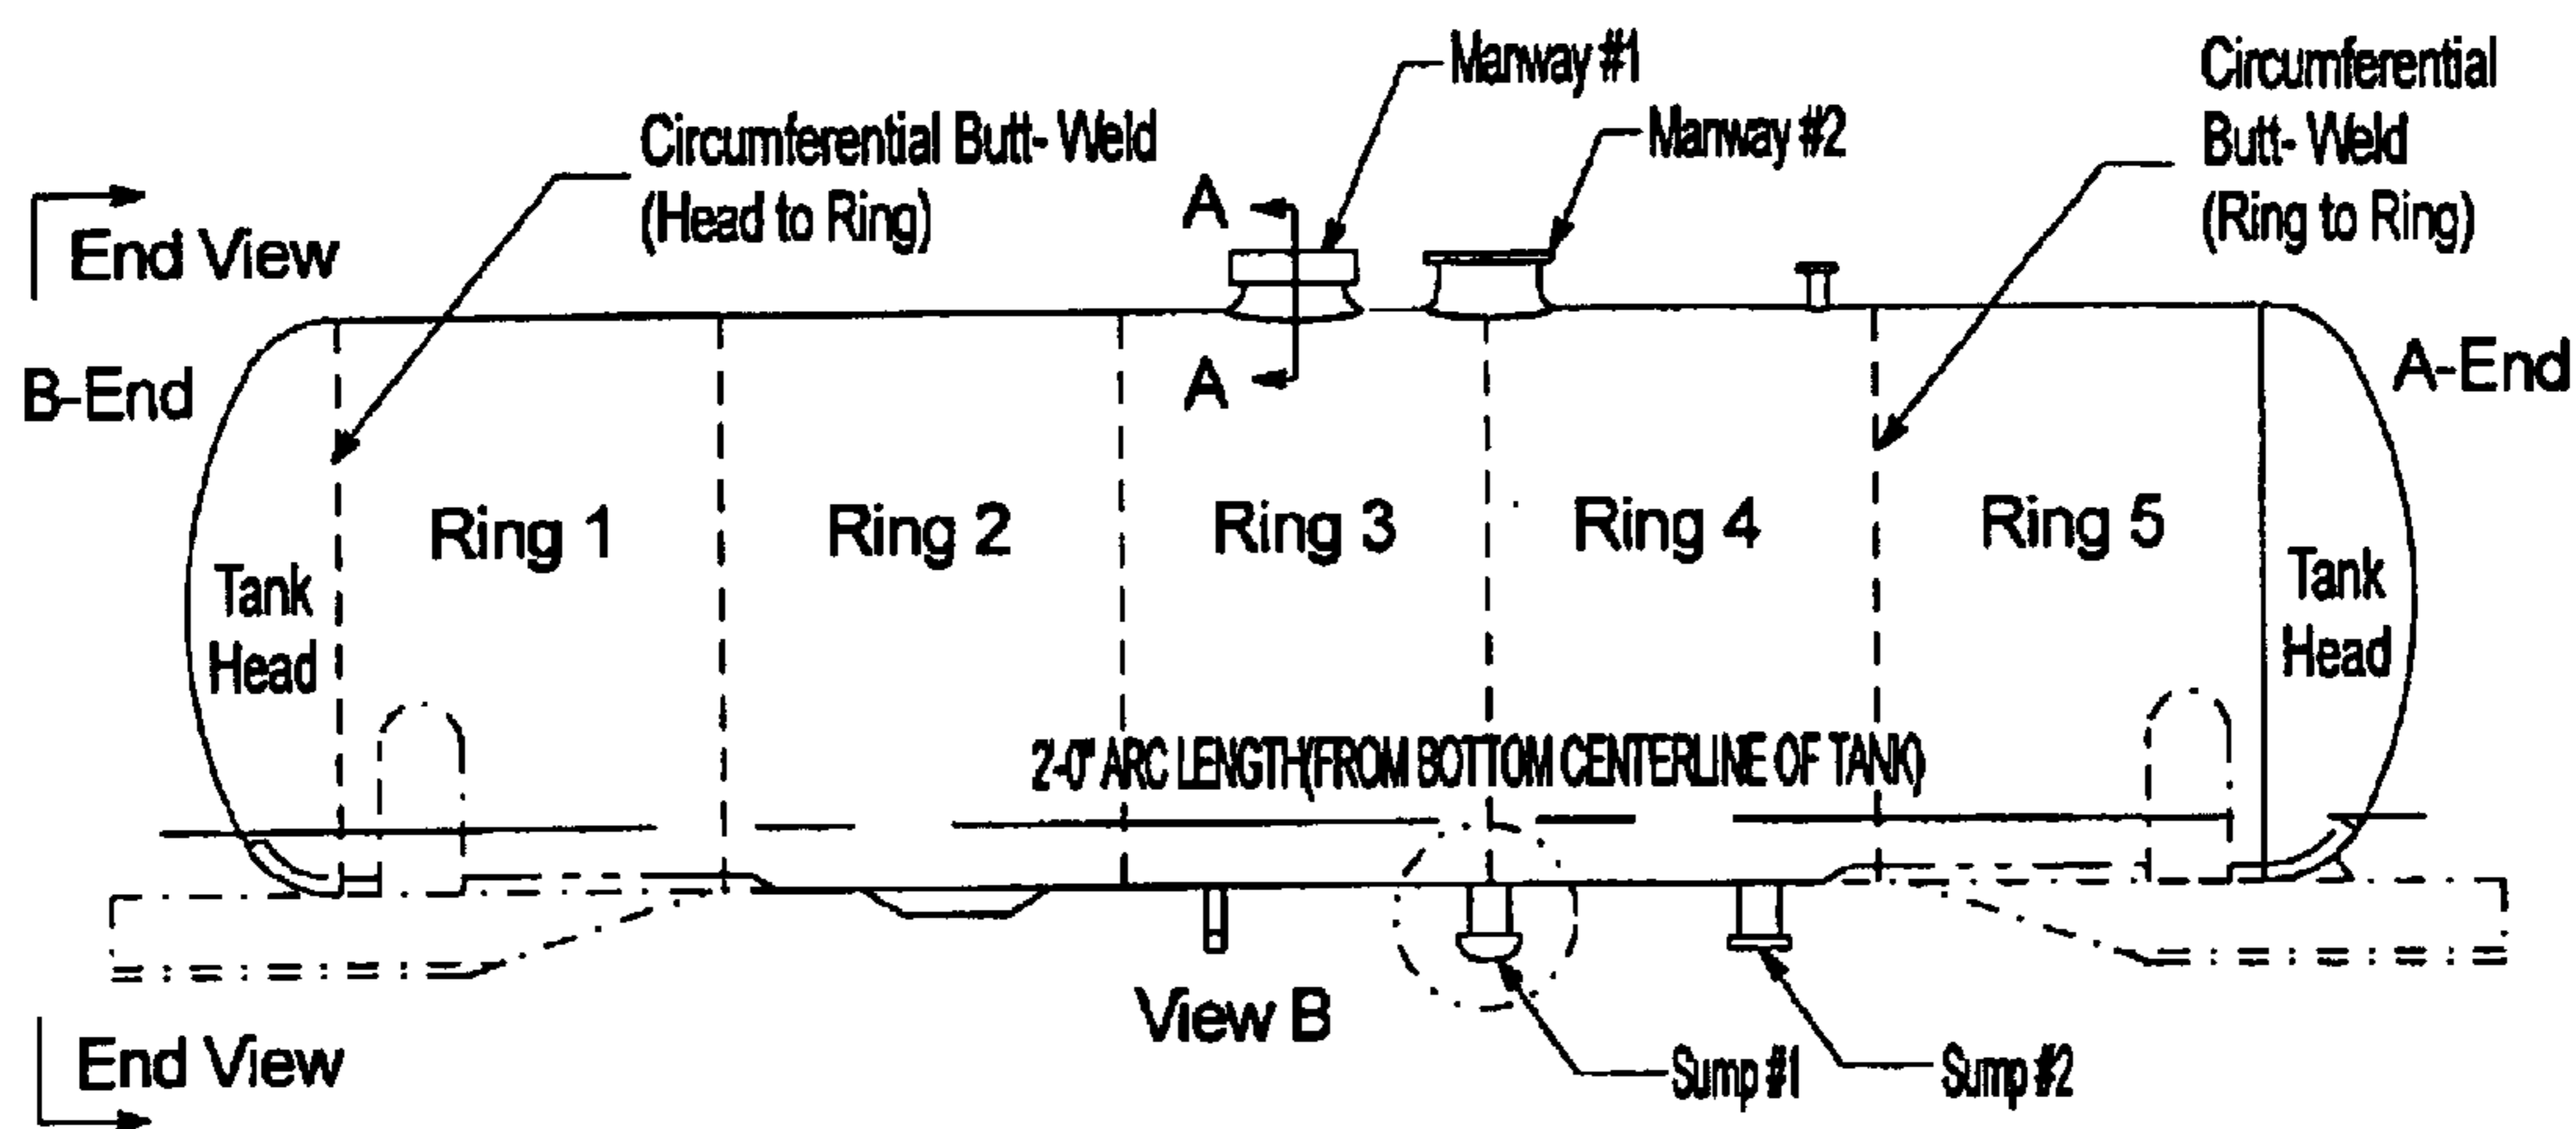
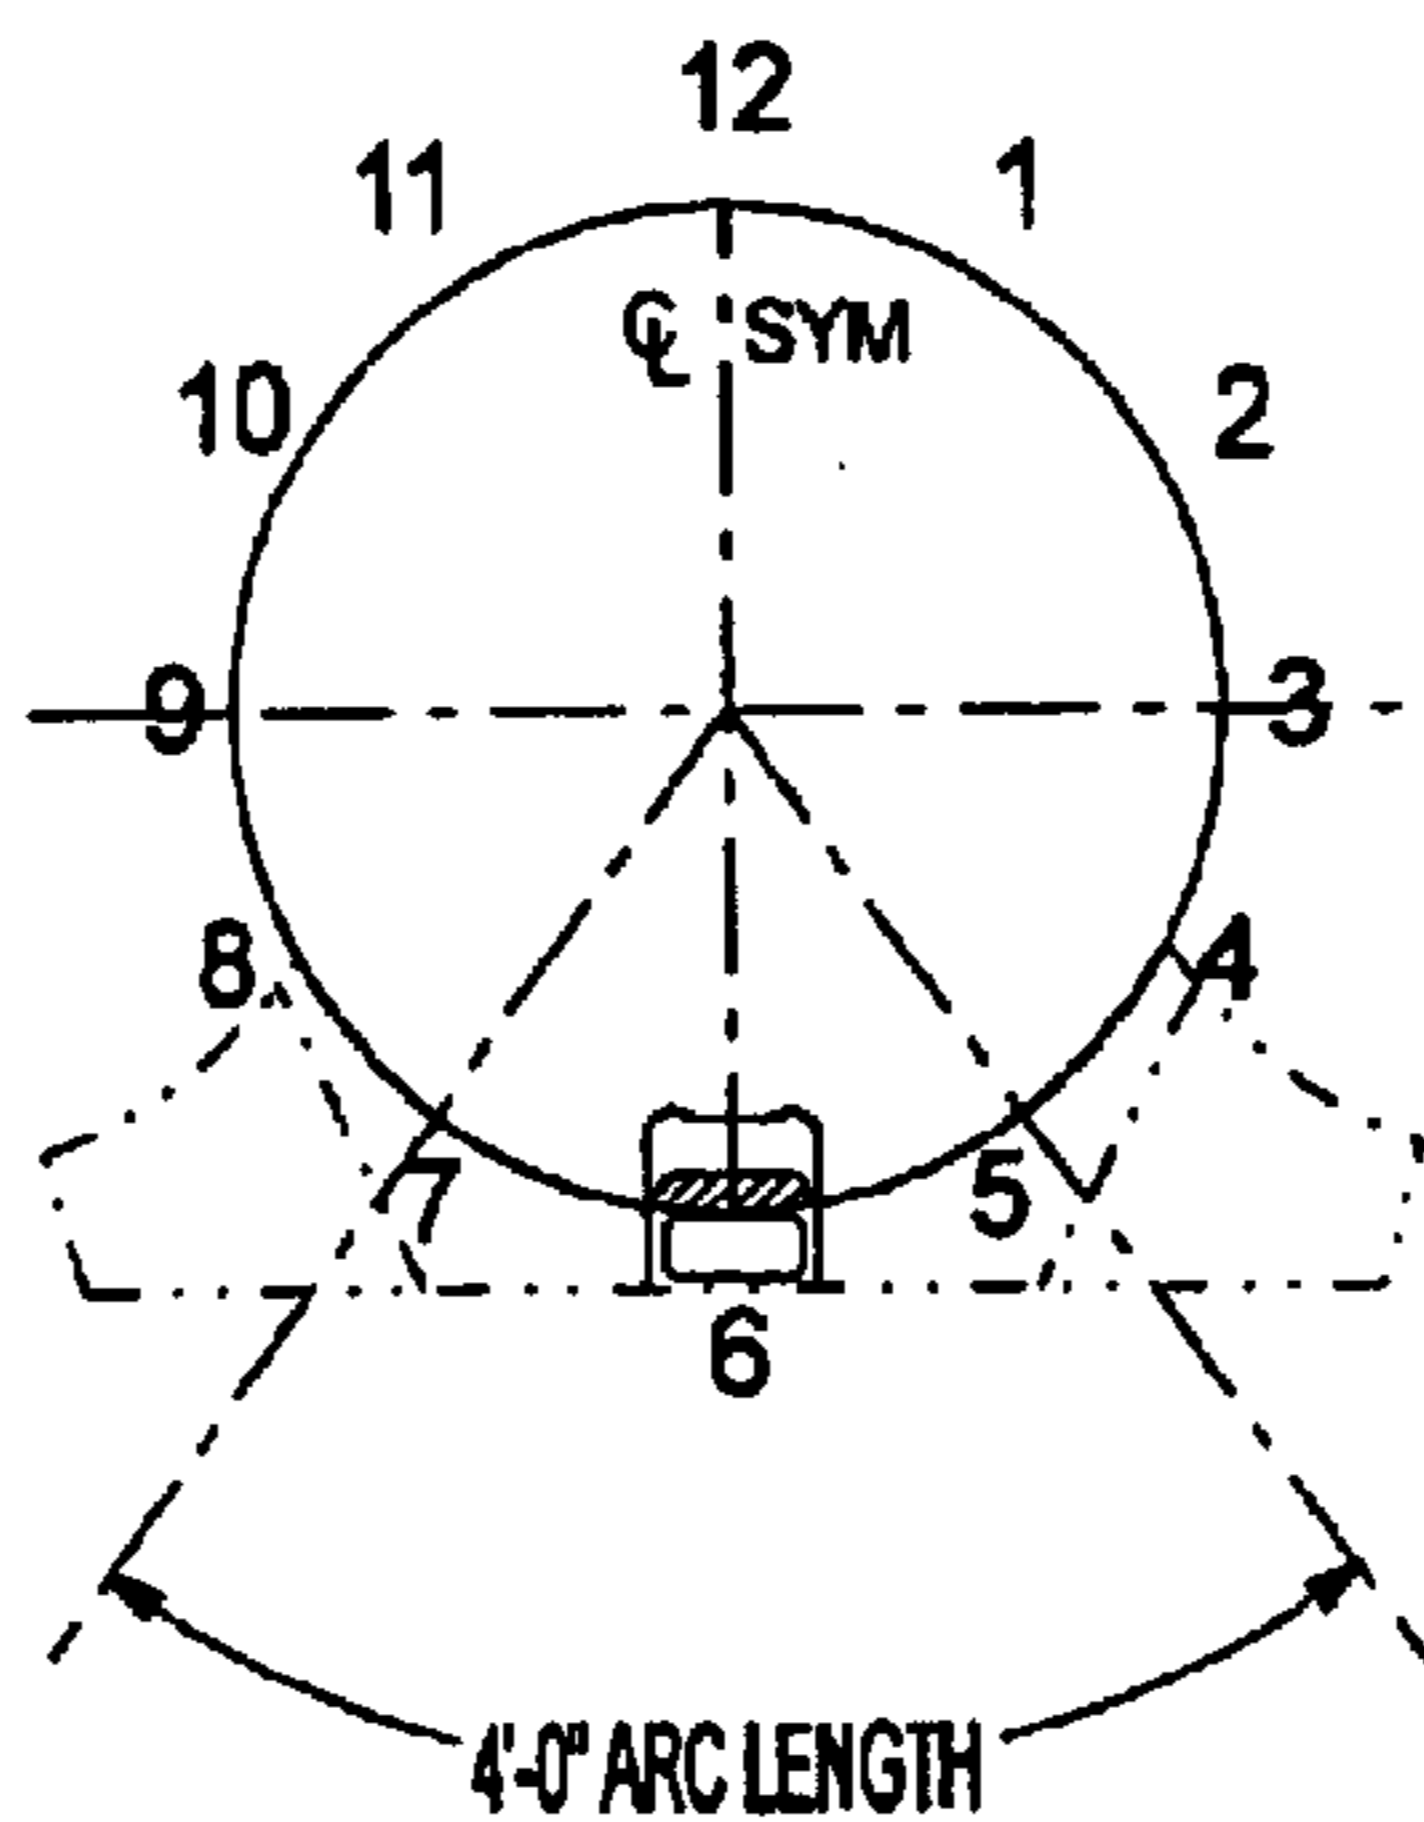
FIG. 14A

FIGS. 14A–14C show various views of tank car circumferential butt welds in accord with ultrasonic inspection.

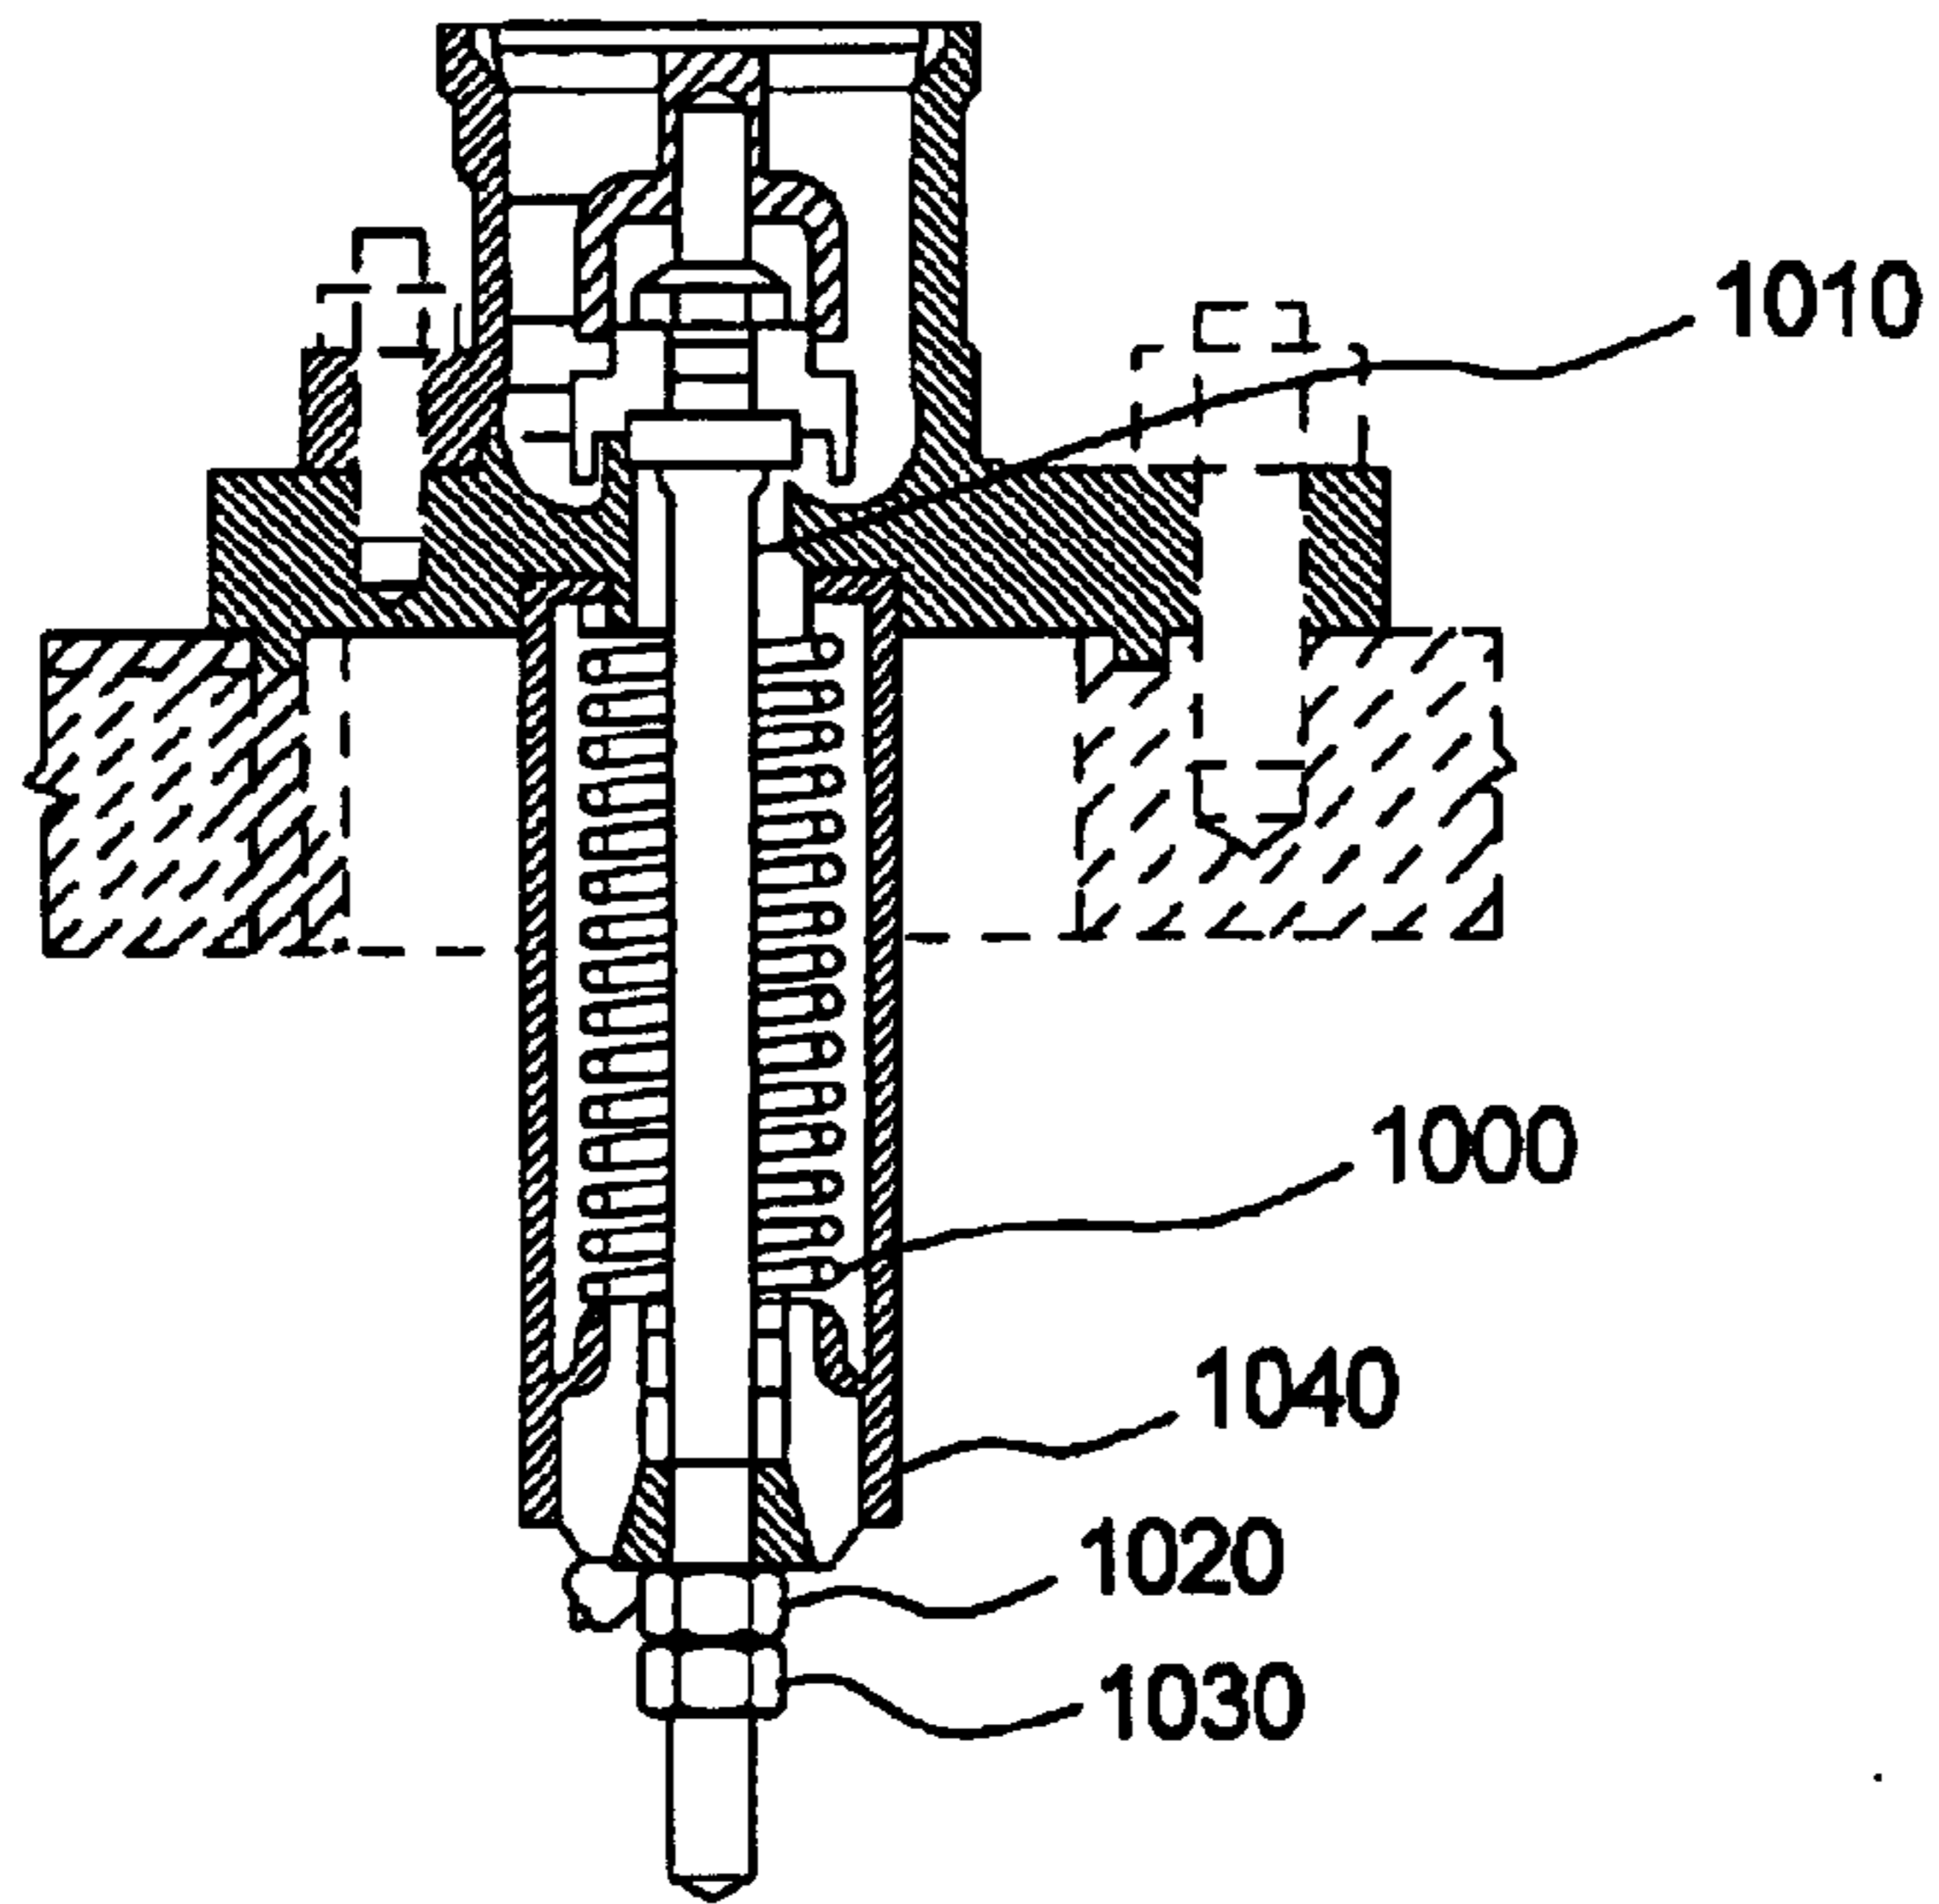
FIG. 15B

FIGS. 15B–15E show a variety of valves tested in accord with the invention.
