(54) **METHOD AND ARRANGEMENT FOR INSPECTION AND REQUALIFICATION OF VEHICLES USED FOR TRANSPORTING COMMODITIES AND/OR HAZARDOUS MATERIALS**

(73) Assignee: **General Electric Railcar Services Corporation**, Chicago, IL (US)

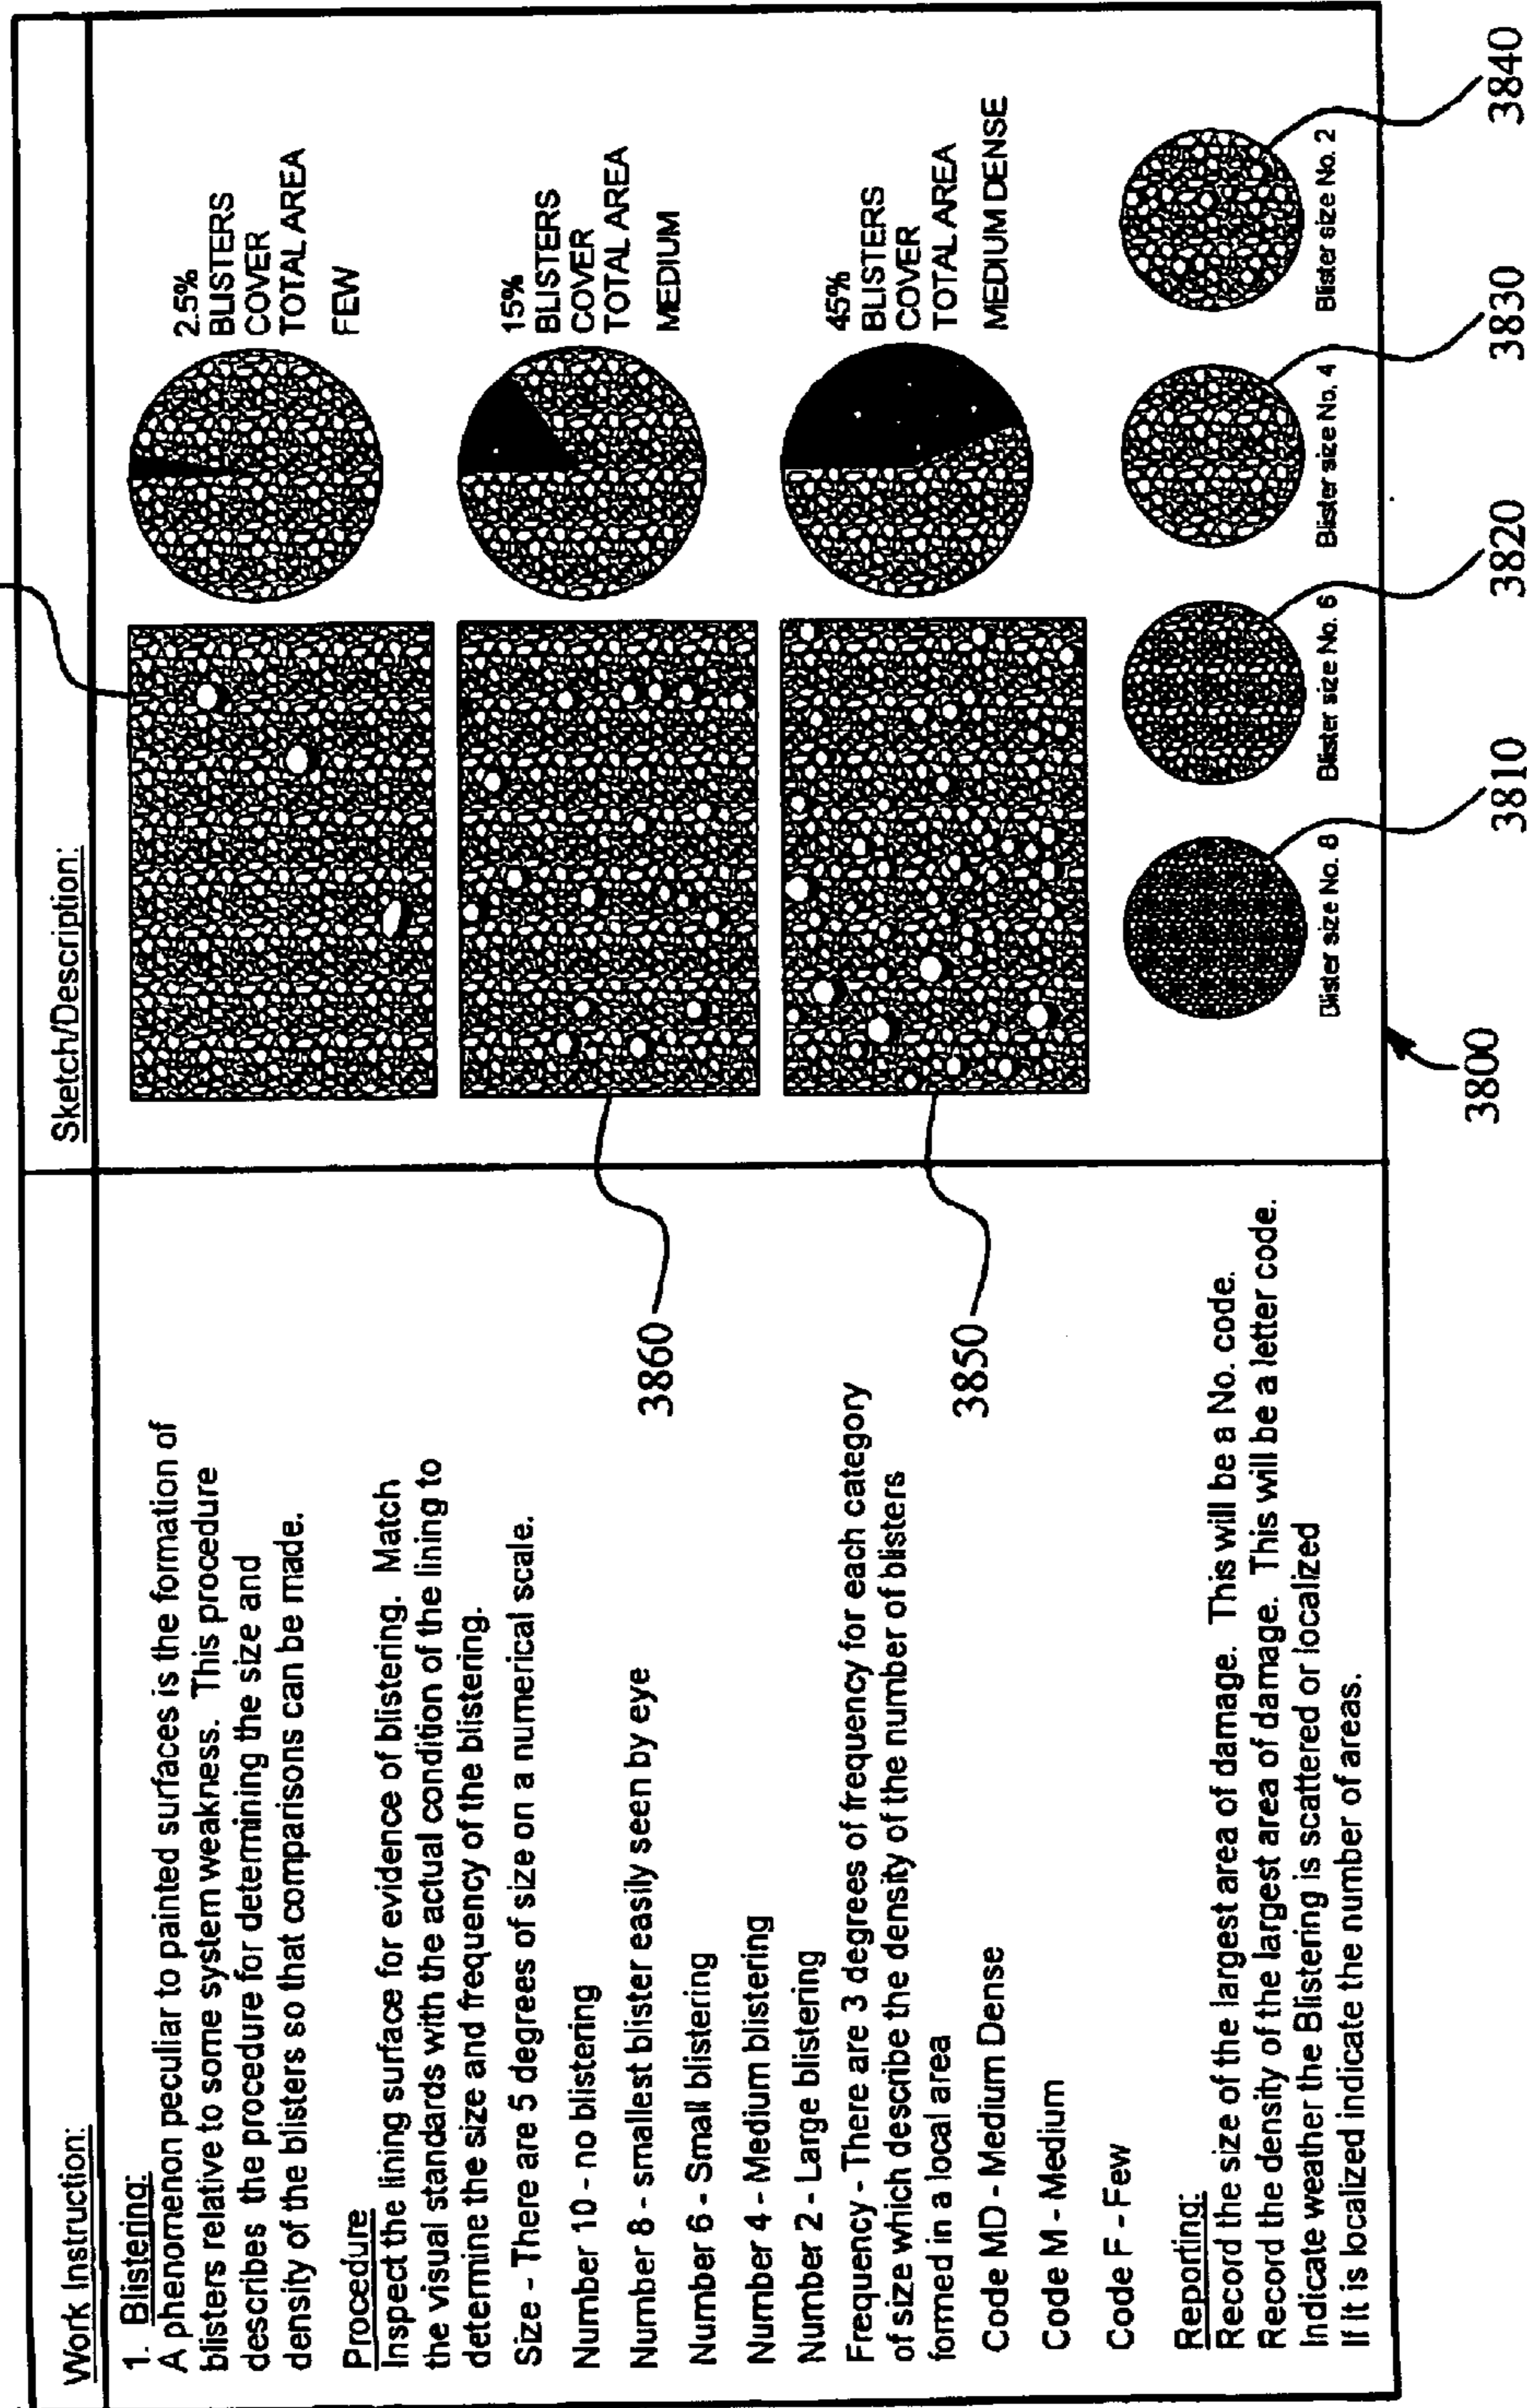
FIG. 20 shows models generated in accord with the invention for a blistering defect condition.

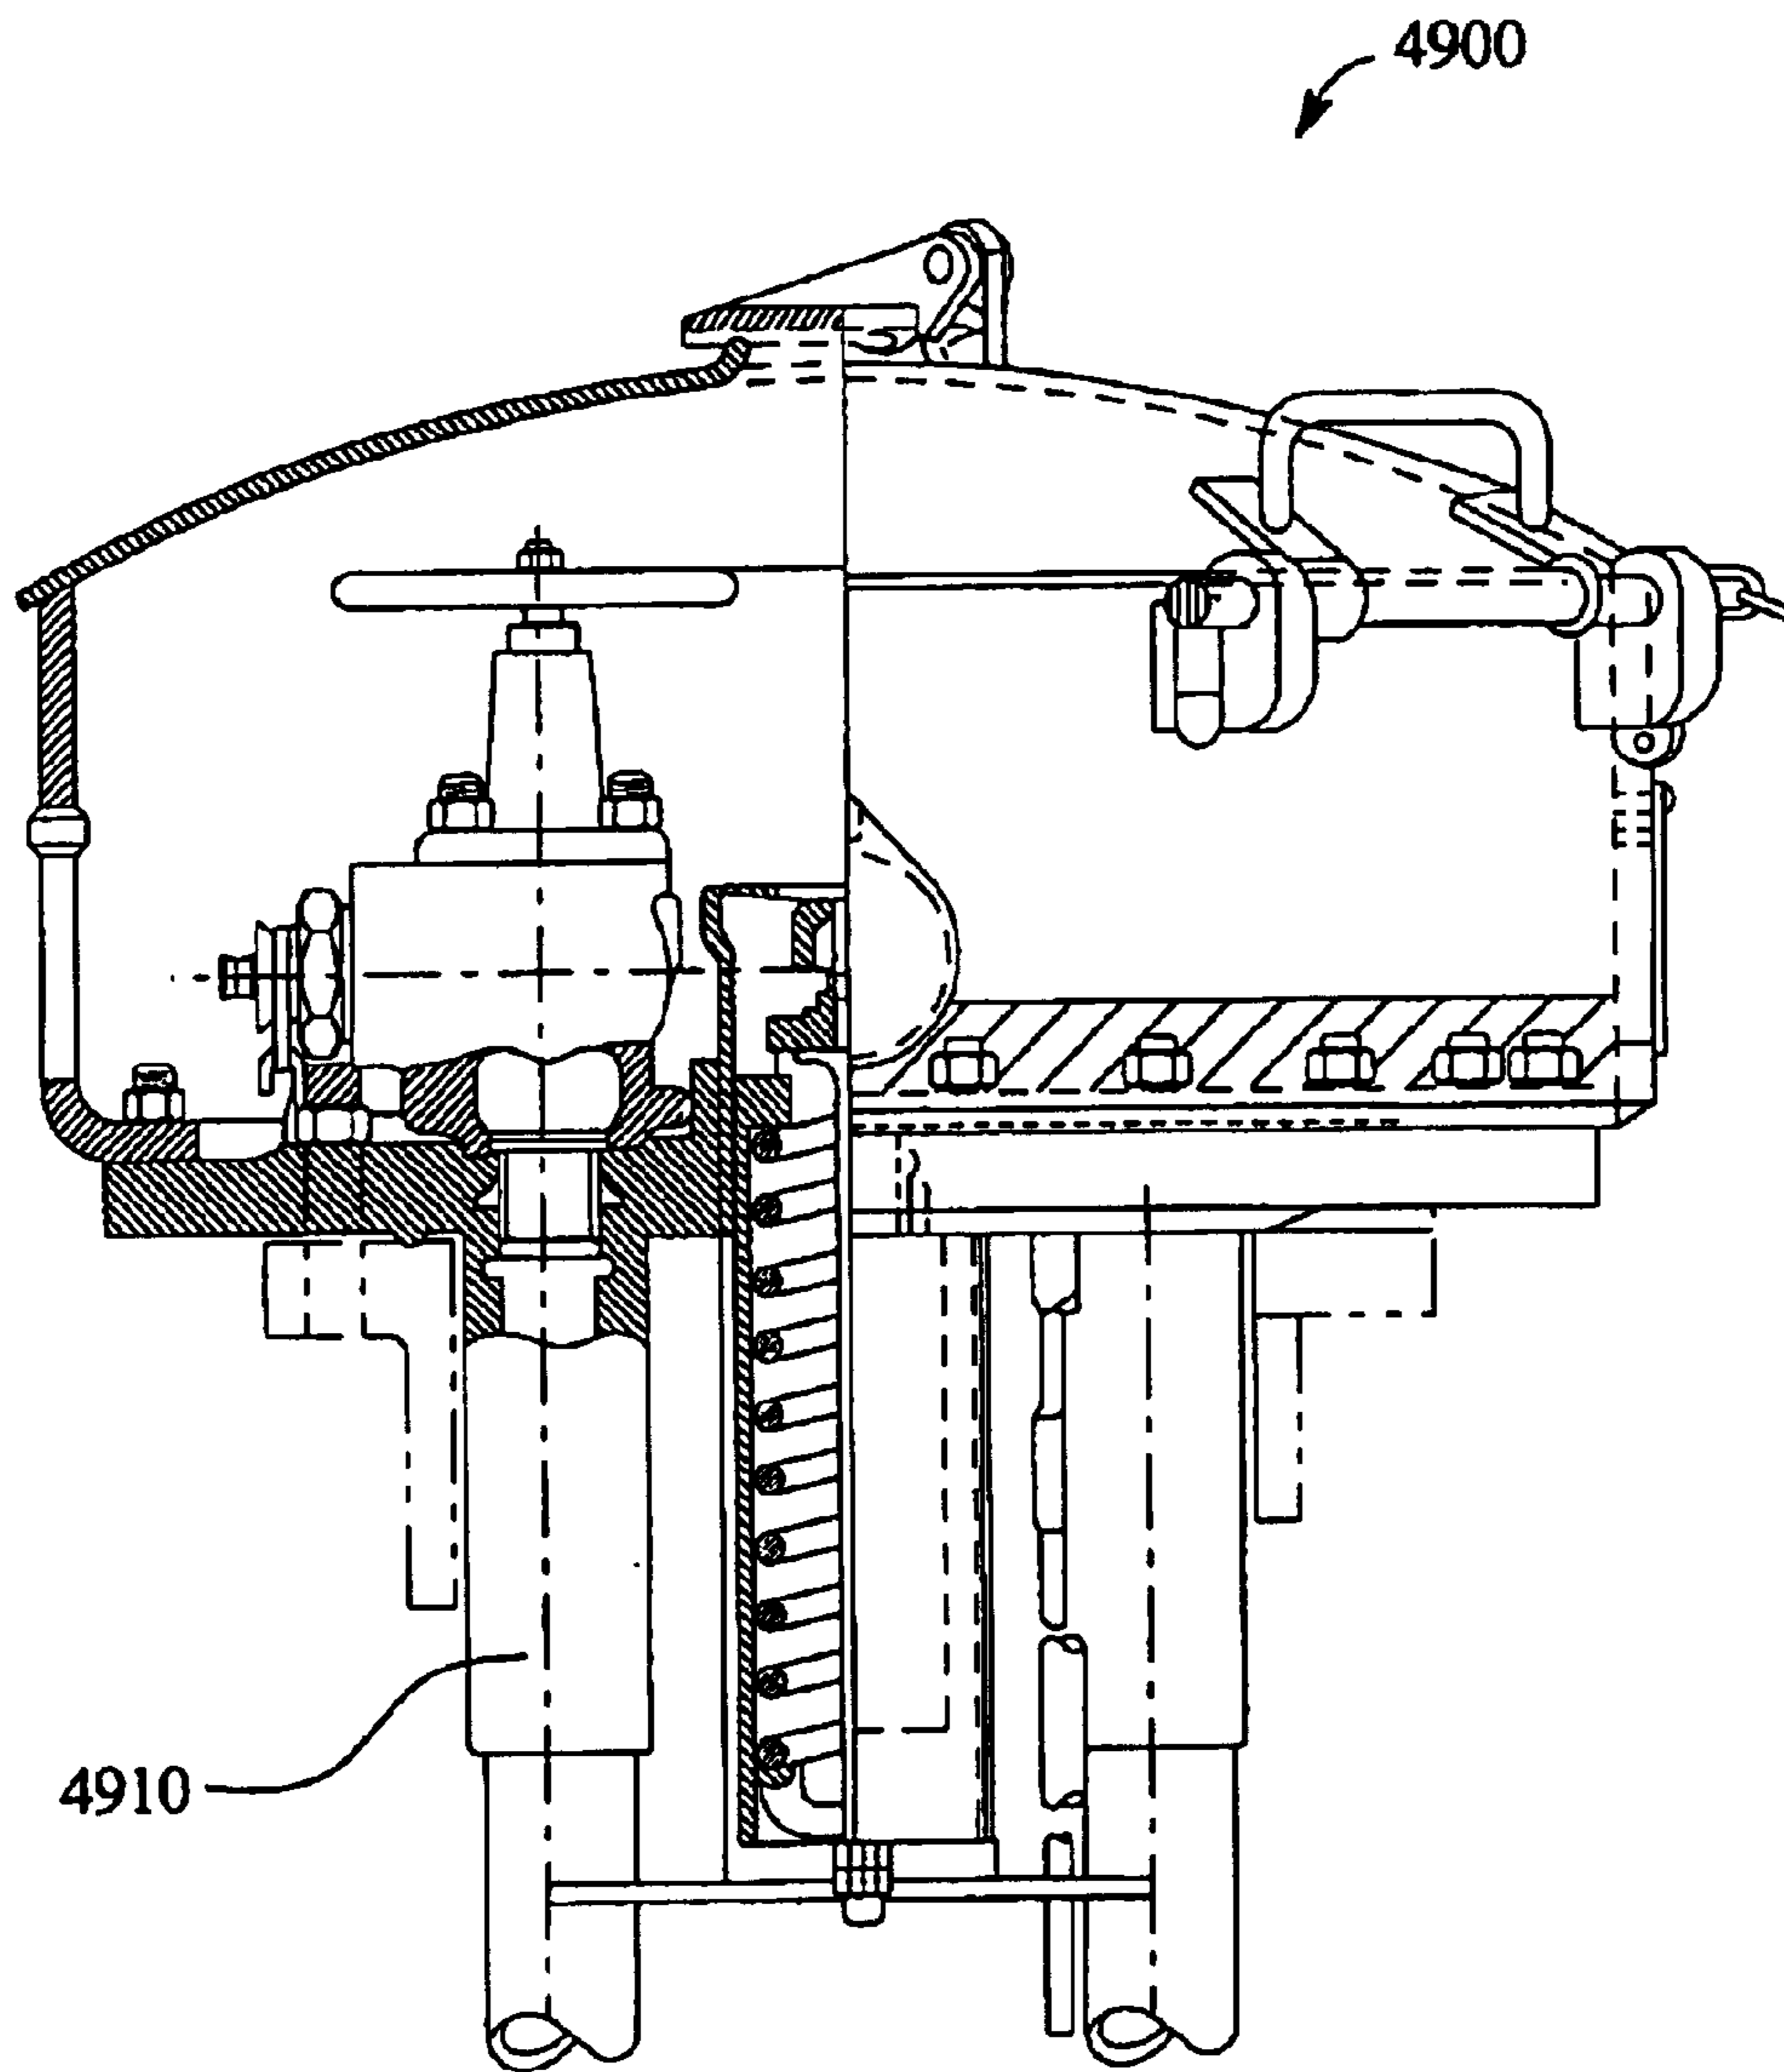
FIG. 23 depicts a typical protective housing arrangement.

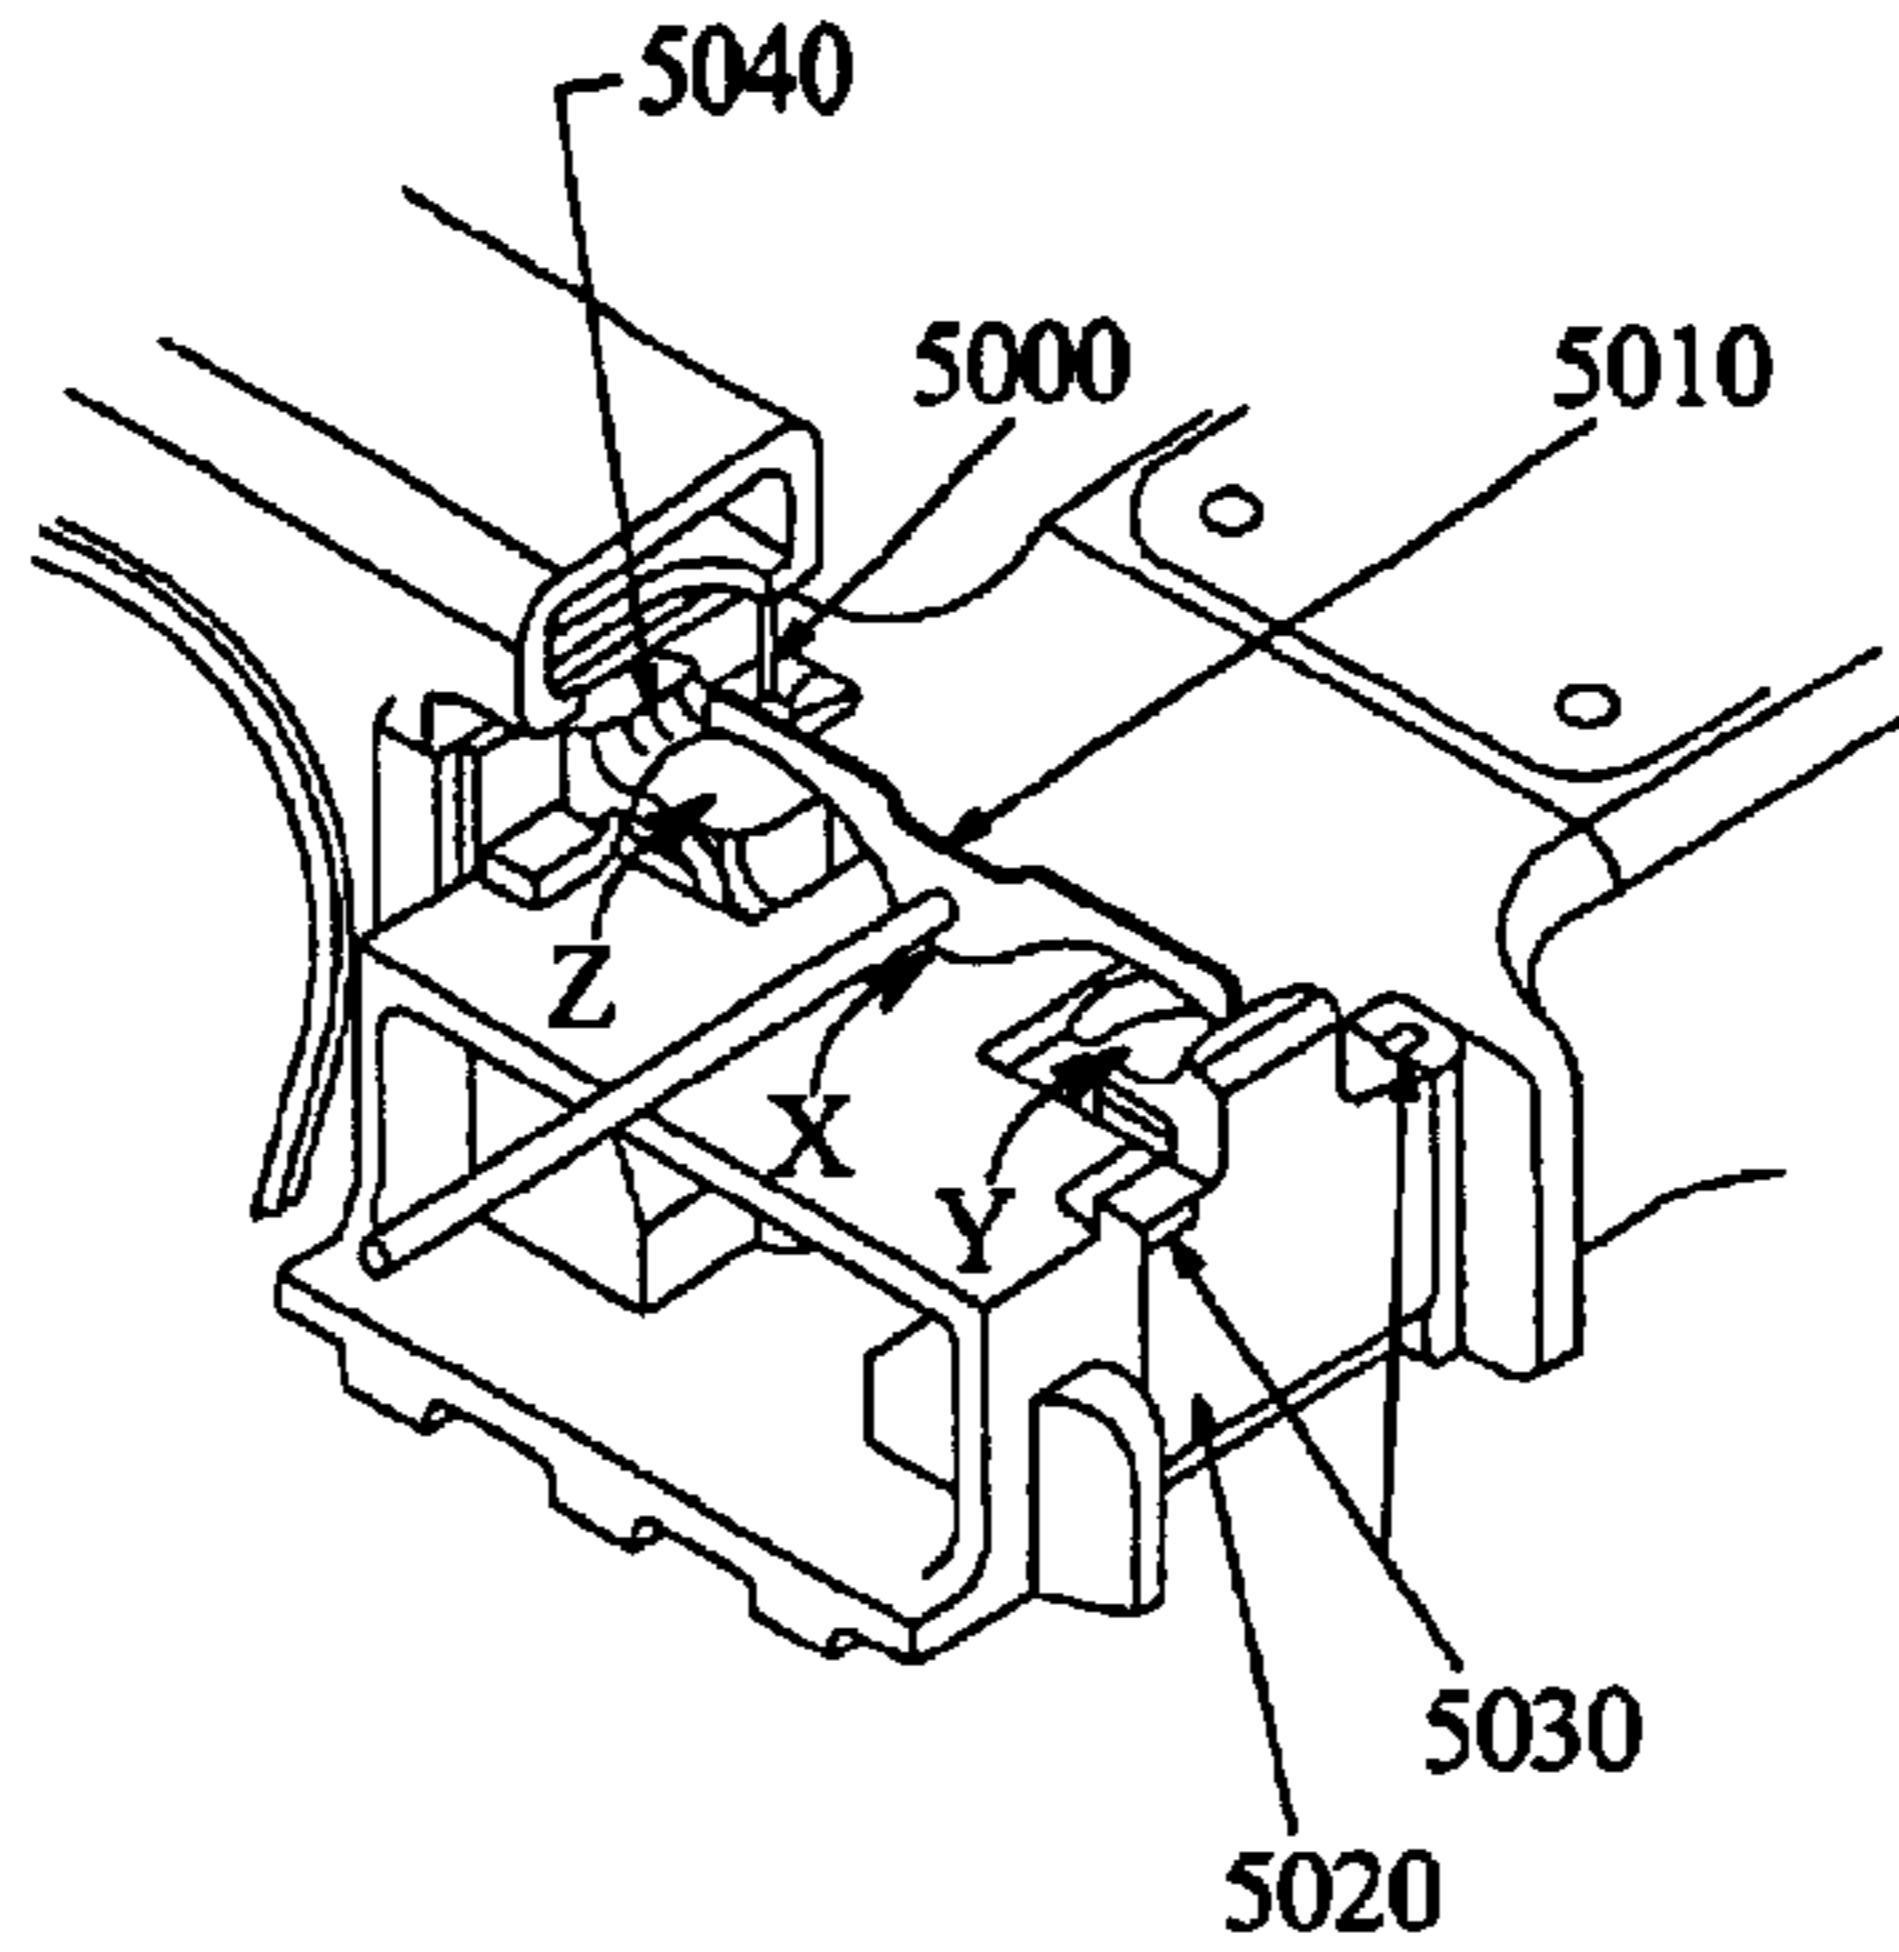
FIG. 24A

FIGS. 24a–h depict a visual truck inspection method.

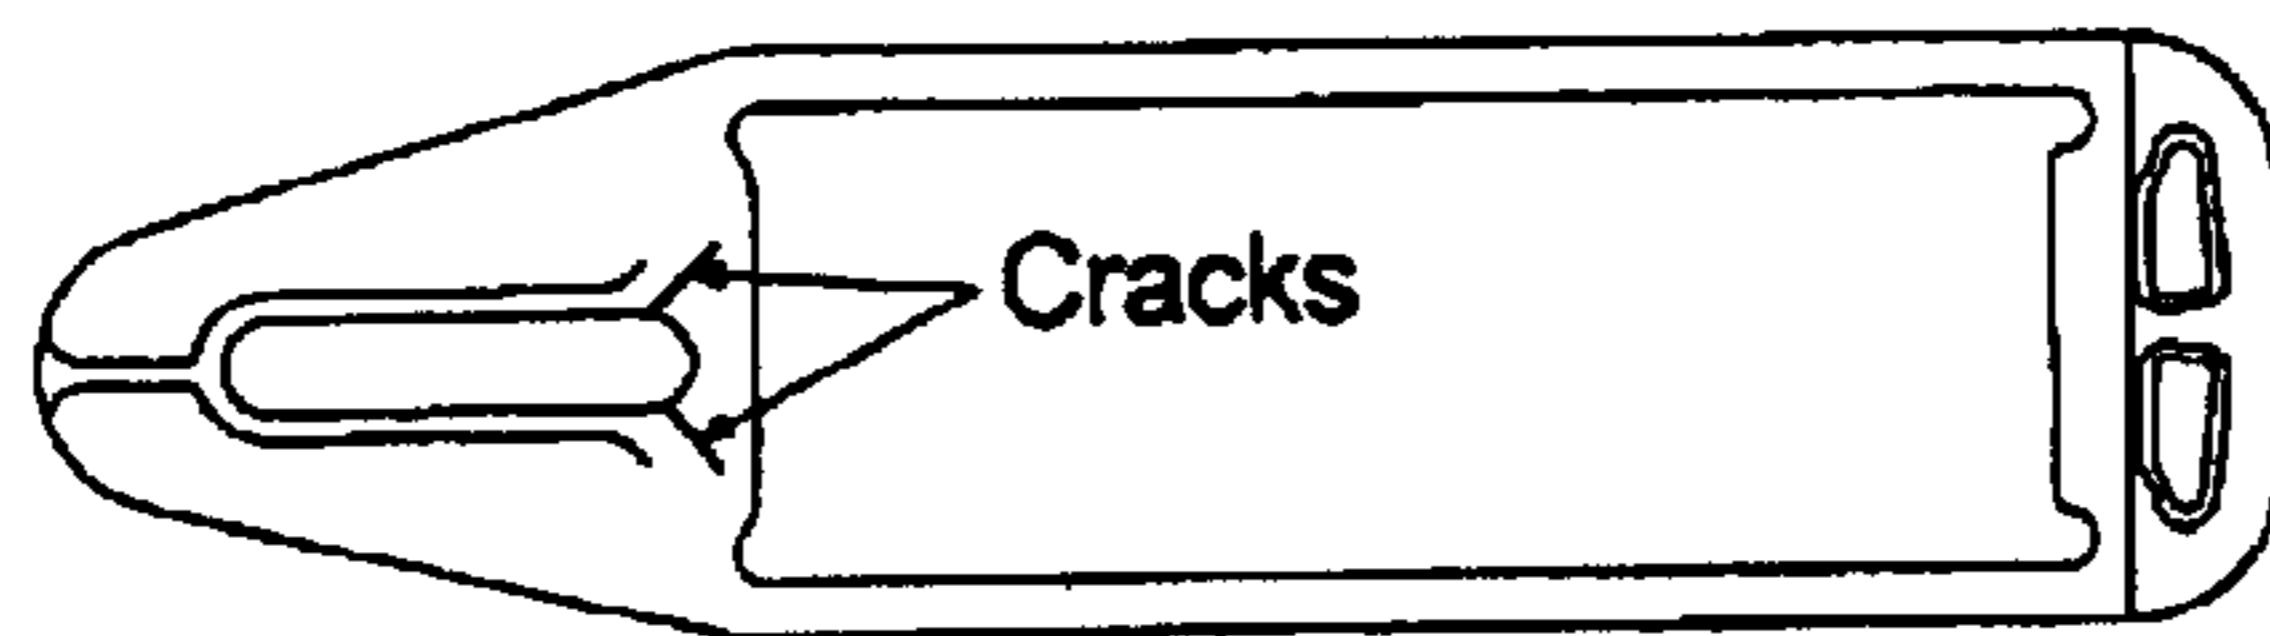
Y45, SY40, OR YS93 DESIGN YOKES

FOR USE WITH TYPE E COUPLER

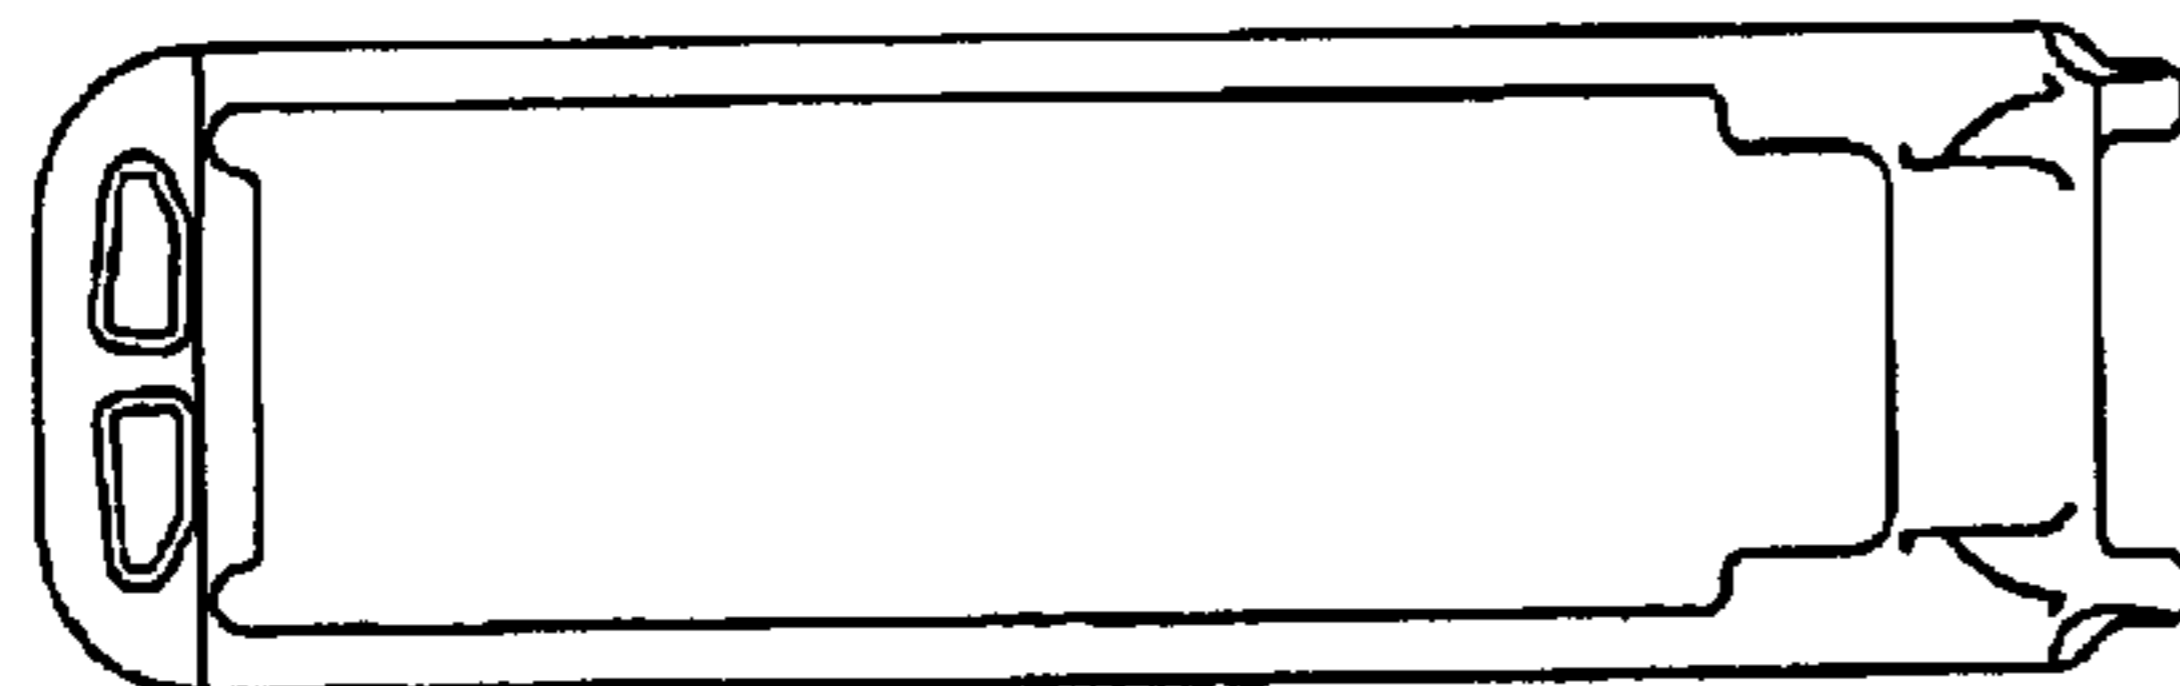
Y41 DESIGN YOKES

FOR USE WITH TYPE E COUPLER

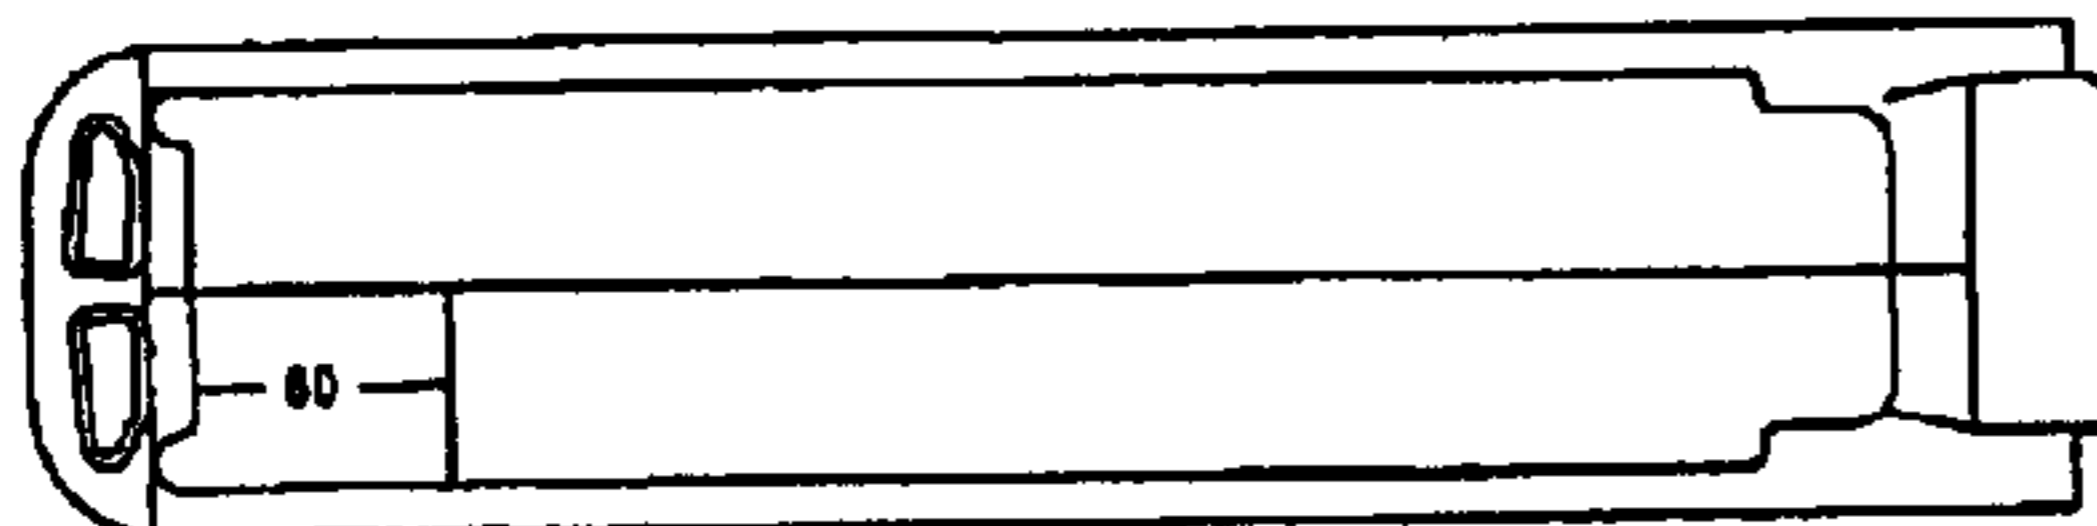
Y45 DESIGN YOKES

FOR USE WITH TYPE E/F AND F COUPLERS

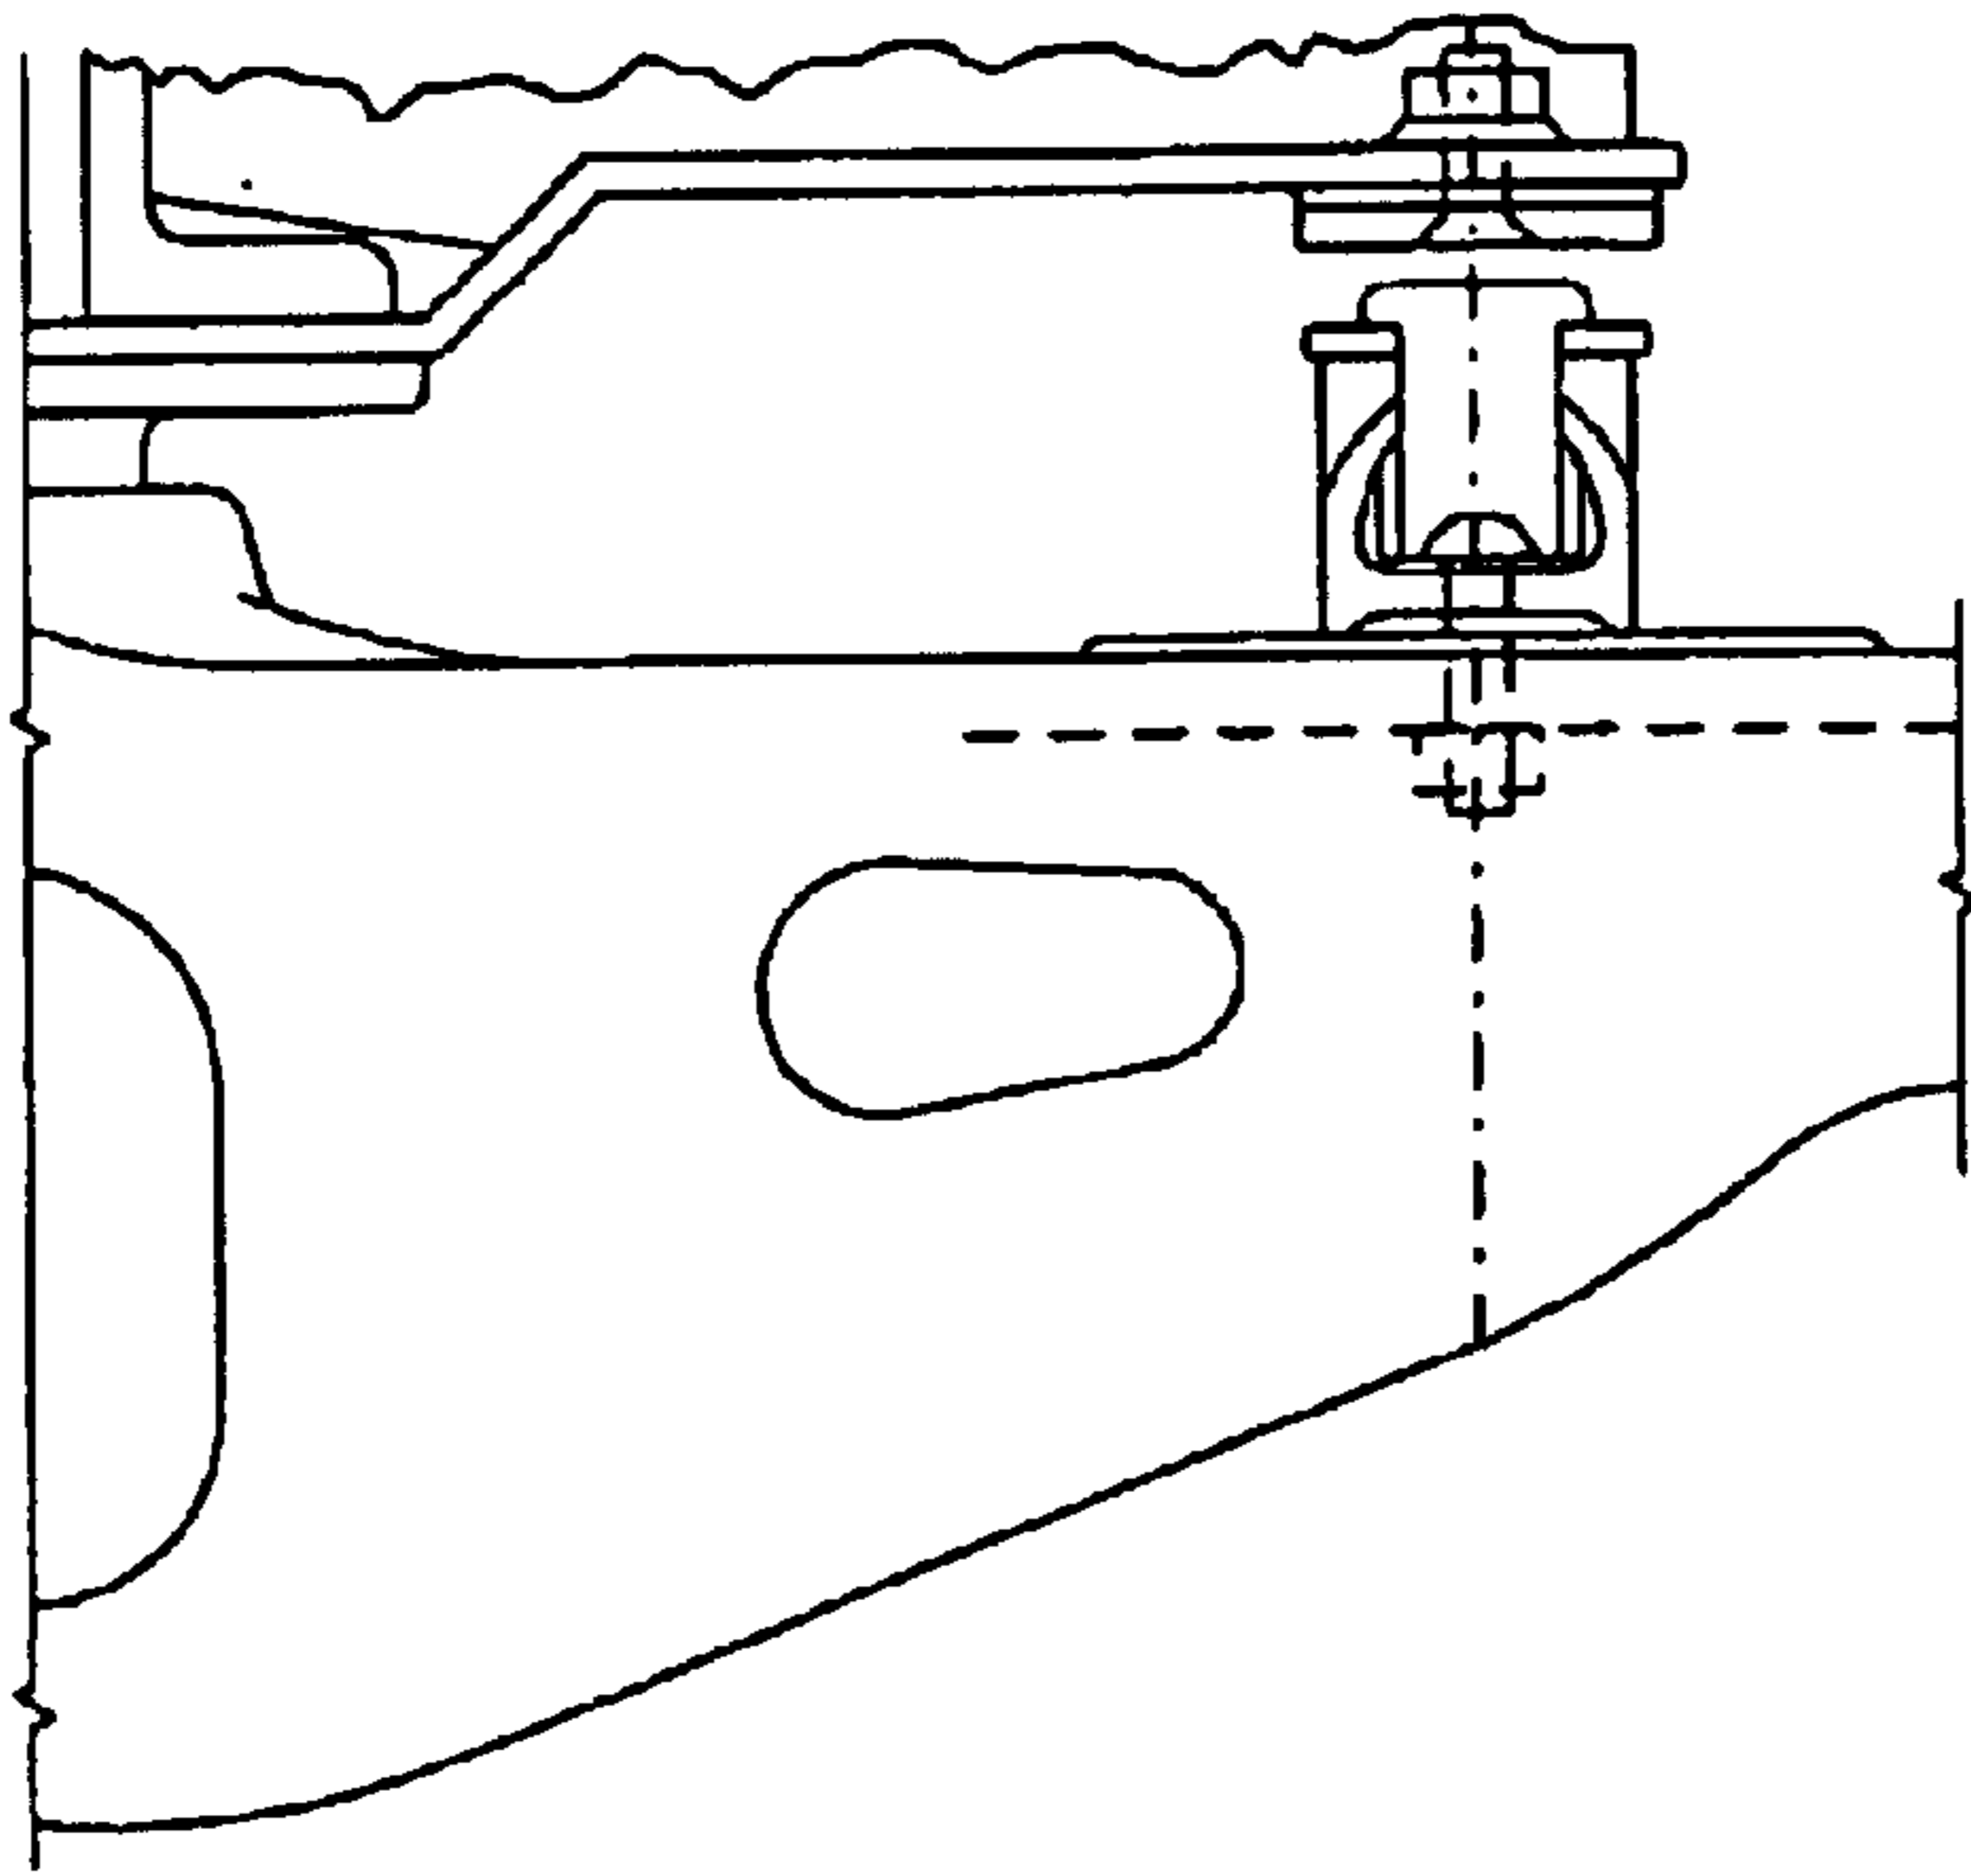
FIG. 26a

FIGS. 26a–b illustrate a body center plate and side bearing visual inspection method.
