(54) **TURBINE NOZZLE SEGMENT AND METHOD OF REPAIRING SAME**

TURBINE NOZZLE SEGMENT AND METHOD OF REPAIRING SAME

This invention relates generally to gas turbine engines and more particularly to the repair of turbine nozzle segments used in such engines.

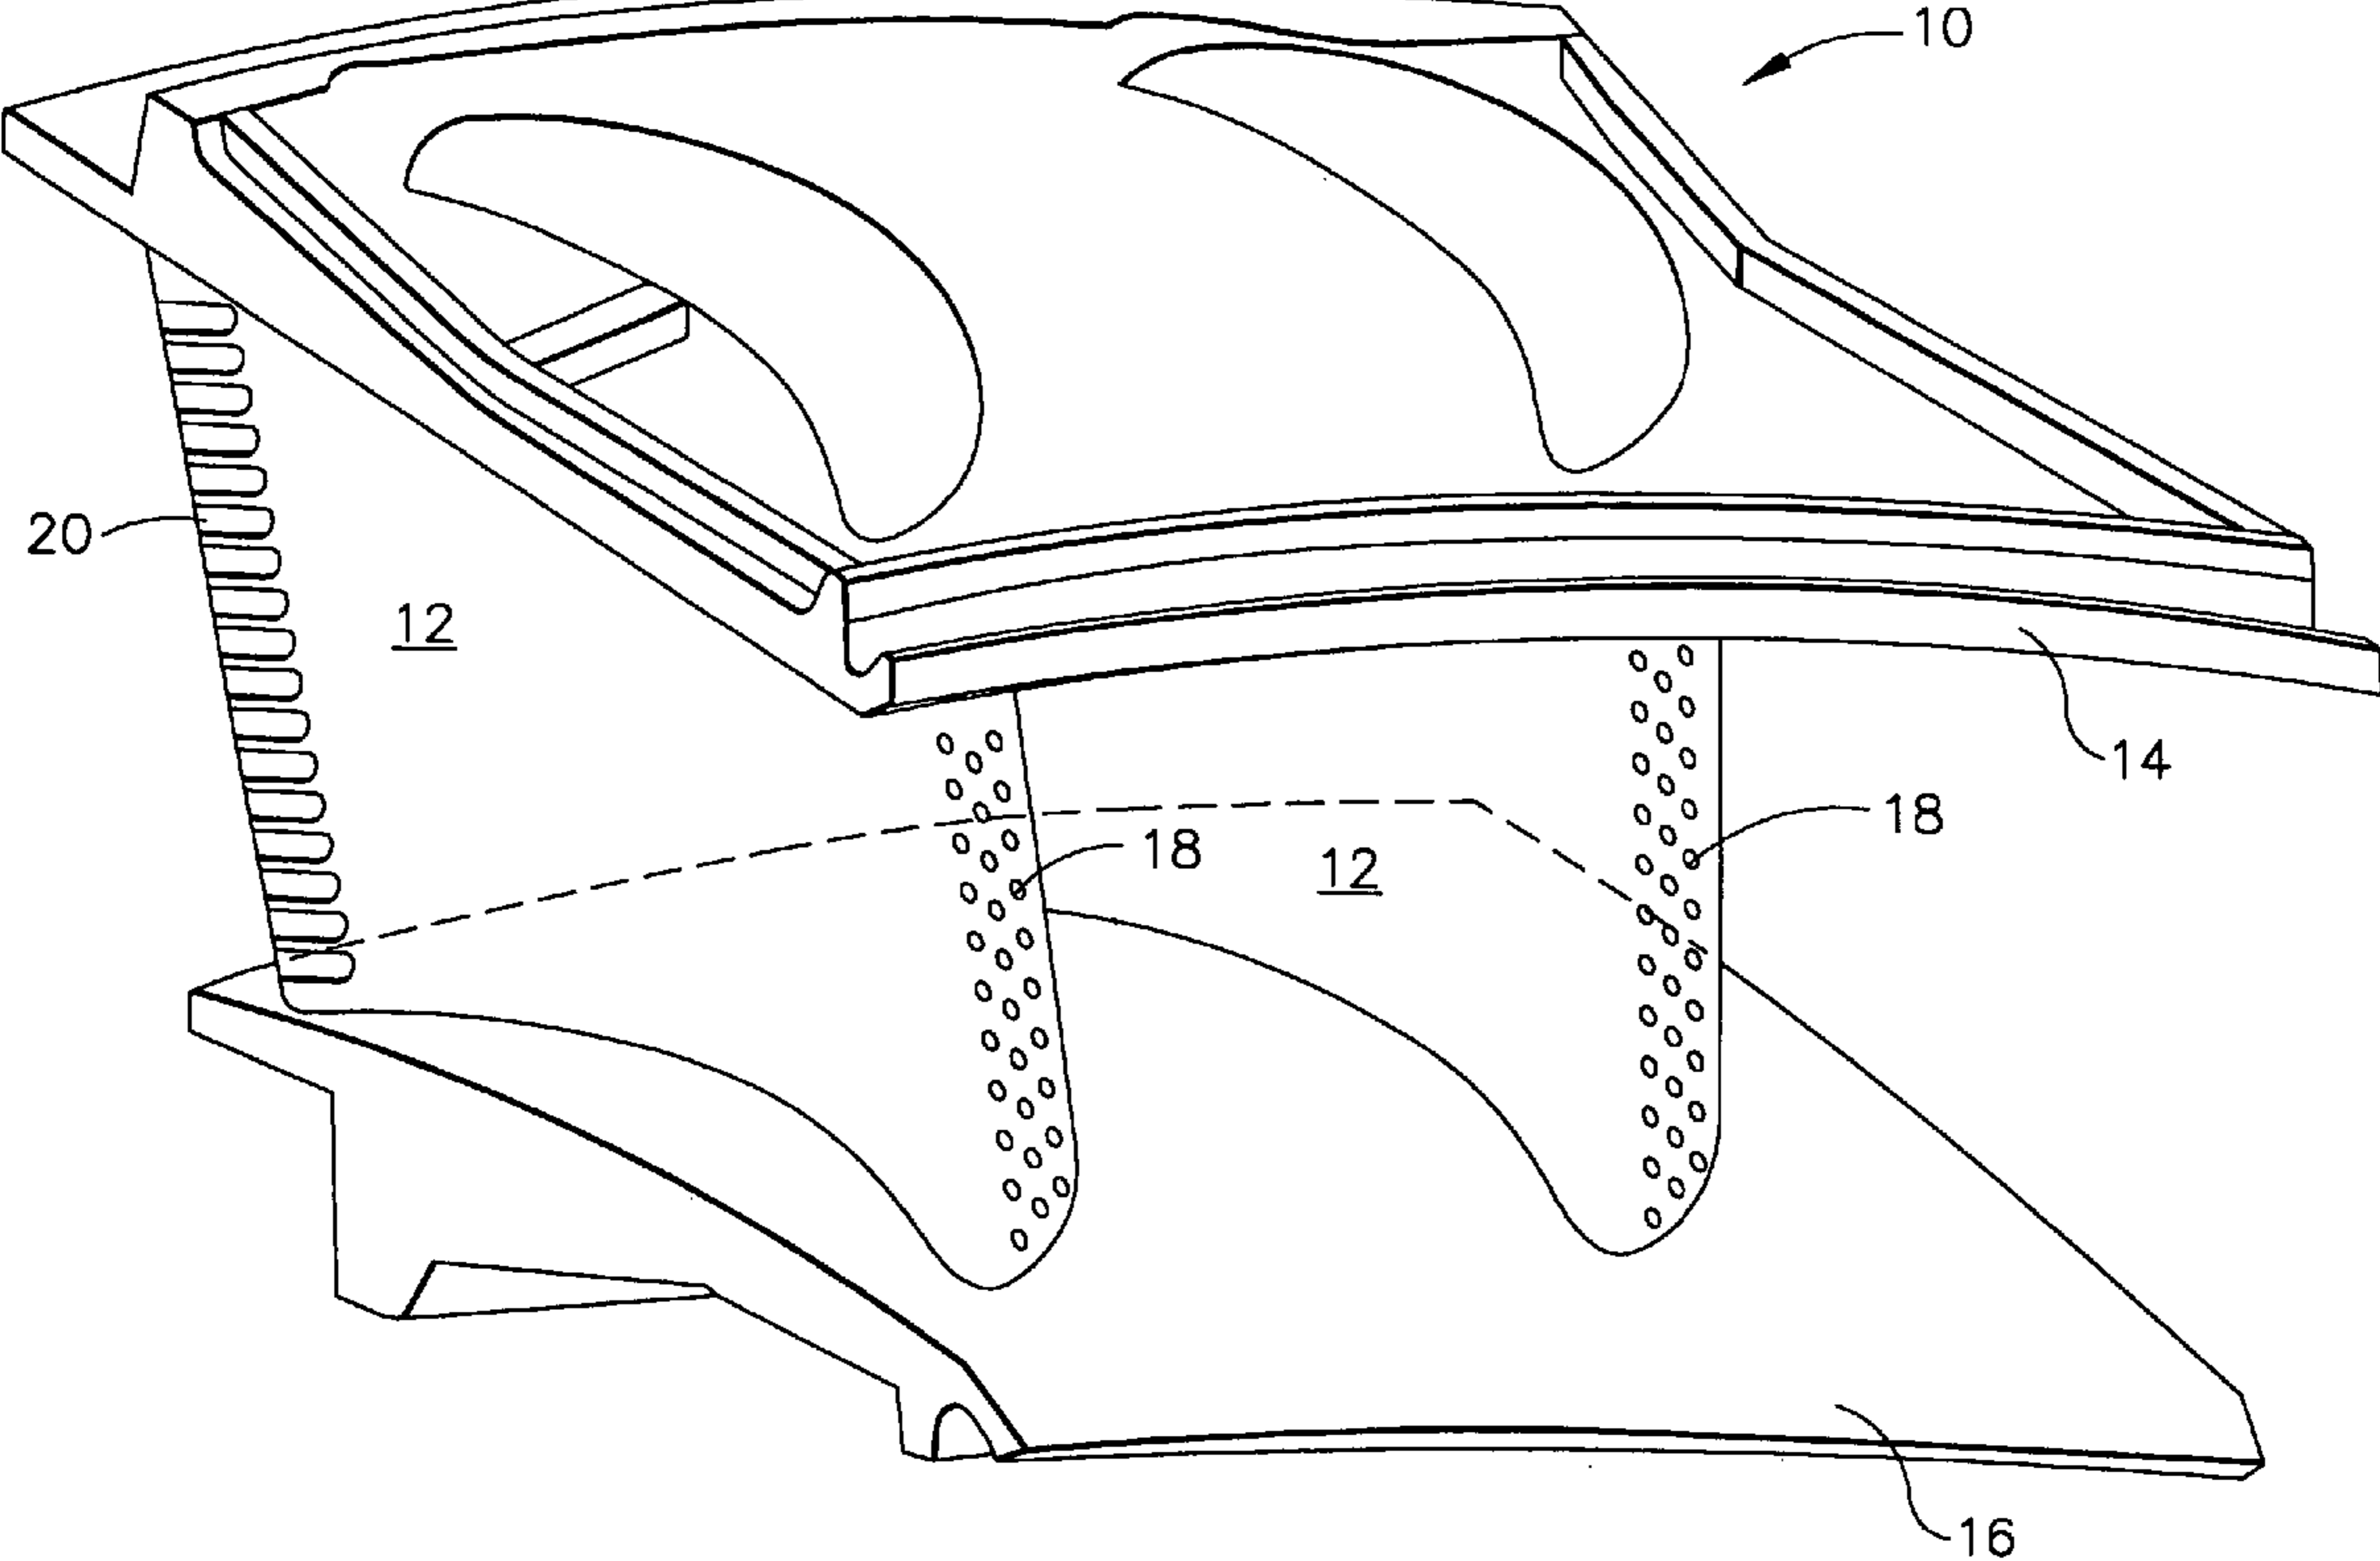
FIG. 1 is a perspective view of a gas turbine engine run turbine nozzle segment;

Referring to the drawings wherein identical reference numerals denote the same elements throughout the various views, FIG. 1 shows a turbine nozzle segment **10** having first and second nozzle vanes **12**. The vanes **12** are disposed between an arcuate outer band **14** and an arcuate inner band

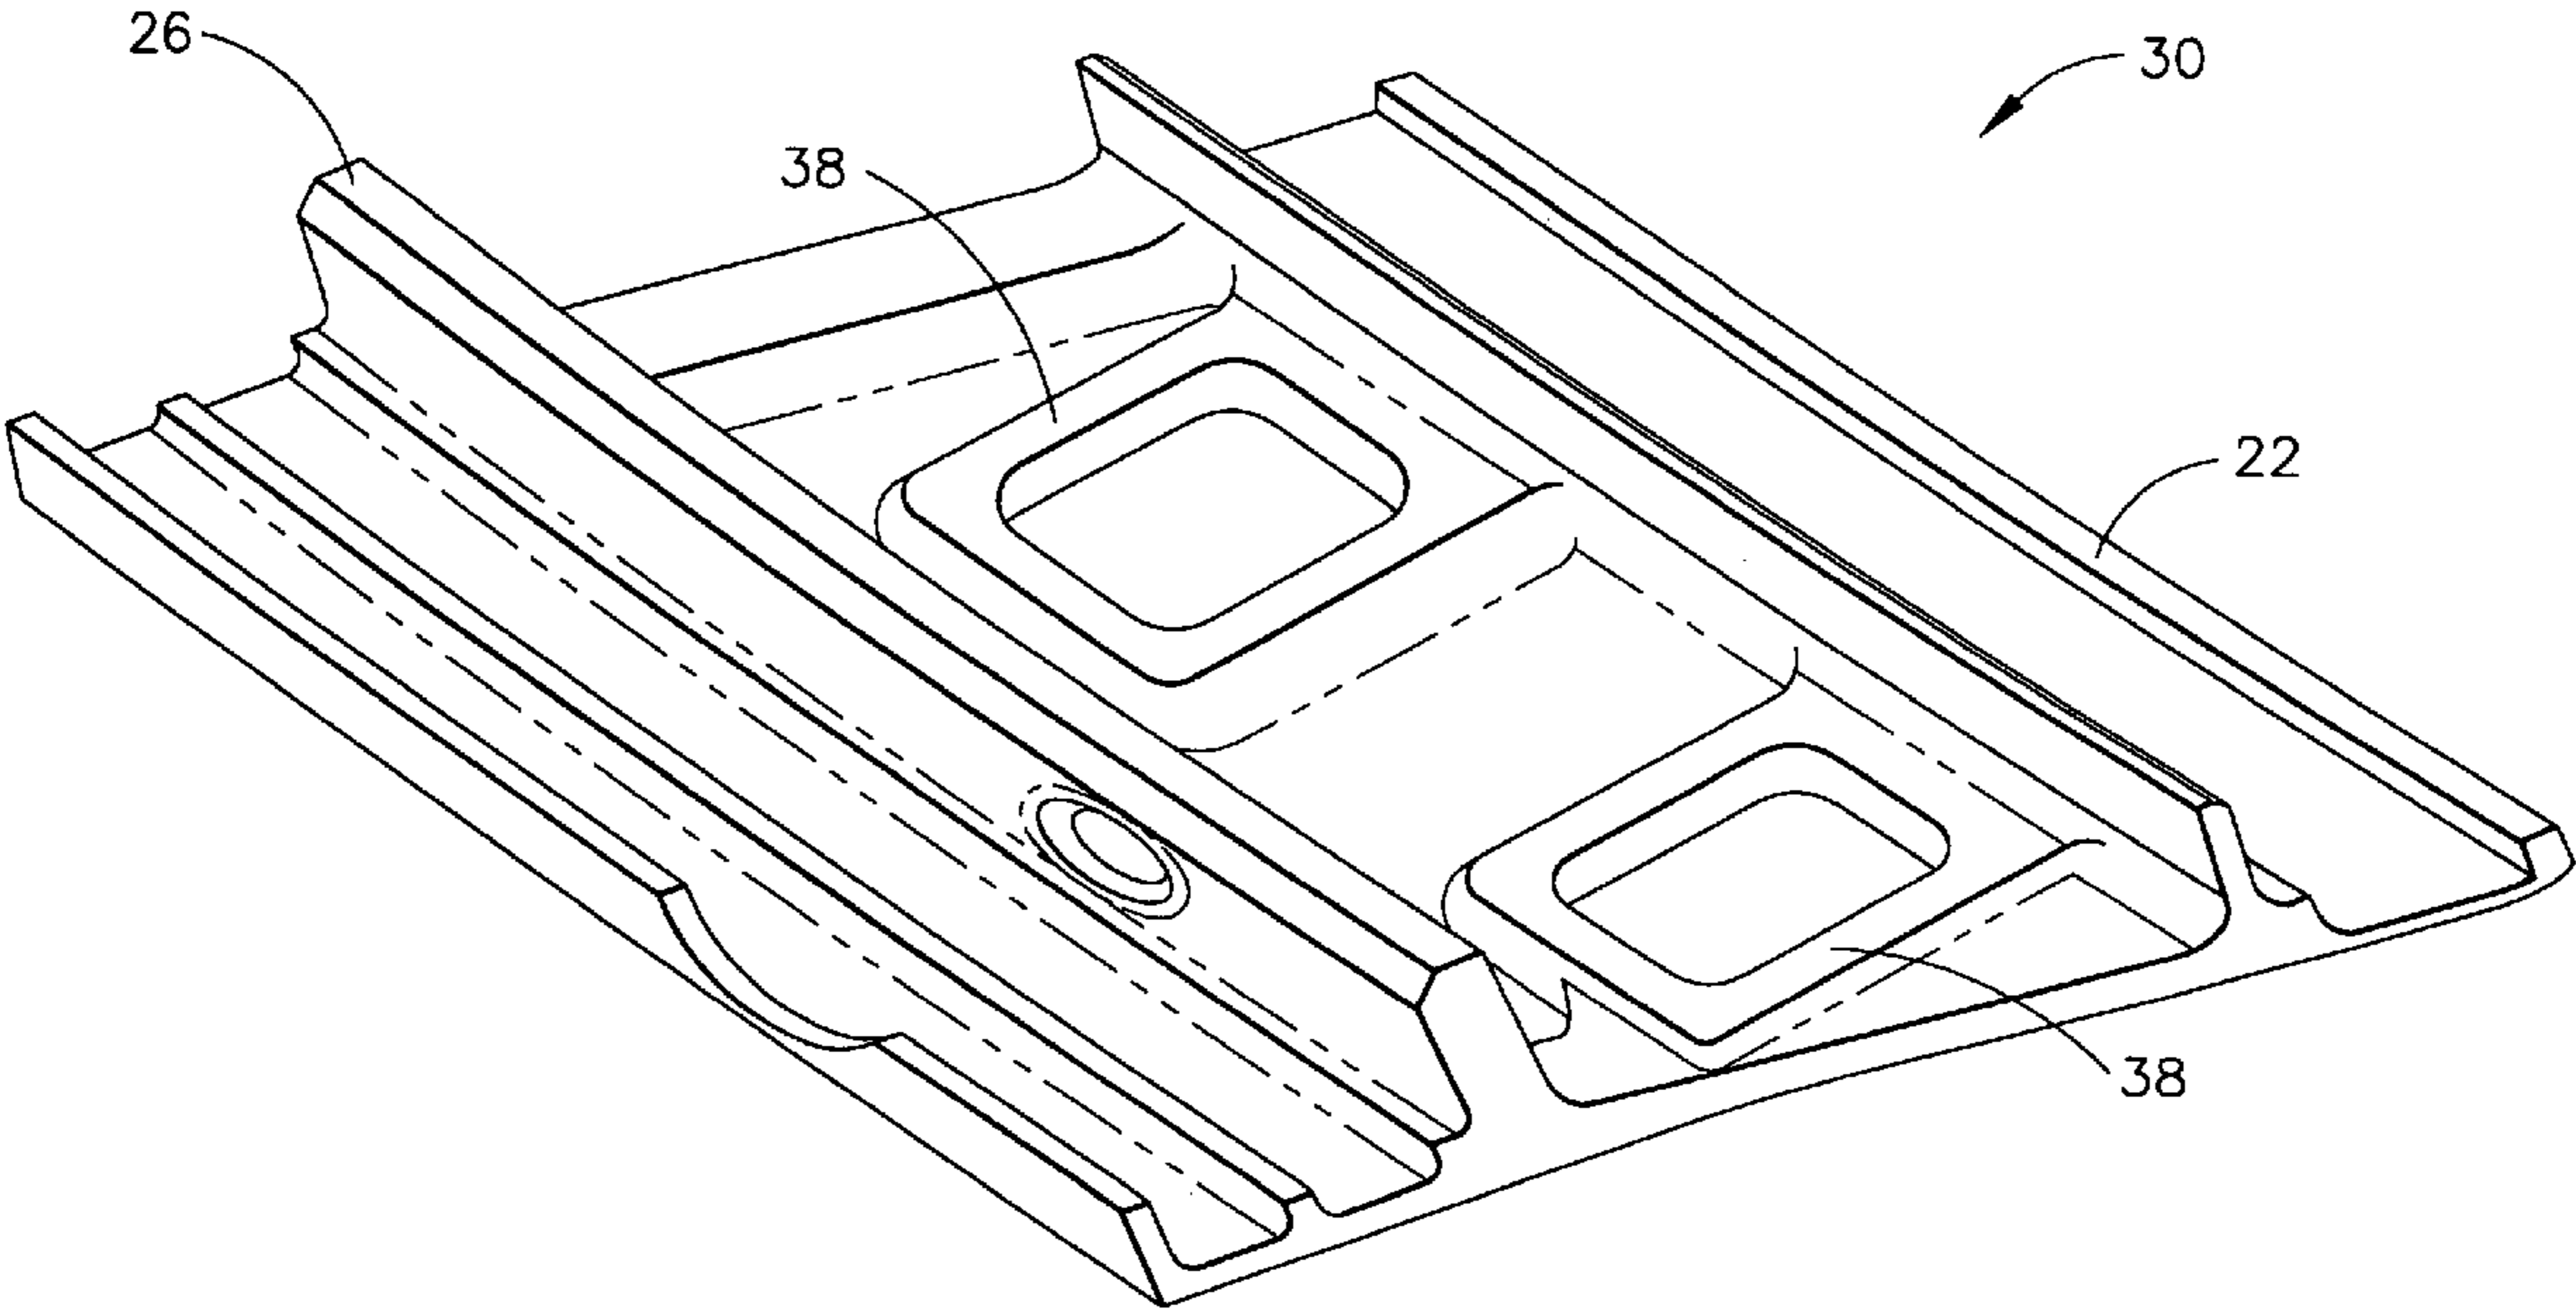
FIG. 2 is a bottom perspective view of a replacement inner band segment used in the repair method of the present invention;

The repair method includes the principal steps of separating the inner band 16 from the nozzle segment 10, and then joining a specially designed, newly manufactured replacement inner band segment to the structure from which the inner band 16 was removed. FIGS. 2 and 3 show different views of one of the newly manufactured replacement inner band segments at 30. In the illustrated example the replacement inner band segment 30 is an integrally cast piece having a cold side 22 (the side facing away from the hot gas flowpath) and a hot side 24 (the side facing the hot gas flowpath), and includes conventional structure such as support flanges 26. The support flange 26 provides structural support to the inner band 16 and also provides a mounting function when the nozzle segment 10 is installed in an engine.

As shown in FIG. 2, at least one reinforcement feature referred to as a collar 38 is integrally formed on the cold side 22 of the replacement inner band segment 30. The collar 38 is a solid, upraised block which strengthens the replacement inner band segment 30 between the structural supports. It may be a continuous lateral member or it may be divided into two or more upraised portions as illustrated. Two recessed pockets 40, best seen in FIG. 3, are formed in the hot side 24 of the replacement inner band segment 30. The perimeter of the pockets 40 approximates the airfoil contour of the vanes 12. The recesses 40 are integrally formed as part of the replacement inner band segment 30 or can be gener-

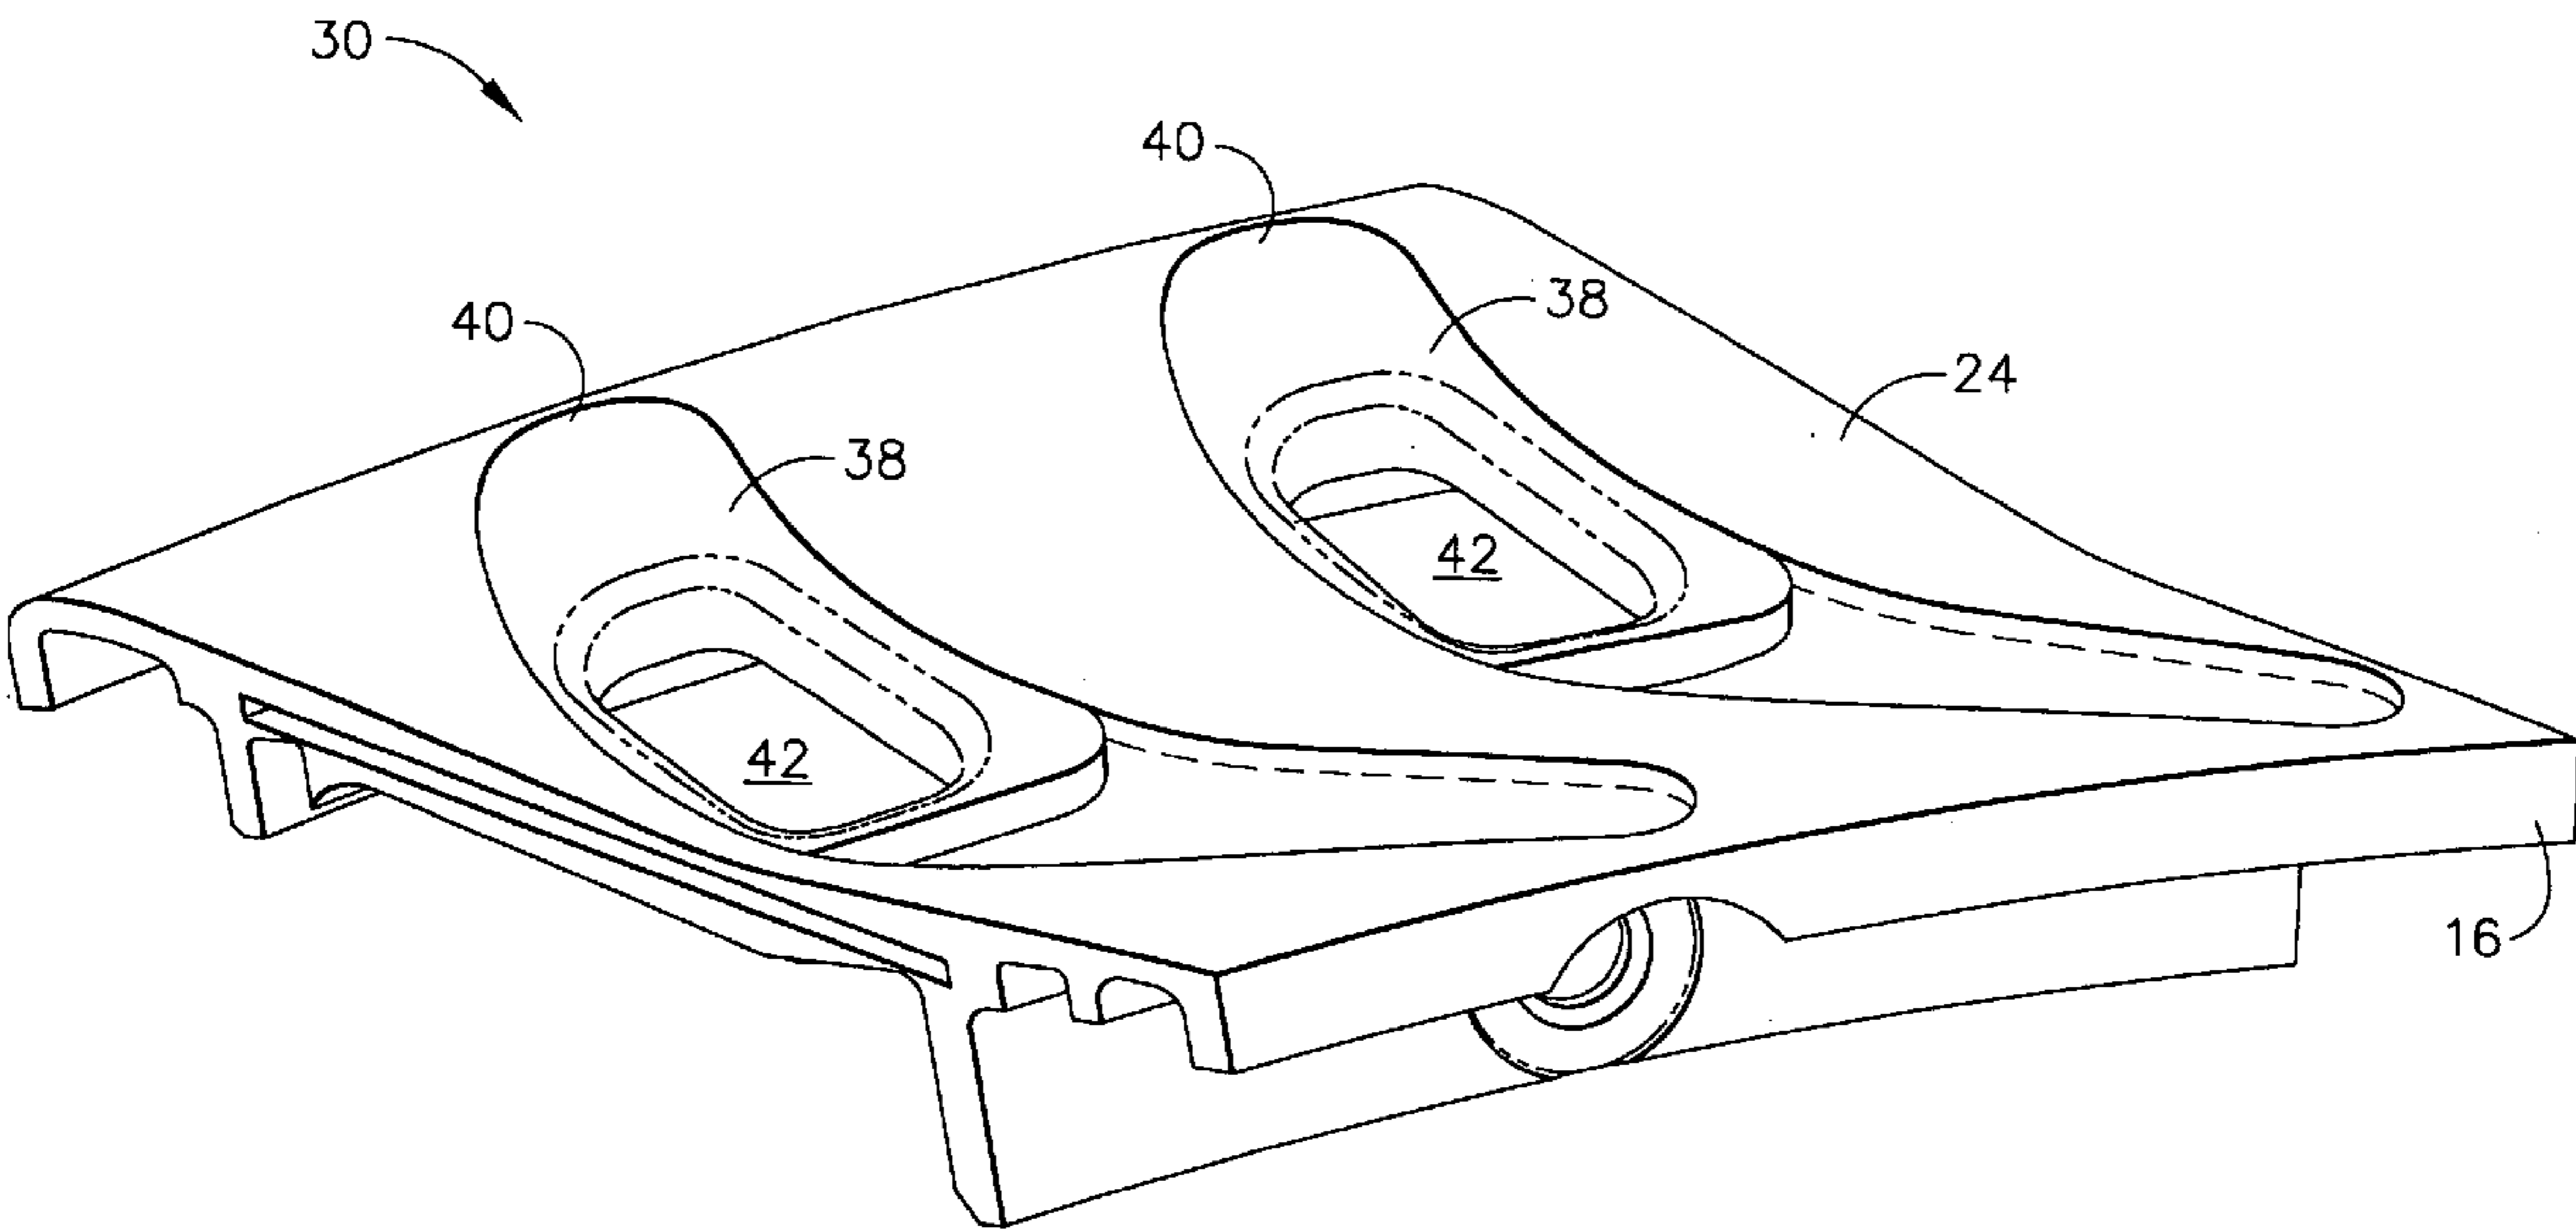
FIG. 3 is a top perspective view of the replacement inner band segment of FIG. 2;

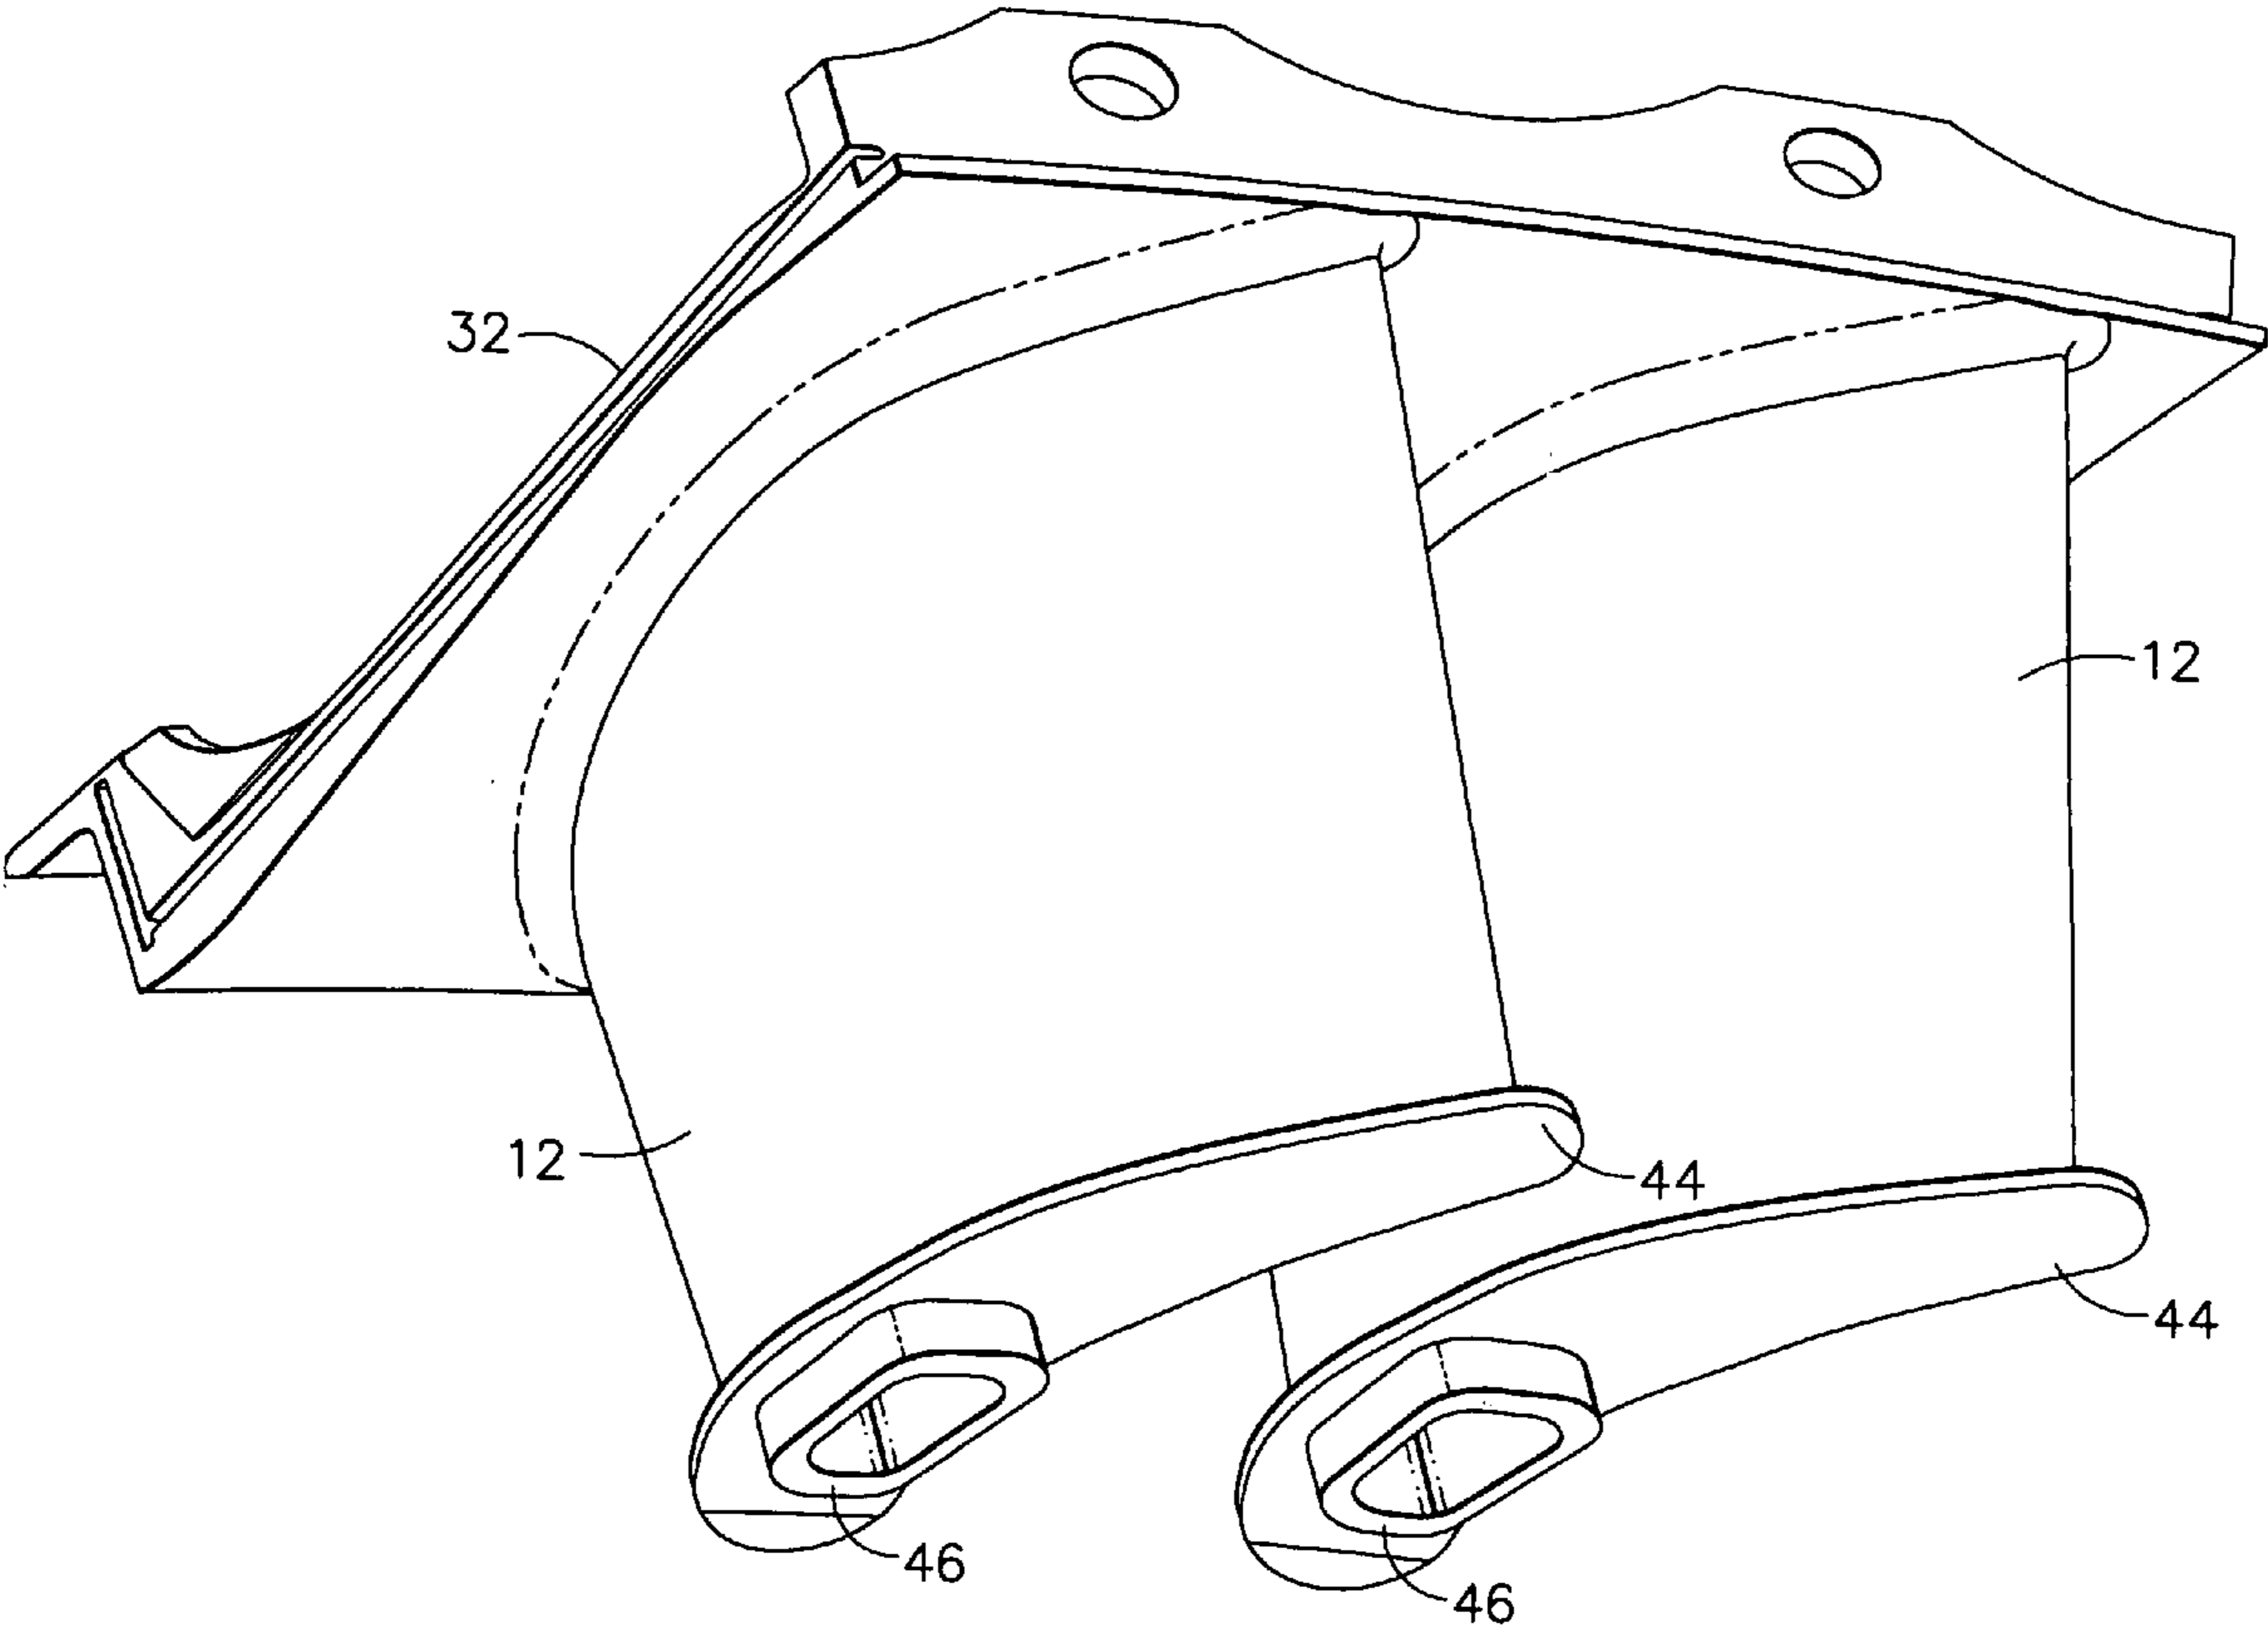
FIG. 4 is a perspective view of the outer band and vanes of the turbine nozzle segment of FIG. 1 after machining thereof; and

The next step is to separate the inner band 16 from the rest of the nozzle segment 10 without damaging the airfoils. Separation is accomplished by rough cutting through the inner band 16 around the perimeter of both vanes 12. The cutting can be performed by any conventional means such as an abrasive cutting wheel or electrical discharge machining. After separation, the unsalvageable structure is discarded, and the outer band 14 and vanes 12 are prepared for joining to the replacement inner band segment 30. As shown in FIG. 4, it is seen that the inner band 16 is separated and machined in such a manner to leave a mounting platform 44 integrally formed on the radially inner end of each vane 12. Each mounting platform 44 has a raised boss 46 integrally formed on the underside thereof as a result of the separation process.

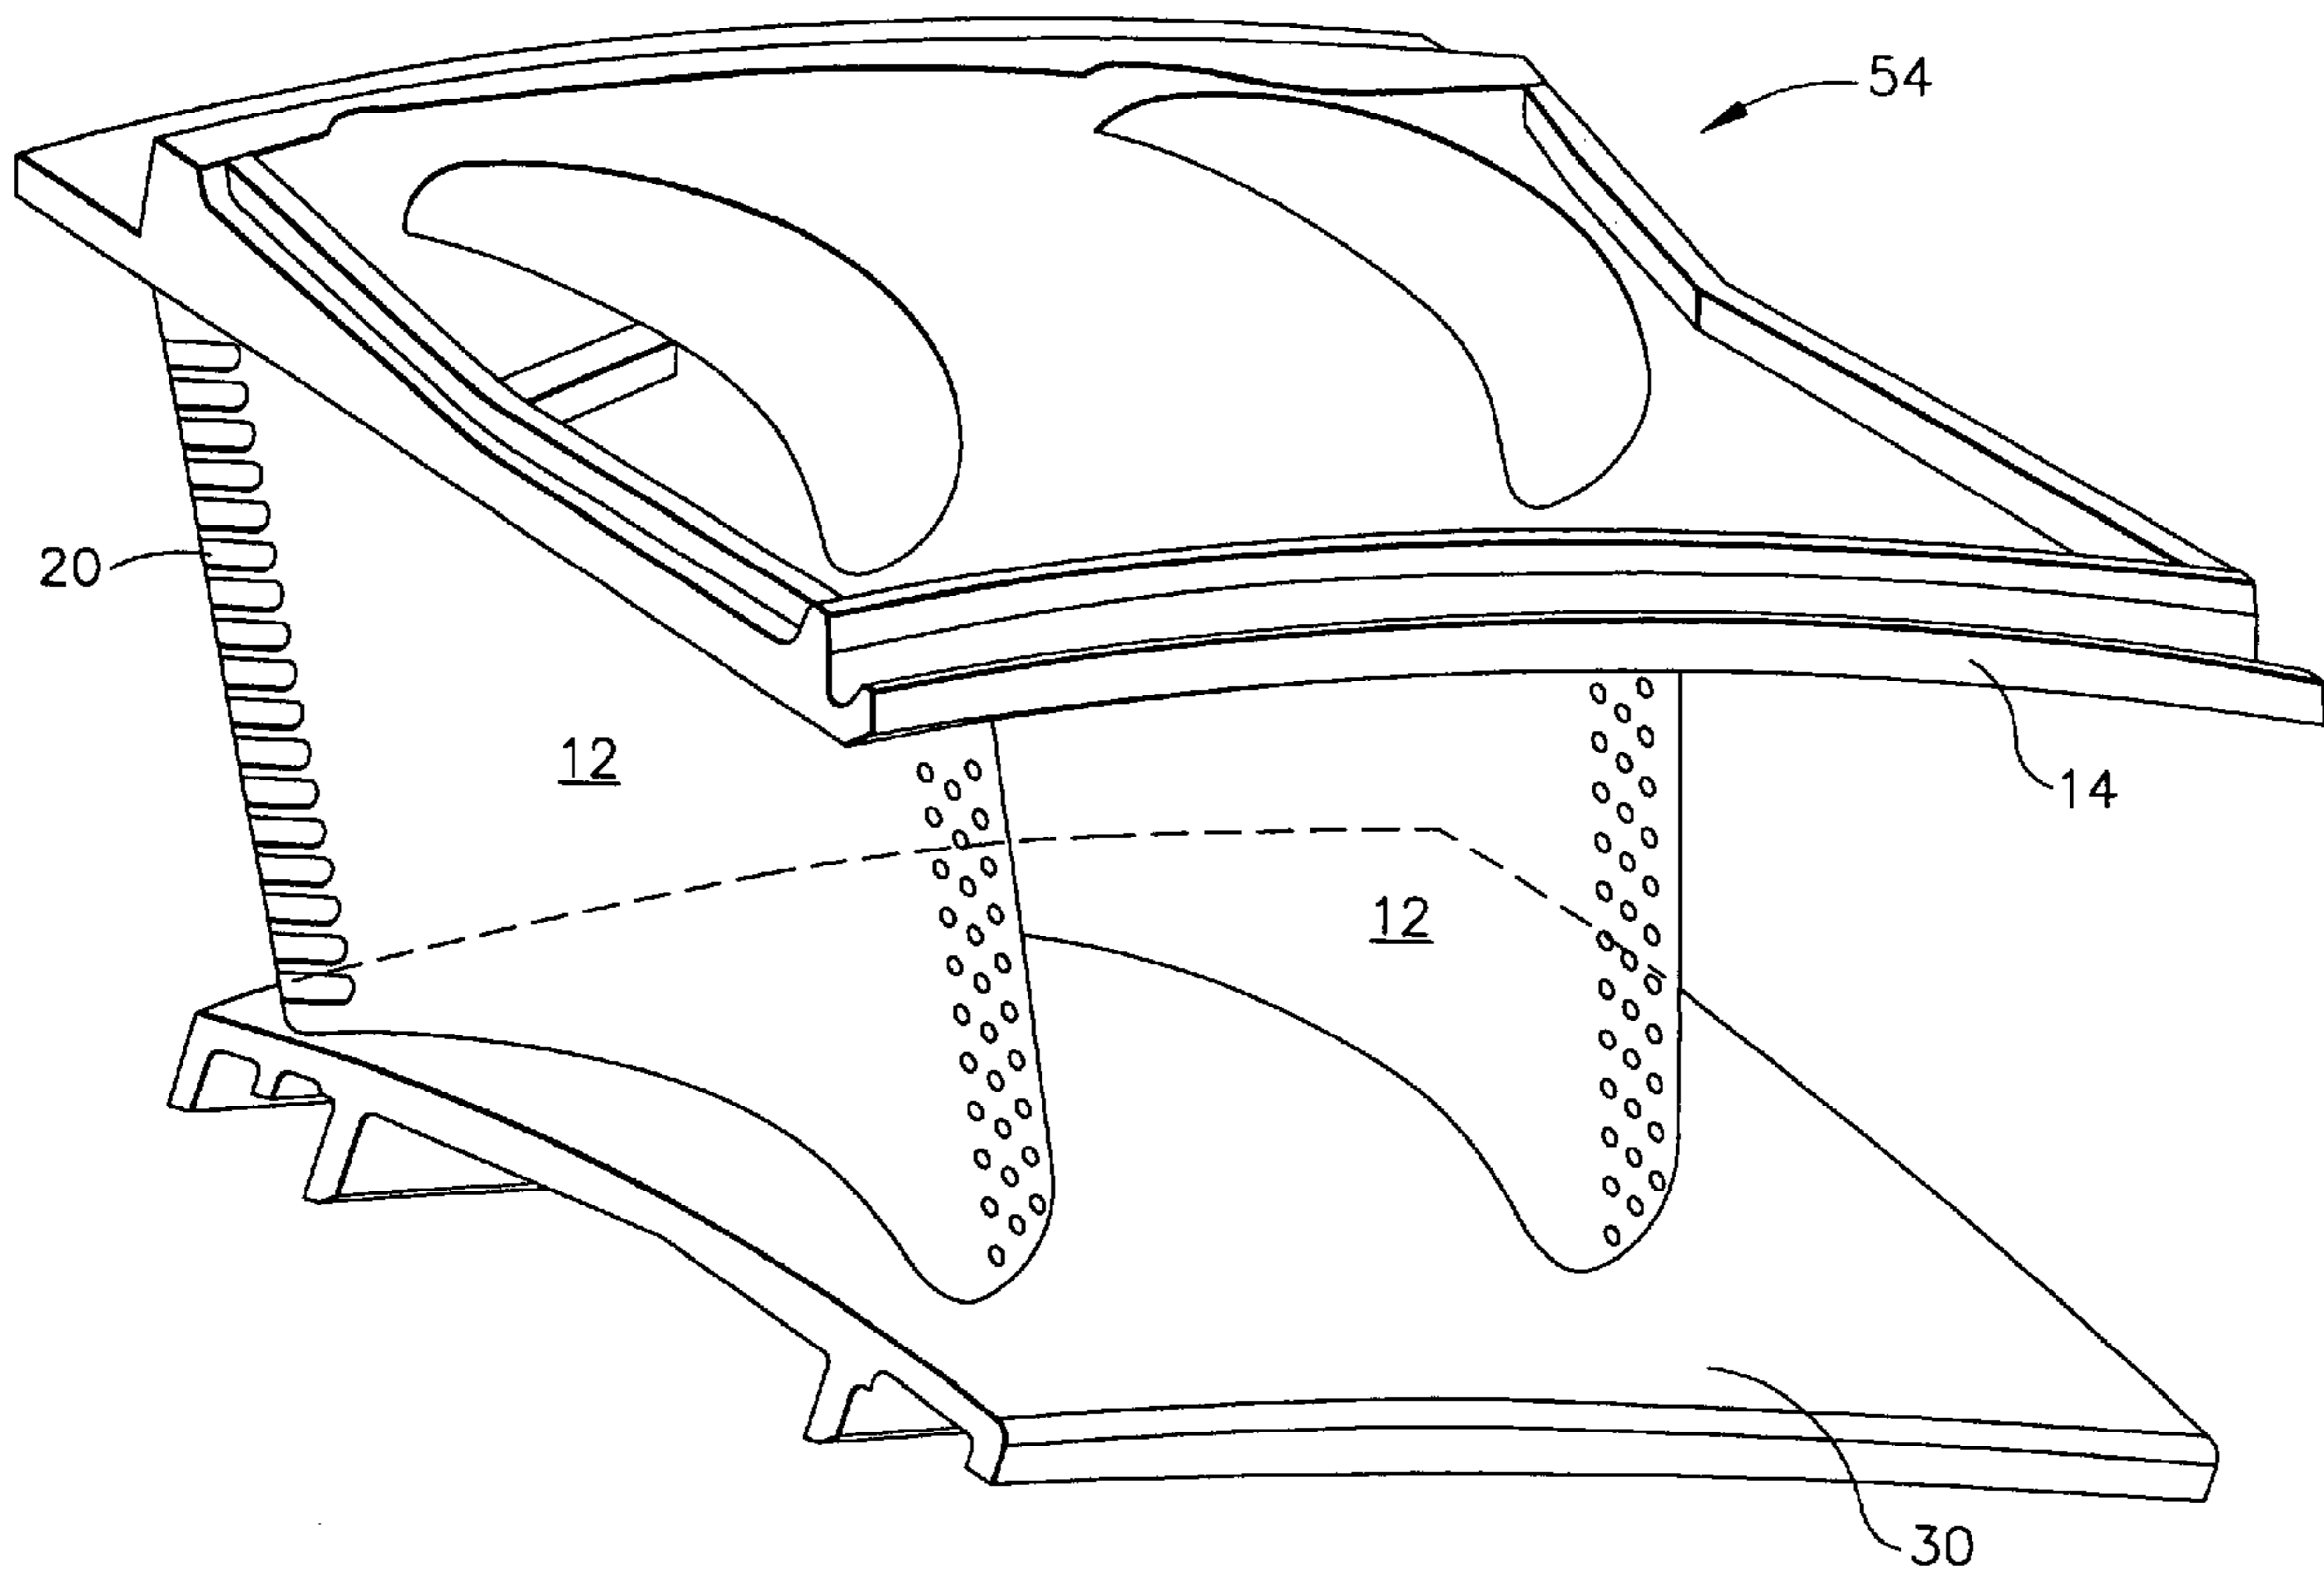
FIG. 5 is a perspective view of a repaired turbine nozzle segment.
