(54) **METHOD FOR REPAIRING A DAMAGED
BLADE OF A BLISK**

**METHOD FOR REPAIRING A DAMAGED
BLADE OF A BLISK**

This invention relates to a repair procedure for a BLISK in which an airfoil has been damaged and, more particularly, to a titanium-alloy BLISK in which the repair procedure restricts the formation of alpha case to the repaired region and thus does not affect the dimensions of the non-repaired locations of the BLISK.

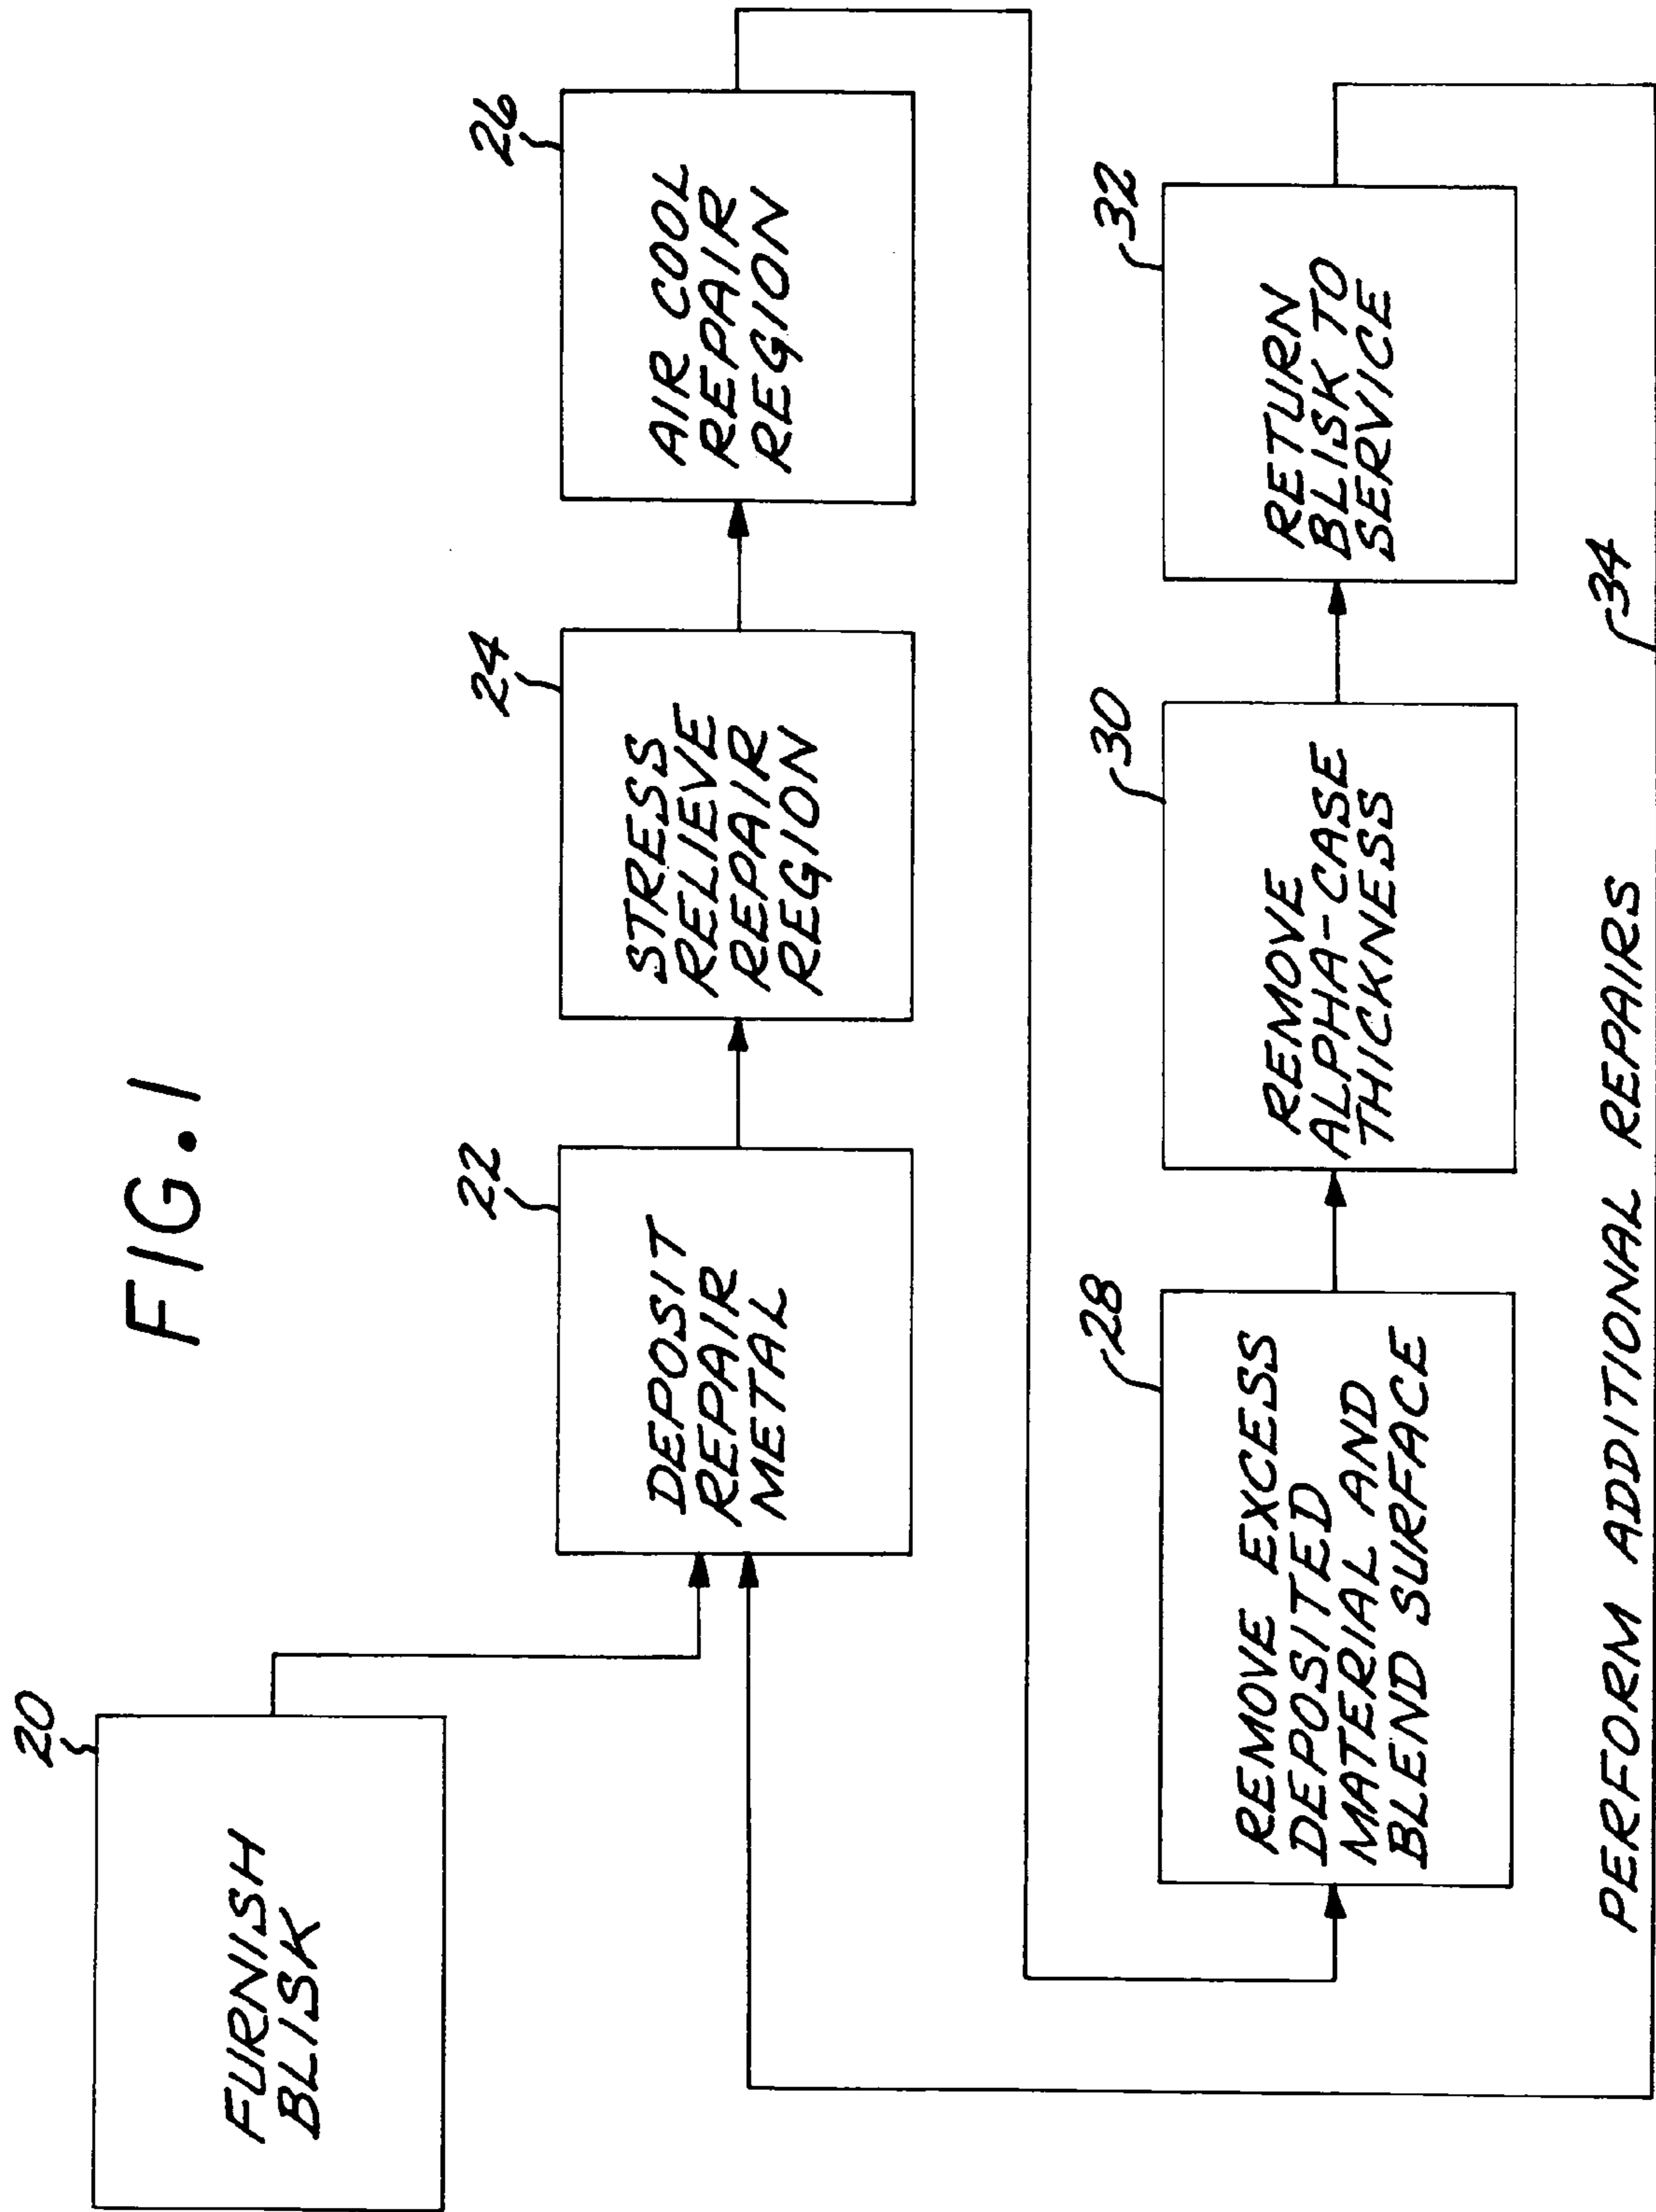
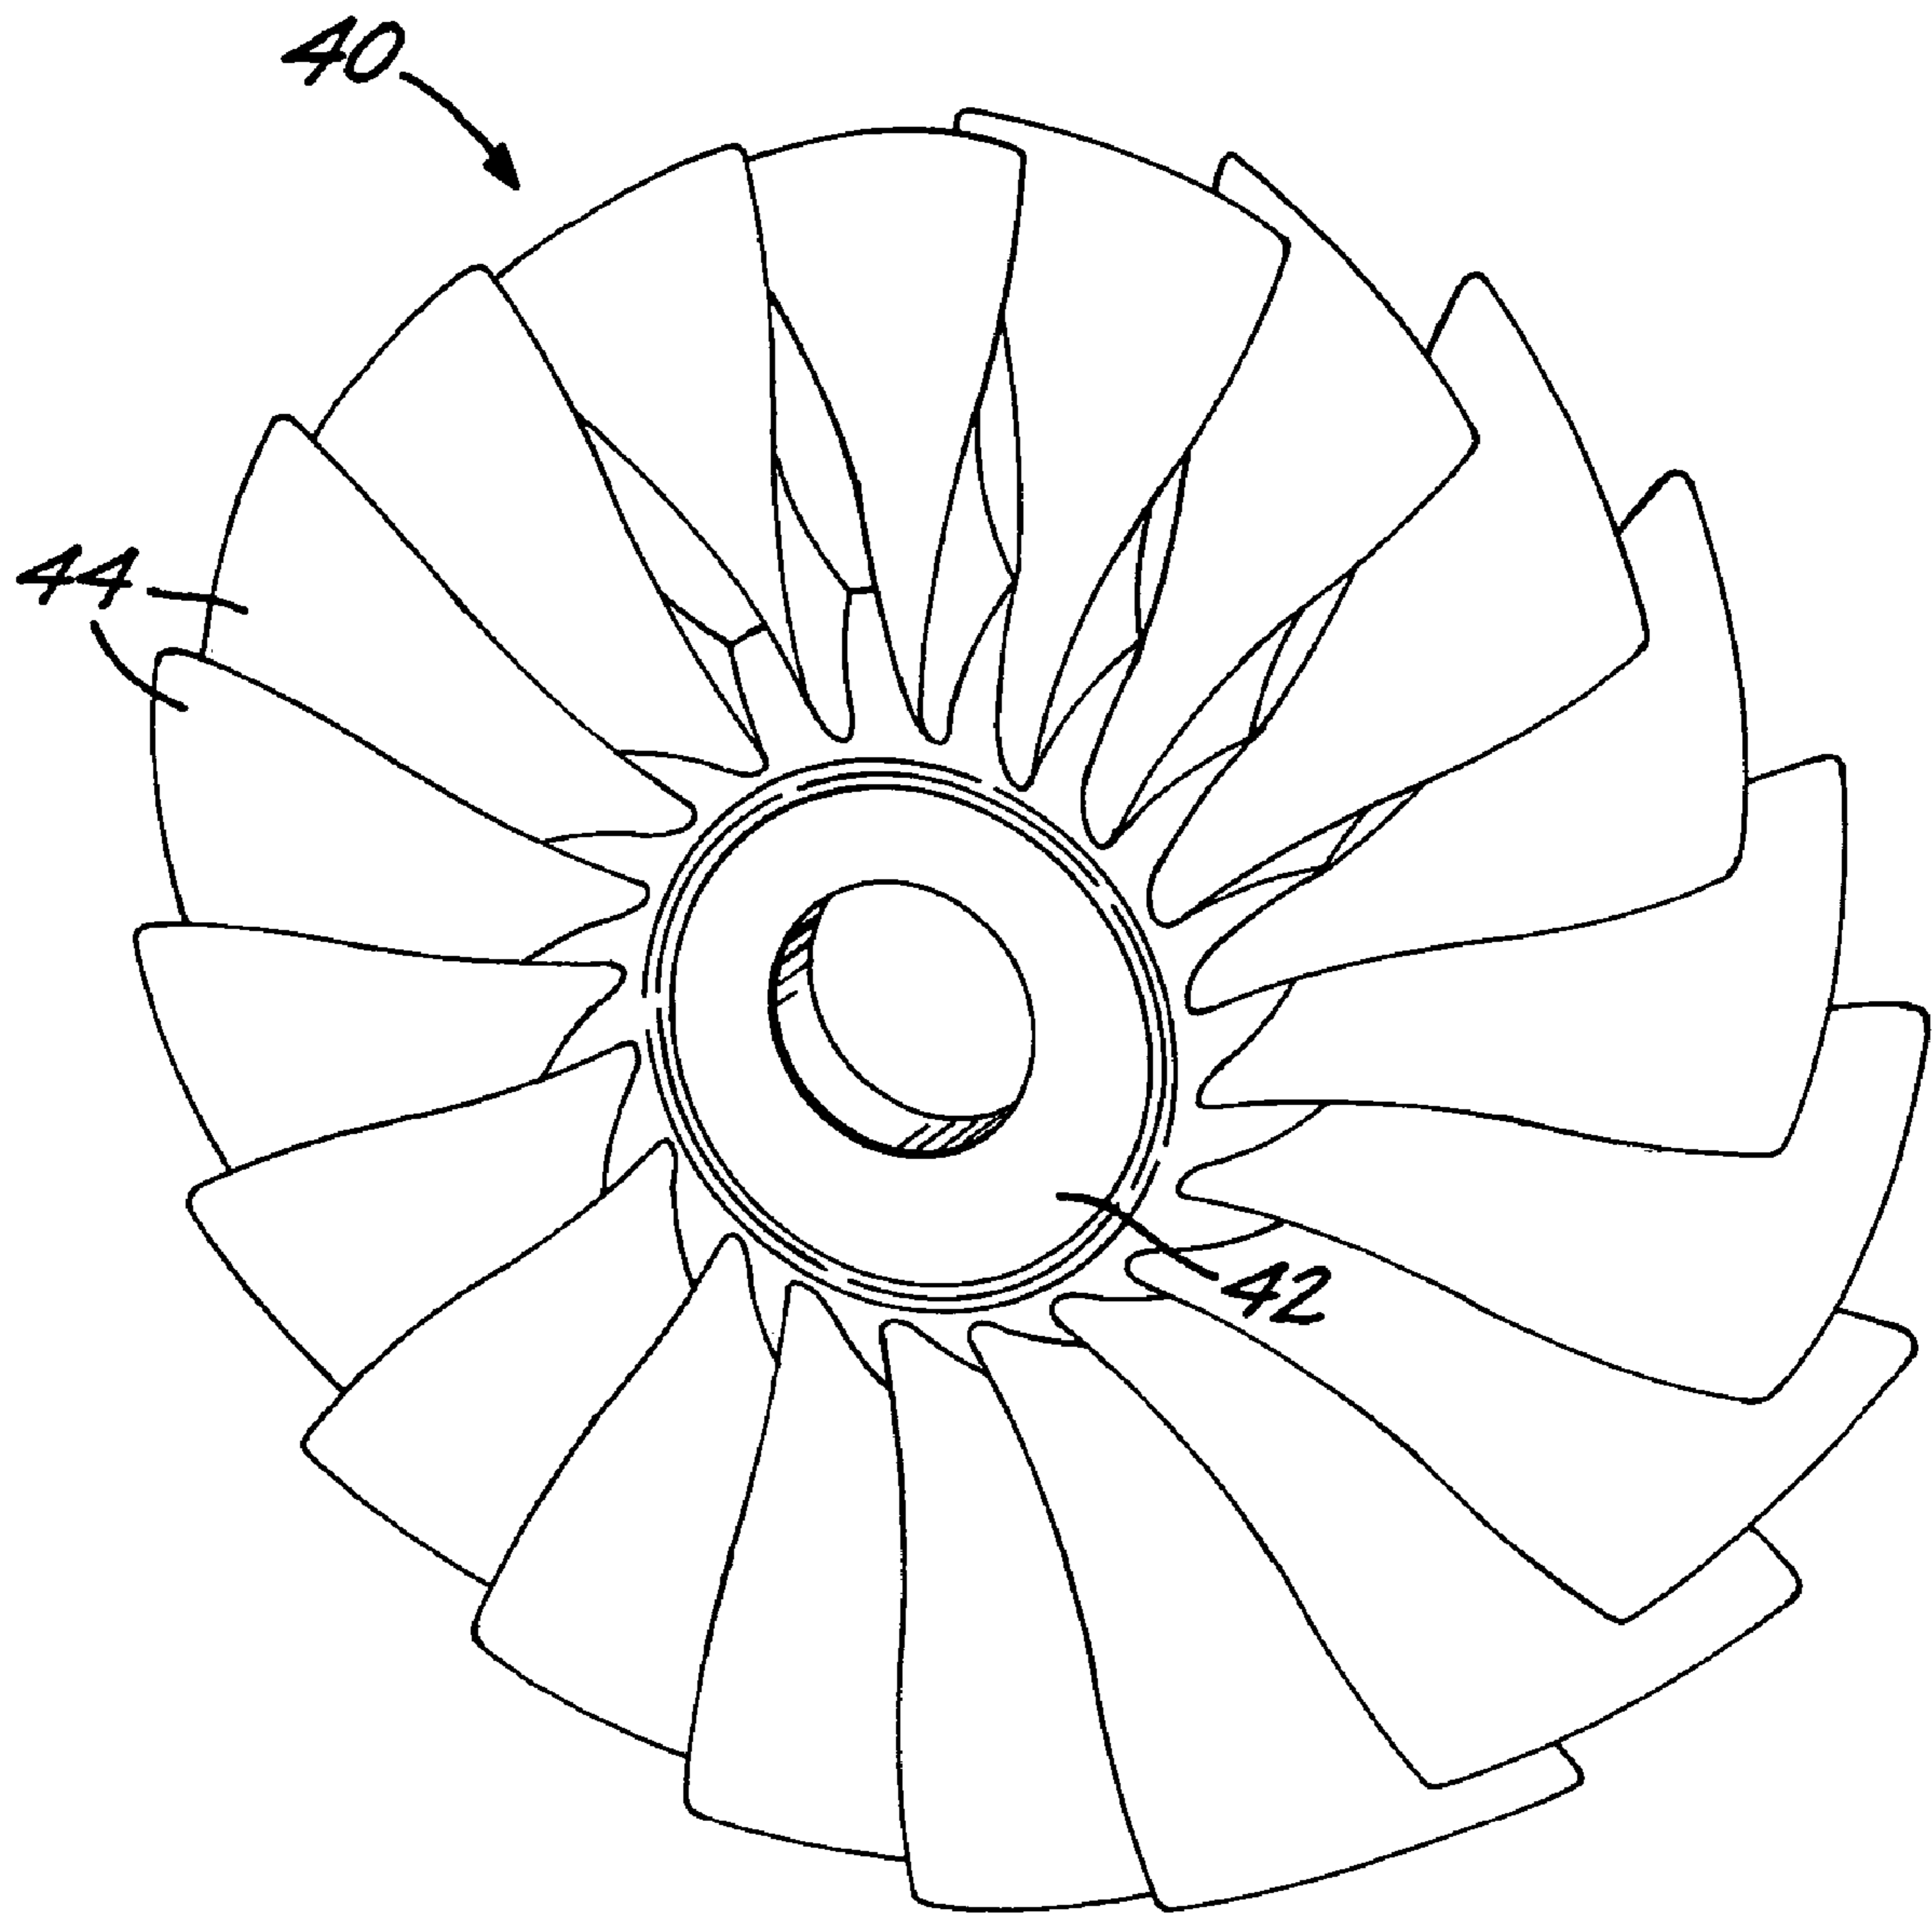
FIG. 2 is a perspective view of a BLISK;

FIG. 3 is a detail of a blade of a BLISK undergoing repair;

FIG. 1 illustrates in block diagram form an embodiment of a method for repairing a BLISK. The method includes furnishing a BLISK 40, step 20. FIG. 2 illustrates such a BLISK 40. "BLISK" is a term of art that is a contraction of the term "bladed disk", which is also sometimes called an integrally bladed rotor or IBR. The BLISK 40 includes a thick-section central disk 42 and a plurality of compressor or turbine blades 44 that are prepared integrally with or metallurgically bonded to the disk 42. The BLISK 40 may be made of any operable material. The disk 42 and the blades 44 may be of the same material or of a different material. In a case of most interest, the entire BLISK 40, including both the disk 42 and the blades 44, are made of a beta-processed titanium-alloy such as Ti-17, having a nominal composition in weight percent of Ti-5Al-4Mo-4Cr-2Sn-2Zr, or Ti-6242, having a nominal composition in weight percent of Ti-6Al-2Sn-4Zr-2Mo.

time of at least about 1 hour, preferably about 2 hours, step 24. FIG. 3 illustrates the stress relieving of "only the repair region 48". A local heating device, such as a heating blanket 52, is placed over the repair region 48 and as small a part of the remainder of the blade 46 as practical. Other types of local heating devices such as ovens and heat lamps may be used instead of the heating blanket 52. The stress relieving 24 is preferably accomplished in air or in an inert gas such as argon. After stress relieving 24, the heat material is preferably air cooled to room temperature, step 26.

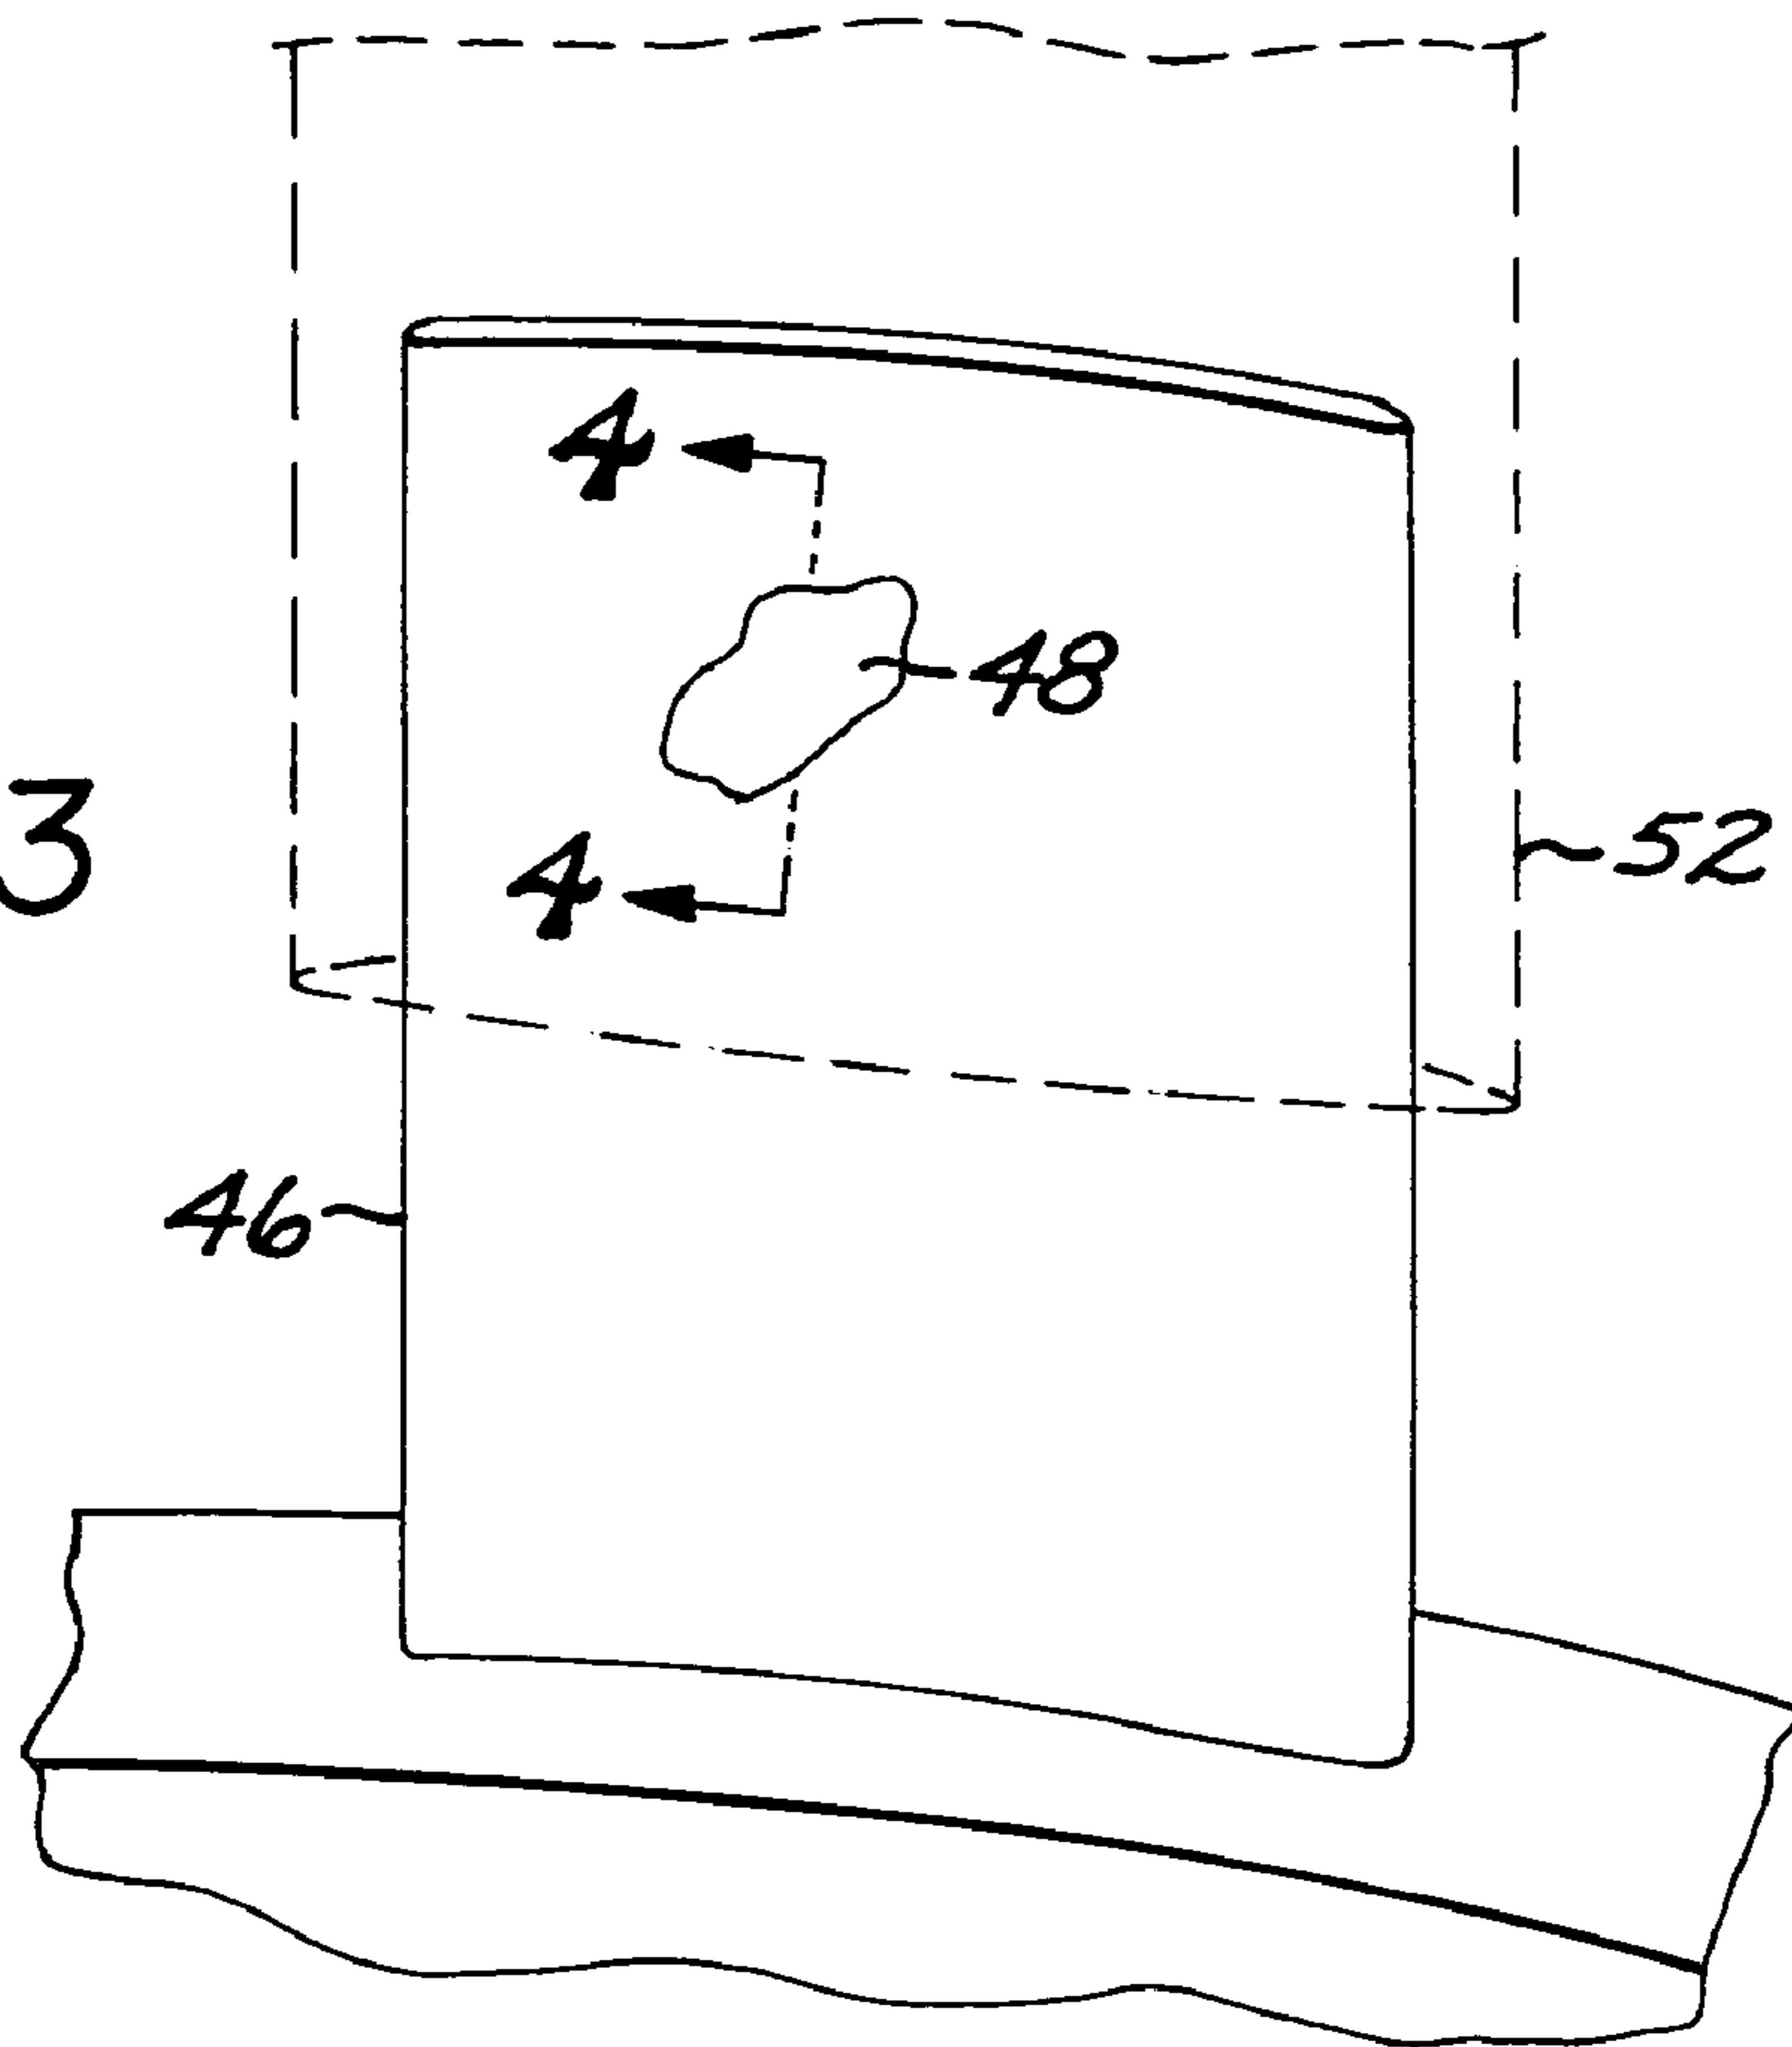
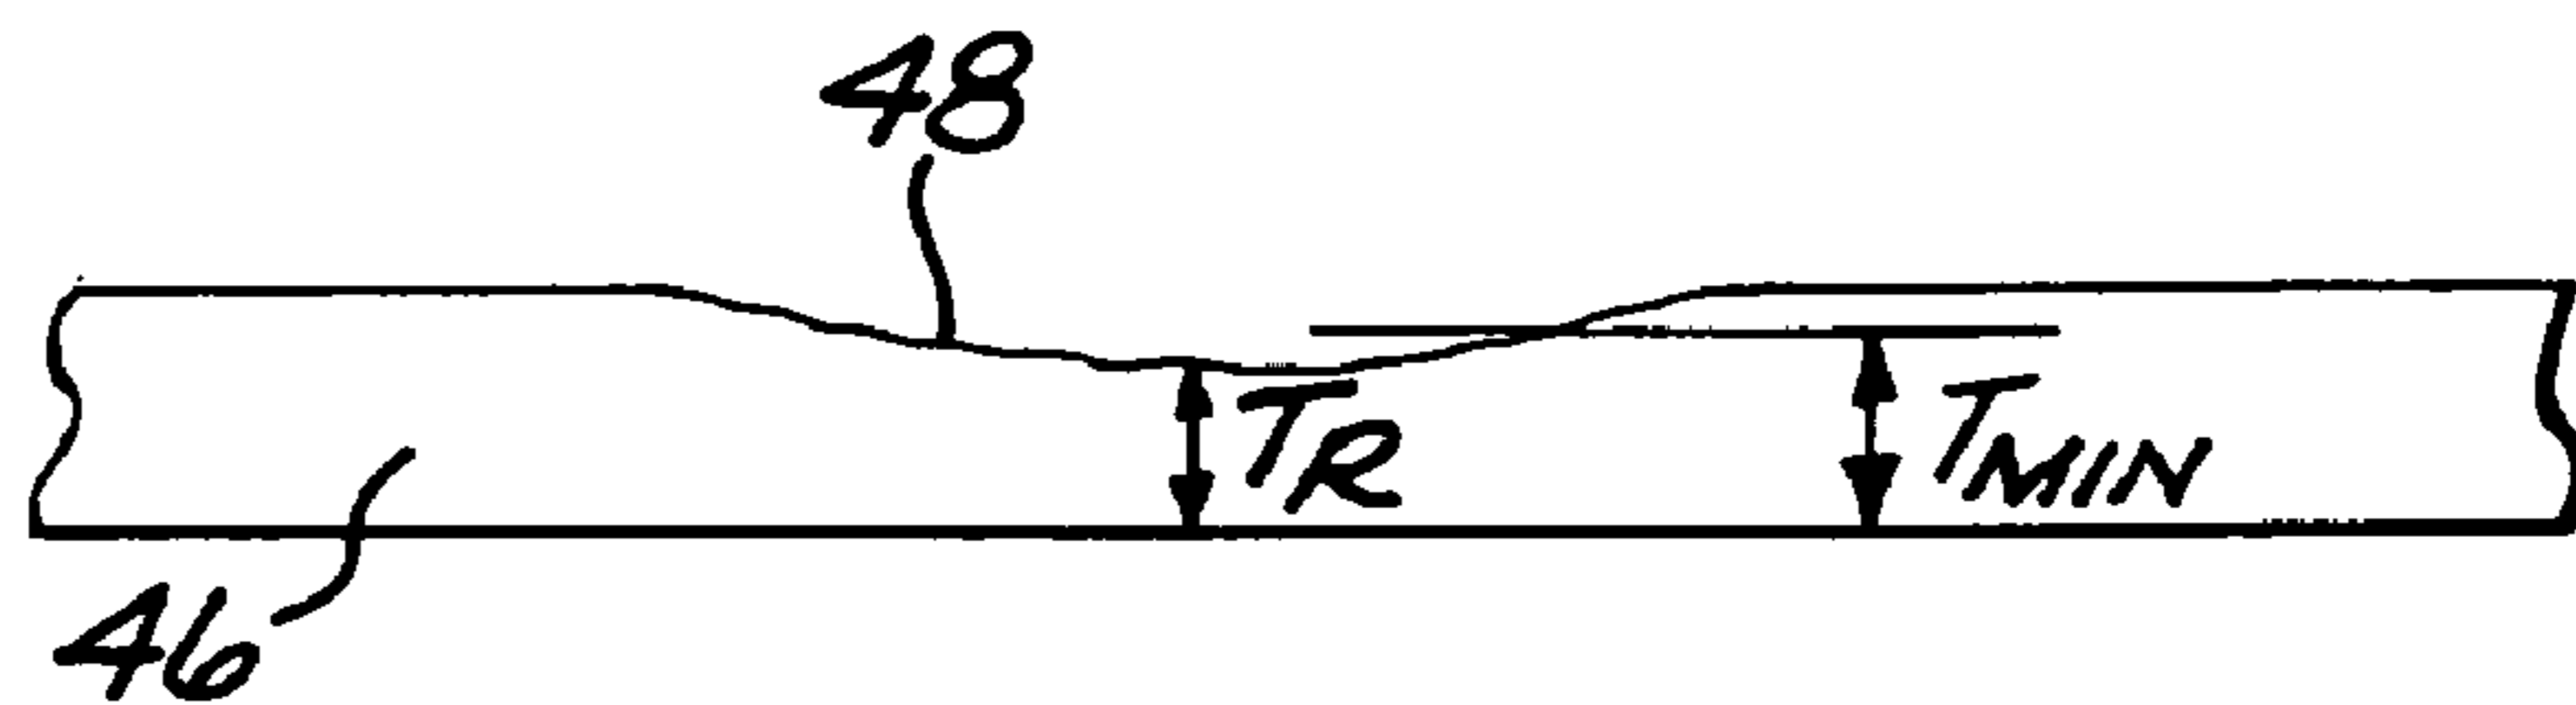
FIG. 4 is a sectional view through the blade of FIG. 3 taken along line 4—4, prior to repair; and

The as-furnished BLISK 40 has at least one damaged blade 46, seen in FIGS. 3–5, and may have more than one damaged blade. The illustrated damage is in the form of a repair region 48 where metal has been removed during service to a local thickness T_R (FIG. 4) that is less than a minimum specified thickness T_{MIN} as a result of the damage during manufacture or prior service. The removal of metal to produce the repair region 48 may occur due to any of a number of factors, such as erosion, corrosion, impact damage, tip rubbing, and the like during service. T_{MIN} is a value established by the engine designers as the minimum thickness of the blades 44 that will provide the required mechanical performance, and is set forth in the specification for the blades 44. The value of T_{MIN} is not established as part of the present approach, and is an input number. The BLISK 40 may have been previously repaired, either in the repair region 48, another region of the damaged blade 46, or on another blade 44, or it may not have been previously repaired. A virtue of the present approach is that it allows the damaged blades of the BLISK 40 to be repaired multiple times.

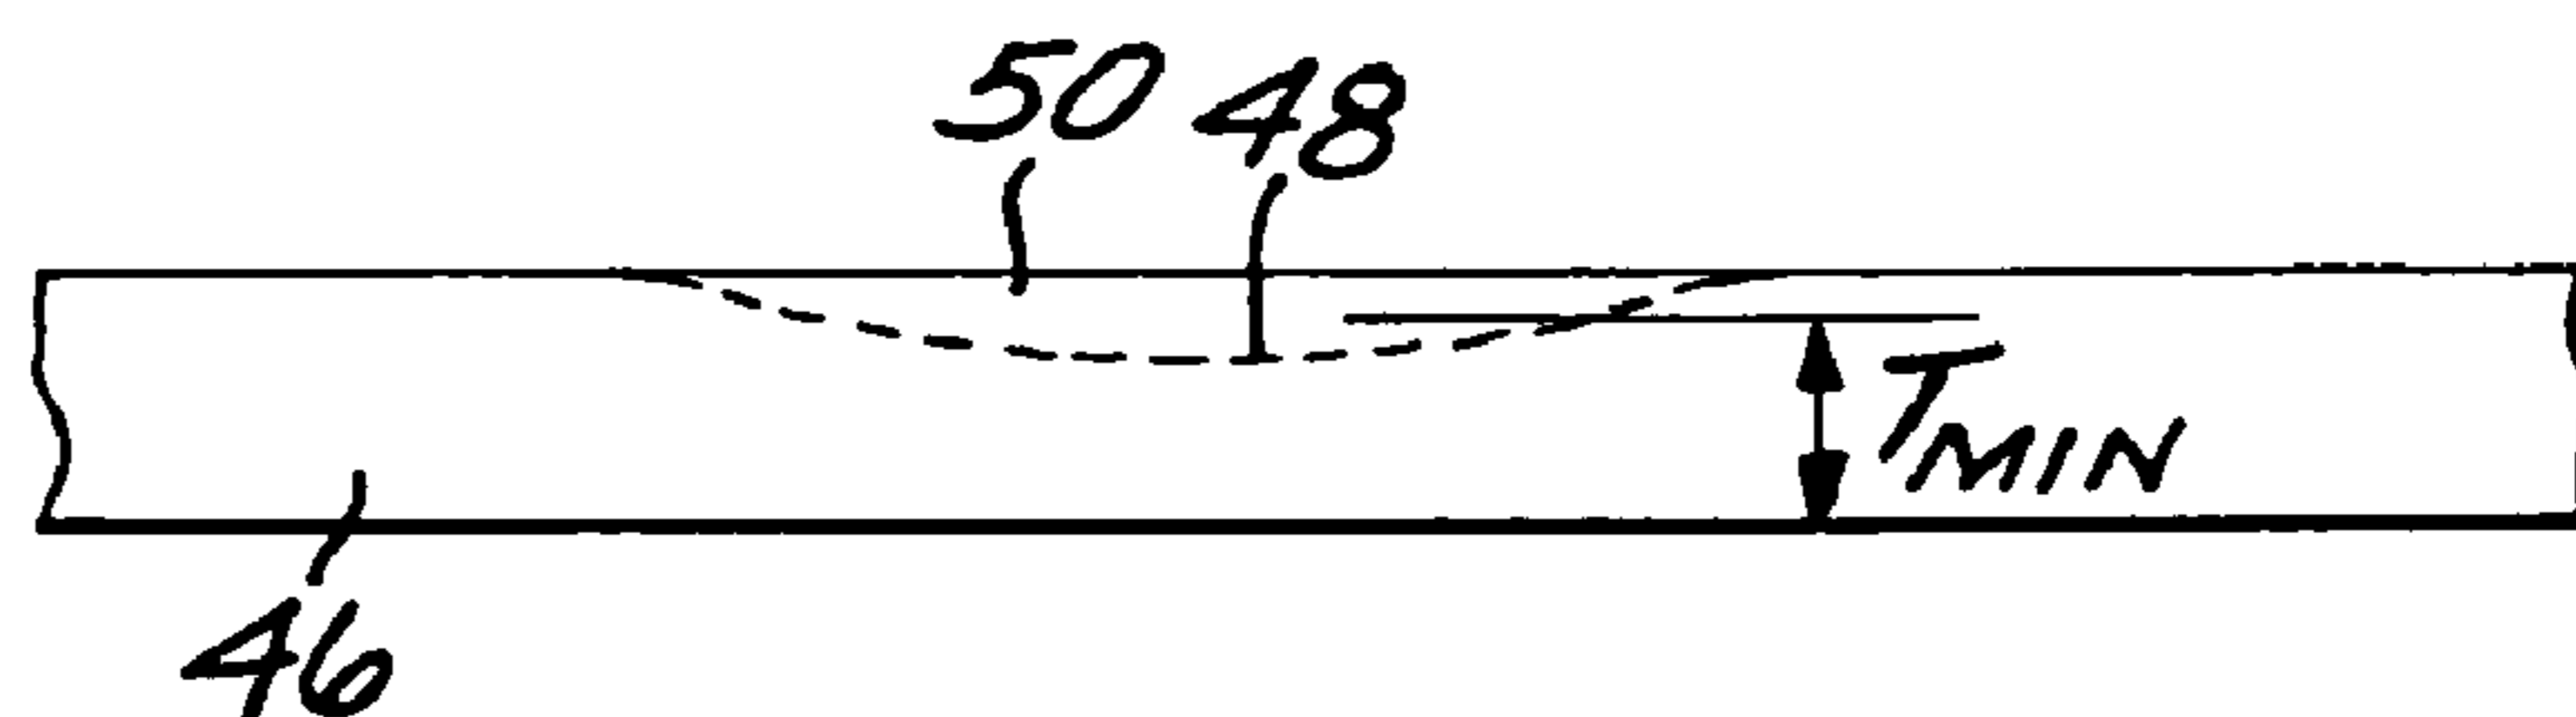
FIG. 5 is a sectional view through the blade of FIG. 3 taken along line 4—4, after repair.

Repair metal 50 is thereafter deposited onto the repair region 48 to increase its thickness to greater than its specified minimum thickness dimension T_{MIN} , step 22, as shown in FIG. 5. The deposition 22 is accomplished by any operable approach, but is typically accomplished by welding or by a thermal spray process. The repair metal 50 may be of the same chemical composition as the damaged blade 46, or a different composition.
