(12) **United States Patent**
DeTurris

(10) **Patent No.:** **US 7,252,727 B2**
(45) **Date of Patent:** **Aug. 7, 2007**

(54) **REPAIR SYSTEM AND METHOD FOR FIBERGLASS BOATS**

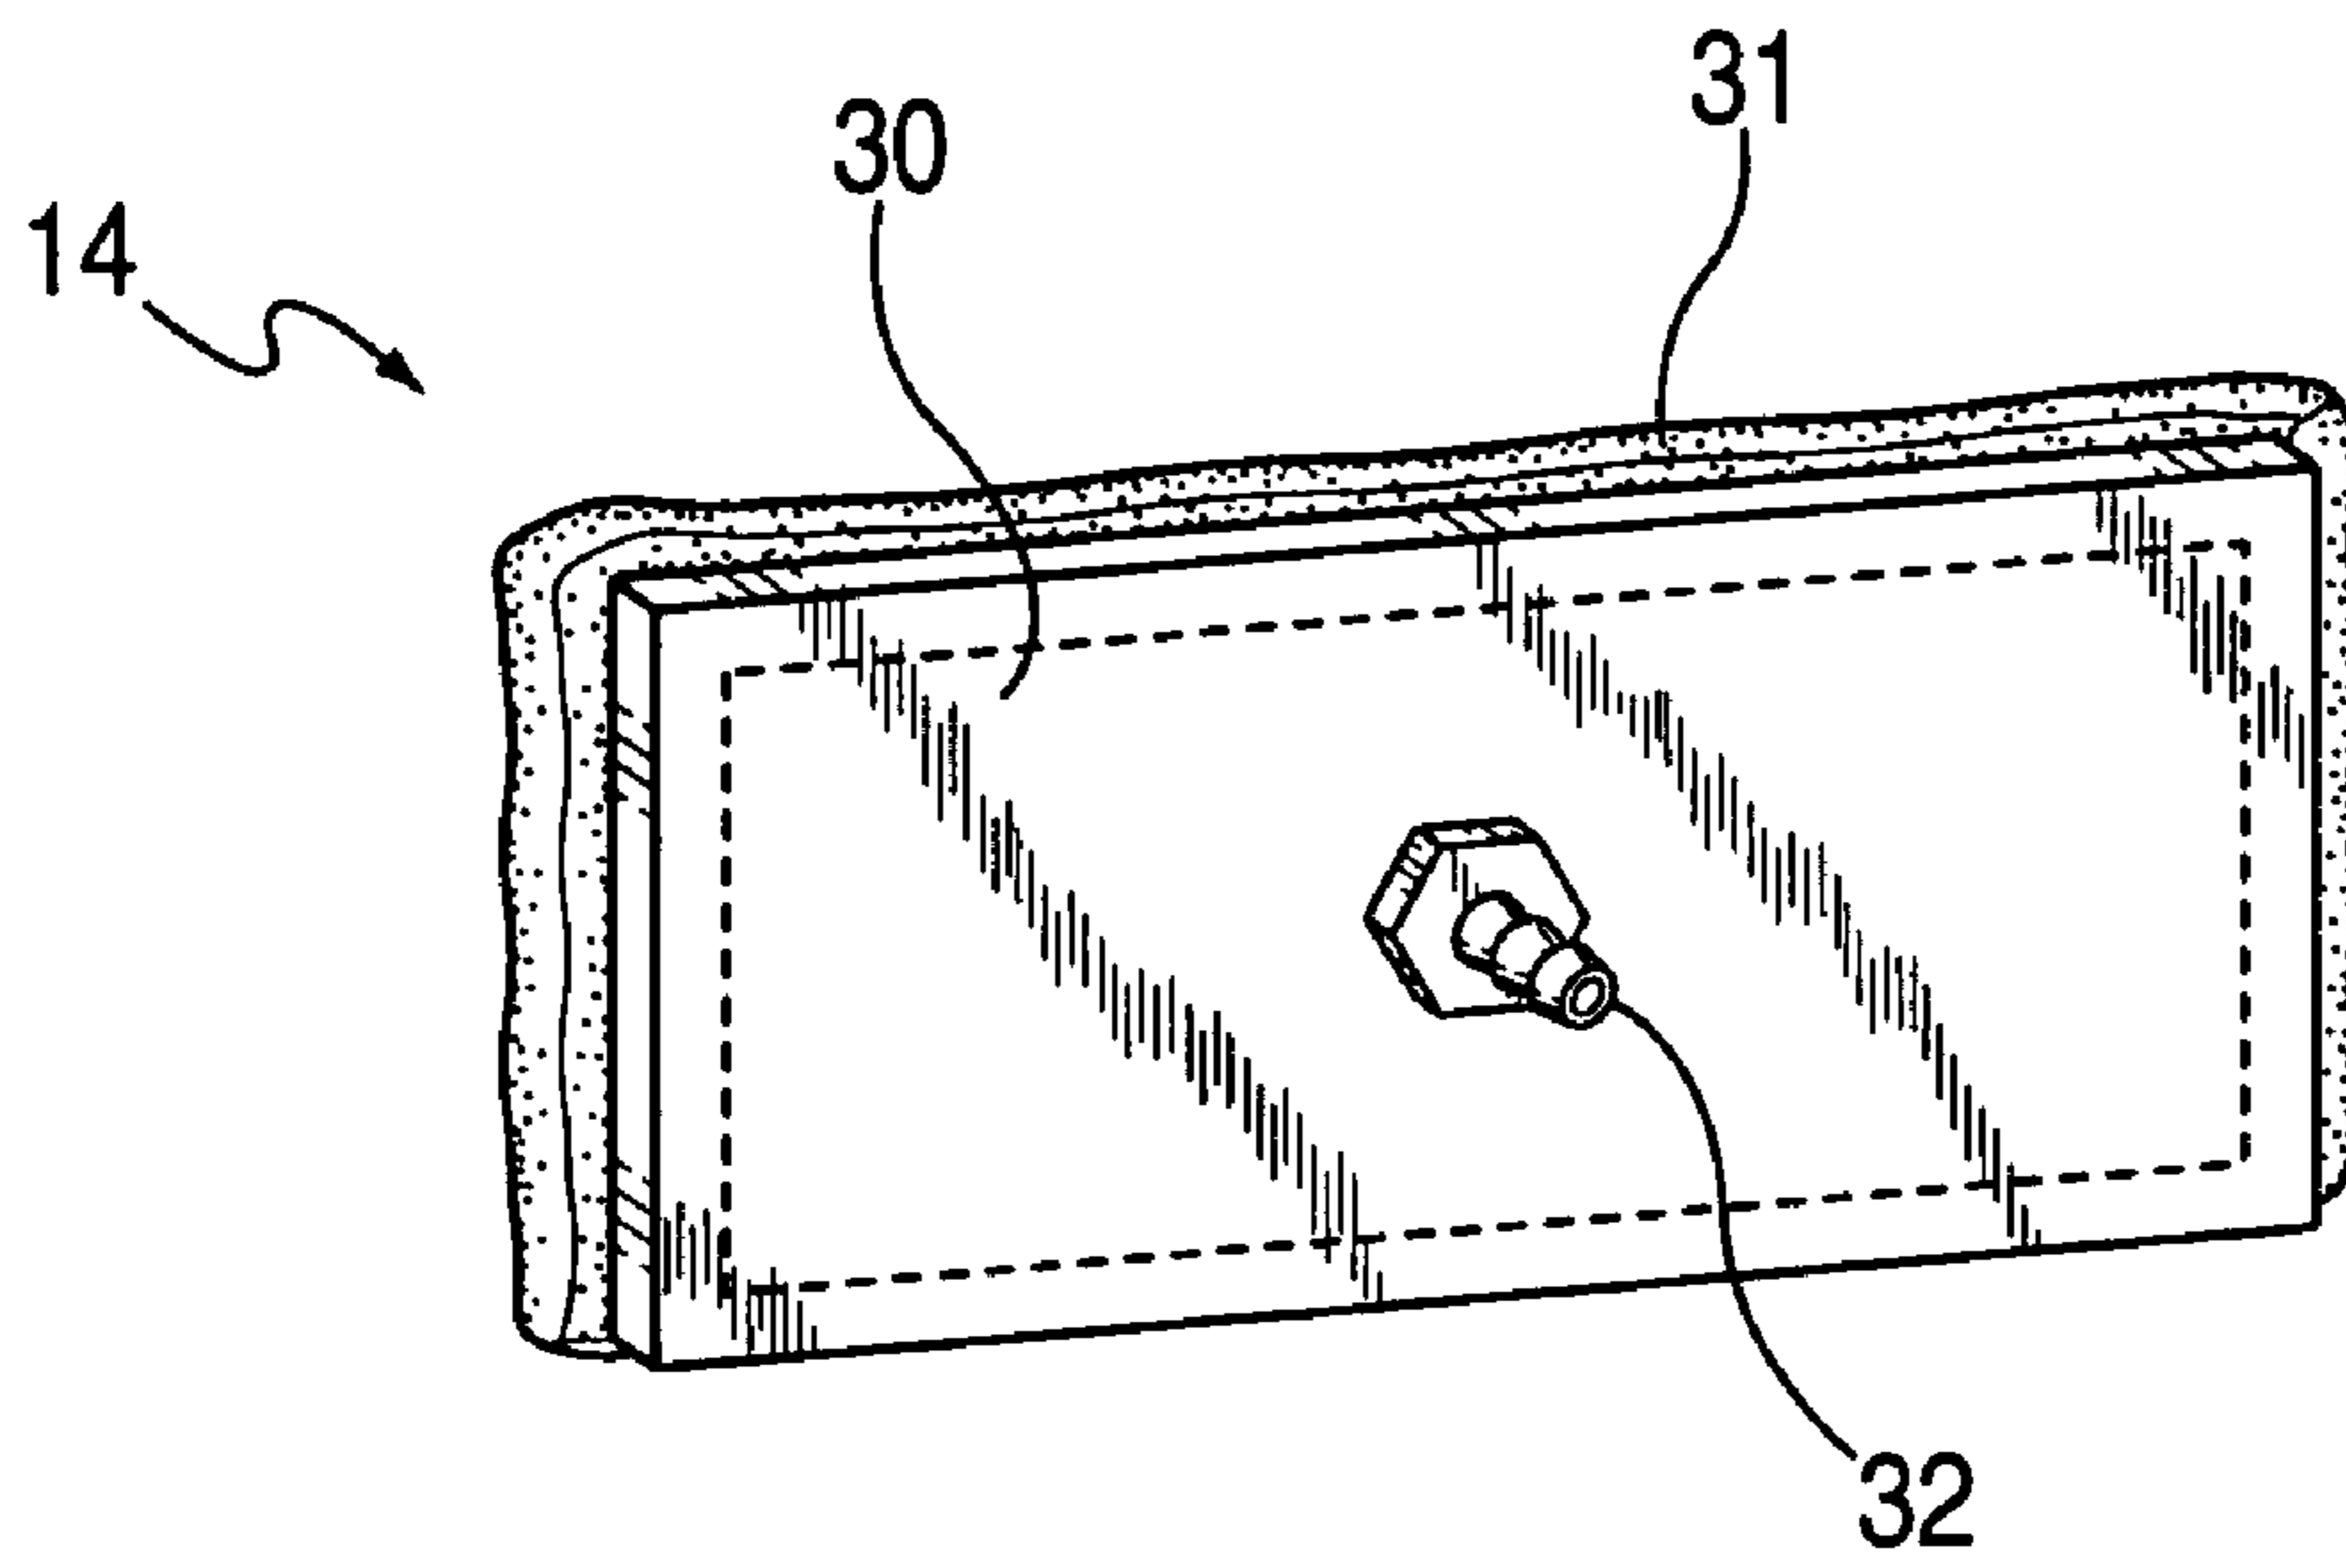
FIG. 3 is a close-up perspective detail view of a vacuum draw plate used in connection with vacuum cleaning of moisture and damaged wood core debris of a boat hull being treated in accordance with the system and method of the present invention;

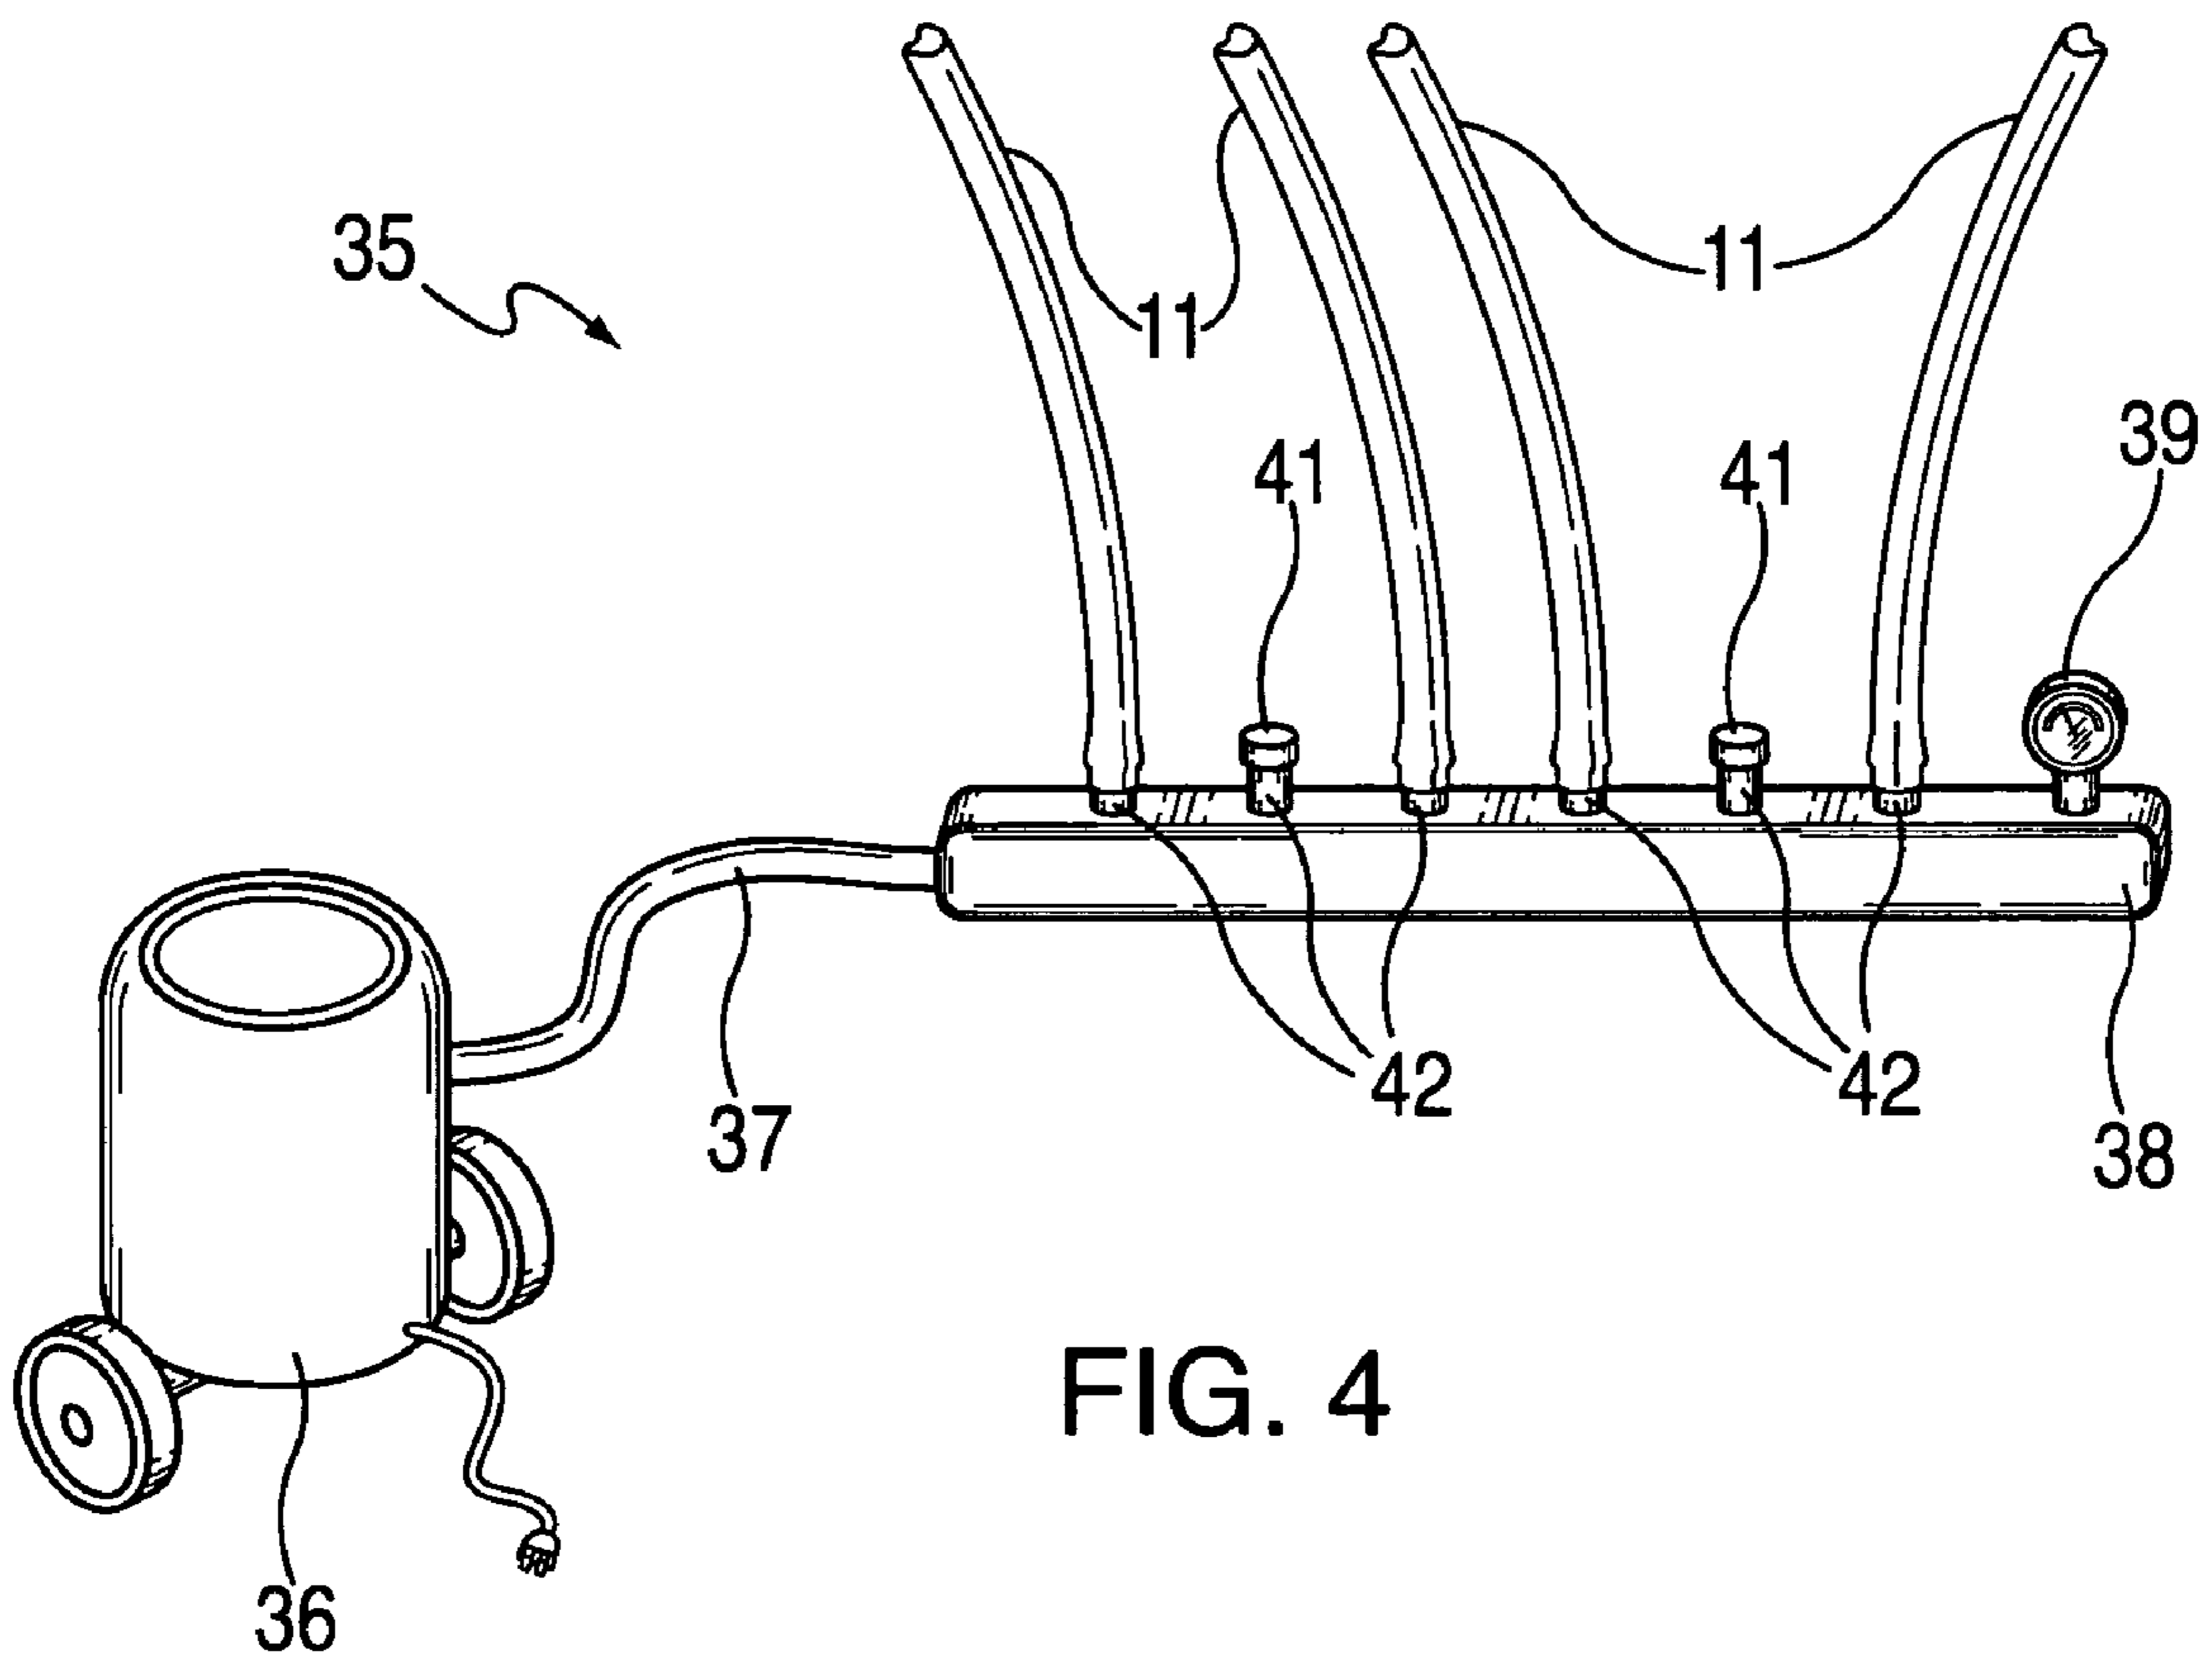
FIG. 4 is a close-up perspective view of the vacuum system of the present invention;

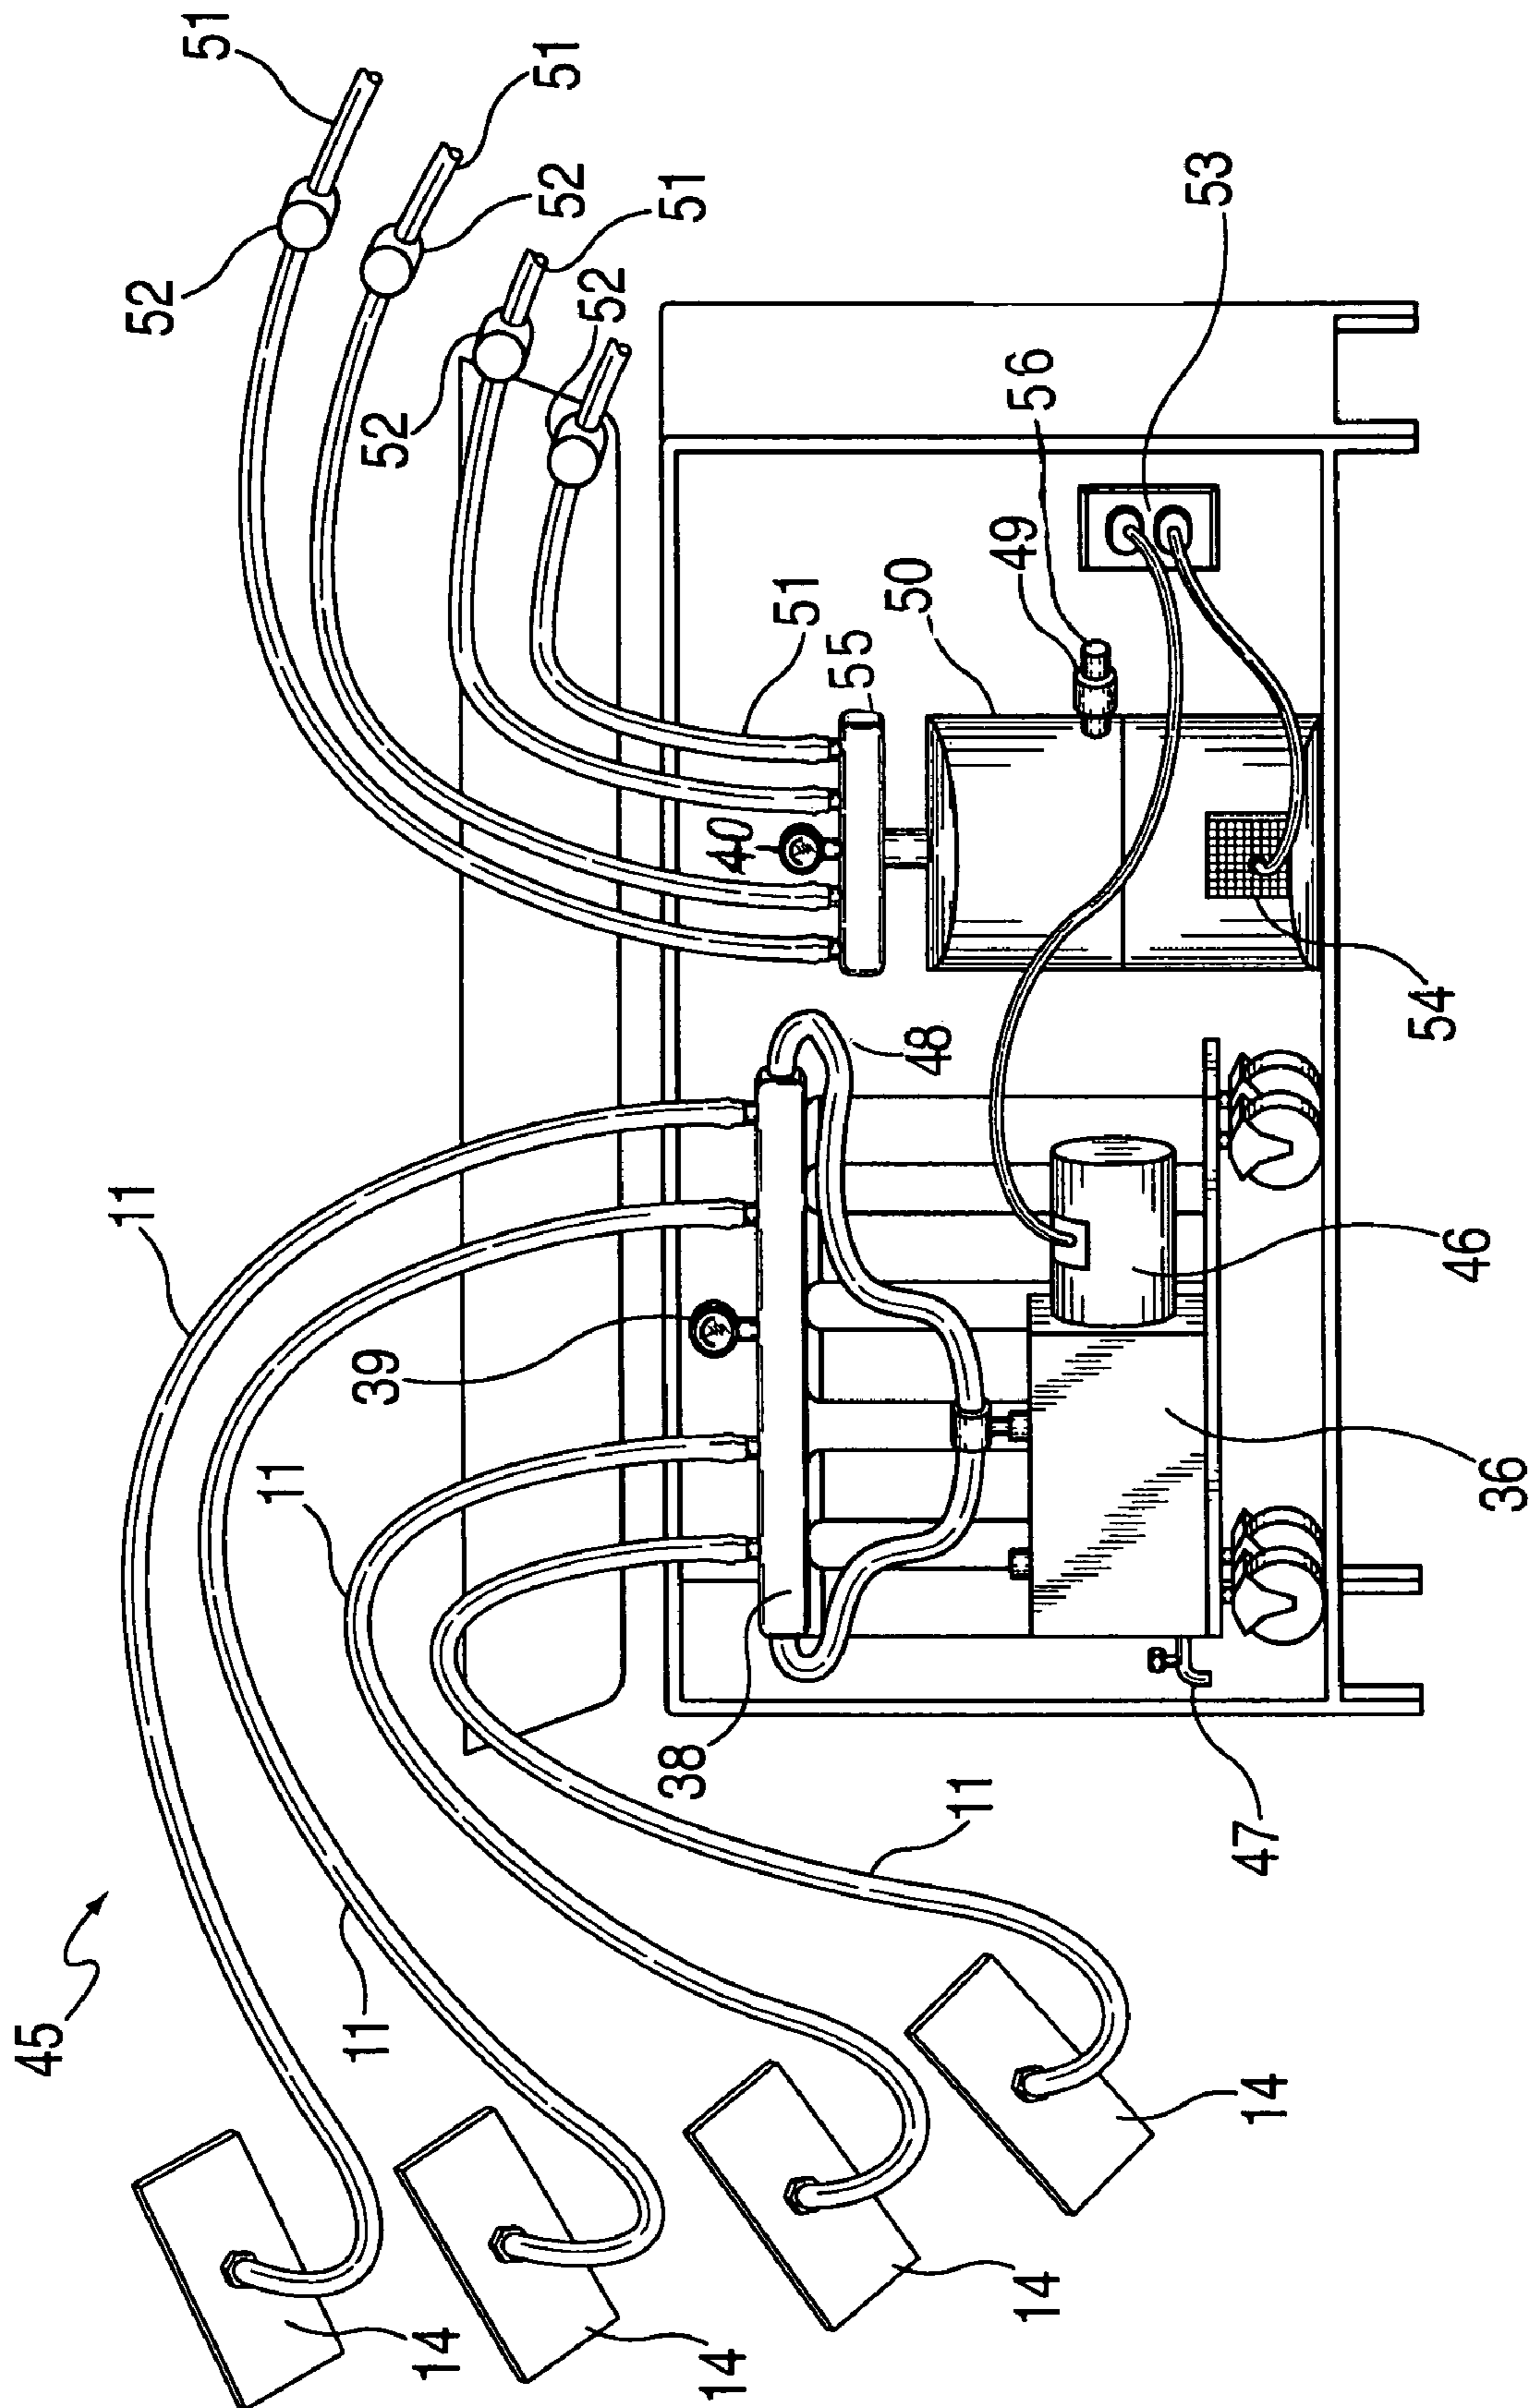
FIG. 4A is a perspective view of the vacuum and pressure systems shown in place at a boat hull to be repaired;

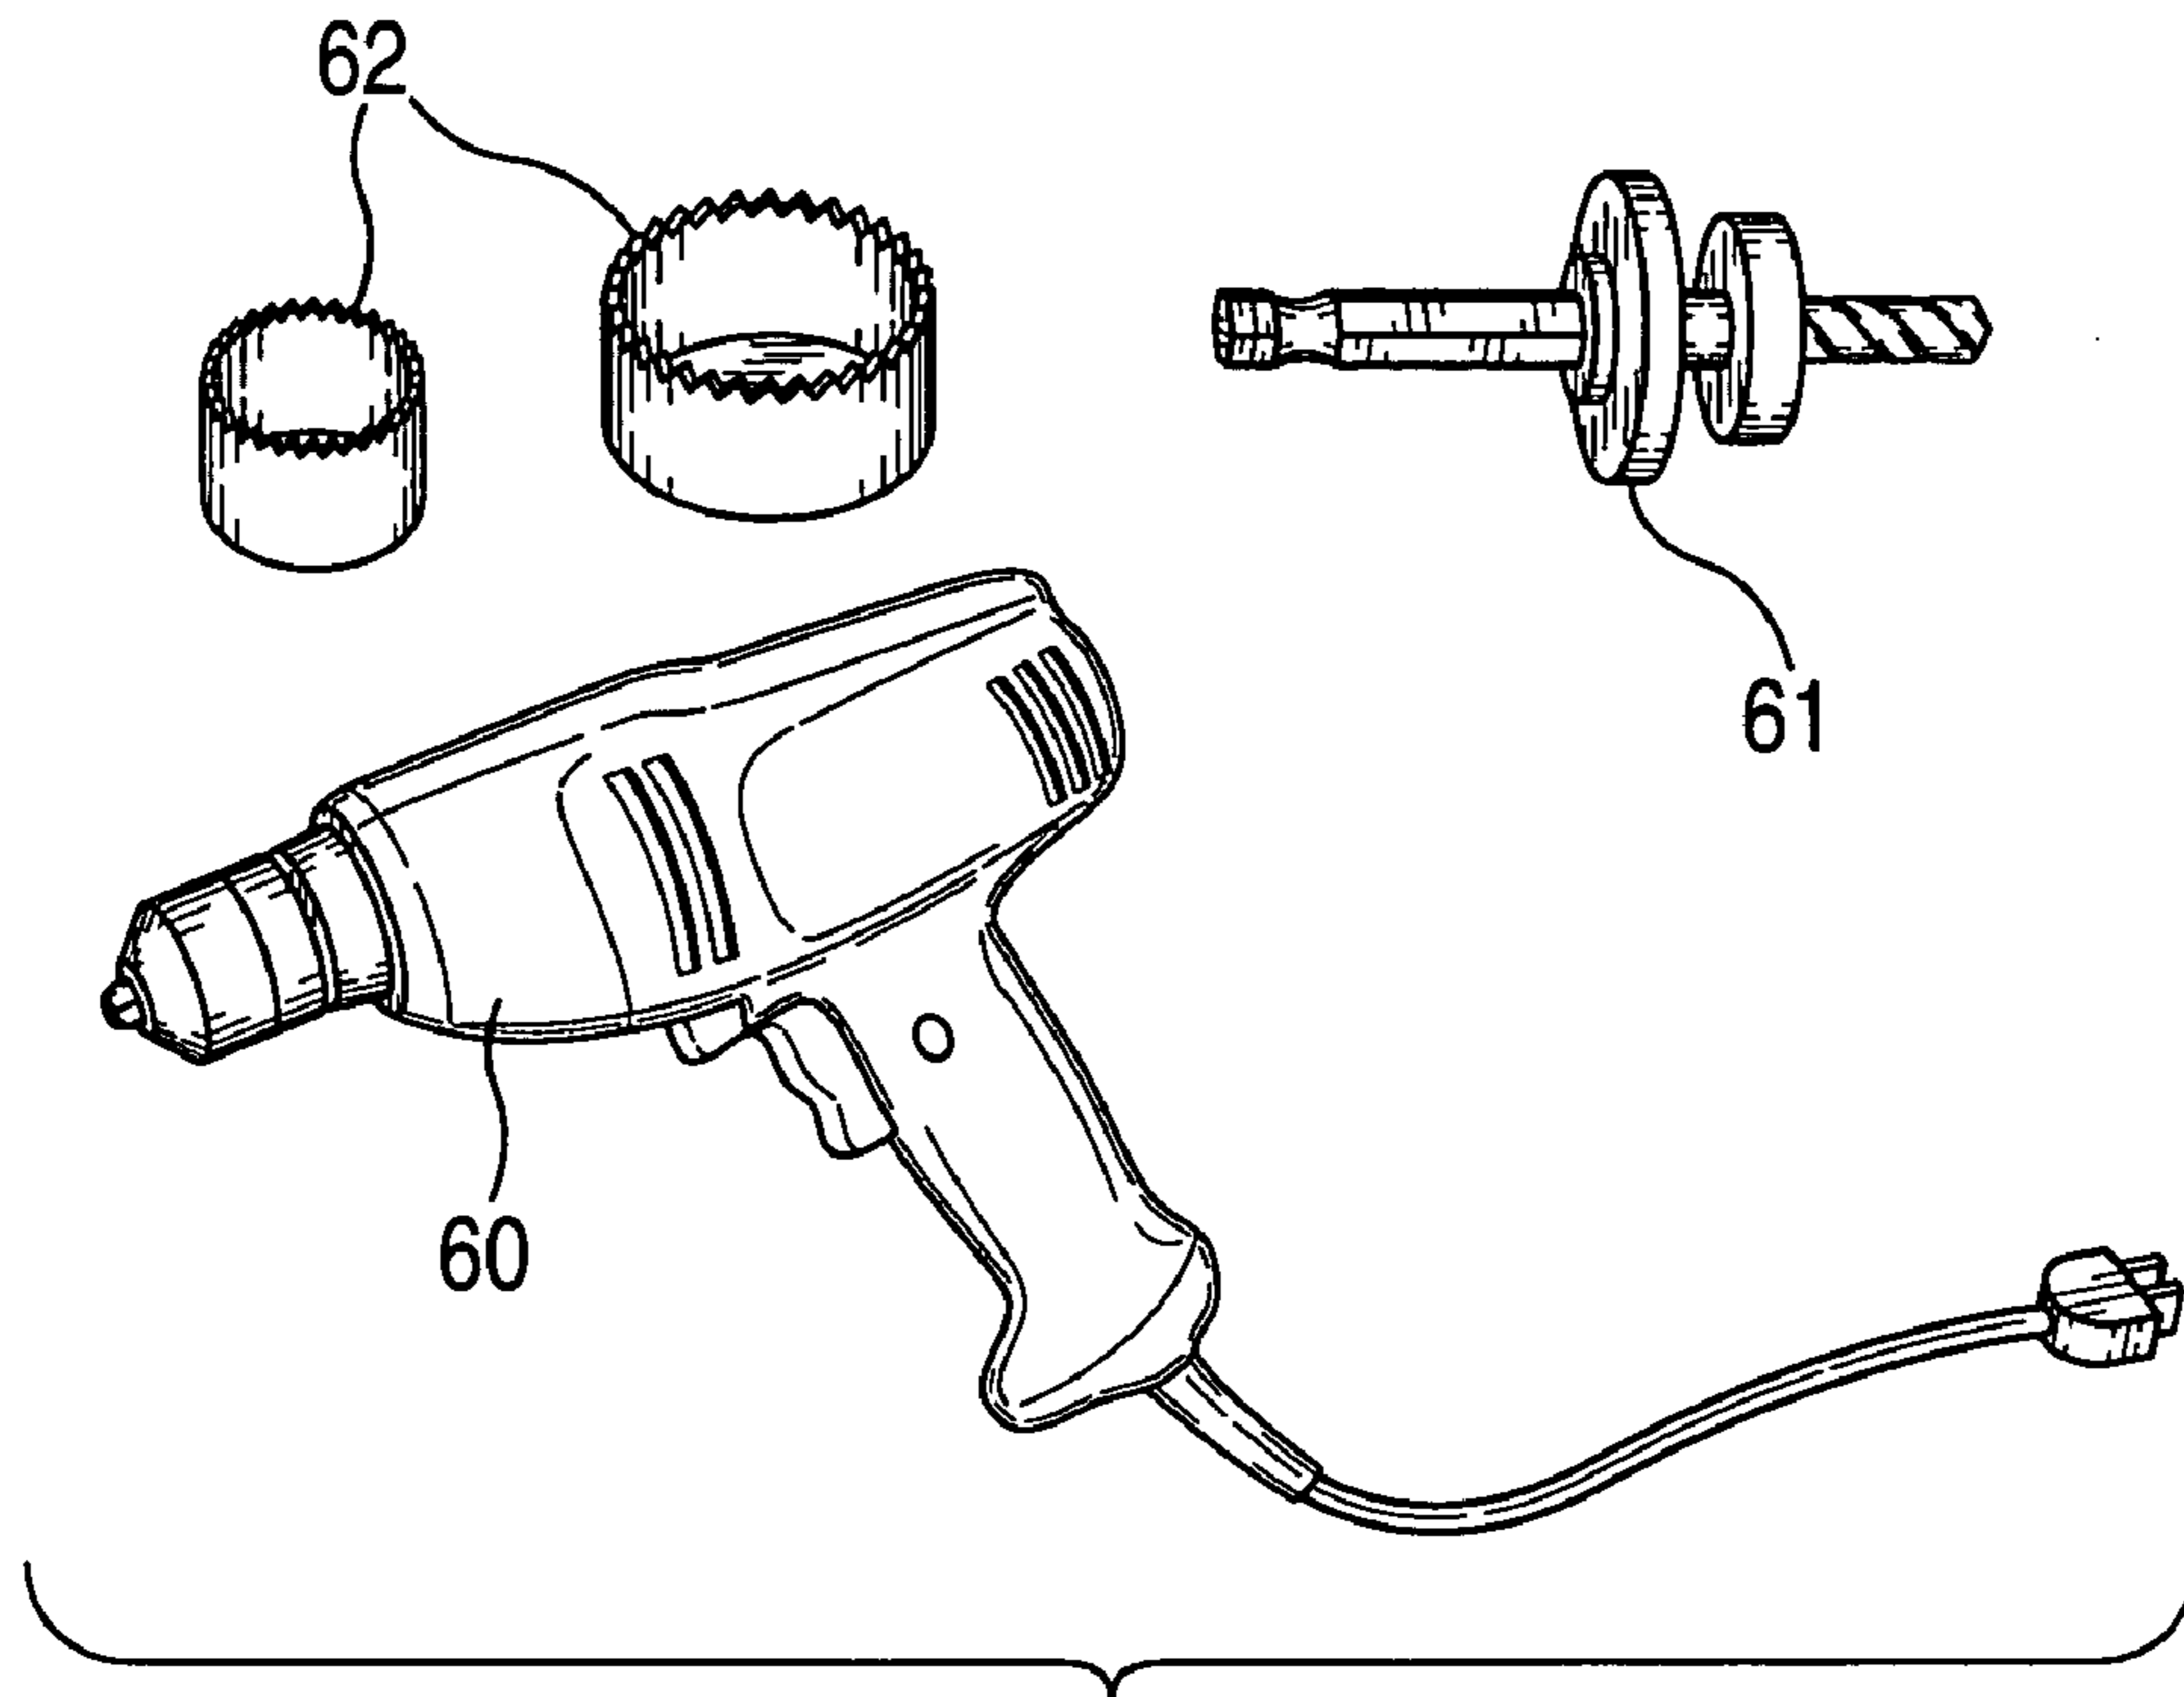
FIG. 5 is a close-up detail view of saw equipment used for introducing incision holes of the system and method of the present invention;

FIG. 5 shows hole saw equipment including electric drill driver 60, mandrel 61, and two sizes of hole saw 62. A cordless version can be used as well.

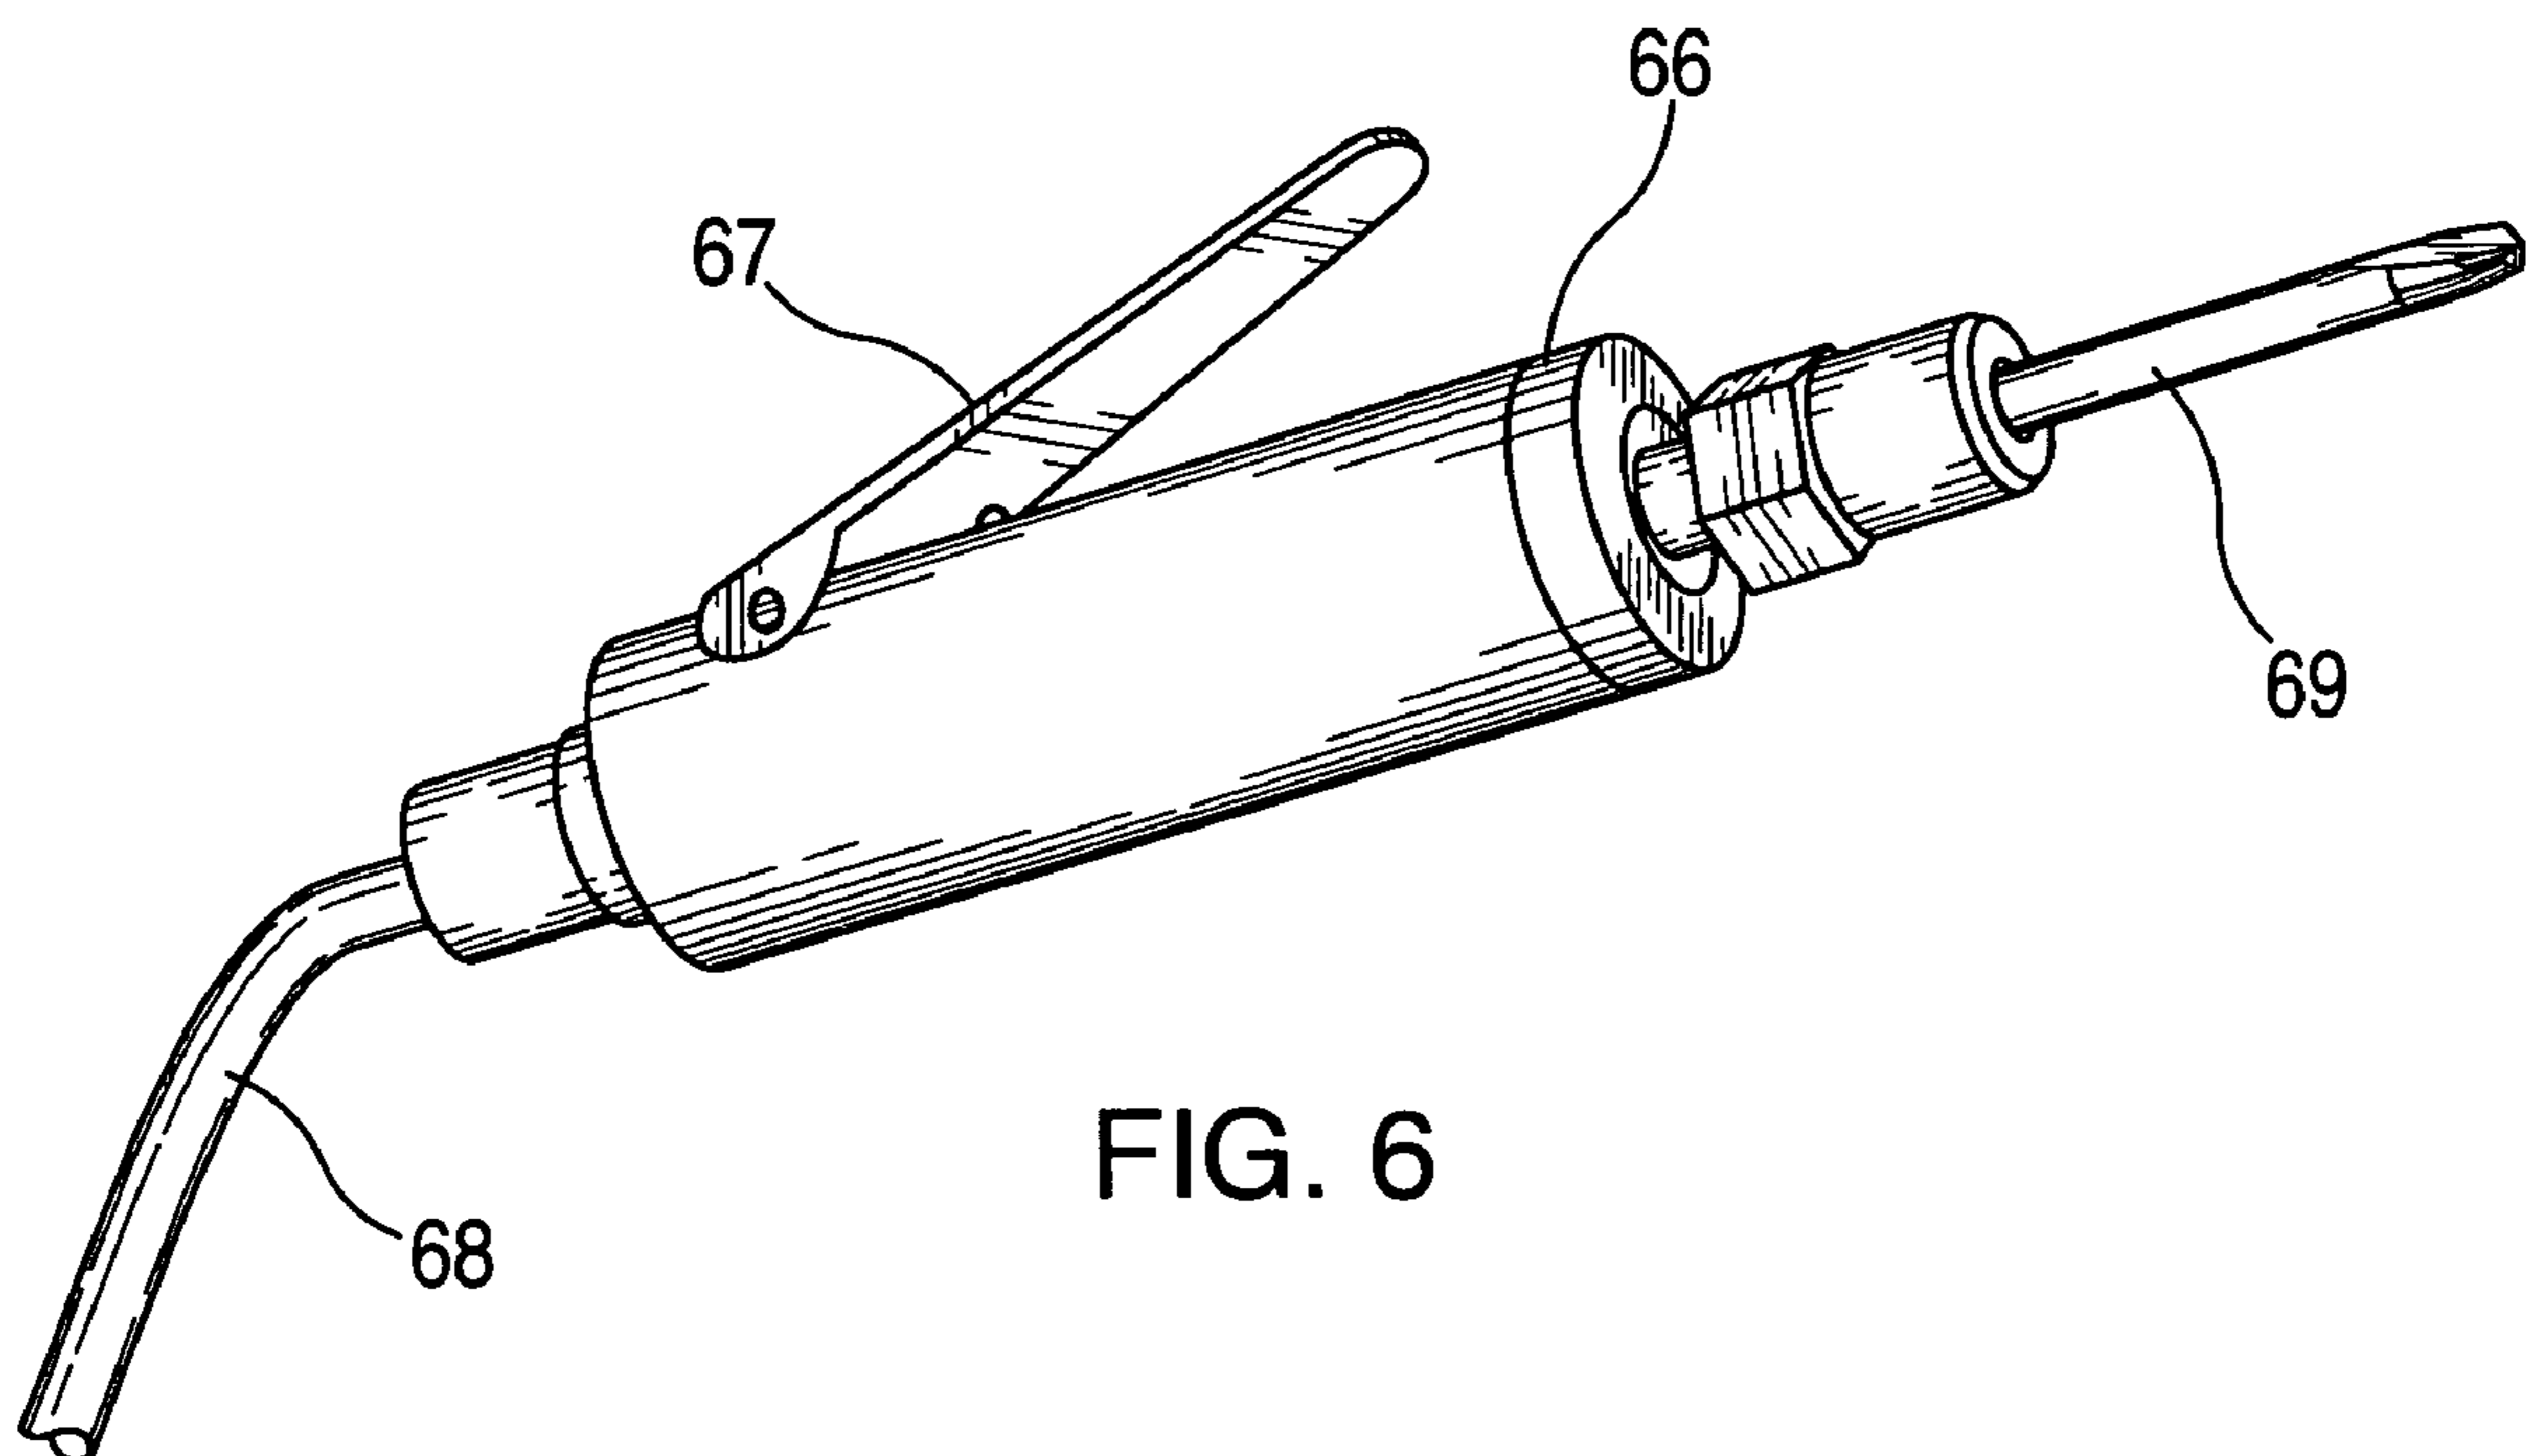
FIG. 6 is a perspective view of a straight oriented hand-held drilling and routing tool of the system and method of the present invention;

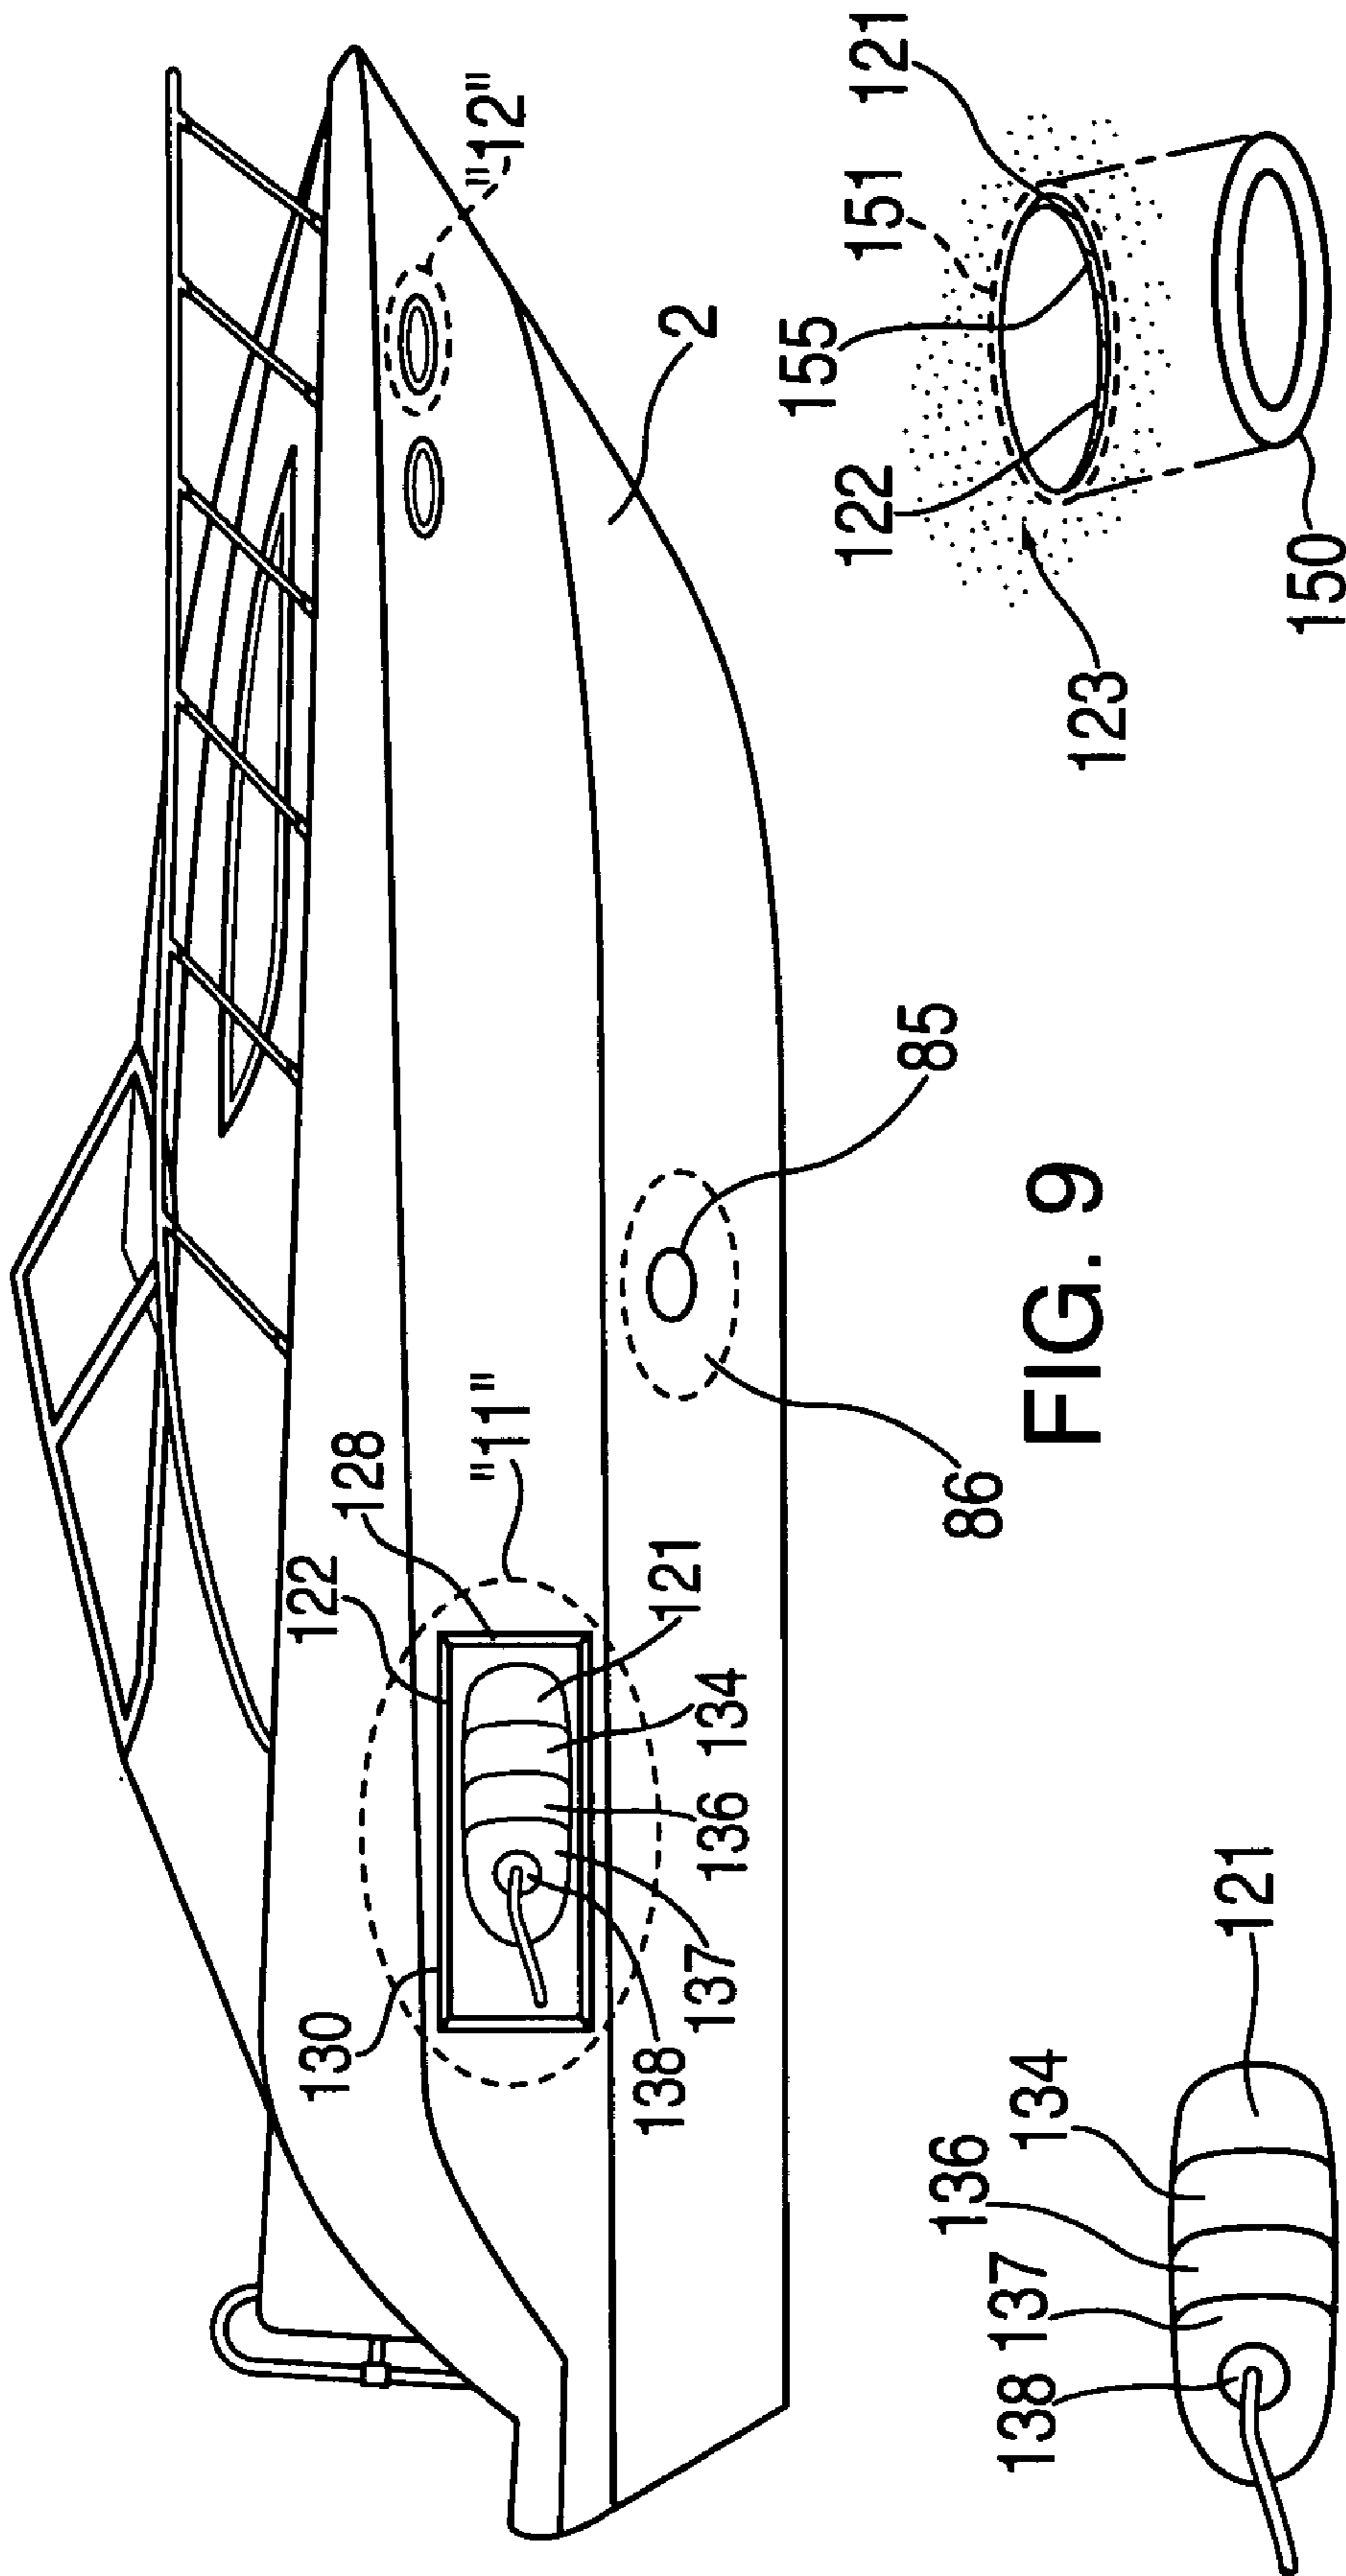
FIG. 9 is a close-up elevational view of a portion of a boat hull being treated in accordance with the system and method of the present invention;

Obviously, all removed items must be replaced after the repair. If the de-coring is performed from the exterior of the hull, access is more easy. The procedure is similar to that in FIG. 11, but it is the outer laminate instead of the inner laminate that is penetrated. Also, It is the schedule and finish of the outer laminate that must be matched in the final steps.

The general preventive maintenance guidelines call for three different approaches applicable to three different regions of a hull. First, all dry areas below the waterline are to be disassembled, de-cored and reassembled with new sealant. The steps in this procedure are detailed in the discussion of FIG. 12. Secondly, all dry areas above the waterline will be cleaned of all old sealant around the outside edge of the hardware; then the hardware is resealed from the exterior with a new bead of sealant. Third, all gunnel/stainless is removed and inspected. The steps for preventive maintenance of this region are described in the text for the maintenance chart of FIG. 10B.
