US007252727B2

(54) **REPAIR SYSTEM AND METHOD FOR FIBERGLASS BOATS**

A method to repair moisture damaged wood core boat hulls remotely identifies and repairs all wet core hull areas and optionally performs preventive maintenance on dry hull areas to restore the integrity of a fiberglass boat hull and prevent new water infiltration damage to a boat hull. The wet area repair guidelines using a surface moisture meter Any balsa cored area reading 15% or above is considered a wet area. Any wood cored area reading 20% or above is considered a wet area. The repair steps involves removing all through-hull fittings or hardware. Wet core areas are then dried out using heat lamps, lights or heaters, hot-vac systems, or octopus vacuum with grid system. If necessary, any area not drying out is de-cored and repaired accordingly. After repairs are finished, all through-hull fittings or hardware is reinstalled using new sealant.

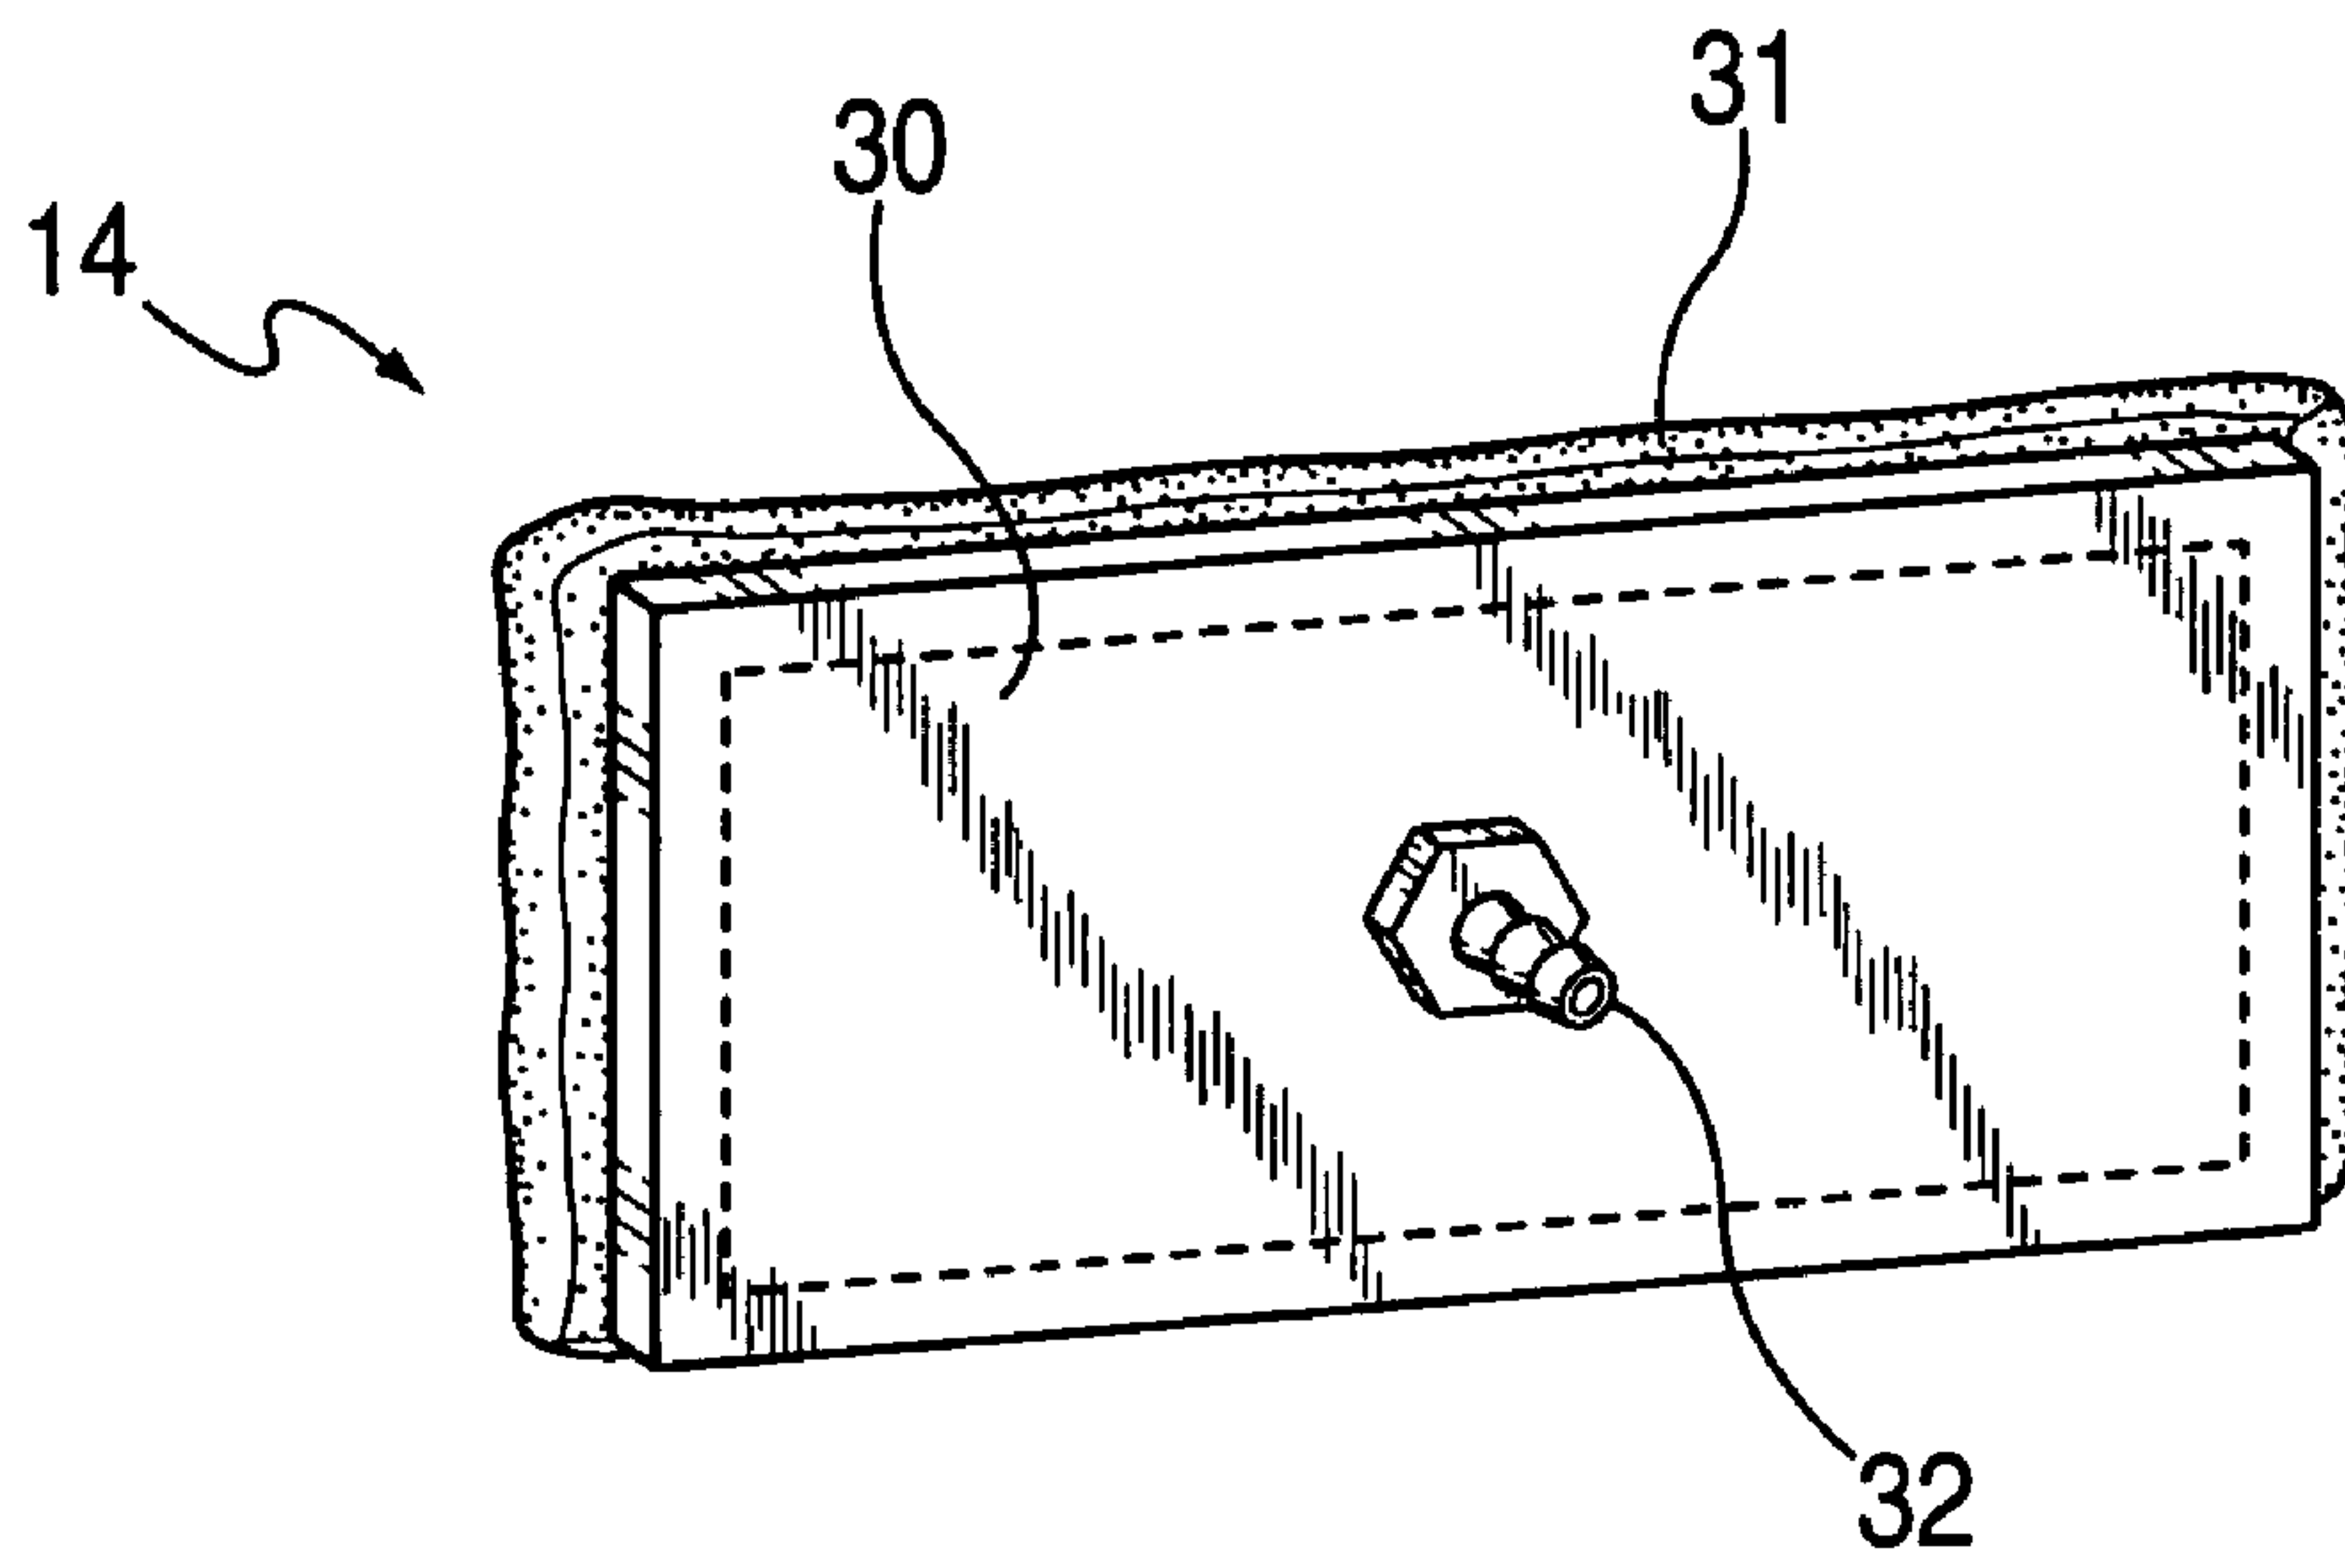
FIG. 3 is a close-up perspective detail view of a vacuum draw plate used in connection with vacuum cleaning of moisture and damaged wood core debris of a boat hull being treated in accordance with the system and method of the present invention;

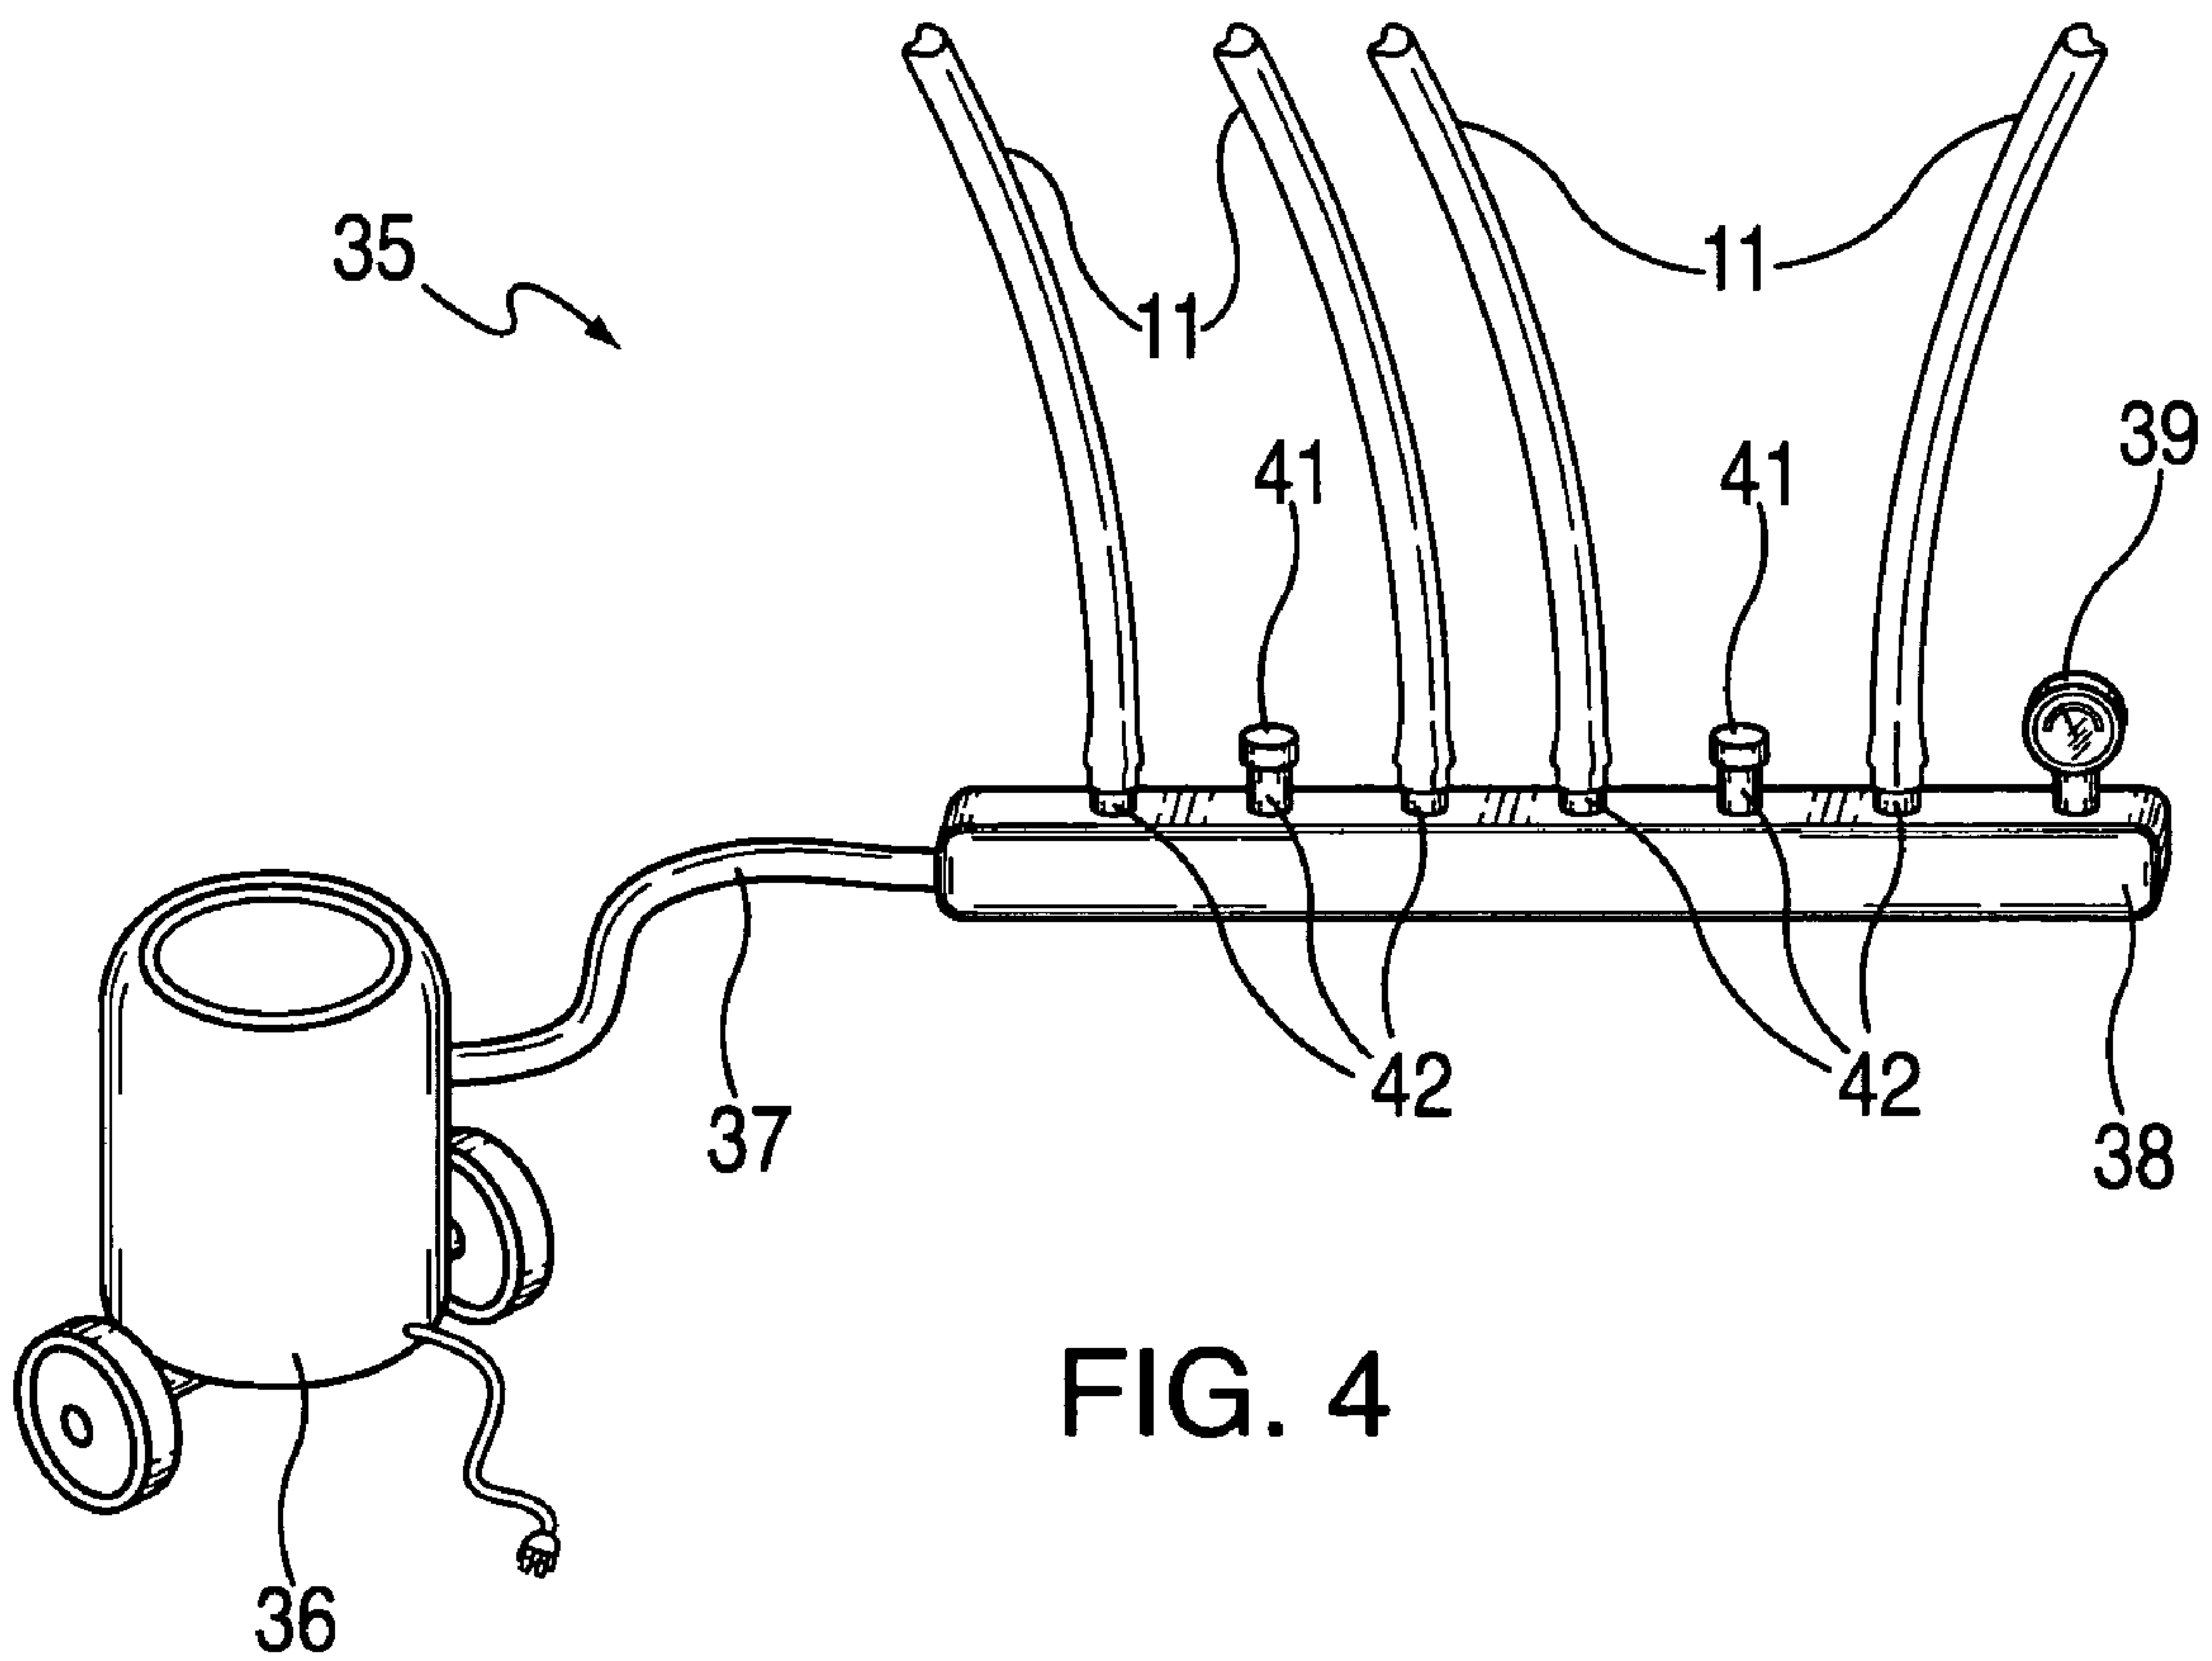
FIG. 4 is a close-up perspective view of the vacuum system of the present invention;

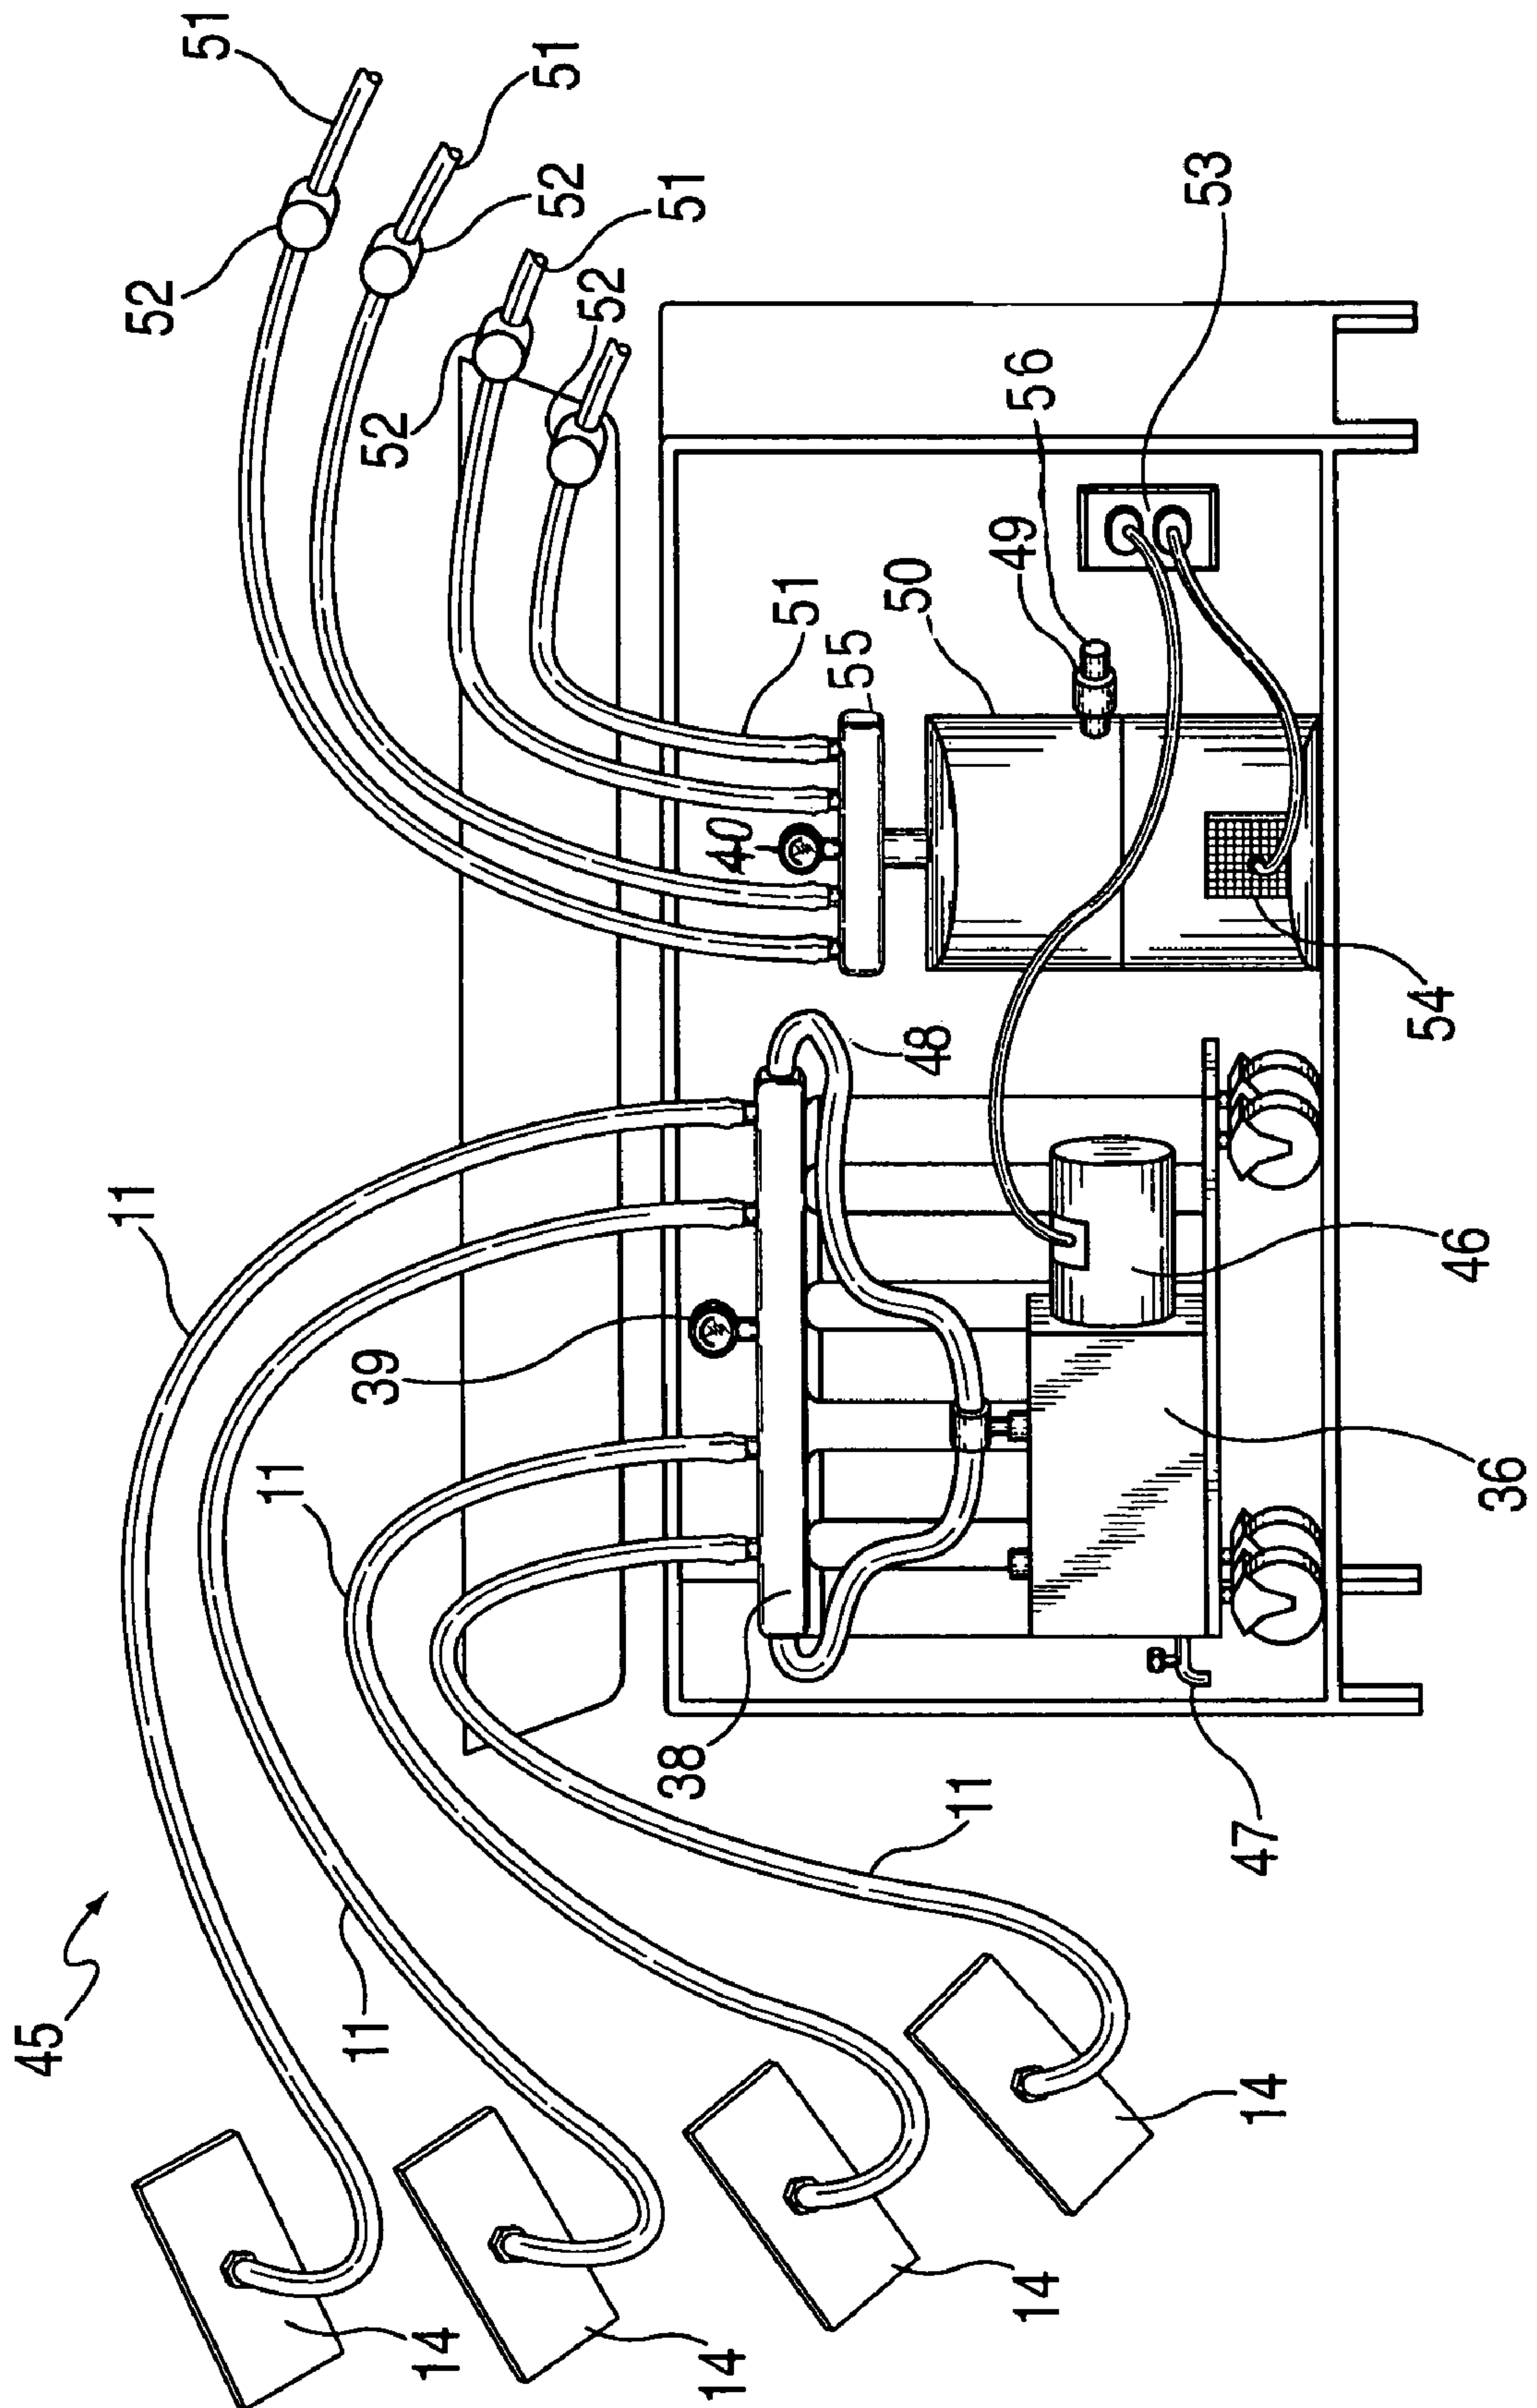
FIG. 4A is a perspective view of the vacuum and pressure systems shown in place at a boat hull to be repaired;

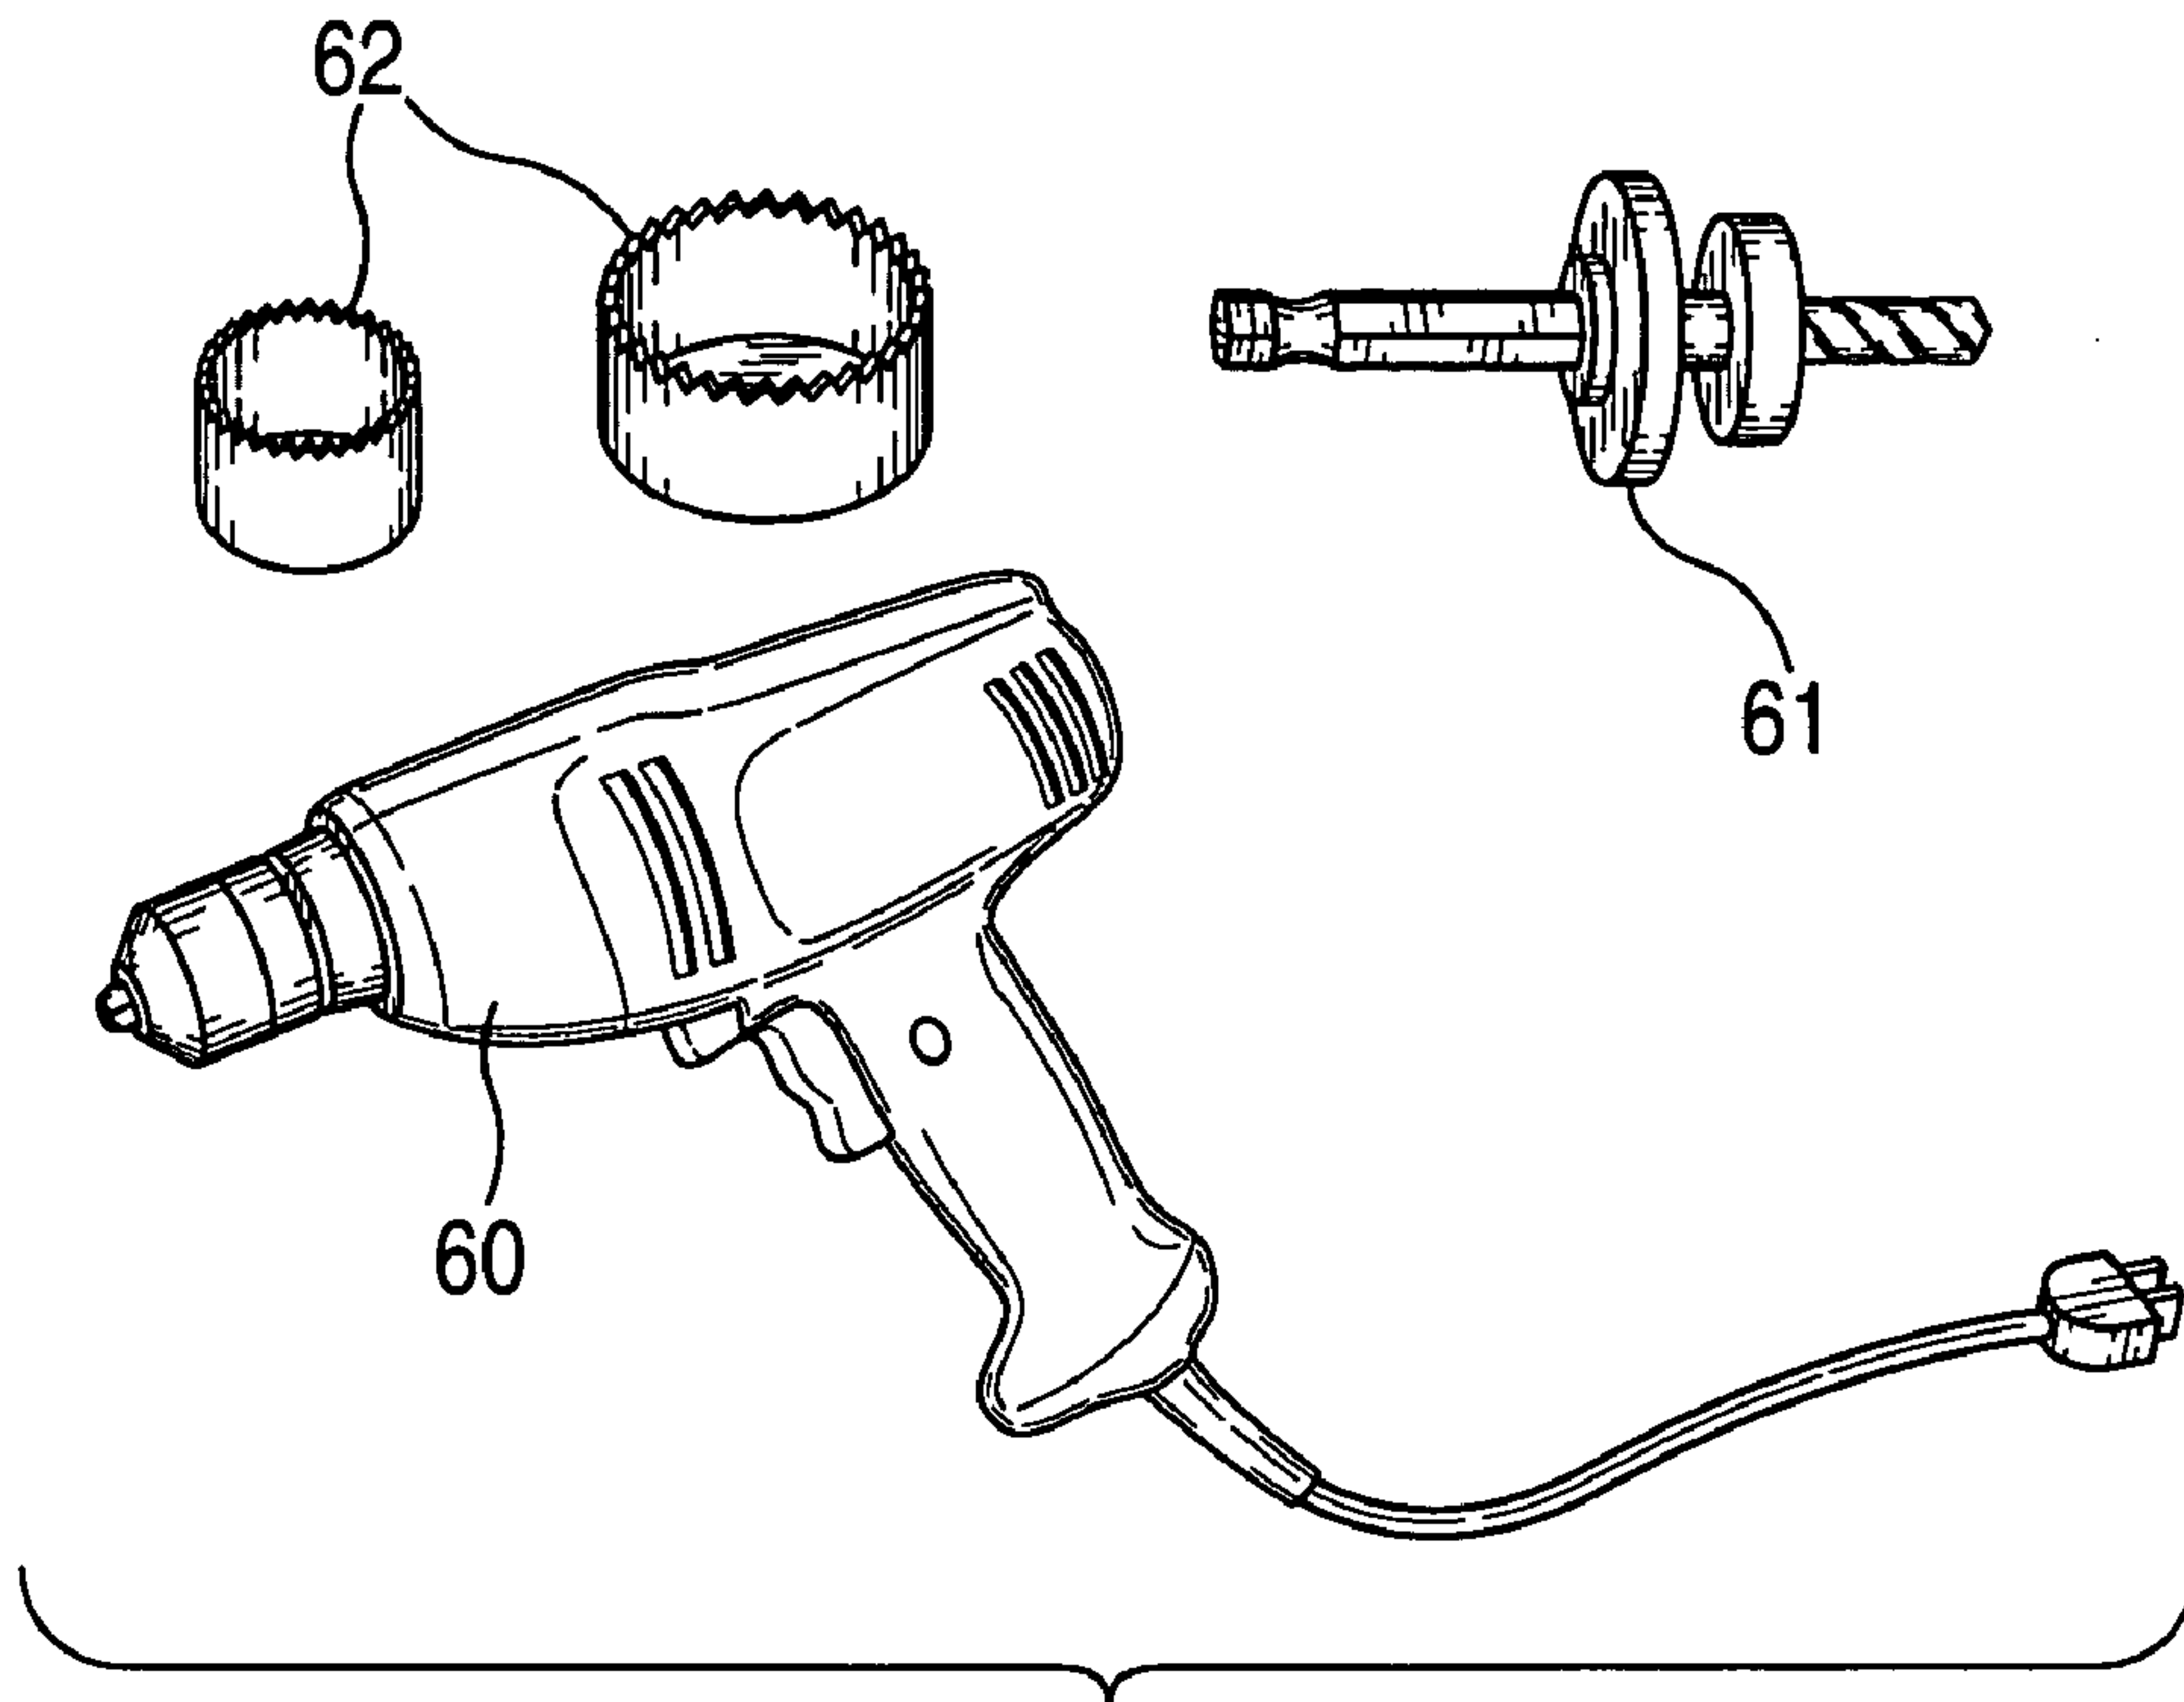
FIG. 5 is a close-up detail view of saw equipment used for introducing incision holes of the system and method of the present invention;

FIG. 5 shows hole saw equipment including electric drill driver 60, mandrel 61, and two sizes of hole saw 62. A cordless version can be used as well.

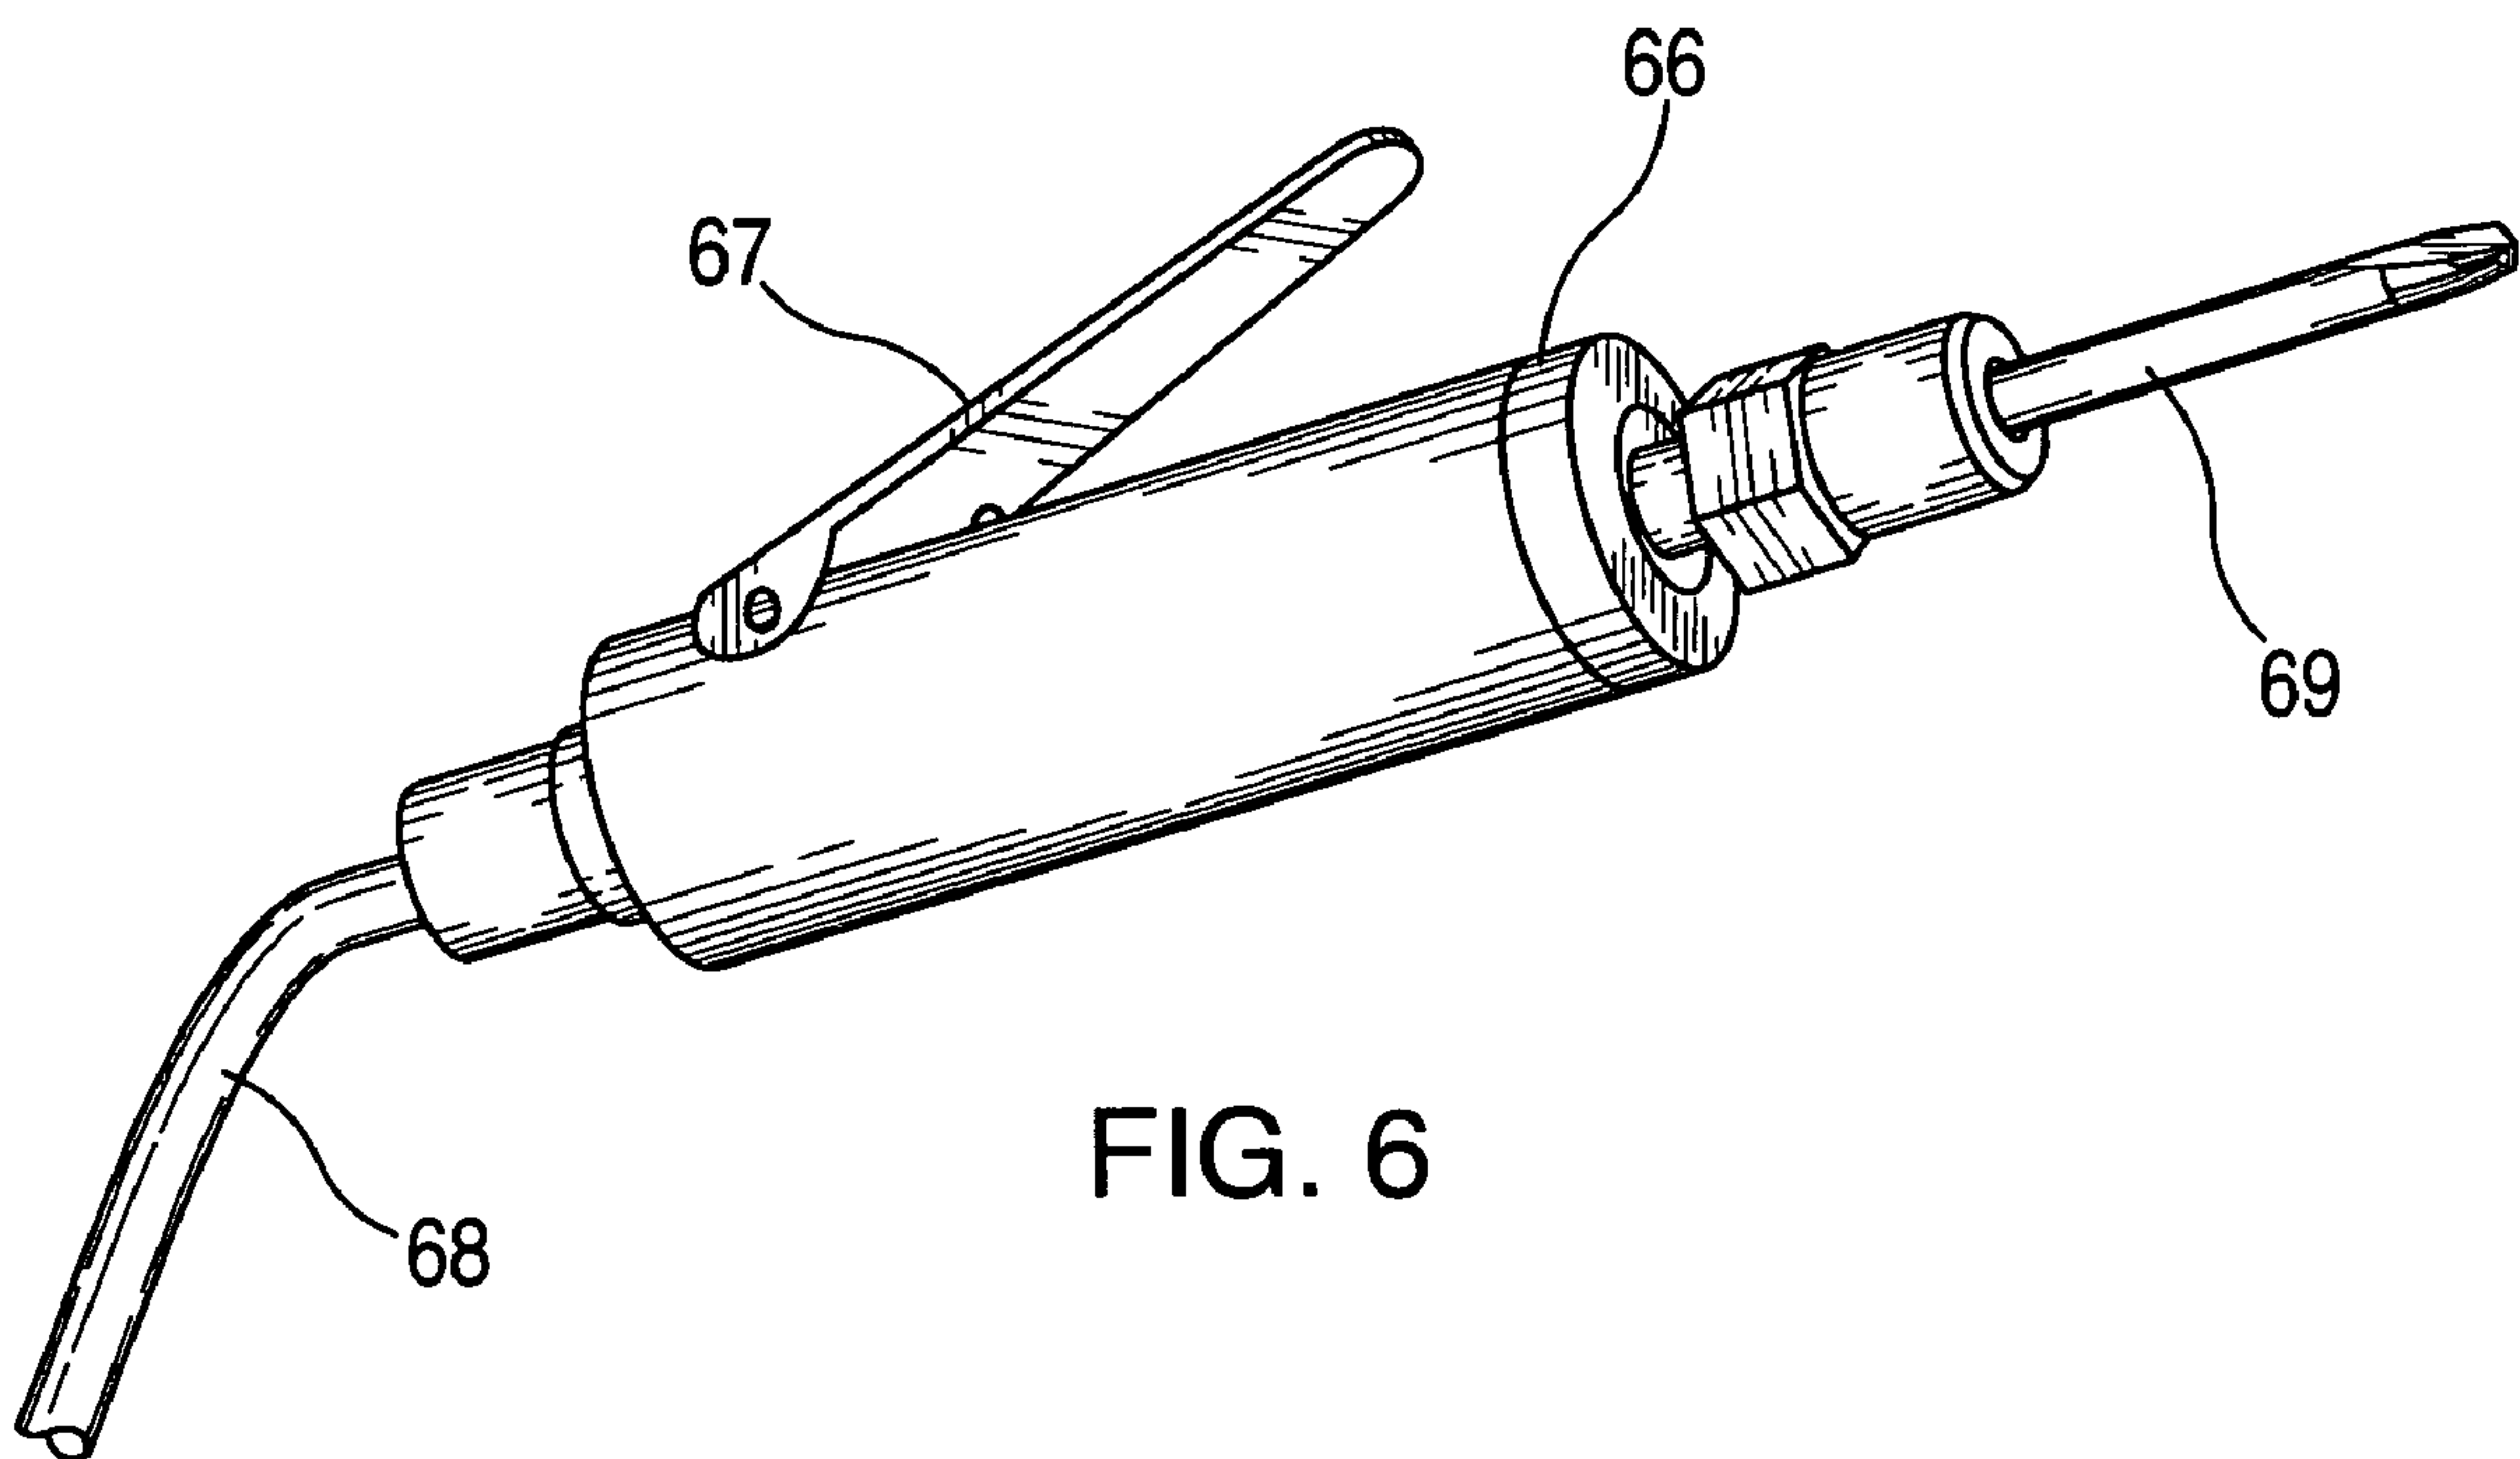
FIG. 6 is a perspective view of a straight oriented hand-held drilling and routing tool of the system and method of the present invention;

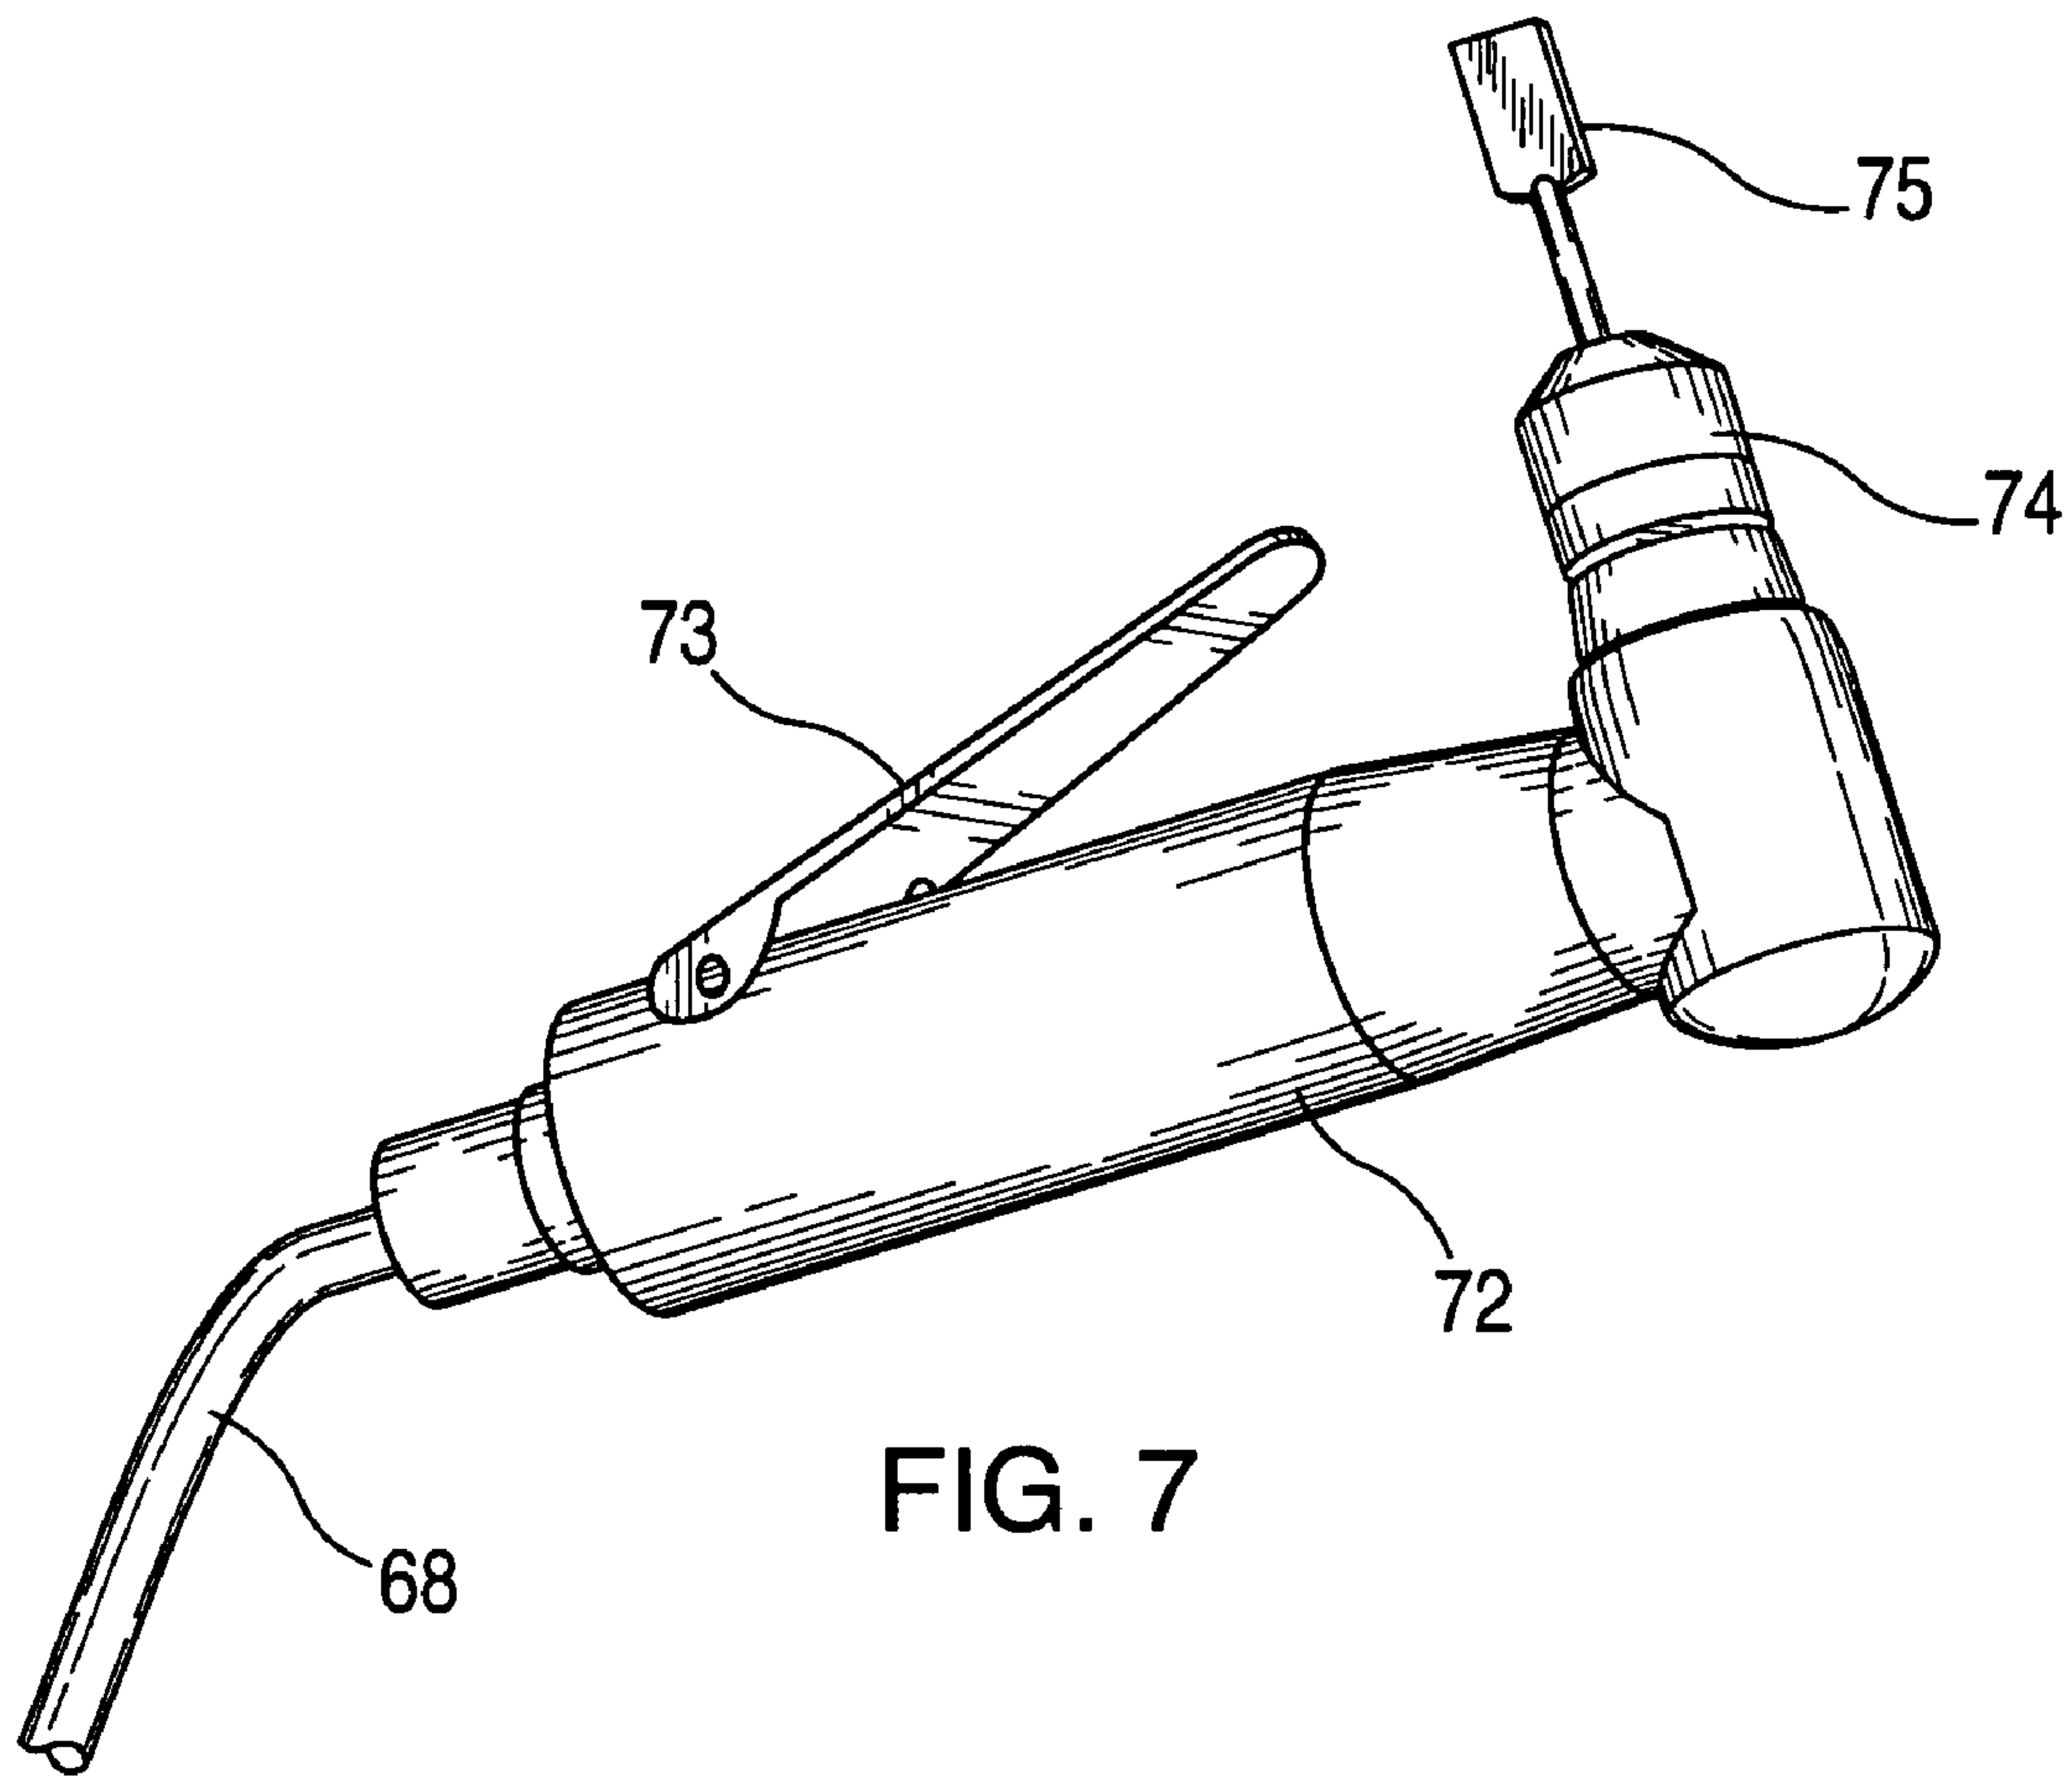
FIG. 7 is a perspective view of a bent, right angle oriented hand-held drilling and routing tool of the system and method of the present invention;
