US007252727B2

(54) **REPAIR SYSTEM AND METHOD FOR FIBERGLASS BOATS**

A method to repair moisture damaged wood core boat hulls remotely identifies and repairs all wet core hull areas and optionally performs preventive maintenance on dry hull areas to restore the integrity of a fiberglass boat hull and prevent new water infiltration damage to a boat hull. The wet area repair guidelines using a surface moisture meter Any balsa cored area reading 15% or above is considered a wet area. Any wood cored area reading 20% or above is considered a wet area. The repair steps involves removing all through-hull fittings or hardware. Wet core areas are then dried out using heat lamps, lights or heaters, hot-vac systems, or octopus vacuum with grid system. If necessary, any area not drying out is de-cored and repaired accordingly. After repairs are finished, all through-hull fittings or hardware is reinstalled using new sealant.

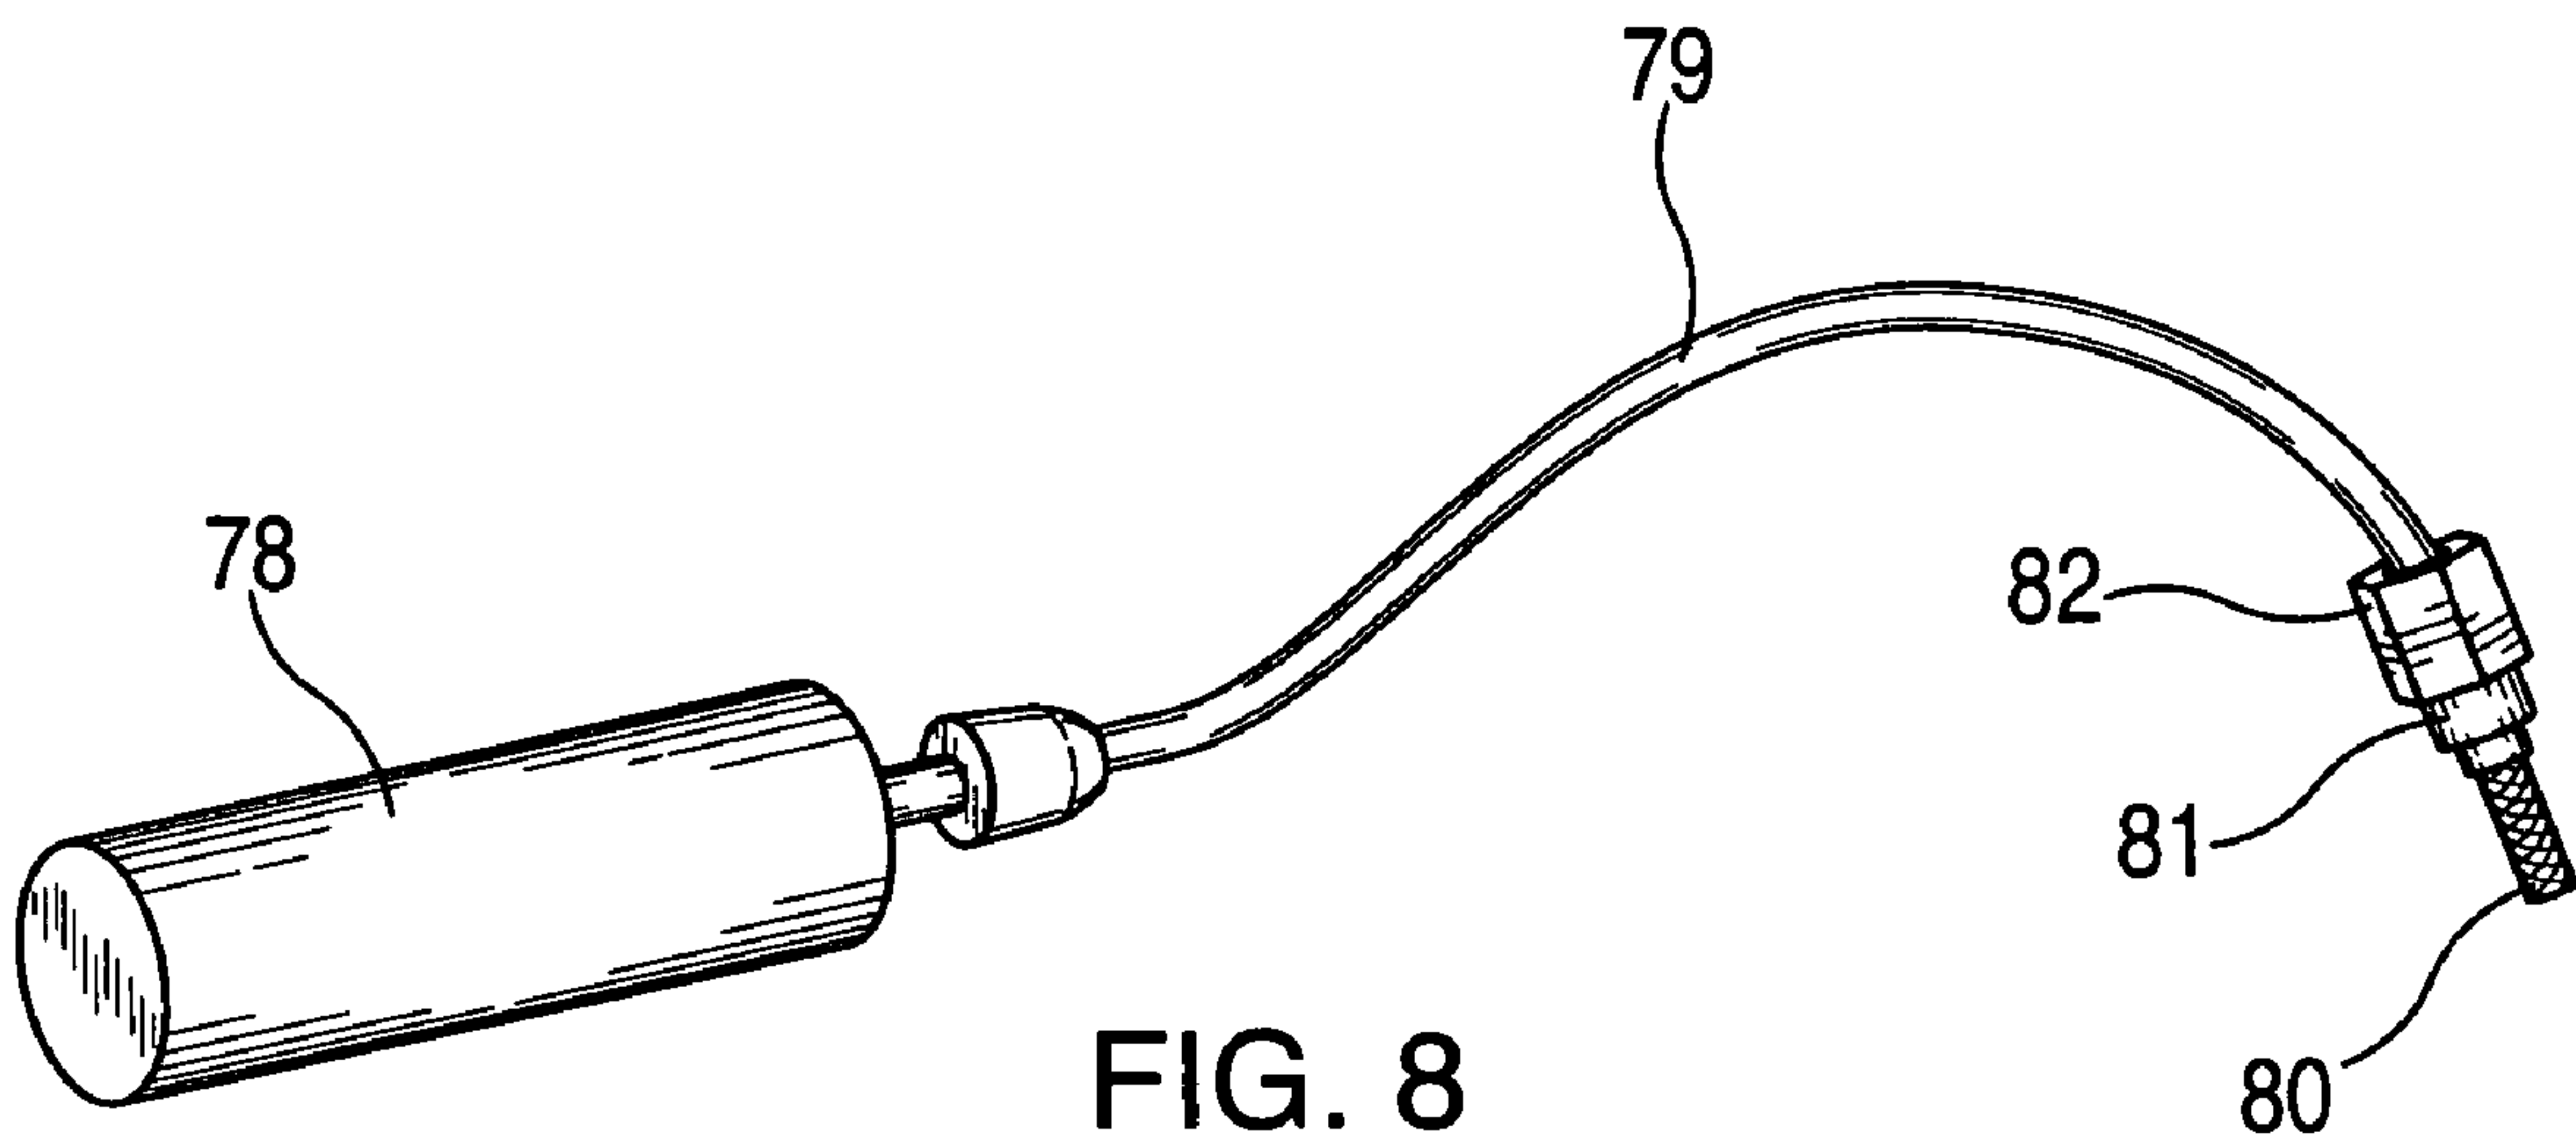
FIG. 8 is a perspective view of a flexible oriented hand-held drilling and routing tool of the system and method of the present invention;

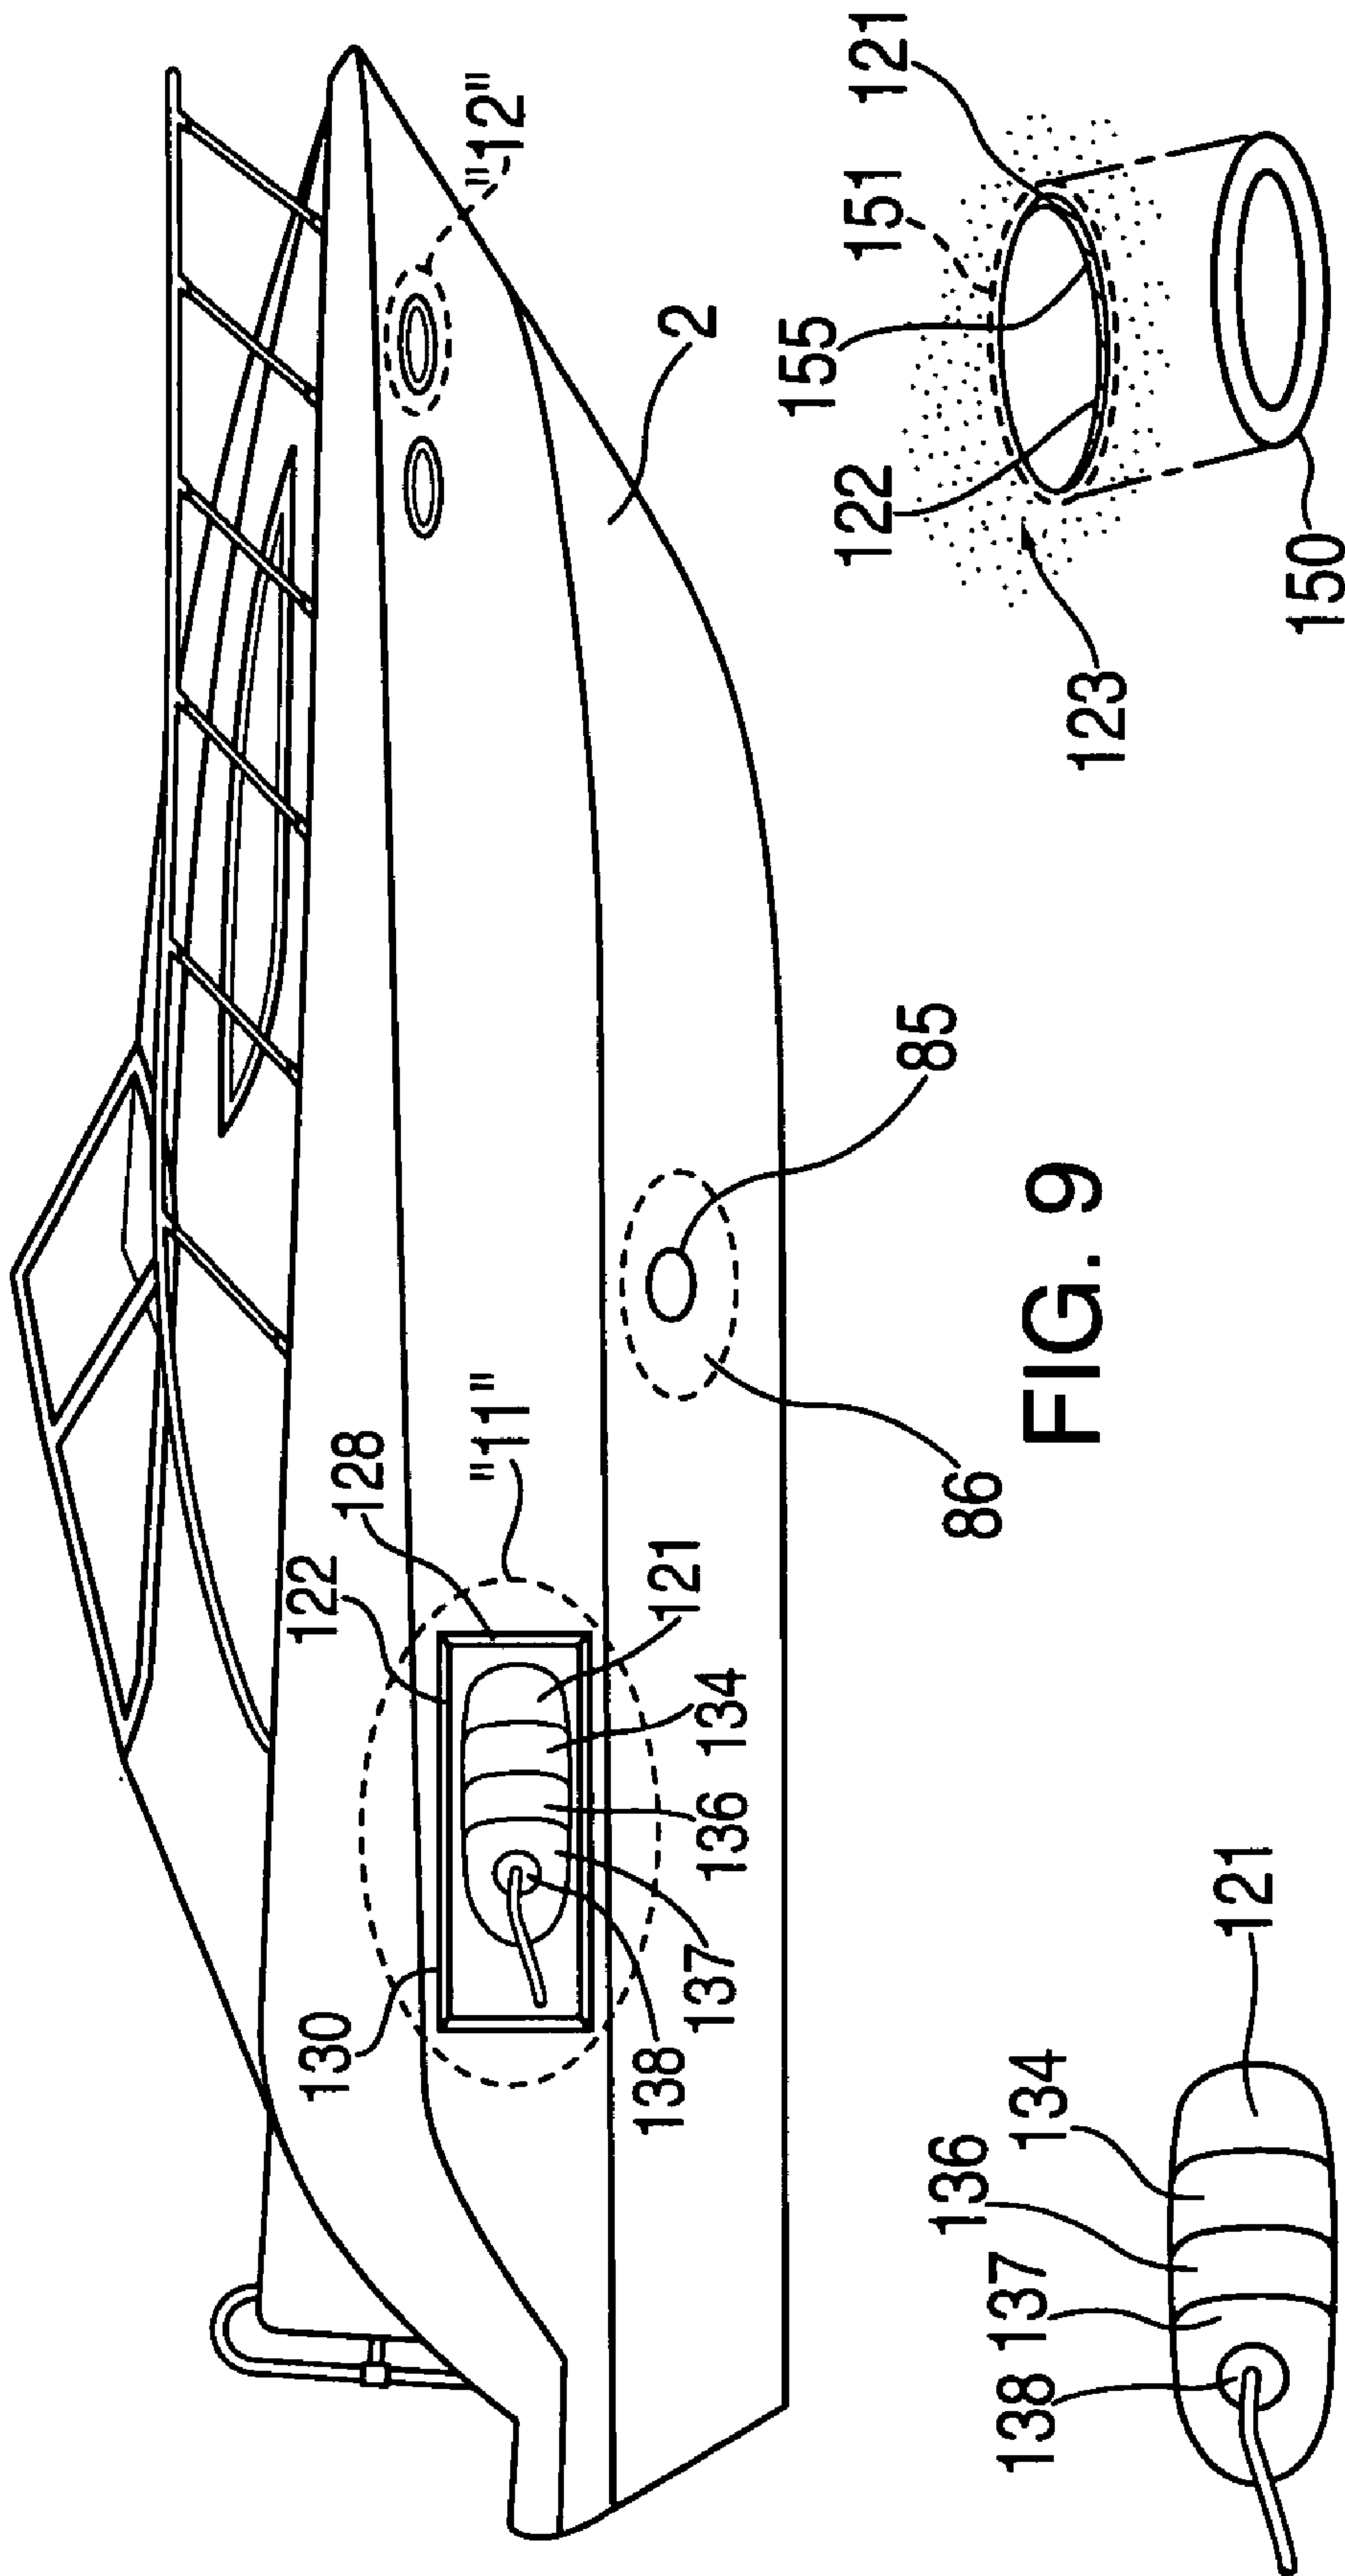
FIG. 9 is a close-up elevational view of a portion of a boat hull being treated in accordance with the system and method of the present invention;

Obviously, all removed items must be replaced after the repair. If the de-coring is performed from the exterior of the hull, access is more easy. The procedure is similar to that in FIG. 11, but it is the outer laminate instead of the inner laminate that is penetrated. Also, It is the schedule and finish of the outer laminate that must be matched in the final steps.

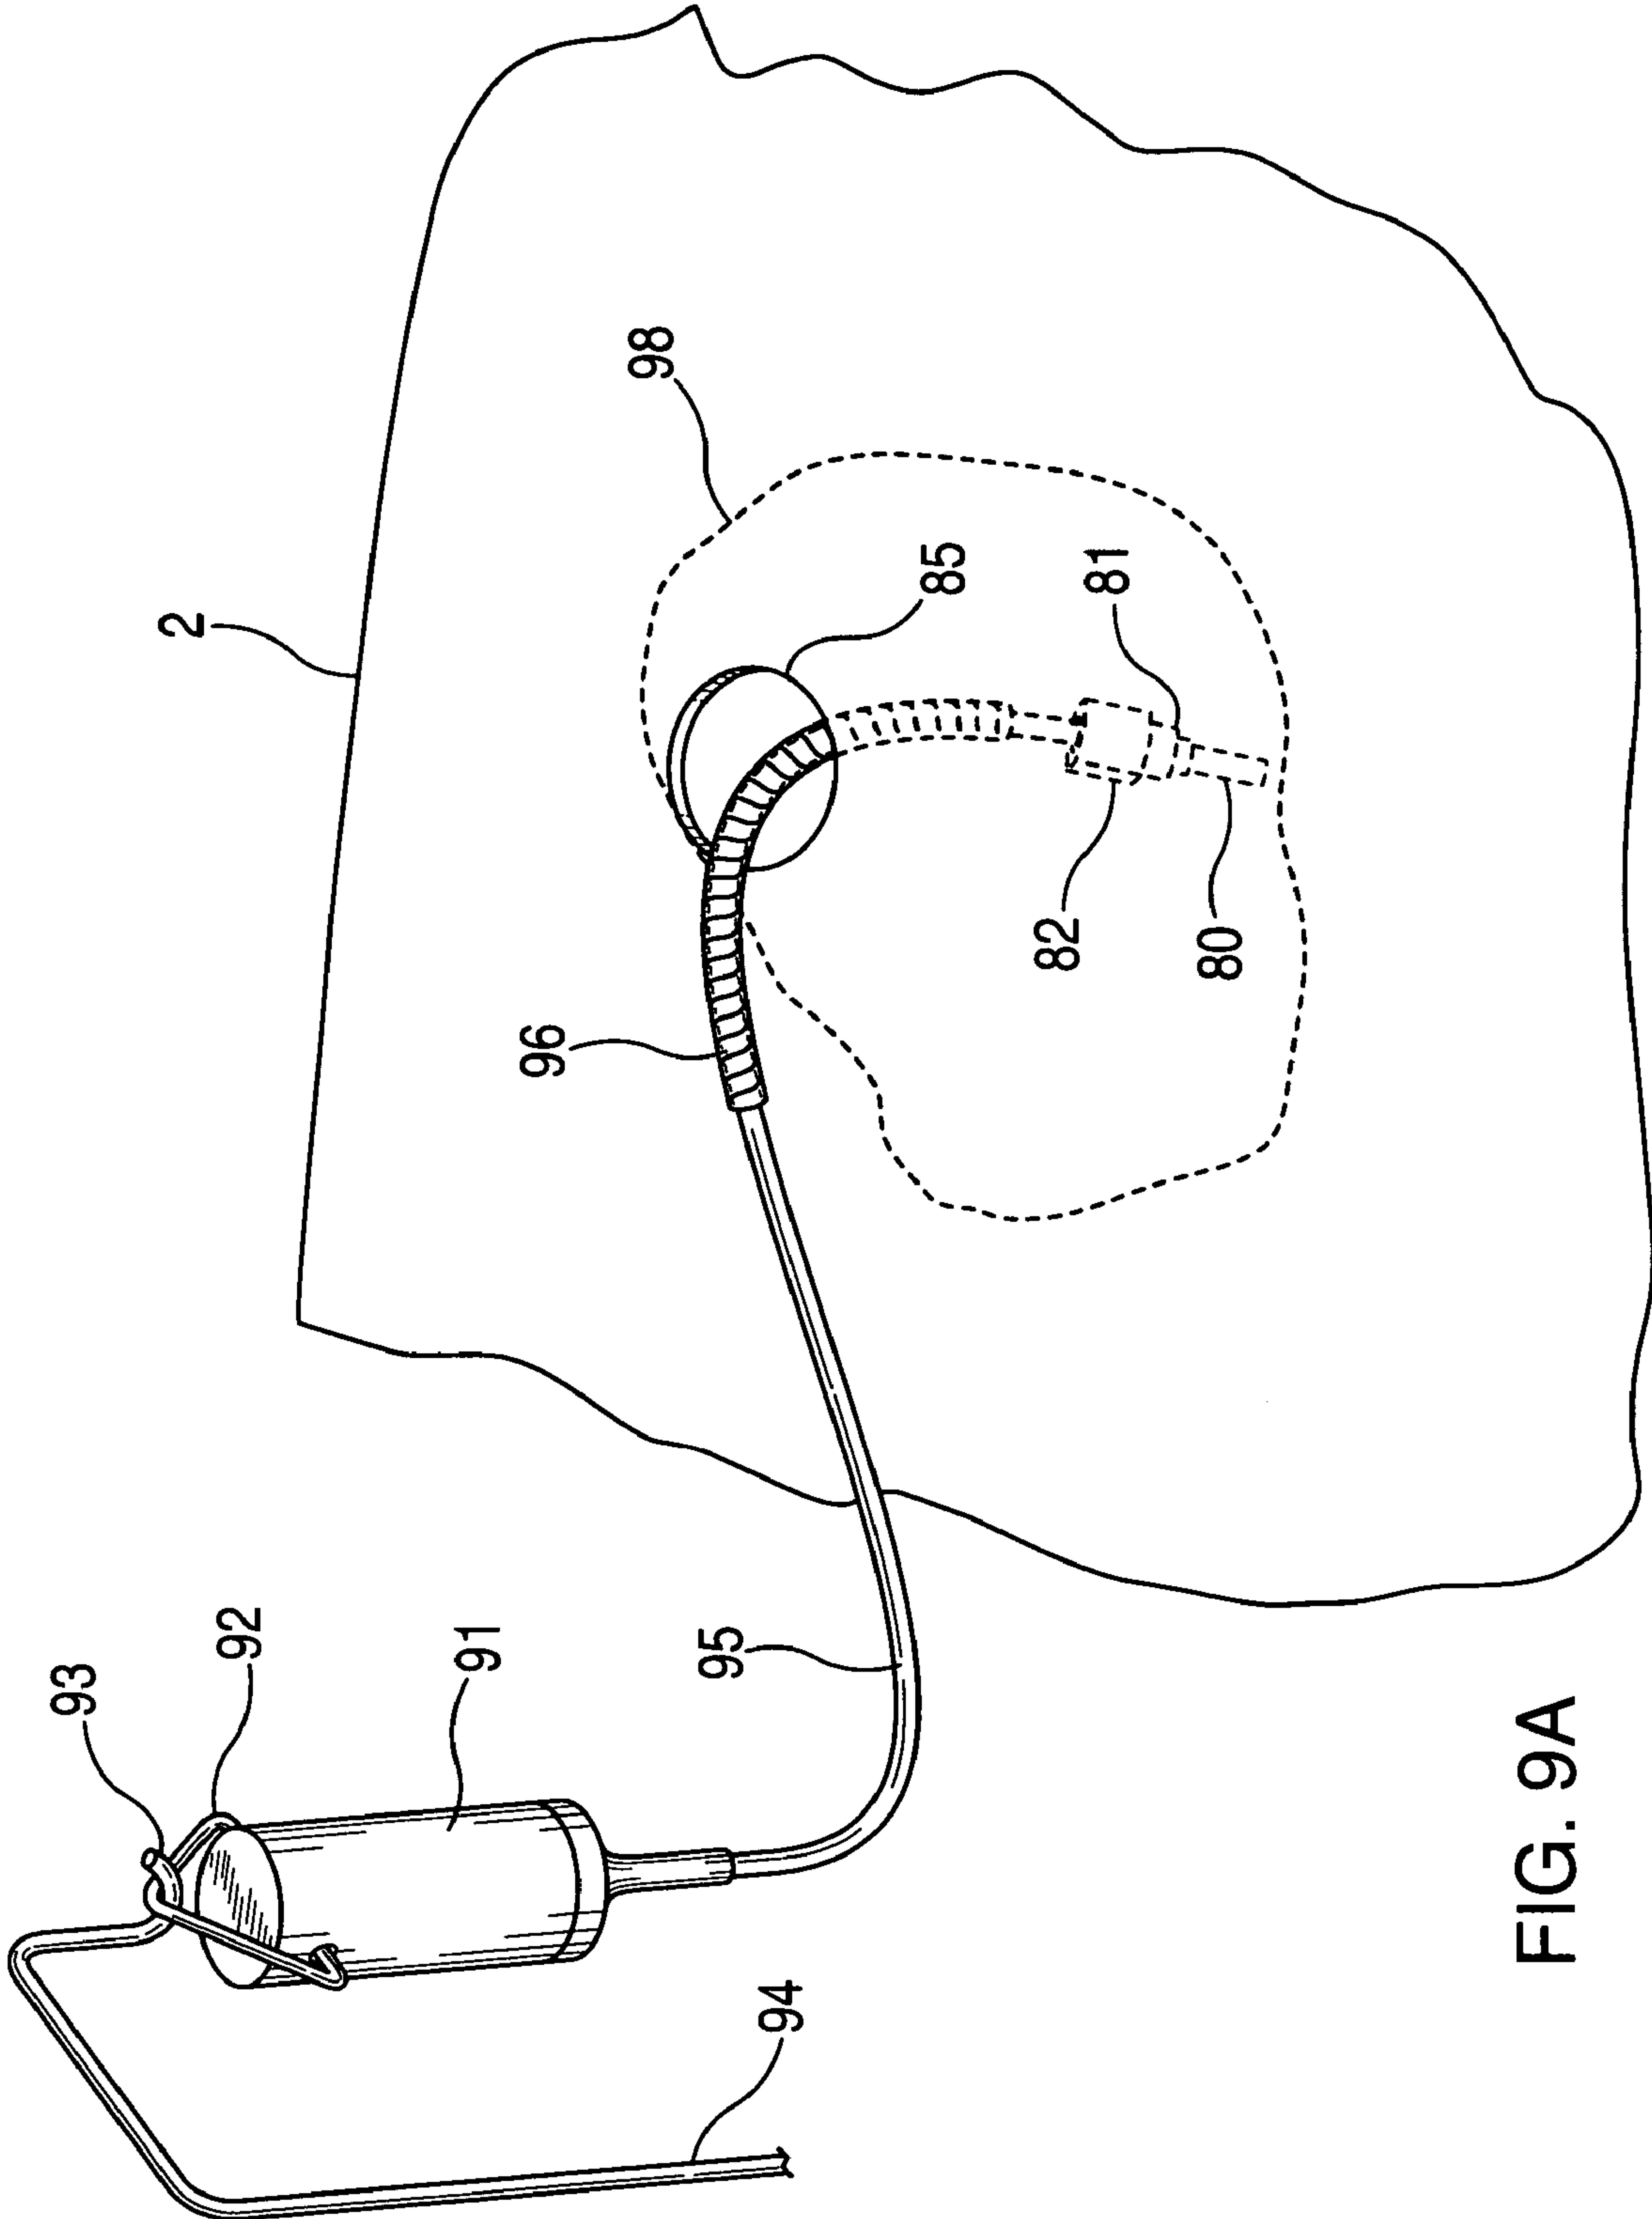
FIG. 9A is a close-up elevational view of a flexible auger used on a portion of a boat hull being treated with the system and method of the present invention;

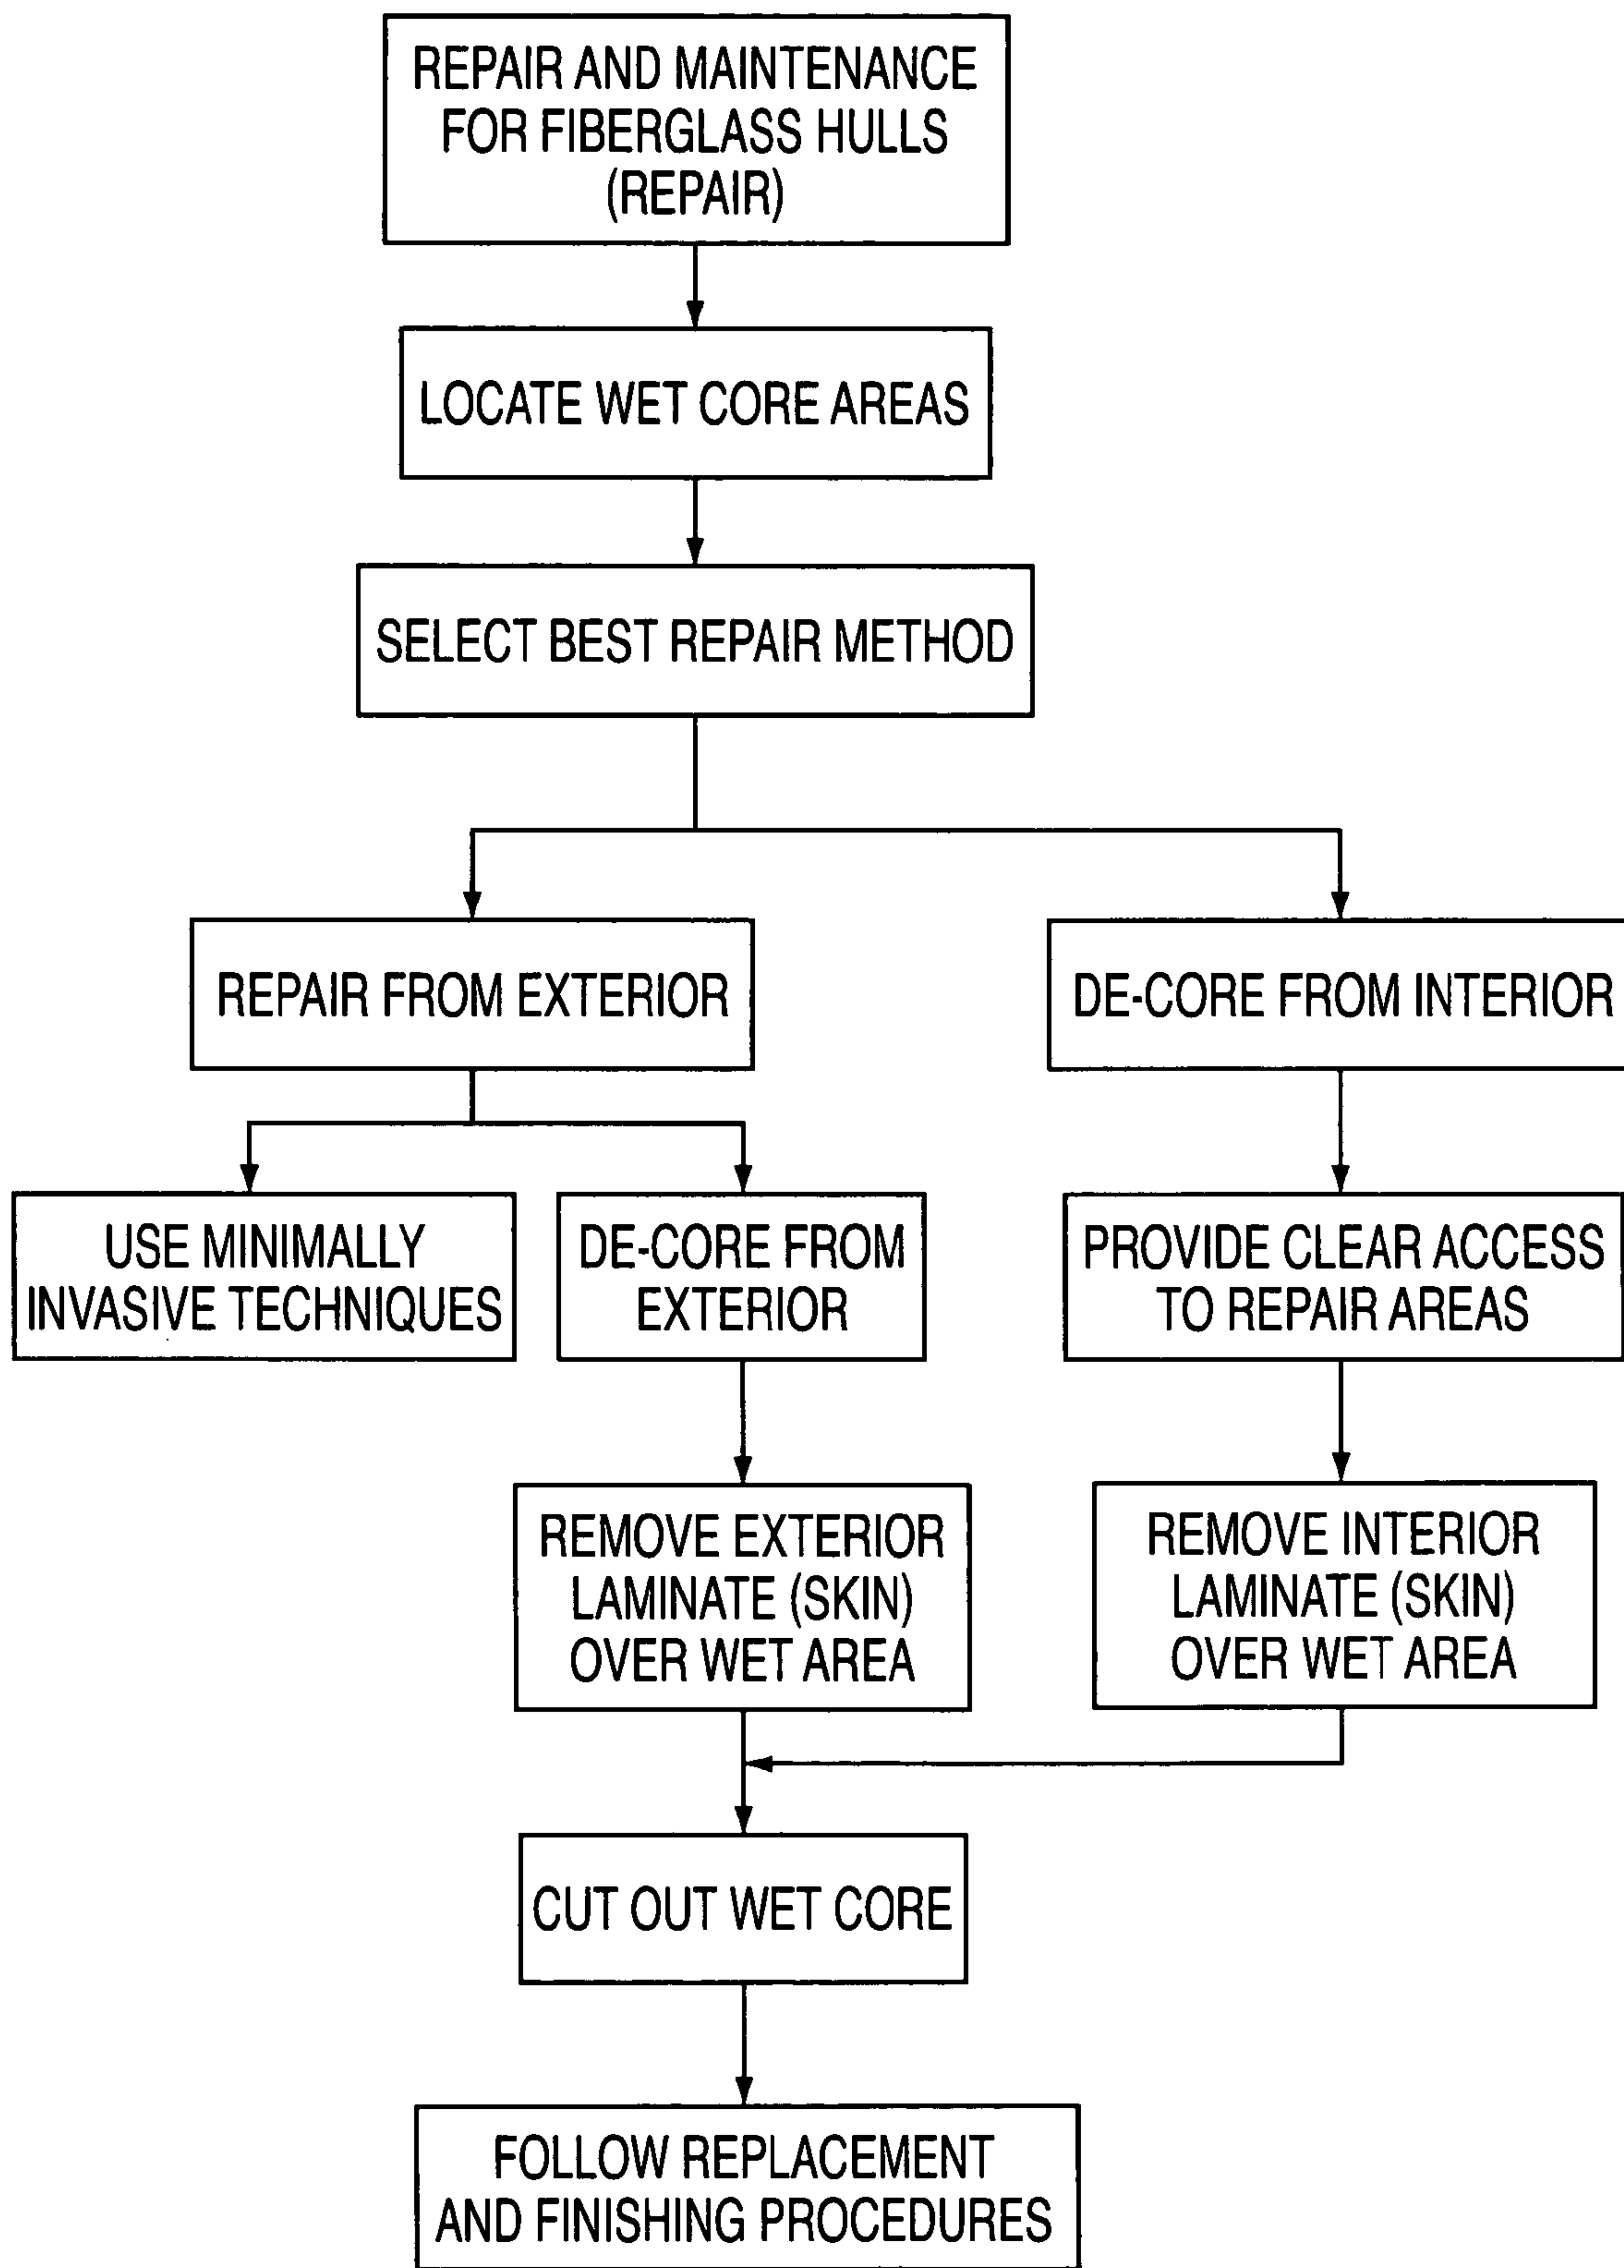
FIG. 10A is a chart showing the relation between the different repair techniques of this invention for repair of wet core damaged areas in fiberglass boat hulls;
