(10) **Patent No.:** **US 7,278,829 B2**
(45) **Date of Patent:** **Oct. 9, 2007**

(54) **GAS TURBINE BLADE HAVING A MONOCRYSTALLINE AIRFOIL WITH A REPAIR SQUEALER TIP, AND REPAIR METHOD**

A repaired gas turbine blade includes a turbine blade body having a monocrystalline airfoil made of a first nickel-base superalloy, and a repair squealer tip welded to a tip of the airfoil. The repair squealer tip is made of a second nickel-base superalloy different from the first nickel-base superalloy and having less than about 0.15 weight percent total of carbon, boron, silicon, zirconium, and hafnium.

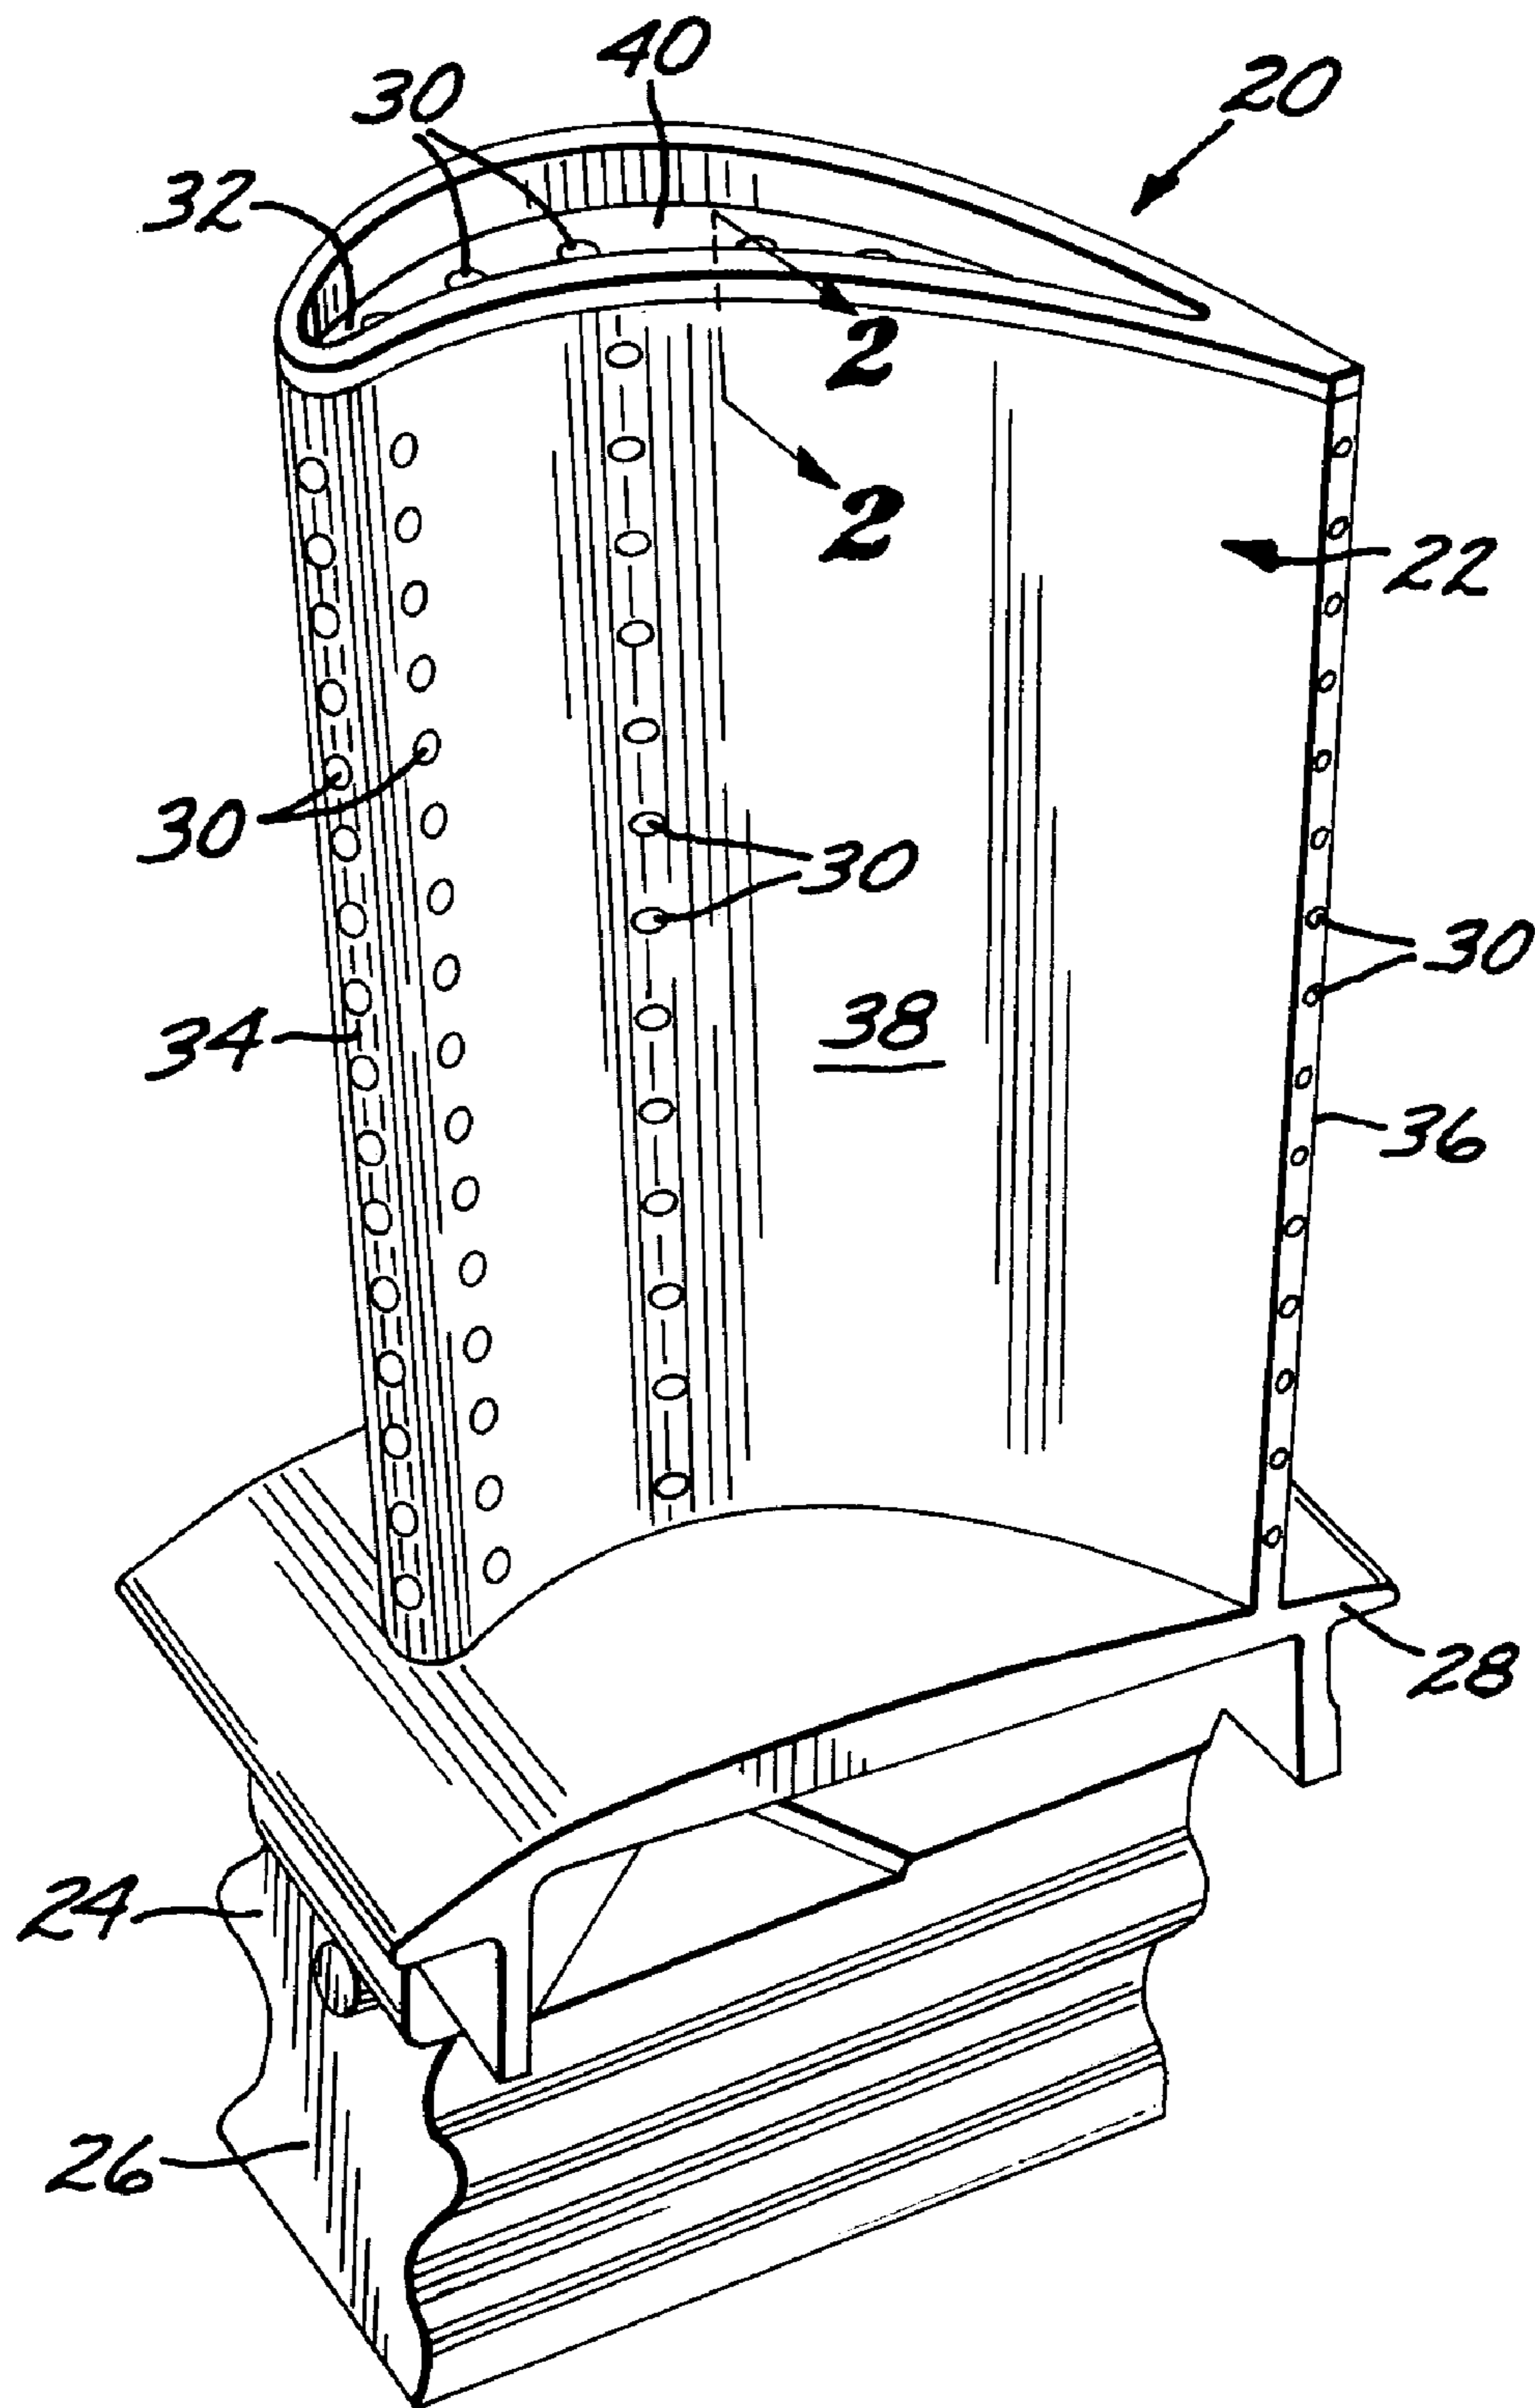
FIG. 1 depicts a gas turbine blade 20 which has preferably previously been in service. The previous service is operation in a gas turbine engine in its normal operating circumstances. The gas turbine blade 20 has an airfoil 22 against which the flow of hot combustion gas impinges during service operation, a downwardly extending shank 24, and an attachment in the form of a dovetail 26 which attaches the gas turbine blade 20 to a gas turbine disk (not shown) of the gas turbine engine. A platform 28 extends transversely outwardly at a location between the airfoil 22, and the shank 24 and dovetail 26. The airfoil 22 may be hollow so that cooling air may be forced through the airfoil 22, with the flow of cooling air exiting the airfoil 22 through air-flow holes 30 found on a tip 32, a leading edge 34, a trailing edge 36, and the lateral sides 38 of the airfoil 22.

FIG. 1 is a perspective view of a gas turbine blade; FIG. 2 is a sectional detail of the gas turbine blade of FIG. 1, taken on line 2-2, after service but prior to repair; FIG. 3 is a sectional detail of the gas turbine blade of FIG. 1, taken on line 2-2, after service and after repair; and FIG. 4 is a block flow diagram of an approach for practicing an embodiment of the invention.

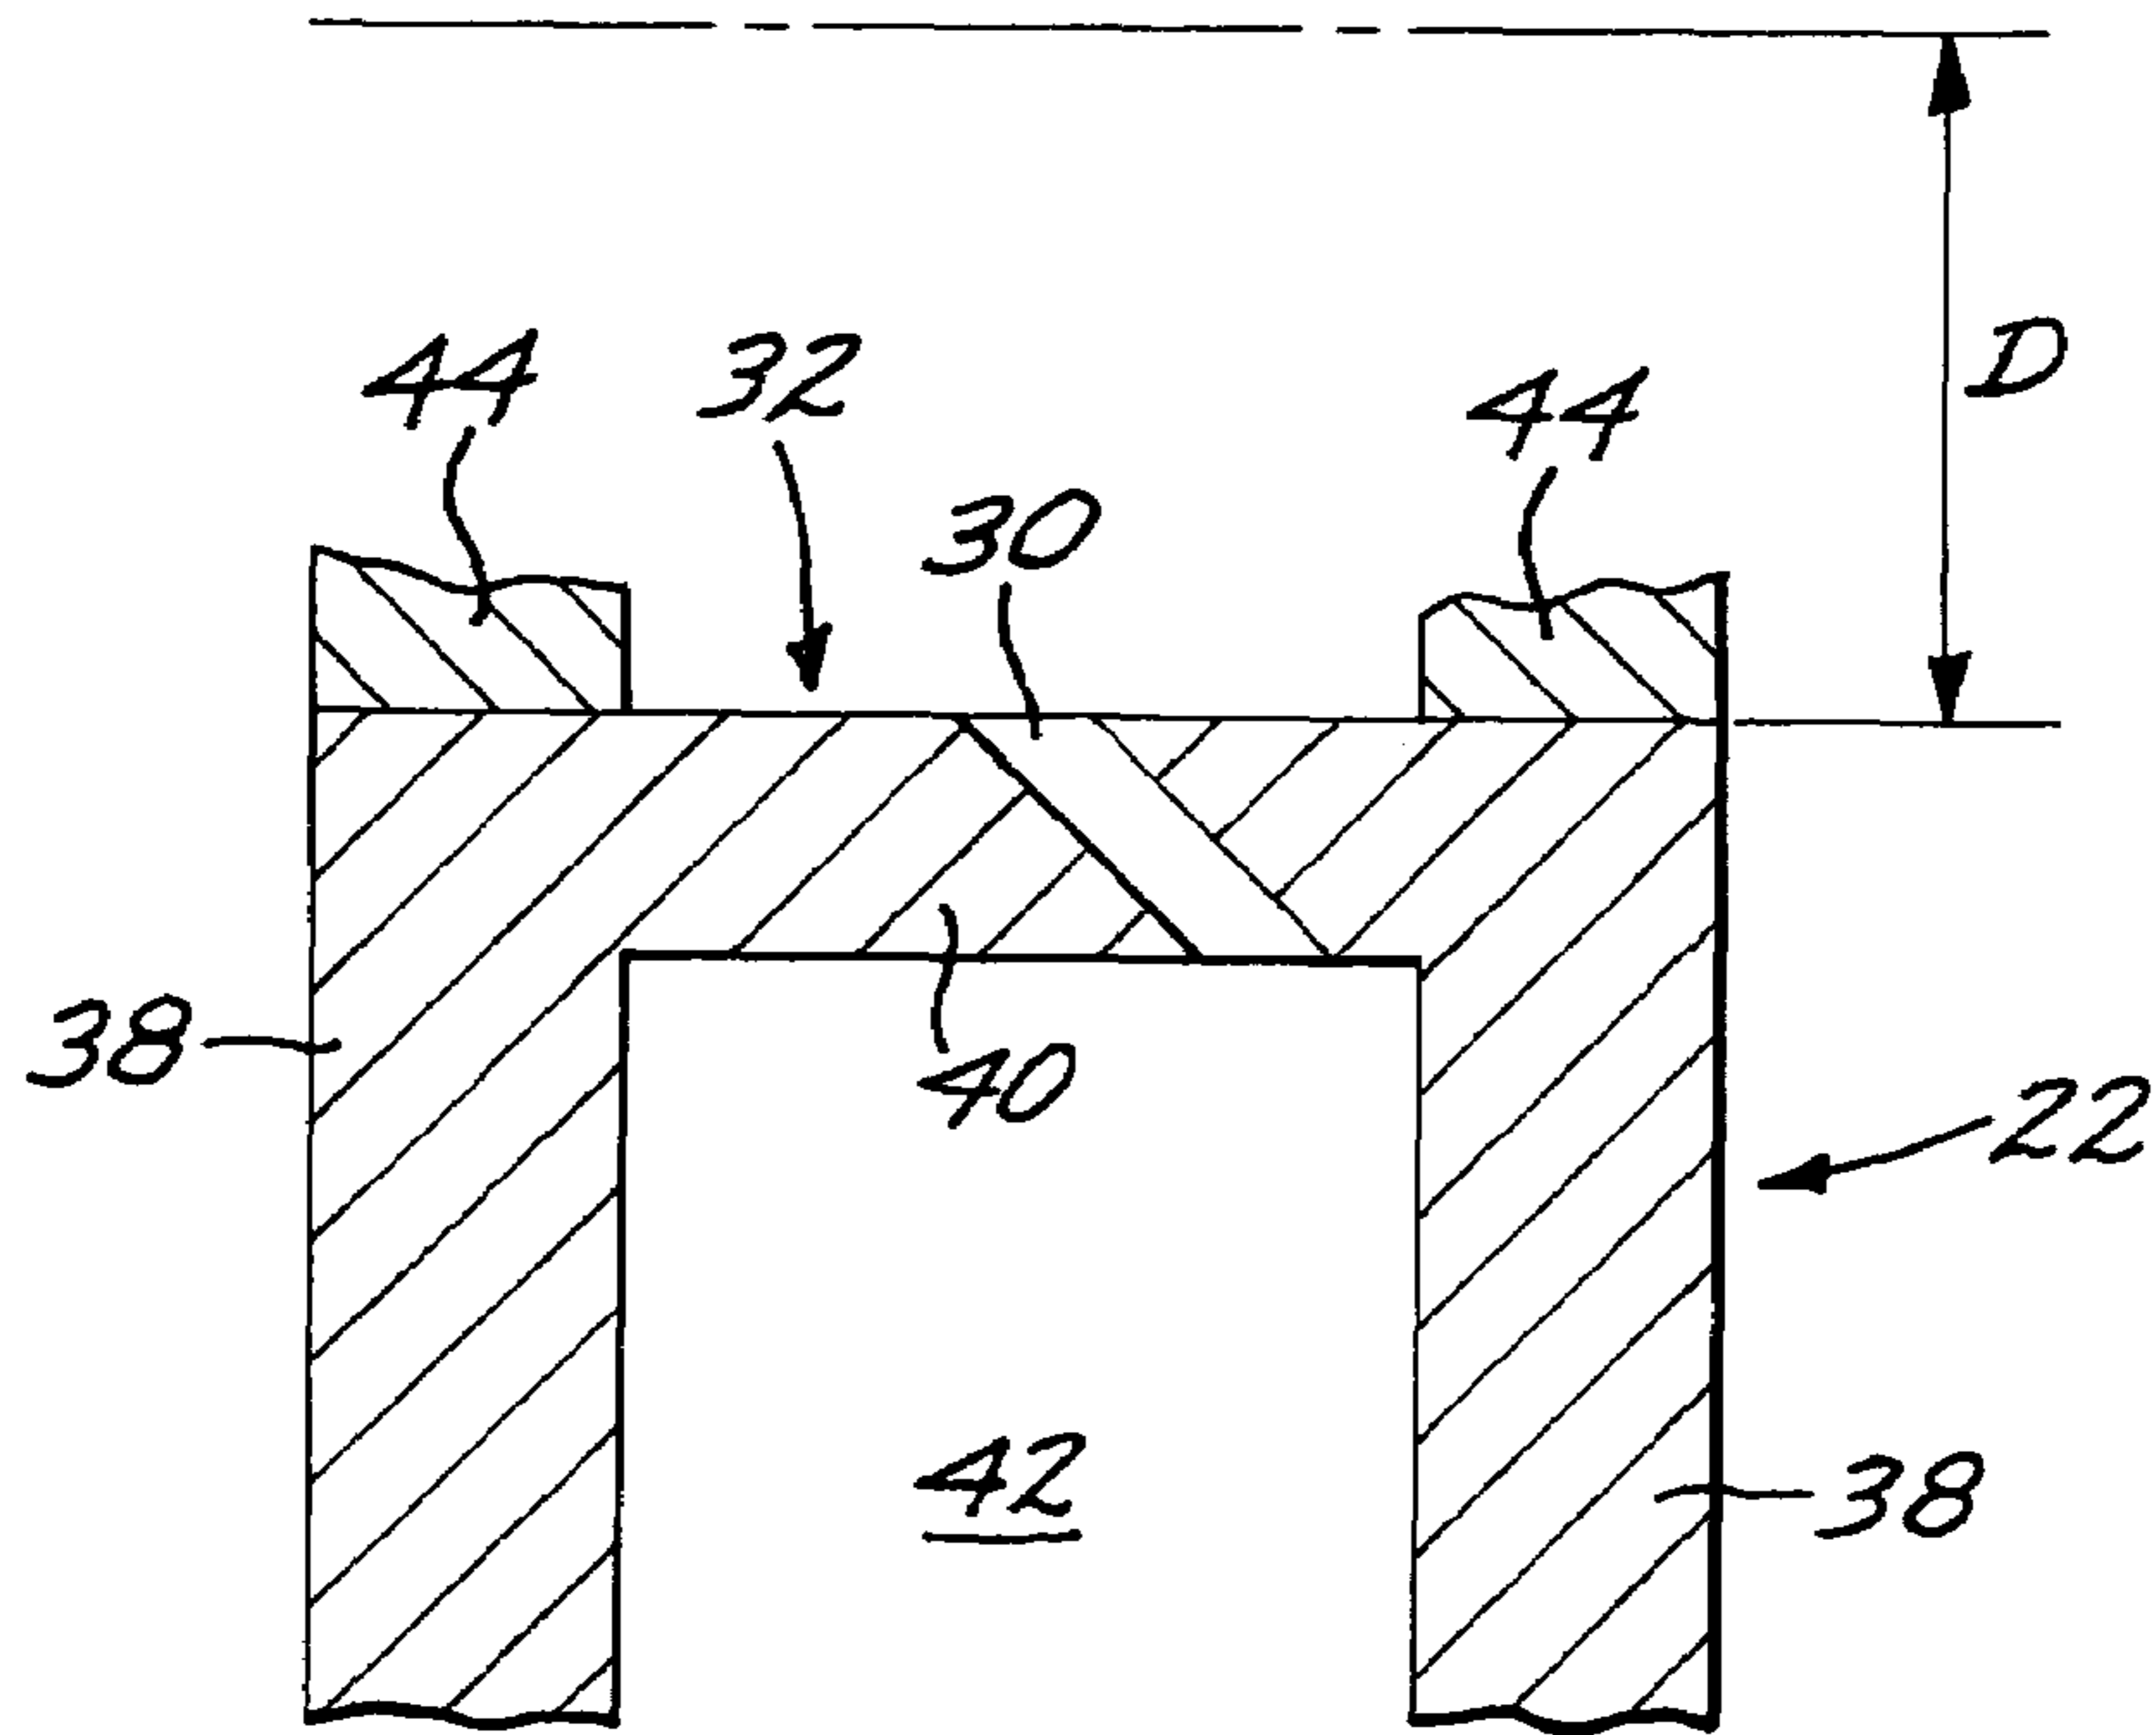
FIG. 2 illustrates the region near the tip 32 of the airfoil 22 (which is also the tip of the turbine blade 20) in greater detail. The airfoil 22 includes its lateral sides 38 and a tip cap 40, which together define a hollow volume 42 through which the cooling air passes to exit at the air-flow hole 30.

The squealer tip of a new-make gas turbine blade 20 starts out with a length indicated by the dimensional marker D, but is gradually worn, oxidized, corroded, and burned away to a length such as shown for the squealer tip 44 of FIG. 2. This shortening of the squealer tip 44 allows hot combustion gas to leak around the gas turbine, so that the efficiency of the gas turbine is reduced. It is therefore conventional practice during refurbishment of the gas turbine to repair and lengthen the squealer tips of the gas turbine blades 20 back to substantially the same length as indicated by the dimension D. The loss of efficiency of the gas turbine due to damage to the squealer tip is thereby eliminated.

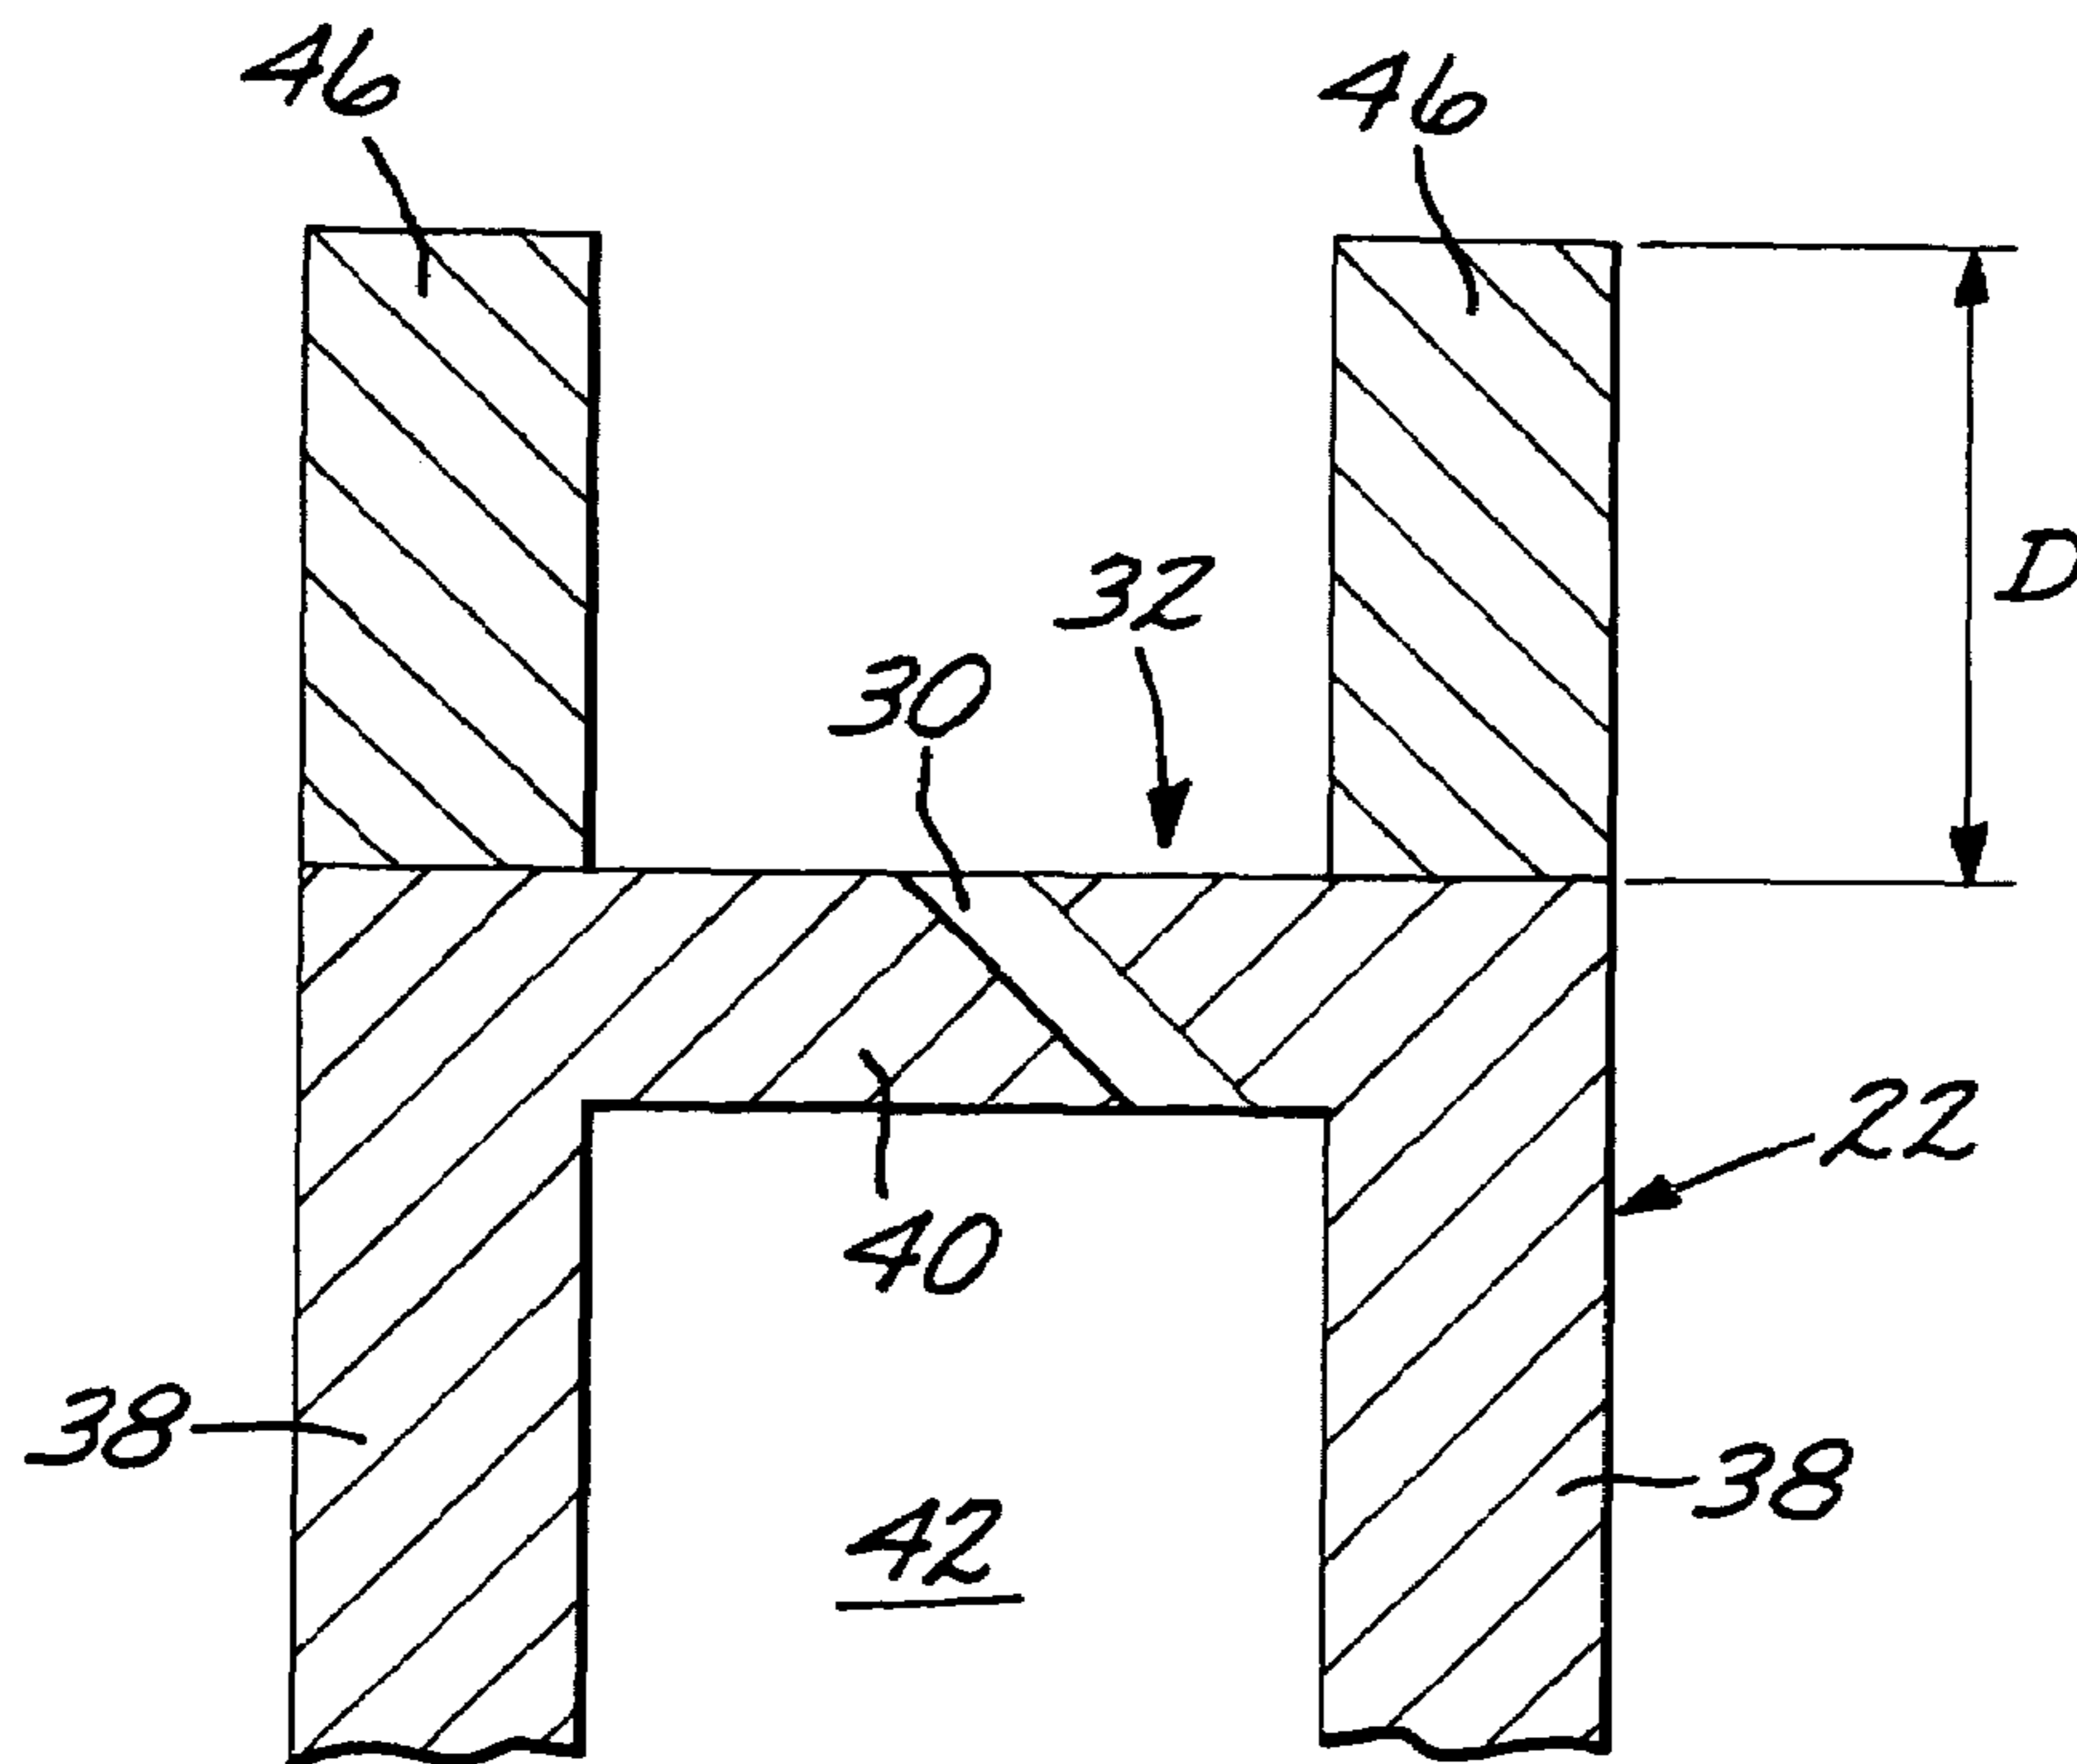
FIG. 3

To effect the repair, there is a repair squealer tip 46 welded to the tip 32 of the airfoil 22 to restore the length of the squealer tip to the desired value D, as shown in FIG. 3. The repair squealer tip 46 is made of a second nickel-base
