(10) **Patent No.:** **US 7,283,227 B2**  
(45) **Date of Patent:** **Oct. 16, 2007**

(54) **OBLIQUE TRANSMISSION ILLUMINATION INSPECTION SYSTEM AND METHOD FOR INSPECTING A GLASS SHEET**

(73) Assignee: **Corning Incorporated**, Corning, NY (US)

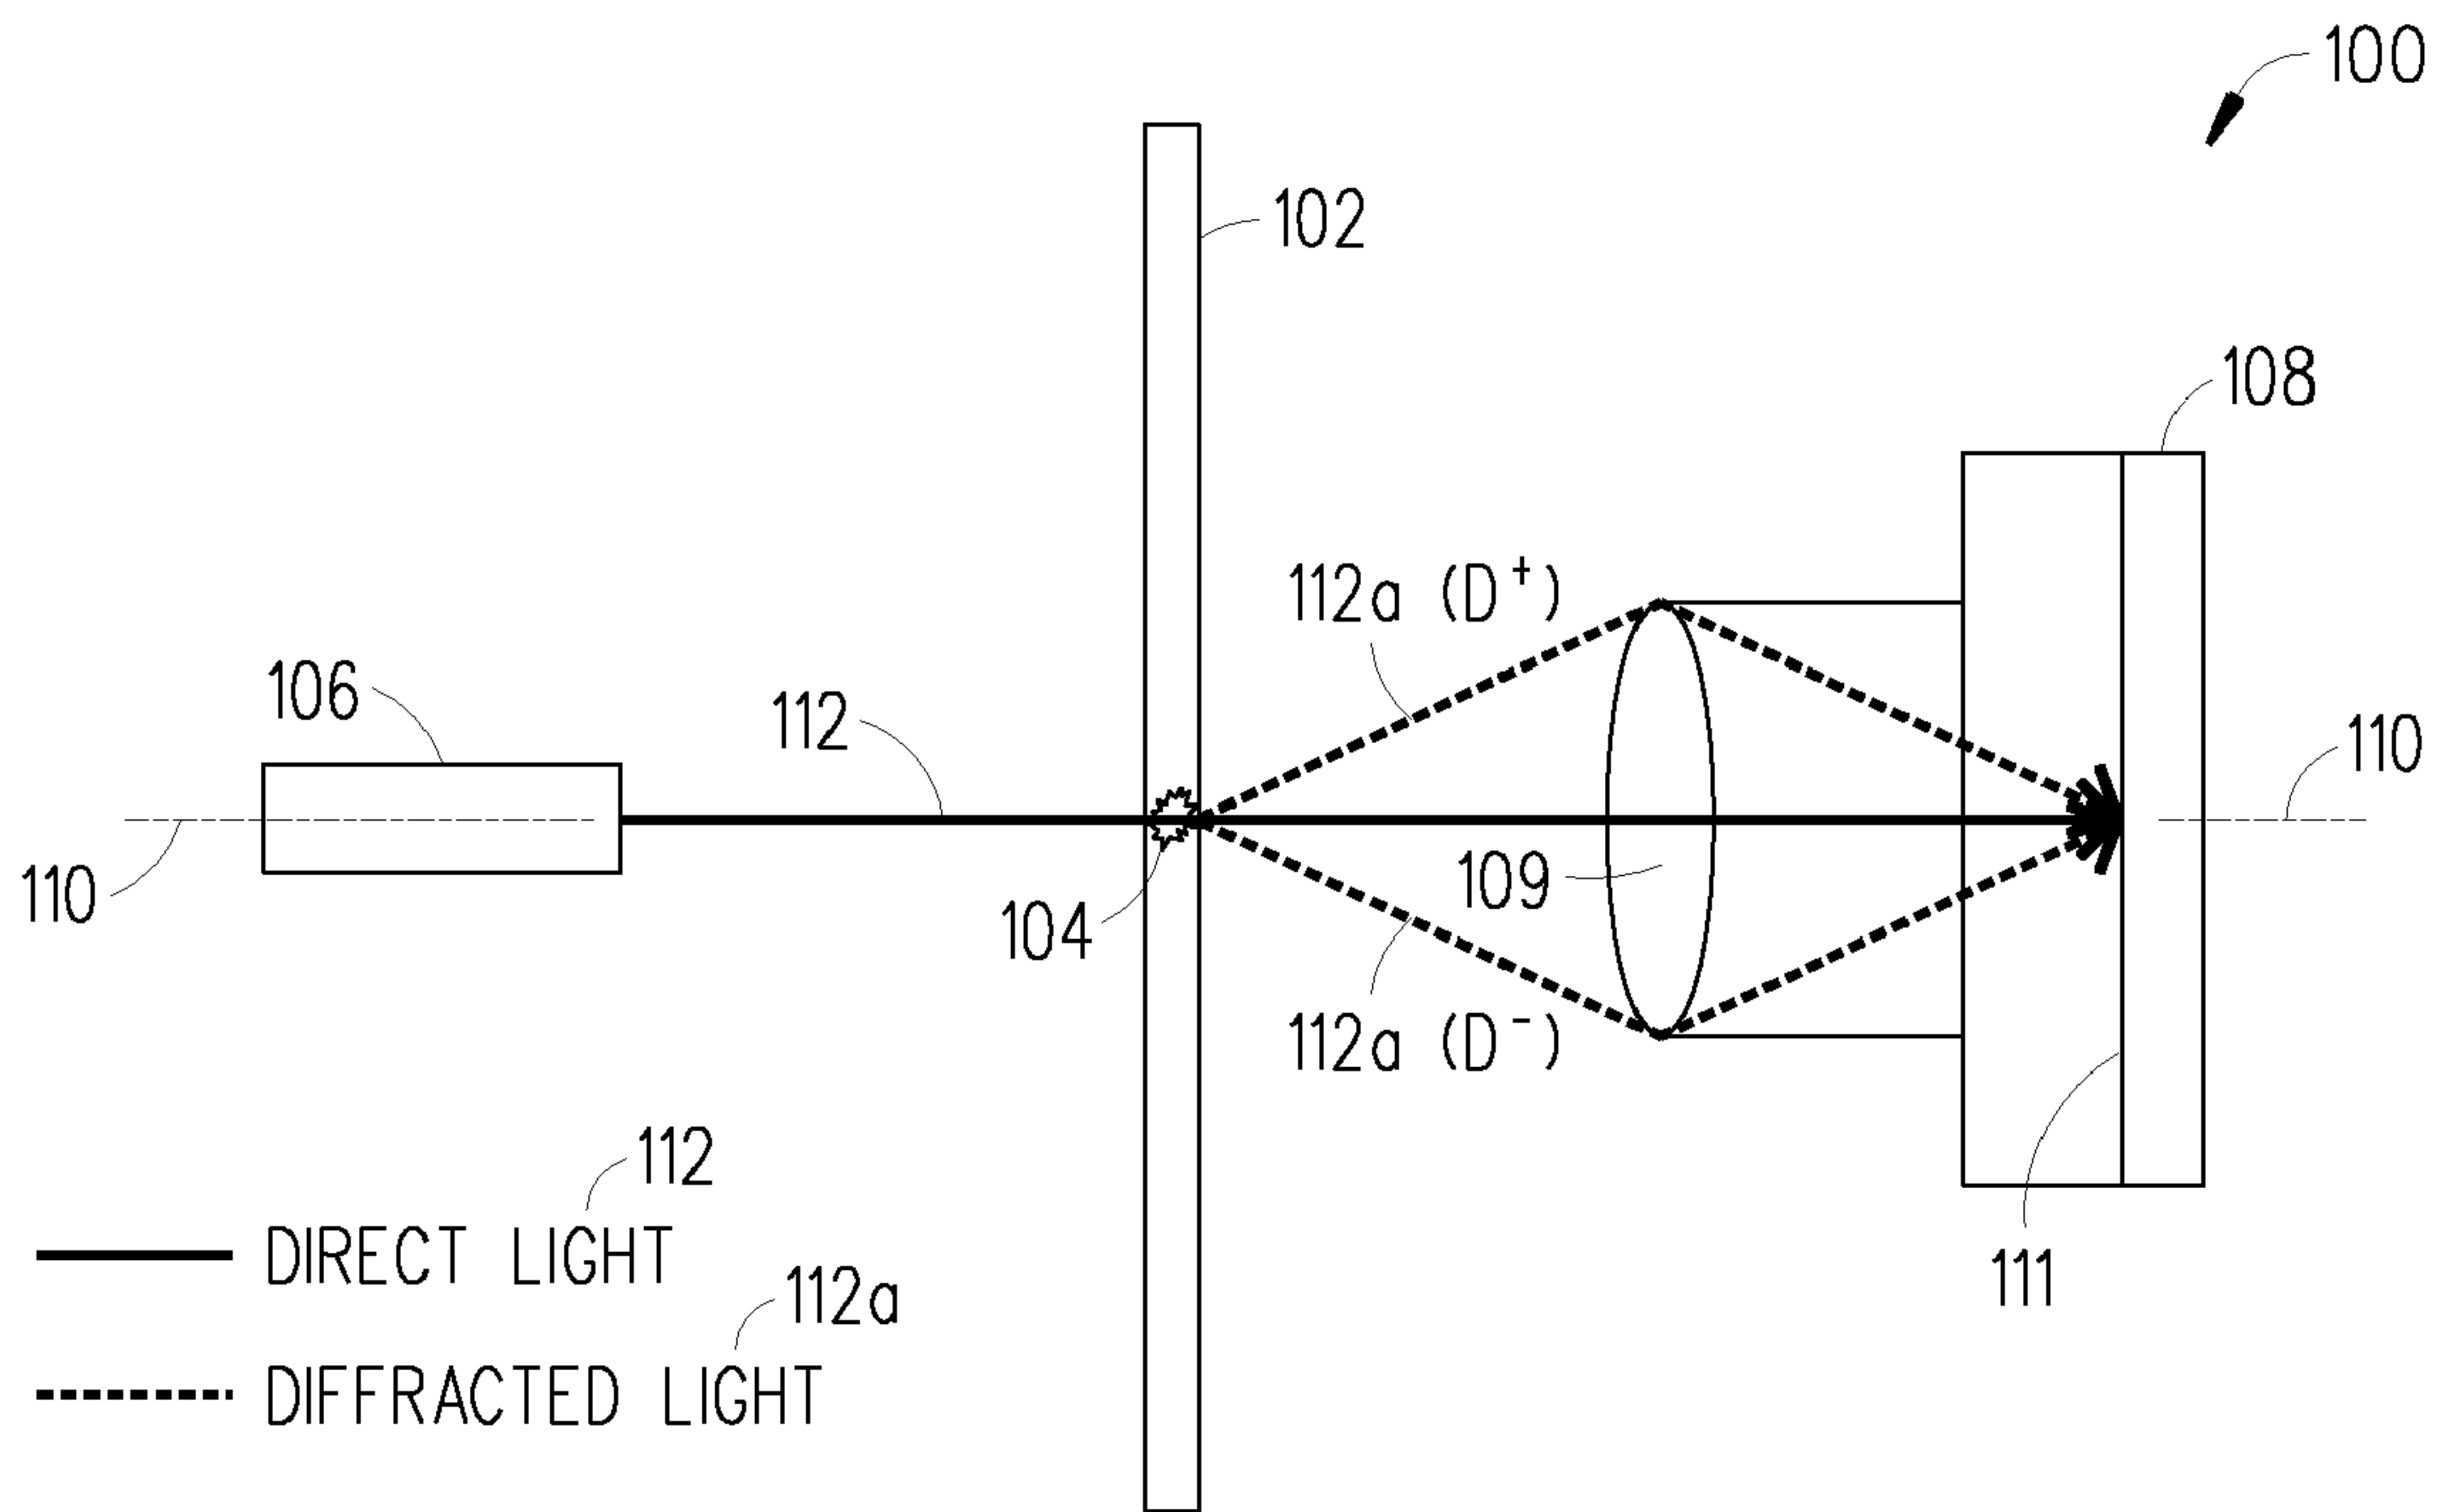
FIG. 1 (PRIOR ART) is a diagram illustrating the basic components of a traditional bright field illumination inspection system;

Referring to FIG. 1 (PRIOR ART), there is shown a traditional bright field illumination inspection system **100** that is currently used to inspect a glass sheet **102** and identify defects **104** (one shown) on or within the glass sheet **102**. The inspection system **100** includes a light source **106** (e.g., fiber line light source **106**) and a CCD camera **108**. The light source **106** and CCD camera **108** are located on opposite sides of the glass sheet **102**, and the light source **106** is located on an optic axis **110** of the CCD camera **108**. In operation, the light source **106** emits a light beam **112** which passes through a portion of the glass sheet **102**. As shown, the CCD camera **108** and in particular a camera lens **109** receives direct light **112** that passed un-deviated through the transparent defect **104**. In addition, the CCD camera **108**/camera lens **109** receives light **112a** ( $D^+$ ) and **112a** ( $D^-$ ) that was diffracted by the transparent defect **104**. The camera lens **109** focuses the light **112**, **112a** ( $D^+$ ) and **112a** ( $D^-$ ) onto an image plane **111** within the CCD camera **108**. The CCD camera **108** then creates an image which is used to detect, characterize and classify the defect **104**.

Although this type of lighting affords a compact design and employs industry standard lighting techniques, the image contrast of certain transparent glass defects, such as silica, scratches, and stains, is relatively poor (see FIG. 5). The poor image contrast hinders the characterization and classification of the transparent defect **104**, which adversely impacts the quality of the inspection process. This poor image contrast is primarily due to the interference between the light **112** that passed un-deviated through the transparent defect **104** and the light **112a** ( $D^+$ ) and **112a** ( $D^-$ ) that was diffracted by the transparent defect **104**. In this configuration, light **112a** ( $D^+$ ) and **112a** ( $D^-$ ) respectively have a positive diffraction order  $D^+$  and a negative diffraction order  $D^-$  both of which interfere with the un-deviated light **112** to essentially wash out the contrast of the transparent defect **104** in the image. The two problematic diffraction orders  $D^+$  and  $D^-$  are present because of the symmetry in the bright field lighting technique (i.e. the light source **106** is located on the optic axis **110** of the CCD camera **108**). The resulting poor image contrast and other shortcomings associated with the bright field illumination inspection system **100** are addressed by the present invention.

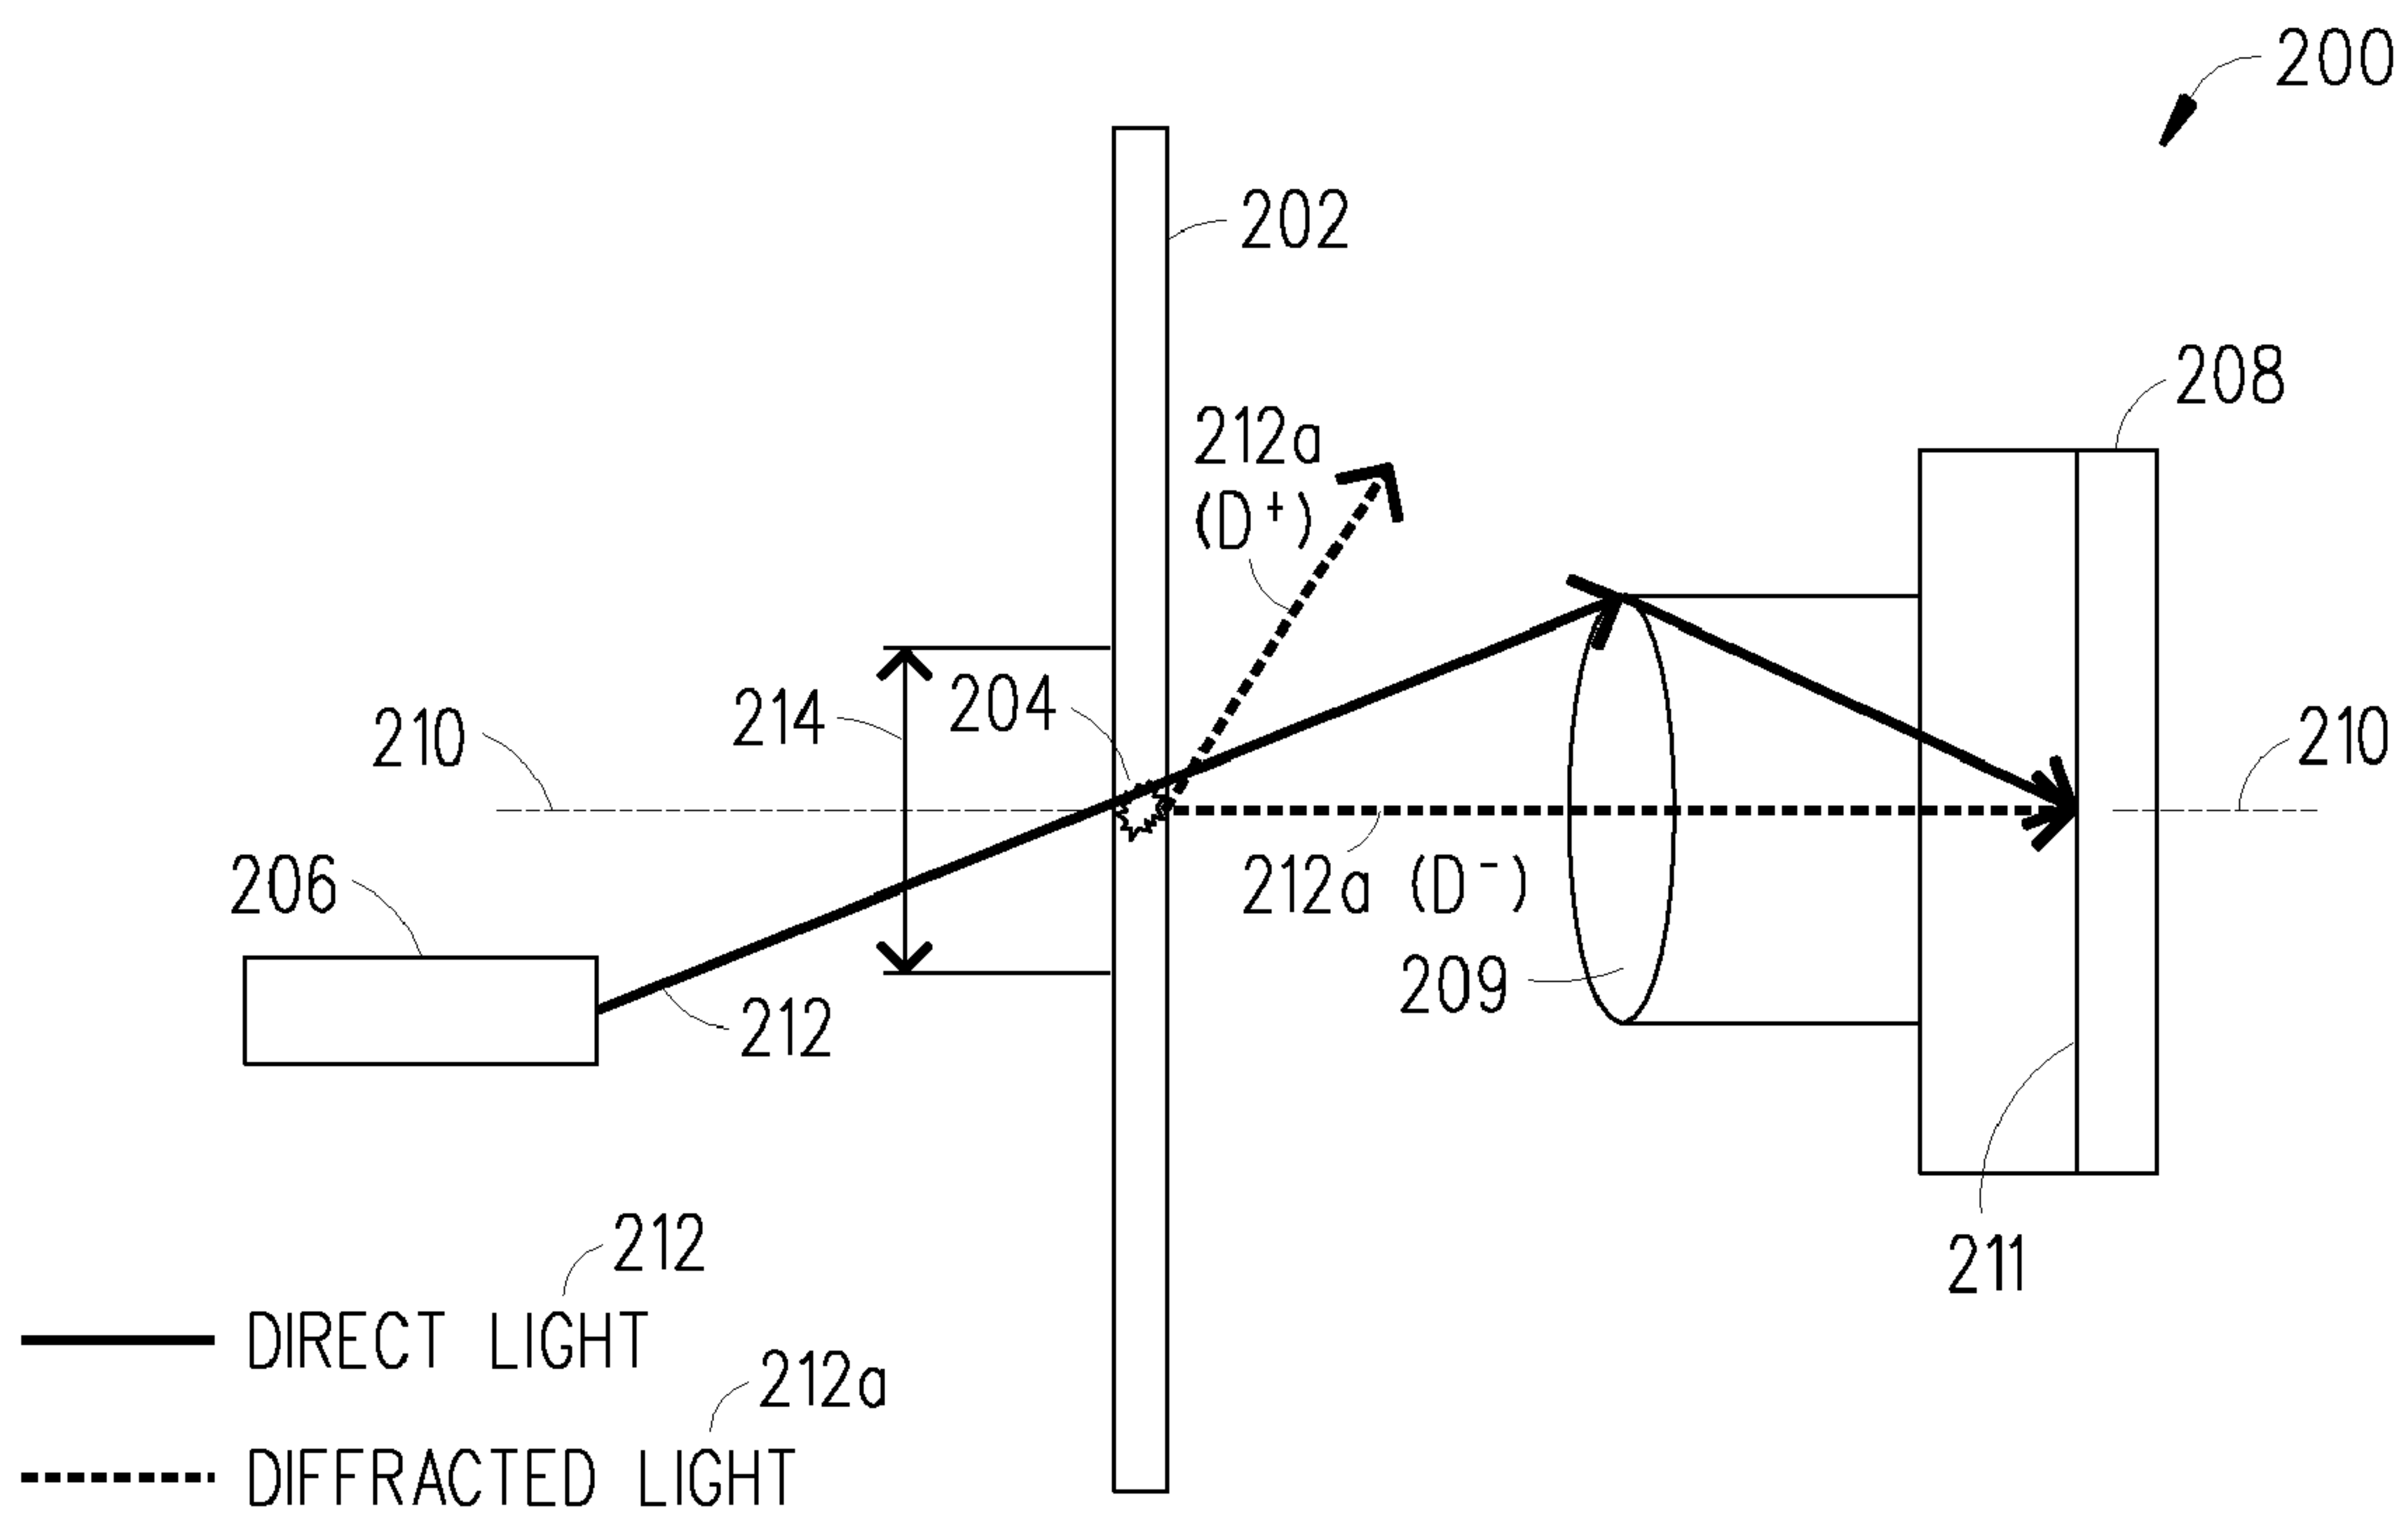
FIG. 2 is a diagram illustrating the basic components of an oblique illumination inspection system in accordance with a first embodiment of the present invention;

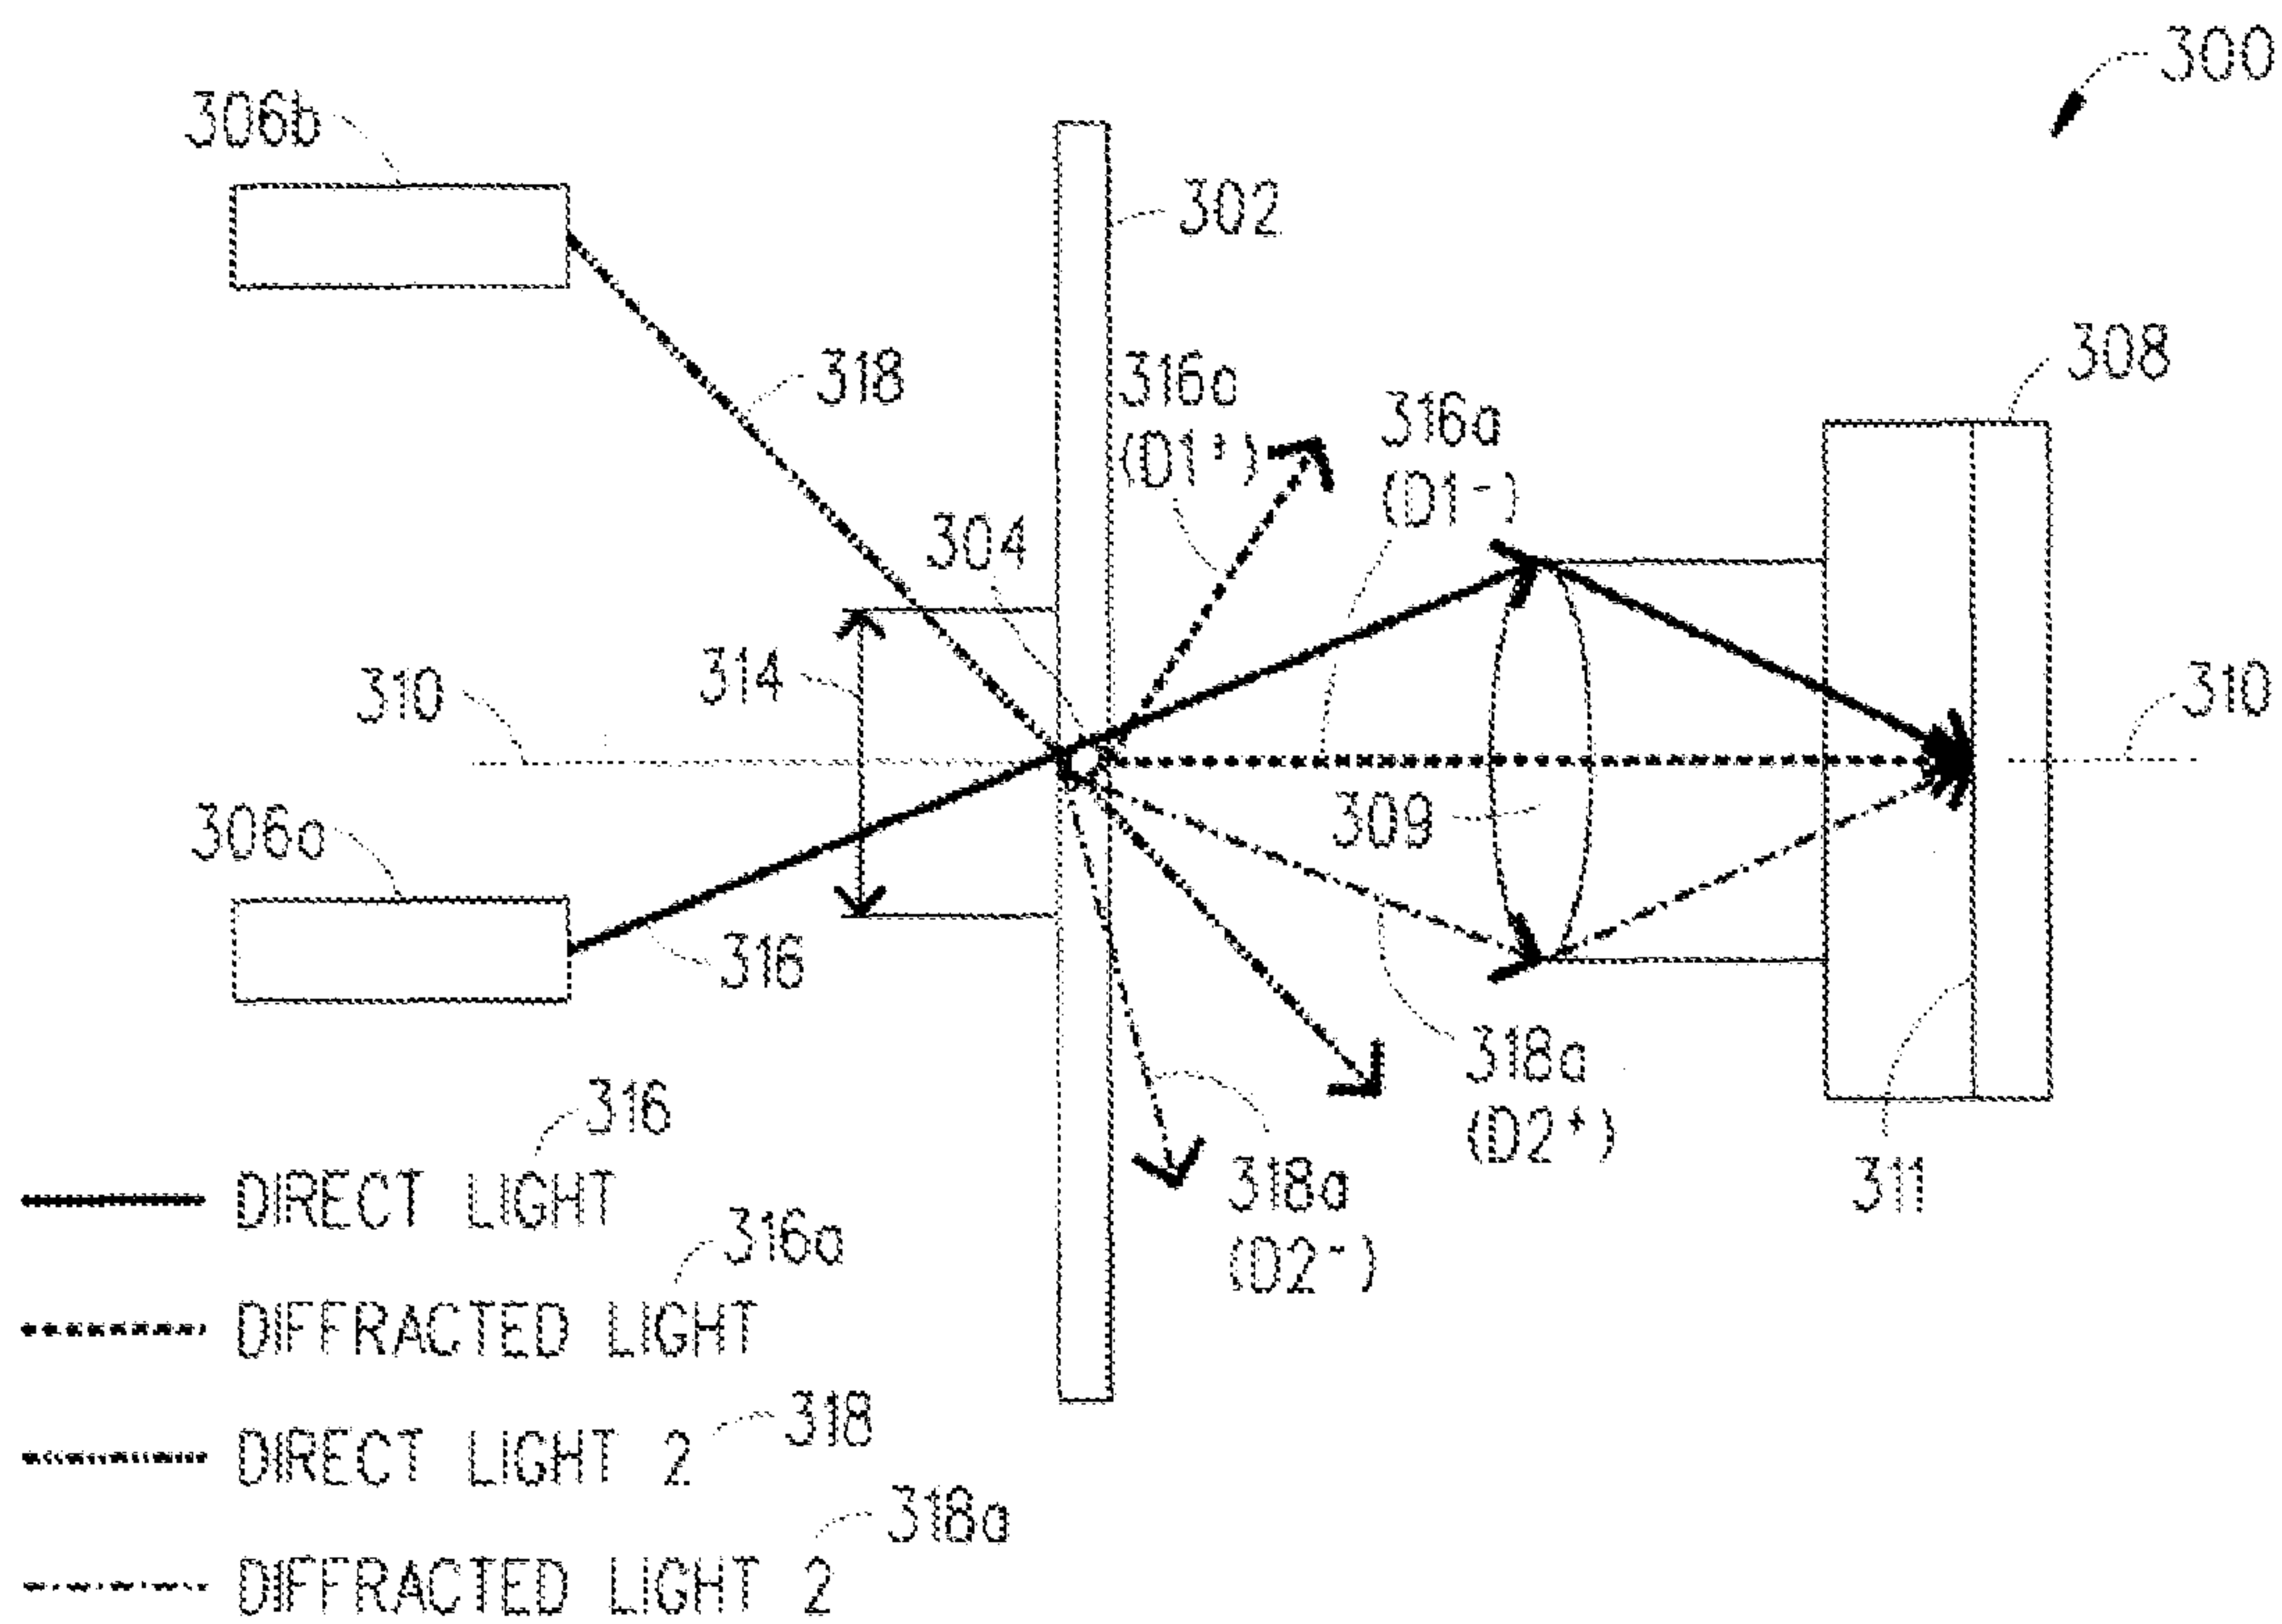
FIG. 3 is a diagram illustrating the basic components of an oblique illumination inspection system in accordance with a second embodiment of the present invention;

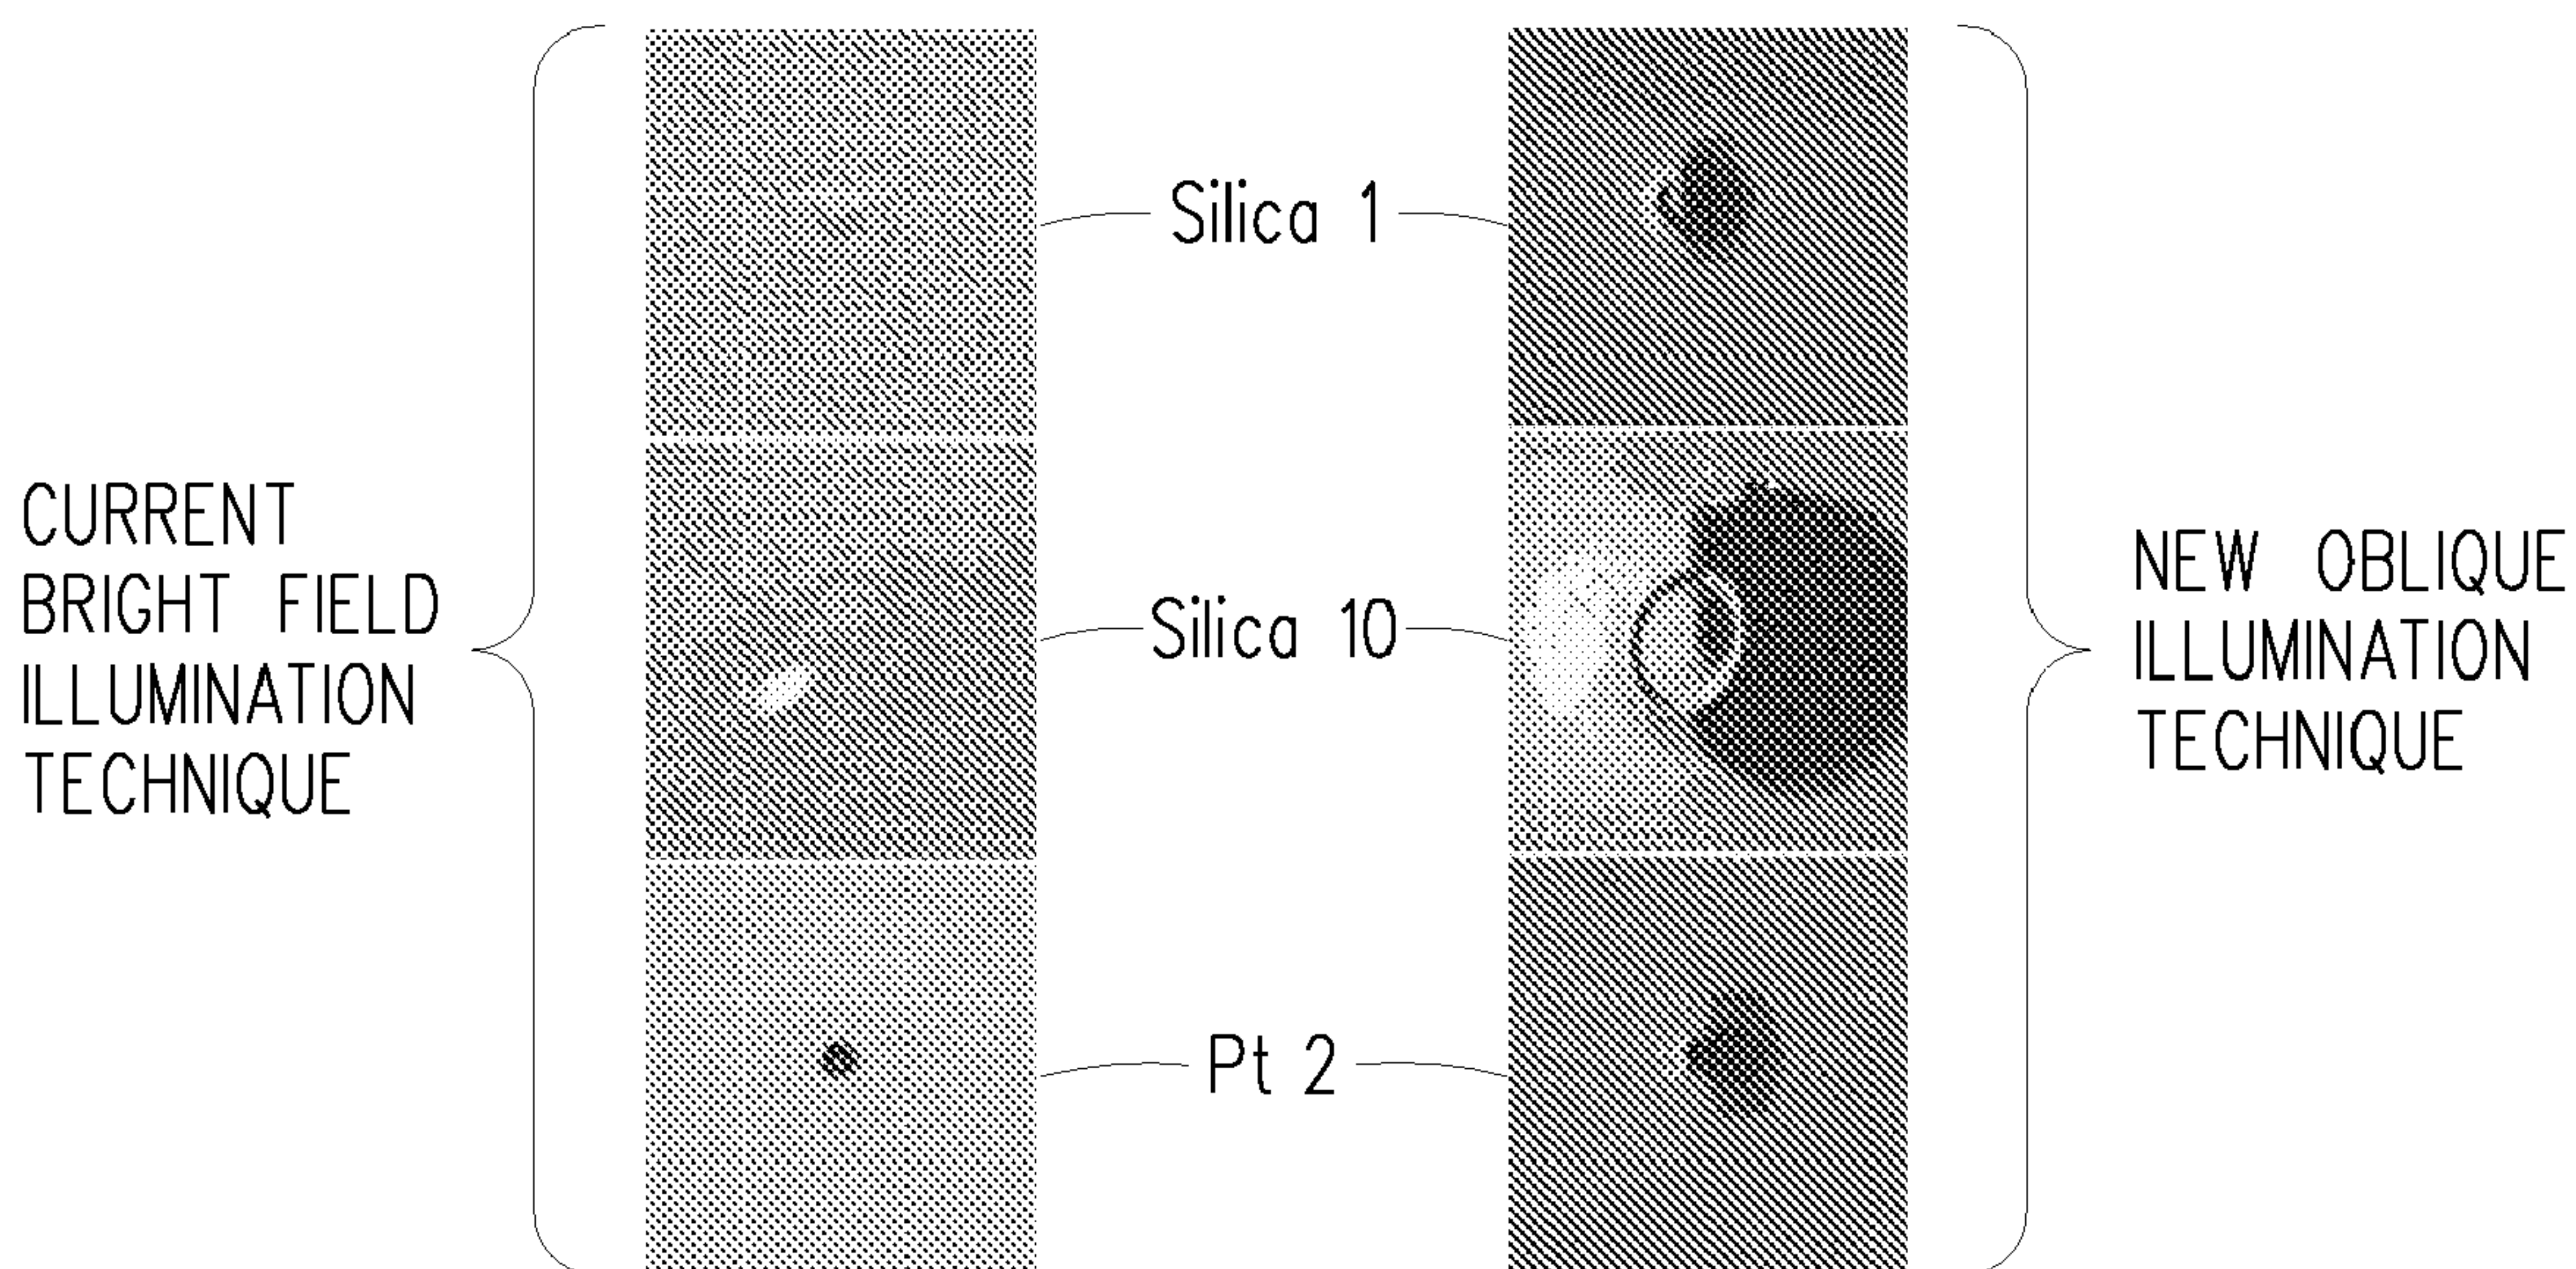
FIG. 5 has several images of defects obtained by using the traditional bright field illumination inspection system shown in FIG. 1 and several images of the same defects that were obtained by using the oblique illumination inspection system shown in FIG. 3 in accordance with the present invention; and
