(10) **Patent No.:** **US 7,331,133 B2**  
(45) **Date of Patent:** **Feb. 19, 2008**

(54) **METHOD OF IDENTIFYING AND DOCUMENTING HAIL DAMAGE**

A consistent and effective method of identifying and documenting vehicle dent damage includes the steps of identifying dents on a damaged vehicle, applying an easily visible magnetic marker over each dent on the damaged vehicle, counting the markers on the damaged vehicle, photographing the markers on the damaged vehicle and removing the markers from the damaged vehicle.

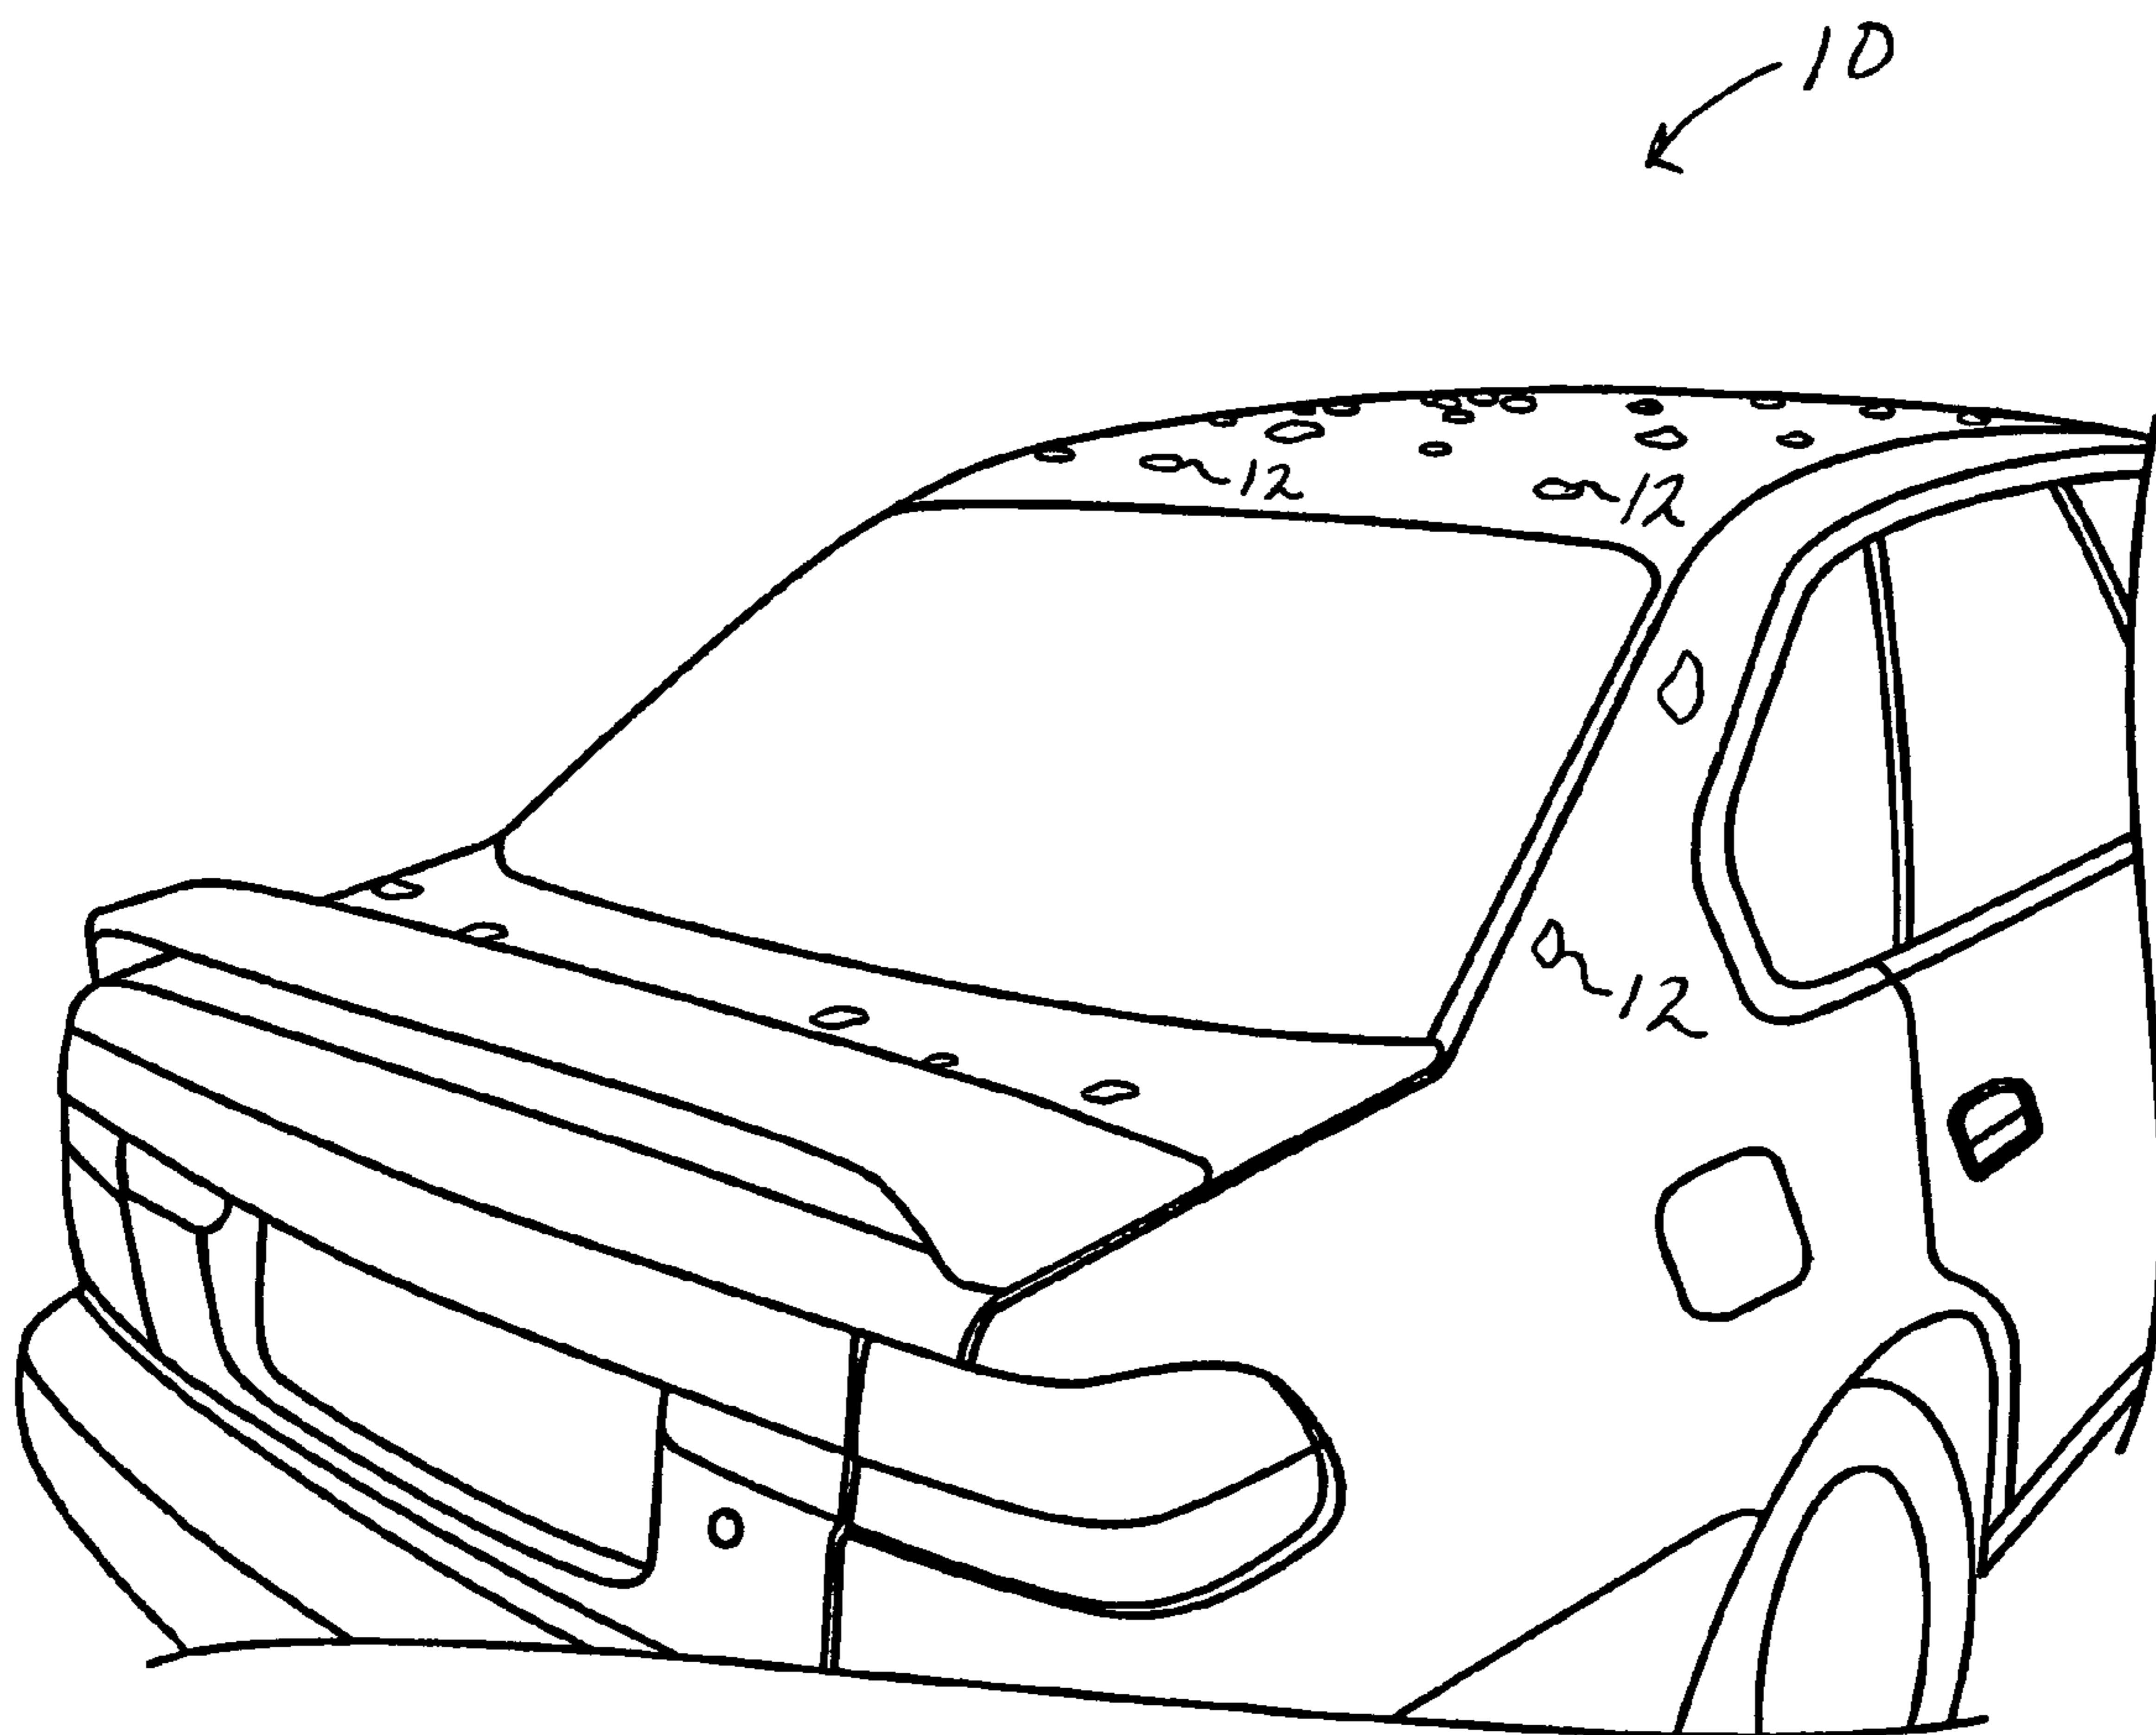
FIG. 1 is a partial perspective view of a hail damaged vehicle, with the hail dents enlarged for clarity;

A method of identifying and documenting hail damage is shown in FIGS. 1-5. FIG. 1 shows a vehicle 10 that has been damaged, in this case by hail. The hail dents 12 have been enlarged in the drawing for clarity. Vehicle dents, especially those caused by hail such as dents 12, can typically be numerous, difficult to see and very random.

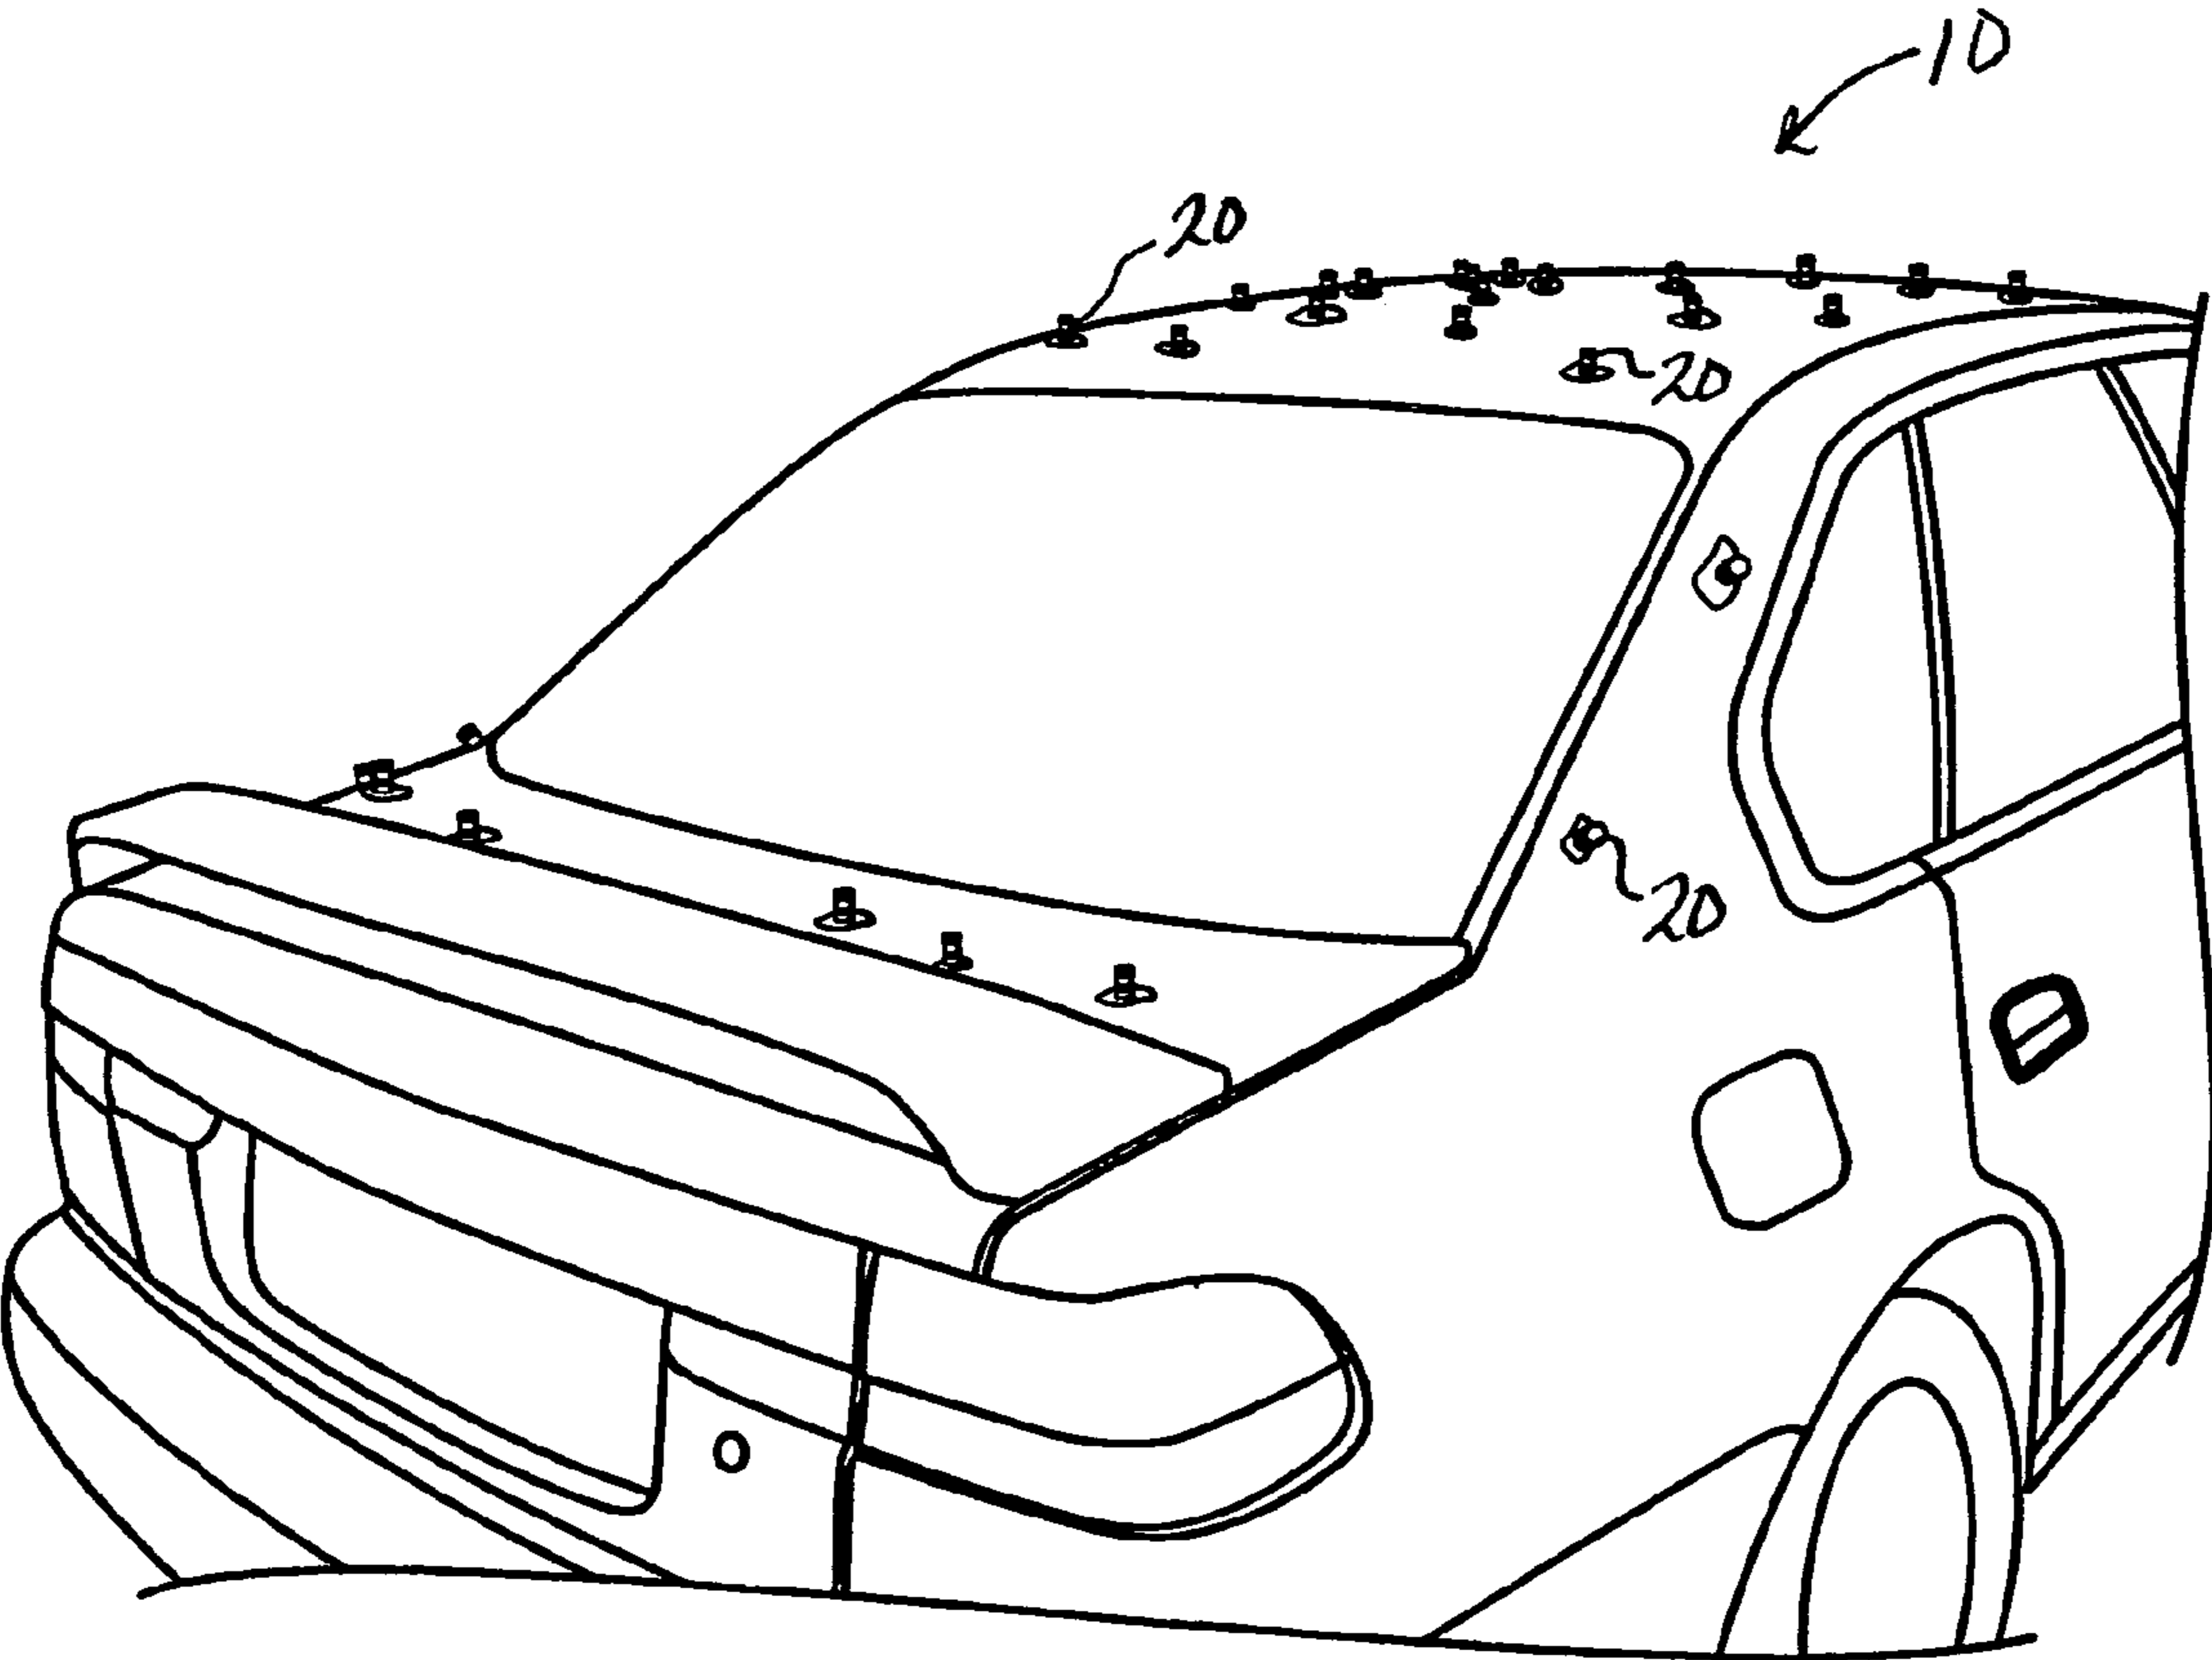
FIG. 2 shows the vehicle of FIG. 1 but with a dent marker placed on each dent in accordance with the present invention;

Magnet markers 20, as shown in detail in FIGS. 4 and 5, are attached to the damaged vehicle 10 over each dent 12, as shown in FIG. 2. The magnet markers 20 can be of various sizes to correspond to the size of the dent 12 over which they are placed.

Magnet markers **20** are placed over each vehicle dent **12** as shown in FIG. 2. Magnet markers **20** are easily secured over each dent **12** since the bottom surface of the magnet **22** adheres to the vehicle's metal surfaces including a side surface as shown. The damage to the vehicle **10** is now easily documented in photographs and/or video as desired. The marker components **24** are easily seen in photos and video. They extend upwardly and/or outwardly from the vehicle's surface unlike dents **12**. Preferably, they are also brightly colored and contrast with the vehicle's paint color.

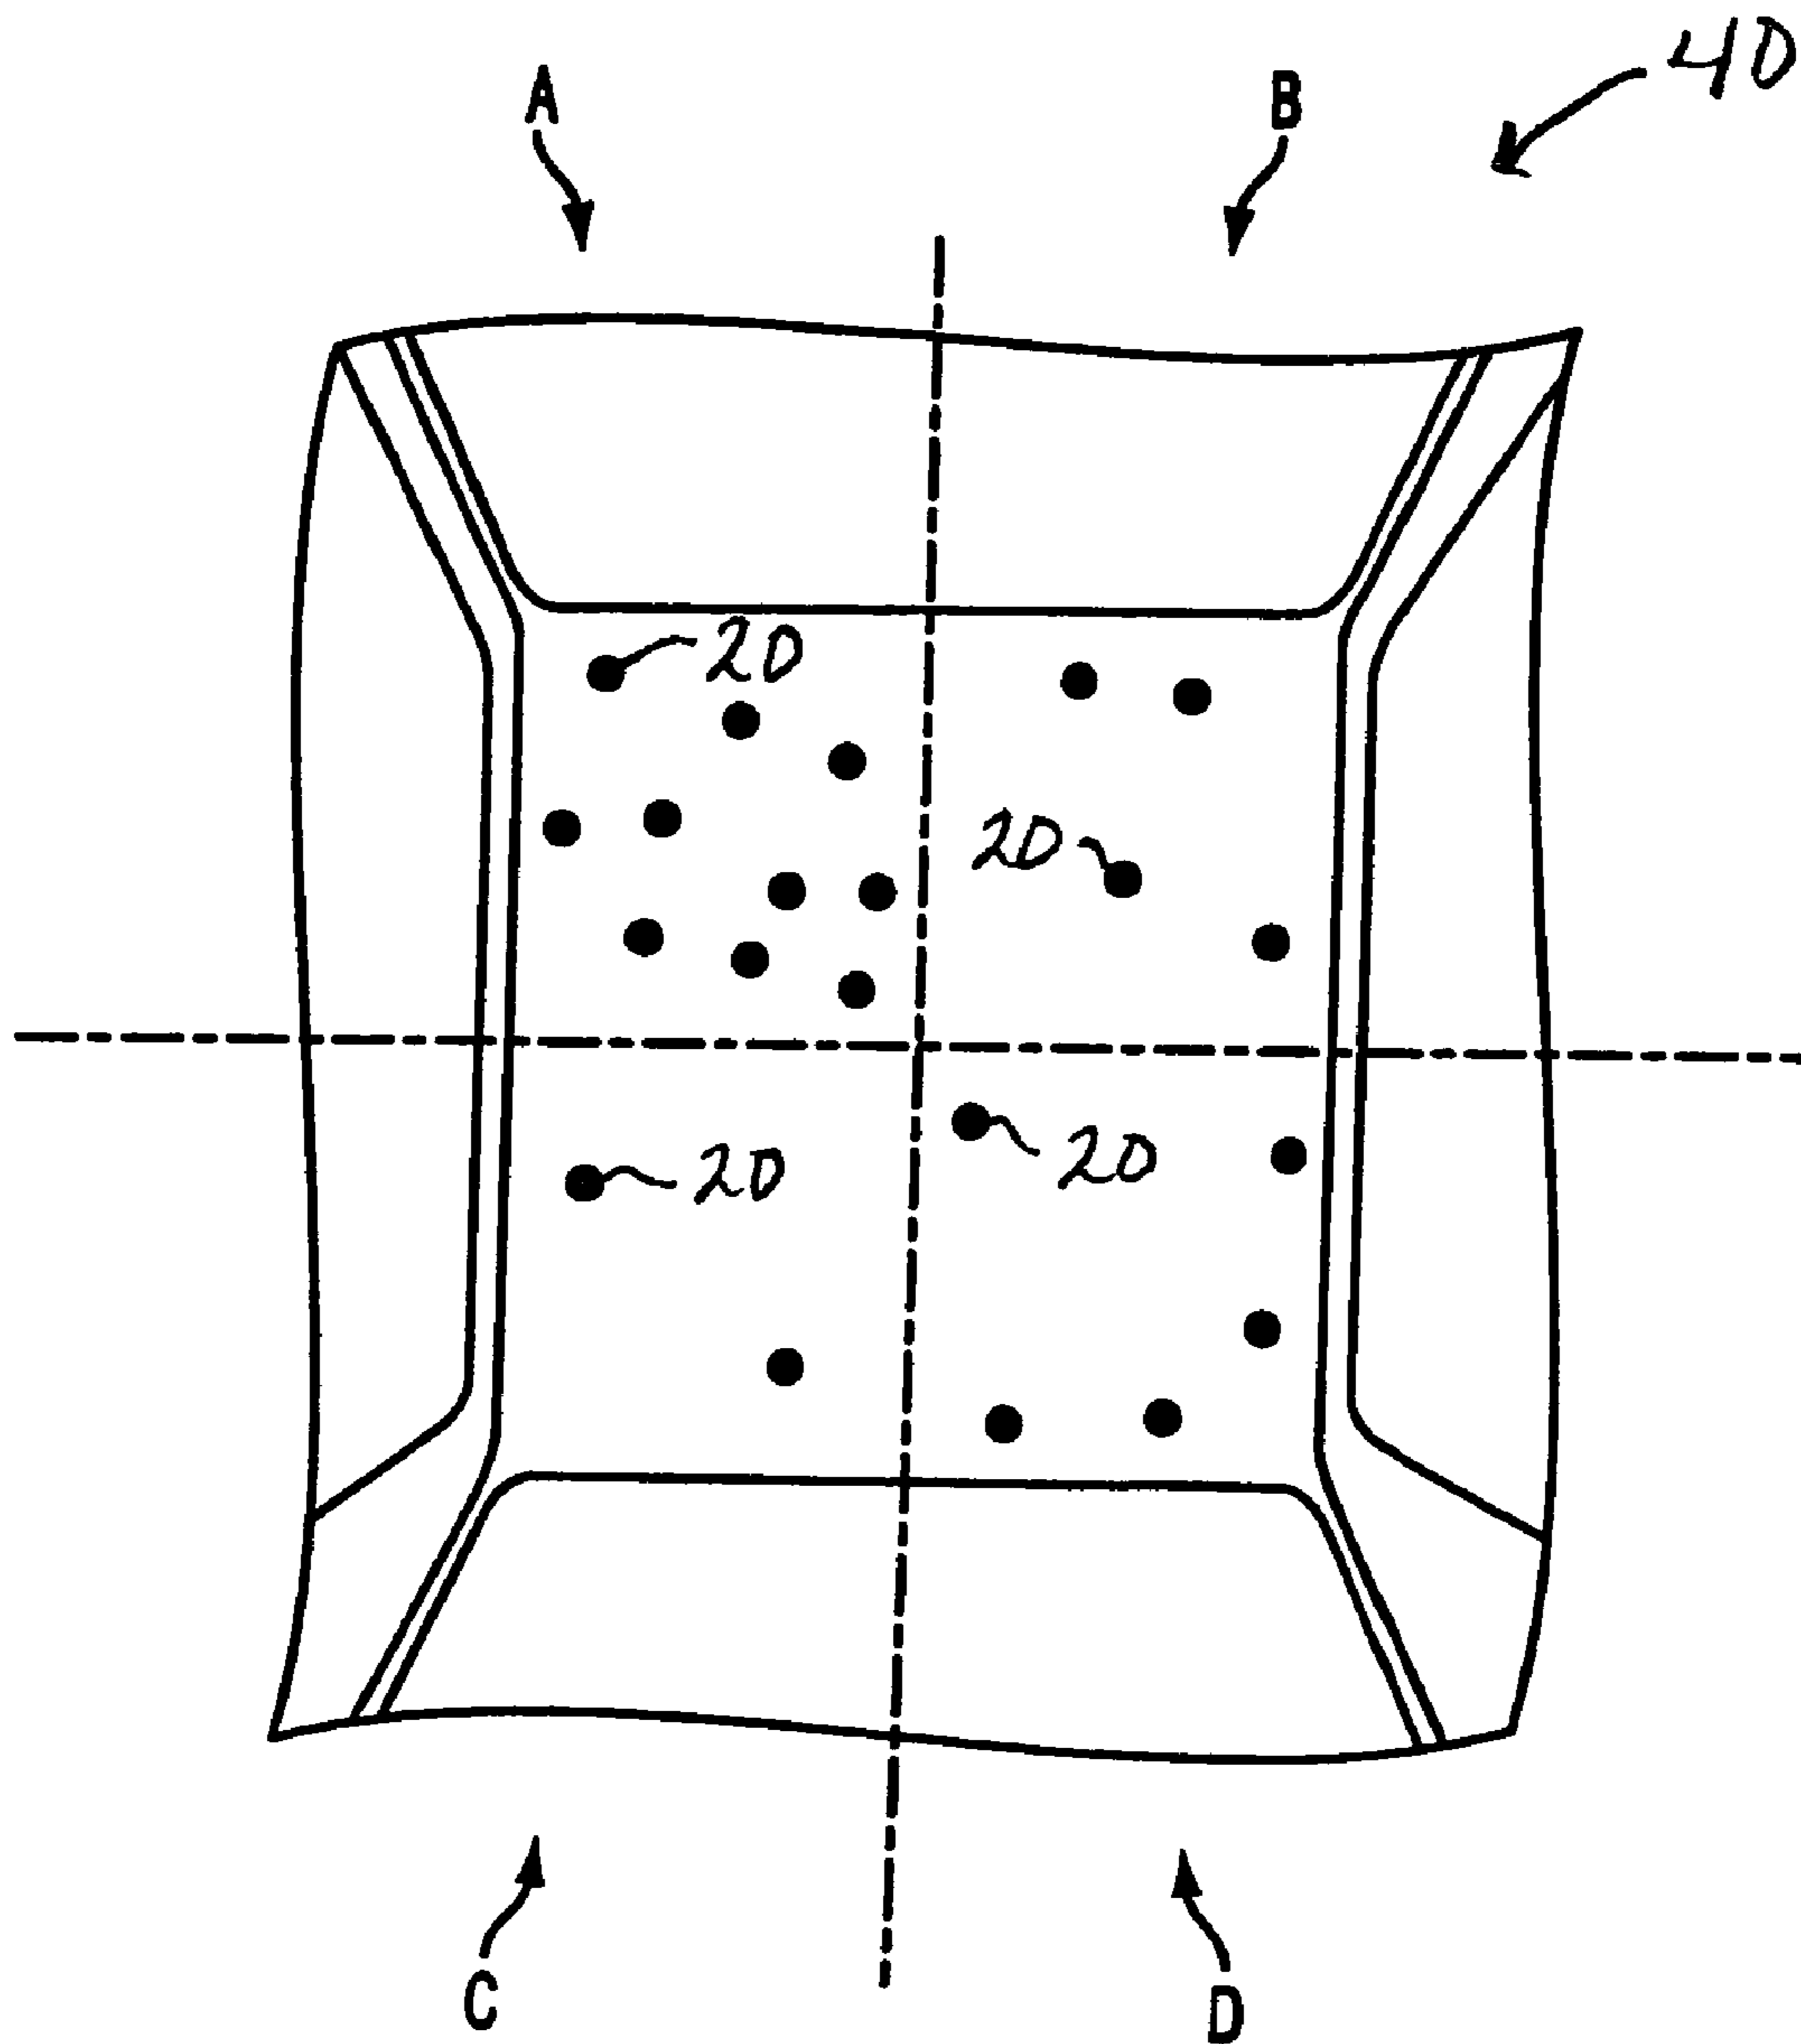
FIG. 3 is a top view of the roof of the vehicle of FIG. 2 divided into quadrants to show the randomness of hail damage;

As shown in FIGS. 1-3, vehicle dents, especially those caused by hail, such as dents **12**, can typically be numerous and occur very randomly over the surface of the vehicle **10**. FIG. 3 highlights this randomness. FIG. 3 shows the roof **40** of the dented vehicle **10** with the magnet markers **20** placed over each dent **12**. To illustrate the random nature of hail dents, the roof **40** is divided into four quadrants, A, B, C and D. Quadrant A has ten dents **12**, quadrant B has four dents **12**, quadrant C has only two dents **12** and quadrant D has five dents **12**. This illustrates the need for magnet markers **20** to be placed over each dent **12**. Otherwise, an accurate assessment of the dent damage to the vehicle **10** would not be obtained. Any estimate could be exaggerated, if for instance an estimate was based on the number of dents in quadrant A, or could be greatly underestimated if for instance an estimate was based on the number of dents in quadrant C.

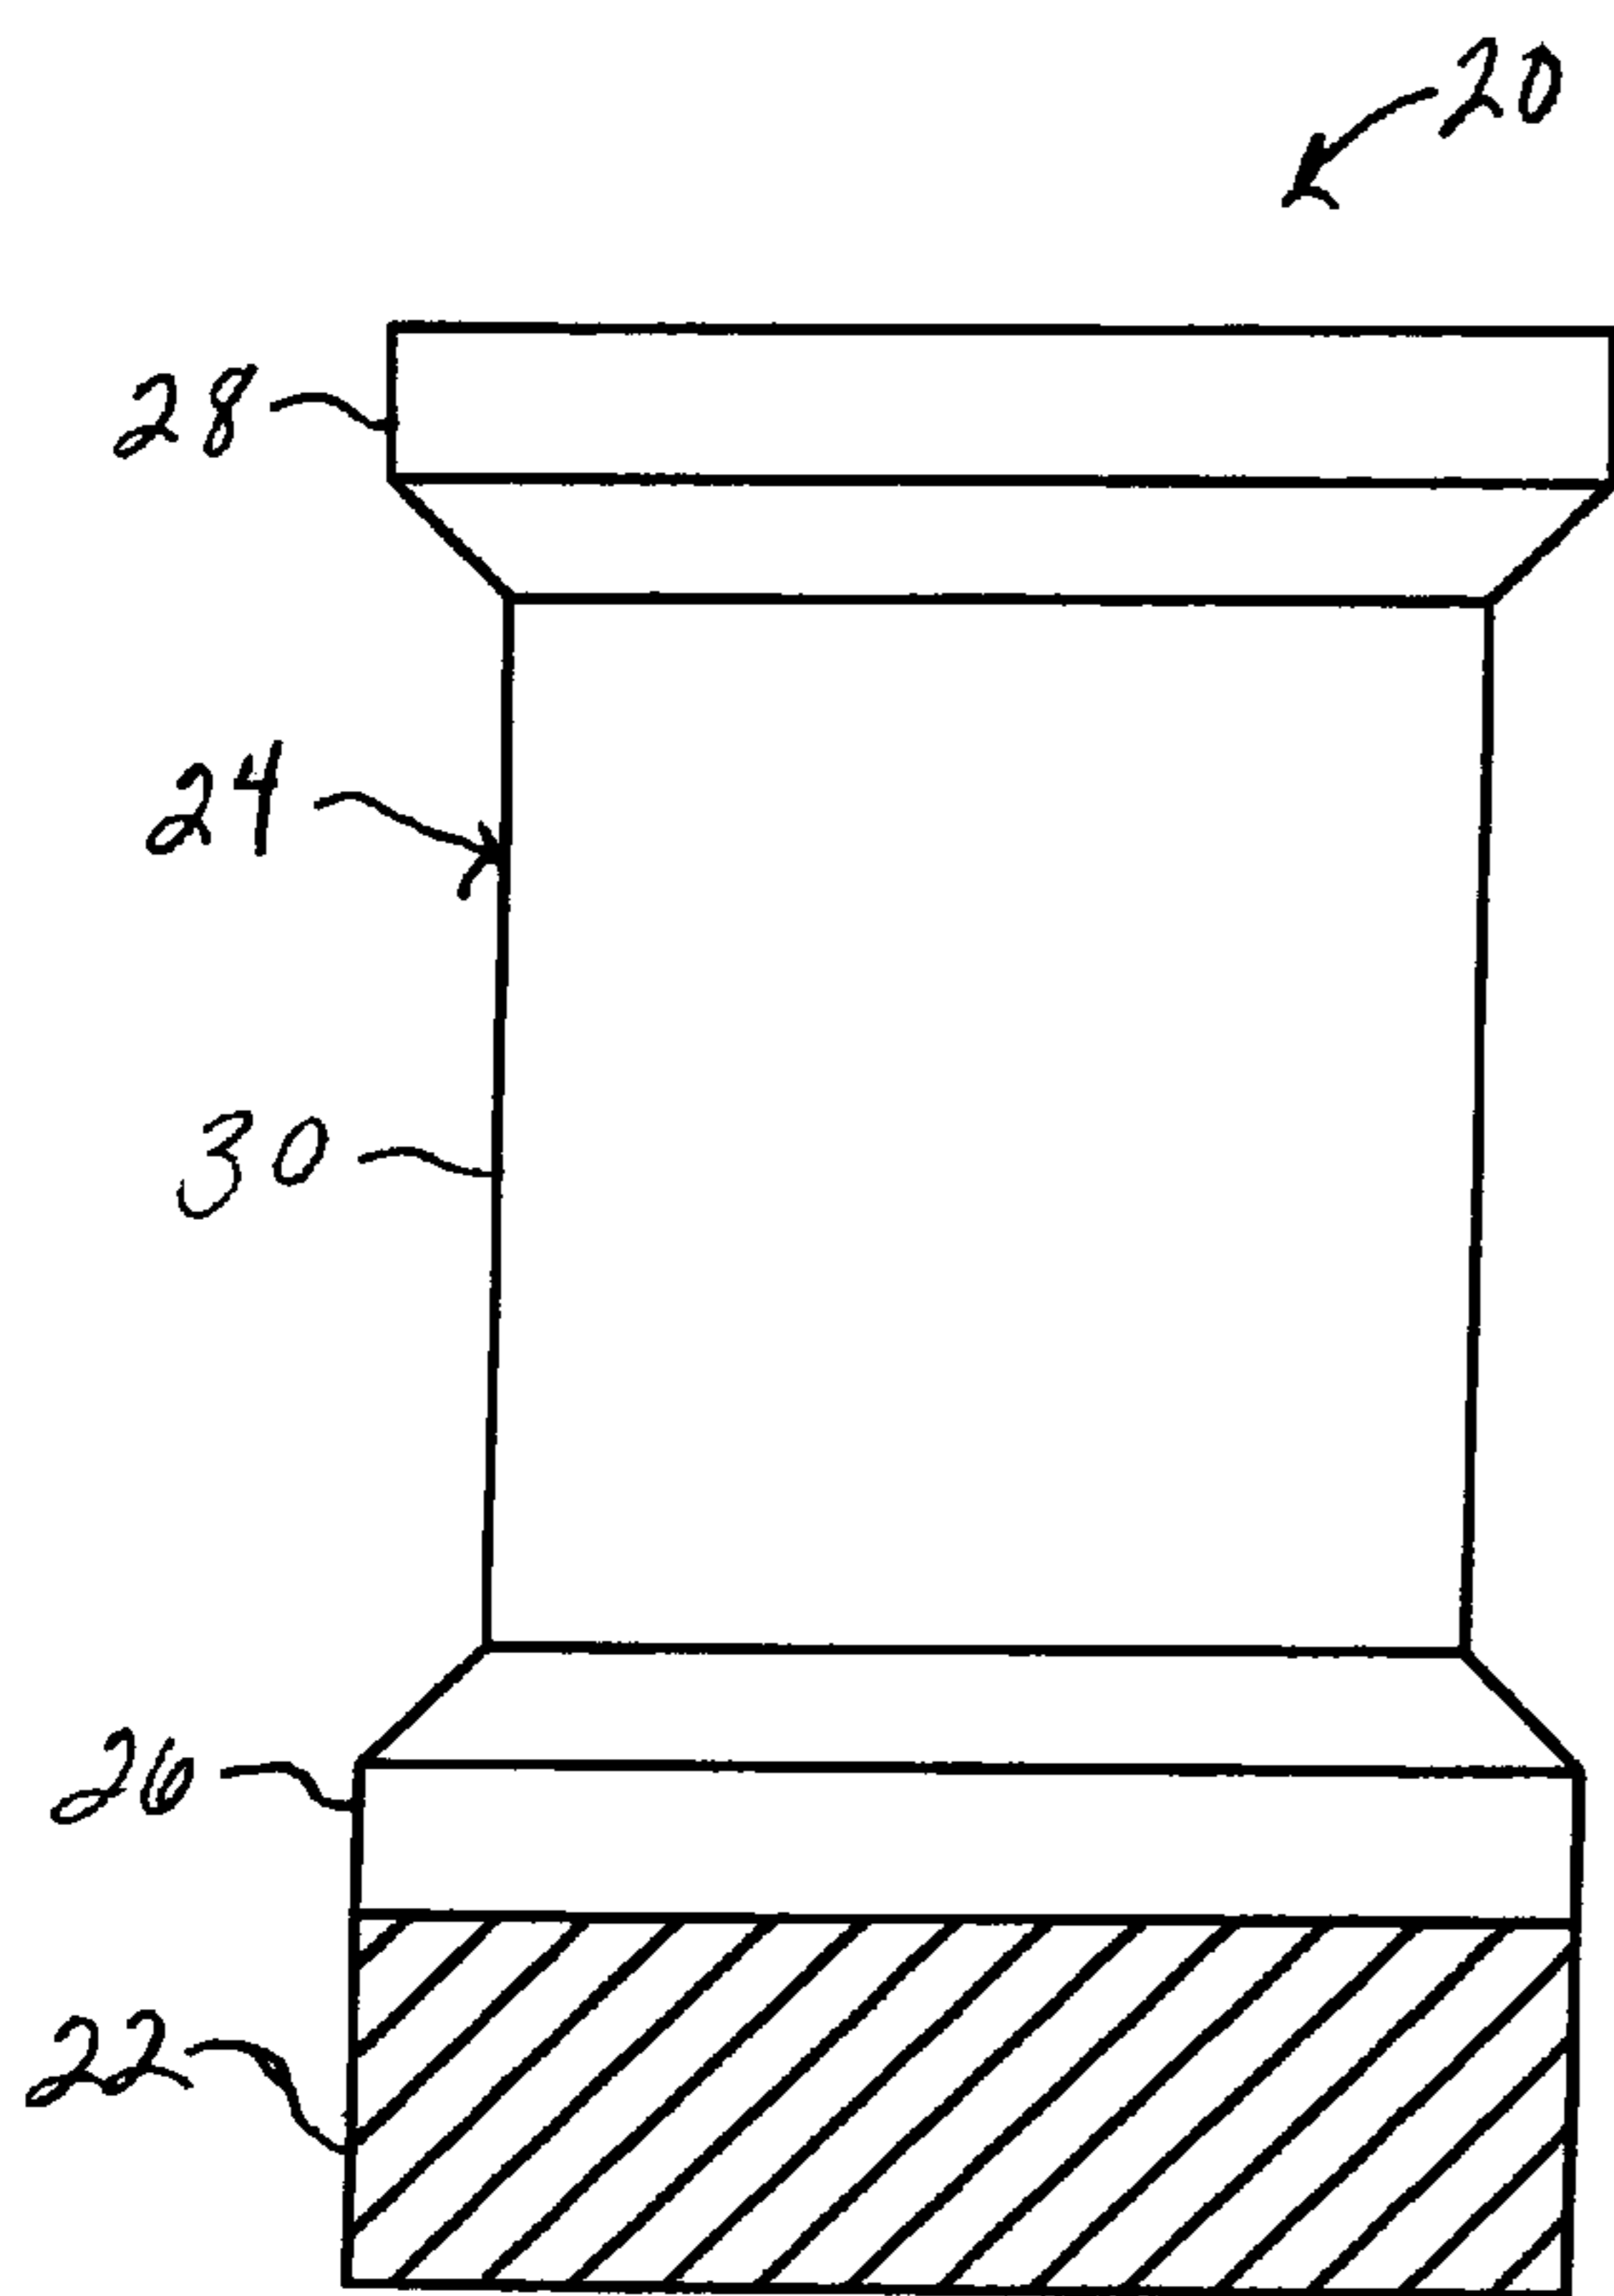
FIG. 4 is a side view of a marker used in accordance with the present invention; and

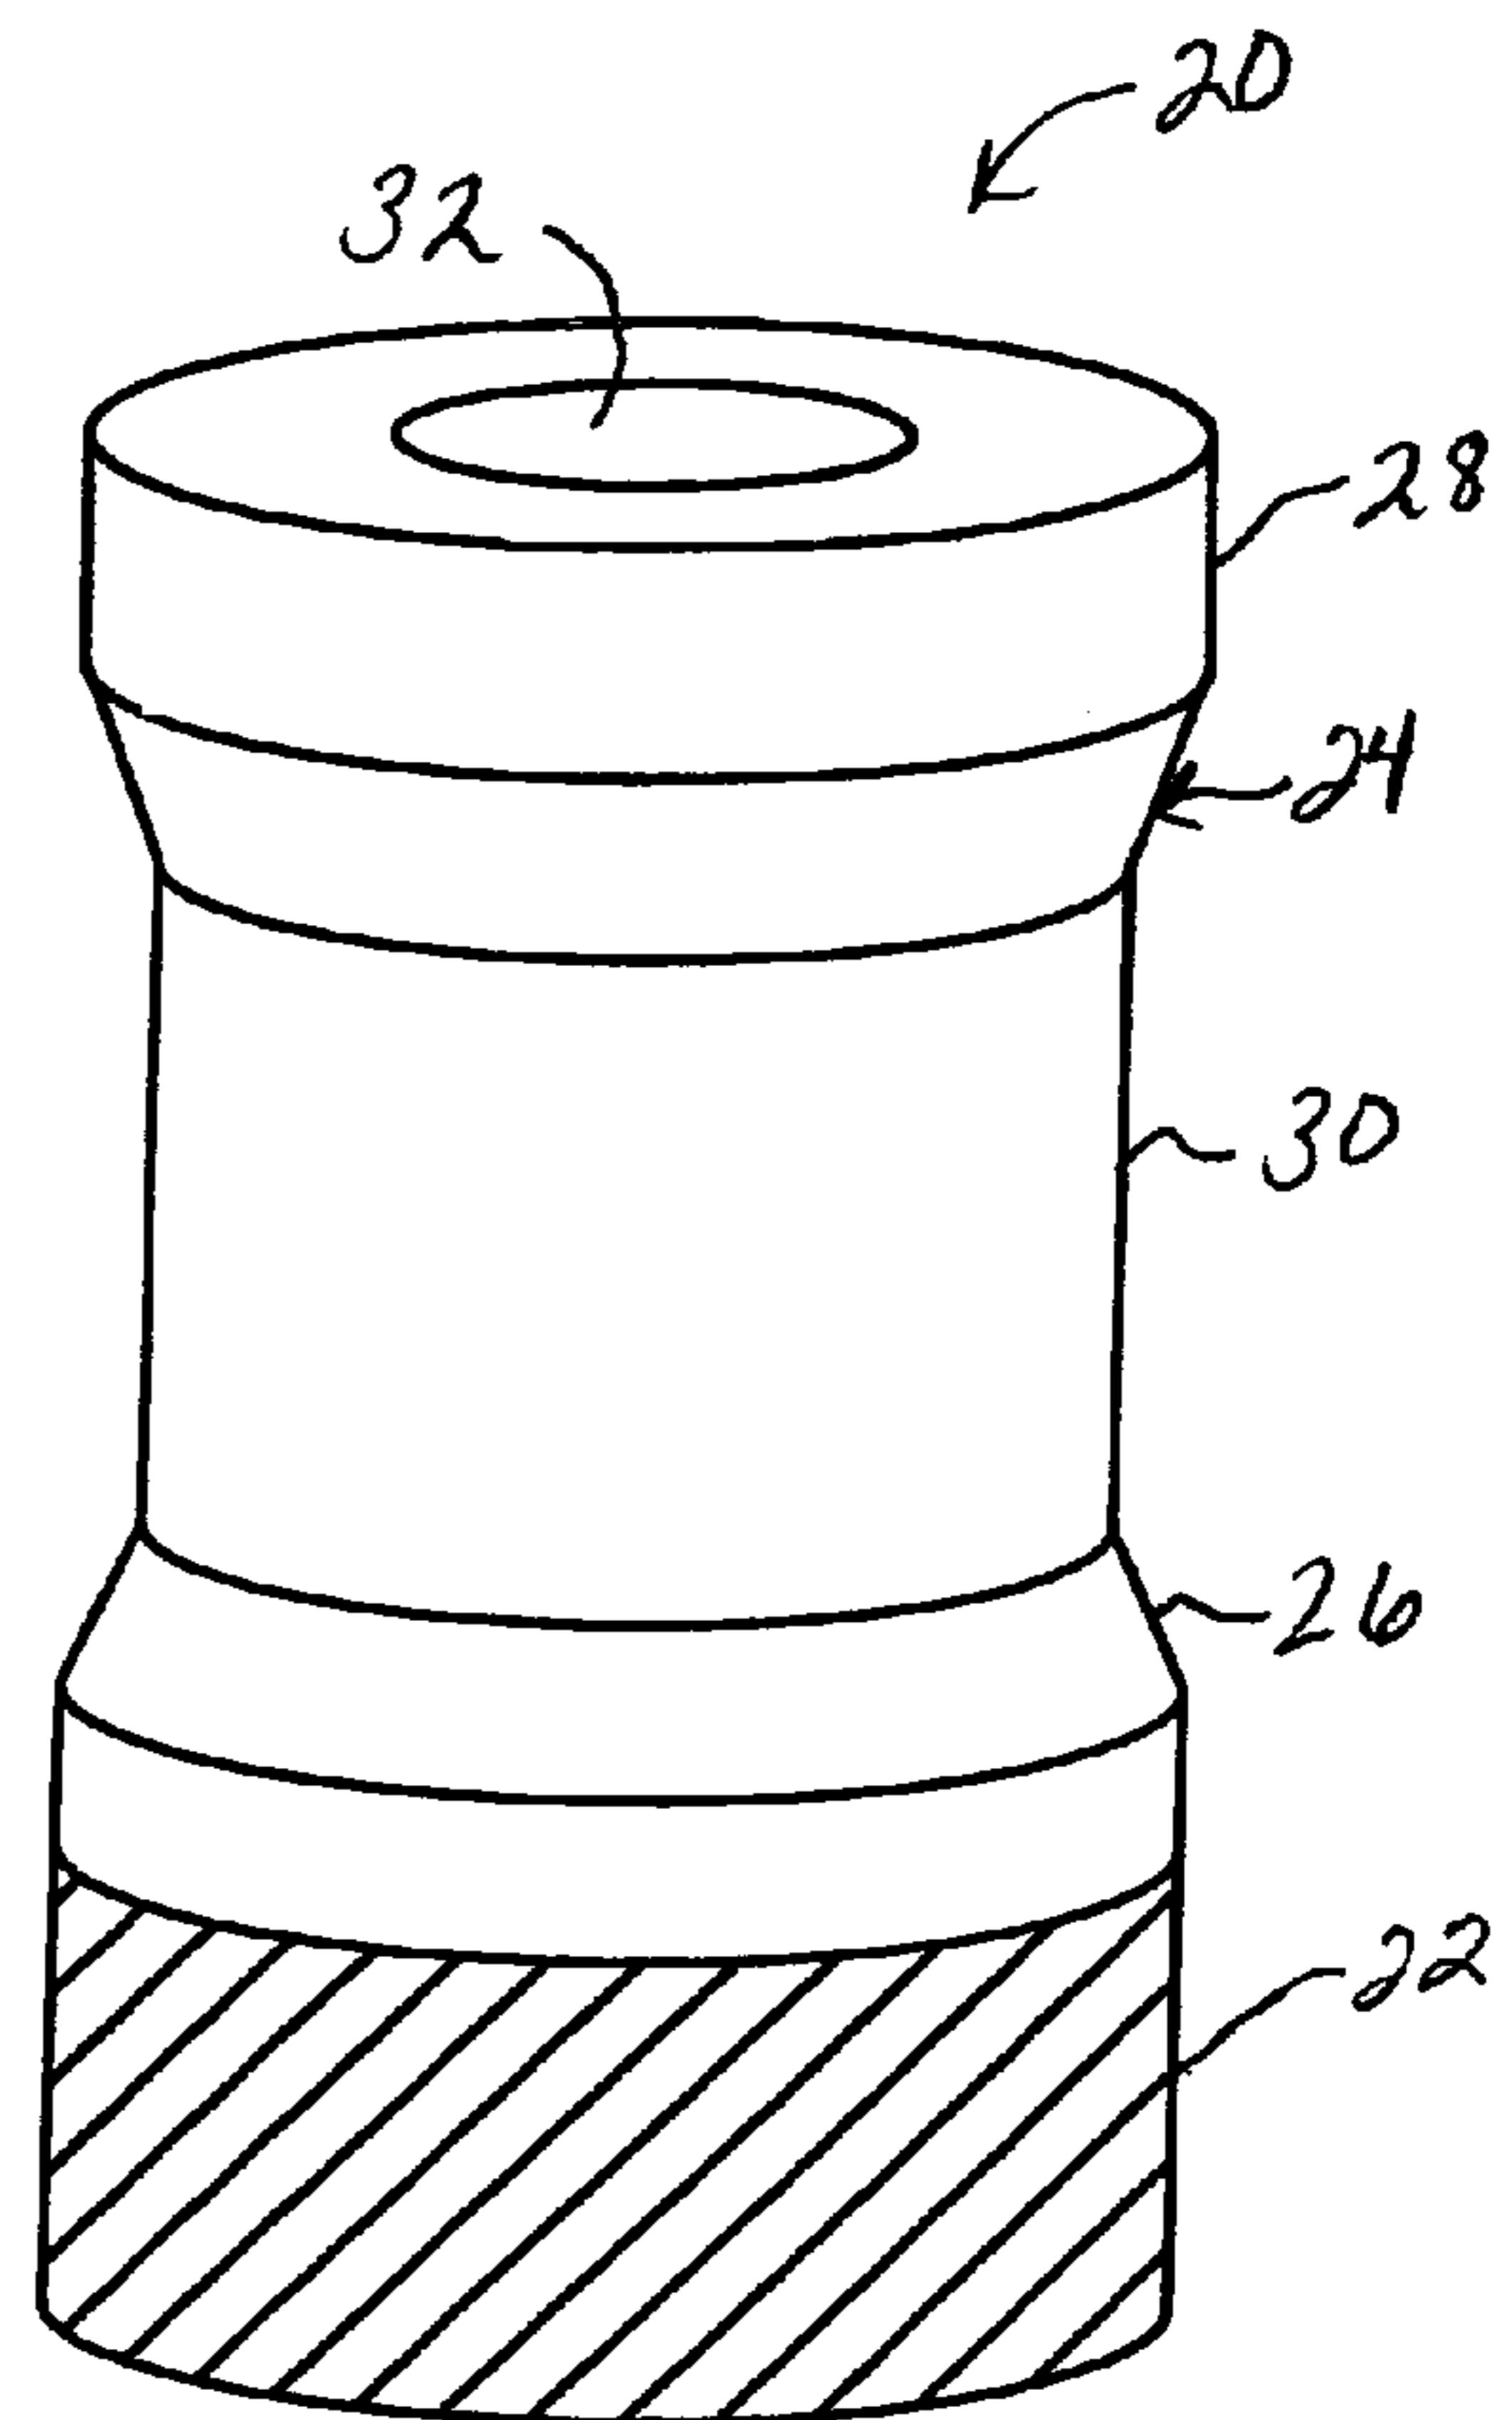
FIG. 5 is a perspective view of the marker of FIG. 4.

As shown in FIG. 5, the marker **24** is hollow and includes a throughbore **32**. Thus, marker **24** is as lightweight as possible. Alternatively, the marker components **24** could be electronic, providing the capability for electronic or optical documentation.
