REPAIRED TURBINE NOZZLE

The present invention relates to a repair of the trailing edge of an airfoil and particularly relates to a coupon having a trailing edge cooling configuration for replacement of a damaged trailing edge portion of a nozzle airfoil for a gas turbine. The present invention also relates to methods for repairing the trailing edge portion of the airfoil.

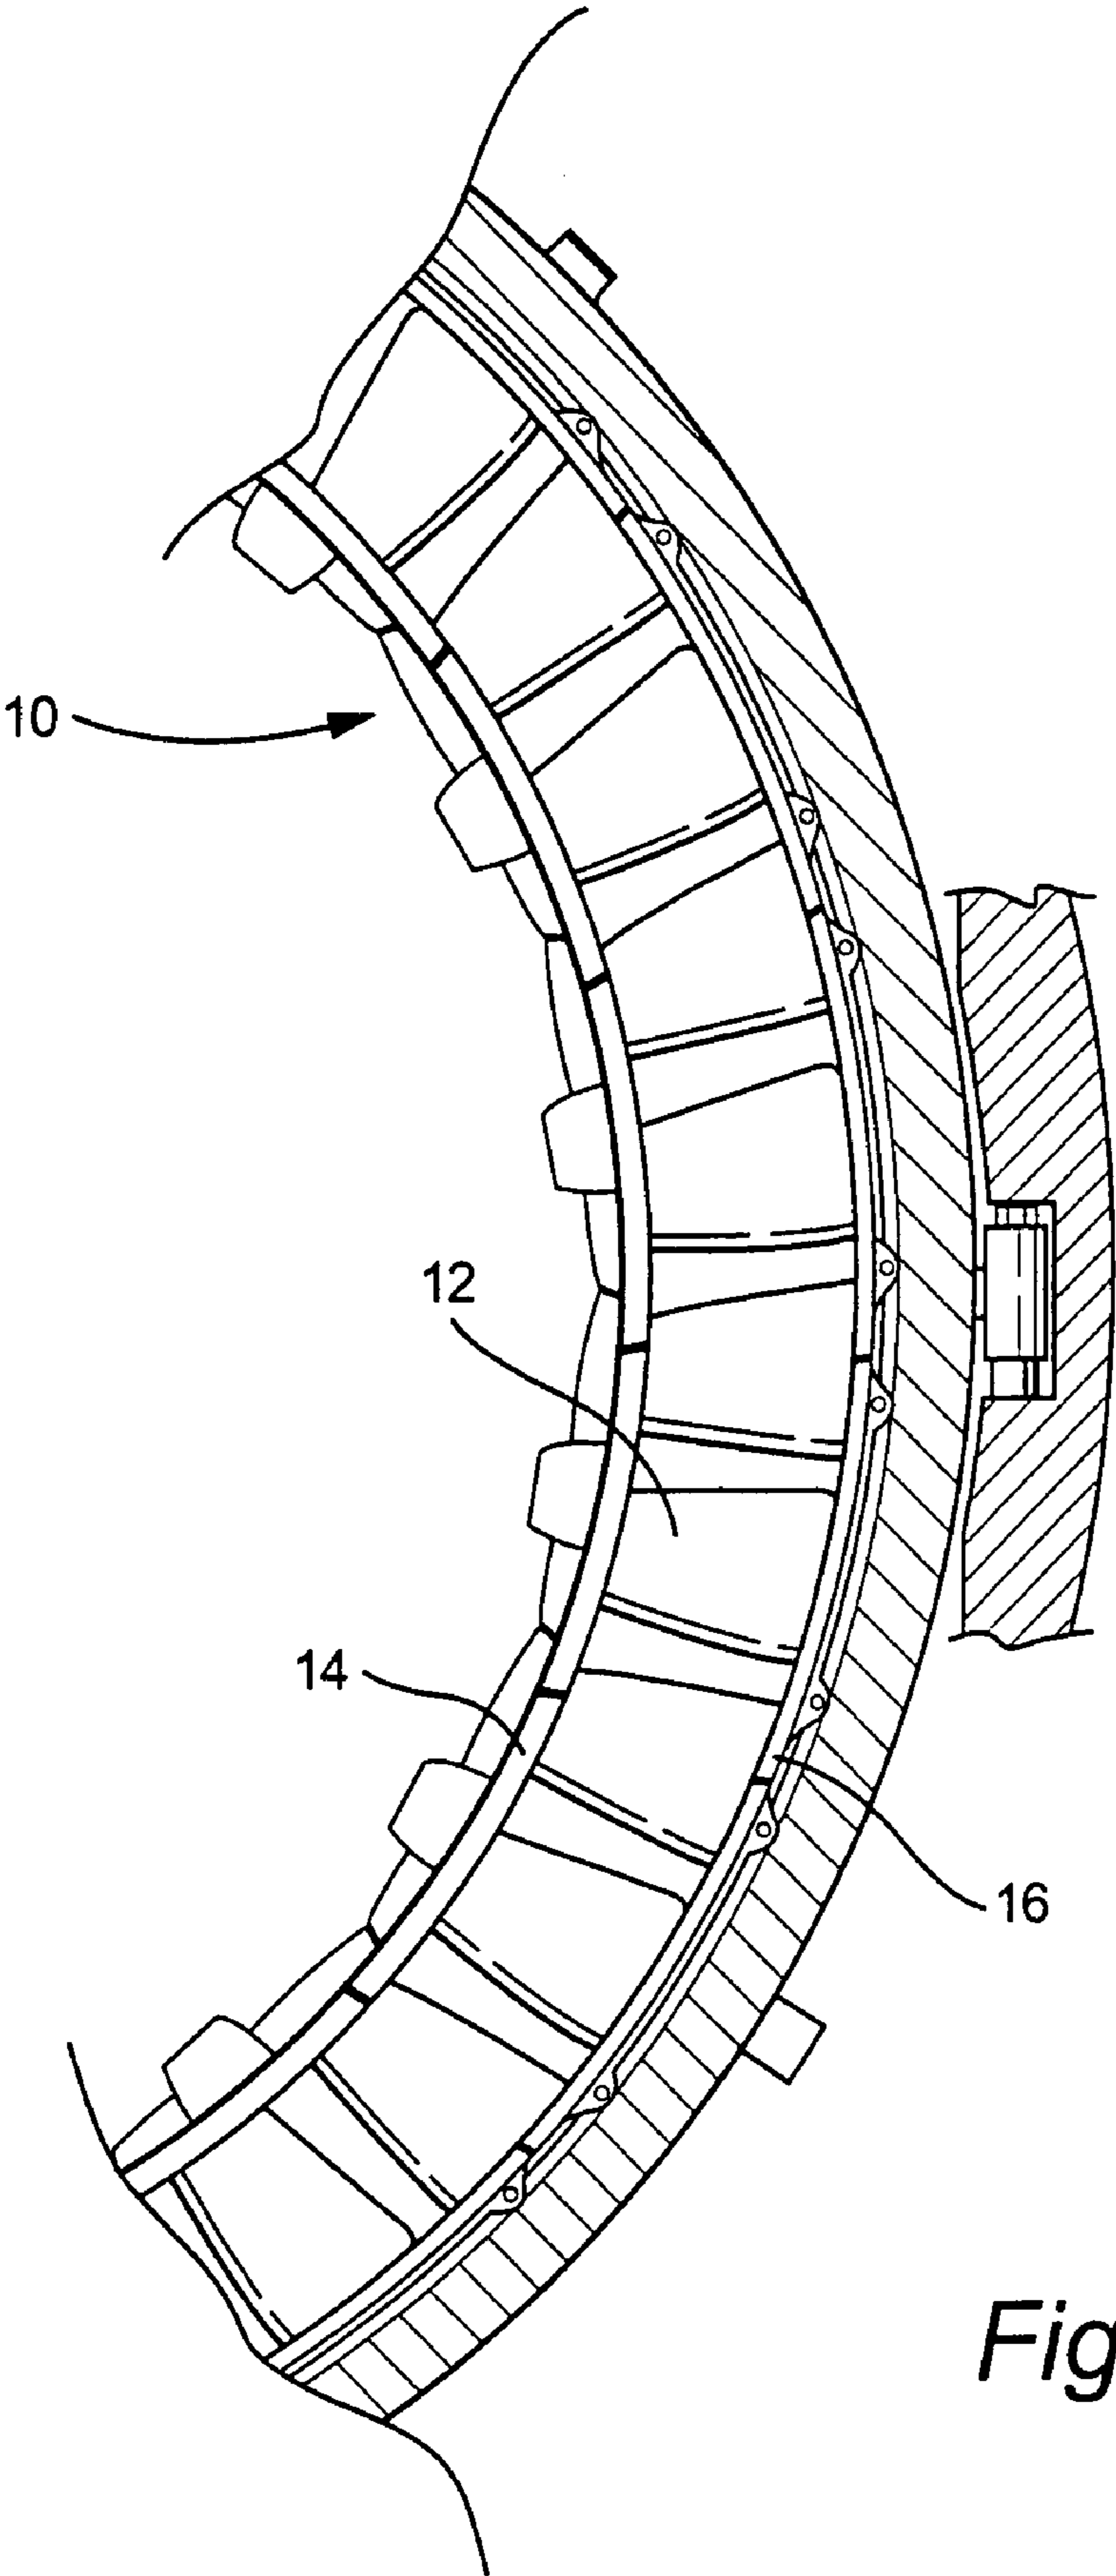
Fig. 1

FIG. 1 is a fragmentary axial view of a plurality of nozzle segments forming part of an annular array of nozzles for a turbine stage;

Referring now to FIG. 1, there is illustrated a plurality of circumferentially spaced nozzle segments, generally designated 10, forming part of a gas turbine and arranged in an annular array about a turbine axis. It will be appreciated that each of the segments 10 includes one or more nozzle vanes or airfoils 12 which extend between an inner platform 14 and outer platform 16. The nozzle airfoils 12 as well as the platforms 14 and 16 define in part a generally axially extending hot gas path through the turbine as well as defining a portion of a turbine stage. In FIGS. 2 and 3, the nozzle segments 10 are illustrated in greater particularity. In this embodiment, a pair of airfoils 12 form part of each segment 10 and extend between the inner and outer platforms 14 and 16, respectively. It will be appreciated that each segment may include one or more airfoils between the platforms. Also illustrated in FIG. 2 is a retaining ring 20 to which the nozzle segment is secured and an inner support ring 22 having a slot 24 for receiving a radially inwardly extending rail 26 of the inner platform 14 for securing the nozzle segment against axial movement in an aft direction.

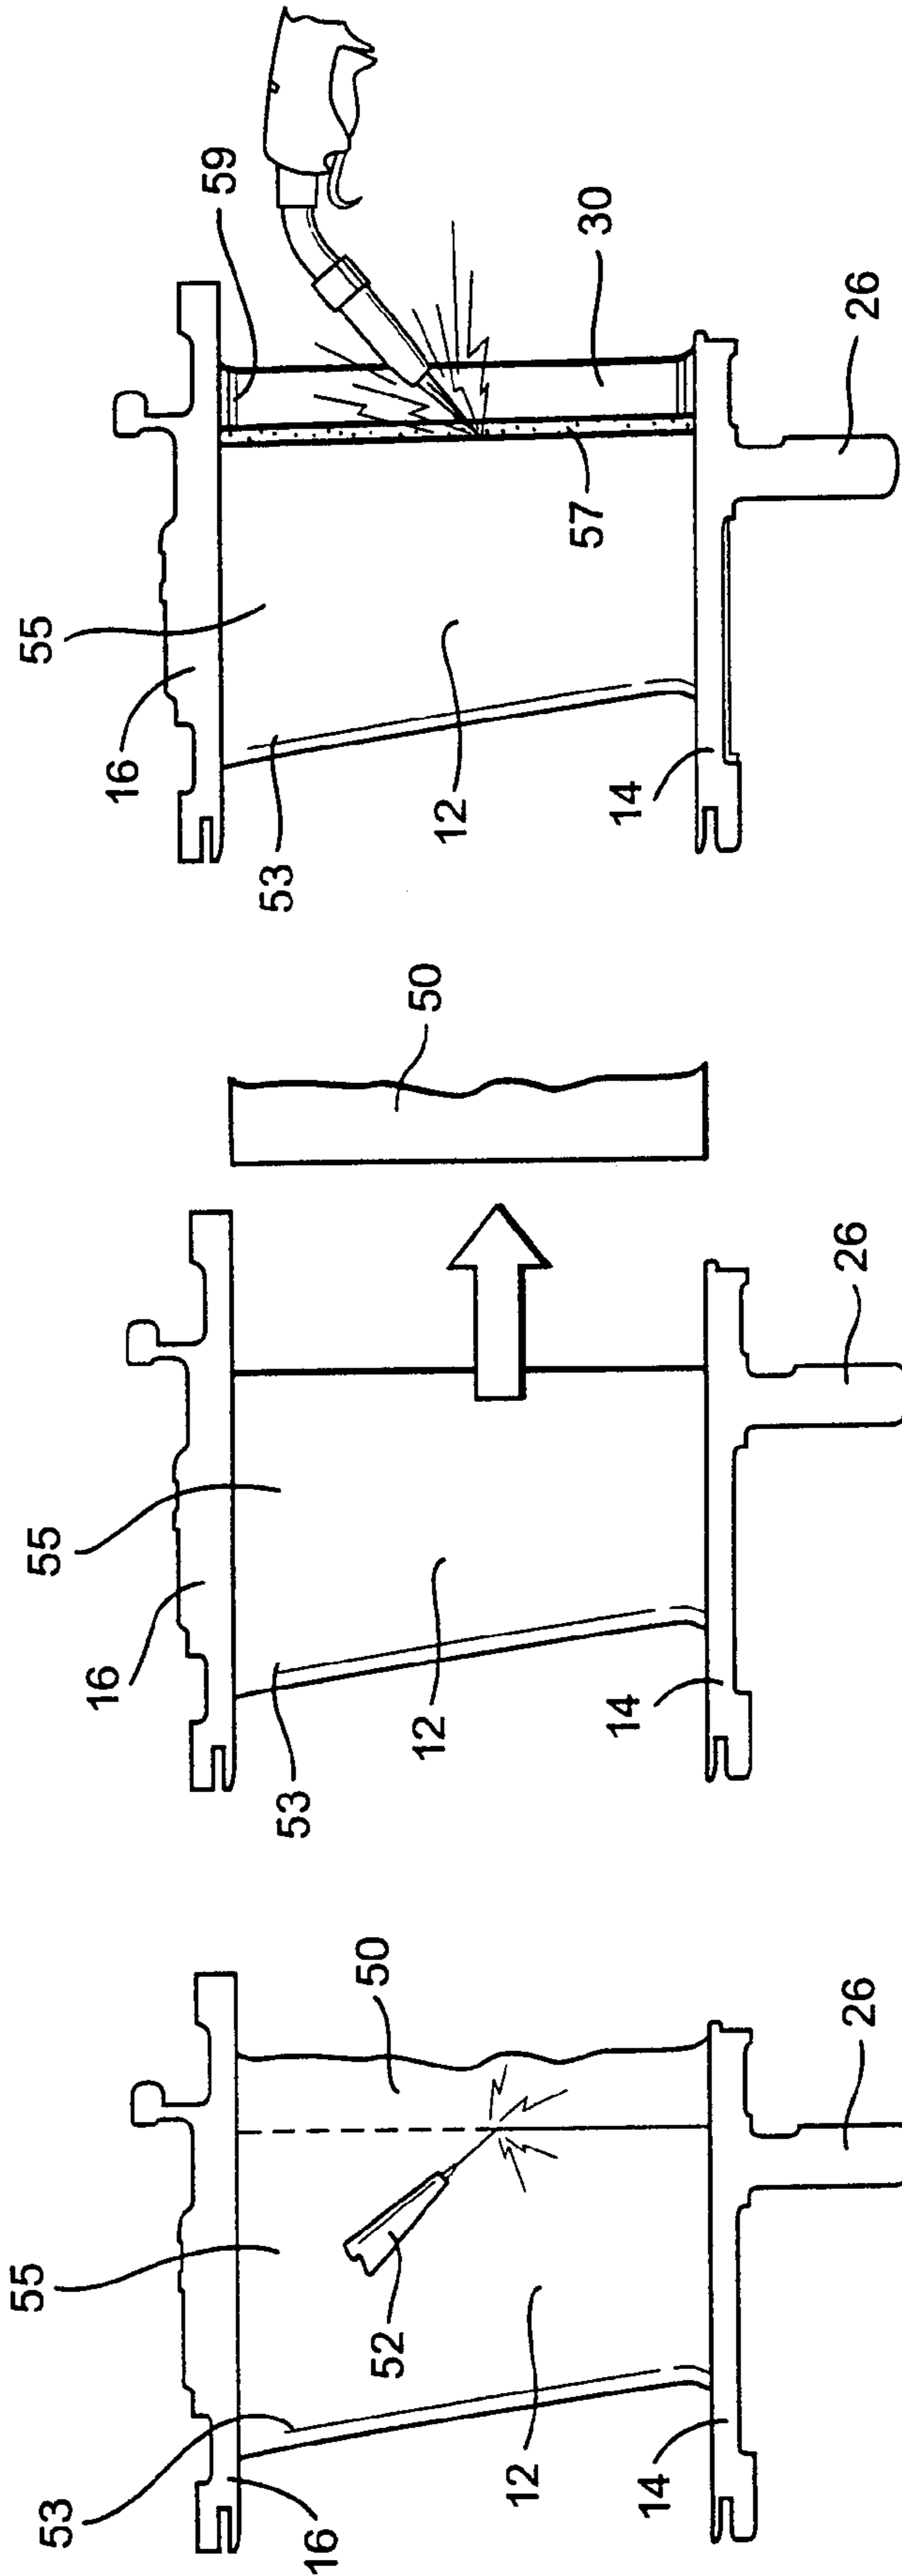
FIGS. 7-9 are schematic illustrations of the manner of repairing the nozzle airfoil.
