(54) **REPAIRED TURBINE NOZZLE**

A trailing edge coupon for the trailing edge of a airfoil of a turbine nozzle segment is welded to an airfoil section of the nozzle segment having a damaged trailing edge portion removed. The coupon includes film cooling holes spaced one from the other along a pressure side wall portion of the coupon and a plurality of radially spaced openings along the trailing edge. By welding the pressure and suction side edges of the coupon to the pressure and side edges of the remaining portion of the airfoil, the operating life of the nozzle is extended.

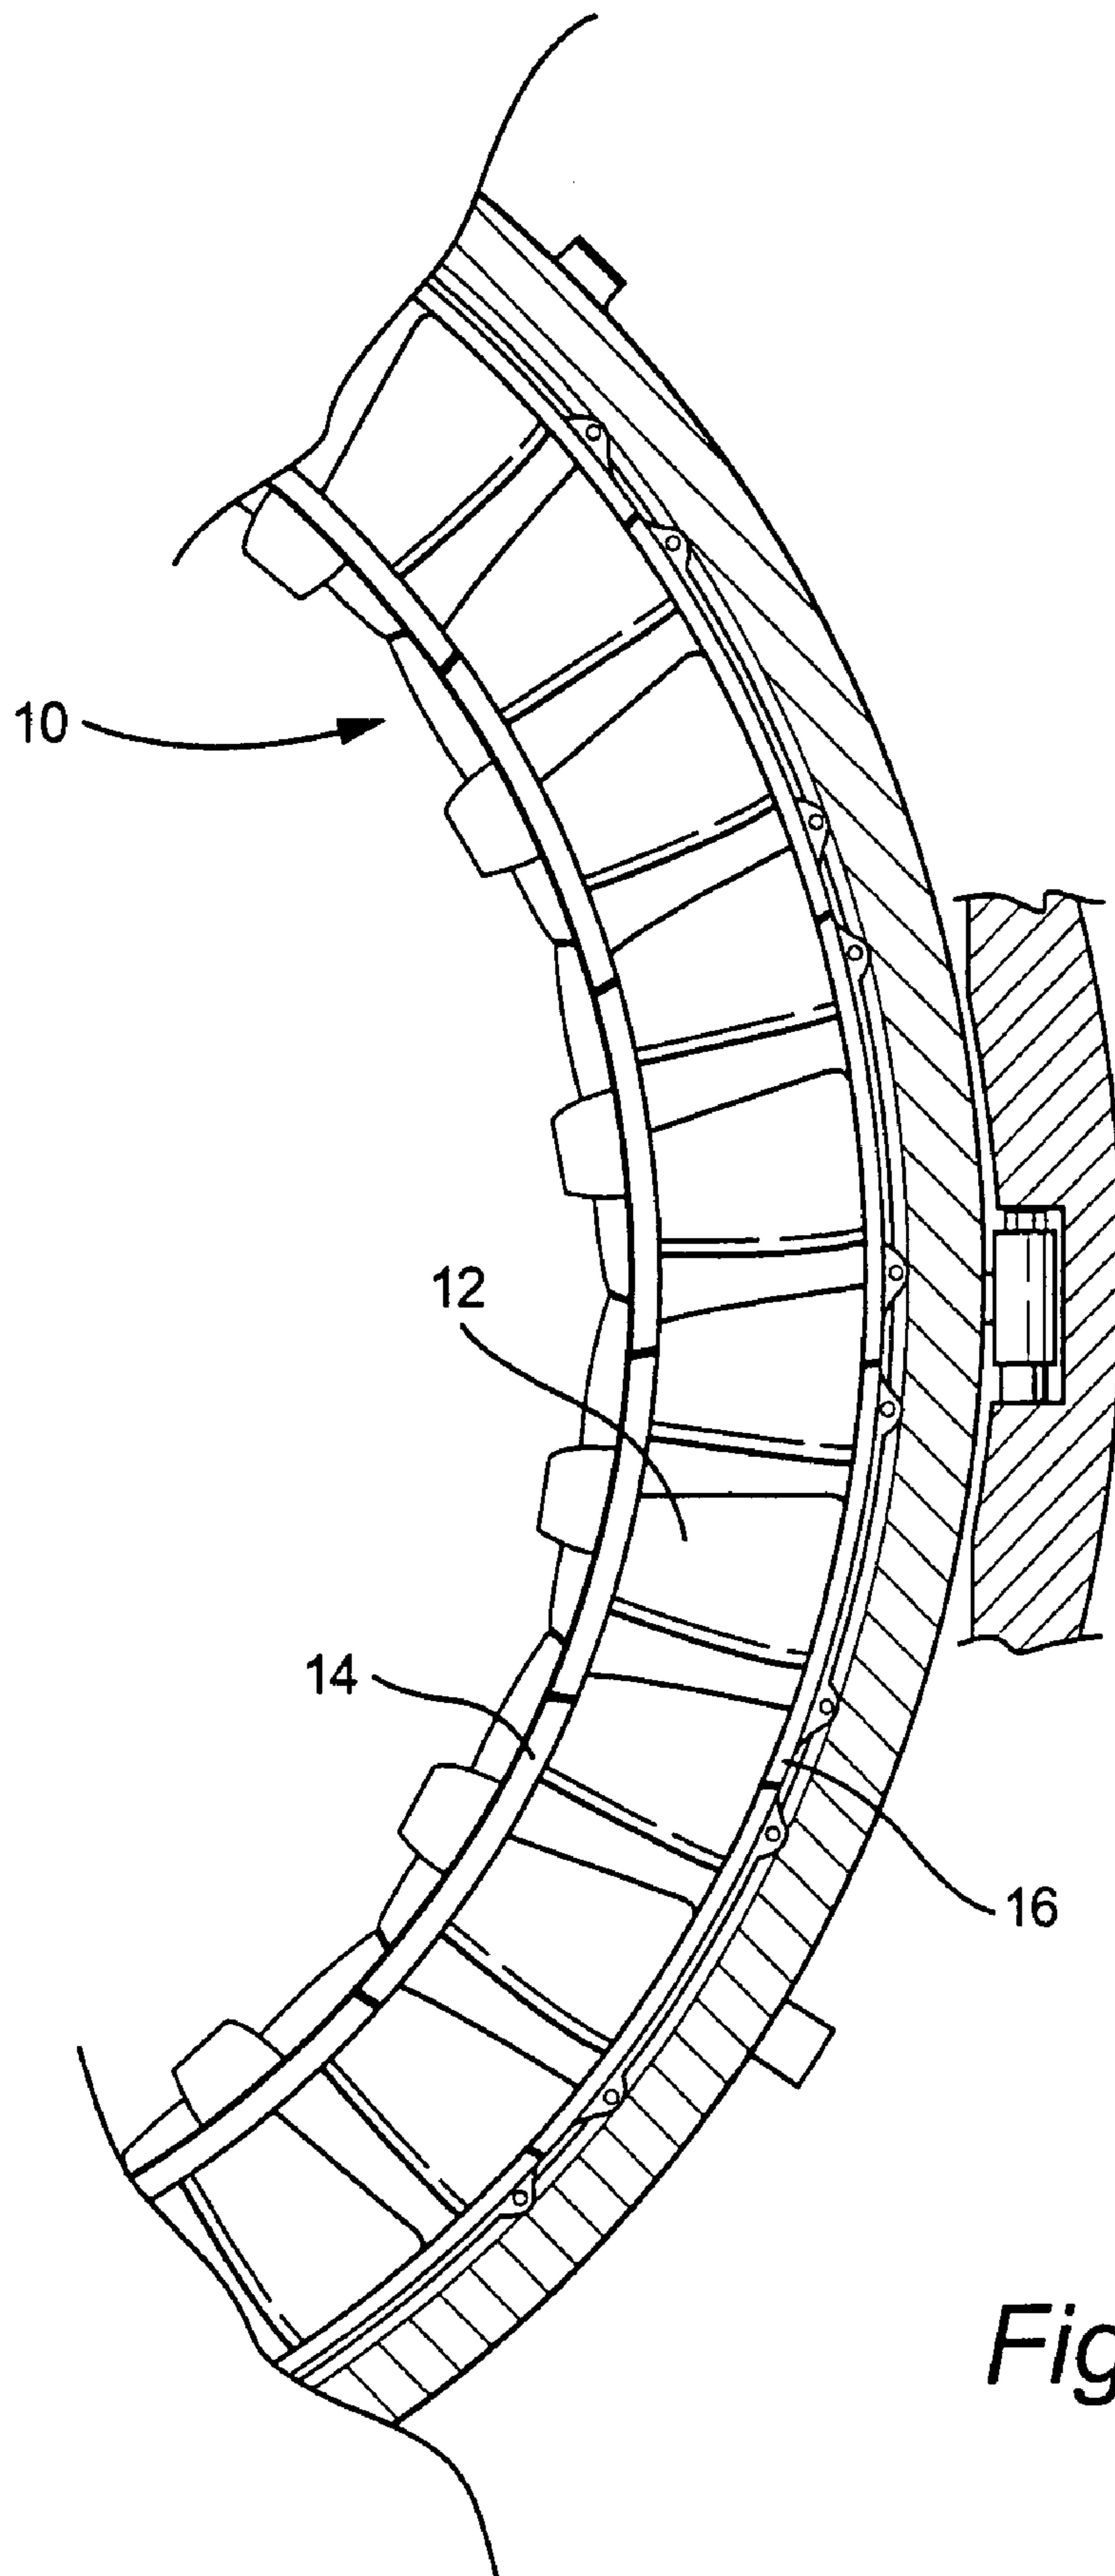
Fig. 1

FIG. 1 is a fragmentary axial view of a plurality of nozzle segments forming part of an annular array of nozzles for a turbine stage;

Referring now to FIG. 1, there is illustrated a plurality of circumferentially spaced nozzle segments, generally designated 10, forming part of a gas turbine and arranged in an annular array about a turbine axis. It will be appreciated that each of the segments 10 includes one or more nozzle vanes or airfoils 12 which extend between an inner platform 14 and outer platform 16. The nozzle airfoils 12 as well as the platforms 14 and 16 define in part a generally axially extending hot gas path through the turbine as well as defining a portion of a turbine stage. In FIGS. 2 and 3, the nozzle segments 10 are illustrated in greater particularity. In this embodiment, a pair of airfoils 12 form part of each segment 10 and extend between the inner and outer platforms 14 and 16, respectively. It will be appreciated that each segment may include one or more airfoils between the platforms. Also illustrated in FIG. 2 is an retaining ring 20 to which the nozzle segment is secured and an inner support ring 22 having a slot 24 for receiving a radially inwardly extending rail 26 of the inner platform 14 for securing the nozzle segment against axial movement in an aft direction.

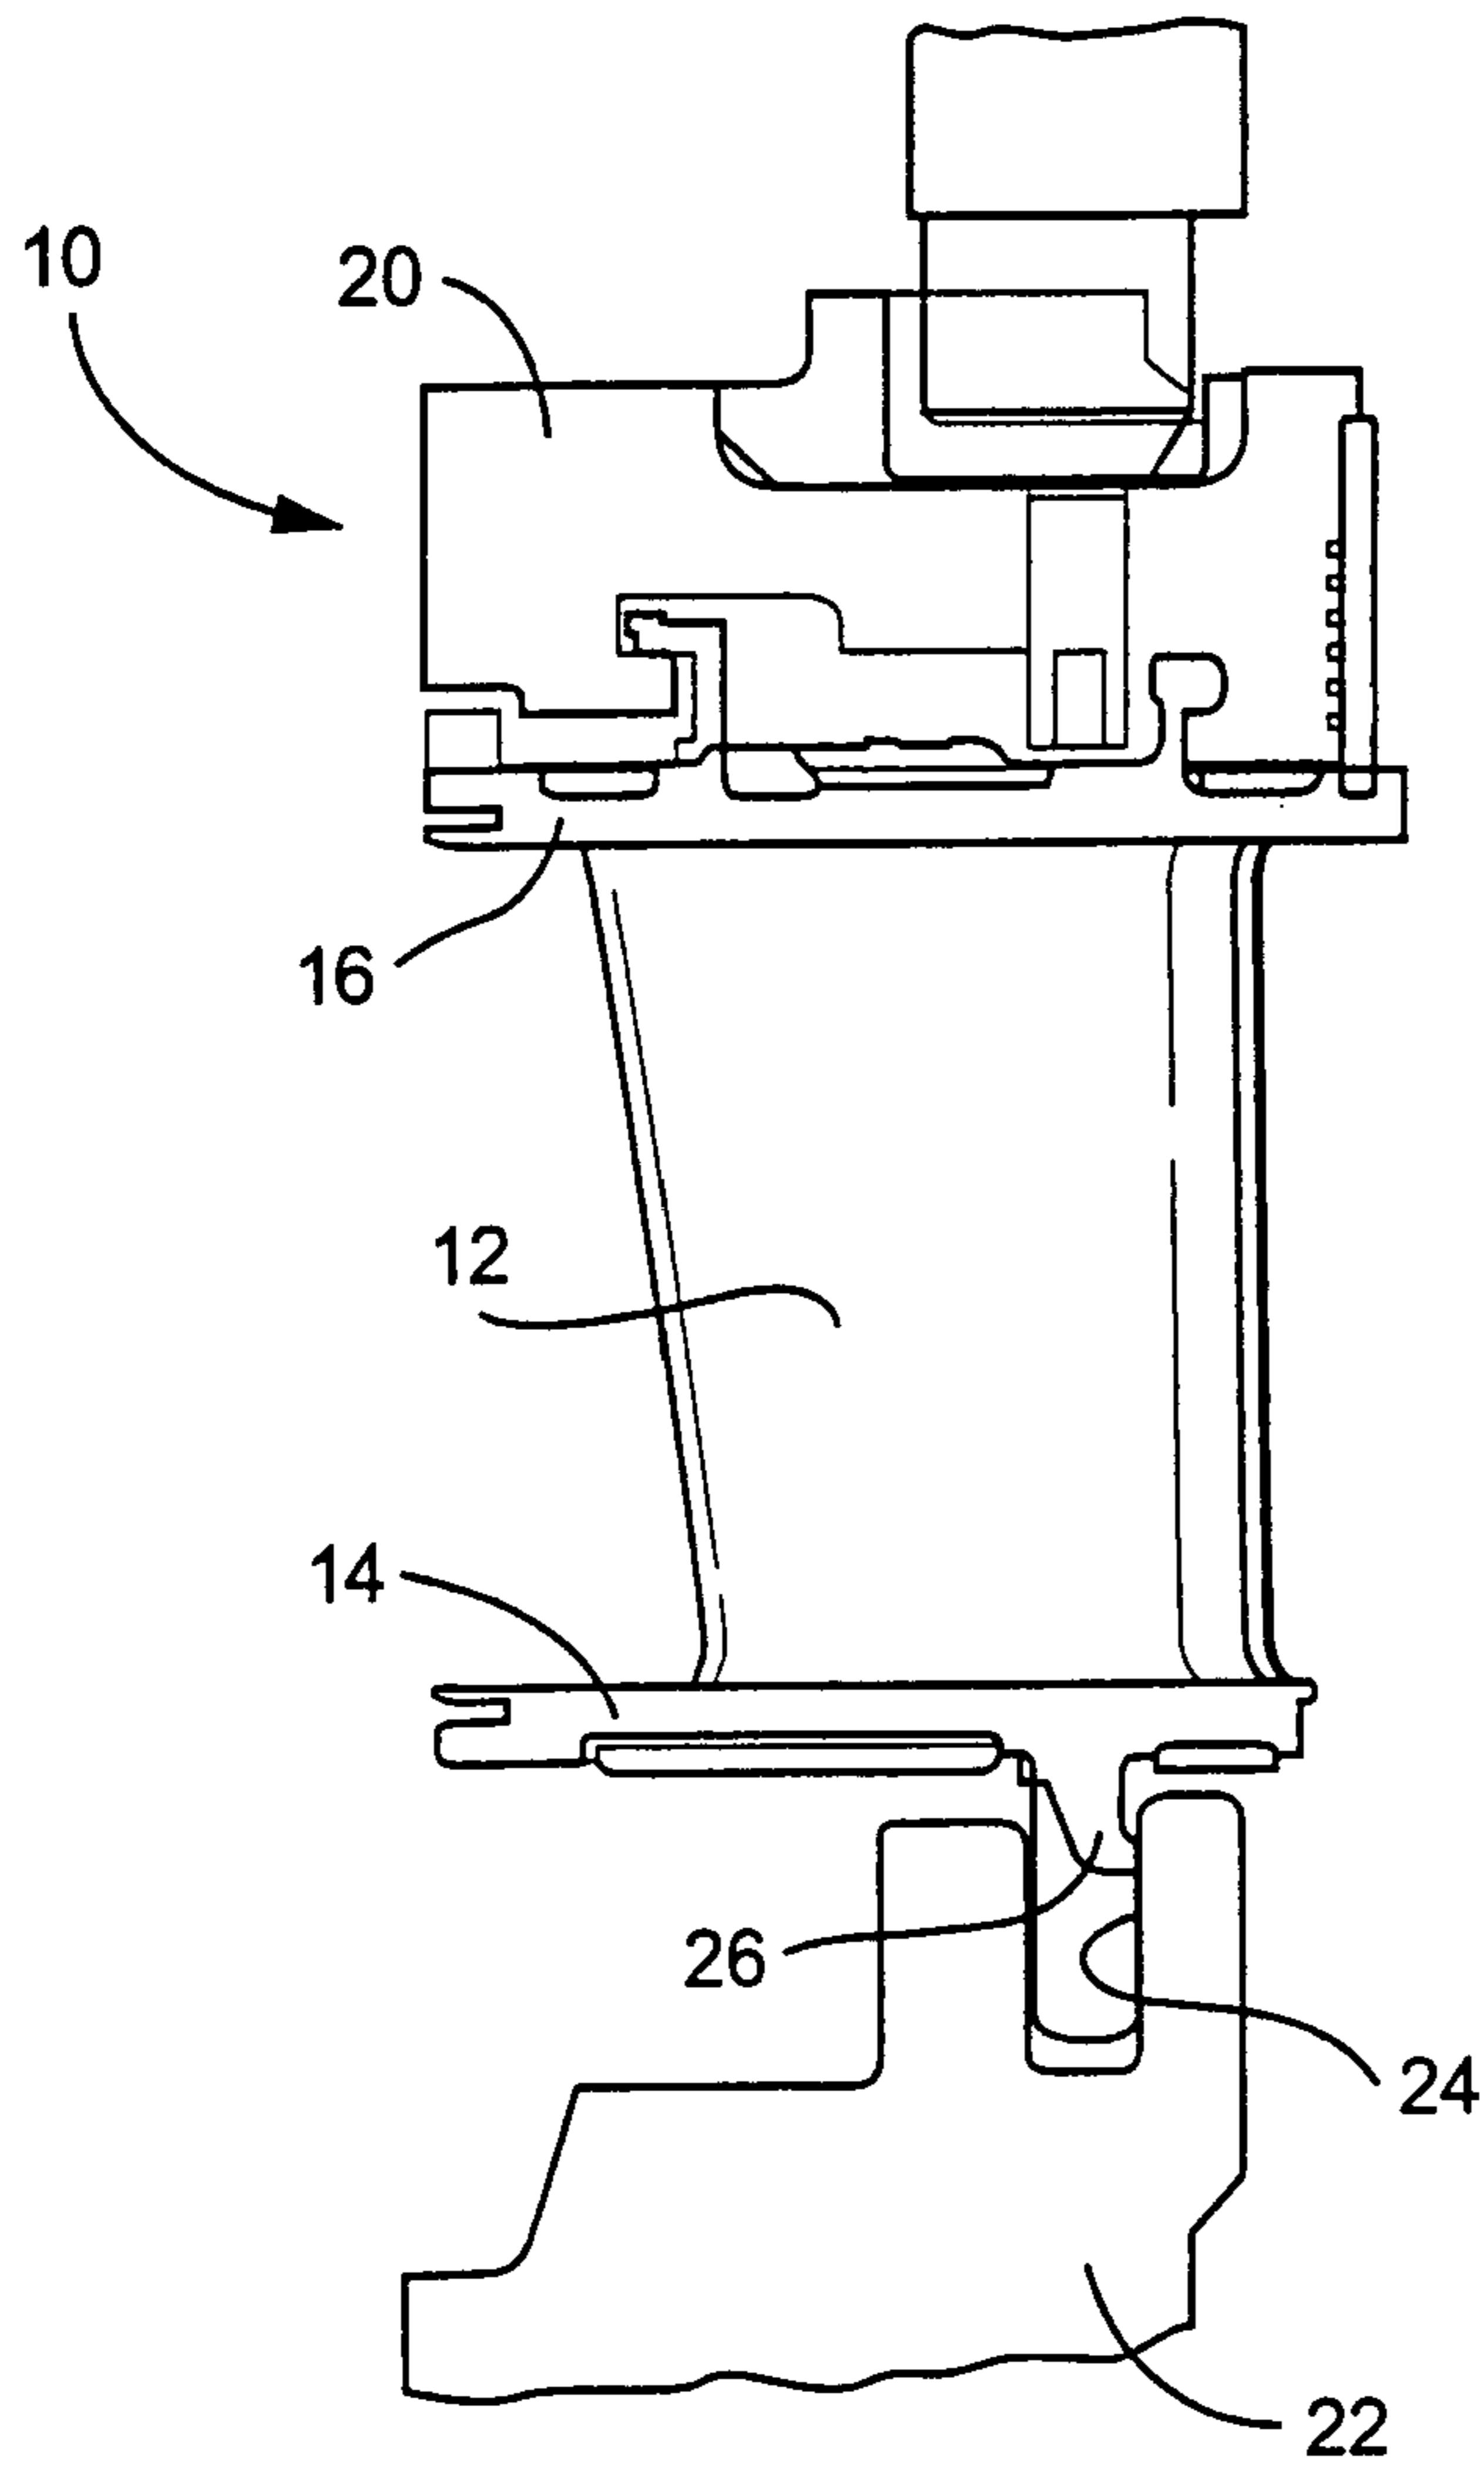
Fig. 2

FIG. 2 is a side elevational view of a nozzle segment installed between portions of an inner and outer casing;

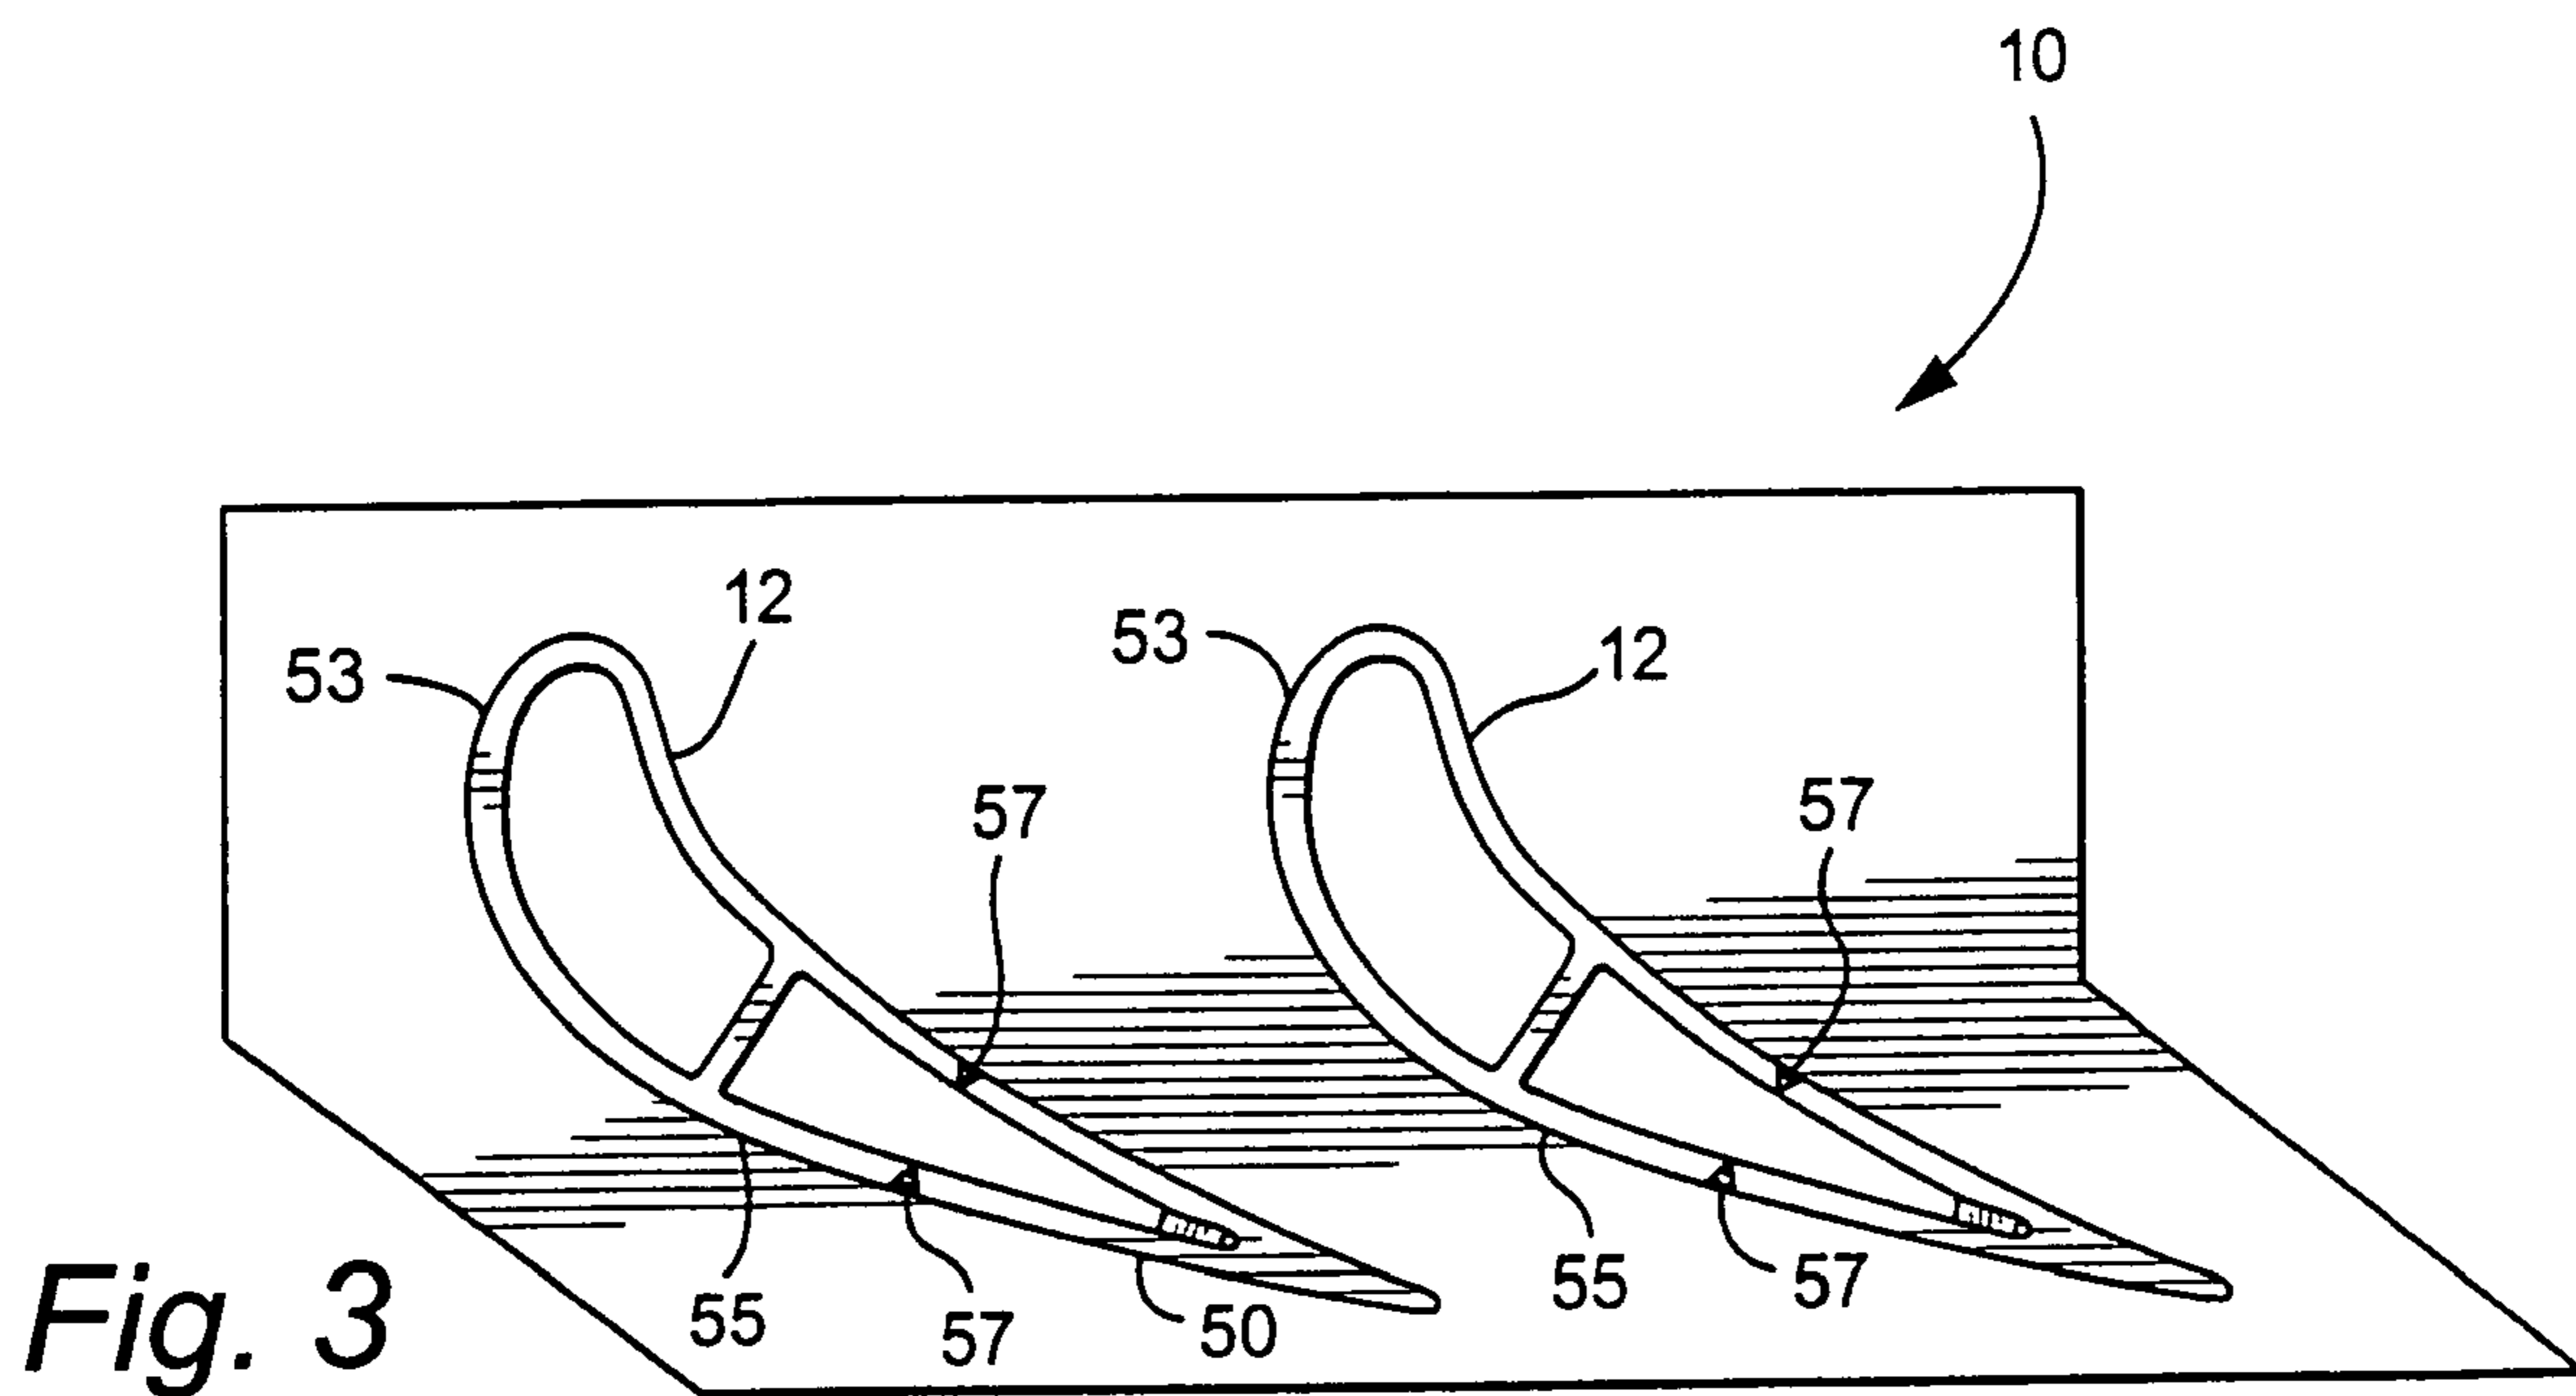
Fig. 3

FIG. 3 is an enlarged cross-sectional view through the airfoils of a nozzle segment illustrating a coupon welded to a reusable portion of the original airfoil;

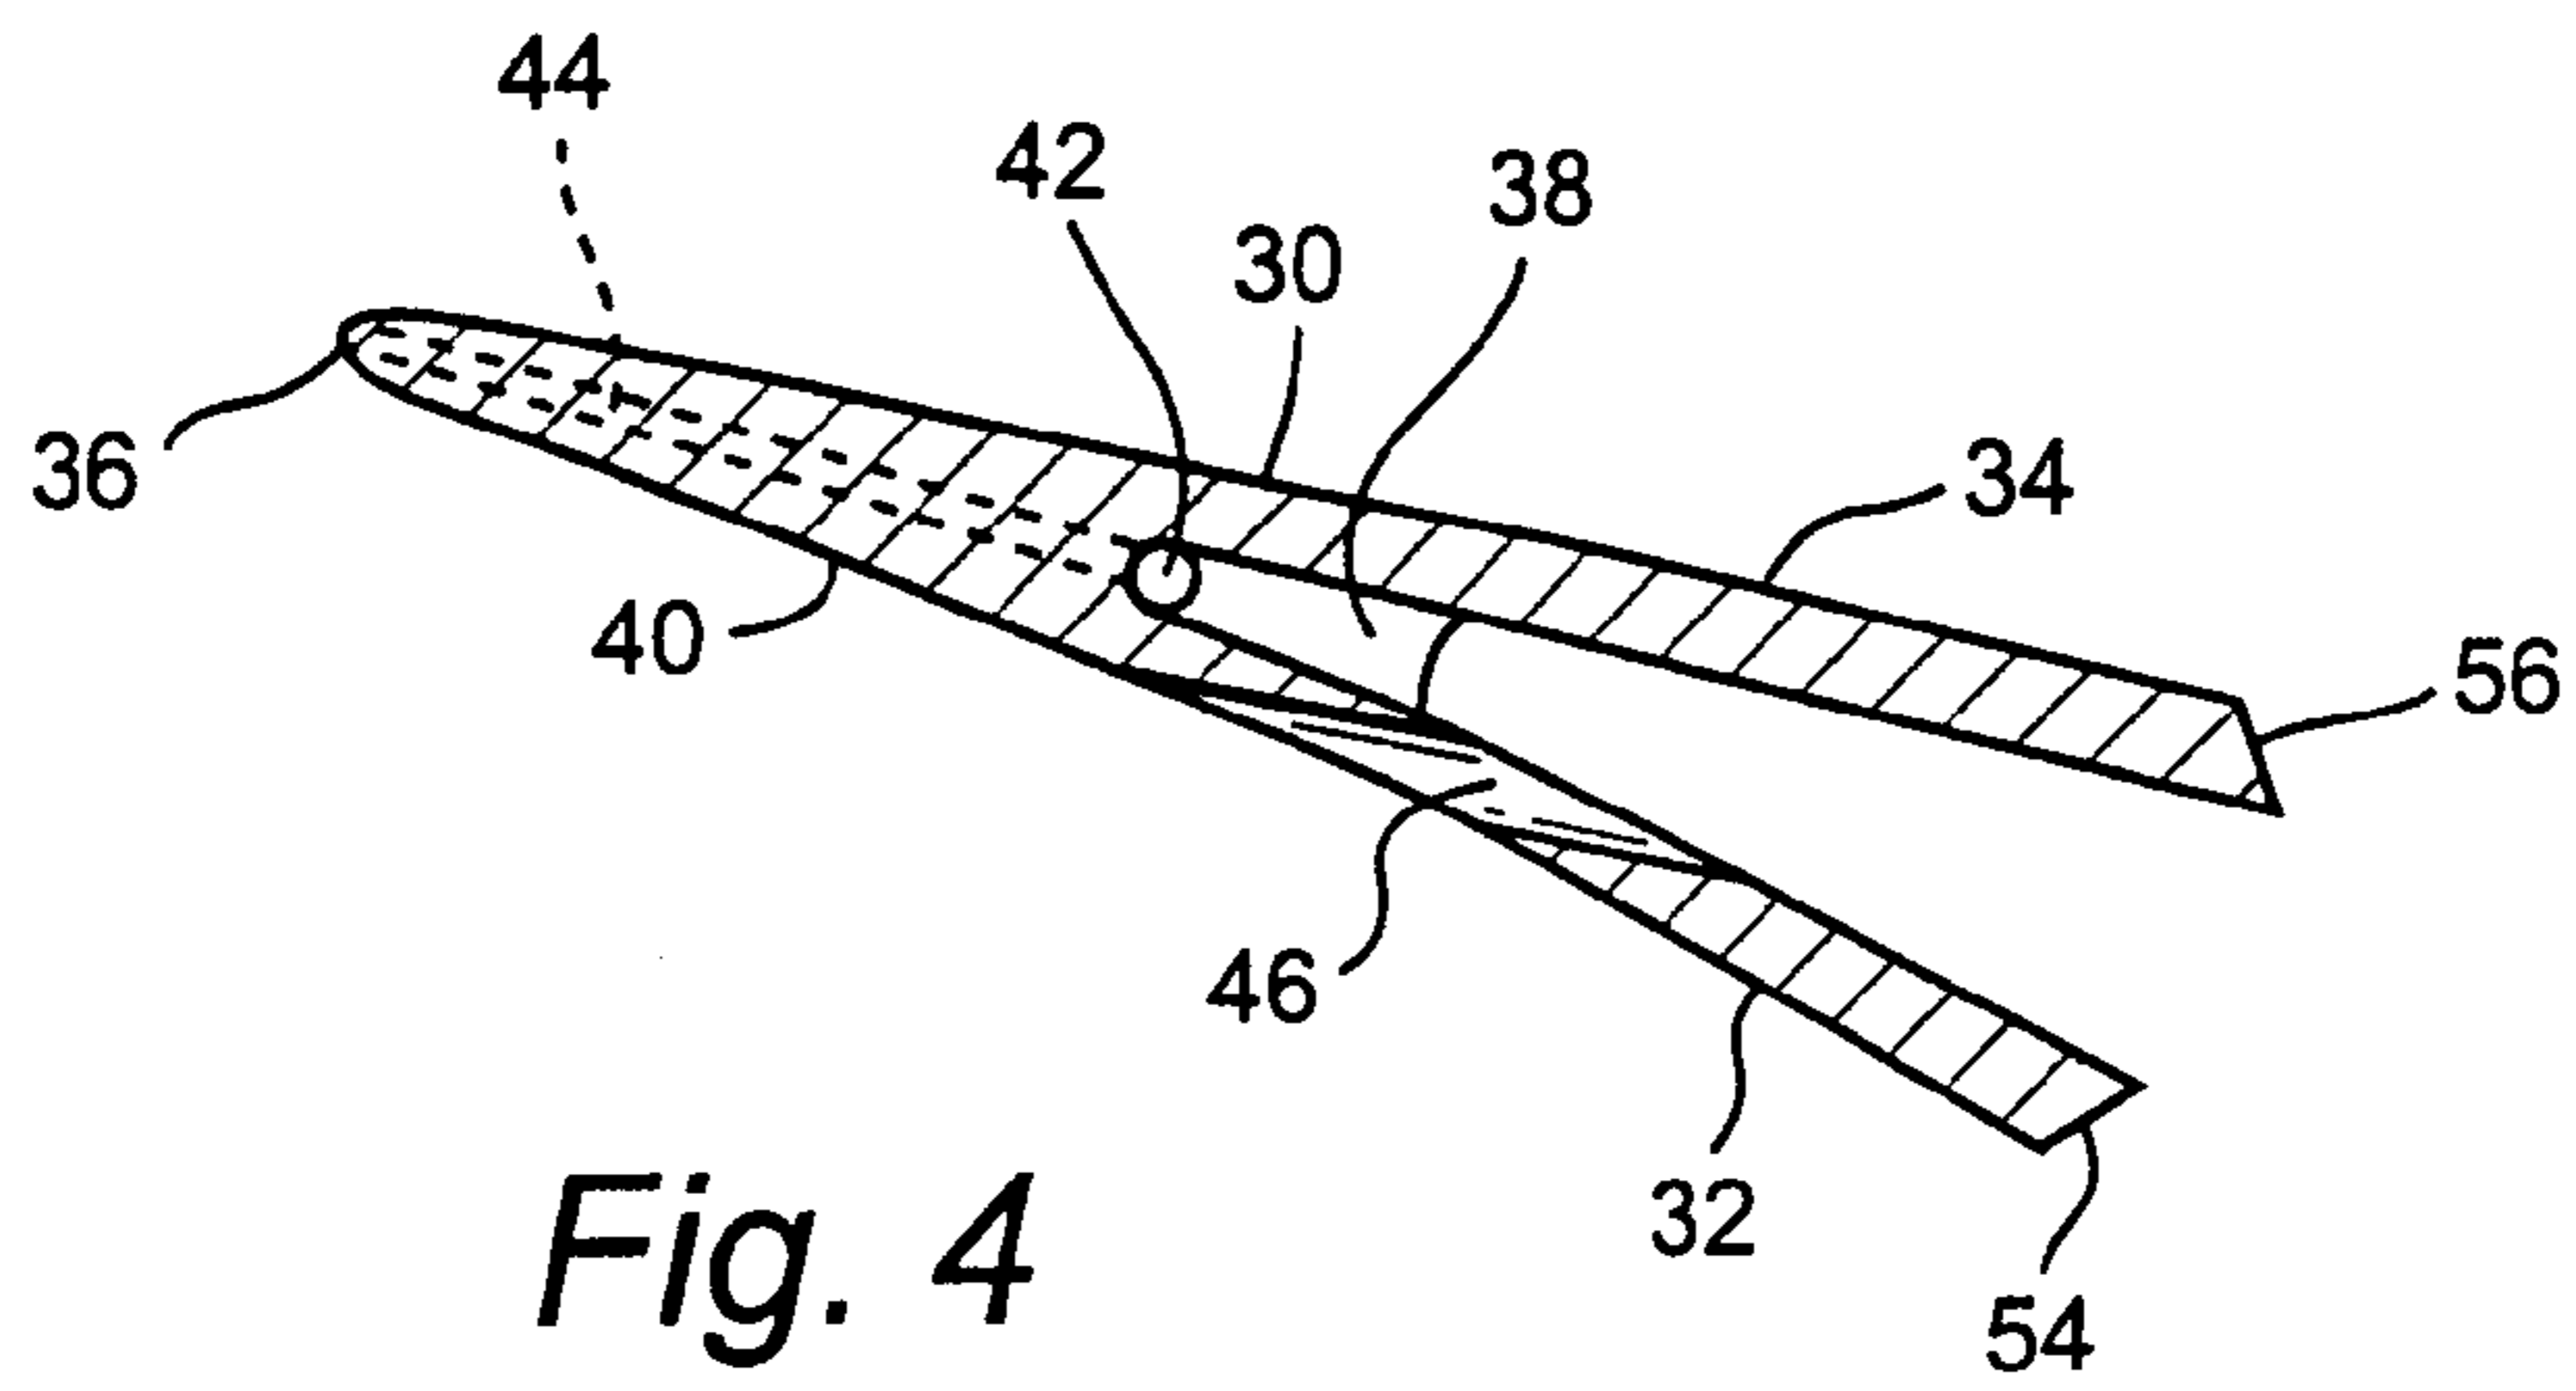
Fig. 4

FIG. 4 is an enlarged cross-sectional view of the coupon for repairing the nozzle airfoil;

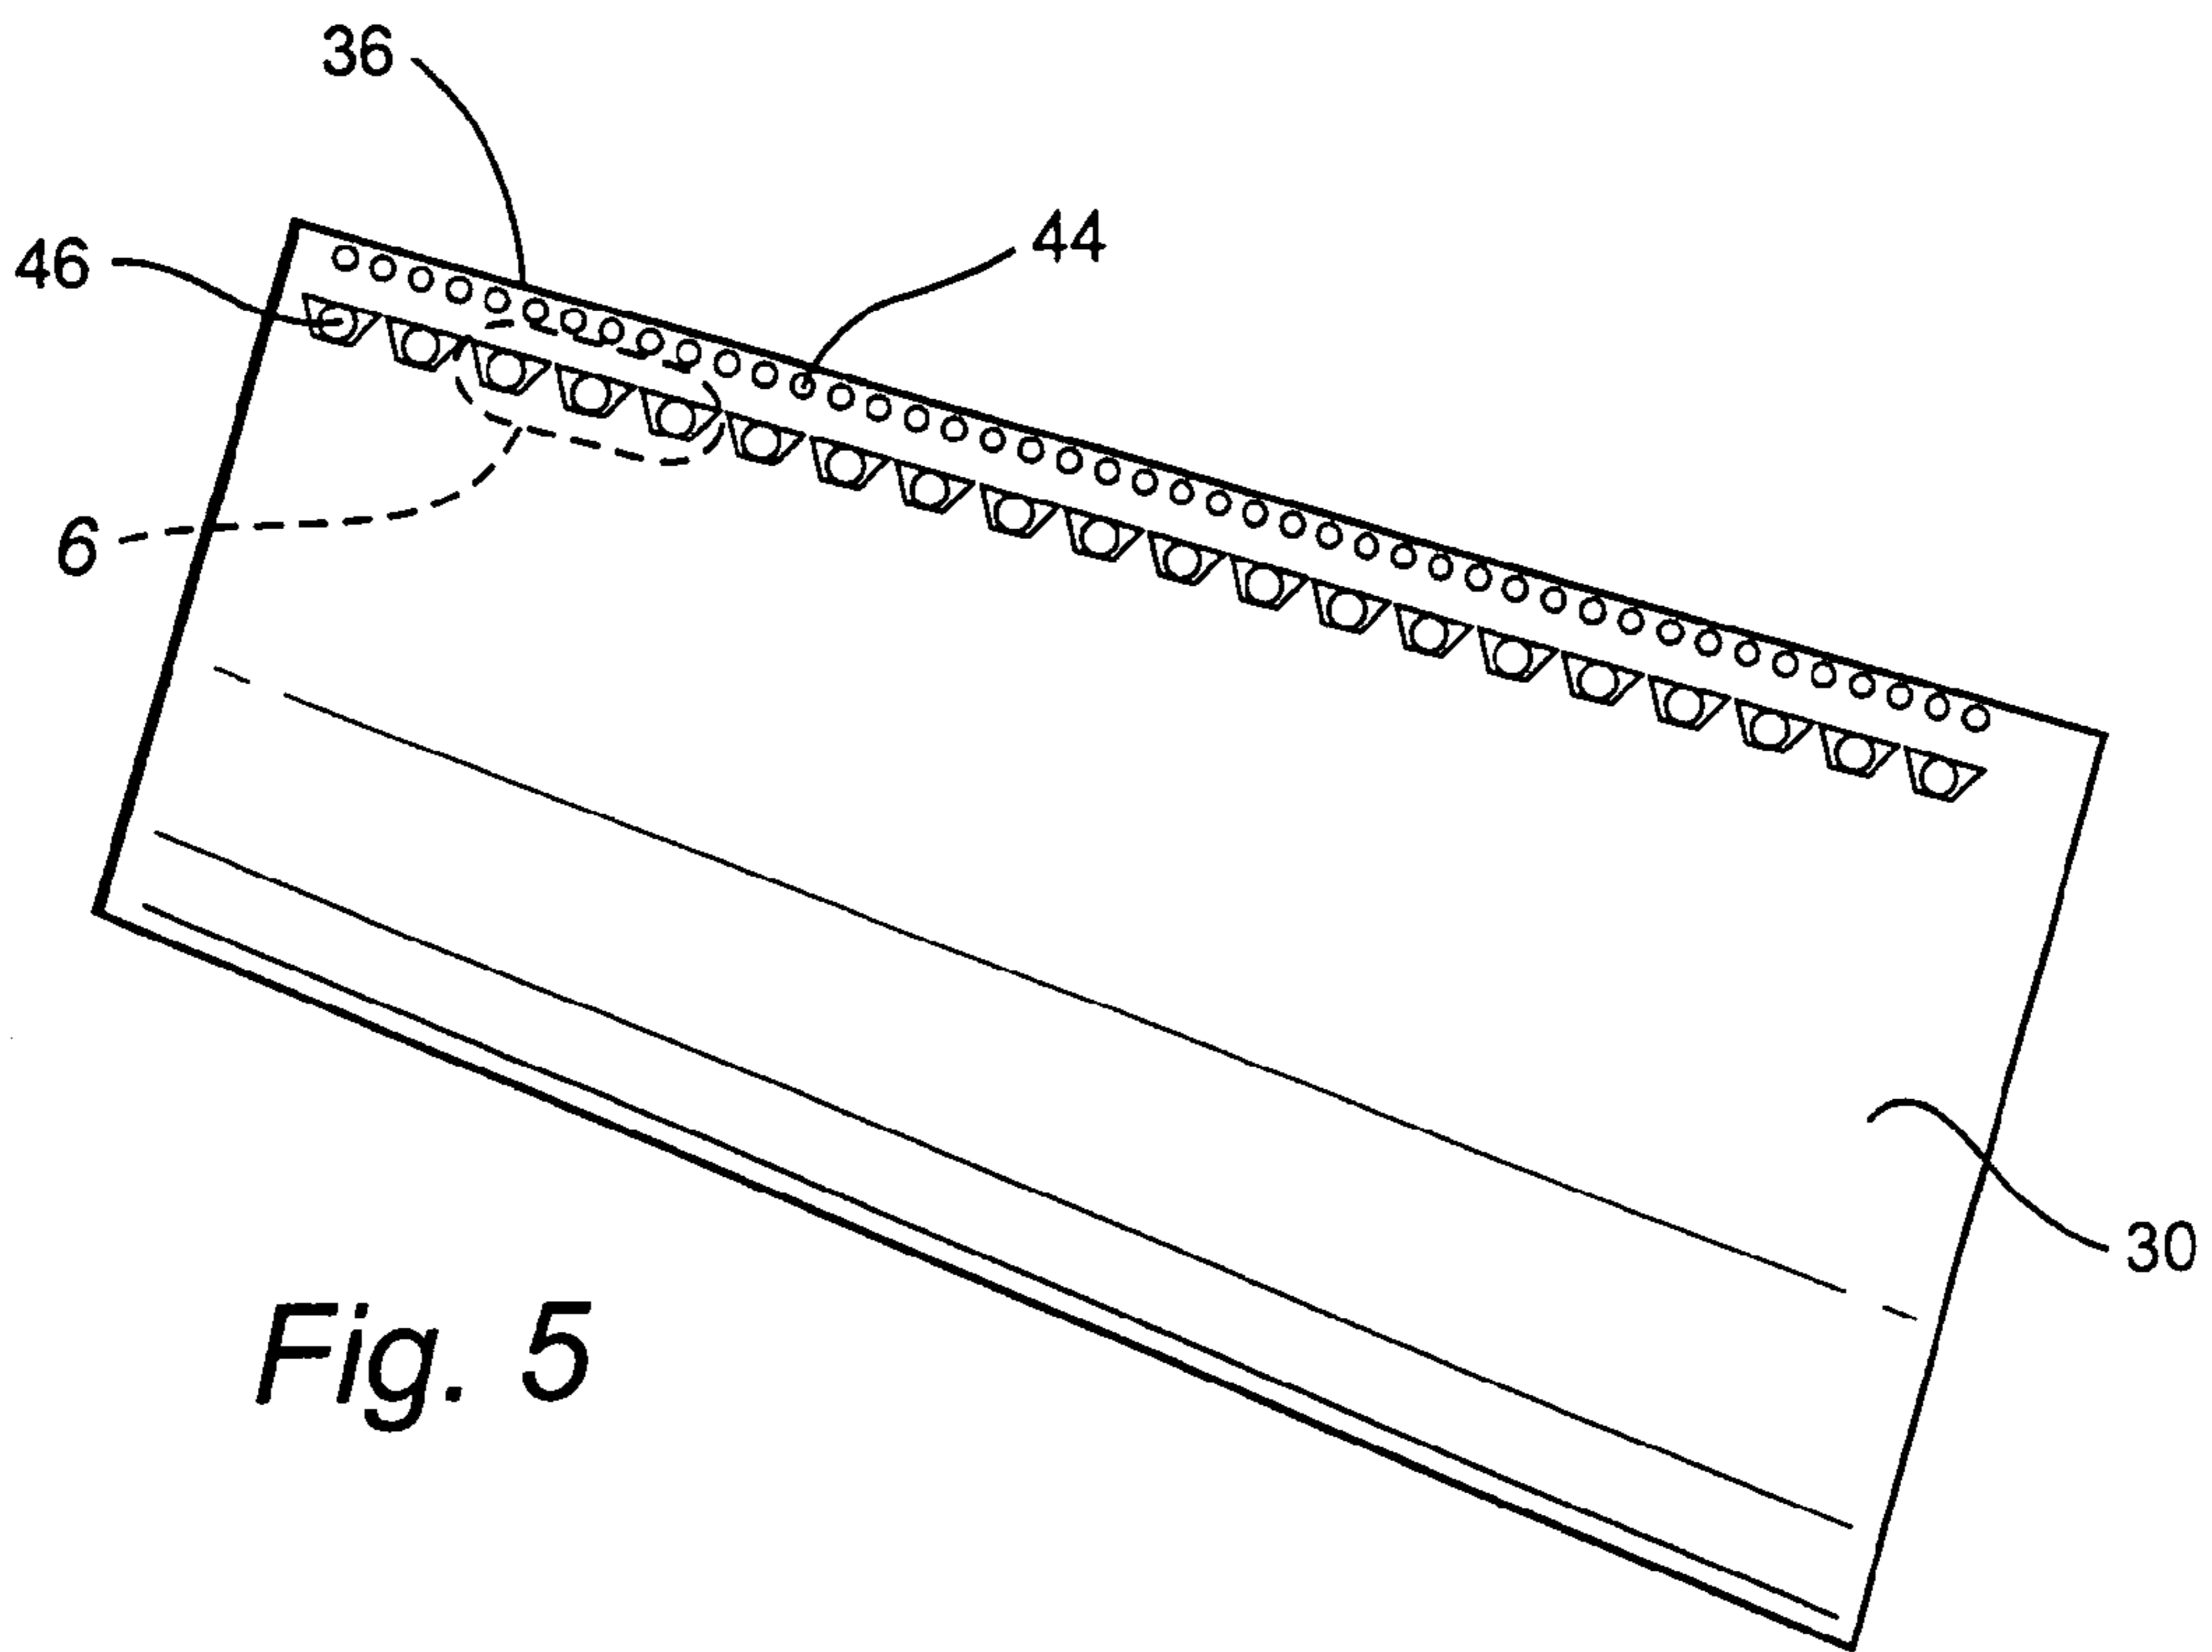
Fig. 5

FIG. 5 is an enlarged side elevational view of the coupon of FIG. 4;

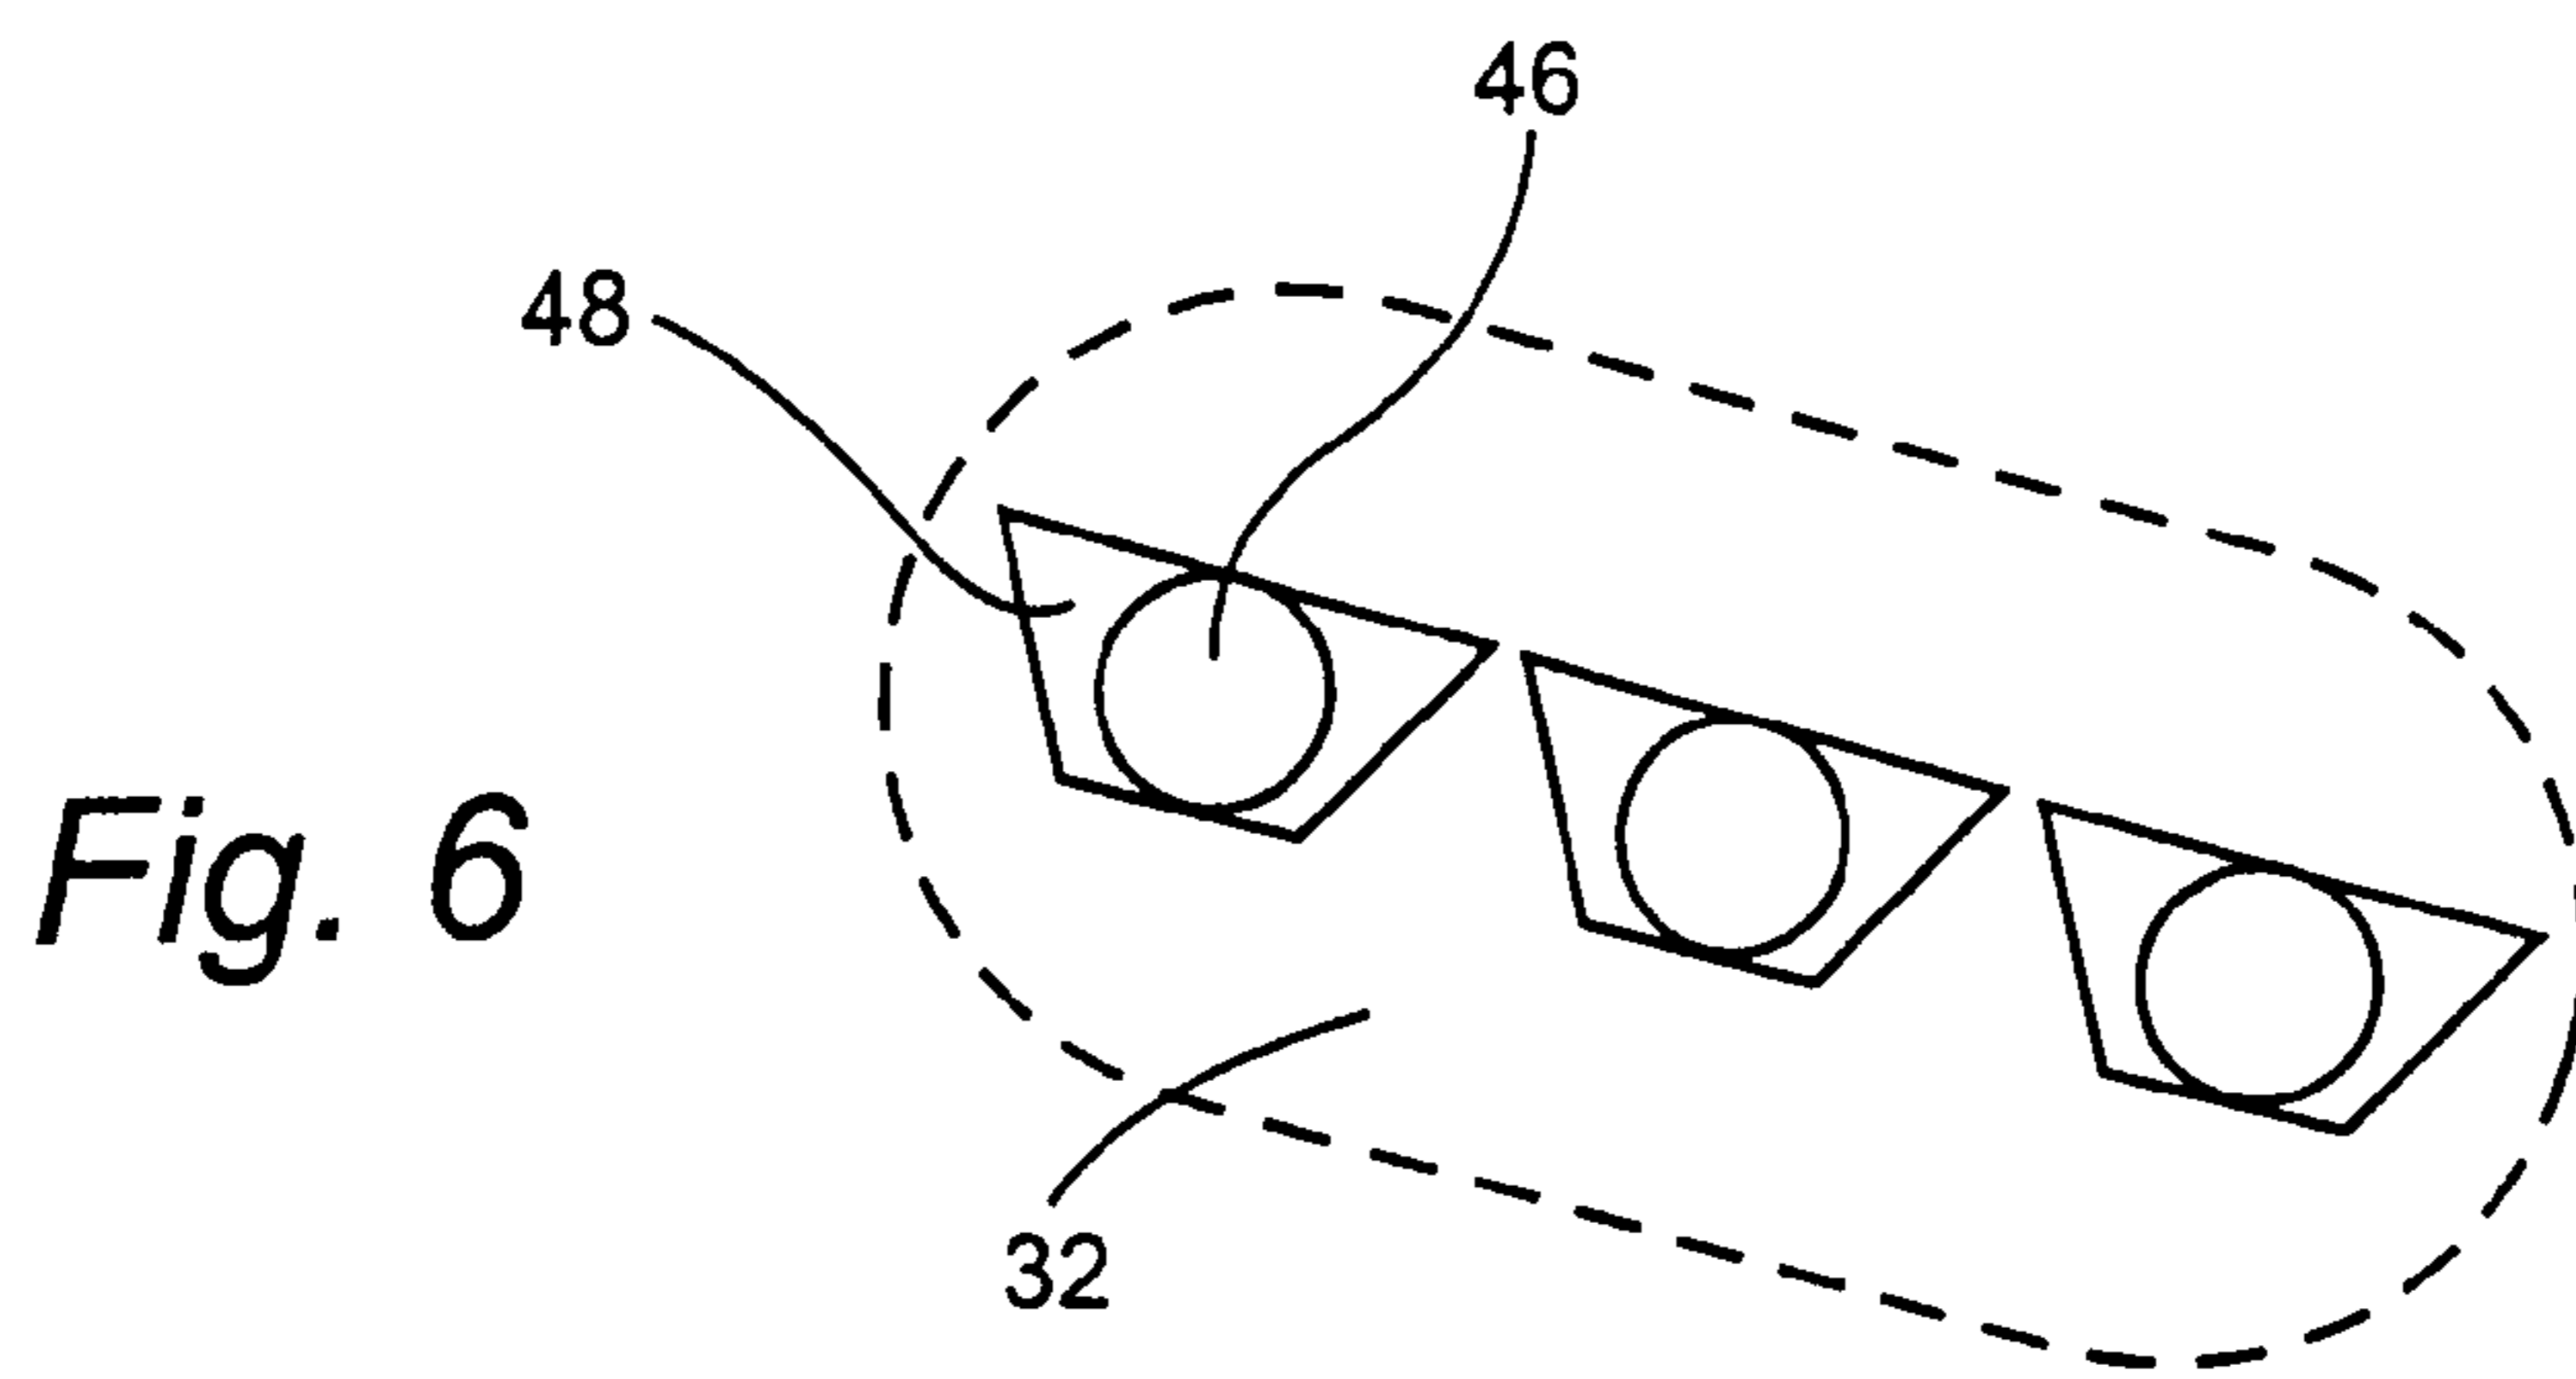
Fig. 6

FIG. 6 is an enlarged view of the film cooling holes along the pressure side of the coupon; and

Additionally, along the pressure side 32 of the coupon 30, there are provided a plurality of generally spaced film cooling holes 46. Cooling air within the repaired airfoil also flows through the film cooling holes 46 and along the pressure side wall 32 of the repaired airfoil to film cool the pressure side trailing edge region. The film cooling holes 46 have external surfaces along the pressure side which are flared as indicated at 48 in FIG. 6. The flare enlarges in the radial and axially aft directions such that the film of cooling air is distributed to overlie substantially the entirety of the pressure side surface of the trailing edge region 40 to the trailing edge 36. With the film cooling holes 46, the flared surfaces thereof as well as the cooling passages 44 exiting through the trailing edge 36, the repaired airfoil containing such cooling configuration has reduced oxidation and potential for cracking.
