(54) **REPAIRED TURBINE NOZZLE**

A trailing edge coupon for the trailing edge of a airfoil of a turbine nozzle segment is welded to an airfoil section of the nozzle segment having a damaged trailing edge portion removed. The coupon includes film cooling holes spaced one from the other along a pressure side wall portion of the coupon and a plurality of radially spaced openings along the trailing edge. By welding the pressure and suction side edges of the coupon to the pressure and side edges of the remaining portion of the airfoil, the operating life of the nozzle is extended.

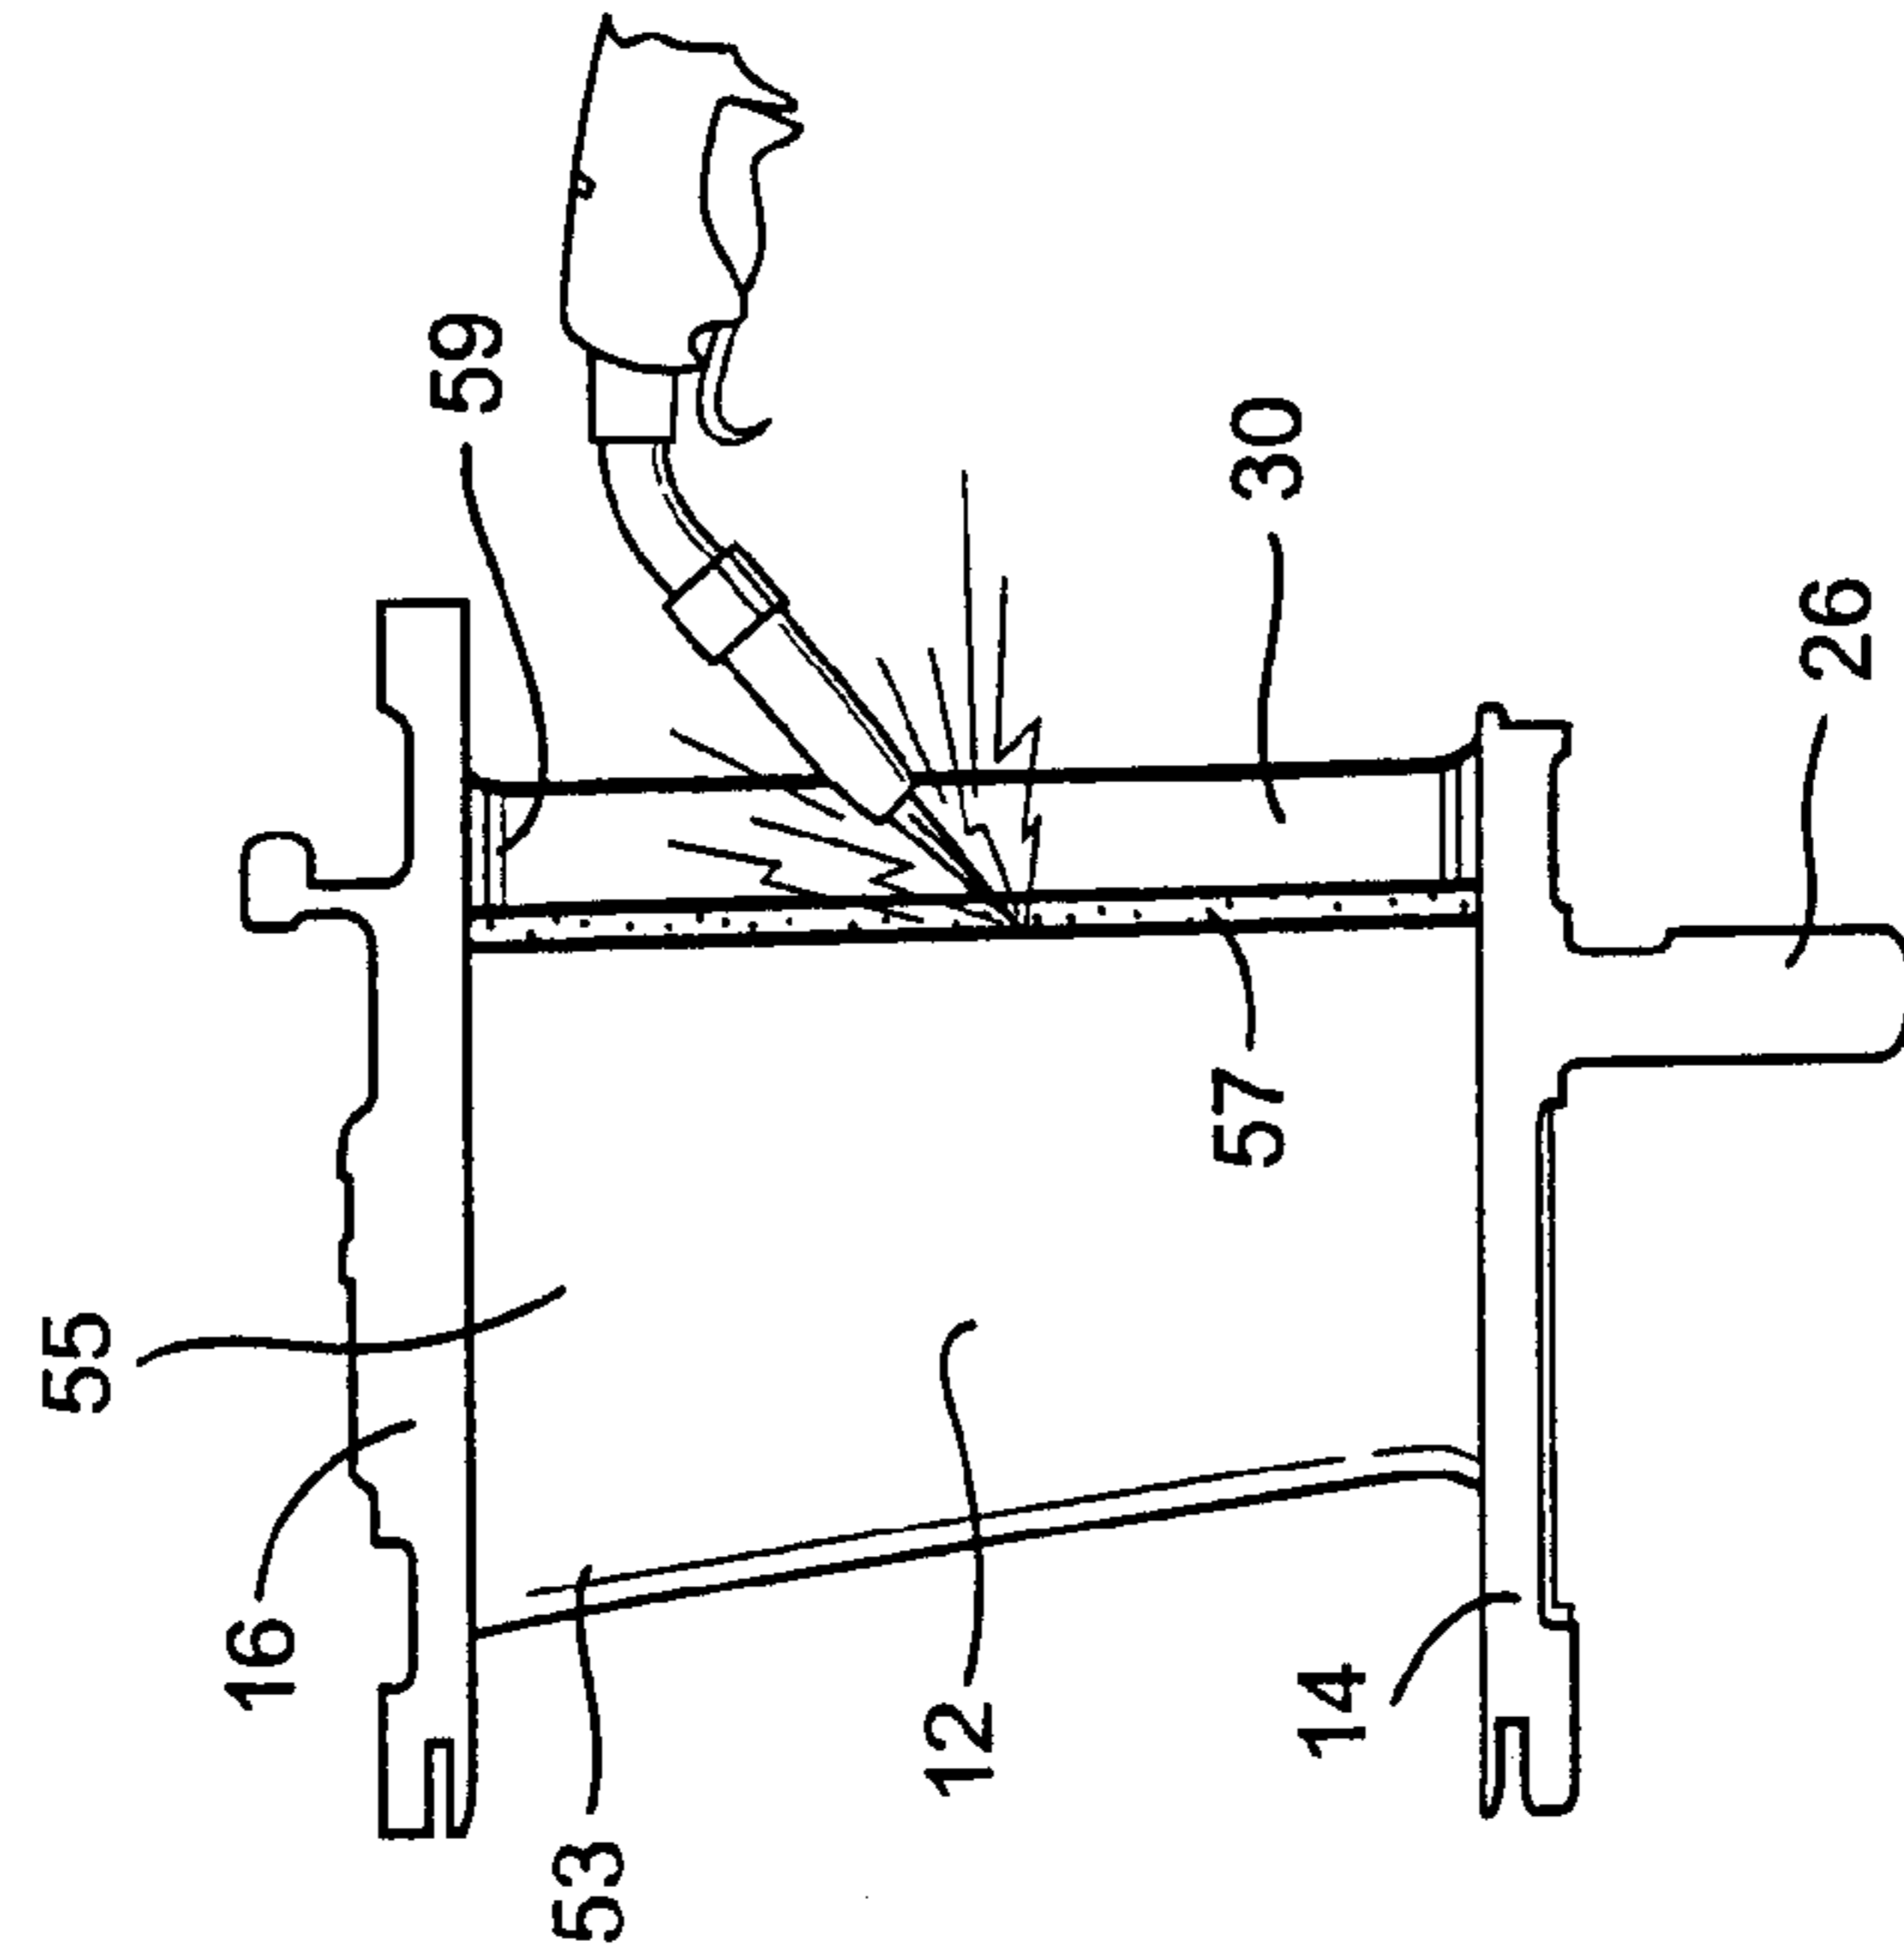
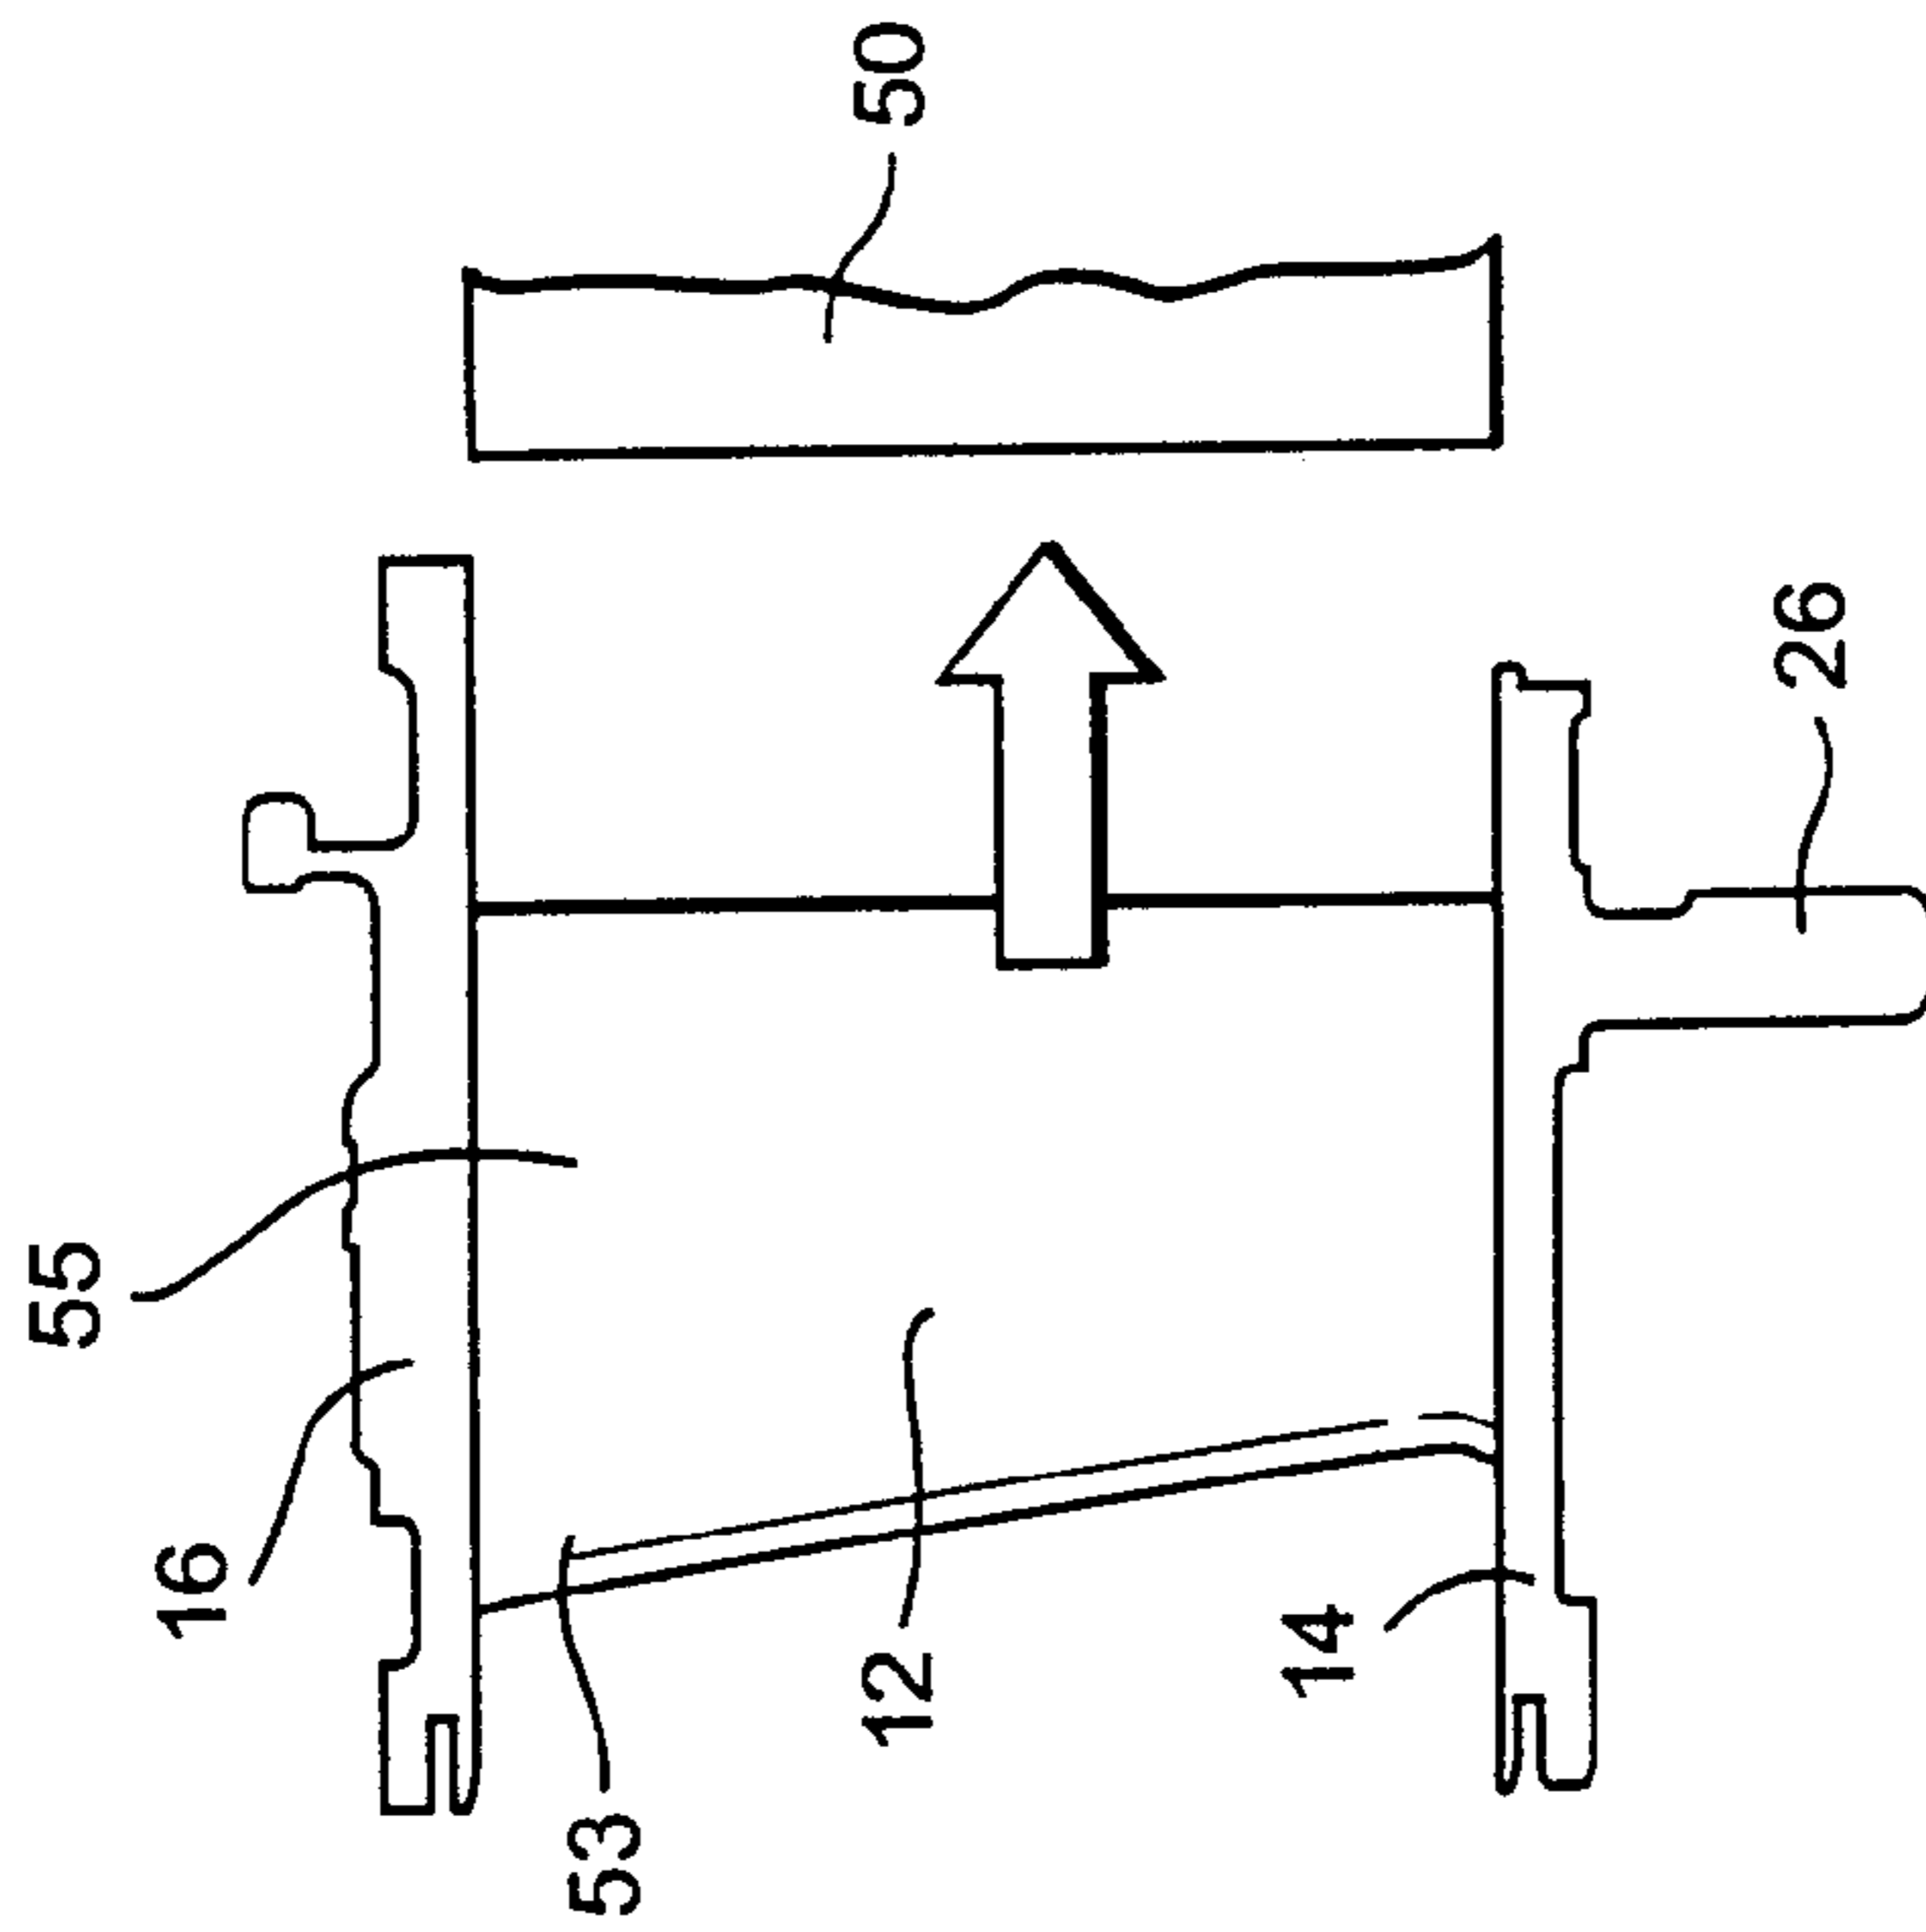
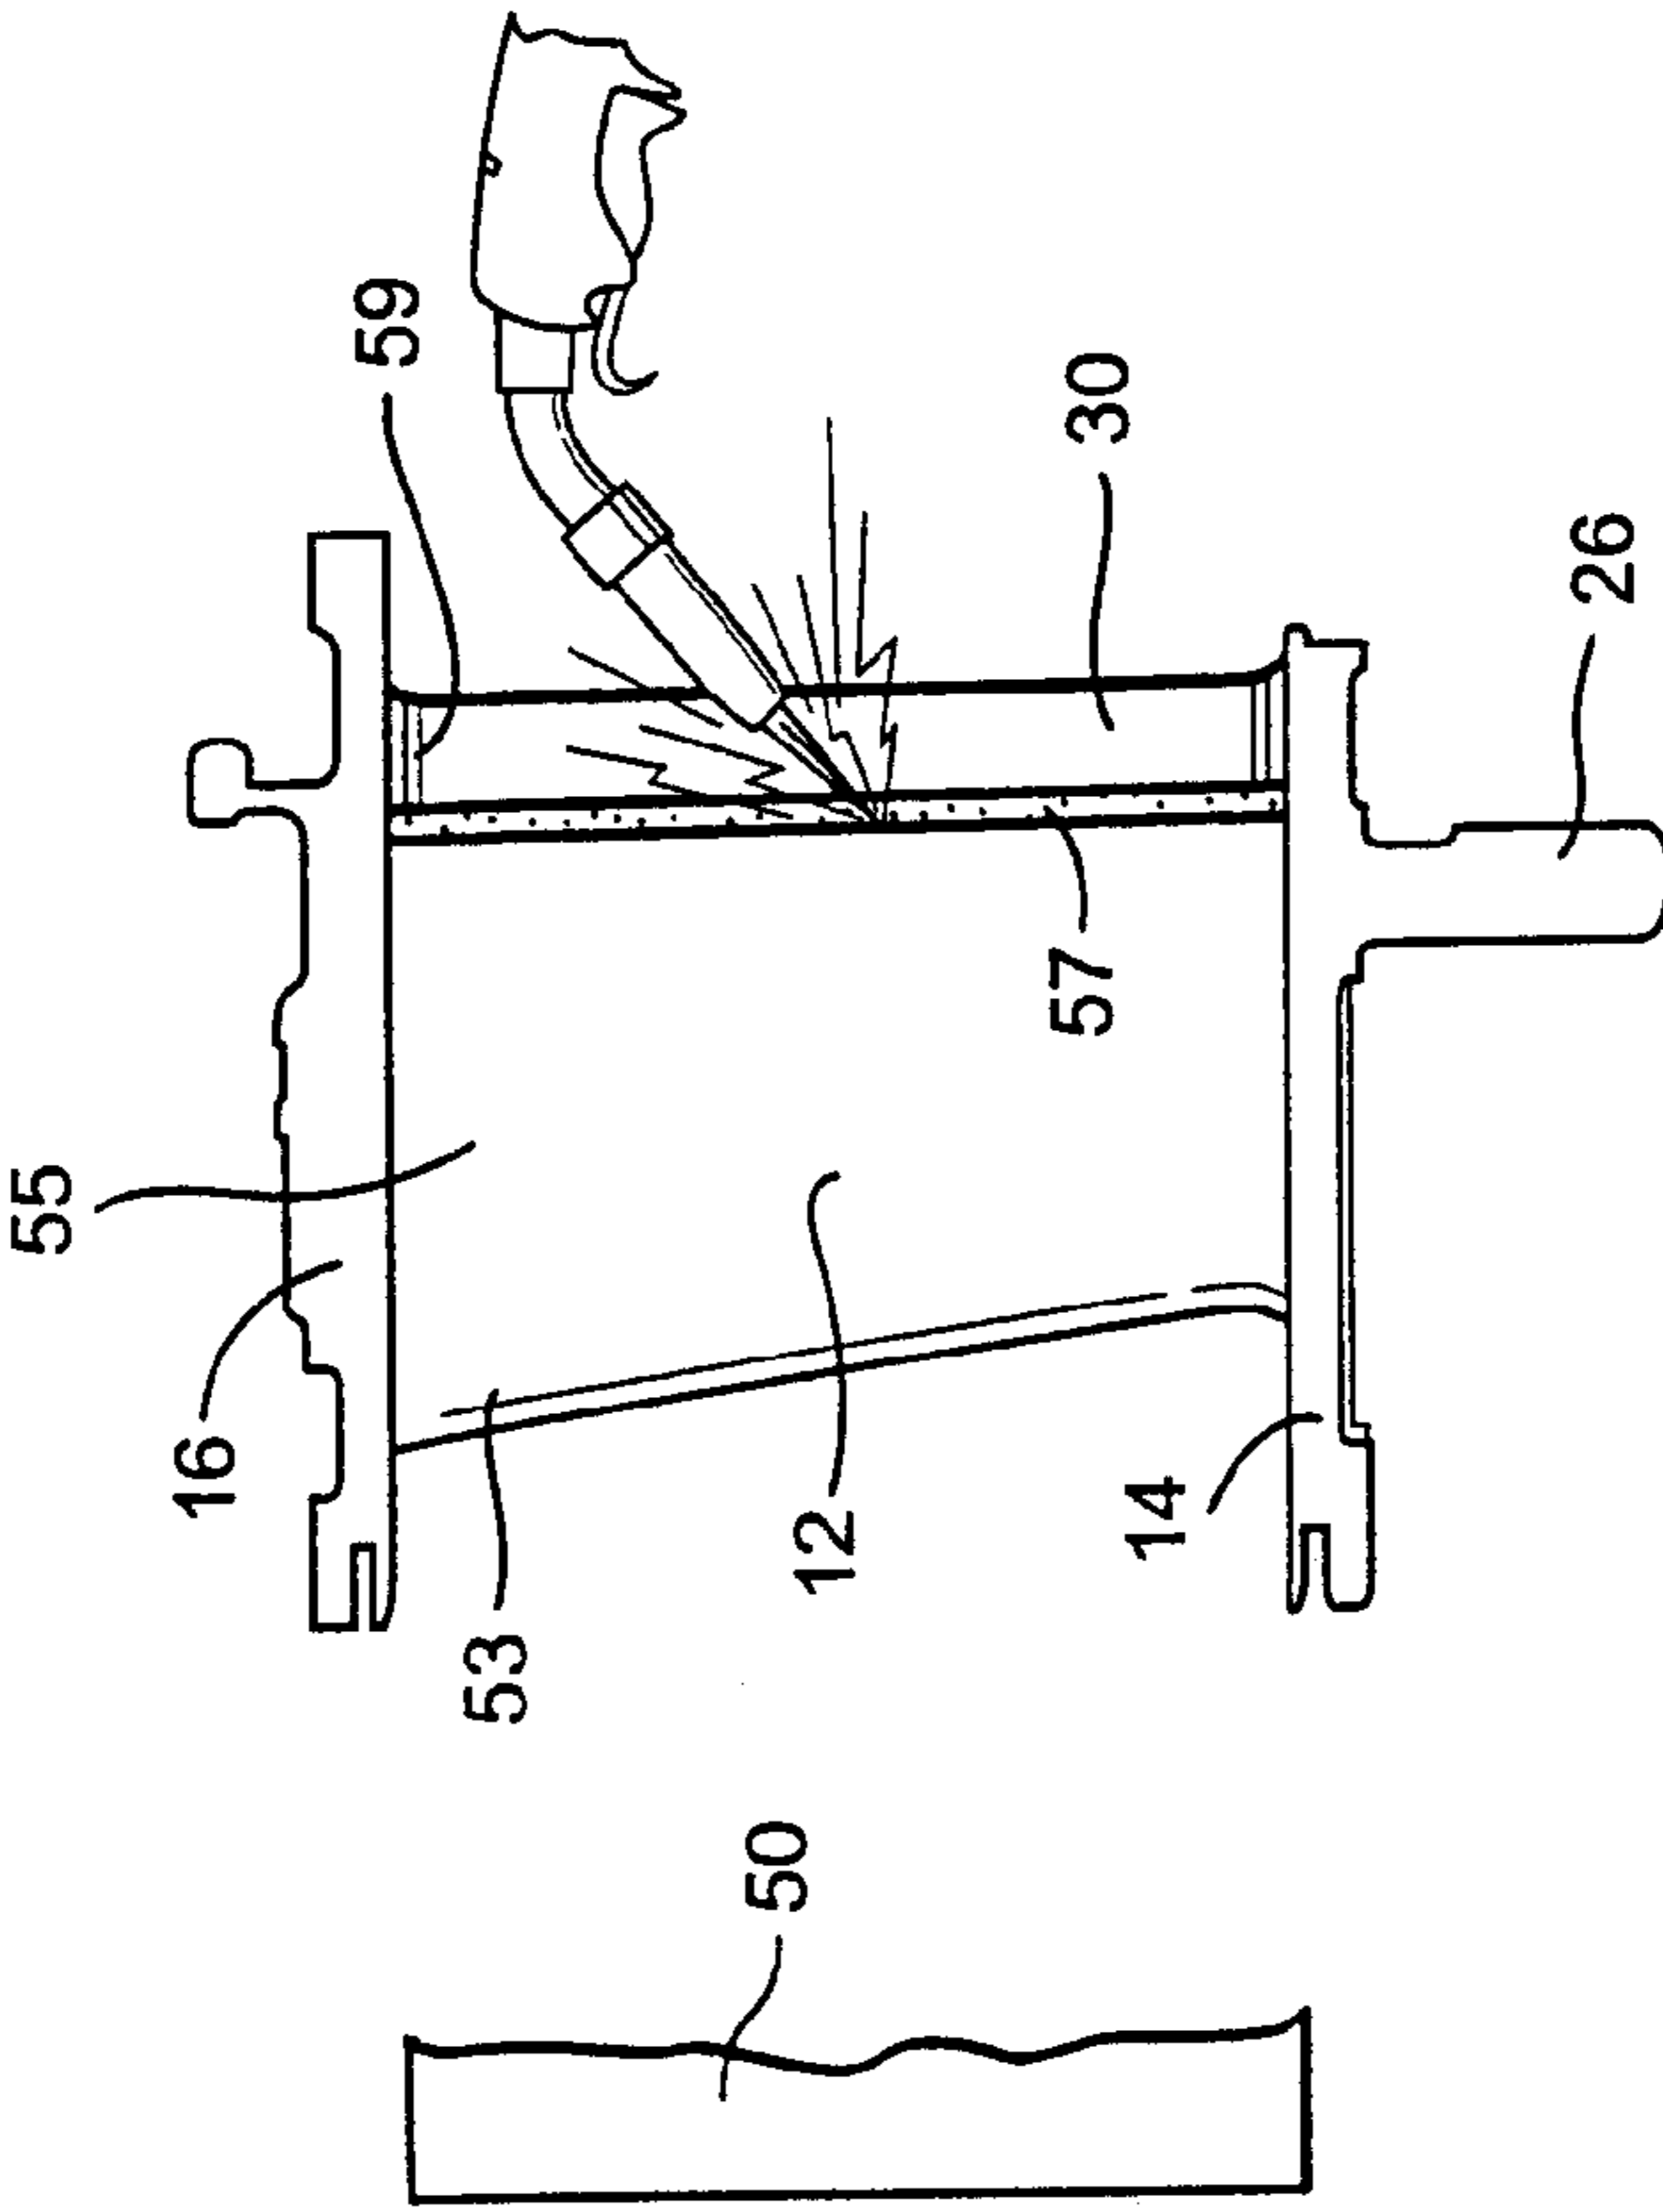
FIGS. 7-9 are schematic illustrations of the manner of repairing the nozzle airfoil.
