(12) **United States Patent**
Bublath et al.

(54) **METHOD FOR REPAIRING A COMPONENT OF A TURBOMACHINE**

(73) Assignee: **Siemens Aktiengesellschaft**, Munich (DE)

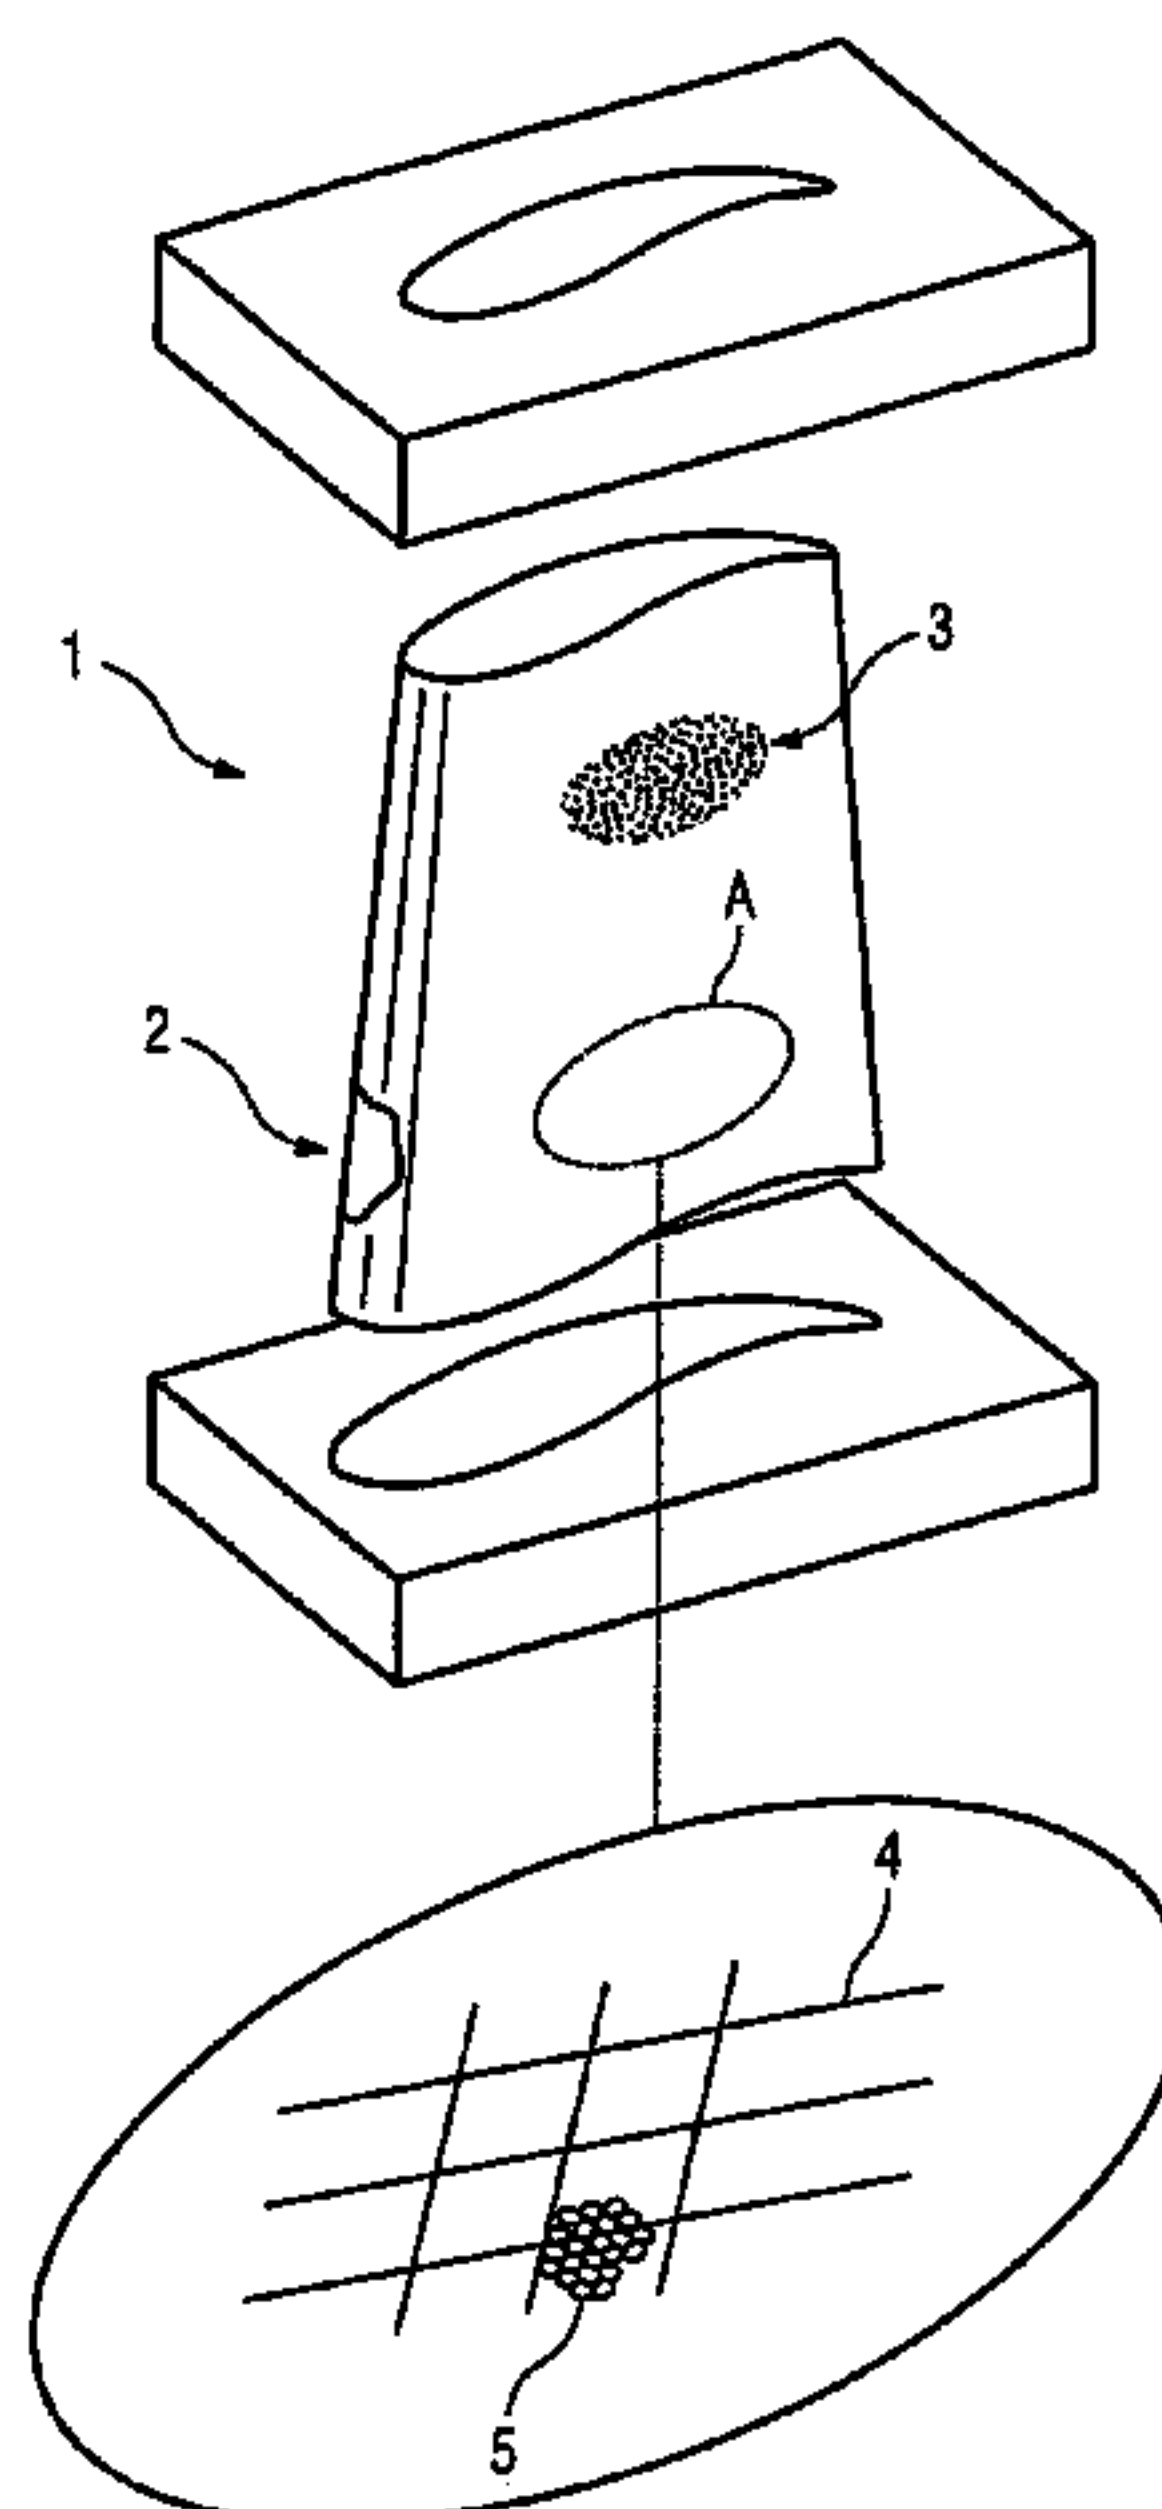
FIG 1

FIG. 1 shows a first configuration of a method according to the invention for repairing a component which is installed in a gas turbine and has been damaged by the effect of foreign bodies,

FIG. 1 shows a first method according to the invention for repairing a guide vane 1 (FIG. 7) of a gas turbine (not represented in further detail), which has been damaged during operation in the gas turbine. The guide vane 1 presented here consists of a ceramic material, for example silicon nitride, silicon carbide, aluminum oxide, zirconium oxide, mullite, glass, glass ceramic and/or the like. This material is conventionally referred to as a matrix. In order to improve the brittle fracture behavior, the matrix material is provided with fiber reinforcement which, for example, may consist of glass, glass ceramic, silicon carbide, silicon nitride or the like, as well as a combination of these, so that a quasi-plastic deformation behavior can be achieved. Besides this, instead of or in addition to the fibers, it is also possible to introduce short fibers i.e. whiskers into the matrix. For environmental reasons, however, the first version is preferred. Gas turbines equipped with such vanes allow a high inlet temperature into the turbine region of from 1100° C. to 1350° C., in which case efficiencies of 31%, 40% or more can be readily achieved.

and mechanically processed or excavated in a first step, as represented in FIG. 1. This is followed by local reconstruction of the ceramic matrix using infiltration or paste application. The repaired region of the component is subsequently sintered and the wall element with the guide vane 1 is reinstalled at its position in the turbine. Depending on the accessibility of the components inside the turbine, the repair may also be carried out when the component is in the installed state.

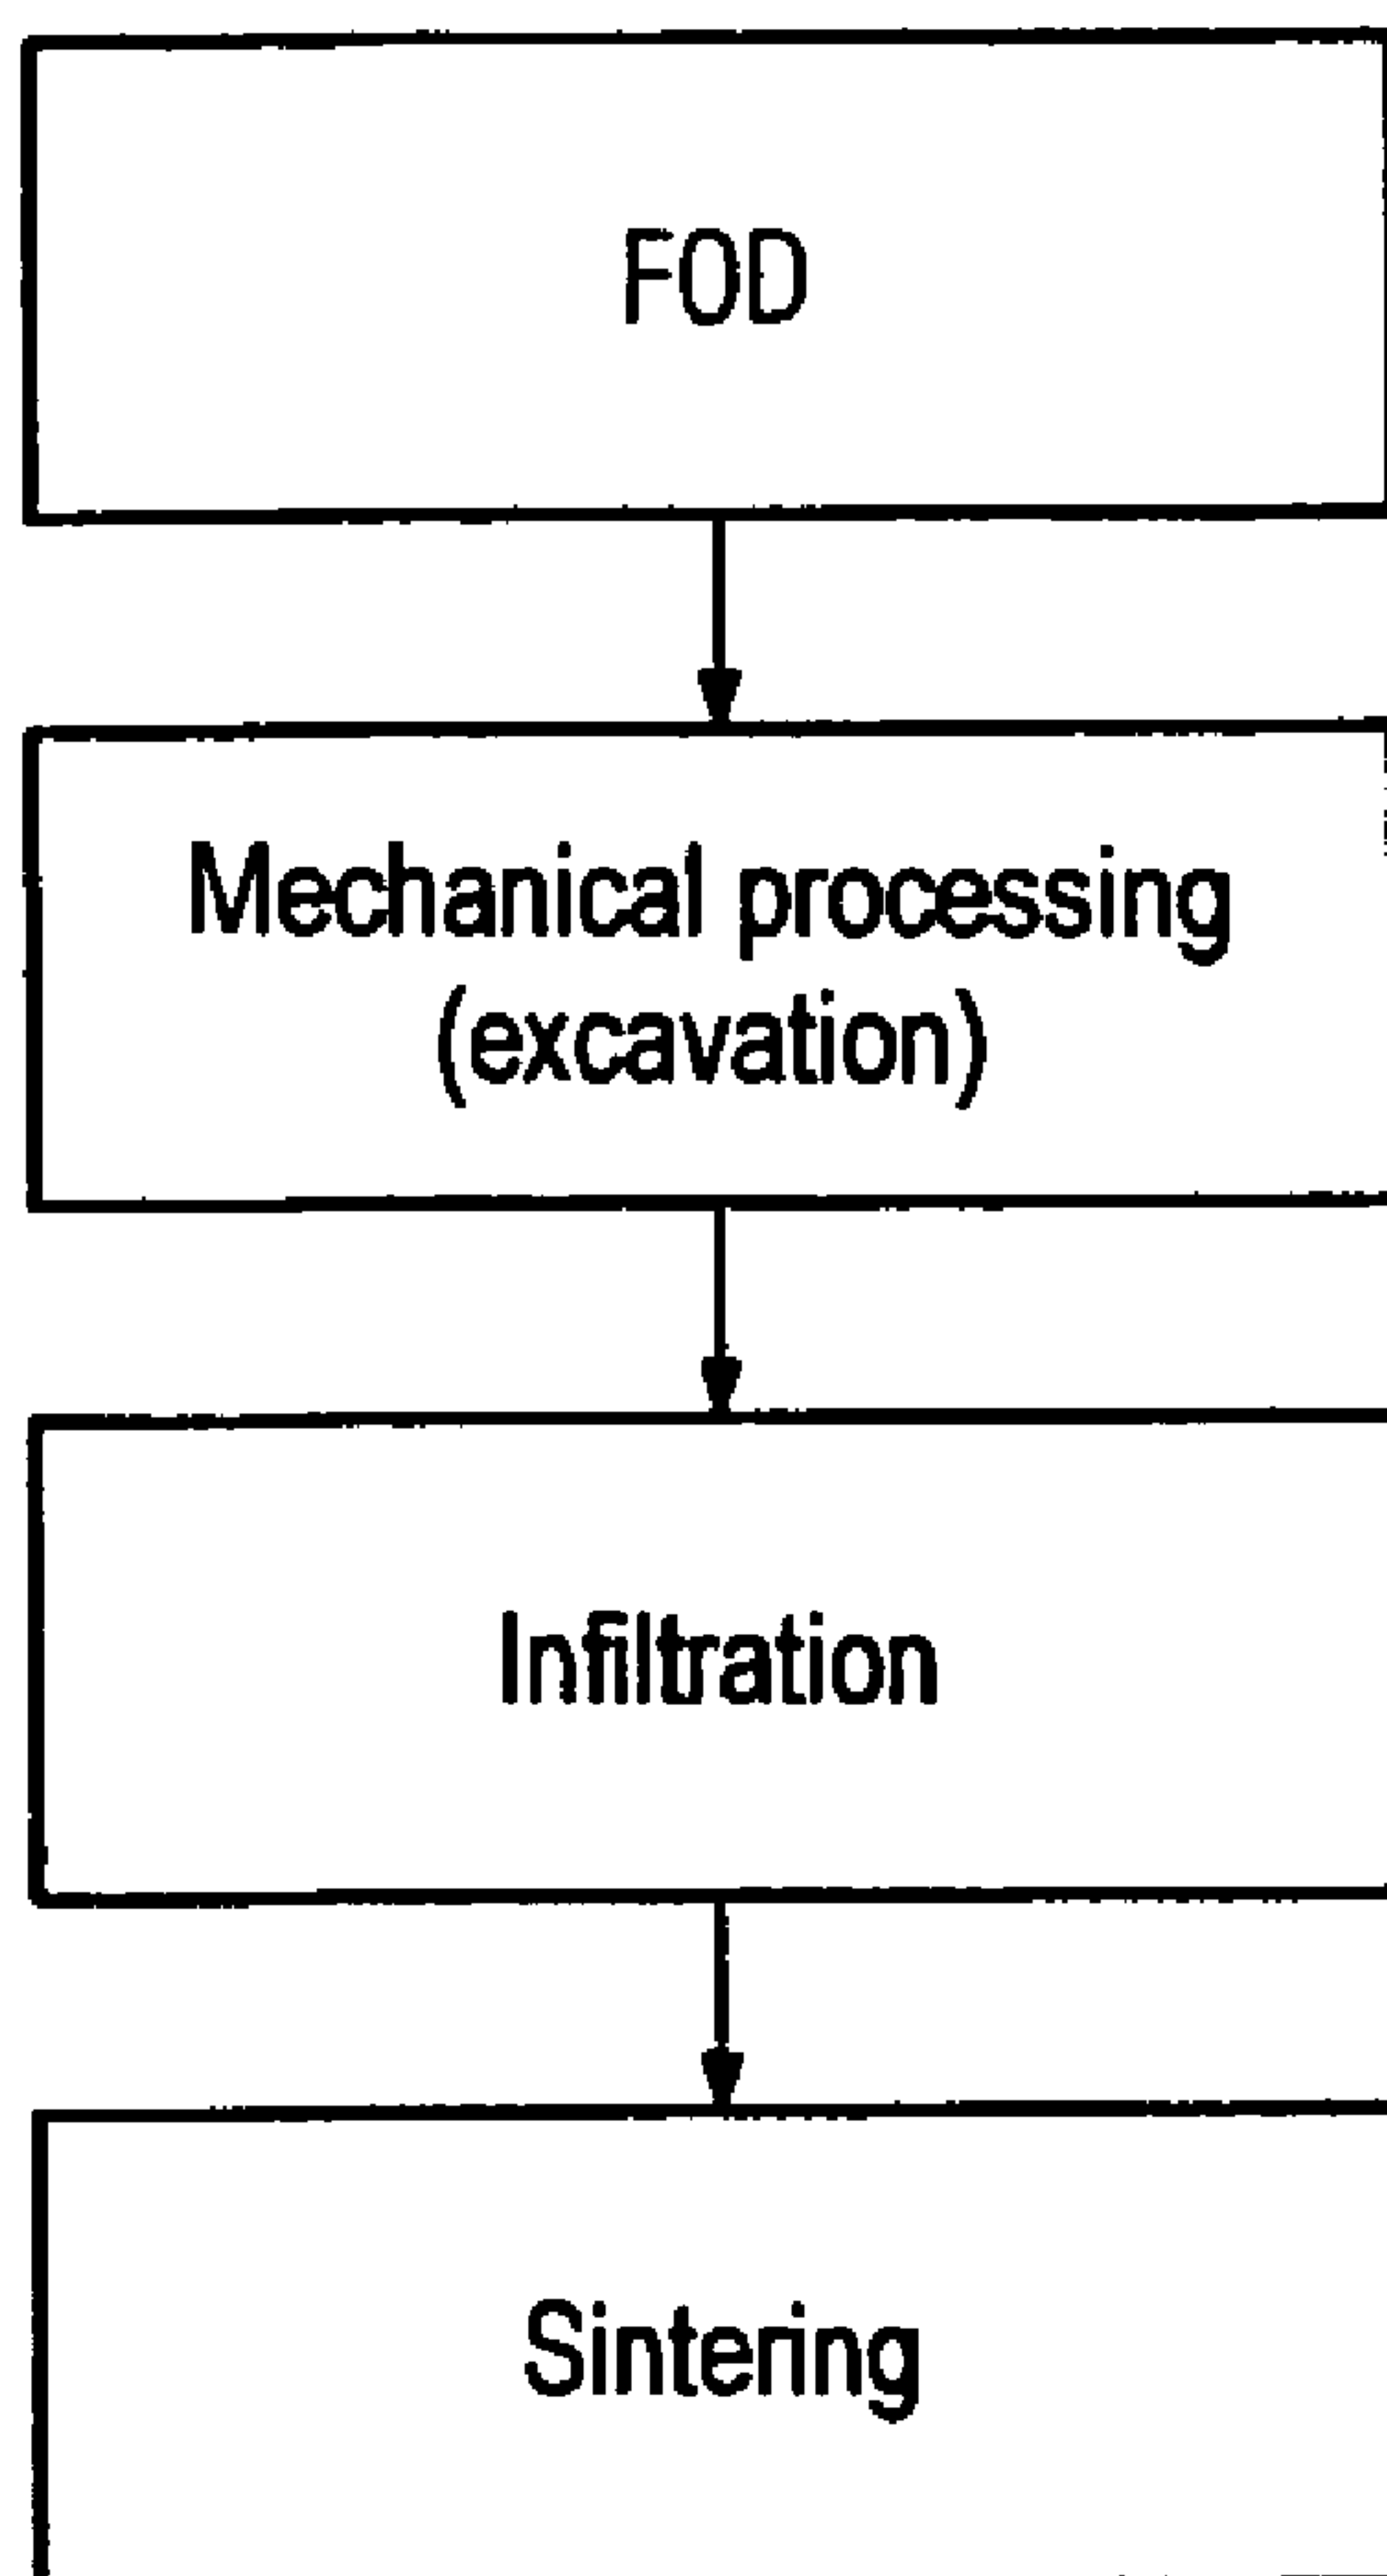
FIG 2

FIG. 2 shows a second method according to the invention for repairing a component installed in a gas turbine,

Another method is proposed according to FIG. 2, the matrix of the damaged component 1 being leached out locally in a first step (FIG. 8). The fibers are inserted in a further step, in which case it is possible to achieve improved mechanical properties compared to the ceramic matrix 5. The steps of infiltration and sintering are subsequently carried out as in the previous example of FIG. 1.

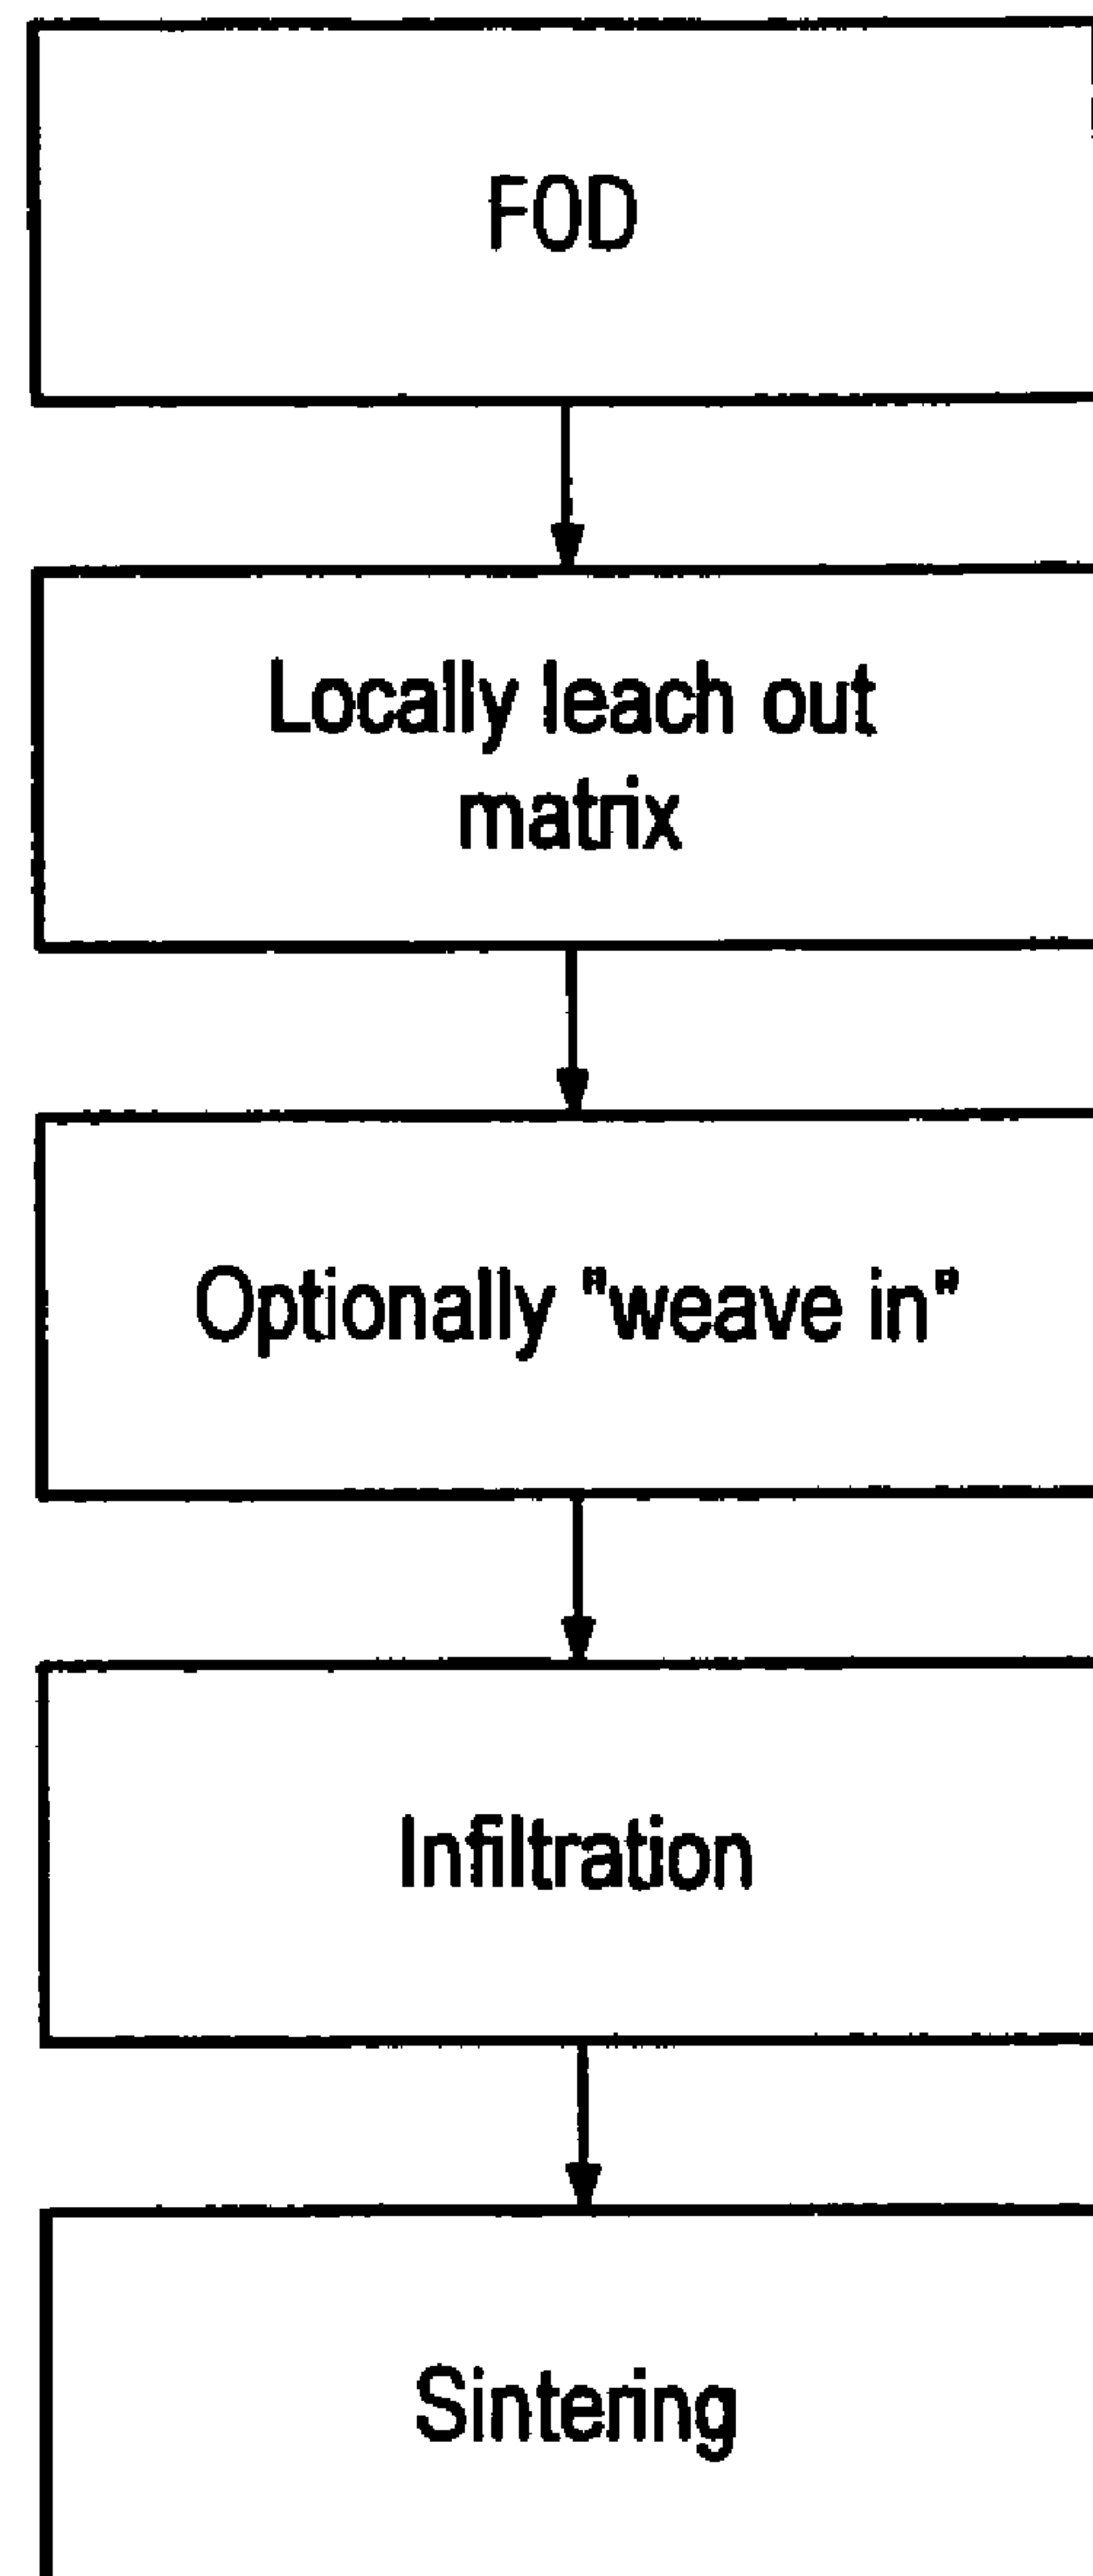
FIG 3

FIG. 3 shows a third configuration of a method according to the invention, for repairing a component extracted from a gas turbine,

FIG. 3 shows a method for removing an ageing effect of the guide vane 1, which has occurred owing to sintering of the ceramic material on the guide vane 1. In order to remove this damage, in a first step the joint is dissolved and the guide vane 1 is subsequently decoated.

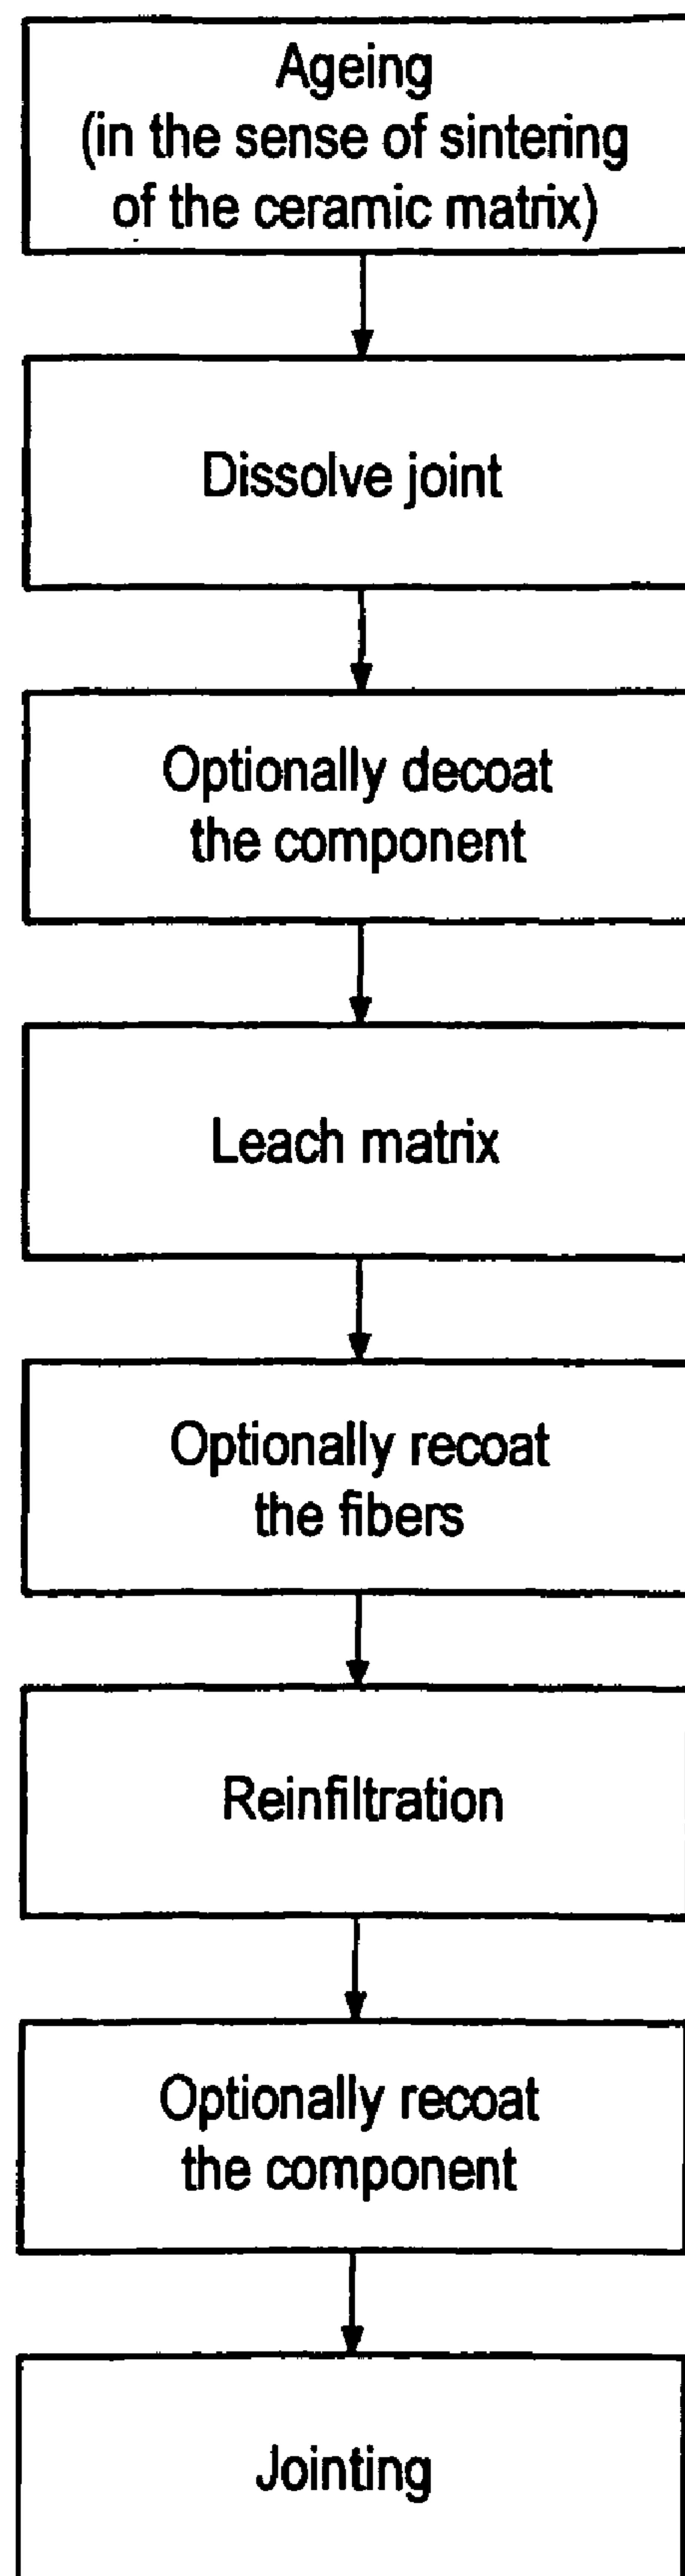
FIG 4

FIG. 4 shows another method according to the invention for repairing a component extracted from a gas turbine,

FIG. 4 shows another method sequence according to the invention in which, in order to repair mechanical damage 2 of the guide vane 1, the joint is first dissolved and then the damaged site is mechanically excavated by grinding. In the following step, by re-infiltration or recontouring, the original shape of the guide vane 1 is restored. The guide vane 1 is then coated and subsequently rejoined.

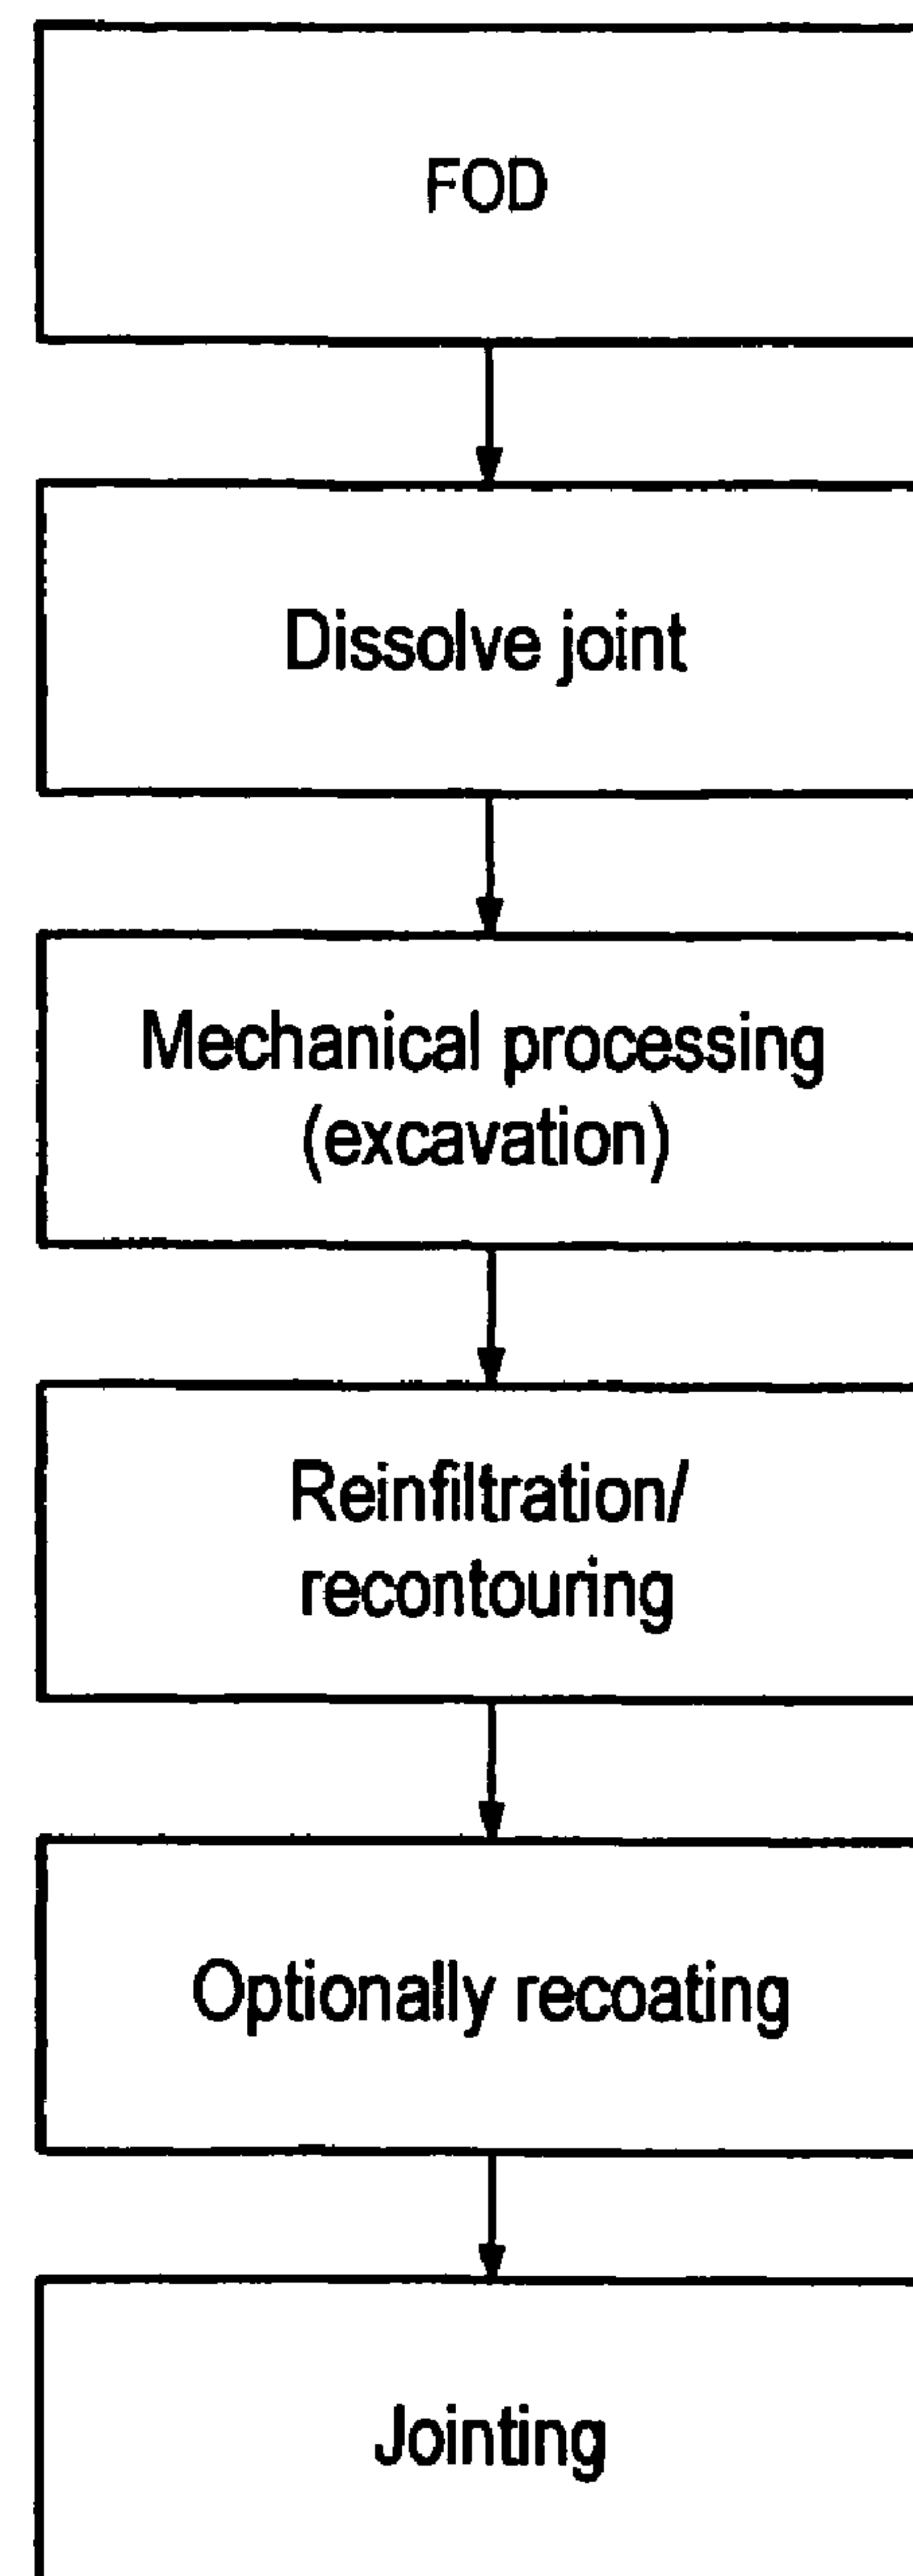
FIG 5

FIG. 5 shows a method according to the invention for repairing a component extracted from a gas turbine, with the production of subsequent surface protection,

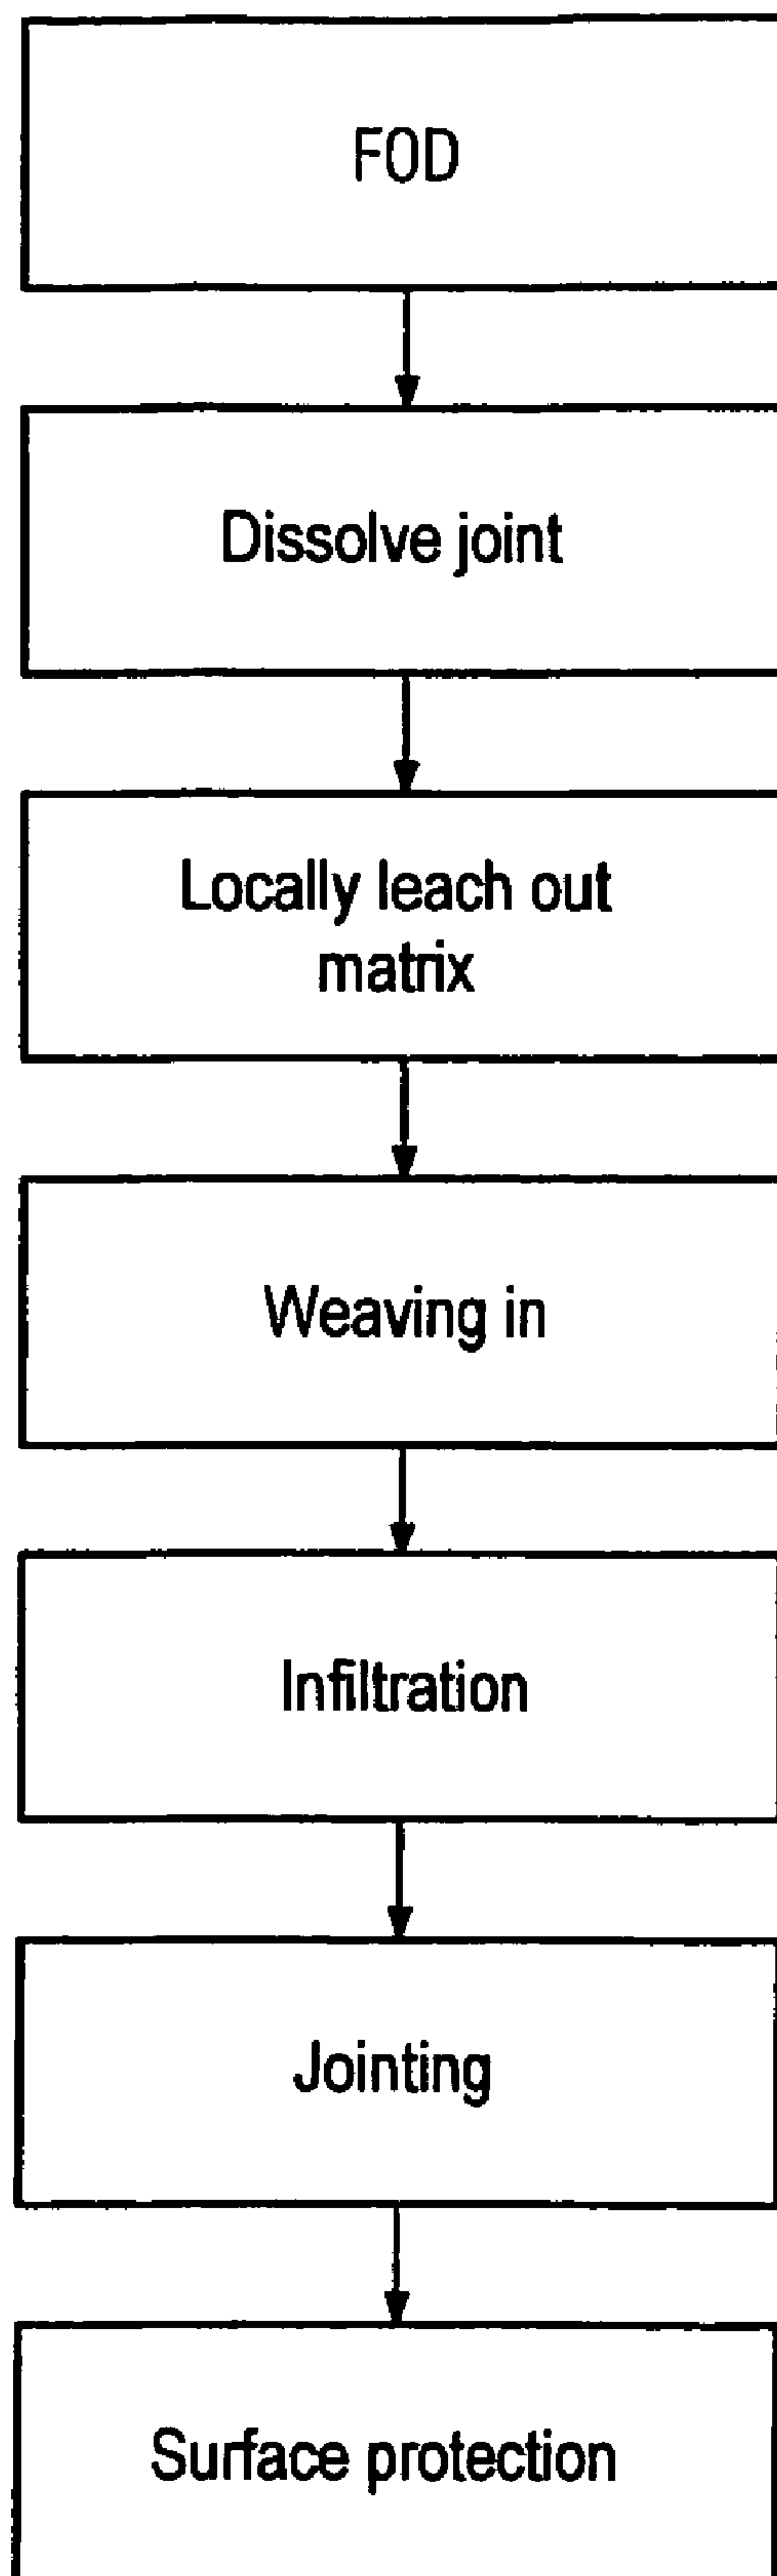
FIG 6

FIG. 6 shows a method for repairing a component with coating of the fibers and surface protection,
