(12) **United States Patent**
Bublath et al.

(10) **Patent No.:** **US 7,500,833 B2**
(45) **Date of Patent:** **Mar. 10, 2009**

(54) **METHOD FOR REPAIRING A COMPONENT OF A TURBOMACHINE**

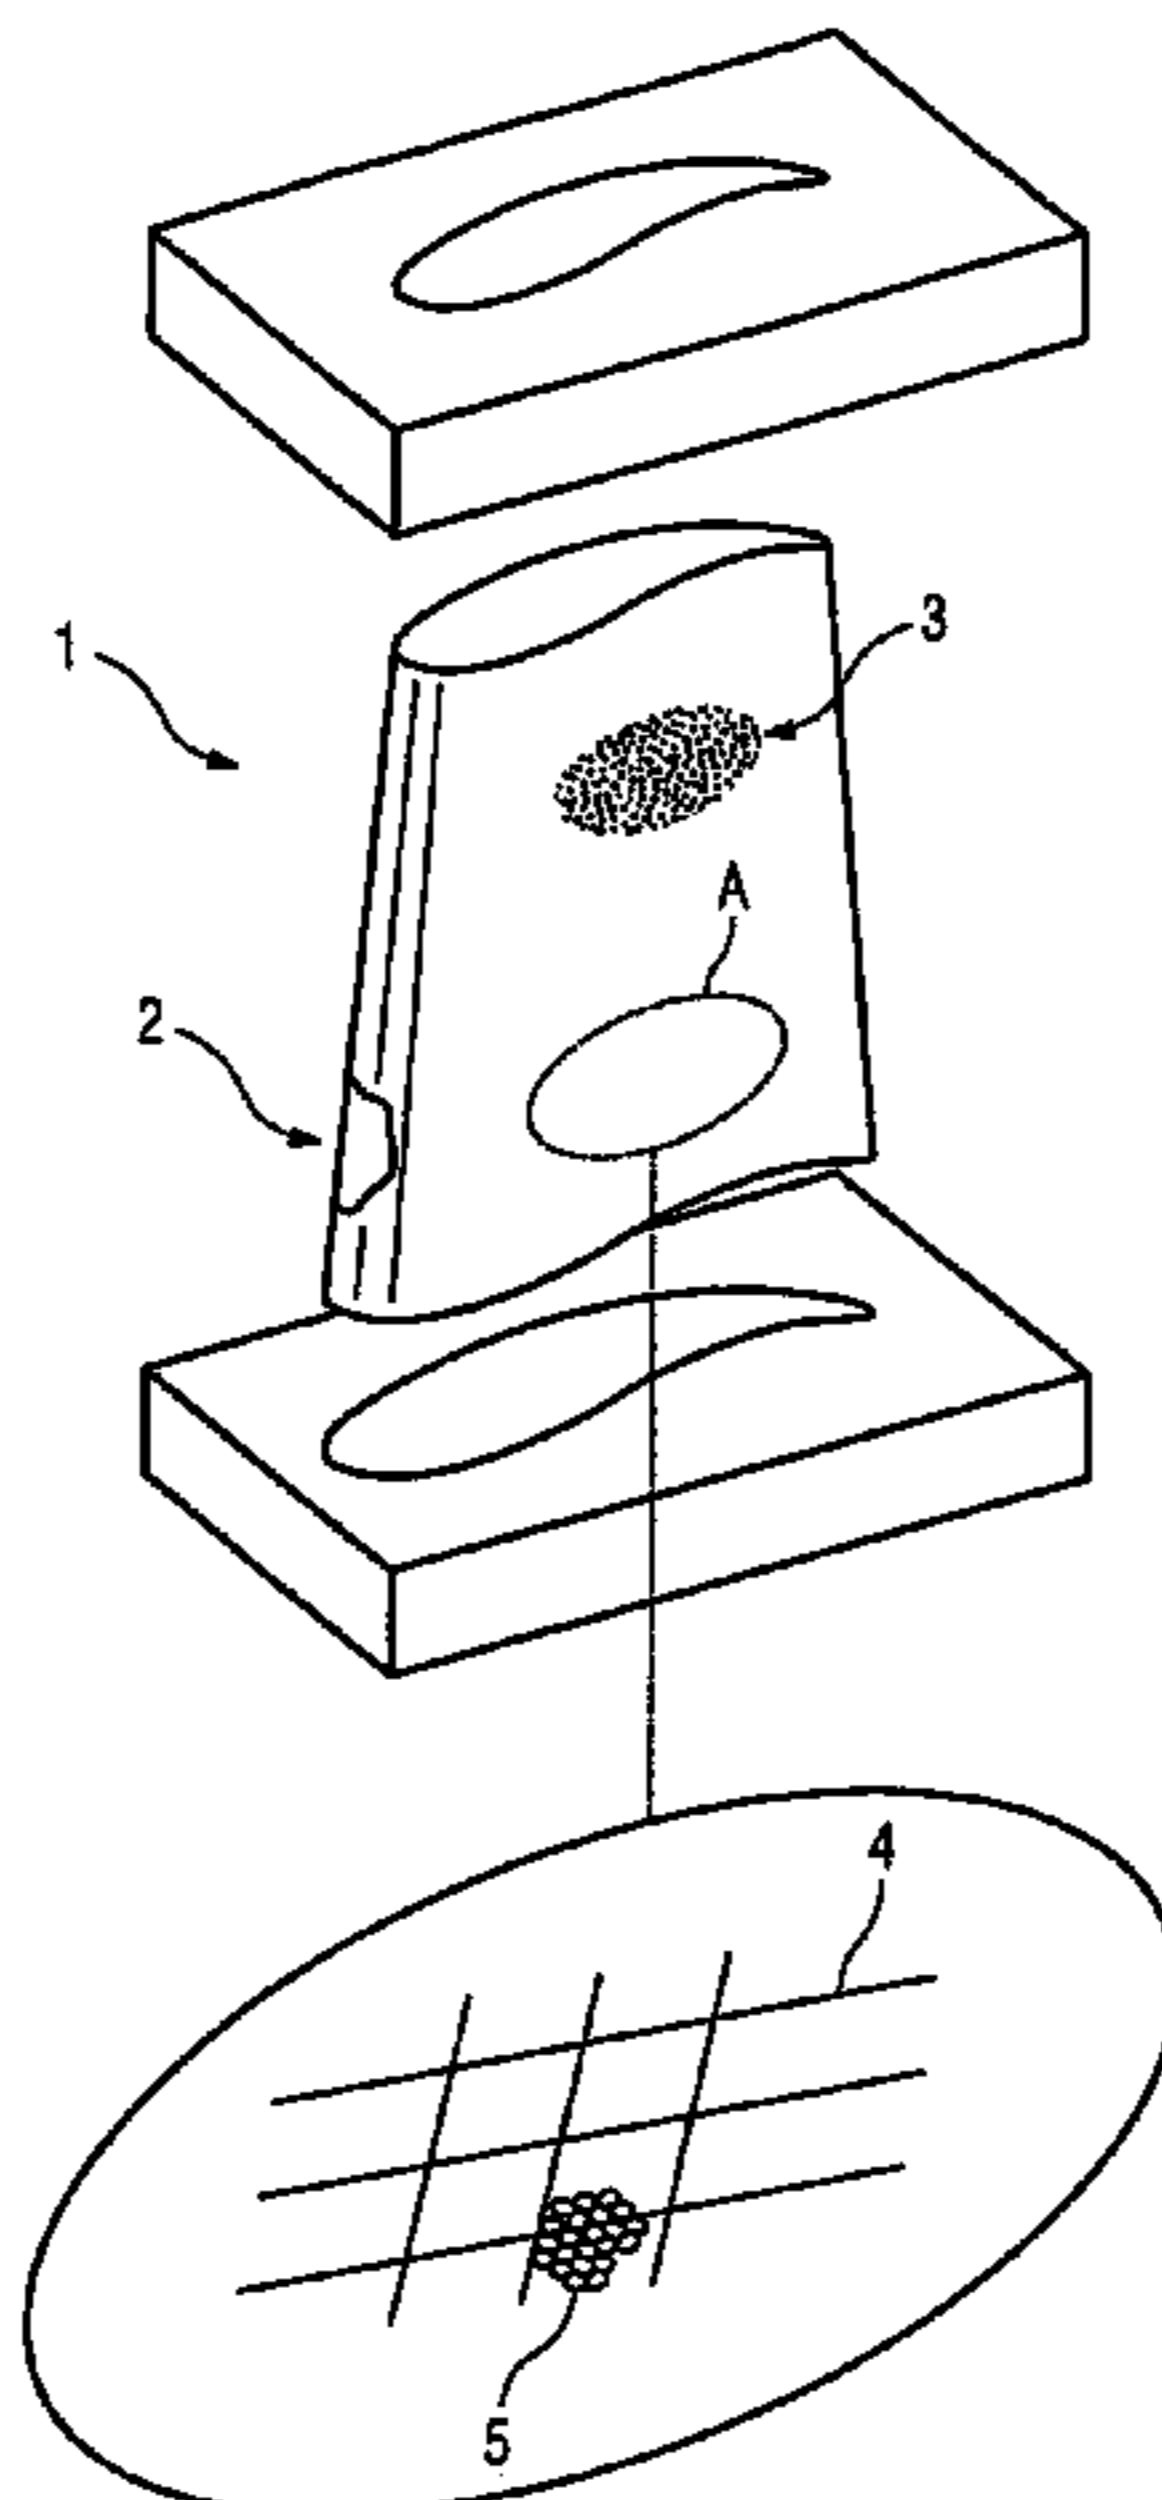
FIG 1

FIG. 1 shows a first configuration of a method according to the invention for repairing a component which is installed in a gas turbine and has been damaged by the effect of foreign bodies,

FIG. 1 shows a first method according to the invention for repairing a guide vane 1 (FIG. 7) of a gas turbine (not represented in further detail), which has been damaged during operation in the gas turbine. The guide vane 1 presented here consists of a ceramic material, for example silicon nitride, silicon carbide, aluminum oxide, zirconium oxide, mullite, glass, glass ceramic and/or the like. This material is conventionally referred to as a matrix. In order to improve the brittle fracture behavior, the matrix material is provided with fiber reinforcement which, for example, may consist of glass, glass ceramic, silicon carbide, silicon nitride or the like, as well as a combination of these, so that a quasi-plastic deformation behavior can be achieved. Besides this, instead of or in addition to the fibers, it is also possible to introduce short fibers i.e. whiskers into the matrix. For environmental reasons, however, the first version is preferred. Gas turbines equipped with such vanes allow a high inlet temperature into the turbine region of from 1100° C. to 1350° C., in which case efficiencies of 31%, 40% or more can be readily achieved.

and mechanically processed or excavated in a first step, as represented in FIG. 1. This is followed by local reconstruction of the ceramic matrix using infiltration or paste application. The repaired region of the component is subsequently sintered and the wall element with the guide vane 1 is reinstalled at its position in the turbine. Depending on the accessibility of the components inside the turbine, the repair may also be carried out when the component is in the installed state.

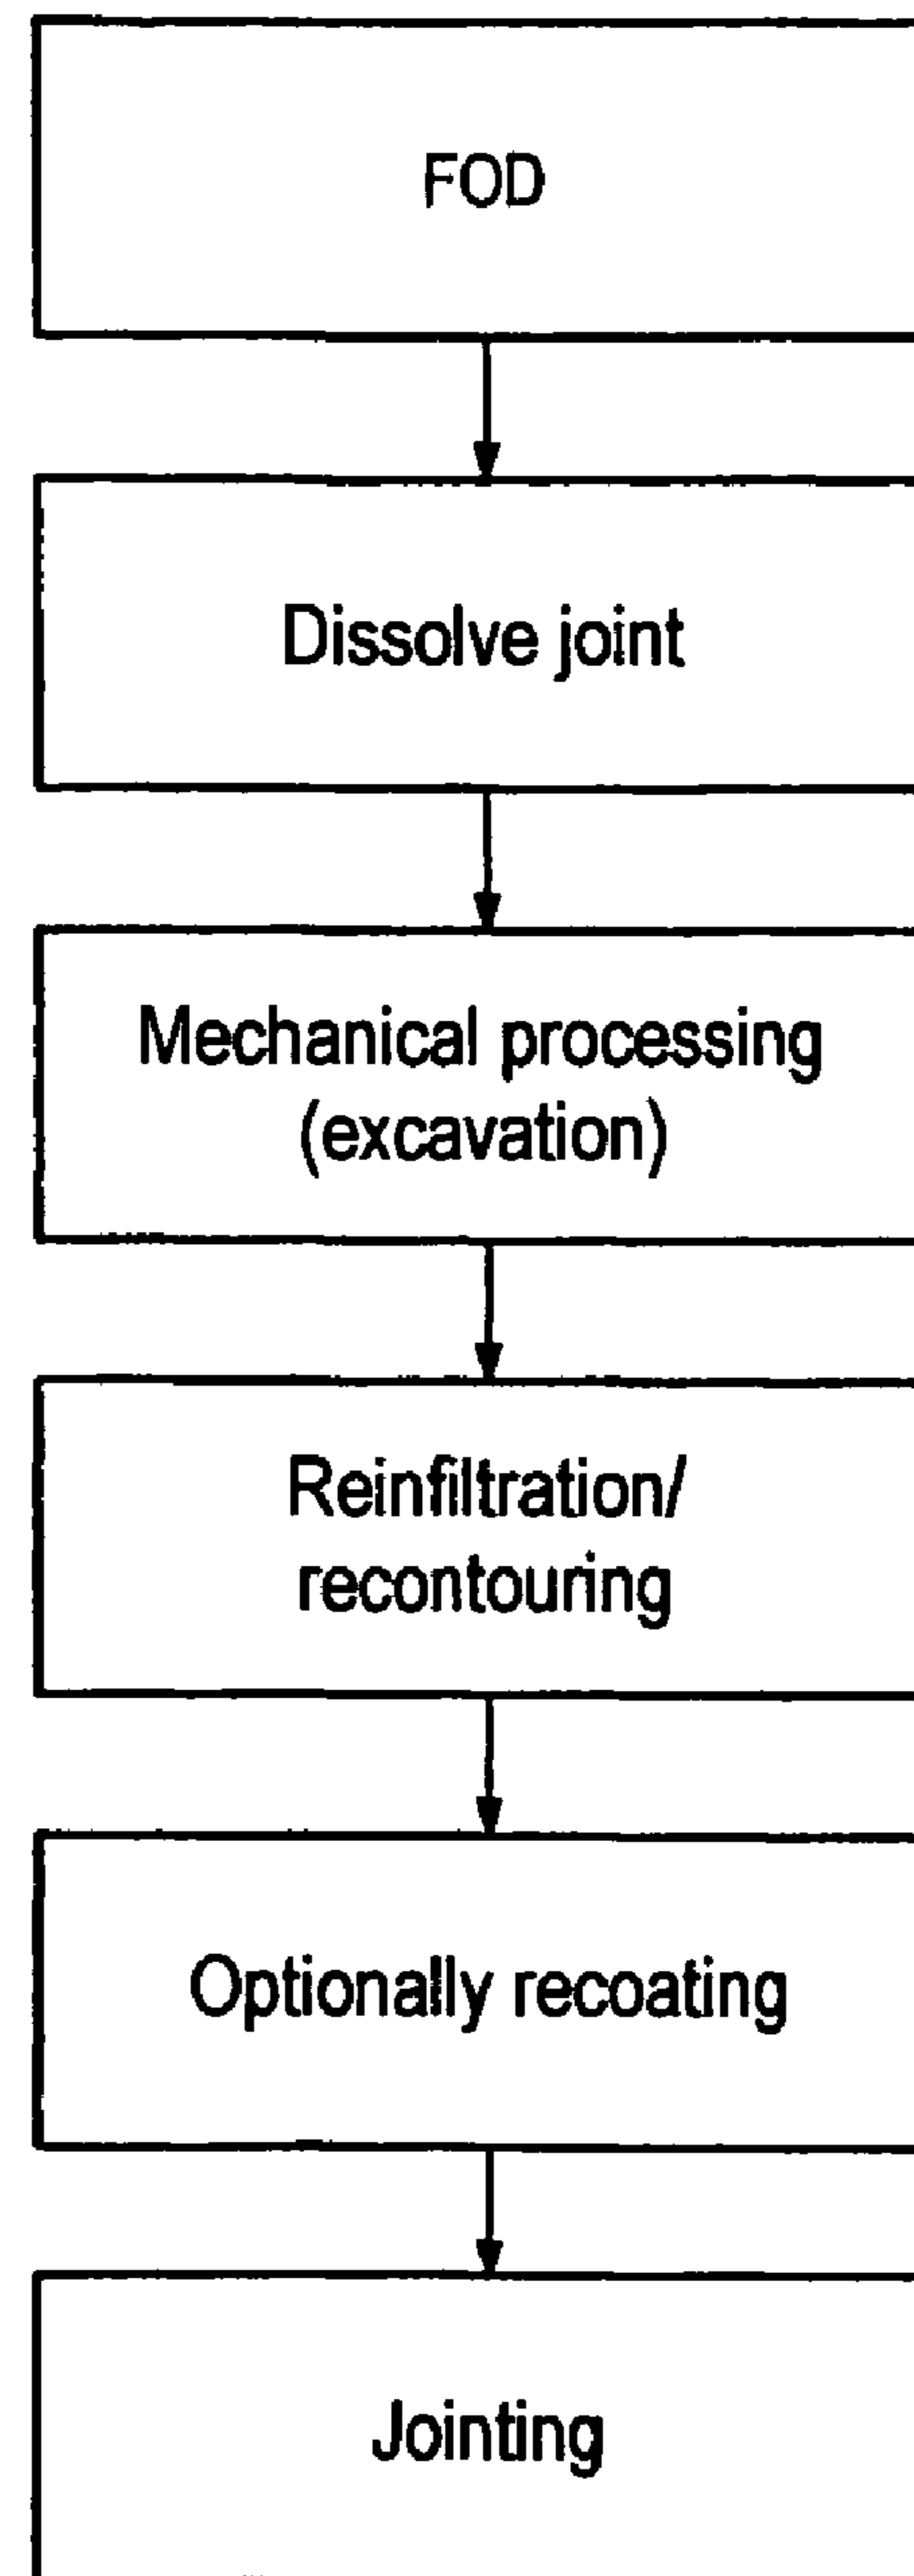
FIG 5

FIG. 5 shows a method according to the invention for repairing a component extracted from a gas turbine, with the production of subsequent surface protection,

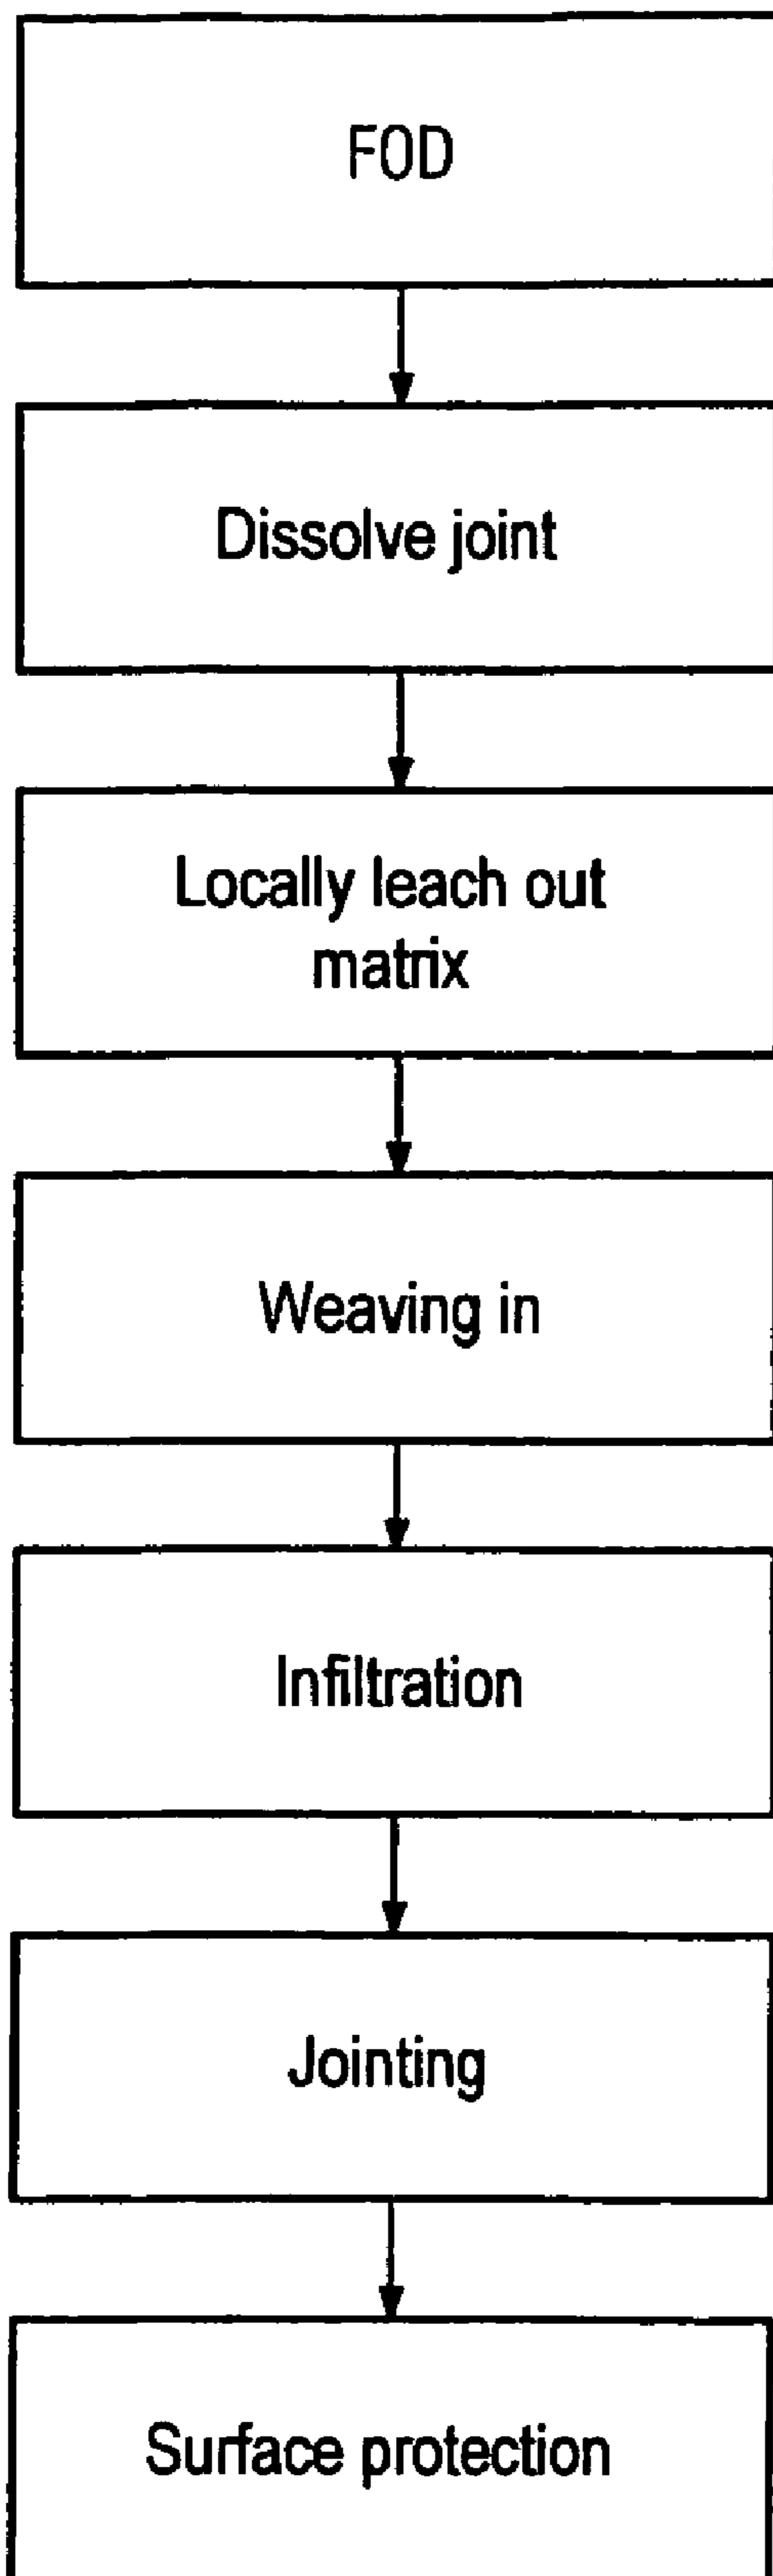
FIG 6

FIG. 6 shows a method for repairing a component with coating of the fibers and surface protection,
