(12) **United States Patent**
Bublath et al.

(10) **Patent No.:** **US 7,500,833 B2**
(45) **Date of Patent:** **Mar. 10, 2009**

(54) **METHOD FOR REPAIRING A COMPONENT OF A TURBOMACHINE**

The invention relates to a method for repairing a damaged and/or aged component of a turbomachine, which is made at least in part of a ceramic composite material. The aim of the invention is to create a method which allows the downtime of the turbomachine caused by damaged components to be reduced while making it possible to repair damaged components. The abovementioned aim is achieved by a generic method for repairing a damaged component (1) of a turbomachine made of a ceramic composite material (4), comprising the following steps: the joint of the component is dissolved; the matrix (5) is extracted and/or the component is machined; infiltration to restore and/or renew the ceramic matrix (5) of the component; and the joint is re-established.

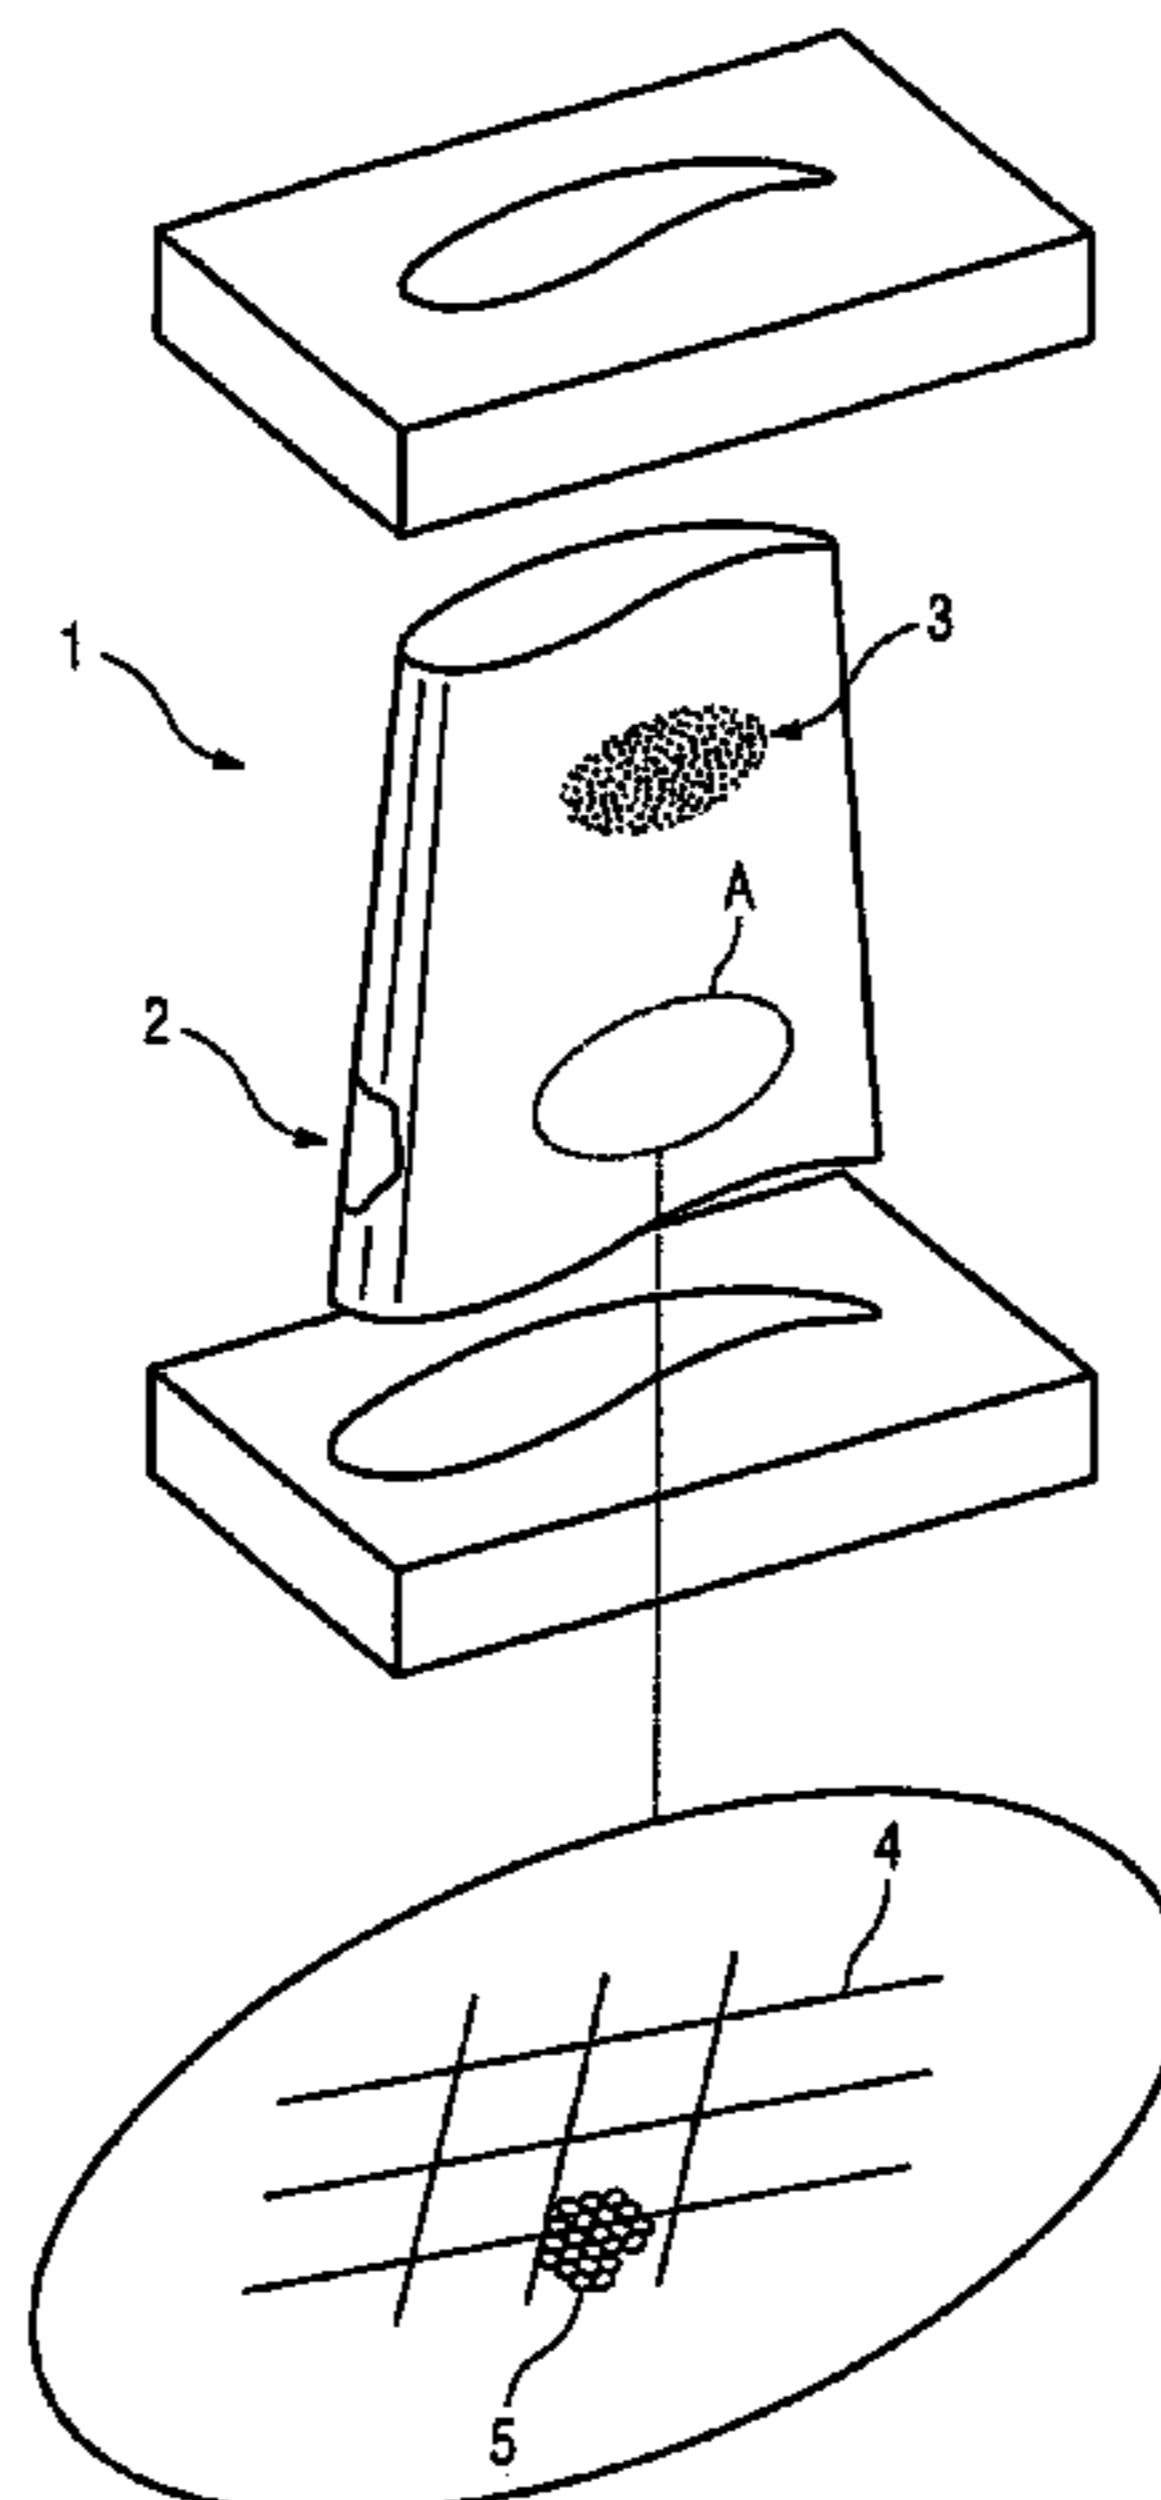
FIG 1

FIG. 1 shows a first configuration of a method according to the invention for repairing a component which is installed in a gas turbine and has been damaged by the effect of foreign bodies,

FIG. 1 shows a first method according to the invention for repairing a guide vane 1 (FIG. 7) of a gas turbine (not represented in further detail), which has been damaged during operation in the gas turbine. The guide vane 1 presented here consists of a ceramic material, for example silicon nitride, silicon carbide, aluminum oxide, zirconium oxide, mullite, glass, glass ceramic and/or the like. This material is conventionally referred to as a matrix. In order to improve the brittle fracture behavior, the matrix material is provided with fiber reinforcement which, for example, may consist of glass, glass ceramic, silicon carbide, silicon nitride or the like, as well as a combination of these, so that a quasi-plastic deformation behavior can be achieved. Besides this, instead of or in addition to the fibers, it is also possible to introduce short fibers i.e. whiskers into the matrix. For environmental reasons, however, the first version is preferred. Gas turbines equipped with such vanes allow a high inlet temperature into the turbine region of from 1100° C. to 1350° C., in which case efficiencies of 31%, 40% or more can be readily achieved.

and mechanically processed or excavated in a first step, as represented in FIG. 1. This is followed by local reconstruction of the ceramic matrix using infiltration or paste application. The repaired region of the component is subsequently sintered and the wall element with the guide vane 1 is reinstalled at its position in the turbine. Depending on the accessibility of the components inside the turbine, the repair may also be carried out when the component is in the installed state.

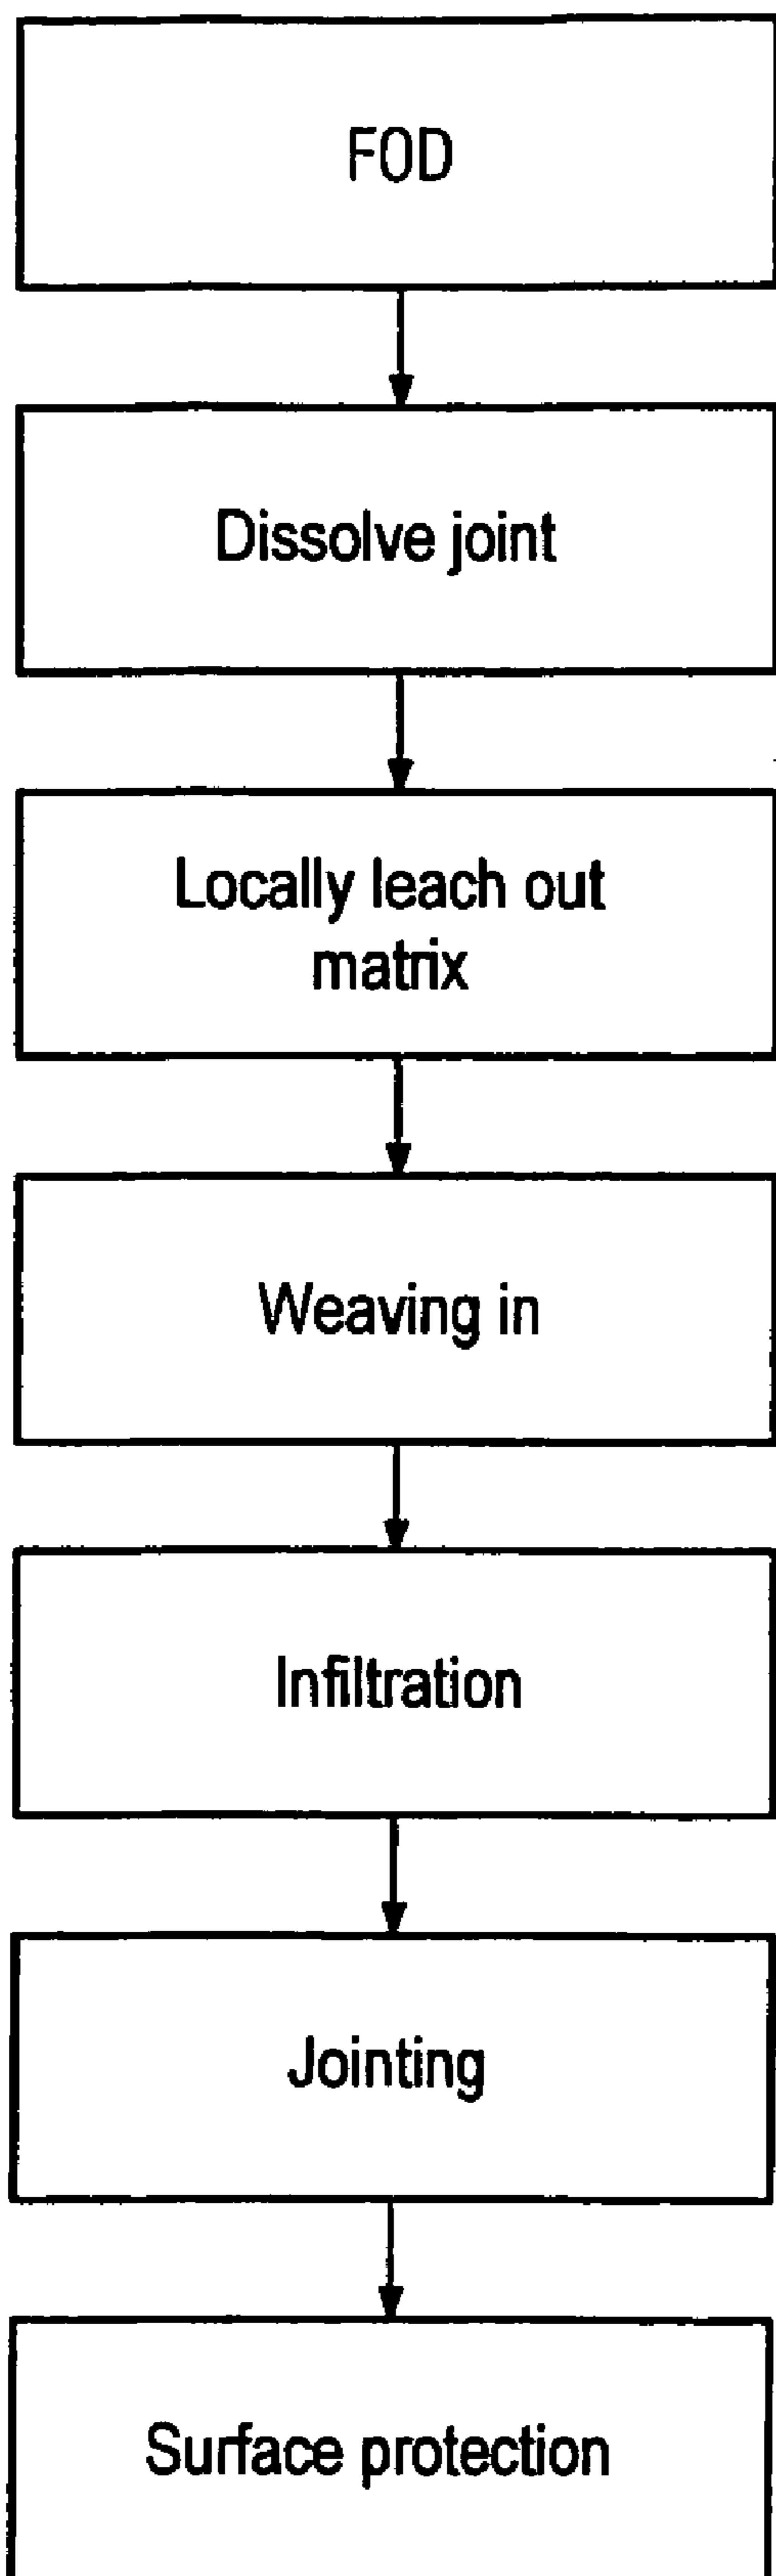
FIG 6

FIG. 6 shows a method for repairing a component with coating of the fibers and surface protection,
