US007546684B2

(54) **METHOD FOR REPAIR AND REPLACEMENT OF COMBUSTOR LINER PANEL**

(73) Assignee: **General Electric Company**, Schenectady, NY (US)

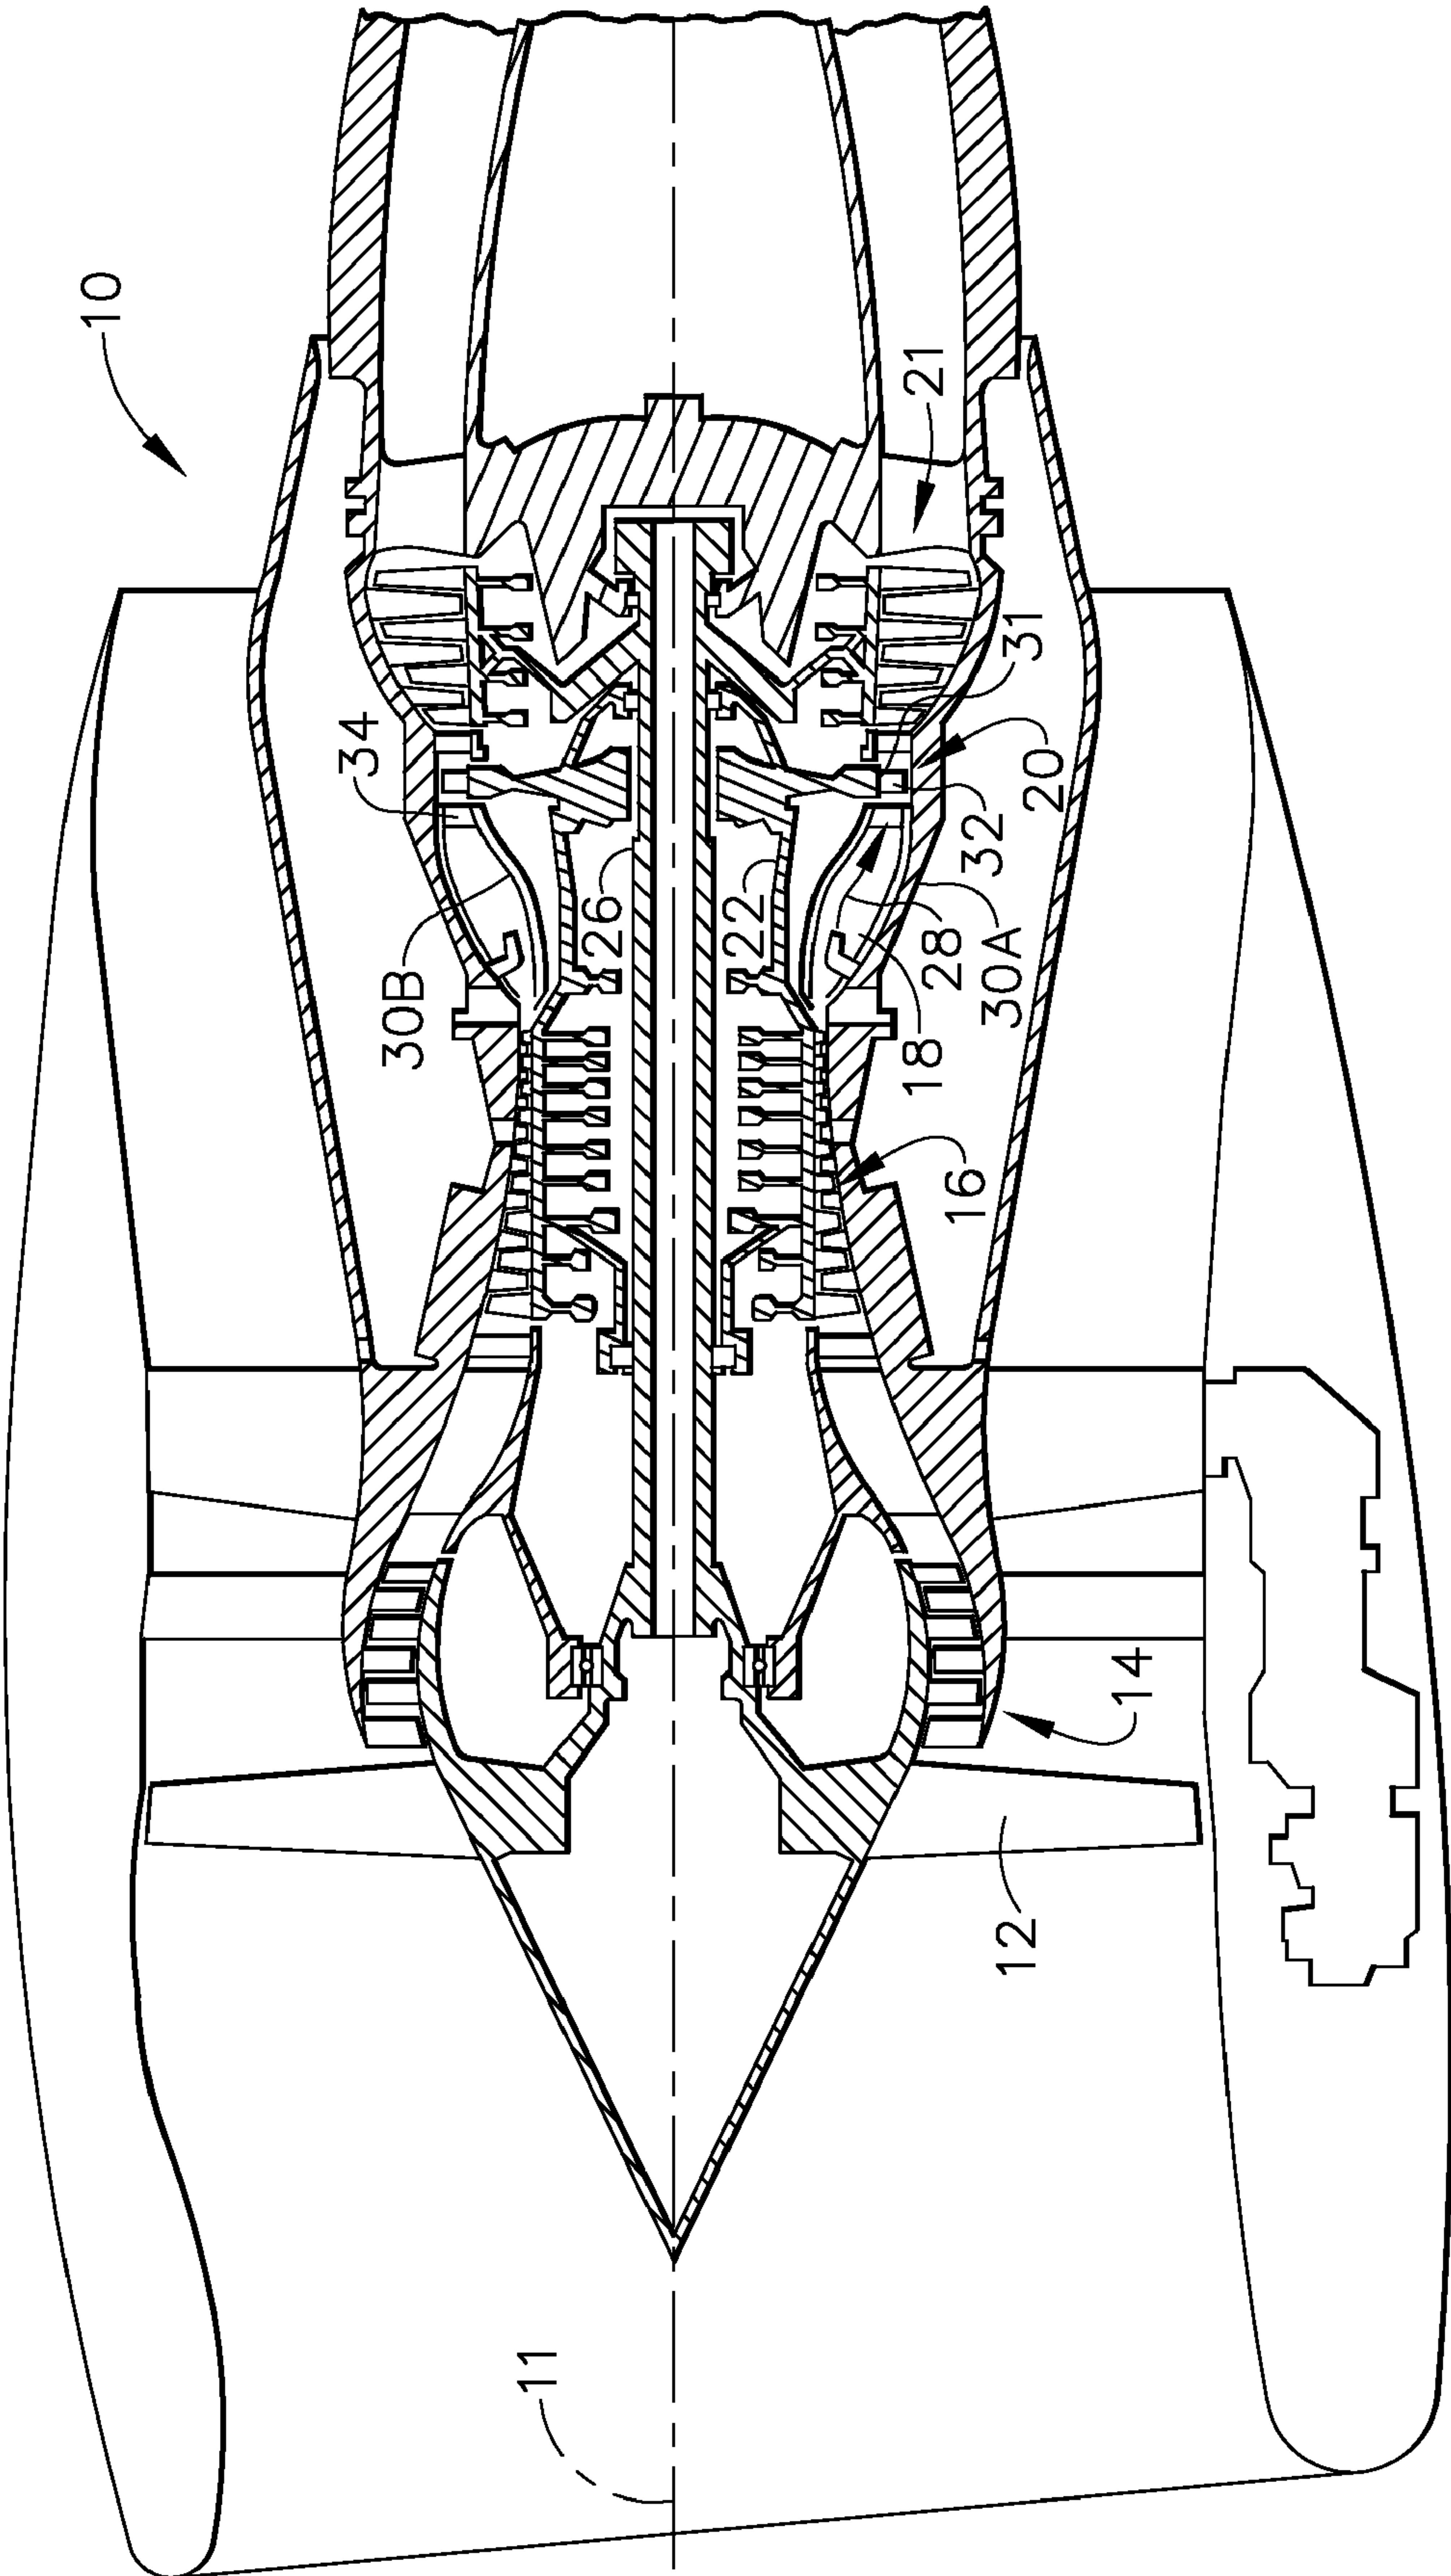
FIG. 1 is a schematic of a typical high bypass gas turbine engine.

FIG. 1 is a schematic of a typical high bypass turbine engine 10. The centerline of the engine is shown at 11, along which the engine shaft 26 is positioned. Air enters the engine 10, passing front fan 12. Some of the air enters the engine core 14 and is directed to the compressor section 16 where it is compressed, while the remainder bypasses the engine core. The compressed air enters the combustion chamber, shown at 30A and 30B where it is mixed with fuel metered from the swirl cup of the fuel injector 18 and ignited. The hot gases of combustion proceed toward the rear of the combustion chamber past the turbine vanes or nozzles 34 and into the turbine rotor 20 where turbine blades 32 in the path of the high pressure gases of combustion are mounted on turbine wheels or disks 31. The high pressure gases pushing on the turbine blades 32 turn the wheels 31 which rotate the engine shaft 26. After the hot gases pass through the turbine section 20, they exit the turbine section at 21 and enter the exhaust as a lower temperature and pressure. The front of the engine is referred to as the forward end and the exhaust of the engine is referred to as the aft end.

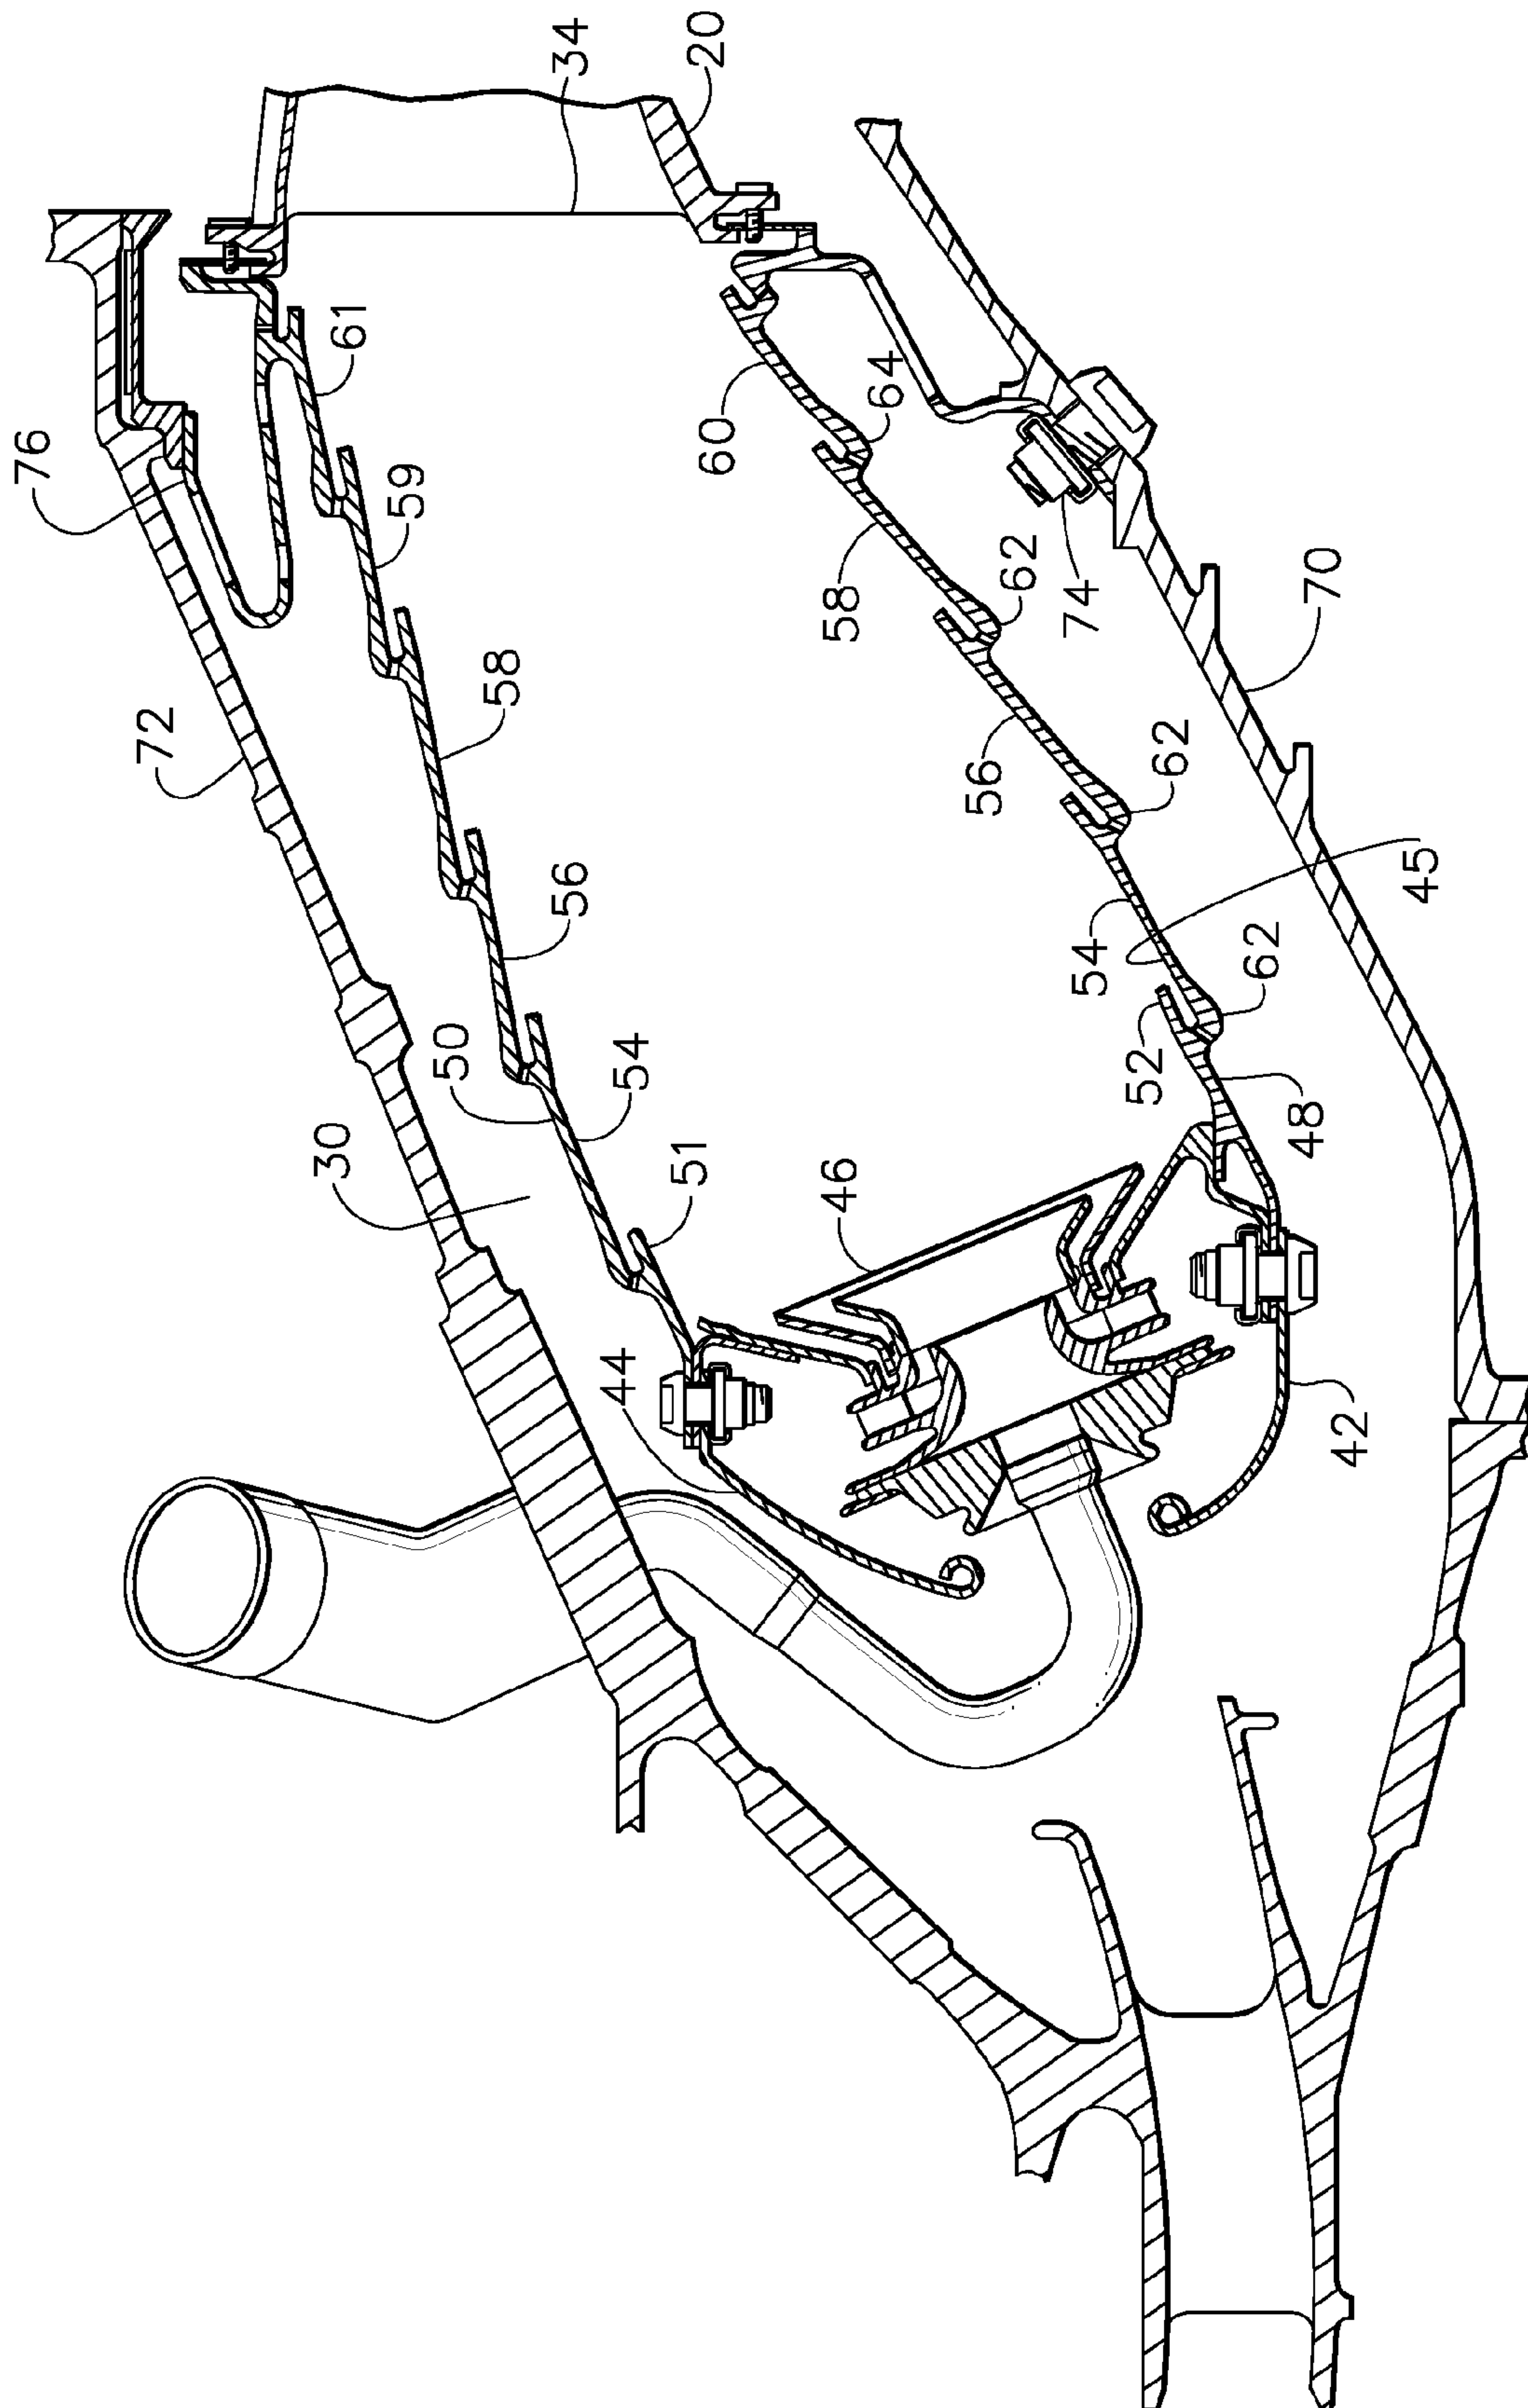
FIG. 2 is a cross sectional view of a typical combustion chamber having liners with multiple film cooling nuggets.

FIG. 2 is a cross sectional view of a typical combustion chamber 30 (either A or B) such as may be found on a CFM-56 engine. This annular combustion chamber 30 is typical of combustion chambers found in all gas turbine engines, and is not restricted to the high bypass turbine engine 10, which is discussed above for illustration purposes. The combustion chamber 30 includes inner cowl 42 and outer cowl 44 bolted to dome assembly 46. The inner liner assembly 48 is comprised of a plurality of panels, panels 52, 54, 56, 58 and an aft panel assembly 60. The panels 52, 54, 56, 58 are shown joined together at joints referred to as nuggets 62. The aft panel assembly 60 is similarly joined to the panels forward of it at a nugget 64. The aft panel assembly 60 contacts the high pressure turbine section 20 at the combustor seal support 36. The panels 51, 54, 56, 58, 59 and 61 are similarly joined together to form the outer liner 50. The outer liner 50 and inner liner 44 are joined together to form combustor 45. Combustor 45 is attached to inner casing 70 and outer casing

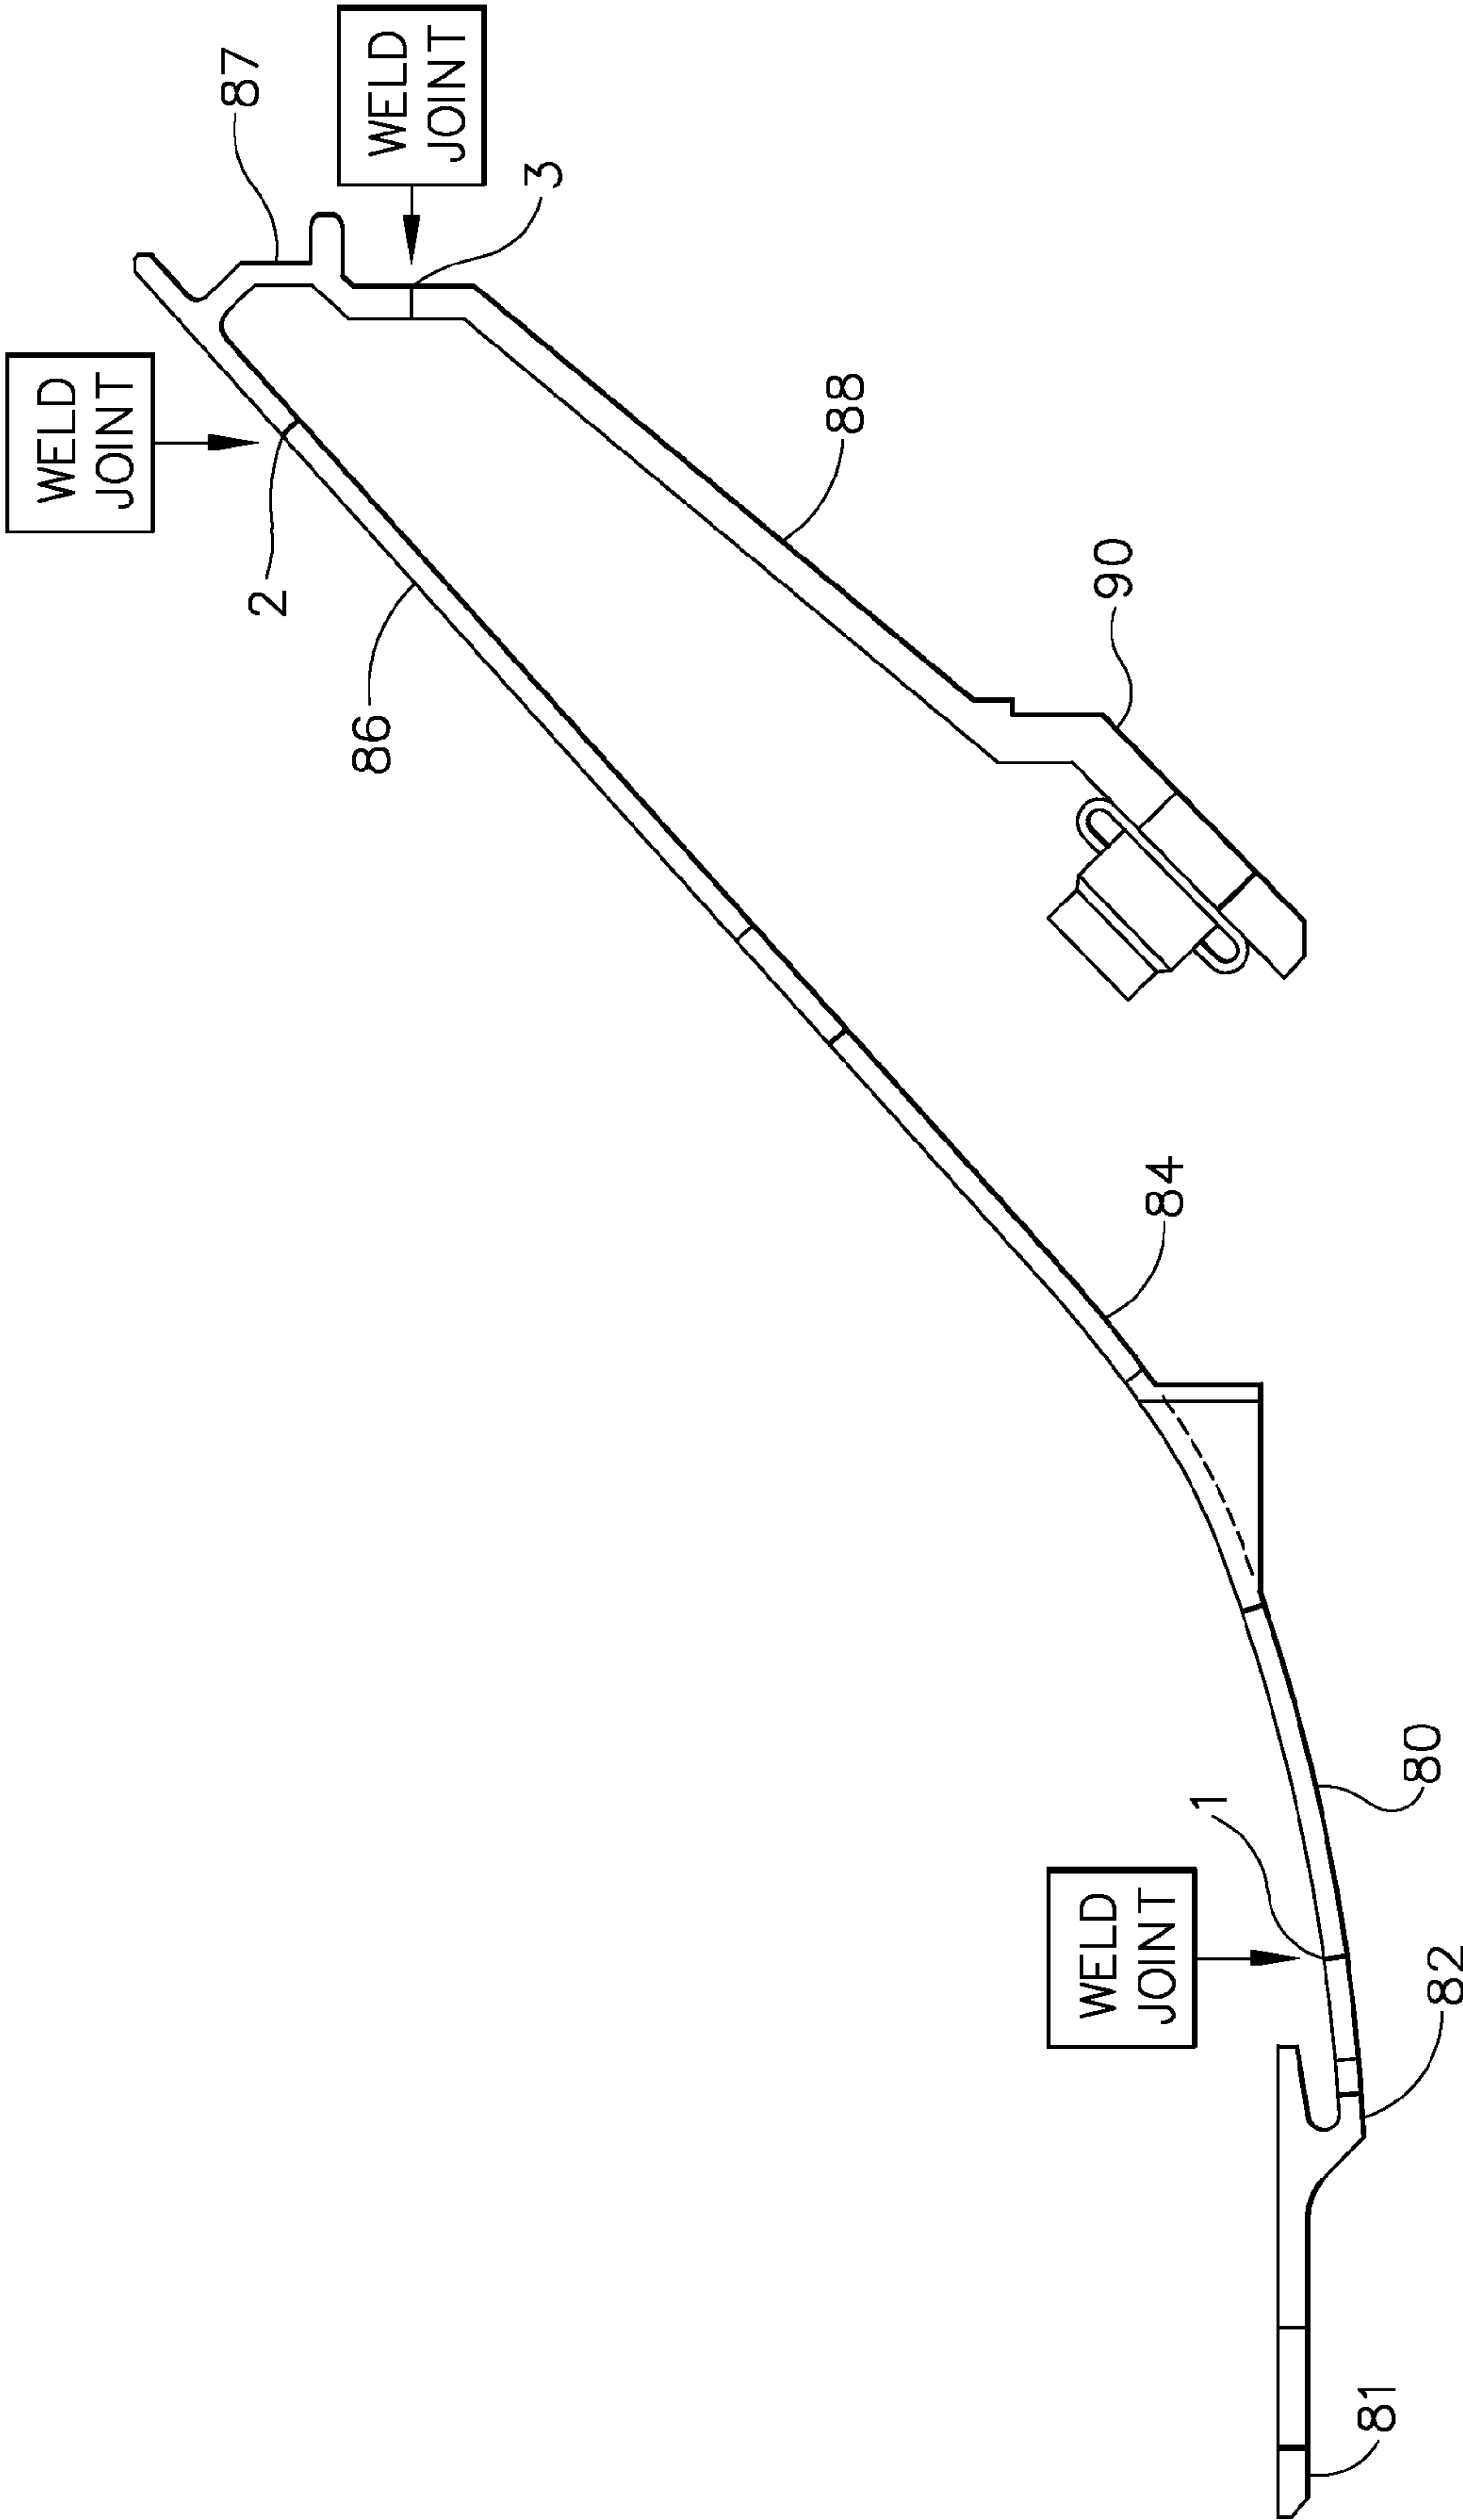
FIG. 3 is a cross-sectional view of the inner liner assembly of the present invention having a single film cooling nugget and a multi-hole cooled panel.

FIG. 3 is a sectional view of an inner liner assembly 80 of a combustion chamber from GE90 engine, which is representative of the present invention. The inner liner assembly 80 from the GE90 differs from the inner liner assembly of the CFM 56 in that inner liner assembly 80 is not comprised of a plurality of panels and an aft panel assembly. Rather, inner liner assembly 80 from the GE90 has a similar configuration to the aft panel assembly 60 of the CFM 56 engine, the GE90 inner liner assembly not having the plurality of panels such as are found in the inner liner assembly of other designs. Notwithstanding this difference, the repair techniques discussed herein are applicable to the inner liner assembly 80 of the GE90 and to the aft panel assembly 60 of the CFM 56 engine, as well as to aft panel assemblies of other designs have the same type of configuration. The inner liner assembly 80 comprises a forward bolt flange 81, a nugget 82, a portion having a plurality of apertures, typically which are drilled, referred to as the multi-hole panel region 84, a portion attached to and aft of the multi-hole panel region, referred to as the aft lip region 86, the aft seal flange region 87 extending downward from the aft lip region 86 and the aft panel support leg 88 attached to the aft seal flange region 87, the aft panel support leg 88 further including an end distal from the attachment to the aft seal flange region, this distal end 90 including a means for attachment with the inner casing. As shown in FIG. 3, the means for attachment is an aperture/bolt arrangement, the threaded aperture in the distal end receiving a bolt extending through inner casing 70. The multi-hole panel region 84 extends across the inner liner assembly substantially perpendicular to the flow of the hot combustion gases. Aft support leg 88 extends downward from aft seal flange region 87 as shown.

chamber, by replacing the multi-hole panel region 84, aft lip region 86 and aft seal flange region 87. This is accomplished by first removing the multi-hole panel region 84 by cutting it from the combustor at joint 1, FIG. 3. Joint 1 can be cut at any convenient location forward of the holes in the multi-hole region forward to forward bolt flange 81, and may be formed at nugget 82. However, typically joint 1 is formed along the thin, uniform thickness of metal aft of nugget 82, as machining preparations for reattachment are more easily formed in this relatively thin, uniformly thick metal. This removal is performed as set forth in the prior art by using any convenient cutting means. However, instead of discarding the portion of the inner liner assembly aft to joint 1, which includes multi-hole panel region 84, aft lip region 86, aft seal flange region 87 and aft panel support leg 88, the aft panel support leg 88 is cut from the aft panel assembly circumferentially 360° at joint 3. The portion of the inner liner assembly 80 between joint 1 and joint 3 can be discarded. This includes not only multi-hole panel region 84, but also aft lip region 86 and aft seal flange region 87.

Refurbishment is initiated by removal of the forward bolt flange **81** and the aft panel support leg **88** from the inner liner assembly **80**. With reference to FIG. 3, first the removed forward bolt flange **81** and aft panel support leg **88** are cleaned and inspected.

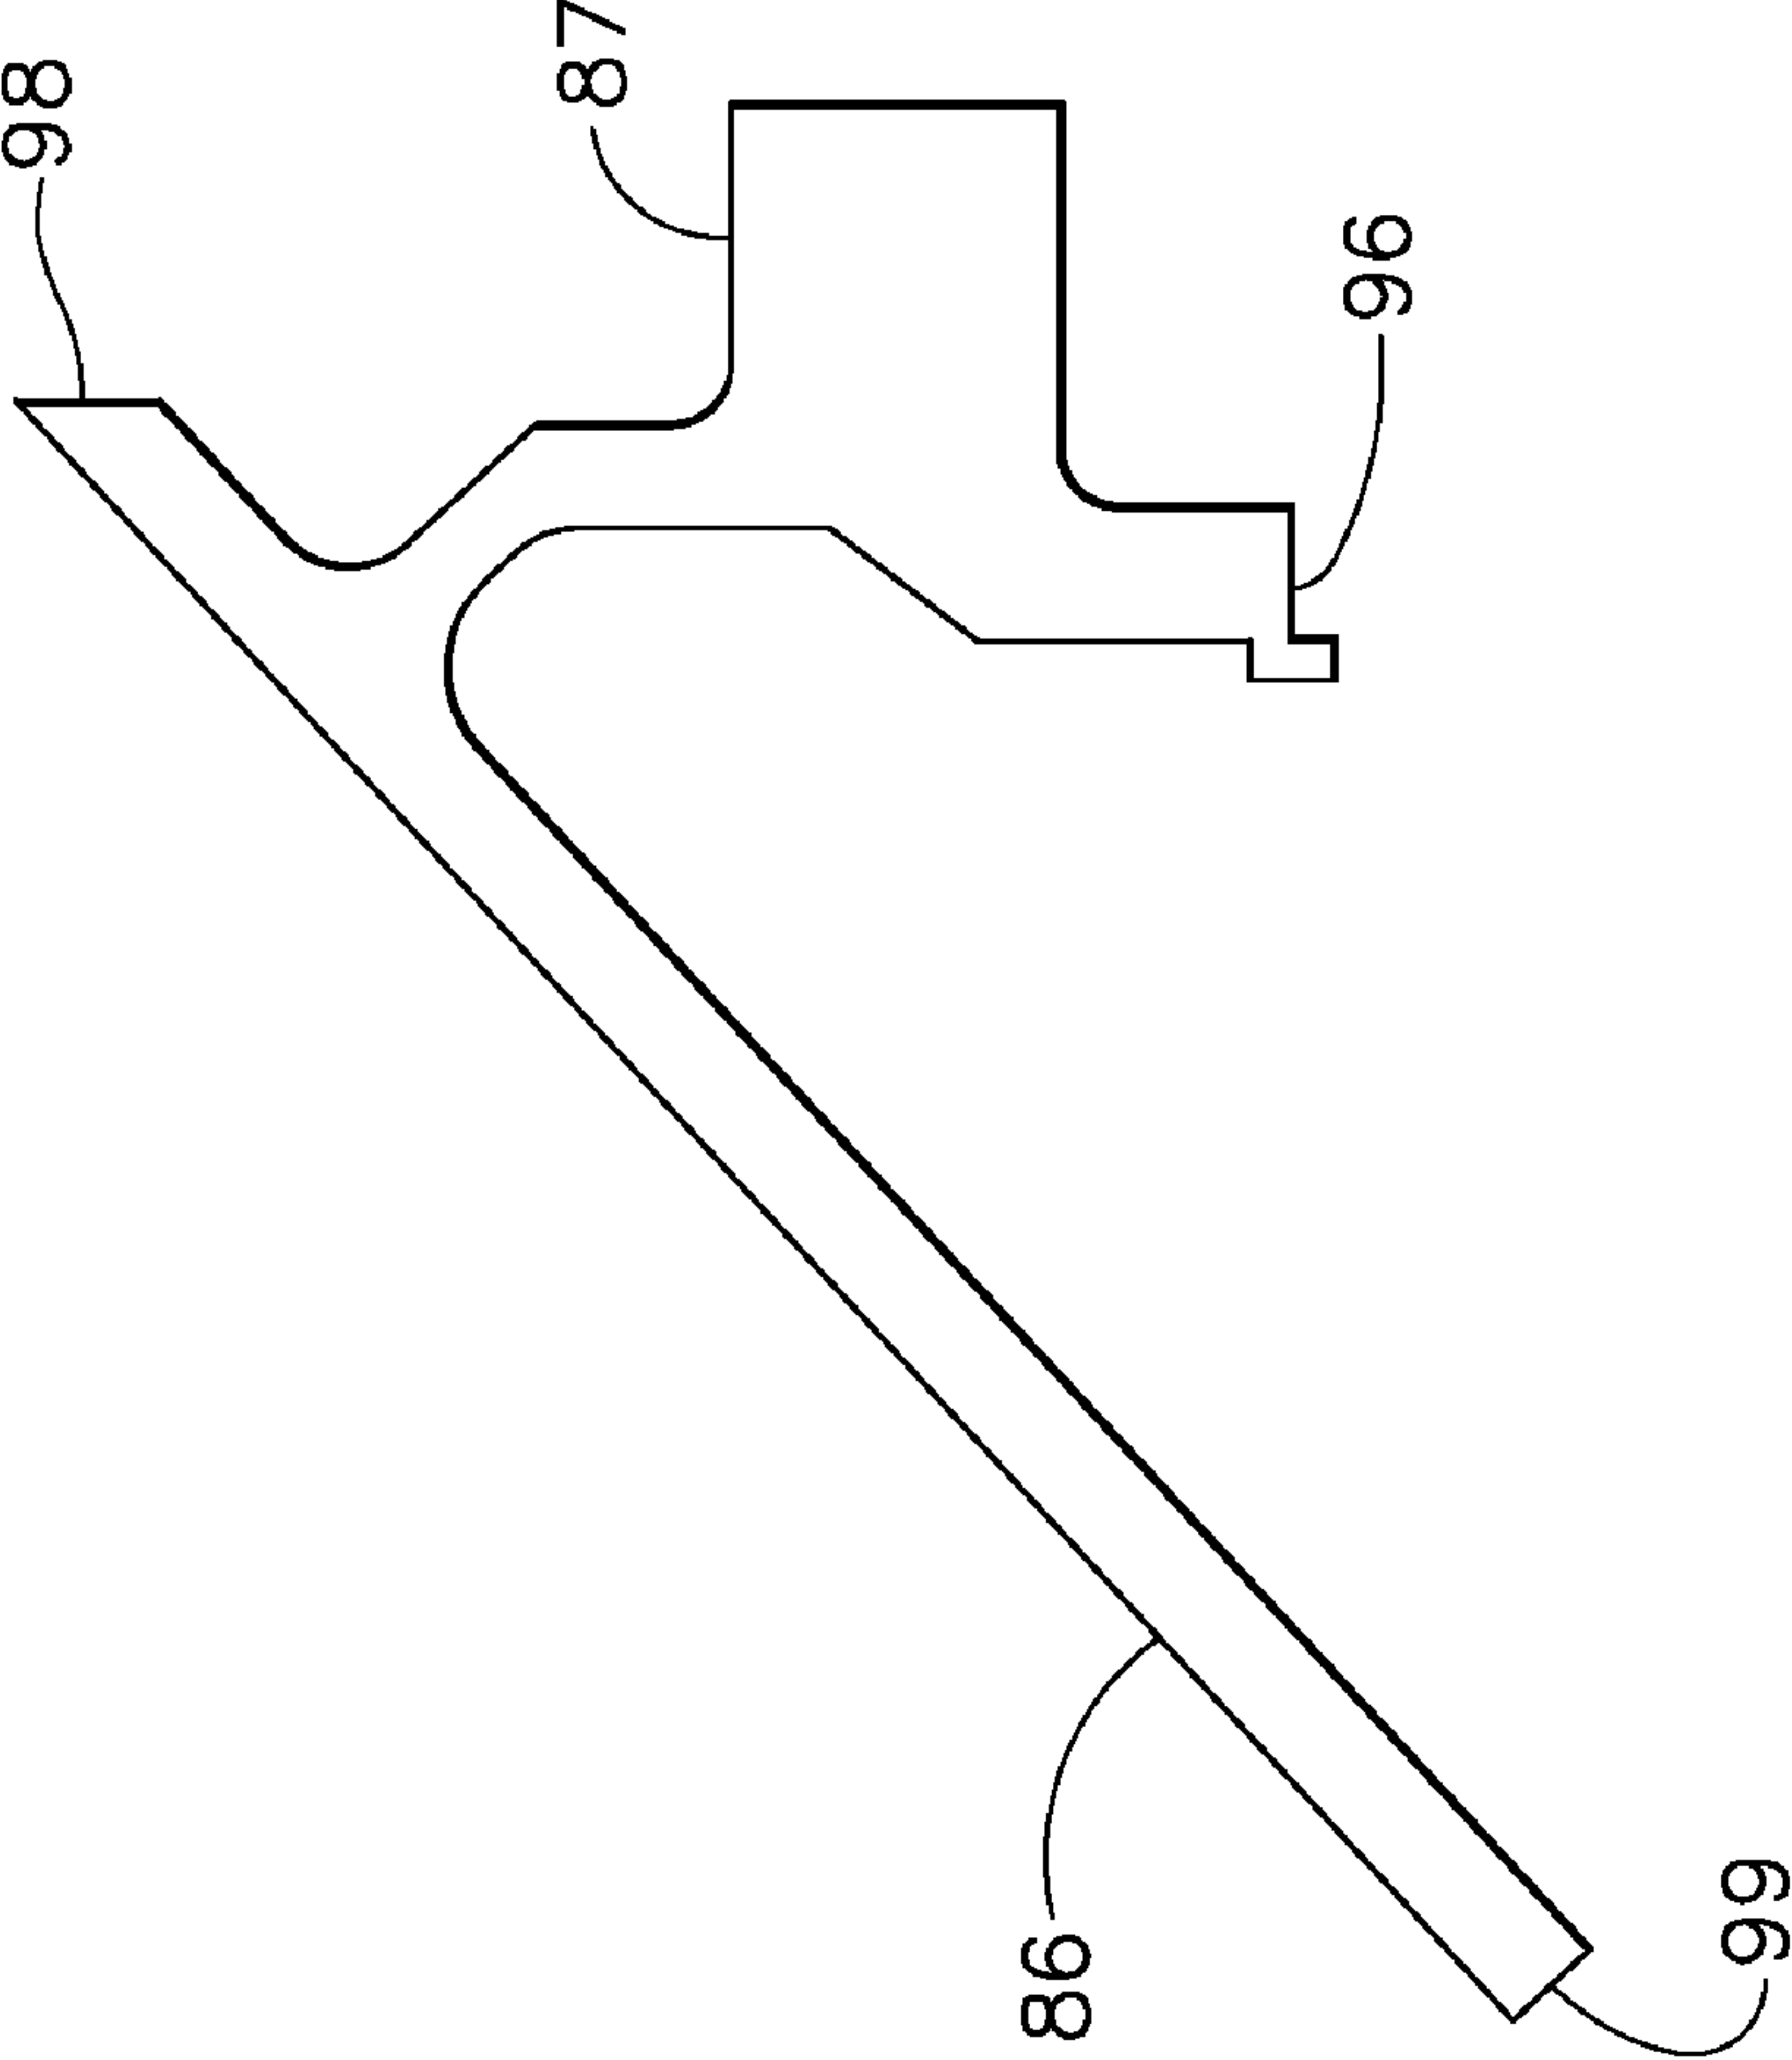
FIG. 4 is a cross-sectional view of the aft panel flange region, including the aft panel, aft lip and seal flange area of the present invention, including the aft panel, aft panel lip and seal flange area.

As the recommended method of repair is by welding, weld preps are provided to the aft panel support leg **88** as well as to the aft lip region **86** of the spare part. As the aft lip region **86** is welded at its forward end to the multi-hole panel region **84** to produce the fabricated replacement spare part, it is necessary to provide a weld prep at its forward end. While welding may be performed by any acceptable method, electron beam welding is one acceptable method and acceptable weld preps for electron beam welding of plate assemblies for a GE90 aft panel assembly are shown in FIG. 4.
