US007603890B2

(54) **METHOD OF INSPECTING A METAL ALLOY PART FOR INCIPIENT MELTING**

A method of inspecting a repaired metal alloy part to analyze a microstructure of the metal part includes placing a replicating material on a surface of the metal part to create an inverted replica of the microstructure. The replicating material is then removed from the surface. An image of the inverted replica on the replicating material is magnified in order to evaluate the microstructure for incipient melting and areas of boride concentration. This inspection method facilitates that evaluation without causing any destruction to the metal part.

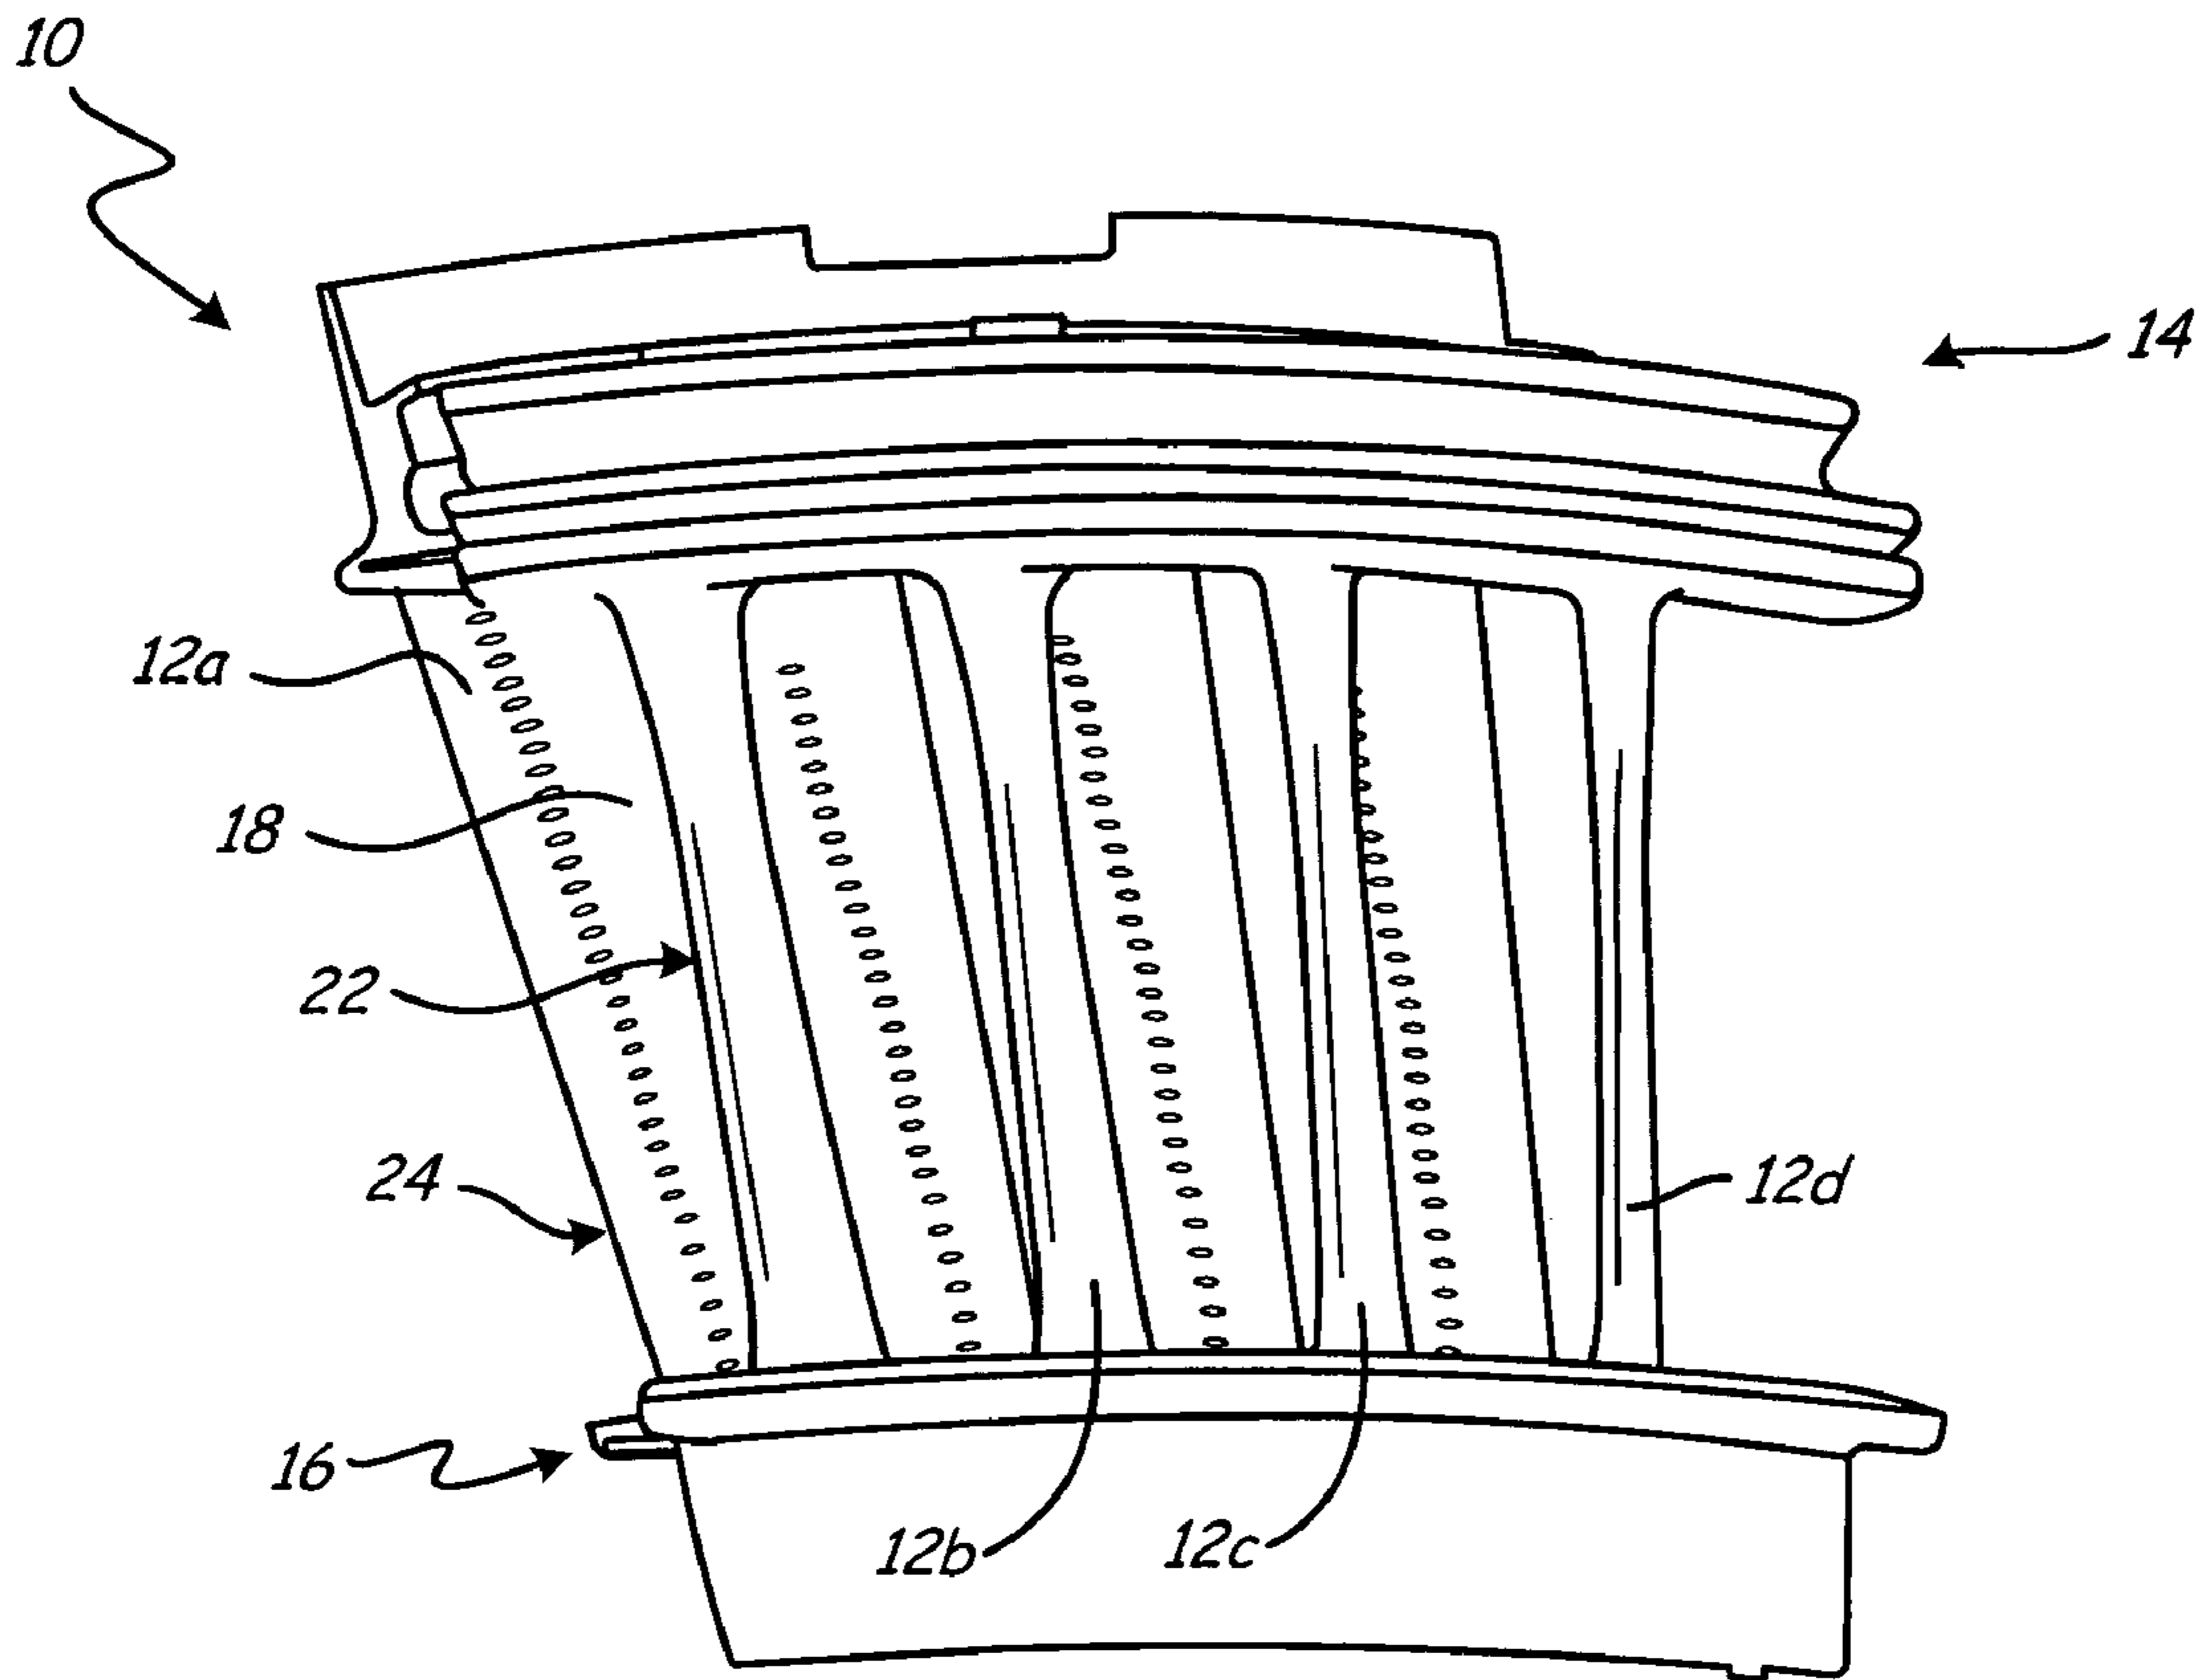
**Fig. 1A**

FIG. 1A is a perspective view of a vane assembly for use in a gas turbine engine.

FIGS. 1A and 1B are perspective views of vane assembly 10, which may be part of a low pressure turbine or a high pressure turbine, both of a gas turbine engine. Vane assembly 10 may also be referred to as a nozzle segment, and may be formed by casting of a metal alloy, such as, for example, a nickel alloy. Vane assembly 10 includes vanes 12 (also known as airfoils), shroud 14 and platform 16. In the embodiment of FIGS. 1A and 1B, vane assembly 10 includes four vanes 12a, 12b, 12c and 12d. Each of vanes 12 includes pressure side 18, suction side 20, leading edge 22 and trailing edge 24.

num and boron. A significant portion of the blend may be made up of the base metal in the alloy used to form vane assembly 10. In the exemplary embodiment of FIGS. 1A and 1B, the base metal is nickel. The braze repair may be applied as a powder, viscous paste, paint, transfer tape, controlled density tape, and plate produced from powder.

In the embodiment shown in FIGS. 1A and 1B, vane assembly 10 includes four airfoils or vanes 12. It is recognized that the inspection method described herein may be used on a vane assembly or nozzle segment having more or less than four airfoils. Moreover, the inspection method may also be used for other gas turbine engine parts that may be repaired with the TURBOFIX® process or similar repair processes.

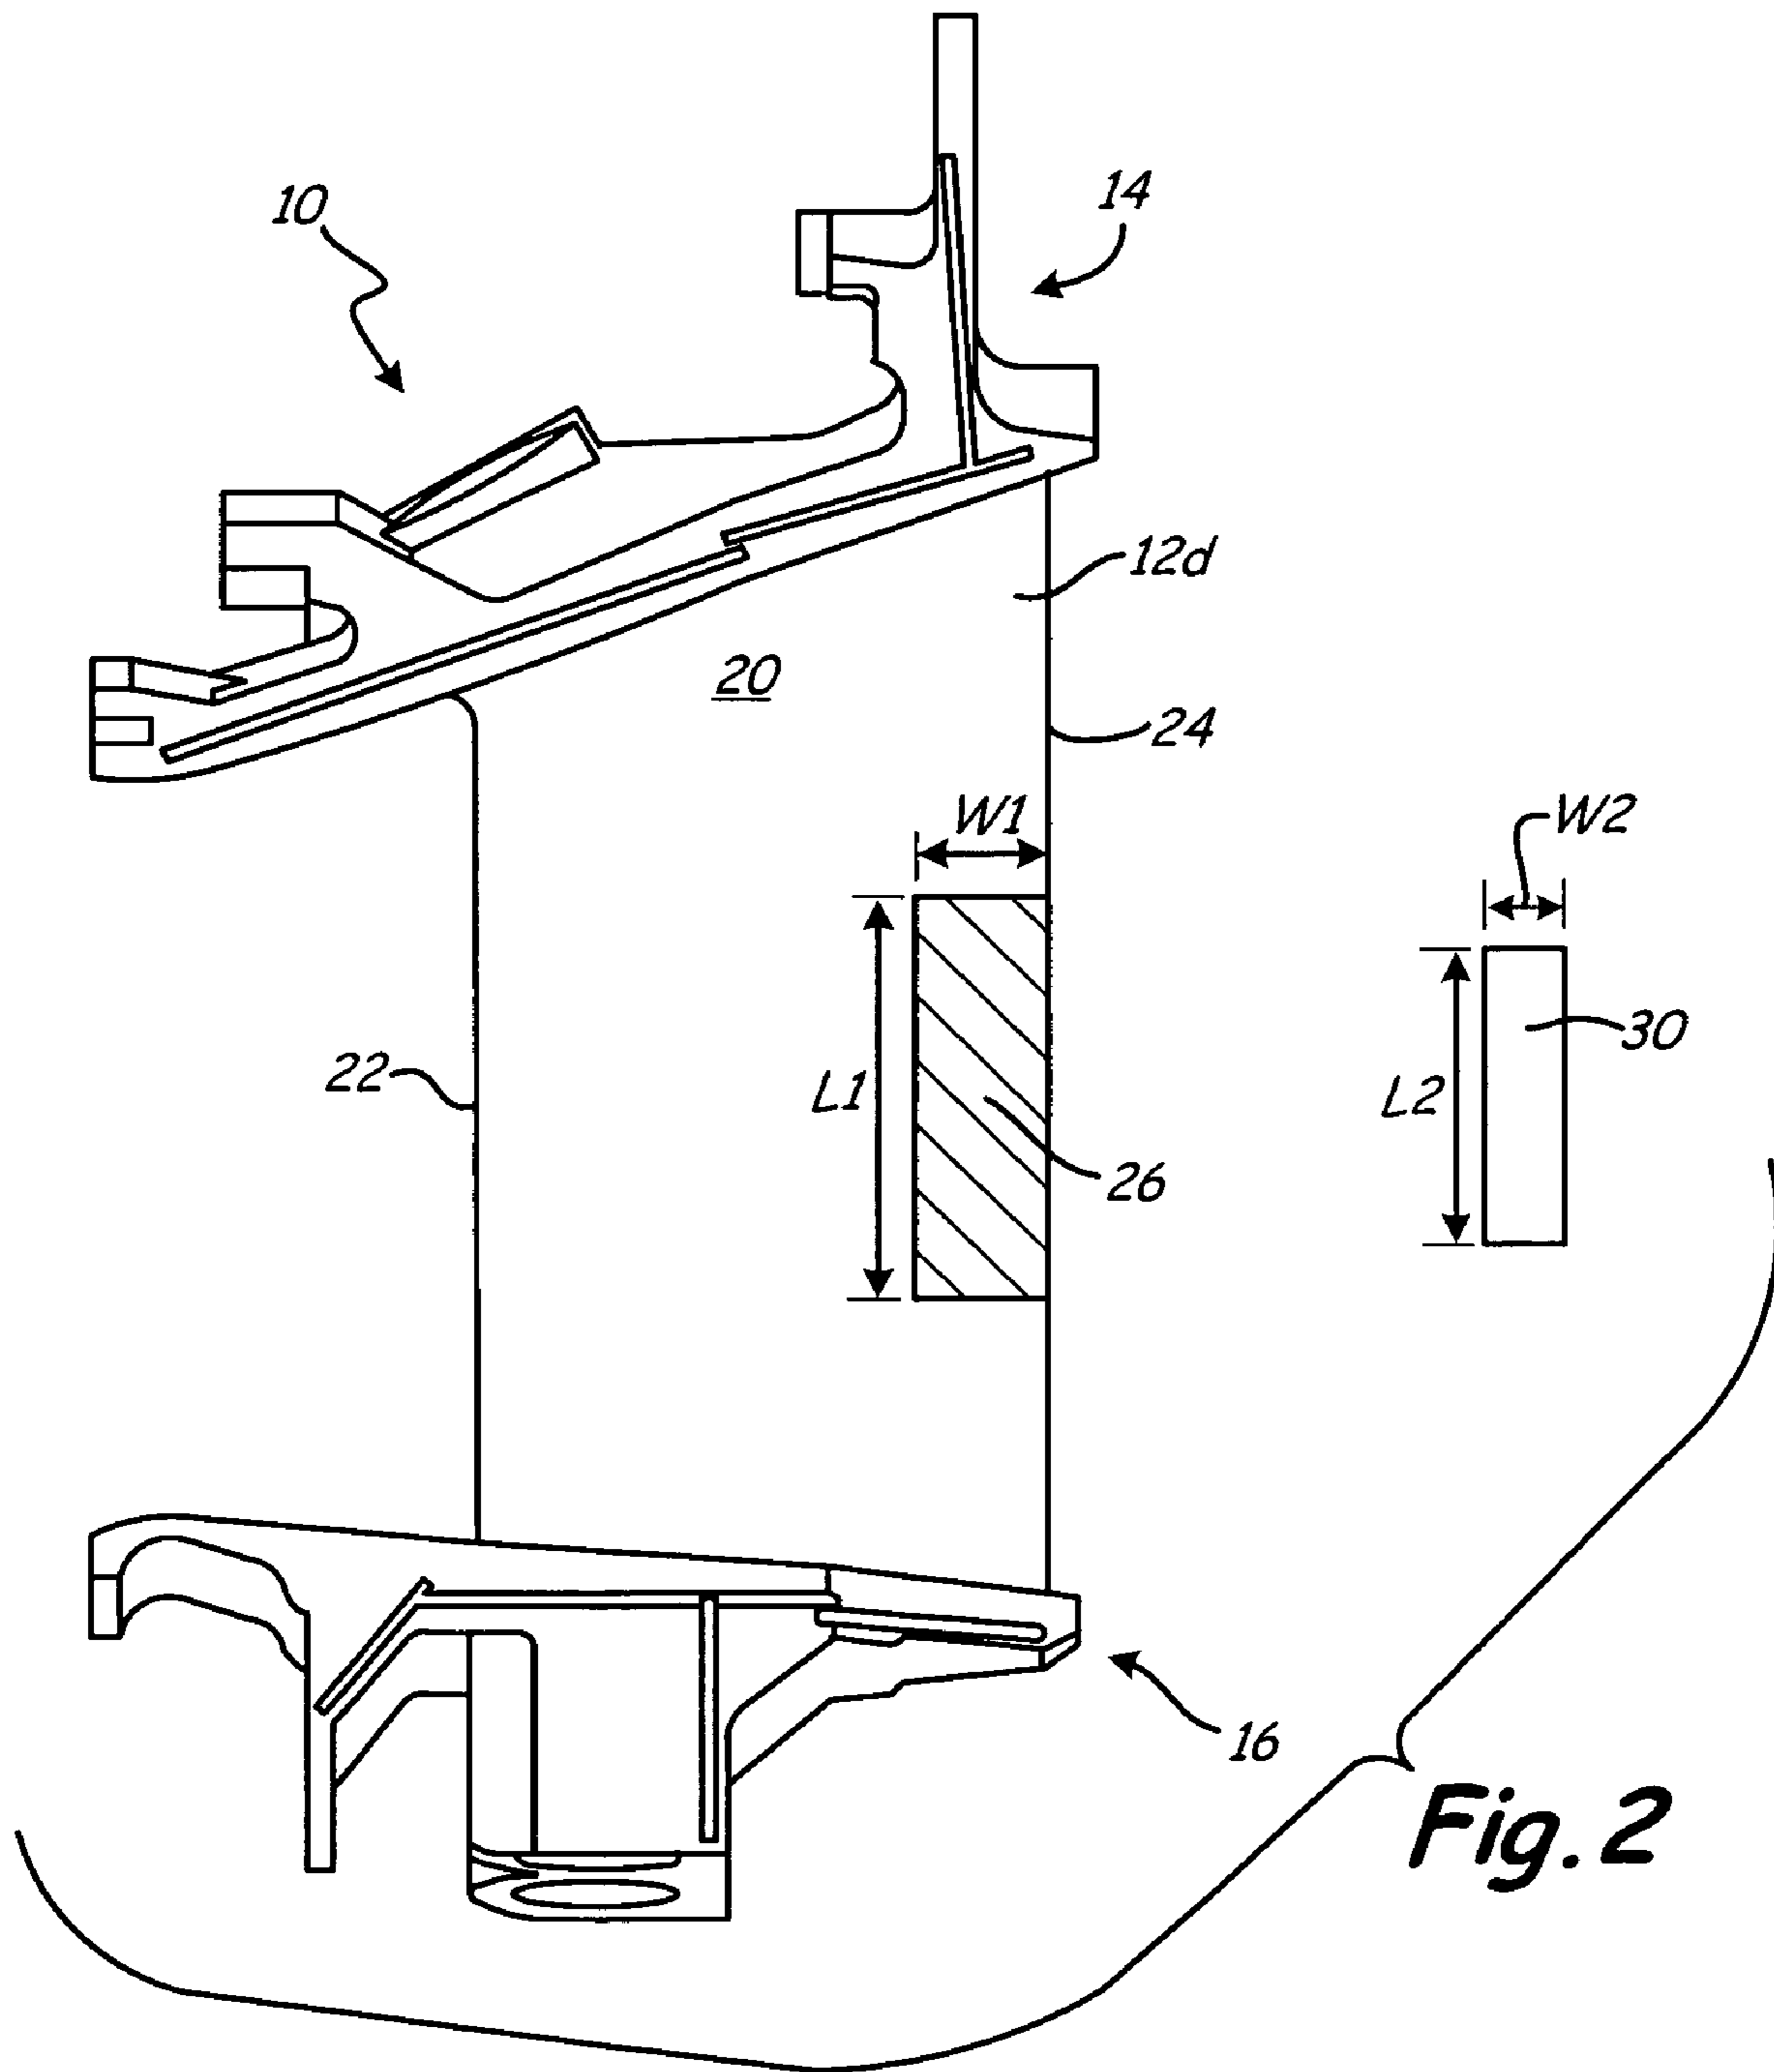
FIG. 2 is a side view of a vane from the vane assembly of FIGS. 1A and 1B.

FIG. 2 is a side view of vane assembly 10 and replicating material 30. Assembly 10 is rotated counter-clockwise approximately 90 degrees relative to FIG. 1B. As shown in FIG. 2, vane assembly includes shroud 14, platform 16, and suction side 20 of fourth vane 12d, having leading edge 22 and trailing edge 24. To determine whether incipient melting has occurred on vane 12d, as well as on other areas of vane assembly 10, a representative section of vane 12d is selected as a replication surface. The representative section is one that is commonly cracked or degraded and mostly likely already underwent the braze alloy repair. In an exemplary embodiment, trailing edge 24 on suction side 20 of outer vane 12d is selected. The metal alloy for this area of vane 12d may be thinner than other areas of vane assembly 10. This is significant because boron from the crack repair process may saturate a thinner section of the metal alloy more quickly. Thus, if incipient melting has occurred on vane assembly 10, it is probable that it occurs at least on trailing edge 24 of suction side 20. Surface 26 represents a replication inspection area for vane assembly 10.
